# IndianOil

## JOURNEY RISK MANAGEMENT (JRM) STUDY

### Salem Terminal TO ARUNACHALAM FUELS

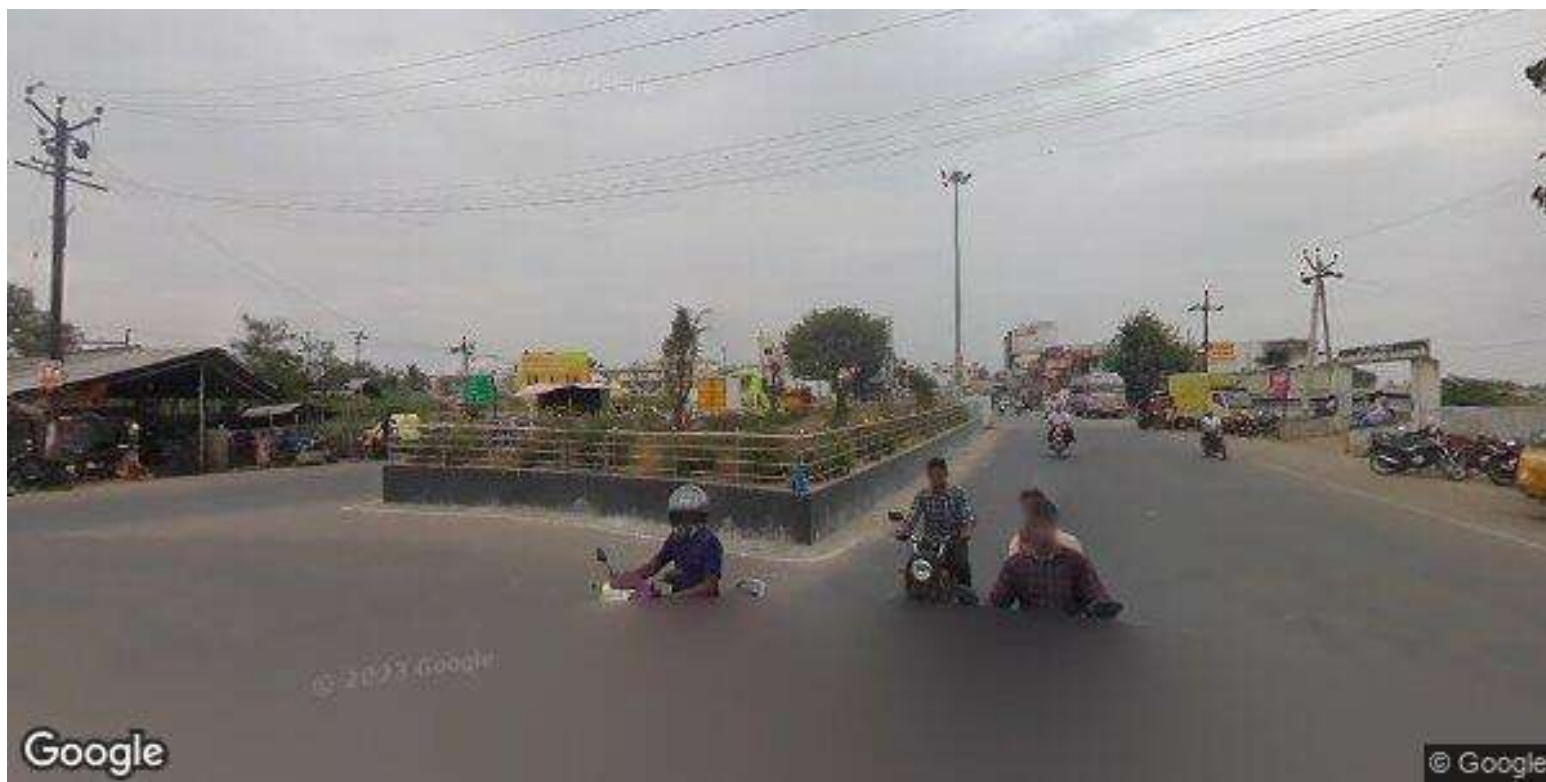
**Coordinates: 11.58435, 77.83651**

**Risk Type: Roundabout**

**Risk Level: High**

**Speed Limit: 15 KM/Hr**

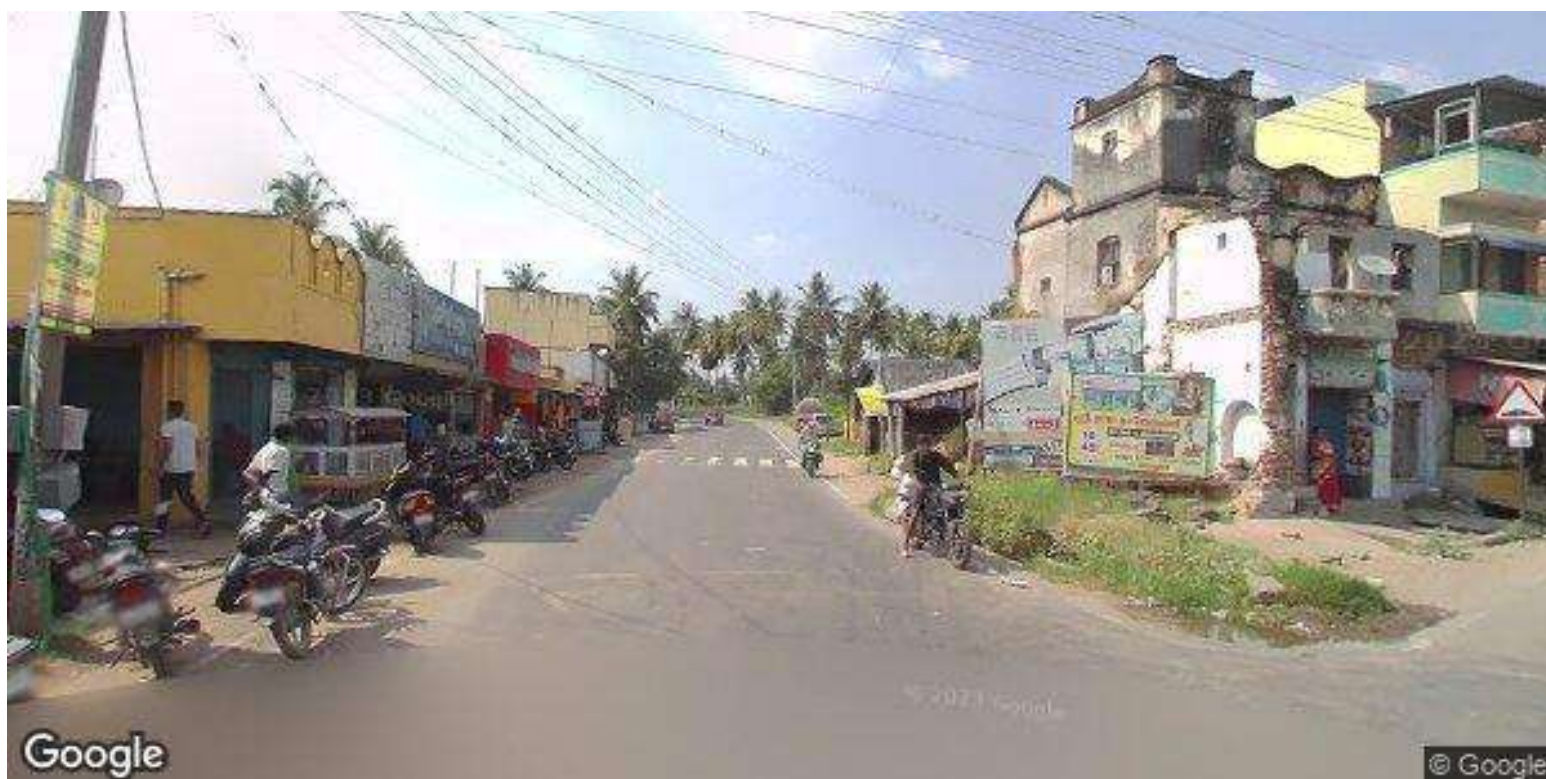
**Coordinates: 11.45007, 77.87201**

**Risk Type: Turn**

**Risk Level: High**

**Speed Limit: 15 KM/Hr**

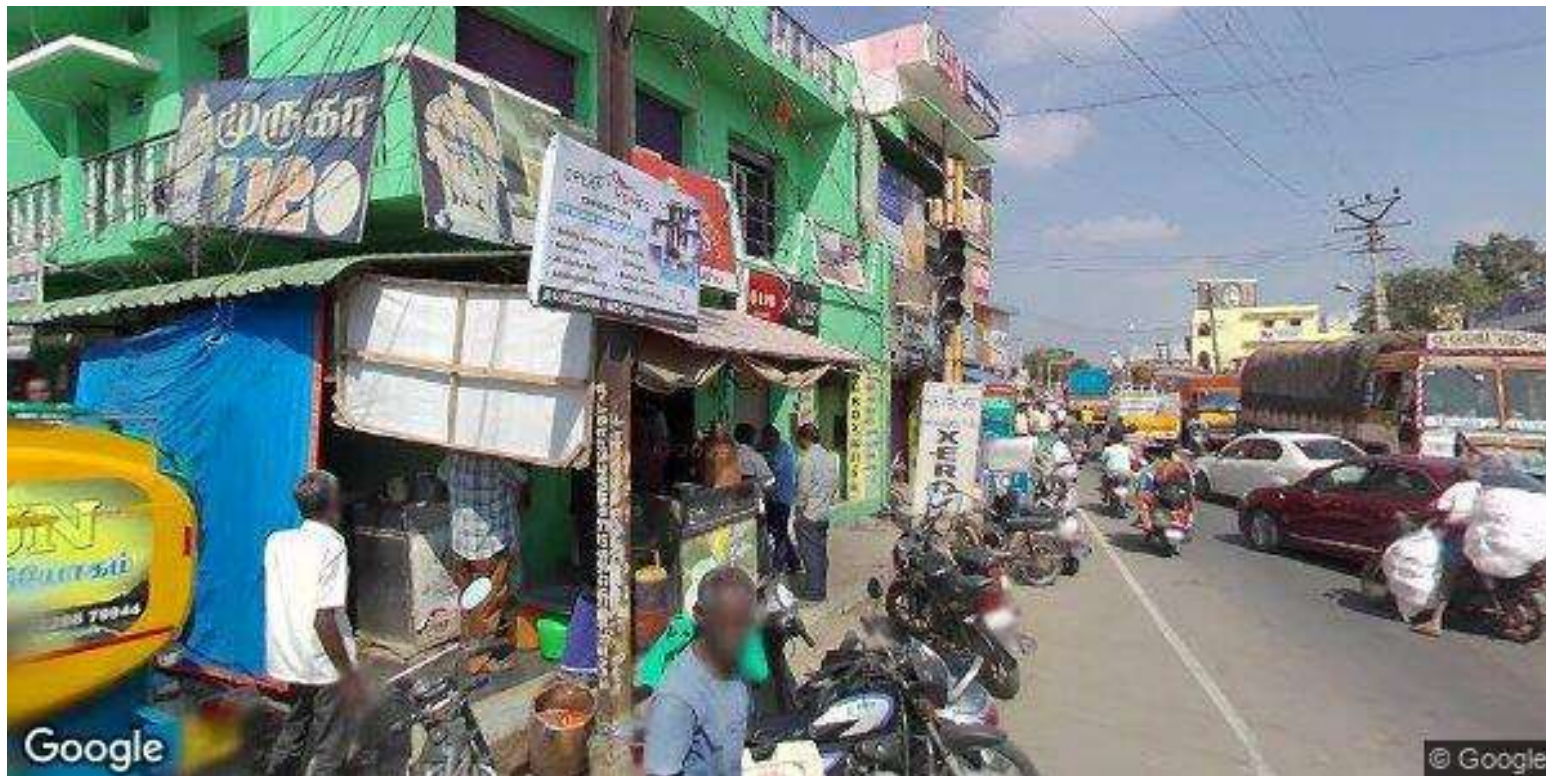
**Coordinates: 11.47407, 77.86839**

**Risk Type: Turn**

**Risk Level: High**

**Speed Limit: 15 KM/Hr**

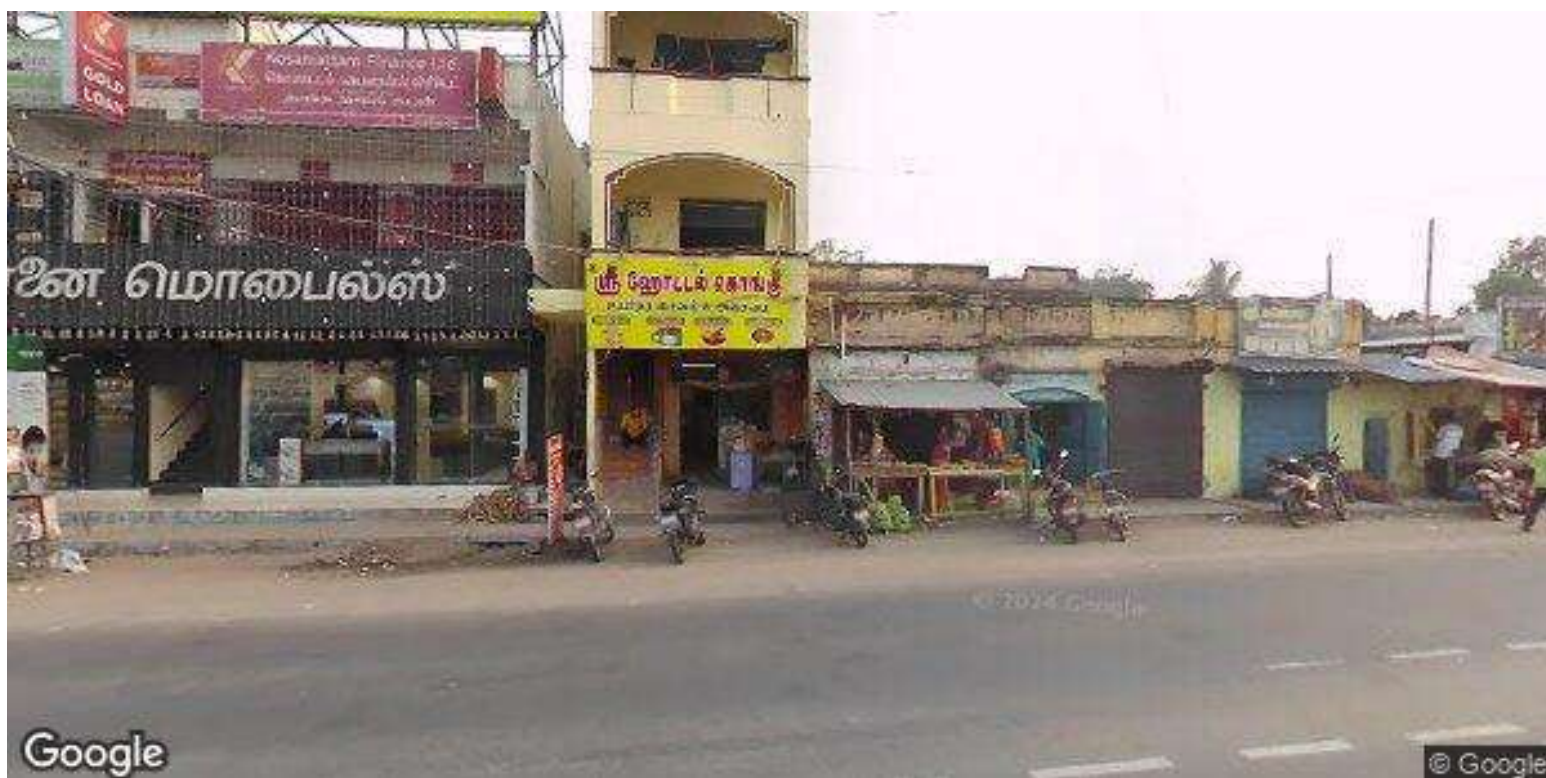
**Coordinates: 11.47451, 77.86914**

**Risk Type: Turn**

**Risk Level: High**

**Speed Limit: 15 KM/Hr**

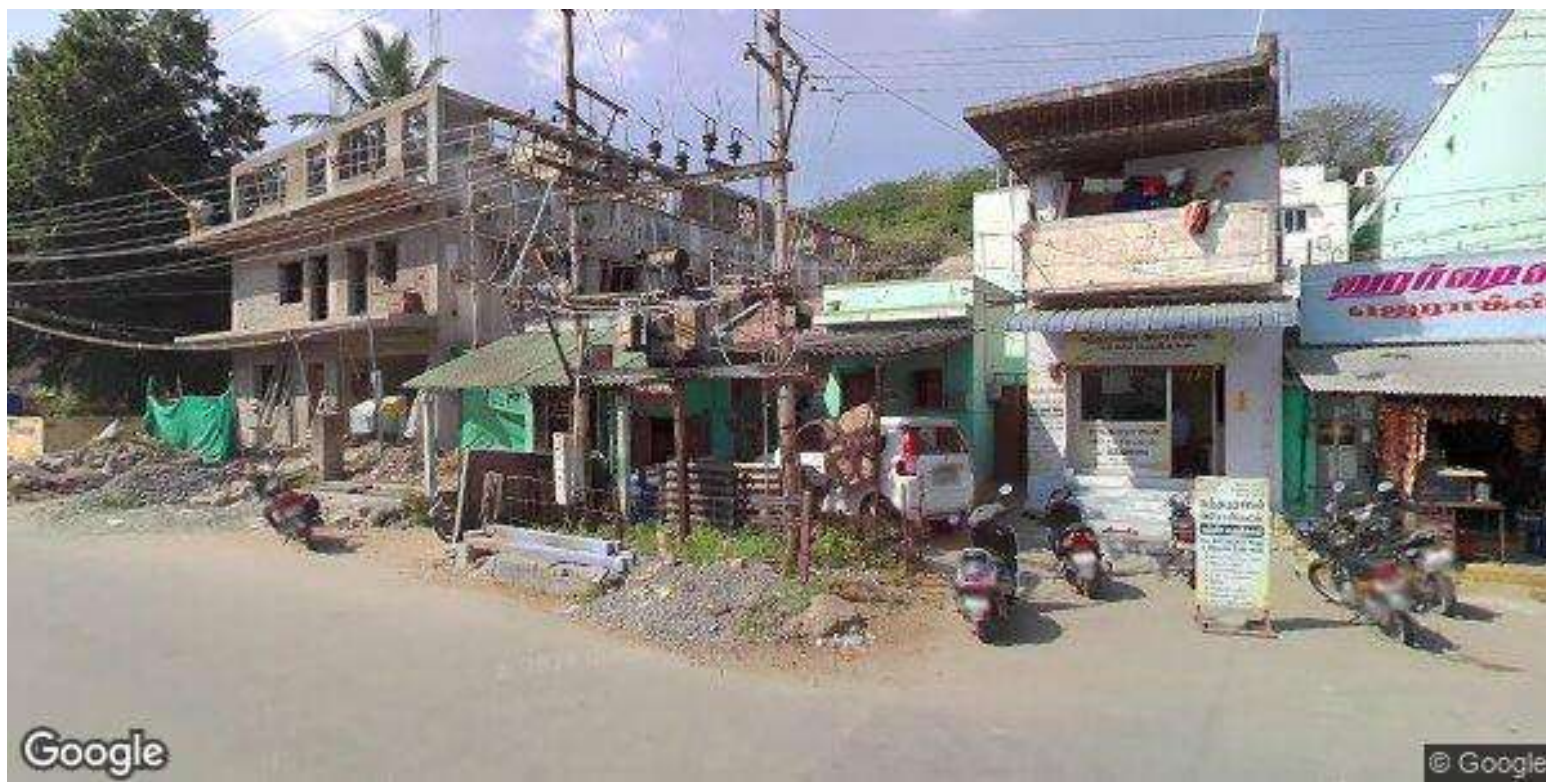
**Coordinates:** 11.47920, 77.86989

**Risk Type:** Turn

**Risk Level:** High

**Speed Limit:** 15 KM/Hr

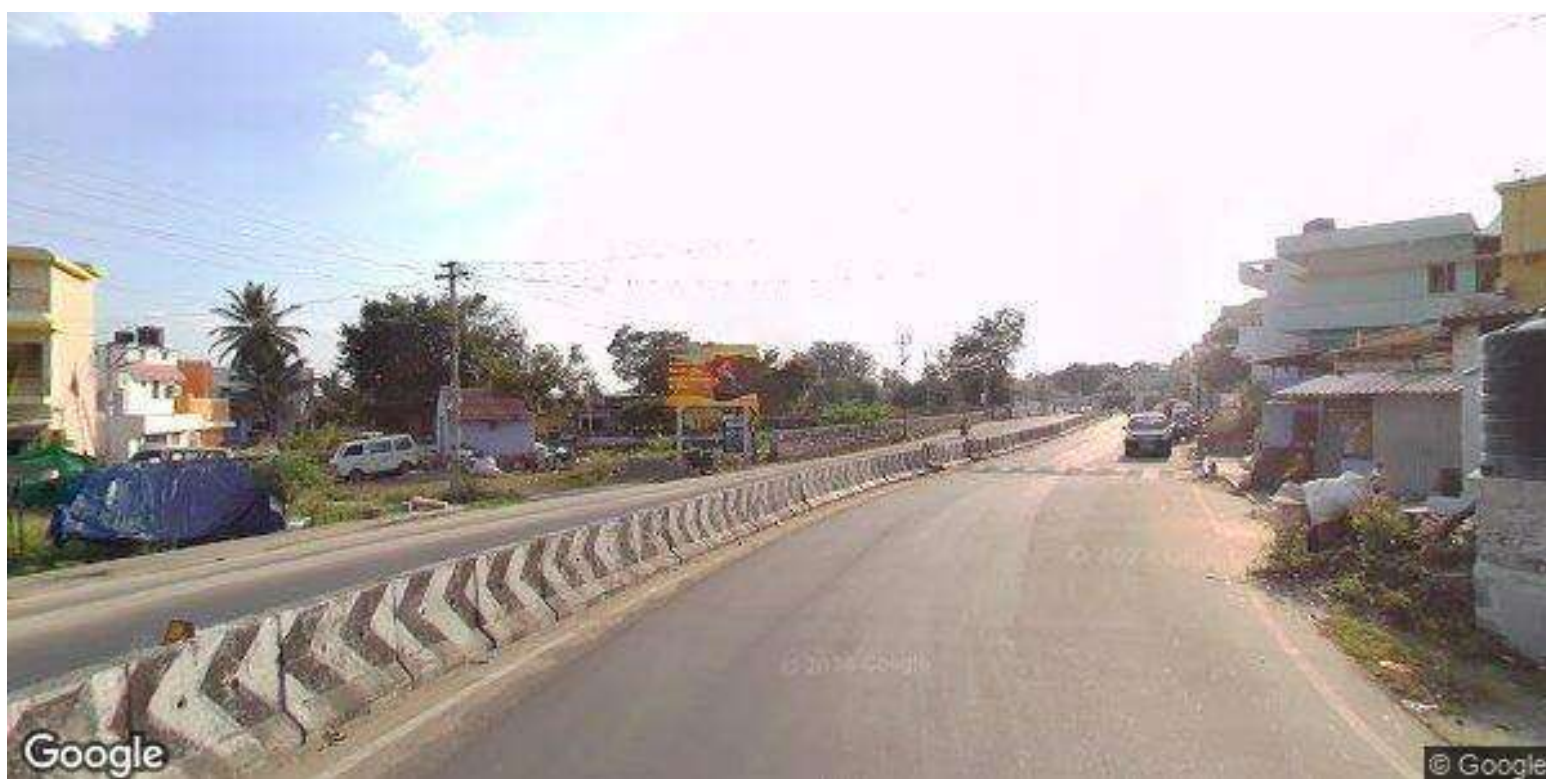
**Coordinates:** 11.48058, 77.87163

**Risk Type:** Turn

**Risk Level:** Medium

**Speed Limit:** 30 KM/Hr

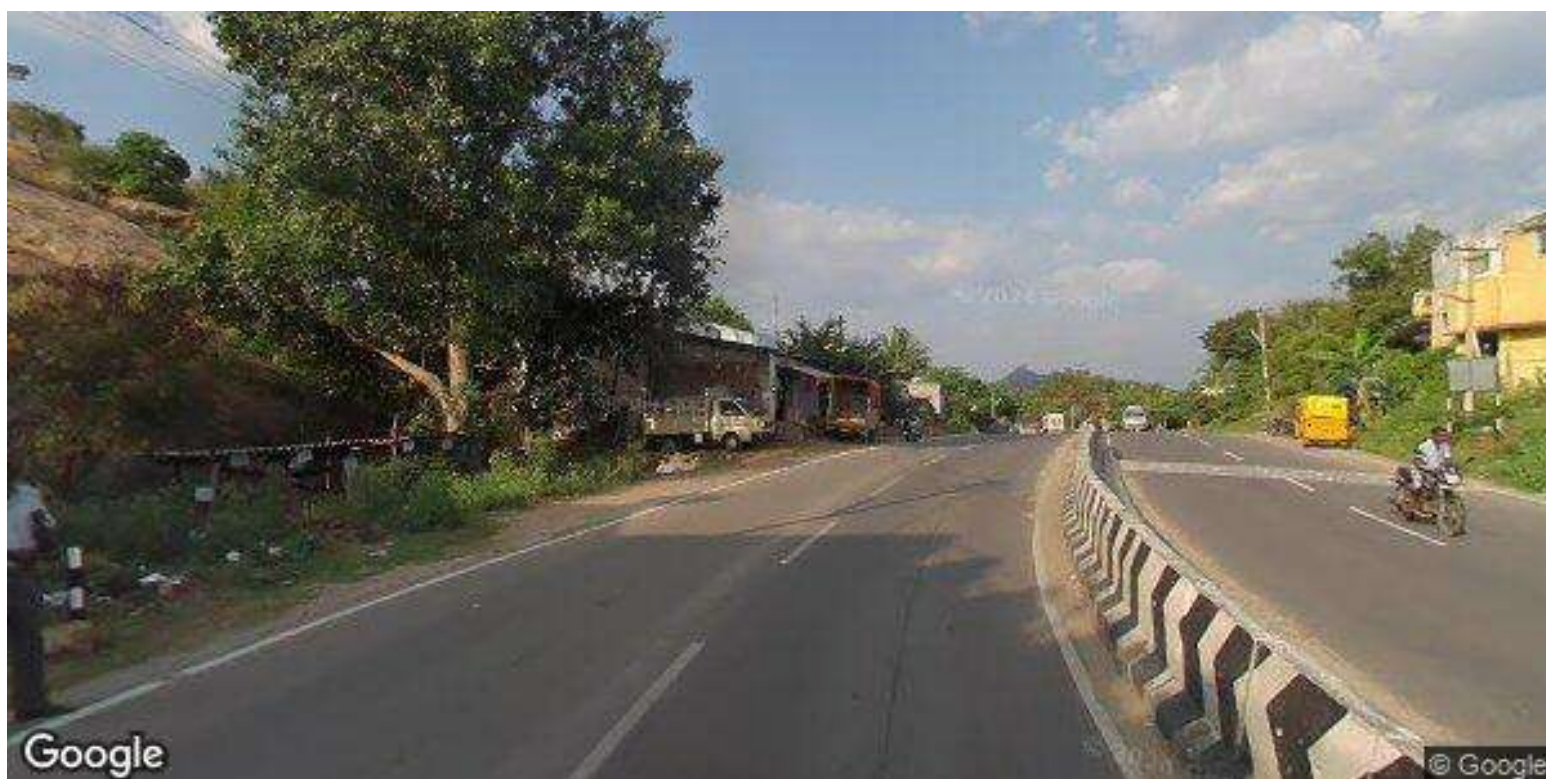
**Risk Type:** Turn  
**Risk Level:** Medium  
**Speed Limit:** 30 KM/Hr  
**Coordinates:** 11.48155, 77.87174

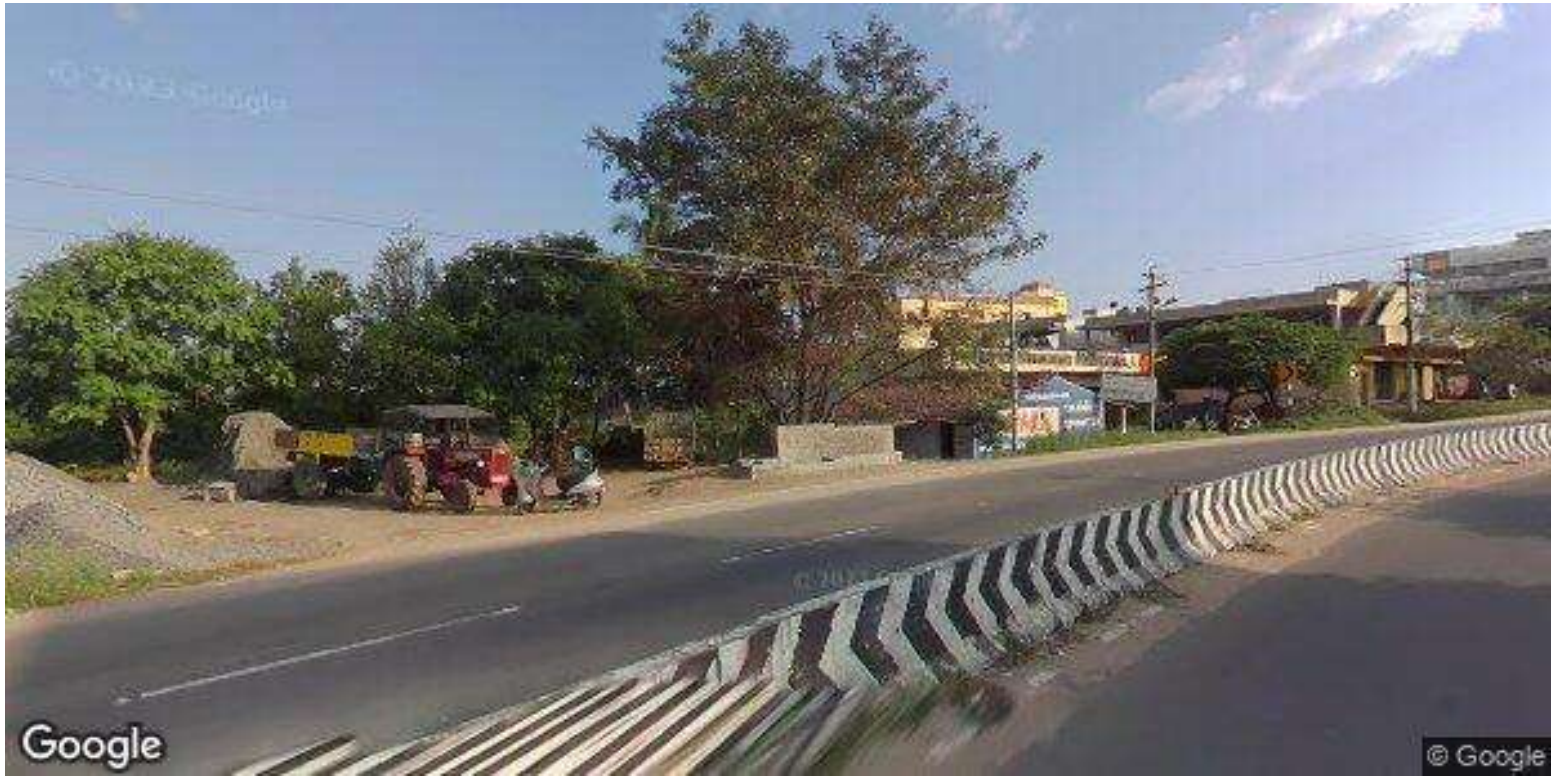
**Risk Type:** Turn  
**Risk Level:** Medium  
**Speed Limit:** 30 KM/Hr  
**Coordinates:** 11.48277, 77.87250

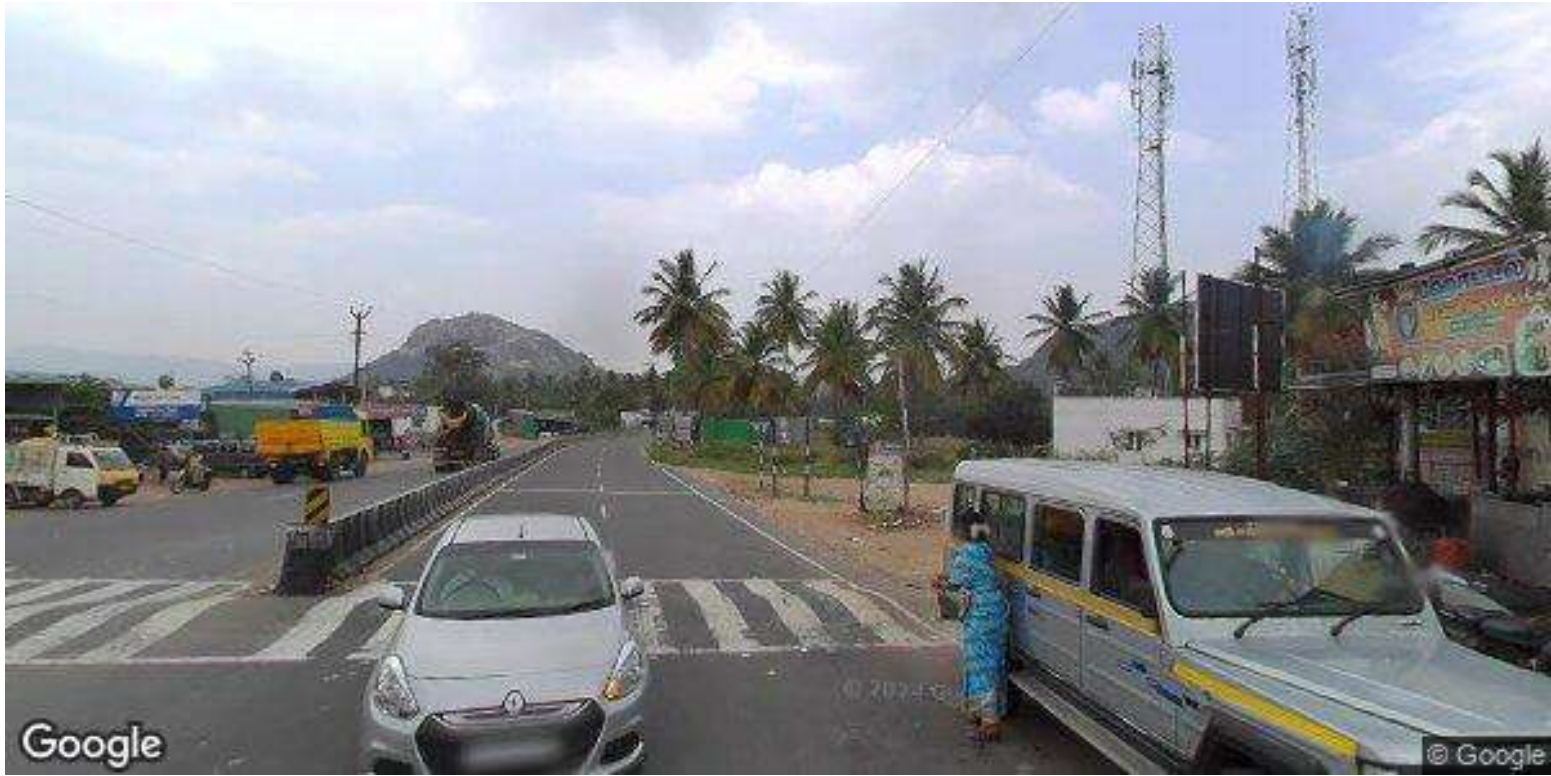
**Risk Type:** Turn  
**Risk Level:** Medium  
**Speed Limit:** 30 KM/Hr  
**Coordinates:** 11.49397, 77.86740

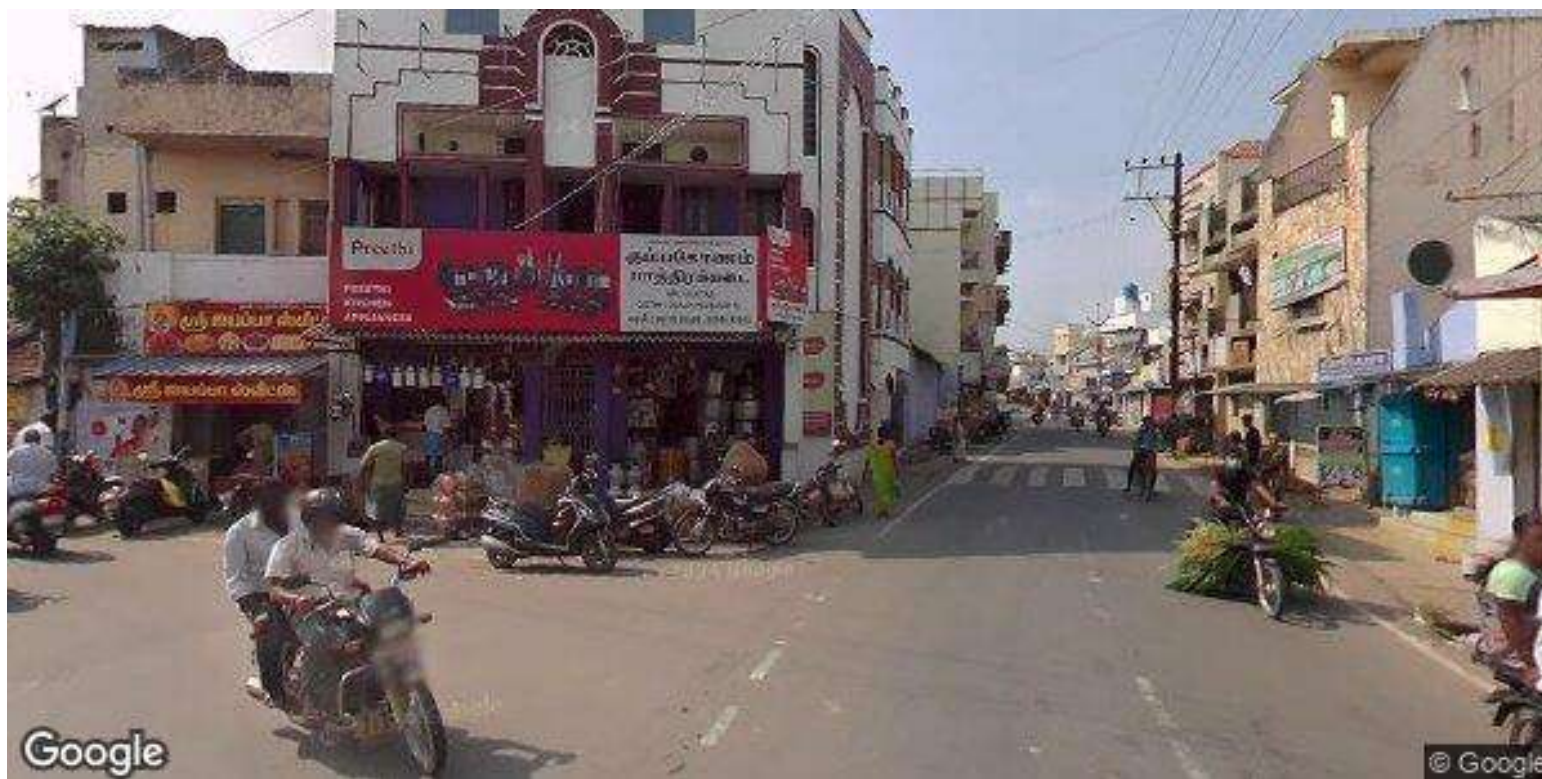
**Coordinates:** 11.58533, 77.83450

**Risk Type:** Turn

**Risk Level:** High

**Speed Limit:** 15 KM/Hr

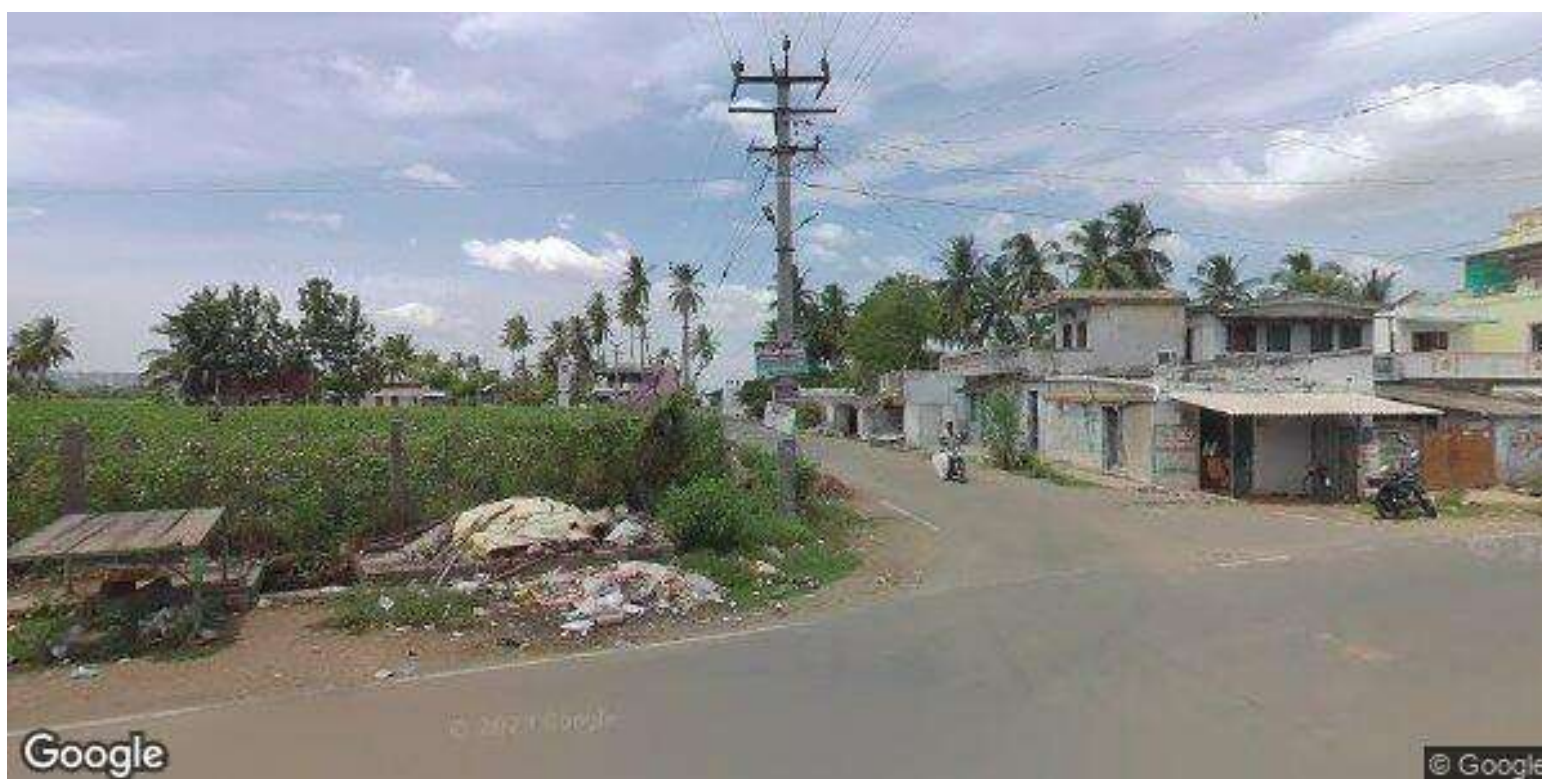
**Coordinates:** 11.56019, 77.74944

**Risk Type:** Turn

**Risk Level:** High

**Speed Limit:** 15 KM/Hr
