# IndianOil

## JOURNEY RISK MANAGEMENT (JRM) STUDY

### Salem Terminal TO SANKAGIRI LORRY OWENER'S ASSOCIAATI

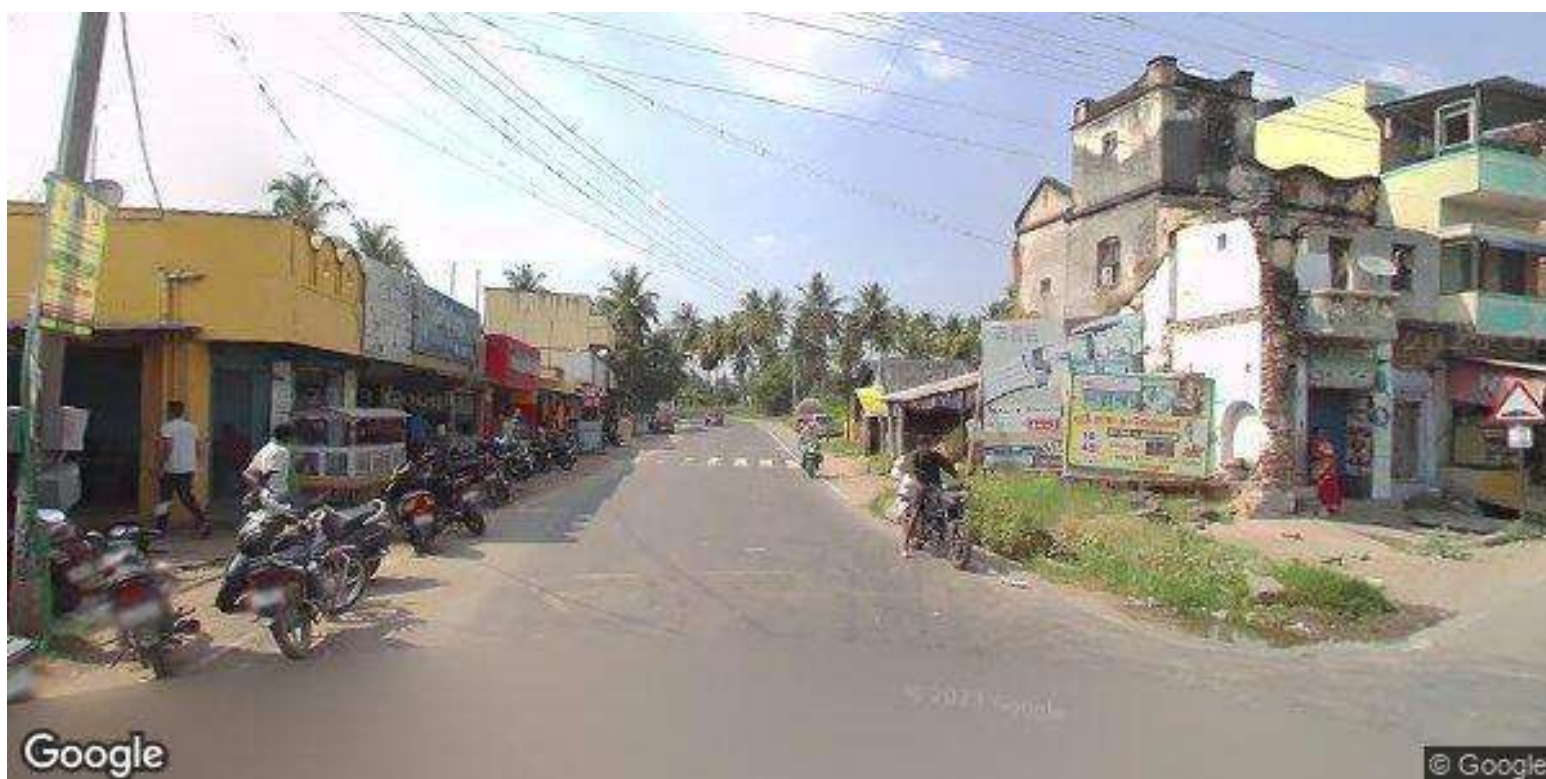
**Coordinates: 11.45007, 77.87201**

**Risk Type: Turn**

**Risk Level: High**

**Speed Limit: 15 KM/Hr**

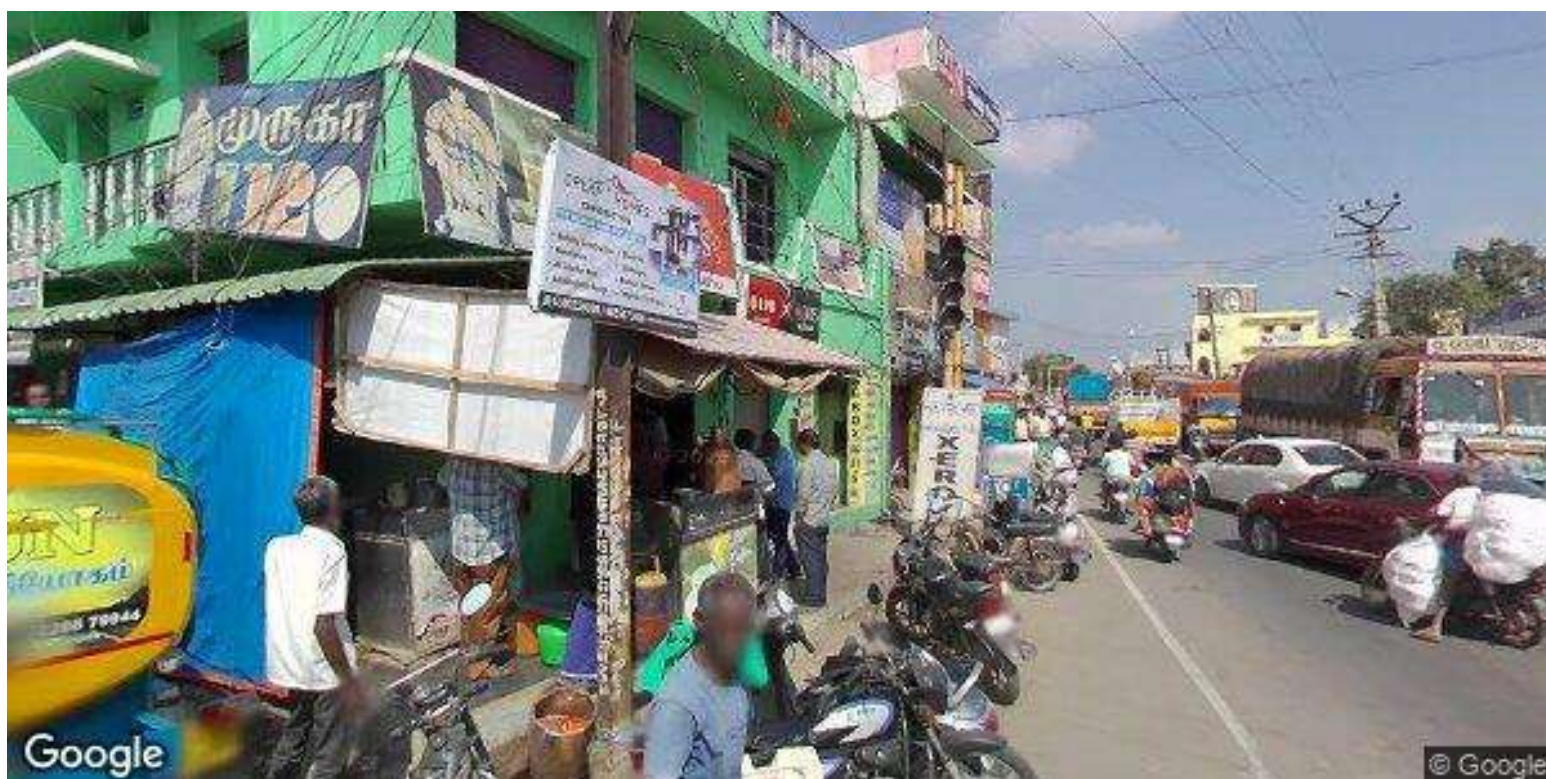
**Coordinates: 11.47407, 77.86839**

**Risk Type: Turn**

**Risk Level: High**

**Speed Limit: 15 KM/Hr**

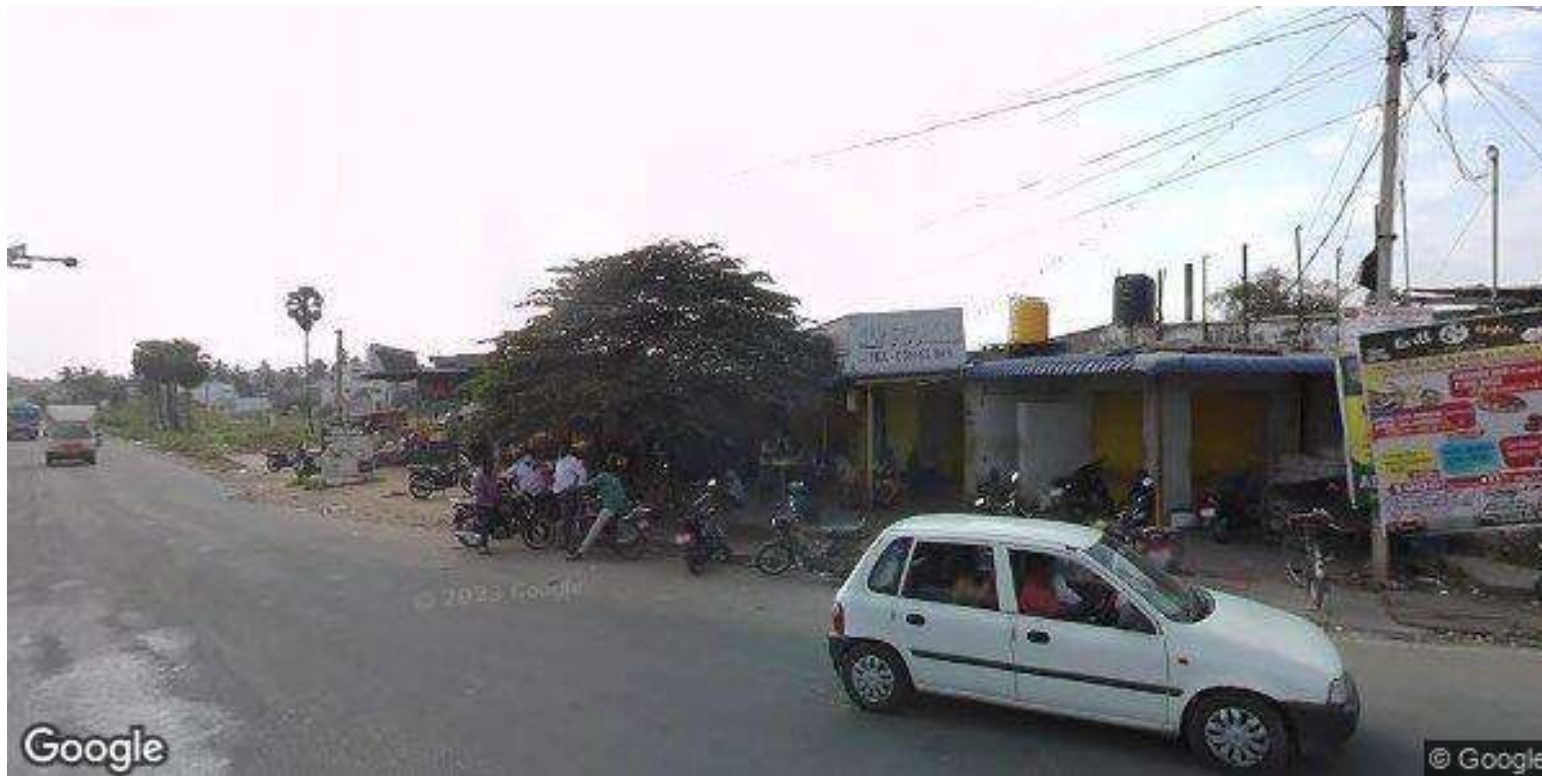
**Coordinates: 11.48369, 77.88781**

**Risk Type: Turn**

**Risk Level: High**

**Speed Limit: 15 KM/Hr**

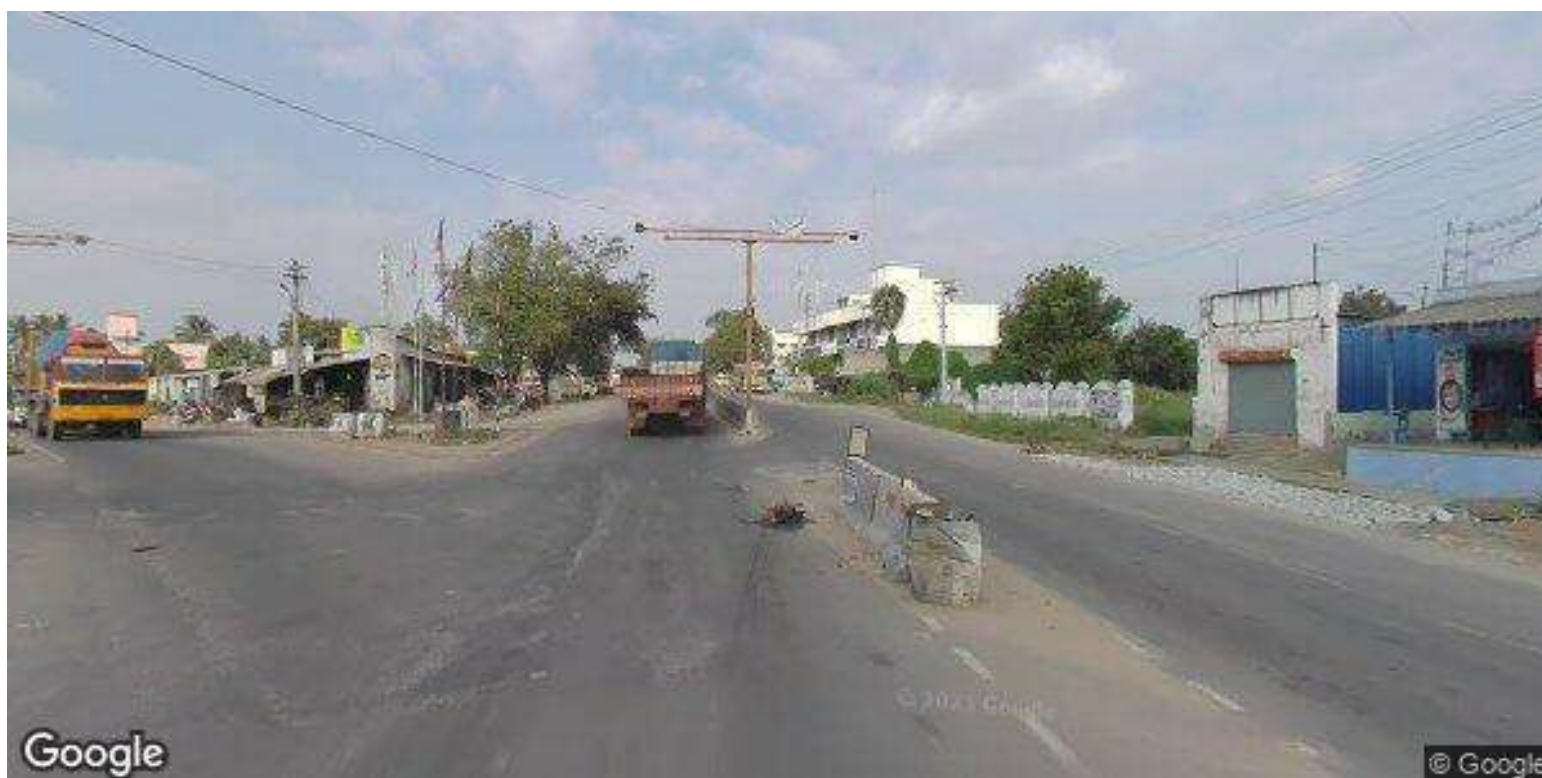
**Coordinates: 11.48370, 77.88787**

**Risk Type: Turn**

**Risk Level: Medium**

**Speed Limit: 30 KM/Hr**

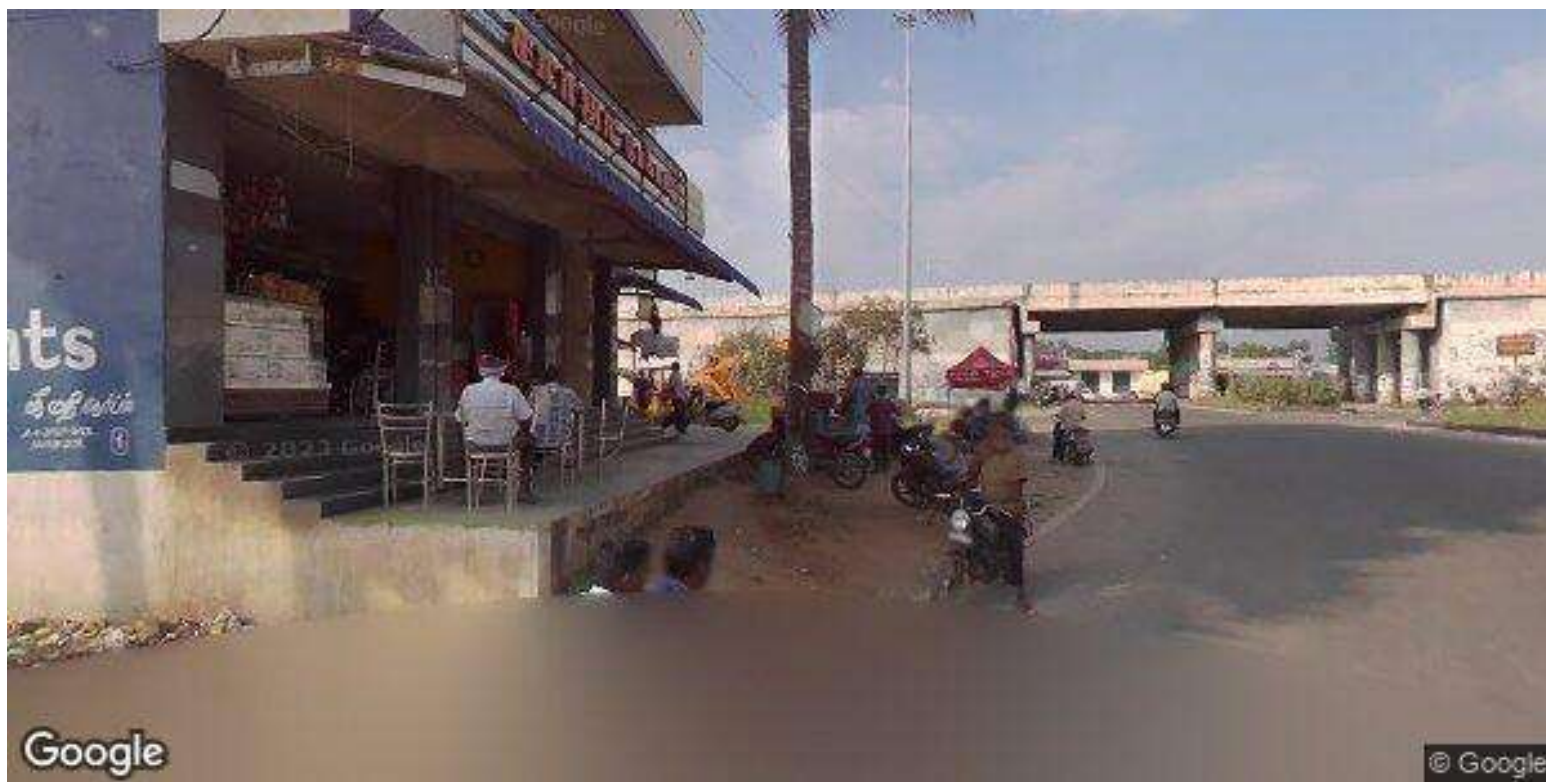
**Coordinates:** 11.49149, 77.89601

**Risk Type:** Turn

**Risk Level:** Medium

**Speed Limit:** 30 KM/Hr

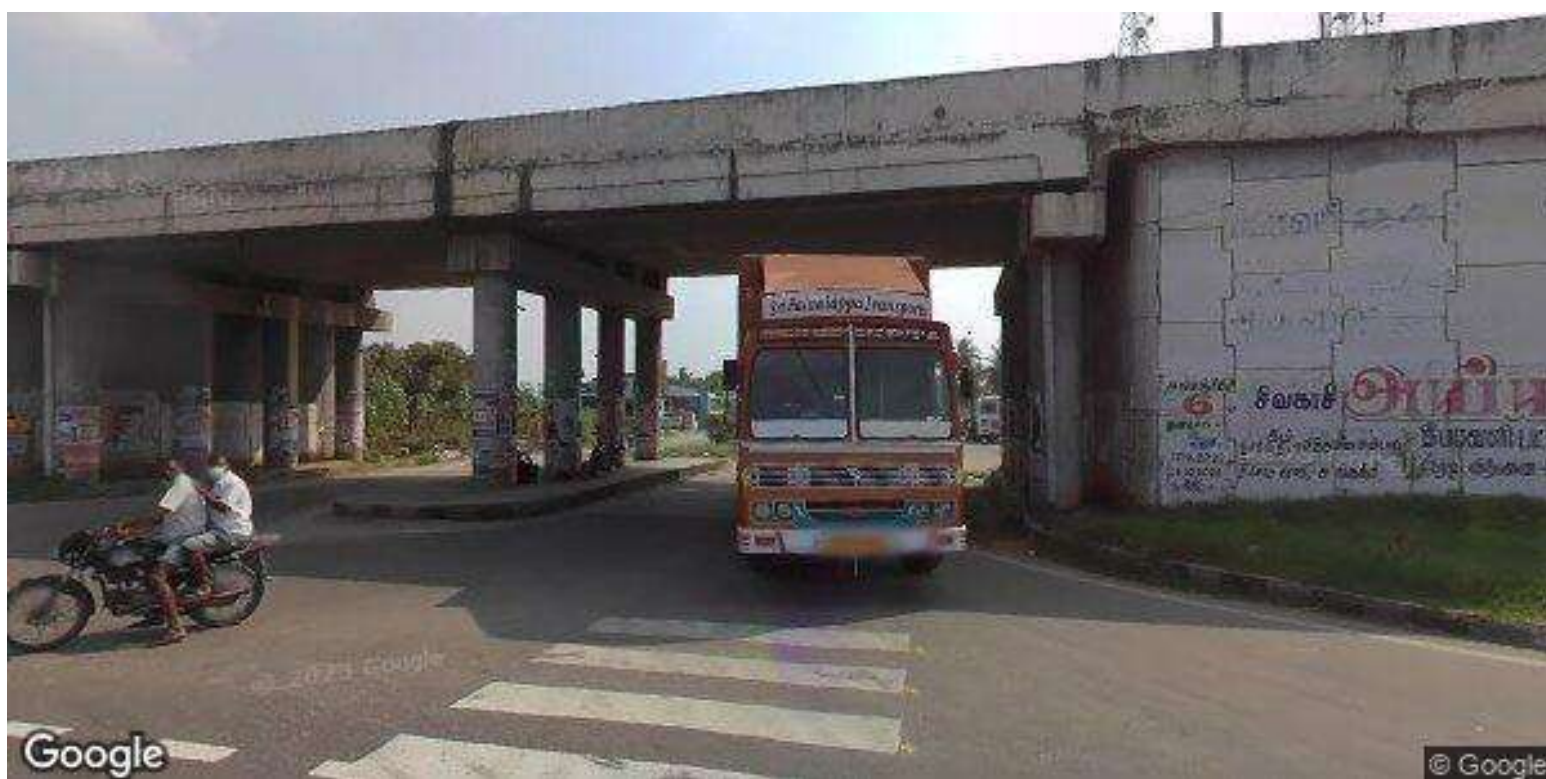
**Coordinates:** 11.49224, 77.89601

**Risk Type:** Turn

**Risk Level:** High

**Speed Limit:** 15 KM/Hr

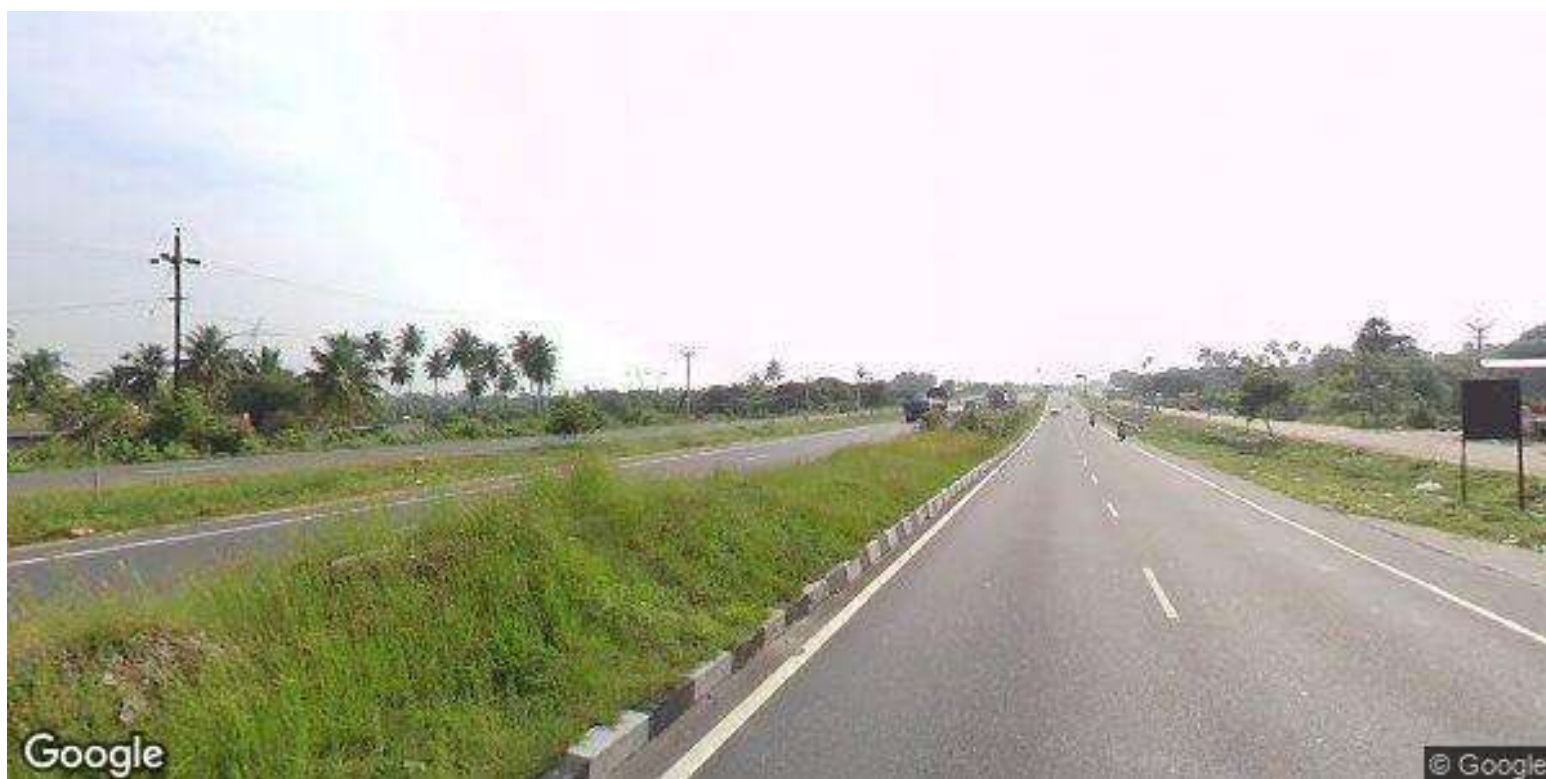
**Coordinates: 11.50108, 77.91039**

**Risk Type: Blind Spot**

**Risk Level: Blind Spot**

**Speed Limit: 10 KM/Hr**

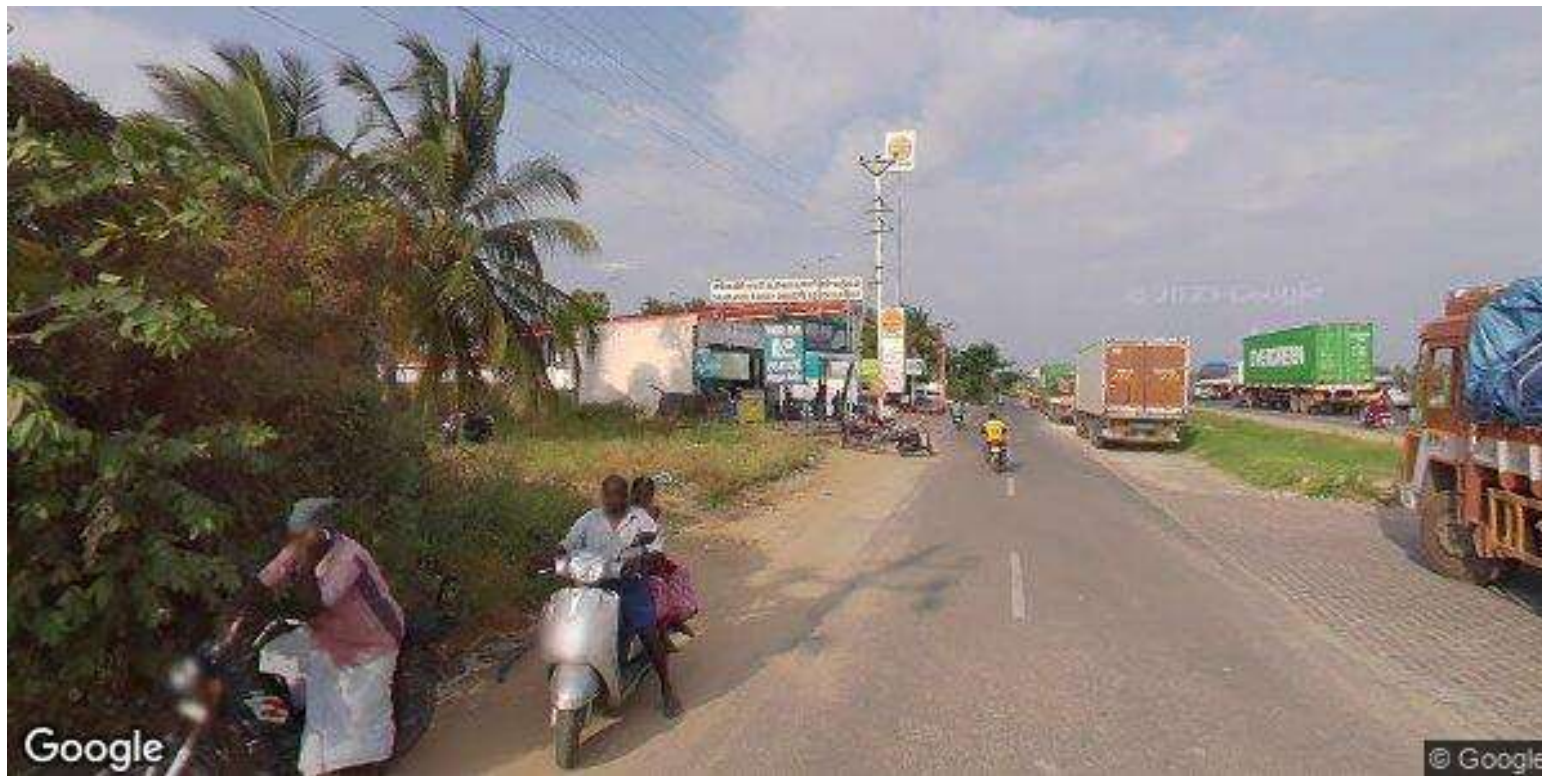
**Coordinates: 11.50119, 77.91025**

**Risk Type: Blind Spot**

**Risk Level: Blind Spot**

**Speed Limit: 10 KM/Hr**

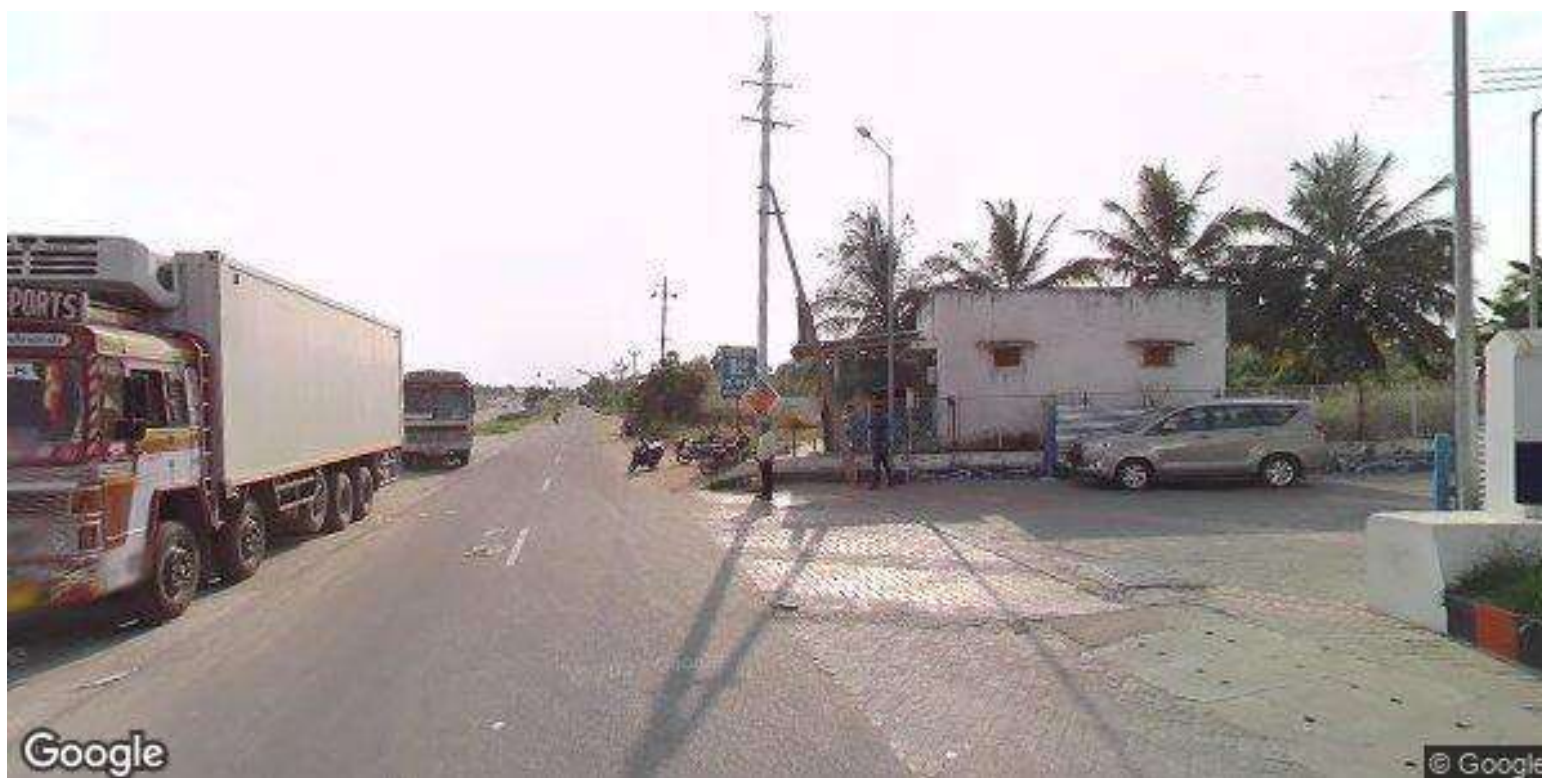
**Coordinates: 11.50150, 77.91052**

**Risk Type: Turn**

**Risk Level: High**

**Speed Limit: 15 KM/Hr**
