# IndianOil

## JOURNEY RISK MANAGEMENT (JRM) STUDY

### Salem Terminal to SRI M.R.S. PETROL BUNK

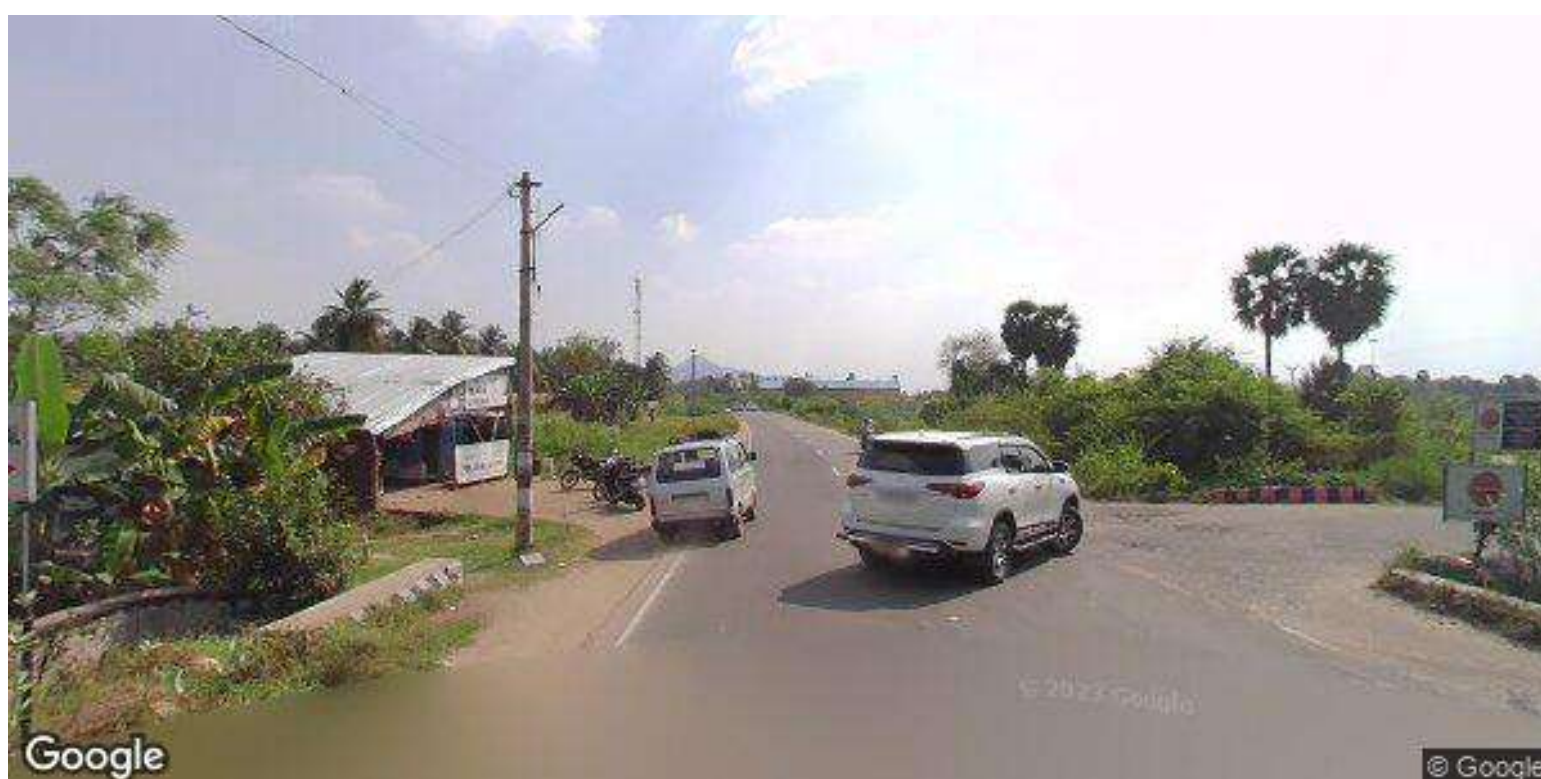
**Coordinates:** 11.44029, 77.87544

**Risk Type:** Turn

**Risk Level:** High

**Speed Limit:** 15 KM/Hr

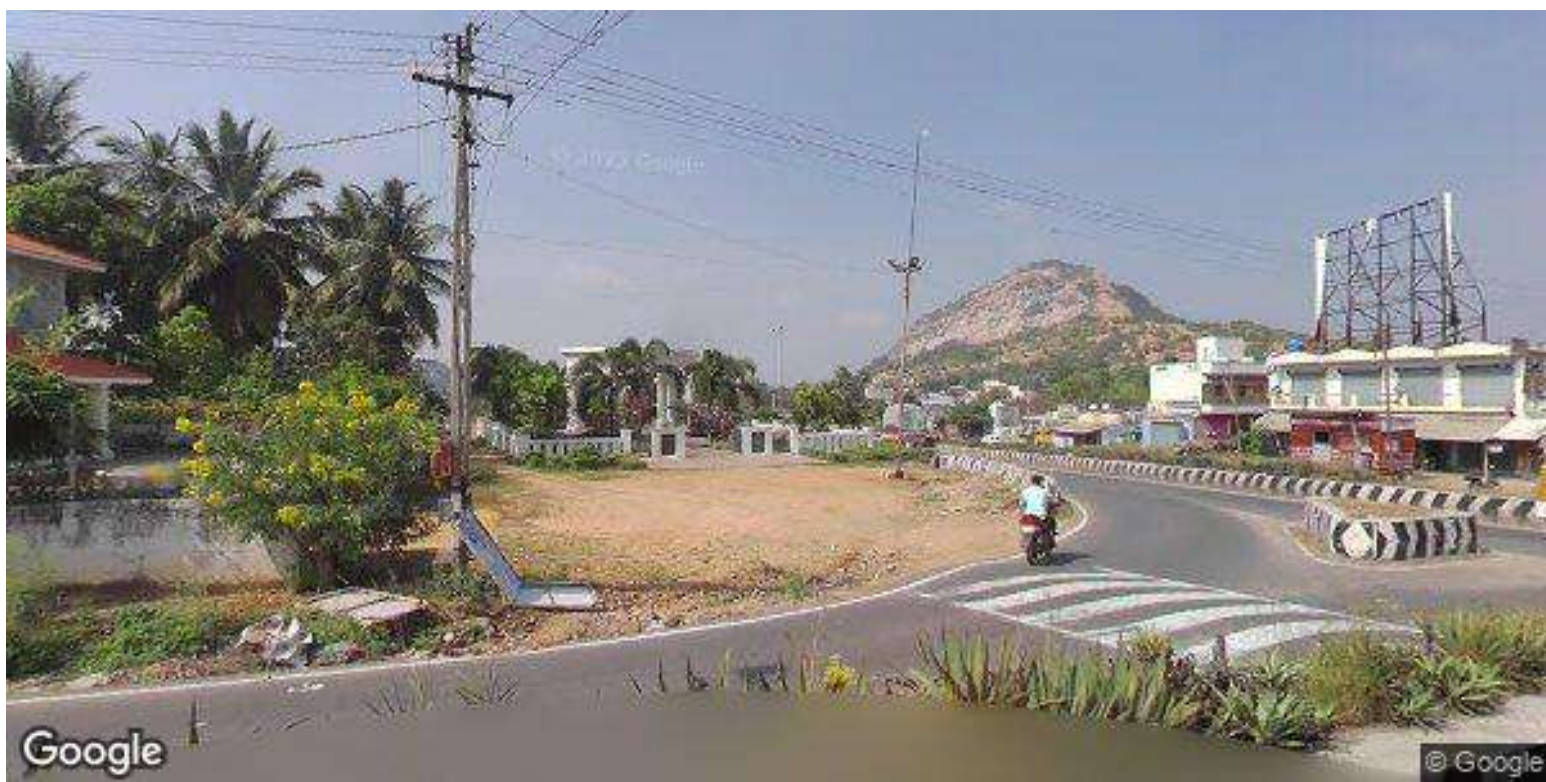
**Coordinates:** 11.46307, 77.84941

**Risk Type:** Turn

**Risk Level:** Medium

**Speed Limit:** 30 KM/Hr

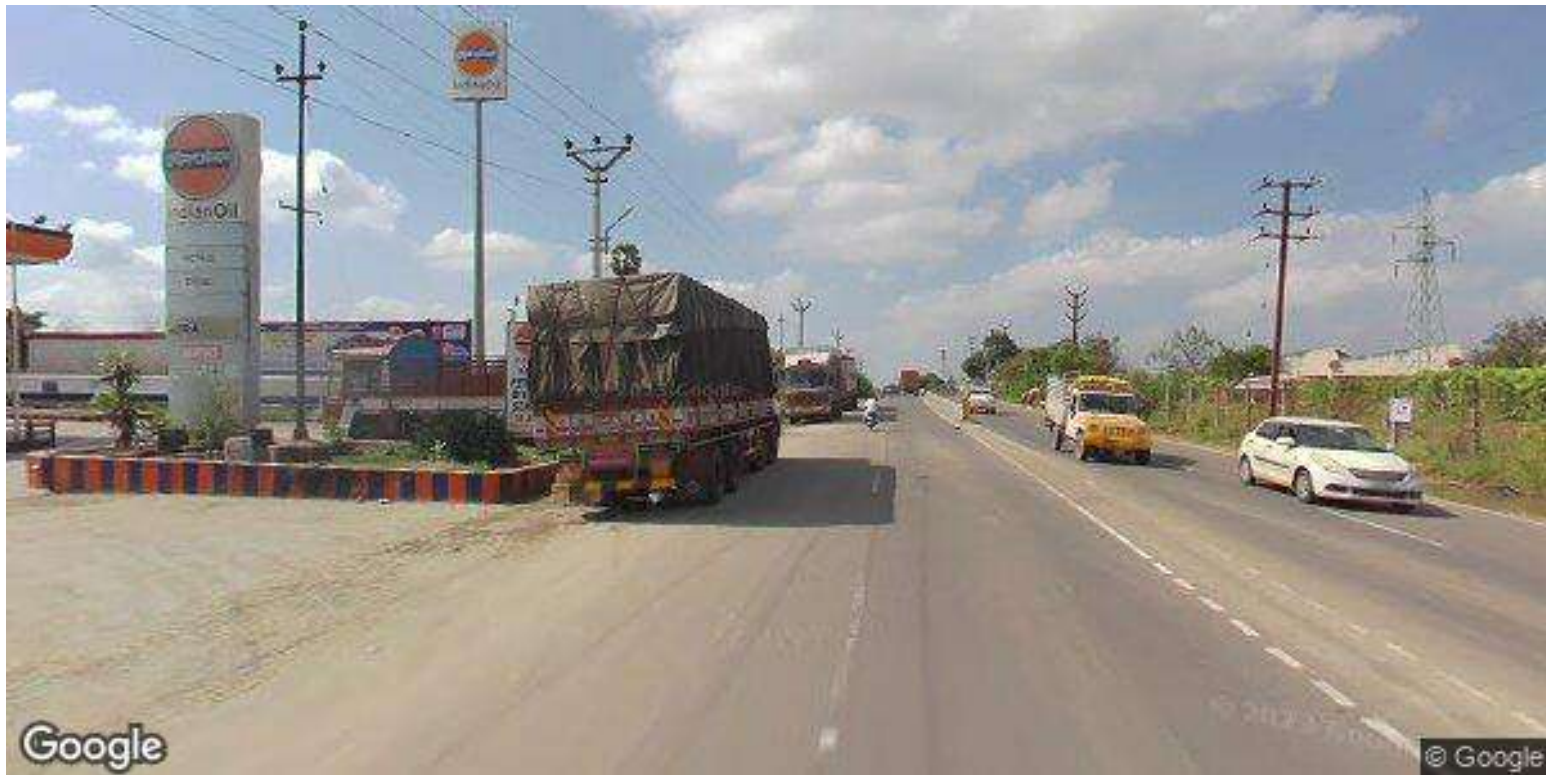
**Coordinates: 11.40198, 77.78225**

**Risk Type: Turn**

**Risk Level: High**

**Speed Limit: 15 KM/Hr**

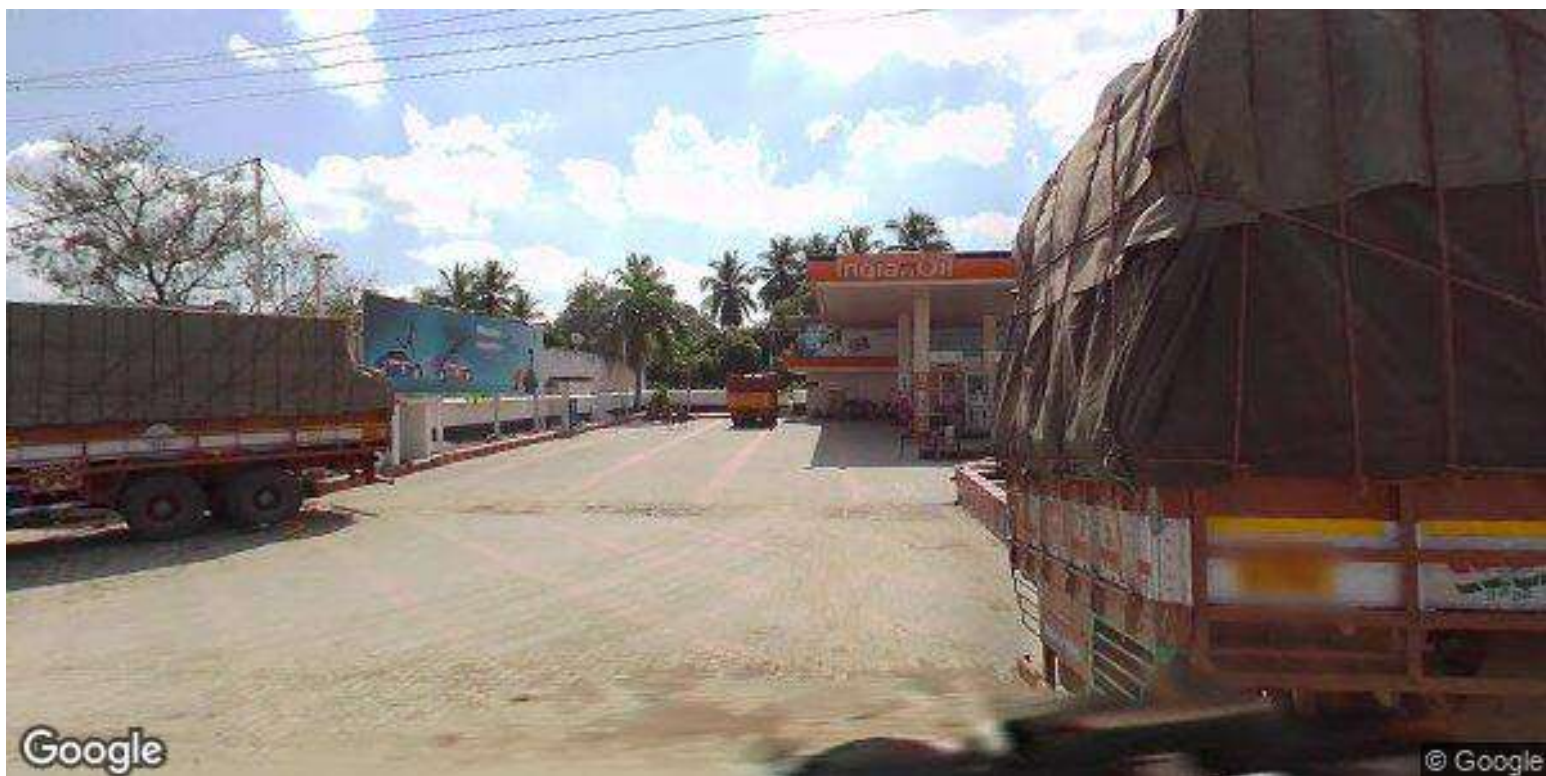
**Coordinates: 11.40172, 77.78236**

**Risk Type: Turn**

**Risk Level: High**

**Speed Limit: 15 KM/Hr**
