## JOURNEY RISK MANAGEMENT (JRM) STUDY

### Salem Terminal to SRI SANKARA FUELS

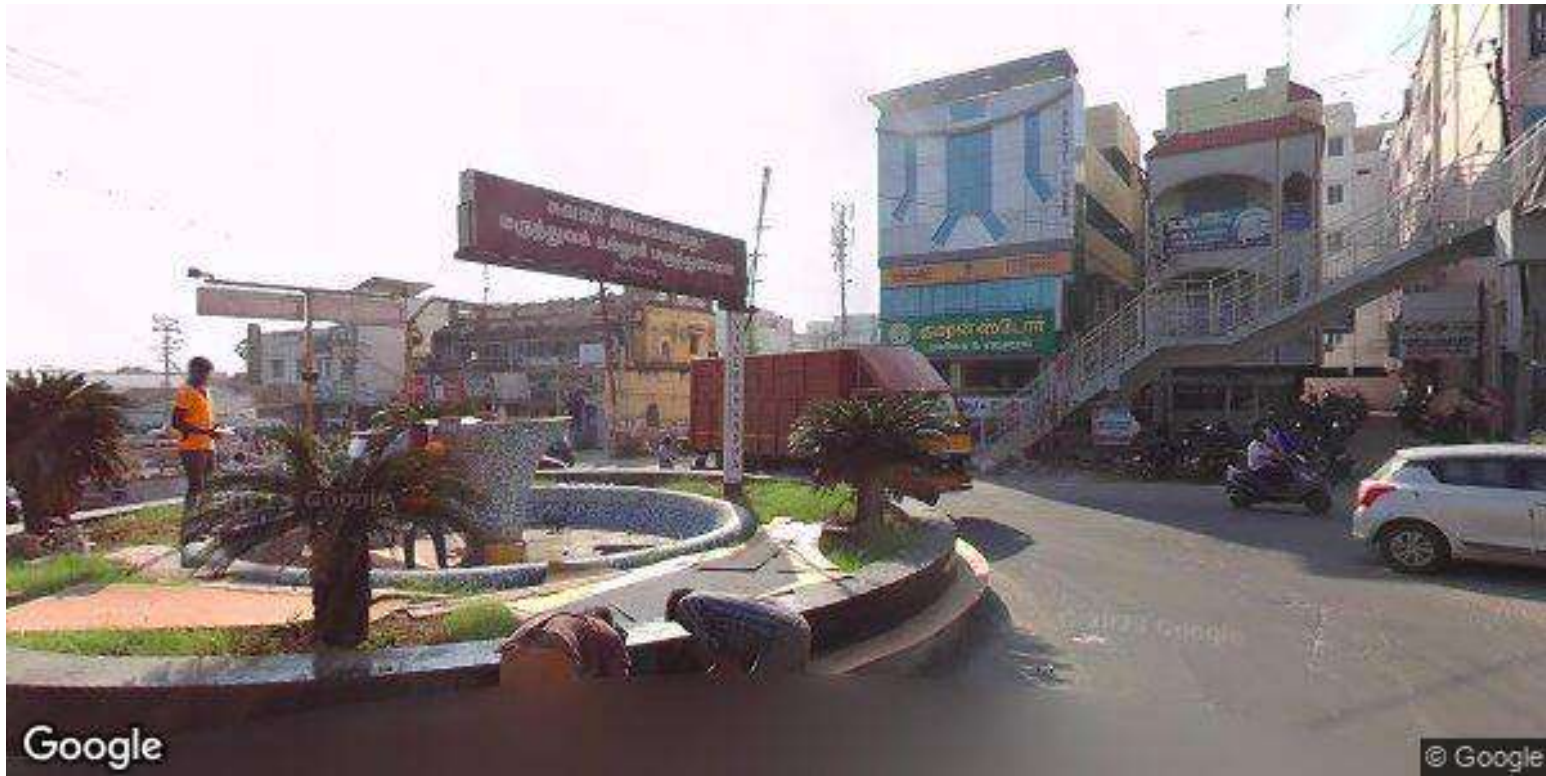
**Coordinates:** 11.38395, 77.89480

**Risk Type:** Roundabout

**Risk Level:** High

**Speed Limit:** 15 KM/Hr

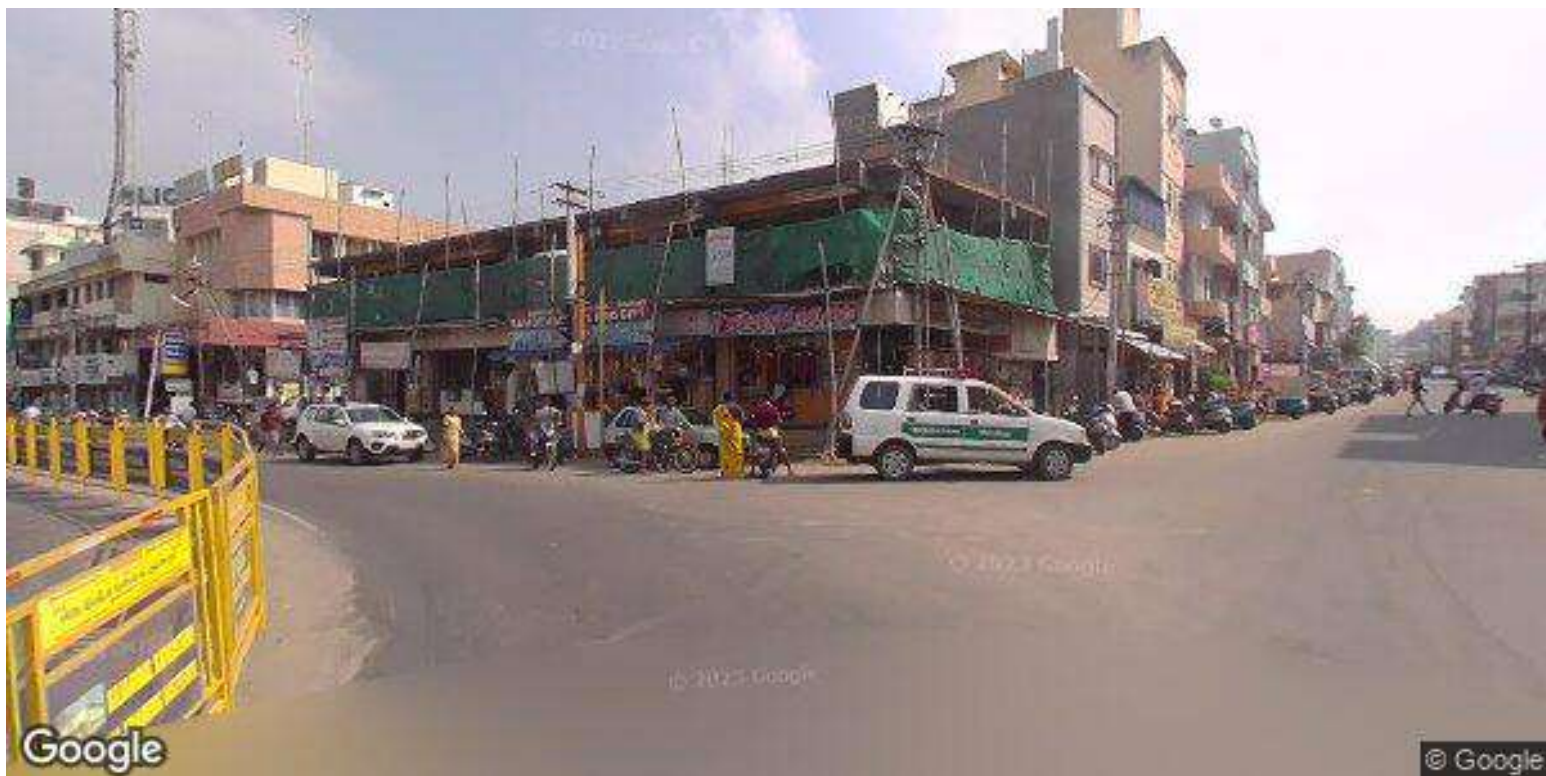
**Risk Type:** Turn  
**Risk Level:** High  
**Speed Limit:** 15 KM/Hr  
**Coordinates:** 11.37868, 77.89498

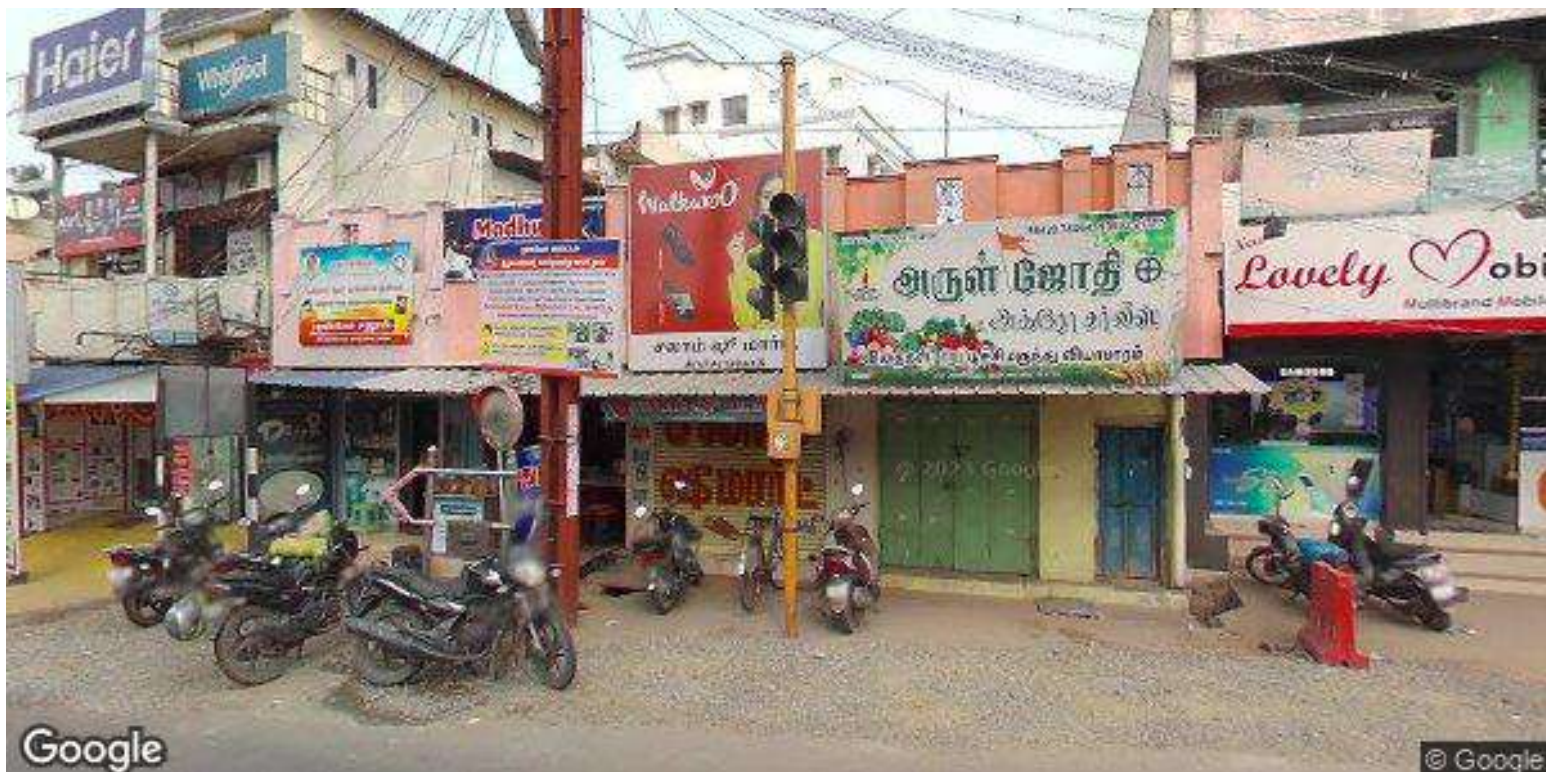
**Coordinates: 11.37850, 77.89453**

**Risk Type: Turn**

**Risk Level: High**

**Speed Limit: 15 KM/Hr**

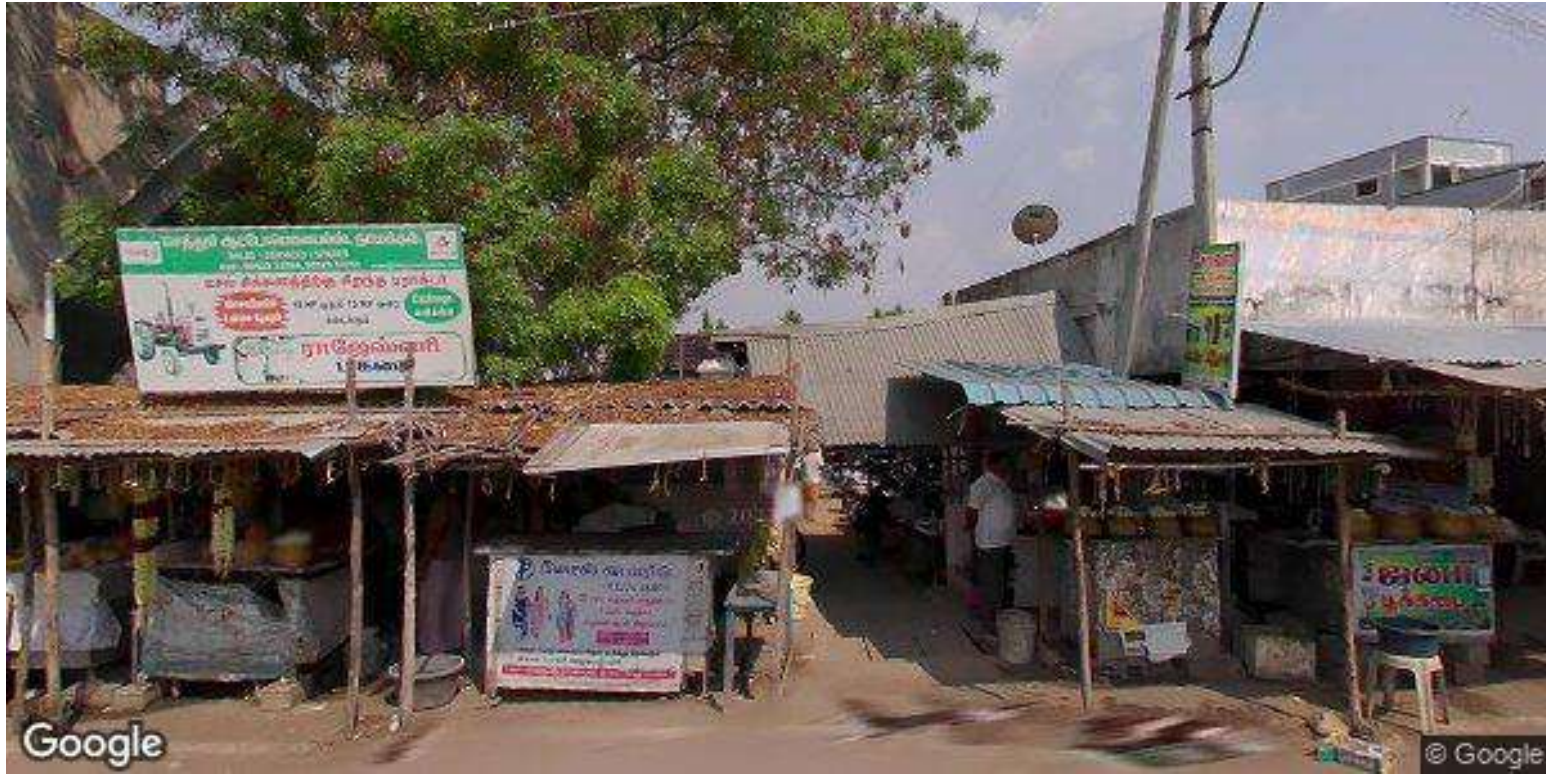
**Coordinates: 11.15573, 78.02176**

**Risk Type: Turn**

**Risk Level: High**

**Speed Limit: 15 KM/Hr**

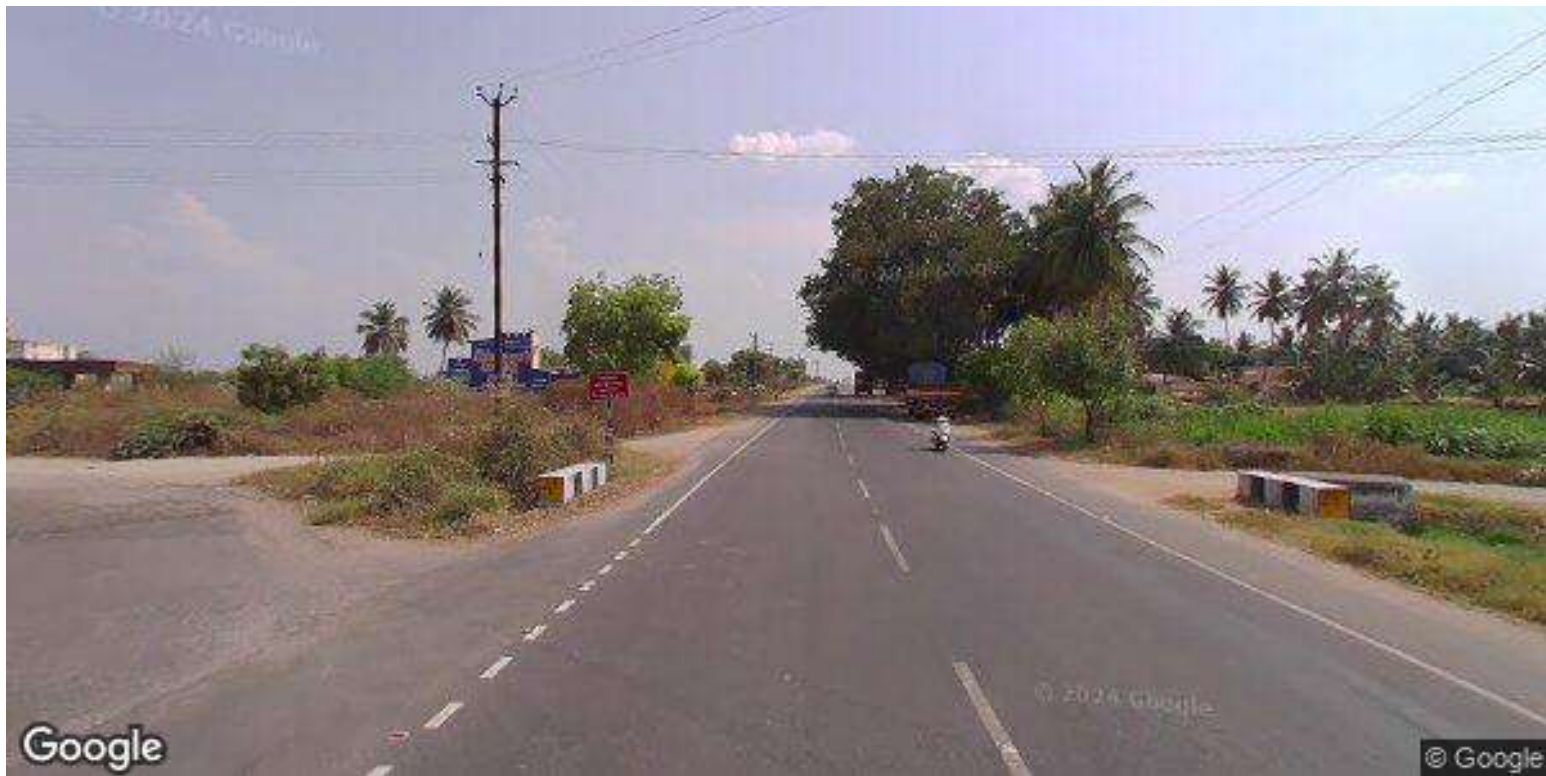
**Coordinates: 11.14545, 78.02208**

**Risk Type: Turn**

**Risk Level: High**

**Speed Limit: 15 KM/Hr**

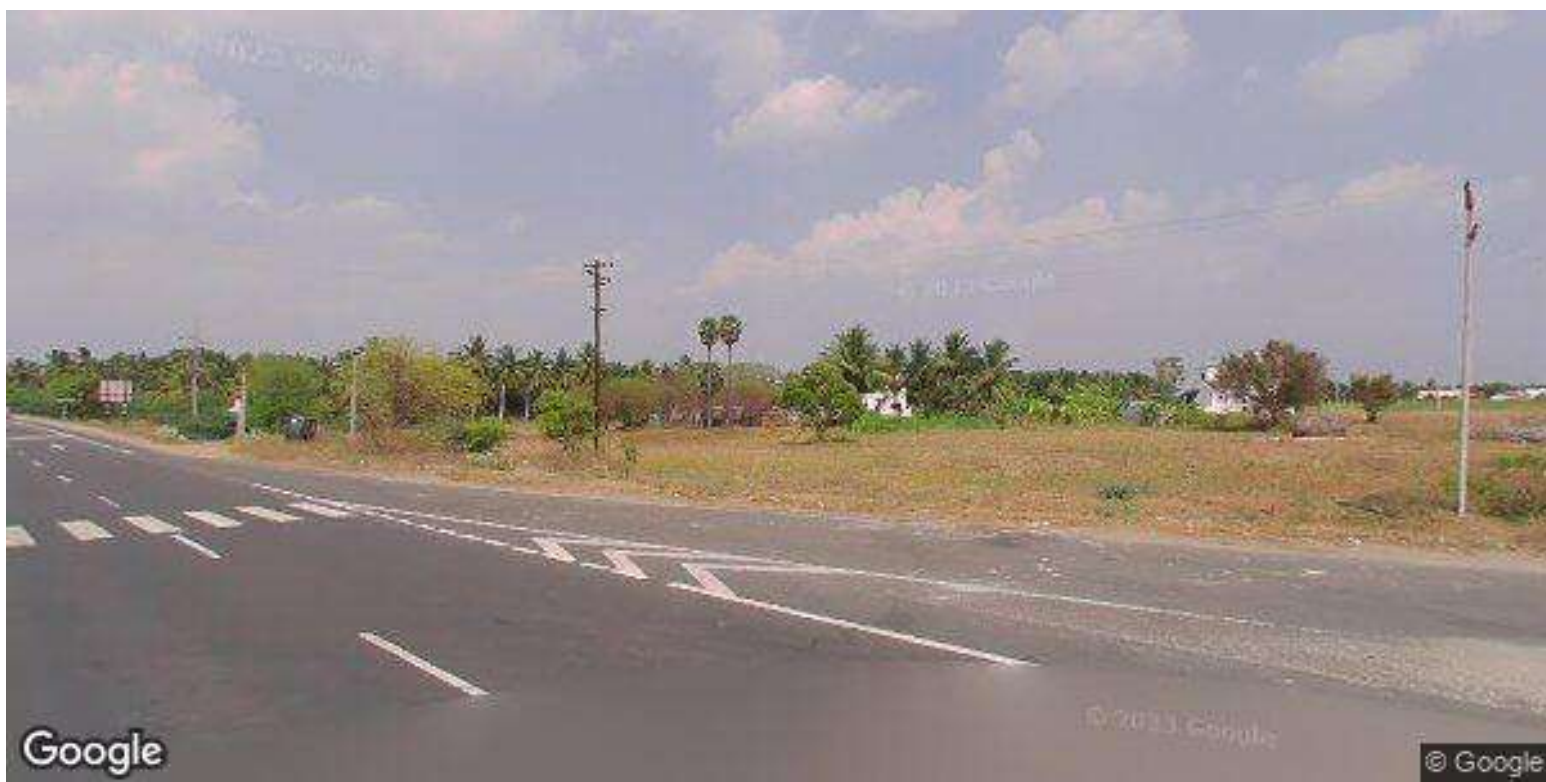
**Coordinates:** 11.14480, 78.02291

**Risk Type:** Turn

**Risk Level:** High

**Speed Limit:** 15 KM/Hr

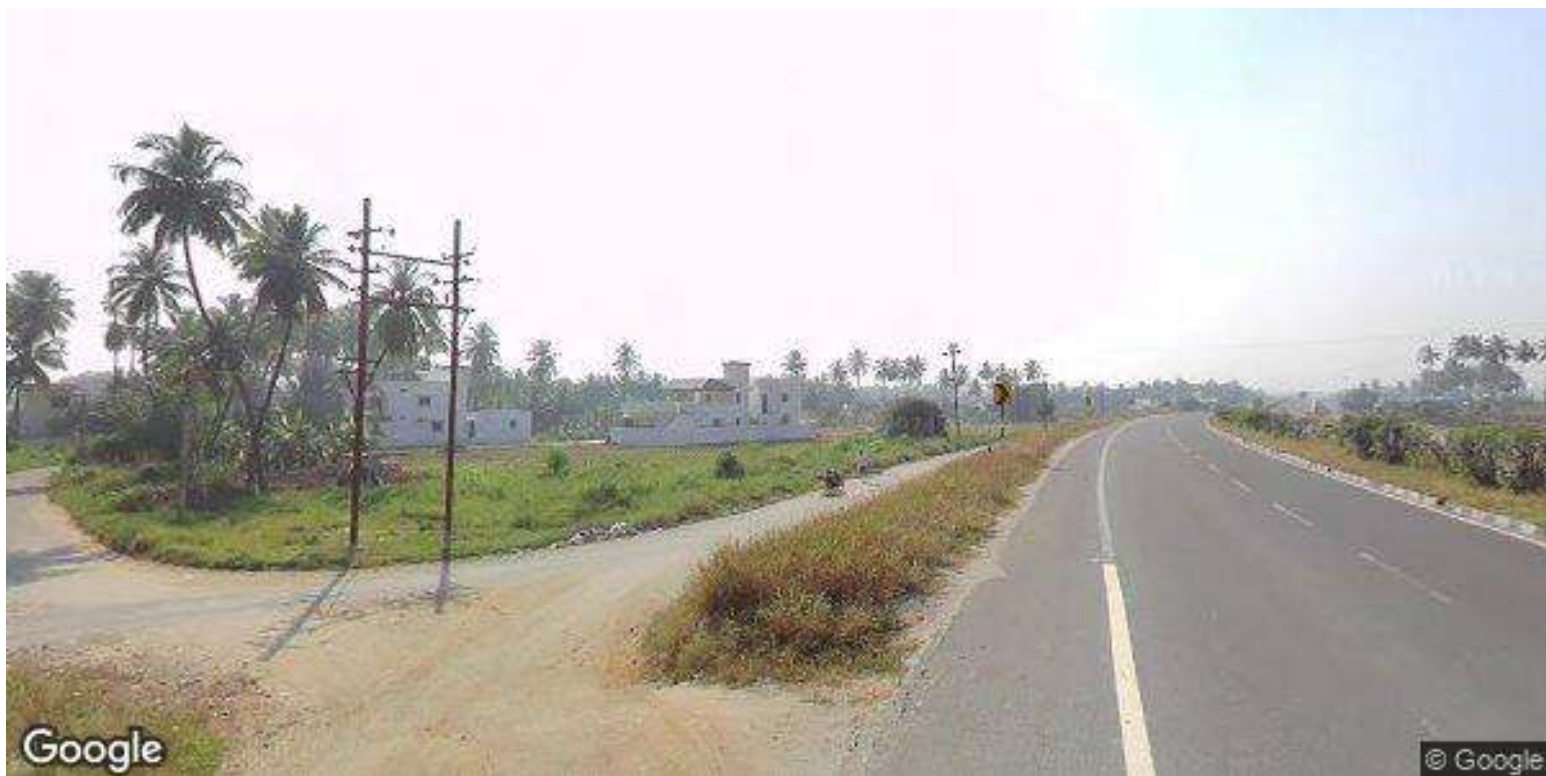
**Coordinates:** 11.11887, 78.01758

**Risk Type:** Turn

**Risk Level:** High

**Speed Limit:** 15 KM/Hr

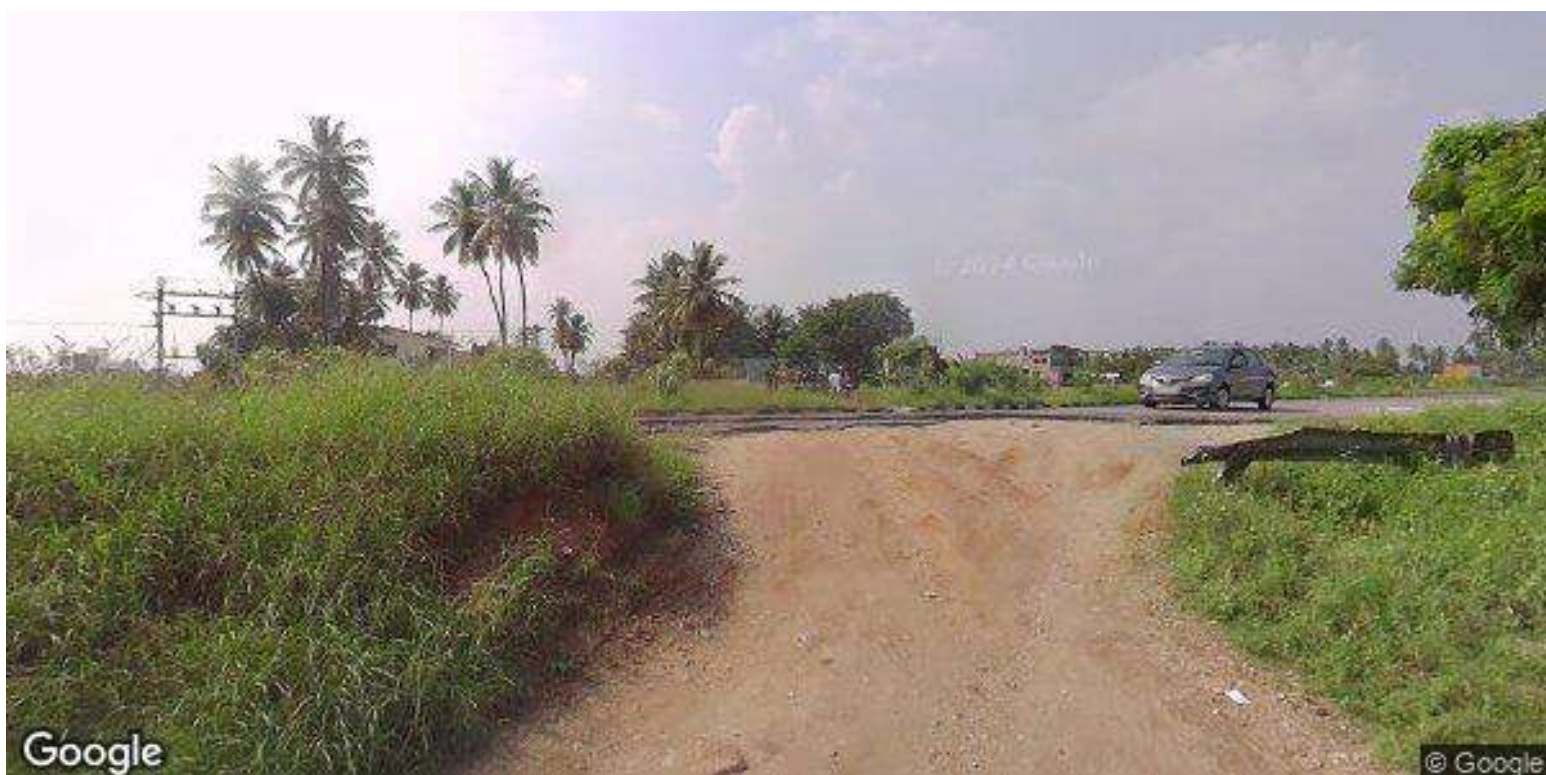
**Risk Type:** Turn  
**Risk Level:** High  
**Speed Limit:** 15 KM/Hr  
**Coordinates:** 11.11883, 78.01771

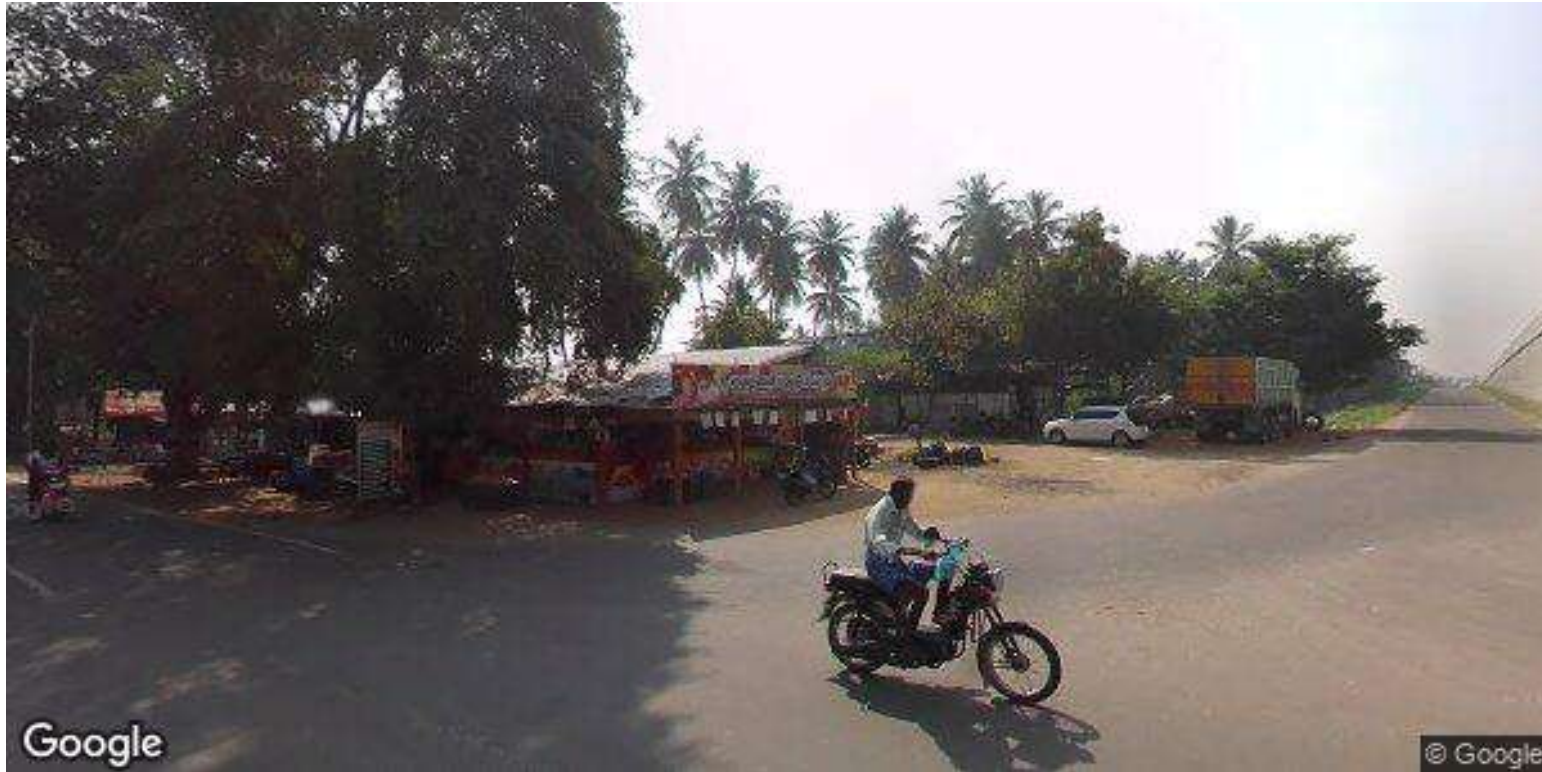
**Risk Type:** Blind Spot  
**Risk Level:** Blind Spot  
**Speed Limit:** 10 KM/Hr  
**Coordinates:** 11.11397, 78.01722

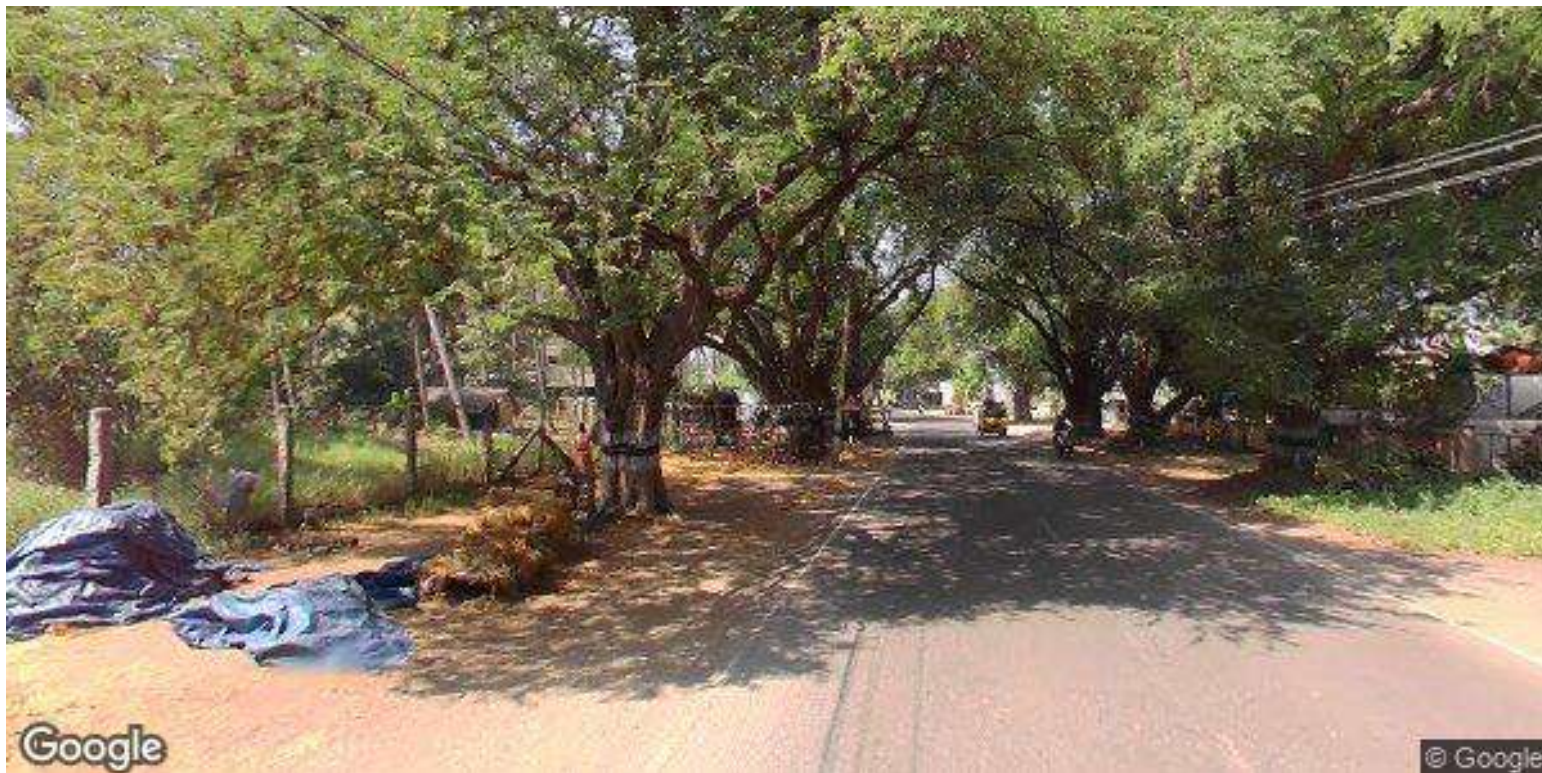
**Risk Type:** Blind Spot  
**Risk Level:** Blind Spot  
**Speed Limit:** 10 KM/Hr  
**Coordinates:** 11.11362, 78.02131

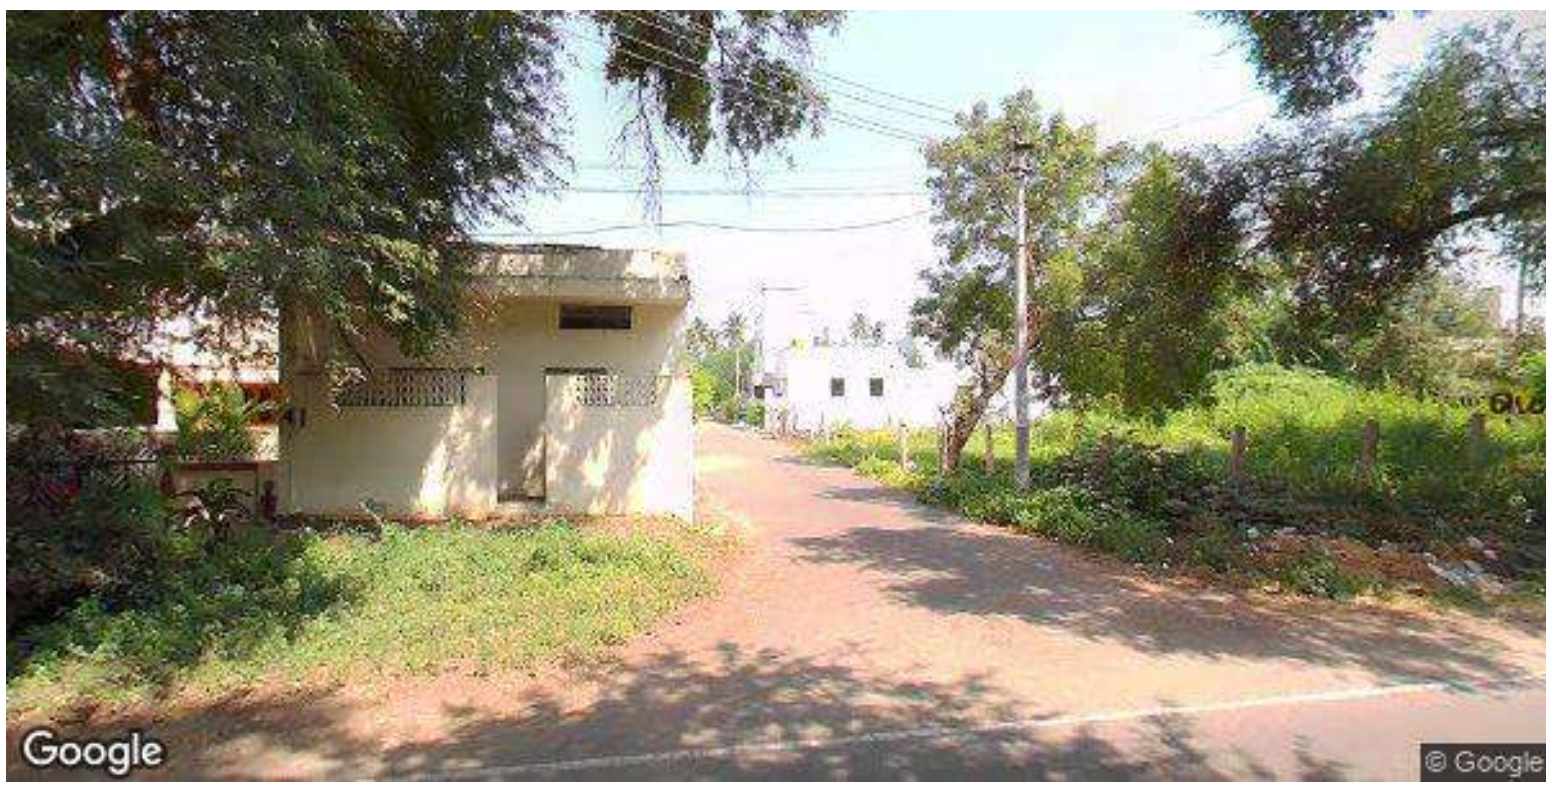
**Coordinates:** 11.11405, 78.02142

**Risk Type:** Blind Spot

**Risk Level:** Blind Spot

**Speed Limit:** 10 KM/Hr
