# IndianOil

## JOURNEY RISK MANAGEMENT (JRM) STUDY

### Salem Terminal TO KULUMAI AGENCIES

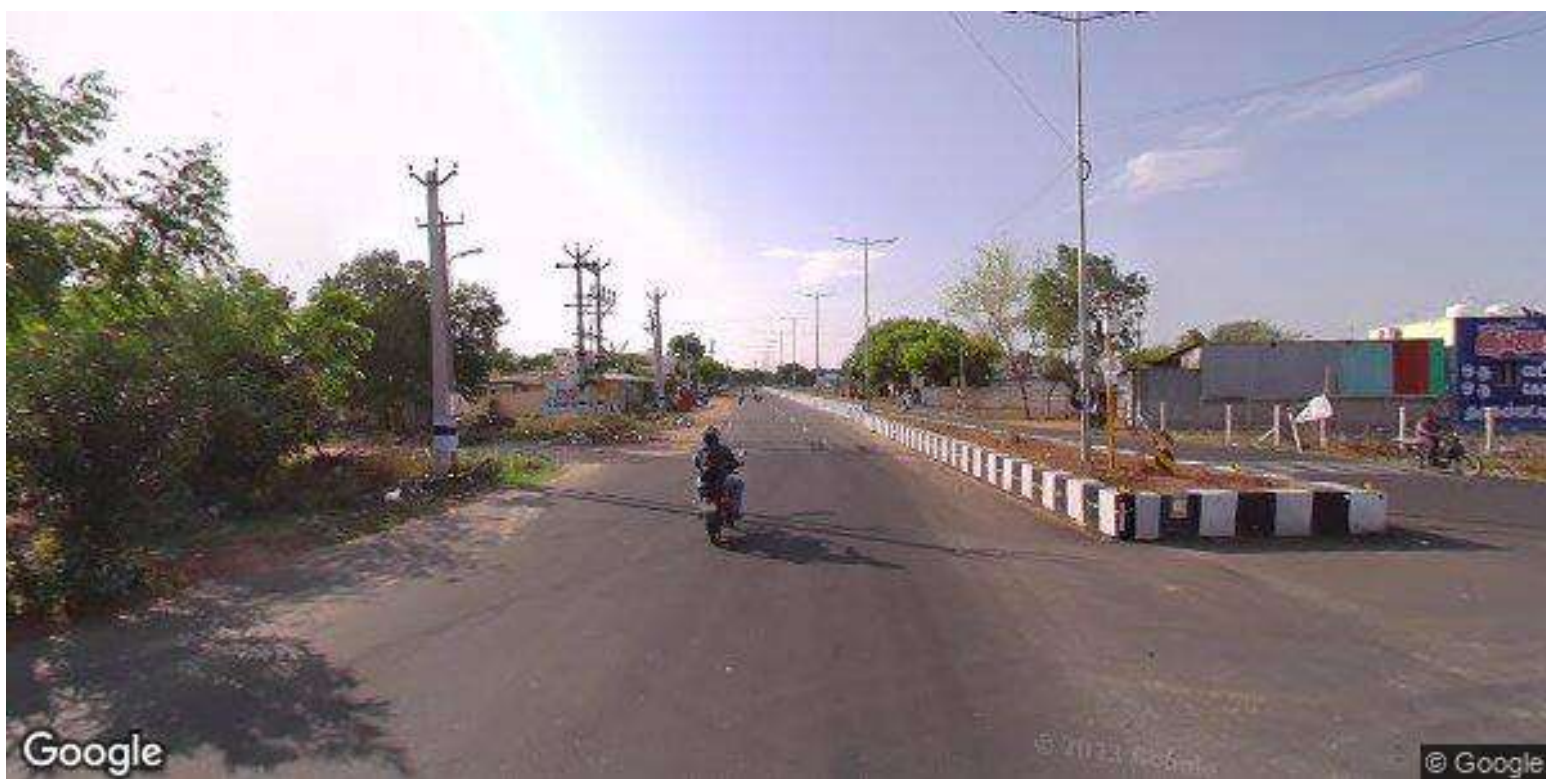
**Coordinates:** 10.9110477, 78.09713769999999

| | Risk Type | Risk Level | Coordinates | Speed Limit |
|---|---|---|---|---|
| 2 | U-Turn | High | 10.9110477, 78.09713769999999 | 10 KM/Hr |

**Risk Type:** U-Turn

**Risk Level:** High

**Speed Limit:** 10 KM/Hr

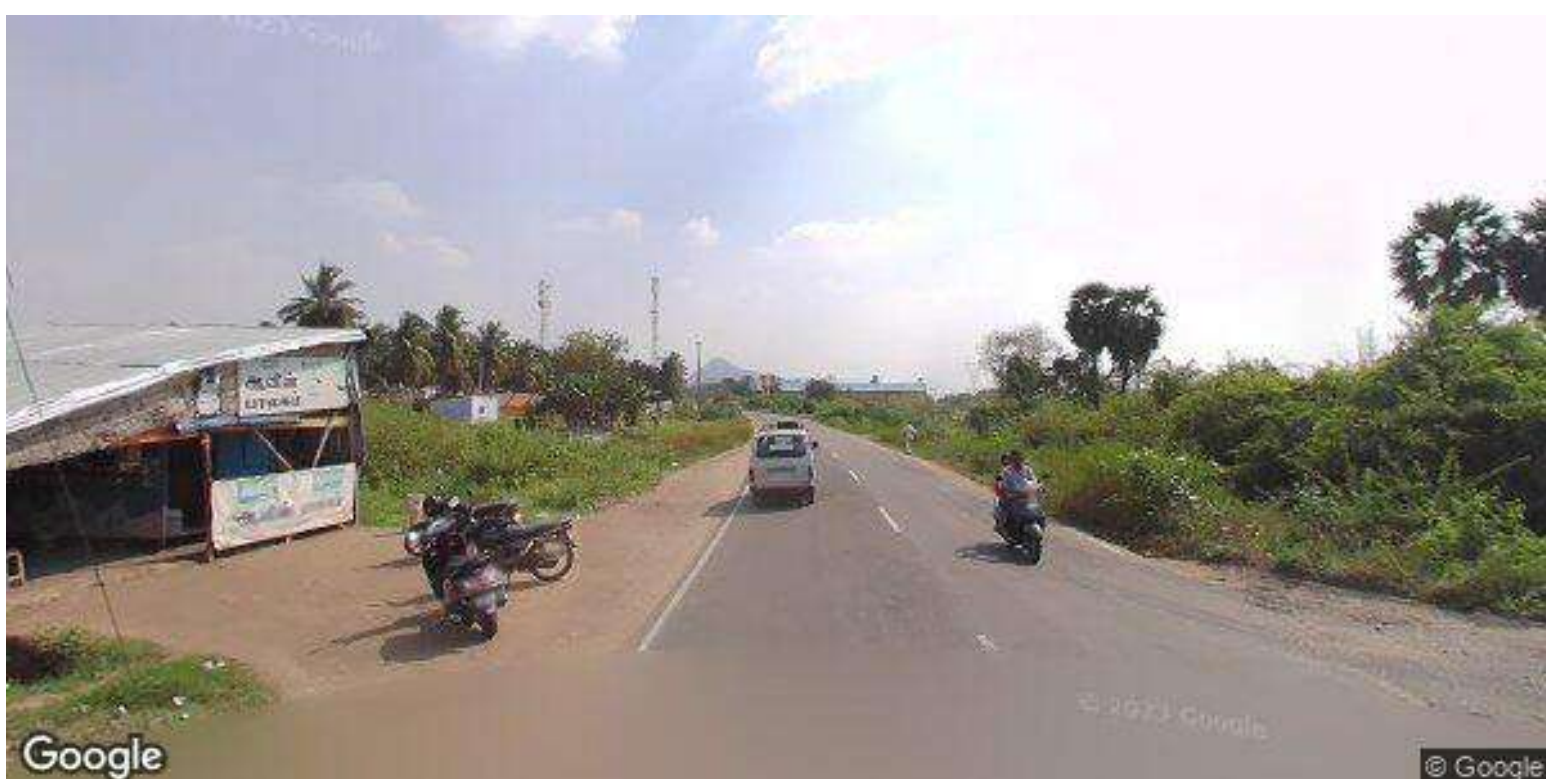
**Coordinates: 11.44022, 77.87546**

| | Risk Type | Risk Level | Coordinates | Speed Limit |
|---|---|---|---|---|
| 5 | Turn | High | 11.44022, 77.87546 | 15 KM/Hr |

**Risk Type: Turn**

**Risk Level: High**

**Speed Limit: 15 KM/Hr**

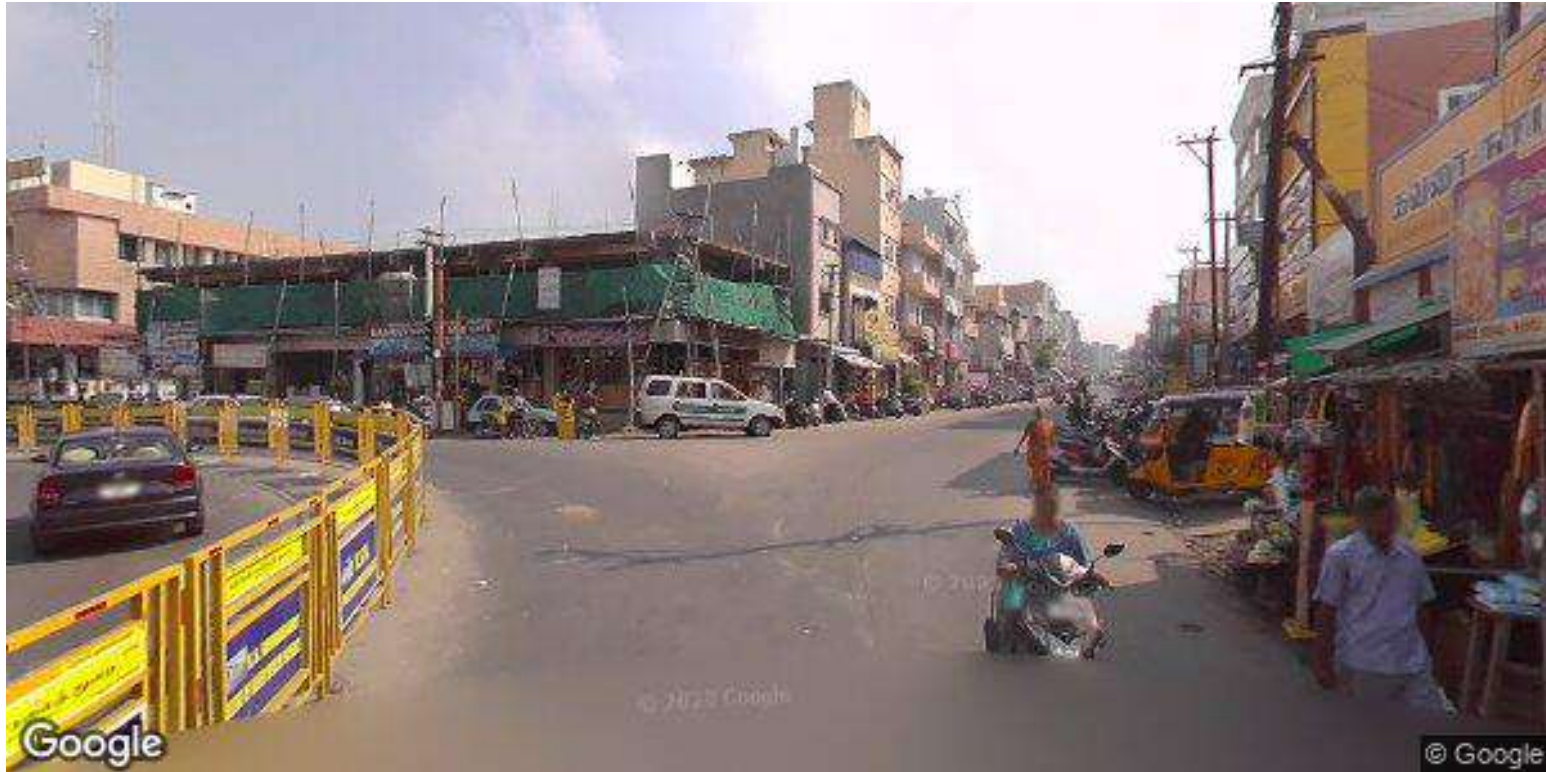
**Coordinates: 11.37862, 77.89488**

| | Risk Type | Risk Level | Coordinates | Speed Limit |
|---|---|---|---|---|
| 6 | Turn | High | 11.37862, 77.89488 | 15 KM/Hr |

**Risk Type: Turn**

**Risk Level: High**

**Speed Limit: 15 KM/Hr**

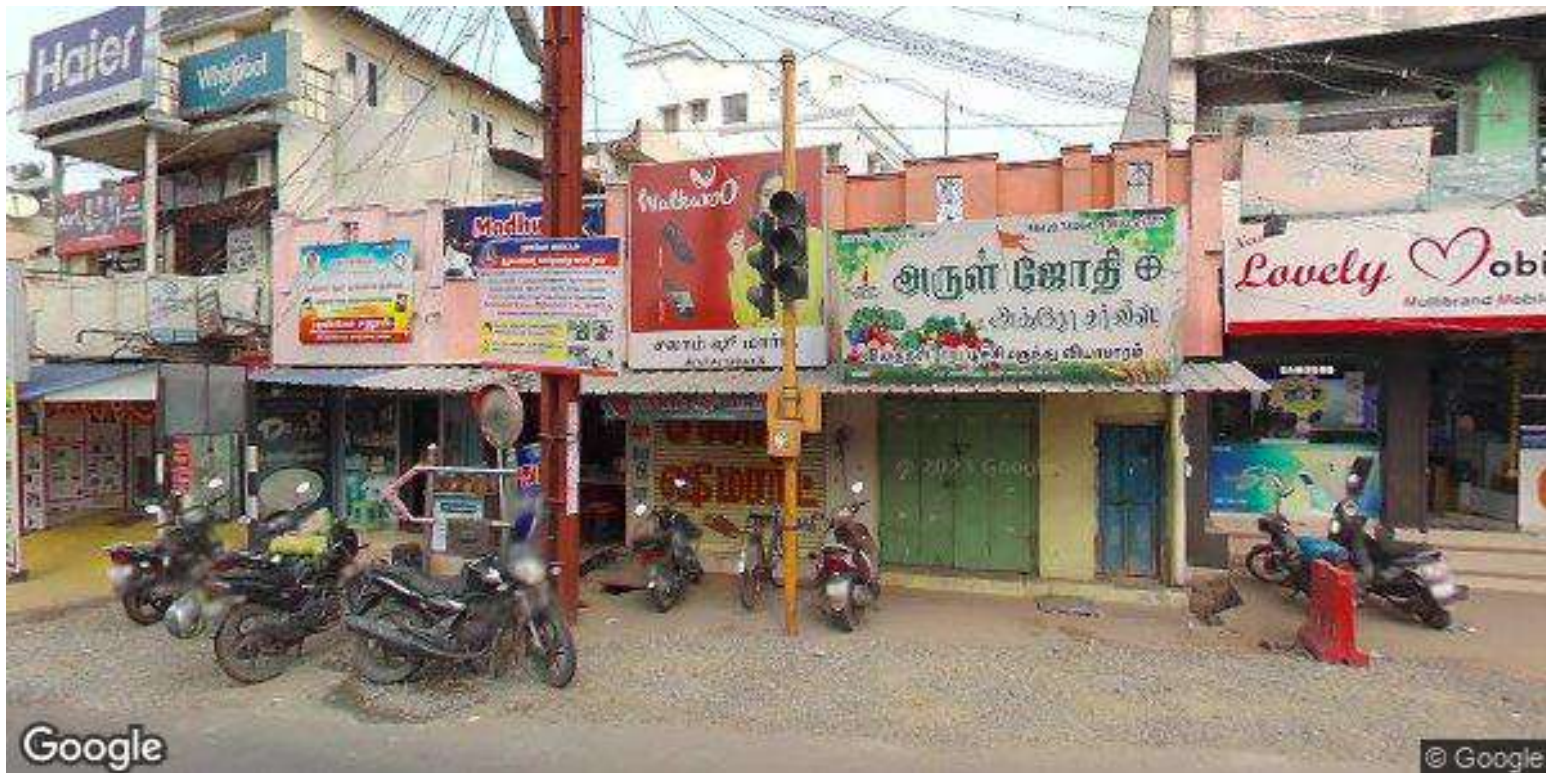
**Coordinates: 11.37850, 77.89453**

| | Risk Type | Risk Level | Coordinates | Speed Limit |
|---|---|---|---|---|
| 7 | Turn | High | 11.37850, 77.89453 | 15 KM/Hr |

**Risk Type: Turn**

**Risk Level: High**

**Speed Limit: 15 KM/Hr**

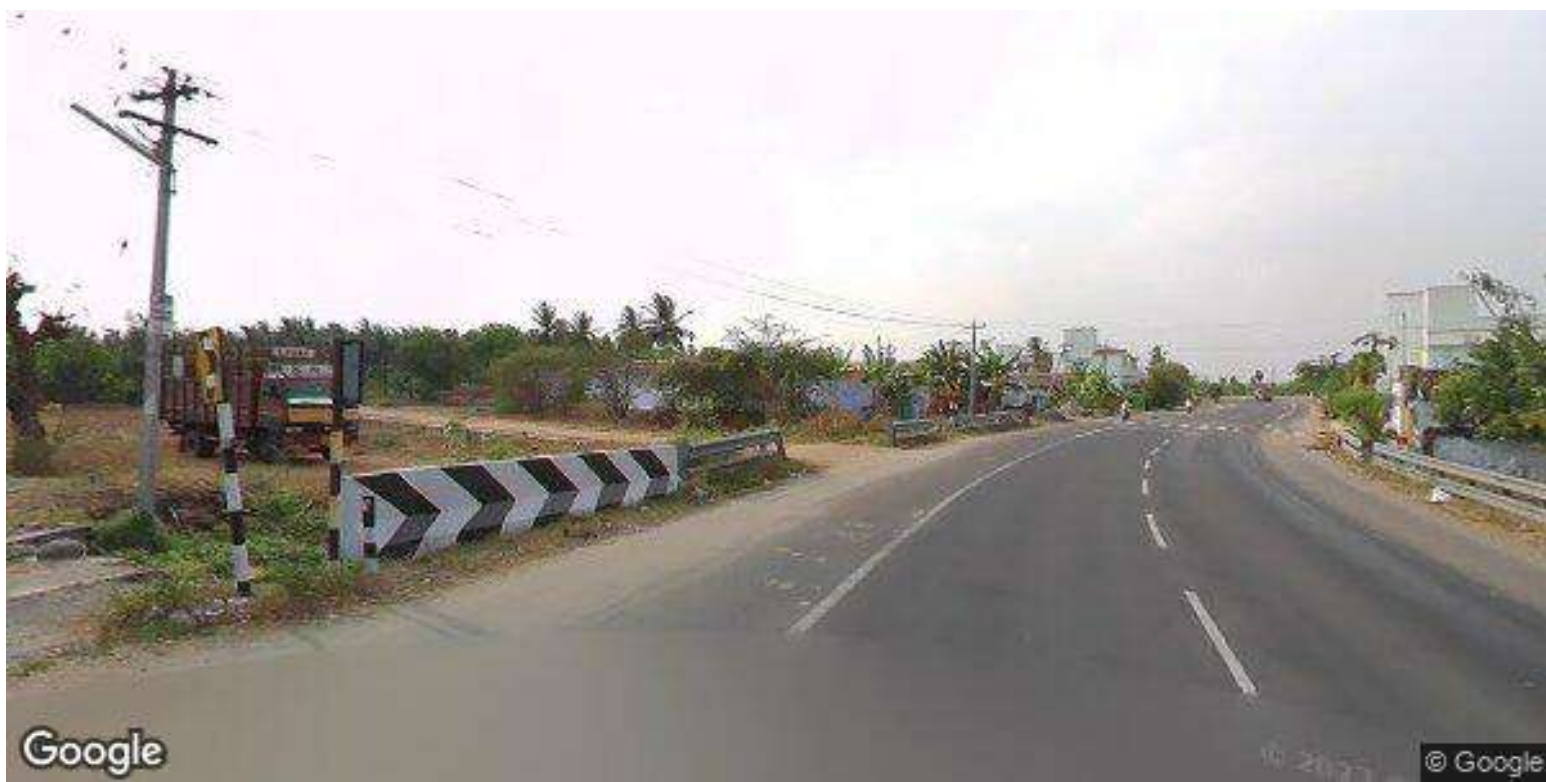
**Coordinates:** 11.16755, 78.01568

| | Risk Type | Risk Level | Coordinates | Speed Limit |
|---|---|---|---|---|
| 8 | Turn | Medium | 11.16755, 78.01568 | 30 KM/Hr |

**Risk Type:** Turn

**Risk Level:** Medium

**Speed Limit:** 30 KM/Hr

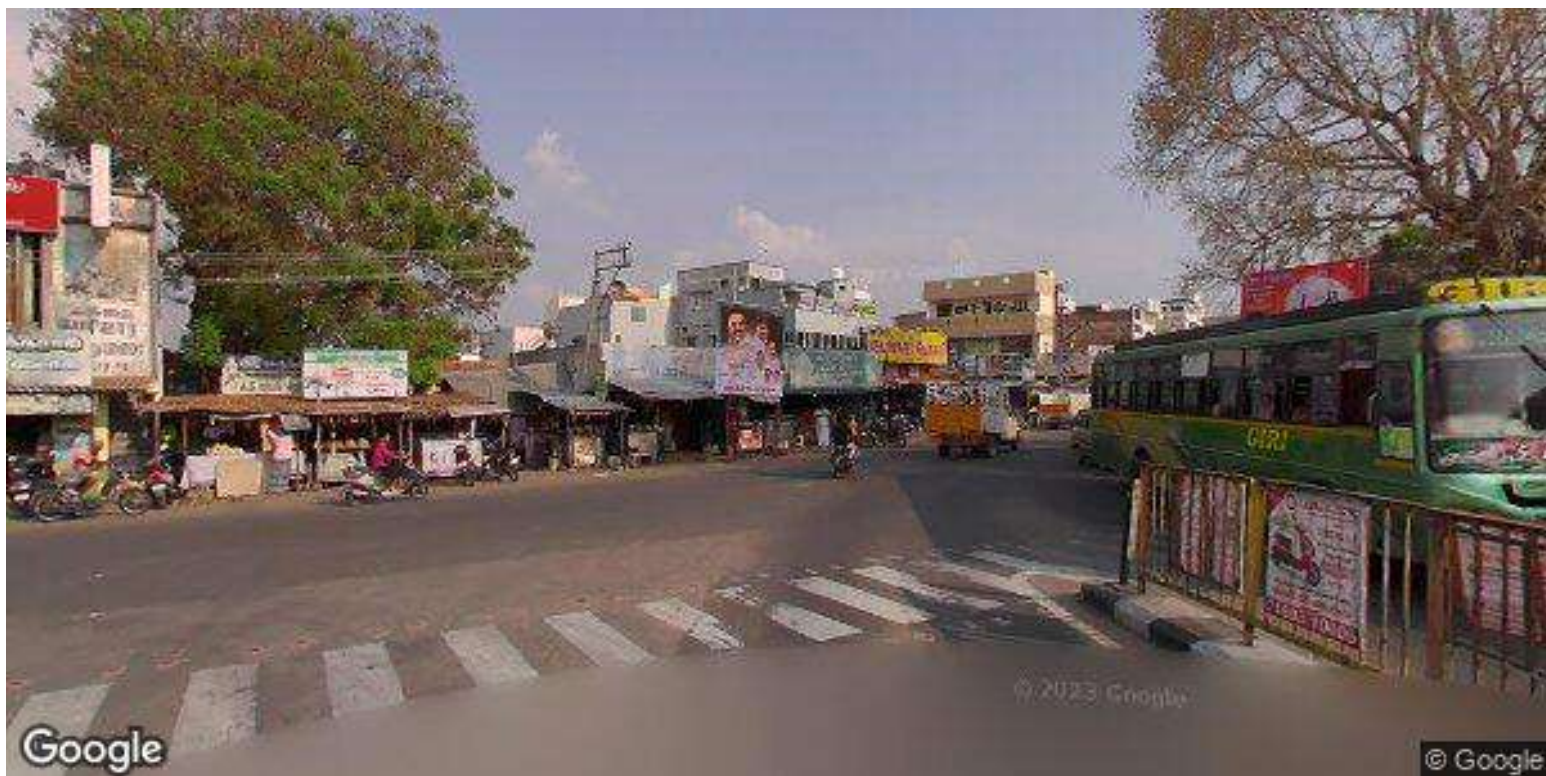
**Coordinates:** 11.15579, 78.02169

| | Risk Type | Risk Level | Coordinates | Speed Limit |
|---|---|---|---|---|
| 9 | Turn | Medium | 11.15579, 78.02169 | 30 KM/Hr |

**Risk Type:** Turn

**Risk Level:** Medium

**Speed Limit:** 30 KM/Hr

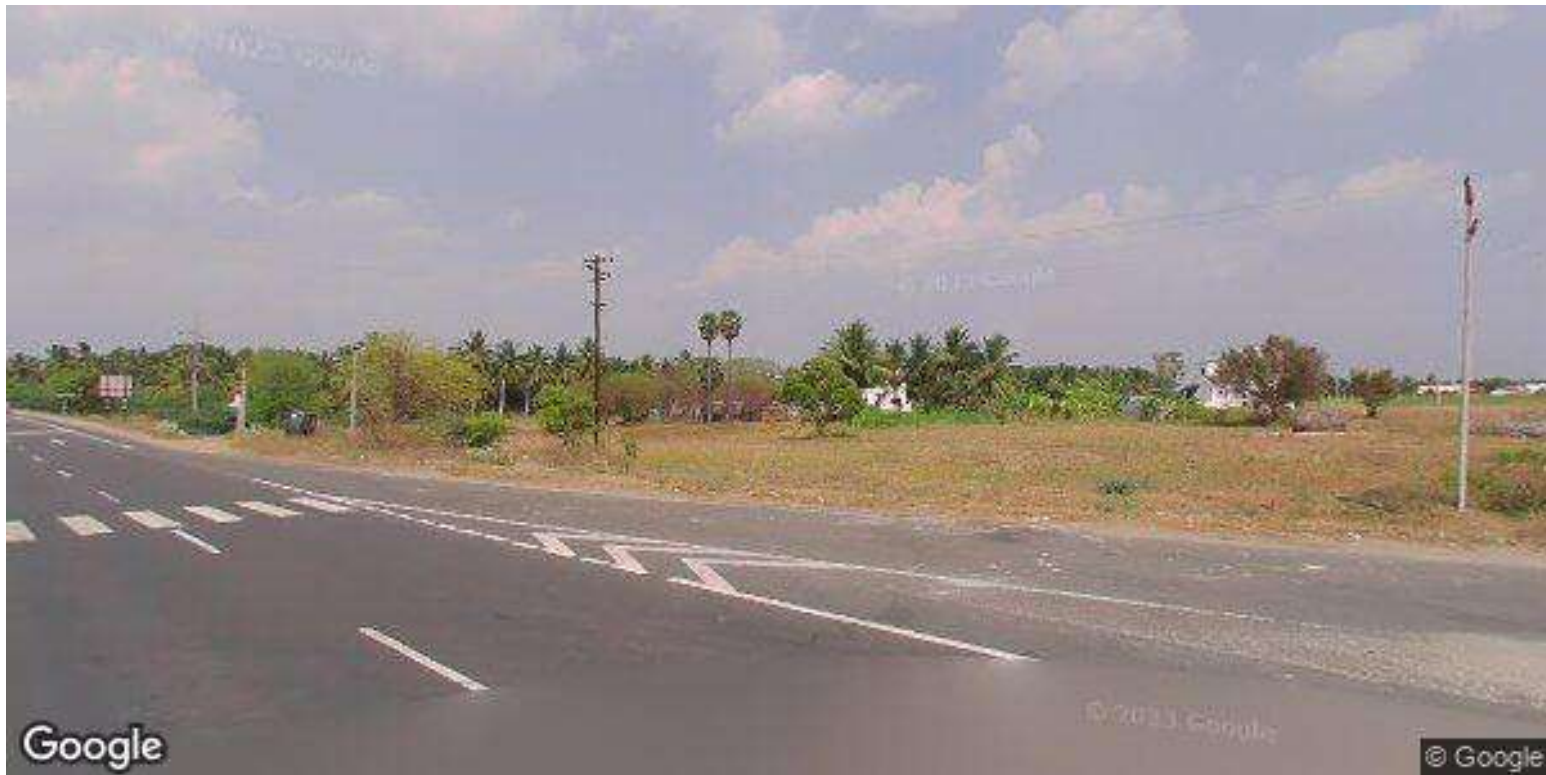
**Coordinates:** 11.14480, 78.02291

| | Risk Type | Risk Level | Coordinates | Speed Limit |
|---|---|---|---|---|
| 11 | Turn | High | 11.14480, 78.02291 | 15 KM/Hr |

**Risk Type:** Turn

**Risk Level:** High

**Speed Limit:** 15 KM/Hr

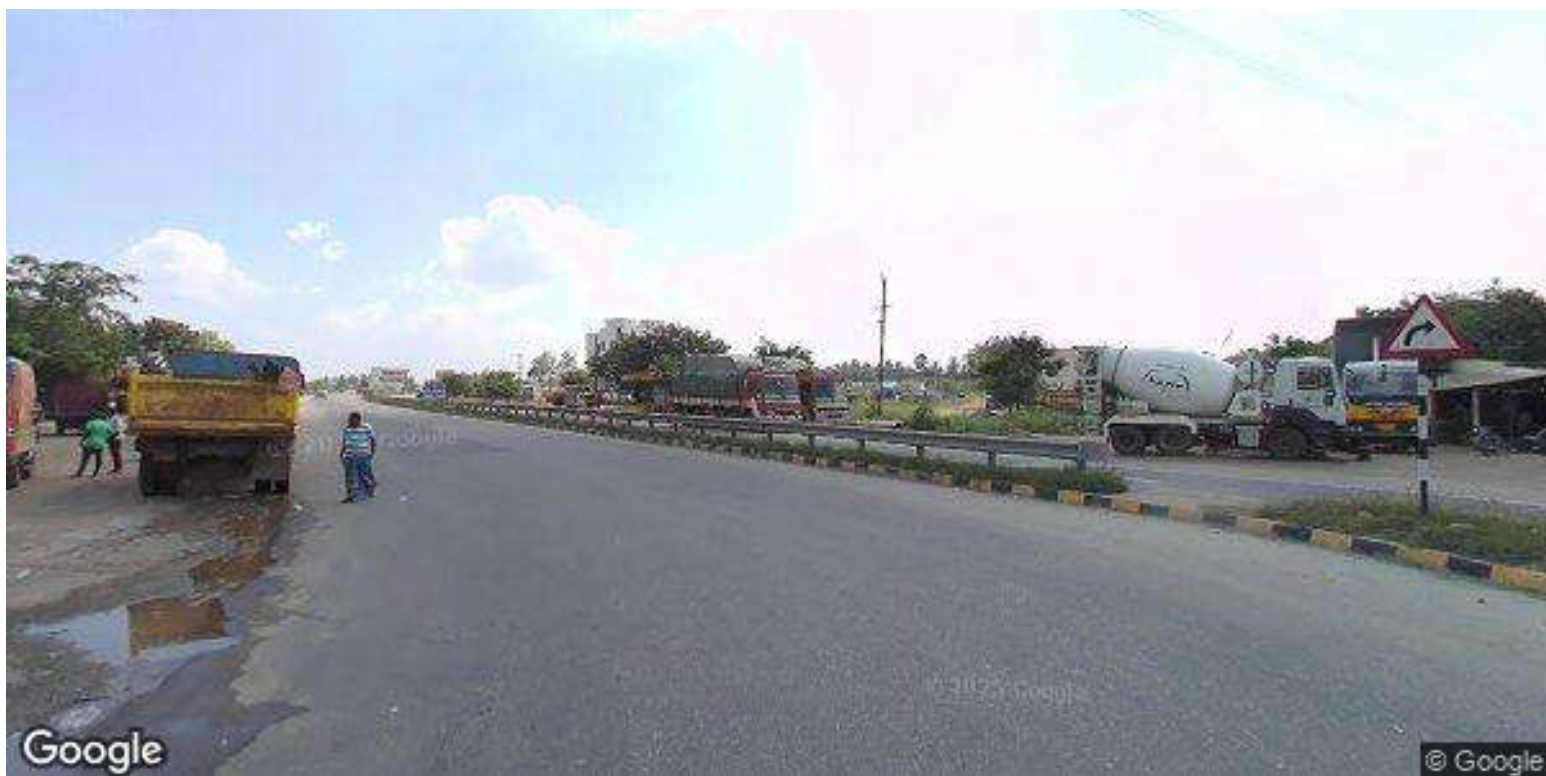
**Coordinates:** 10.92922, 78.05481

| | Risk Type | Risk Level | Coordinates | Speed Limit |
|---|---|---|---|---|
| 12 | Turn | Medium | 10.92922, 78.05481 | 30 KM/Hr |

**Risk Type:** Turn

**Risk Level:** Medium

**Speed Limit:** 30 KM/Hr

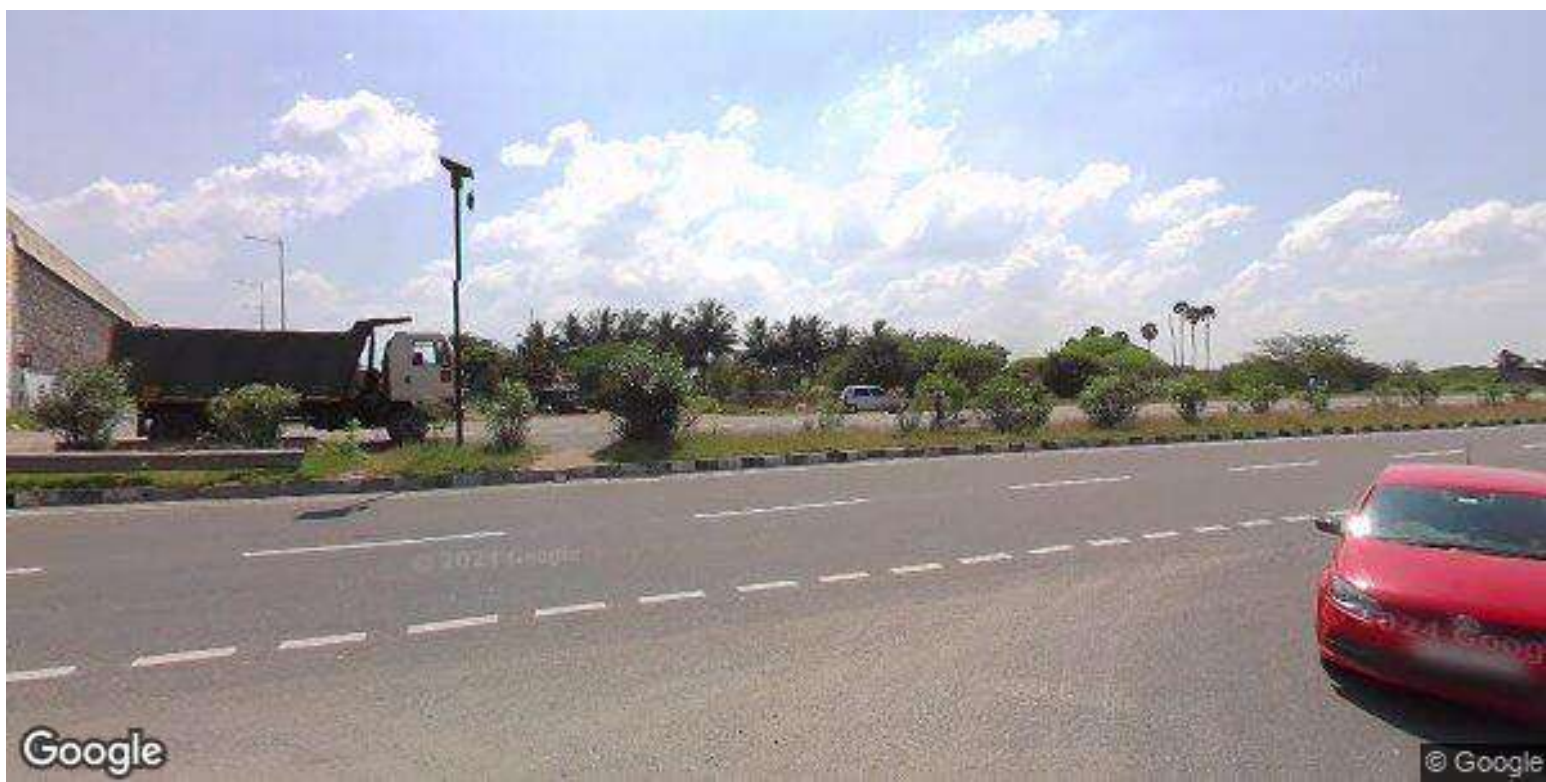
**Coordinates:** 10.90784, 78.09916

| | Risk Type | Risk Level | Coordinates | Speed Limit |
|---|---|---|---|---|
| 13 | Turn | High | 10.90784, 78.09916 | 15 KM/Hr |

**Risk Type:** Turn

**Risk Level:** High

**Speed Limit:** 15 KM/Hr

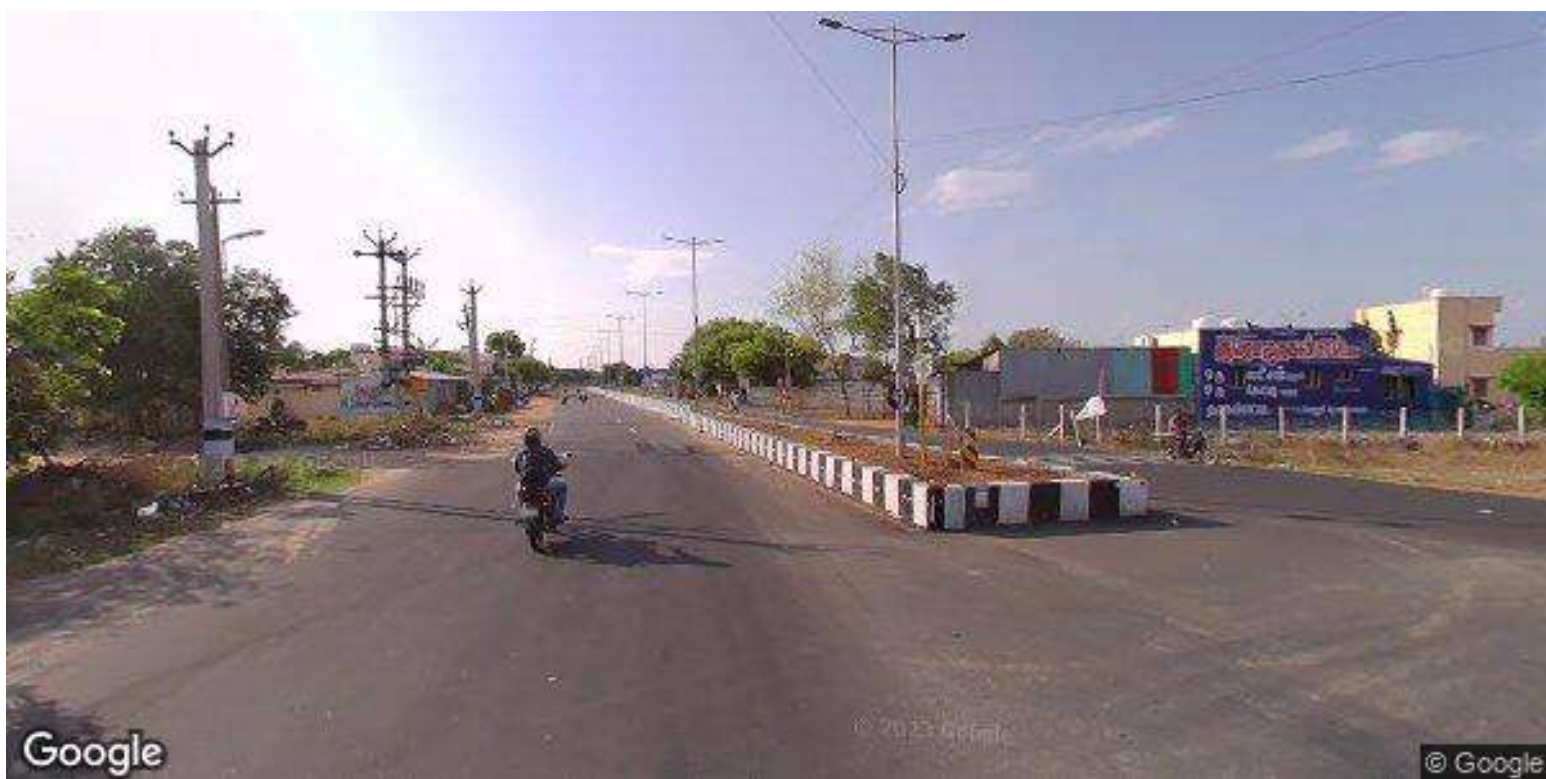
**Coordinates:** 10.91105, 78.09714

| | Risk Type | Risk Level | Coordinates | Speed Limit |
|---|---|---|---|---|
| 14 | Blind Spot | Blind Spot | 10.91105, 78.09714 | 10 KM/Hr |

**Risk Type:** Blind Spot

**Risk Level:** Blind Spot

**Speed Limit:** 10 KM/Hr

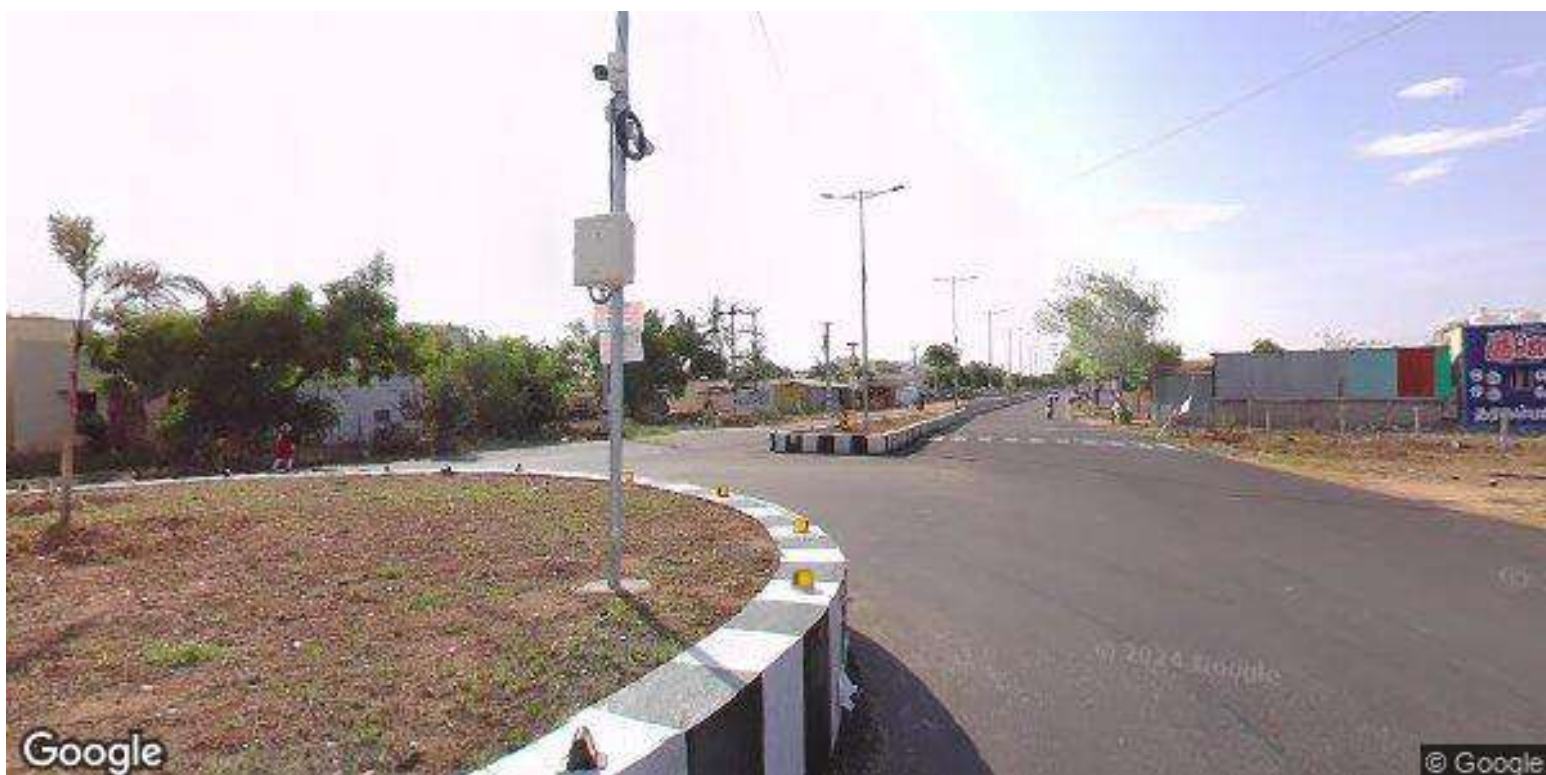
**Coordinates:** 10.91103, 78.09733

| 15 | Turn | High | 10.91103, 78.09733 | 15 KM/Hr |

**Risk Type:** Turn

**Risk Level:** High

**Speed Limit:** 15 KM/Hr
