# IndianOil

## JOURNEY RISK MANAGEMENT (JRM) STUDY

### Salem Terminal TO YADHAVAN AGENCIES

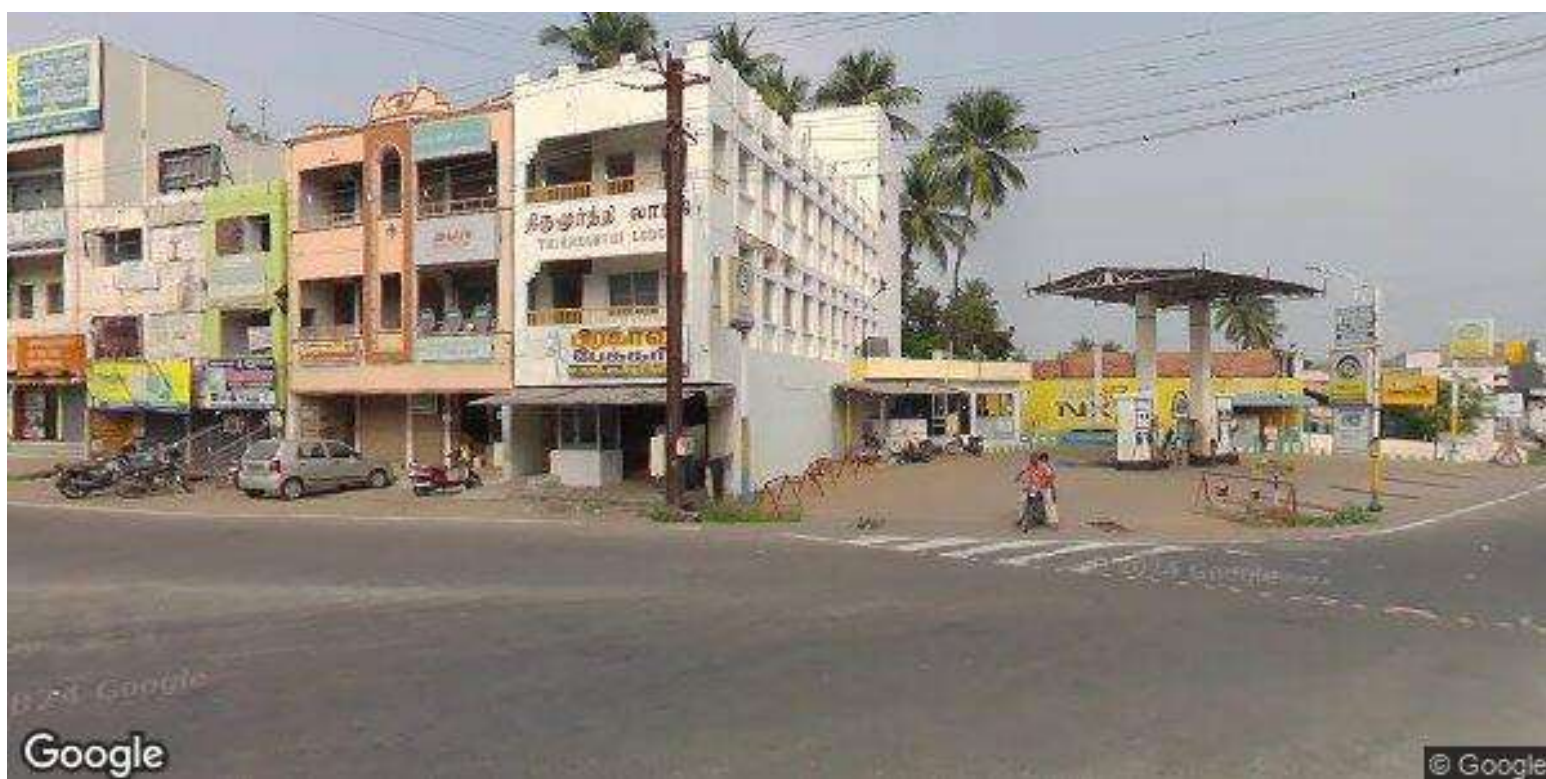
**Coordinates: 11.00172, 77.56268**

**Risk Type: Roundabout**

**Risk Level: High**

**Speed Limit: 15 KM/Hr**

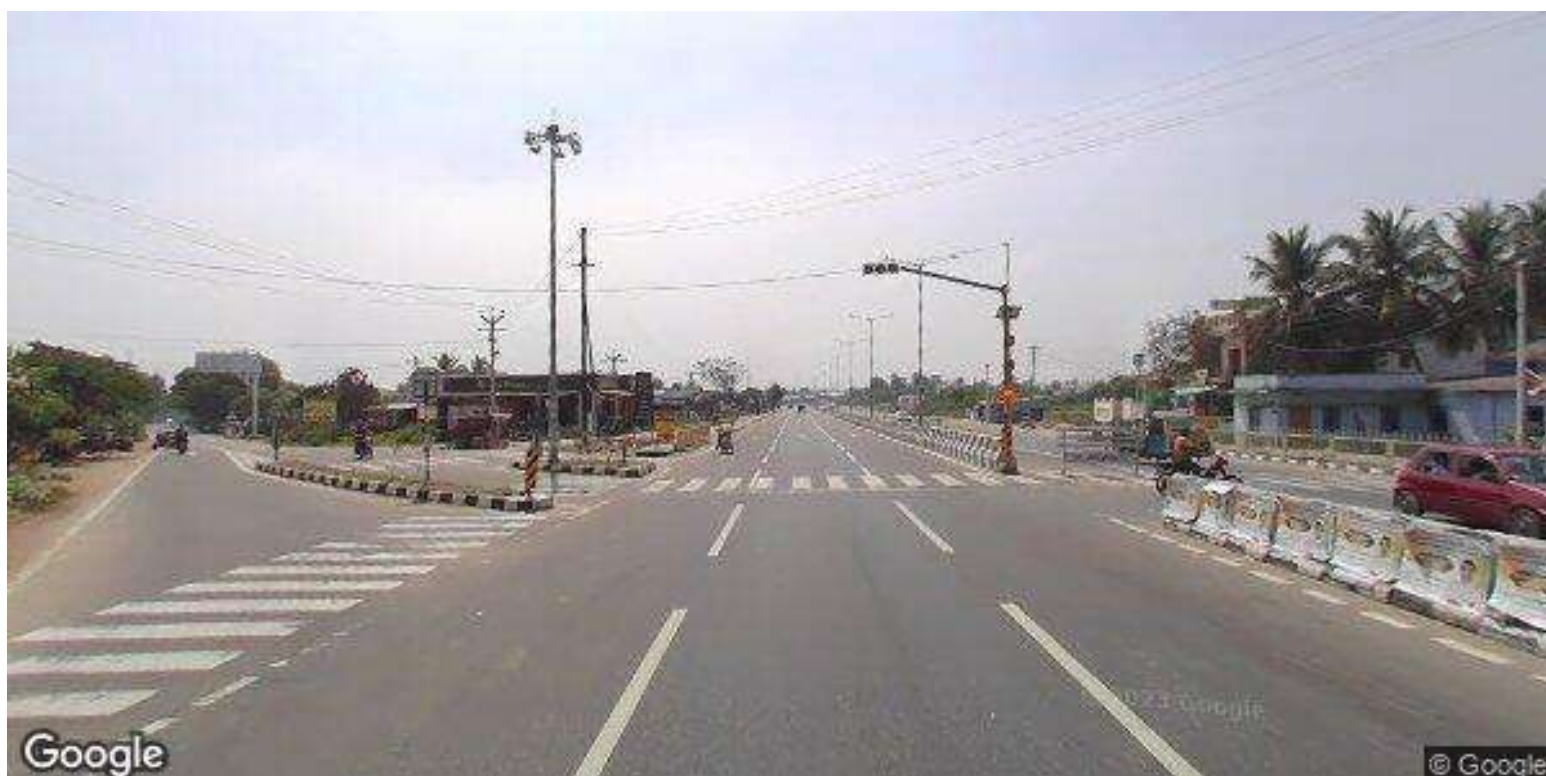
Coordinates: 10.7474551, 77.5187942

Risk Type: U-Turn

Risk Level: High

Speed Limit: 10 KM/Hr

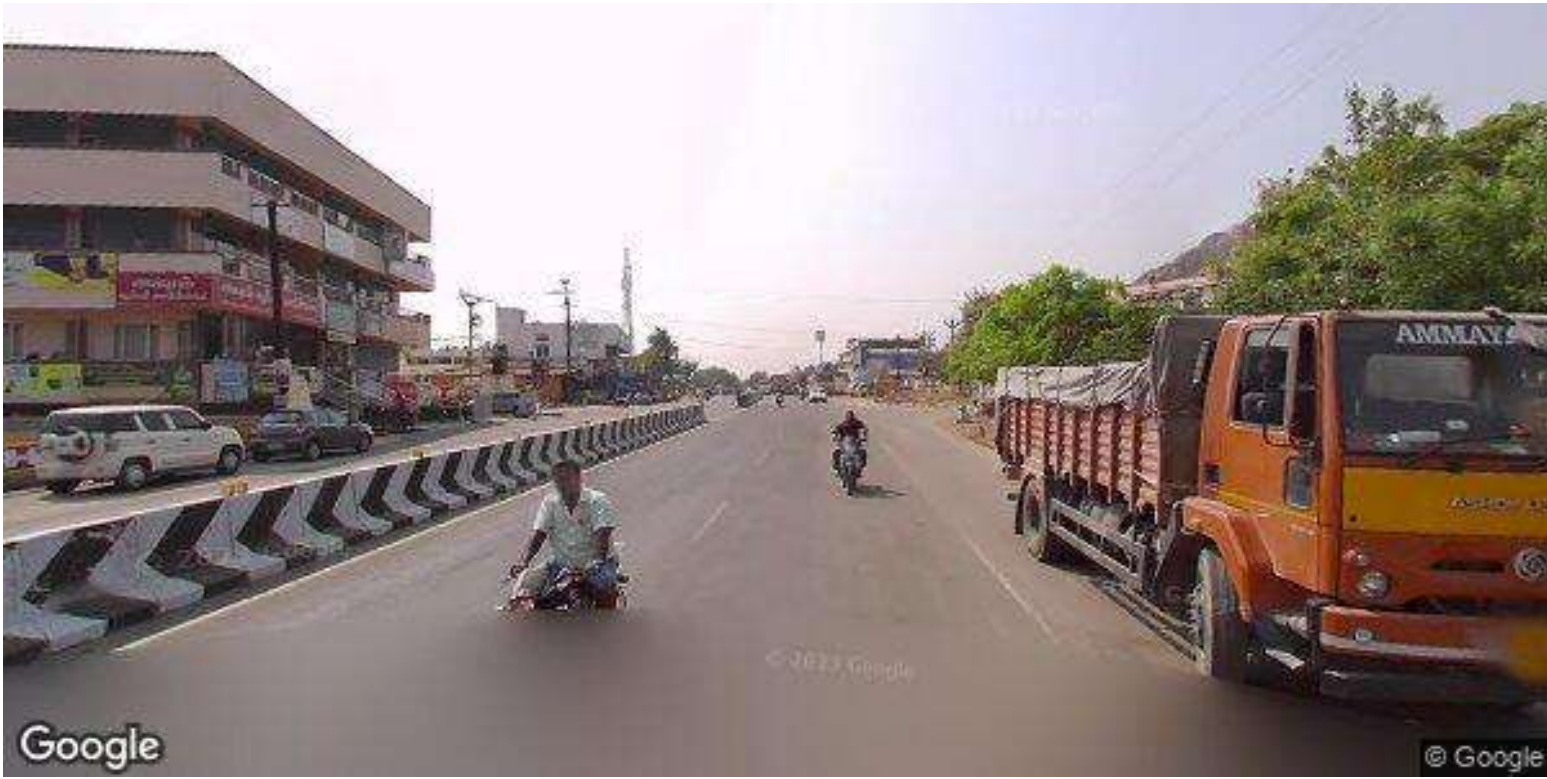
**Risk Type:** Turn  
**Risk Level:** Medium  
**Speed Limit:** 30 KM/Hr  
**Coordinates:** 11.39690, 77.88852

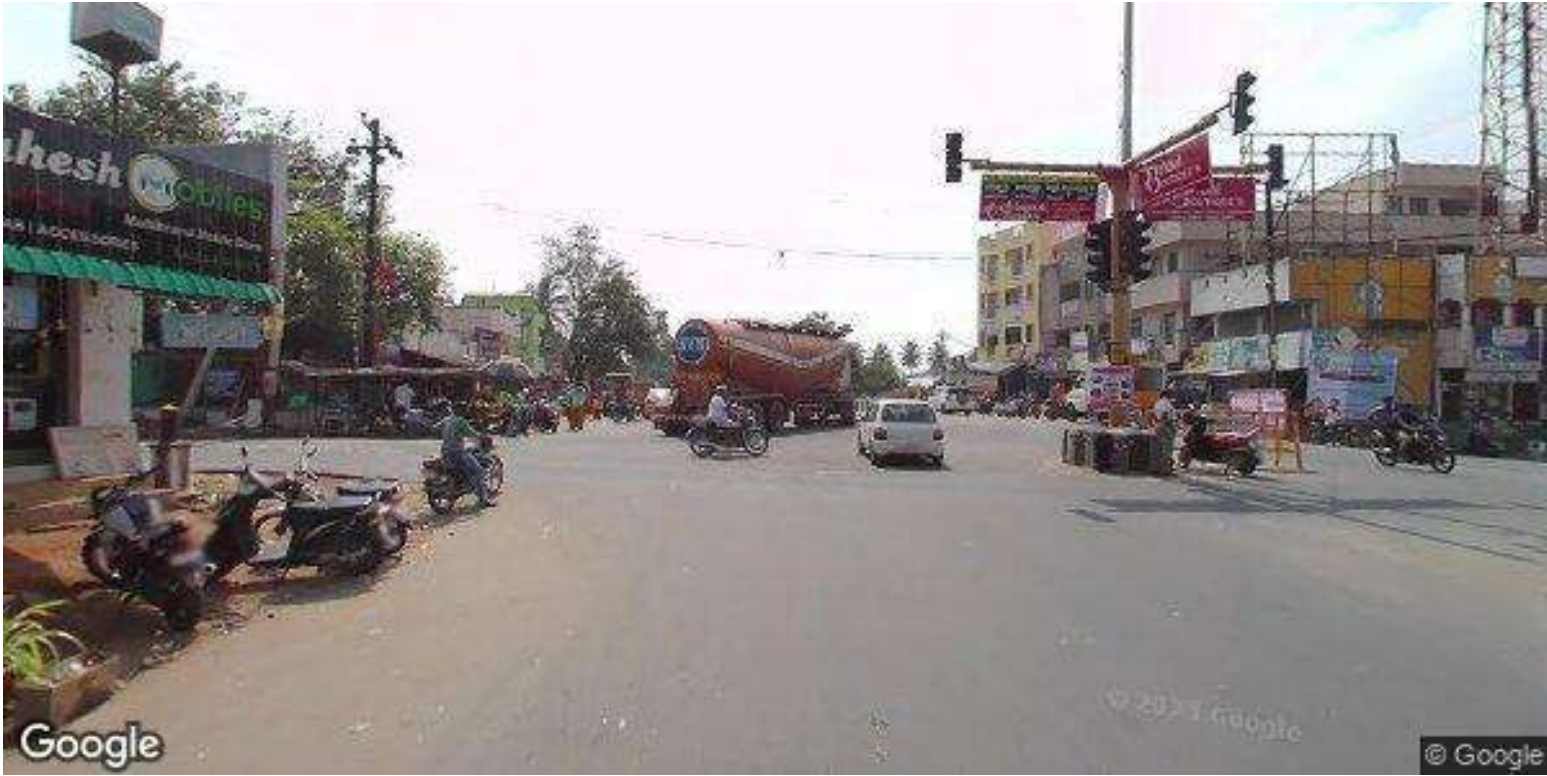
**Risk Type:** Turn  
**Risk Level:** High  
**Speed Limit:** 15 KM/Hr  
**Coordinates:** 11.36616, 77.88885

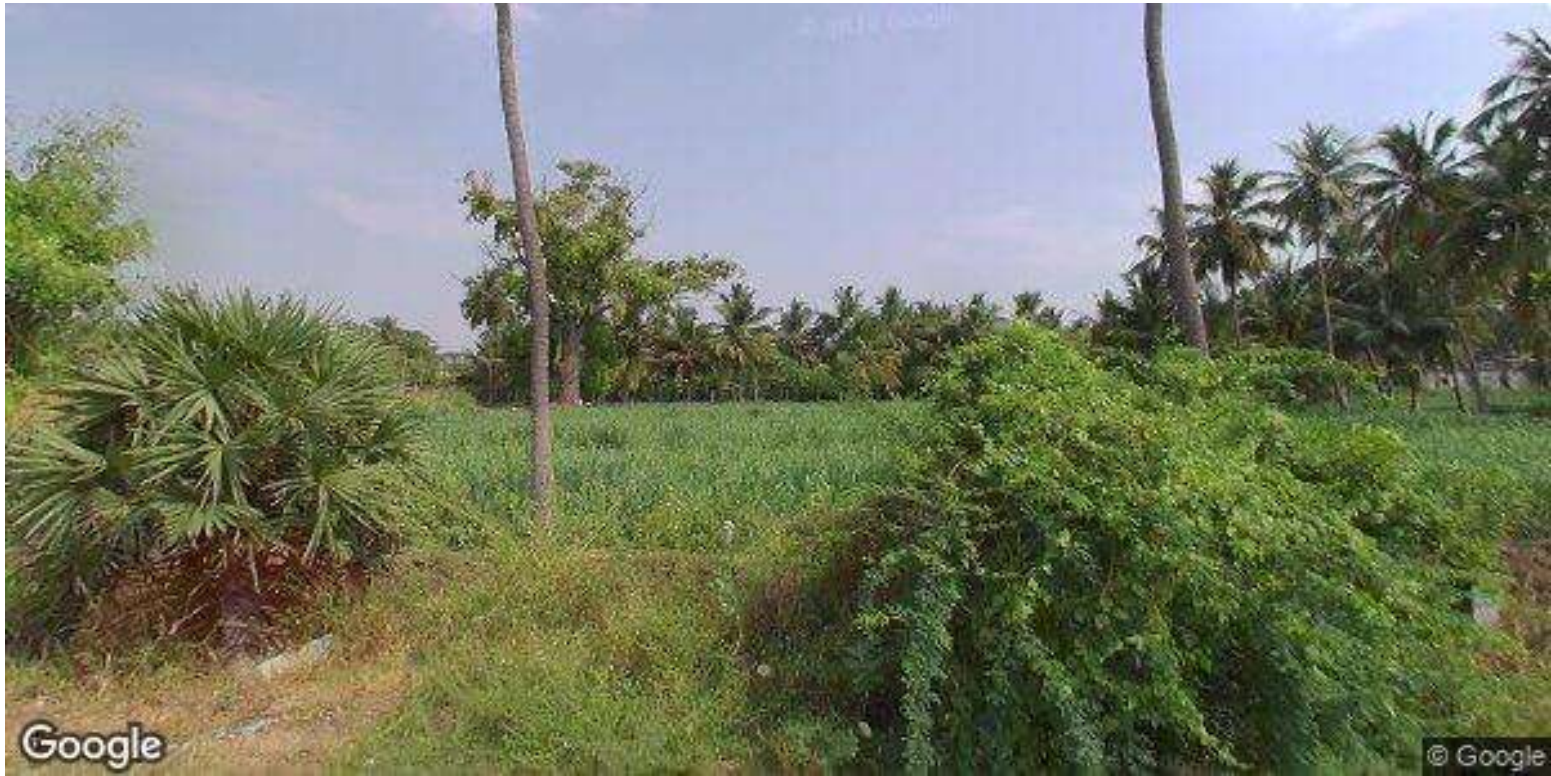
**Risk Type:** Turn  
**Risk Level:** High  
**Speed Limit:** 15 KM/Hr  
**Coordinates:** 11.29125, 77.74646

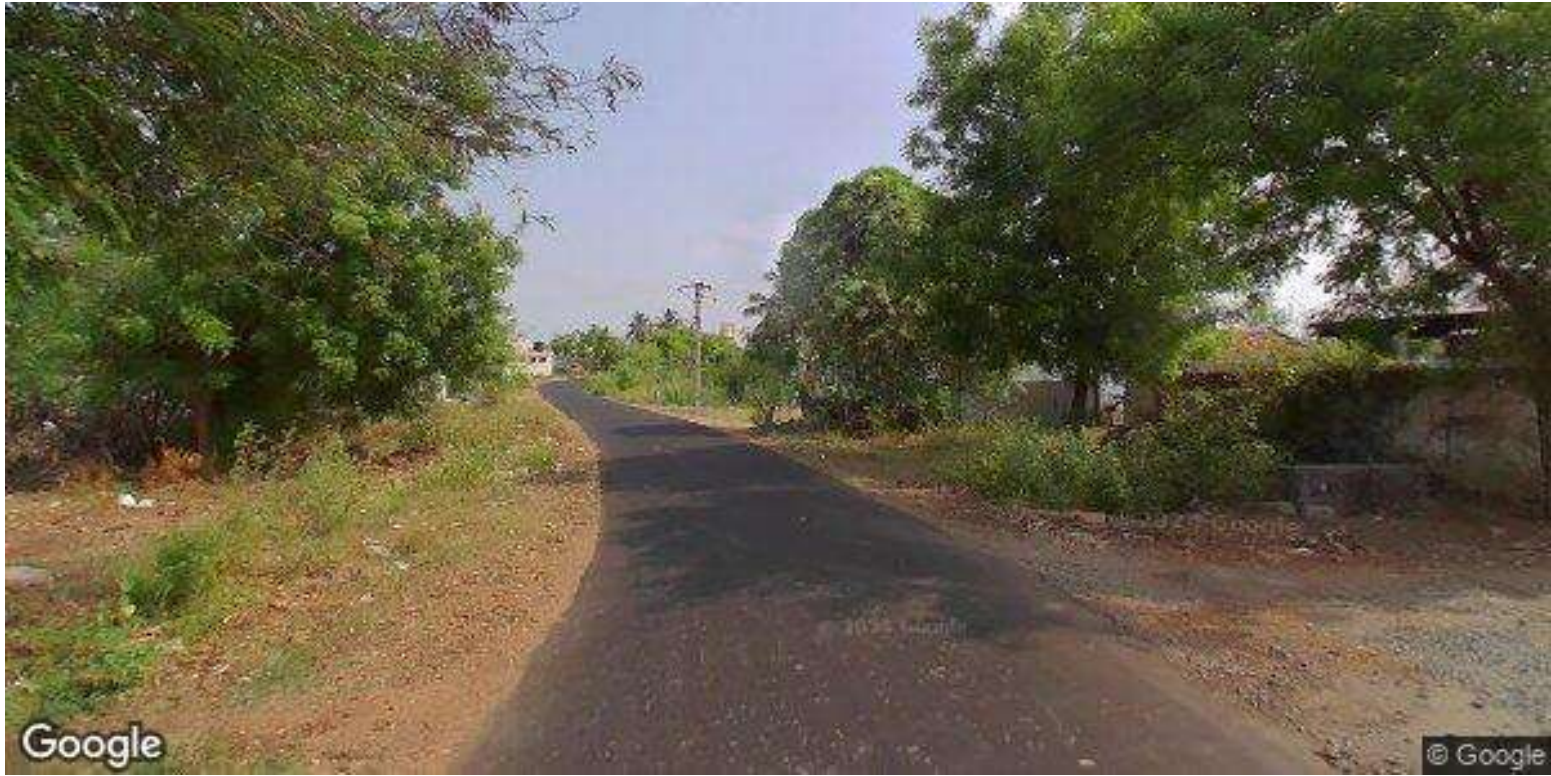
**Risk Type:** Turn  
**Risk Level:** Medium  
**Speed Limit:** 30 KM/Hr  
**Coordinates:** 11.28844, 77.74319

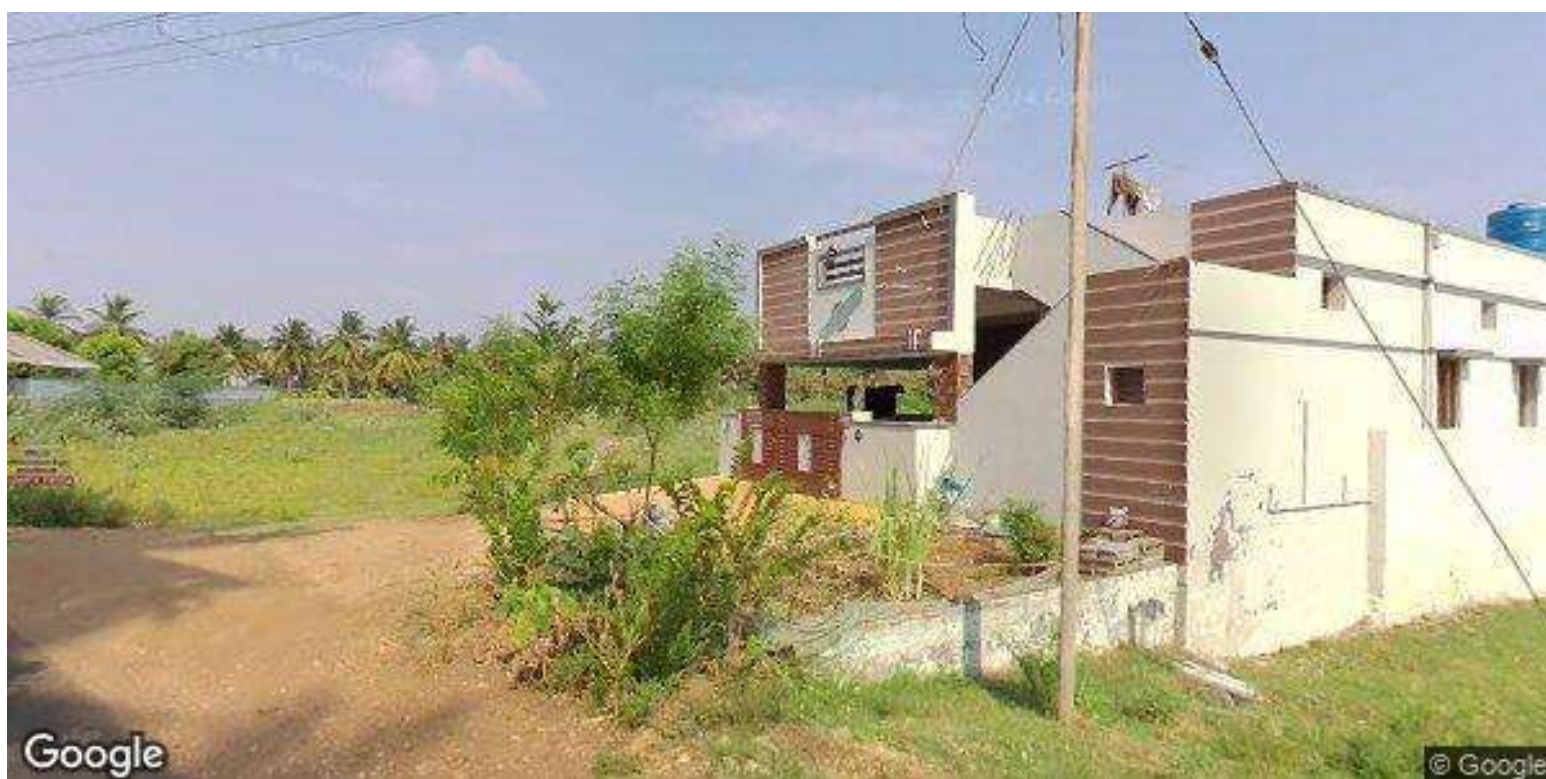
**Coordinates:** 11.27319, 77.72981

**Risk Type:** Turn

**Risk Level:** High

**Speed Limit:** 15 KM/Hr

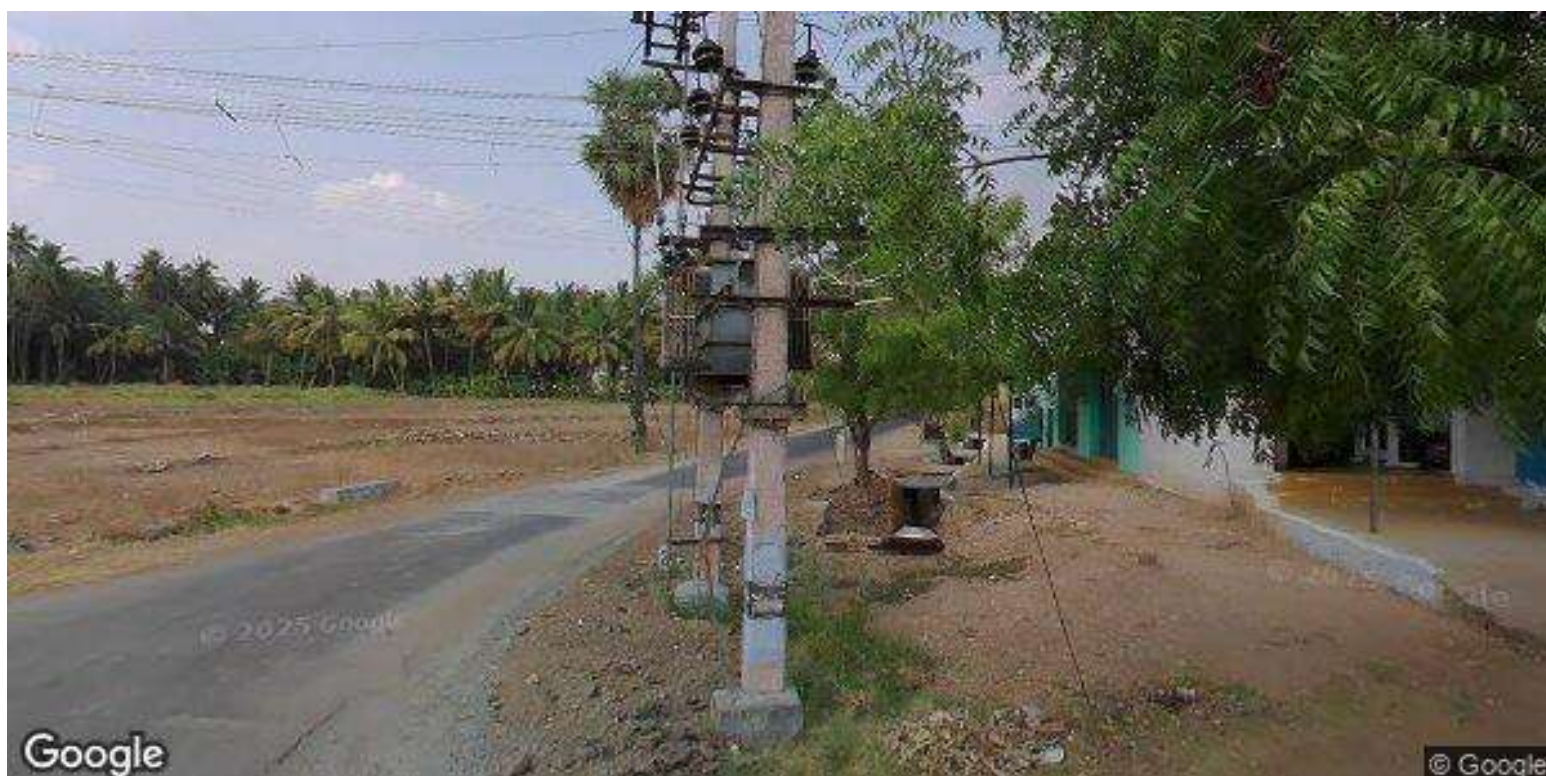
**Risk Type:** Blind Spot  
**Risk Level:** Blind Spot  
**Speed Limit:** 10 KM/Hr  
**Coordinates:** 11.27330, 77.72715

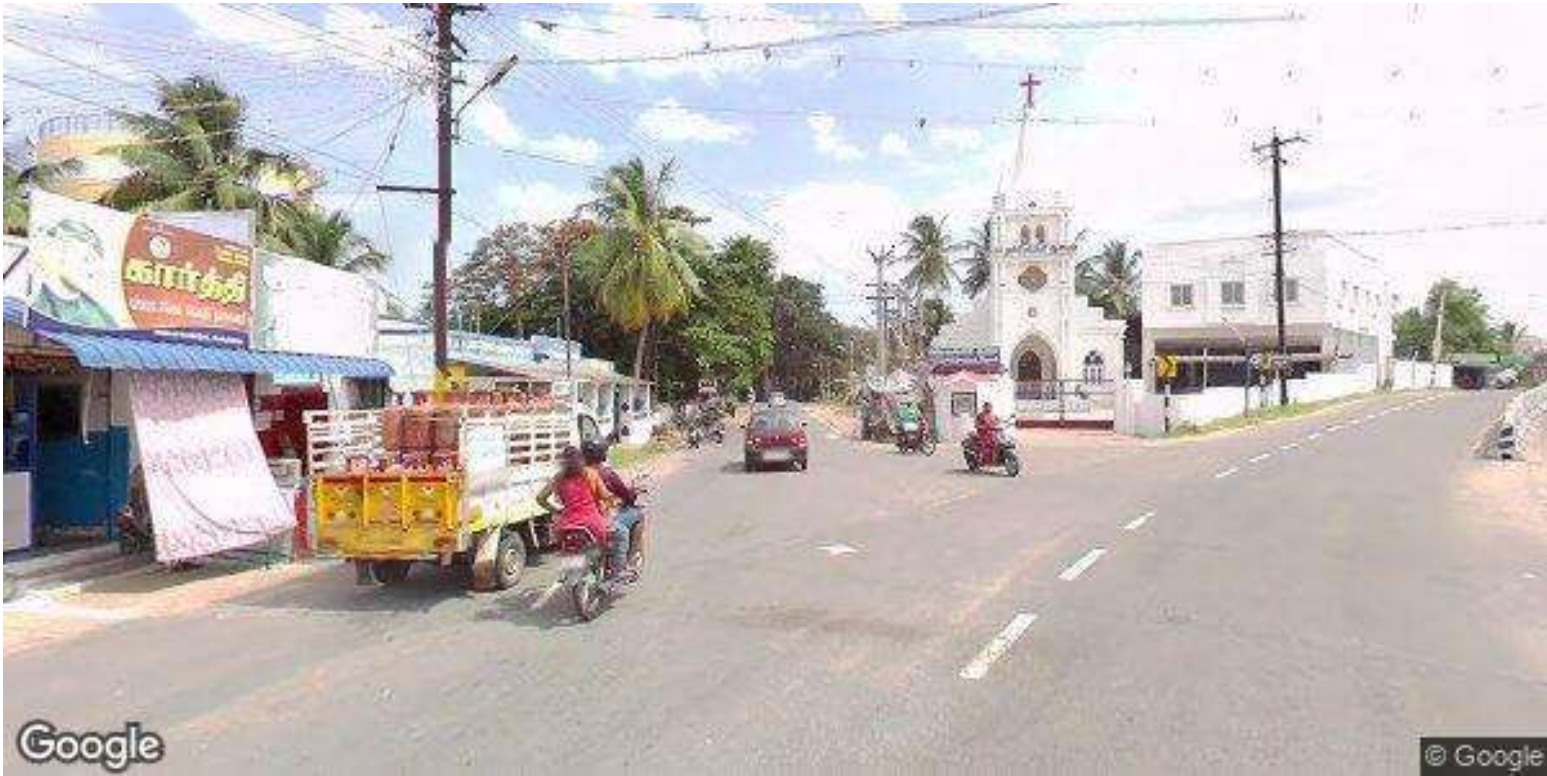
**Risk Type:** Turn  
**Risk Level:** Medium  
**Speed Limit:** 30 KM/Hr  
**Coordinates:** 11.23054, 77.71796

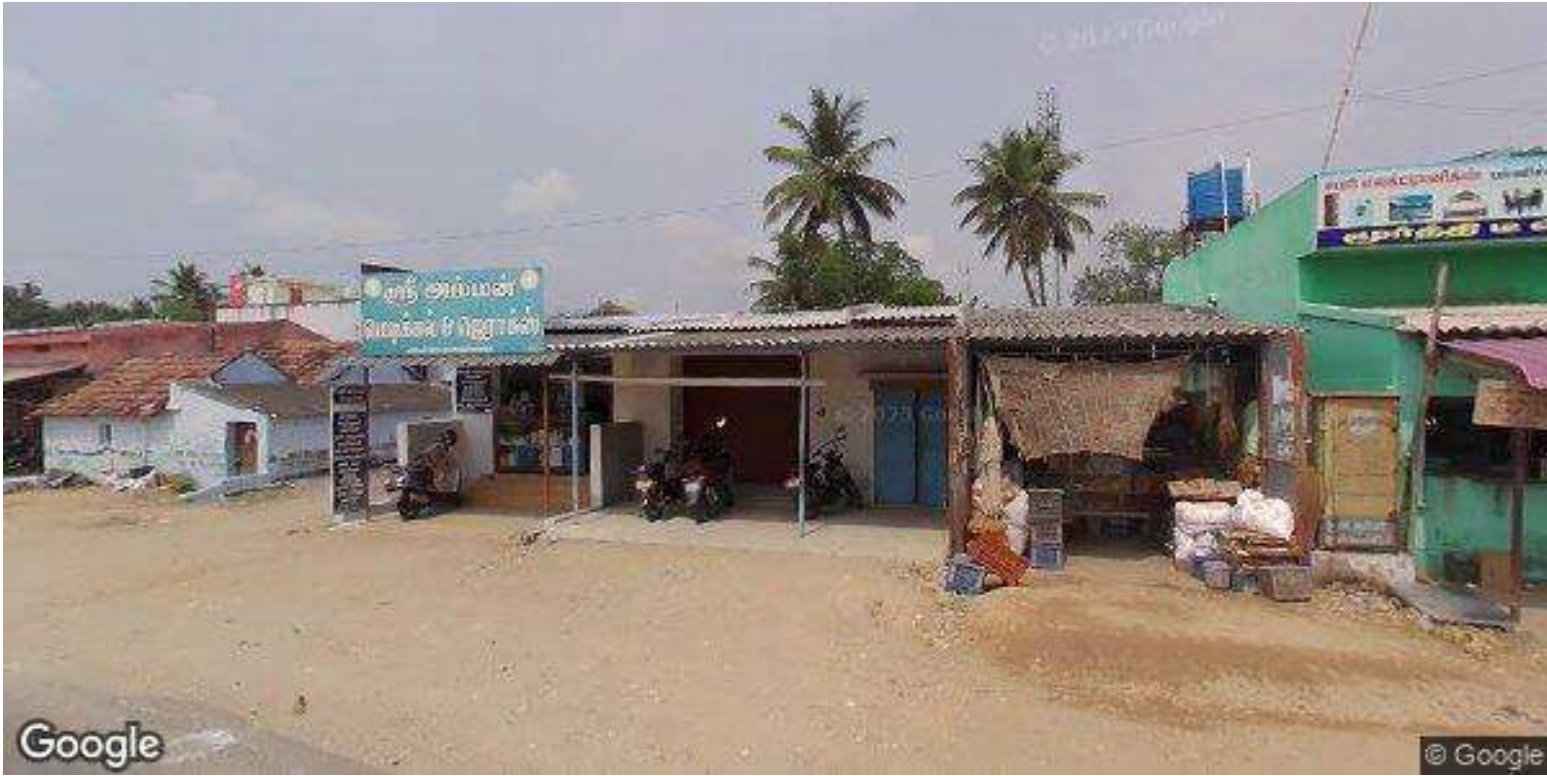
**Risk Type:** Turn  
**Risk Level:** Medium  
**Speed Limit:** 30 KM/Hr  
**Coordinates:** 11.20776, 77.70916

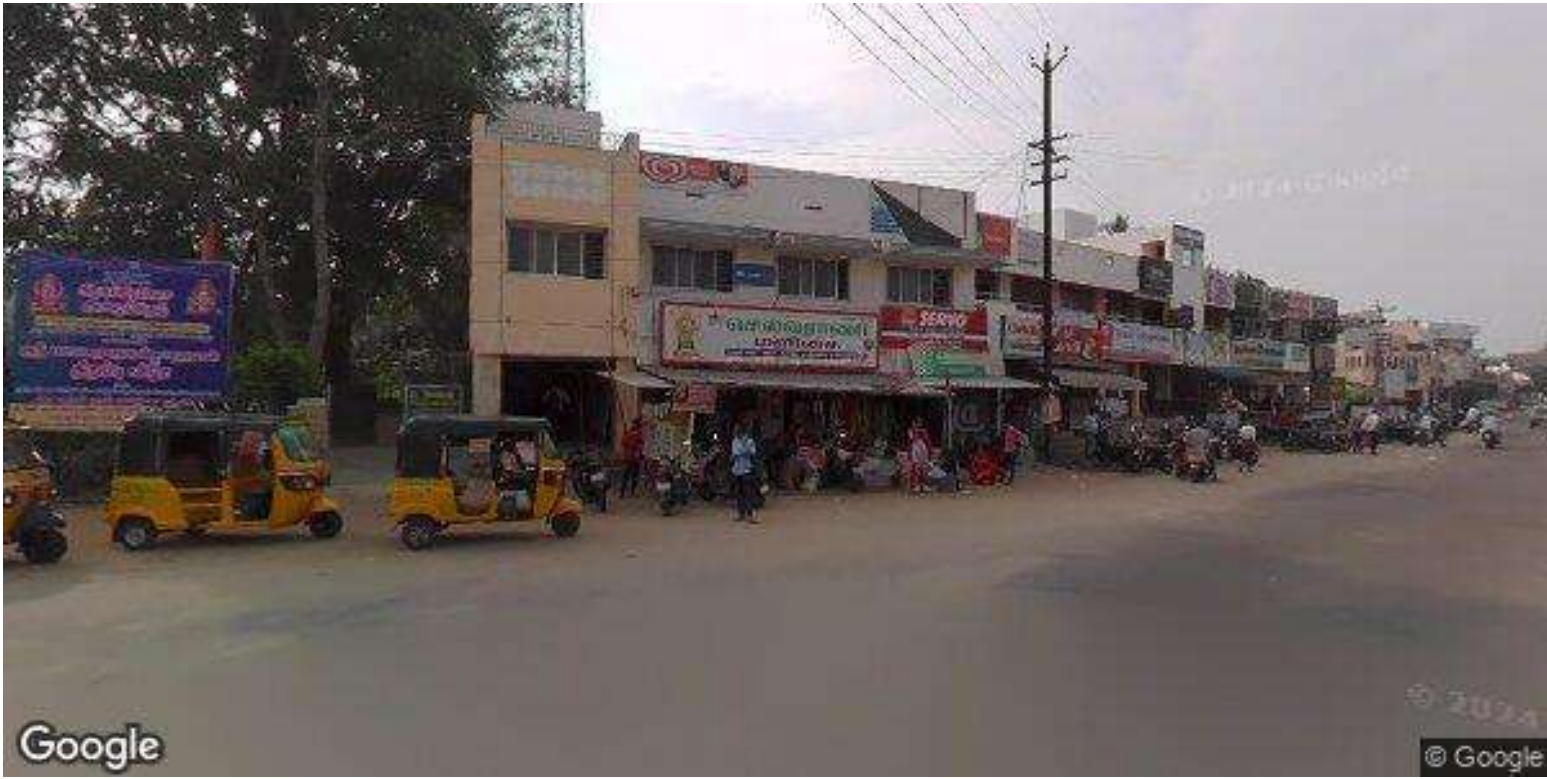
**Risk Type:** Turn  
**Risk Level:** Medium  
**Speed Limit:** 30 KM/Hr  
**Coordinates:** 11.15942, 77.70068

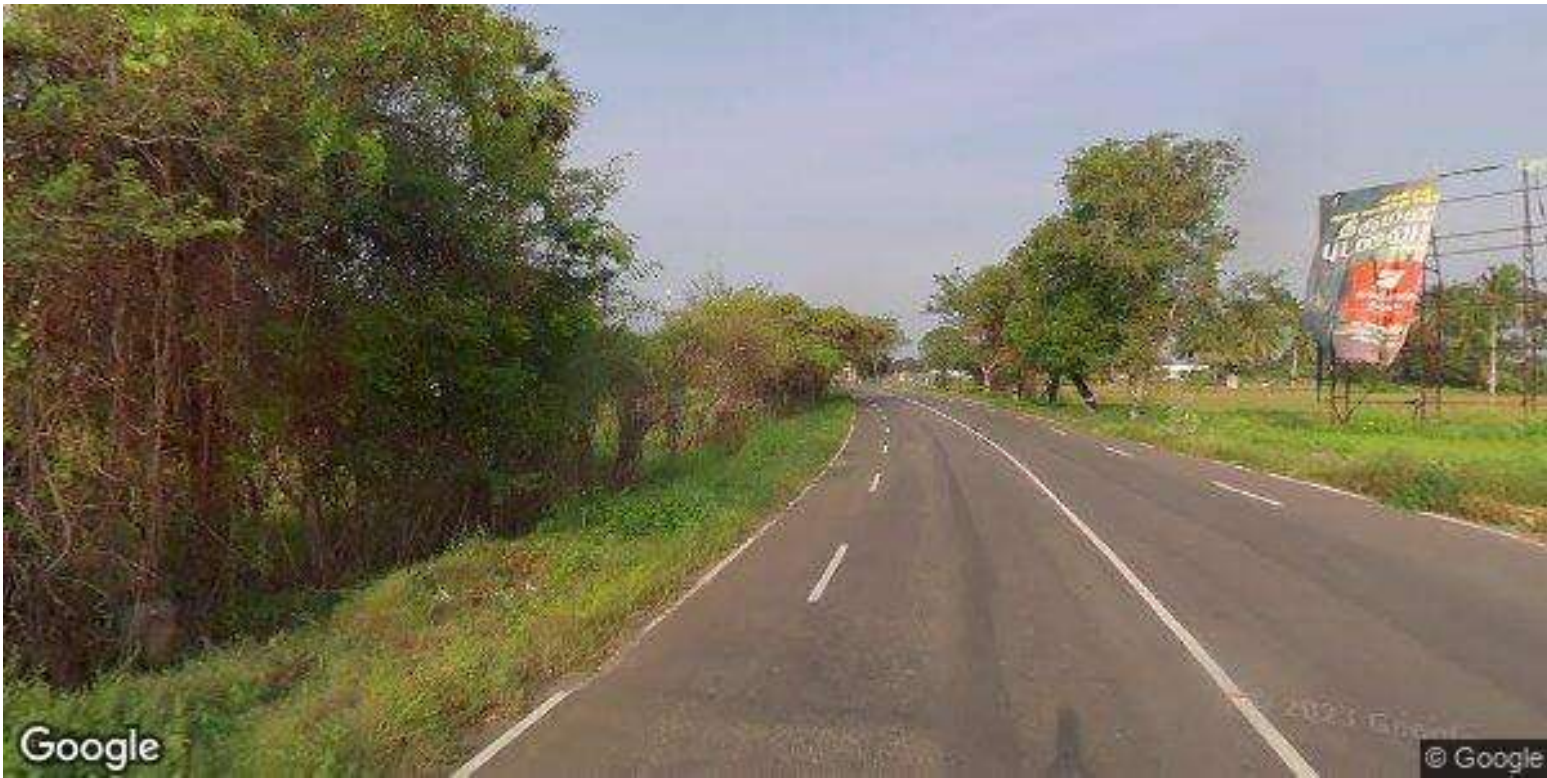
**Risk Type:** Turn  
**Risk Level:** Medium  
**Speed Limit:** 30 KM/Hr  
**Coordinates:** 11.11932, 77.67786

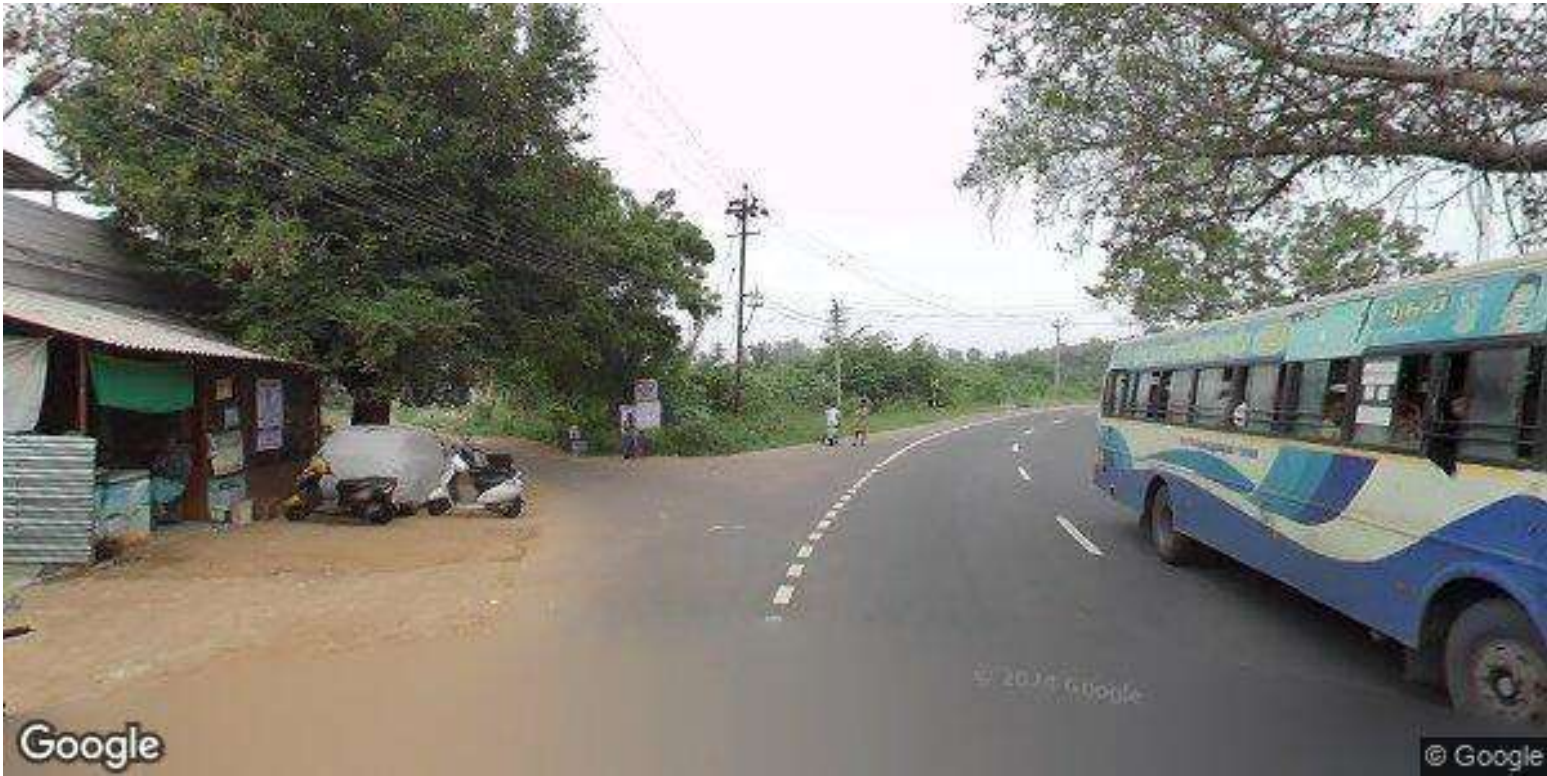
**Risk Type:** Turn  
**Risk Level:** Medium  
**Speed Limit:** 30 KM/Hr  
**Coordinates:** 11.11710, 77.67175

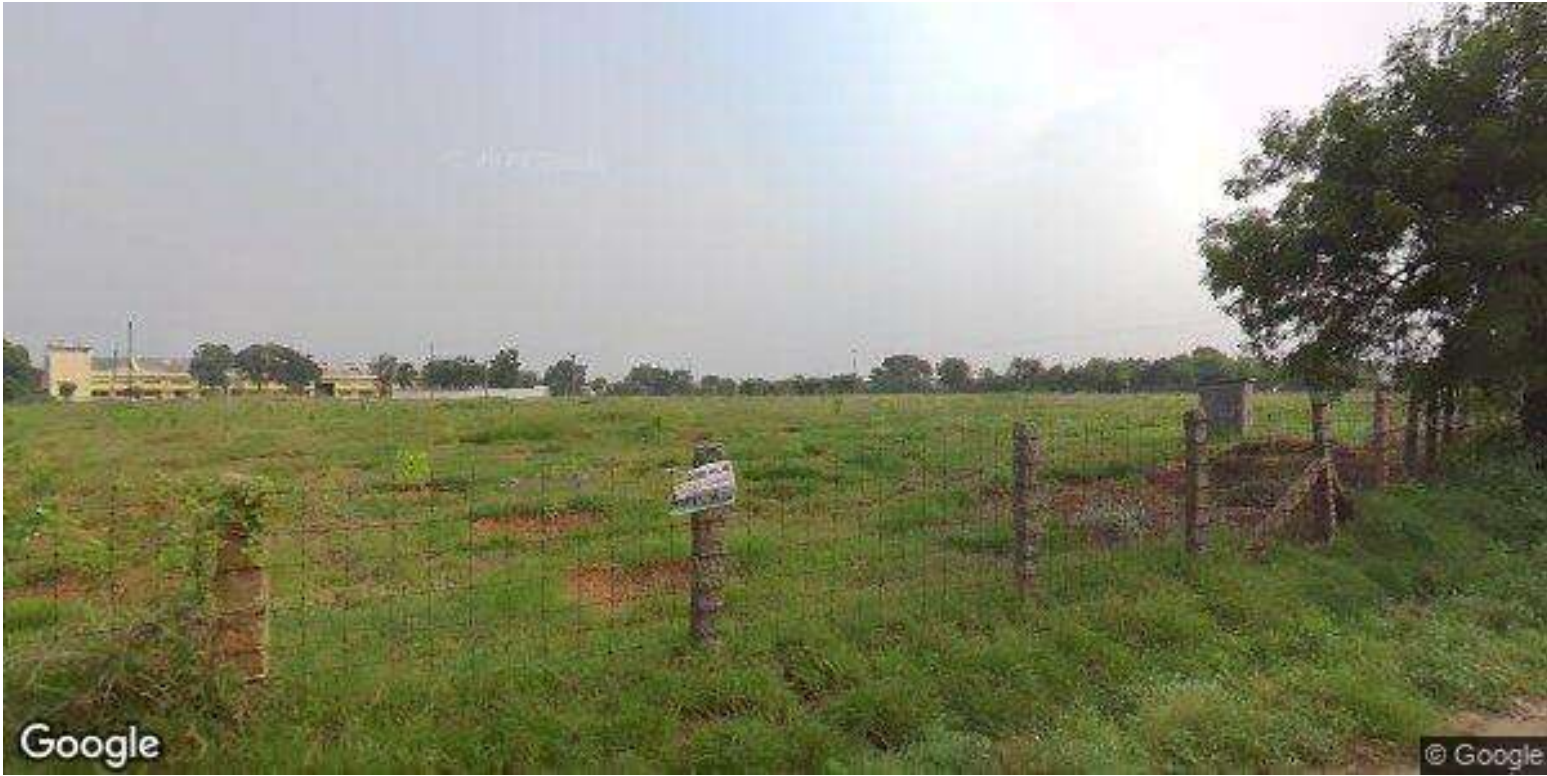
**Risk Type:** Turn  
**Risk Level:** Medium  
**Speed Limit:** 30 KM/Hr  
**Coordinates:** 11.09491, 77.66603

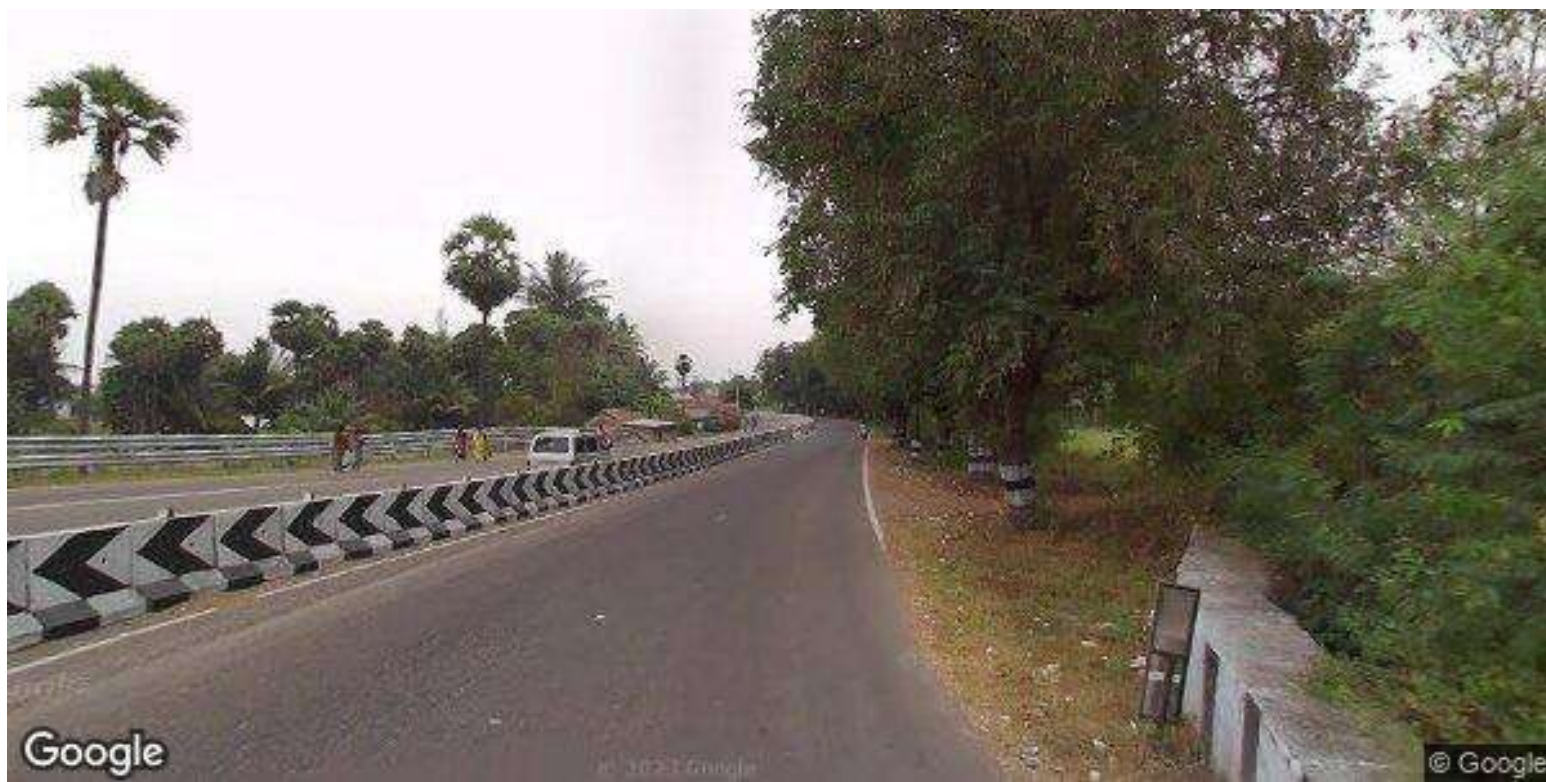
**Coordinates:** 11.08296, 77.65857

**Risk Type:** Turn

**Risk Level:** Medium

**Speed Limit:** 30 KM/Hr

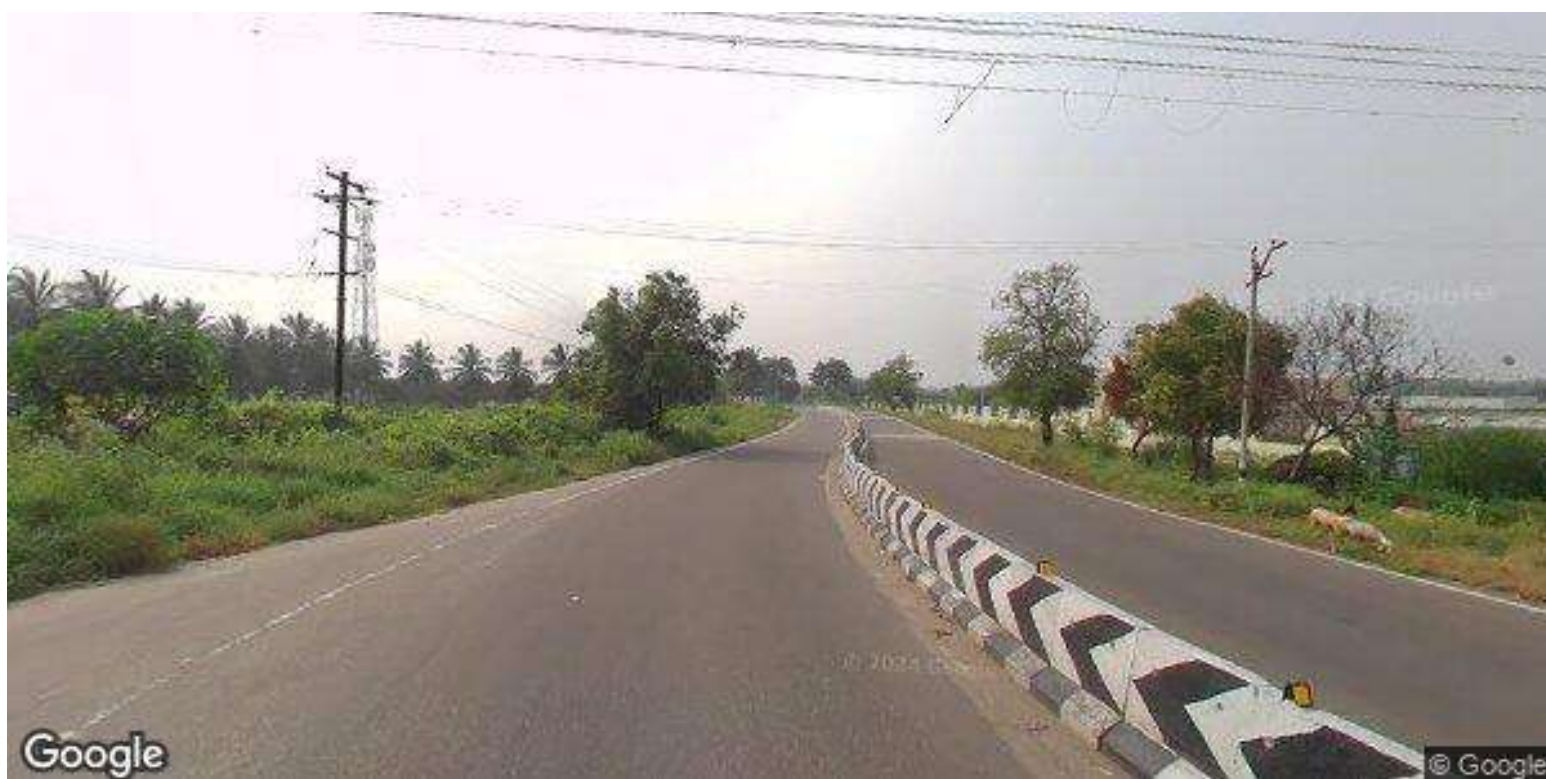
**Coordinates:** 11.06183, 77.63924

**Risk Type:** Turn

**Risk Level:** Medium

**Speed Limit:** 30 KM/Hr

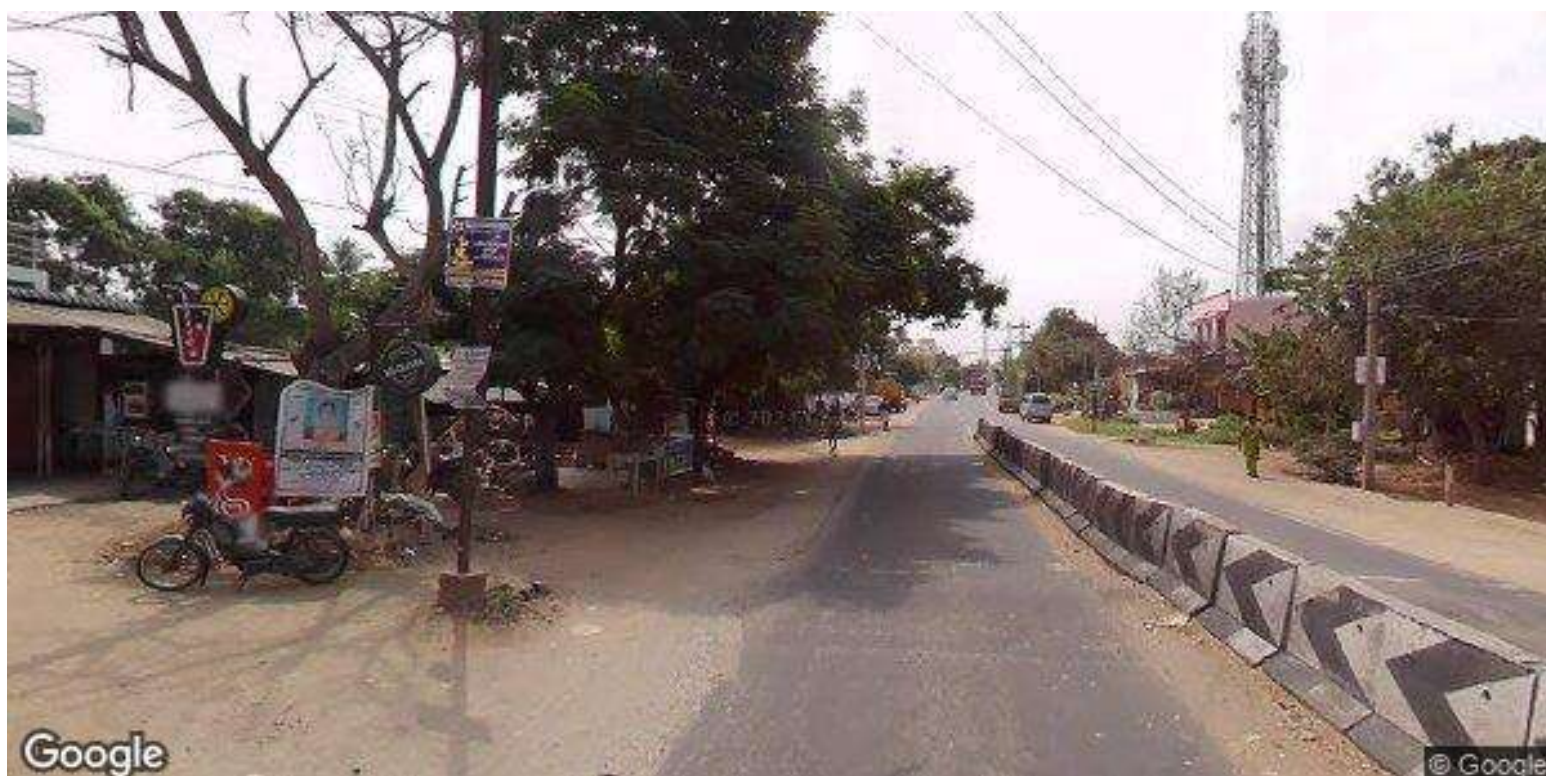
**Risk Type:** Turn  
**Risk Level:** High  
**Speed Limit:** 15 KM/Hr  
**Coordinates:** 11.00826, 77.56962

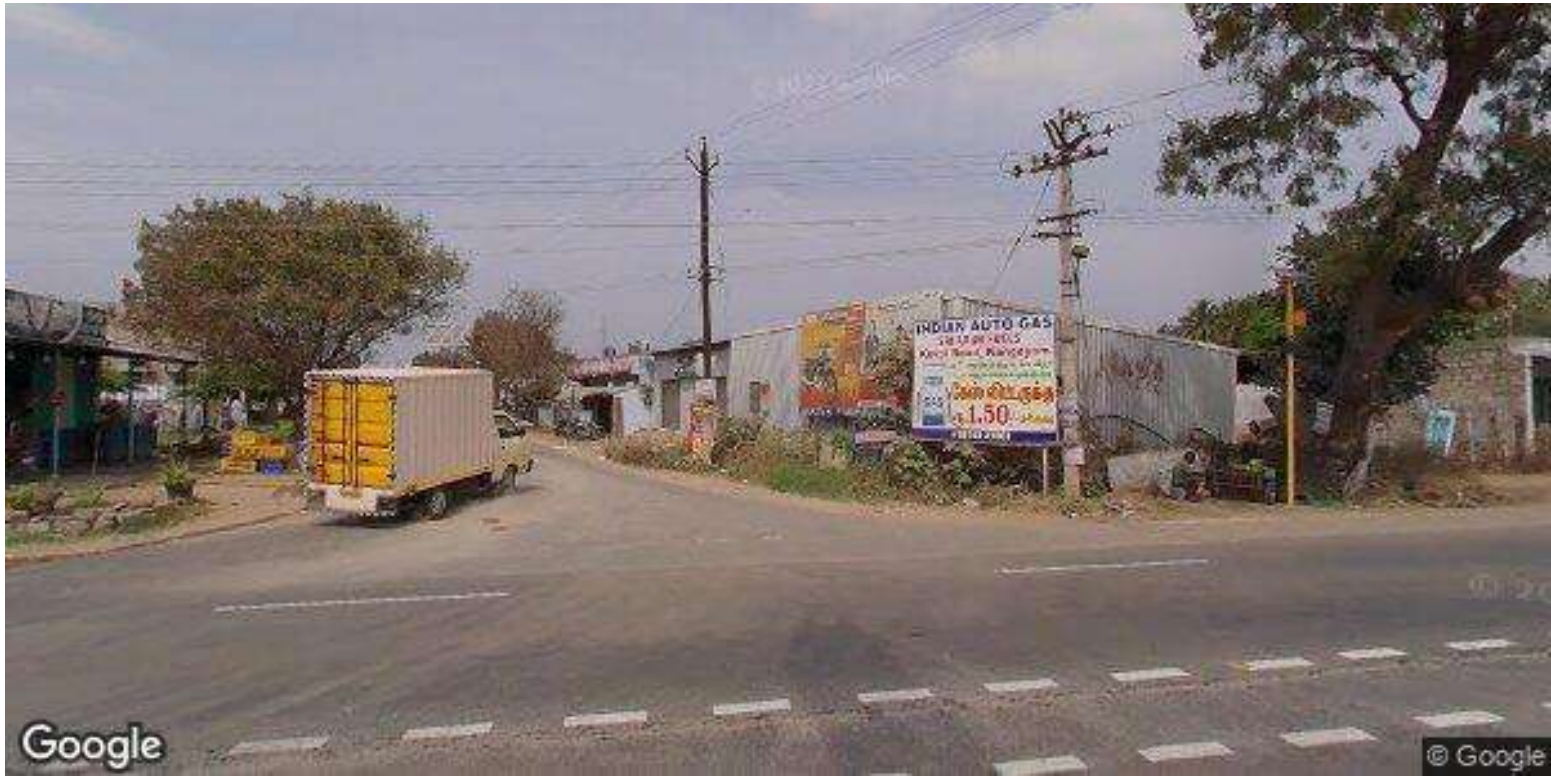
**Risk Type:** Blind Spot  
**Risk Level:** Blind Spot  
**Speed Limit:** 10 KM/Hr  
**Coordinates:** 11.00058, 77.56882
