# IndianOil

## JOURNEY RISK MANAGEMENT (JRM) STUDY

### Salem Terminal TO YADHAVAN AGENCIES

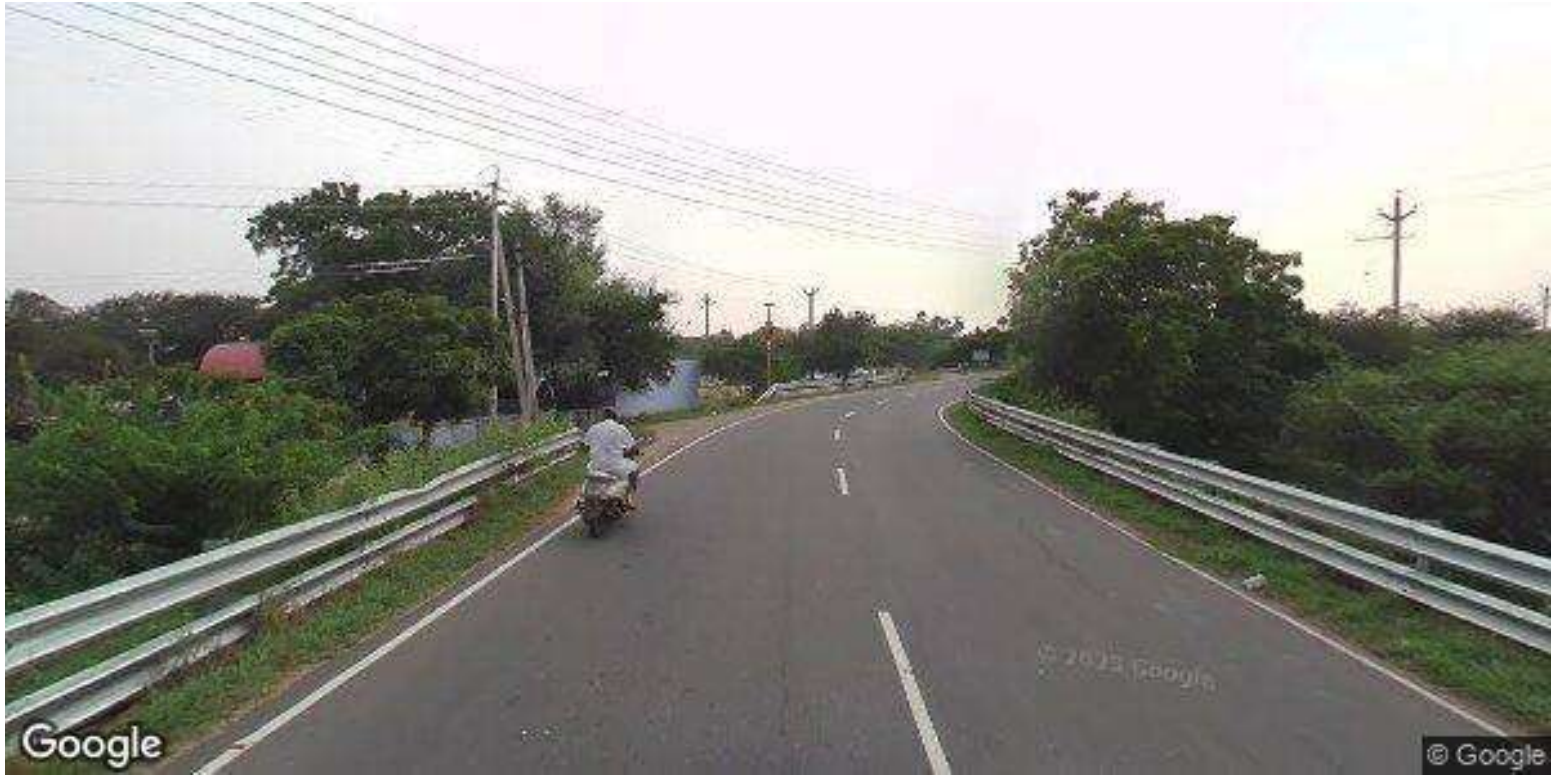
**Risk Type:** Turn  
**Risk Level:** Medium  
**Speed Limit:** 30 KM/Hr  
**Coordinates:** 10.94722, 77.54709

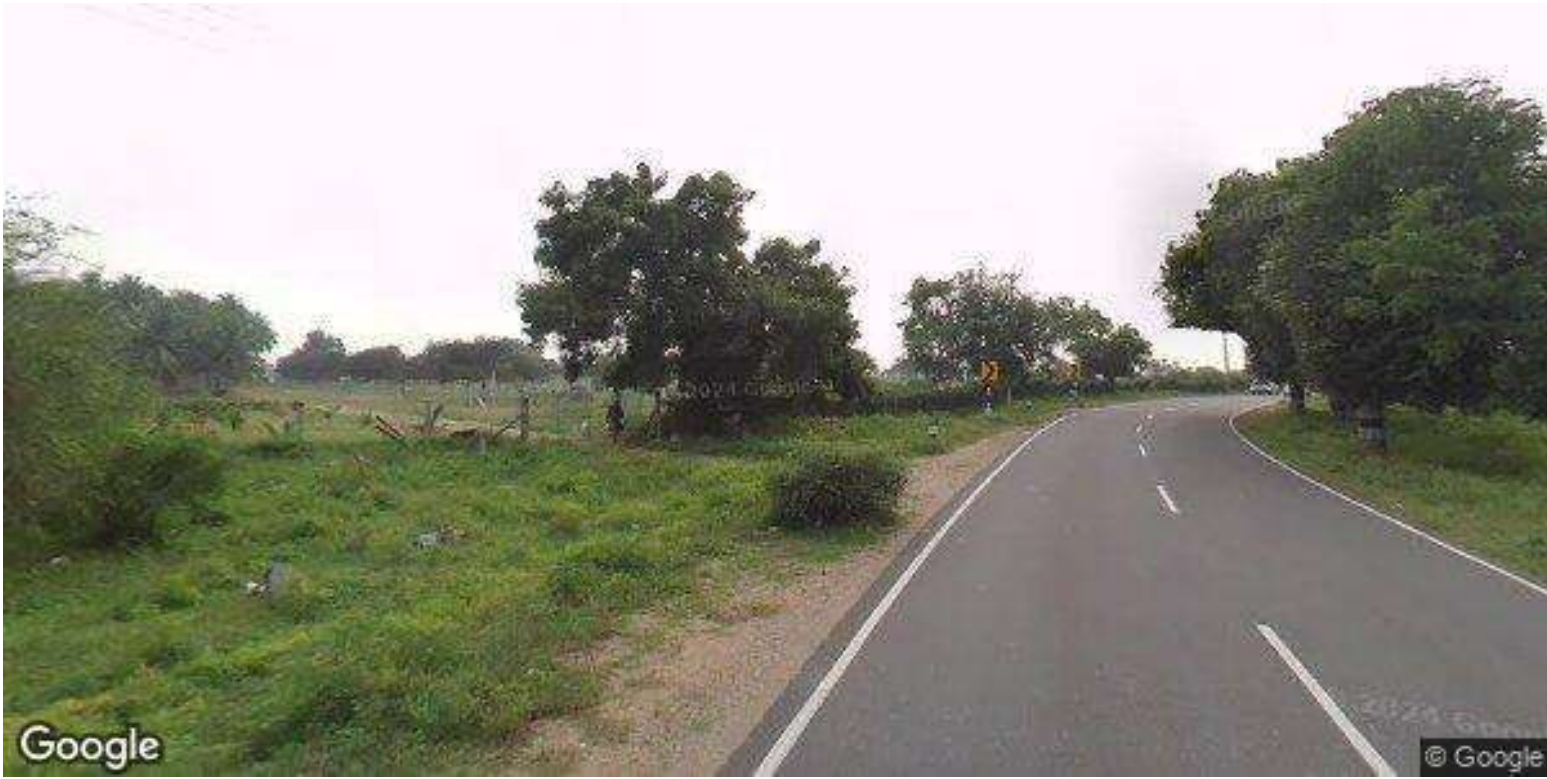
**Risk Type:** Turn  
**Risk Level:** Medium  
**Speed Limit:** 30 KM/Hr  
**Coordinates:** 10.93895, 77.53976

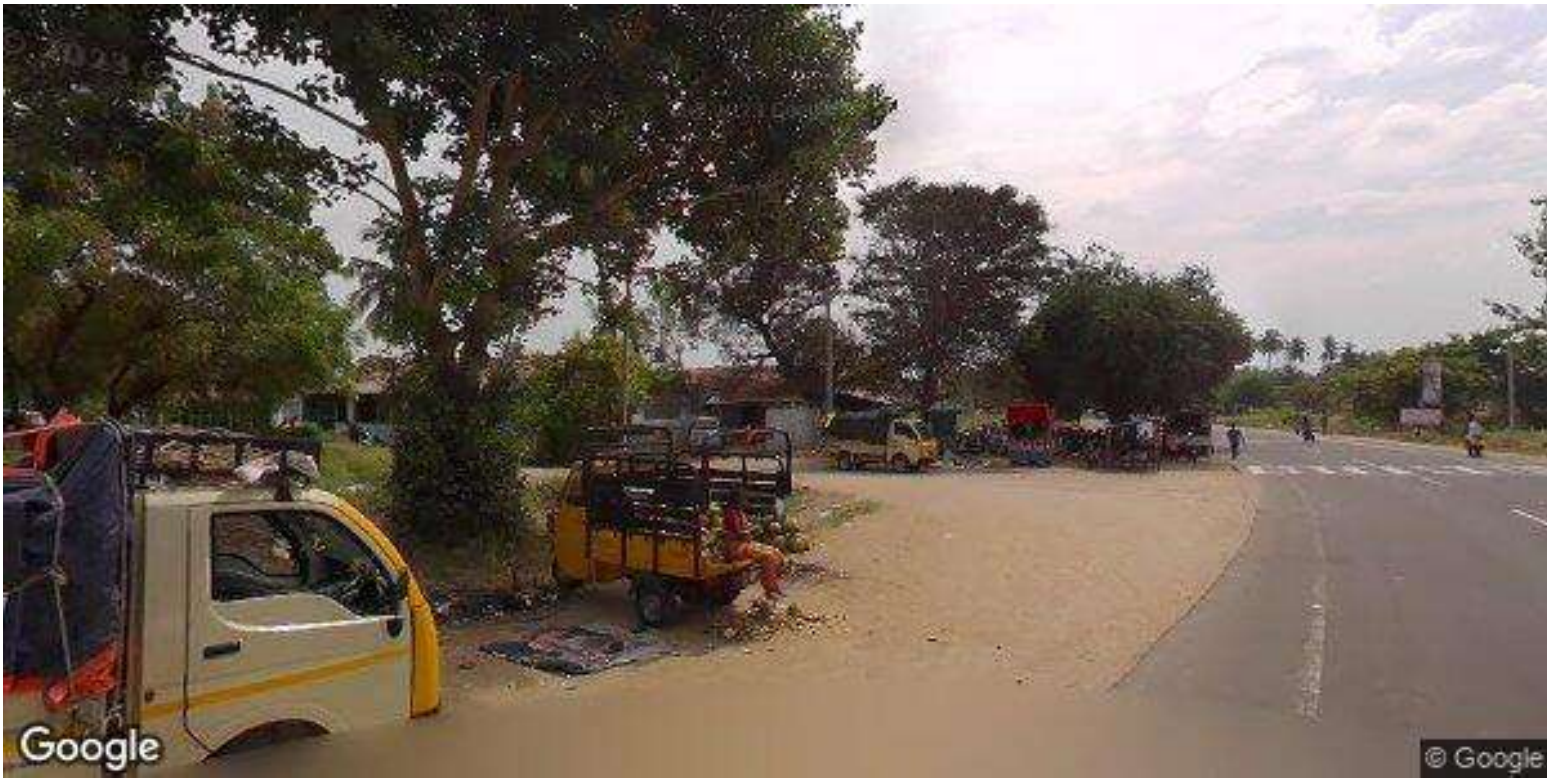
**Risk Type:** Turn  
**Risk Level:** Medium  
**Speed Limit:** 30 KM/Hr  
**Coordinates:** 10.89213, 77.52646

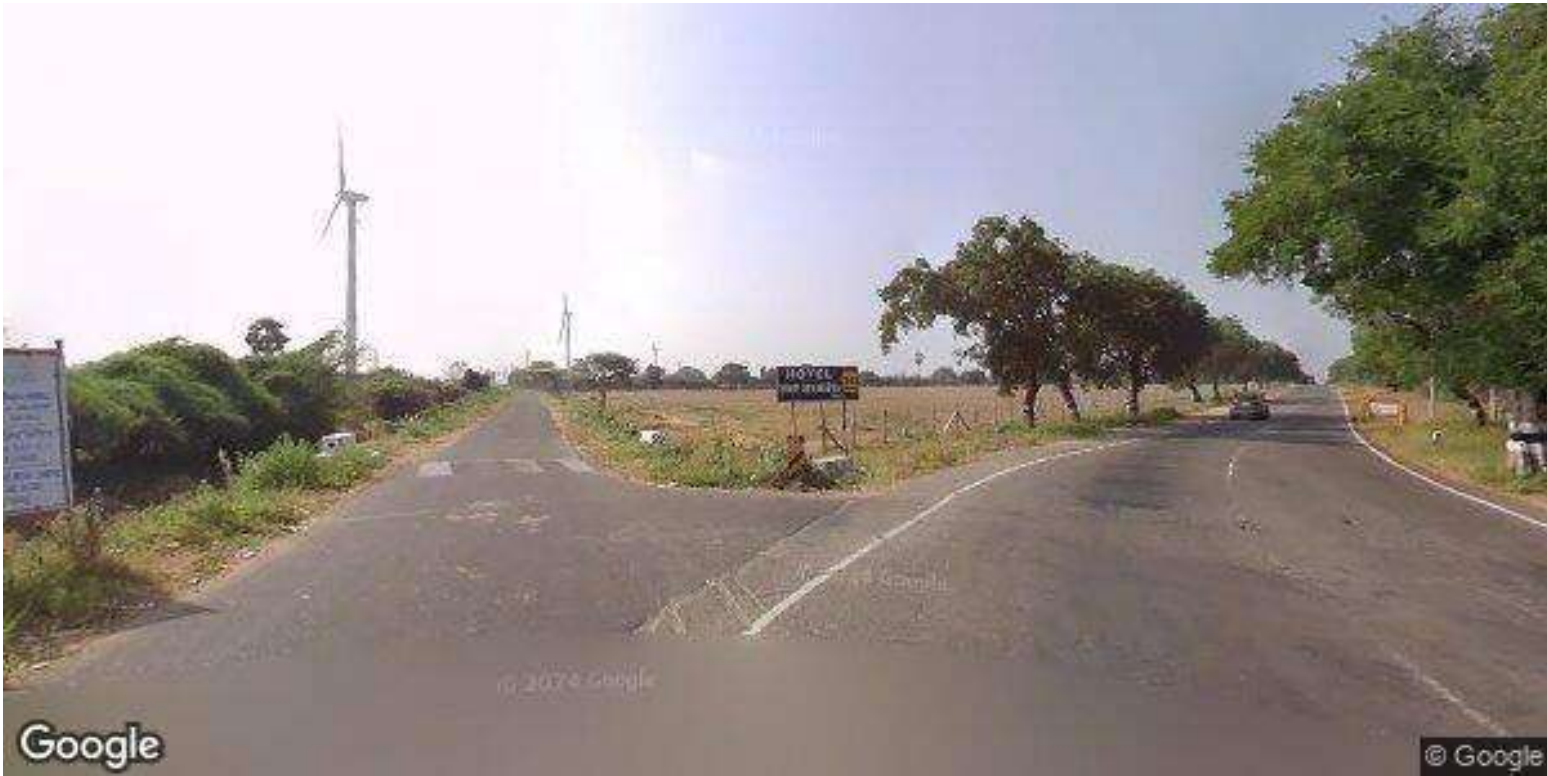
**Risk Type:** Turn  
**Risk Level:** Medium  
**Speed Limit:** 30 KM/Hr  
**Coordinates:** 10.83409, 77.52932

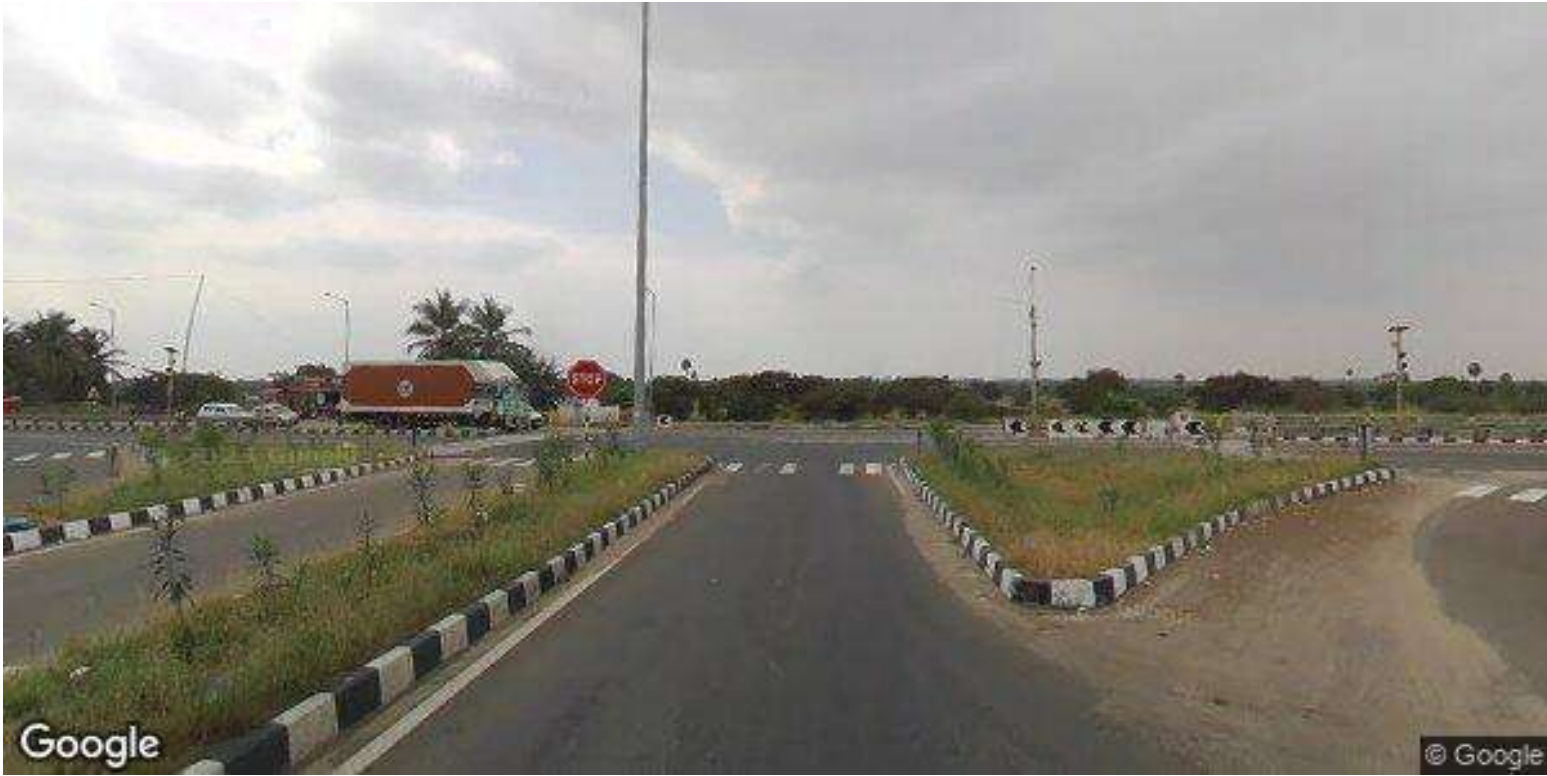
**Risk Type:** Turn  
**Risk Level:** Medium  
**Speed Limit:** 30 KM/Hr  
**Coordinates:** 10.77642, 77.50712

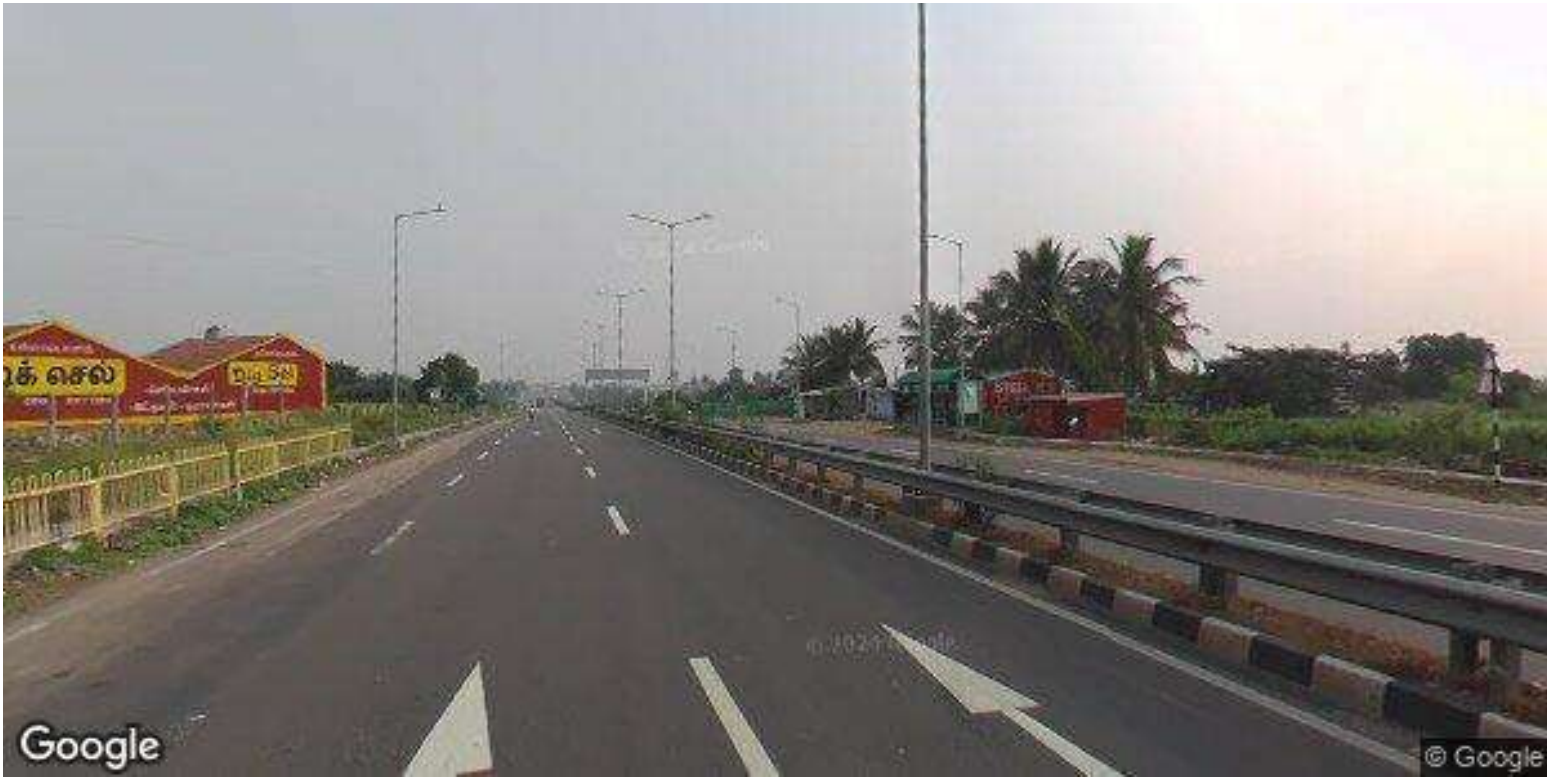
**Risk Type:** Turn  
**Risk Level:** Medium  
**Speed Limit:** 30 KM/Hr  
**Coordinates:** 10.77580, 77.50724

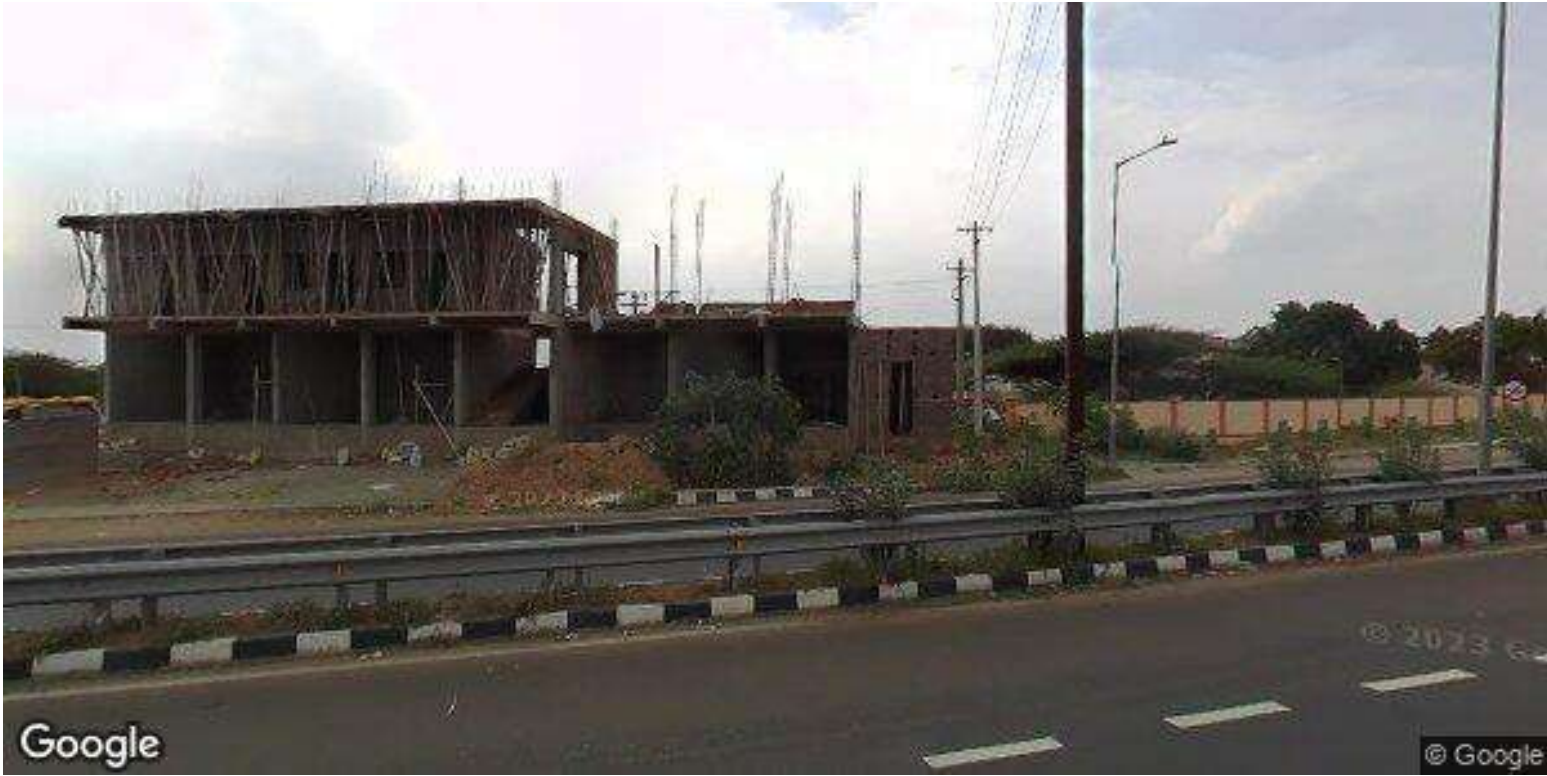
**Risk Type:** Turn  
**Risk Level:** Medium  
**Speed Limit:** 30 KM/Hr  
**Coordinates:** 10.75864, 77.51918

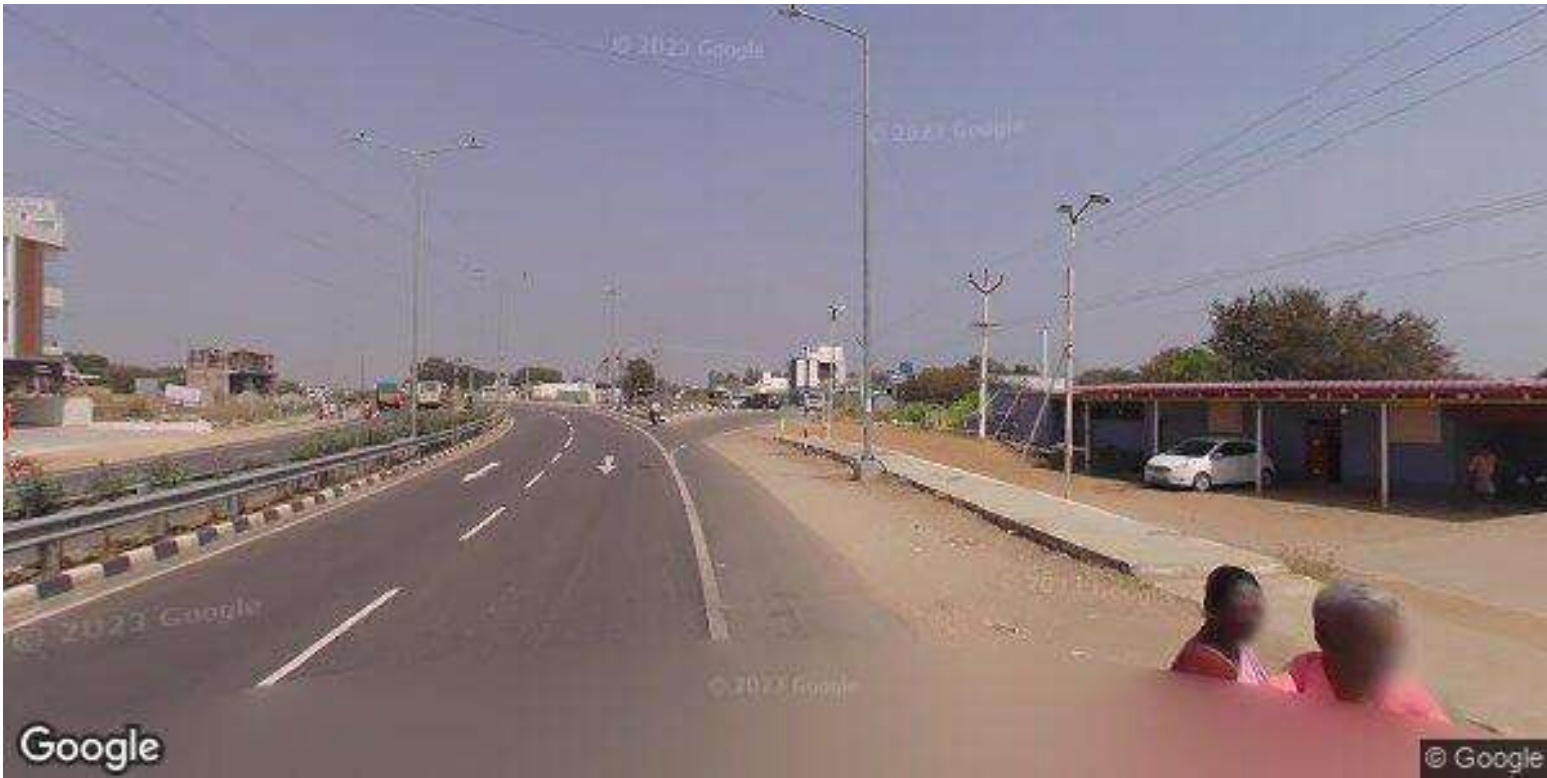
Coordinates: 10.75722, 77.51935

Risk Type: Turn

Risk Level: Medium

Speed Limit: 30 KM/Hr

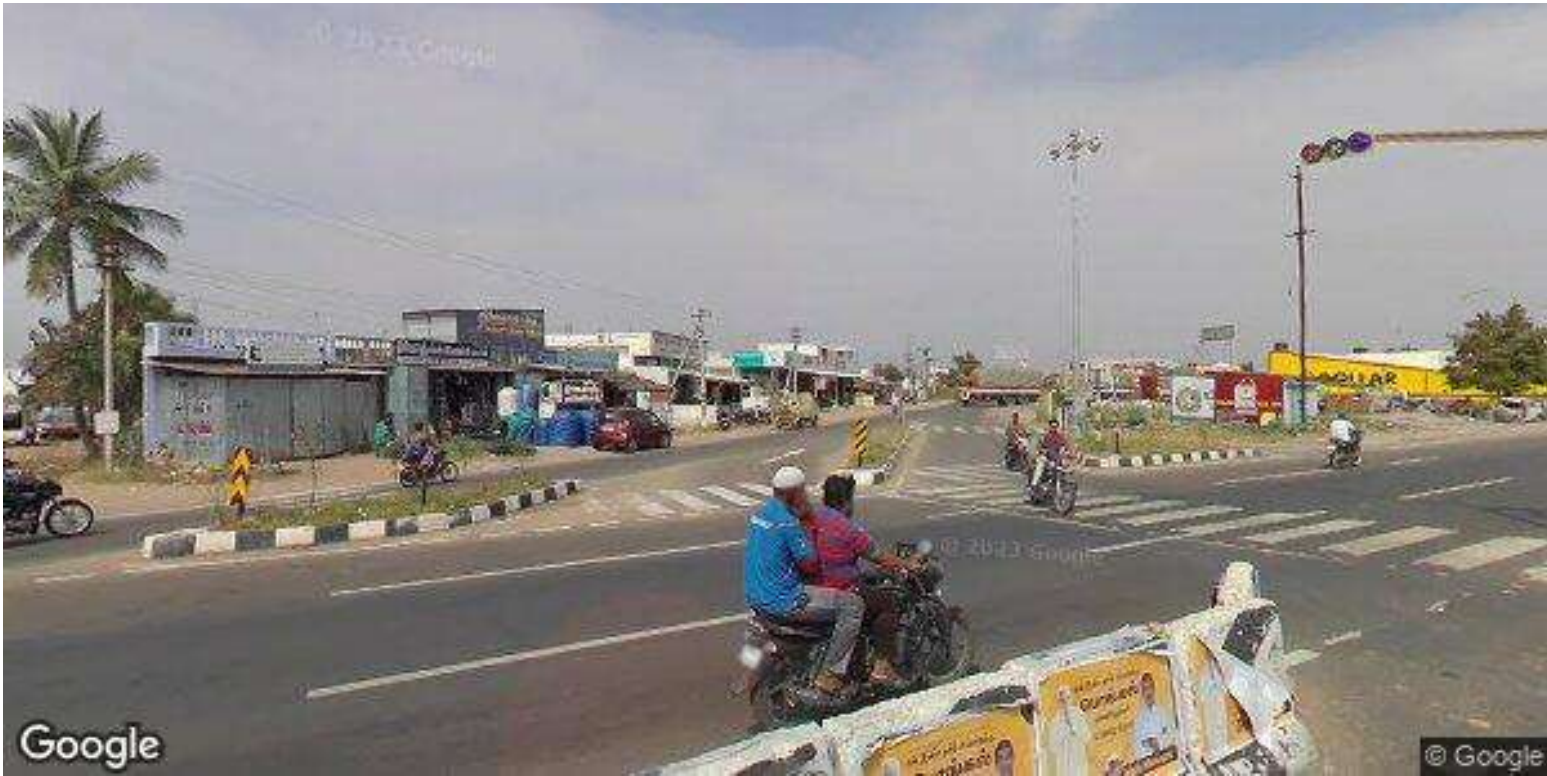
Coordinates: 10.74756, 77.51879

Risk Type: Blind Spot

Risk Level: Blind Spot

Speed Limit: 10 KM/Hr
