## JOURNEY RISK MANAGEMENT (JRM) STUDY

### Salem Terminal TO SWARNAMBIGAI FUEL SERVICE

Route Safety and Risk Assessment Report

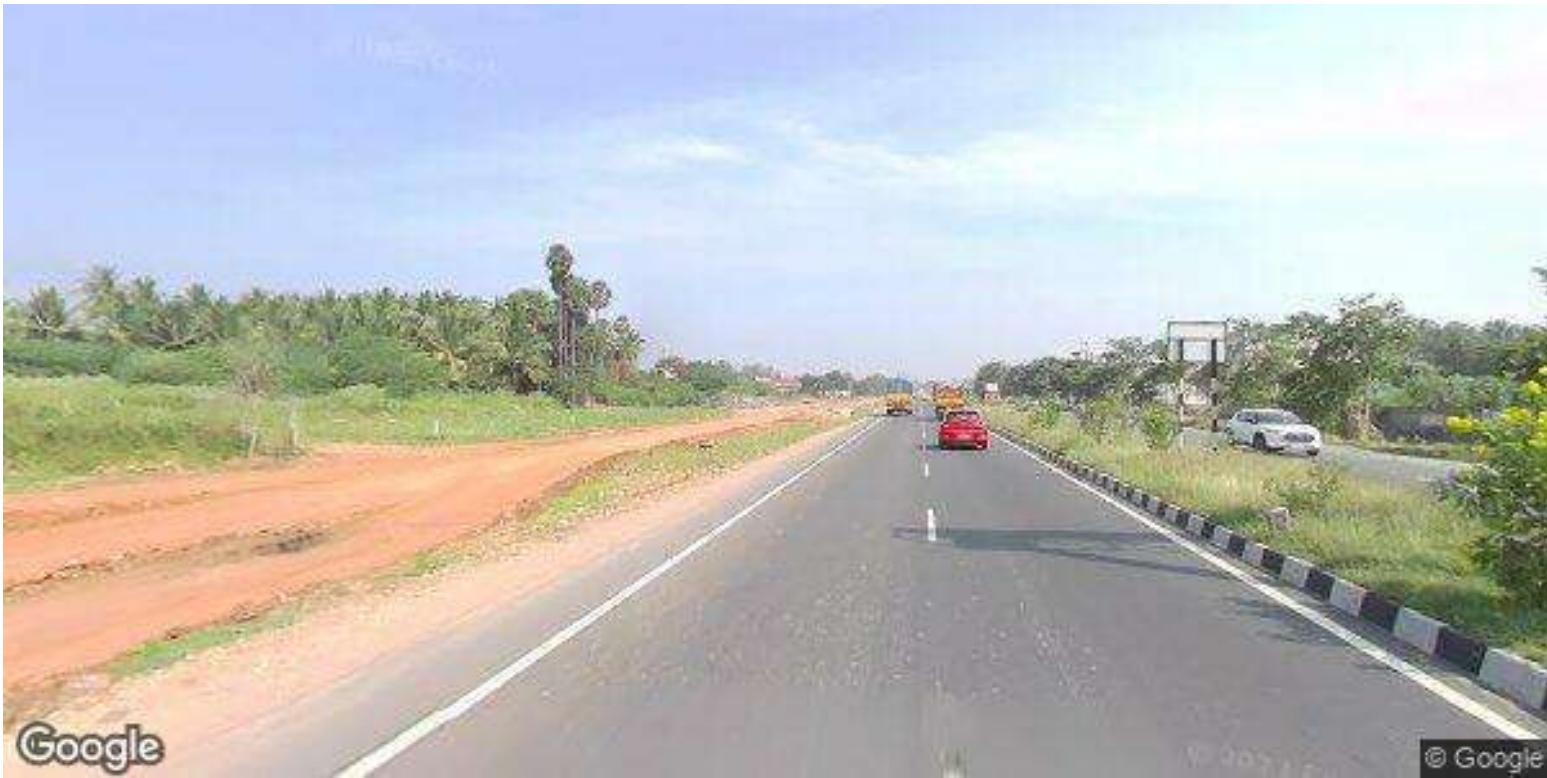
**Coordinates: 11.61753, 78.10608**

**Risk Type: Turn**

**Risk Level: Medium**

**Speed Limit: 30 KM/Hr**

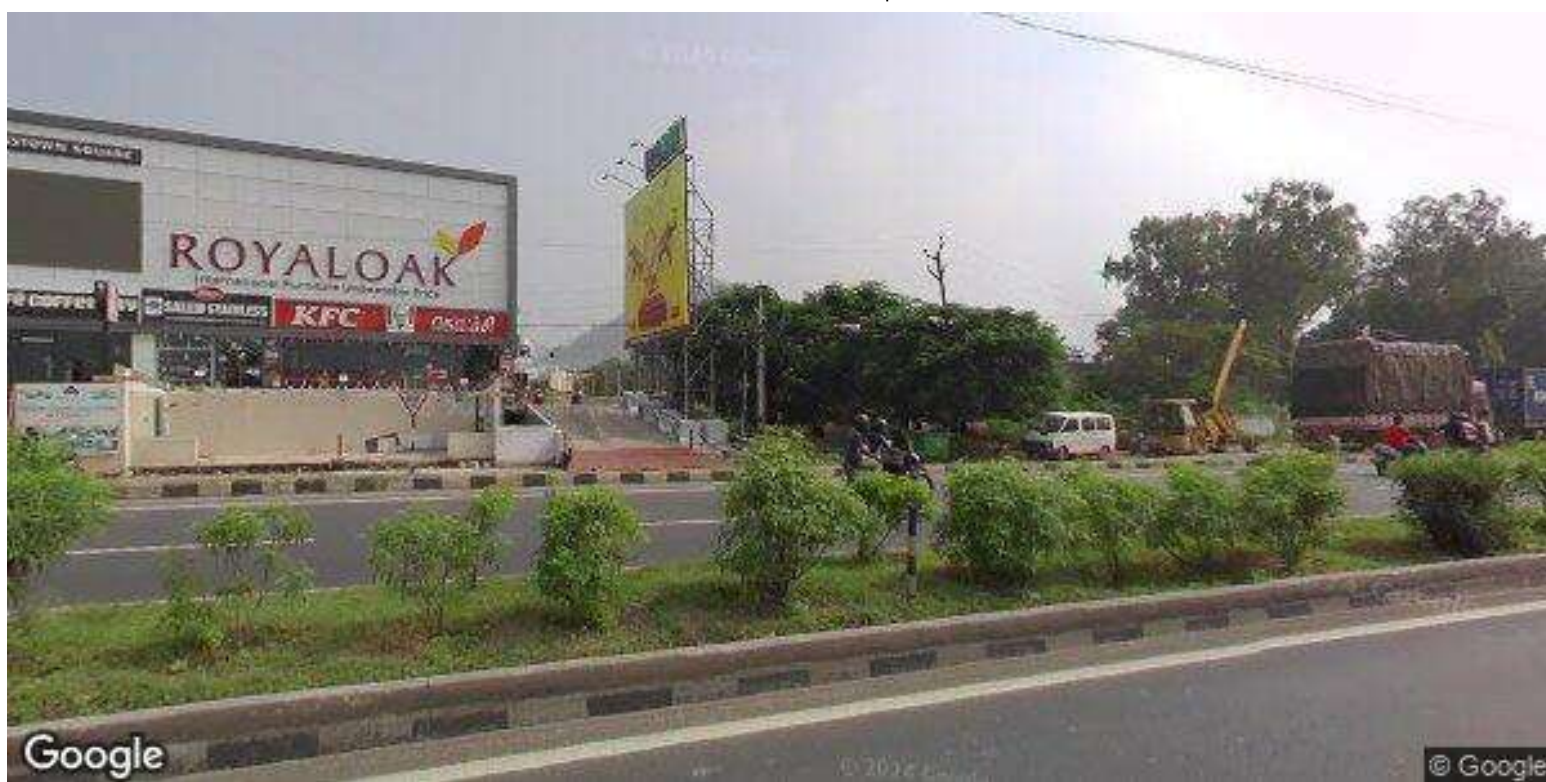
**Coordinates:** 11.68921, 78.11798

**Risk Type:** Turn

**Risk Level:** Medium

**Speed Limit:** 30 KM/Hr

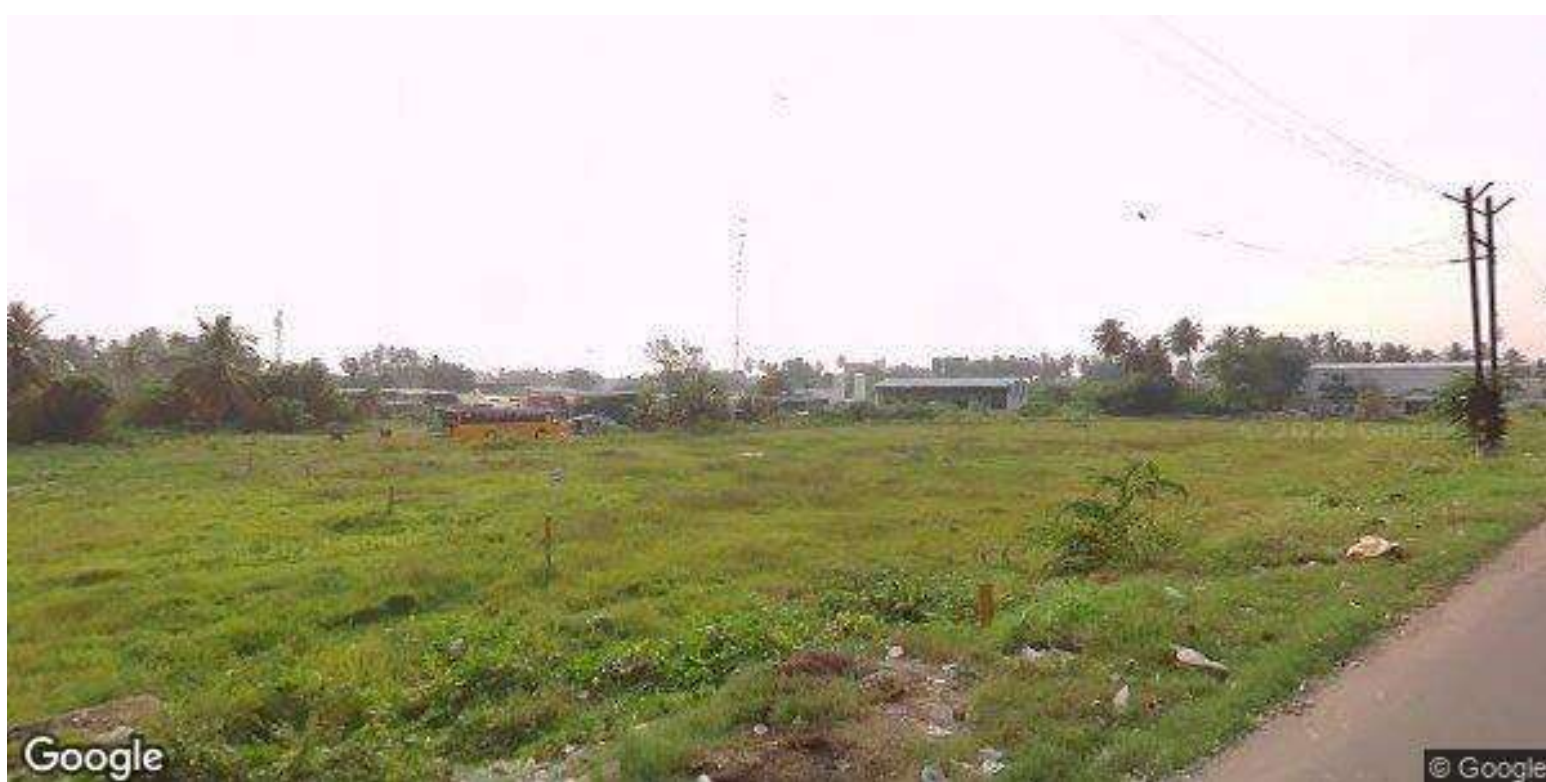
**Coordinates:** 11.68926, 78.11777

**Risk Type:** Turn

**Risk Level:** Medium

**Speed Limit:** 30 KM/Hr

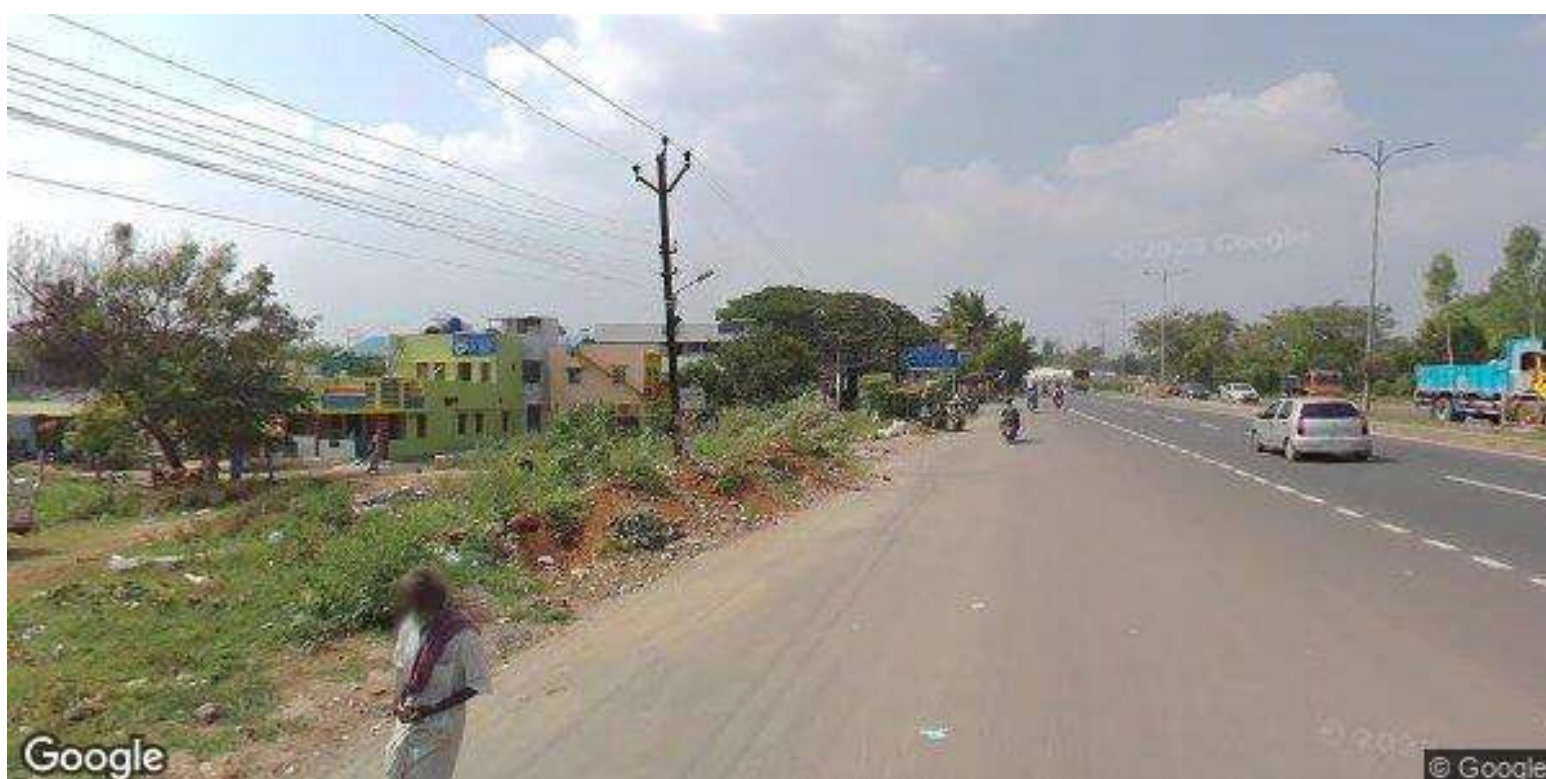
**Risk Type:** Turn  
**Risk Level:** High  
**Speed Limit:** 15 KM/Hr  
**Coordinates:** 11.69390, 78.10964

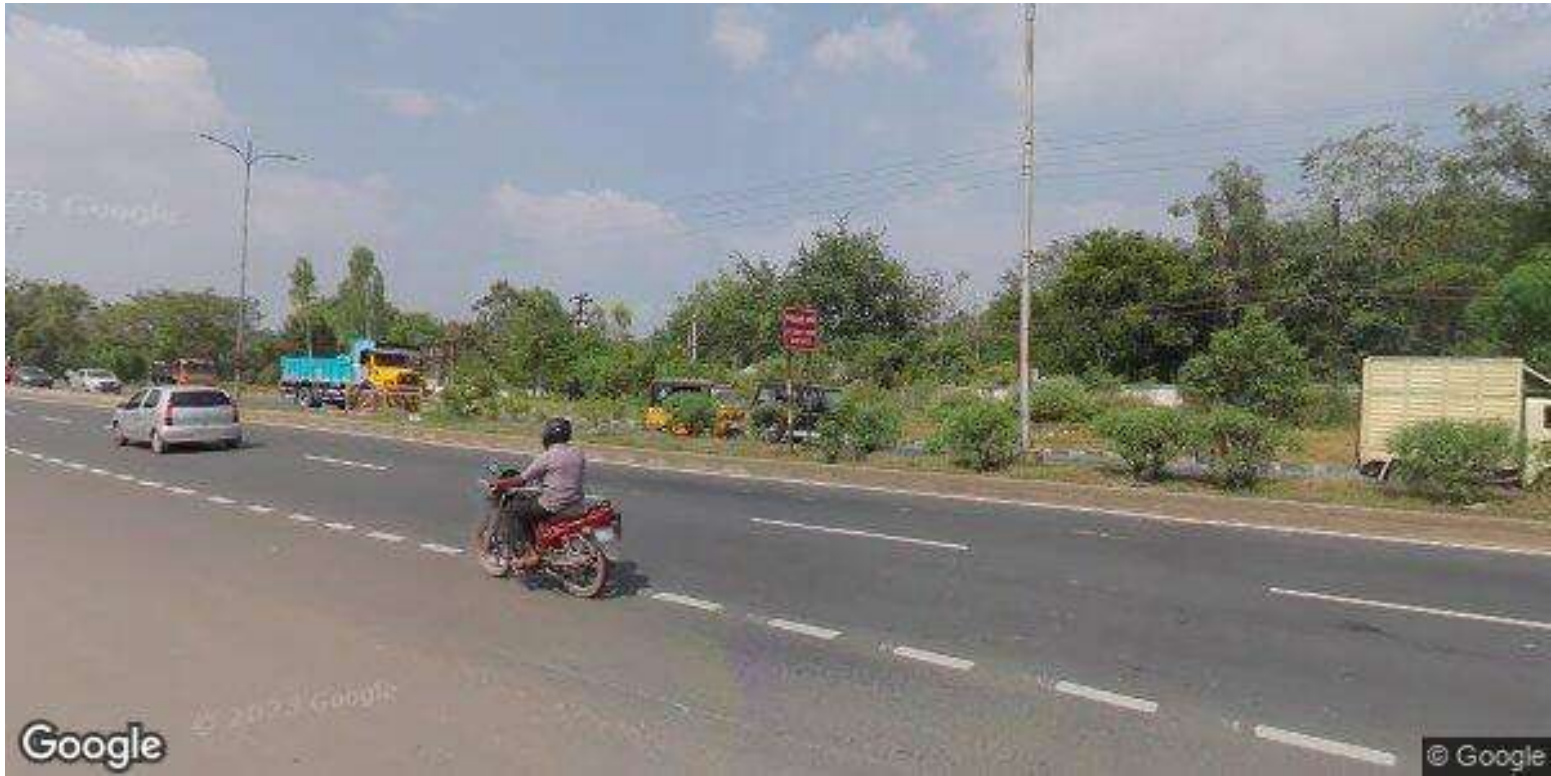
**Risk Type:** Turn  
**Risk Level:** High  
**Speed Limit:** 15 KM/Hr  
**Coordinates:** 11.69394, 78.10964

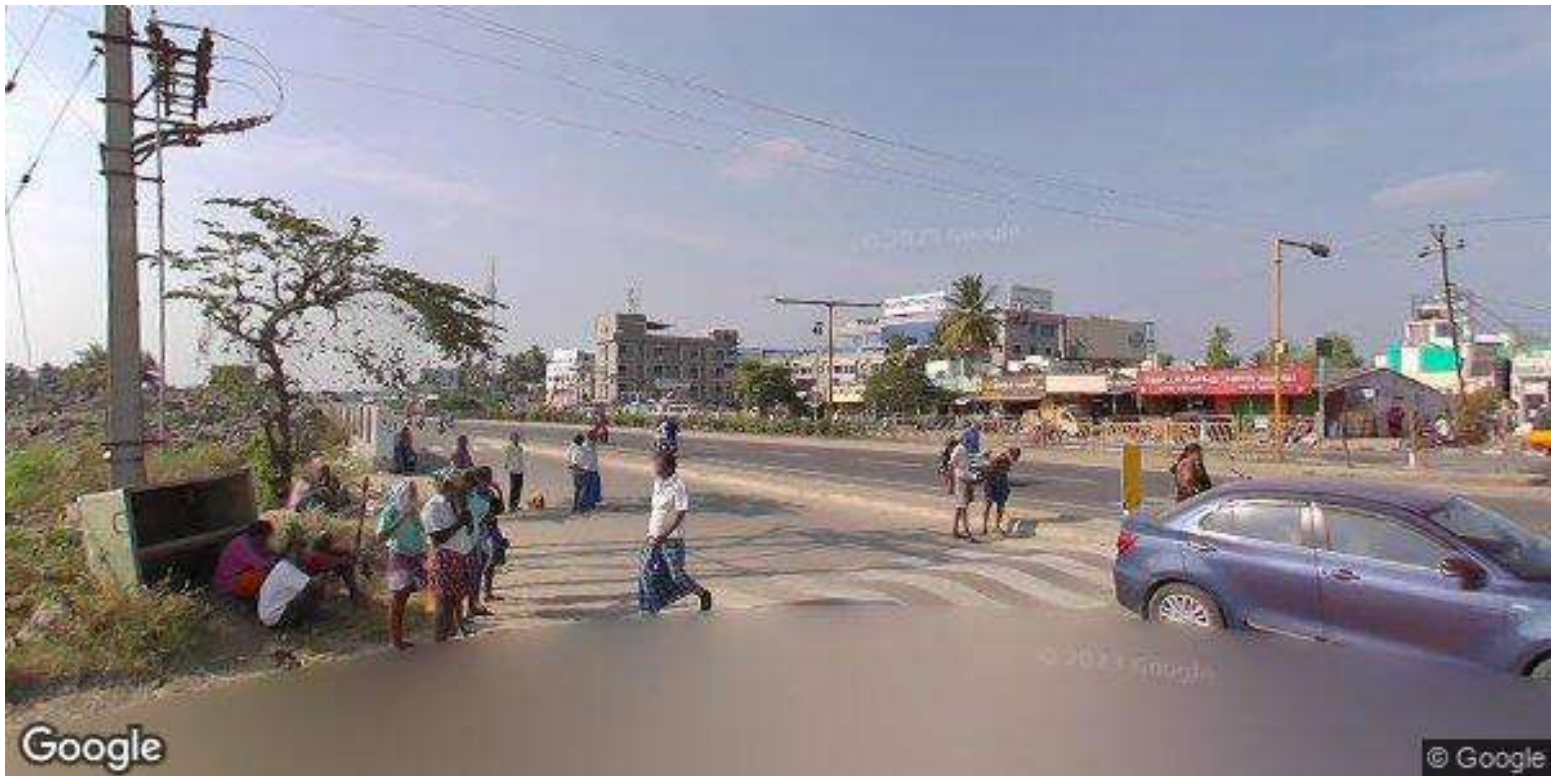
**Risk Type:** Blind Spot  
**Risk Level:** Blind Spot  
**Speed Limit:** 10 KM/Hr  
**Coordinates:** 11.70185, 78.10306

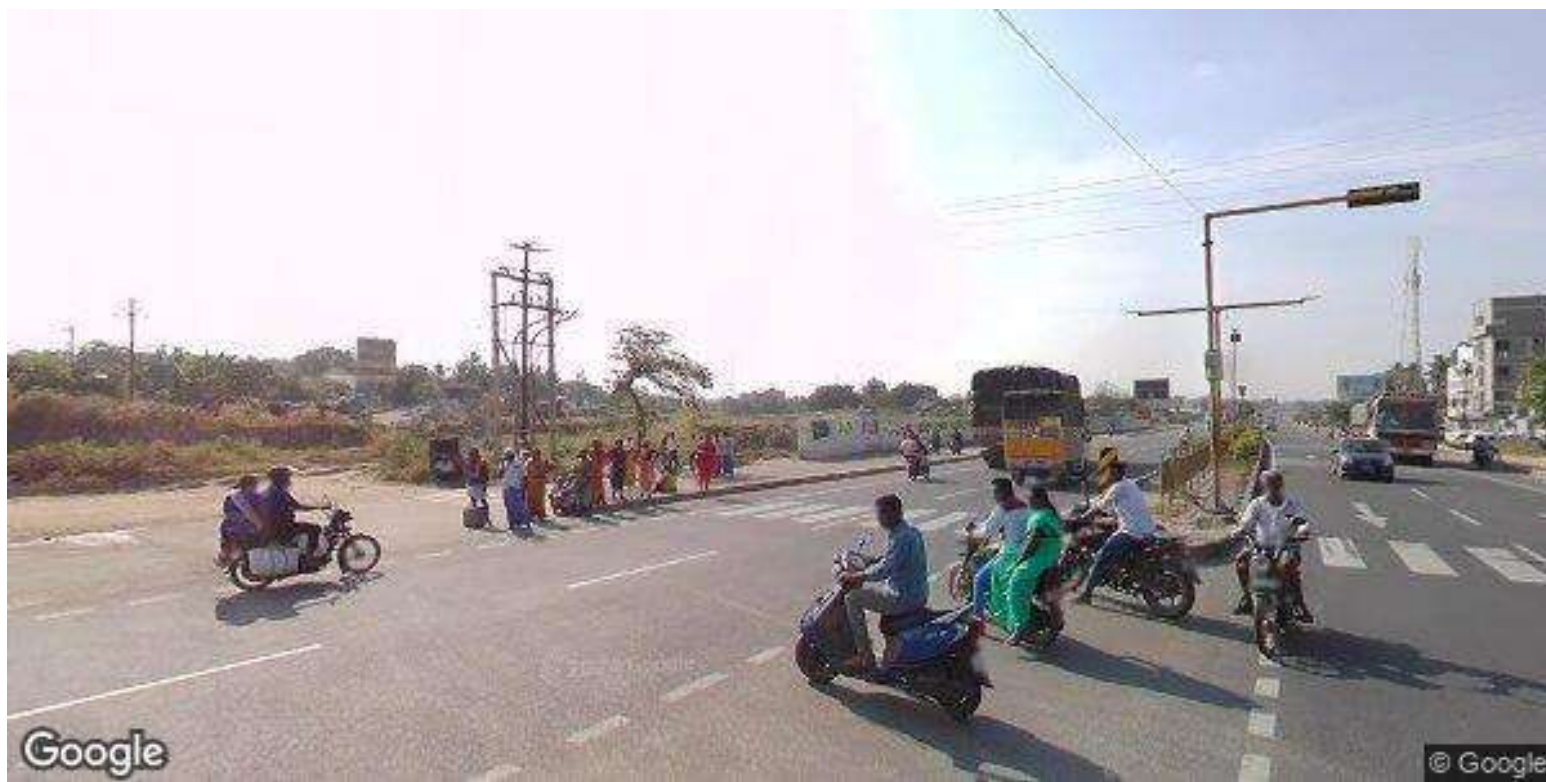
**Coordinates:** 11.70200, 78.10318

**Risk Type:** Turn

**Risk Level:** High

**Speed Limit:** 15 KM/Hr

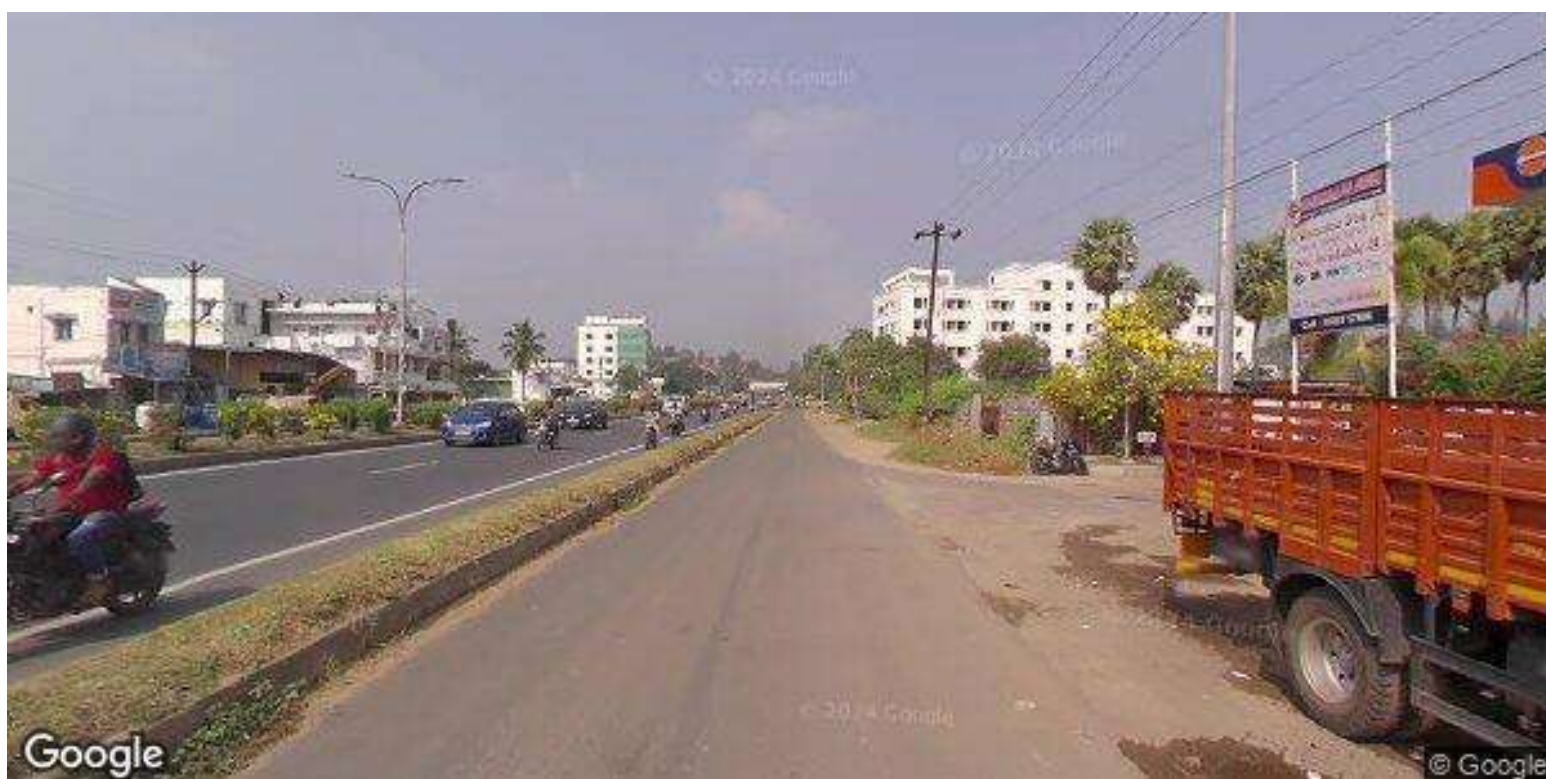
**Coordinates:** 11.69310, 78.11182

**Risk Type:** Blind Spot

**Risk Level:** Blind Spot

**Speed Limit:** 10 KM/Hr
