## JOURNEY RISK MANAGEMENT (JRM) STUDY

### Salem Terminal to RG FUELS

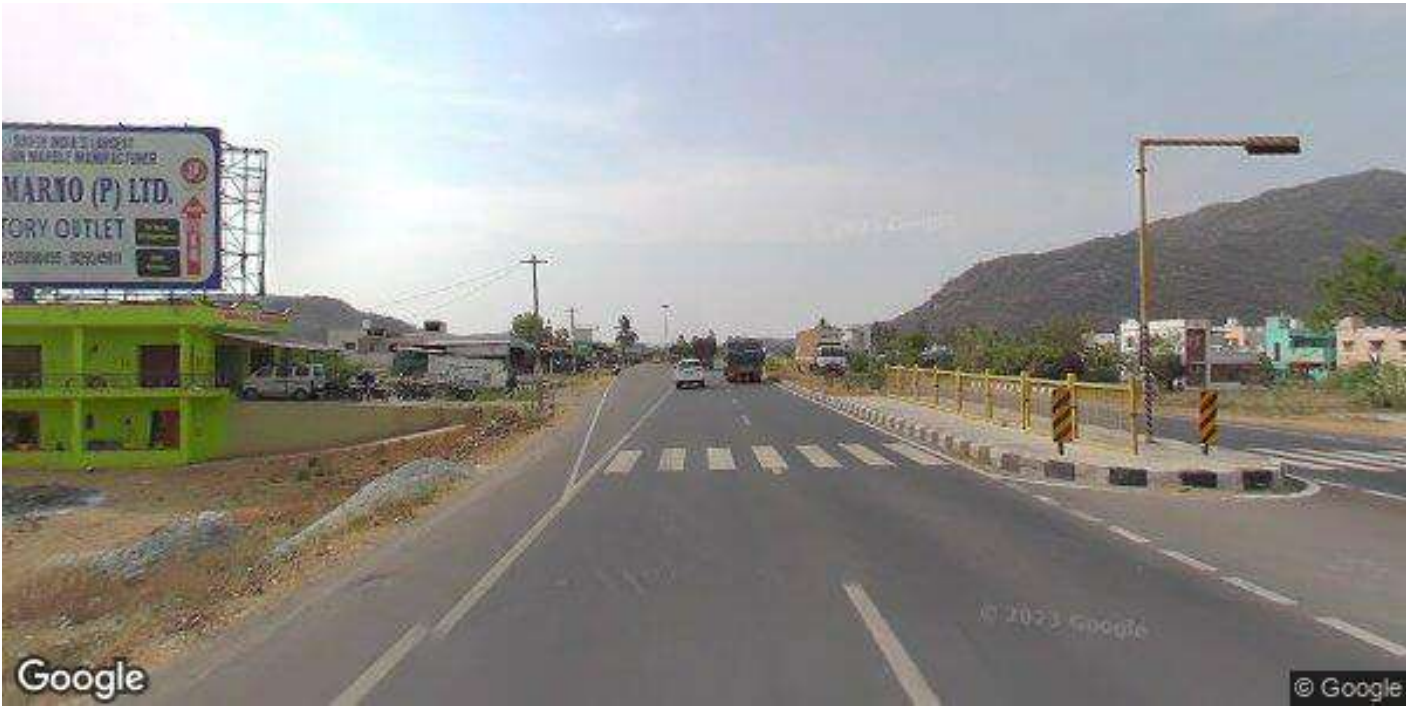
Coordinates: 11.8848607, 78.07615539999999

Risk Type: U-Turn

Risk Level: High

Speed Limit: 10 KM/Hr

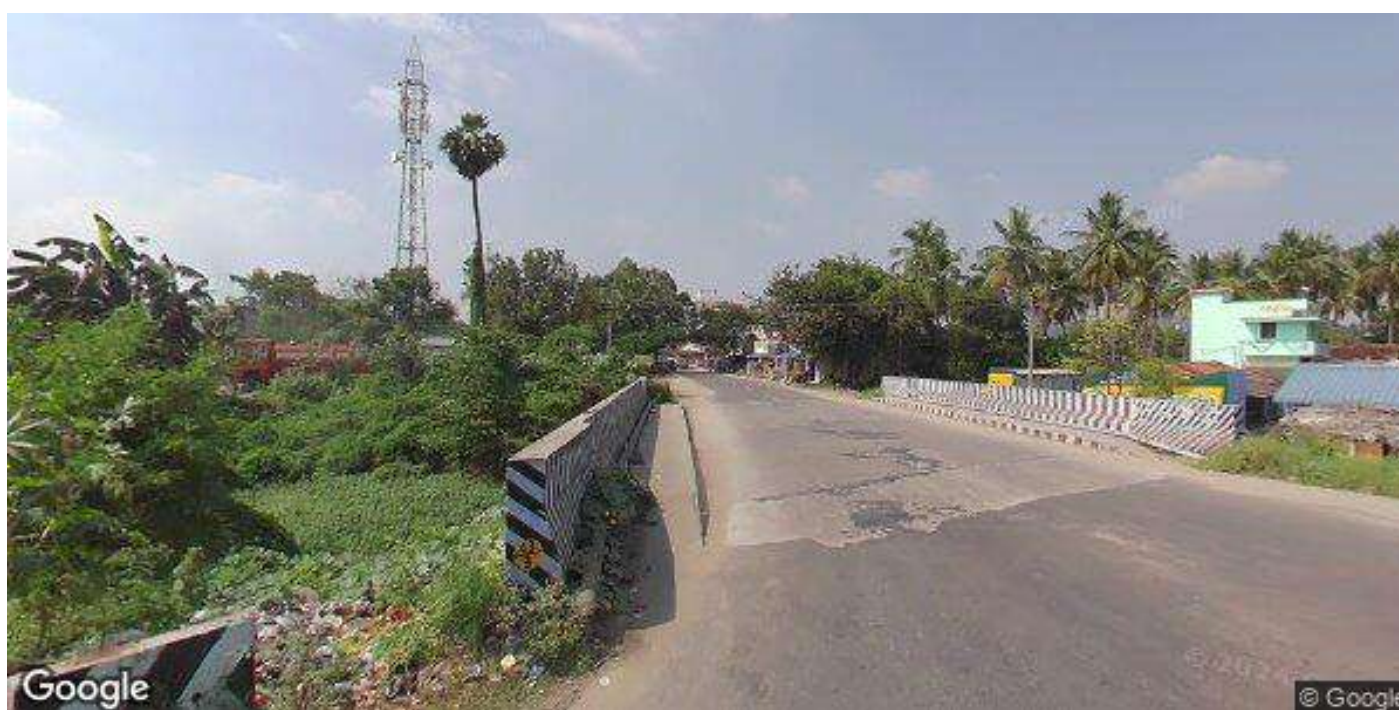
**Risk Type:** Turn  
**Risk Level:** Medium  
**Speed Limit:** 30 KM/Hr  
**Coordinates:** 11.44900, 77.87406

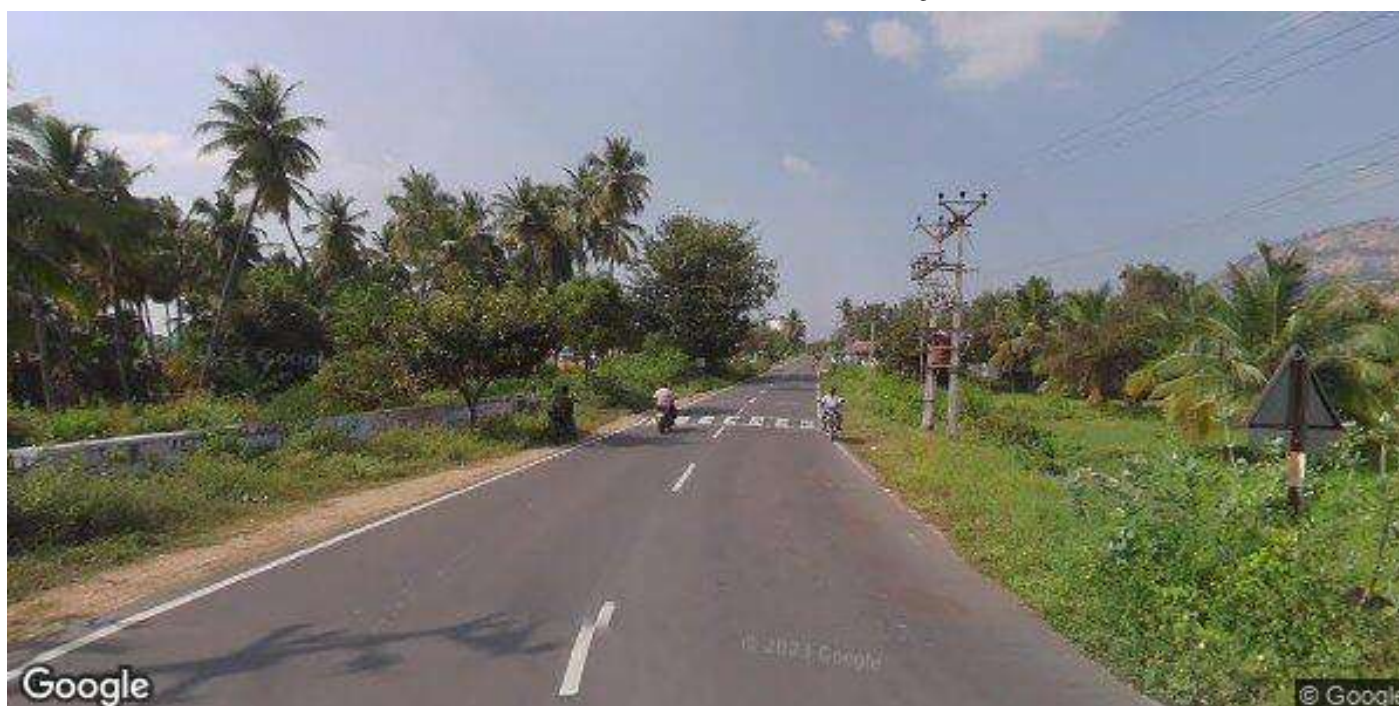
**Risk Type:** Turn  
**Risk Level:** High  
**Speed Limit:** 15 KM/Hr  
**Coordinates:** 11.45353, 77.85697

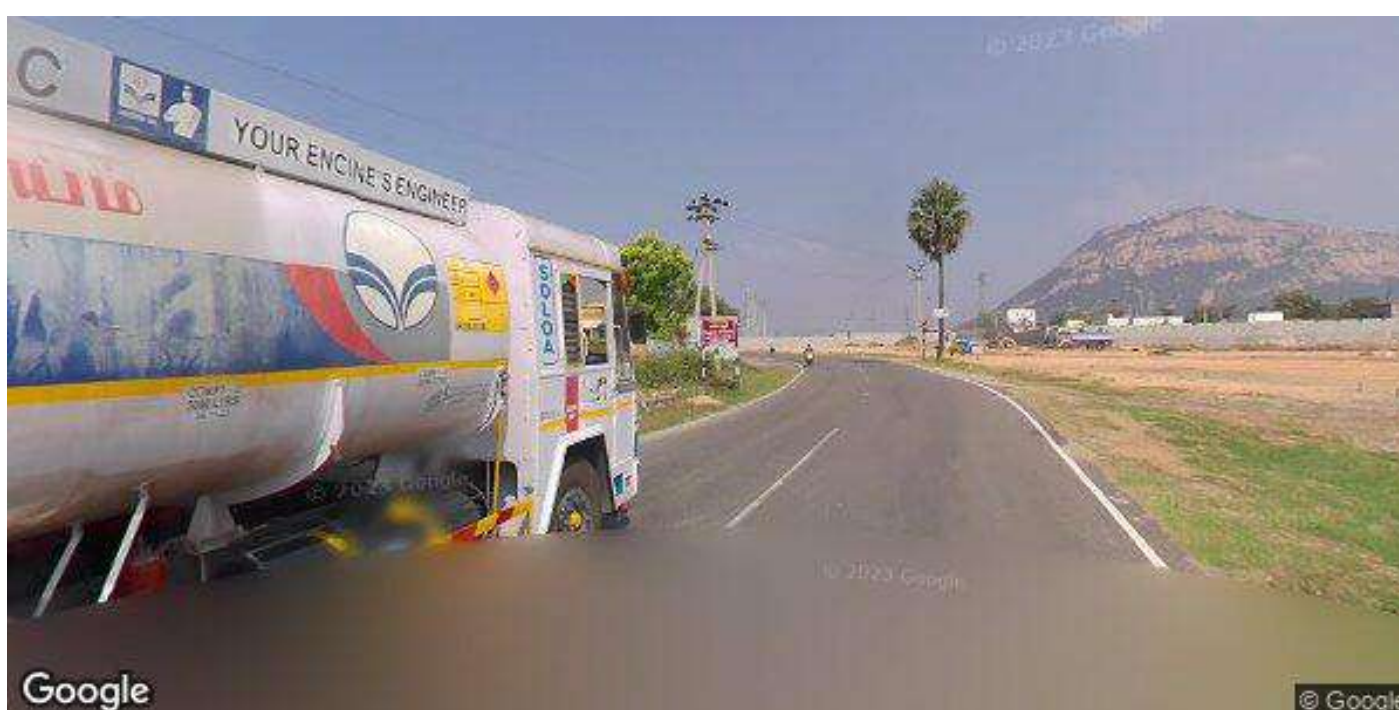
**Risk Type:** Turn  
**Risk Level:** Medium  
**Speed Limit:** 30 KM/Hr  
**Coordinates:** 11.45853, 77.85139

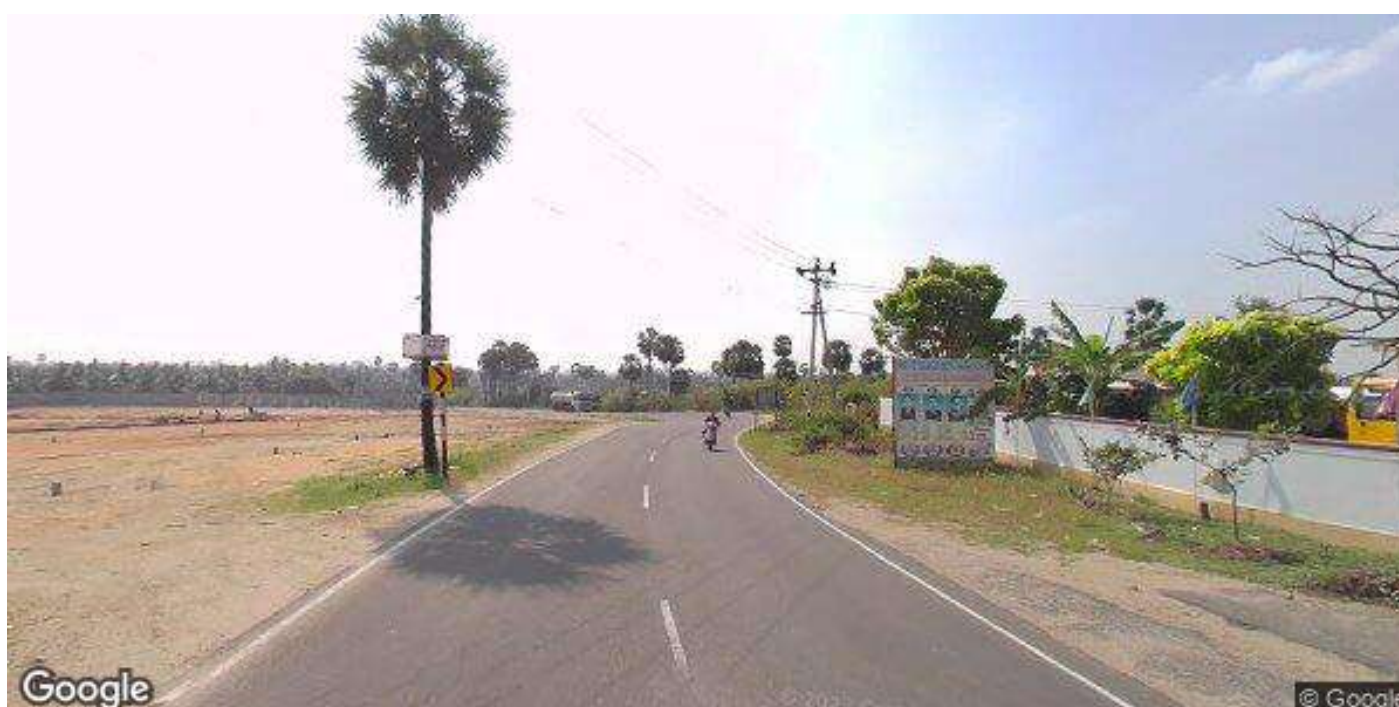
**Risk Type:** Turn  
**Risk Level:** Medium  
**Speed Limit:** 30 KM/Hr  
**Coordinates:** 11.45906, 77.85132

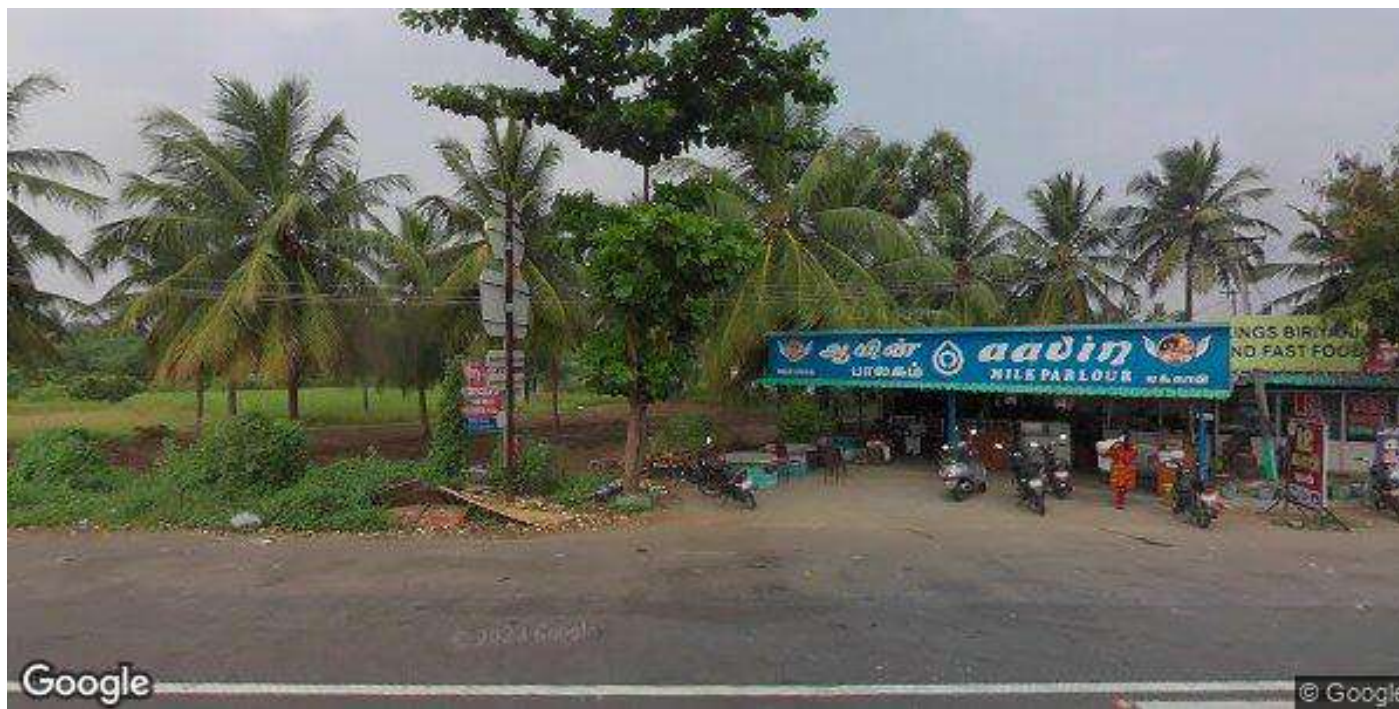
**Risk Type:** Blind Spot  
**Risk Level:** Blind Spot  
**Speed Limit:** 10 KM/Hr  
**Coordinates:** 11.45631, 77.81668

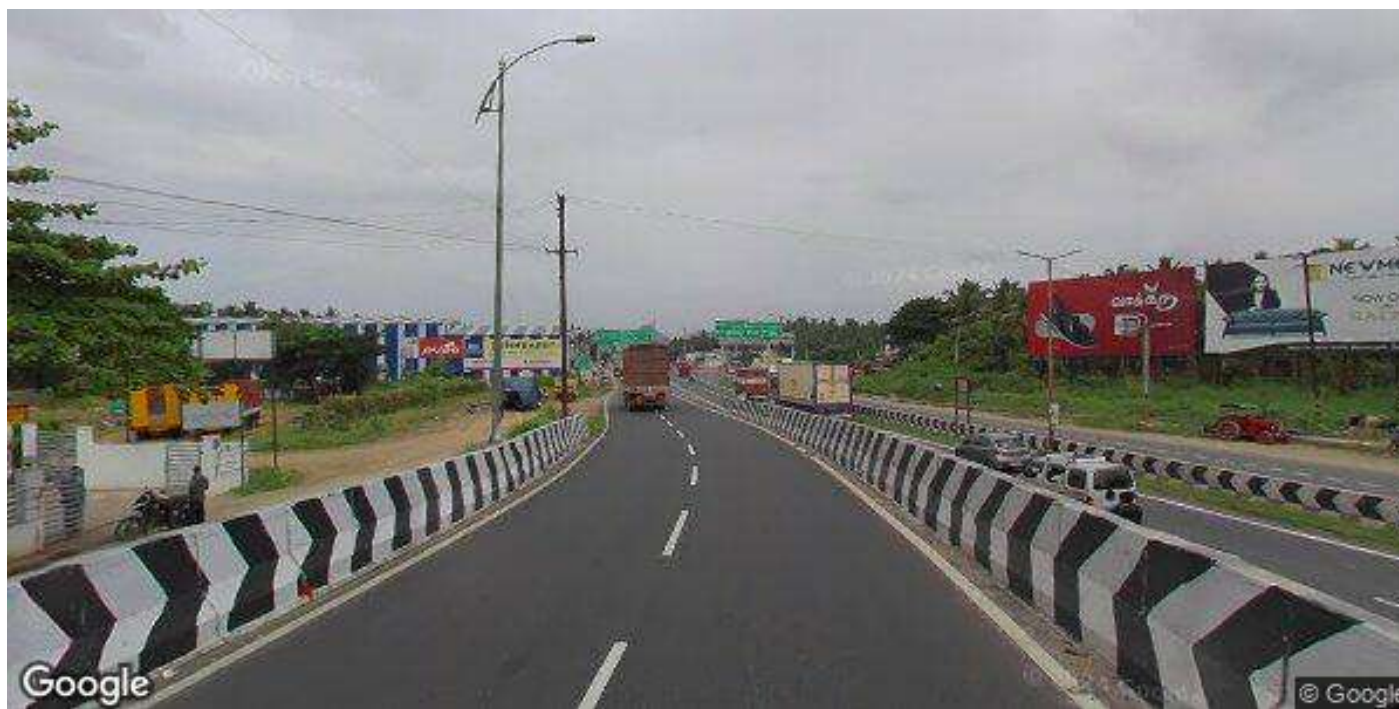
**Risk Type:** Turn  
**Risk Level:** Medium  
**Speed Limit:** 30 KM/Hr  
**Coordinates:** 11.64348, 78.12002

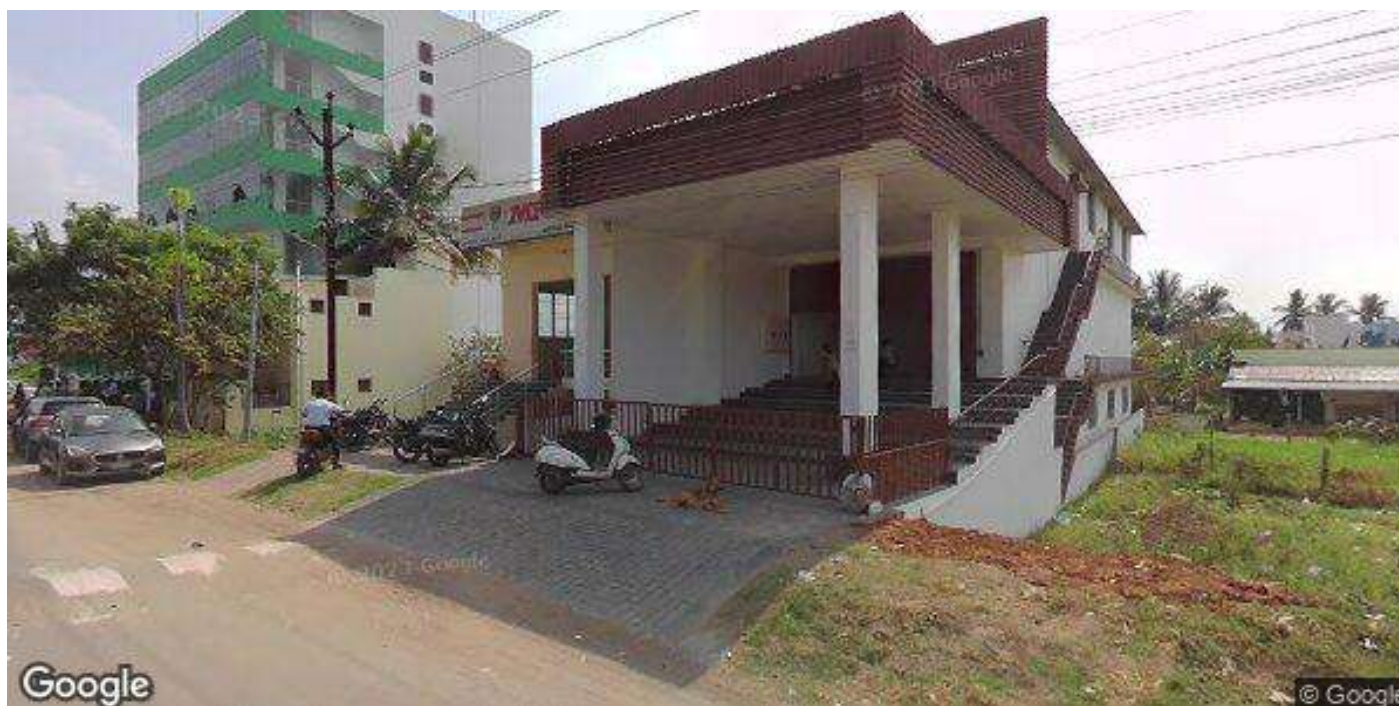
**Risk Type:** Turn  
**Risk Level:** High  
**Speed Limit:** 15 KM/Hr  
**Coordinates:** 11.69388, 78.10965

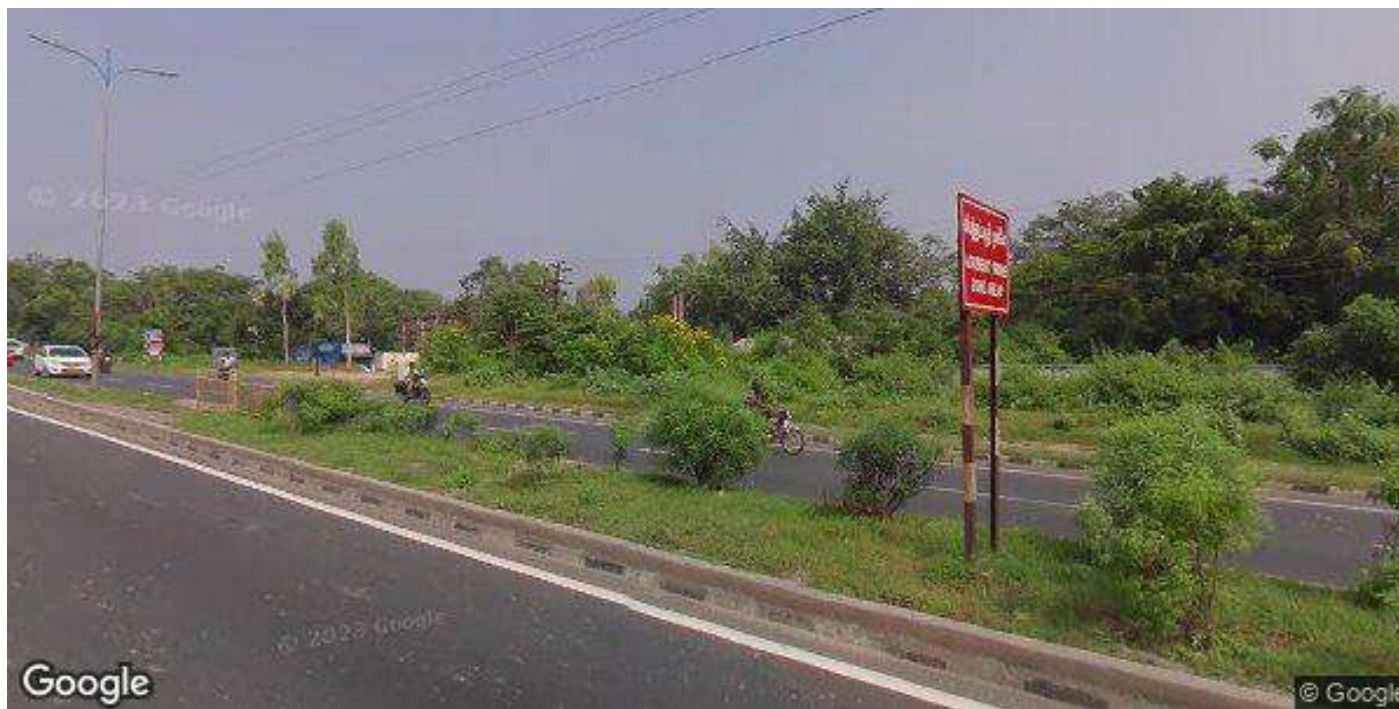
**Risk Type:** Turn  
**Risk Level:** High  
**Speed Limit:** 15 KM/Hr  
**Coordinates:** 11.69400, 78.10963

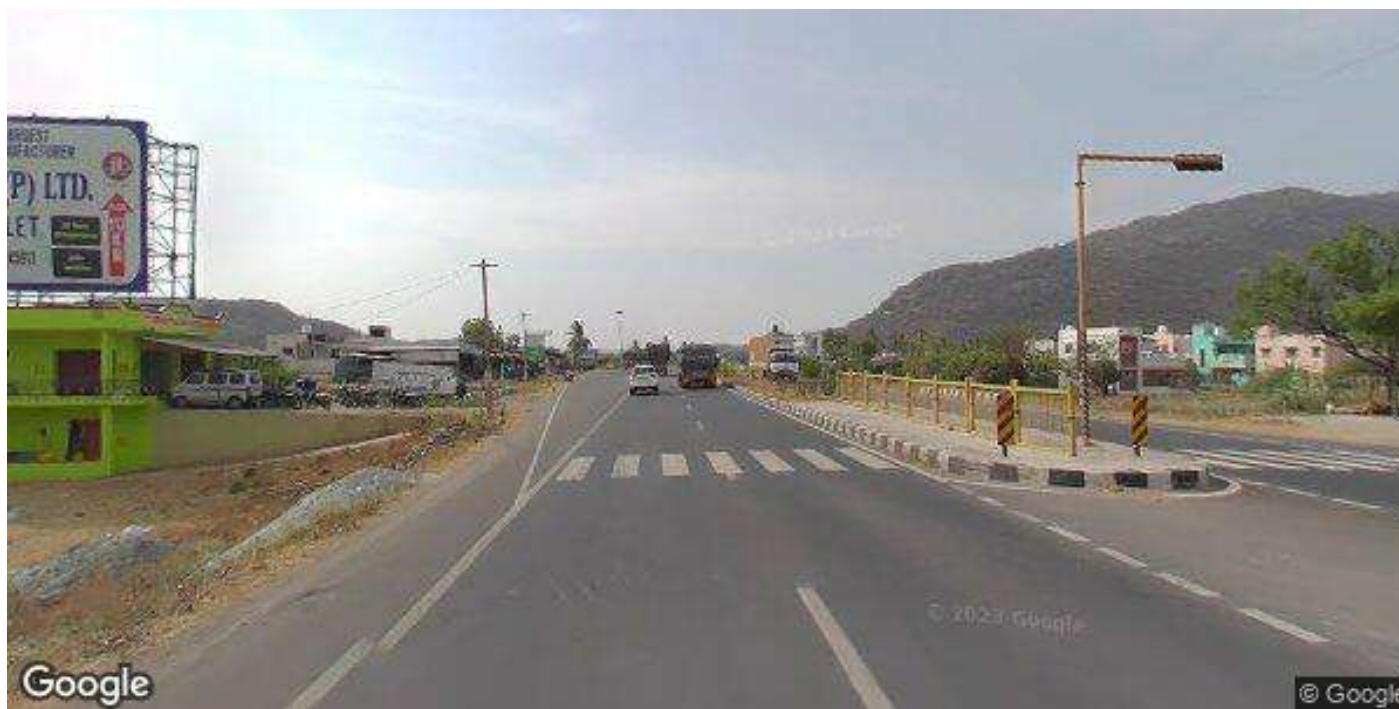
**Risk Type:** Turn  
**Risk Level:** High  
**Speed Limit:** 15 KM/Hr  
**Coordinates:** 11.88486, 78.07616

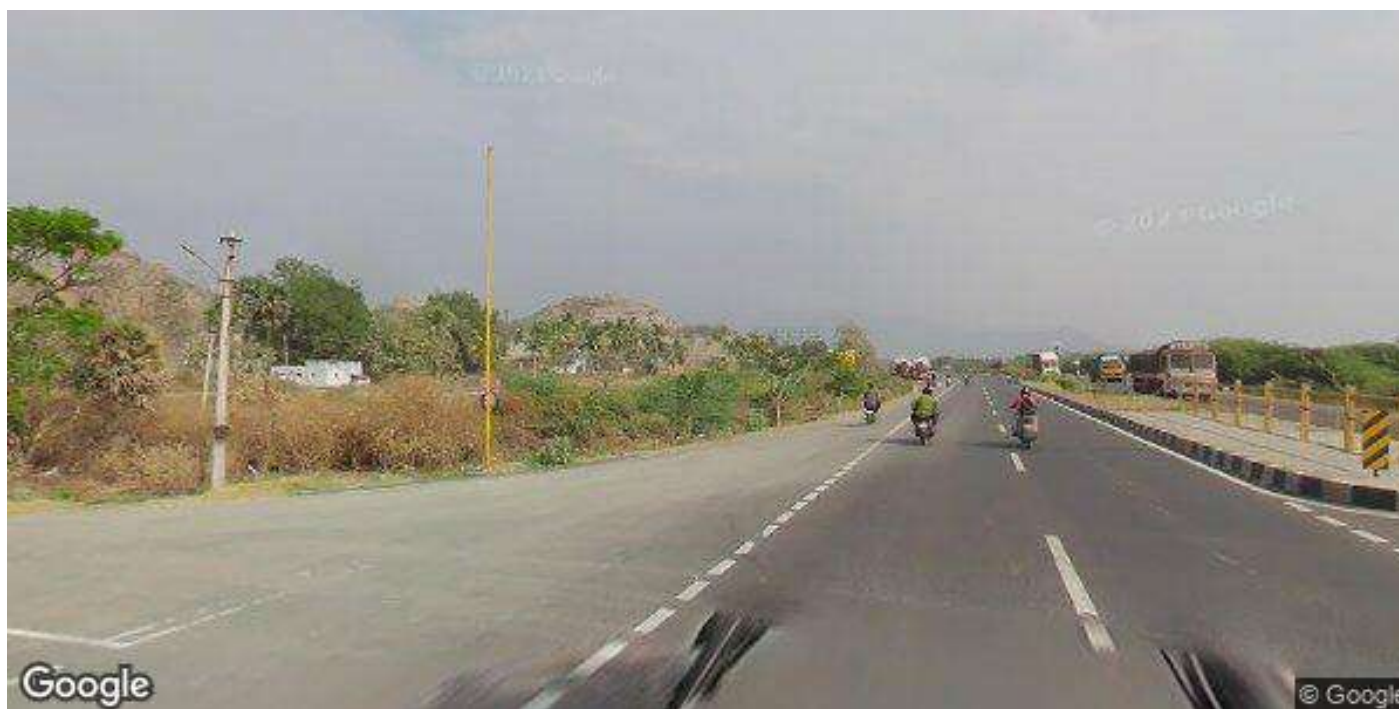
**Risk Type:** Blind Spot  
**Risk Level:** Blind Spot  
**Speed Limit:** 10 KM/Hr  
**Coordinates:** 11.88494, 78.07624

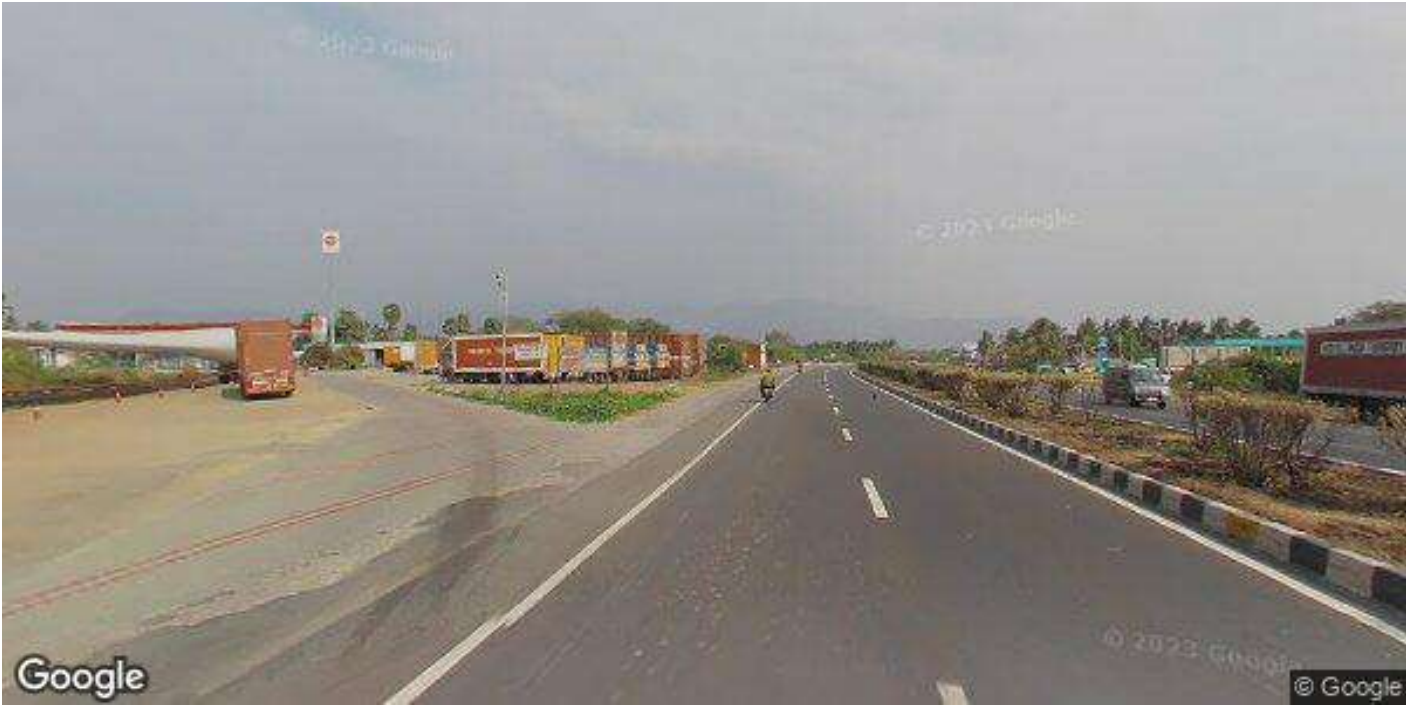
**Risk Type:** Turn  
**Risk Level:** Medium  
**Speed Limit:** 30 KM/Hr  
**Coordinates:** 11.88197, 78.07989
