## JOURNEY RISK MANAGEMENT (JRM) STUDY

### Salem Terminal TO AARTHI AGENCIES

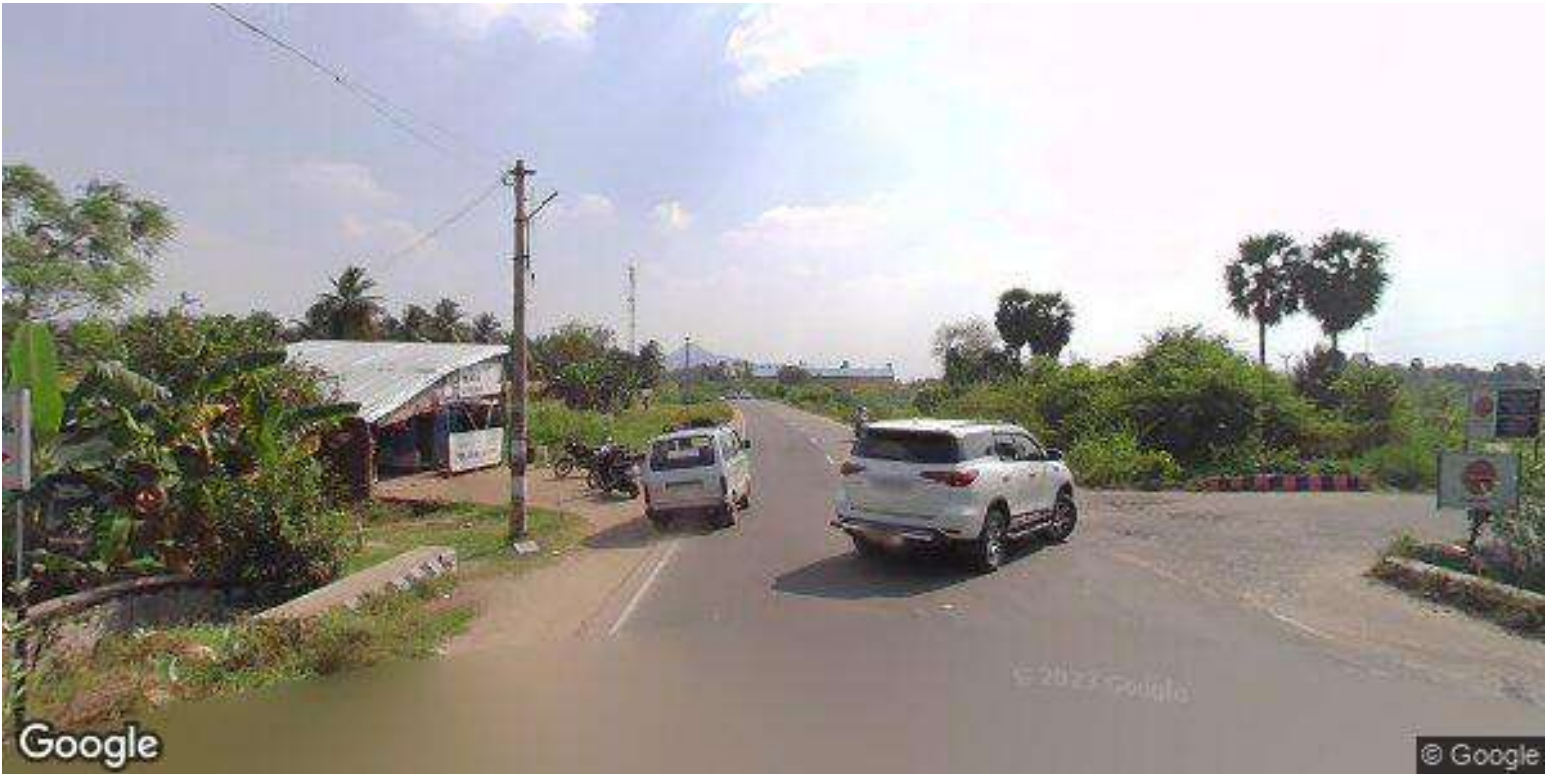
Coordinates: 11.44029, 77.87544

Risk Type: Turn

Risk Level: High

Speed Limit: 15 KM/Hr

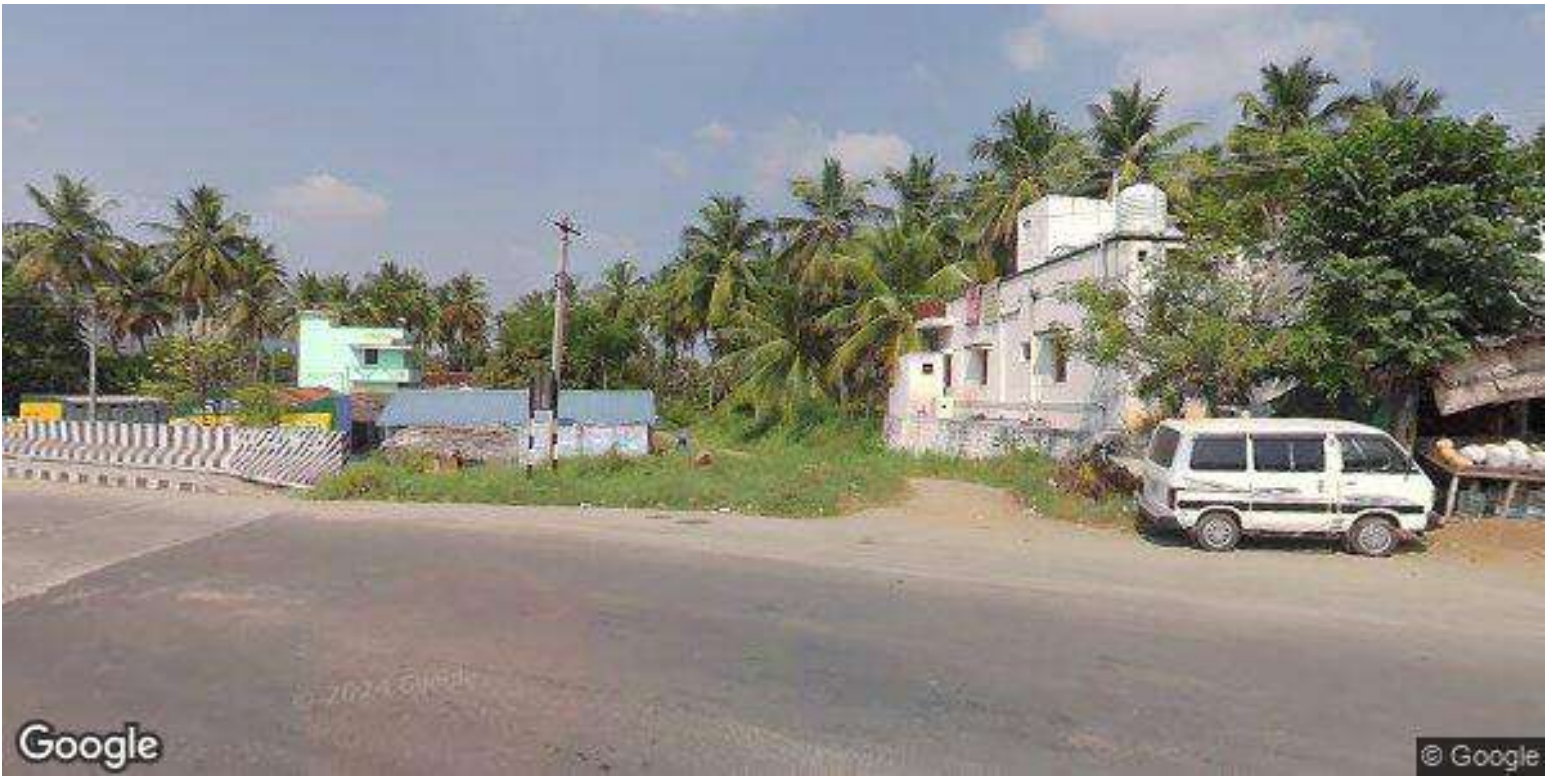
**Risk Type:** Turn  
**Risk Level:** Medium  
**Speed Limit:** 30 KM/Hr  
**Coordinates:** 11.44898, 77.87410

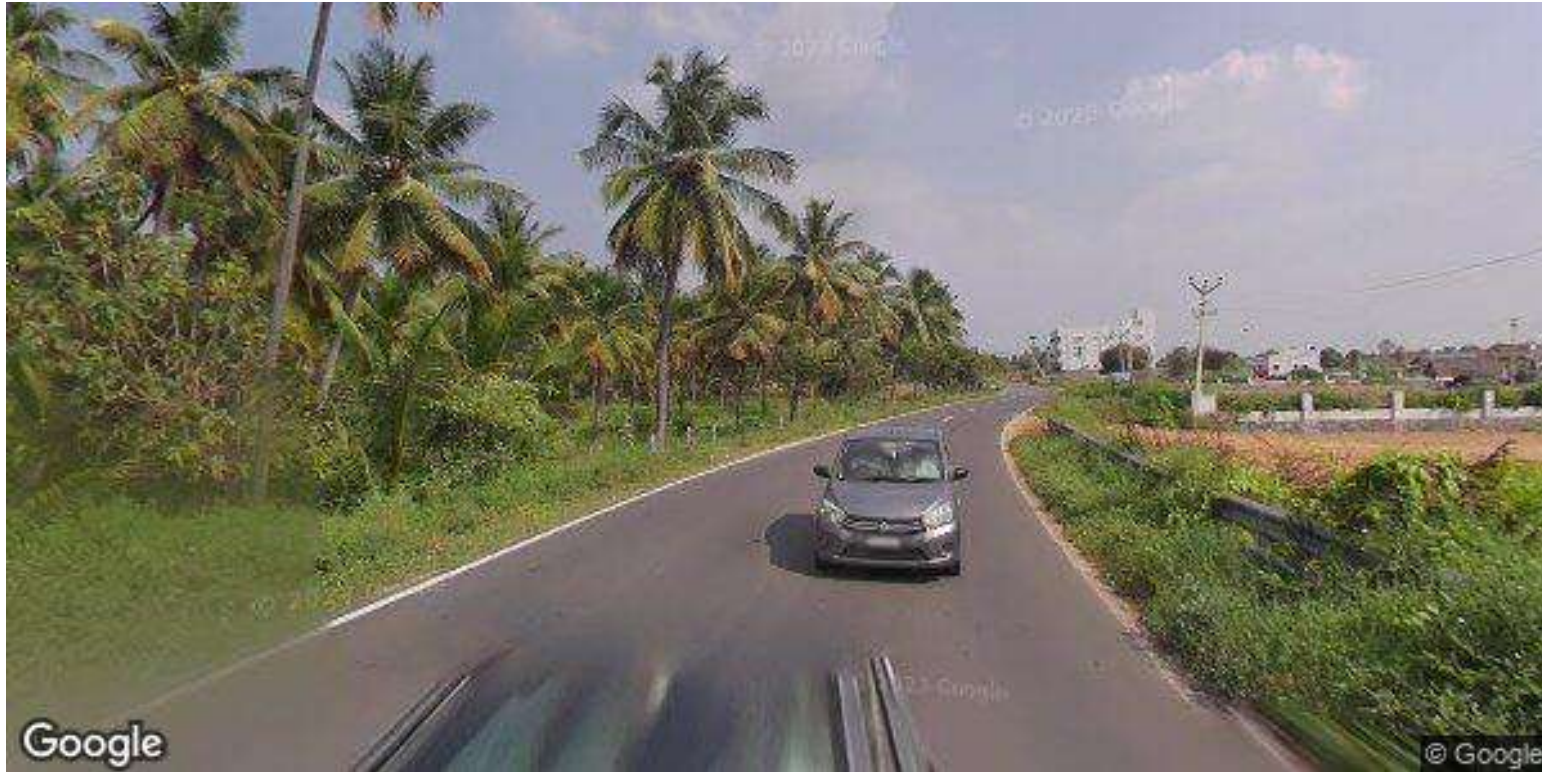
**Risk Type:** Turn  
**Risk Level:** Medium  
**Speed Limit:** 30 KM/Hr  
**Coordinates:** 11.45357, 77.85789

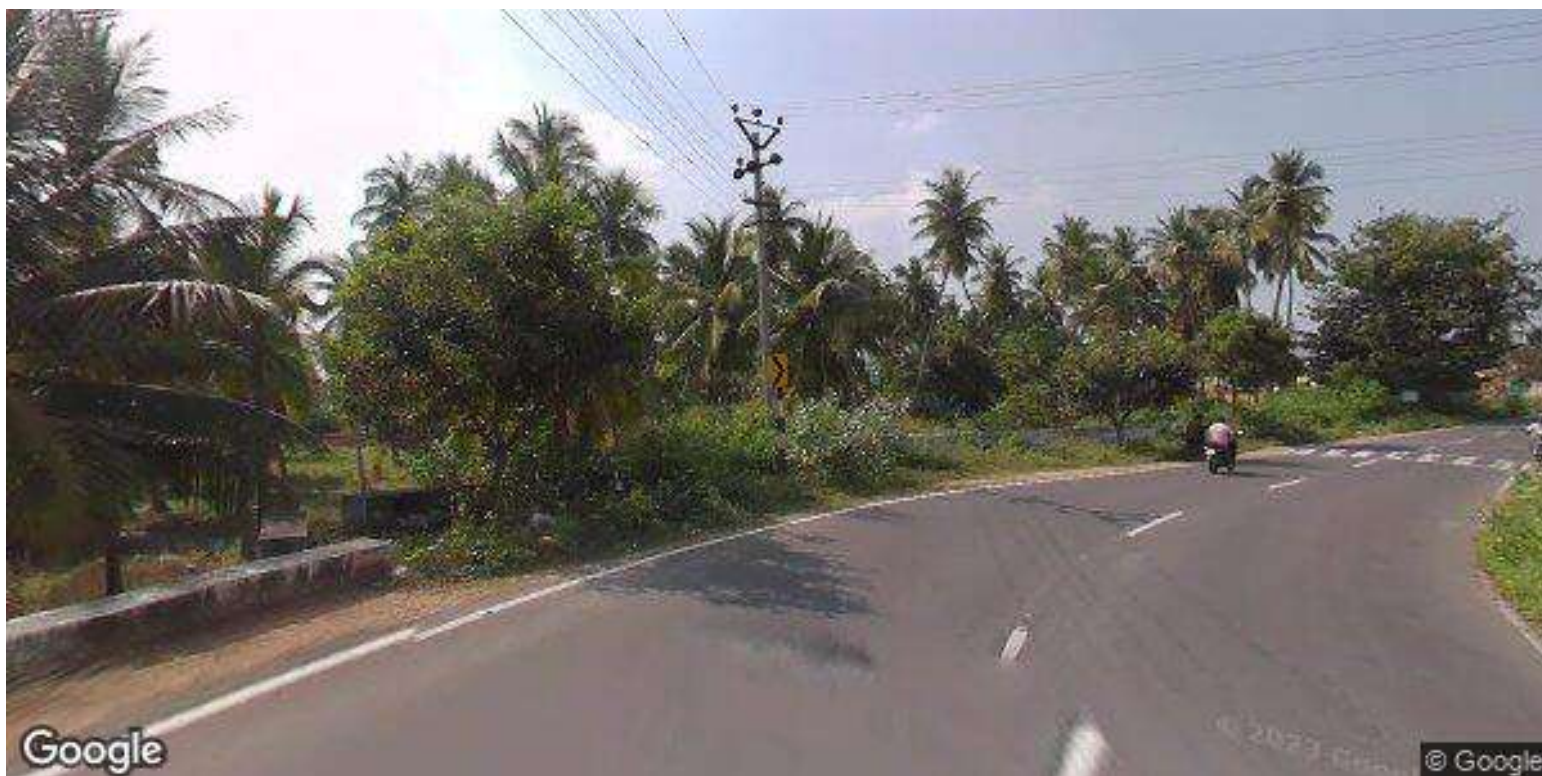
**Risk Type:** Turn  
**Risk Level:** Medium  
**Speed Limit:** 30 KM/Hr  
**Coordinates:** 11.45348, 77.85706

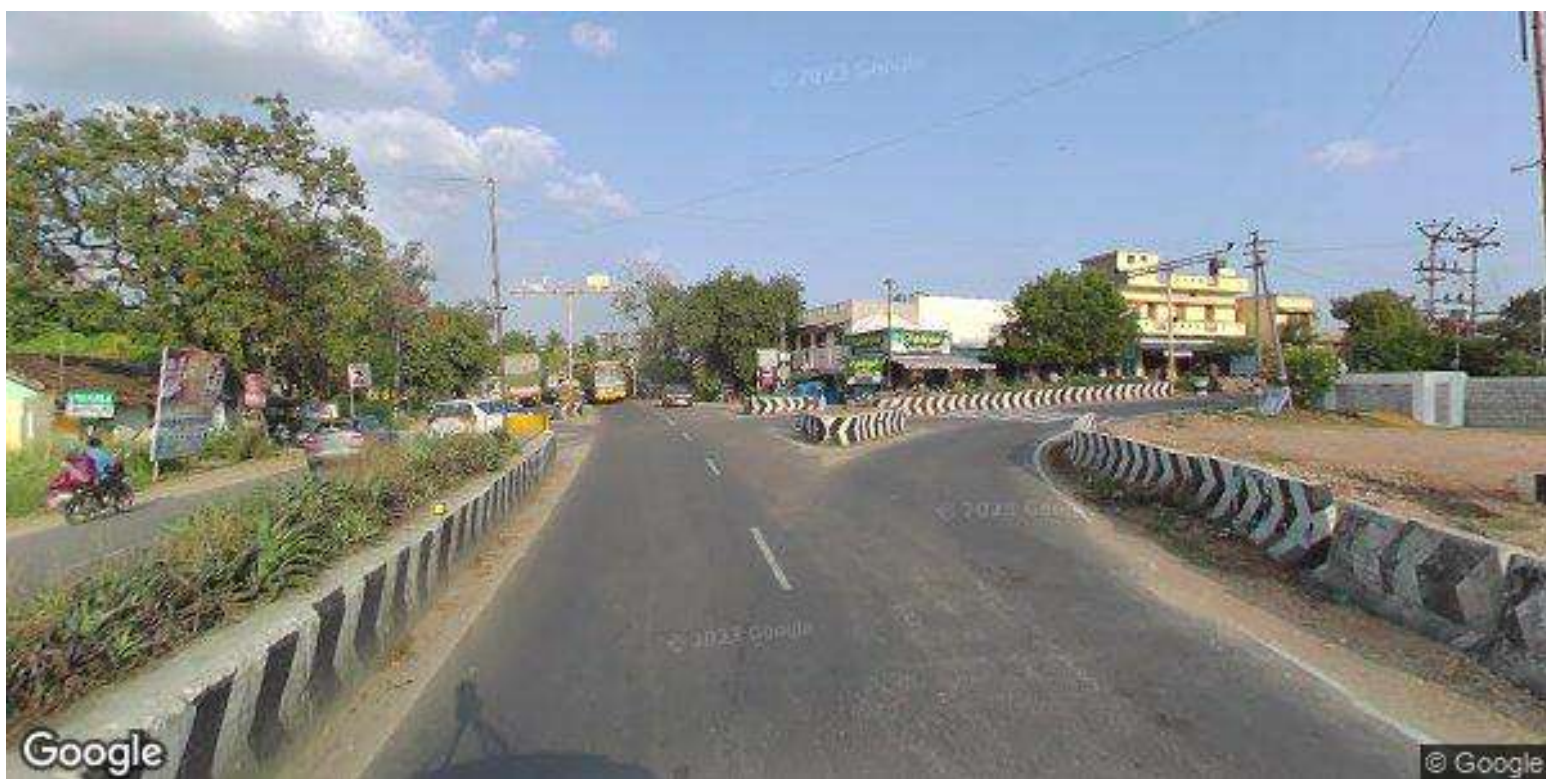
**Coordinates:** 11.46318, 77.84913

**Risk Type:** Turn

**Risk Level:** Medium

**Speed Limit:** 30 KM/Hr

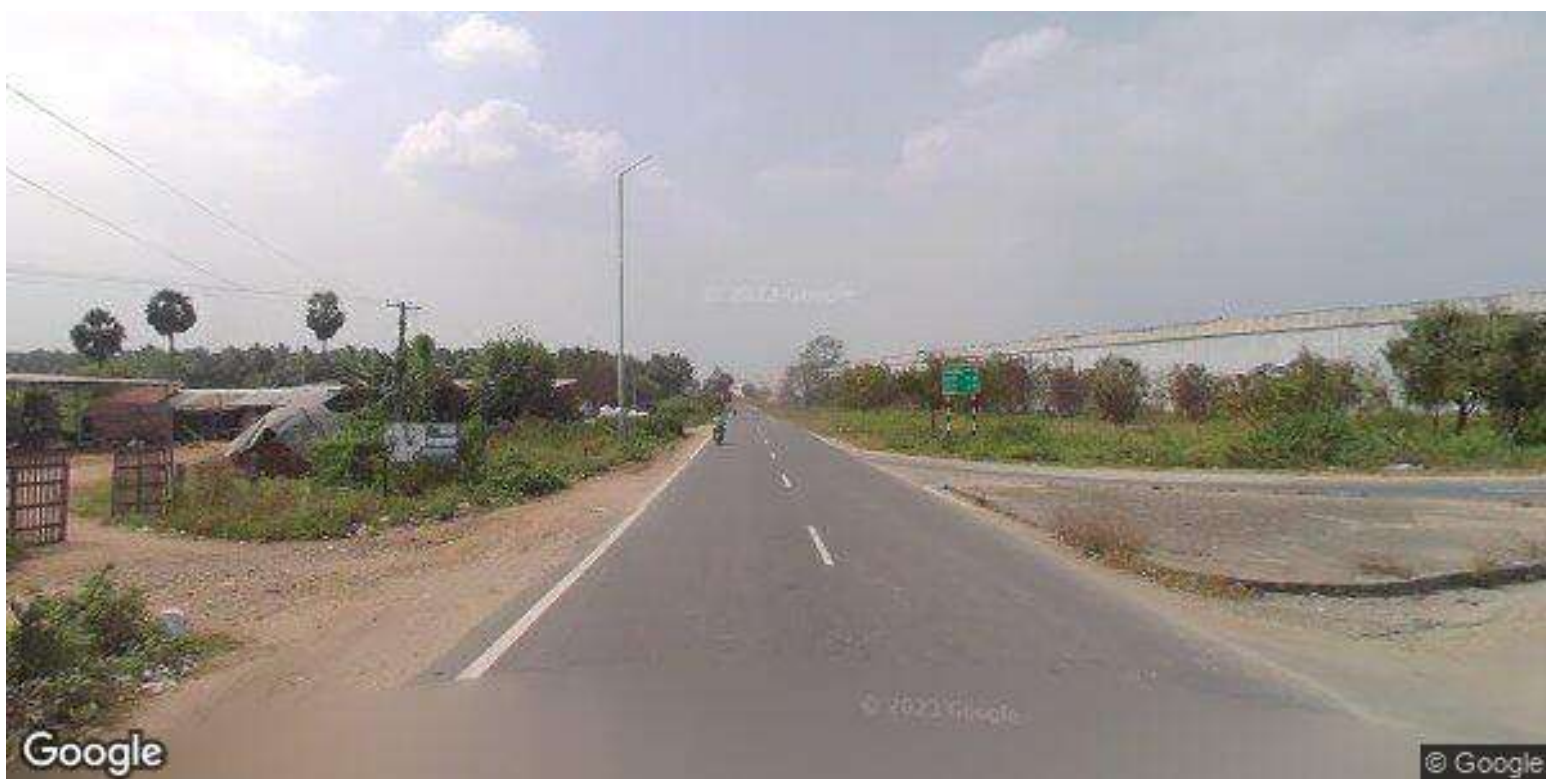
**Risk Type:** Turn  
**Risk Level:** High  
**Speed Limit:** 15 KM/Hr  
**Coordinates:** 11.45542, 77.81725

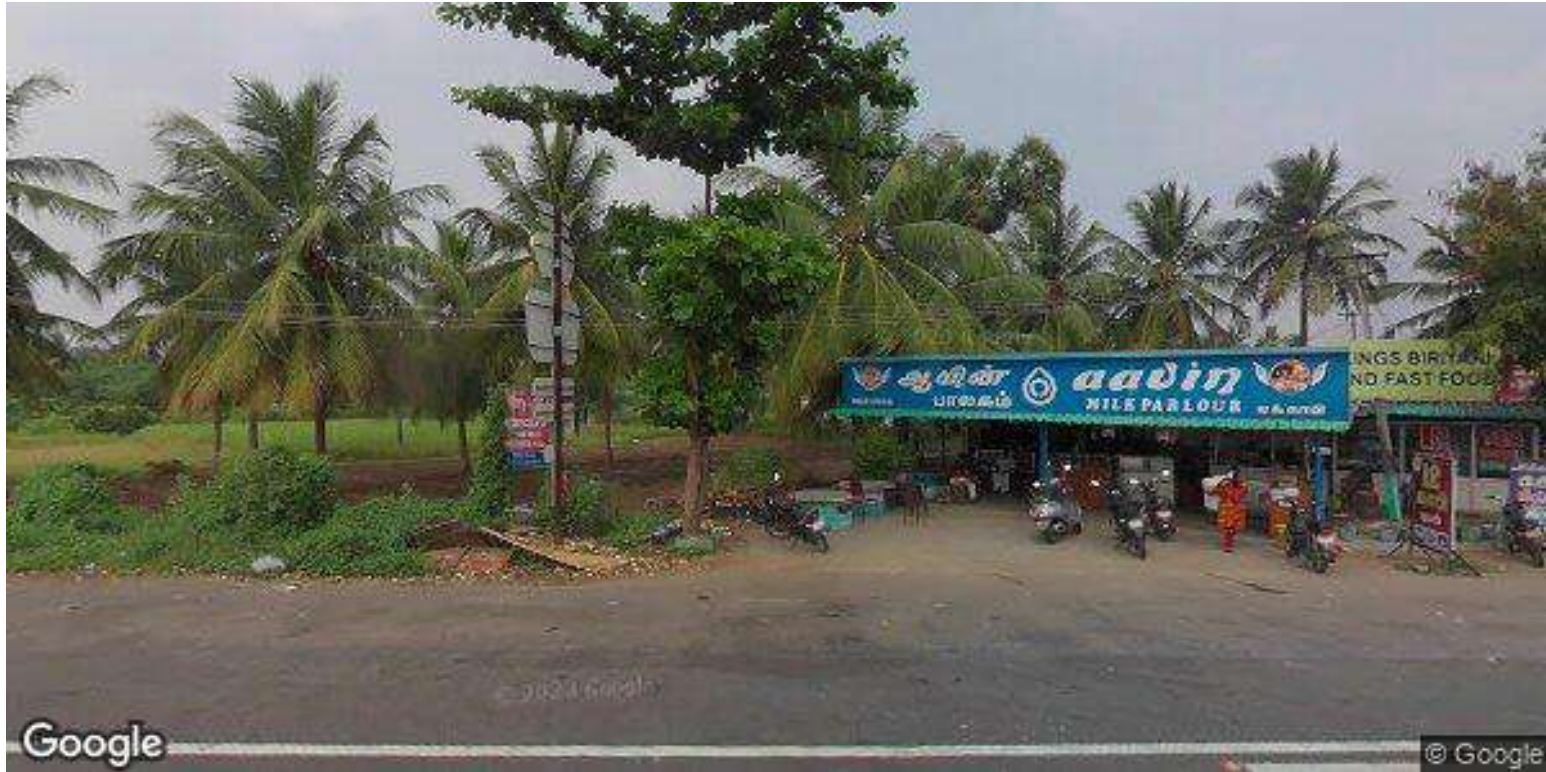
**Risk Type:** Turn  
**Risk Level:** High  
**Speed Limit:** 15 KM/Hr  
**Coordinates:** 11.45631, 77.81668

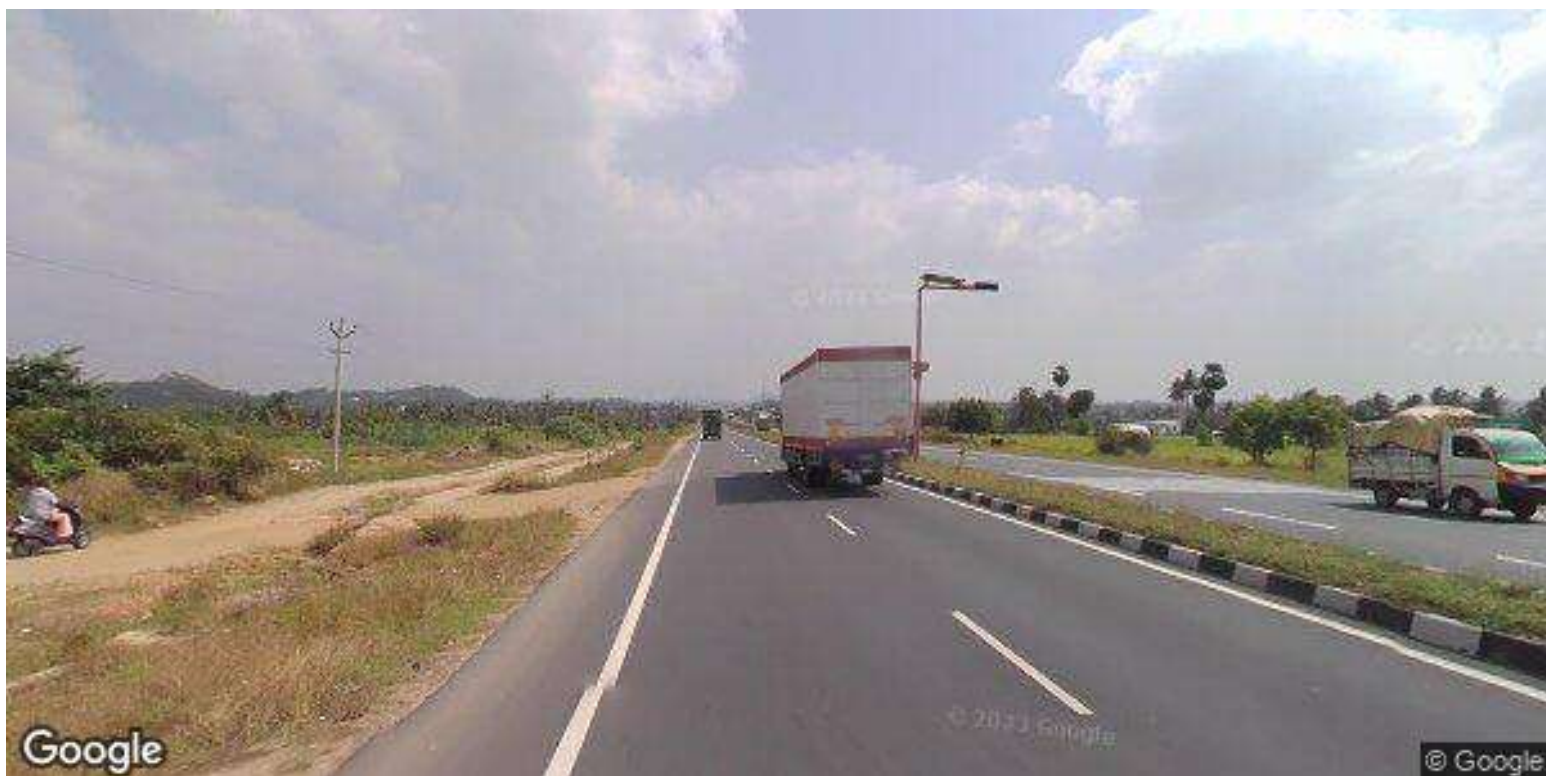
**Risk Type:** Turn  
**Risk Level:** High  
**Speed Limit:** 15 KM/Hr  
**Coordinates:** 11.49409, 77.88004

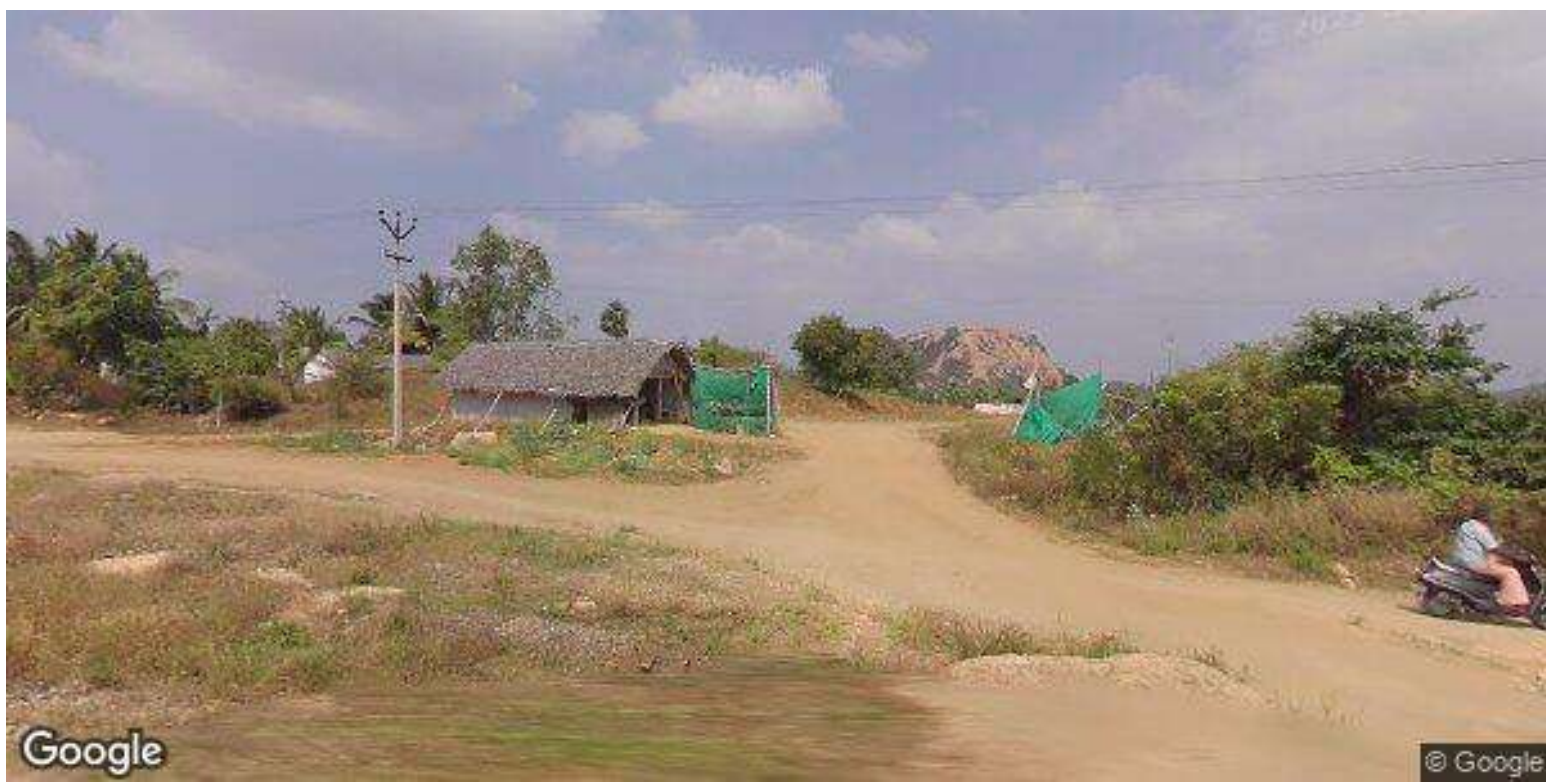
**Coordinates:** 11.49419, 77.88015

**Risk Type:** Turn

**Risk Level:** Medium

**Speed Limit:** 30 KM/Hr

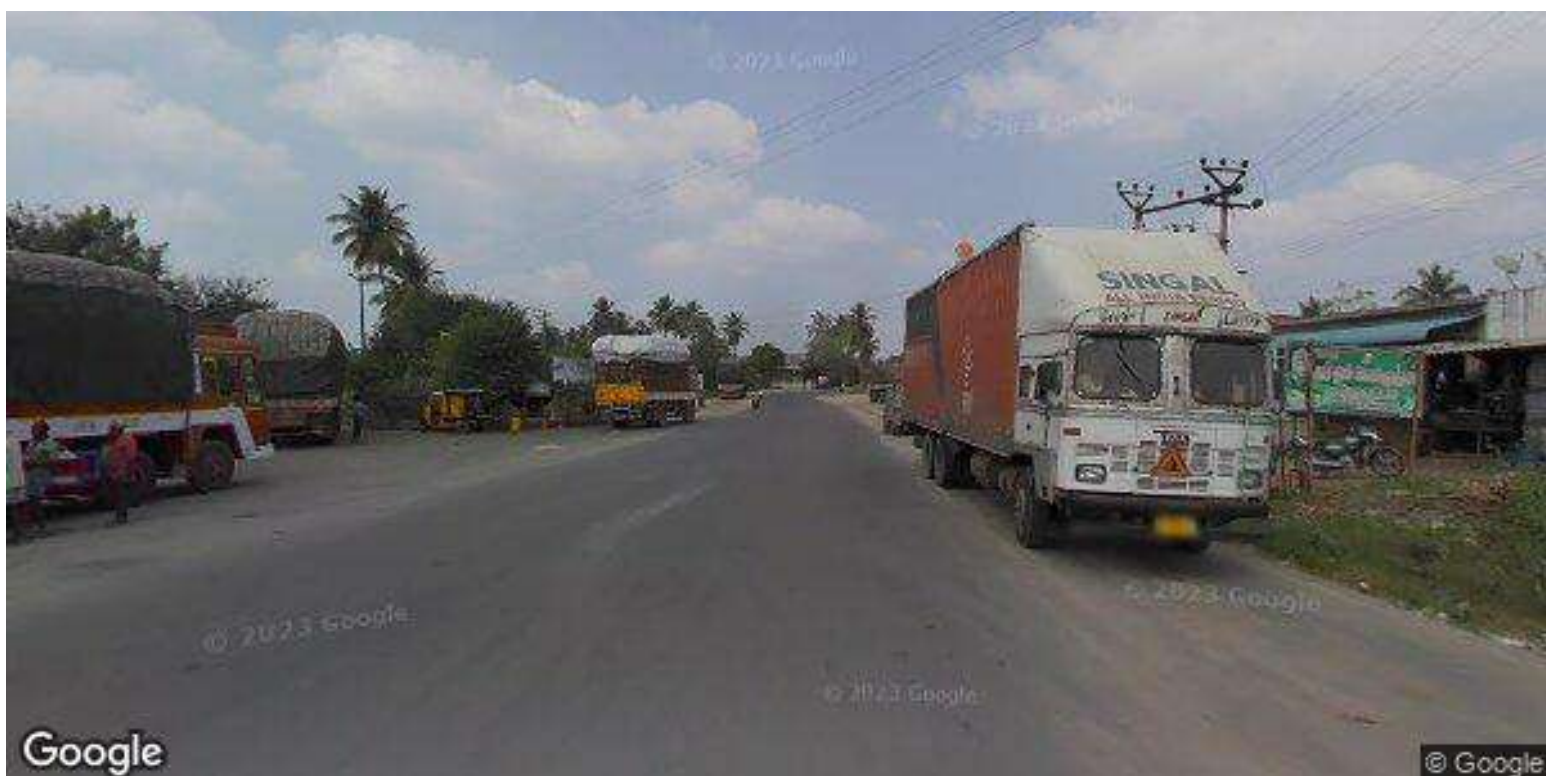
**Coordinates:** 11.49377, 77.88573

**Risk Type:** Turn

**Risk Level:** Medium

**Speed Limit:** 30 KM/Hr

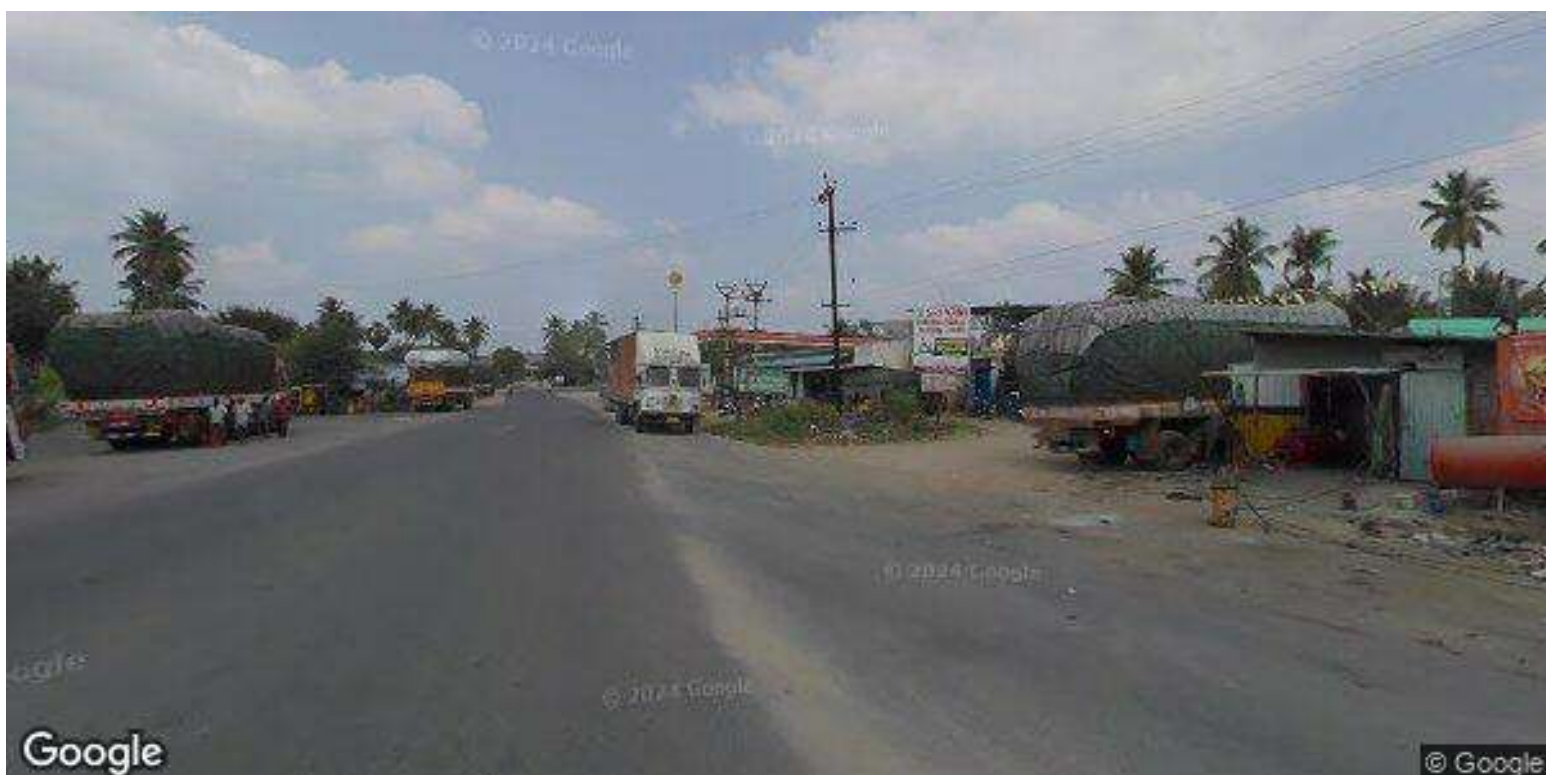
**Risk Type:** Turn  
**Risk Level:** High  
**Speed Limit:** 15 KM/Hr  
**Coordinates:** 11.49363, 77.88590

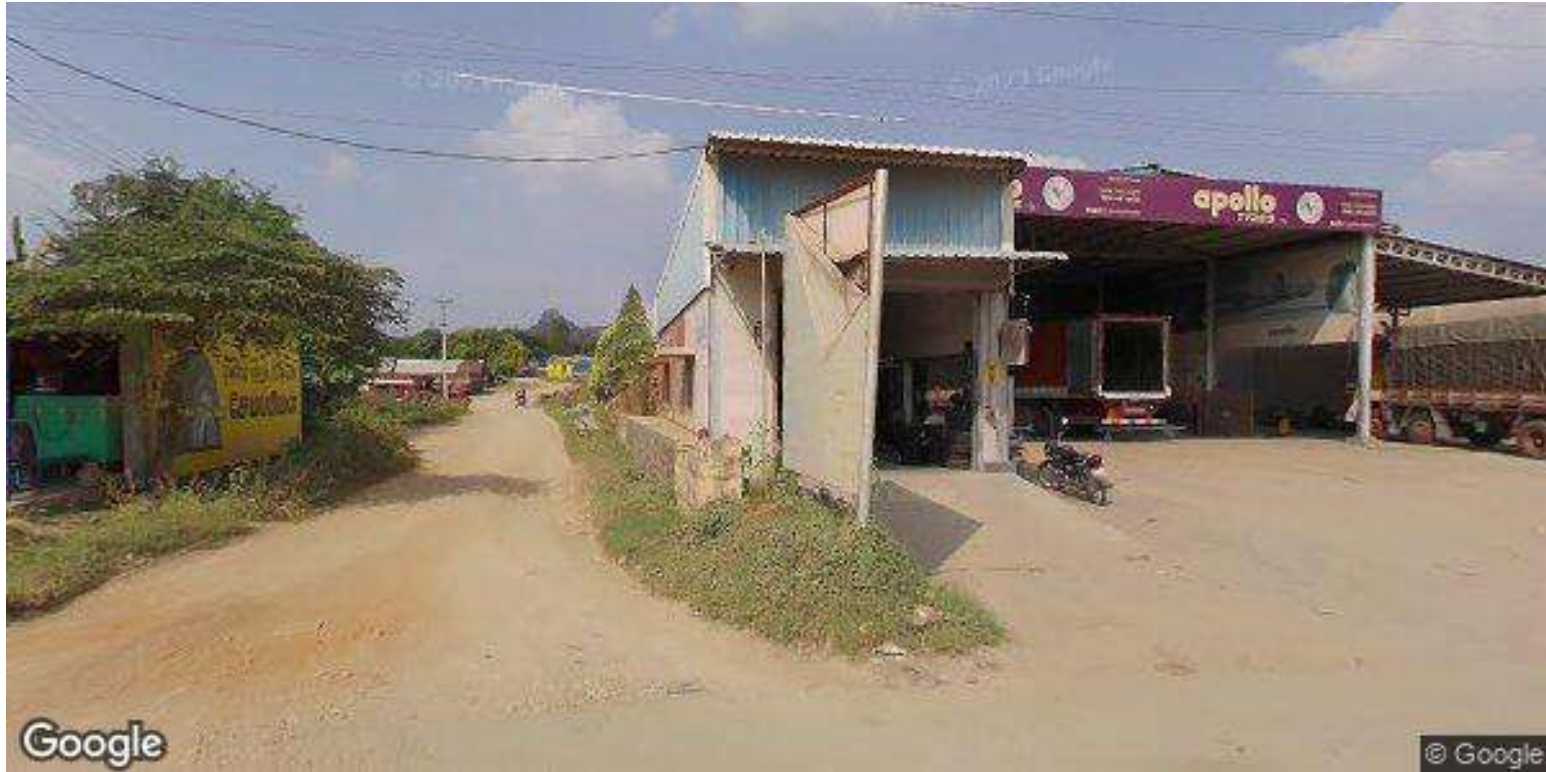
**Risk Type:** Turn  
**Risk Level:** High  
**Speed Limit:** 15 KM/Hr  
**Coordinates:** 11.49235, 77.89561

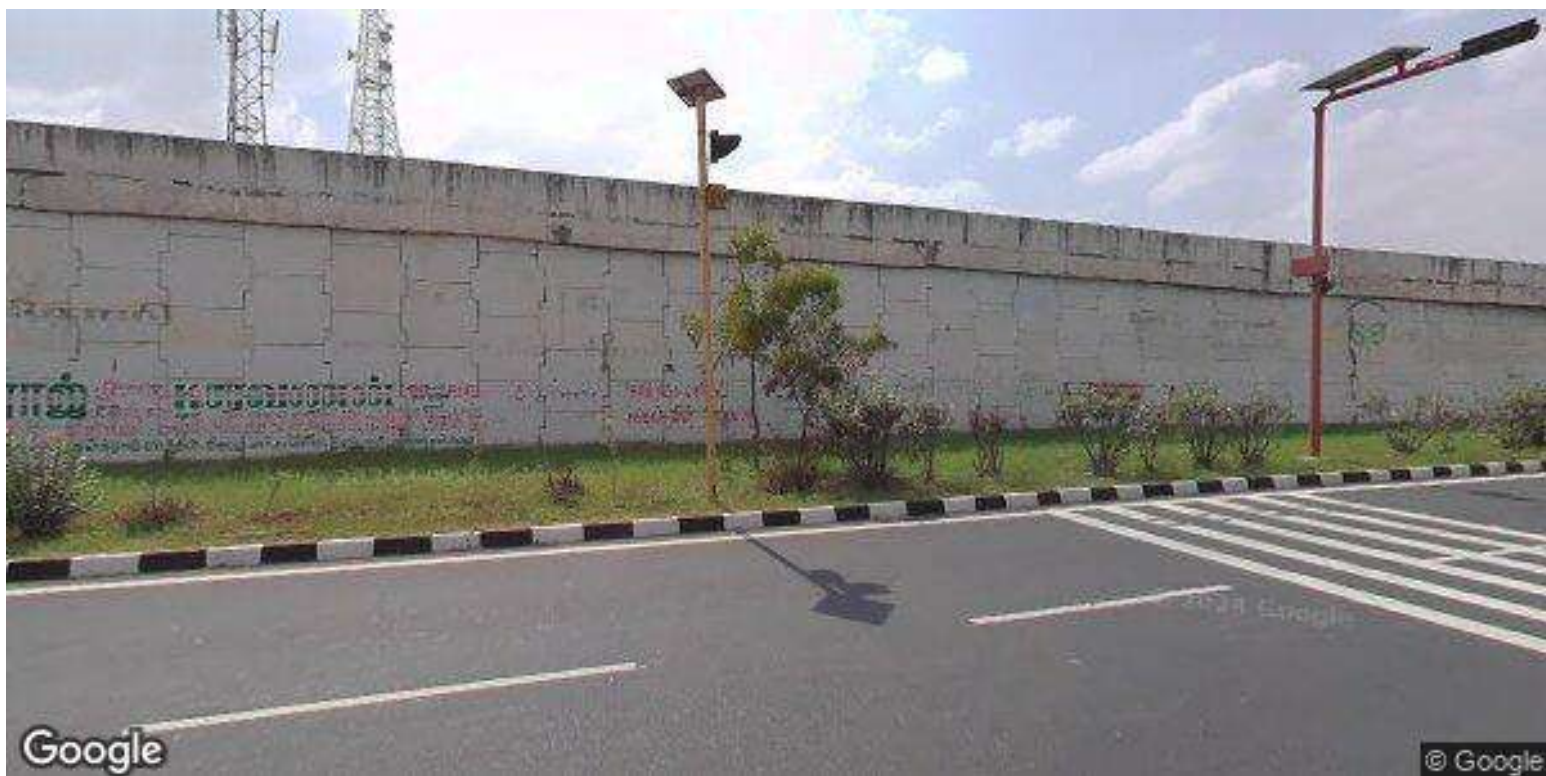
**Risk Type:** Blind Spot  
**Risk Level:** Blind Spot  
**Speed Limit:** 10 KM/Hr  
**Coordinates:** 11.49225, 77.89560
