# IndianOil

## JOURNEY RISK MANAGEMENT (JRM) STUDY

### Salem Terminal TO PRASANA FUELS

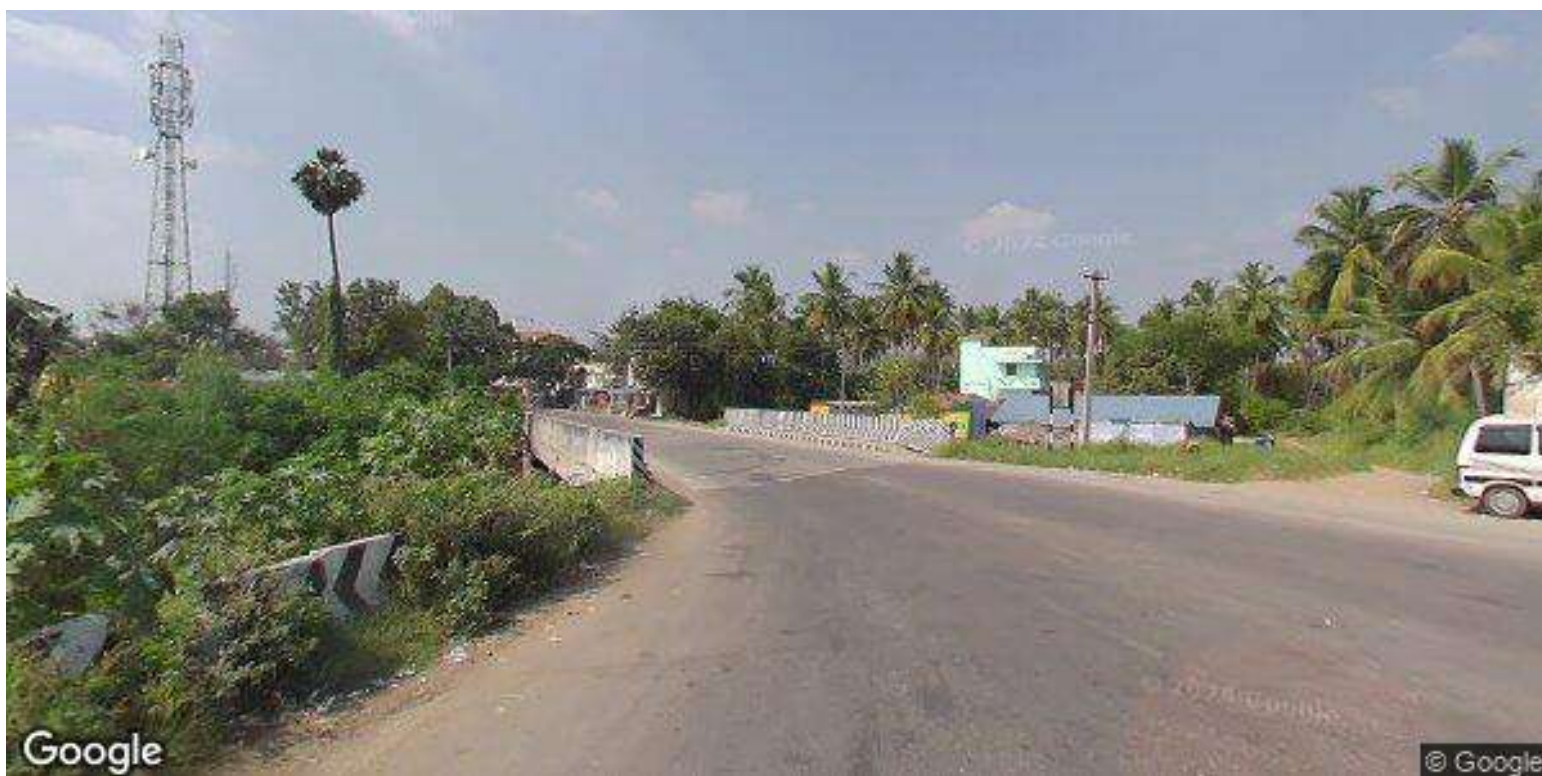
**Coordinates:** 11.44893, 77.87413

**Risk Type:** Turn

**Speed Limit:** 15 KM/Hr

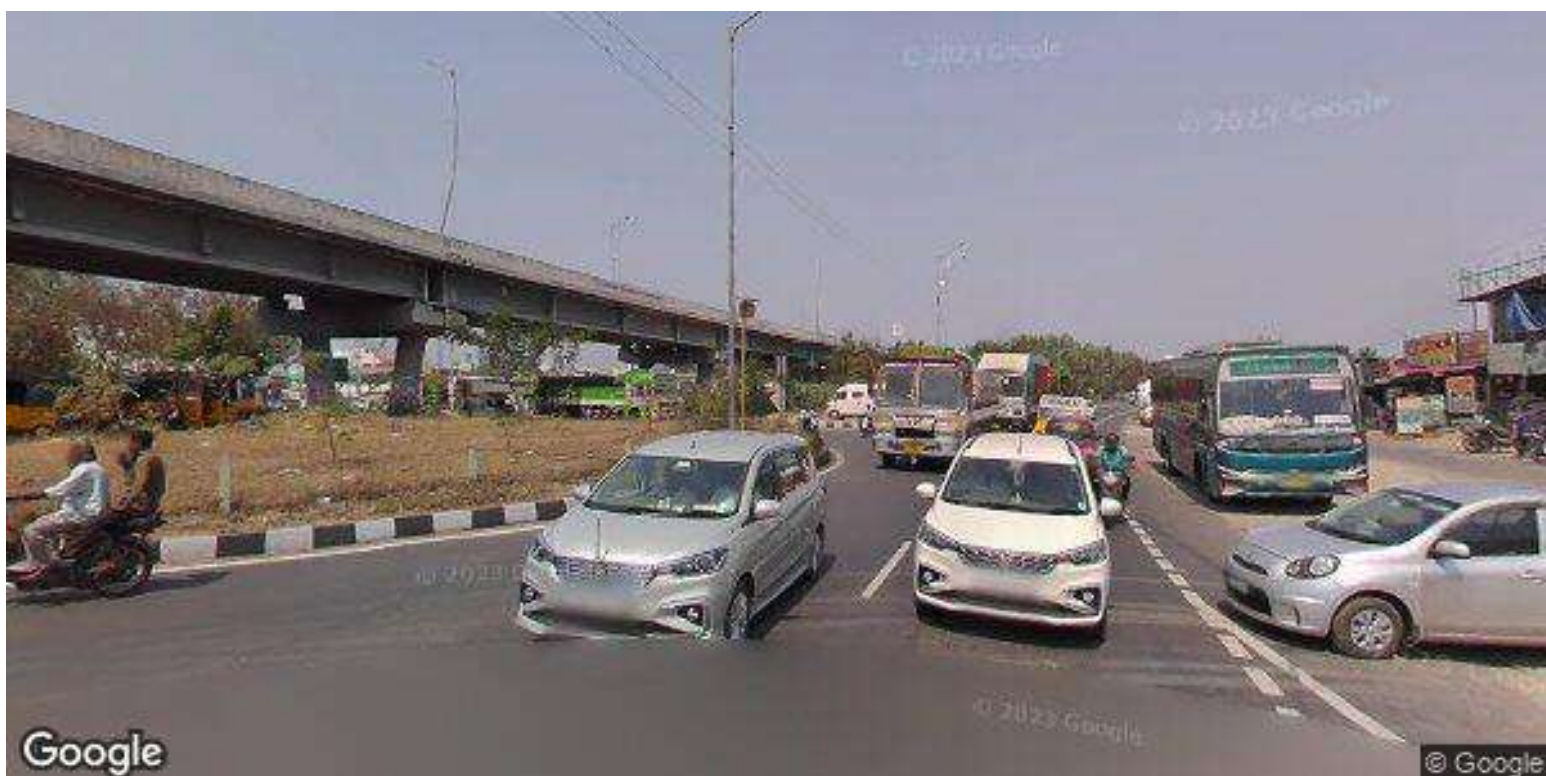
**Coordinates:** 11.43001, 77.67575

**Risk Type:** Turn

**Speed Limit:** 15 KM/Hr

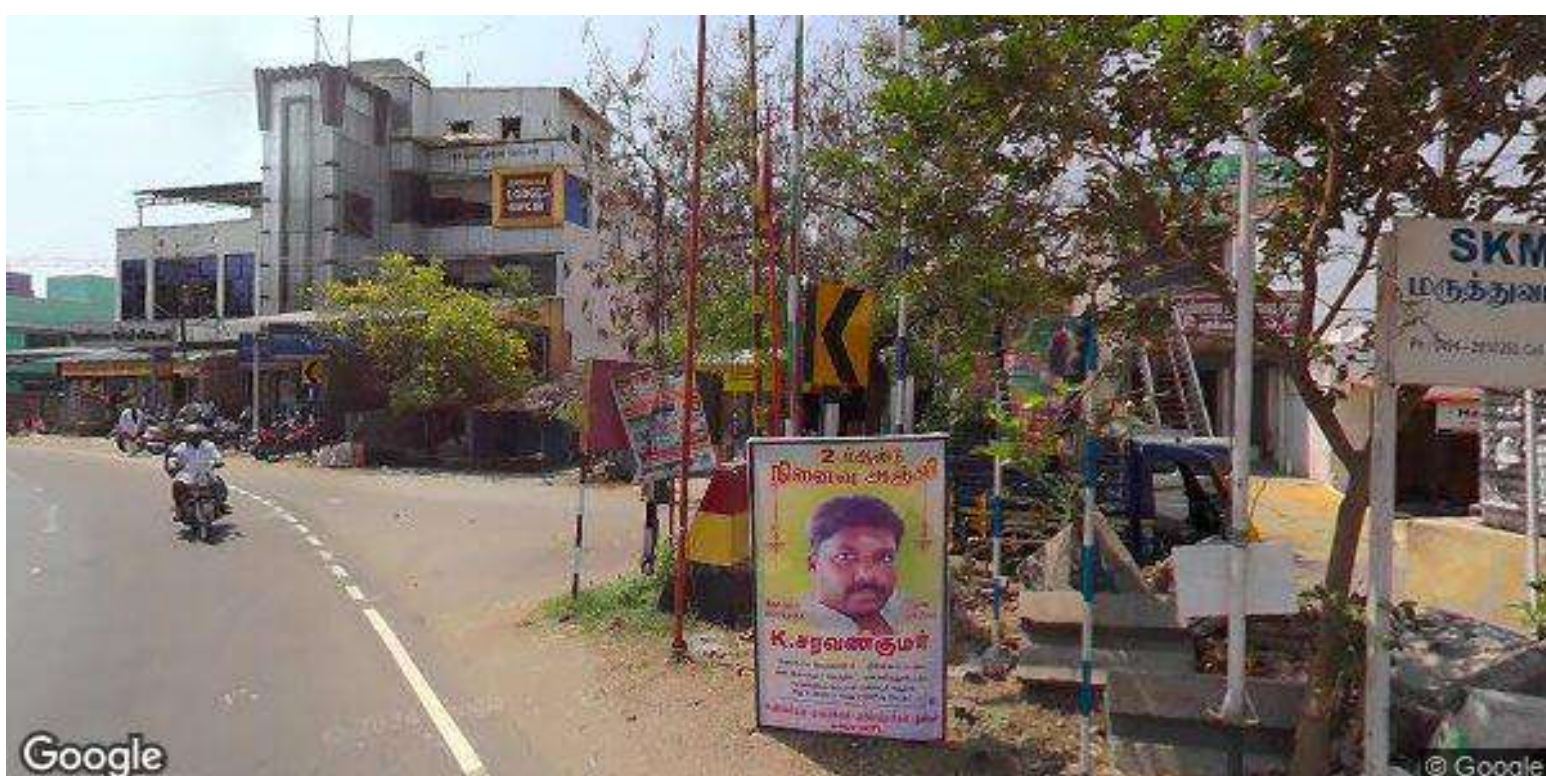
**Coordinates: 11.43782, 77.67821**

**Risk Type: Turn**

**Speed Limit: 15 KM/Hr**

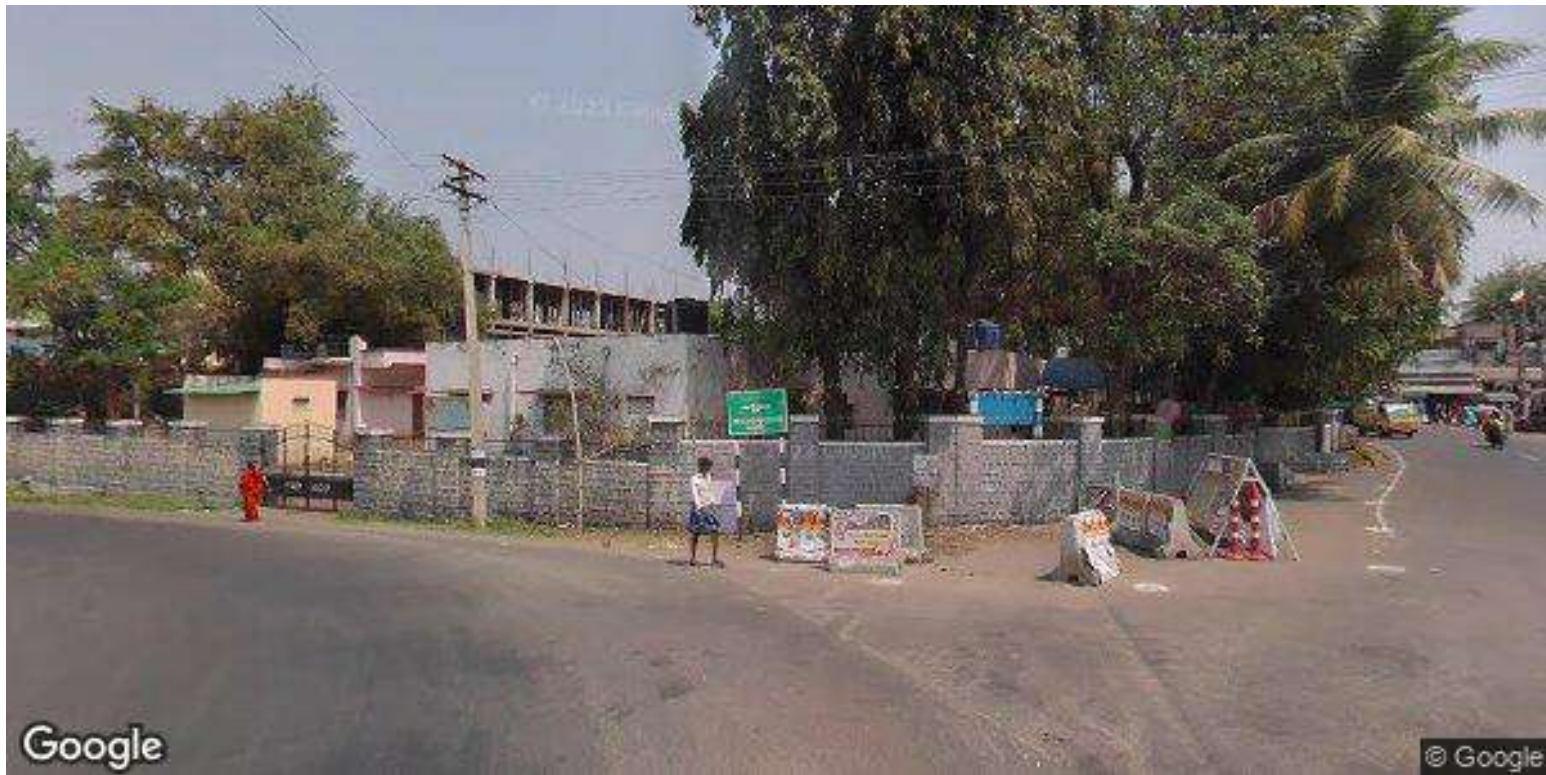
**Coordinates: 11.43865, 77.68226**

**Risk Type: Turn**

**Speed Limit: 15 KM/Hr**

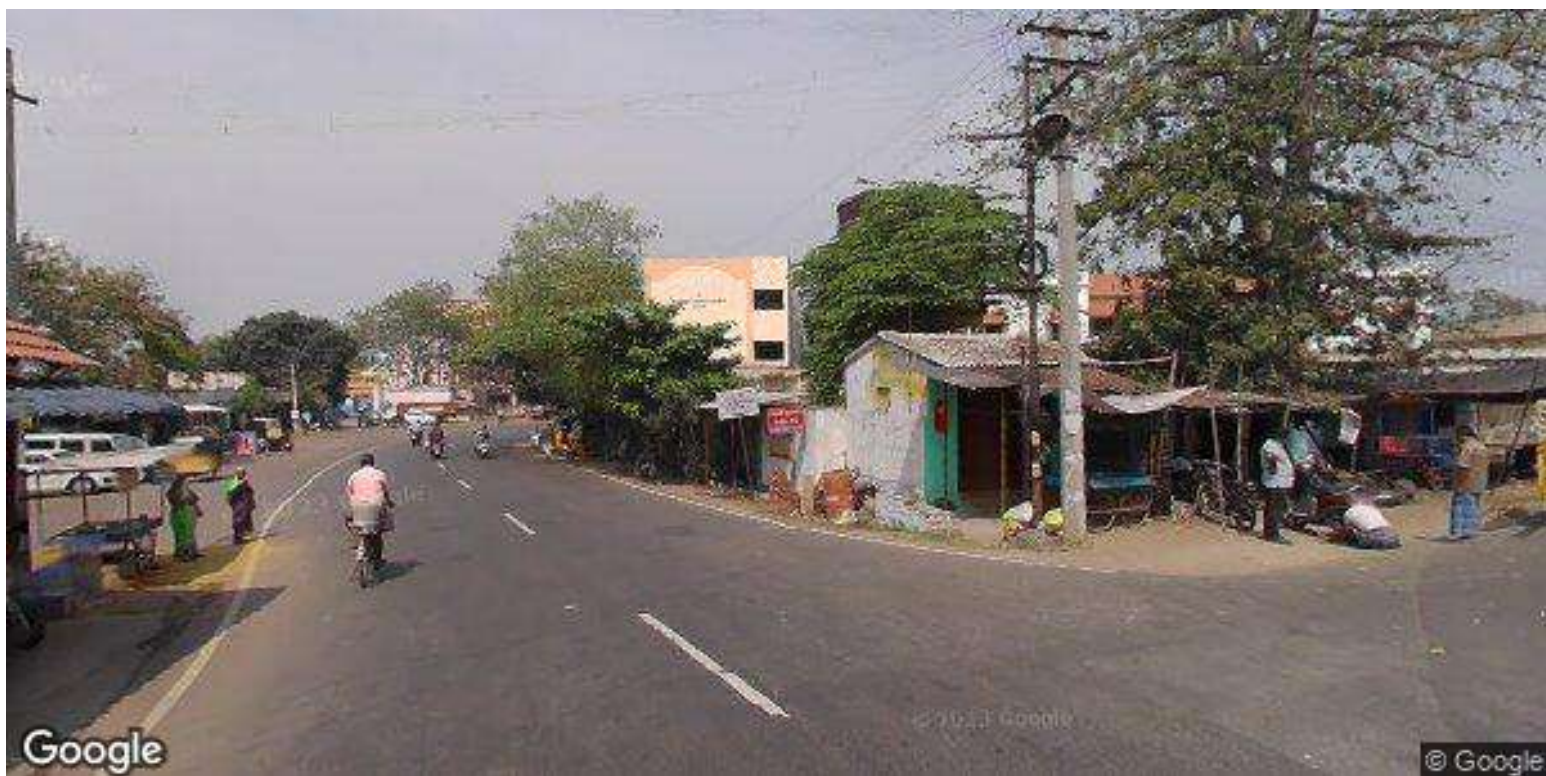
**Coordinates: 11.43965, 77.68224**

**Risk Type: Turn**

**Speed Limit: 15 KM/Hr**

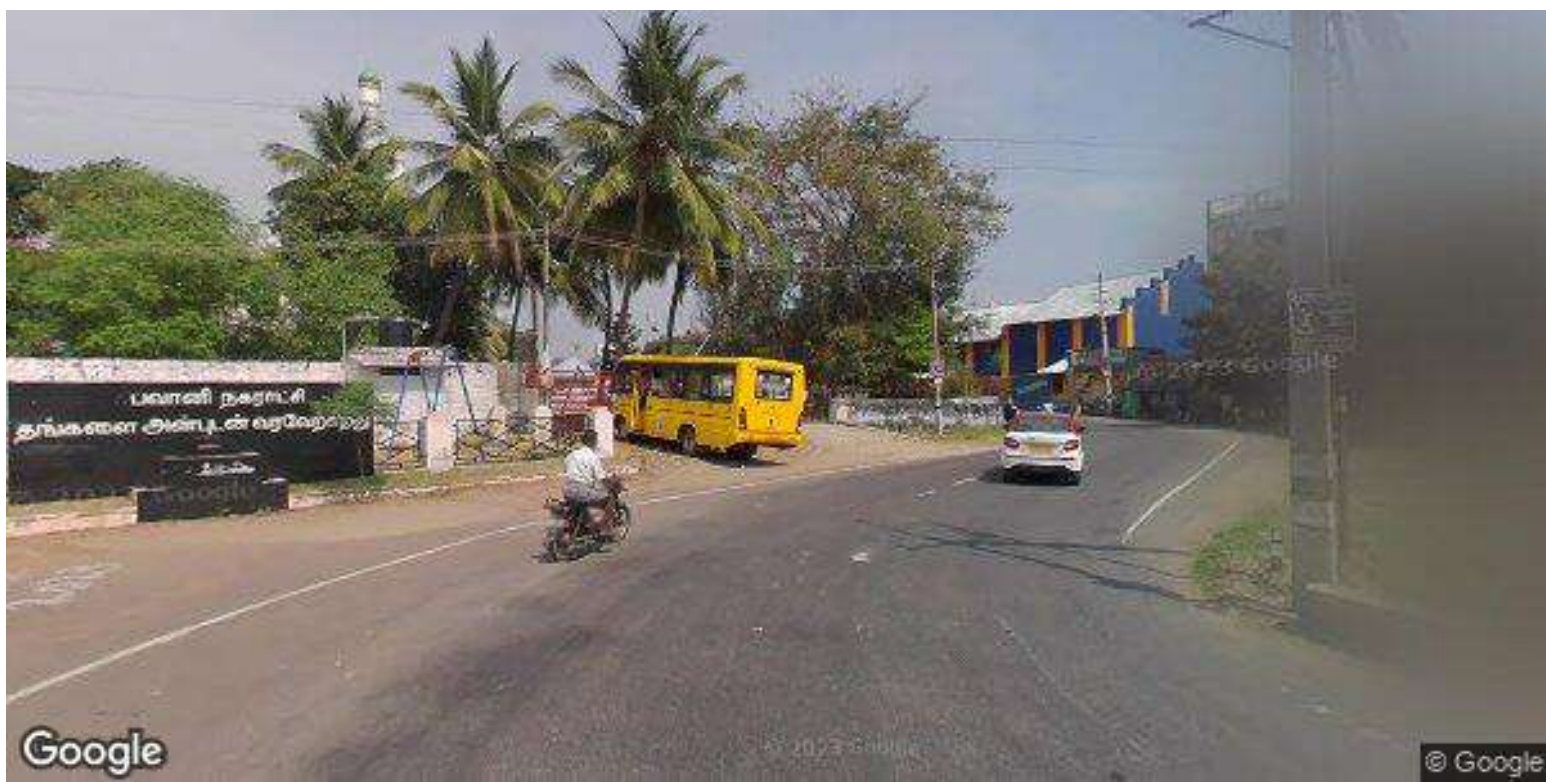
**Coordinates: 11.44101, 77.68186**

**Risk Type: Turn**

**Speed Limit: 15 KM/Hr**

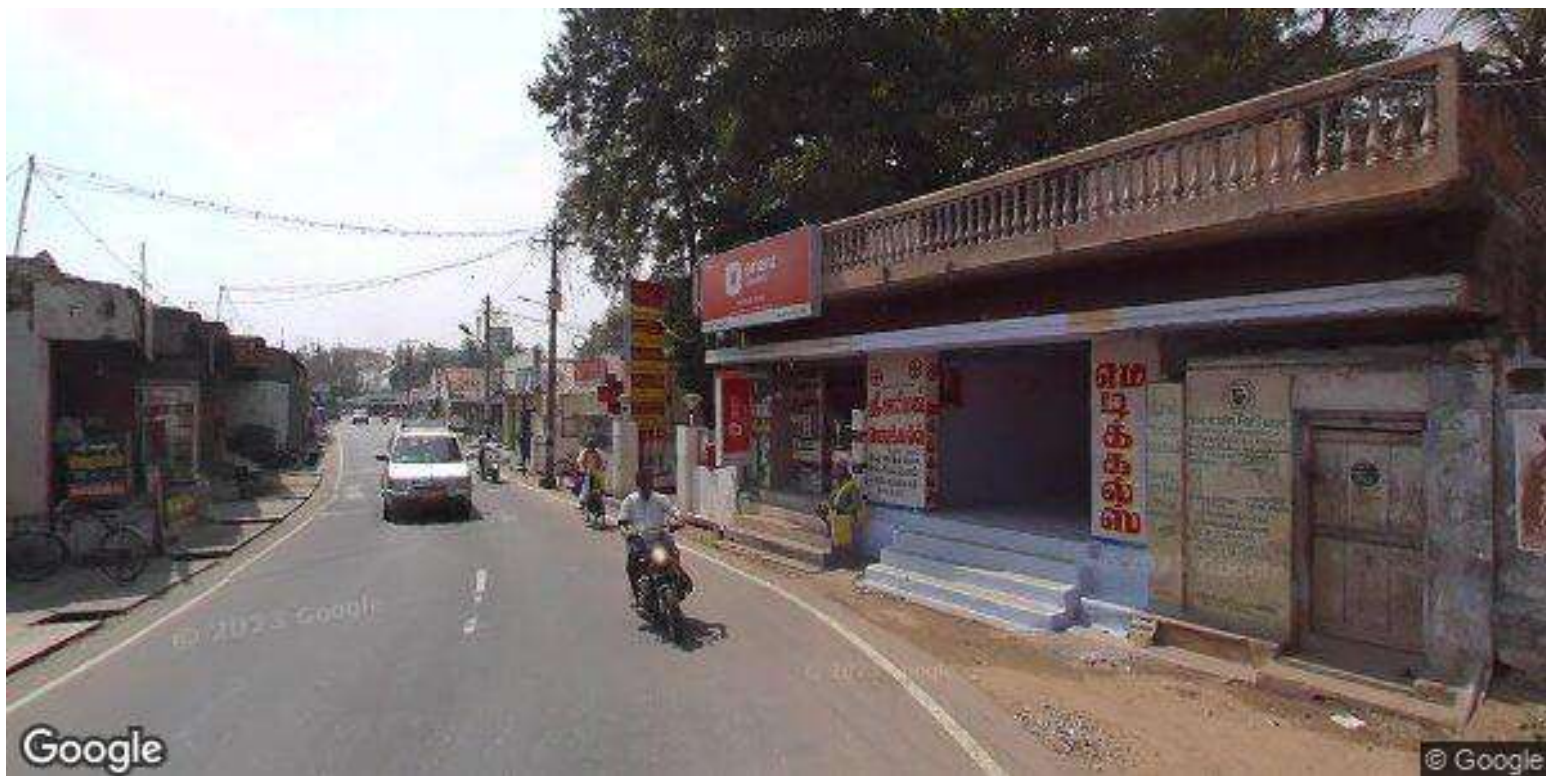
**Coordinates: 11.44291, 77.68256**

**Risk Type: Turn**

**Speed Limit: 15 KM/Hr**

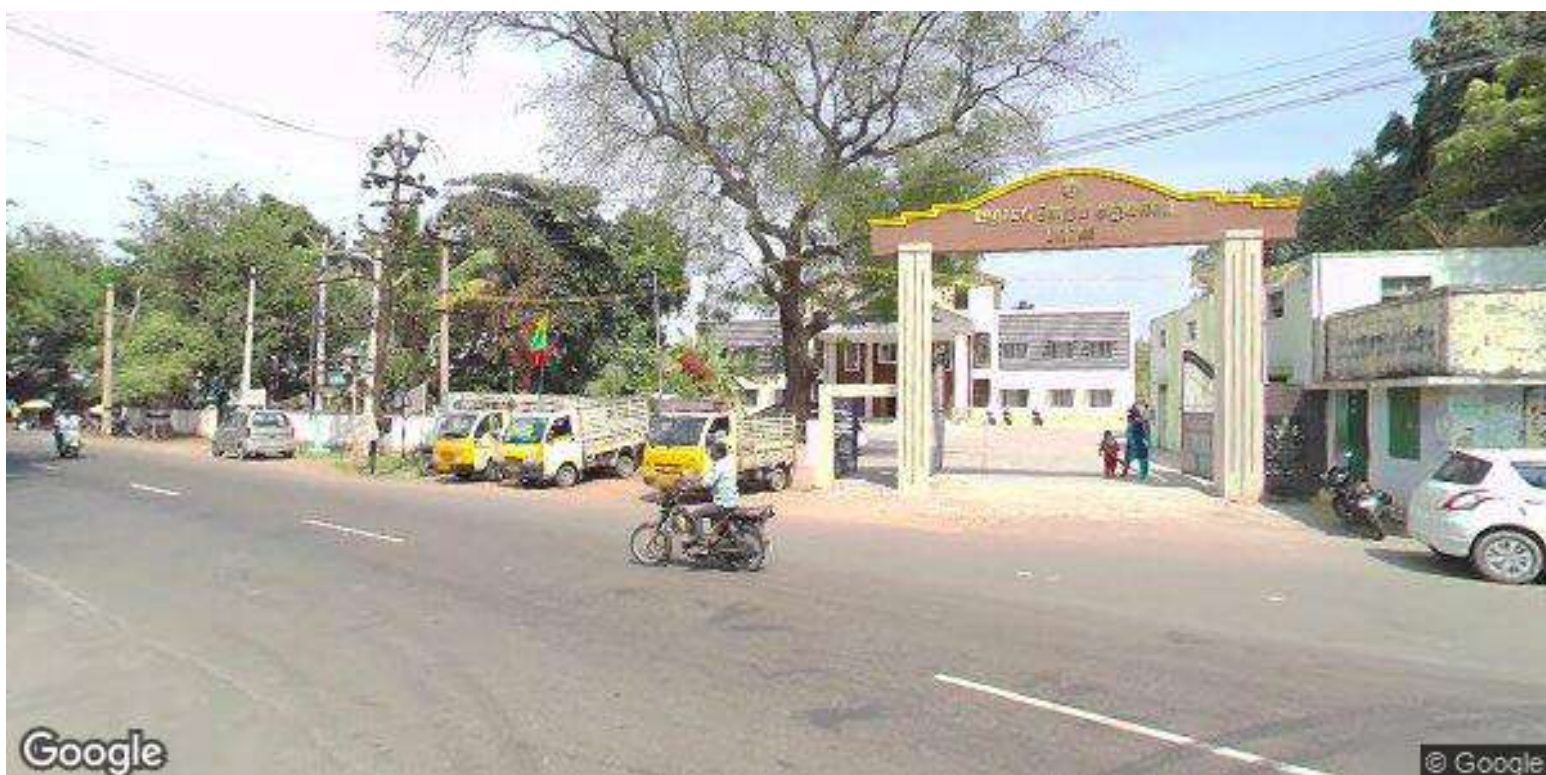
**Coordinates: 11.44853, 77.68331**

**Risk Type: Turn**

**Speed Limit: 15 KM/Hr**

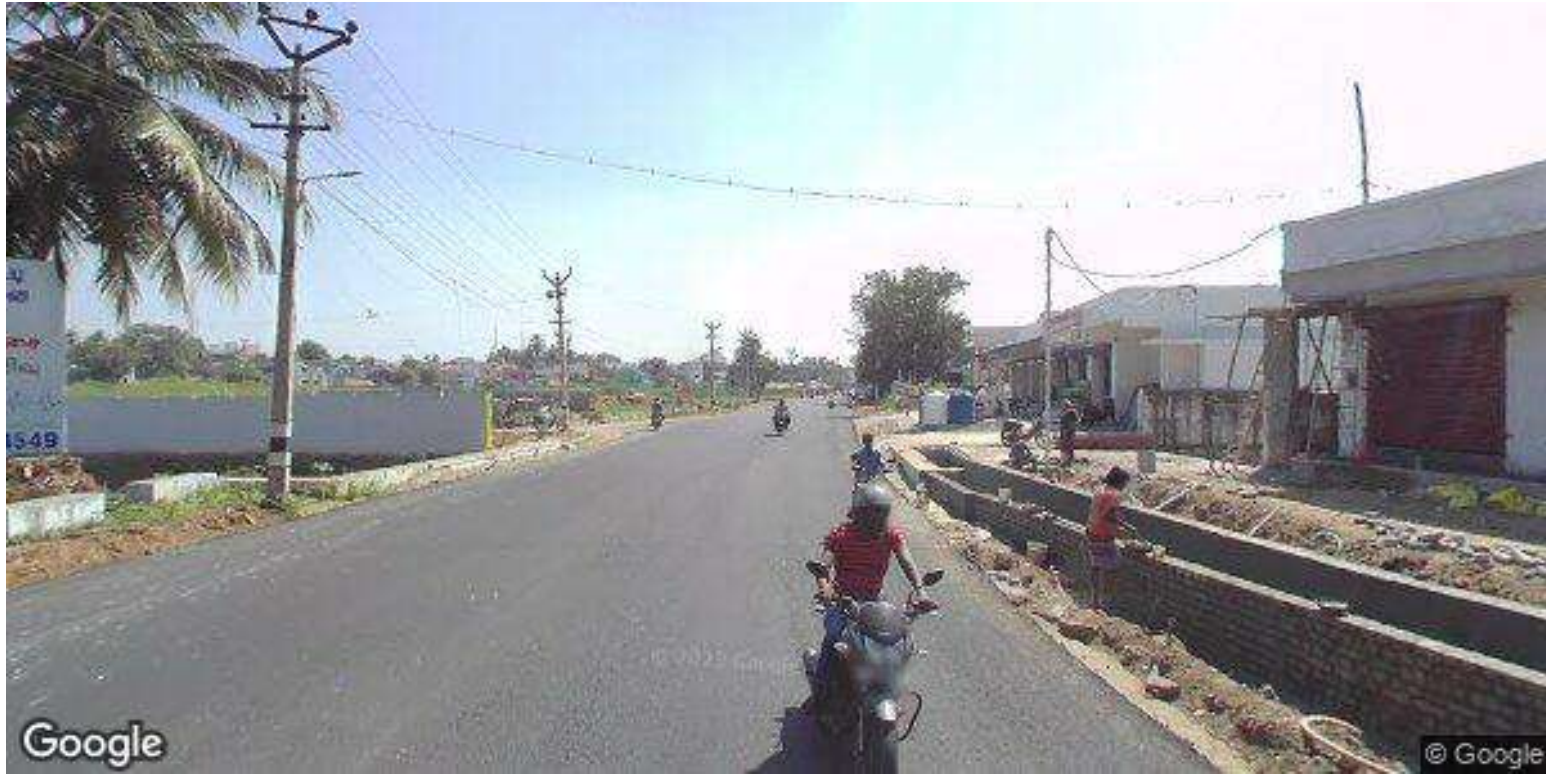
**Coordinates: 11.45408, 77.68022**

**Risk Type: Turn**

**Speed Limit: 15 KM/Hr**

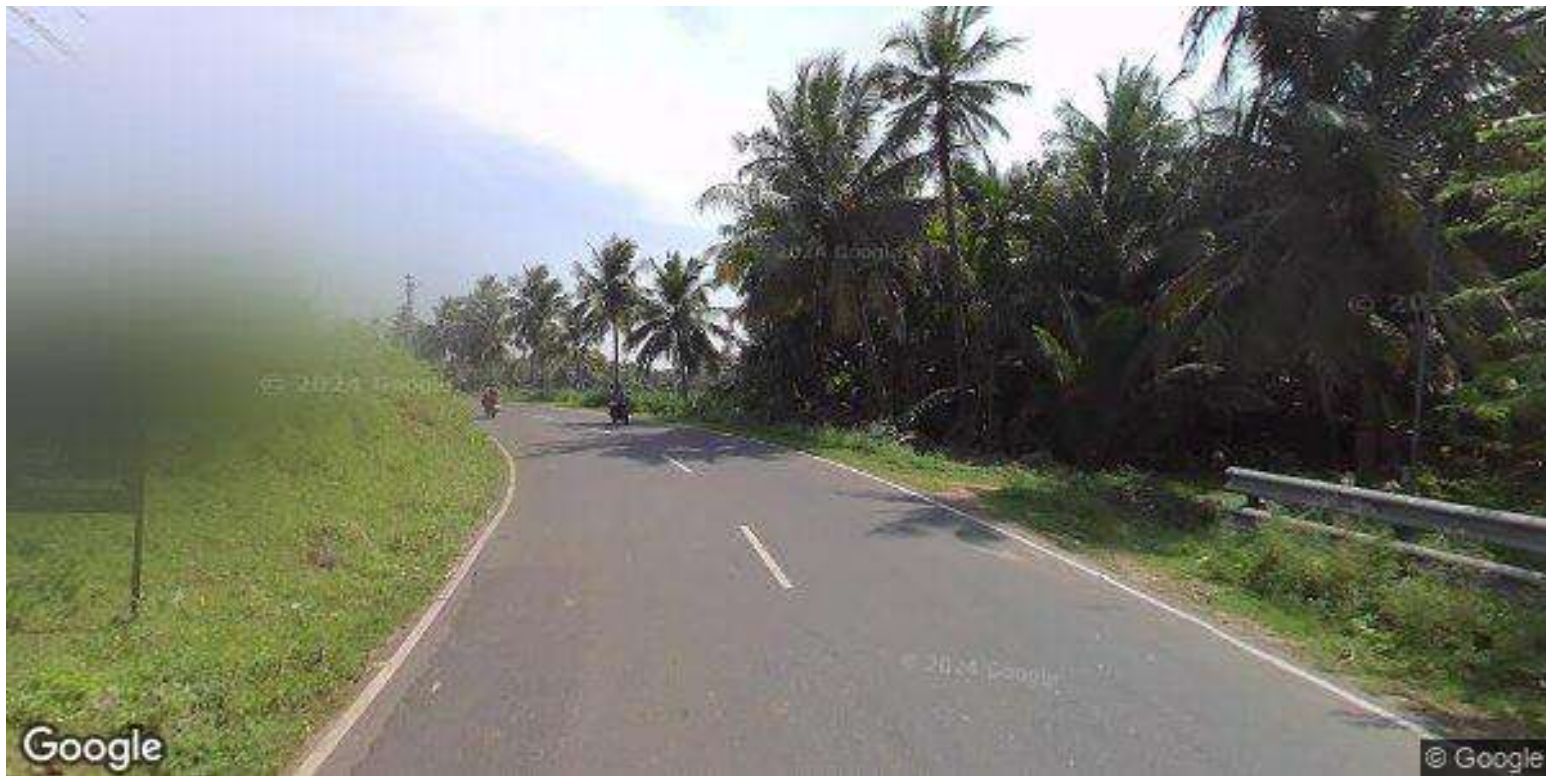
**Coordinates: 11.48208, 77.56626**

**Risk Type: Turn**

**Speed Limit: 15 KM/Hr**

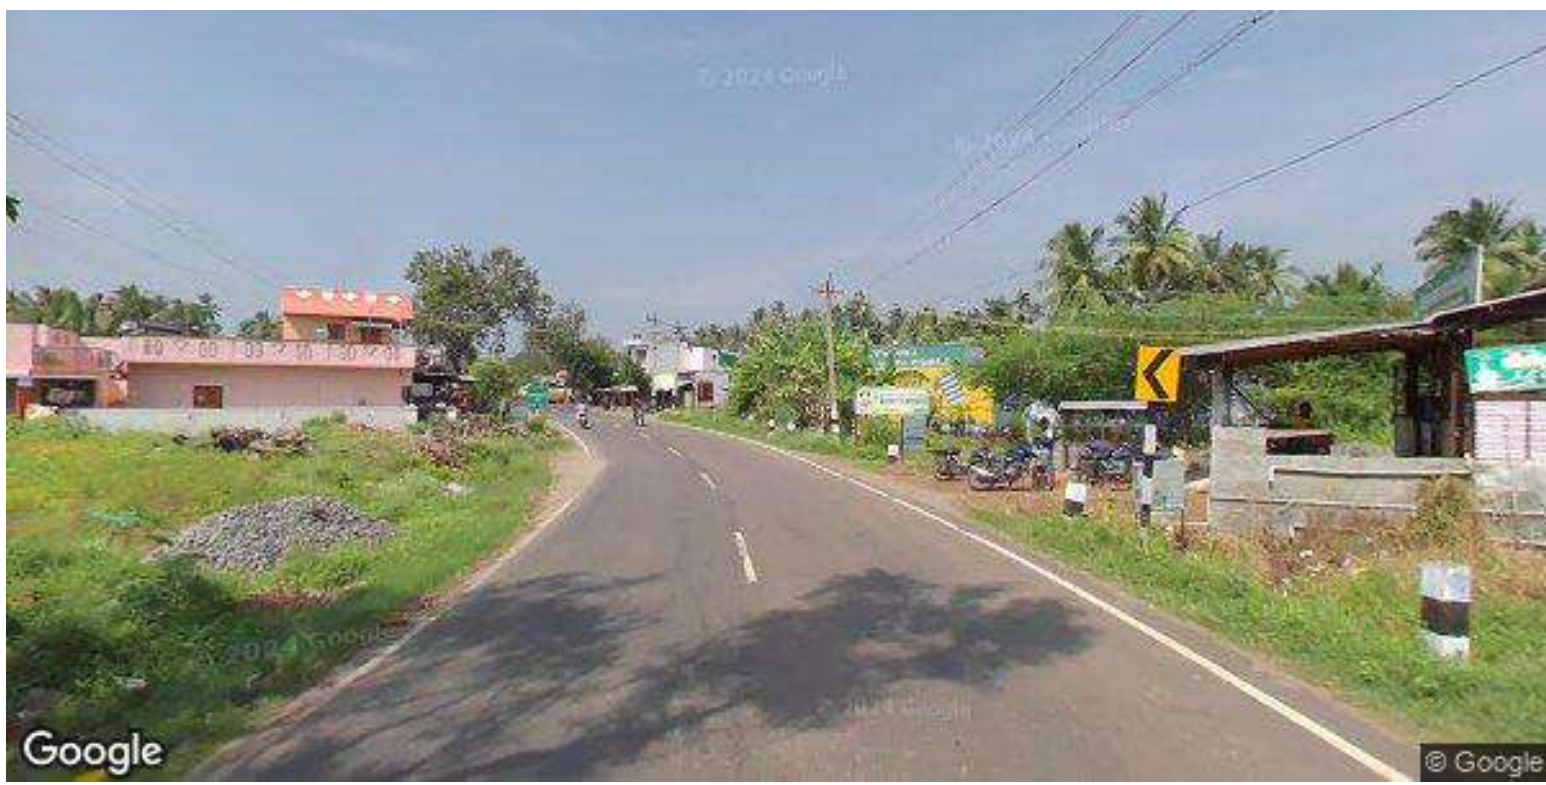
**Coordinates:** 11.48537, 77.56460

**Risk Type:** Turn

**Speed Limit:** 15 KM/Hr
