# IndianOil

## JOURNEY RISK MANAGEMENT (JRM) STUDY

### Salem Terminal to MARRIYAMMAL AGENCIES

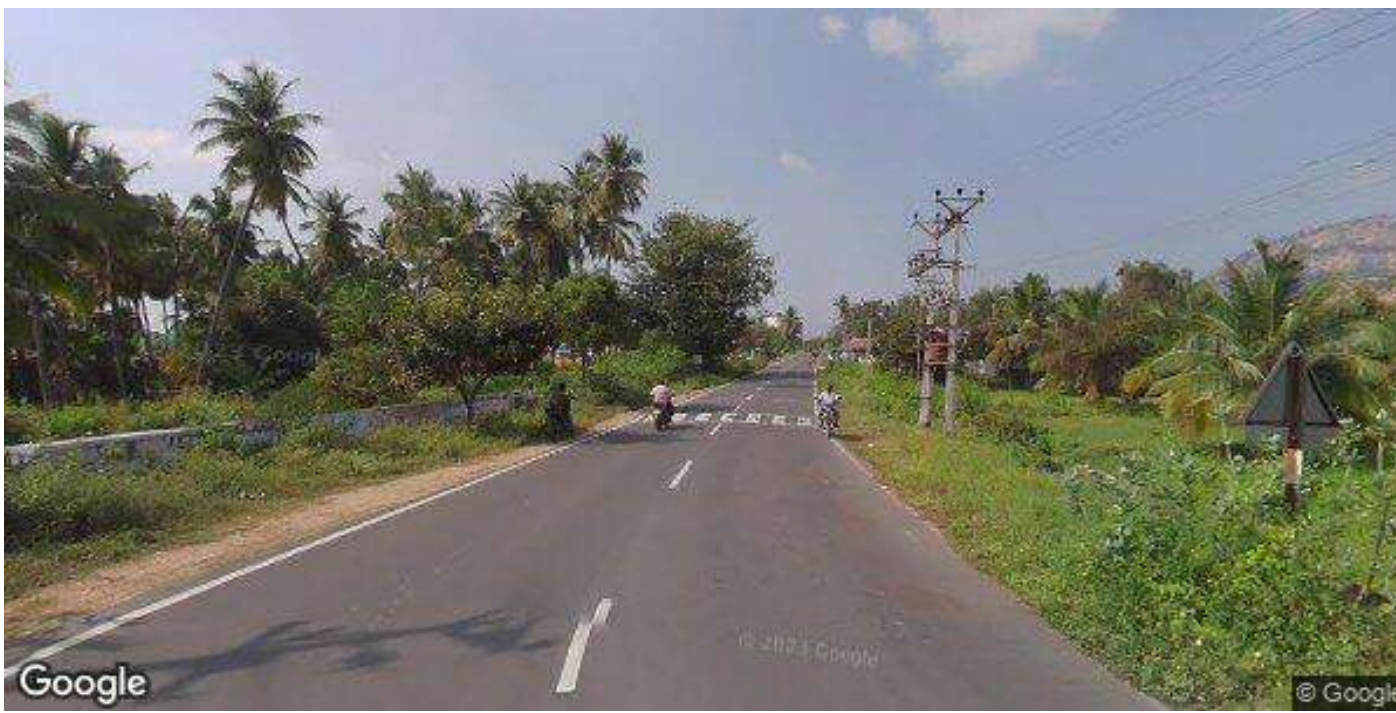
| | Risk Type | Risk Level | Coordinates | Speed Limit |
|---|---|---|---|---|
| 4 | Turn | Medium | 11.45353, 77.85697 | 30 KM/Hr |

**Risk Type:** Turn  
**Risk Level:** Medium  
**Speed Limit:** 30 KM/Hr  
**Coordinates:** 11.45353, 77.85697

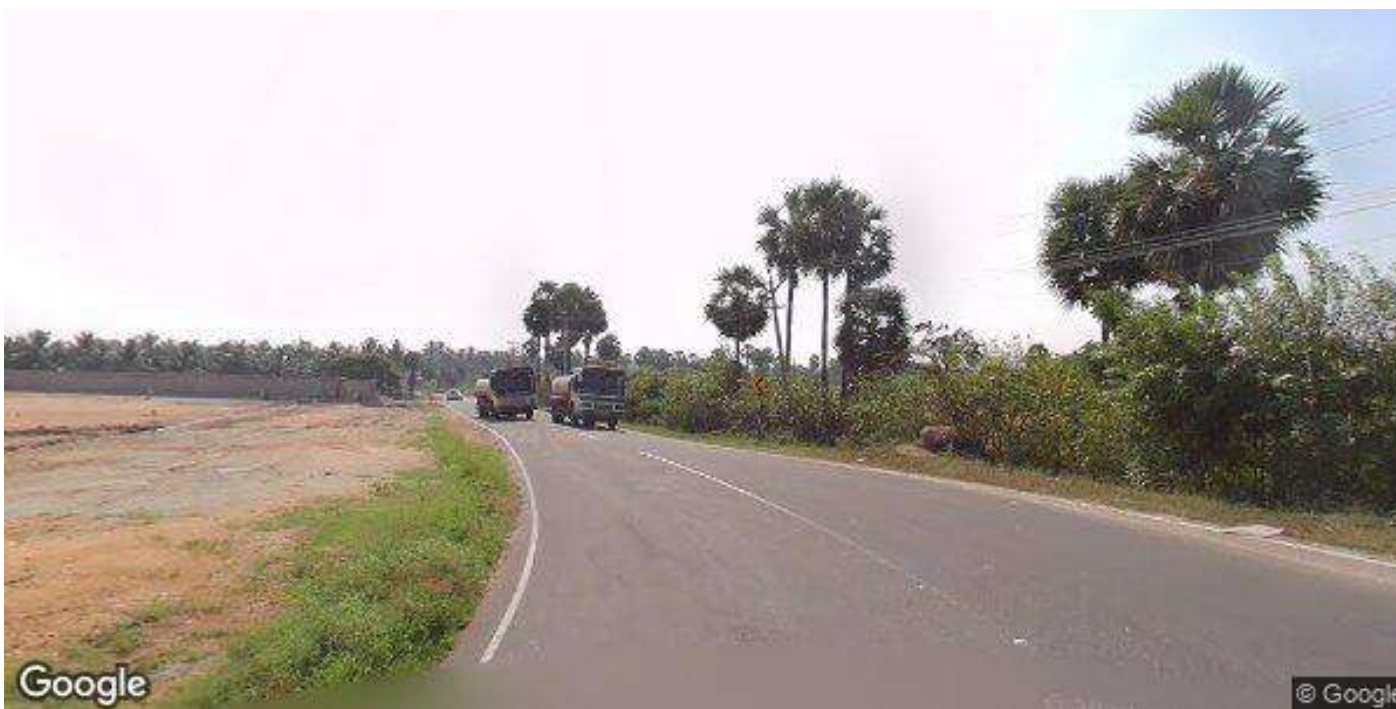
| | Risk Type | Risk Level | Coordinates | Speed Limit |
|---|---|---|---|---|
| 5 | Turn | Medium | 11.45839, 77.85143 | 30 KM/Hr |

**Risk Type:** Turn  
**Risk Level:** Medium  
**Speed Limit:** 30 KM/Hr  
**Coordinates:** 11.45839, 77.85143

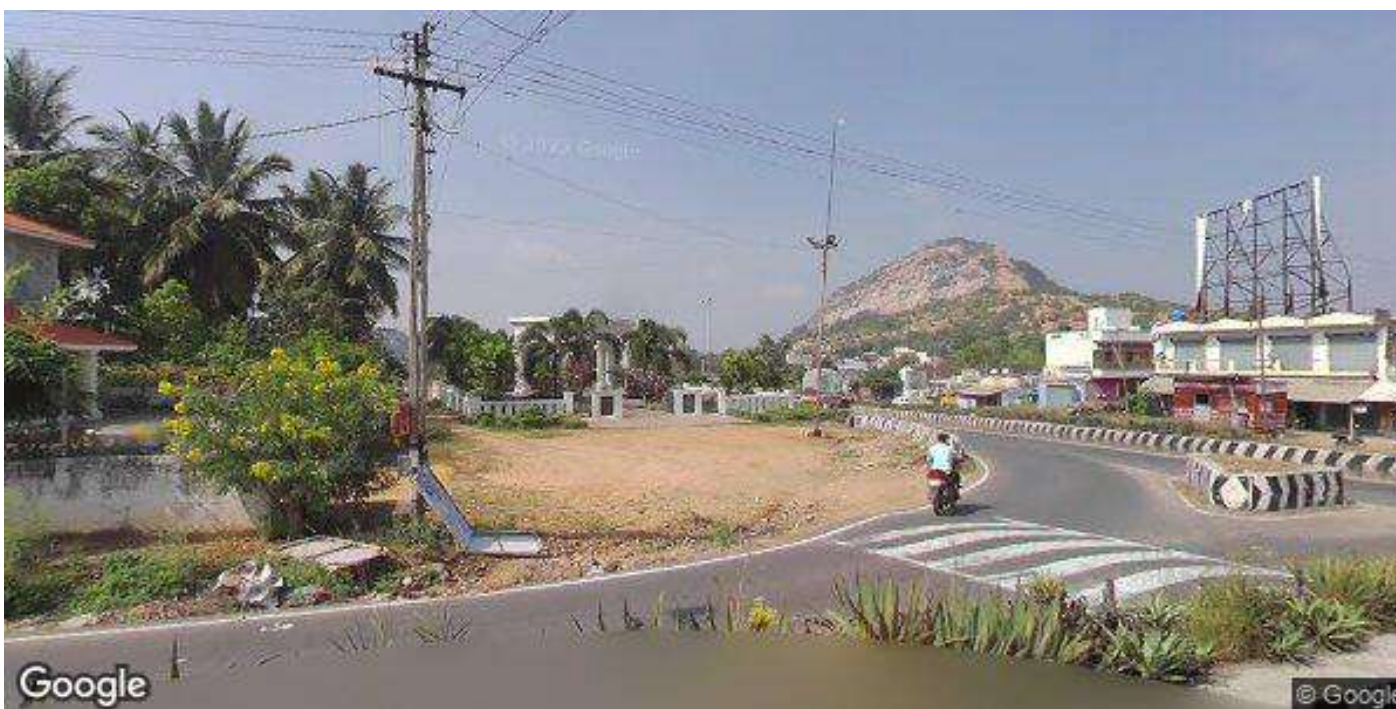
| | Risk Type | Risk Level | Coordinates | Speed Limit |
|---|---|---|---|---|
| 6 | Turn | Medium | 11.46307, 77.84941 | 30 KM/Hr |

**Risk Type:** Turn  
**Risk Level:** Medium  
**Speed Limit:** 30 KM/Hr  
**Coordinates:** 11.46307, 77.84941

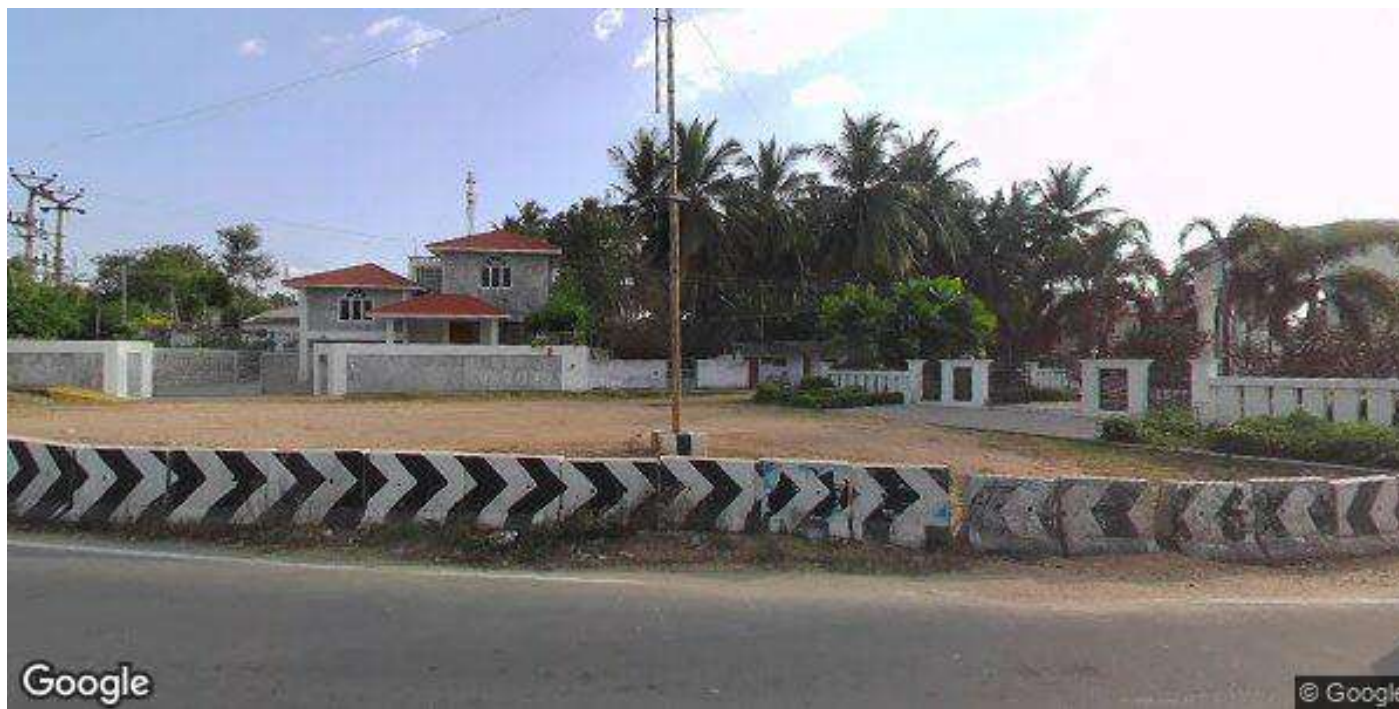
| | Risk Type | Risk Level | Coordinates | Speed Limit |
|---|---|---|---|---|
| 7 | Turn | Medium | 11.46316, 77.84921 | 30 KM/Hr |

**Risk Type:** Turn  
**Risk Level:** Medium  
**Speed Limit:** 30 KM/Hr  
**Coordinates:** 11.46316, 77.84921

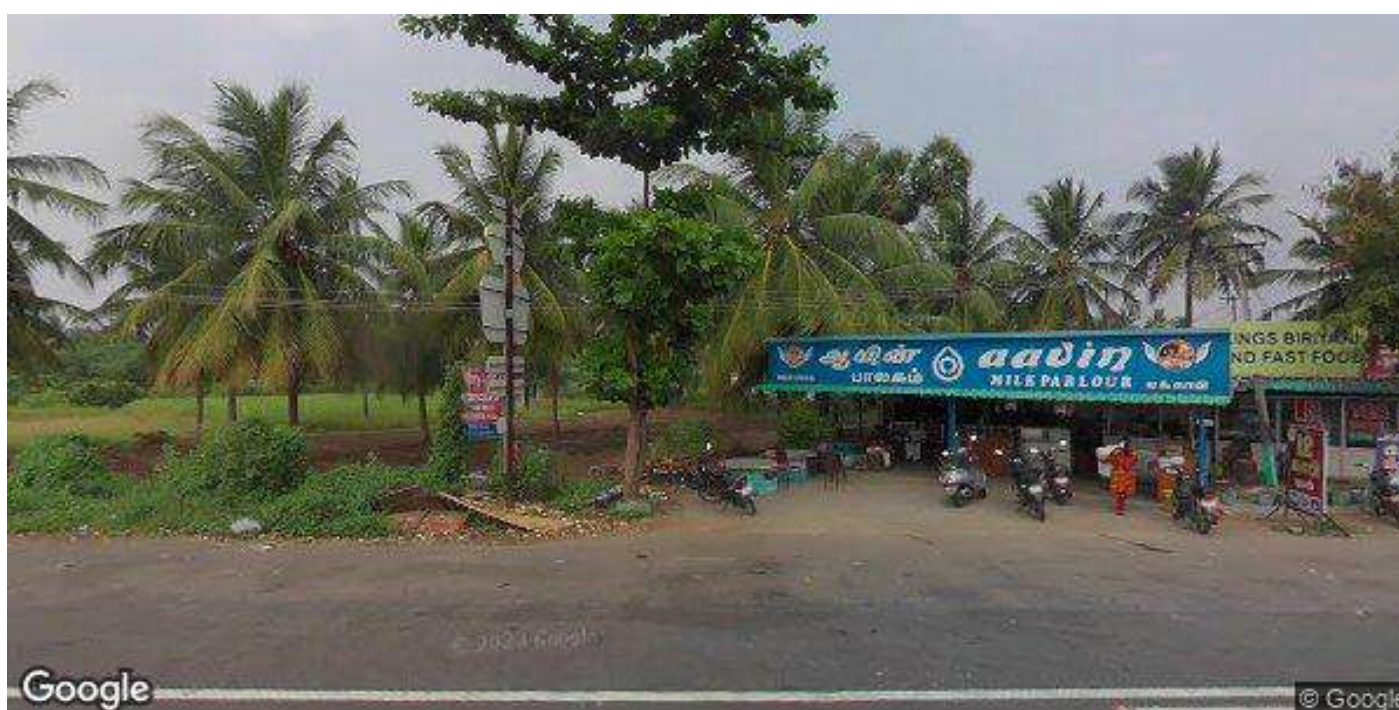
| | Risk Type | Risk Level | Coordinates | Speed Limit |
|---|---|---|---|---|
| 9 | Blind Spot | Blind Spot | 11.45631, 77.81668 | 10 KM/Hr |

**Risk Type:** Blind Spot  
**Risk Level:** Blind Spot  
**Speed Limit:** 10 KM/Hr  
**Coordinates:** 11.45631, 77.81668

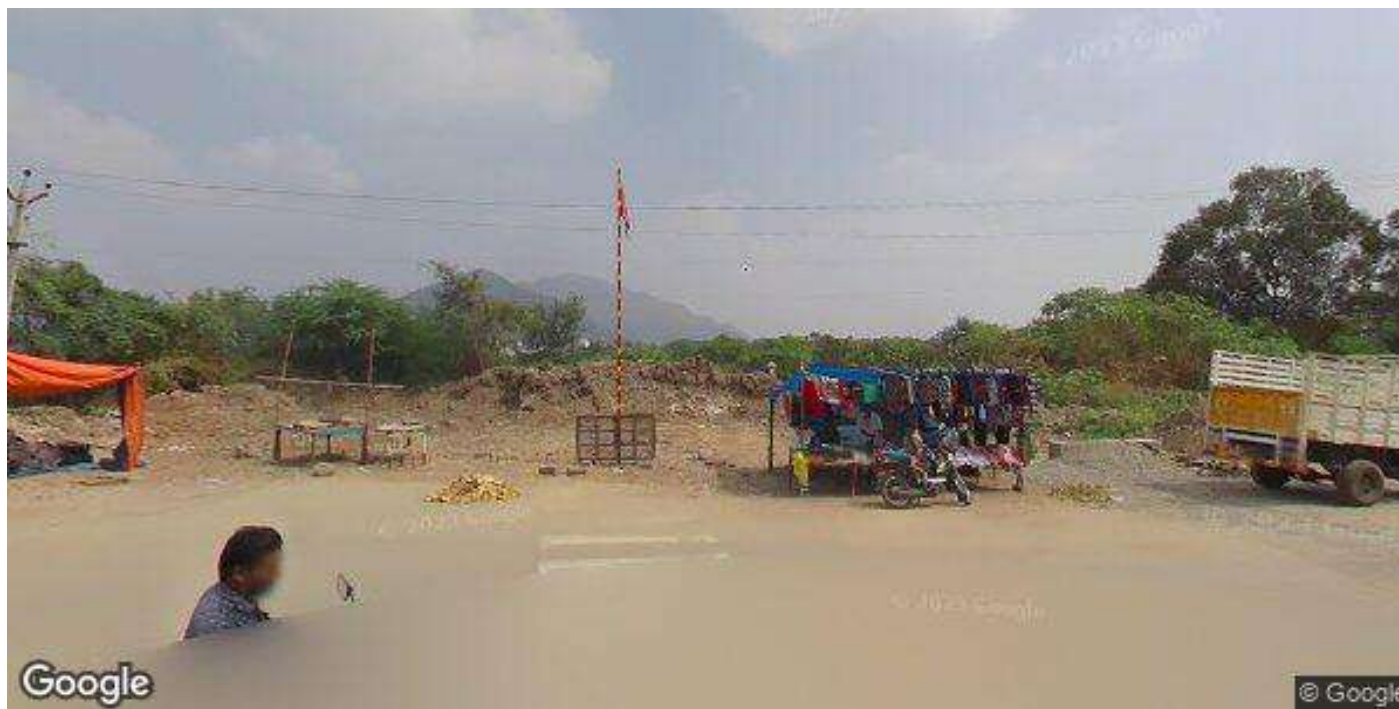
| | Risk Type | Risk Level | Coordinates | Speed Limit |
|---|---|---|---|---|
| 11 | Turn | Medium | 11.60320, 78.00504 | 30 KM/Hr |

**Risk Type:** Turn  
**Risk Level:** Medium  
**Speed Limit:** 30 KM/Hr  
**Coordinates:** 11.60320, 78.00504

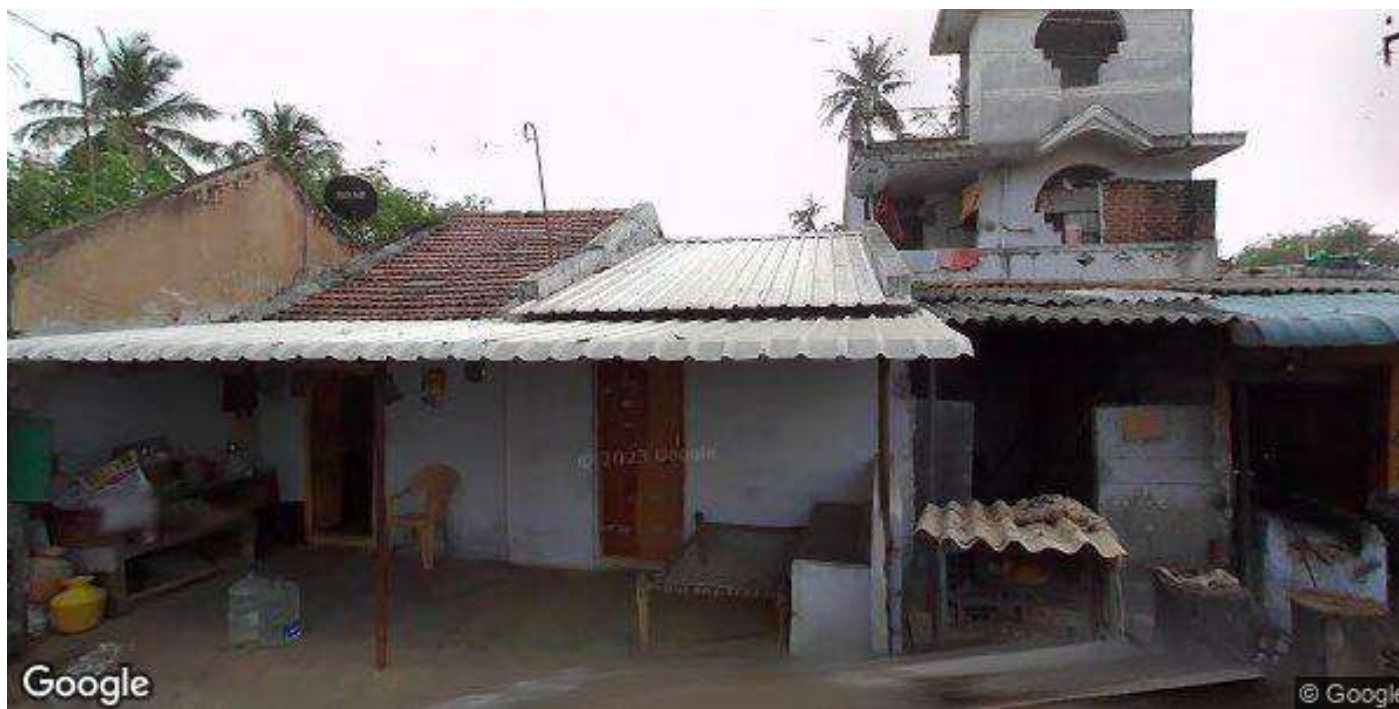
| | Risk Type | Risk Level | Coordinates | Speed Limit |
|---|---|---|---|---|
| 12 | Turn | Medium | 11.60480, 78.00617 | 30 KM/Hr |

**Risk Type:** Turn  
**Risk Level:** Medium  
**Speed Limit:** 30 KM/Hr  
**Coordinates:** 11.60480, 78.00617

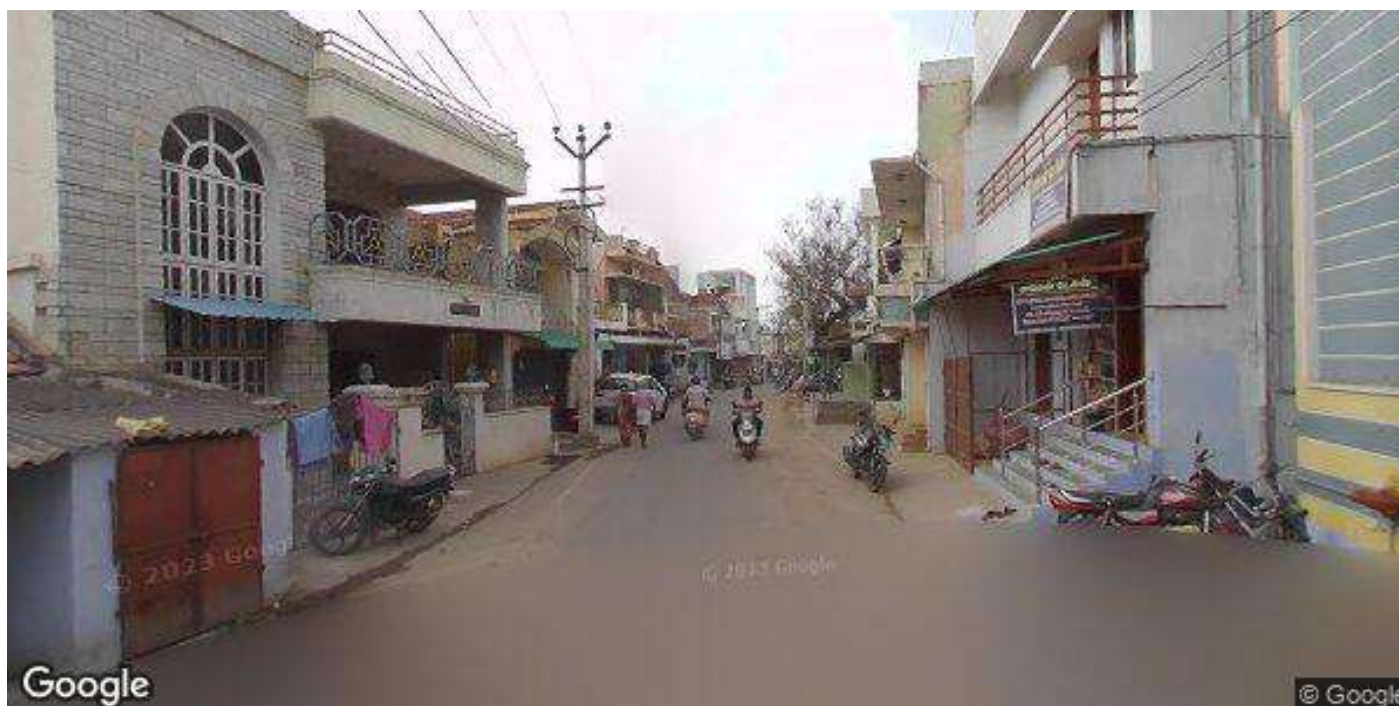
| | Risk Type | Risk Level | Coordinates | Speed Limit |
|---|---|---|---|---|
| 13 | Turn | Medium | 11.60481, 78.00747 | 30 KM/Hr |

**Risk Type:** Turn  
**Risk Level:** Medium  
**Speed Limit:** 30 KM/Hr  
**Coordinates:** 11.60481, 78.00747

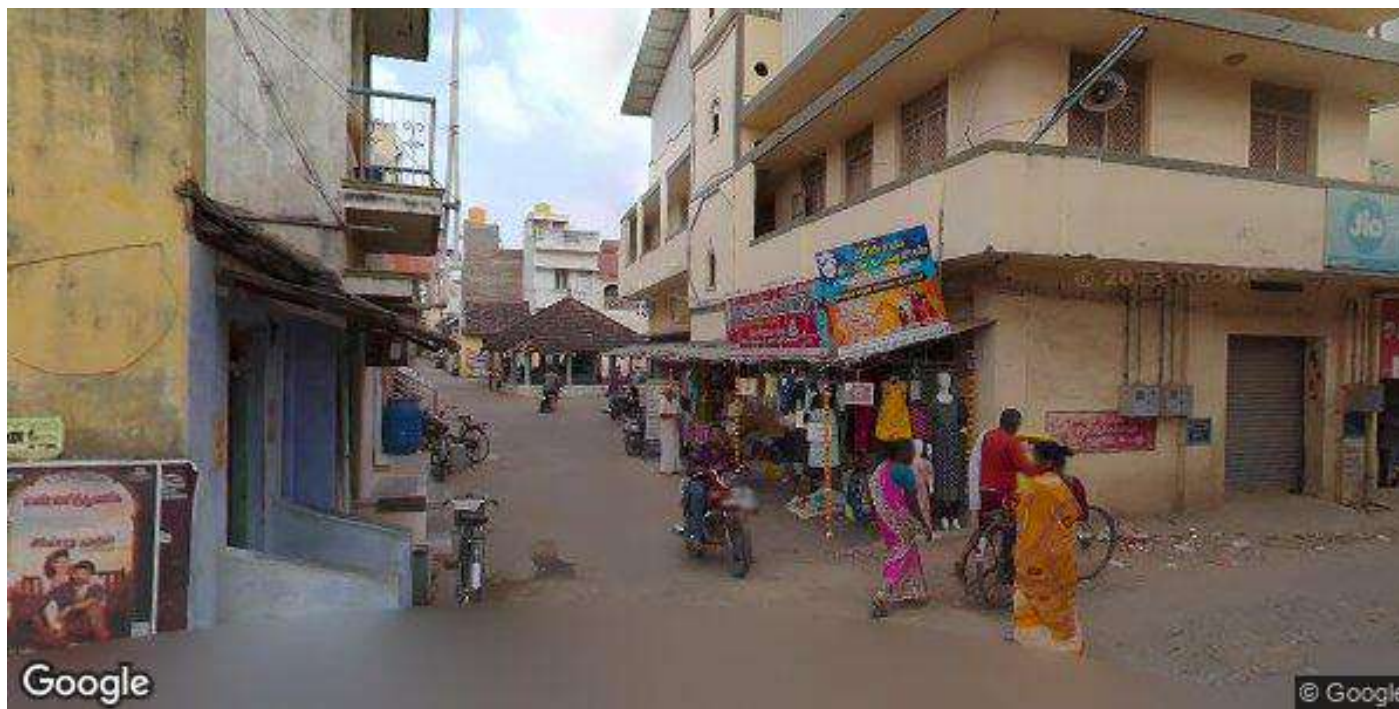
| | Risk Type | Risk Level | Coordinates | Speed Limit |
|---|---|---|---|---|
| 14 | Turn | High | 11.60552, 78.00827 | 15 KM/Hr |

**Risk Type:** Turn  
**Risk Level:** High  
**Speed Limit:** 15 KM/Hr  
**Coordinates:** 11.60552, 78.00827

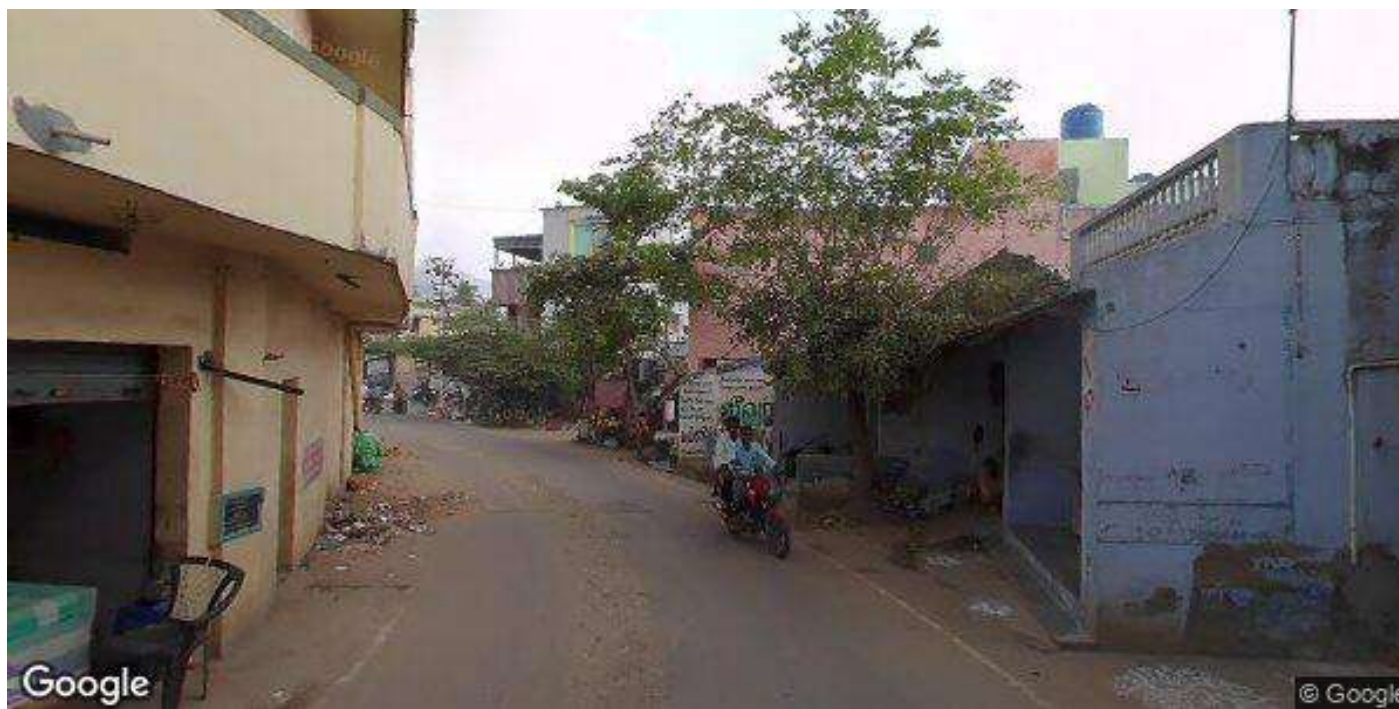
| | Risk Type | Risk Level | Coordinates | Speed Limit |
|---|---|---|---|---|
| 15 | Turn | Medium | 11.60546, 78.00846 | 30 KM/Hr |

**Risk Type:** Turn  
**Risk Level:** Medium  
**Speed Limit:** 30 KM/Hr  
**Coordinates:** 11.60546, 78.00846

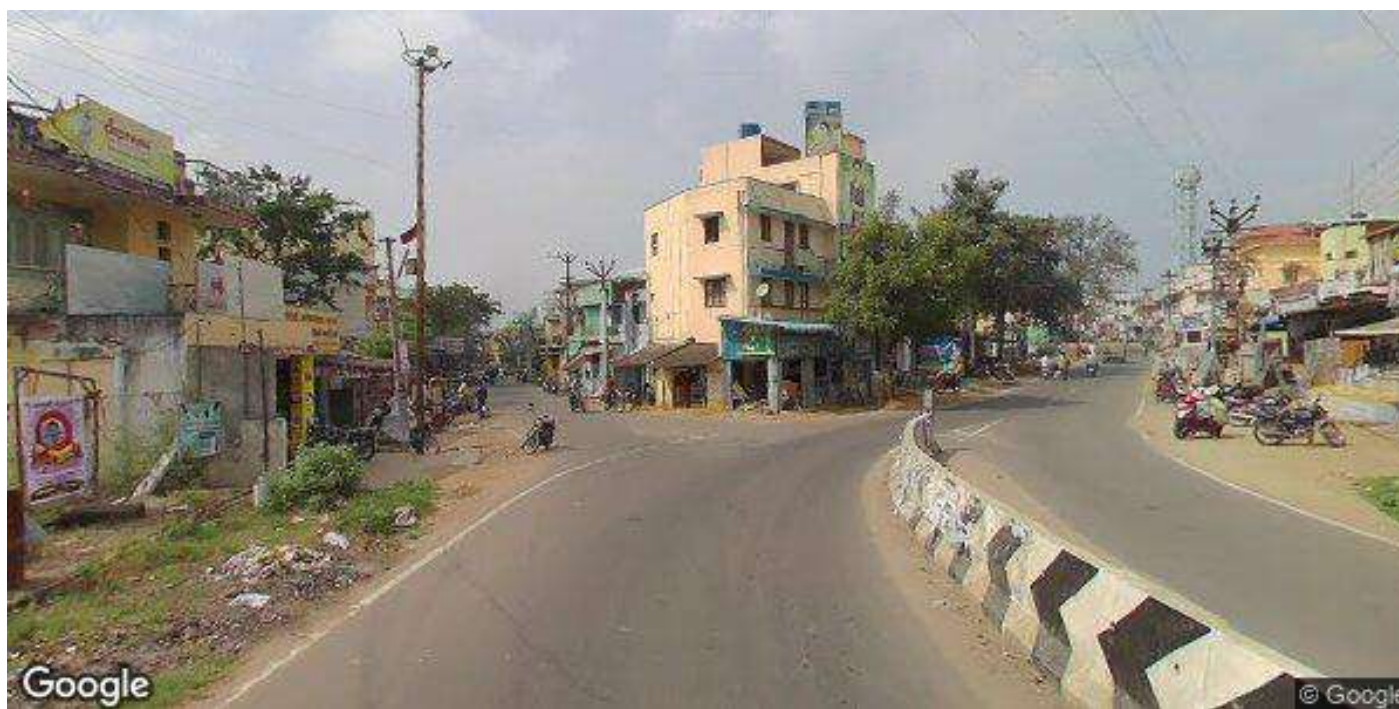
| | Risk Type | Risk Level | Coordinates | Speed Limit |
|---|---|---|---|---|
| 16 | Turn | Medium | 11.60751, 78.01086 | 30 KM/Hr |

**Risk Type:** Turn  
**Risk Level:** Medium  
**Speed Limit:** 30 KM/Hr  
**Coordinates:** 11.60751, 78.01086

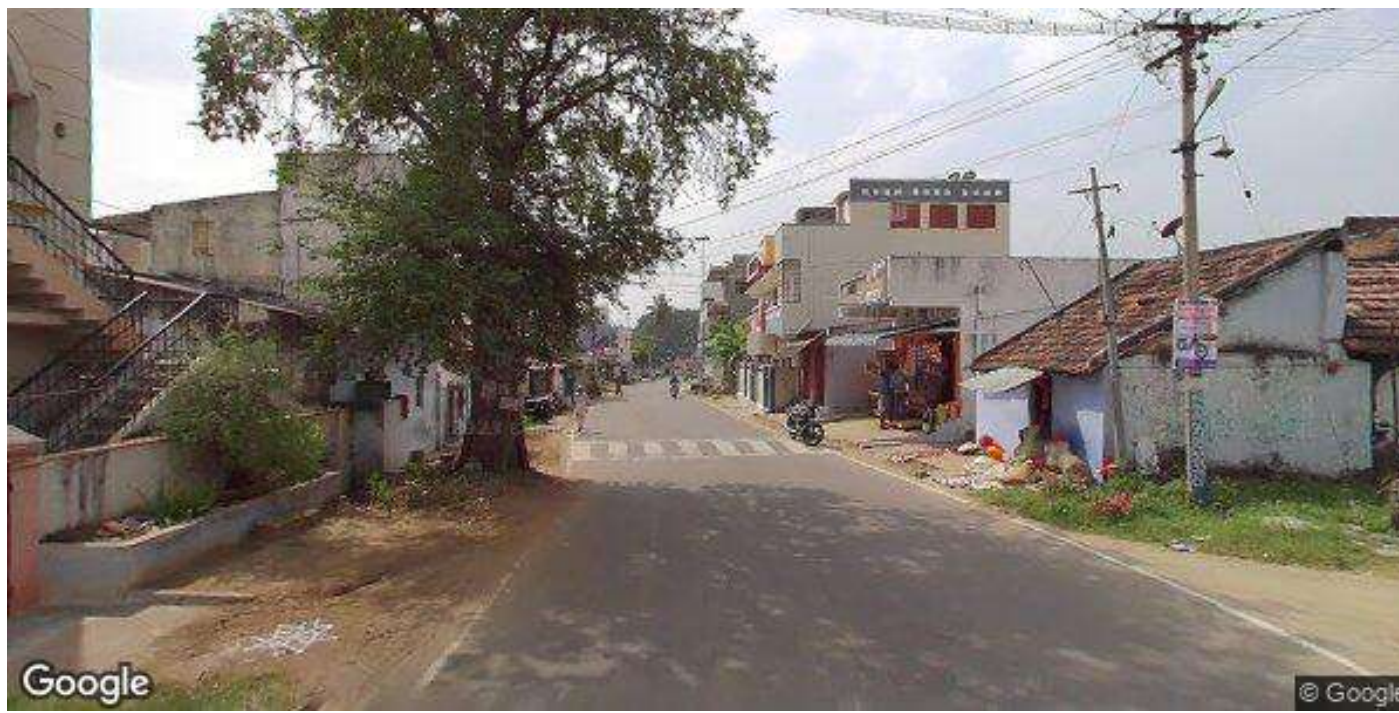
| | Risk Type | Risk Level | Coordinates | Speed Limit |
|---|---|---|---|---|
| 17 | Turn | Medium | 11.61152, 78.01356 | 30 KM/Hr |

**Risk Type:** Turn  
**Risk Level:** Medium  
**Speed Limit:** 30 KM/Hr  
**Coordinates:** 11.61152, 78.01356

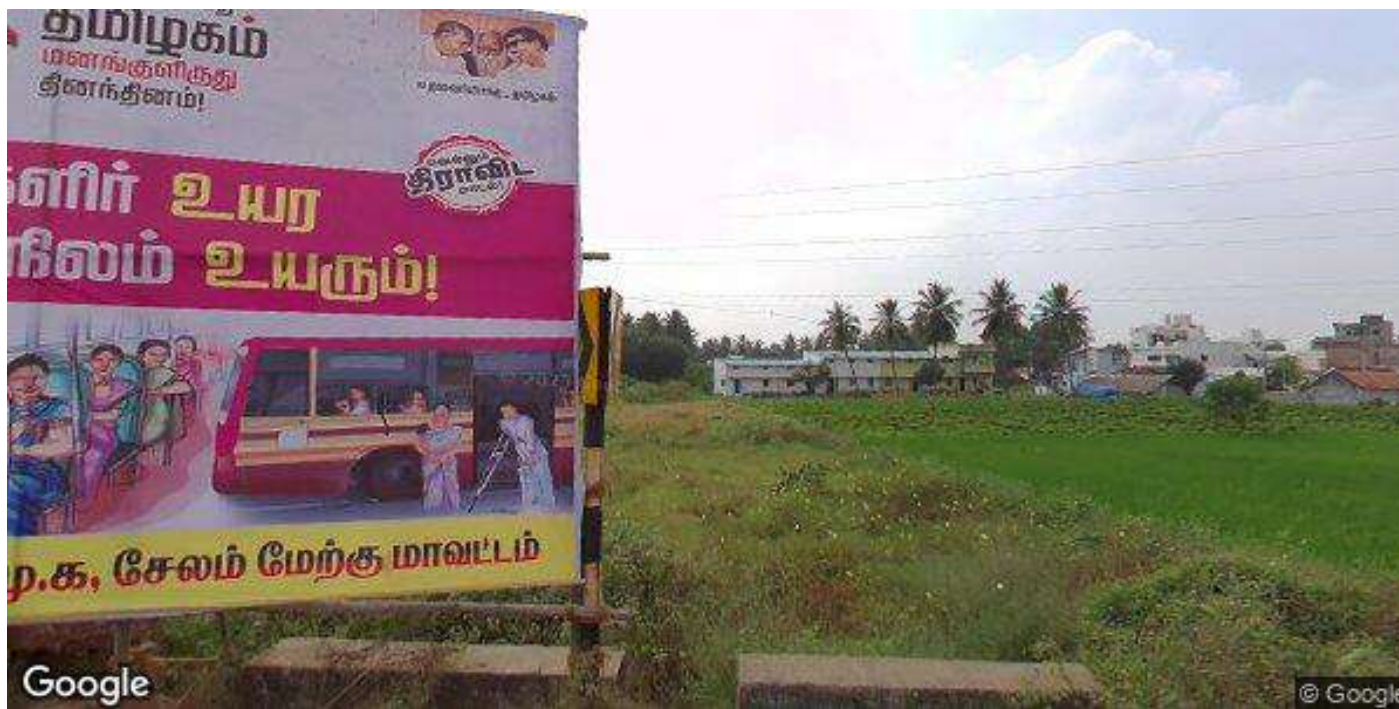
| | Risk Type | Risk Level | Coordinates | Speed Limit |
|---|---|---|---|---|
| 18 | Turn | High | 11.61170, 78.01516 | 15 KM/Hr |

**Risk Type:** Turn  
**Risk Level:** High  
**Speed Limit:** 15 KM/Hr  
**Coordinates:** 11.61170, 78.01516

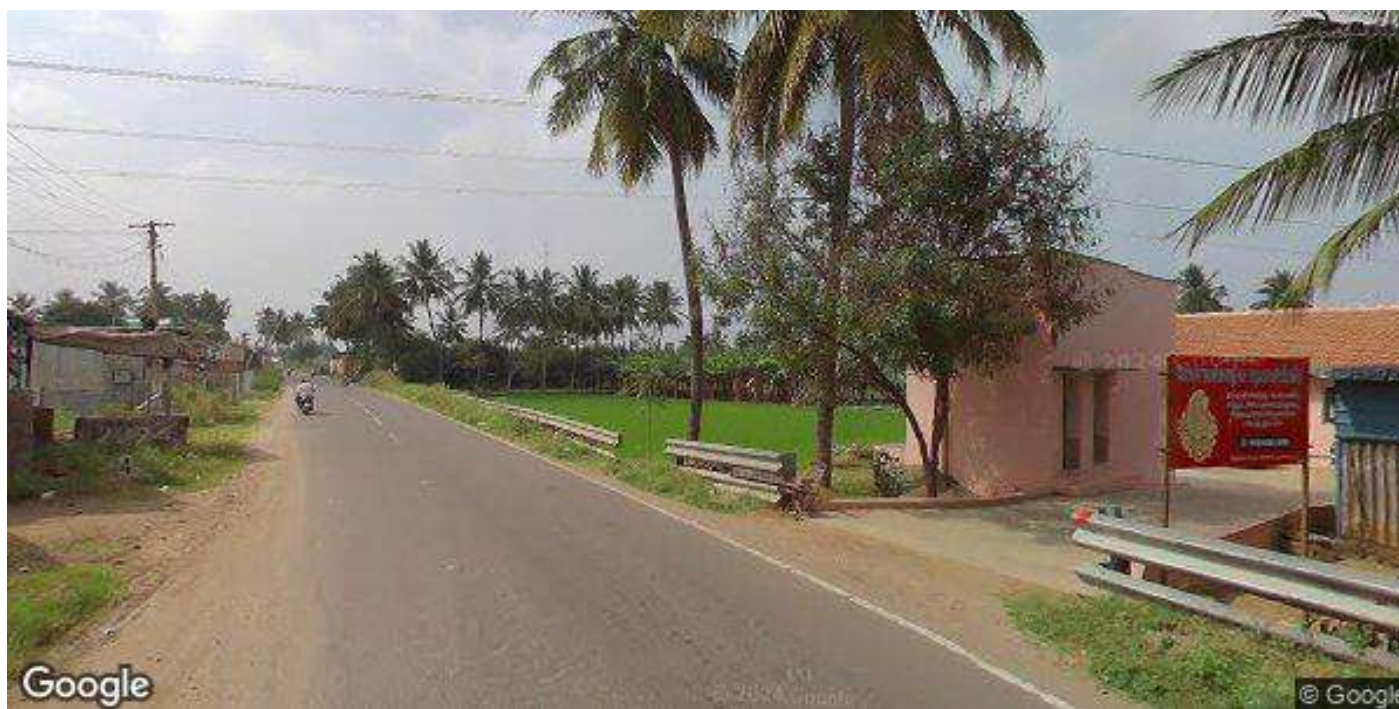
| | Risk Type | Risk Level | Coordinates | Speed Limit |
|---|---|---|---|---|
| 19 | Turn | Medium | 11.61418, 78.01669 | 30 KM/Hr |

**Risk Type:** Turn  
**Risk Level:** Medium  
**Speed Limit:** 30 KM/Hr  
**Coordinates:** 11.61418, 78.01669

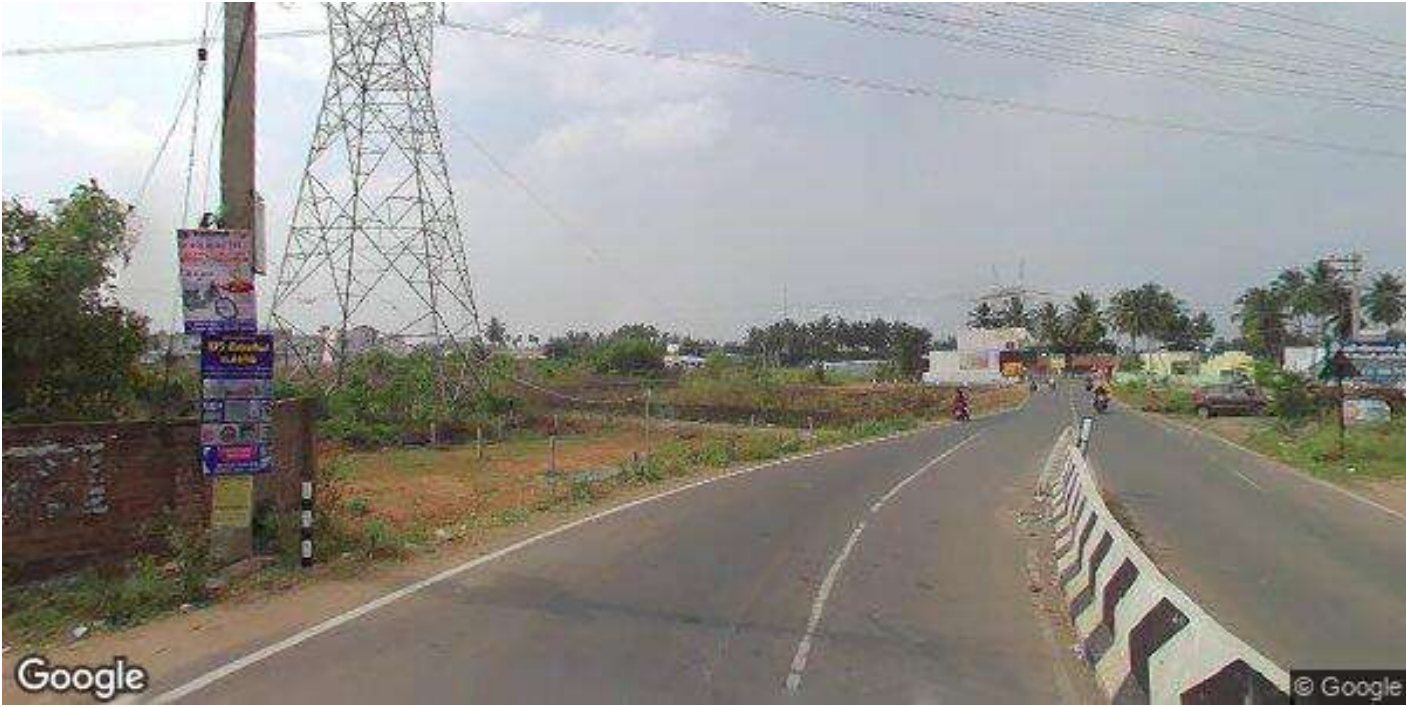
| | Risk Type | Risk Level | Coordinates | Speed Limit |
|---|---|---|---|---|
| 20 | Turn | Medium | 11.61440, 78.01791 | 30 KM/Hr |

**Risk Type:** Turn  
**Risk Level:** Medium  
**Speed Limit:** 30 KM/Hr  
**Coordinates:** 11.61440, 78.01791
