## JOURNEY RISK MANAGEMENT (JRM) STUDY

### Salem Terminal to S.M.P FUELS

#### Objective of the JRM Report

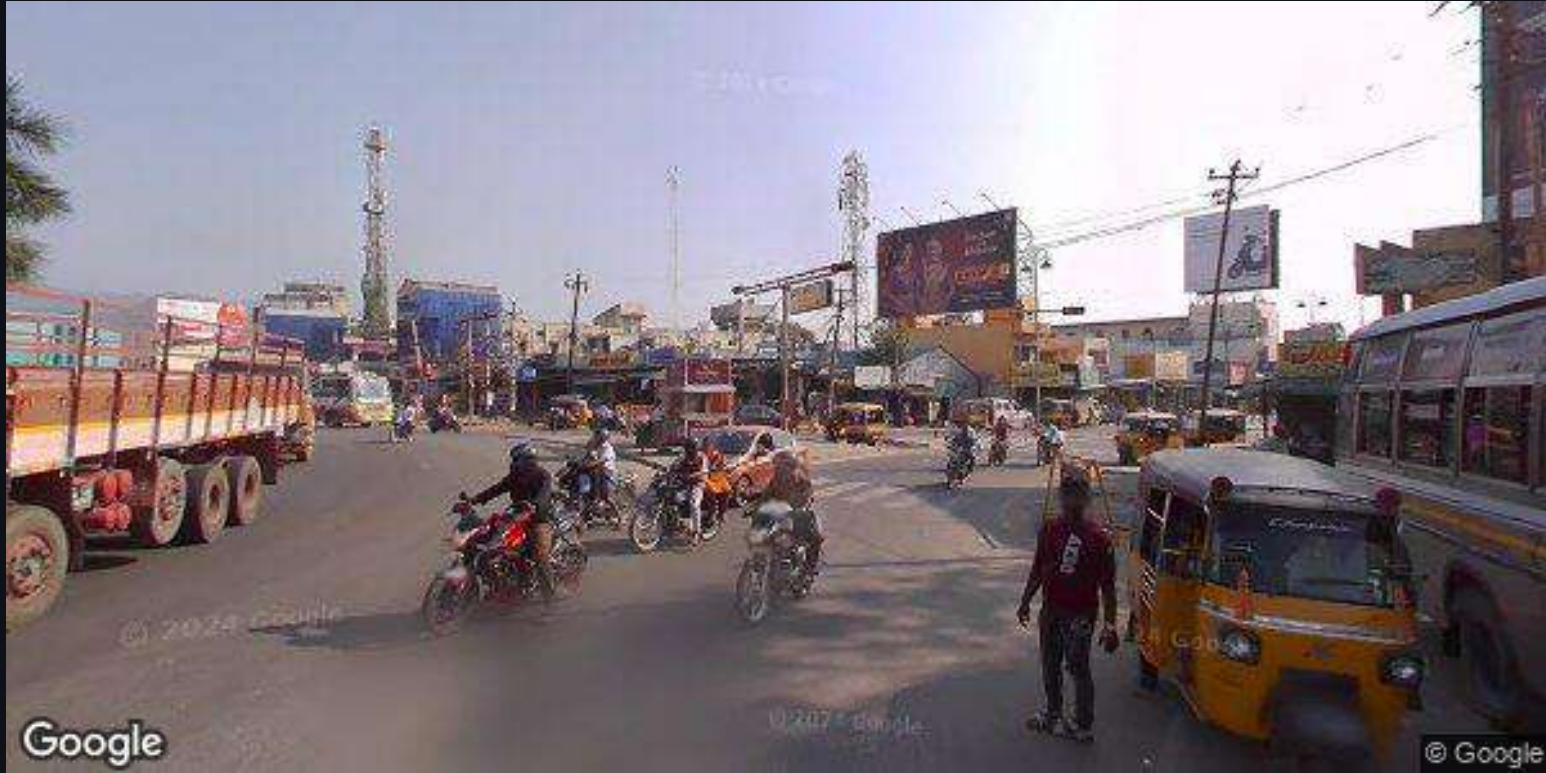
**Coordinates:** 11.63266, 78.12699

**Risk Type:** Roundabout

**Risk Level:** High

**Speed Limit:** 15 KM/Hr

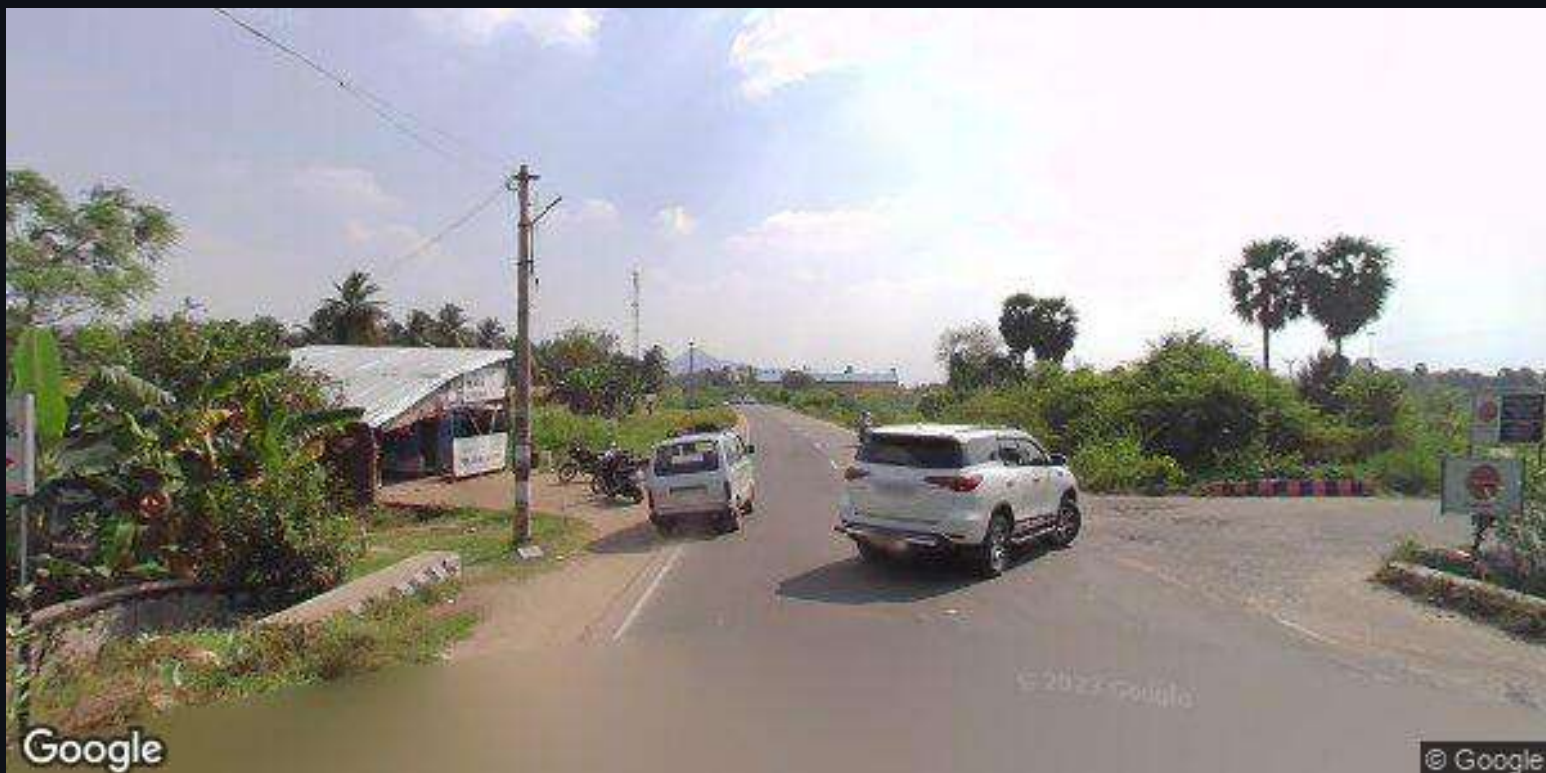
**Coordinates:** 11.44029, 77.87544

**Risk Type:** Turn

**Risk Level:** High

**Speed Limit:** 15 KM/Hr

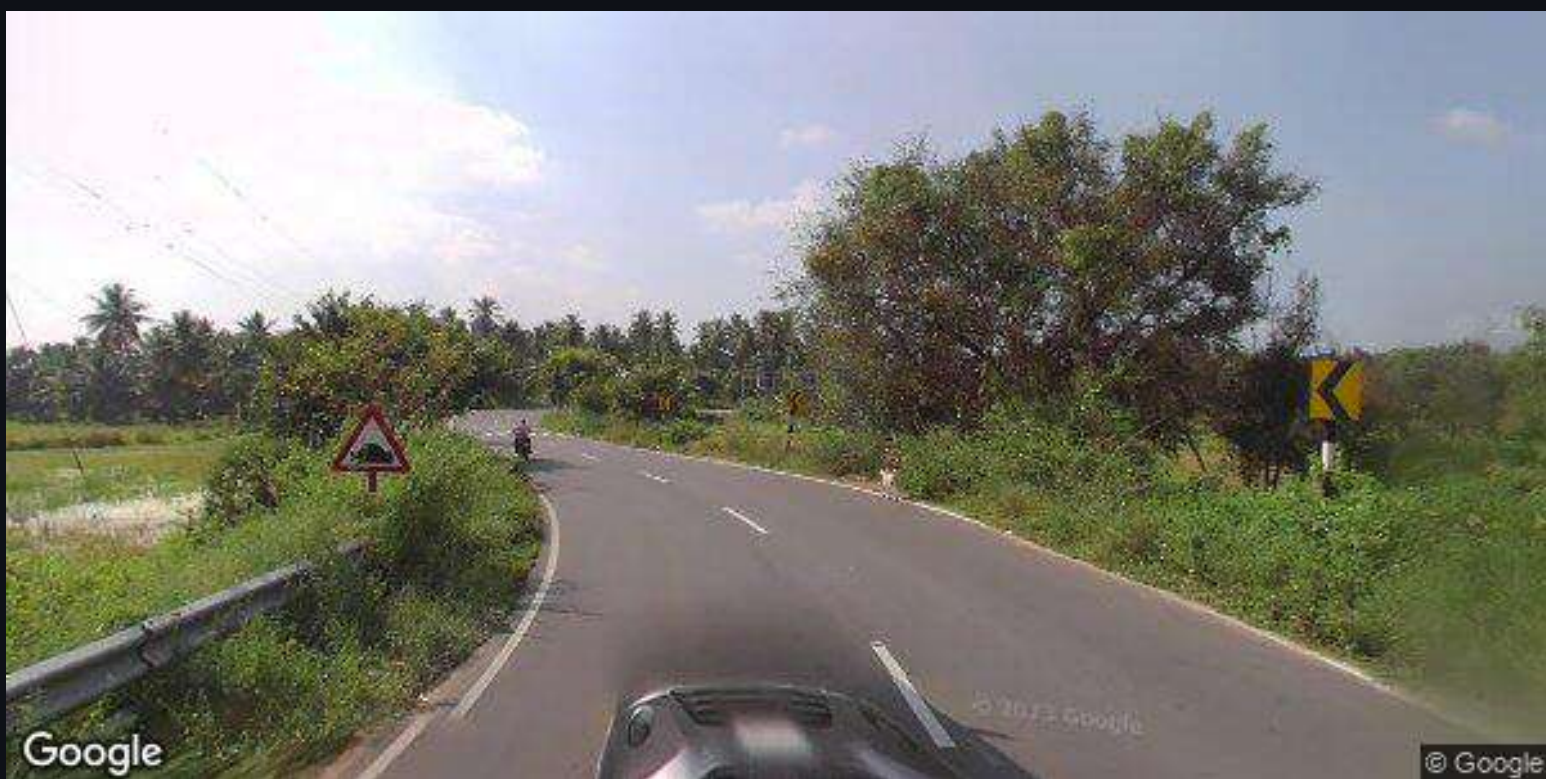
**Coordinates: 11.45358, 77.85781**

**Risk Type: Turn**

**Risk Level: Medium**

**Speed Limit: 30 KM/Hr**

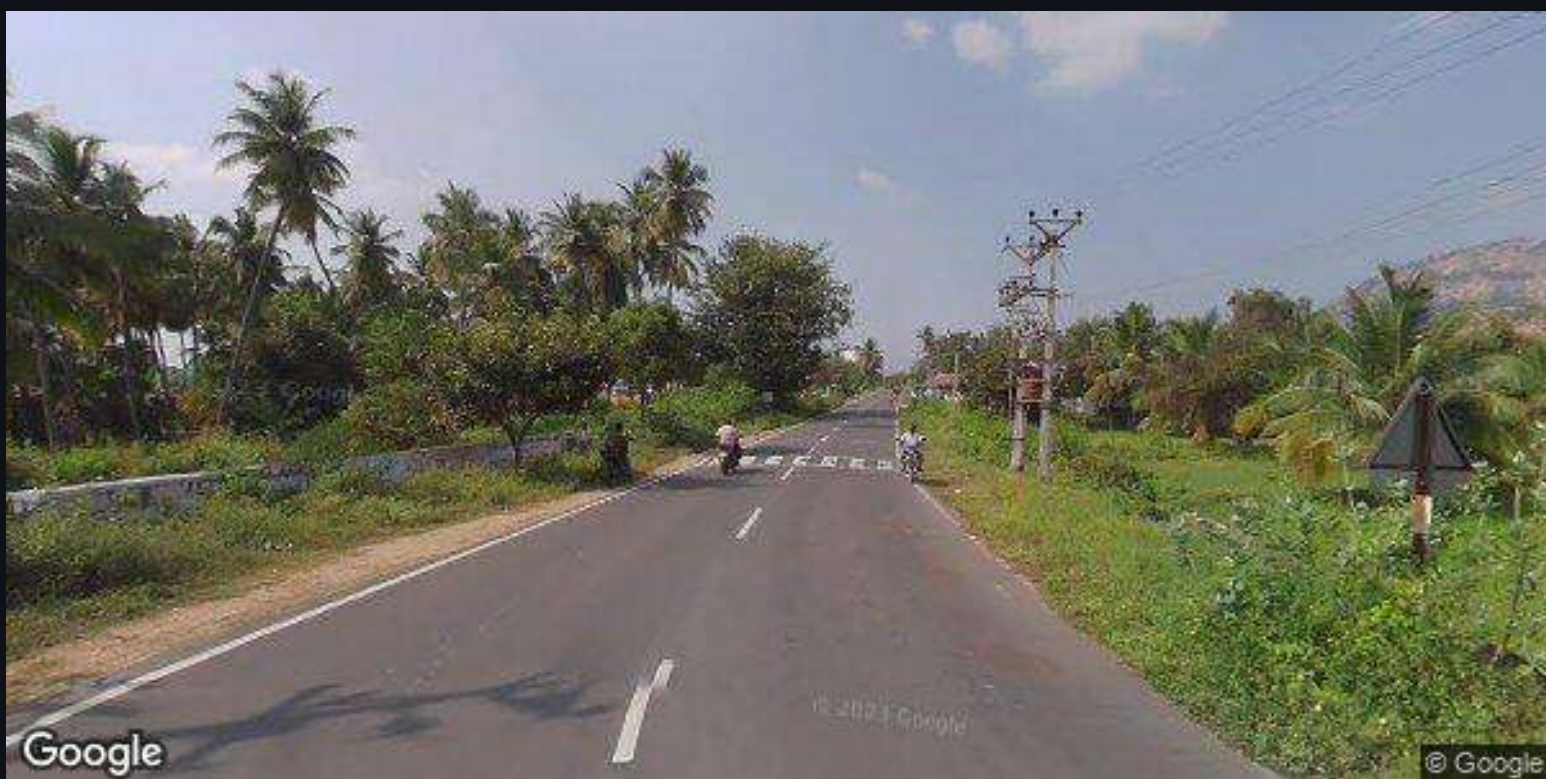
**Coordinates: 11.45353, 77.85697**

**Risk Type: Turn**

**Risk Level: High**

**Speed Limit: 15 KM/Hr**

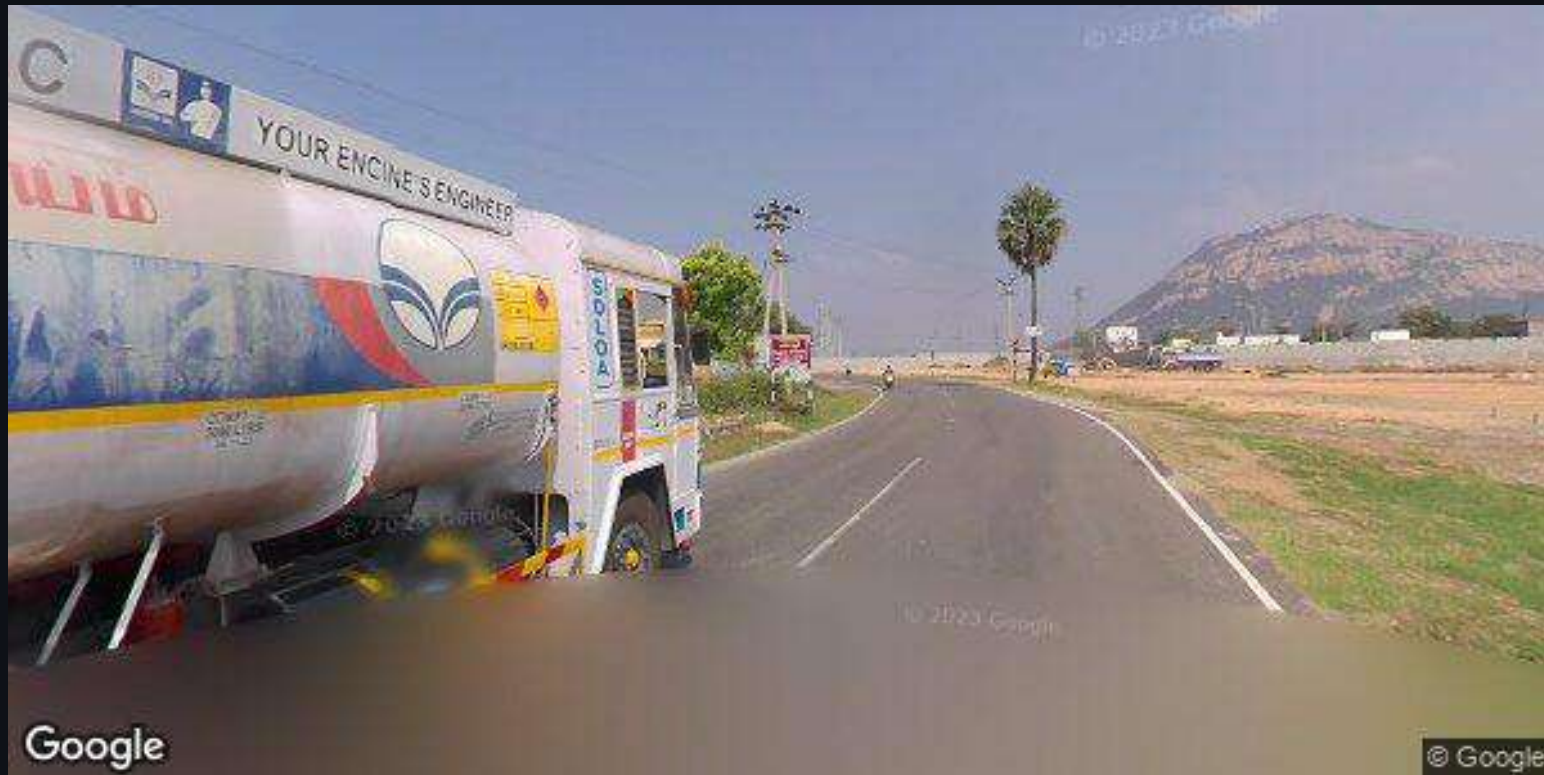
**Coordinates: 11.45853, 77.85139**

**Risk Type: Turn**

**Risk Level: Medium**

**Speed Limit: 30 KM/Hr**

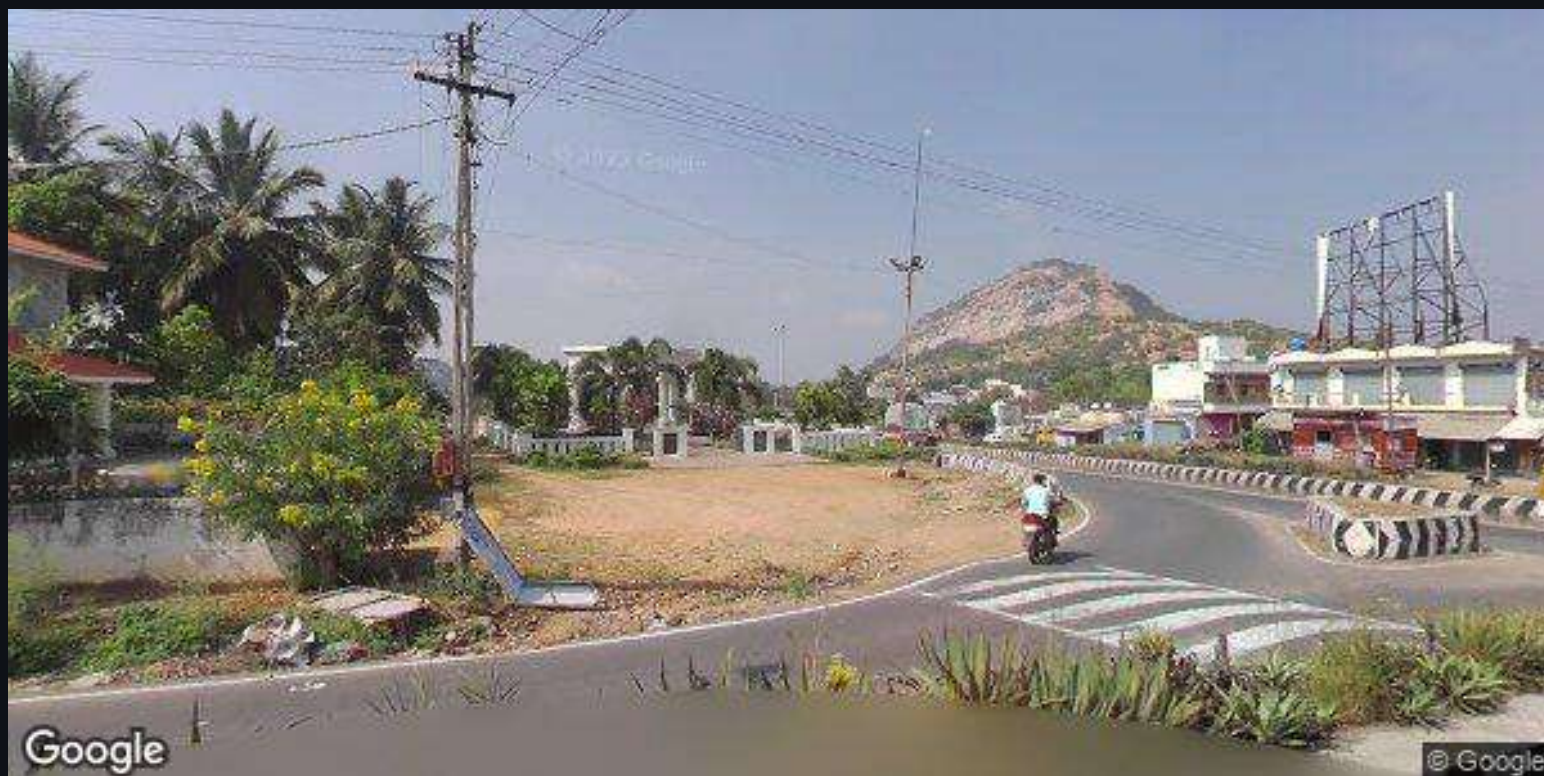
**Coordinates: 11.46307, 77.84941**

**Risk Type: Turn**

**Risk Level: Medium**

**Speed Limit: 30 KM/Hr**

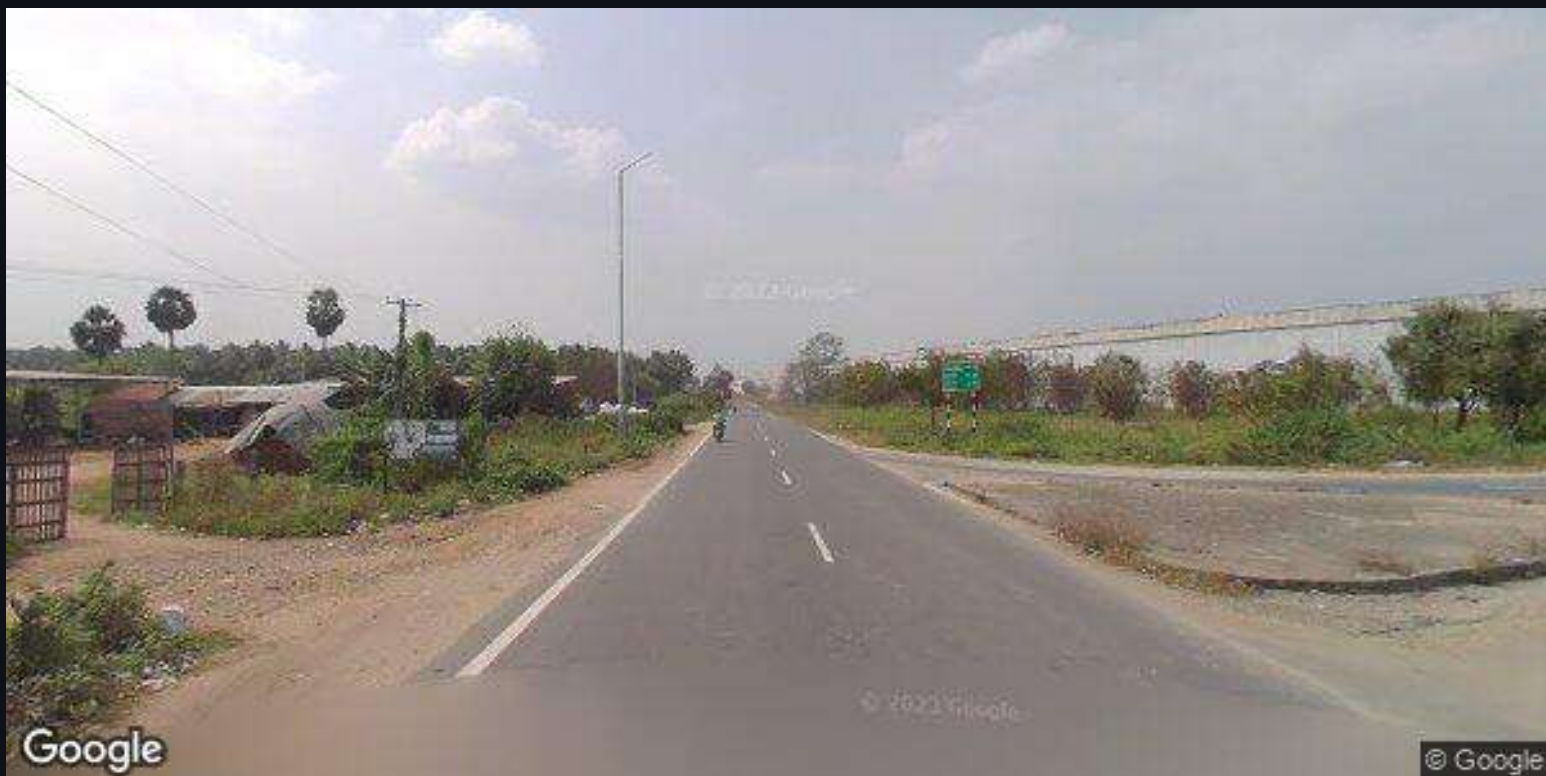
**Coordinates:** 11.45542, 77.81725

**Risk Type:** Turn

**Risk Level:** High

**Speed Limit:** 15 KM/Hr

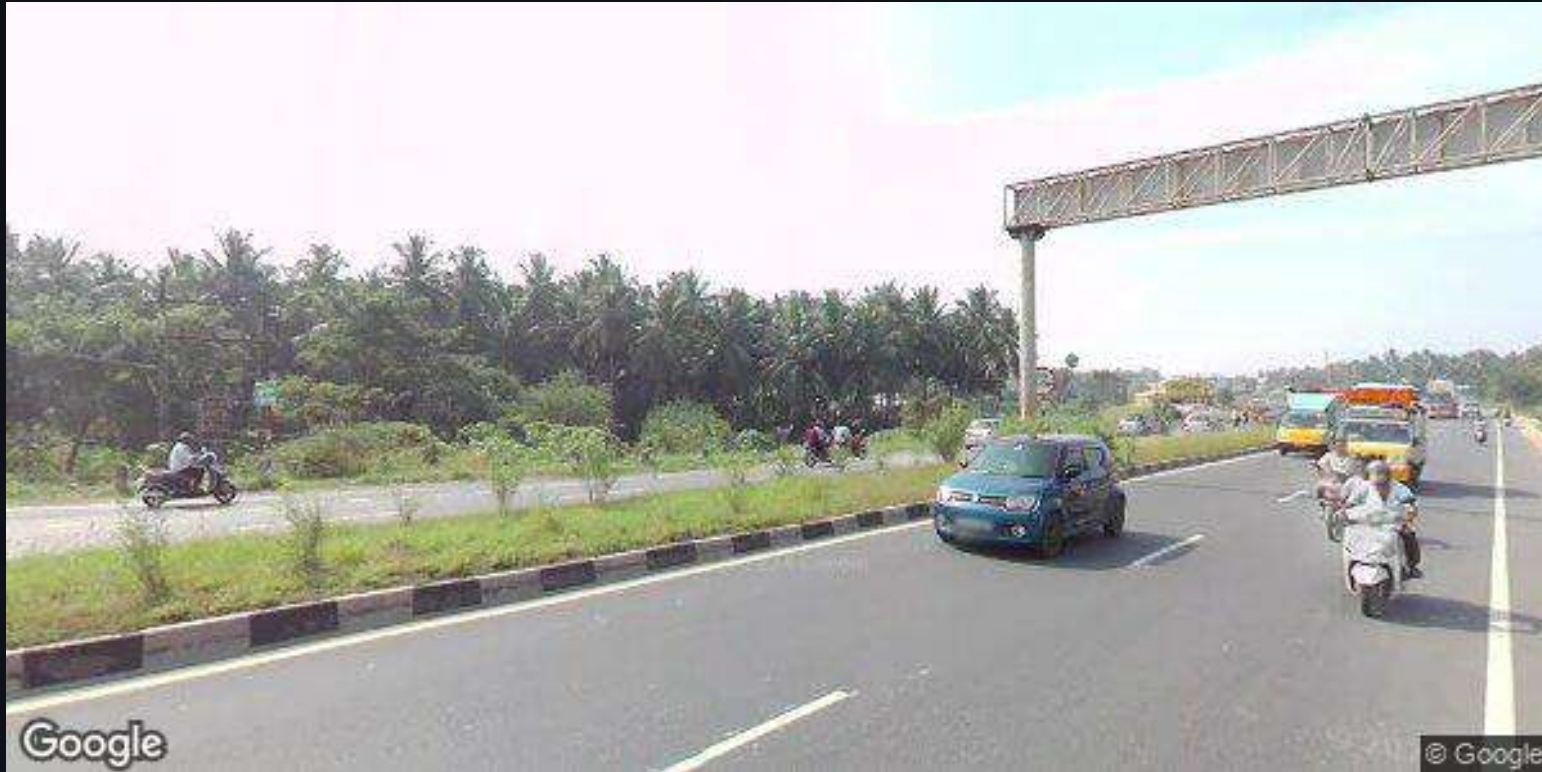
**Risk Type:** Turn  
**Risk Level:** Medium  
**Speed Limit:** 30 KM/Hr  
**Coordinates:** 11.60942, 78.10056

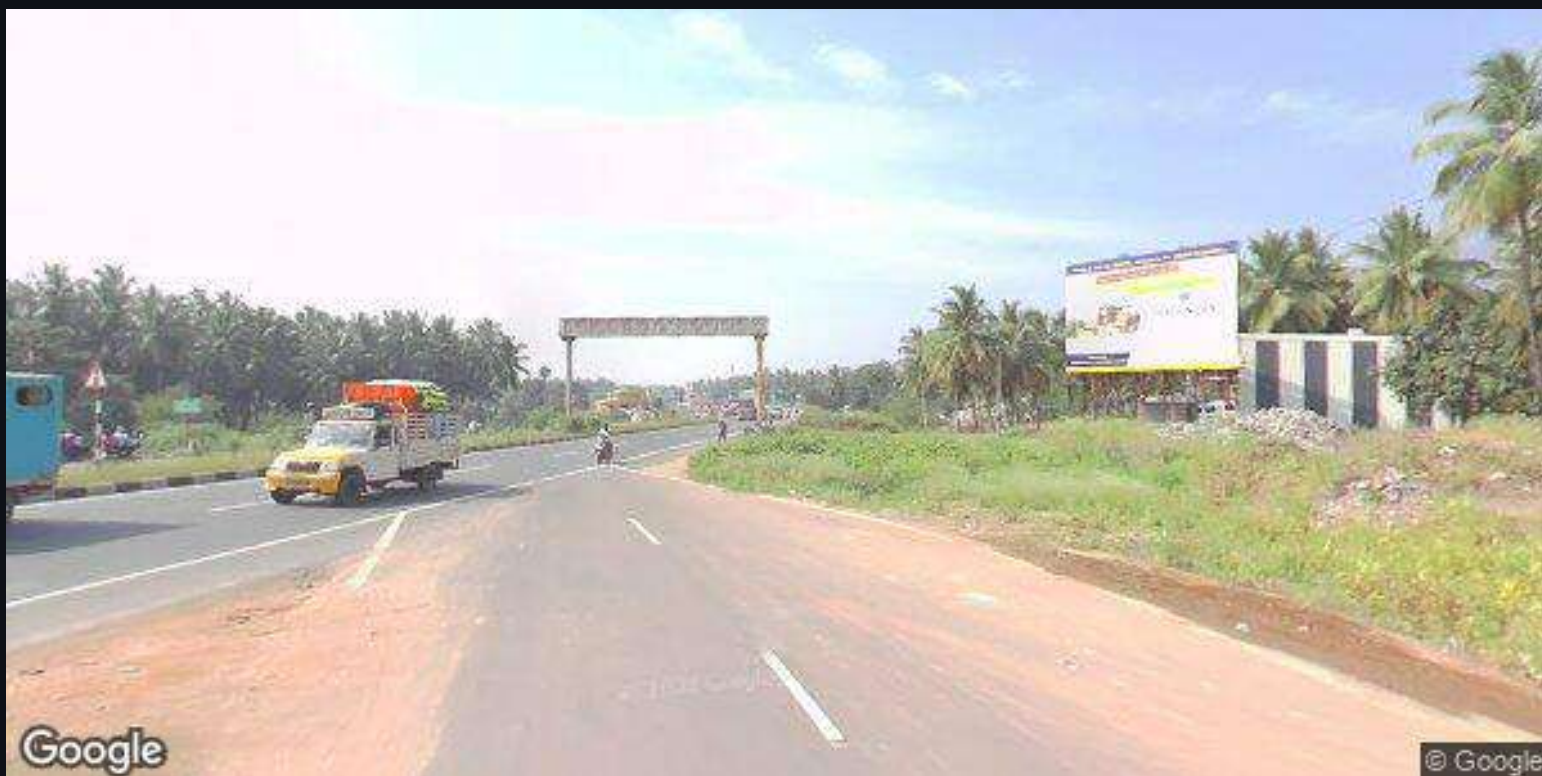
**Risk Type:** Turn  
**Risk Level:** Medium  
**Speed Limit:** 30 KM/Hr  
**Coordinates:** 11.60965, 78.10070

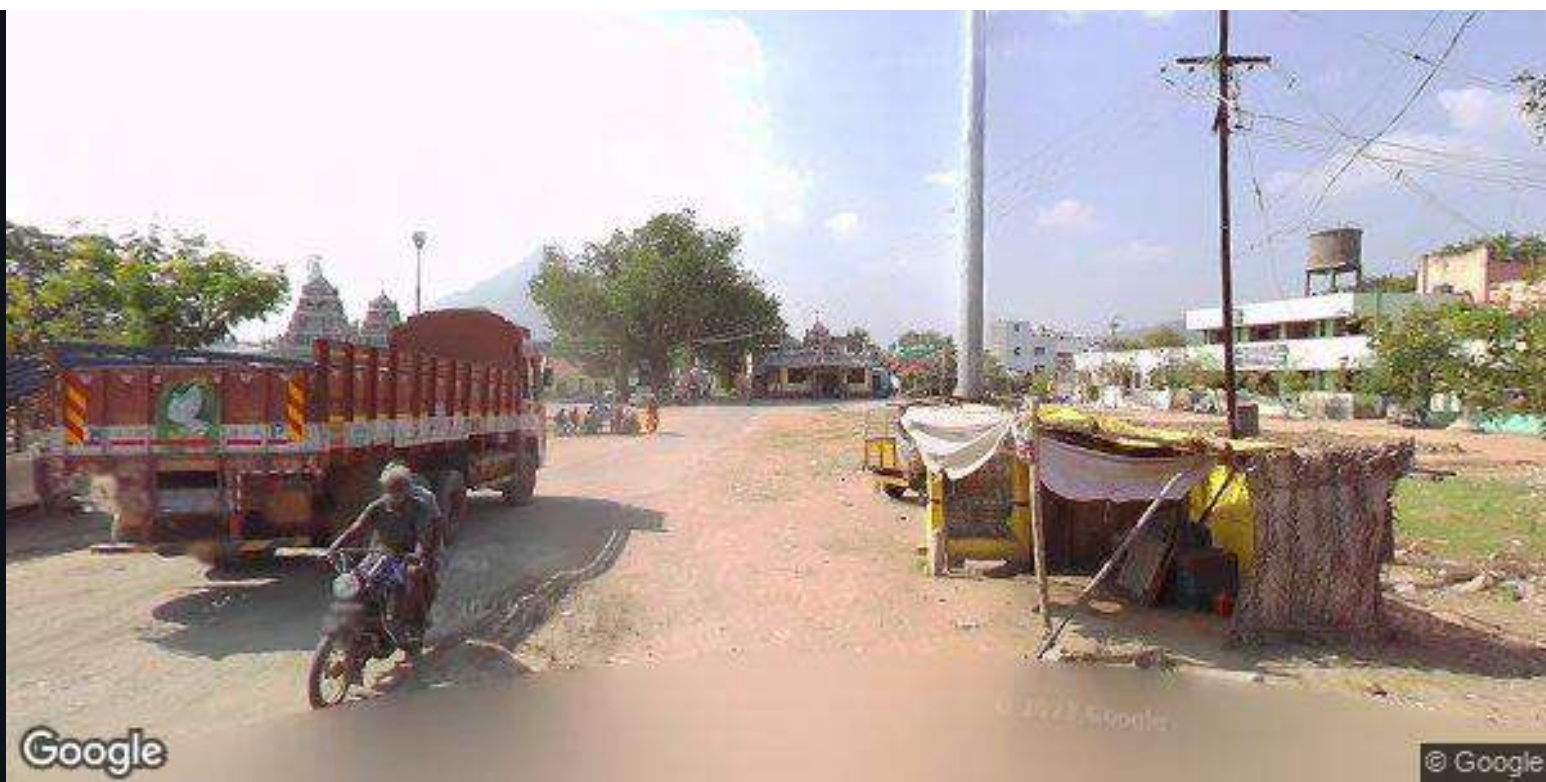
**Risk Type:** Blind Spot  
**Risk Level:** Blind Spot  
**Speed Limit:** 10 KM/Hr  
**Coordinates:** 11.62145, 78.10740

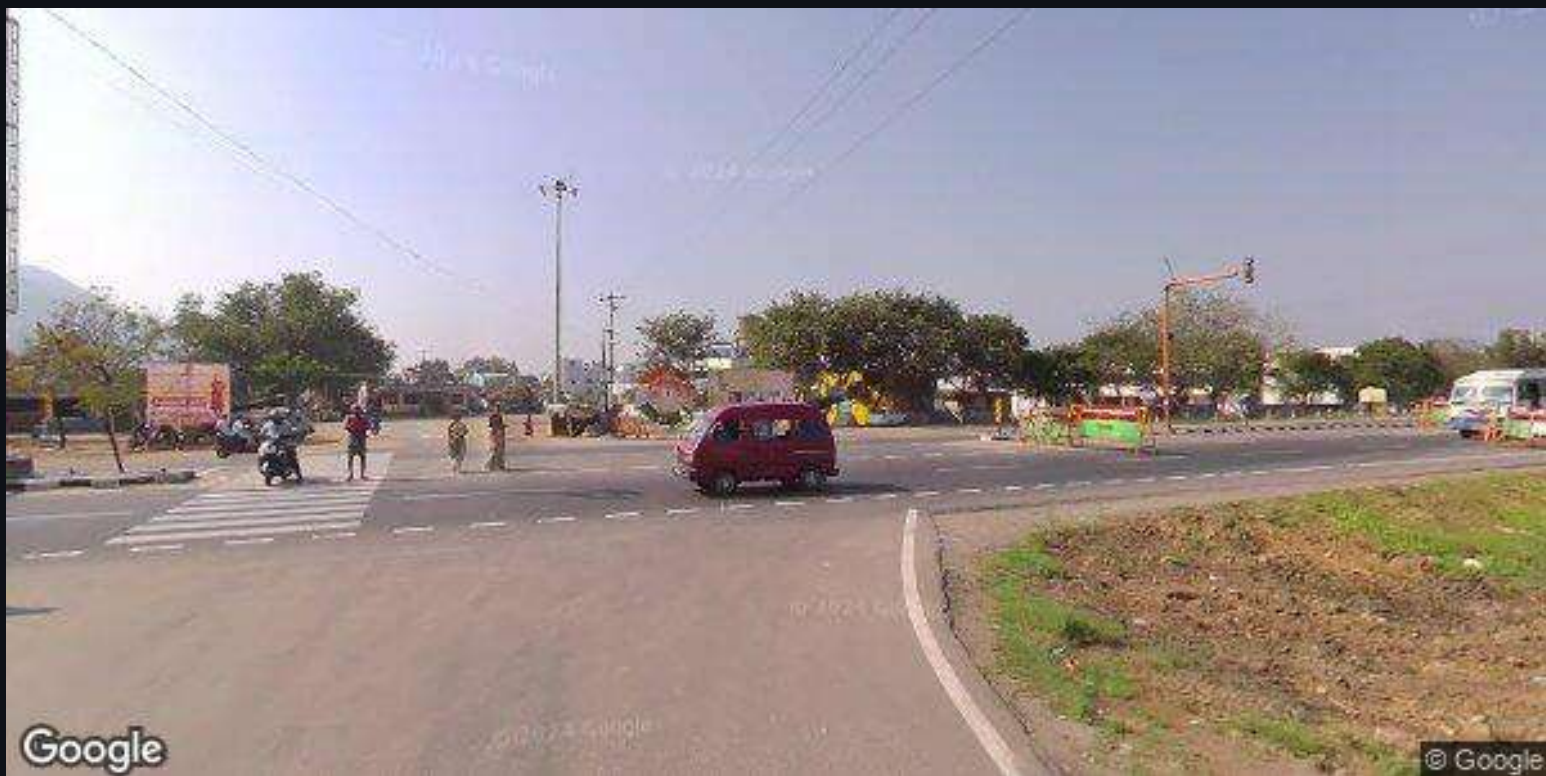
**Risk Type:** Turn  
**Risk Level:** High  
**Speed Limit:** 15 KM/Hr  
**Coordinates:** 11.62130, 78.10776

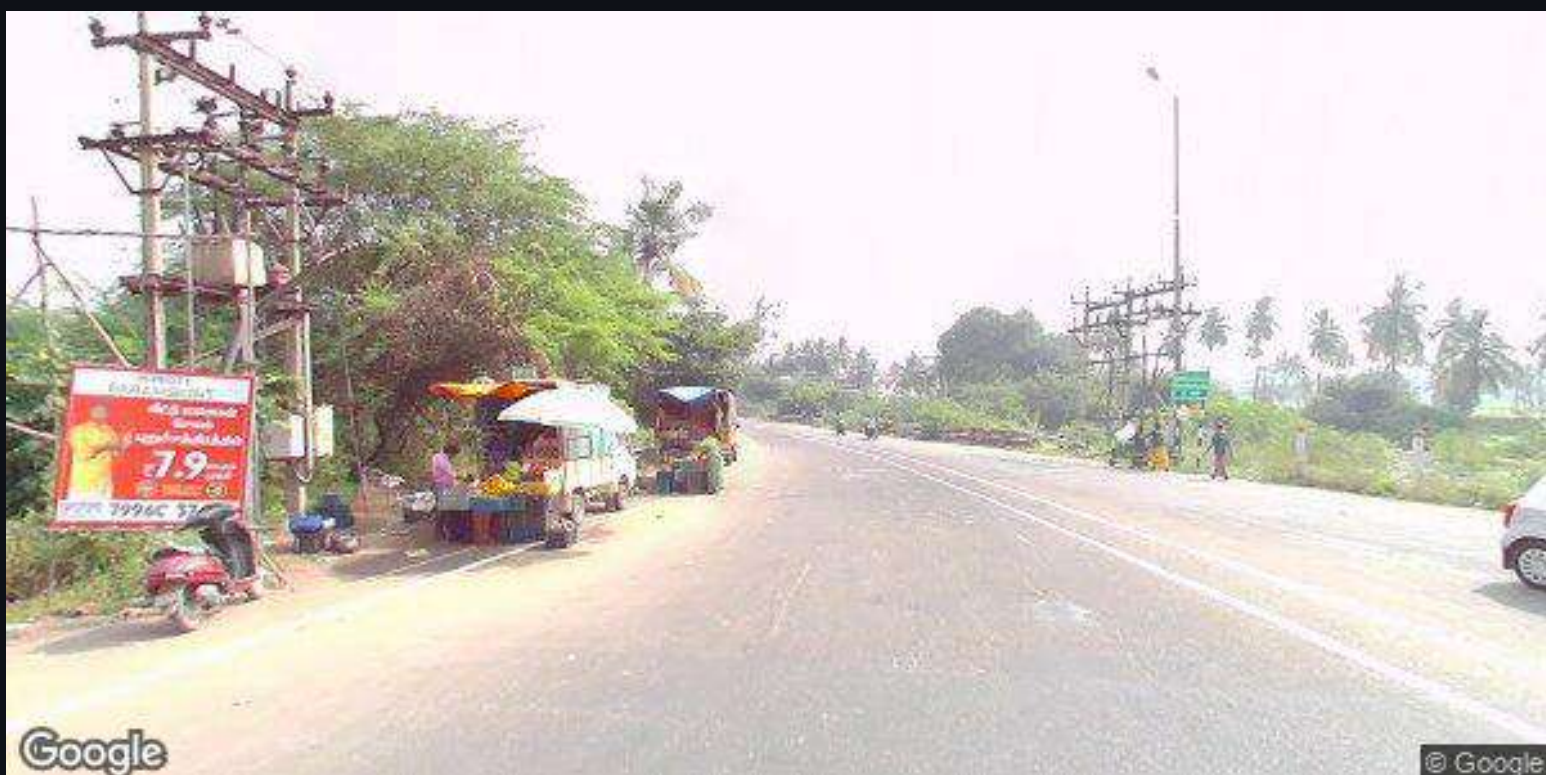
**Risk Type:** Blind Spot  
**Risk Level:** Blind Spot  
**Speed Limit:** 10 KM/Hr  
**Coordinates:** 11.61217, 78.10439

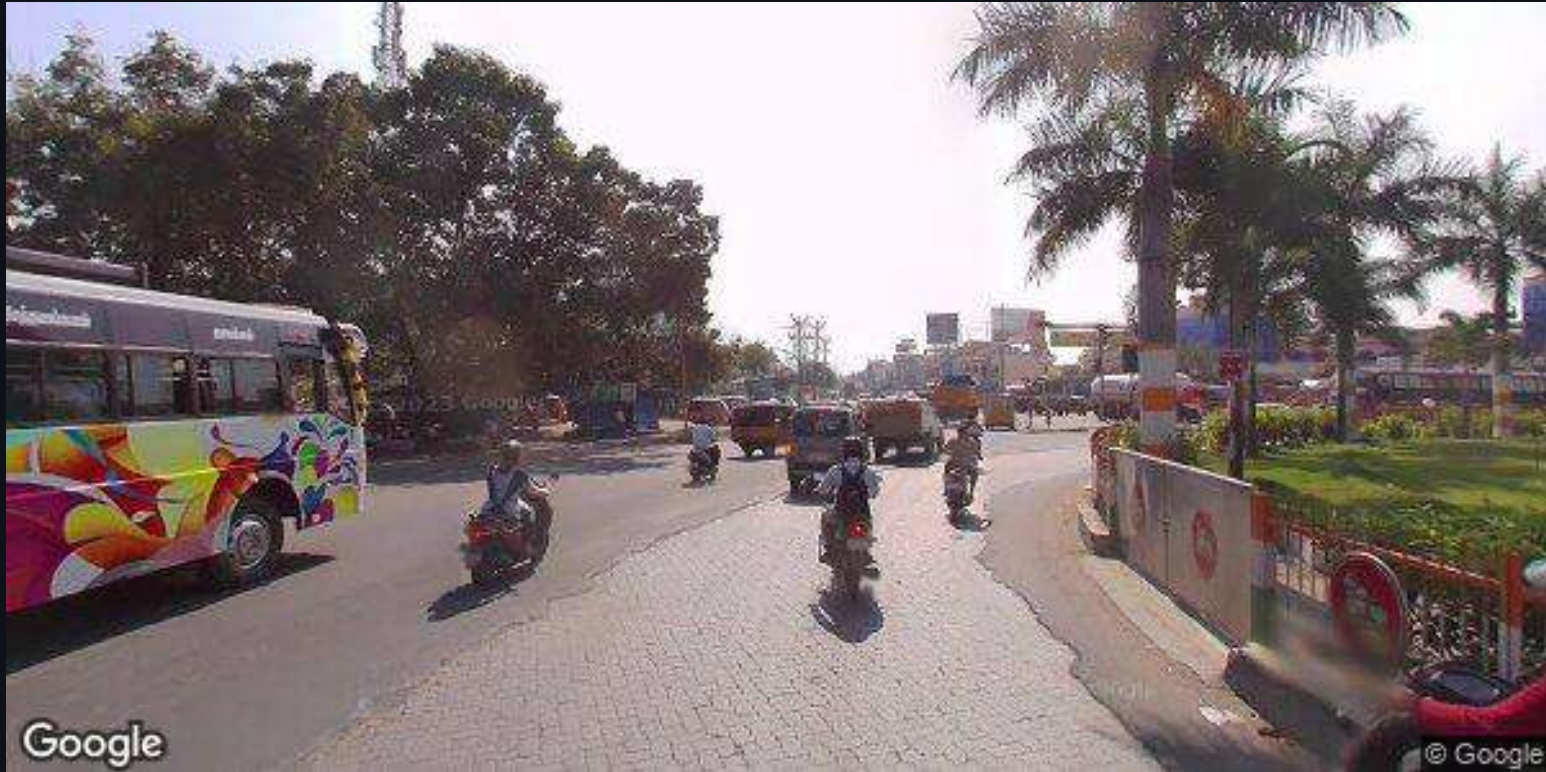
**Risk Type:** Turn  
**Risk Level:** High  
**Speed Limit:** 15 KM/Hr  
**Coordinates:** 11.63297, 78.12749

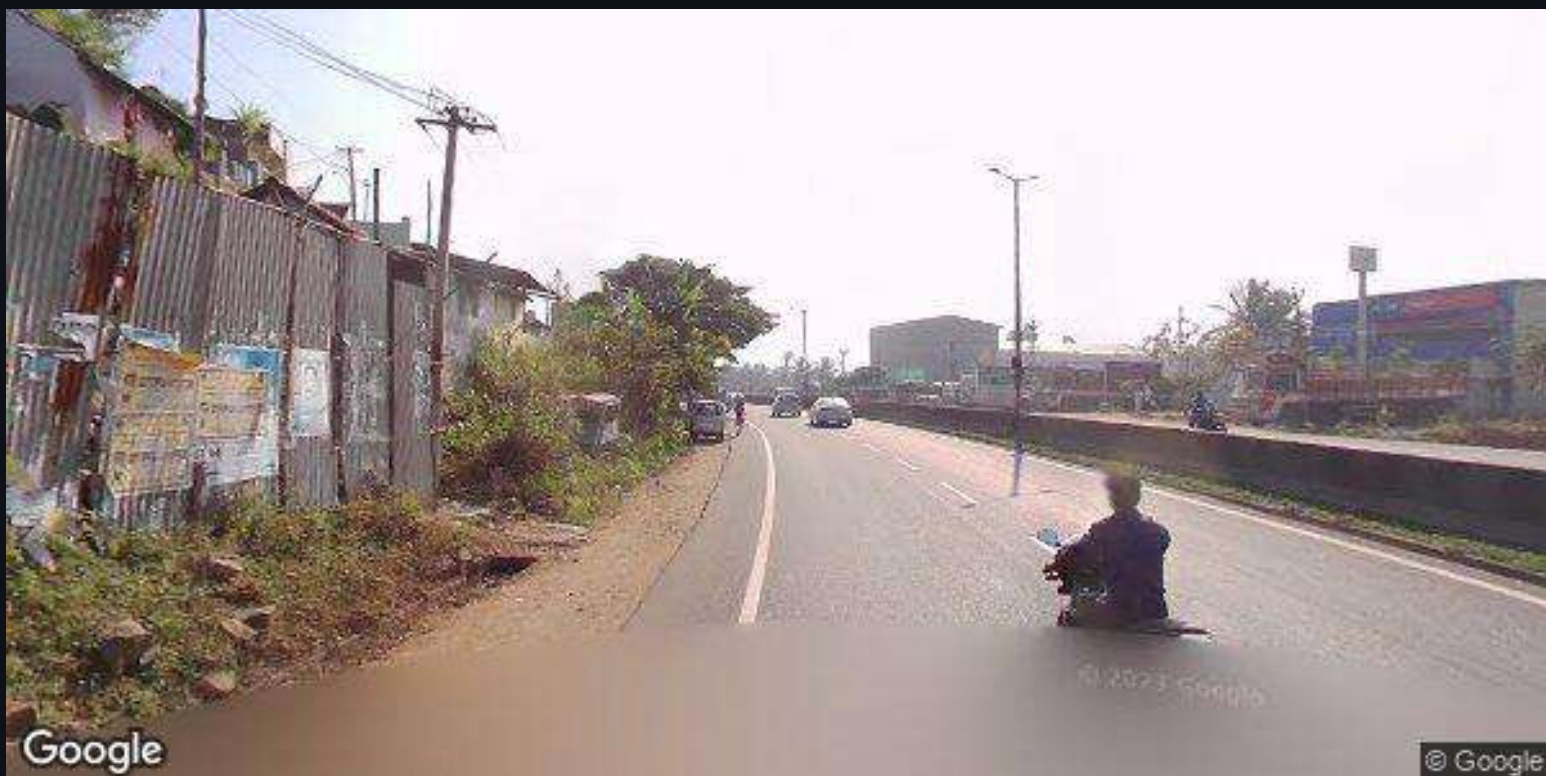
**Risk Type:** Turn  
**Risk Level:** Medium  
**Speed Limit:** 30 KM/Hr  
**Coordinates:** 11.62826, 78.13337

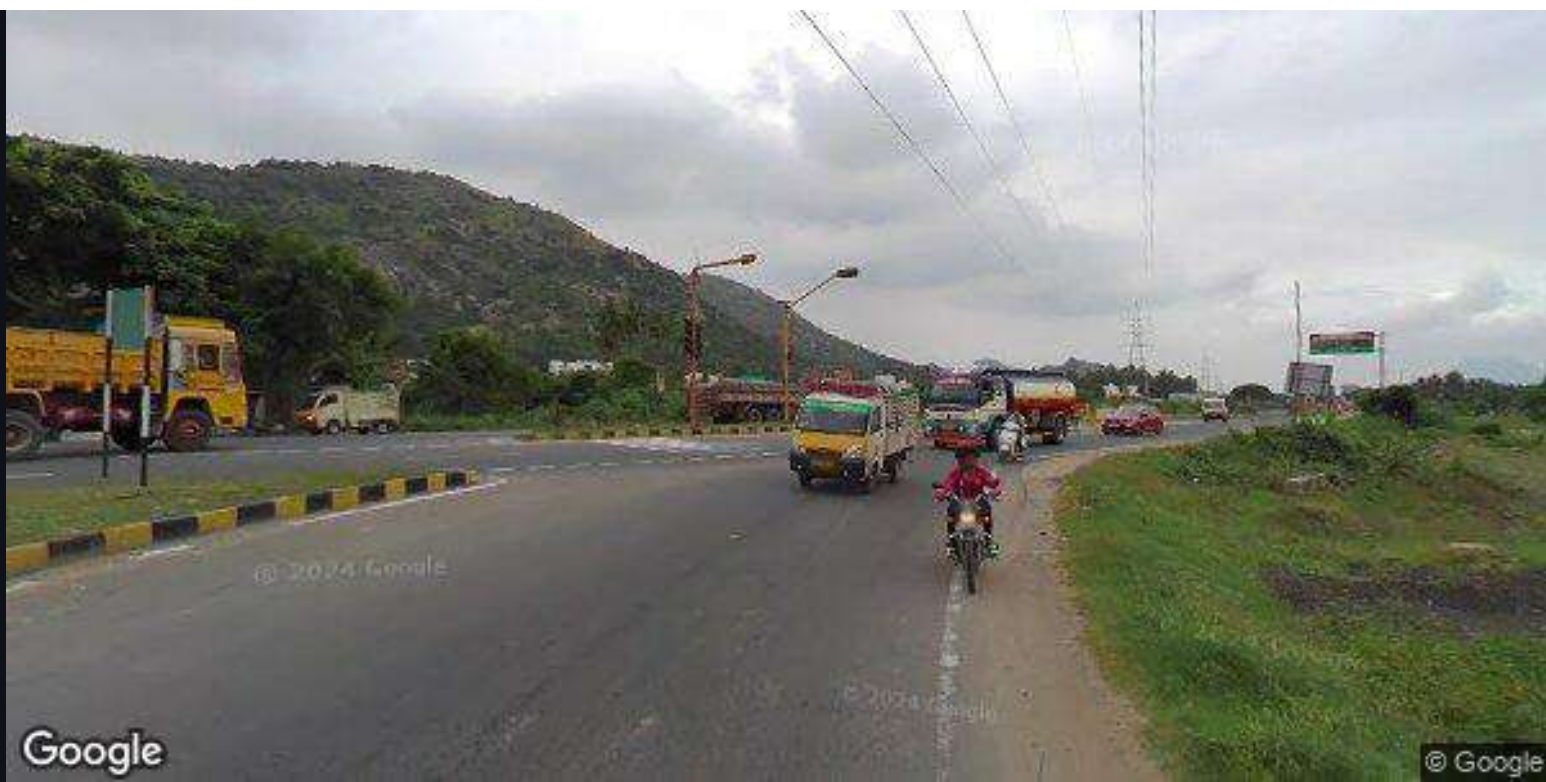
**Coordinates: 11.65632, 78.20220**

**Risk Type: Turn**

**Risk Level: Medium**

**Speed Limit: 30 KM/Hr**

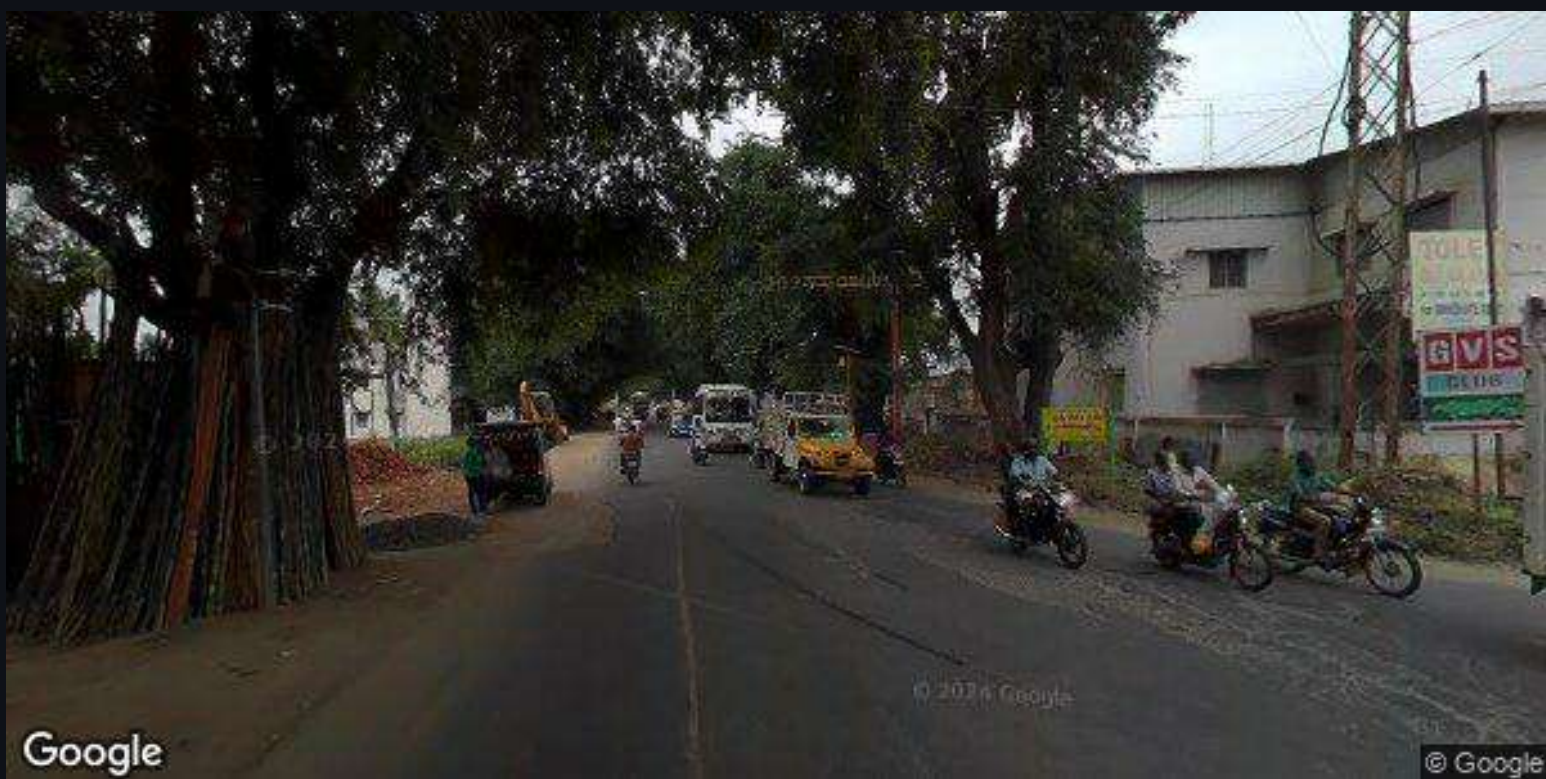
**Coordinates: 11.66380, 78.20648**

**Risk Type: Turn**

**Risk Level: High**

**Speed Limit: 15 KM/Hr**

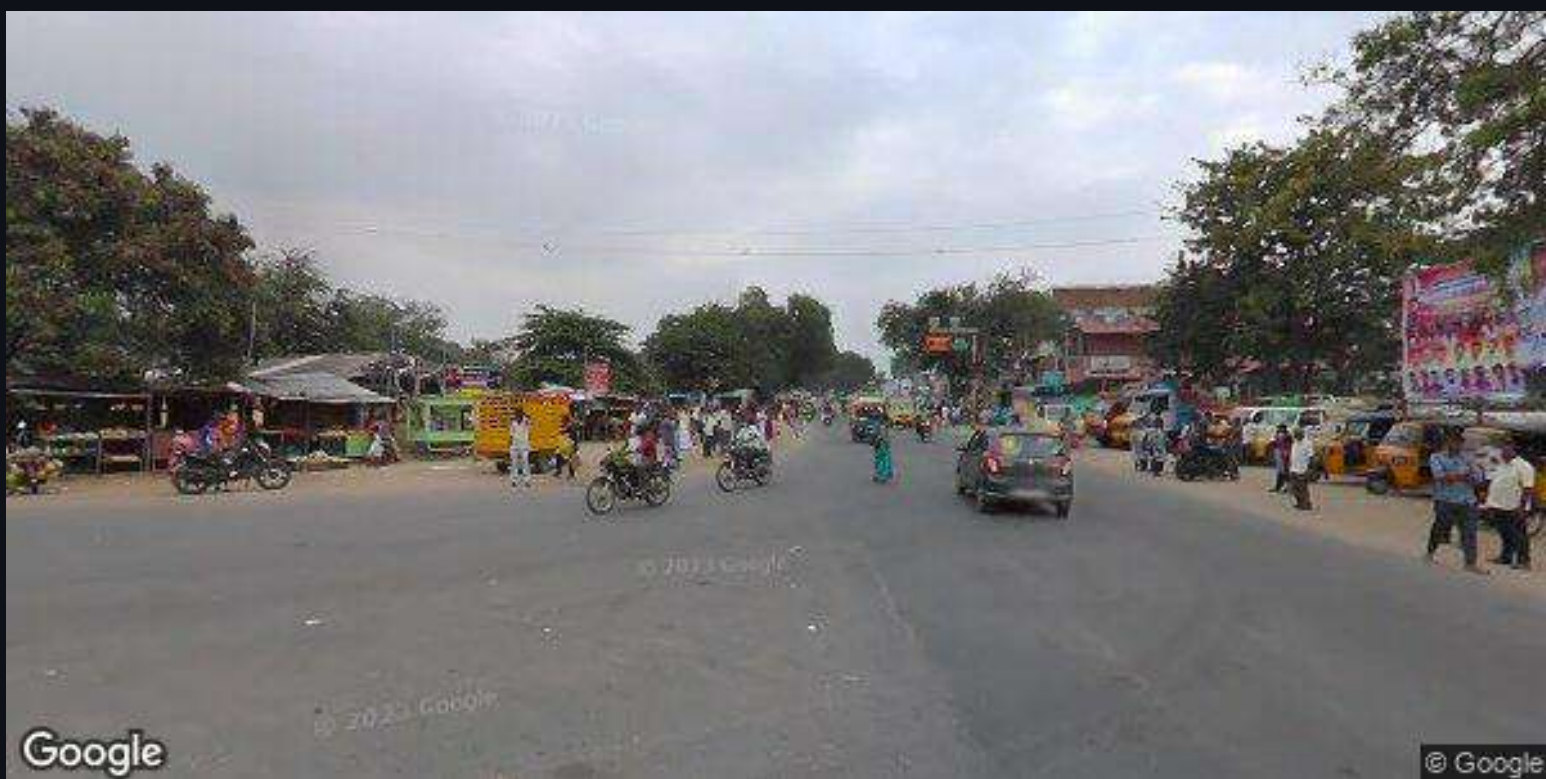
**Coordinates:** 11.67111, 78.23134

**Risk Type:** Turn

**Risk Level:** High

**Speed Limit:** 15 KM/Hr

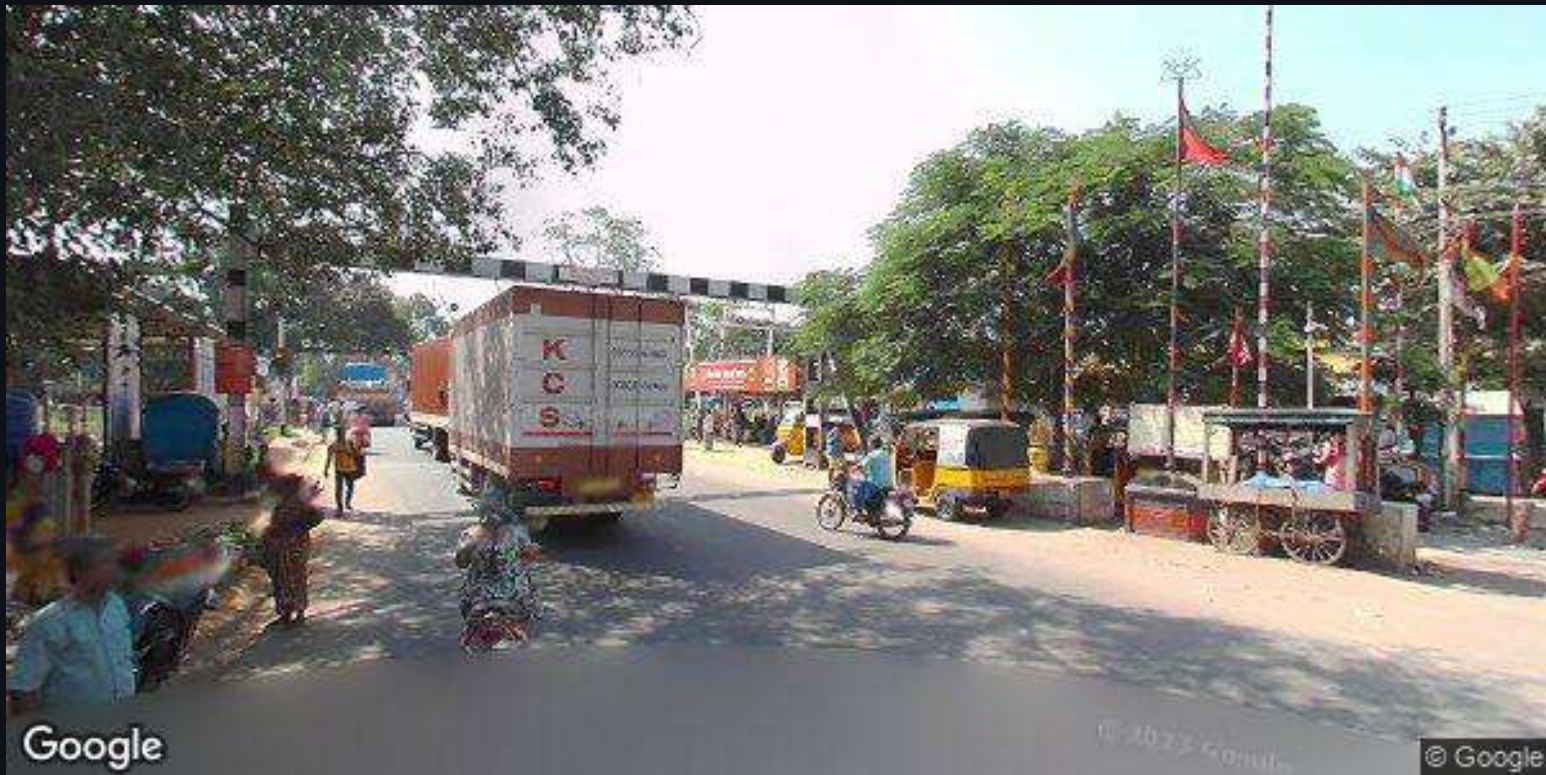
**Coordinates:** 11.67190, 78.23144

**Risk Type:** Turn

**Risk Level:** Medium

**Speed Limit:** 30 KM/Hr

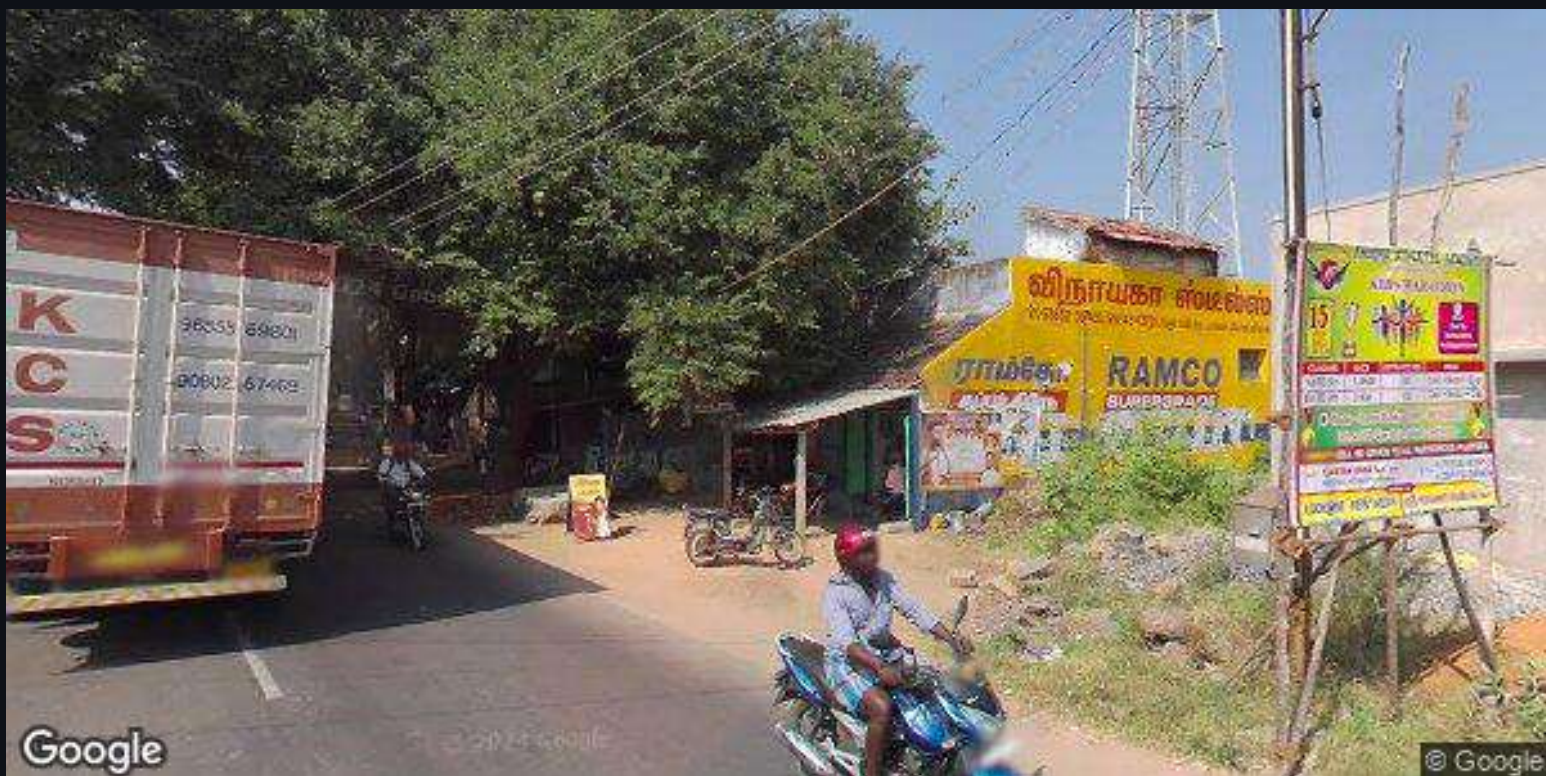
**Coordinates:** 11.67429, 78.23896

**Risk Type:** Turn

**Risk Level:** Medium

**Speed Limit:** 30 KM/Hr
