## JOURNEY RISK MANAGEMENT (JRM) STUDY

### Salem Terminal to S.M.P FUELS

#### Objective of the JRM Report

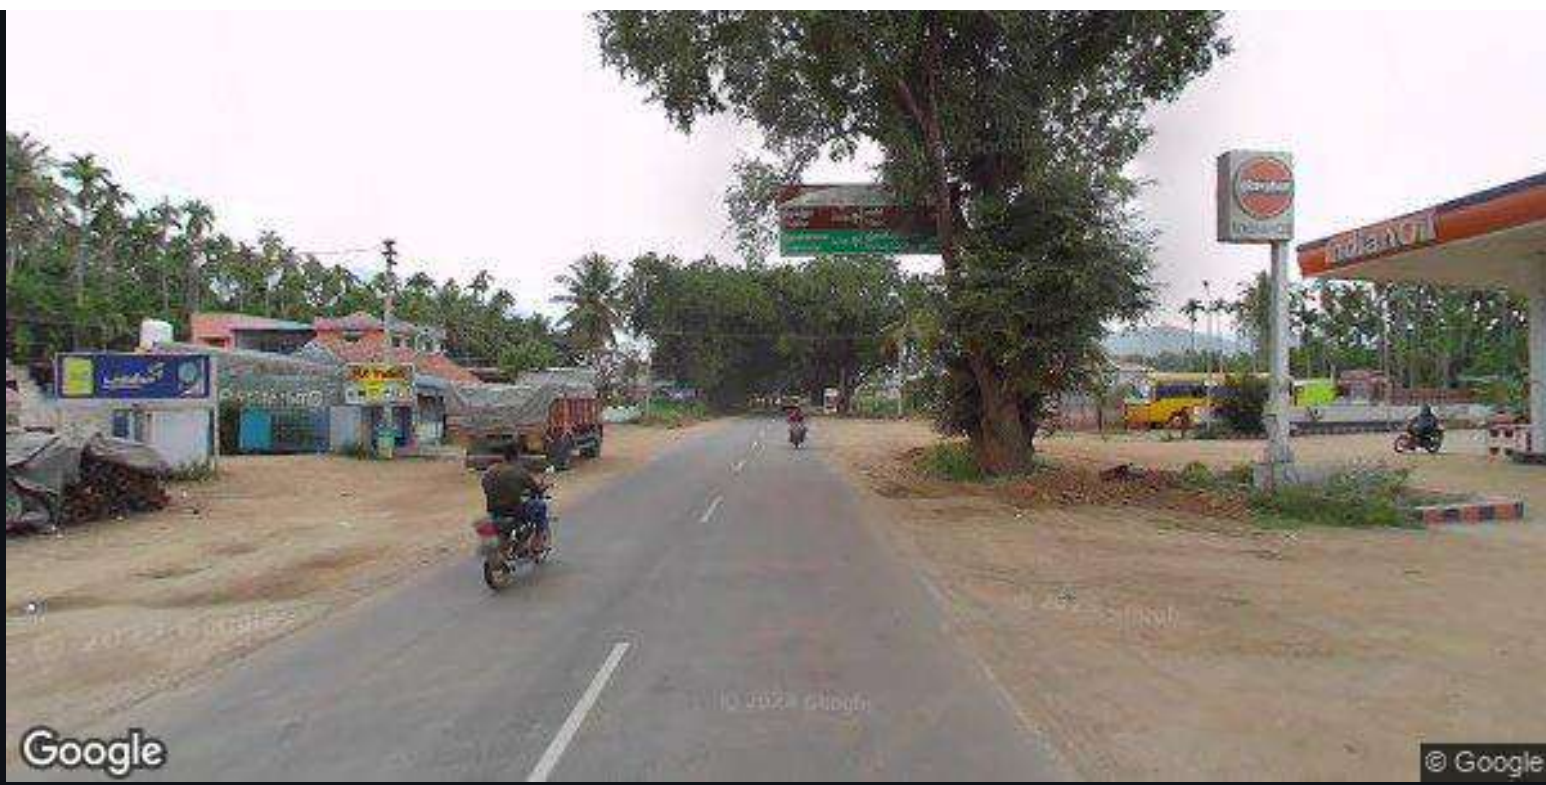
**Coordinates: 11.74622, 78.28147**

**Risk Type: Turn**

**Risk Level: High**

**Speed Limit: 15 KM/Hr**
