# IndianOil

## JOURNEY RISK MANAGEMENT (JRM) STUDY

### Salem Terminal TO MURUGAN FUELS

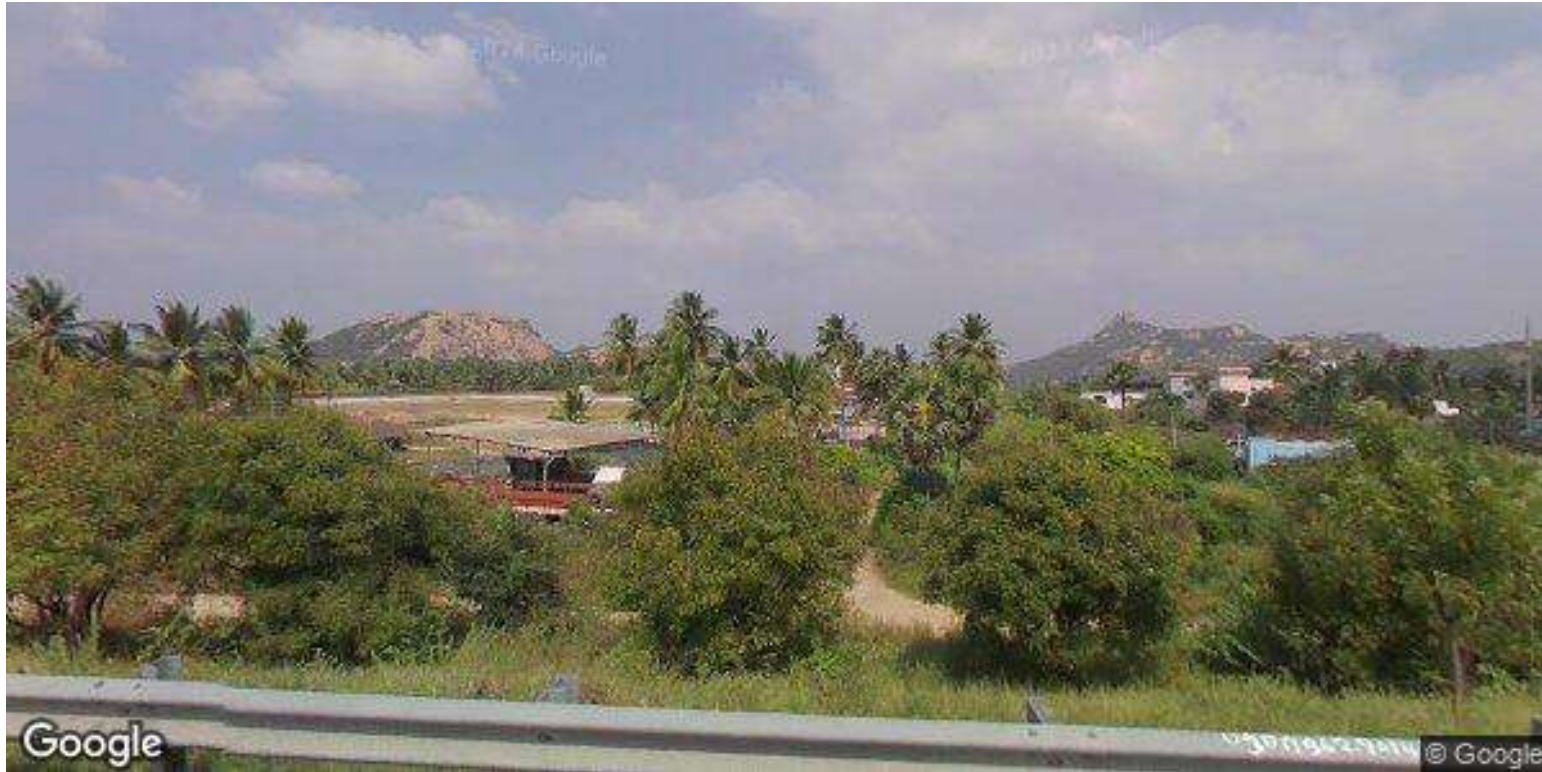
**Risk Type:** Turn  
**Risk Level:** High  
**Speed Limit:** 15 KM/Hr  
**Coordinates:** 11.49383, 77.88442

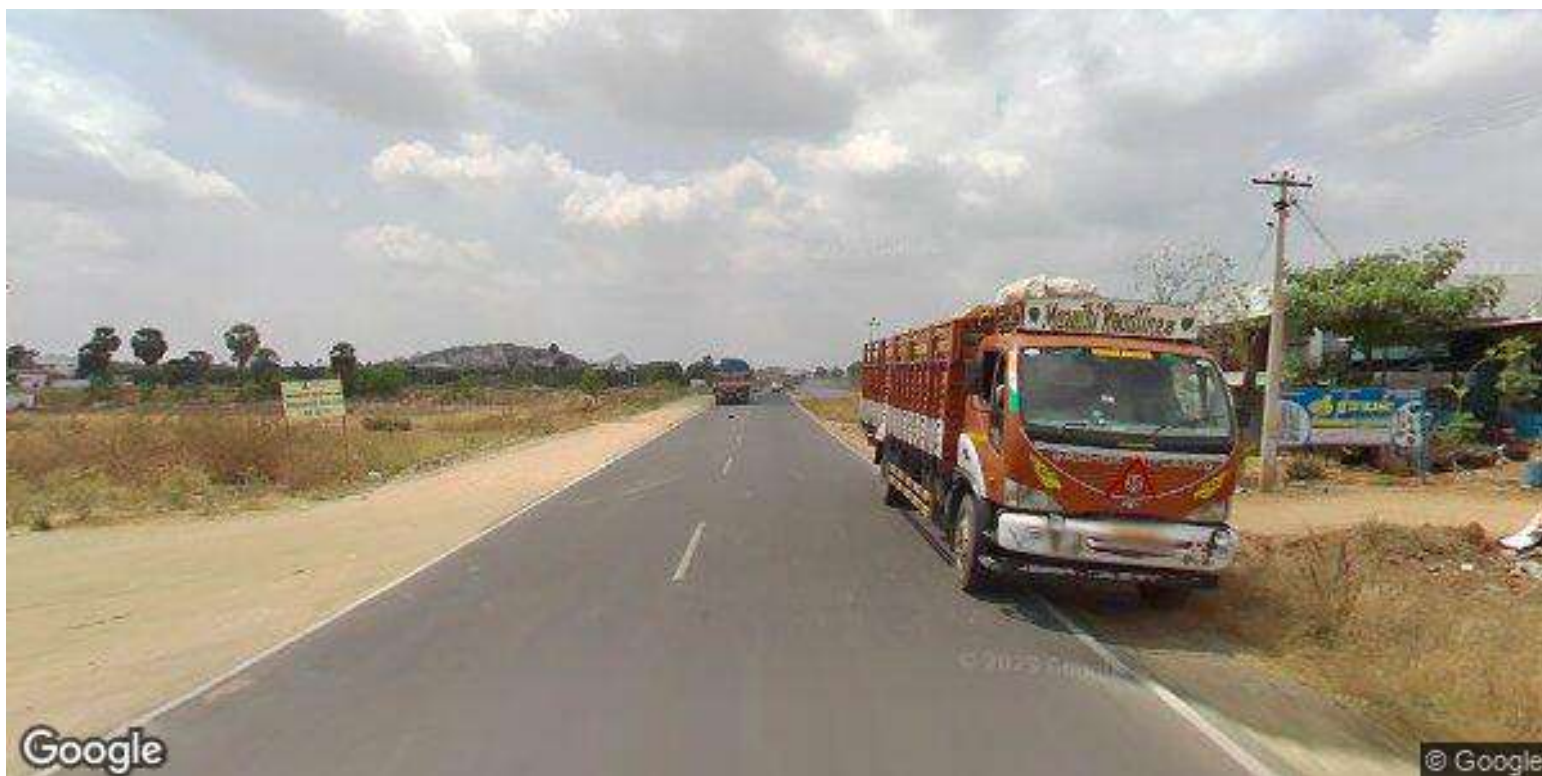
**Risk Type:** Turn  
**Risk Level:** High  
**Speed Limit:** 15 KM/Hr  
**Coordinates:** 11.55608, 77.89762

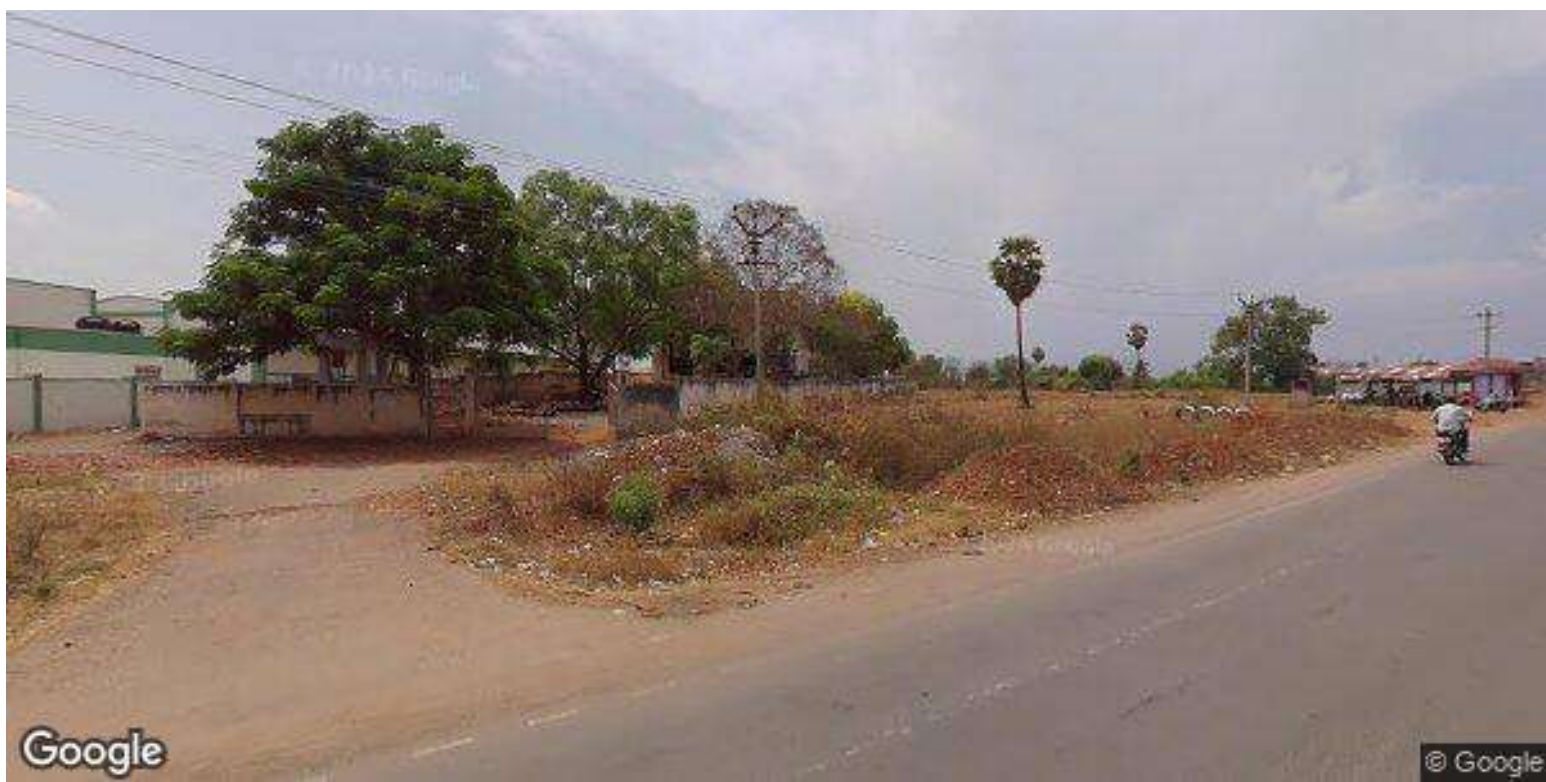
**Coordinates:** 11.58320, 77.90646

**Risk Type:** Turn

**Risk Level:** High

**Speed Limit:** 15 KM/Hr

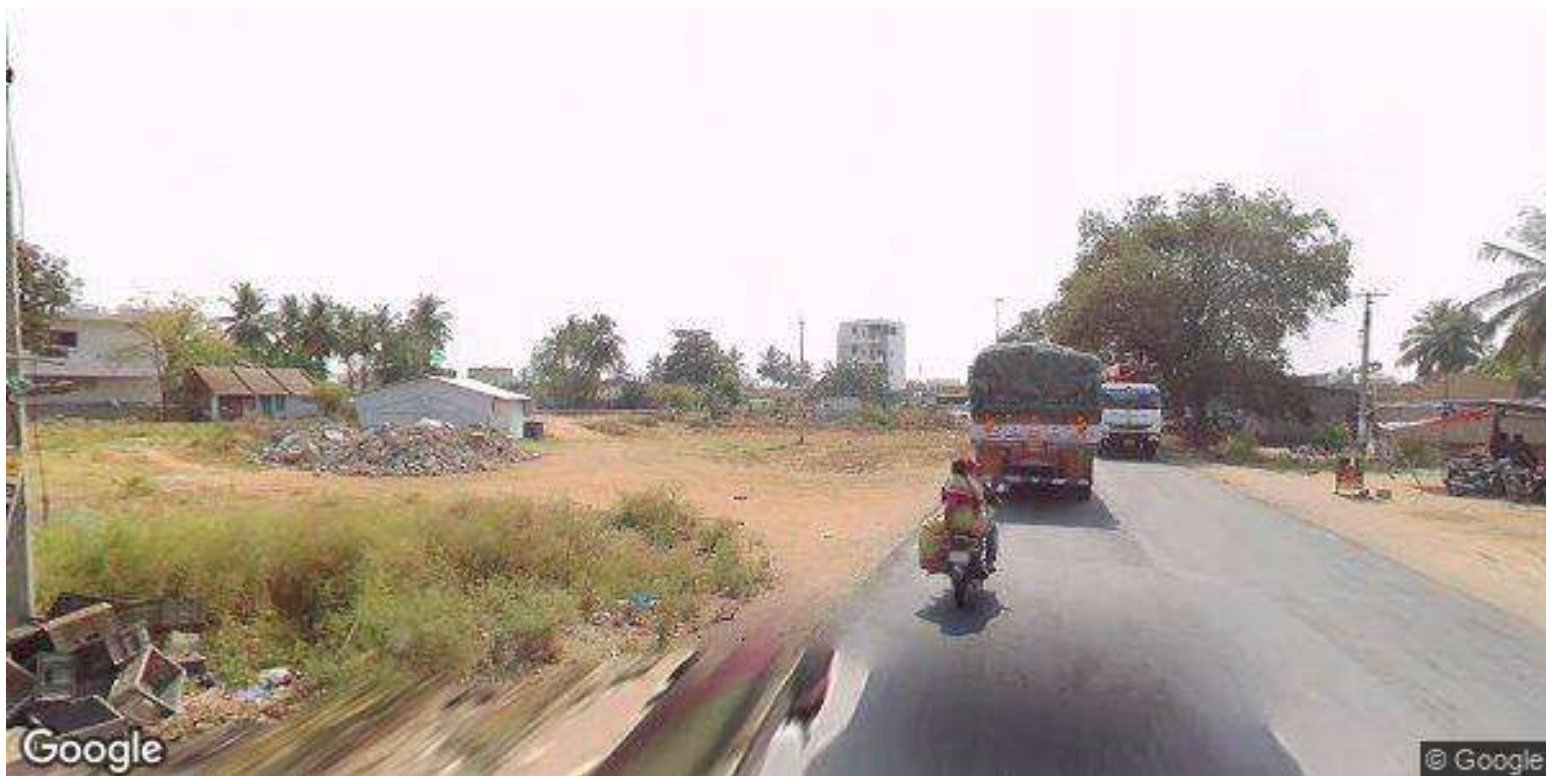
**Coordinates:** 11.59290, 77.90736

**Risk Type:** Turn

**Risk Level:** Medium

**Speed Limit:** 30 KM/Hr

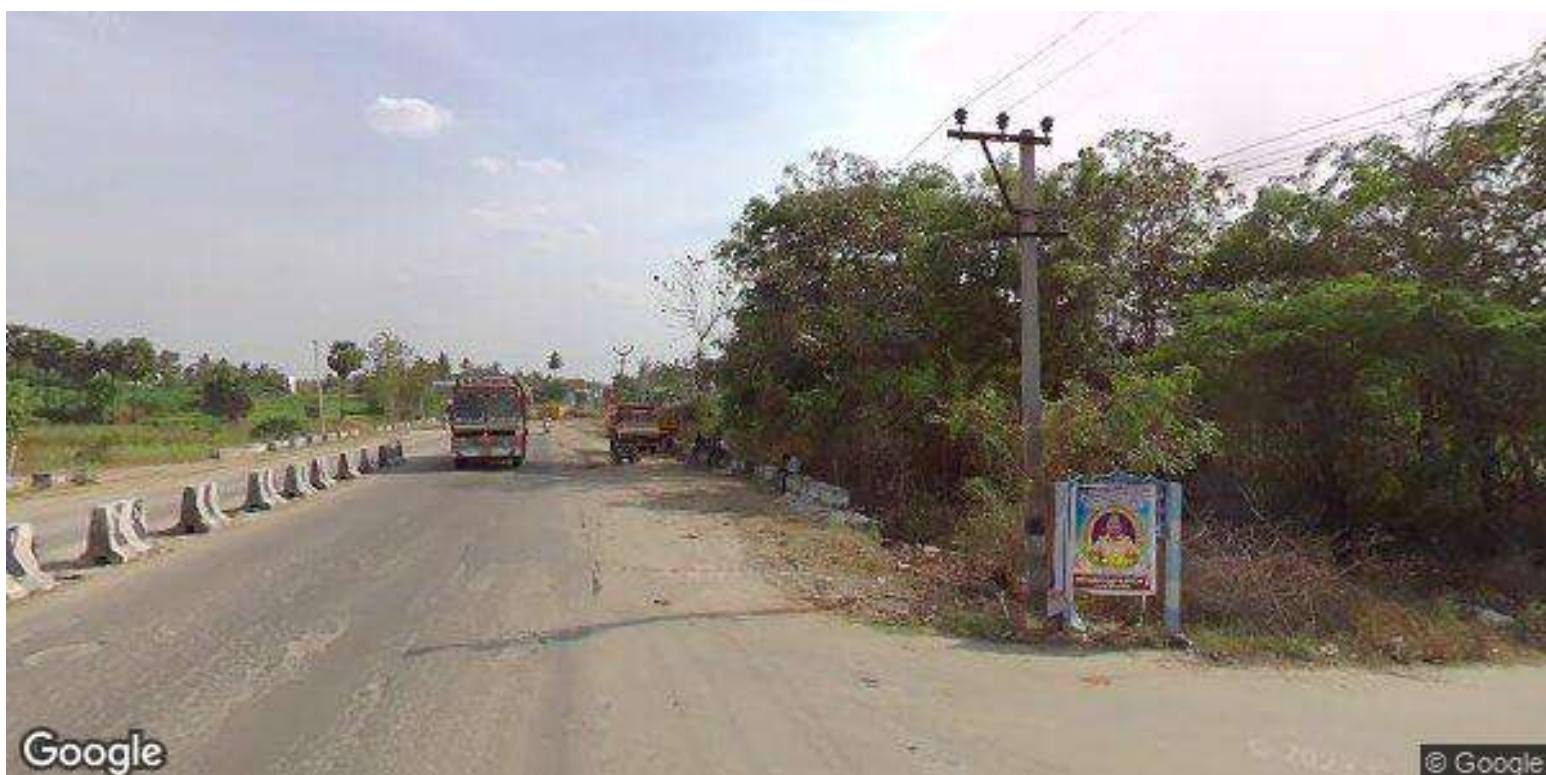
**Risk Type:** Turn  
**Risk Level:** Medium  
**Speed Limit:** 30 KM/Hr  
**Coordinates:** 11.63833, 77.94818

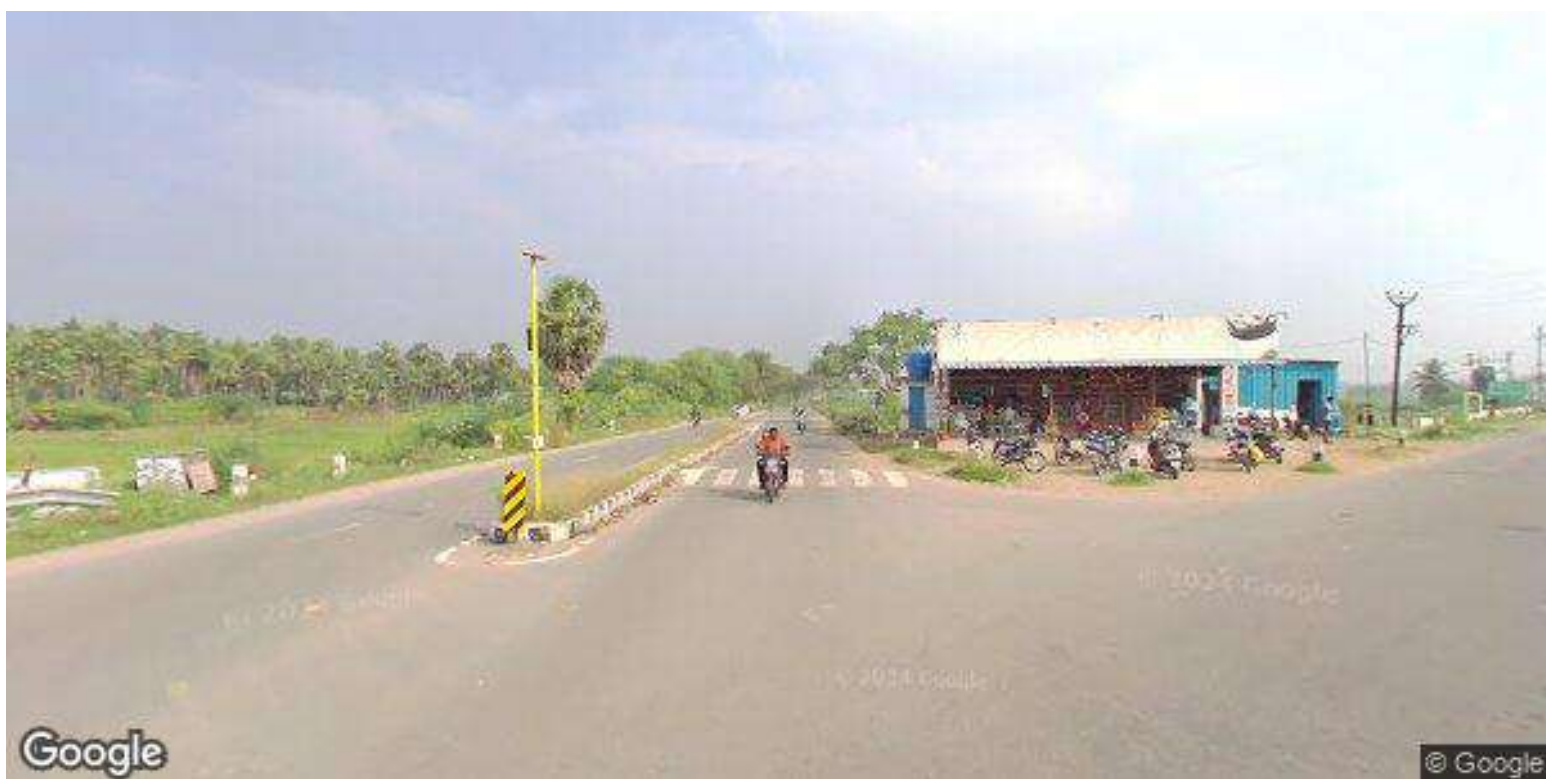
**Coordinates:** 11.67870, 77.96846

**Risk Type:** Turn

**Risk Level:** Medium

**Speed Limit:** 30 KM/Hr

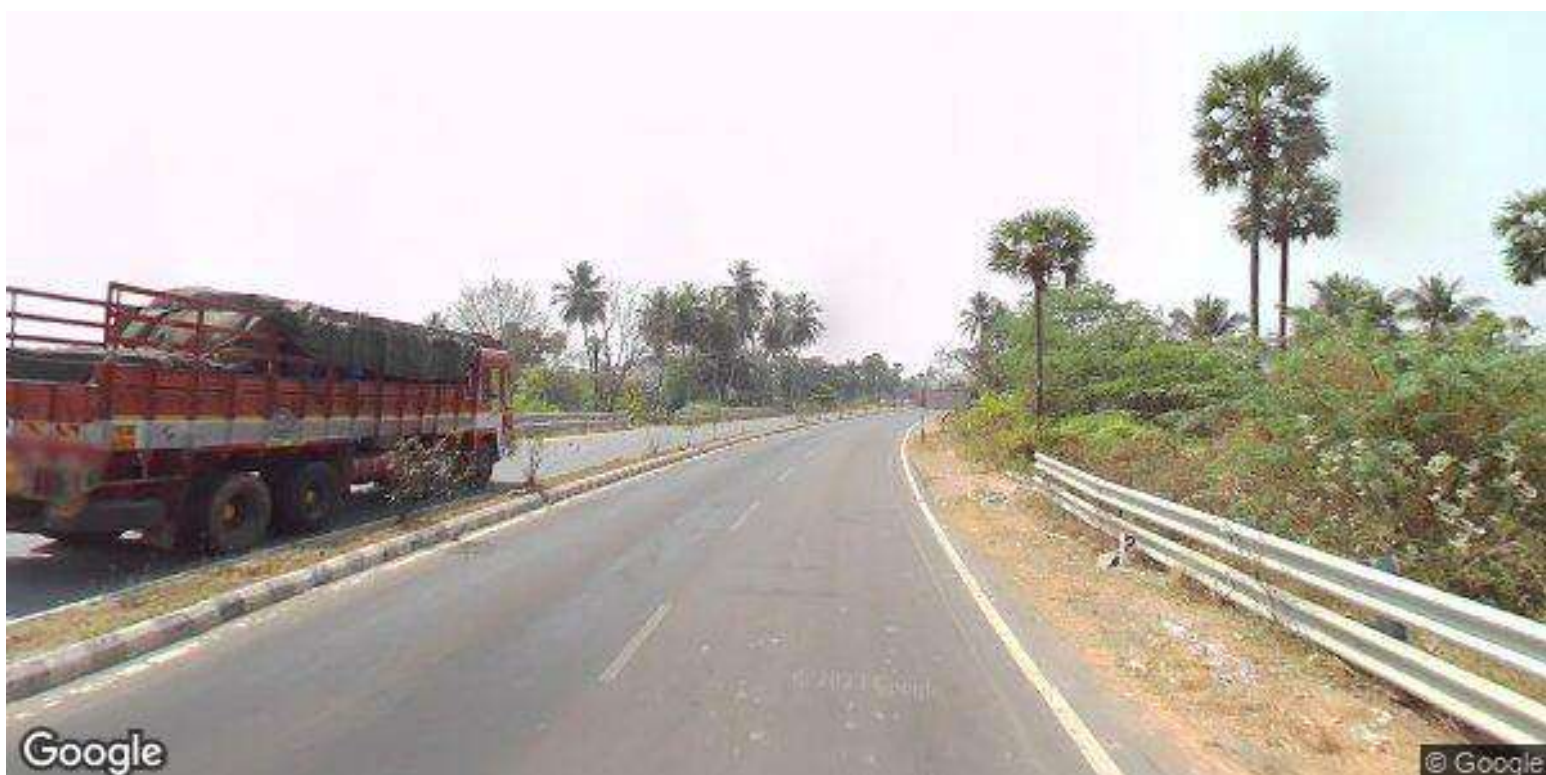
**Coordinates:** 11.70077, 77.97957

**Risk Type:** Turn

**Risk Level:** Medium

**Speed Limit:** 30 KM/Hr

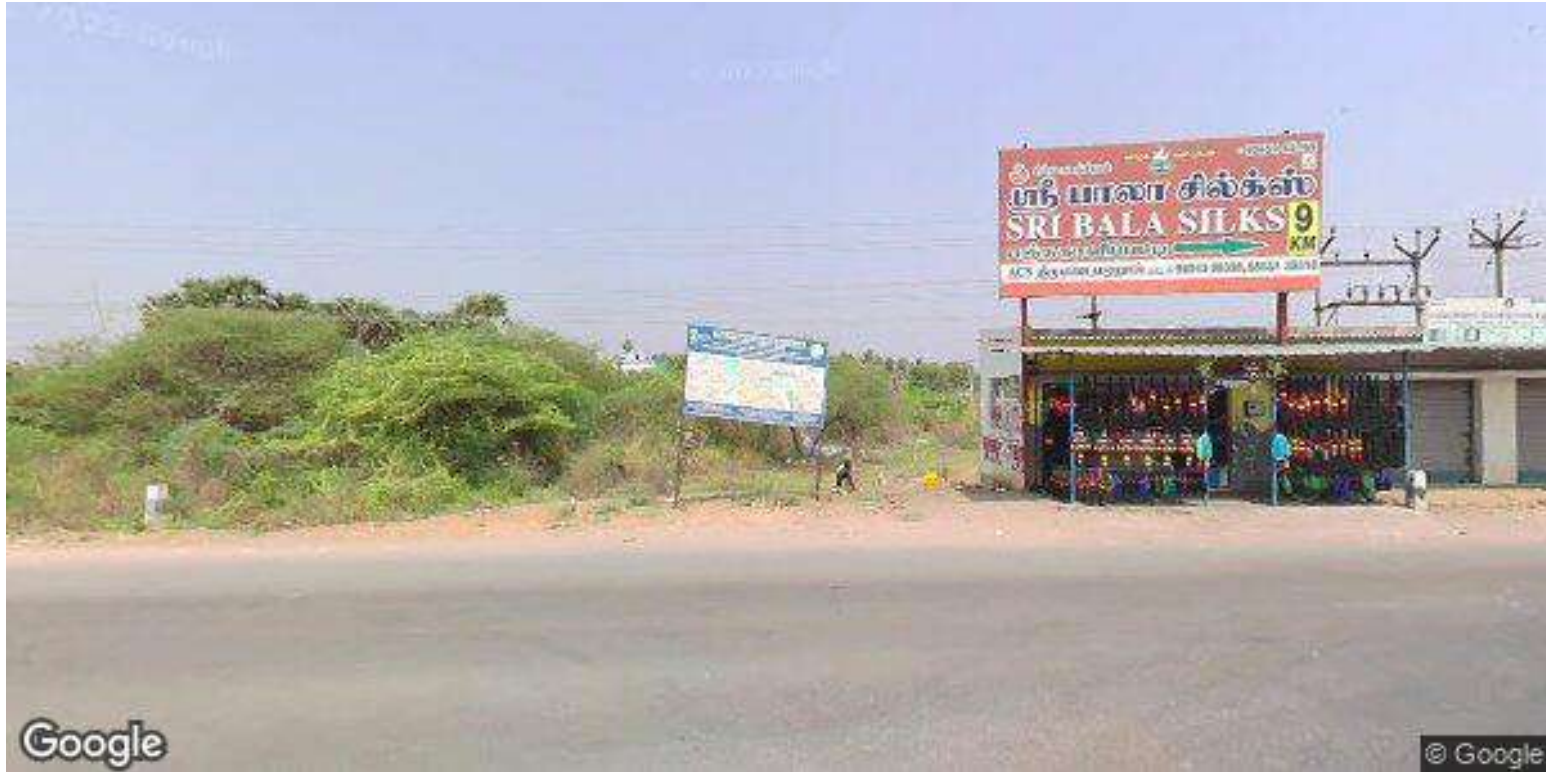
**Coordinates:** 11.70223, 77.97860

**Risk Type:** Turn

**Risk Level:** High

**Speed Limit:** 15 KM/Hr

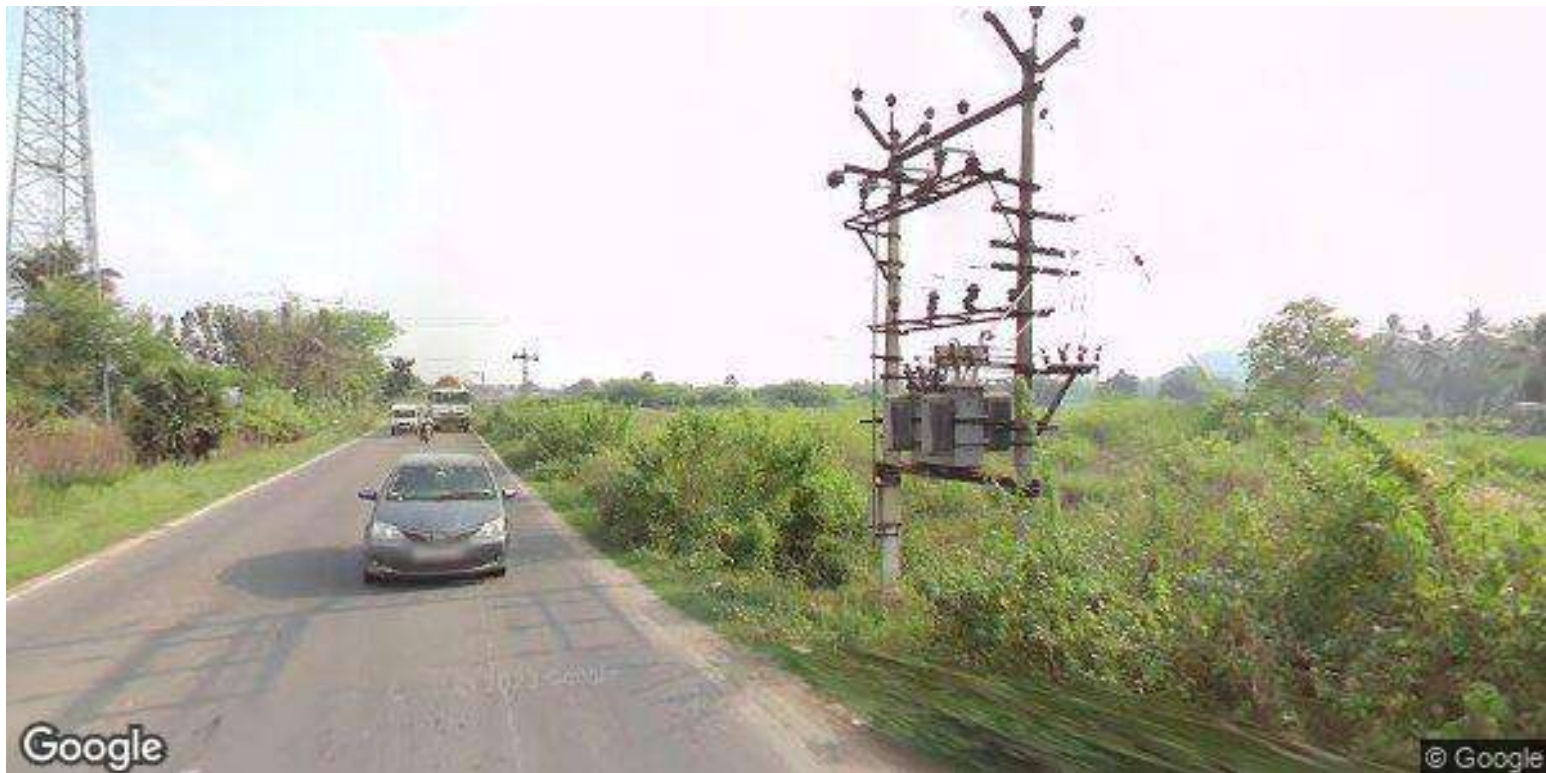
**Coordinates:** 11.71402, 77.99586

**Risk Type:** Turn

**Risk Level:** Medium

**Speed Limit:** 30 KM/Hr

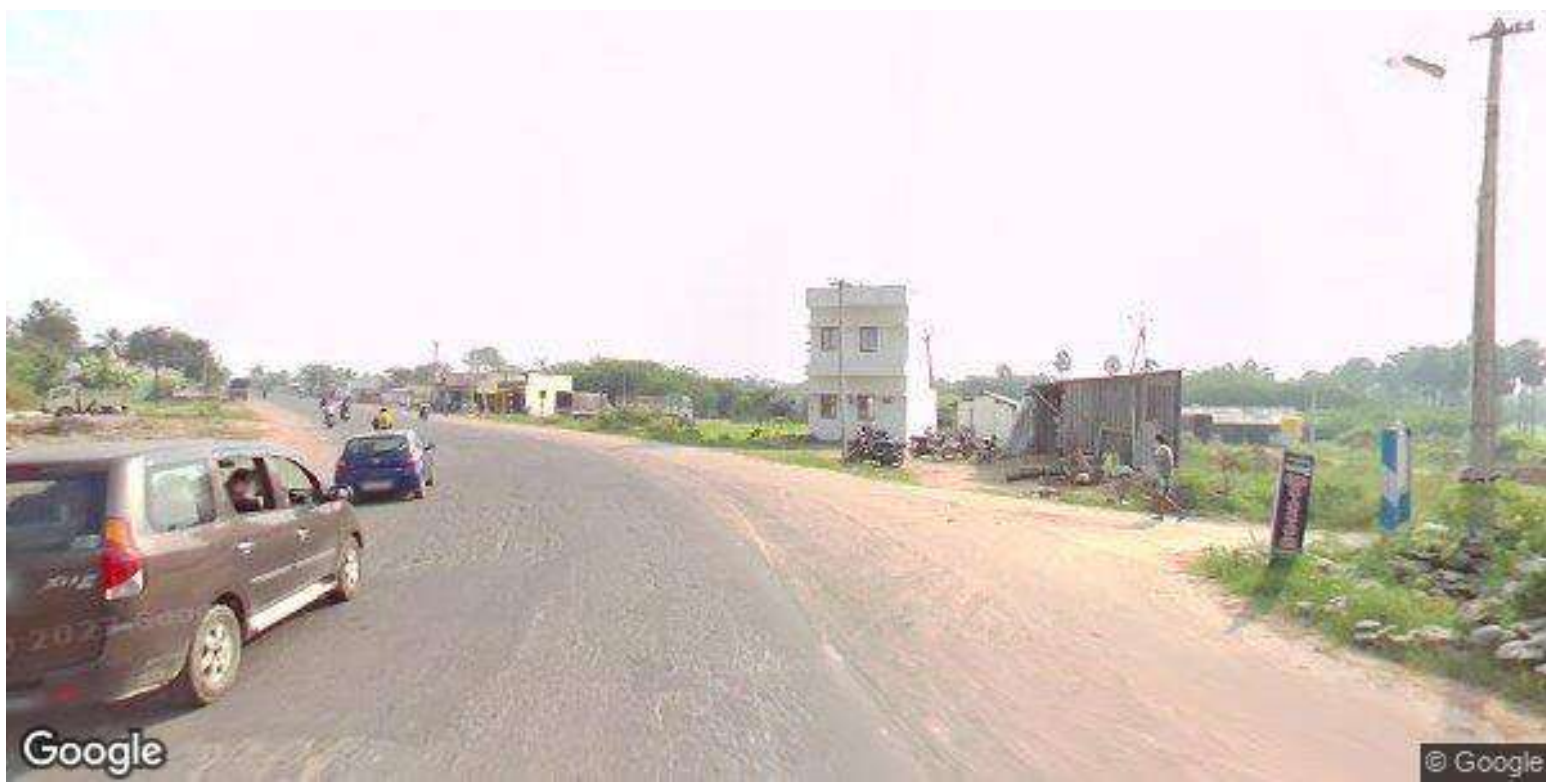
**Coordinates:** 11.71918, 78.01127

**Risk Type:** Turn

**Risk Level:** Medium

**Speed Limit:** 30 KM/Hr

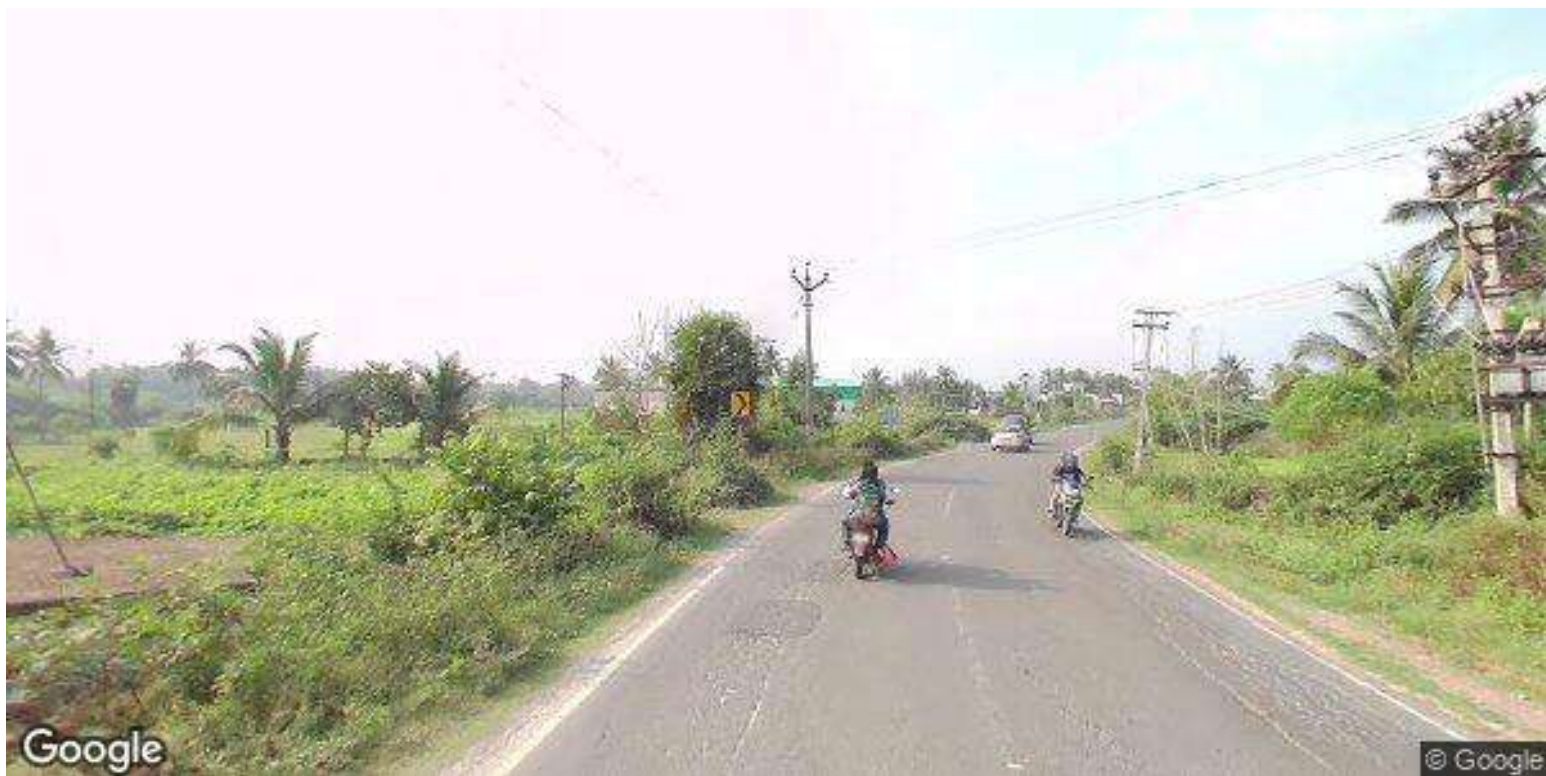
**Coordinates:** 11.72782, 78.02307

**Risk Type:** Turn

**Risk Level:** Medium

**Speed Limit:** 30 KM/Hr

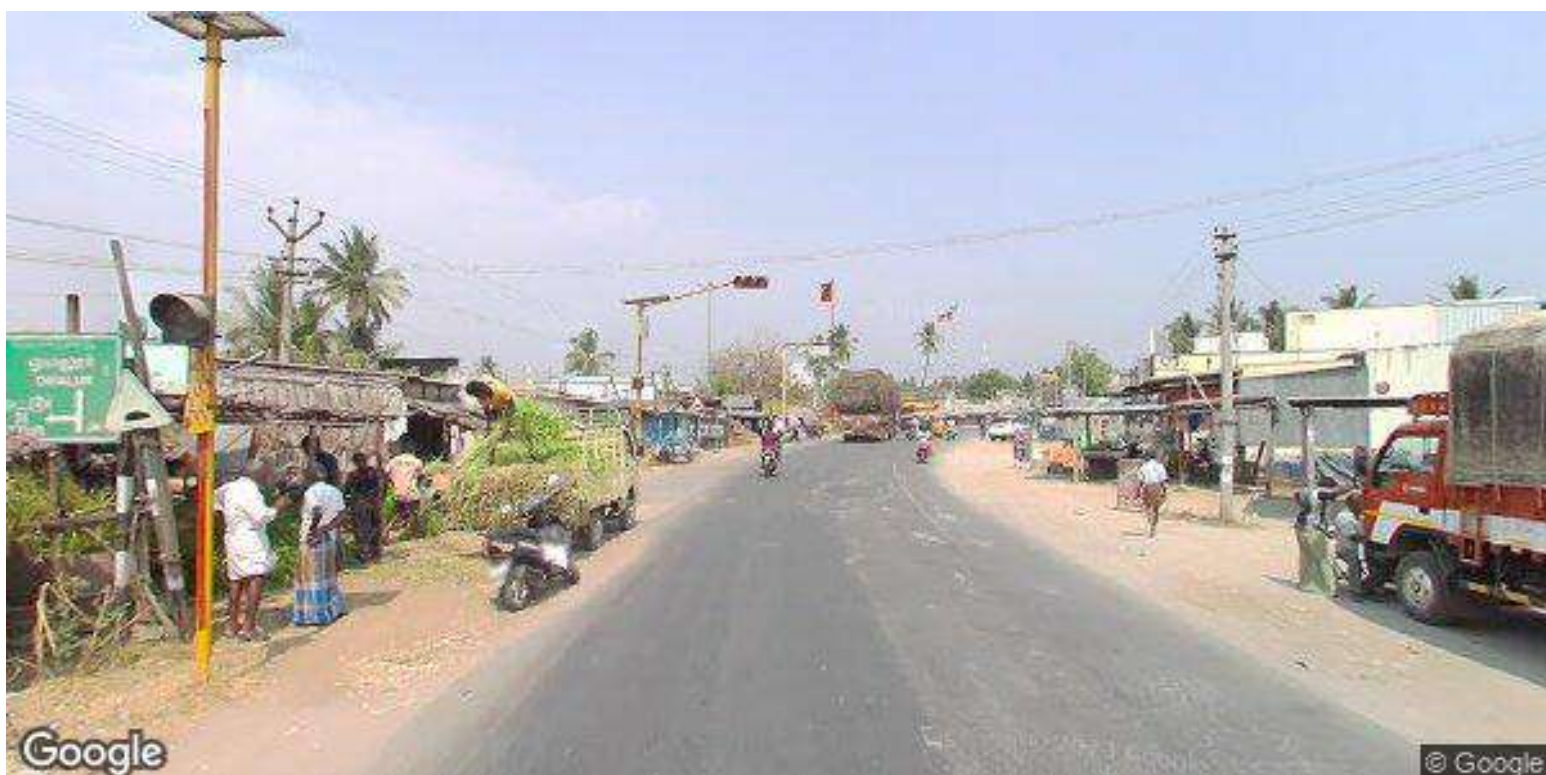
**Coordinates:** 11.73773, 78.03459

**Risk Type:** Turn

**Risk Level:** Medium

**Speed Limit:** 30 KM/Hr

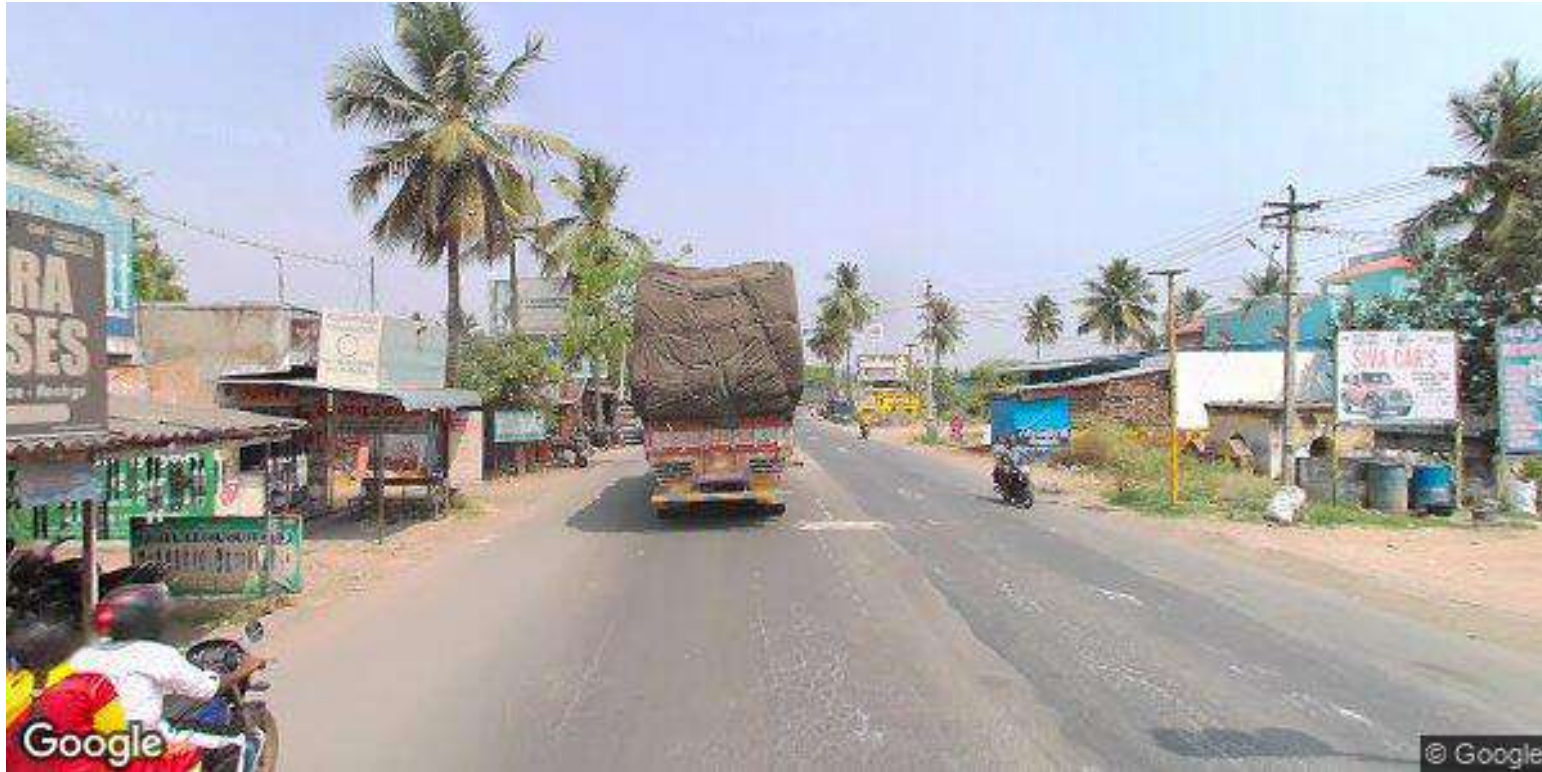
**Coordinates:** 11.73776, 78.03580

**Risk Type:** Turn

**Risk Level:** Medium

**Speed Limit:** 30 KM/Hr

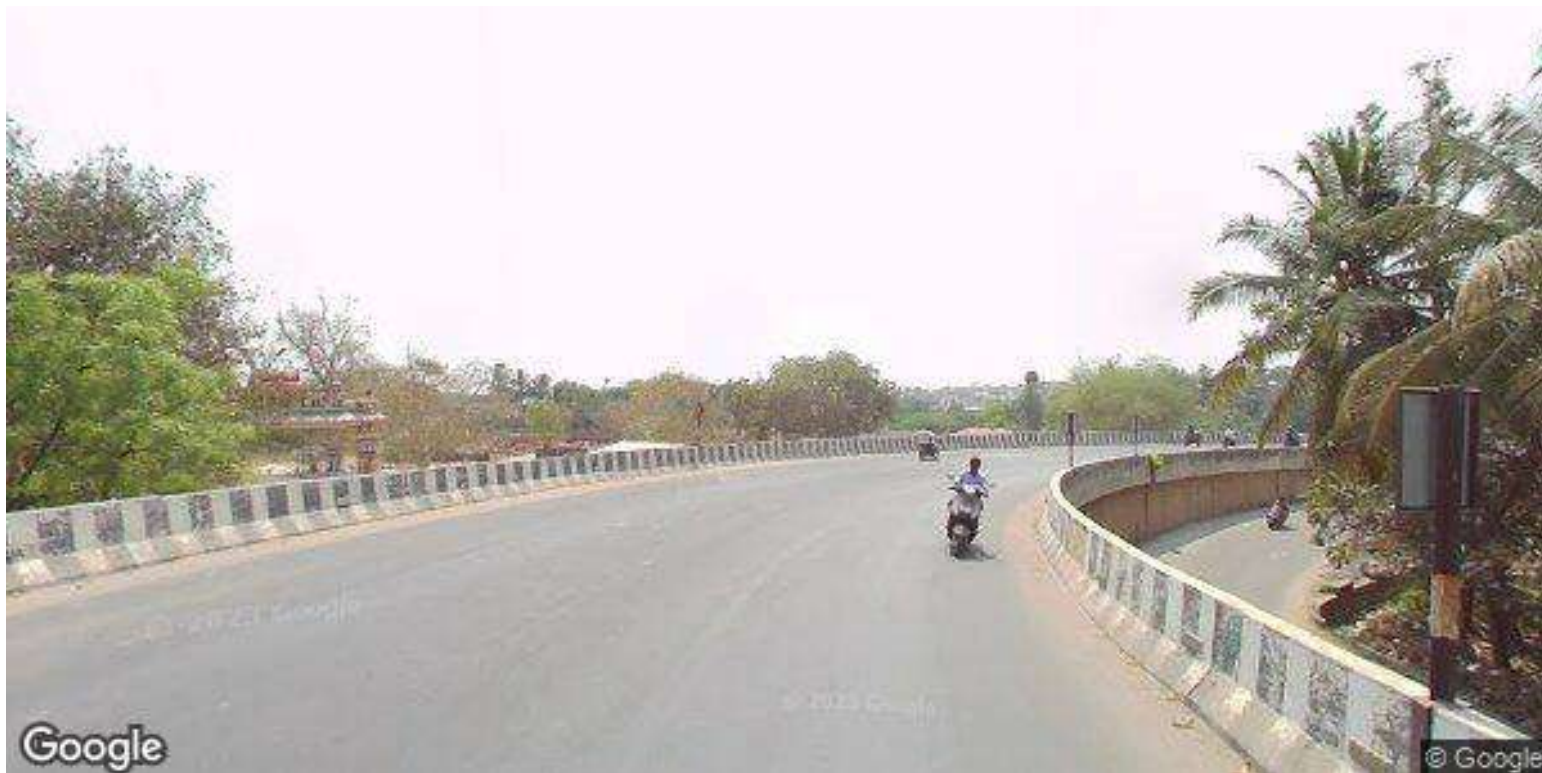
**Coordinates:** 11.73658, 78.03897

**Risk Type:** Turn

**Risk Level:** Medium

**Speed Limit:** 30 KM/Hr

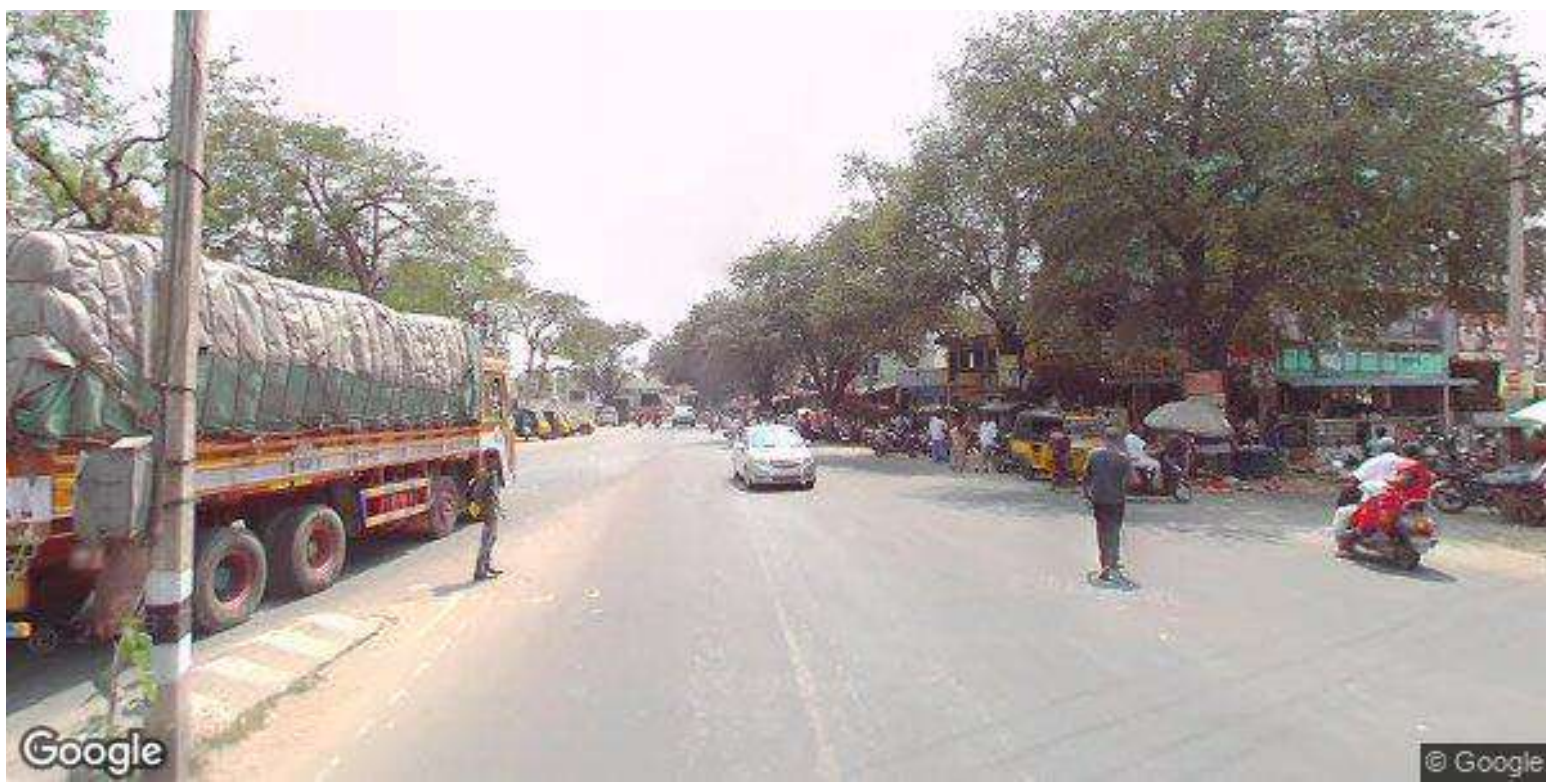
**Coordinates:** 11.74271, 78.04717

**Risk Type:** Turn

**Risk Level:** Medium

**Speed Limit:** 30 KM/Hr

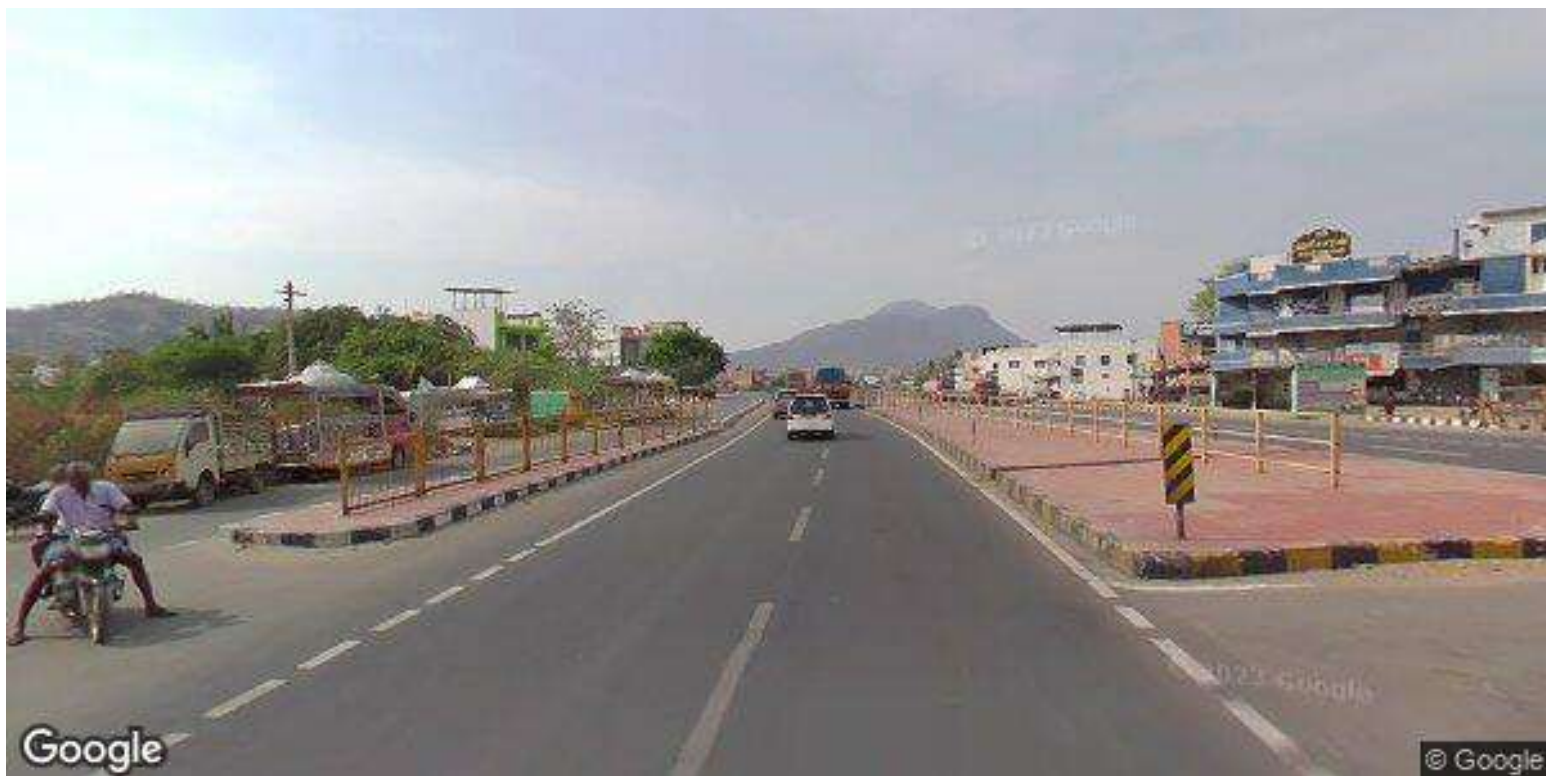
**Coordinates:** 11.87104, 78.08356

**Risk Type:** Blind Spot

**Risk Level:** Blind Spot

**Speed Limit:** 10 KM/Hr

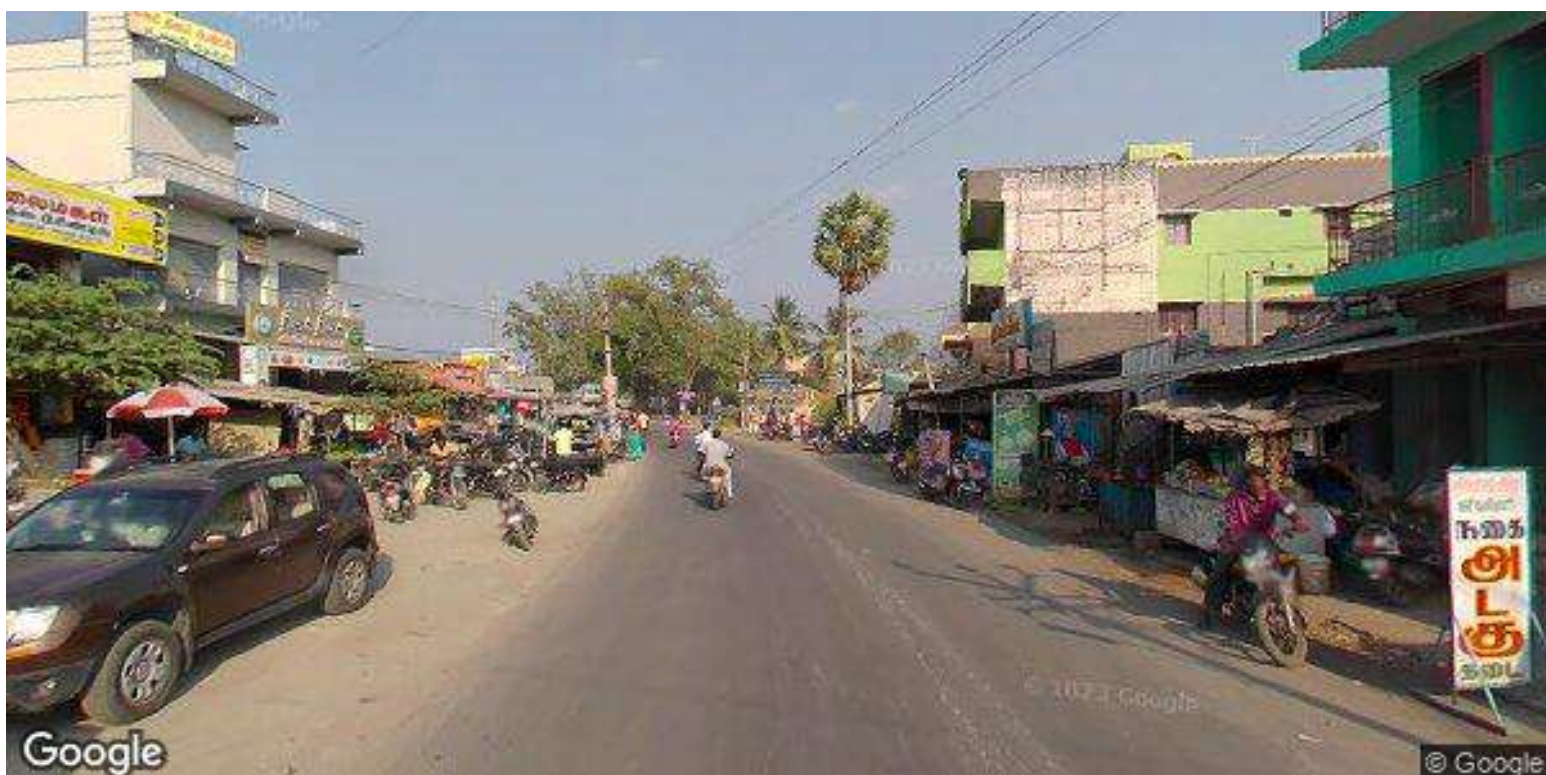
**Risk Type:** Turn  
**Risk Level:** Medium  
**Speed Limit:** 30 KM/Hr  
**Coordinates:** 11.87071, 78.08450

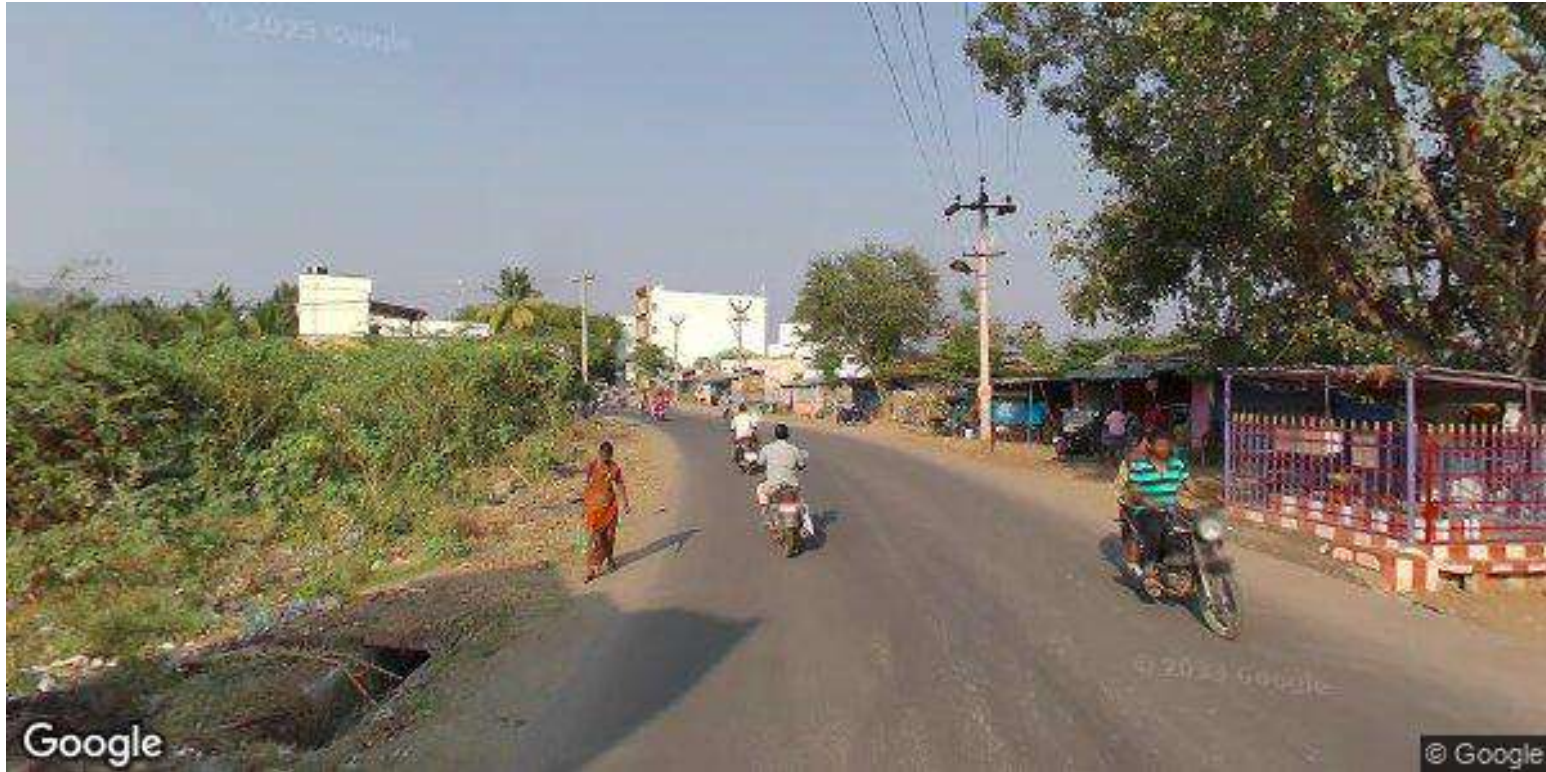
**Risk Type:** Turn  
**Risk Level:** Medium  
**Speed Limit:** 30 KM/Hr  
**Coordinates:** 11.87089, 78.08558

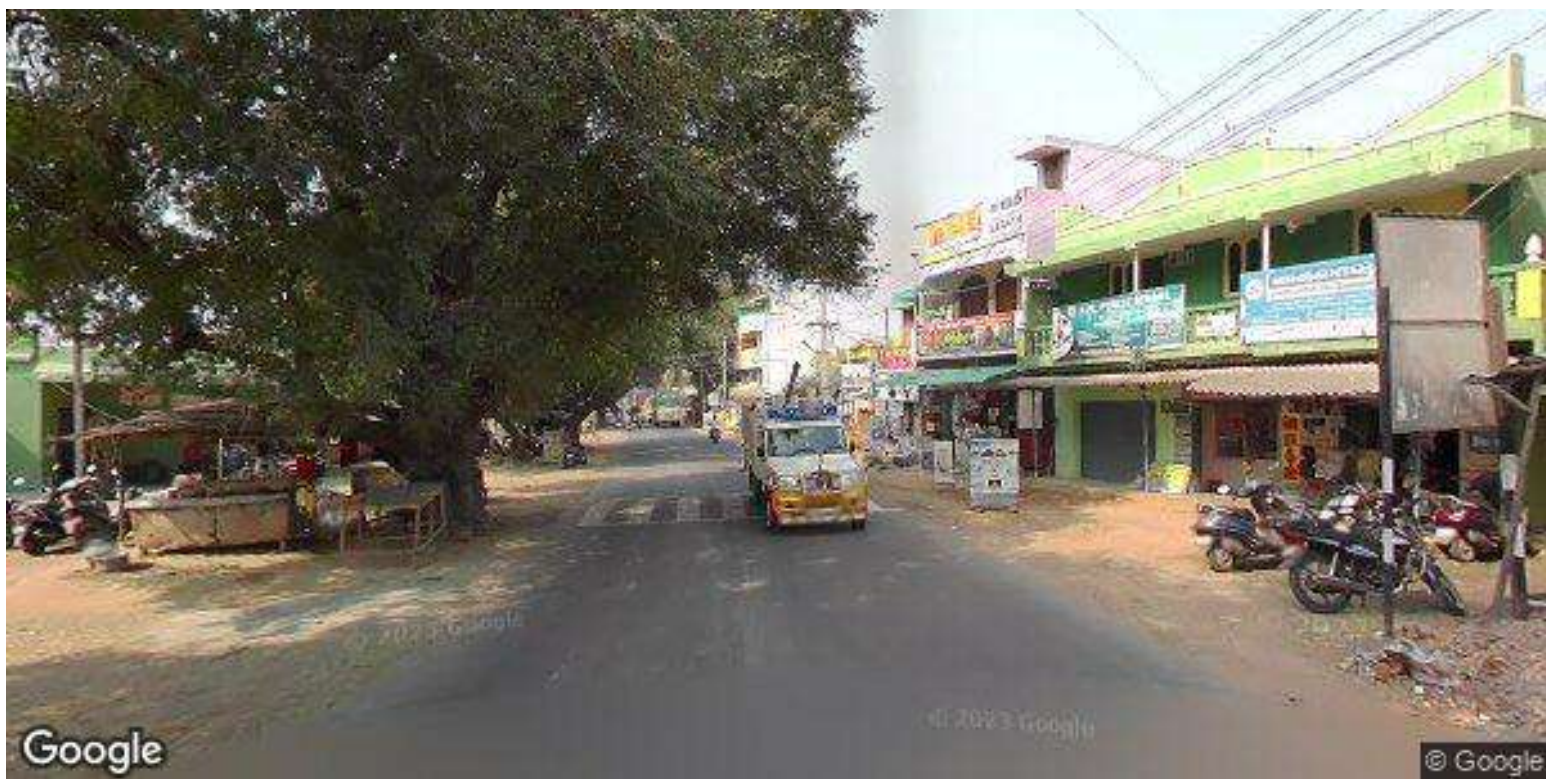
**Risk Type:** Turn  
**Risk Level:** Medium  
**Speed Limit:** 30 KM/Hr  
**Coordinates:** 11.87249, 78.08707
