# IndianOil

## JOURNEY RISK MANAGEMENT (JRM) STUDY

### Salem Terminal TO MURUGAN FUELS

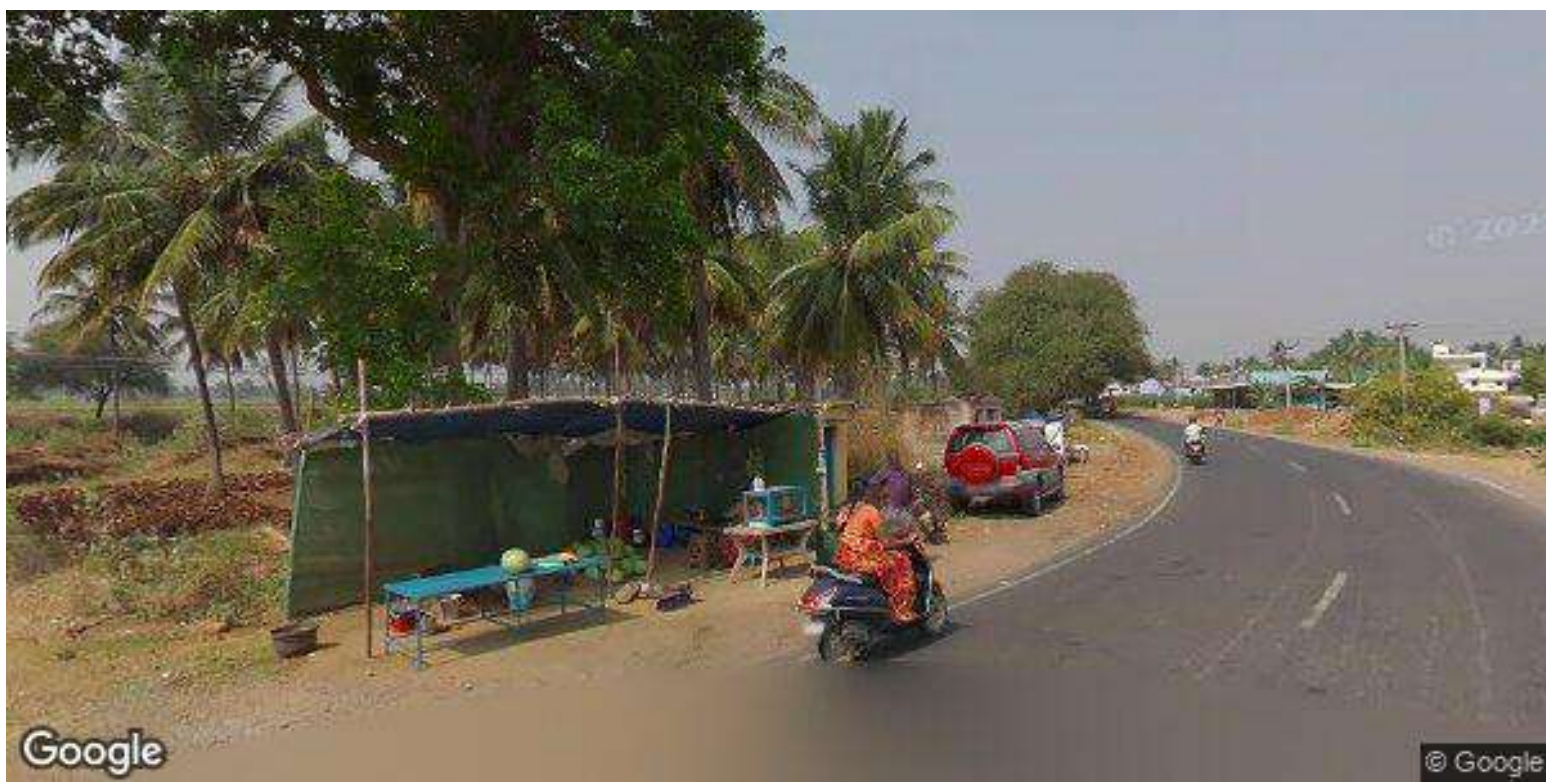
**Coordinates:** 11.86893, 78.12084

**Risk Type:** Turn

**Risk Level:** Medium

**Speed Limit:** 30 KM/Hr

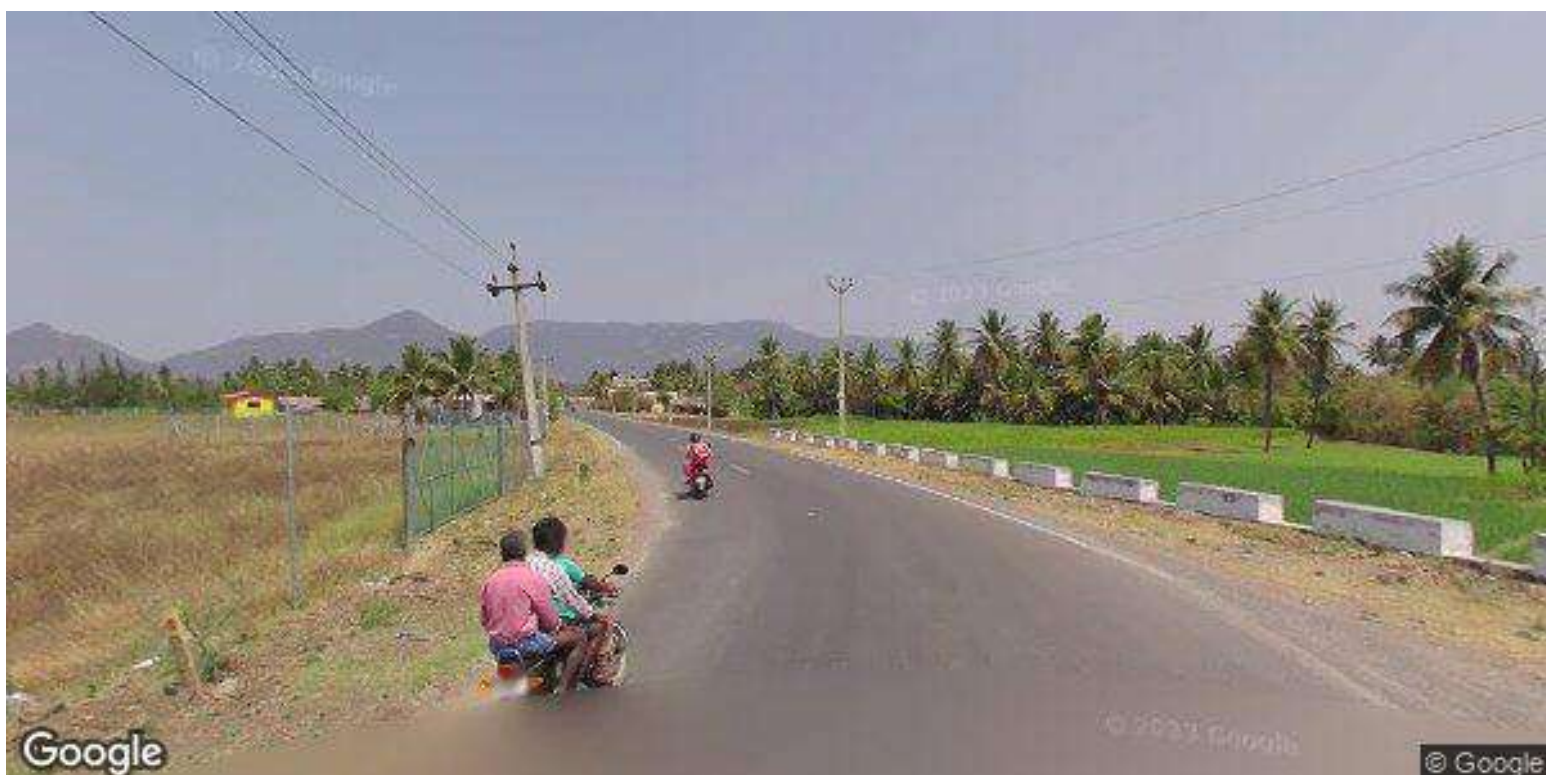
**Risk Type:** Turn  
**Risk Level:** High  
**Speed Limit:** 15 KM/Hr  
**Coordinates:** 11.97329, 78.23713

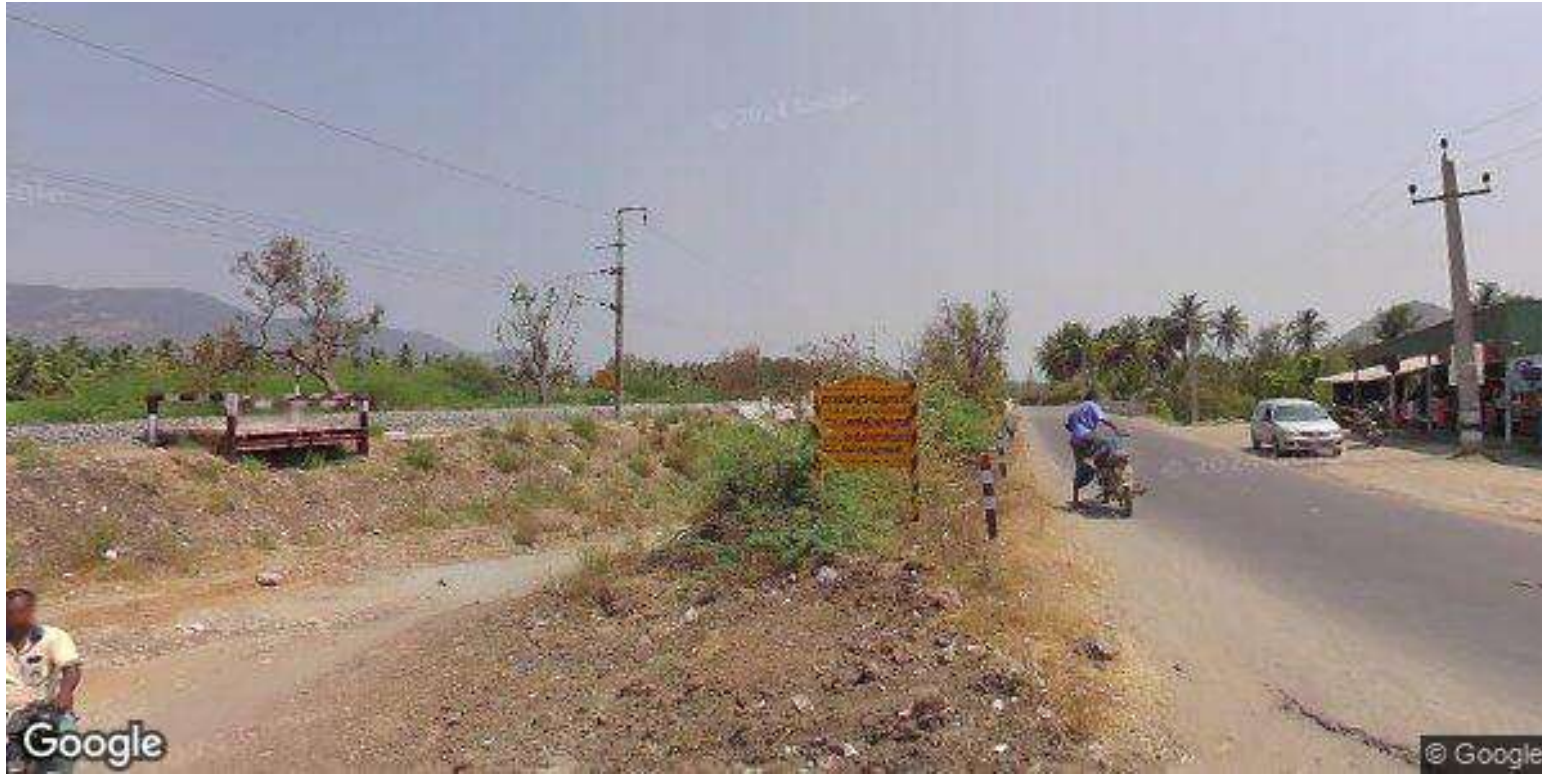
**Risk Type:** Turn  
**Risk Level:** High  
**Speed Limit:** 15 KM/Hr  
**Coordinates:** 11.97765, 78.23556

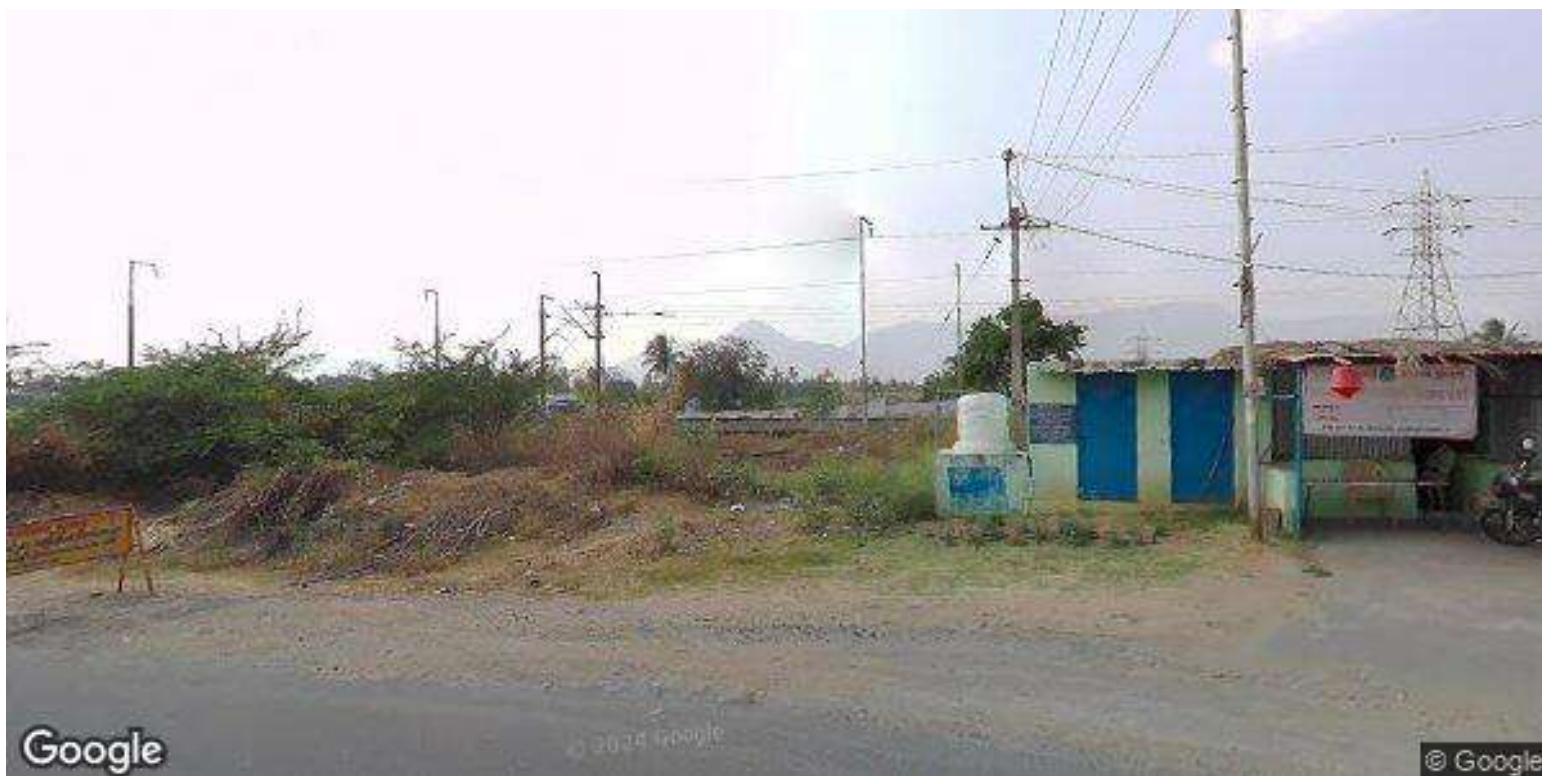
**Risk Type:** Turn  
**Risk Level:** High  
**Speed Limit:** 15 KM/Hr  
**Coordinates:** 11.98242, 78.24309

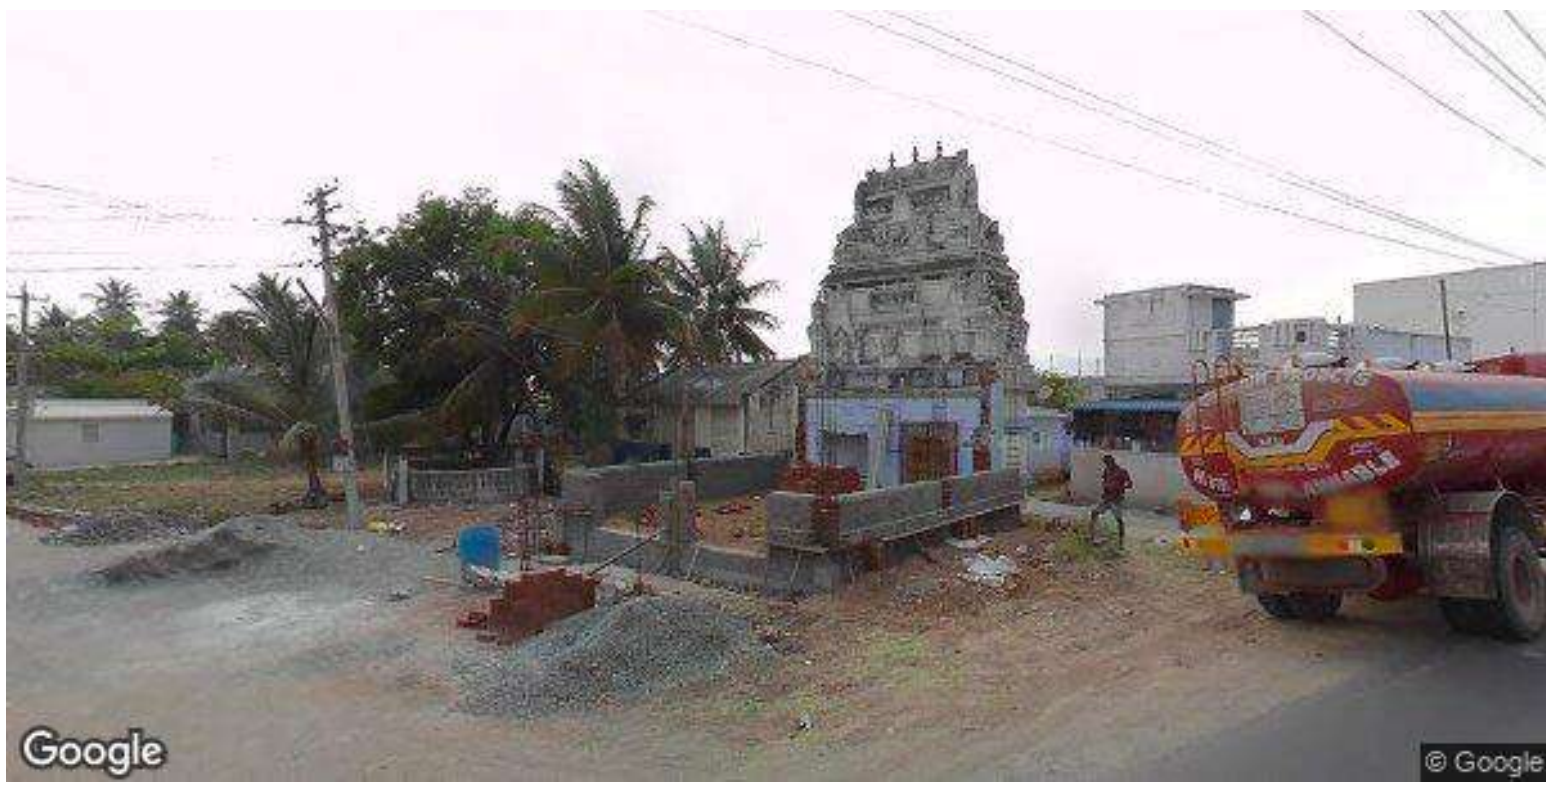
**Coordinates:** 11.98205, 78.24333

**Risk Type:** Turn

**Risk Level:** High

**Speed Limit:** 15 KM/Hr

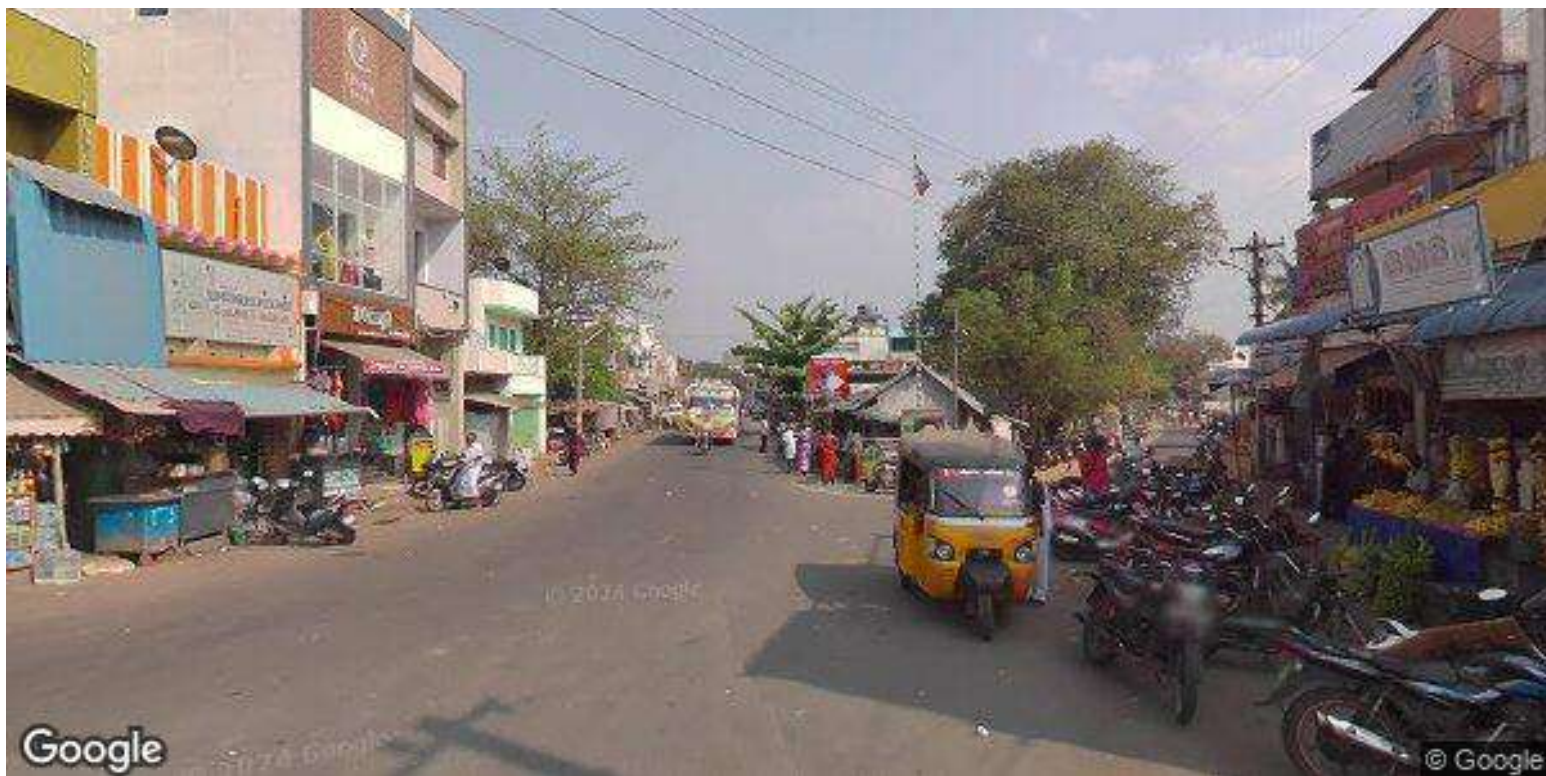
**Coordinates:** 11.98346, 78.24637

**Risk Type:** Turn

**Risk Level:** High

**Speed Limit:** 15 KM/Hr

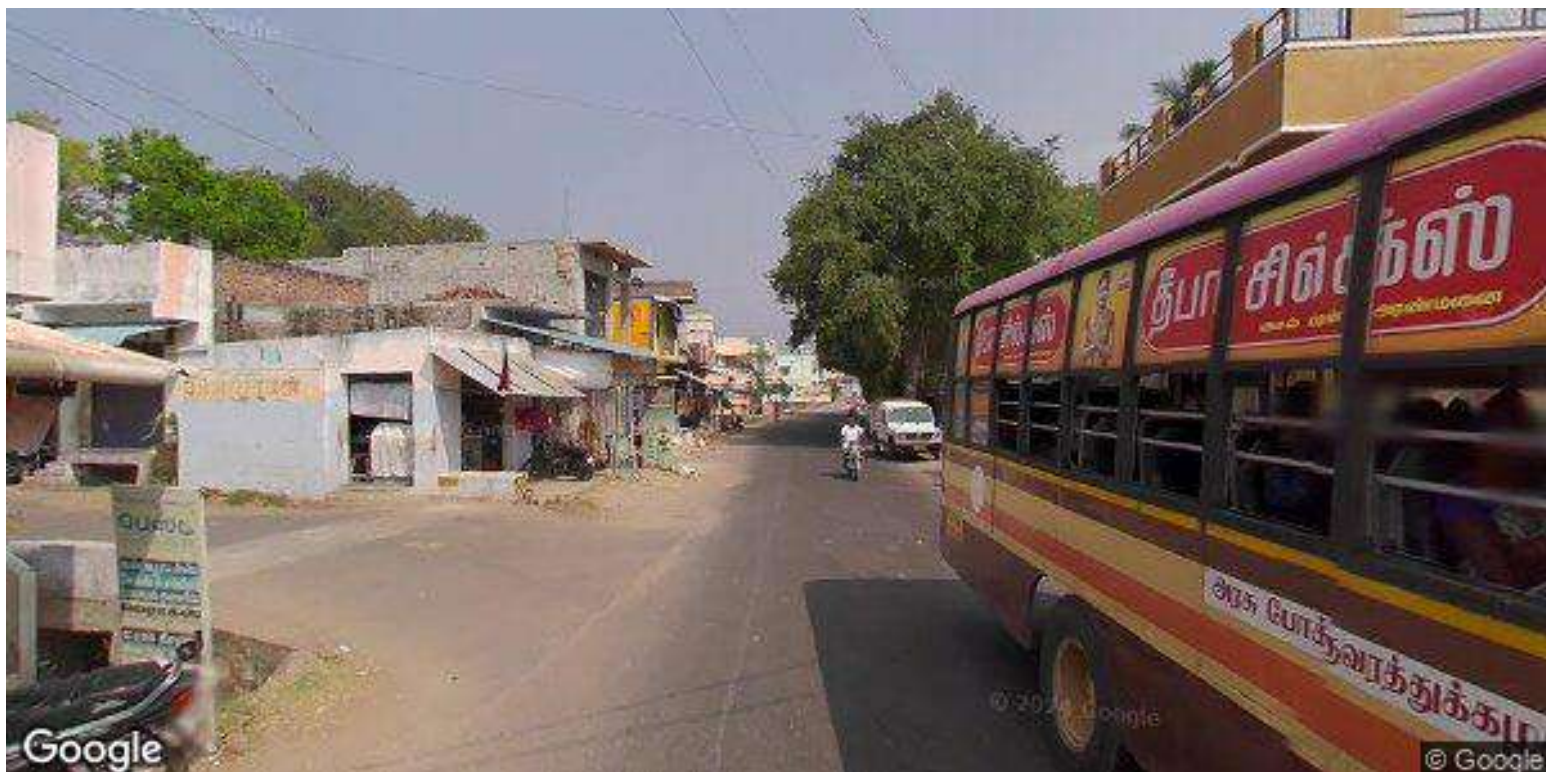
**Coordinates:** 11.96949, 78.26940

**Risk Type:** Turn

**Risk Level:** High

**Speed Limit:** 15 KM/Hr
