# IndianOil

## JOURNEY RISK MANAGEMENT (JRM) STUDY

### Salem Terminal to SRI VK TRADER

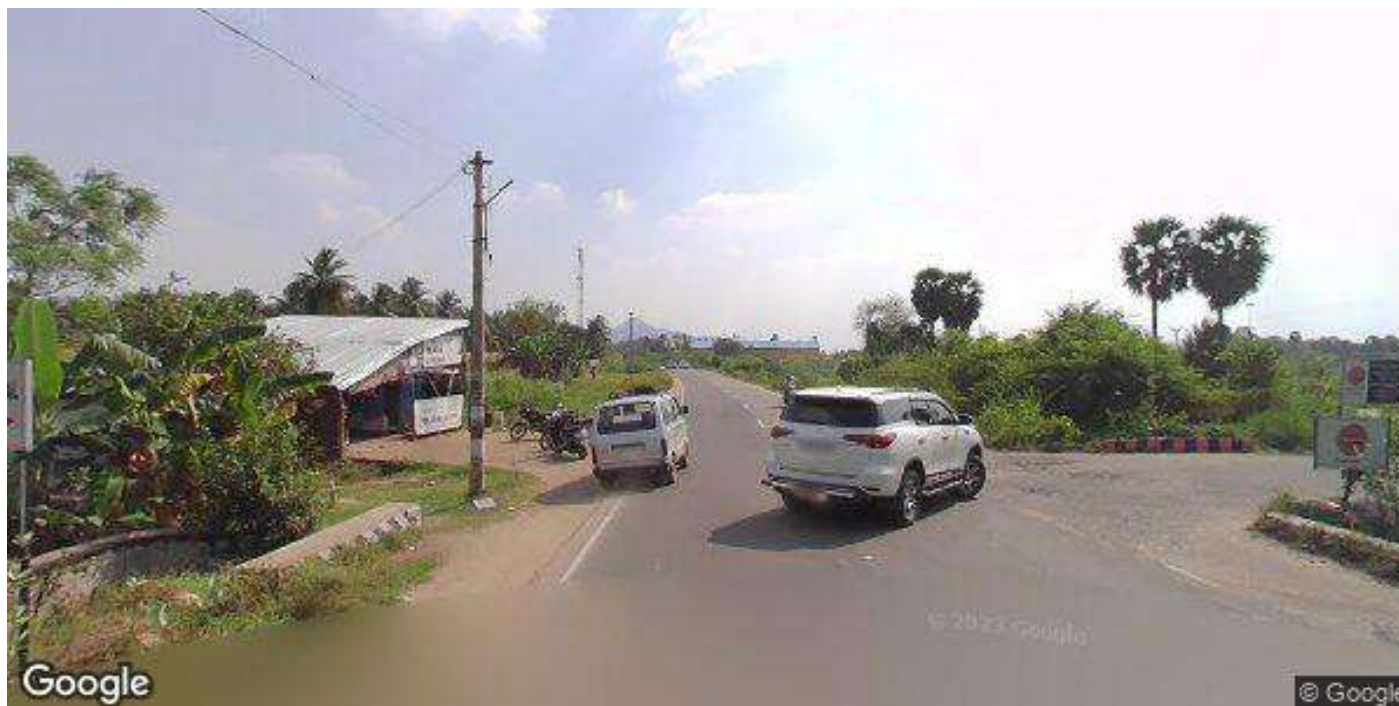
**Risk Type:** Turn  
**Risk Level:** High  
**Speed Limit:** 15 KM/Hr  
**Coordinates:** 11.44029, 77.87544

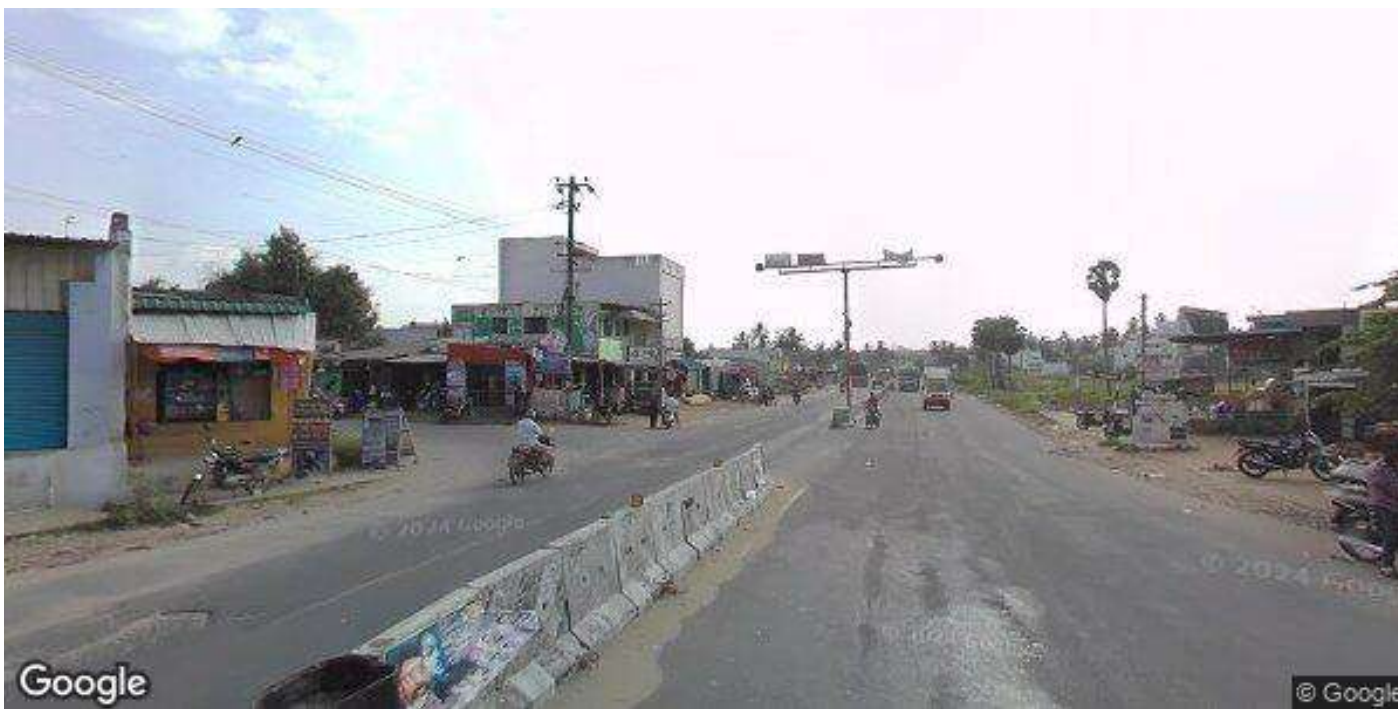
**Risk Type:** Blind Spot  
**Risk Level:** Blind Spot  
**Speed Limit:** 10 KM/Hr  
**Coordinates:** 11.48364, 77.88780

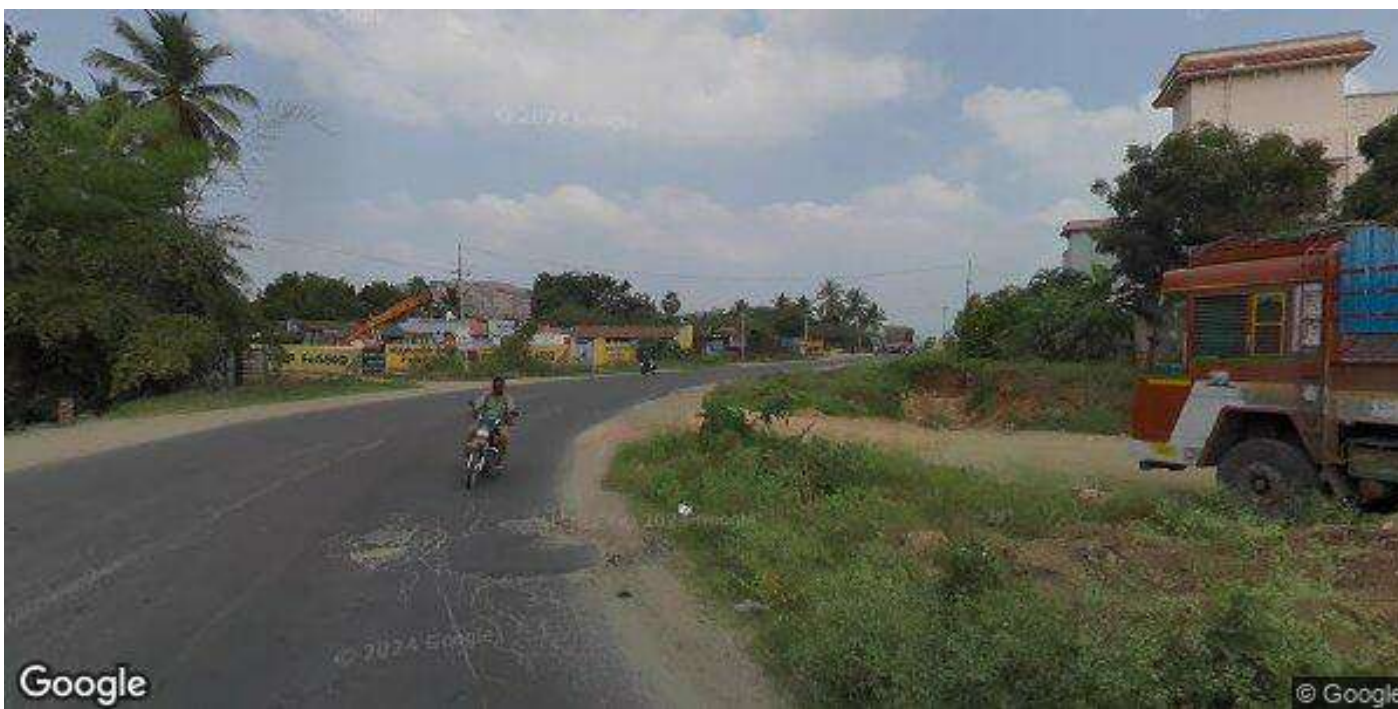
**Risk Type:** Turn  
**Risk Level:** Medium  
**Speed Limit:** 30 KM/Hr  
**Coordinates:** 11.49441, 77.88495

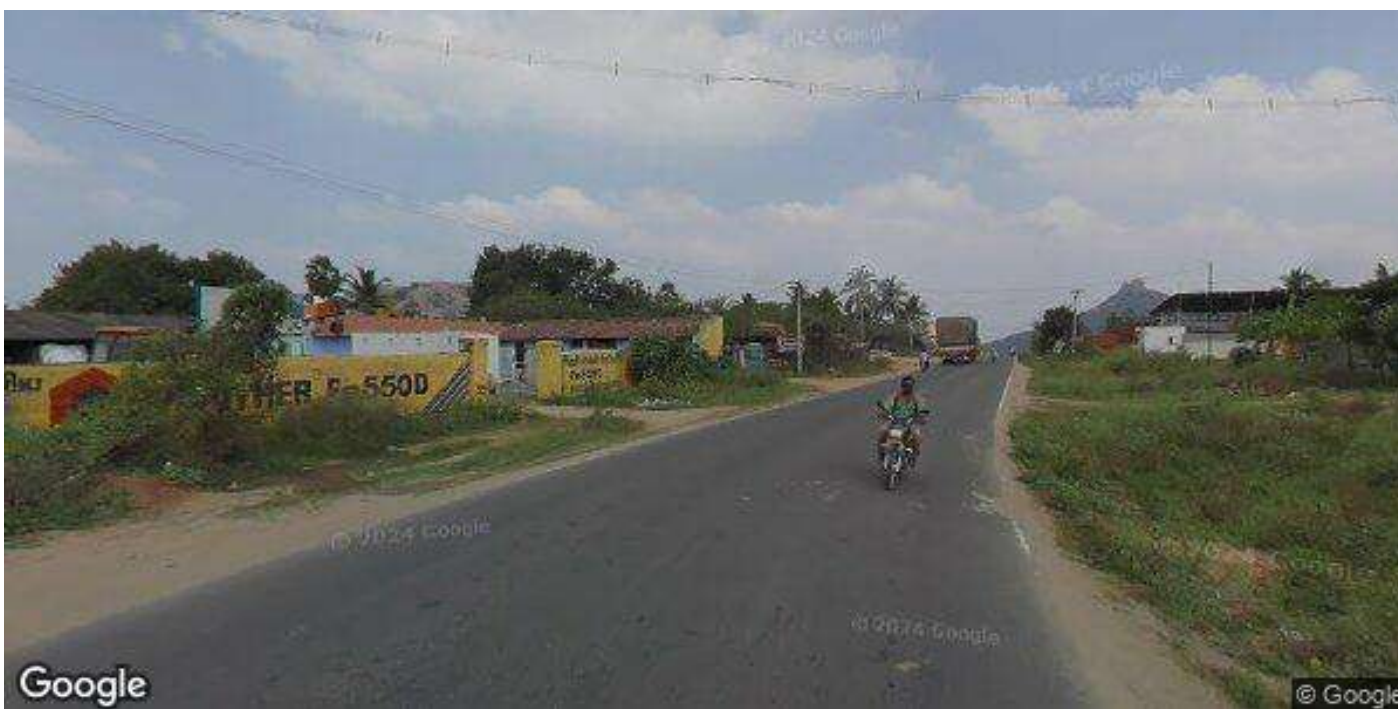
**Risk Type:** Turn  
**Risk Level:** Medium  
**Speed Limit:** 30 KM/Hr  
**Coordinates:** 11.49469, 77.88488

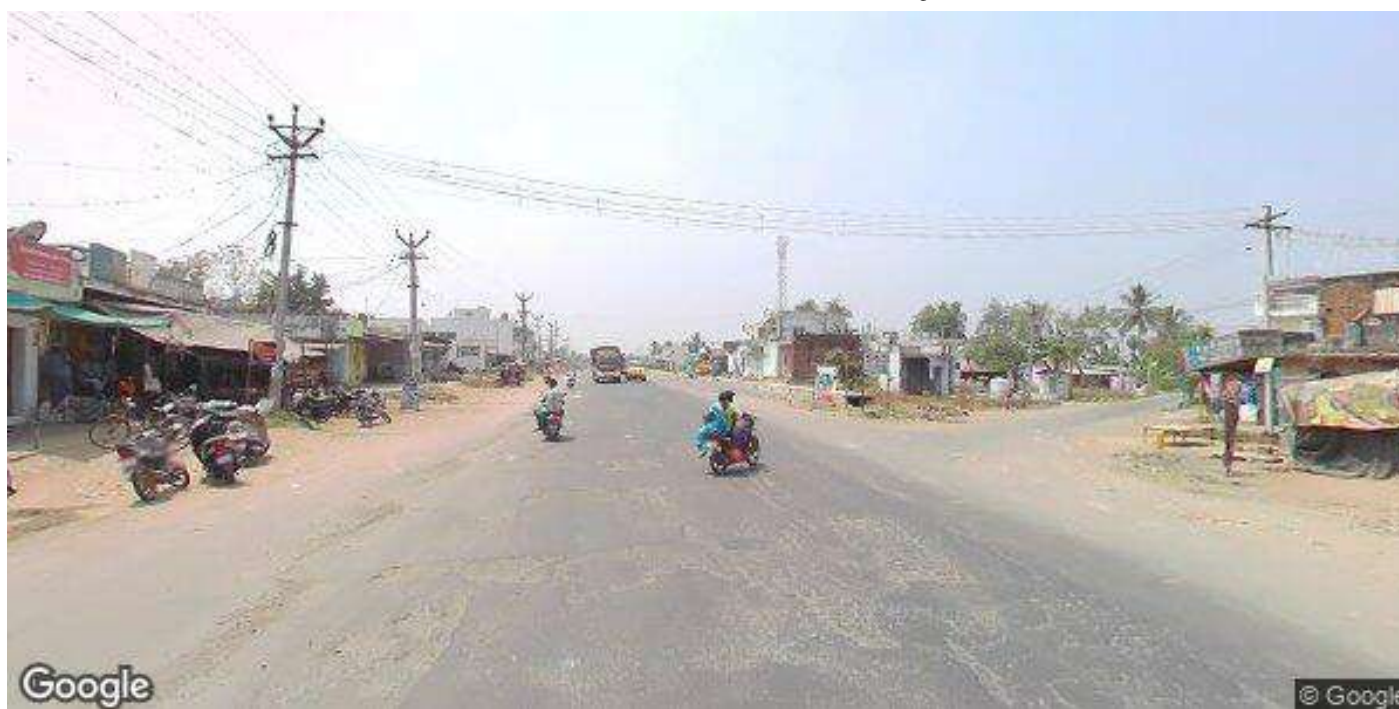
**Risk Type:** Turn  
**Risk Level:** High  
**Speed Limit:** 15 KM/Hr  
**Coordinates:** 11.66252, 77.96048

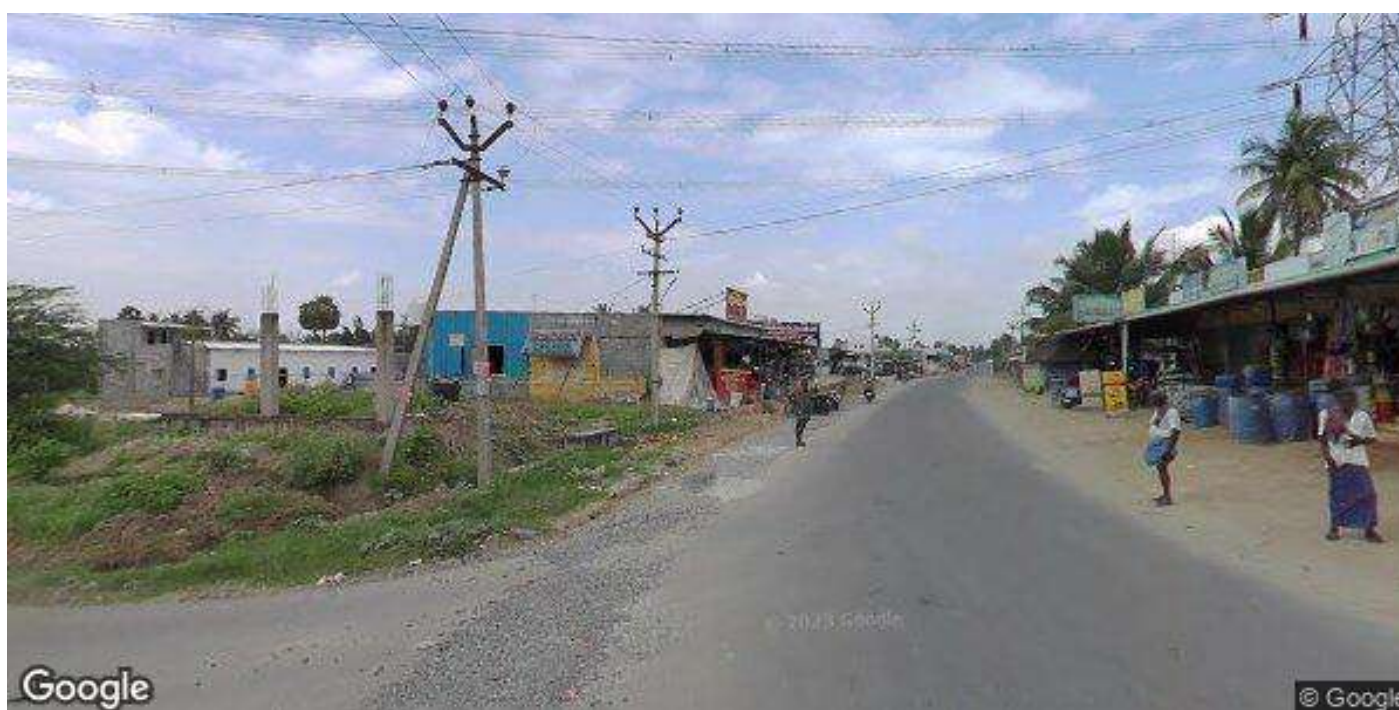
**Risk Type:** Turn  
**Risk Level:** High  
**Speed Limit:** 15 KM/Hr  
**Coordinates:** 11.66821, 78.00077

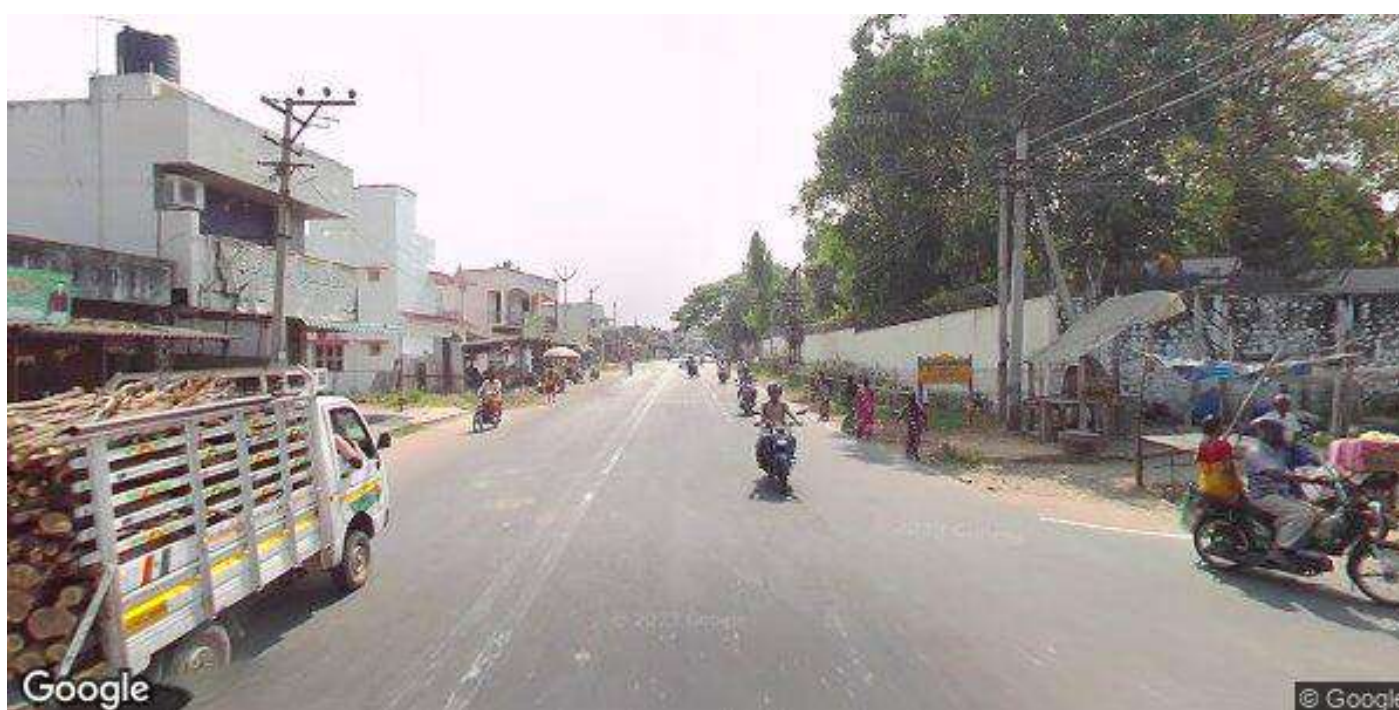
**Risk Type:** Blind Spot  
**Risk Level:** Blind Spot  
**Speed Limit:** 10 KM/Hr  
**Coordinates:** 11.67303, 78.00187

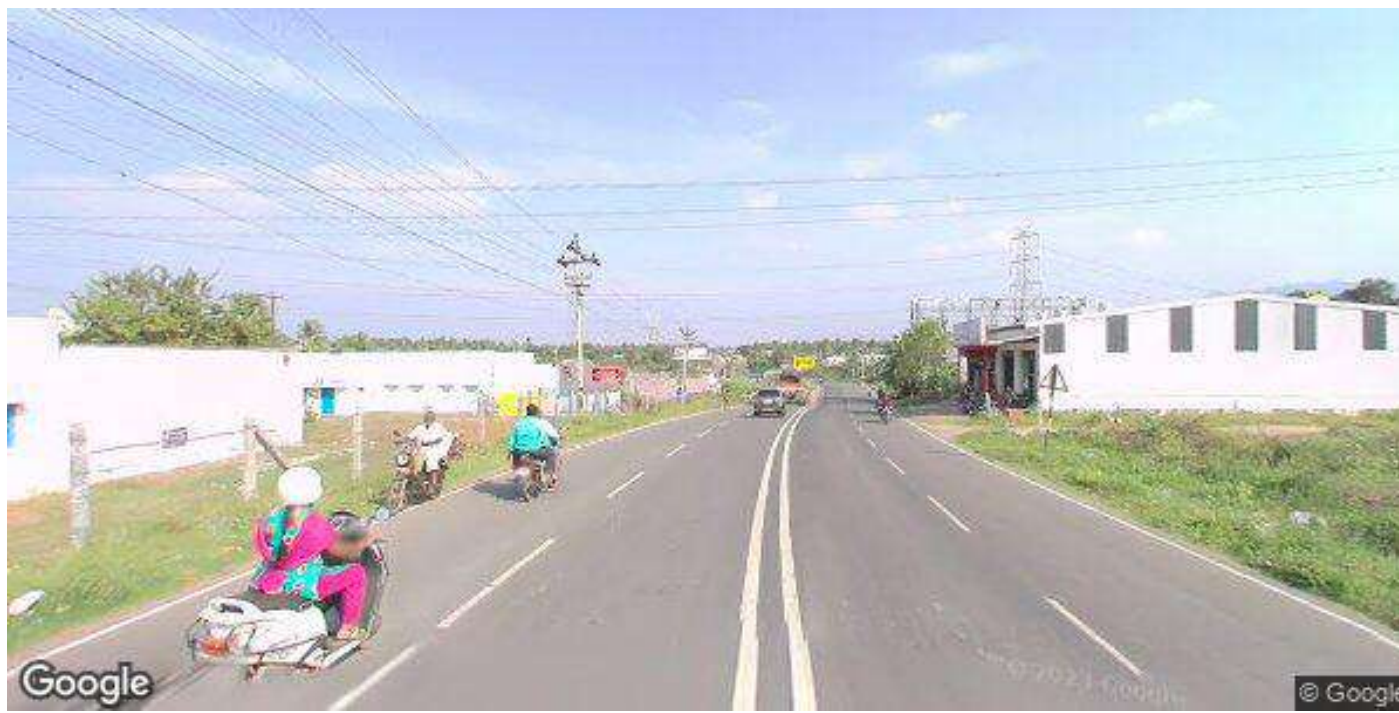
**Risk Type:** Blind Spot  
**Risk Level:** Blind Spot  
**Speed Limit:** 10 KM/Hr  
**Coordinates:** 11.67370, 77.99409

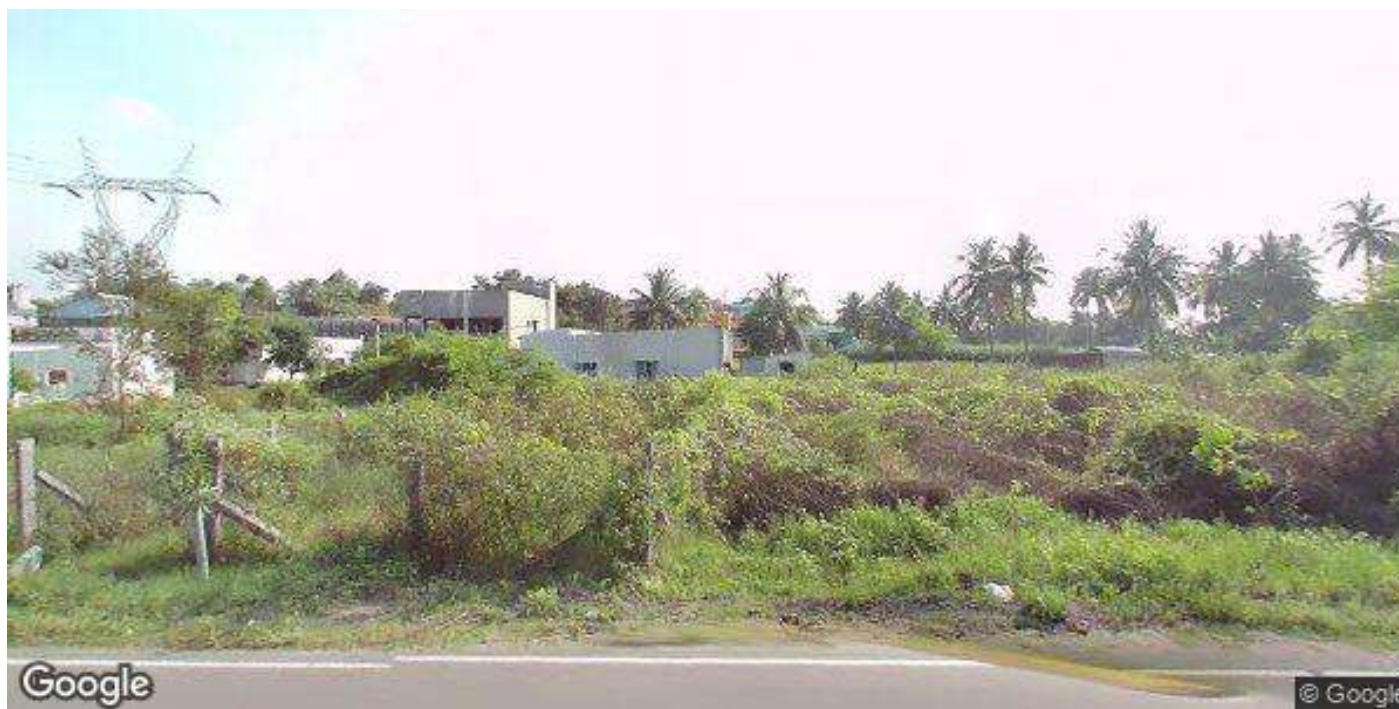
**Risk Type:** Turn  
**Risk Level:** High  
**Speed Limit:** 15 KM/Hr  
**Coordinates:** 11.67340, 77.99404

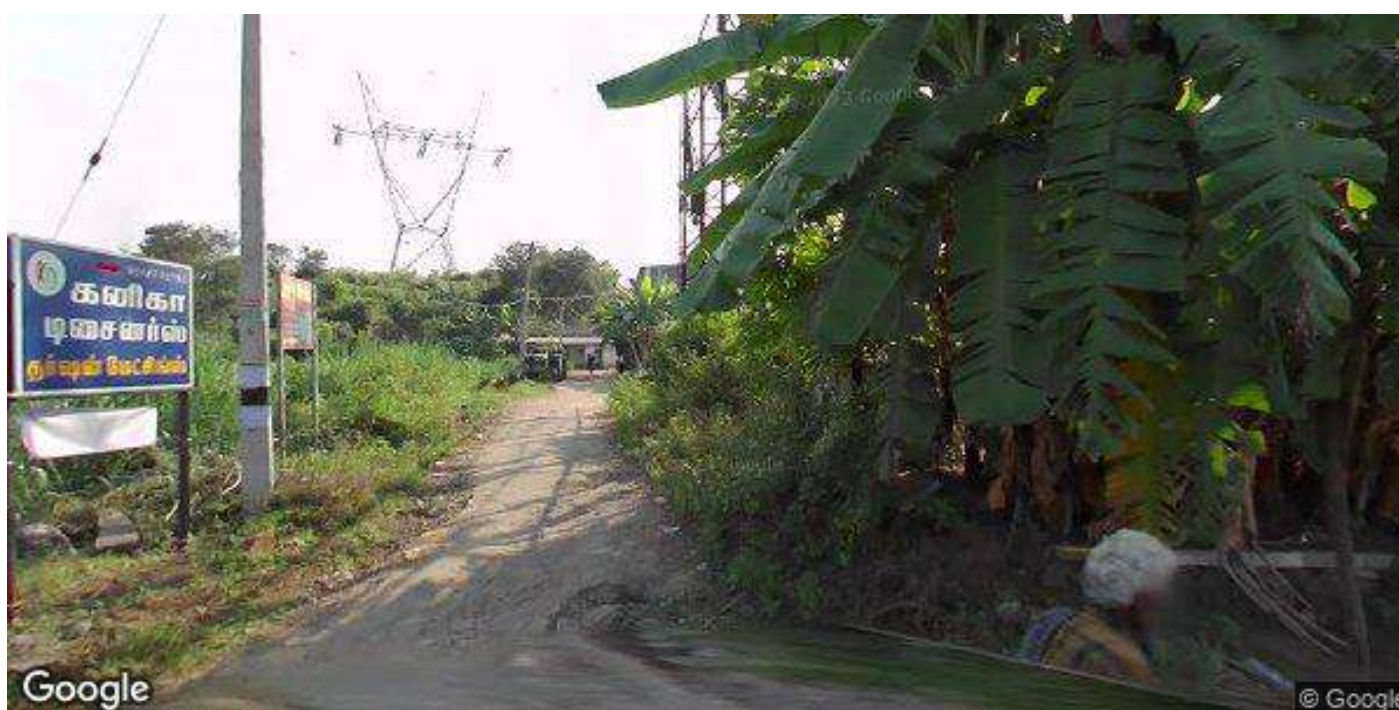
**Risk Type:** Turn  
**Risk Level:** High  
**Speed Limit:** 15 KM/Hr  
**Coordinates:** 11.67327, 77.99475

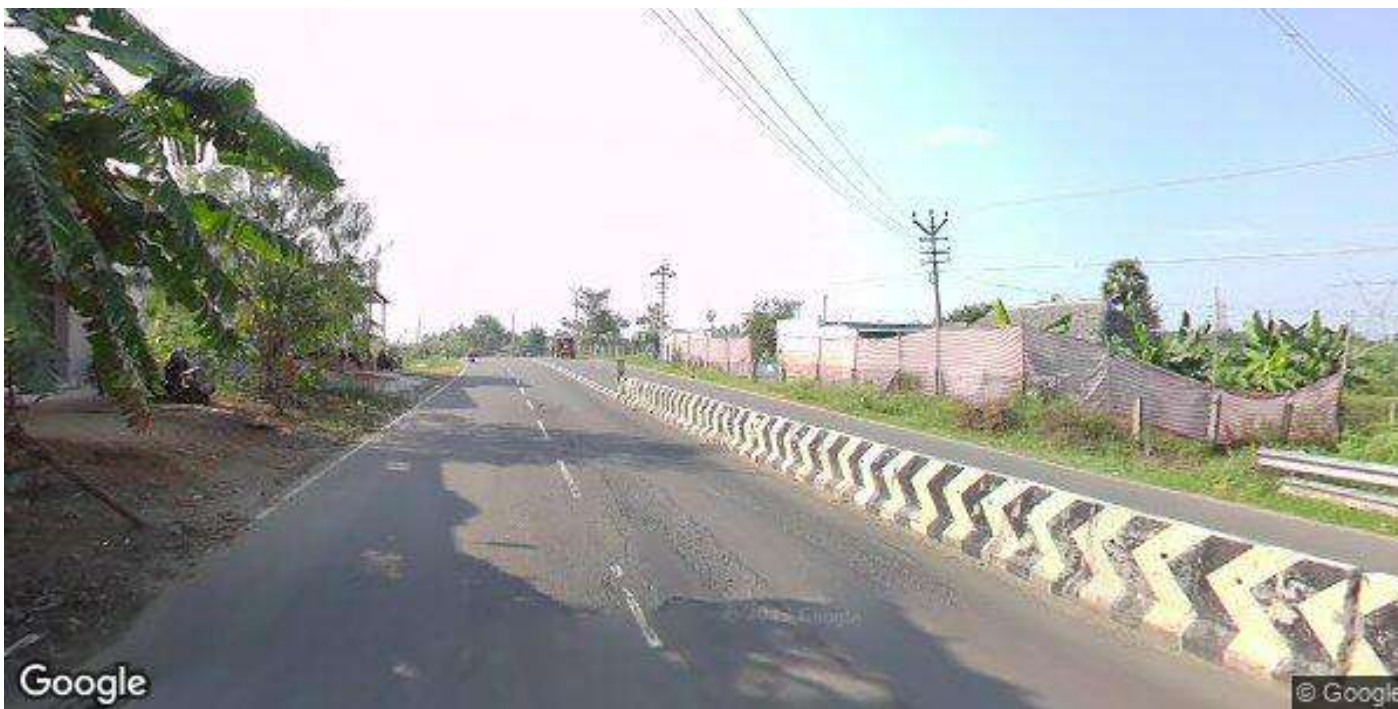
**Risk Type:** Turn  
**Risk Level:** High  
**Speed Limit:** 15 KM/Hr  
**Coordinates:** 11.67356, 77.99482

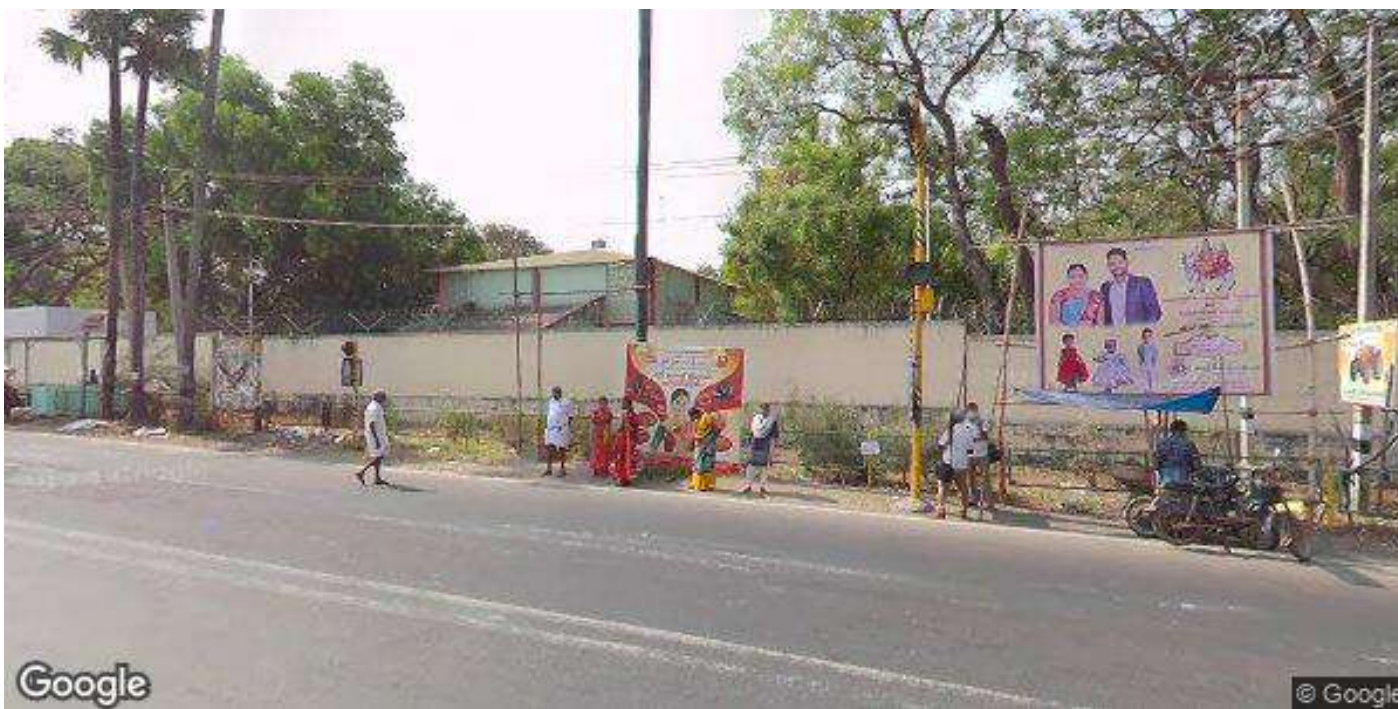
**Risk Type:** Turn  
**Risk Level:** High  
**Speed Limit:** 15 KM/Hr  
**Coordinates:** 11.67276, 78.00377

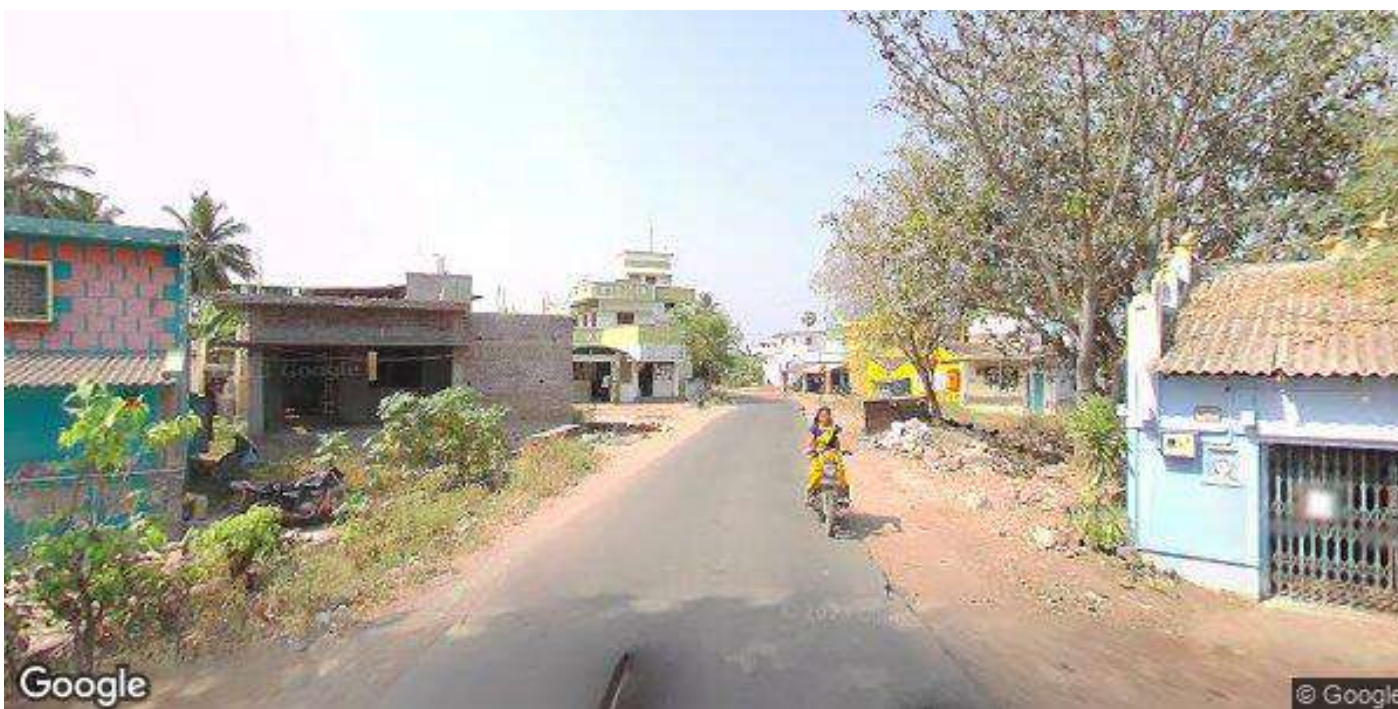
**Risk Type:** Turn  
**Risk Level:** Medium  
**Speed Limit:** 30 KM/Hr  
**Coordinates:** 11.68005, 78.00701

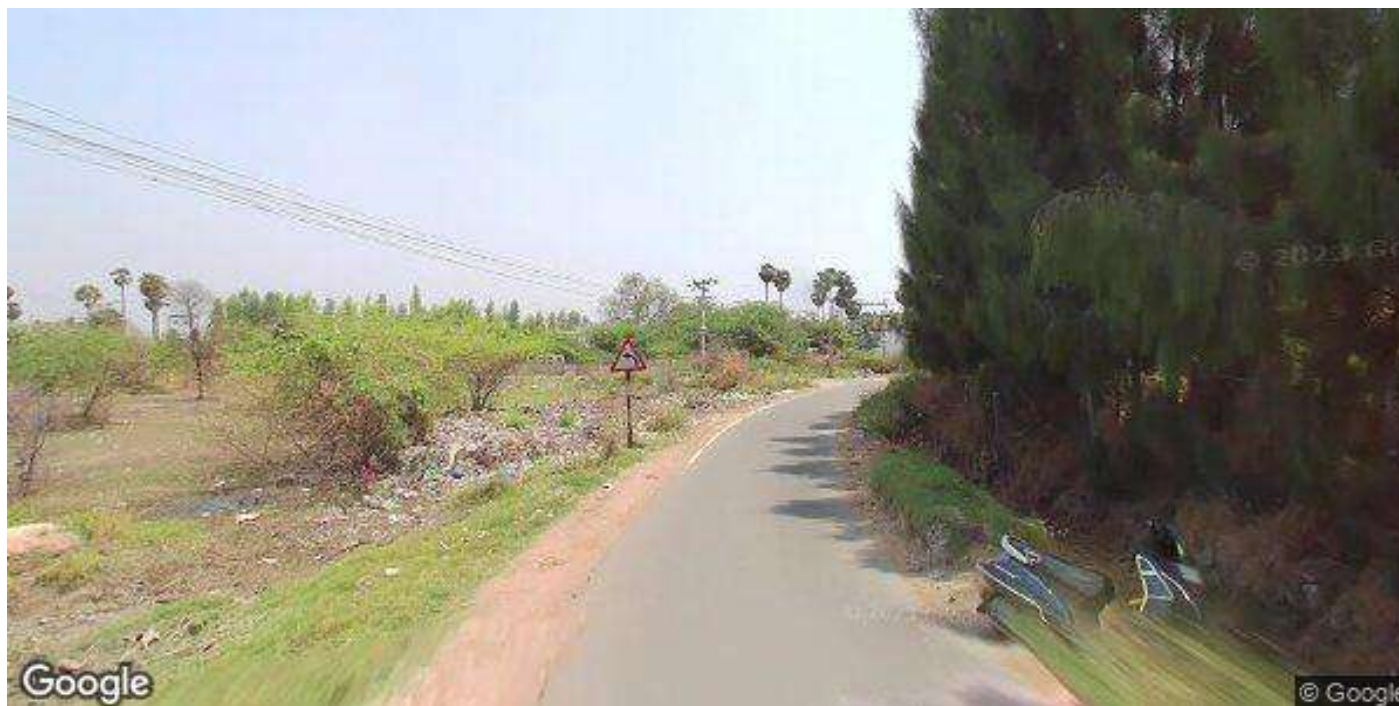
**Risk Type:** Turn  
**Risk Level:** Medium  
**Speed Limit:** 30 KM/Hr  
**Coordinates:** 11.69847, 78.02406

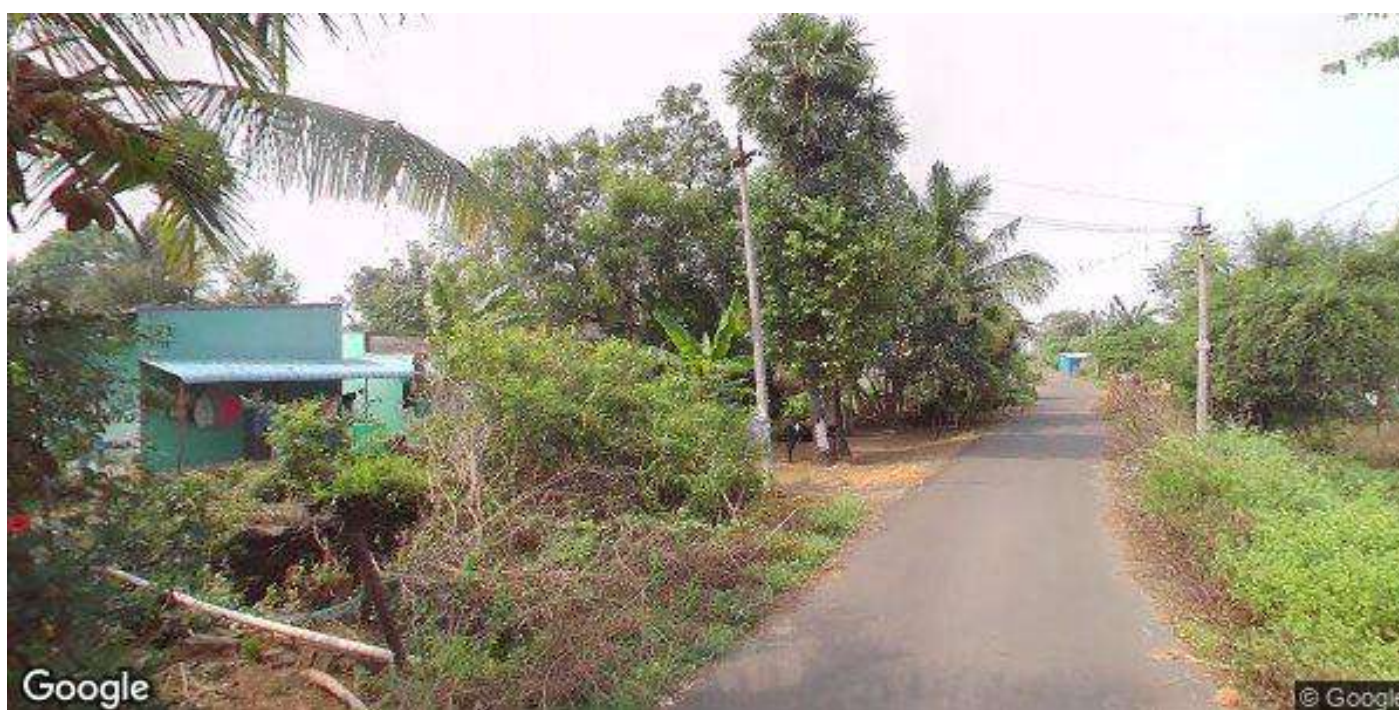
**Risk Type:** Turn  
**Risk Level:** Medium  
**Speed Limit:** 30 KM/Hr  
**Coordinates:** 11.69784, 78.03990

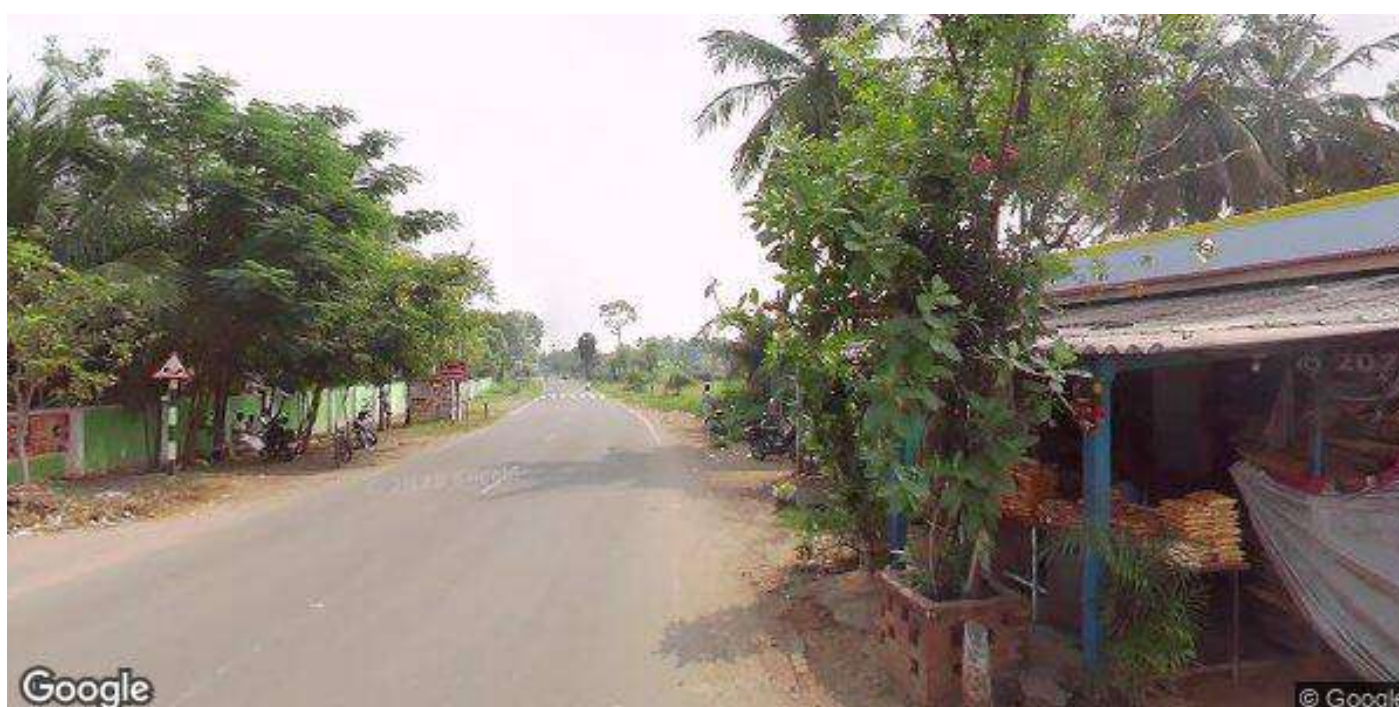
**Risk Type:** Turn  
**Risk Level:** High  
**Speed Limit:** 15 KM/Hr  
**Coordinates:** 11.70268, 78.04958

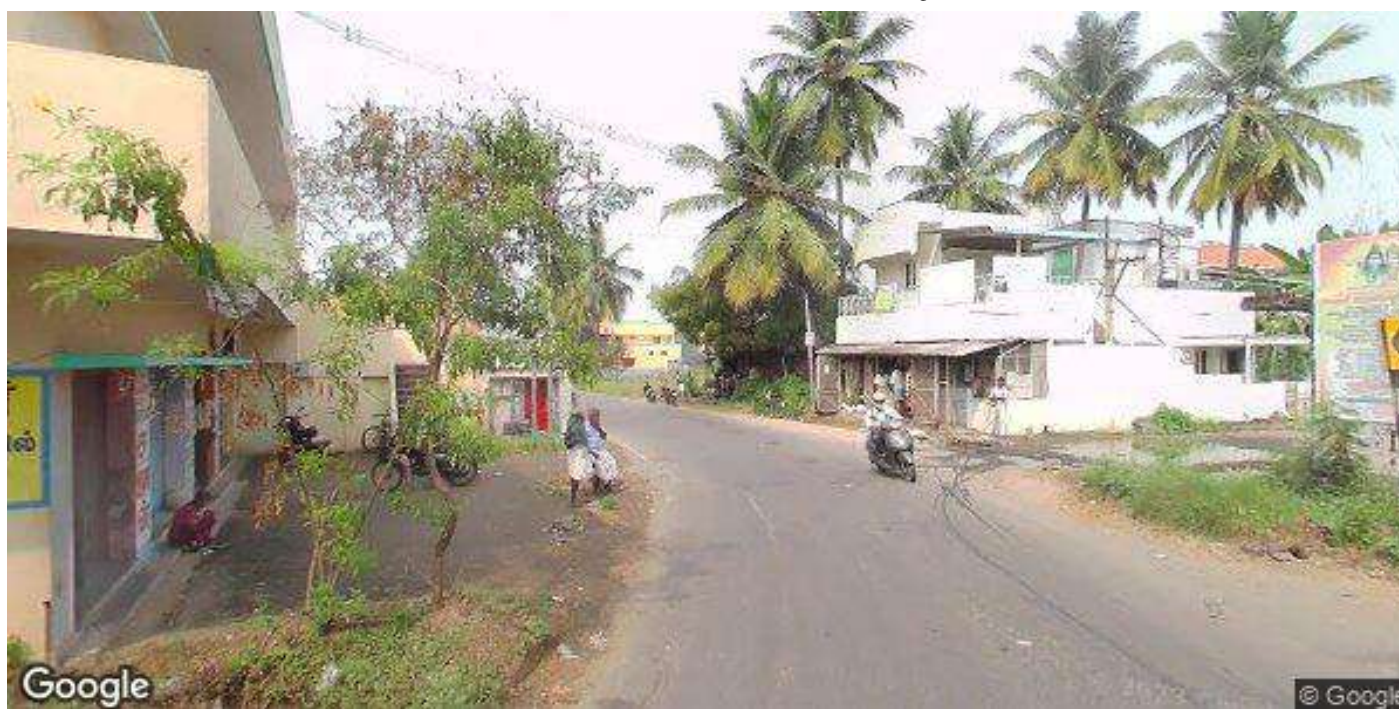
**Risk Type:** Turn

**Risk Level:** High

**Speed Limit:** 15 KM/Hr

**Coordinates:** 11.69948, 78.05515

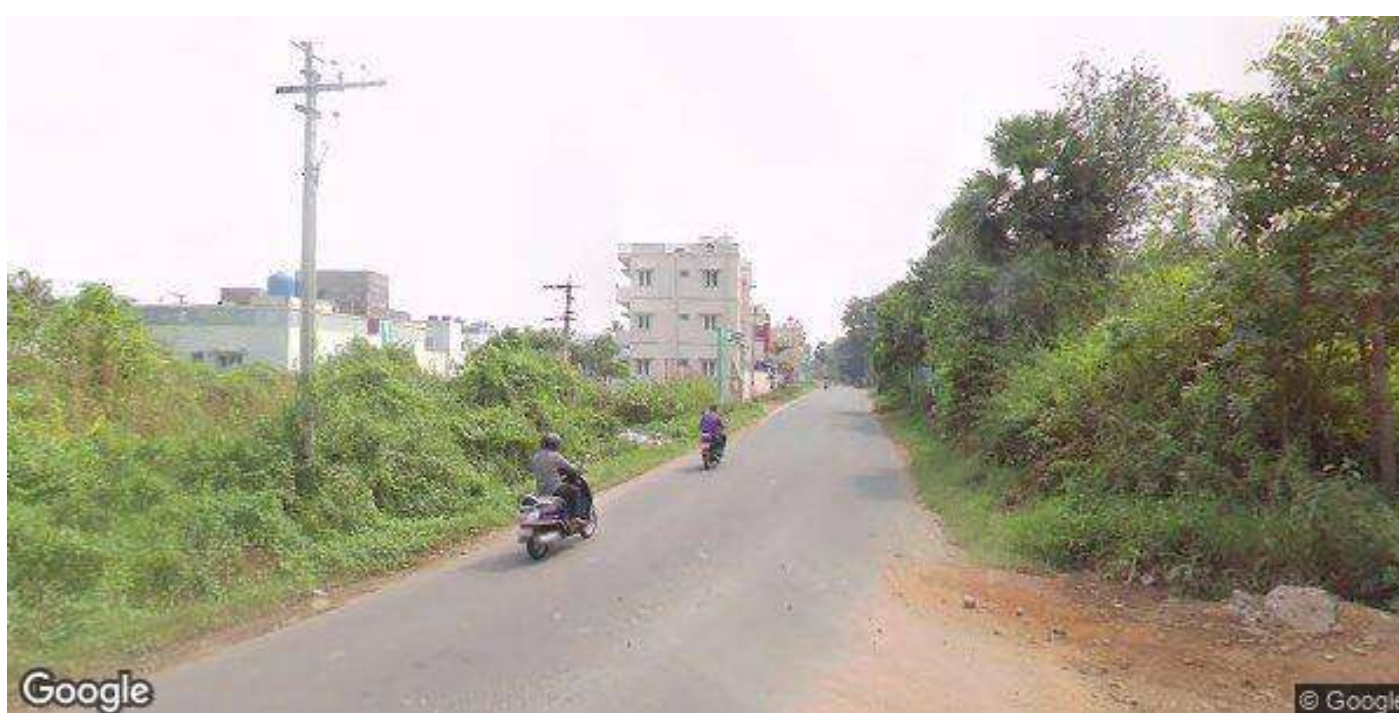
**Risk Type:** Turn

**Risk Level:** Medium

**Speed Limit:** 30 KM/Hr

**Coordinates:** 11.69868, 78.05541
