## JOURNEY RISK MANAGEMENT (JRM) STUDY

### Salem Terminal TO KUMAR AGENCIES

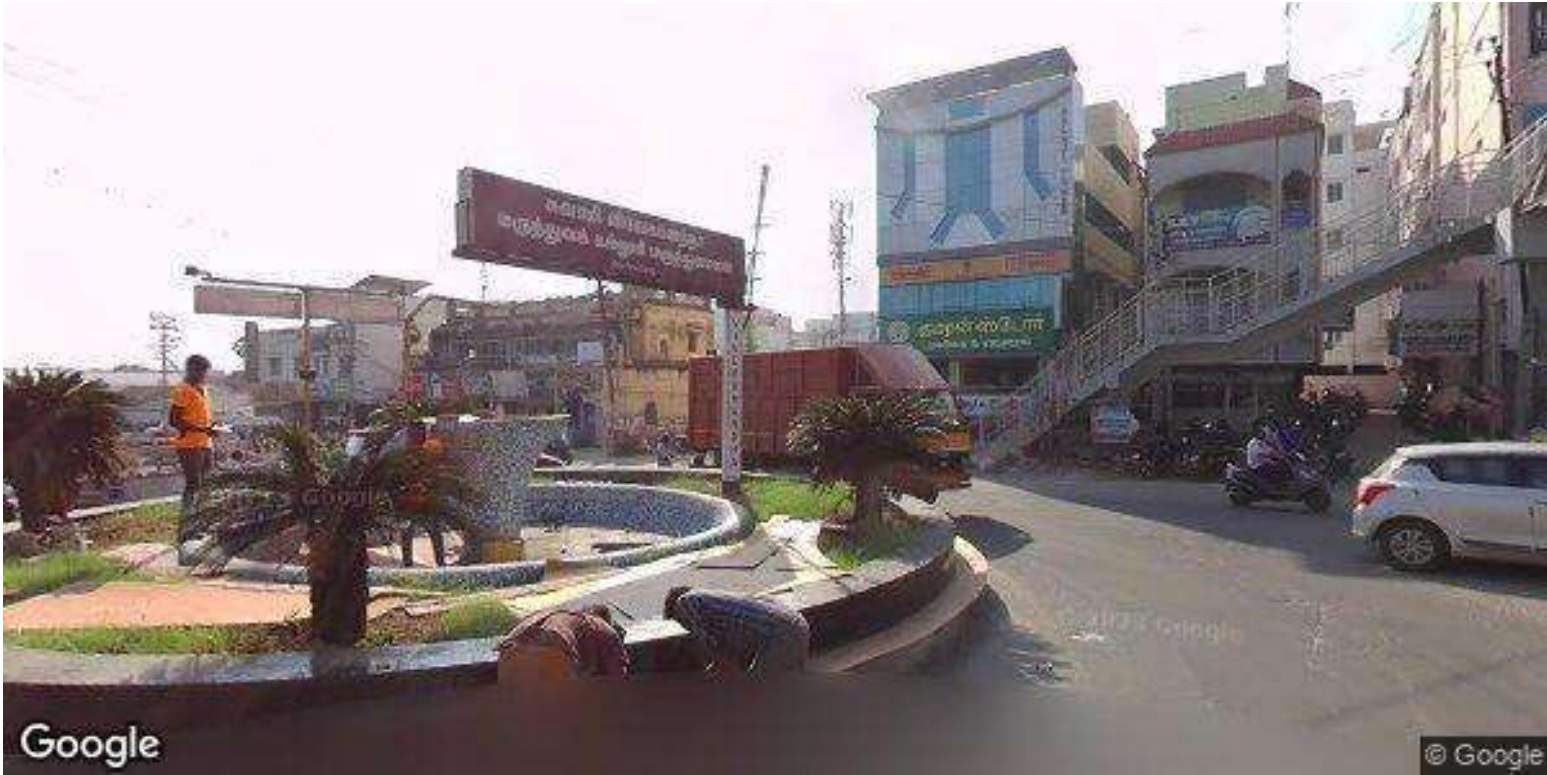
Risk Type: Roundabout  
Risk Level: High  
Speed Limit: 15 KM/Hr  
Coordinates: 11.38395, 77.89480

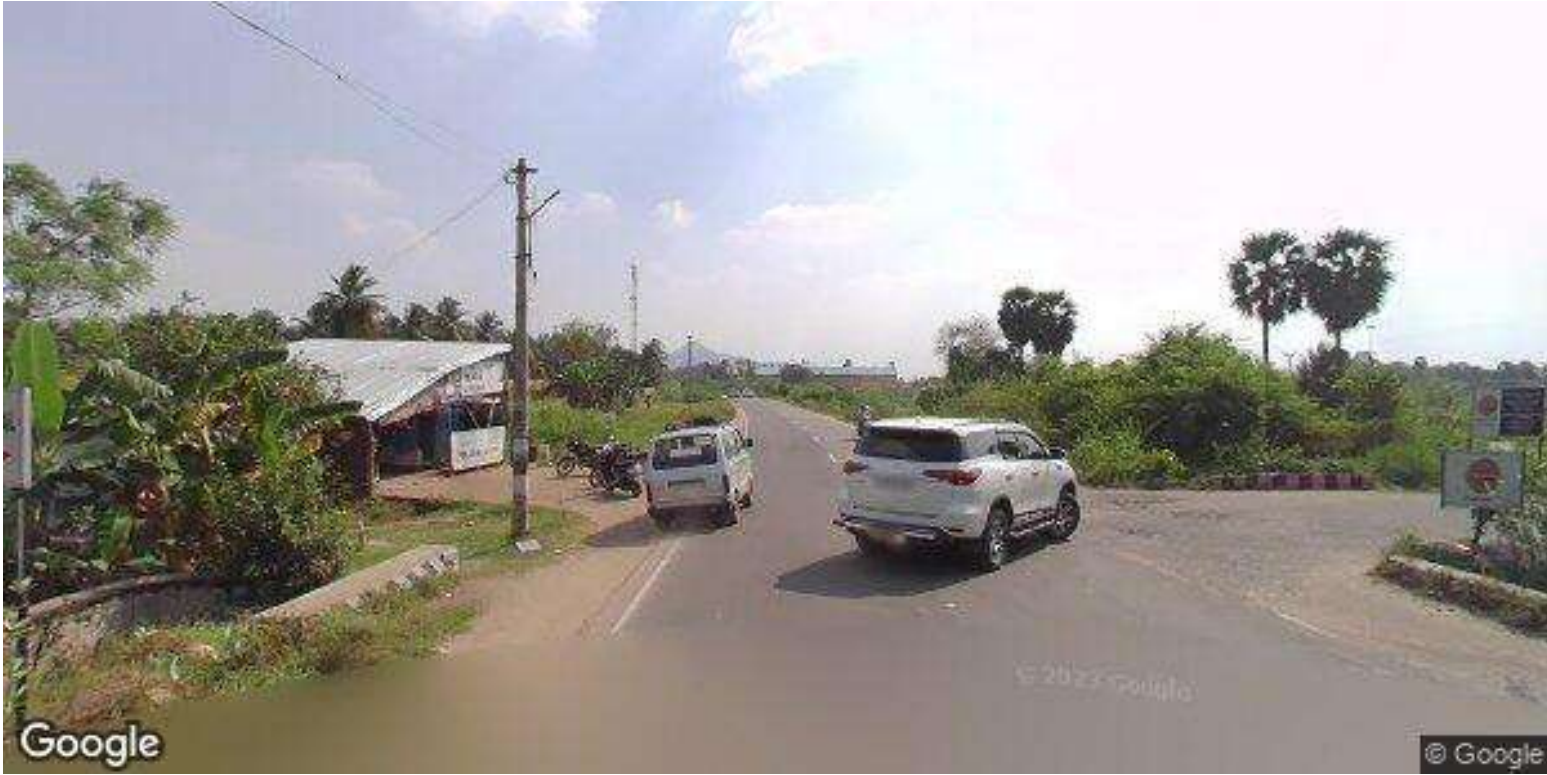
Risk Type: Blind Spot  
Risk Level: Blind Spot

**Speed Limit: 10 KM/Hr**

**Coordinates: 11.44029, 77.87544**

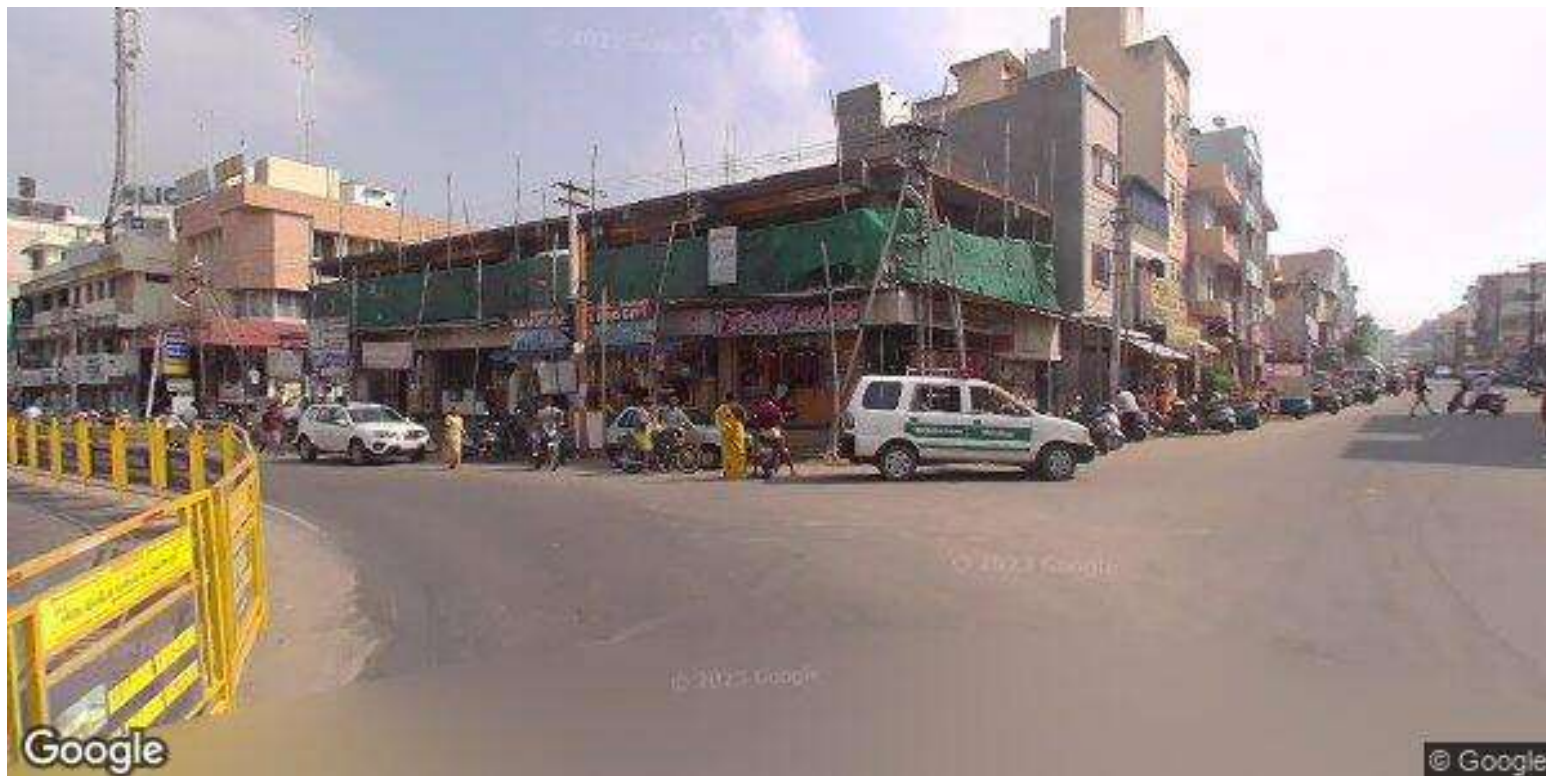
**Risk Type: Turn**

**Risk Level: High**

**Speed Limit: 15 KM/Hr**

**Coordinates: 11.37868, 77.89498**

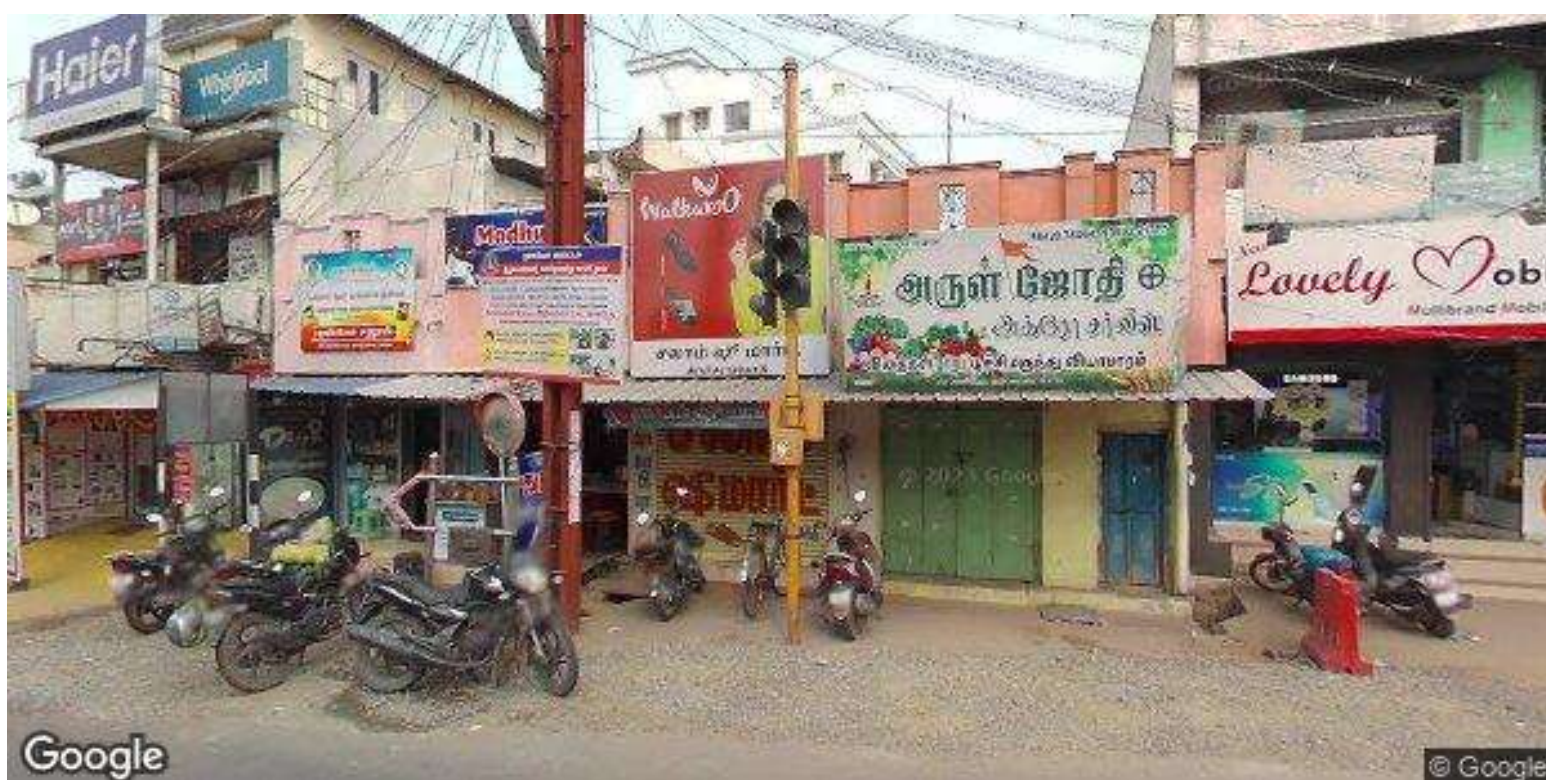
**Risk Type: Turn**

**Risk Level: High**

**Speed Limit: 15 KM/Hr**

**Coordinates: 11.37850, 77.89453**

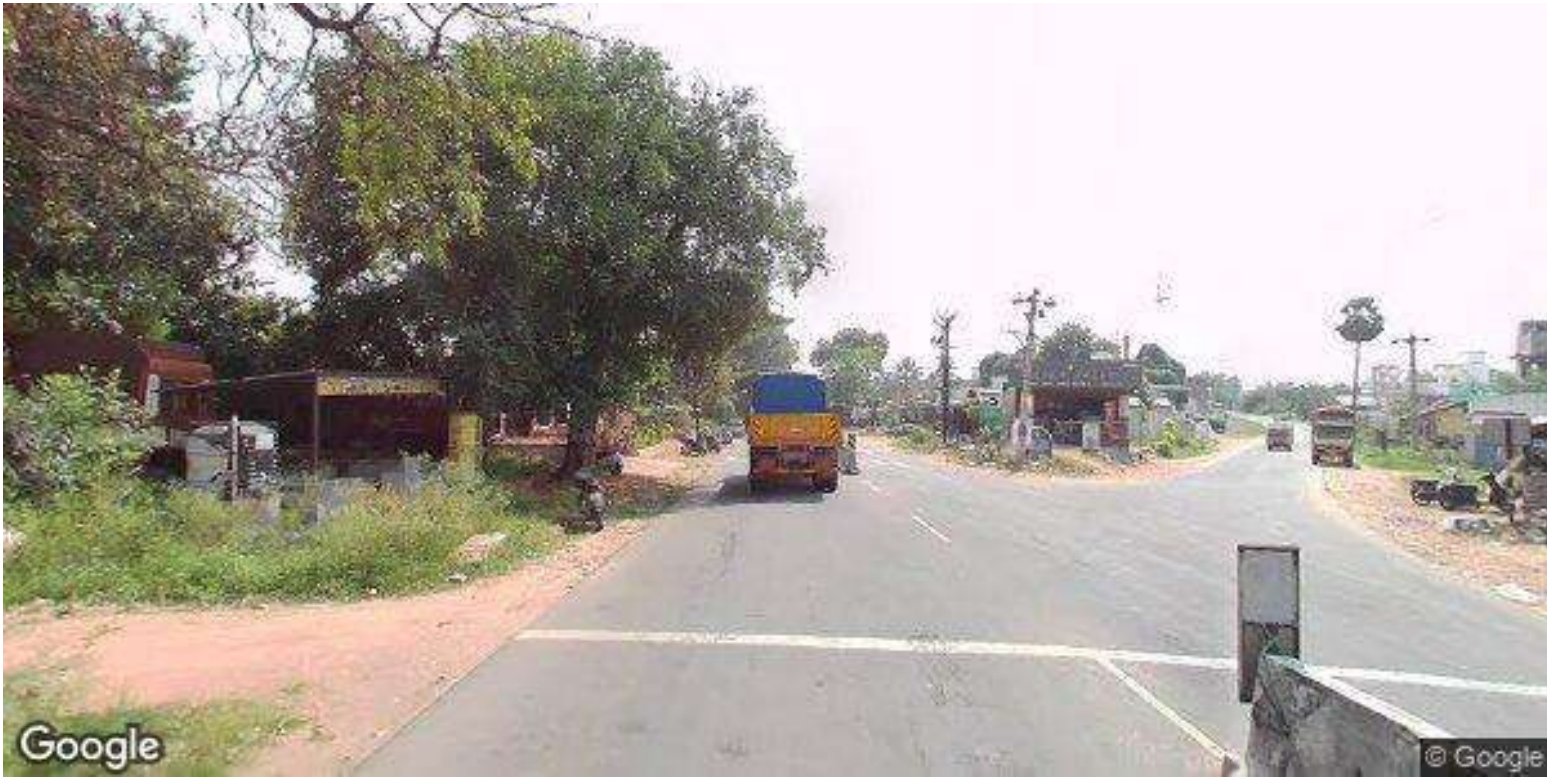
**Risk Type:** Turn  
**Risk Level:** Medium  
**Speed Limit:** 30 KM/Hr  
**Coordinates:** 11.35759, 77.89191

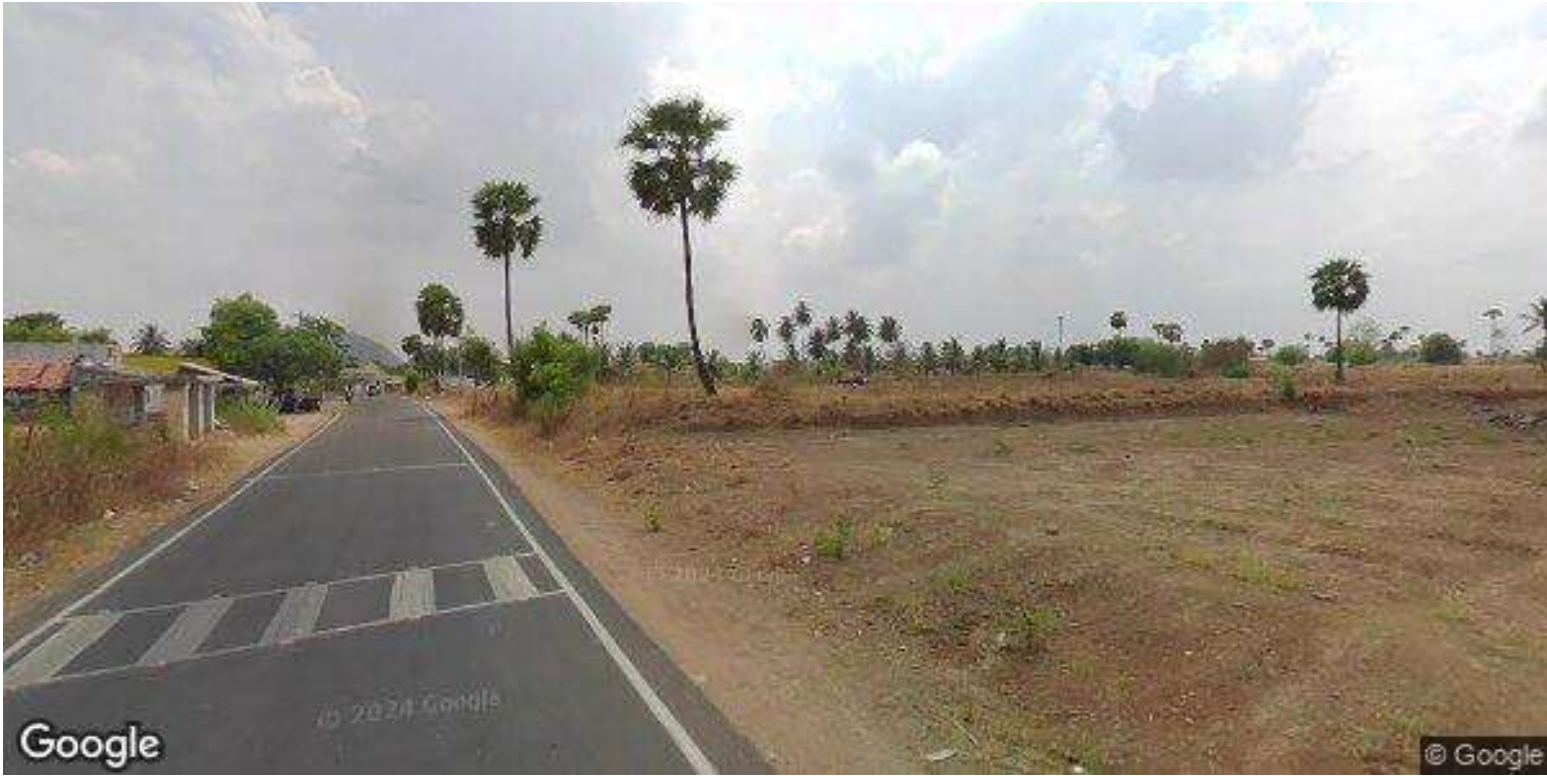
**Risk Type:** Turn  
**Risk Level:** Medium  
**Speed Limit:** 30 KM/Hr  
**Coordinates:** 11.33071, 77.88660

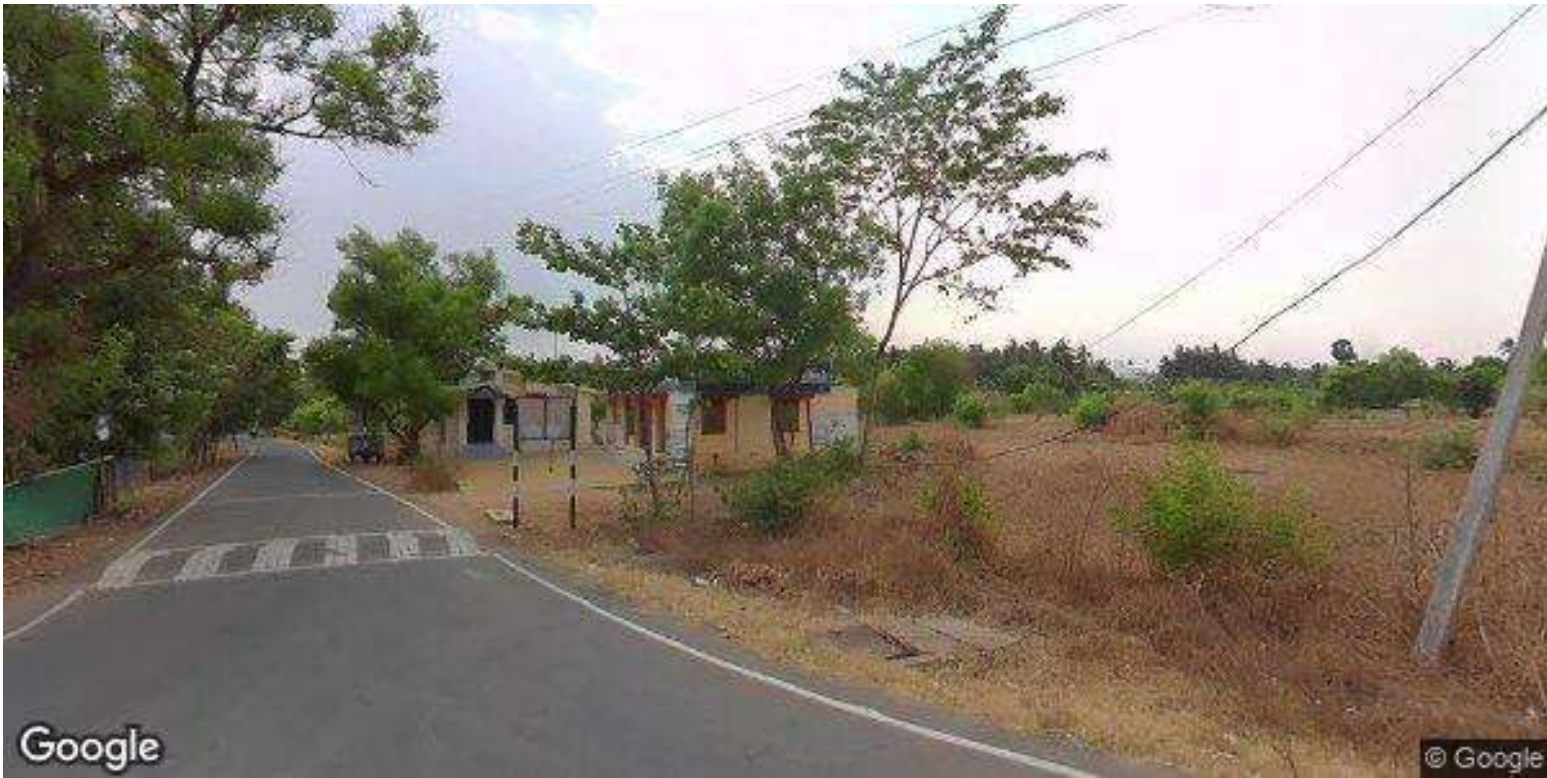
**Risk Type:** Turn  
**Risk Level:** High  
**Speed Limit:** 15 KM/Hr  
**Coordinates:** 11.33065, 77.88650

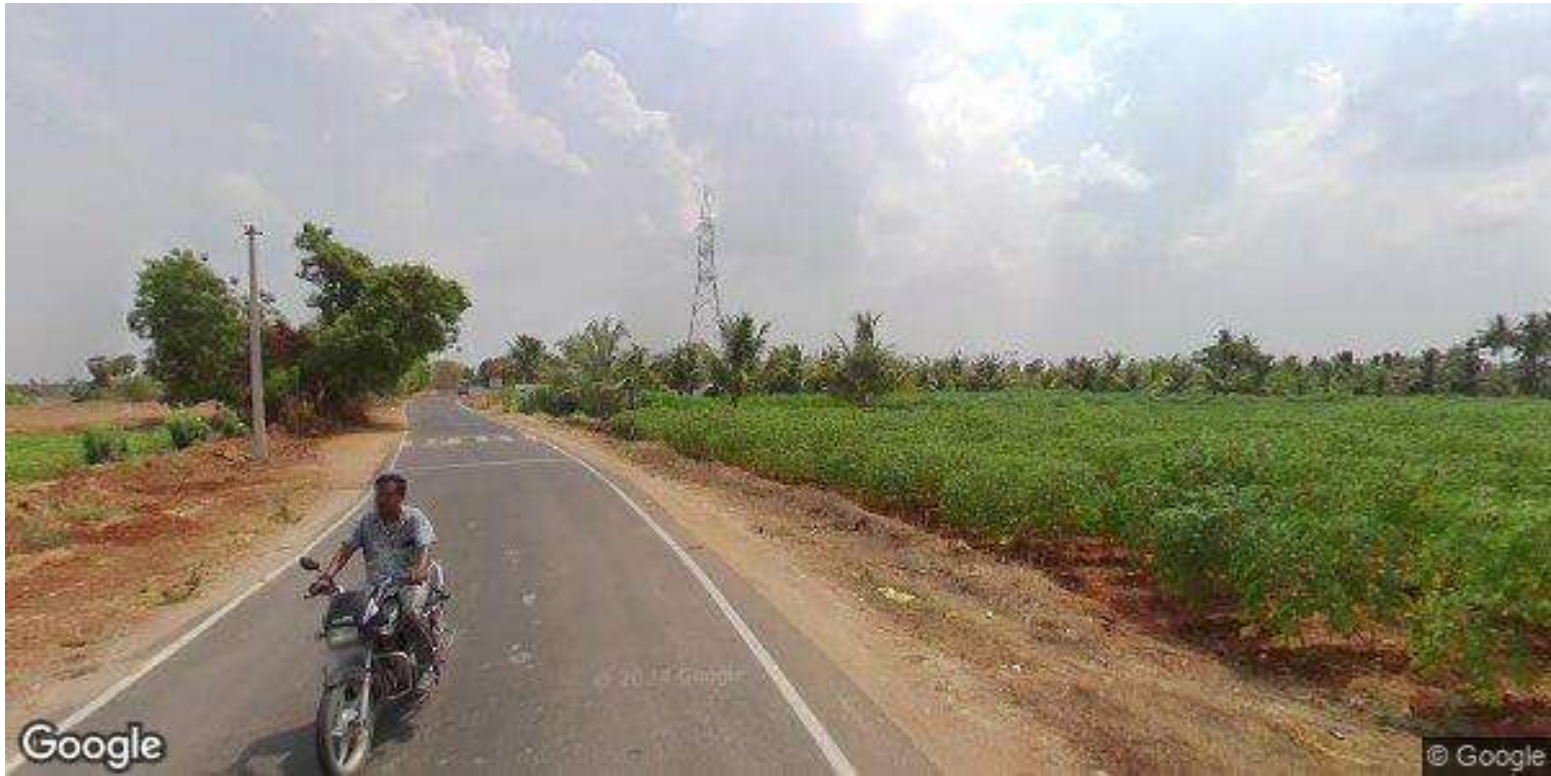
**Risk Type:** Turn  
**Risk Level:** Medium  
**Speed Limit:** 30 KM/Hr  
**Coordinates:** 11.32155, 77.88499

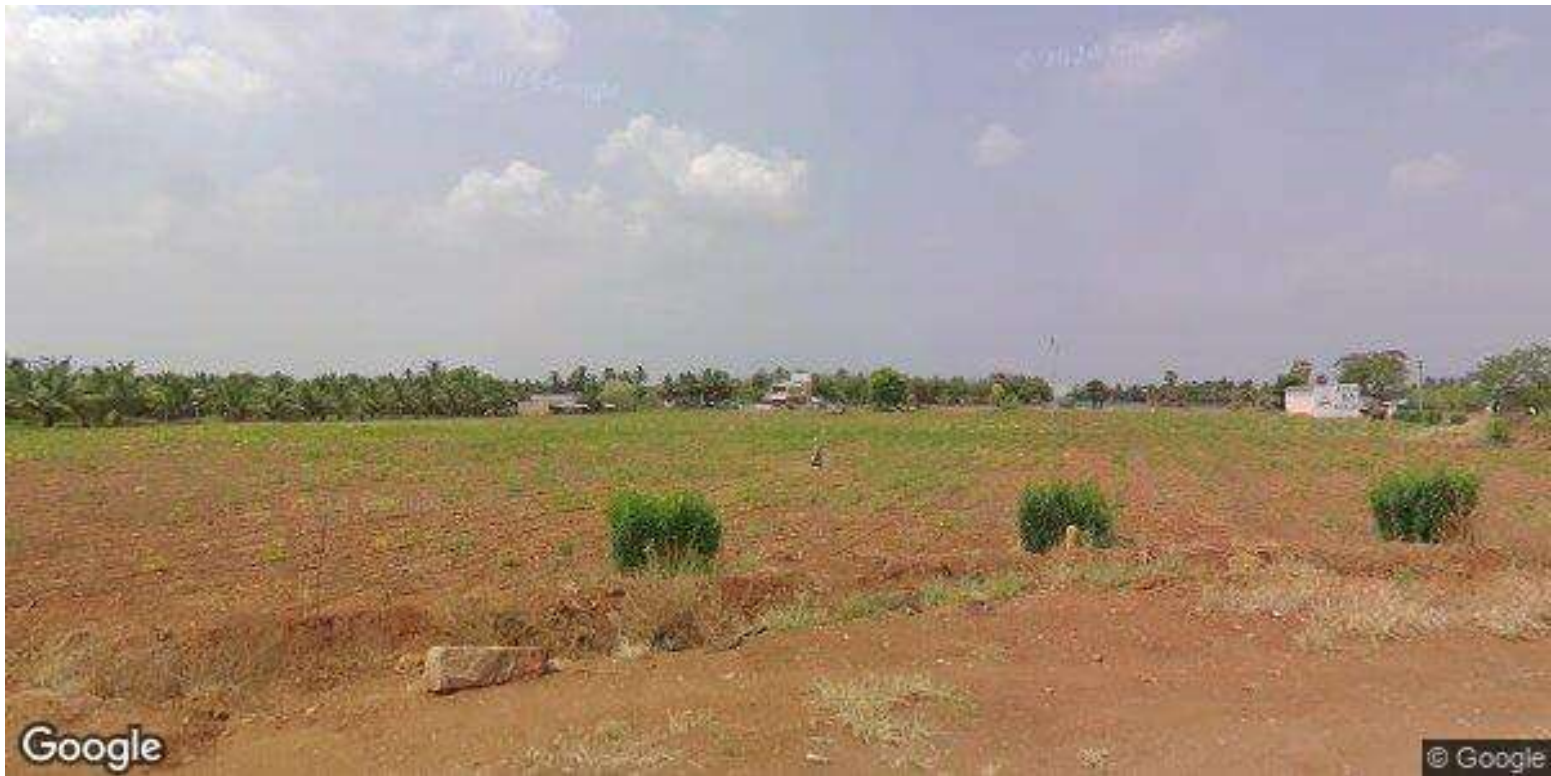
**Risk Type:** Turn  
**Risk Level:** Medium  
**Speed Limit:** 30 KM/Hr  
**Coordinates:** 11.32130, 77.88484

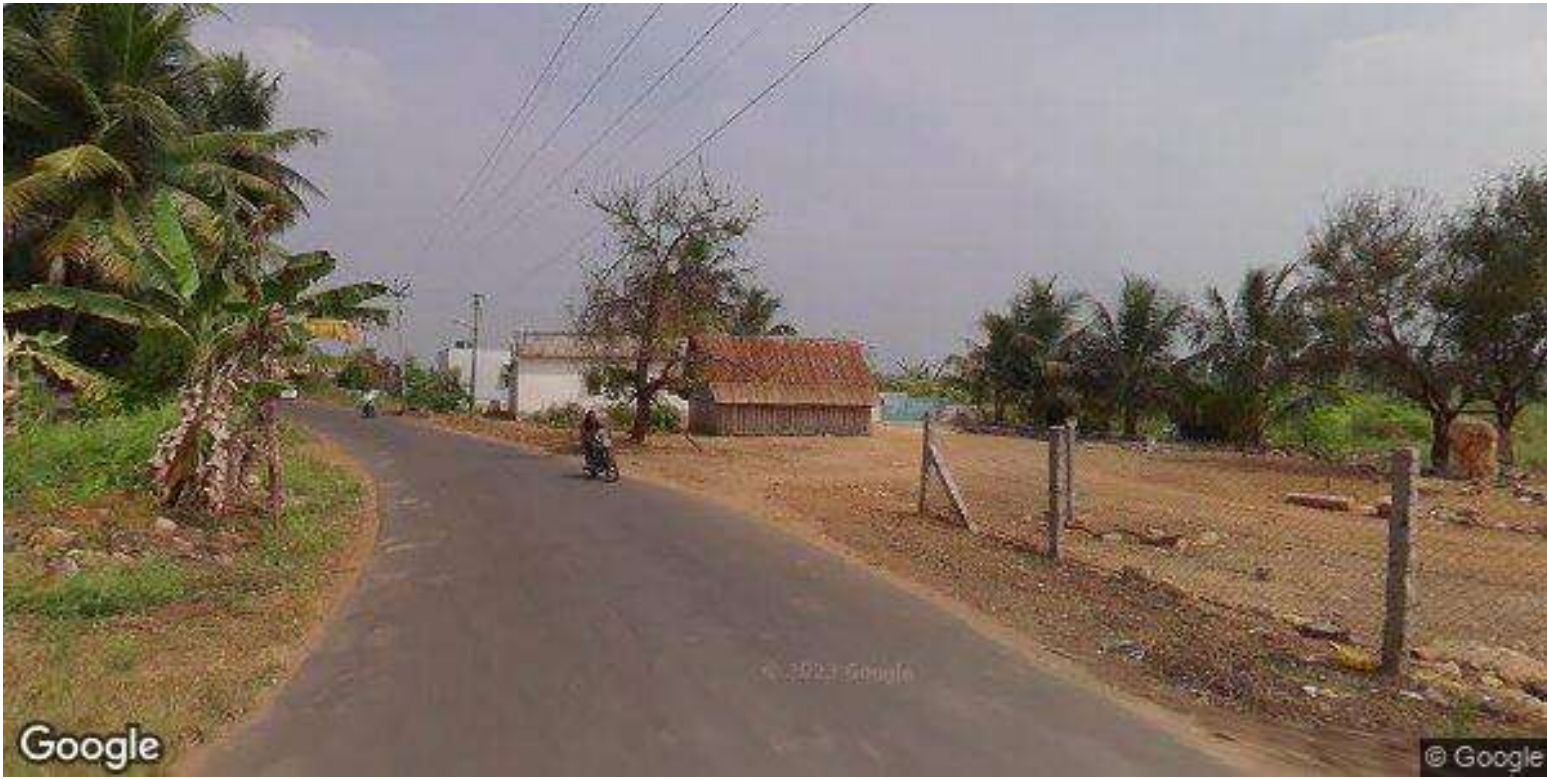
**Risk Type:** Turn  
**Risk Level:** Medium  
**Speed Limit:** 30 KM/Hr  
**Coordinates:** 11.31205, 77.88131

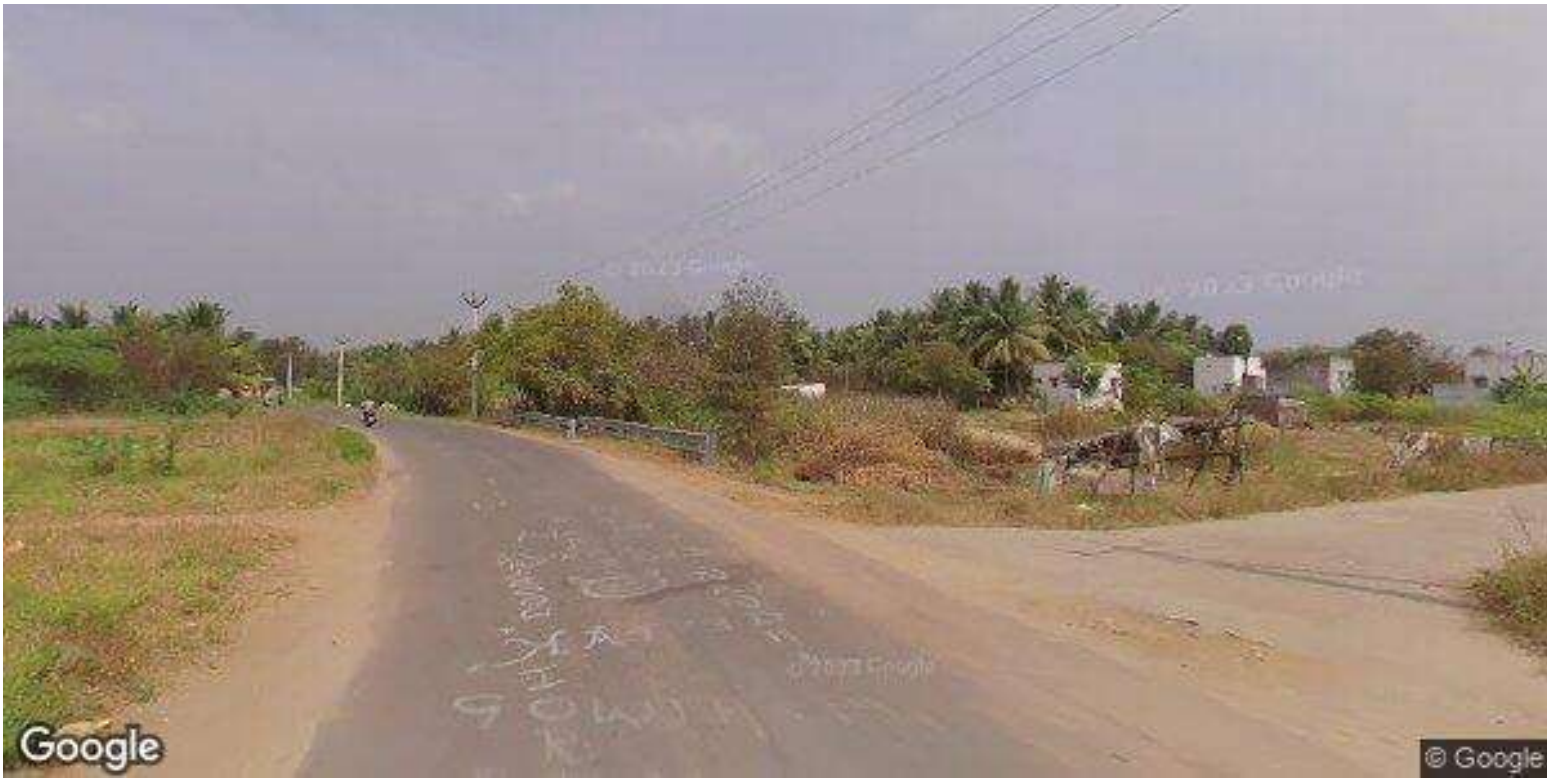
**Risk Type:** Turn  
**Risk Level:** Medium  
**Speed Limit:** 30 KM/Hr  
**Coordinates:** 11.30805, 77.87934

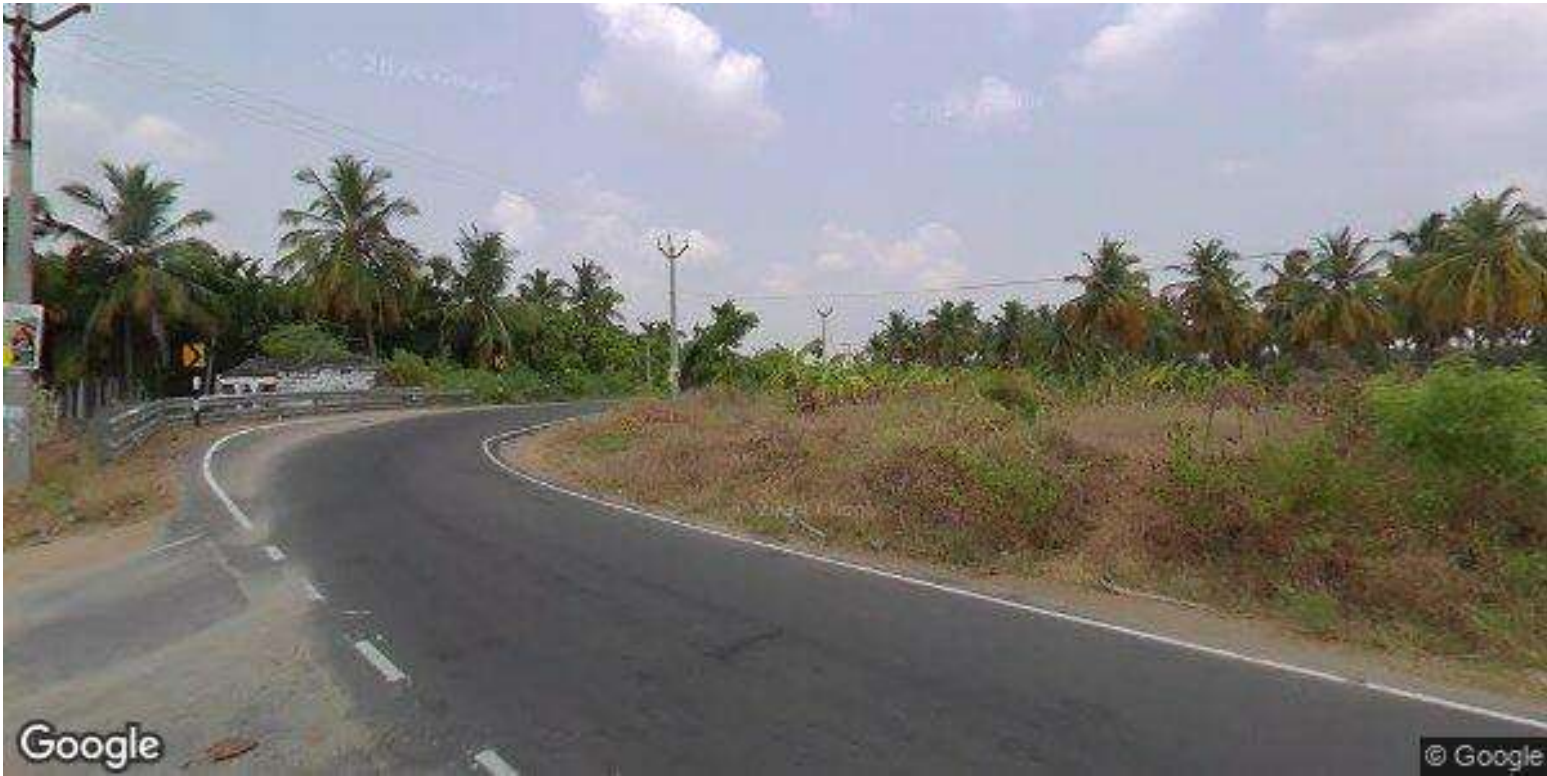
**Risk Type:** Turn  
**Risk Level:** High  
**Speed Limit:** 15 KM/Hr  
**Coordinates:** 11.29763, 77.87710

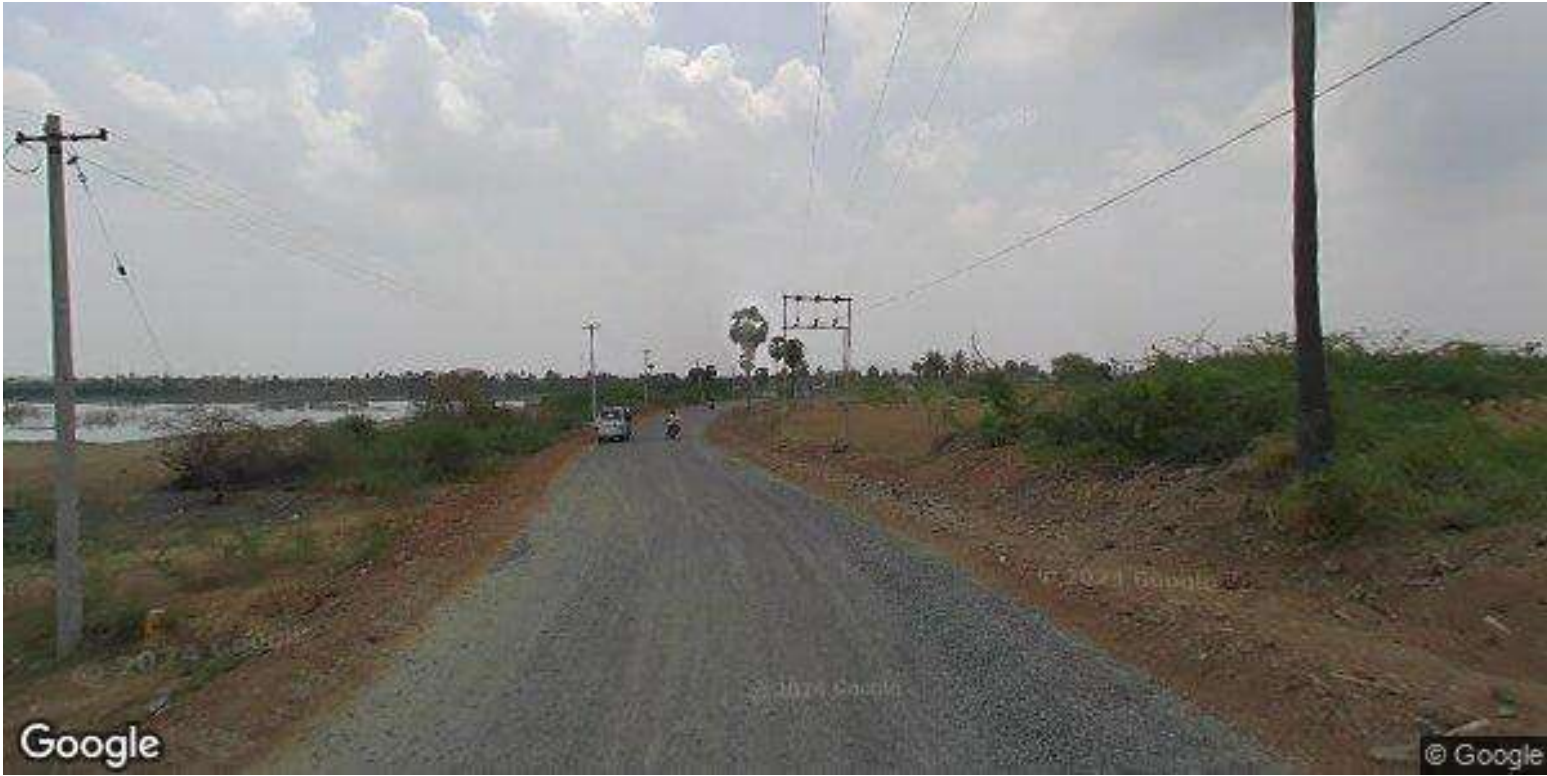
**Risk Type:** Turn  
**Risk Level:** Medium  
**Speed Limit:** 30 KM/Hr  
**Coordinates:** 11.27590, 77.87354

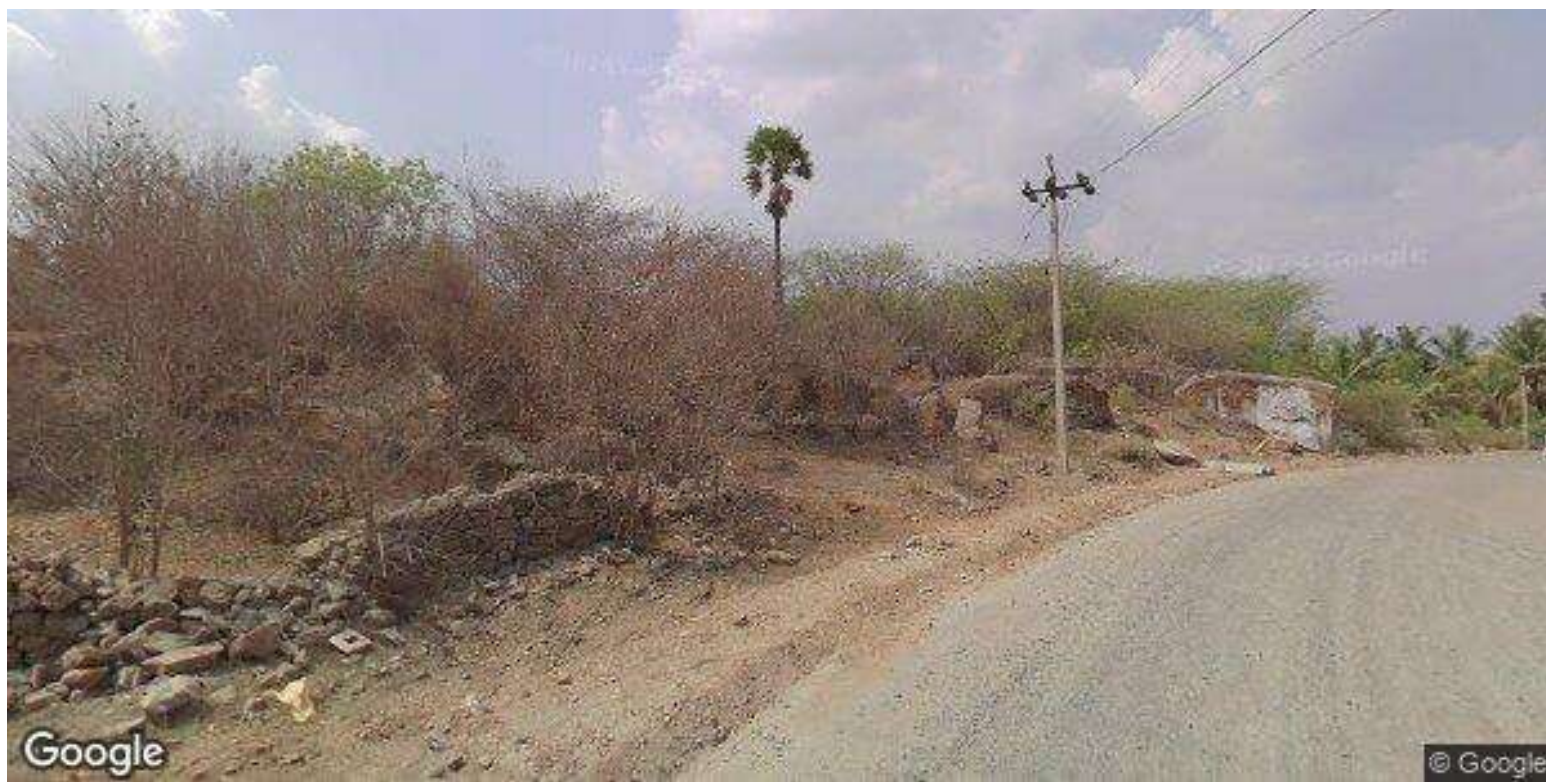
**Risk Type:** Turn

**Risk Level:** Medium

**Speed Limit:** 30 KM/Hr

**Coordinates:** 11.27057, 77.86827

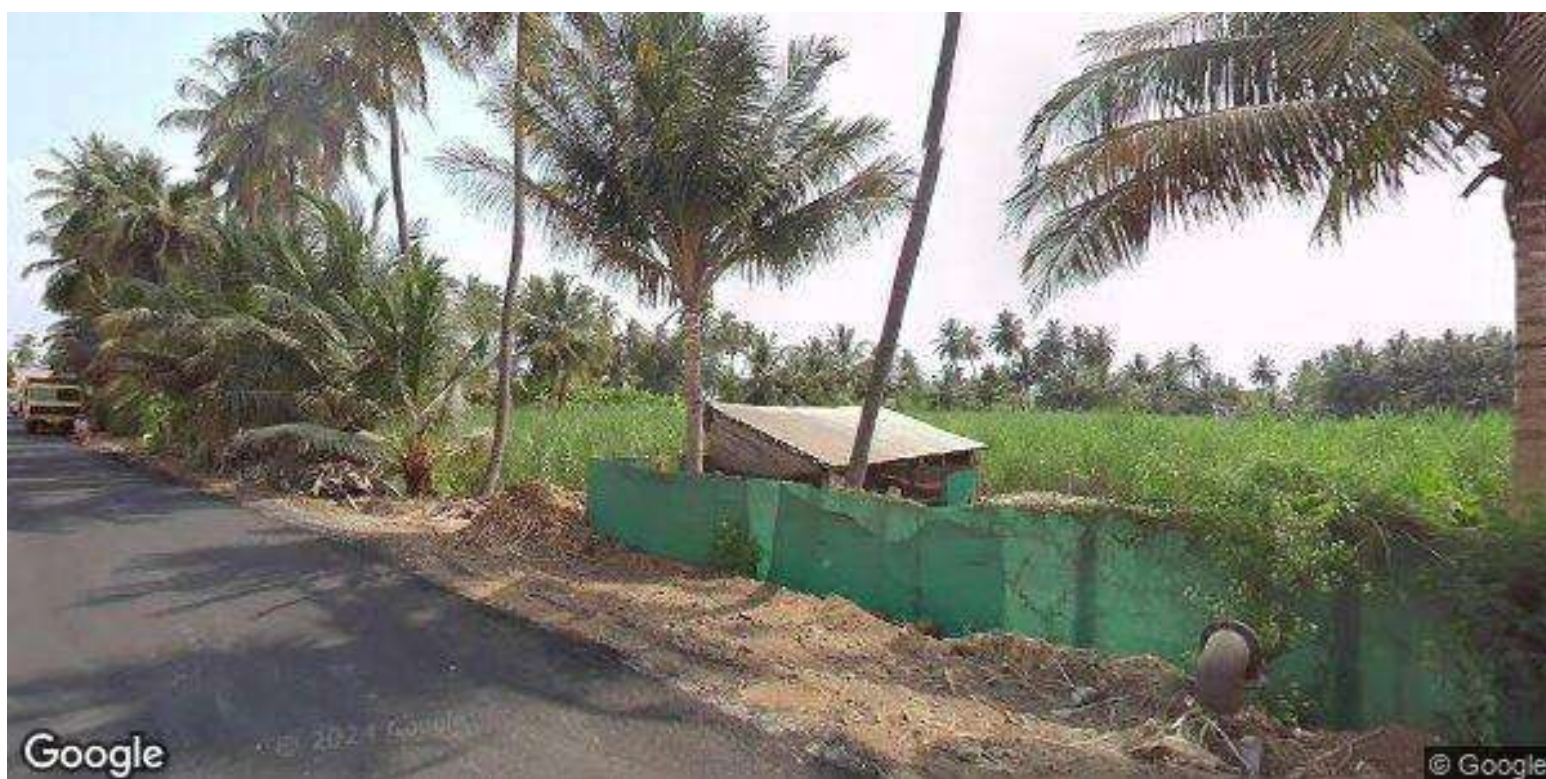
**Risk Type:** Turn

**Risk Level:** High

**Speed Limit:** 15 KM/Hr

**Coordinates:** 11.26017, 77.85606

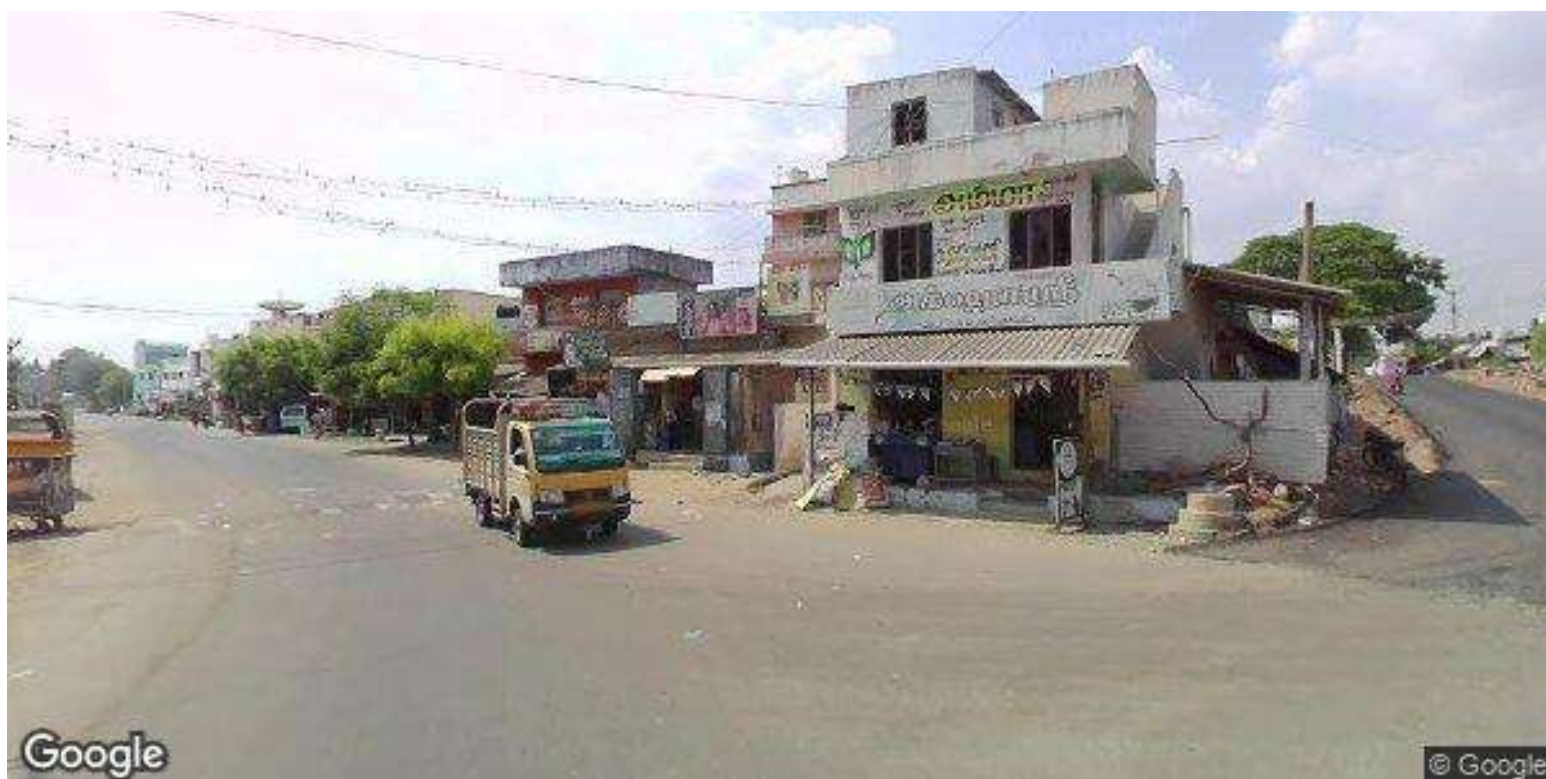
**Risk Type:** Turn  
**Risk Level:** High  
**Speed Limit:** 15 KM/Hr  
**Coordinates:** 11.25802, 77.85511

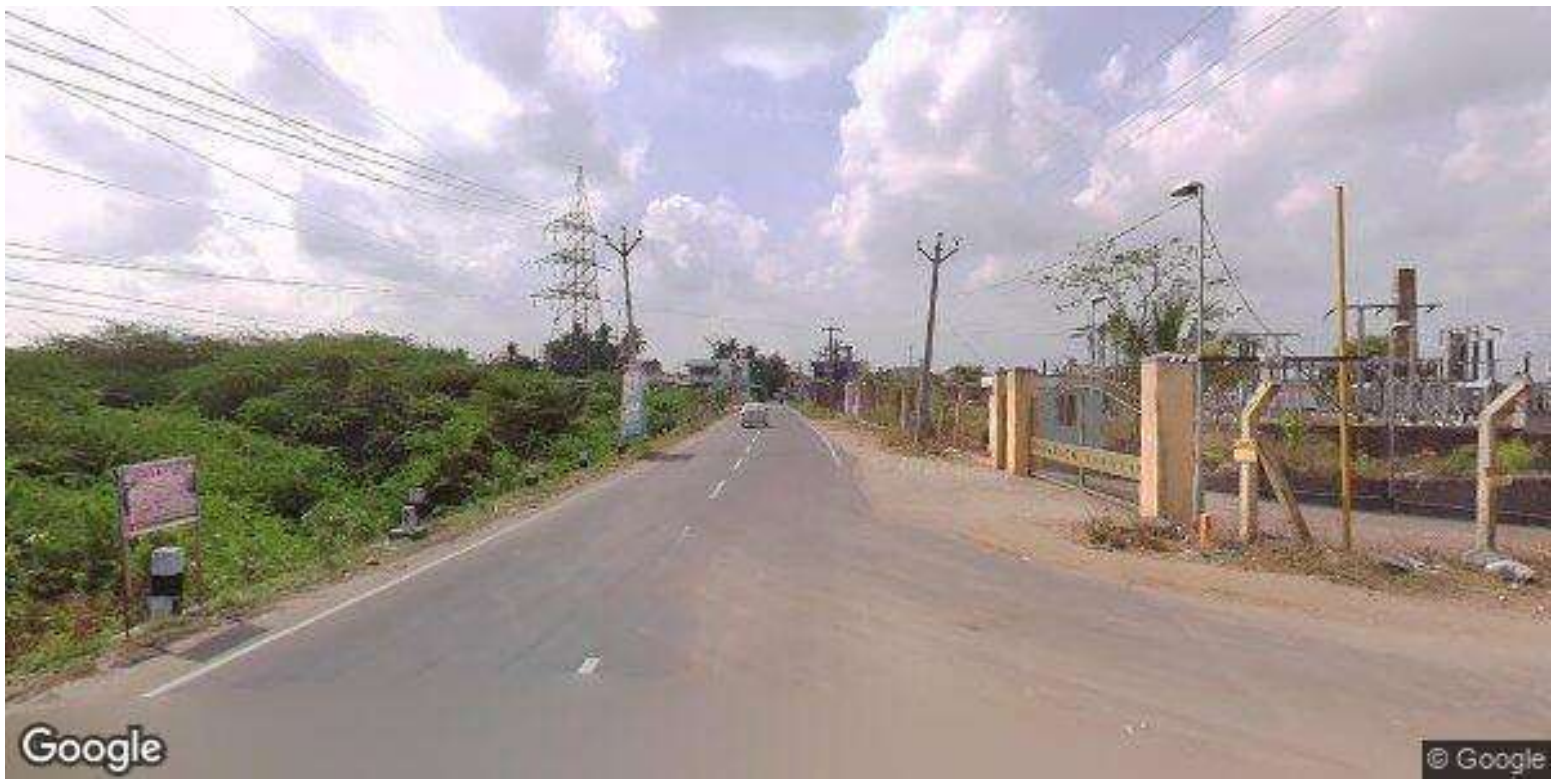
**Risk Type:** Turn  
**Risk Level:** High  
**Speed Limit:** 15 KM/Hr  
**Coordinates:** 11.24384, 77.86689

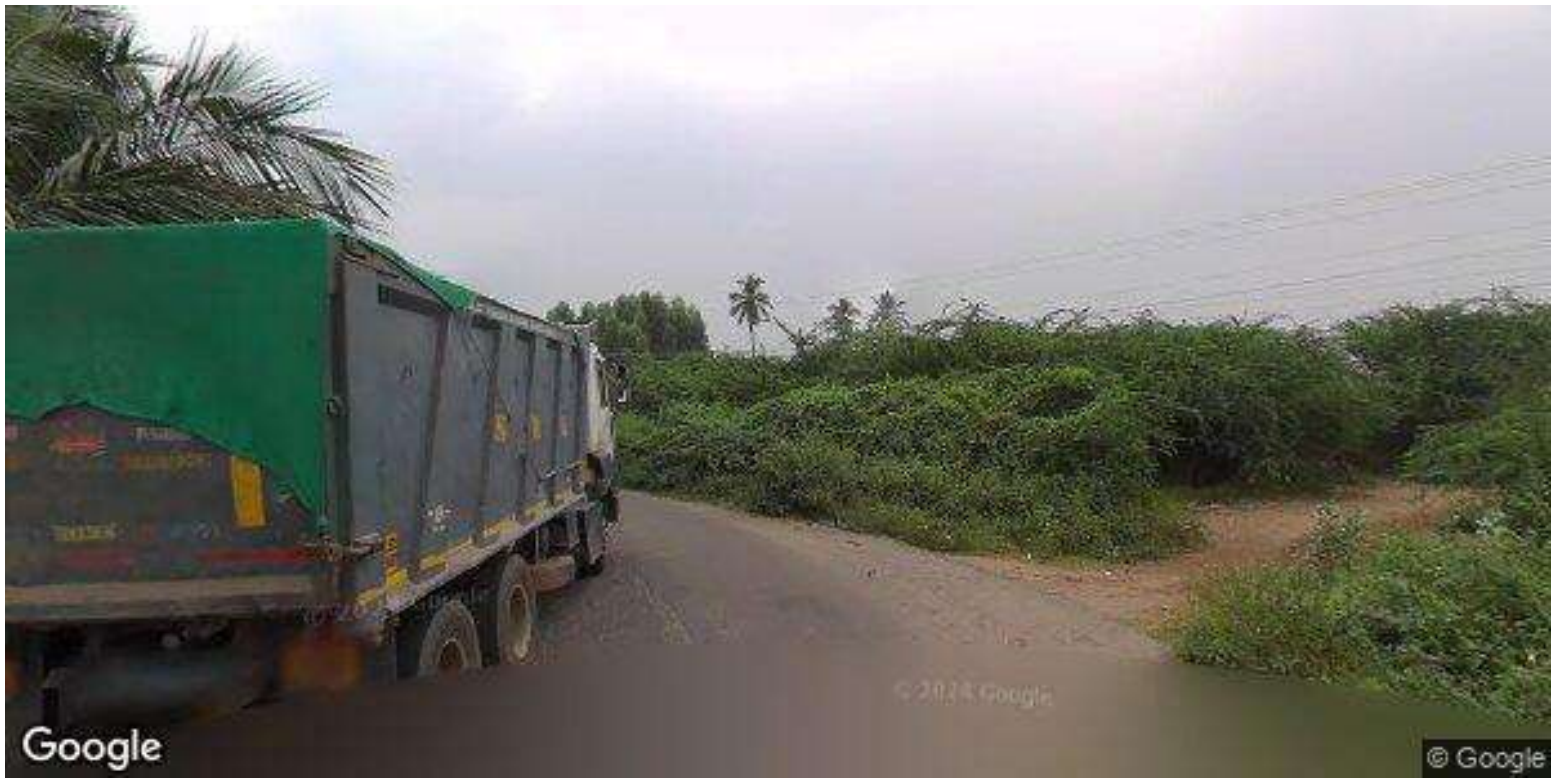
**Risk Type:** Turn  
**Risk Level:** High  
**Speed Limit:** 15 KM/Hr  
**Coordinates:** 11.24100, 77.86030
