## JOURNEY RISK MANAGEMENT (JRM) STUDY

### Salem Terminal TO KUMAR AGENCIES

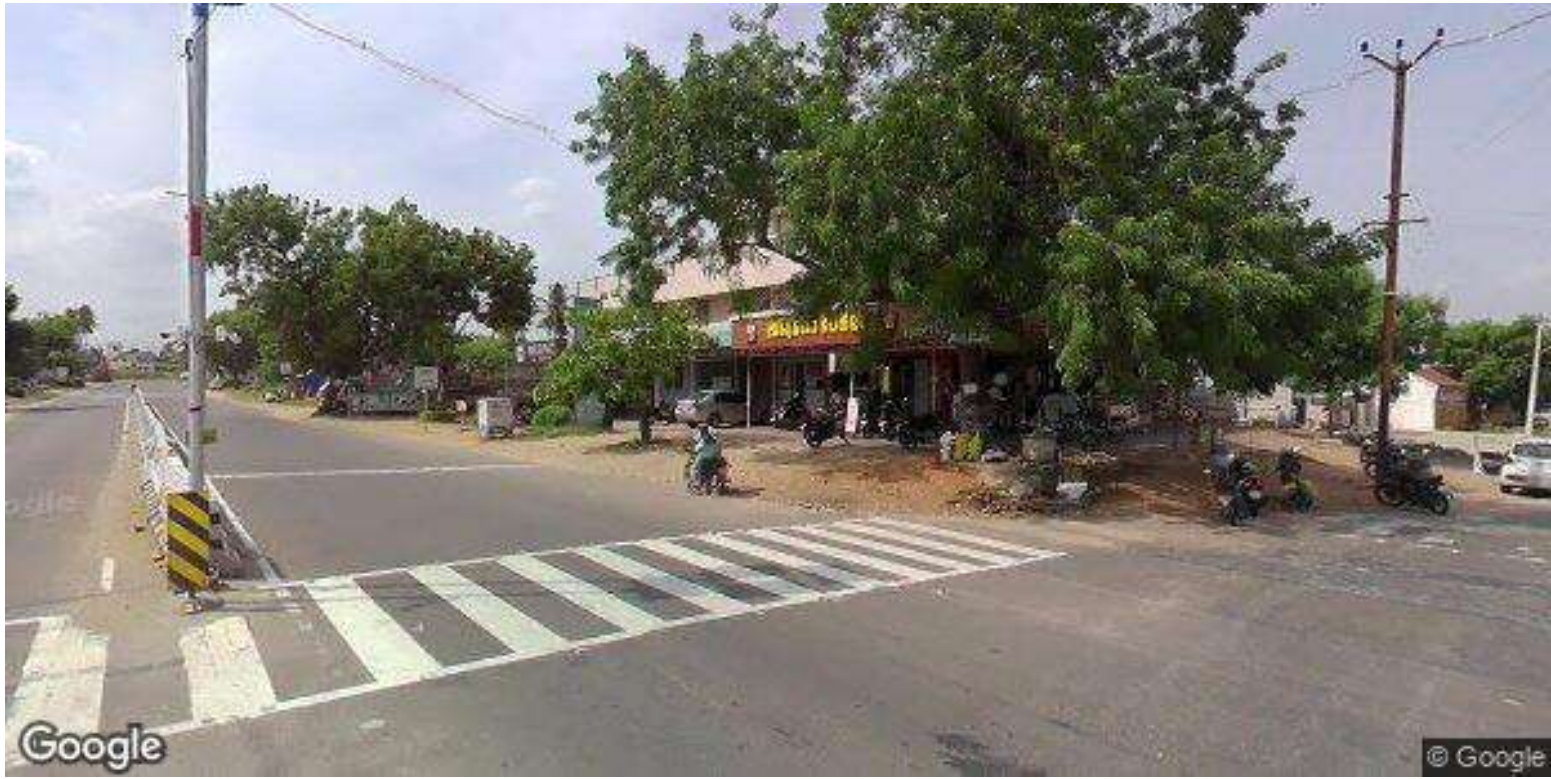
Risk Type: Turn

Risk Level: High

Speed Limit: 15 KM/Hr

Coordinates: 11.22377, 77.83980
