# IndianOil

## JOURNEY RISK MANAGEMENT (JRM) STUDY

### Salem Terminal TO SHREE VARNIKHA ENTERPRISES

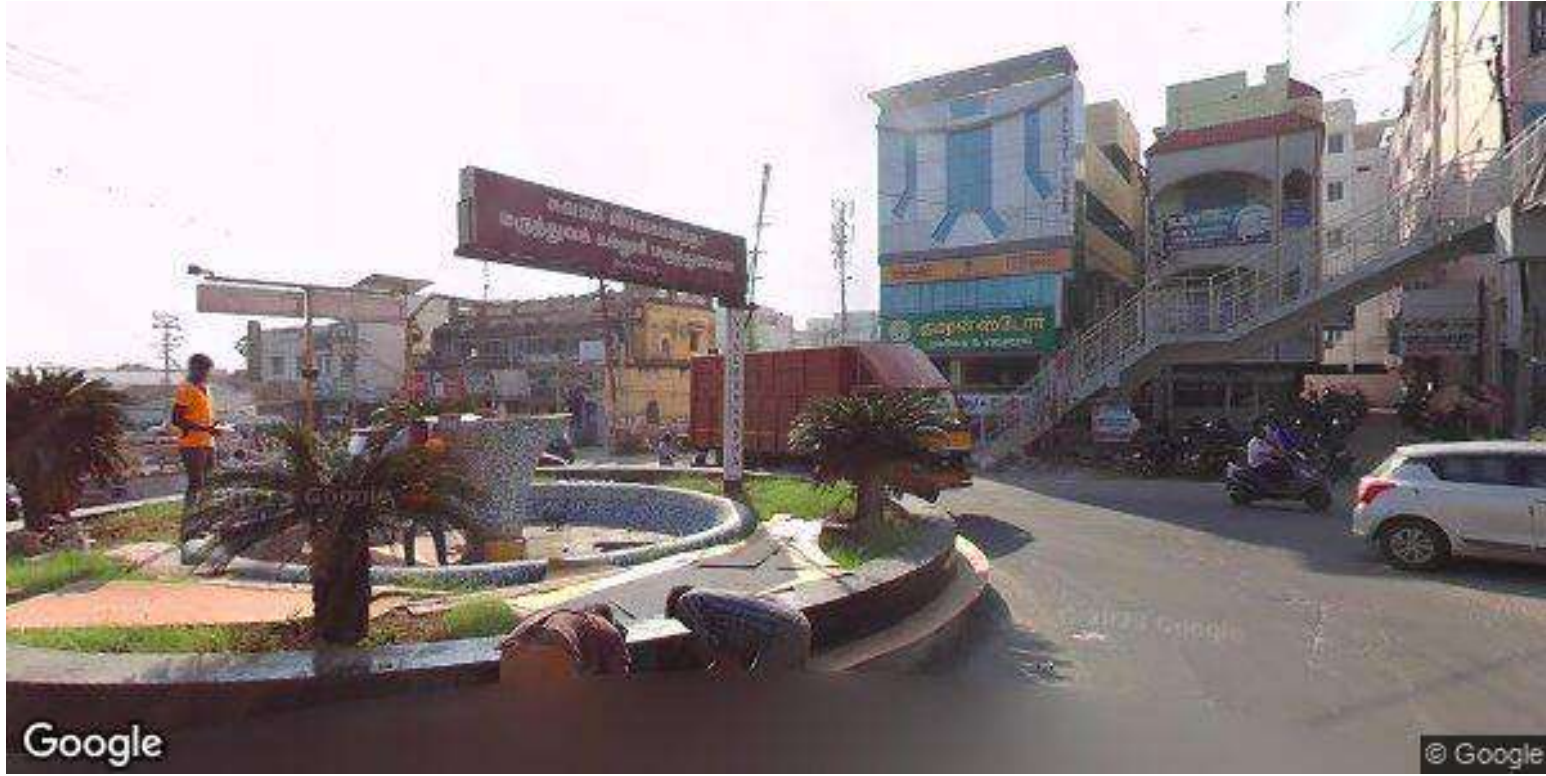
**Coordinates:** 11.38395, 77.89480

**Risk Type:** Roundabout

**Risk Level:** High

**Speed Limit:** 15 KM/Hr

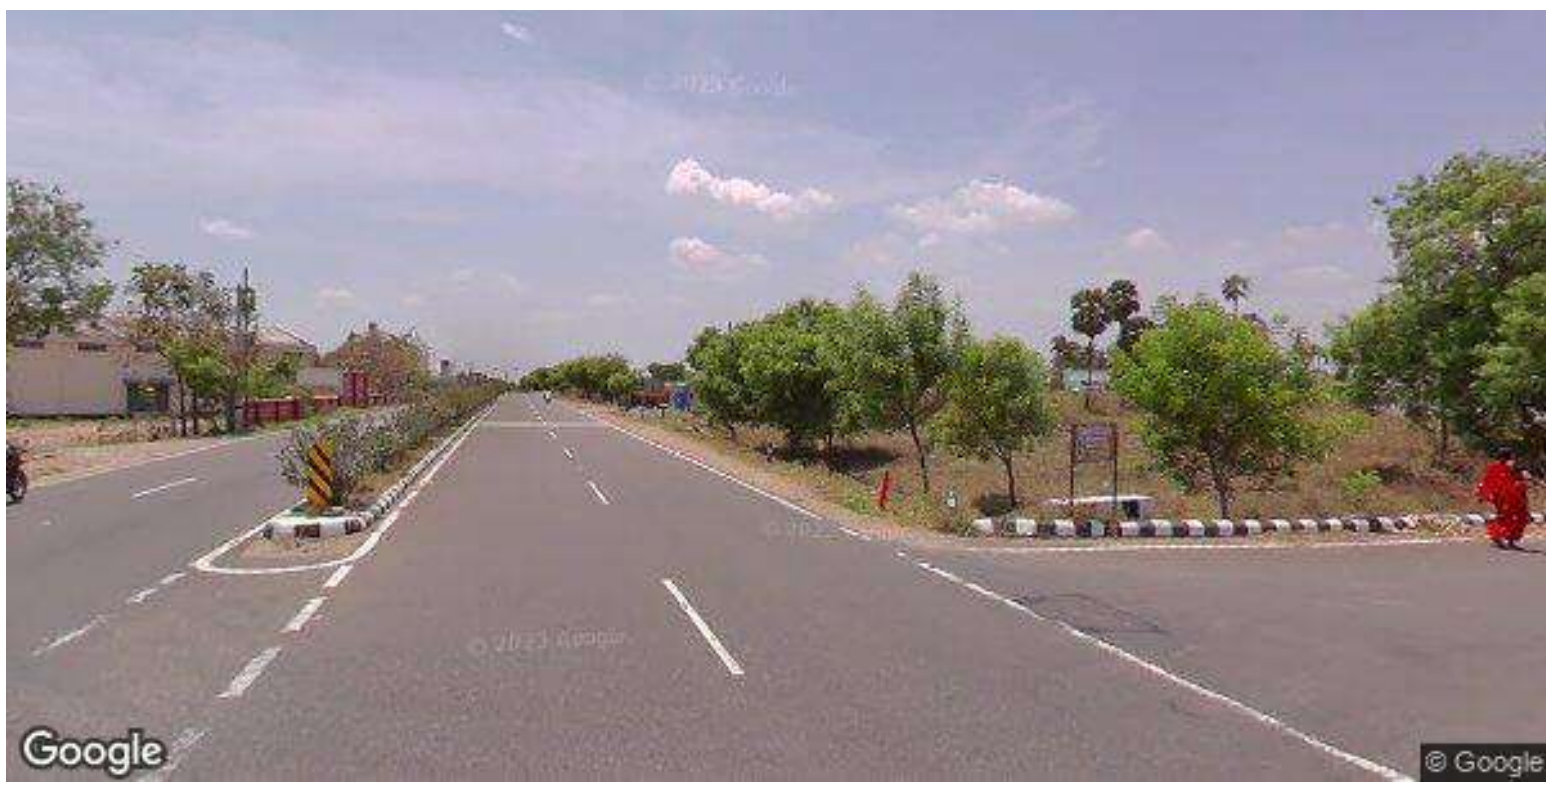
**Coordinates:** 11.27561, 78.08152

**Risk Type:** Blind Spot

**Risk Level:** Blind Spot

**Speed Limit:** 10 KM/Hr

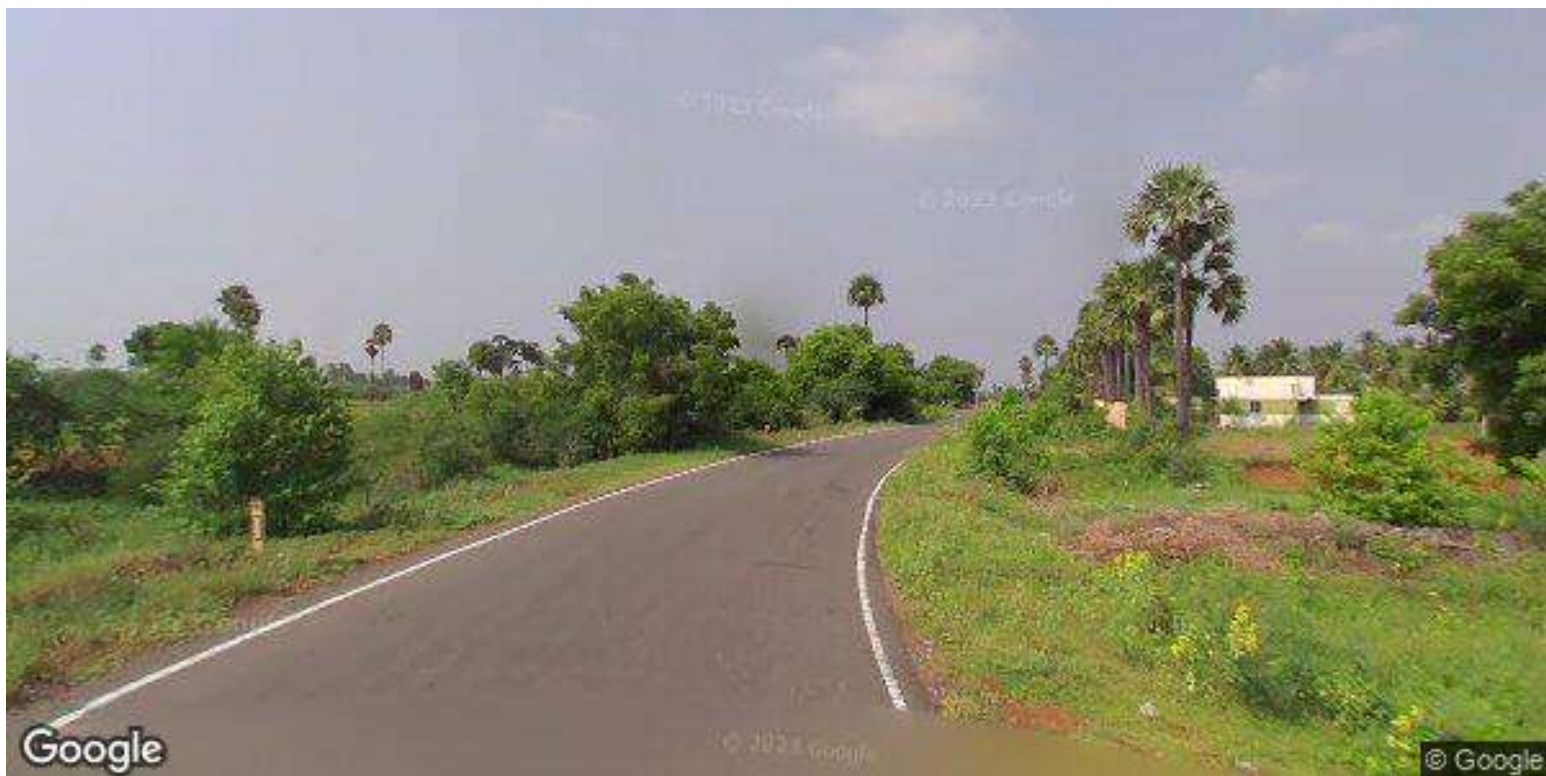
**Coordinates:** 11.28062, 78.08817

**Risk Type:** Turn

**Risk Level:** Medium

**Speed Limit:** 30 KM/Hr
