# IndianOil

## JOURNEY RISK MANAGEMENT (JRM) STUDY

### Salem Terminal to PONNI SERVICE STATION

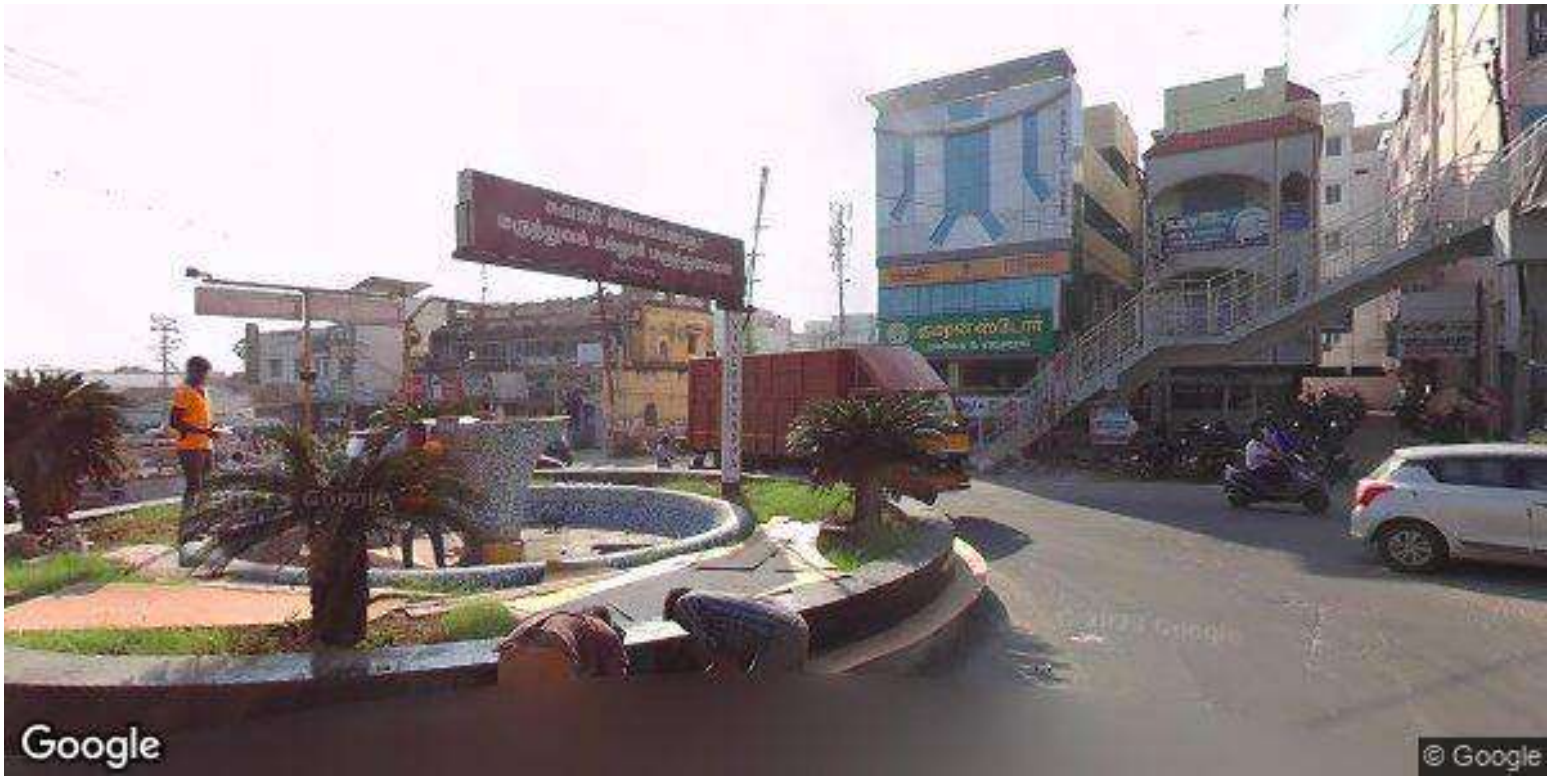
Risk Type: Roundabout  
Risk Level: High  
Speed Limit: 15 KM/Hr  
Coordinates: 11.38395, 77.89480

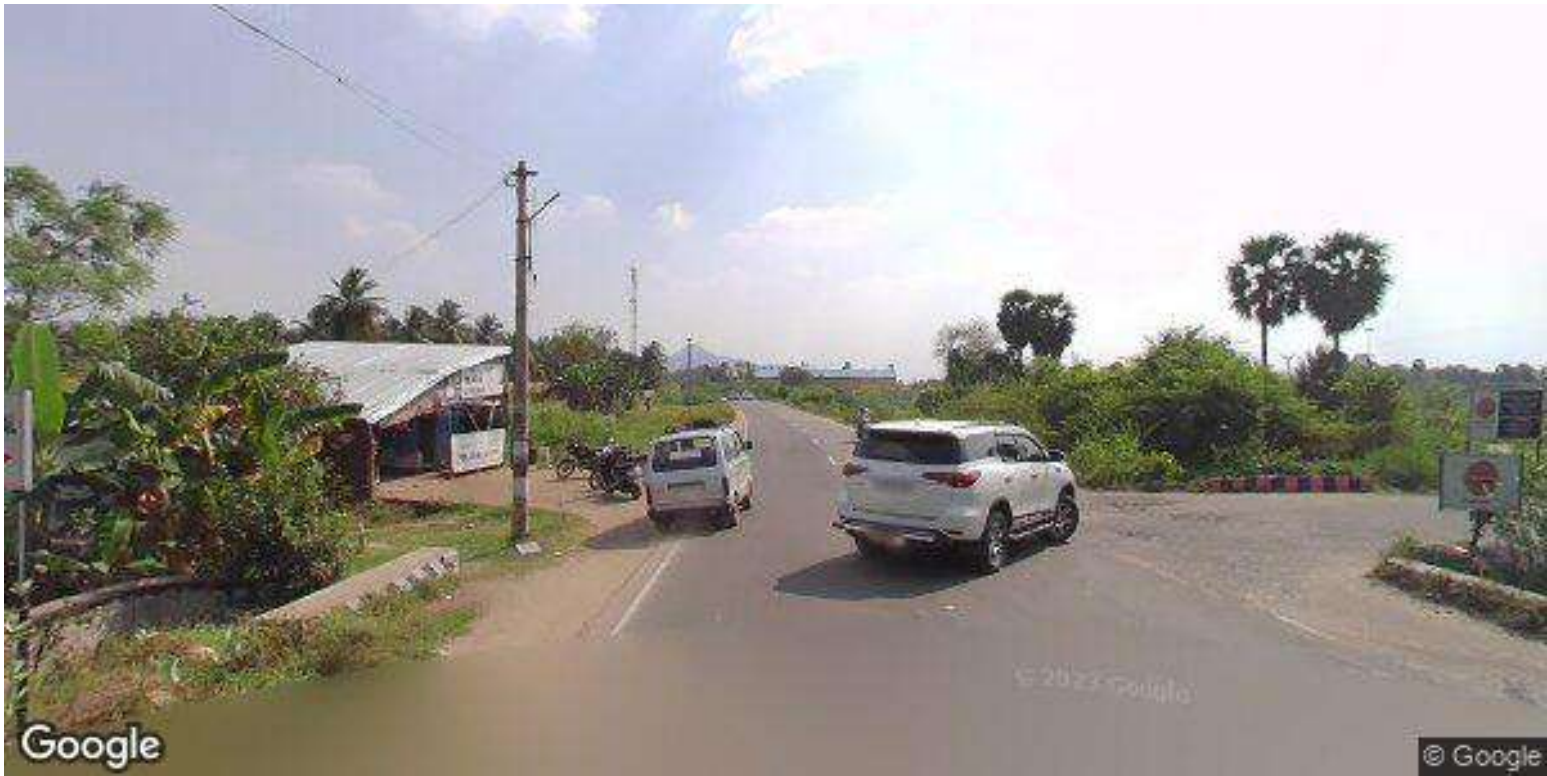
Risk Type: Blind Spot  
Risk Level: Blind Spot  
Speed Limit: 10 KM/Hr  
Coordinates: 11.44029, 77.87544

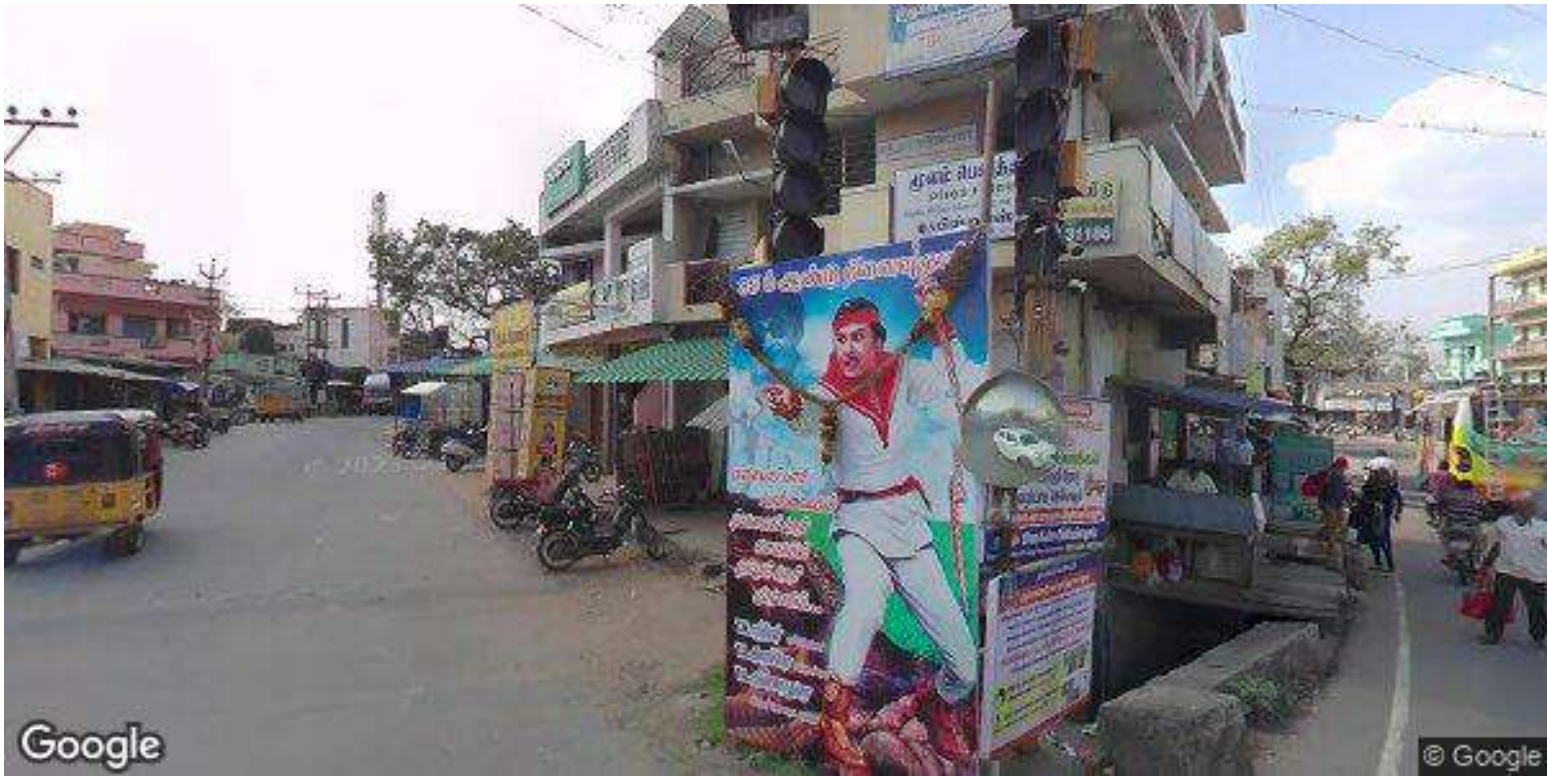
**Risk Type:** Turn  
**Risk Level:** Medium  
**Speed Limit:** 30 KM/Hr  
**Coordinates:** 11.38342, 77.89975

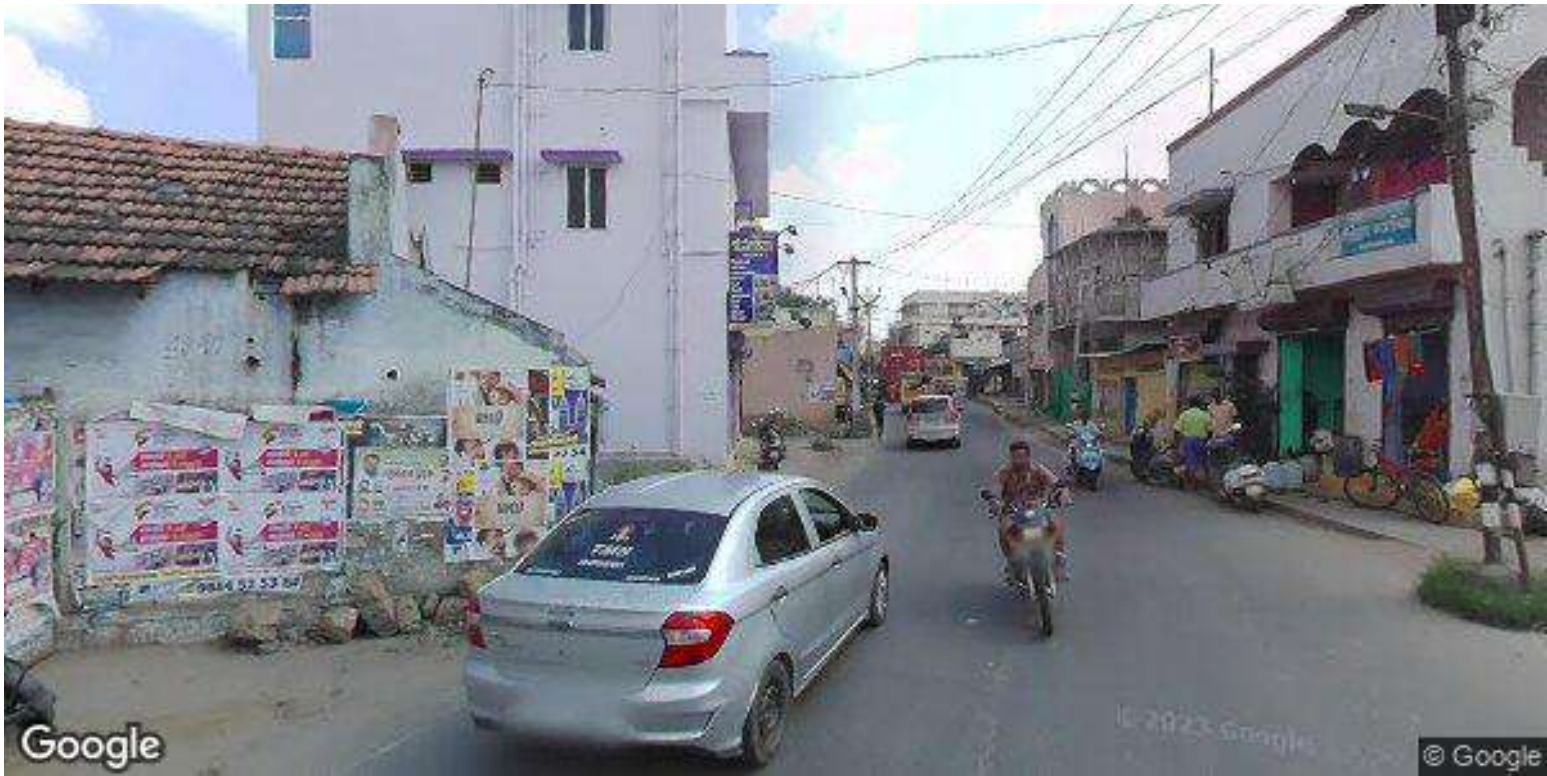
**Risk Type:** Turn  
**Risk Level:** Medium  
**Speed Limit:** 30 KM/Hr  
**Coordinates:** 11.38295, 77.90001

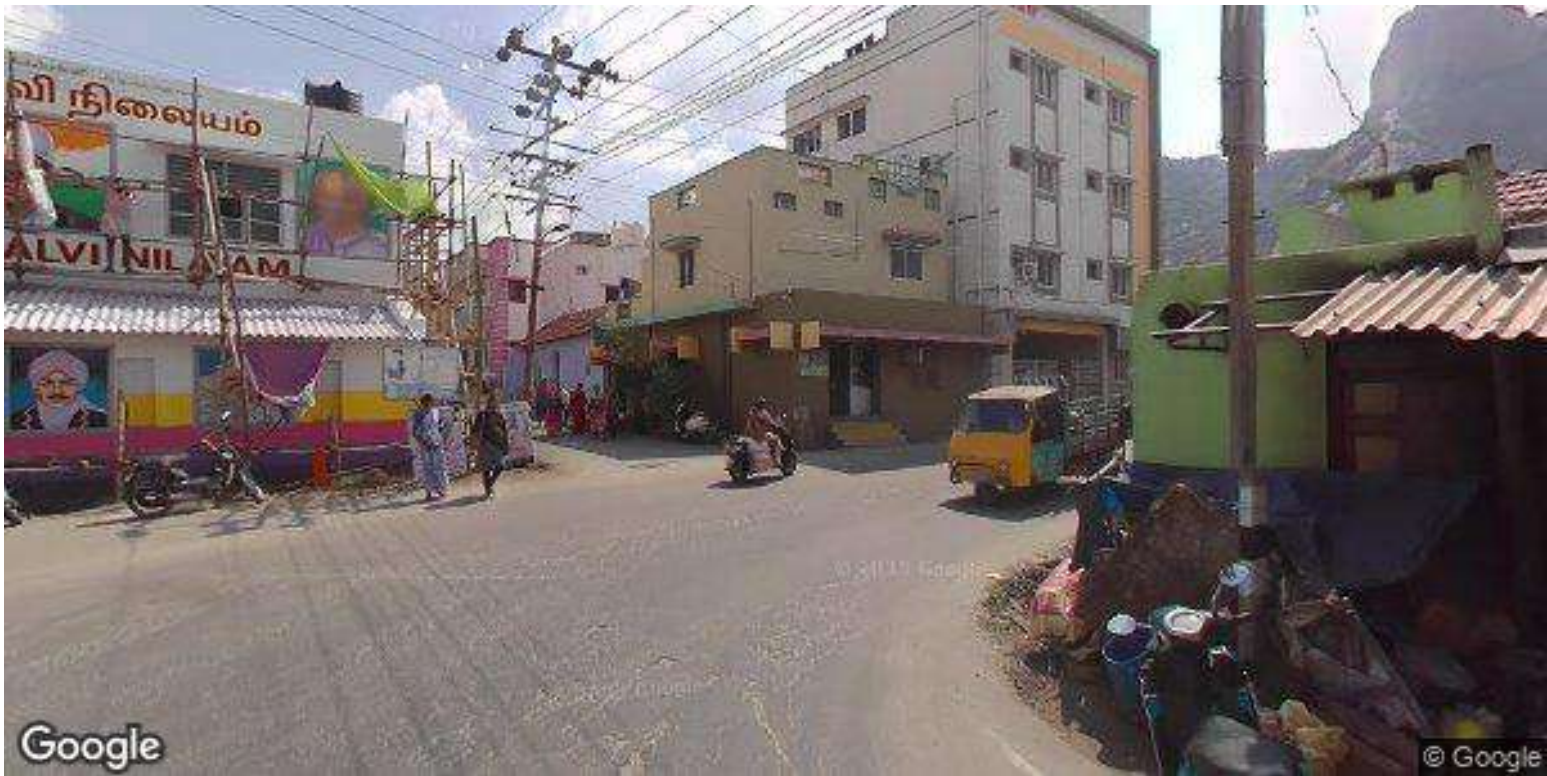
**Risk Type:** Turn  
**Risk Level:** High  
**Speed Limit:** 15 KM/Hr  
**Coordinates:** 11.38186, 77.90258

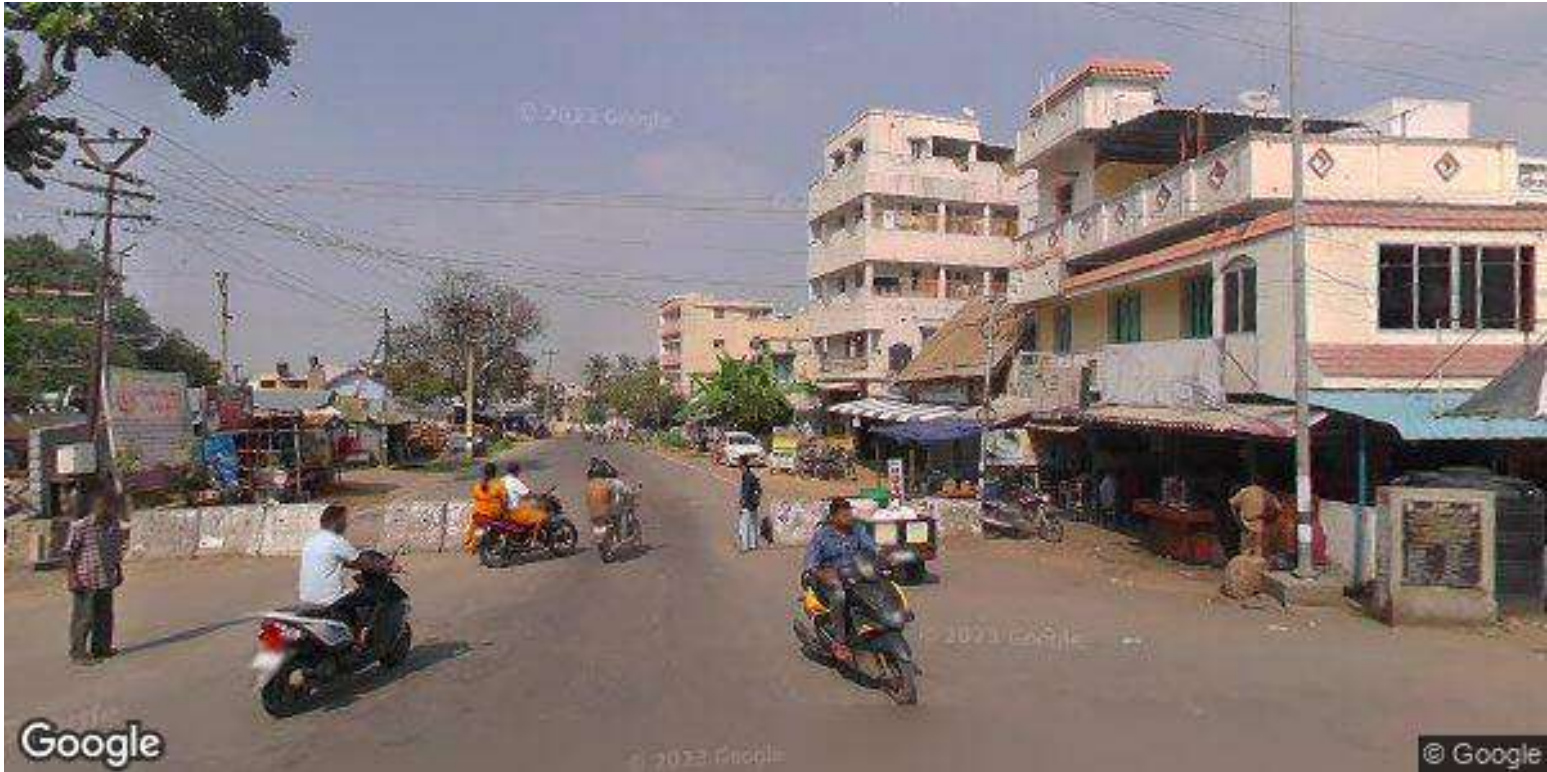
**Risk Type:** Blind Spot  
**Risk Level:** Blind Spot  
**Speed Limit:** 10 KM/Hr  
**Coordinates:** 11.37841, 77.90140

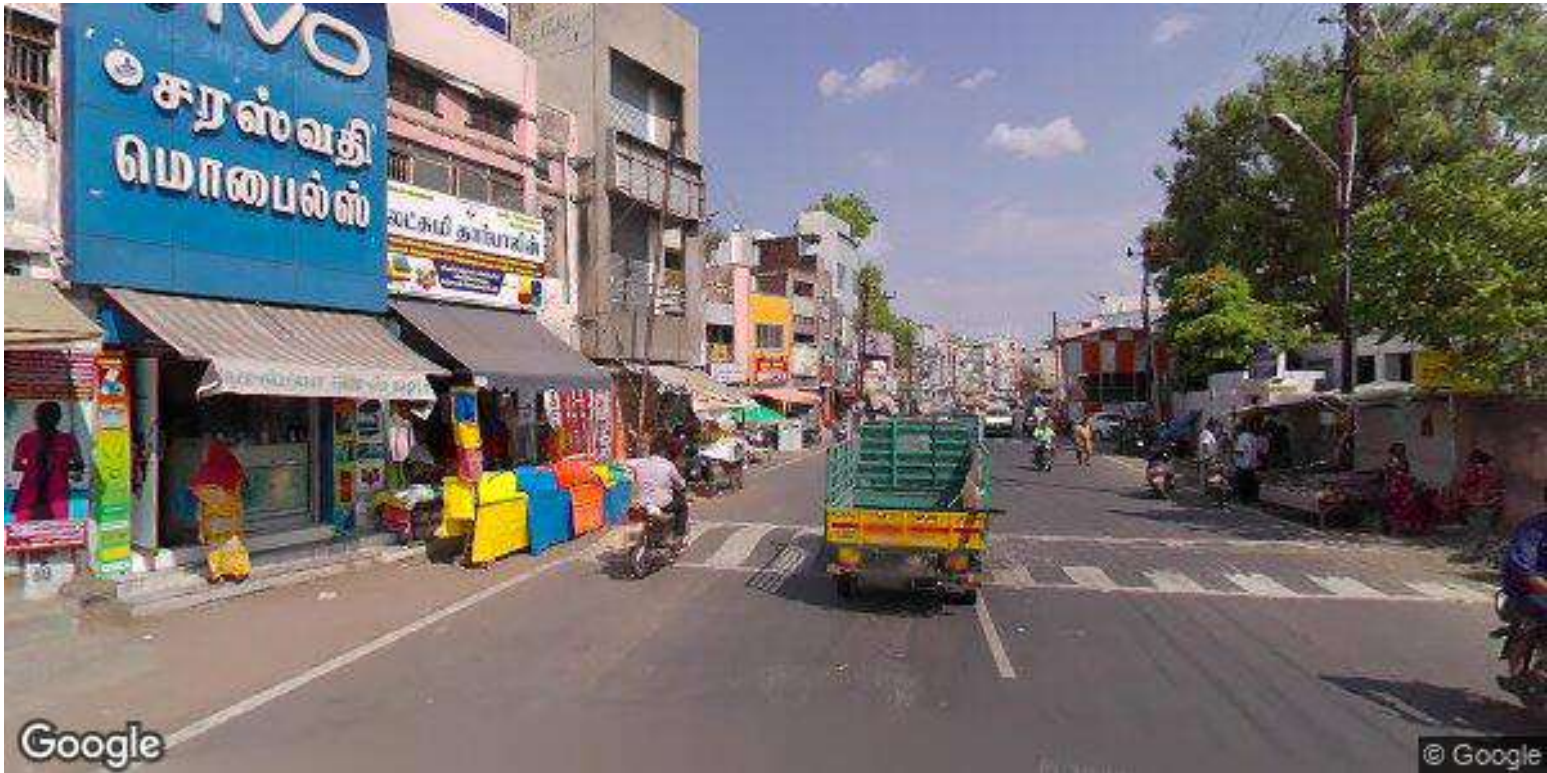
**Risk Type:** Turn  
**Risk Level:** Medium  
**Speed Limit:** 30 KM/Hr  
**Coordinates:** 11.22407, 78.16640

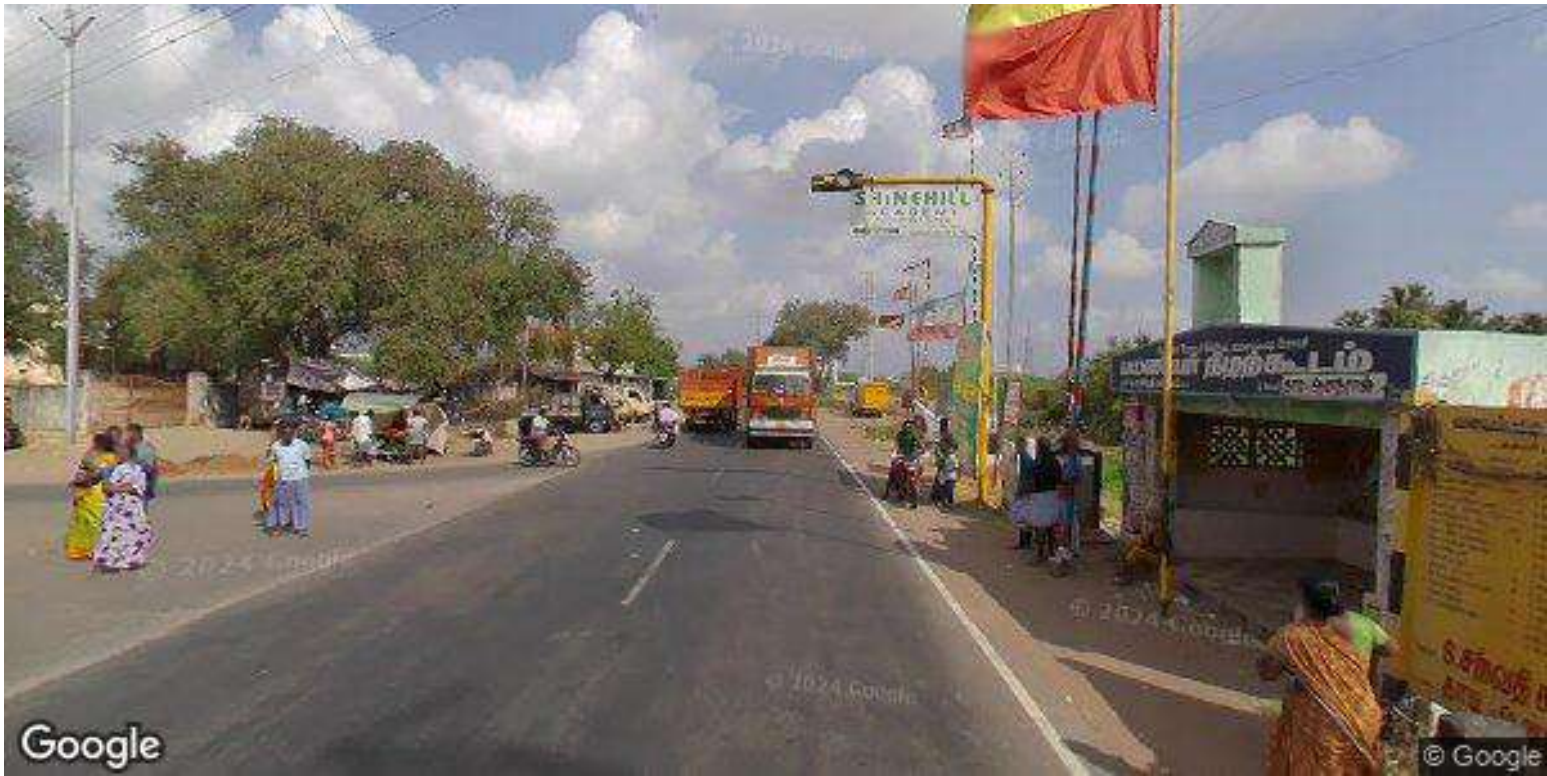
**Risk Type:** Blind Spot  
**Risk Level:** Blind Spot  
**Speed Limit:** 10 KM/Hr  
**Coordinates:** 11.12517, 78.23183

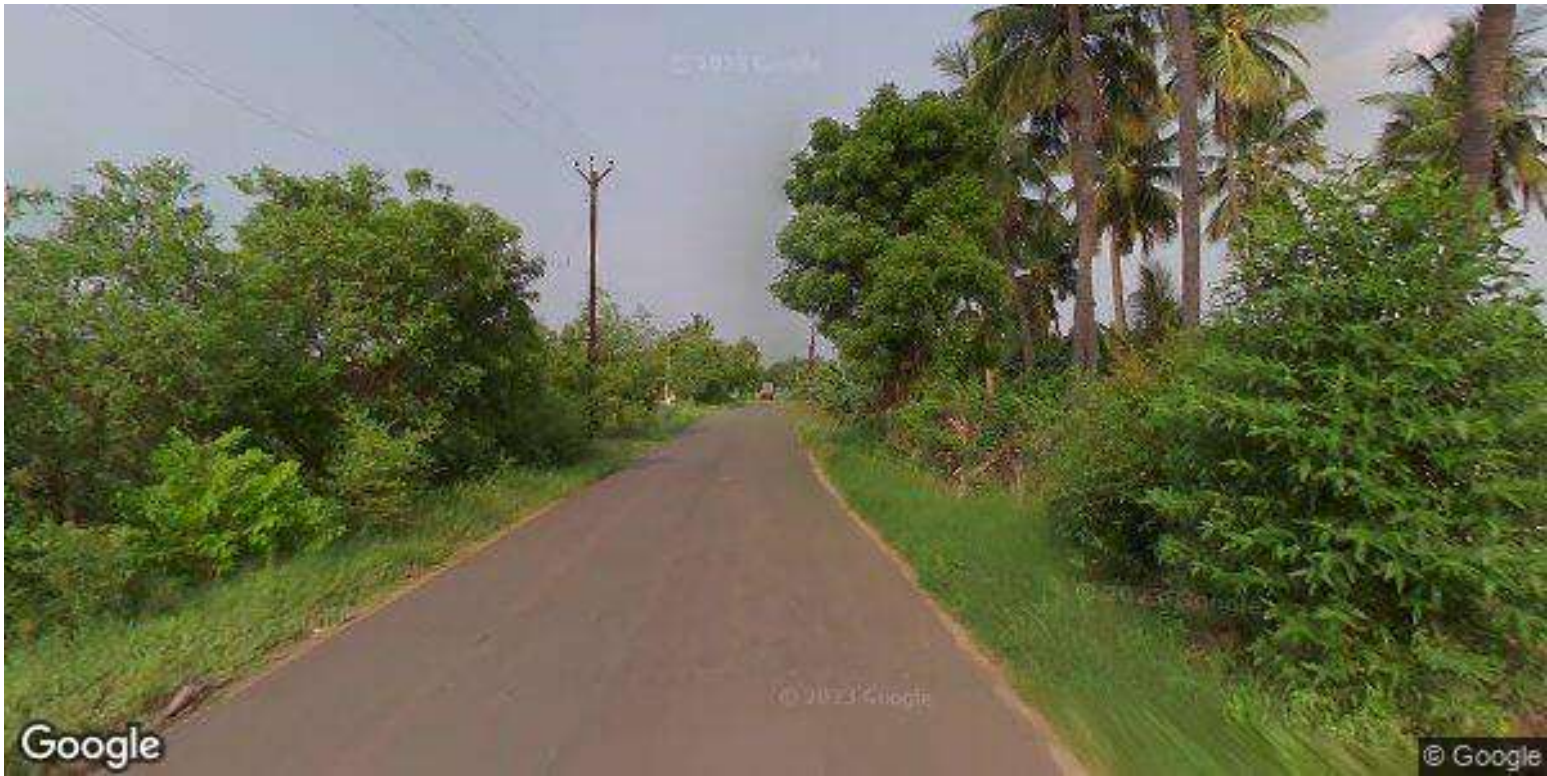
**Risk Type:** Turn  
**Risk Level:** High  
**Speed Limit:** 15 KM/Hr  
**Coordinates:** 11.09393, 78.18710
