# IndianOil

## JOURNEY RISK MANAGEMENT (JRM) STUDY

### Salem Terminal to KANNAPPAN AGENCY

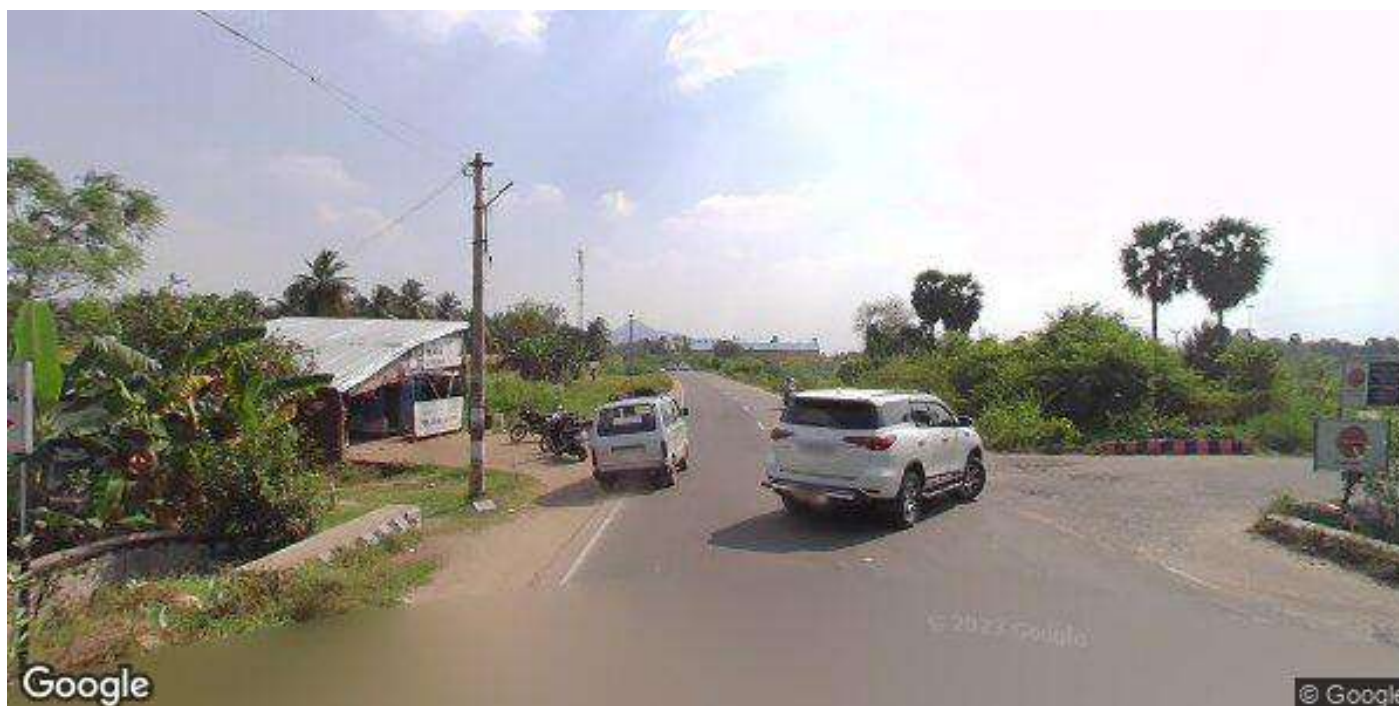
| | Risk Type | Risk Level | Coordinates | Speed Limit |
|---|---|---|---|---|
| 2 | Blind Spot | Blind Spot | 11.44029, 77.87544 | 10 KM/Hr |

**Risk Type:** Blind Spot  
**Risk Level:** Blind Spot  
**Speed Limit:** 10 KM/Hr  
**Coordinates:** 11.44029, 77.87544

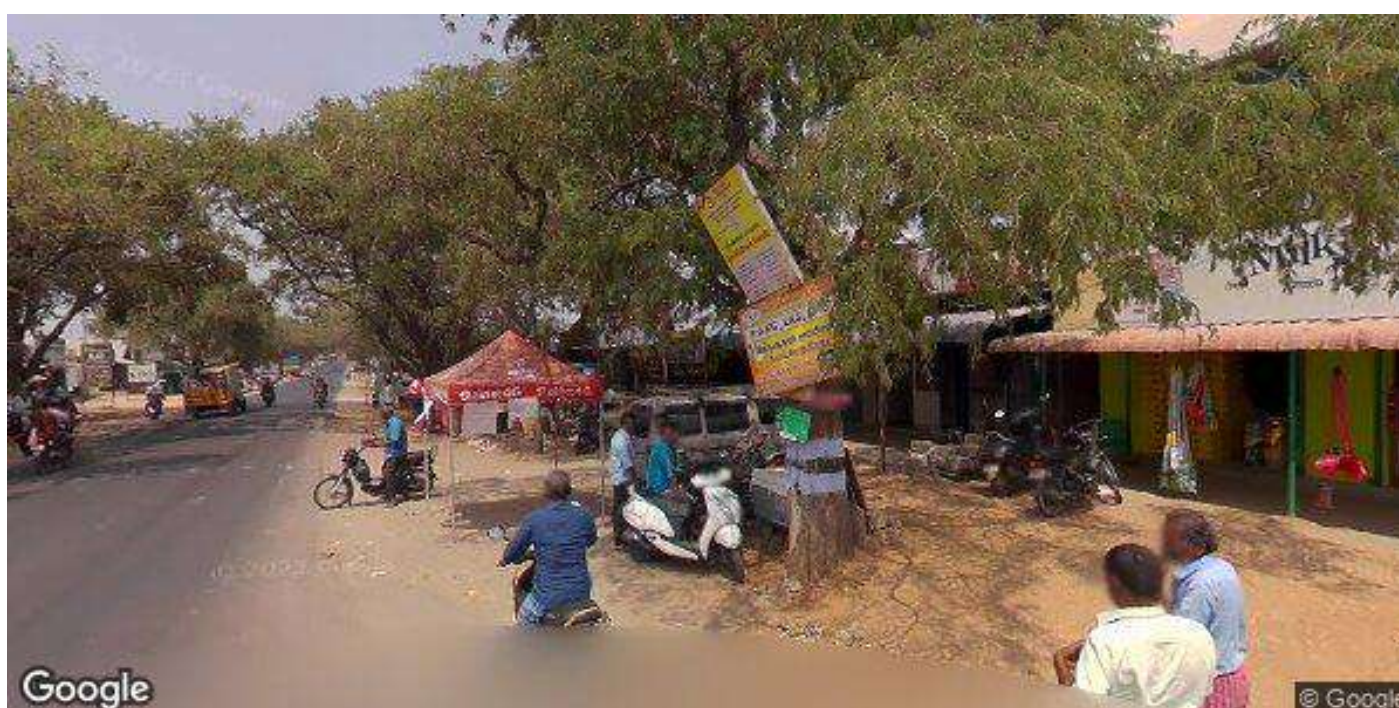
| | Risk Type | Risk Level | Coordinates | Speed Limit |
|---|---|---|---|---|
| 3 | Turn | High | 11.41981, 77.88078 | 15 KM/Hr |

**Risk Type:** Turn  
**Risk Level:** High  
**Speed Limit:** 15 KM/Hr  
**Coordinates:** 11.41981, 77.88078

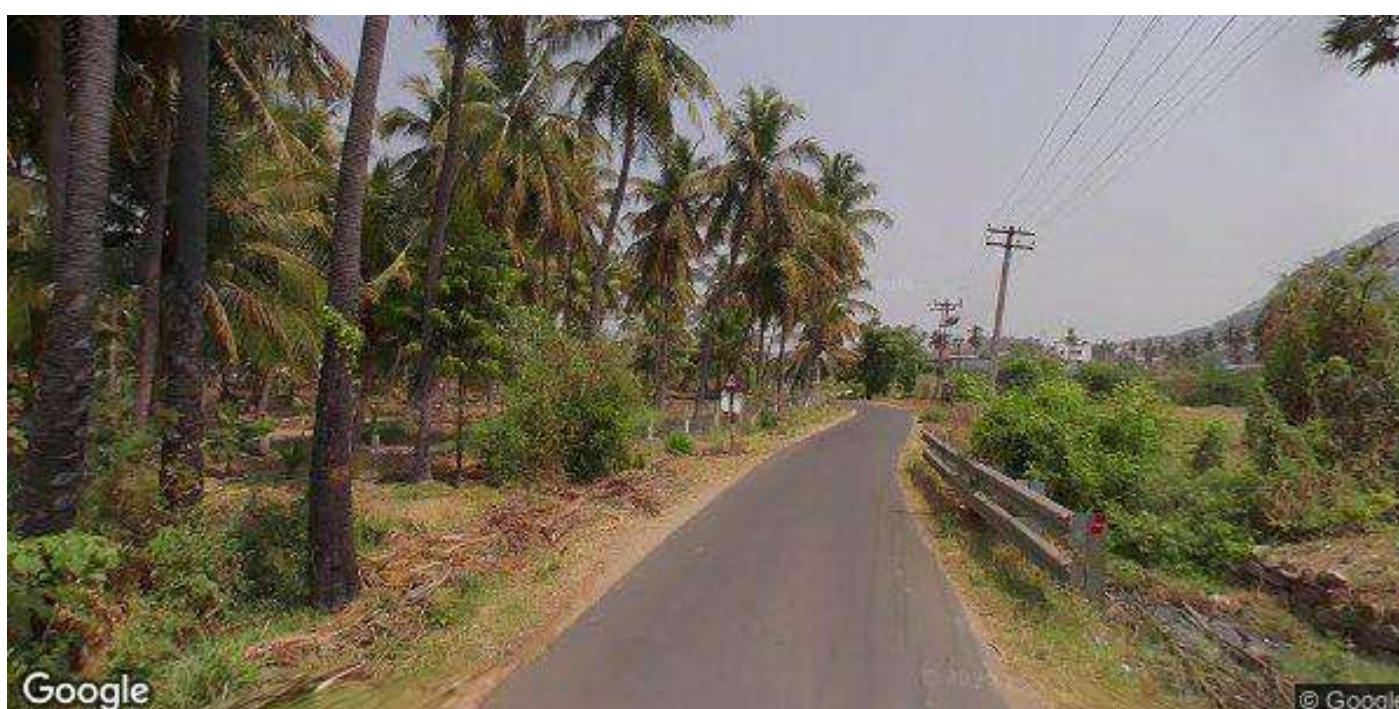
**Risk Type:** Turn  
**Risk Level:** Medium

**Speed Limit: 30 KM/Hr**  
**Coordinates: 11.41876, 77.88487**

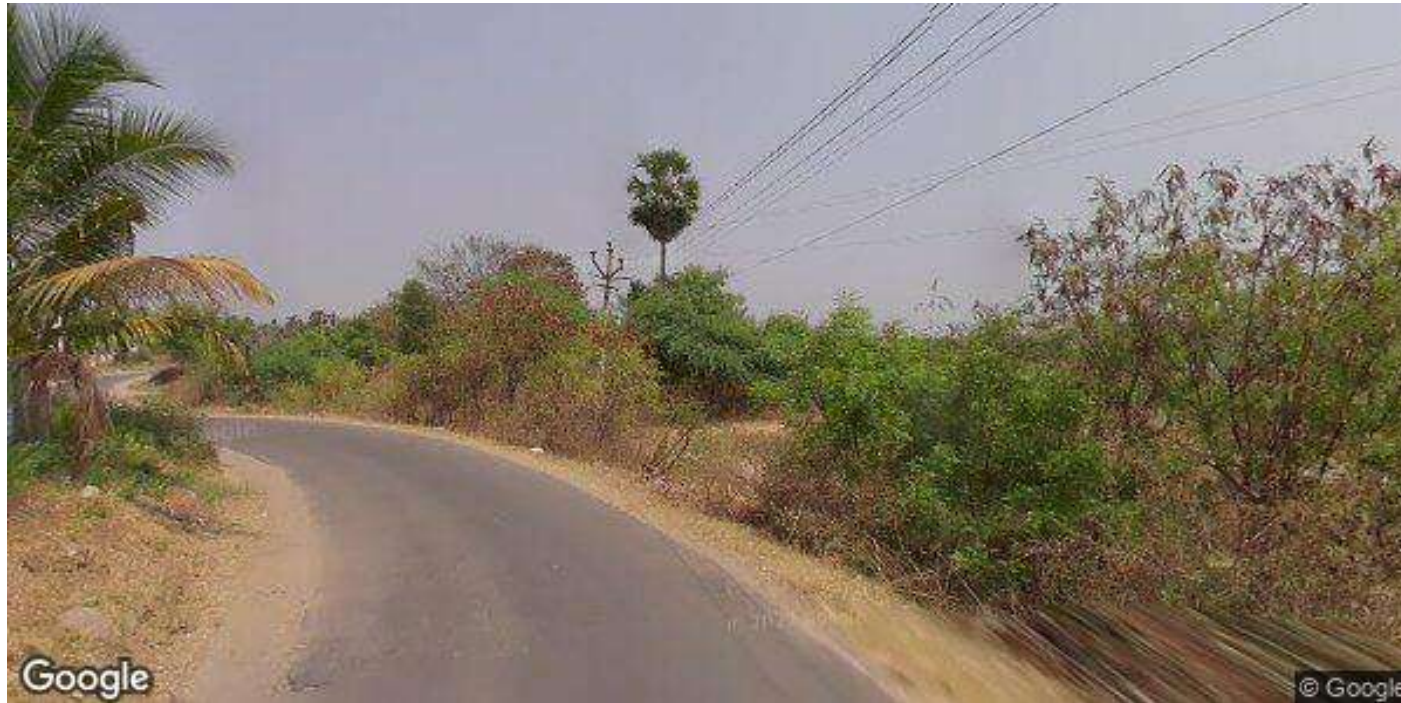
**Risk Type: Turn**  
**Risk Level: Medium**  
**Speed Limit: 30 KM/Hr**  
**Coordinates: 11.41829, 77.88568**

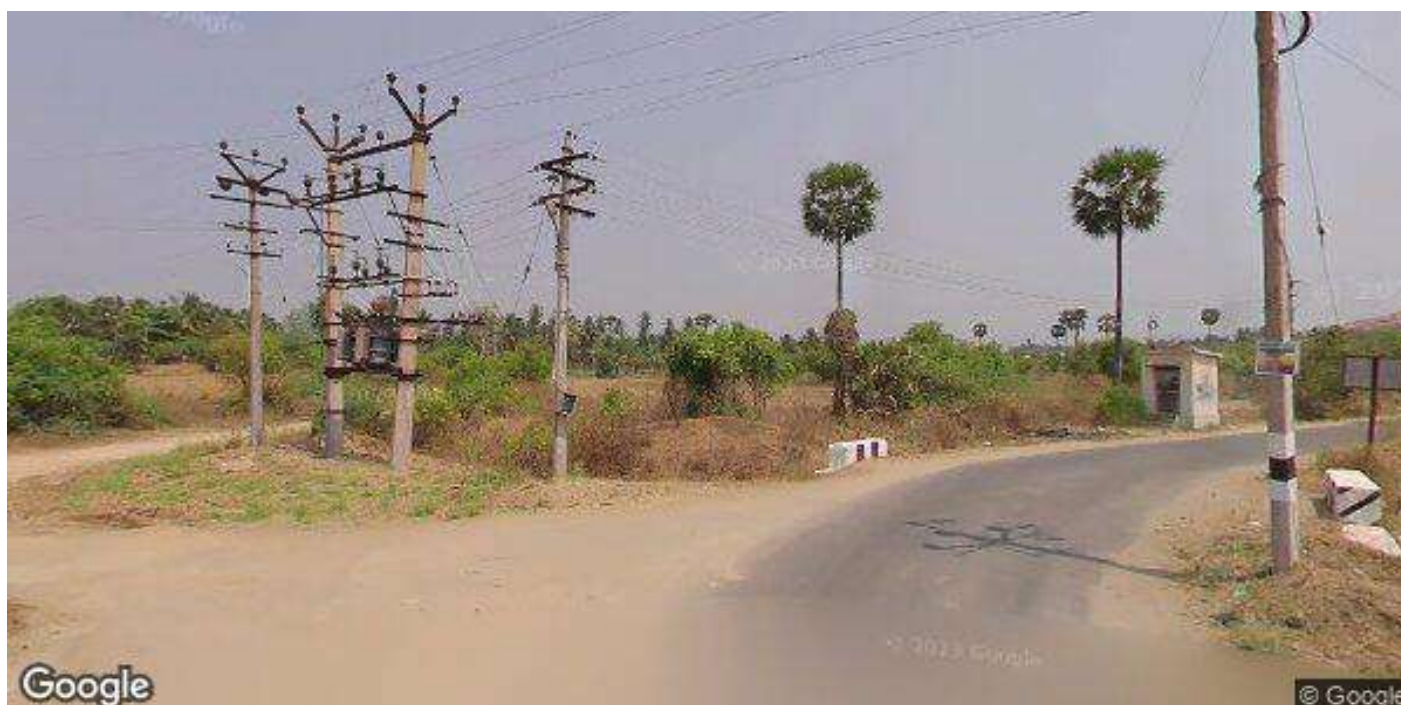
**Risk Type: Turn**  
**Risk Level: High**  
**Speed Limit: 15 KM/Hr**  
**Coordinates: 11.41859, 77.88692**

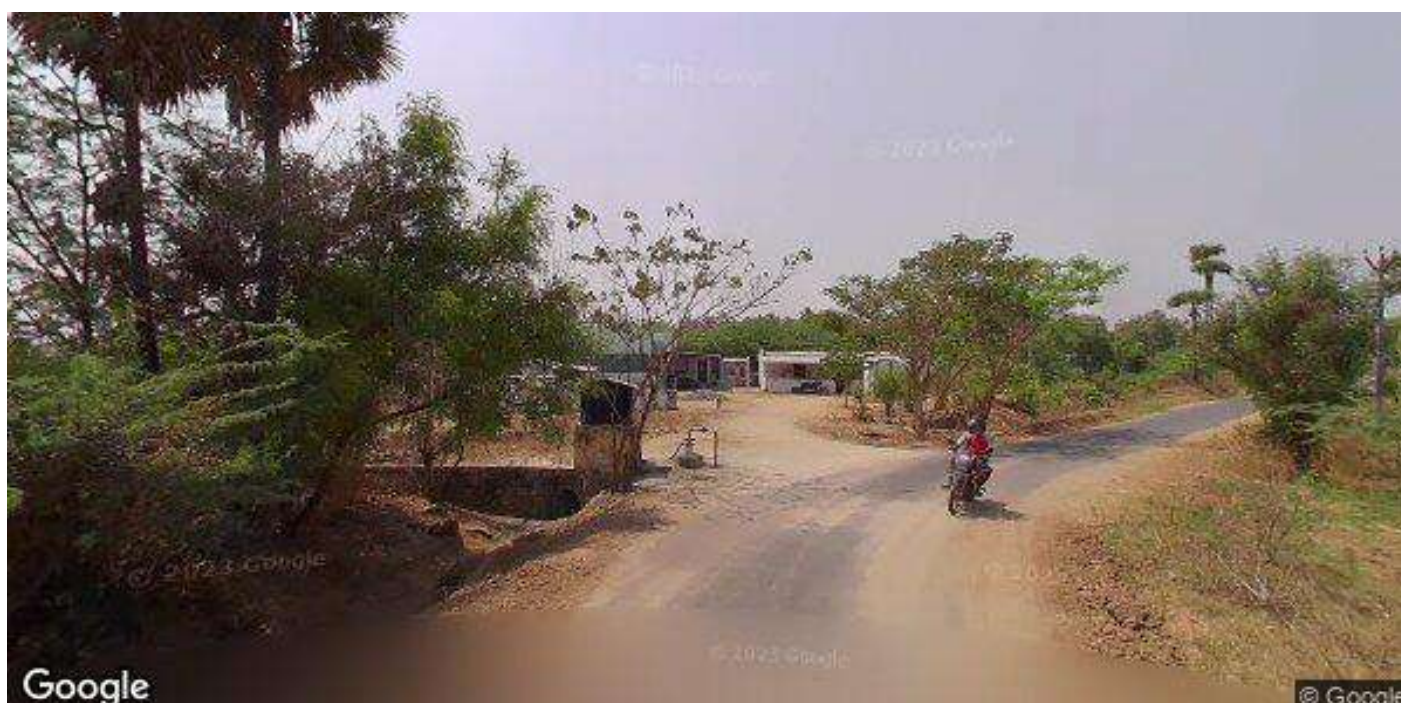
**Risk Type:** Turn  
**Risk Level:** Medium  
**Speed Limit:** 30 KM/Hr  
**Coordinates:** 11.41761, 77.88739

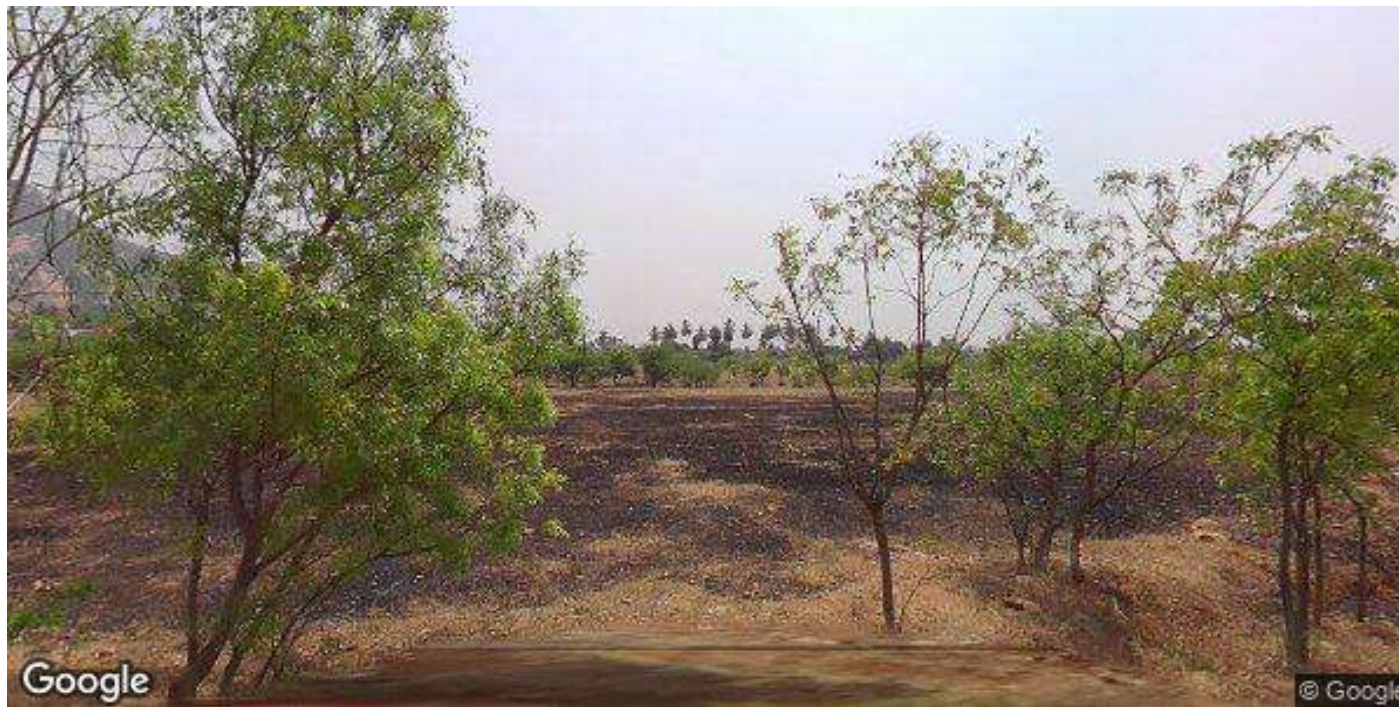
**Risk Type:** Turn  
**Risk Level:** Medium  
**Speed Limit:** 30 KM/Hr  
**Coordinates:** 11.41716, 77.88935

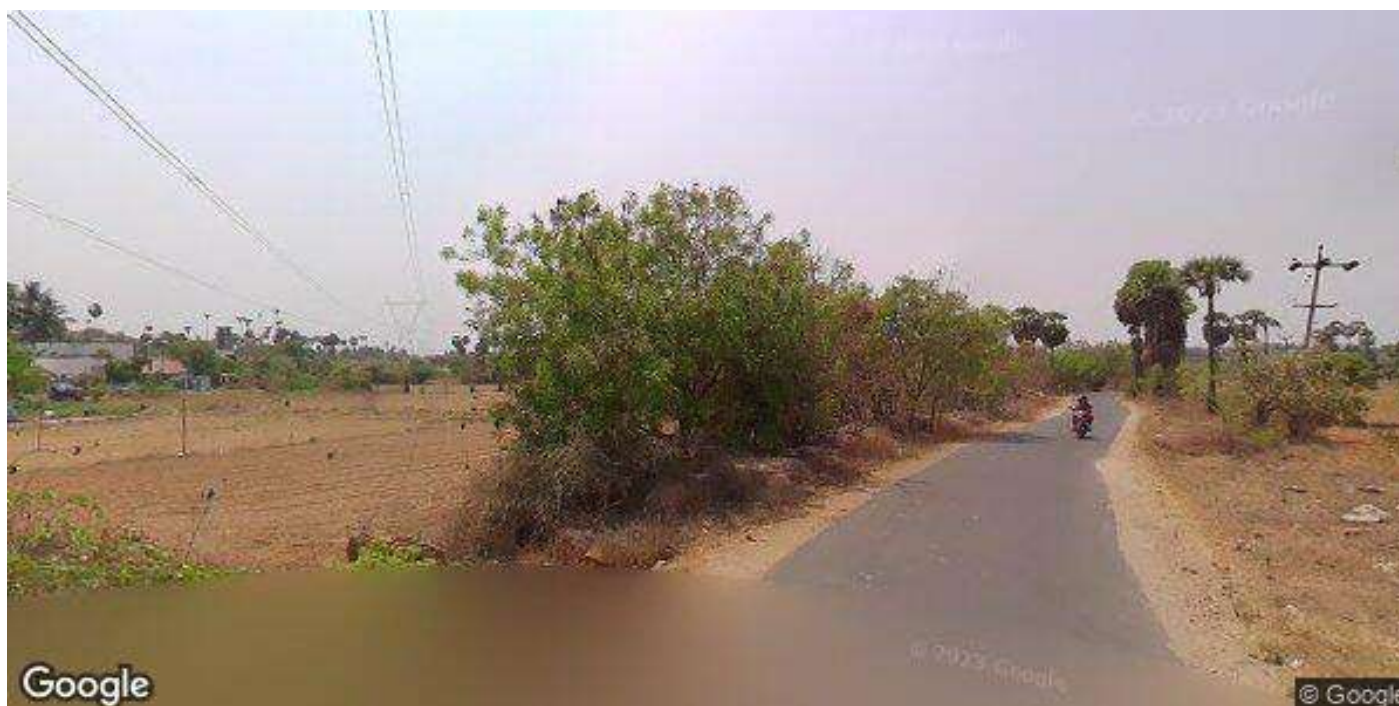
**Risk Type:** Turn  
**Risk Level:** Medium  
**Speed Limit:** 30 KM/Hr  
**Coordinates:** 11.41630, 77.89077

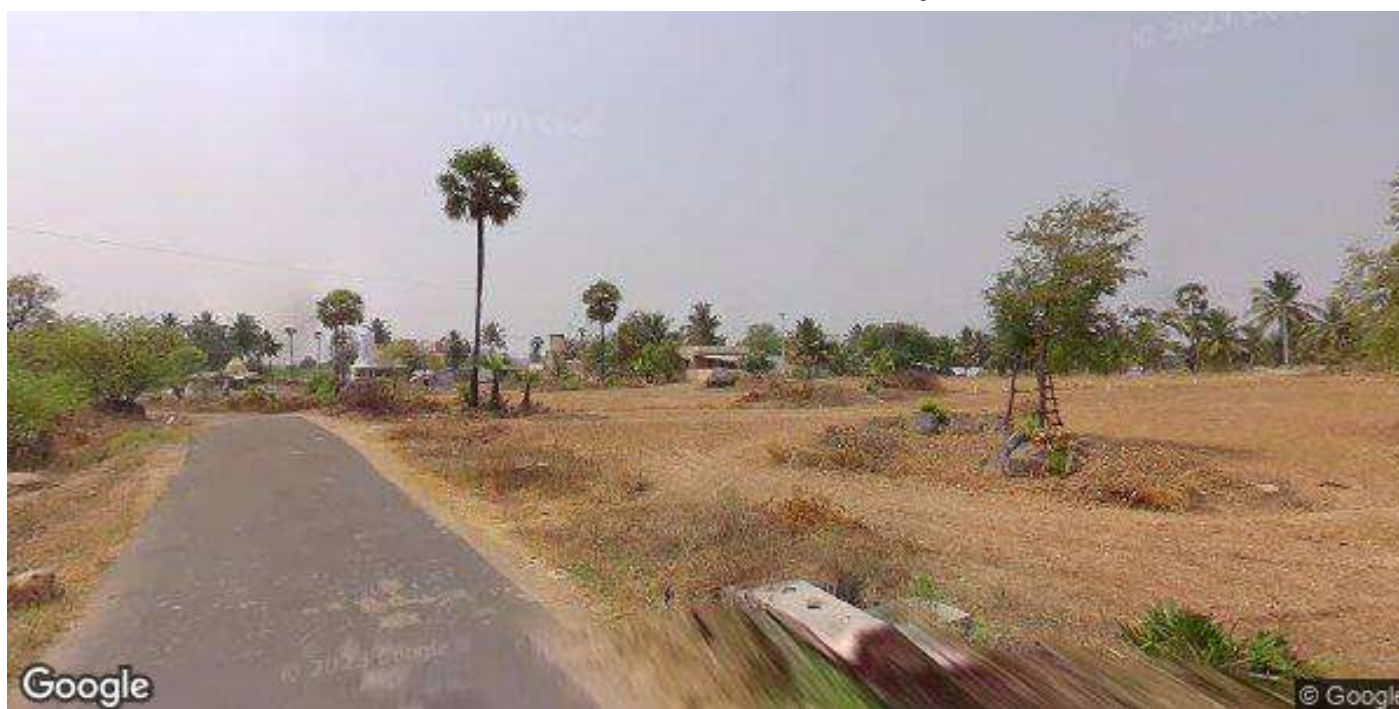
**Risk Type:** Turn  
**Risk Level:** Medium  
**Speed Limit:** 30 KM/Hr  
**Coordinates:** 11.41603, 77.89479

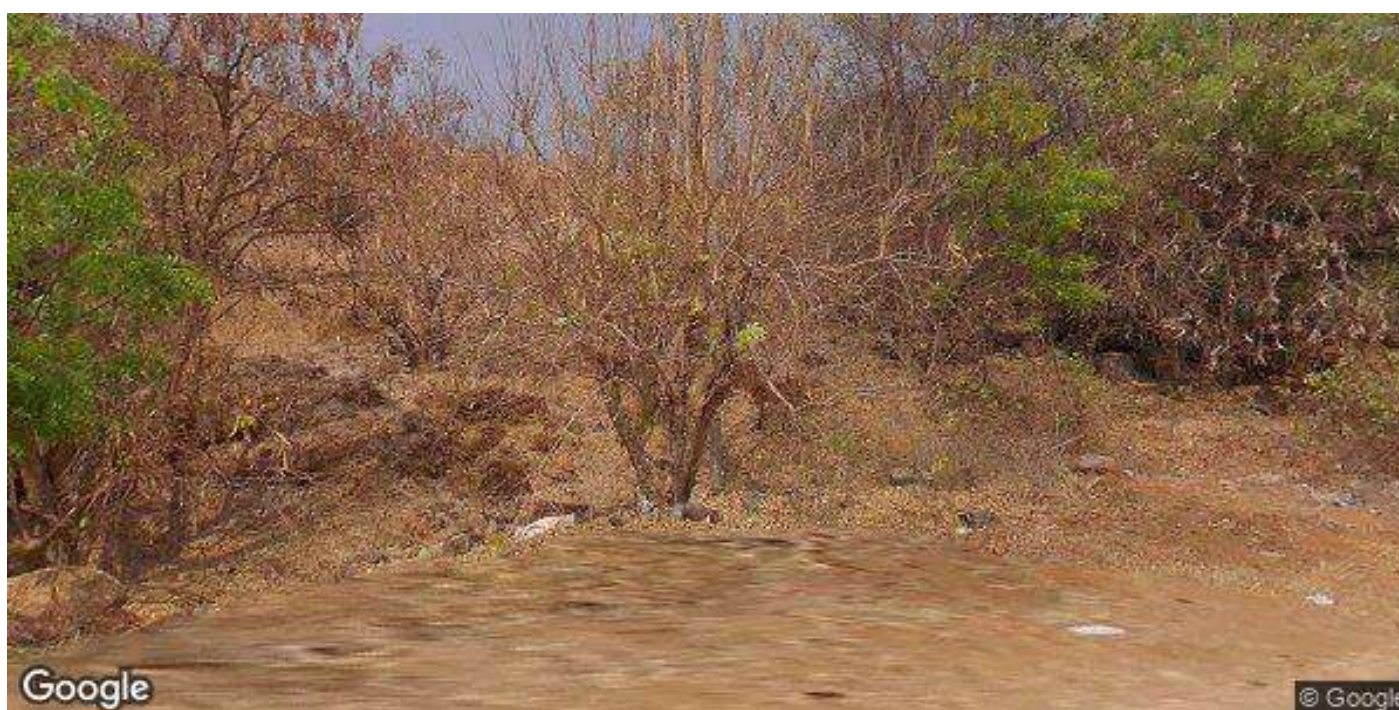
**Risk Type:** Turn  
**Risk Level:** Medium  
**Speed Limit:** 30 KM/Hr  
**Coordinates:** 11.41439, 77.90025

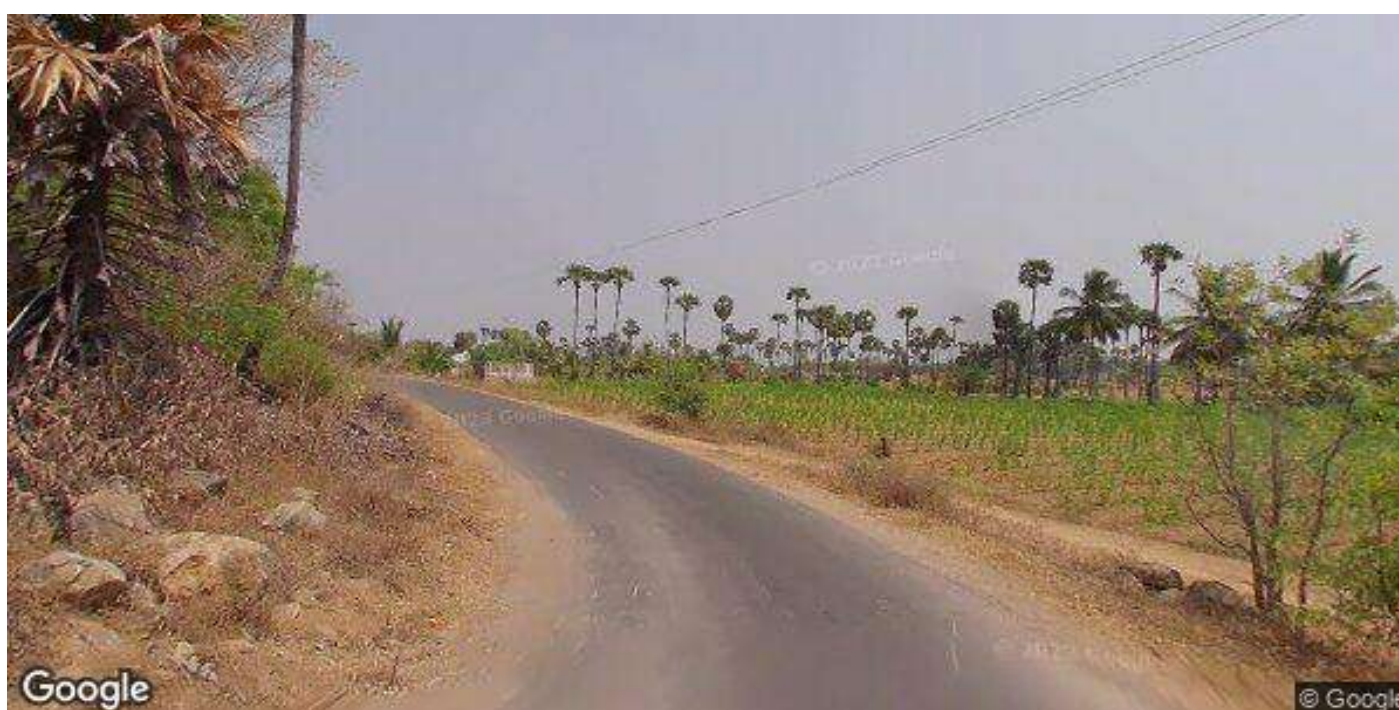
**Risk Type:** Turn  
**Risk Level:** High  
**Speed Limit:** 15 KM/Hr  
**Coordinates:** 11.41377, 77.90073

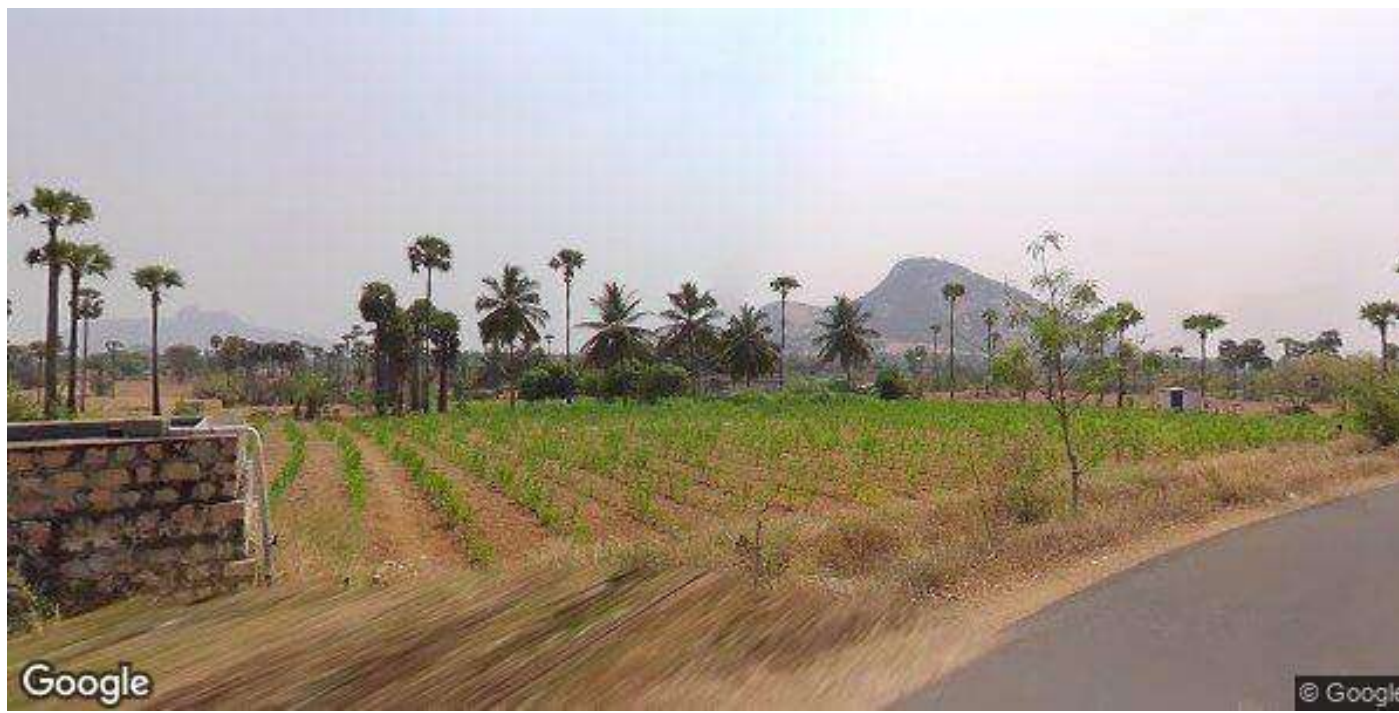
**Risk Type:** Turn  
**Risk Level:** Medium  
**Speed Limit:** 30 KM/Hr  
**Coordinates:** 11.41375, 77.90128

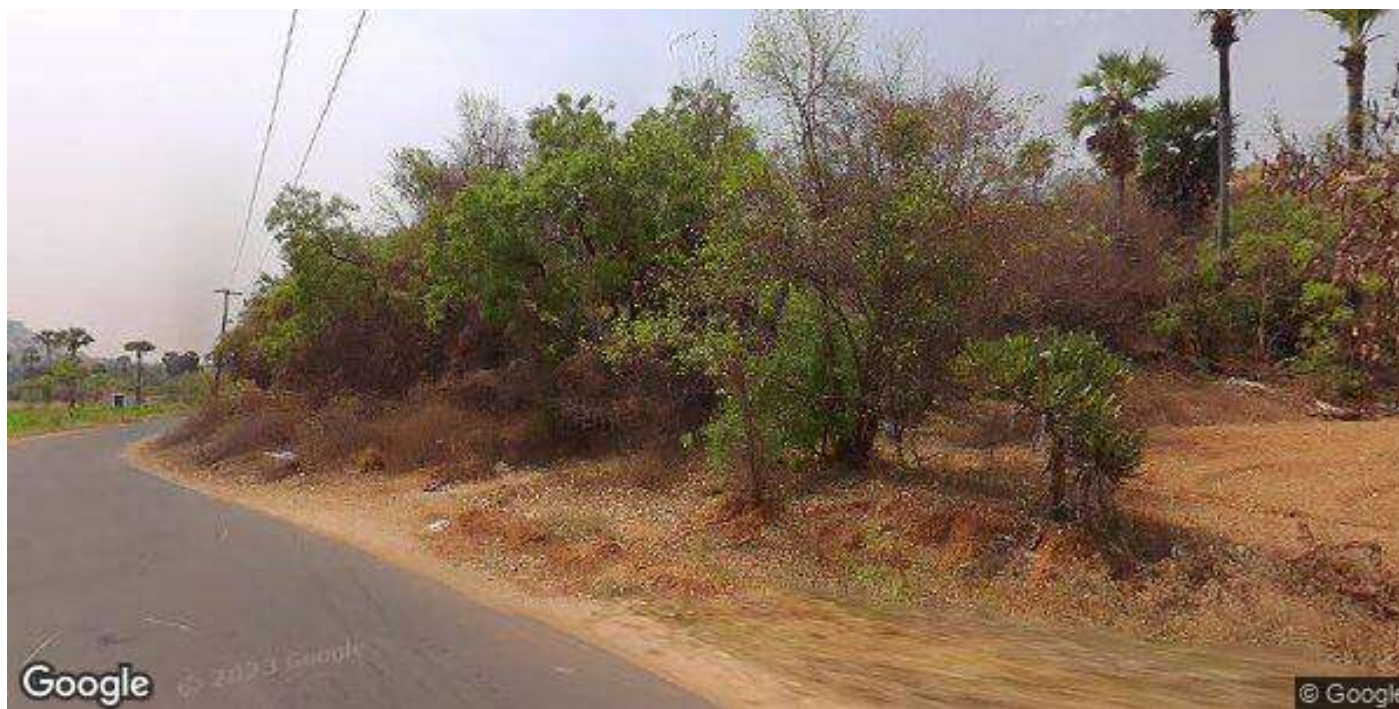
**Risk Type:** Turn  
**Risk Level:** Medium  
**Speed Limit:** 30 KM/Hr  
**Coordinates:** 11.41389, 77.90161

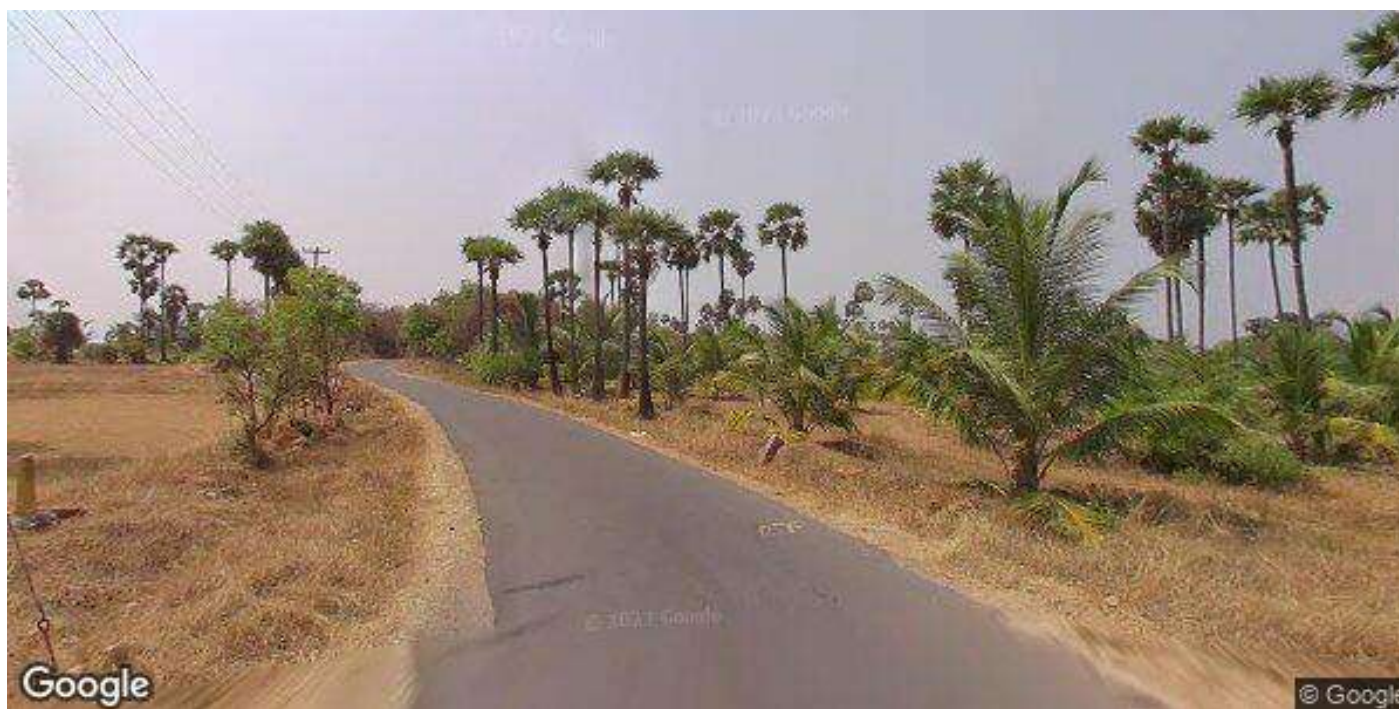
**Risk Type:** Turn  
**Risk Level:** Medium  
**Speed Limit:** 30 KM/Hr  
**Coordinates:** 11.41325, 77.90313

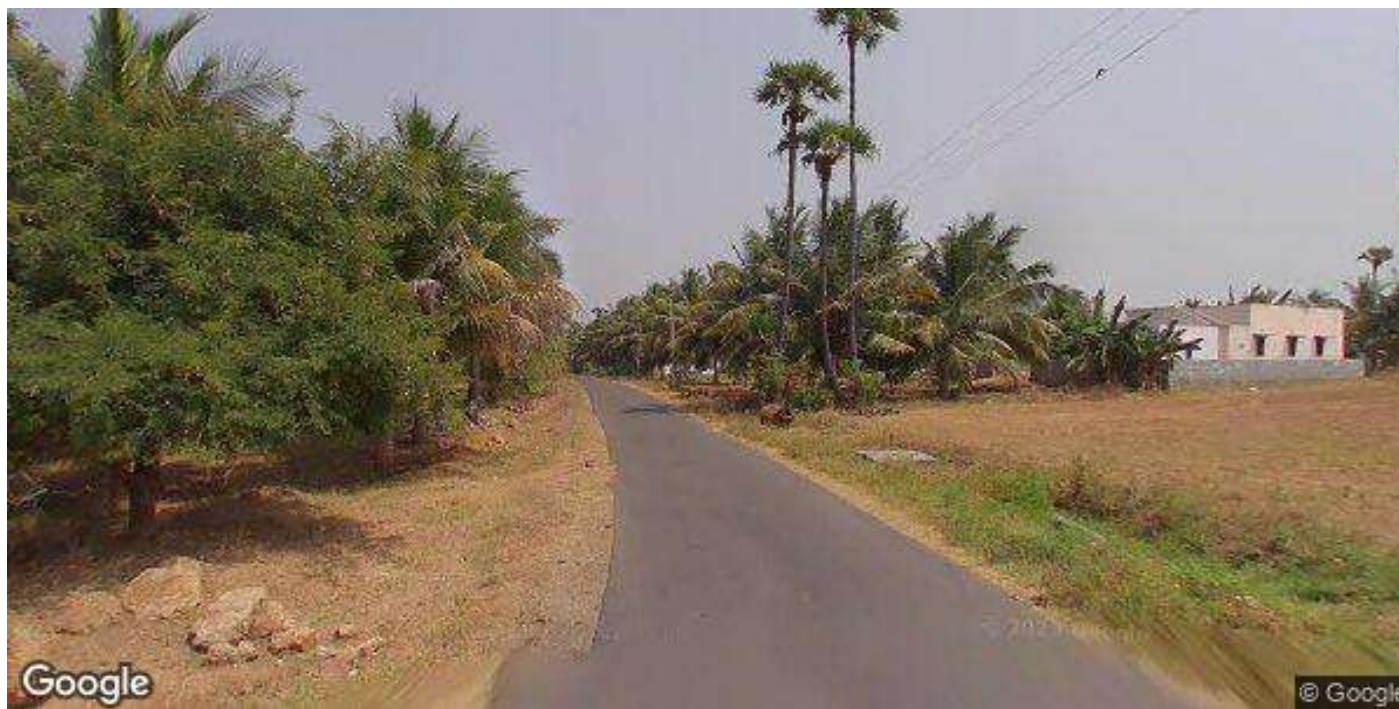
**Risk Type:** Turn  
**Risk Level:** Medium  
**Speed Limit:** 30 KM/Hr  
**Coordinates:** 11.41276, 77.90349

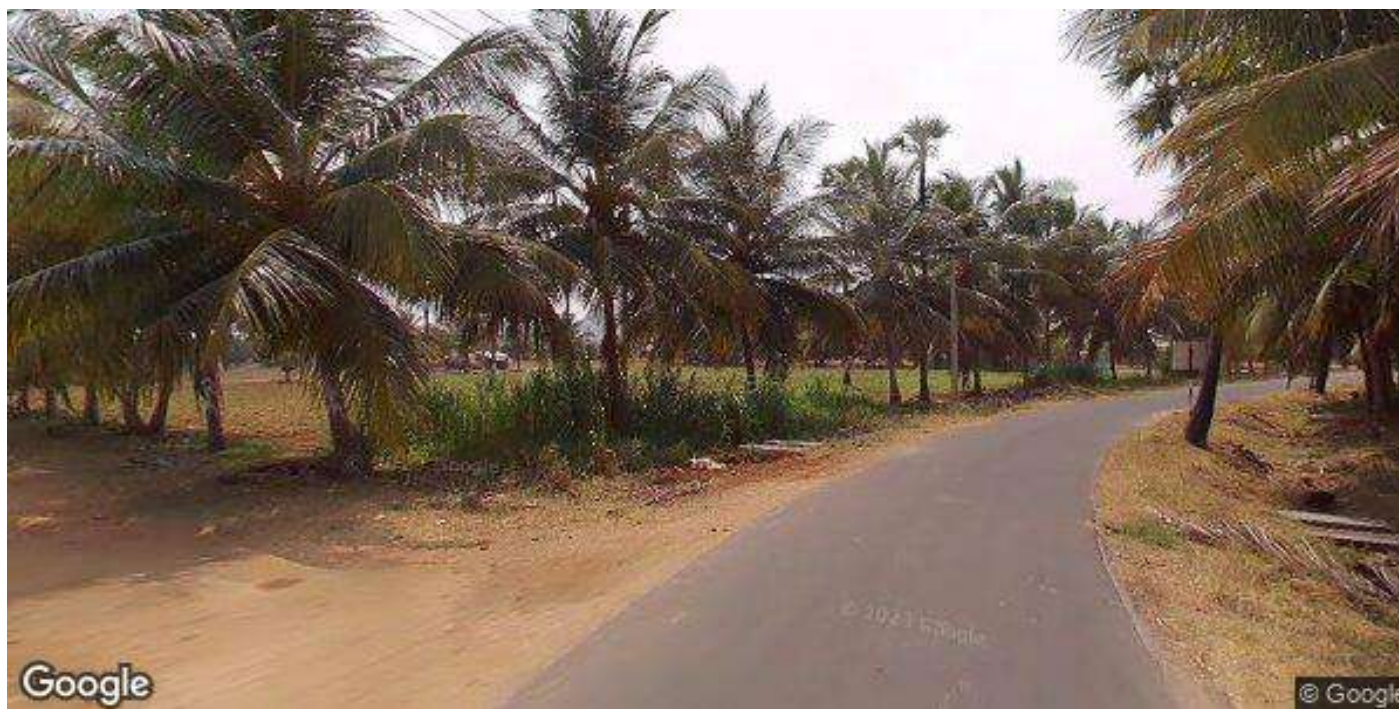
**Risk Type:** Turn  
**Risk Level:** High  
**Speed Limit:** 15 KM/Hr  
**Coordinates:** 11.41230, 77.90485

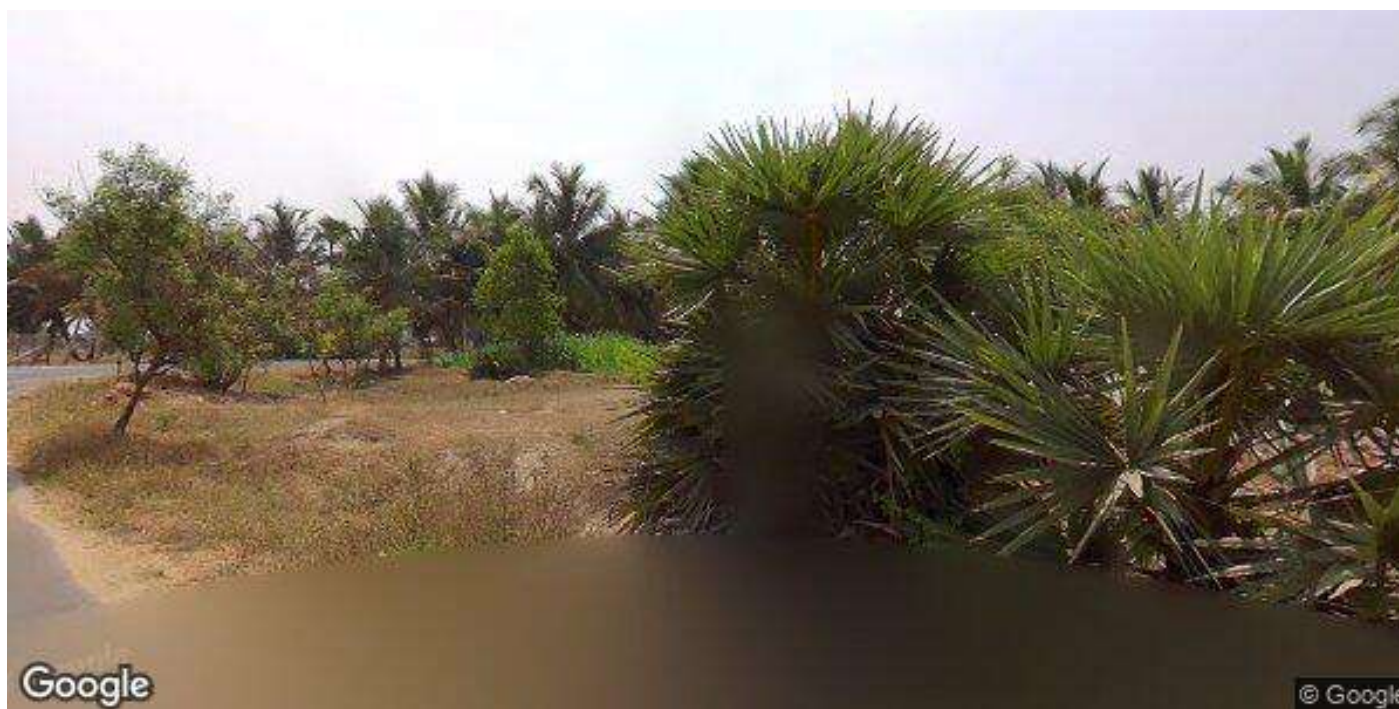
**Risk Type:** Turn  
**Risk Level:** Medium  
**Speed Limit:** 30 KM/Hr  
**Coordinates:** 11.41262, 77.90506

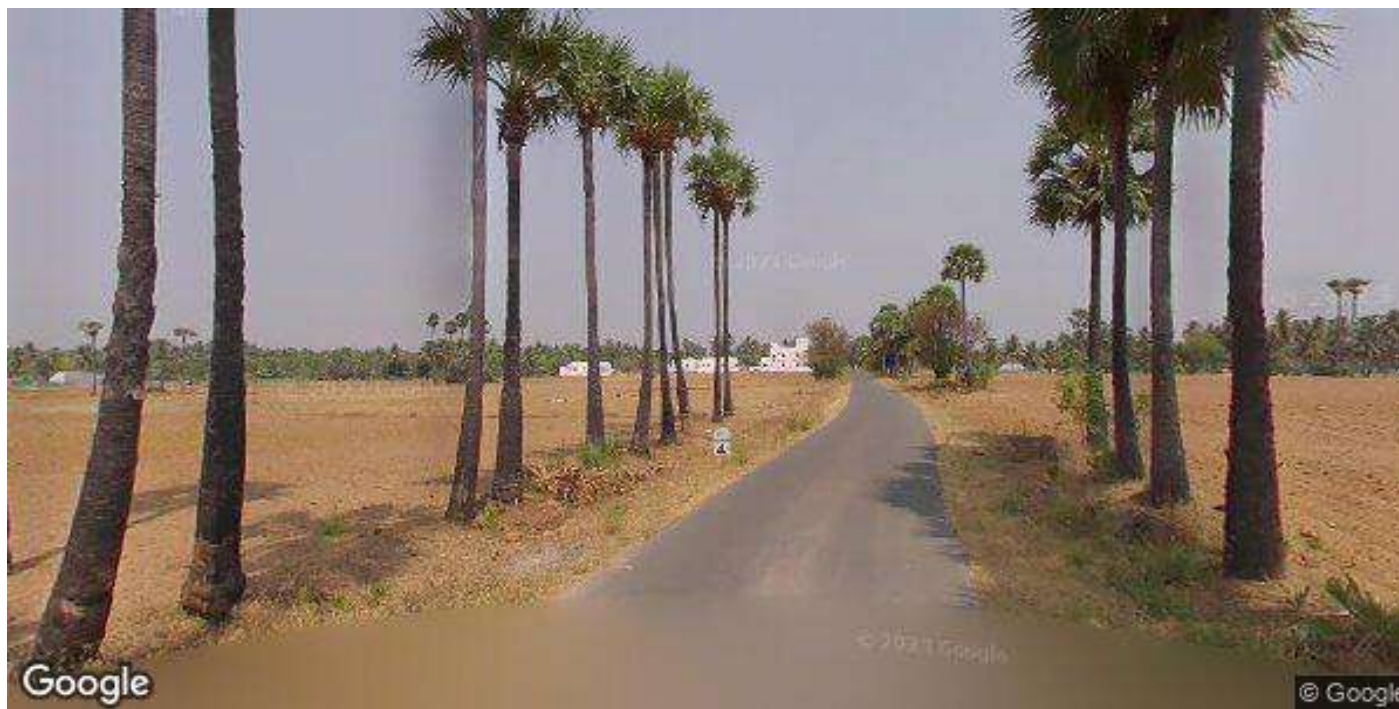
**Risk Type:** Turn  
**Risk Level:** Medium  
**Speed Limit:** 30 KM/Hr  
**Coordinates:** 11.41273, 77.90524

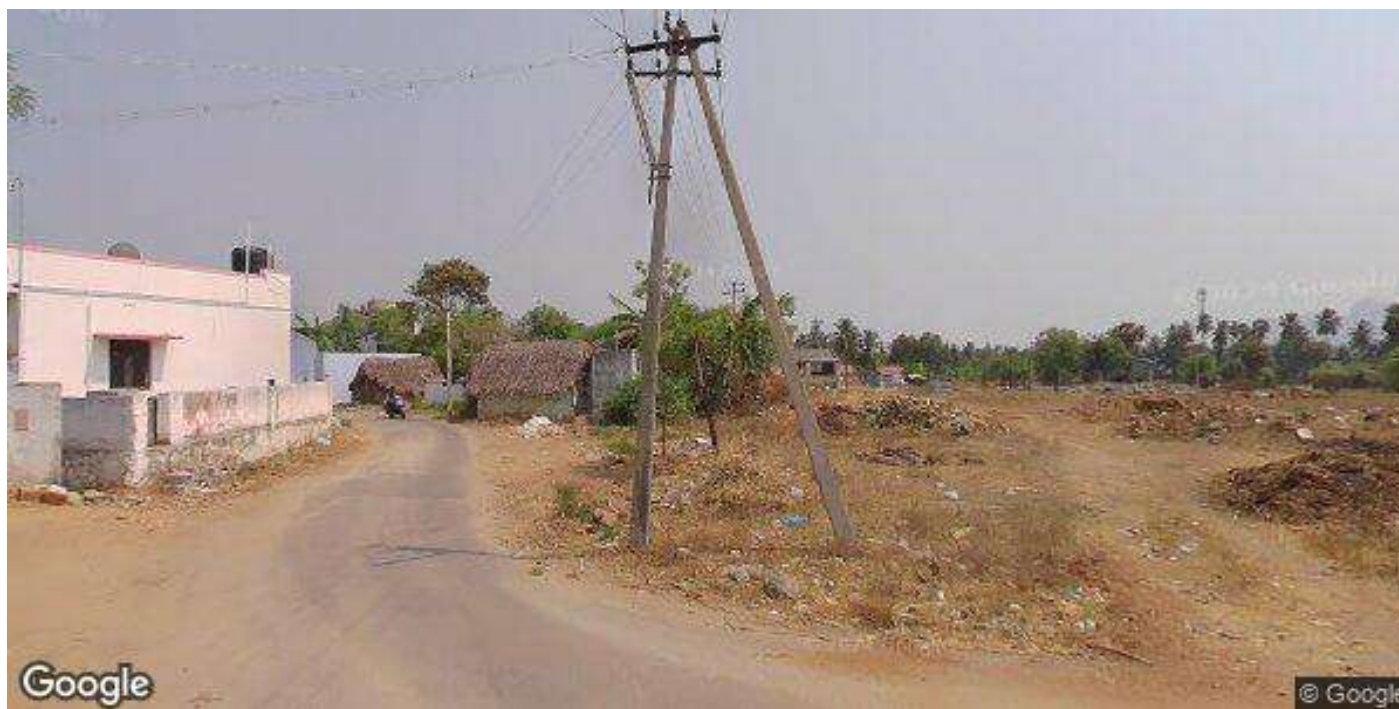
**Risk Type:** Turn  
**Risk Level:** High  
**Speed Limit:** 15 KM/Hr  
**Coordinates:** 11.41329, 77.90978

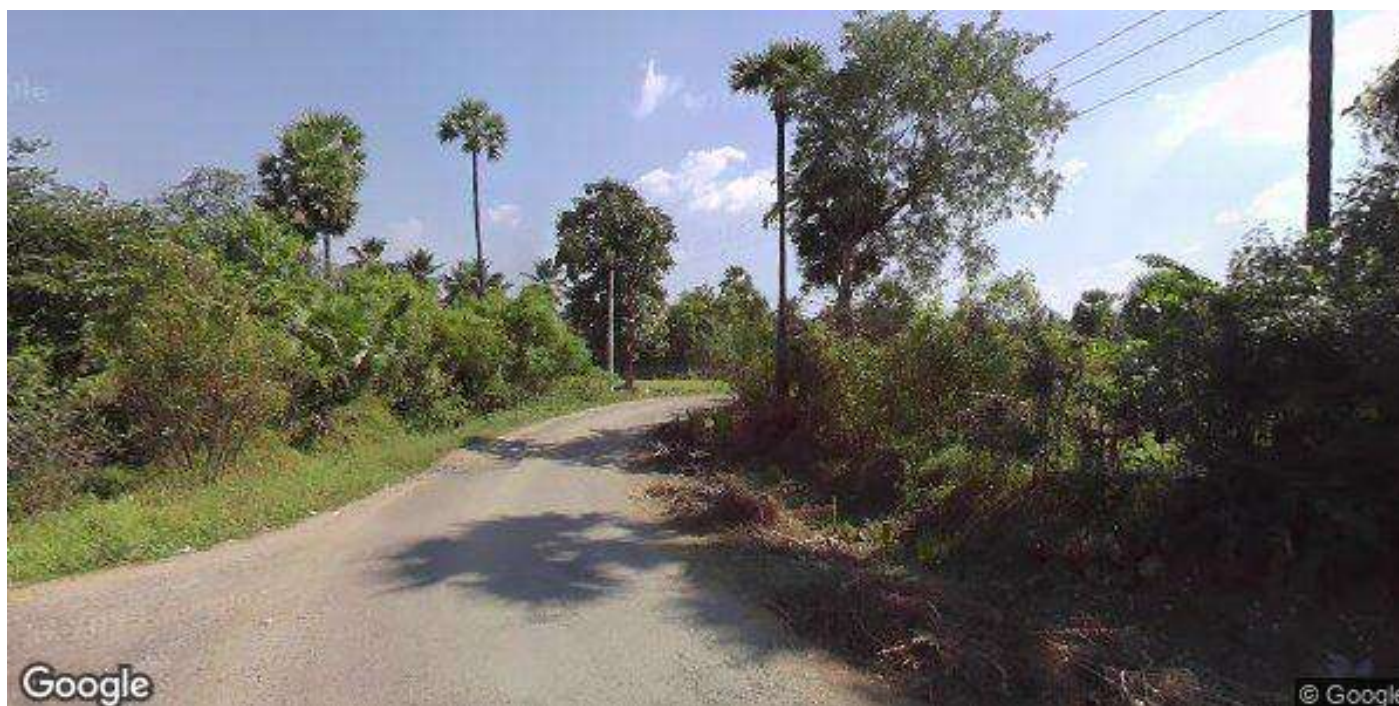
**Risk Type:** Turn  
**Risk Level:** High  
**Speed Limit:** 15 KM/Hr  
**Coordinates:** 11.41424, 77.91433

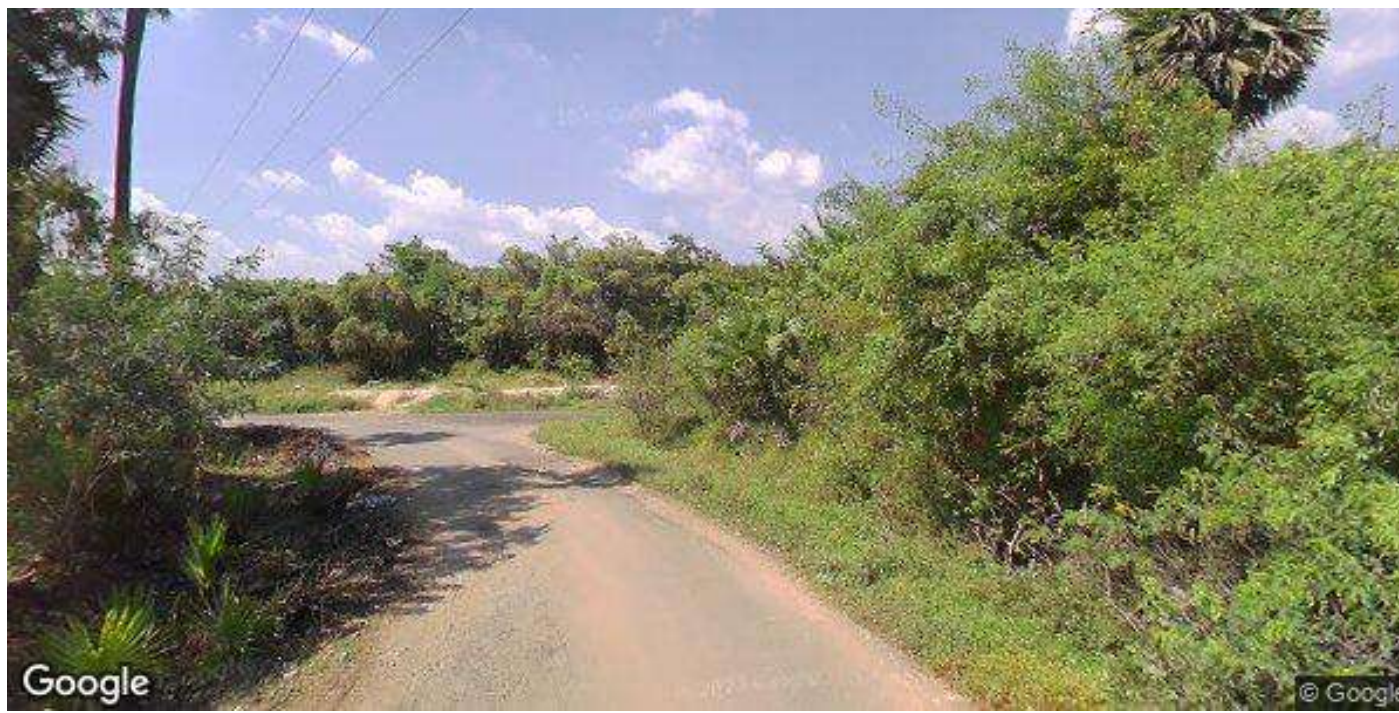
**Risk Type:** Turn  
**Risk Level:** Medium  
**Speed Limit:** 30 KM/Hr  
**Coordinates:** 11.41409, 77.91458

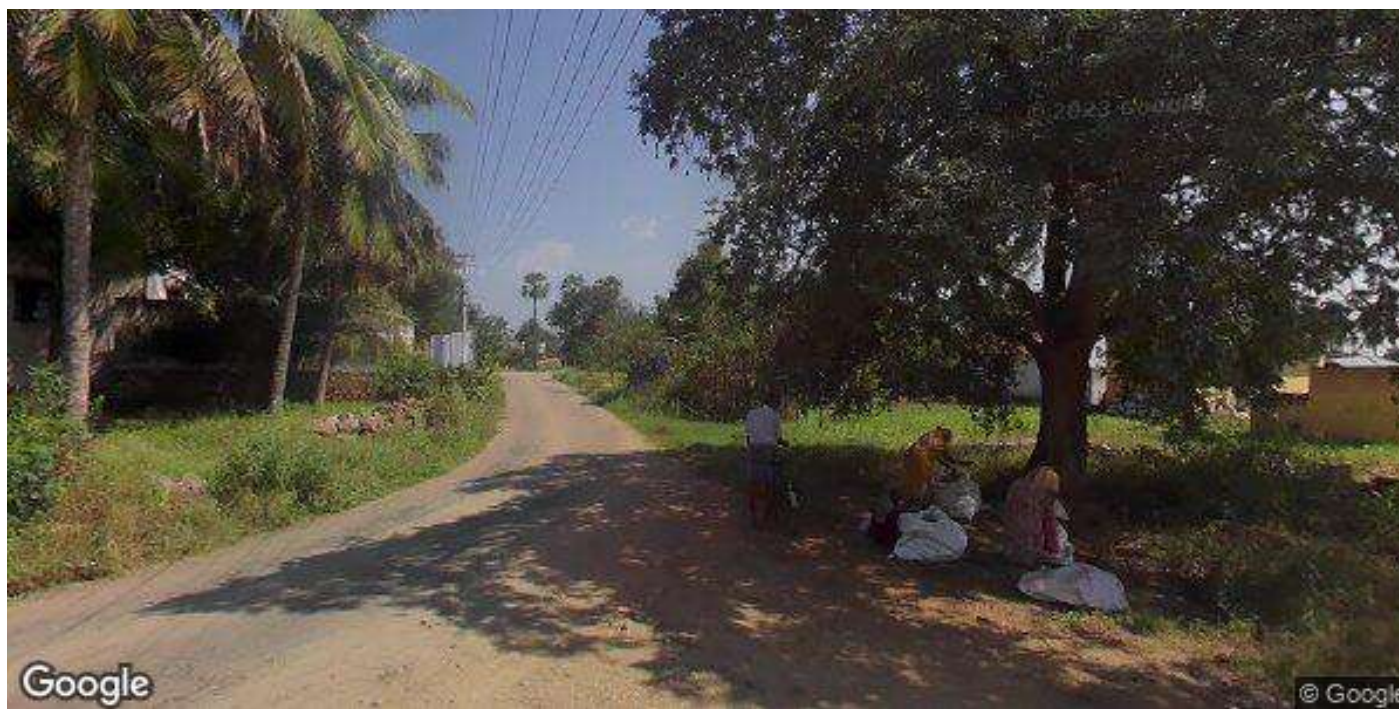
**Risk Type:** Turn  
**Risk Level:** High  
**Speed Limit:** 15 KM/Hr  
**Coordinates:** 11.41208, 77.91551
