## JOURNEY RISK MANAGEMENT (JRM) STUDY

### Salem Terminal to CKM FUELS STATION

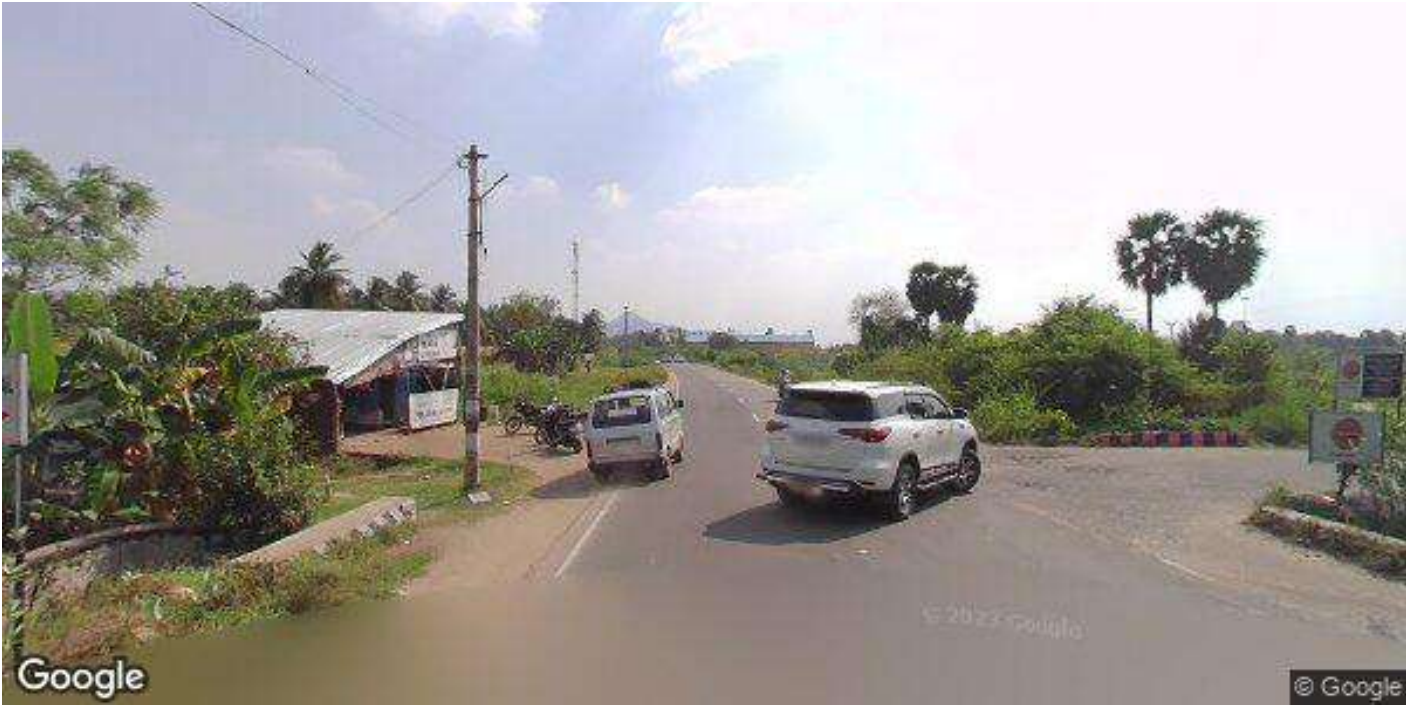
| | Risk Type | Risk Level | Coordinates | Speed Limit |
|---|---|---|---|---|
| 1 | Turn | High | 11.44029, 77.87544 | 15 KM/Hr |

Risk Type: Turn  
Risk Level: High  
Speed Limit: 15 KM/Hr  
Coordinates: 11.44029, 77.87544

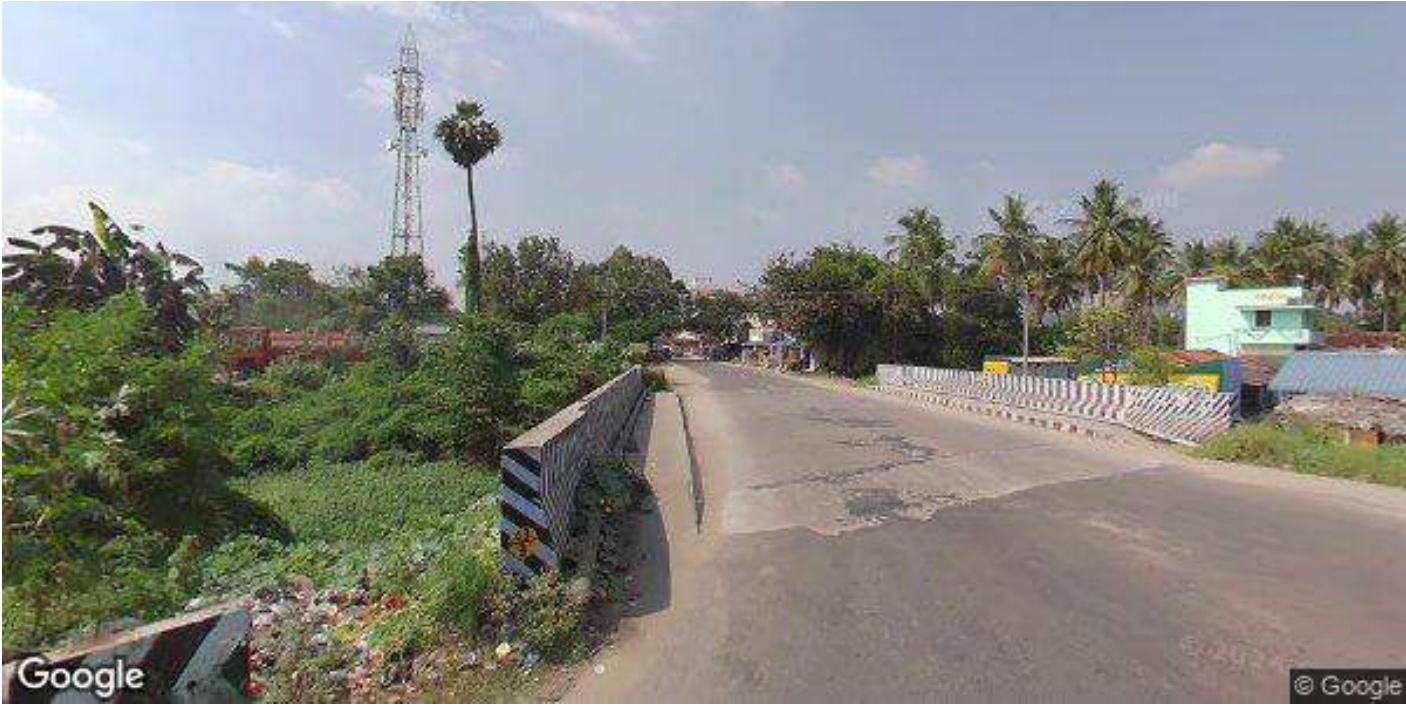
| | Risk Type | Risk Level | Coordinates | Speed Limit |
|---|---|---|---|---|
| 2 | Turn | Medium | 11.44900, 77.87406 | 30 KM/Hr |

Risk Type: Turn  
Risk Level: Medium  
Speed Limit: 30 KM/Hr  
Coordinates: 11.44900, 77.87406

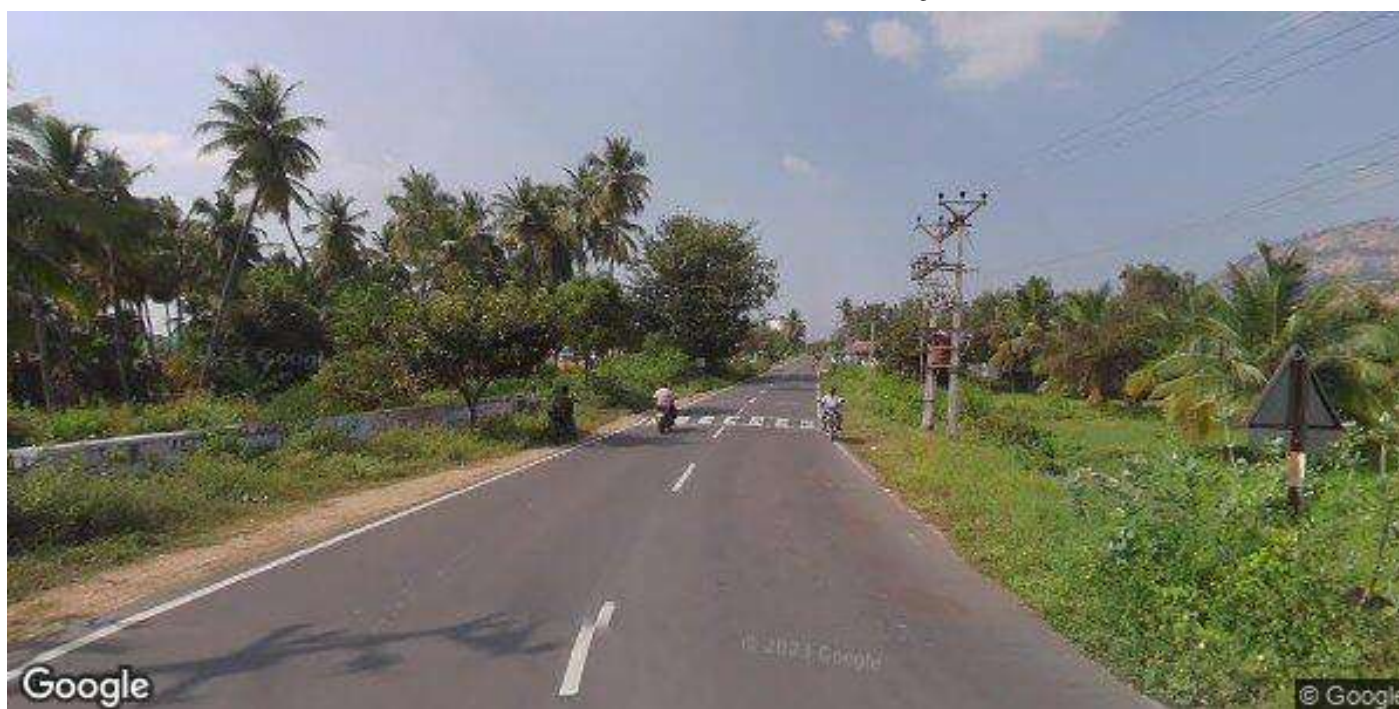
| | Risk Type | Risk Level | Coordinates | Speed Limit |
|---|---|---|---|---|
| 3 | Turn | High | 11.45353, 77.85697 | 15 KM/Hr |

**Risk Type:** Turn  
**Risk Level:** High  
**Speed Limit:** 15 KM/Hr  
**Coordinates:** 11.45353, 77.85697

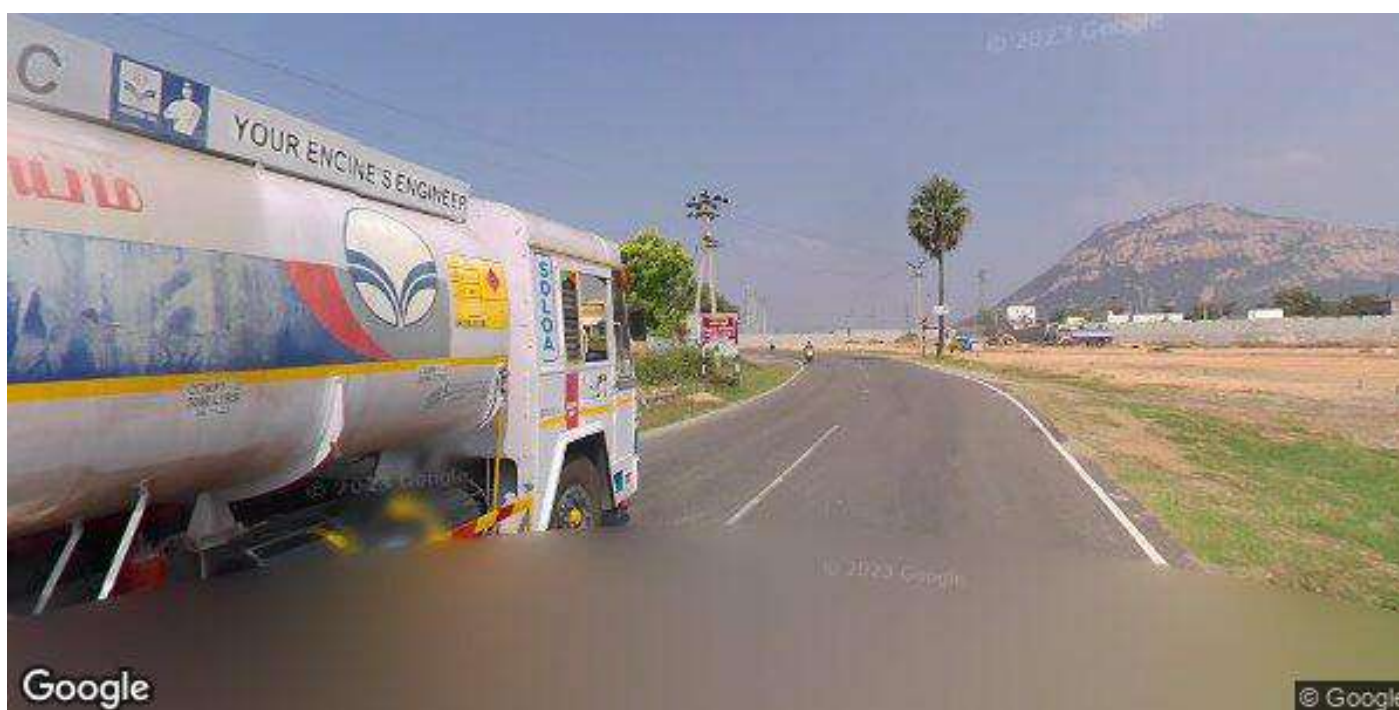
| | Risk Type | Risk Level | Coordinates | Speed Limit |
|---|---|---|---|---|
| 4 | Turn | Medium | 11.45853, 77.85139 | 30 KM/Hr |

**Risk Type:** Turn  
**Risk Level:** Medium  
**Speed Limit:** 30 KM/Hr  
**Coordinates:** 11.45853, 77.85139

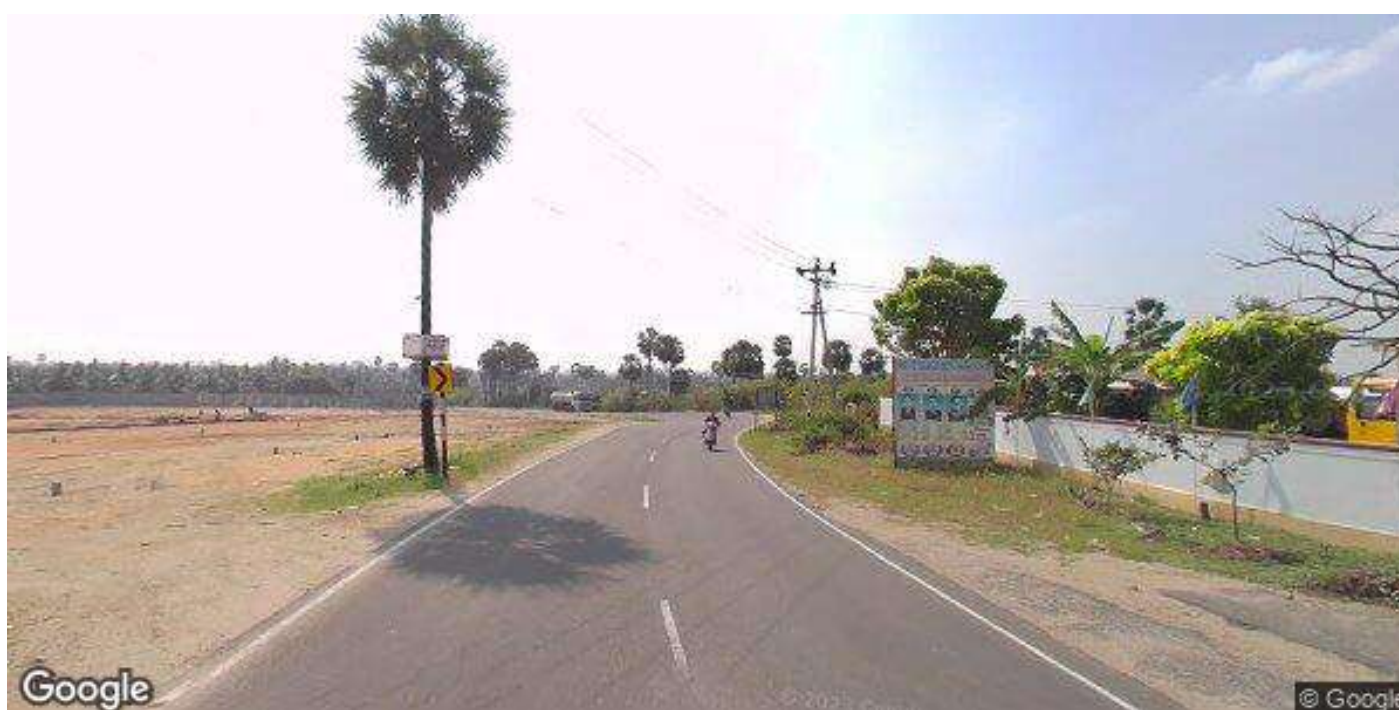
| | Risk Type | Risk Level | Coordinates | Speed Limit |
|---|---|---|---|---|
| 5 | Turn | Medium | 11.45906, 77.85132 | 30 KM/Hr |

**Risk Type:** Turn  
**Risk Level:** Medium  
**Speed Limit:** 30 KM/Hr  
**Coordinates:** 11.45906, 77.85132

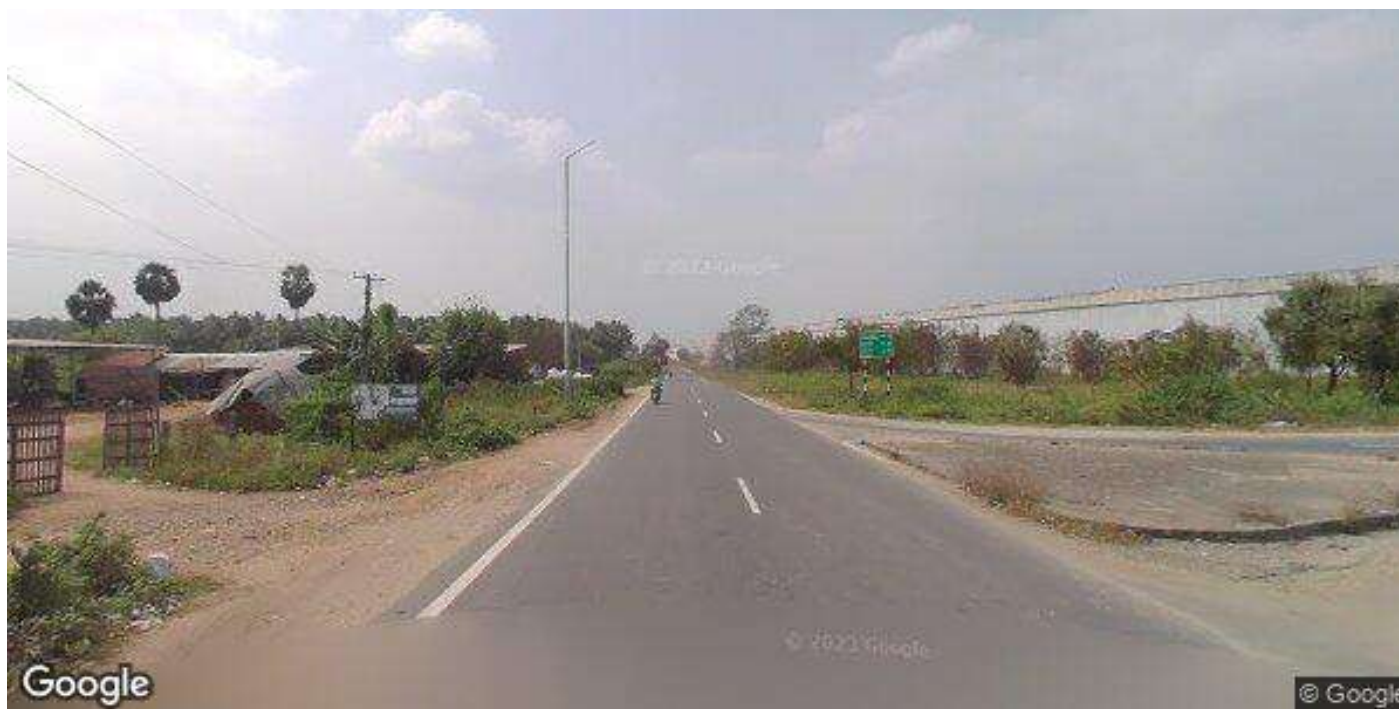
| | Risk Type | Risk Level | Coordinates | Speed Limit |
|---|---|---|---|---|
| 7 | Turn | High | 11.45542, 77.81725 | 15 KM/Hr |

**Risk Type:** Turn  
**Risk Level:** High  
**Speed Limit:** 15 KM/Hr  
**Coordinates:** 11.45542, 77.81725

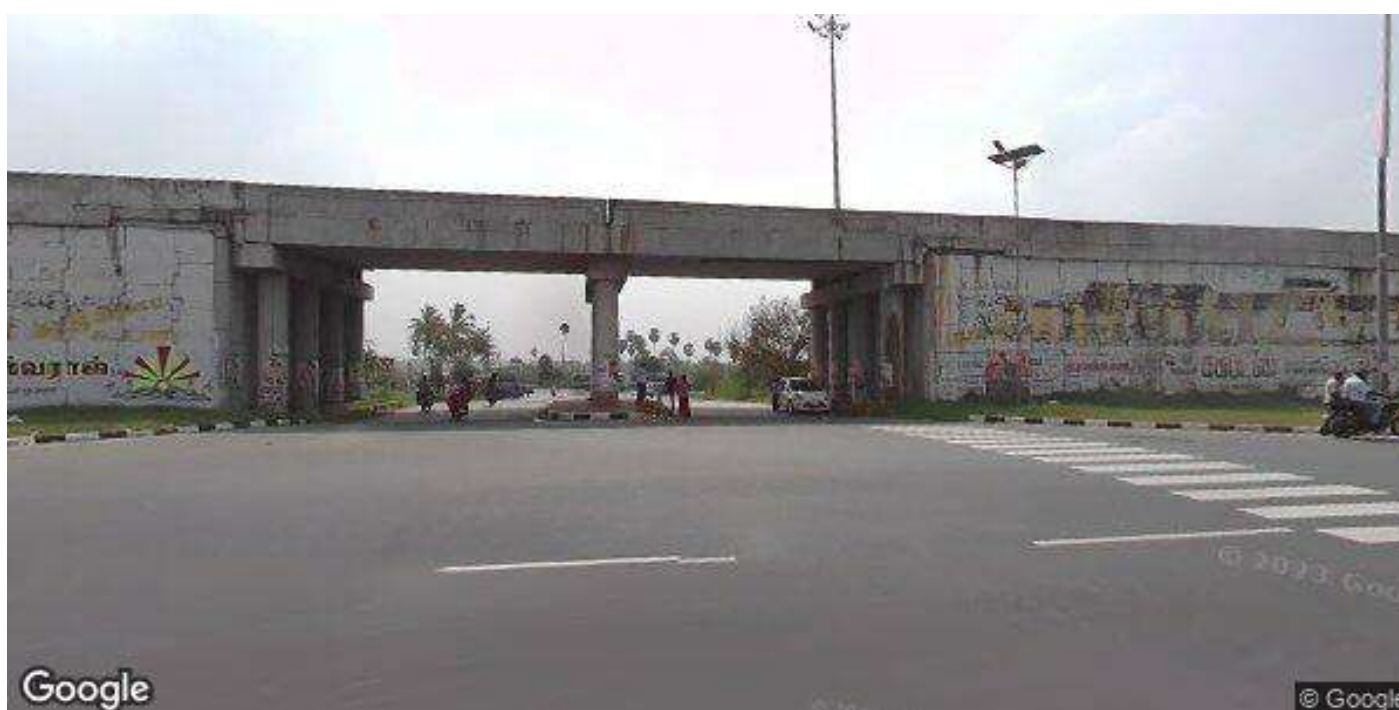
| | Risk Type | Risk Level | Coordinates | Speed Limit |
|---|---|---|---|---|
| 8 | Turn | High | 11.45636, 77.81678 | 15 KM/Hr |

**Risk Type:** Turn  
**Risk Level:** High  
**Speed Limit:** 15 KM/Hr  
**Coordinates:** 11.45636, 77.81678

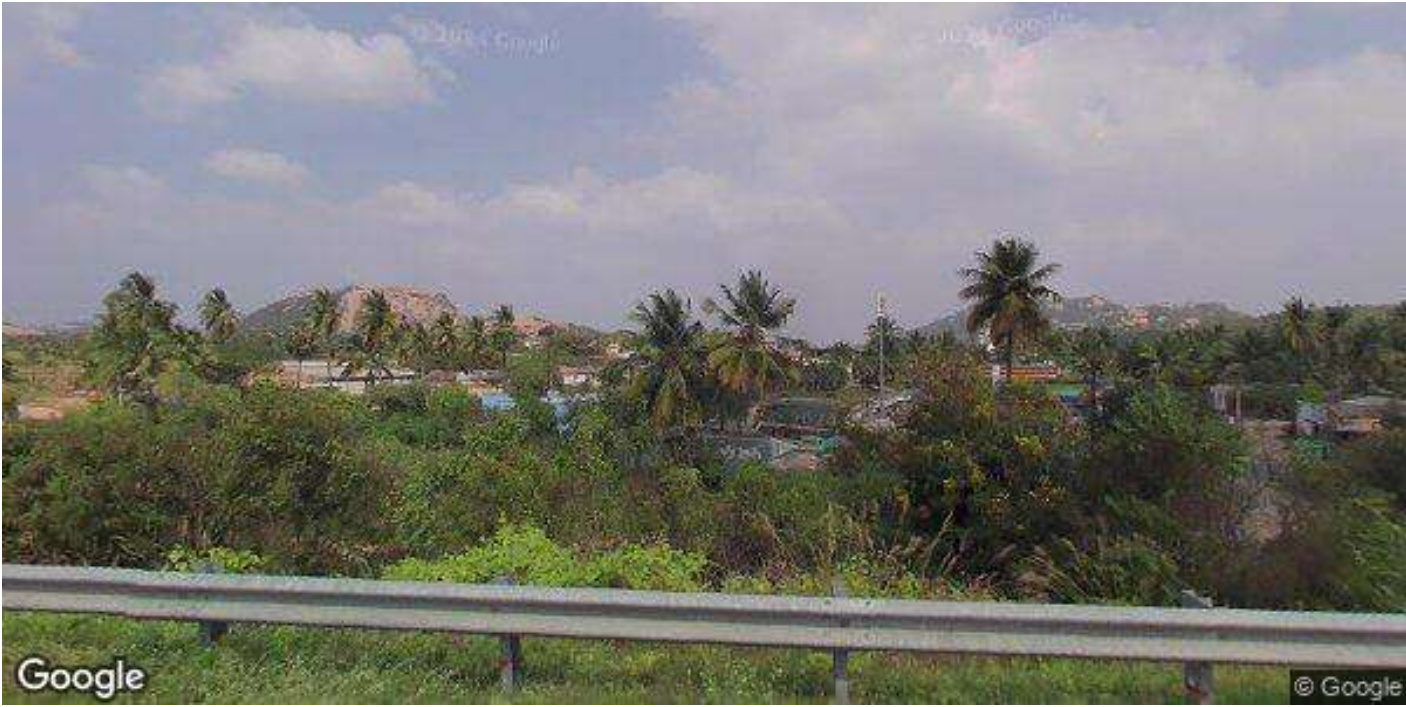
| | Risk Type | Risk Level | Coordinates | Speed Limit |
|---|---|---|---|---|
| 9 | Turn | Medium | 11.49383, 77.88501 | 30 KM/Hr |

**Risk Type:** Turn  
**Risk Level:** Medium  
**Speed Limit:** 30 KM/Hr  
**Coordinates:** 11.49383, 77.88501

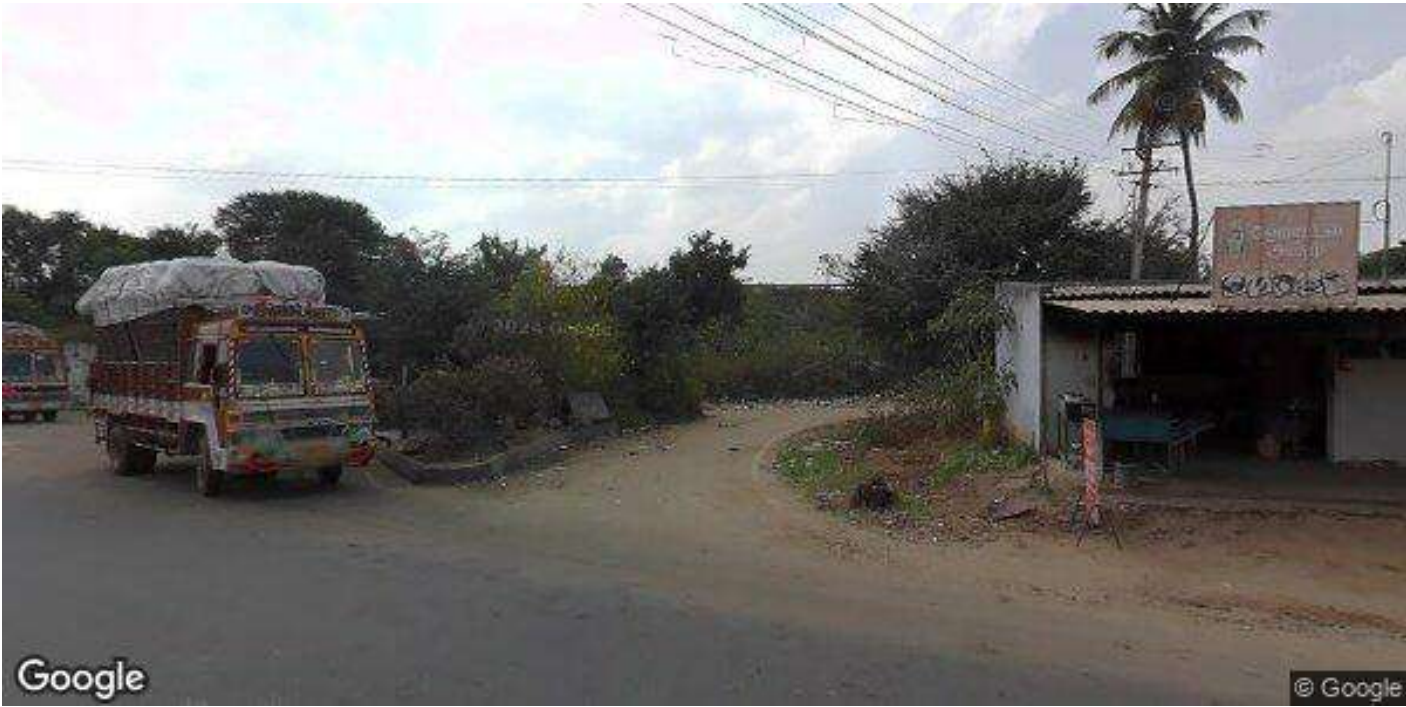
| | Risk Type | Risk Level | Coordinates | Speed Limit |
|---|---|---|---|---|
| 10 | Blind Spot | Blind Spot | 11.49400, 77.88538 | 10 KM/Hr |

**Risk Type:** Blind Spot  
**Risk Level:** Blind Spot  
**Speed Limit:** 10 KM/Hr  
**Coordinates:** 11.49400, 77.88538

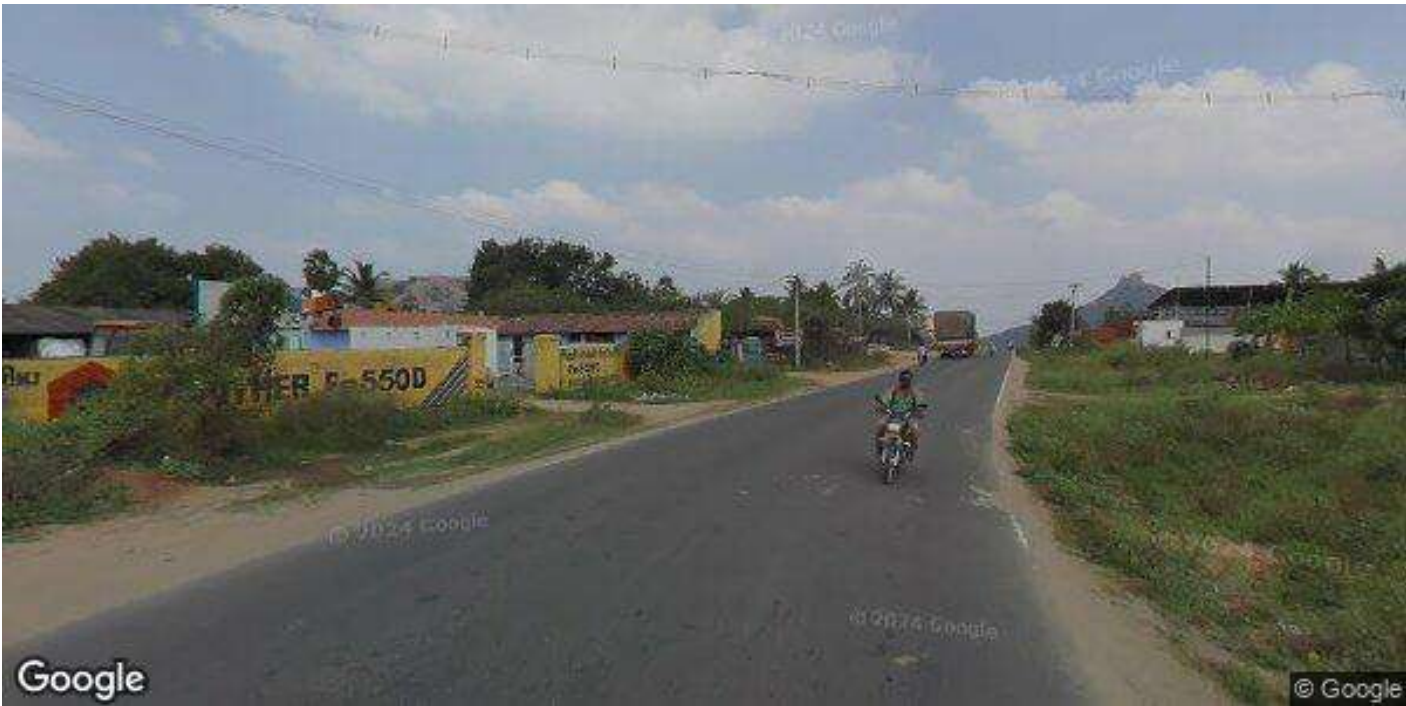
| | Risk Type | Risk Level | Coordinates | Speed Limit |
|---|---|---|---|---|
| 11 | Turn | High | 11.49469, 77.88488 | 15 KM/Hr |

**Risk Type:** Turn  
**Risk Level:** High  
**Speed Limit:** 15 KM/Hr  
**Coordinates:** 11.49469, 77.88488

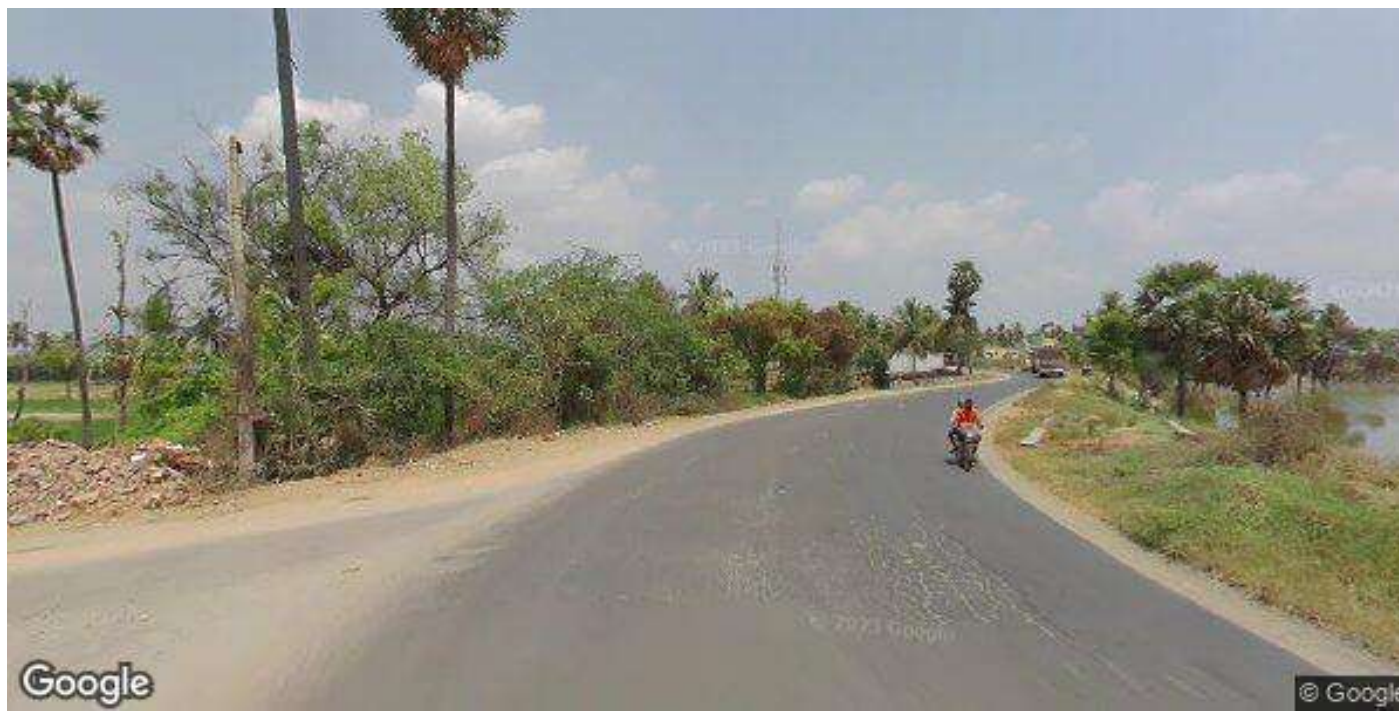
| | Risk Type | Risk Level | Coordinates | Speed Limit |
|---|---|---|---|---|
| 12 | Turn | Medium | 11.56083, 77.89921 | 30 KM/Hr |

**Risk Type:** Turn  
**Risk Level:** Medium  
**Speed Limit:** 30 KM/Hr  
**Coordinates:** 11.56083, 77.89921

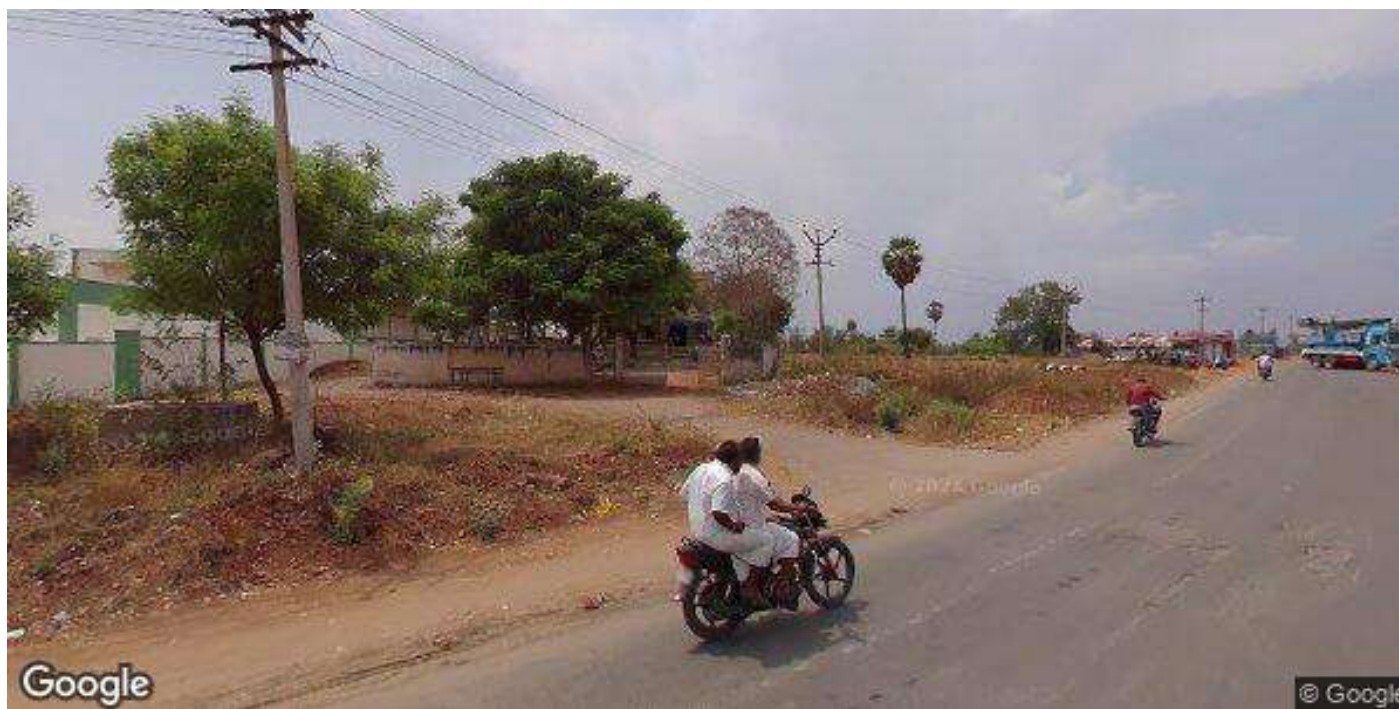
| | Risk Type | Risk Level | Coordinates | Speed Limit |
|---|---|---|---|---|
| 13 | Turn | Medium | 11.58309, 77.90652 | 30 KM/Hr |

**Risk Type:** Turn  
**Risk Level:** Medium  
**Speed Limit:** 30 KM/Hr  
**Coordinates:** 11.58309, 77.90652

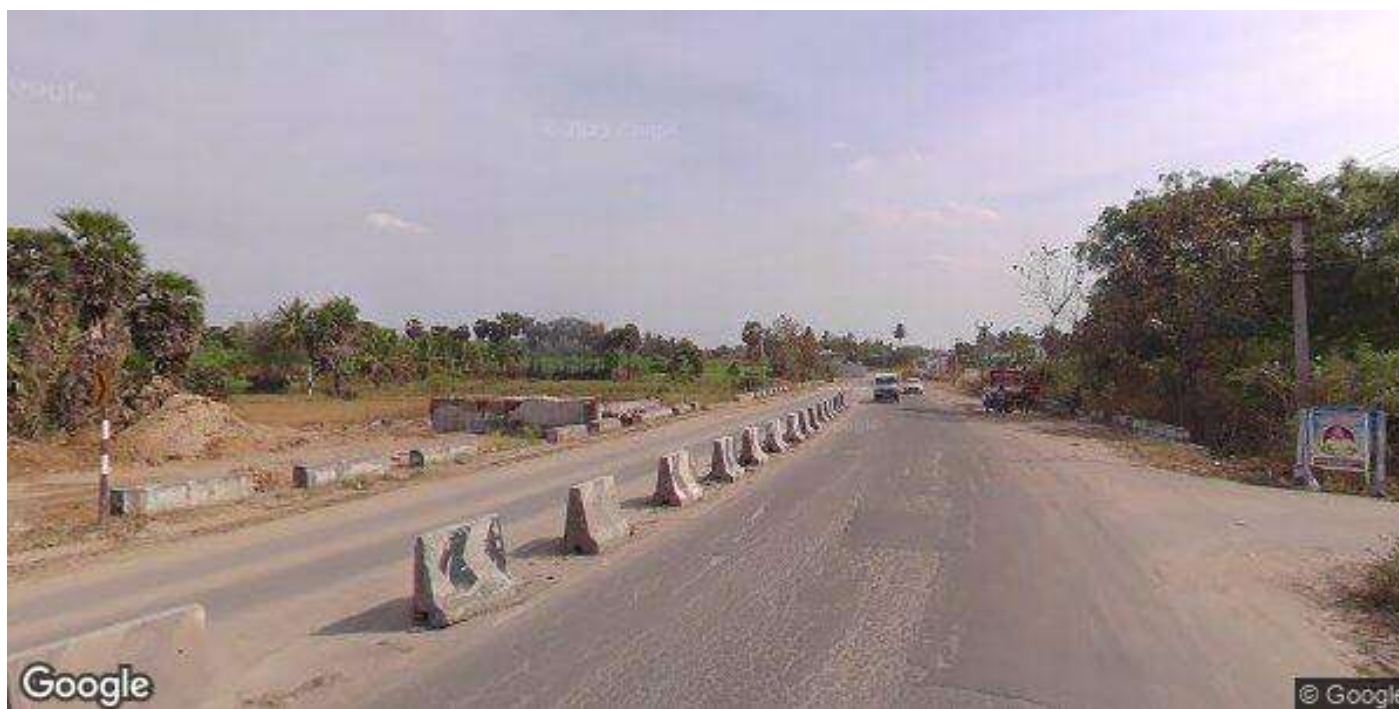
| | Risk Type | Risk Level | Coordinates | Speed Limit |
|---|---|---|---|---|
| 14 | Turn | Medium | 11.63843, 77.94821 | 30 KM/Hr |

**Risk Type:** Turn  
**Risk Level:** Medium  
**Speed Limit:** 30 KM/Hr  
**Coordinates:** 11.63843, 77.94821

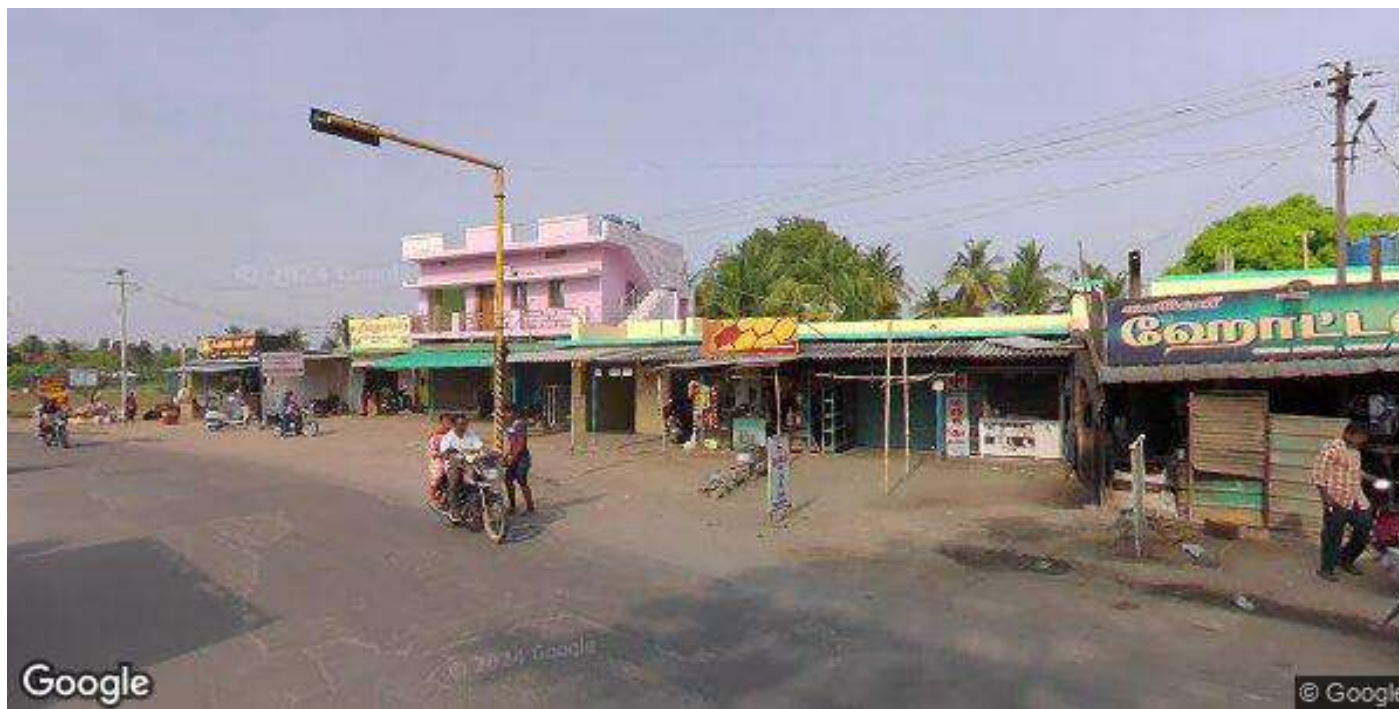
| | Risk Type | Risk Level | Coordinates | Speed Limit |
|---|---|---|---|---|
| 15 | Turn | High | 11.64192, 77.95195 | 15 KM/Hr |

**Risk Type:** Turn  
**Risk Level:** High  
**Speed Limit:** 15 KM/Hr  
**Coordinates:** 11.64192, 77.95195

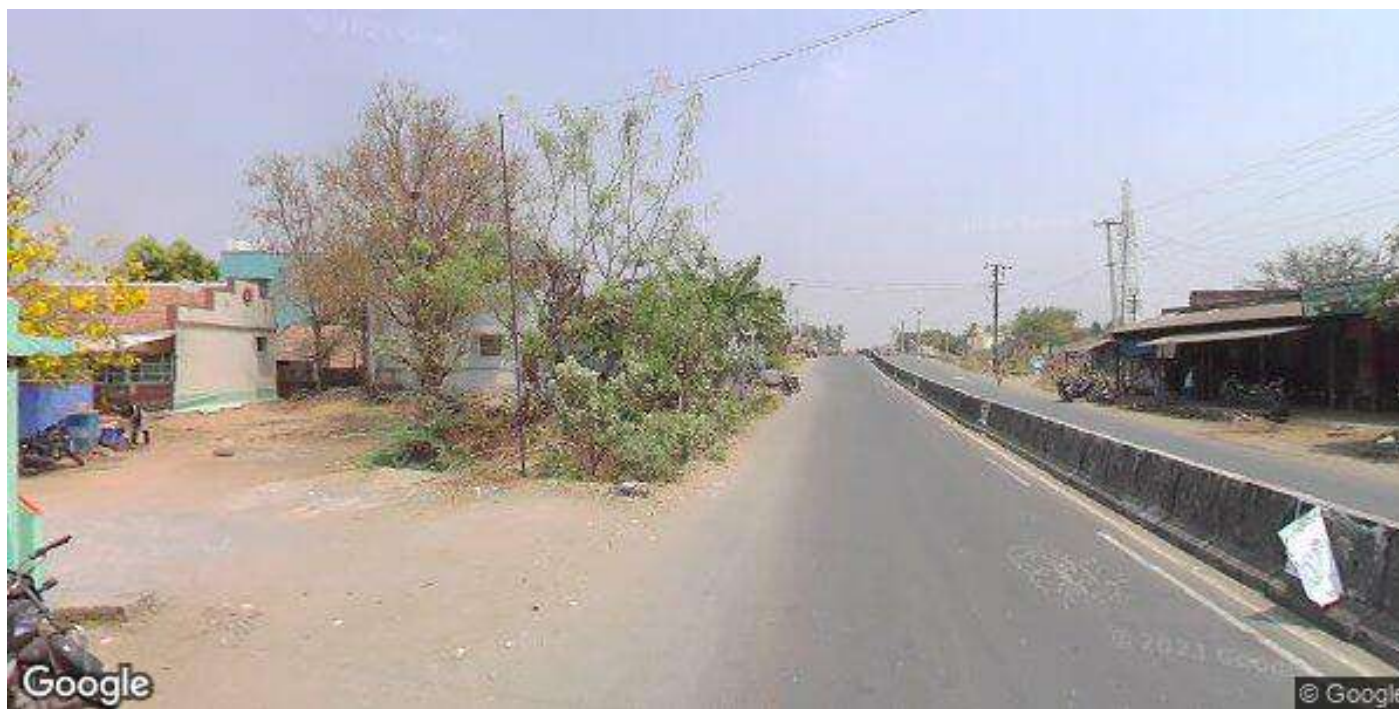
| | Risk Type | Risk Level | Coordinates | Speed Limit |
|---|---|---|---|---|
| 16 | Turn | Medium | 11.64747, 77.95129 | 30 KM/Hr |

**Risk Type:** Turn  
**Risk Level:** Medium  
**Speed Limit:** 30 KM/Hr  
**Coordinates:** 11.64747, 77.95129

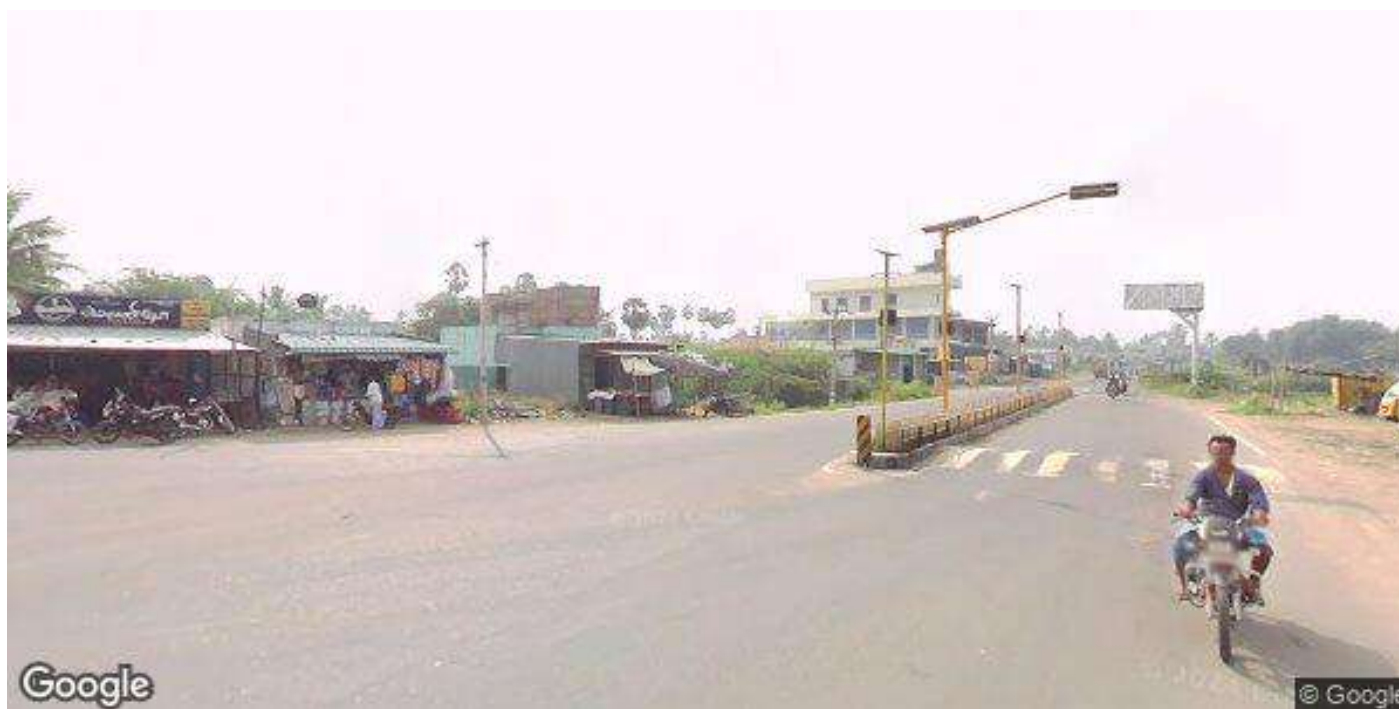
| | Risk Type | Risk Level | Coordinates | Speed Limit |
|---|---|---|---|---|
| 17 | Turn | High | 11.67868, 77.96836 | 15 KM/Hr |

**Risk Type:** Turn  
**Risk Level:** High  
**Speed Limit:** 15 KM/Hr  
**Coordinates:** 11.67868, 77.96836

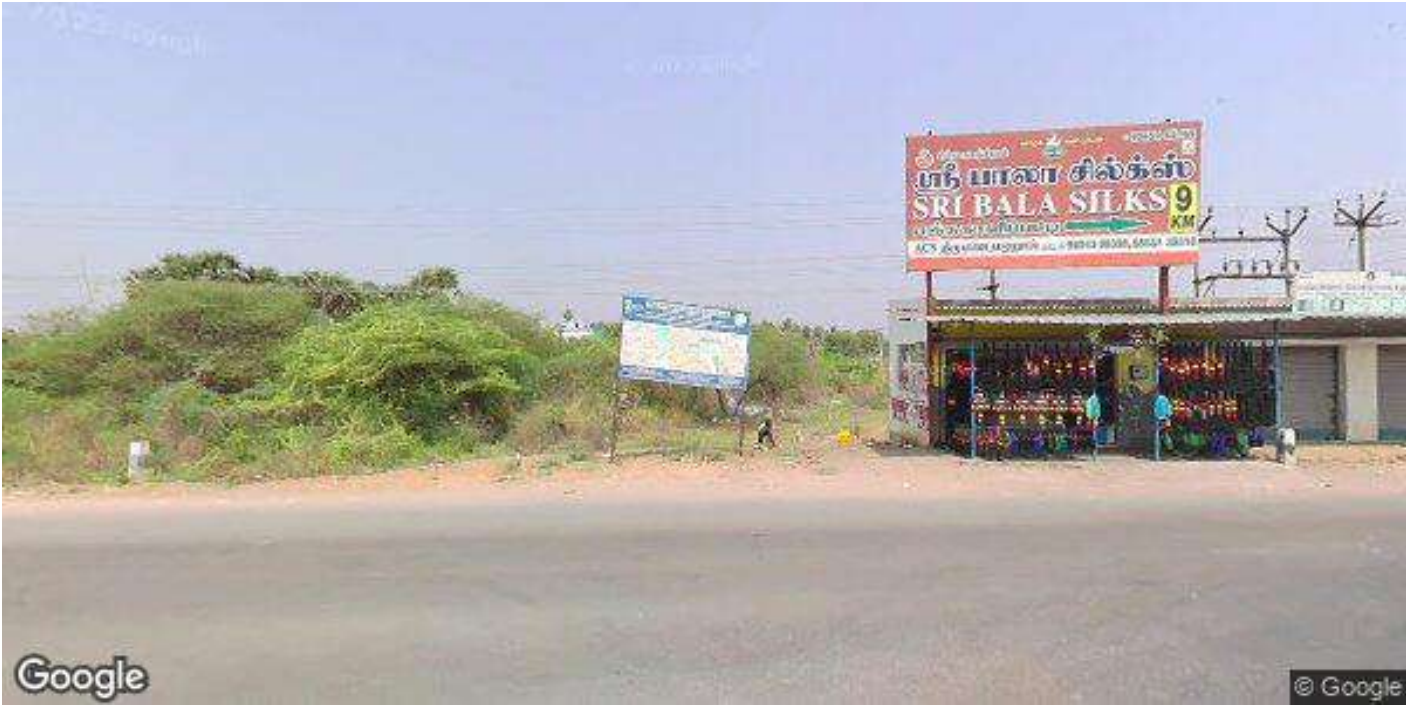
| | Risk Type | Risk Level | Coordinates | Speed Limit |
|---|---|---|---|---|
| 18 | Turn | High | 11.70223, 77.97860 | 15 KM/Hr |

**Risk Type:** Turn  
**Risk Level:** High  
**Speed Limit:** 15 KM/Hr  
**Coordinates:** 11.70223, 77.97860

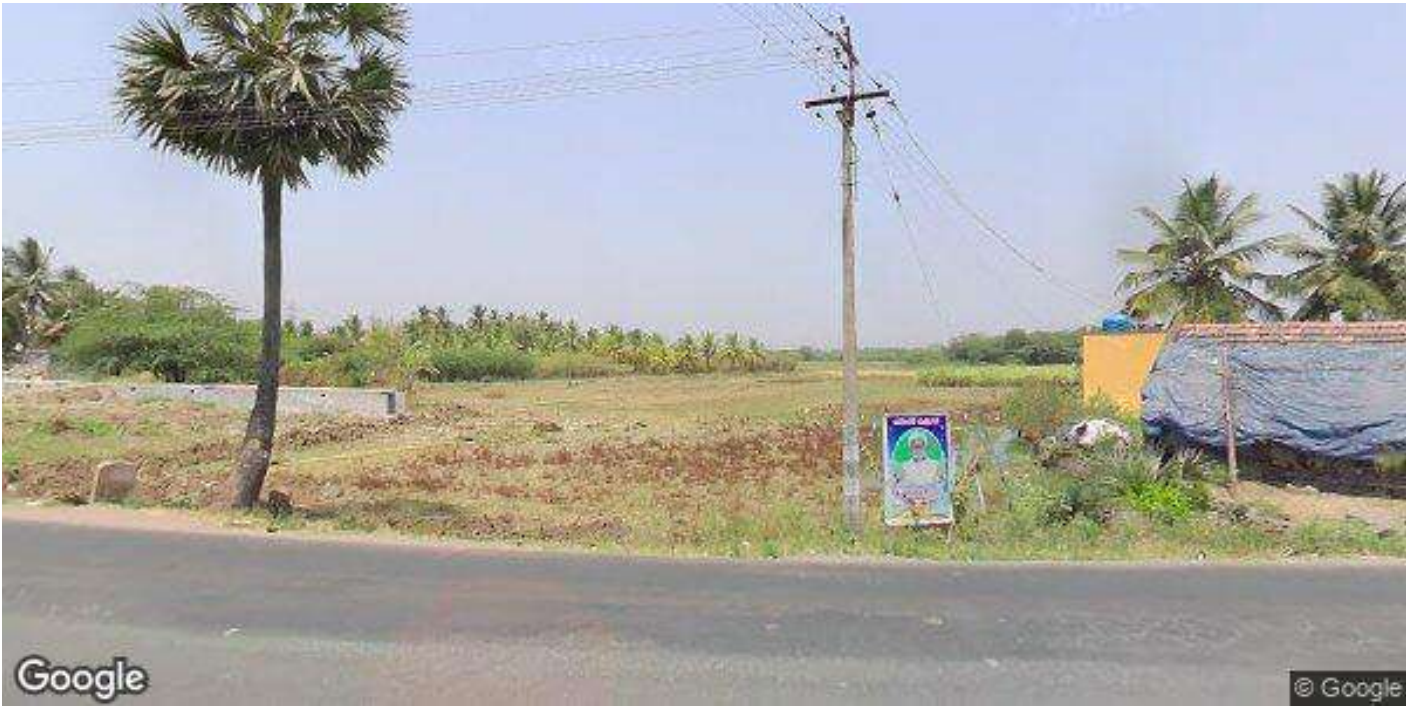
| | Risk Type | Risk Level | Coordinates | Speed Limit |
|---|---|---|---|---|
| 19 | Turn | Medium | 11.71380, 77.99532 | 30 KM/Hr |

**Risk Type:** Turn  
**Risk Level:** Medium  
**Speed Limit:** 30 KM/Hr  
**Coordinates:** 11.71380, 77.99532

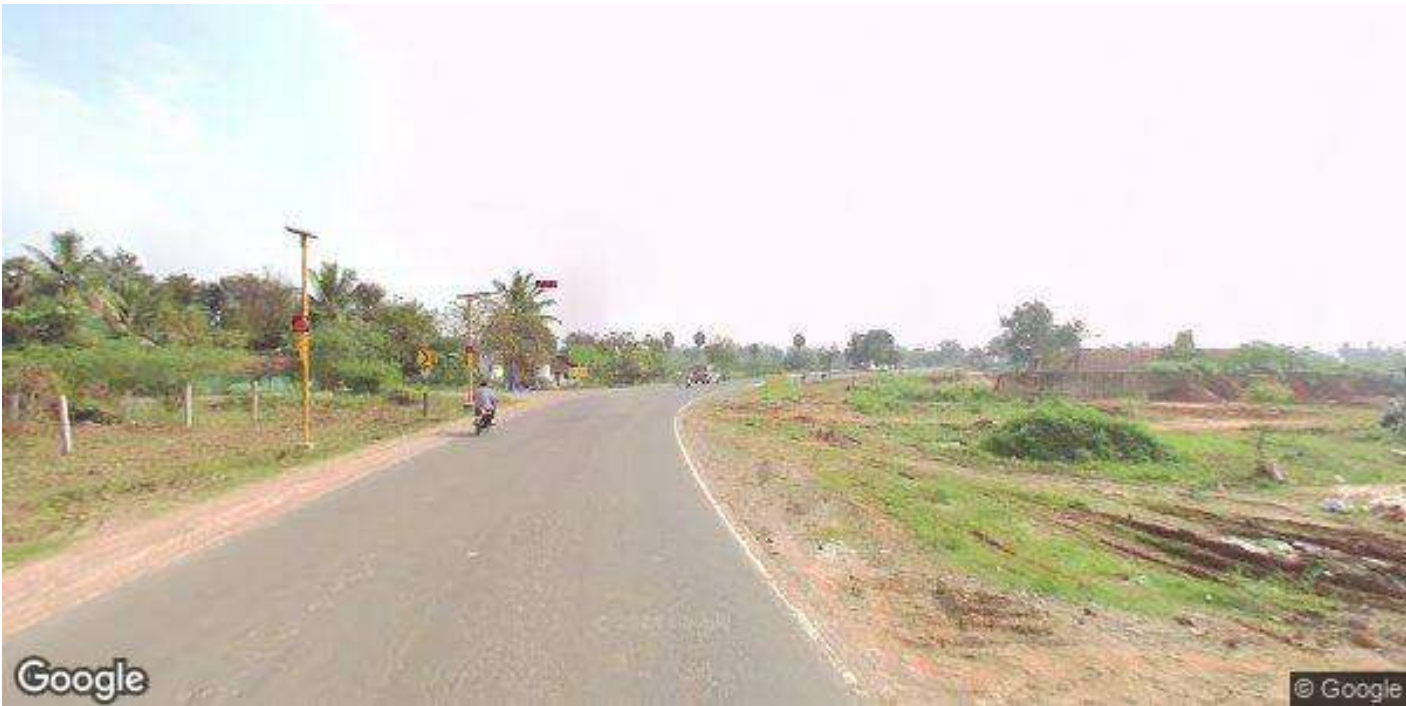
| | Risk Type | Risk Level | Coordinates | Speed Limit |
|---|---|---|---|---|
| 20 | Turn | Medium | 11.71731, 78.00006 | 30 KM/Hr |

**Risk Type:** Turn  
**Risk Level:** Medium  
**Speed Limit:** 30 KM/Hr  
**Coordinates:** 11.71731, 78.00006

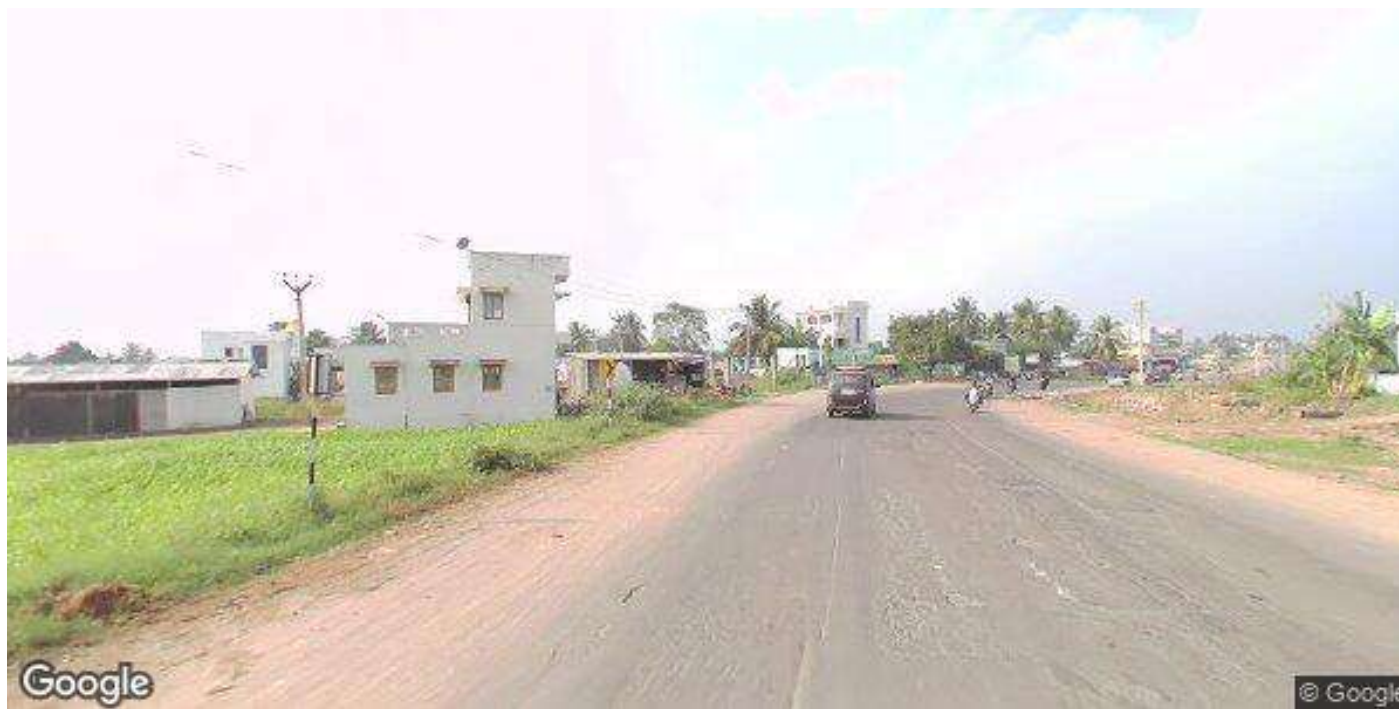
| | Risk Type | Risk Level | Coordinates | Speed Limit |
|---|---|---|---|---|
| 21 | Turn | Medium | 11.71947, 78.01172 | 30 KM/Hr |

**Risk Type:** Turn  
**Risk Level:** Medium  
**Speed Limit:** 30 KM/Hr  
**Coordinates:** 11.71947, 78.01172

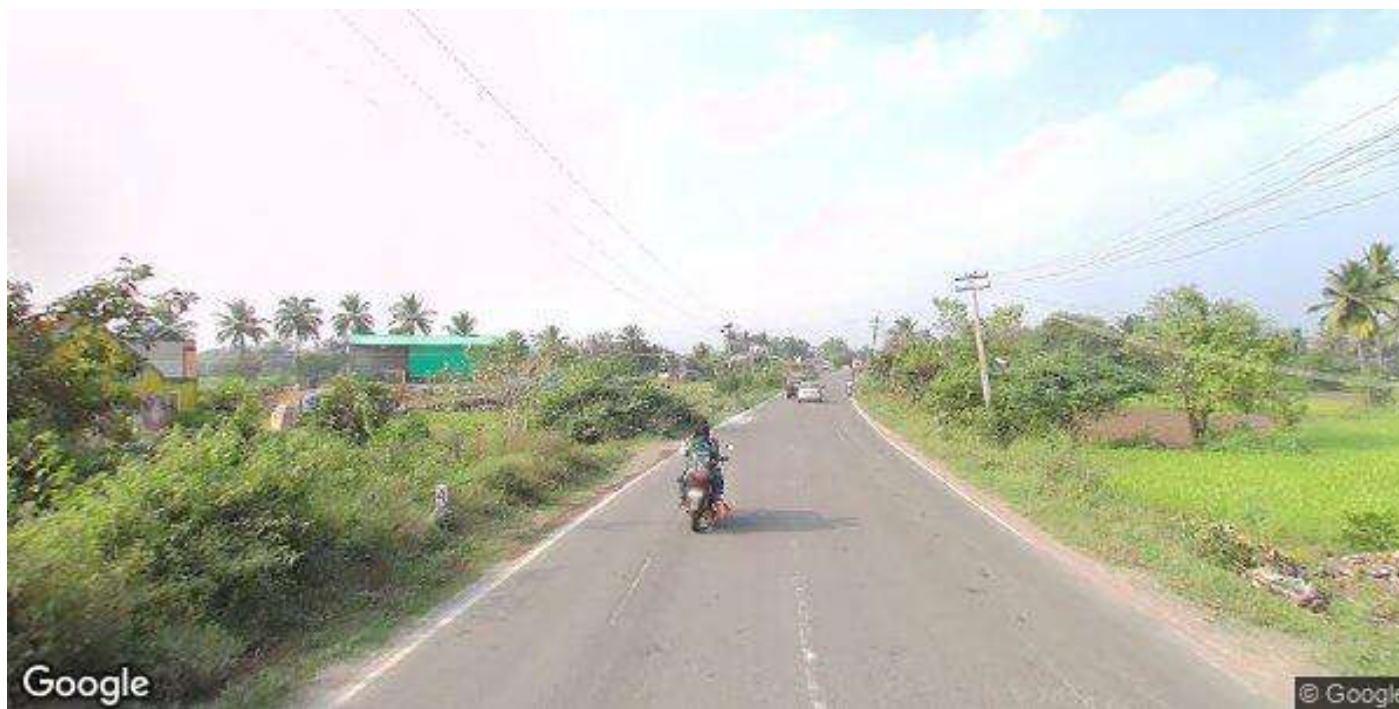
| | Risk Type | Risk Level | Coordinates | Speed Limit |
|---|---|---|---|---|
| 22 | Turn | Medium | 11.72760, 78.02285 | 30 KM/Hr |

**Risk Type:** Turn  
**Risk Level:** Medium  
**Speed Limit:** 30 KM/Hr  
**Coordinates:** 11.72760, 78.02285
