## JOURNEY RISK MANAGEMENT (JRM) STUDY

### Salem Terminal to CKM FUELS STATION

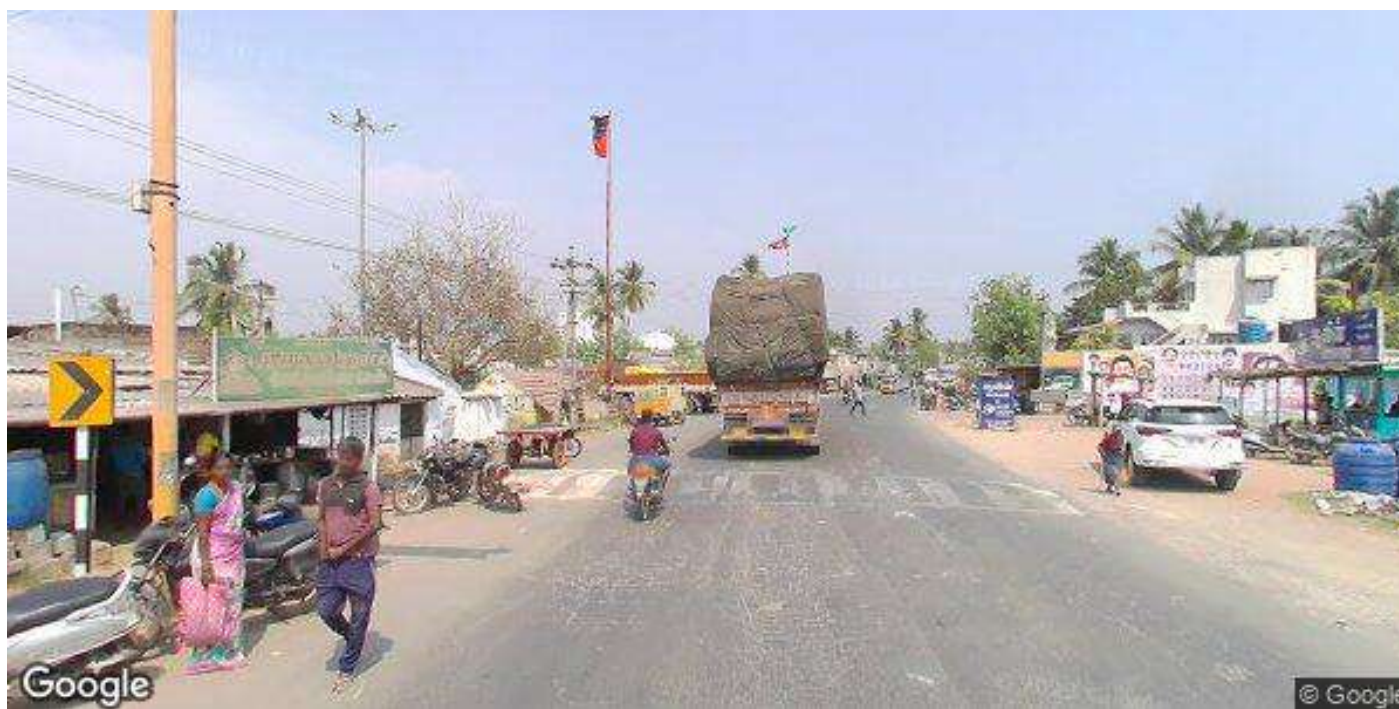
| | Risk Type | Risk Level | Coordinates | Speed Limit |
|---|---|---|---|---|
| 23 | Turn | Medium | 11.73785, 78.03496 | 30 KM/Hr |

**Risk Type:** Turn  
**Risk Level:** Medium  
**Speed Limit:** 30 KM/Hr  
**Coordinates:** 11.73785, 78.03496

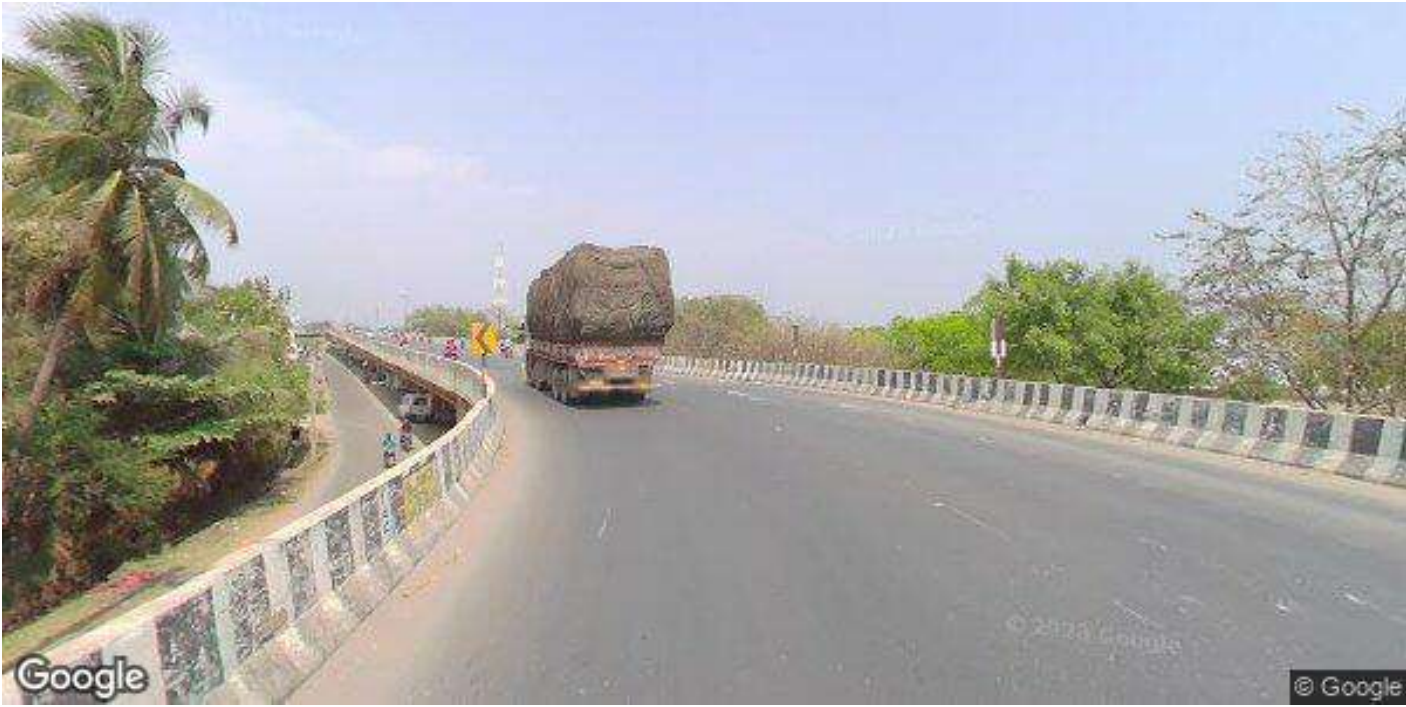
| | Risk Type | Risk Level | Coordinates | Speed Limit |
|---|---|---|---|---|
| 24 | Turn | High | 11.73653, 78.03886 | 15 KM/Hr |

**Risk Type:** Turn  
**Risk Level:** High  
**Speed Limit:** 15 KM/Hr  
**Coordinates:** 11.73653, 78.03886

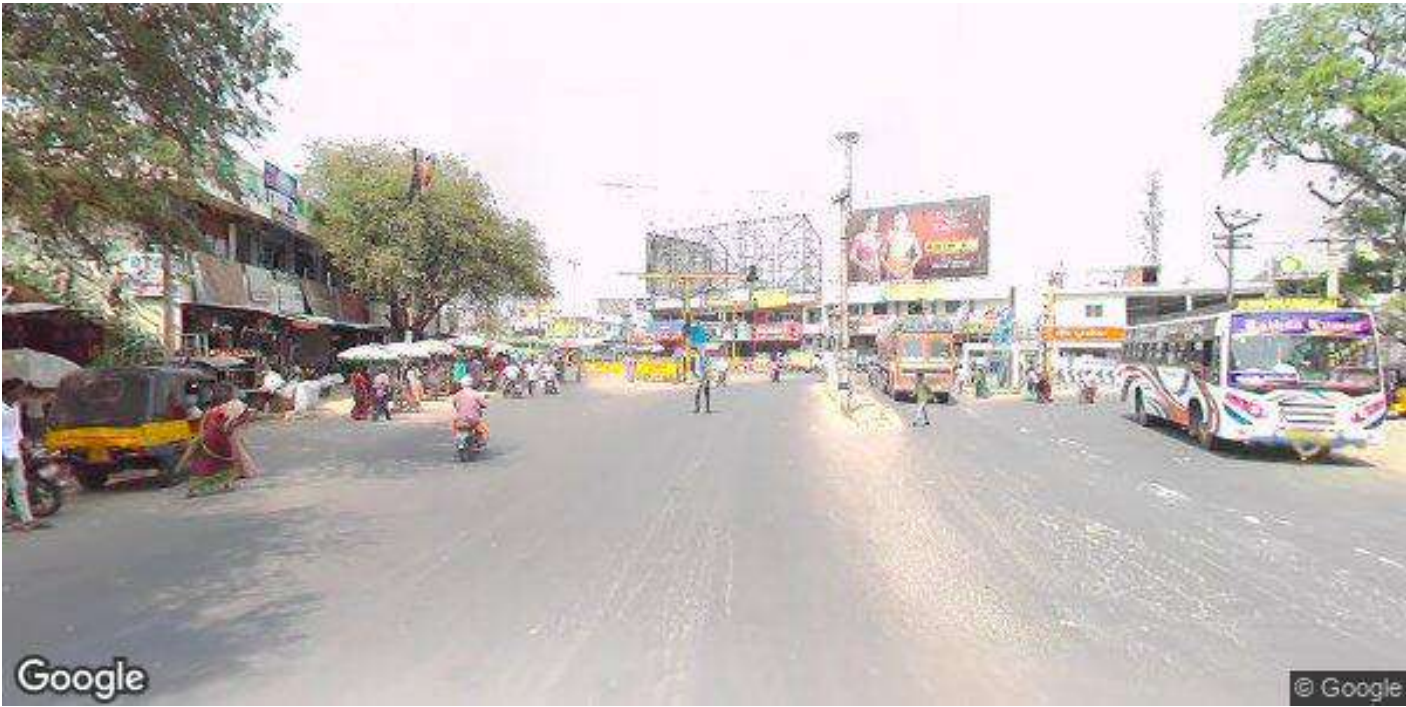
| | Risk Type | Risk Level | Coordinates | Speed Limit |
|---|---|---|---|---|
| 25 | Turn | Medium | 11.74252, 78.04705 | 30 KM/Hr |

**Risk Type:** Turn  
**Risk Level:** Medium  
**Speed Limit:** 30 KM/Hr  
**Coordinates:** 11.74252, 78.04705

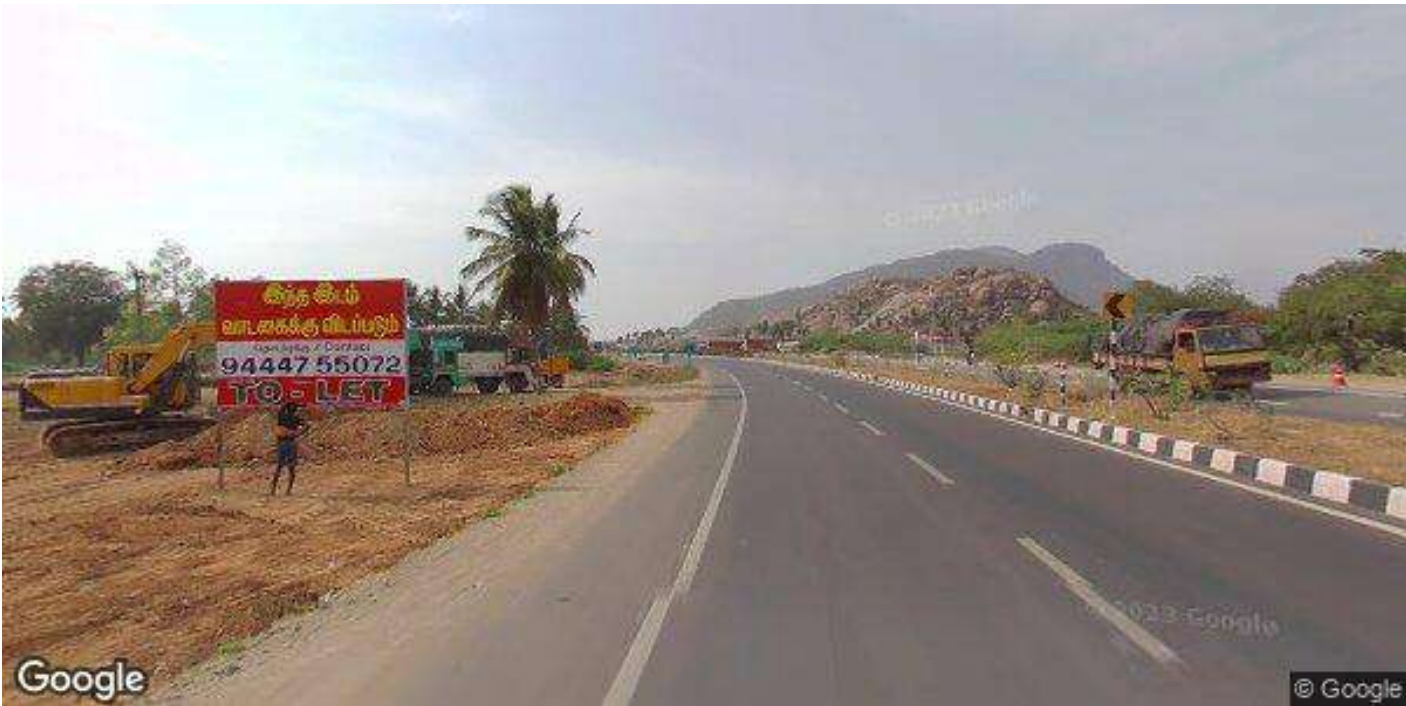
| | Risk Type | Risk Level | Coordinates | Speed Limit |
|---|---|---|---|---|
| 26 | Turn | Medium | 11.87998, 78.08170 | 30 KM/Hr |

**Risk Type:** Turn  
**Risk Level:** Medium  
**Speed Limit:** 30 KM/Hr  
**Coordinates:** 11.87998, 78.08170

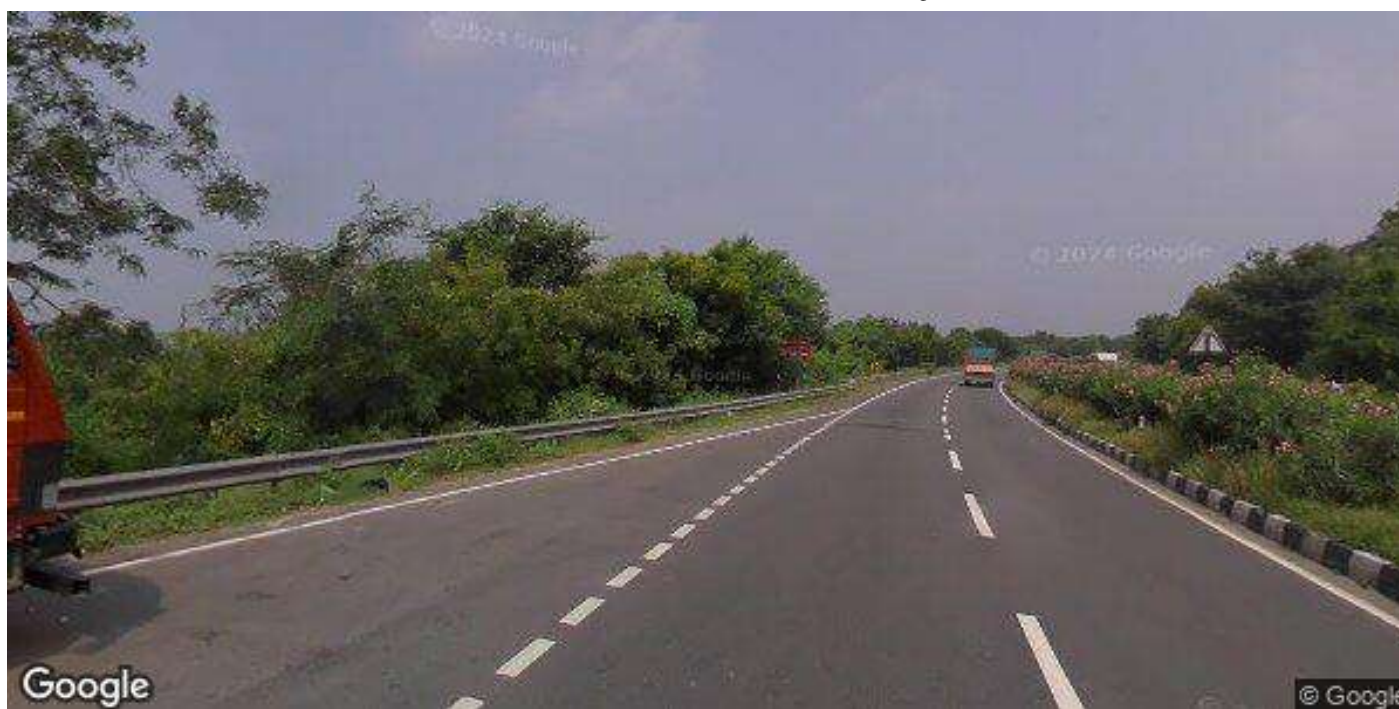
| | Risk Type | Risk Level | Coordinates | Speed Limit |
|---|---|---|---|---|
| 27 | Turn | Medium | 11.91266, 78.05852 | 30 KM/Hr |

**Risk Type:** Turn  
**Risk Level:** Medium  
**Speed Limit:** 30 KM/Hr  
**Coordinates:** 11.91266, 78.05852

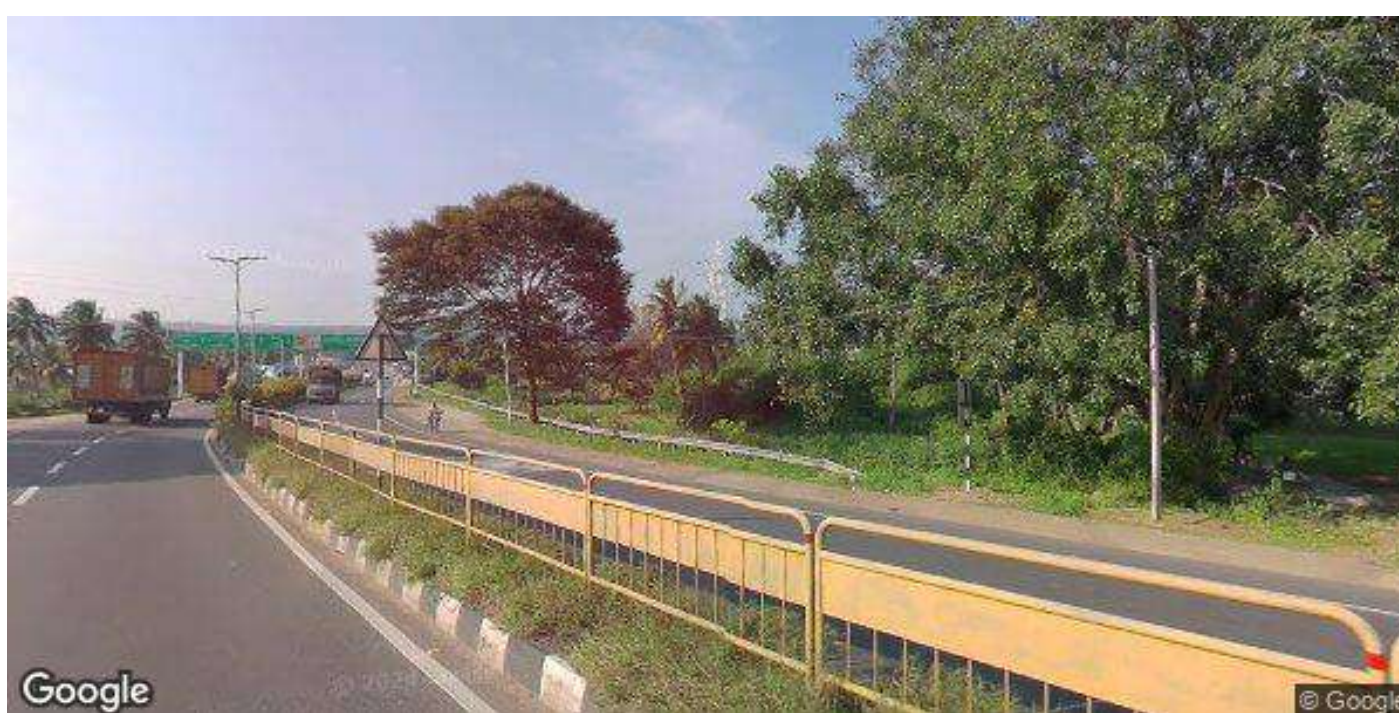
| | Risk Type | Risk Level | Coordinates | Speed Limit |
|---|---|---|---|---|
| 28 | Turn | Medium | 11.93746, 78.05331 | 30 KM/Hr |

**Risk Type:** Turn  
**Risk Level:** Medium  
**Speed Limit:** 30 KM/Hr  
**Coordinates:** 11.93746, 78.05331

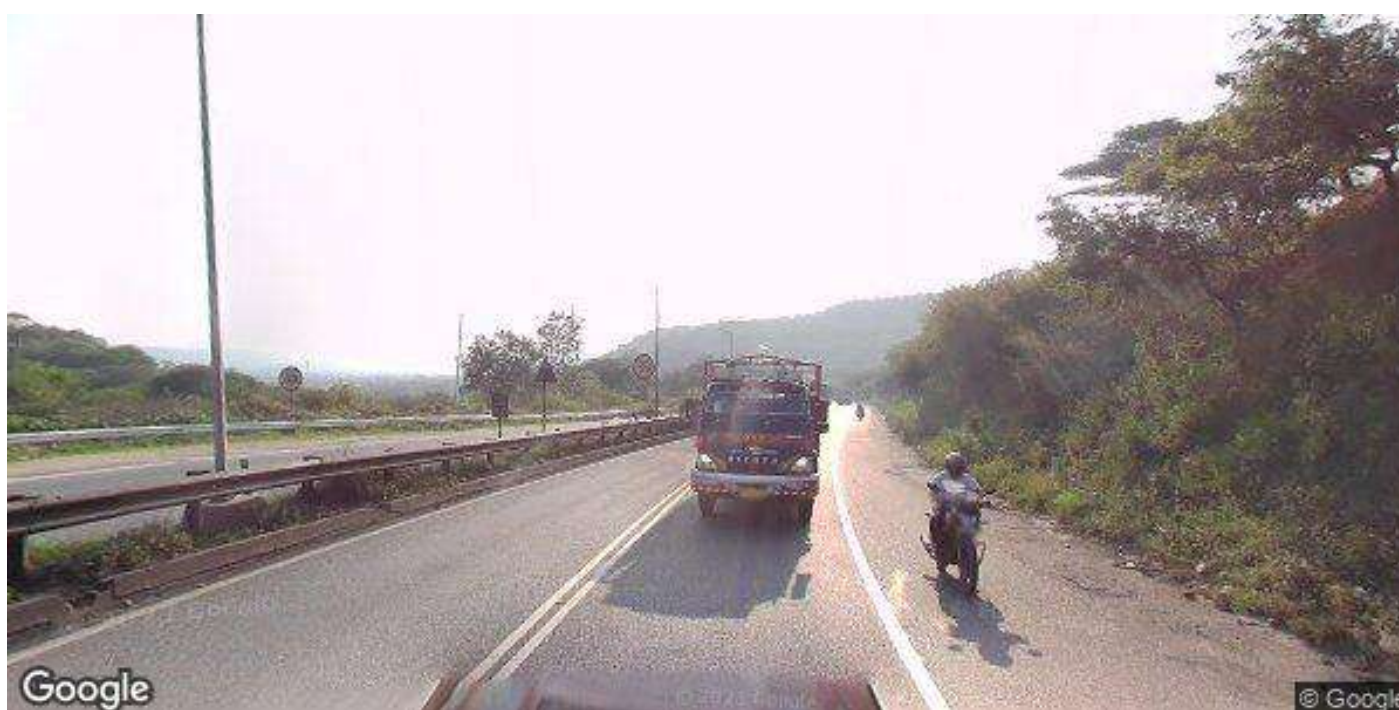
| | Risk Type | Risk Level | Coordinates | Speed Limit |
|---|---|---|---|---|
| 29 | Turn | Medium | 11.95803, 78.04964 | 30 KM/Hr |

**Risk Type:** Turn  
**Risk Level:** Medium  
**Speed Limit:** 30 KM/Hr  
**Coordinates:** 11.95803, 78.04964

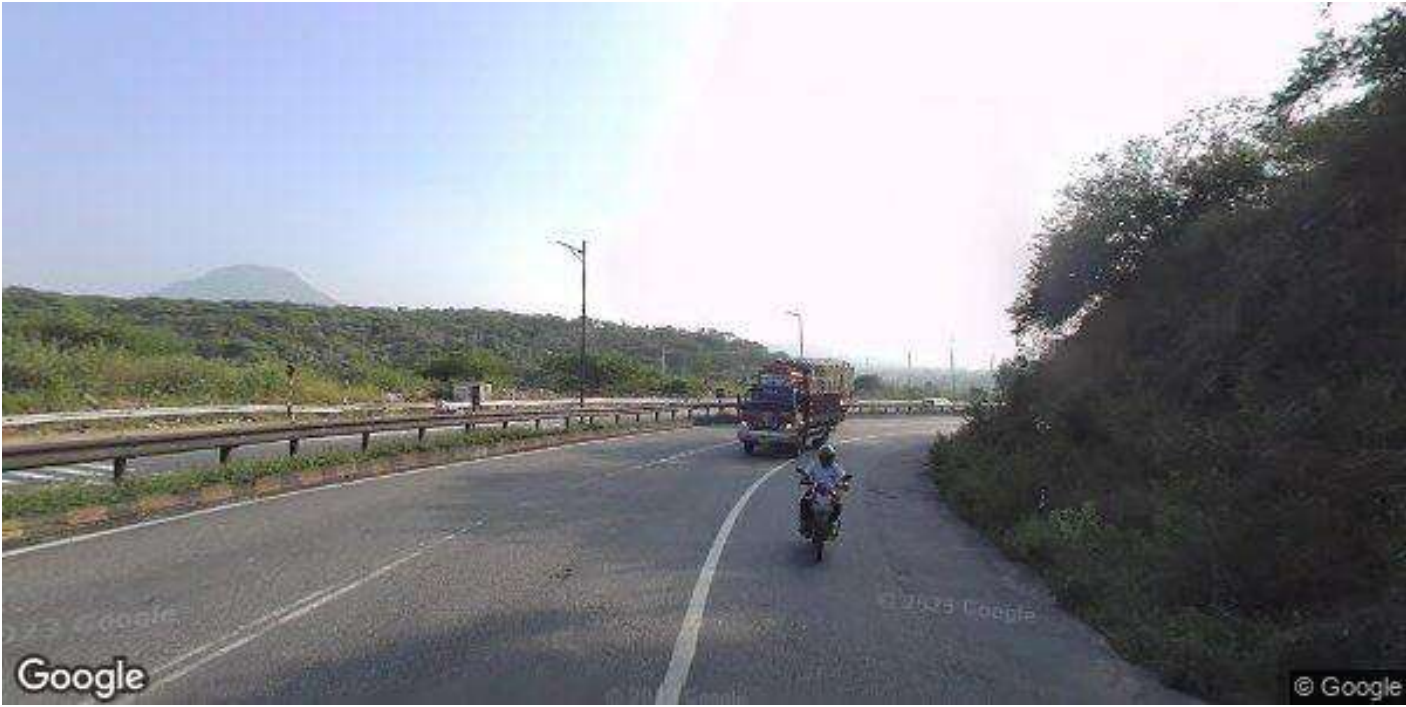
| | Risk Type | Risk Level | Coordinates | Speed Limit |
|---|---|---|---|---|
| 30 | Turn | Medium | 11.95854, 78.04990 | 30 KM/Hr |

**Risk Type:** Turn  
**Risk Level:** Medium  
**Speed Limit:** 30 KM/Hr  
**Coordinates:** 11.95854, 78.04990

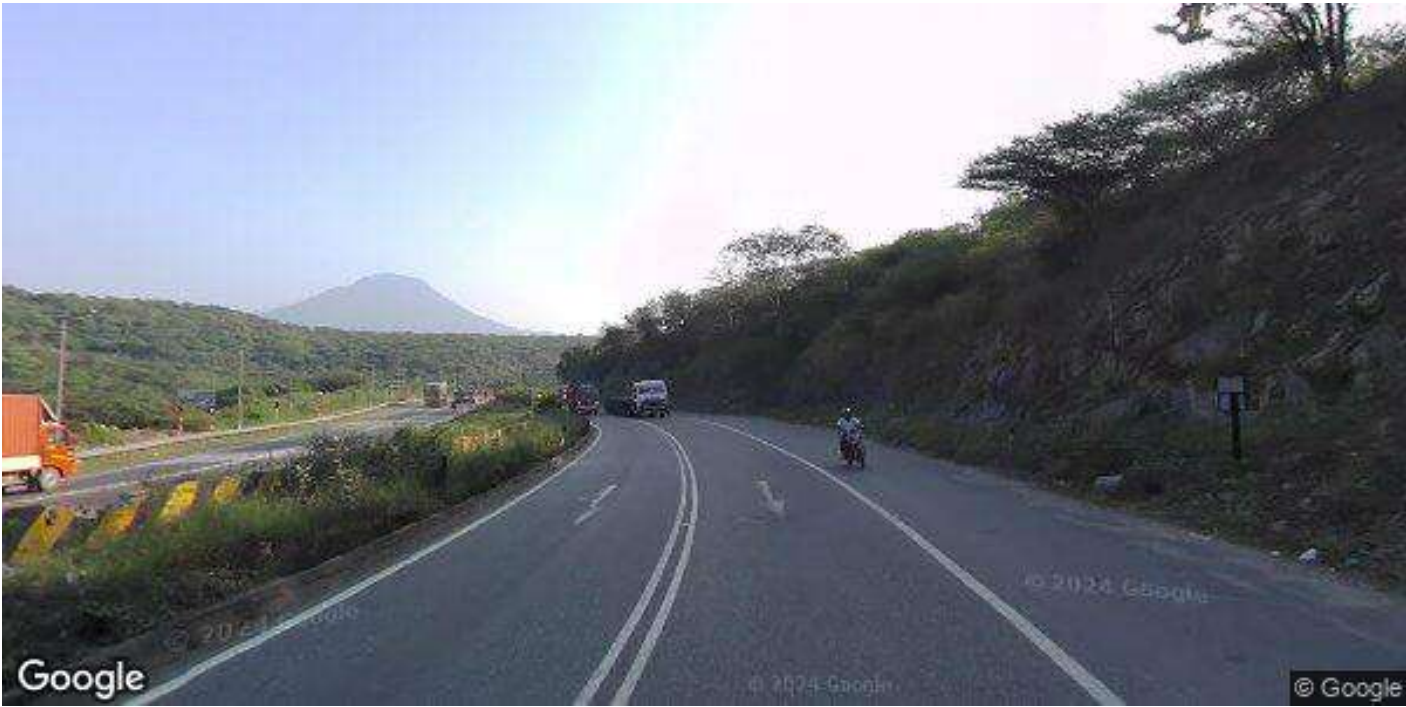
| | Risk Type | Risk Level | Coordinates | Speed Limit |
|---|---|---|---|---|
| 31 | Turn | Medium | 11.96015, 78.04945 | 30 KM/Hr |

**Risk Type:** Turn  
**Risk Level:** Medium  
**Speed Limit:** 30 KM/Hr  
**Coordinates:** 11.96015, 78.04945

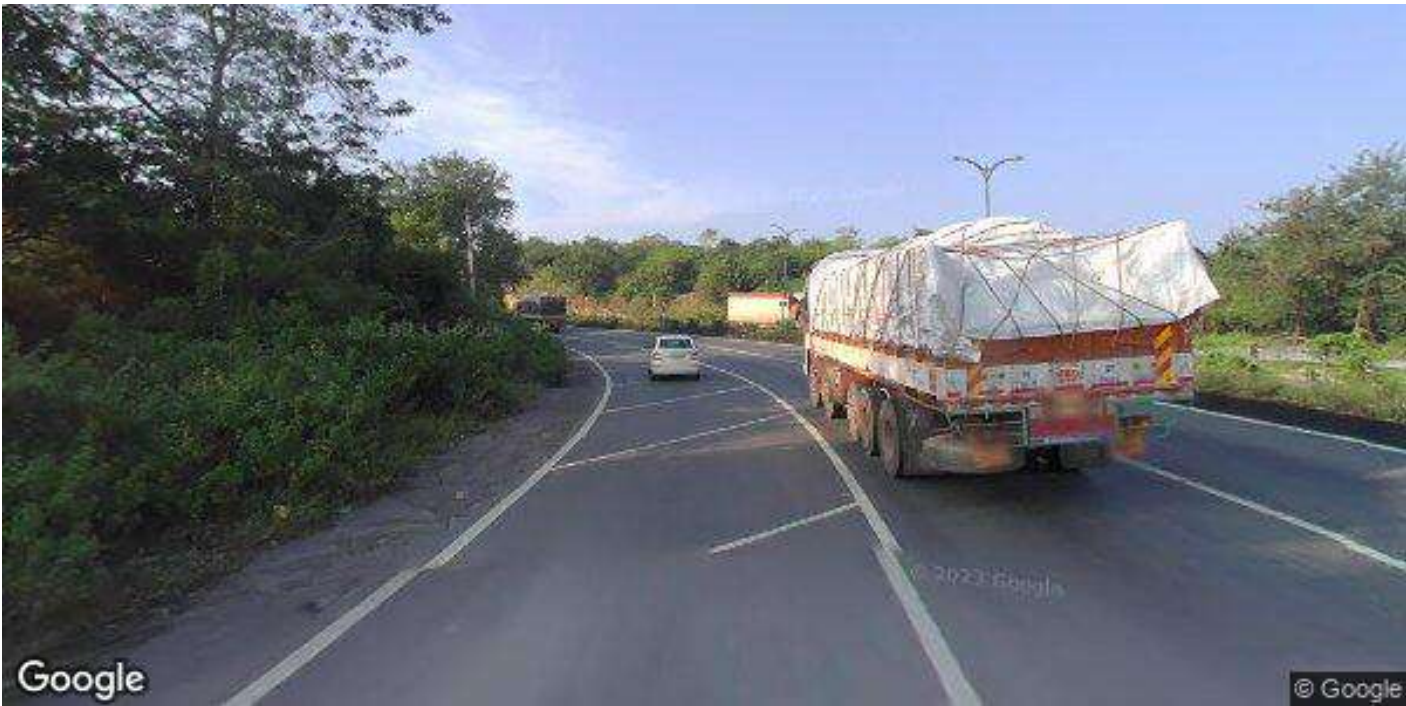
| | Risk Type | Risk Level | Coordinates | Speed Limit |
|---|---|---|---|---|
| 32 | Turn | Medium | 11.96370, 78.05142 | 30 KM/Hr |

**Risk Type:** Turn  
**Risk Level:** Medium  
**Speed Limit:** 30 KM/Hr  
**Coordinates:** 11.96370, 78.05142

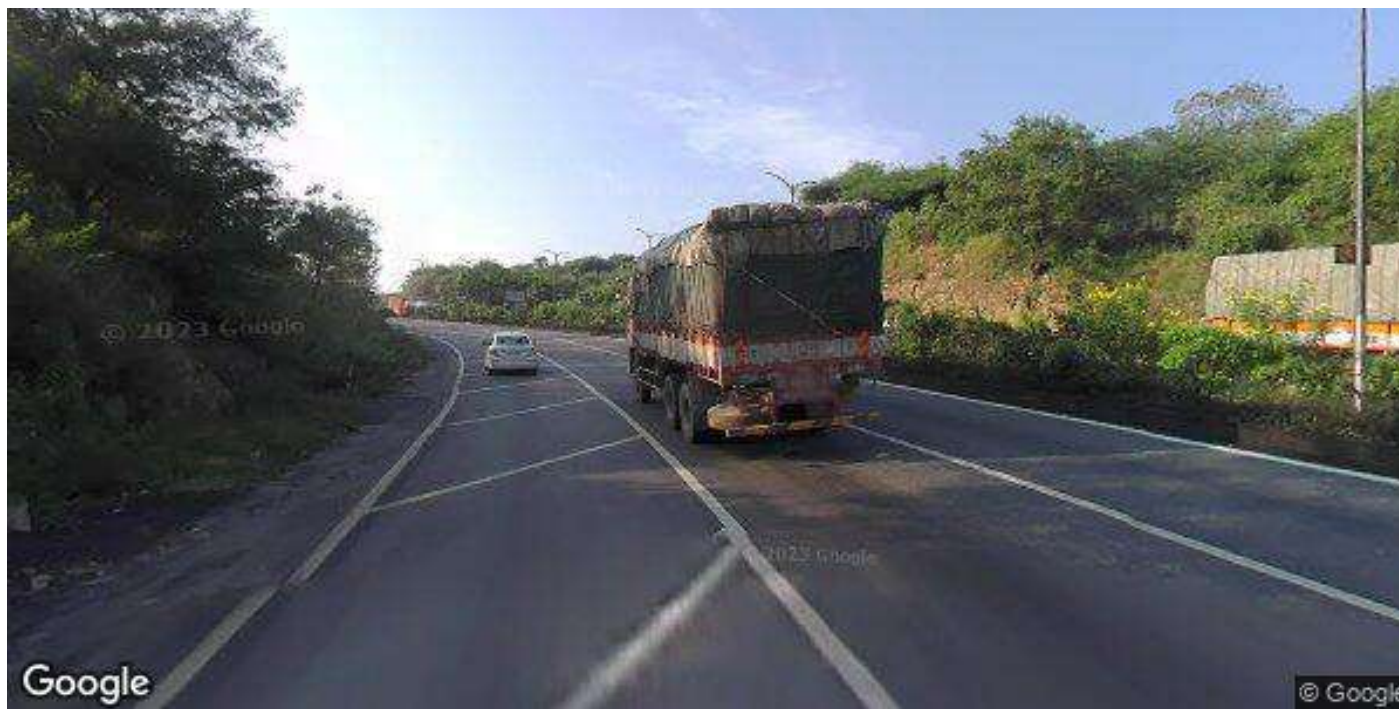
| | Risk Type | Risk Level | Coordinates | Speed Limit |
|---|---|---|---|---|
| 33 | Turn | Medium | 11.96433, 78.05113 | 30 KM/Hr |

**Risk Type:** Turn  
**Risk Level:** Medium  
**Speed Limit:** 30 KM/Hr  
**Coordinates:** 11.96433, 78.05113

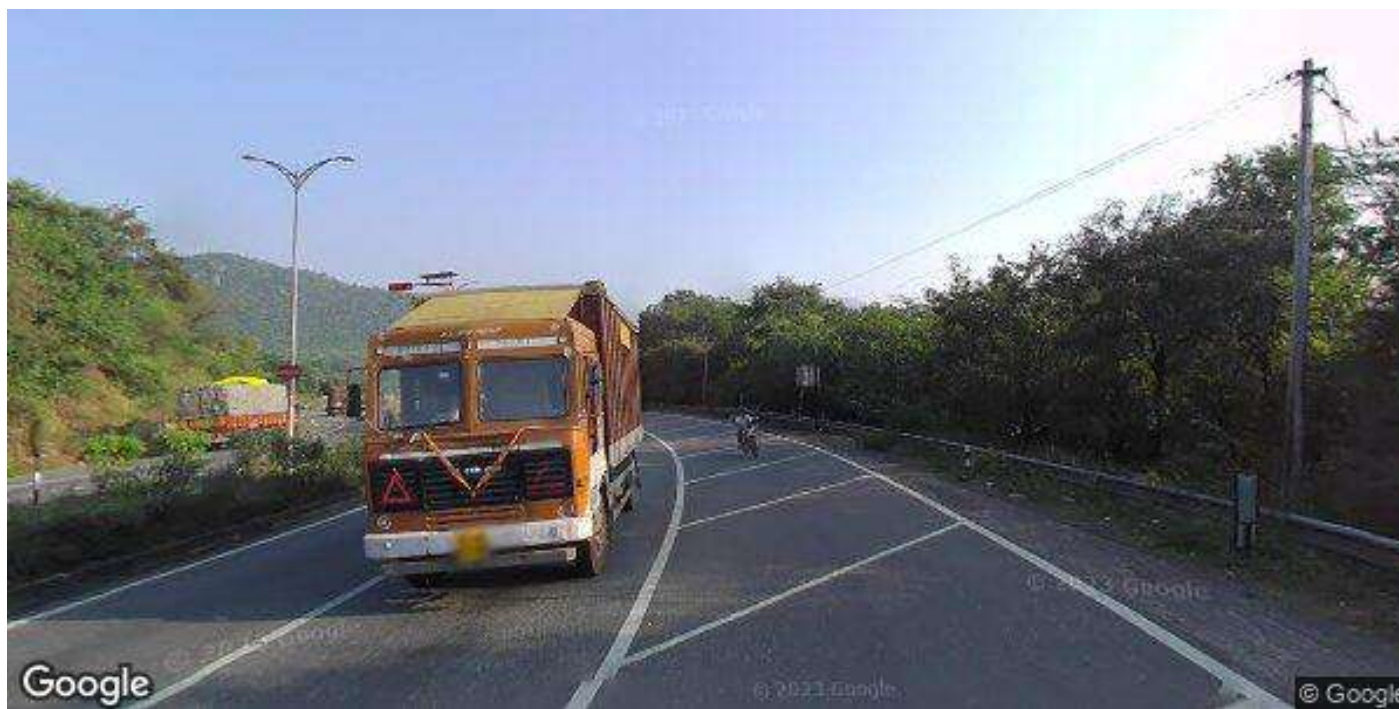
| | Risk Type | Risk Level | Coordinates | Speed Limit |
|---|---|---|---|---|
| 34 | Turn | High | 11.96542, 78.04938 | 15 KM/Hr |

**Risk Type:** Turn  
**Risk Level:** High  
**Speed Limit:** 15 KM/Hr  
**Coordinates:** 11.96542, 78.04938

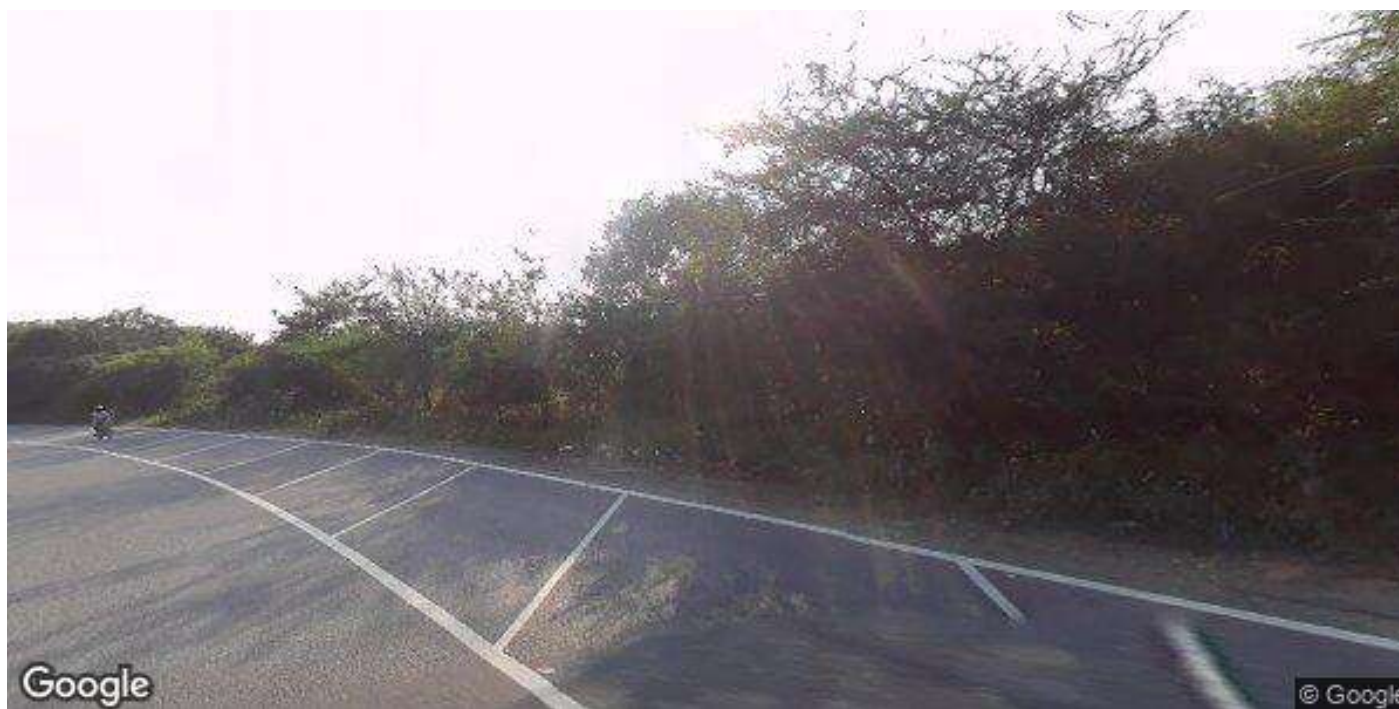
| | Risk Type | Risk Level | Coordinates | Speed Limit |
|---|---|---|---|---|
| 35 | Turn | High | 11.96650, 78.04927 | 15 KM/Hr |

**Risk Type:** Turn  
**Risk Level:** High  
**Speed Limit:** 15 KM/Hr  
**Coordinates:** 11.96650, 78.04927

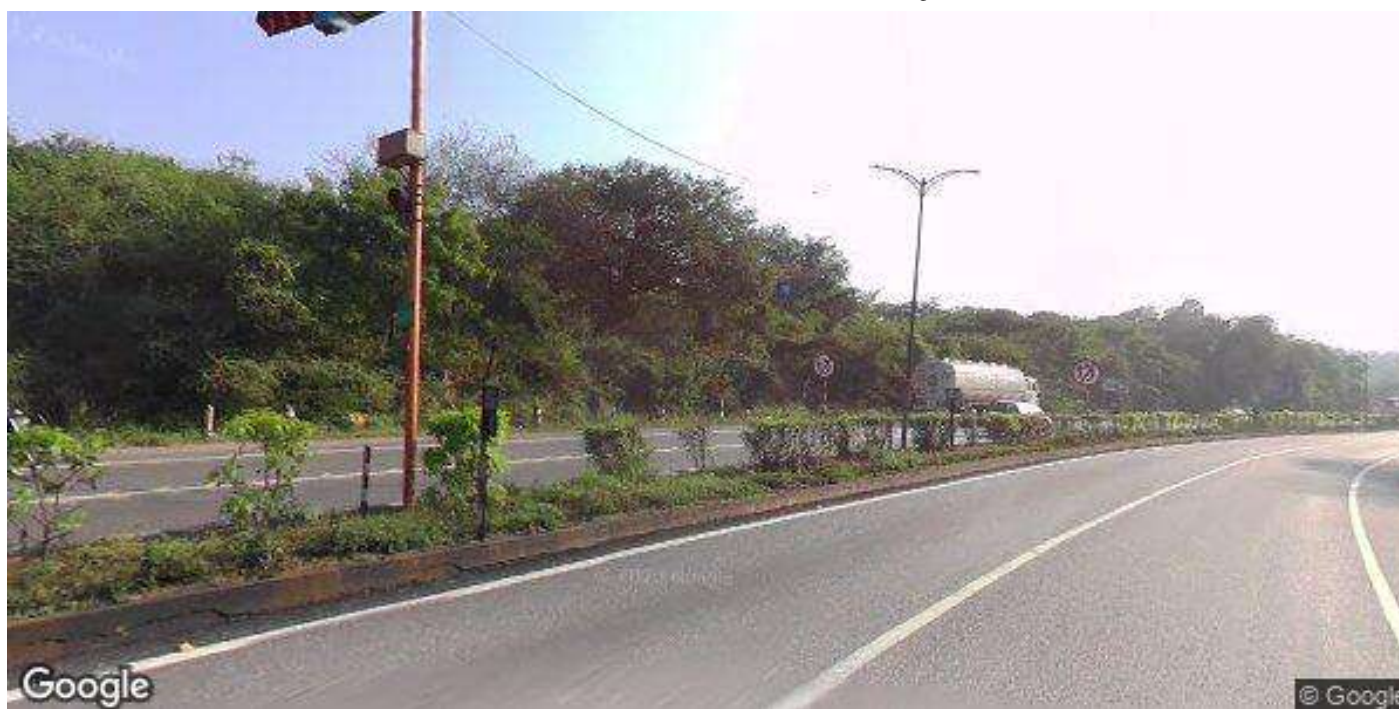
| | Risk Type | Risk Level | Coordinates | Speed Limit |
|---|---|---|---|---|
| 36 | Turn | Medium | 11.96804, 78.05080 | 30 KM/Hr |

**Risk Type:** Turn  
**Risk Level:** Medium  
**Speed Limit:** 30 KM/Hr  
**Coordinates:** 11.96804, 78.05080

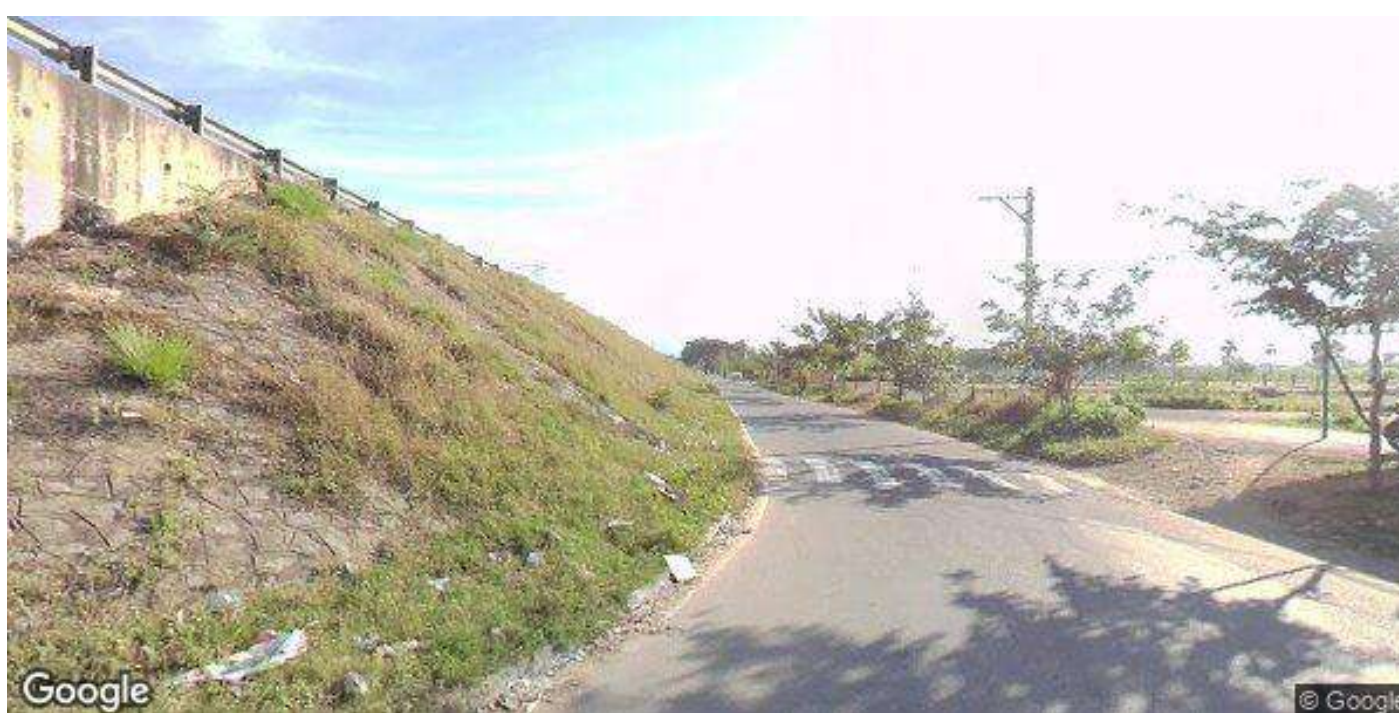
| | Risk Type | Risk Level | Coordinates | Speed Limit |
|---|---|---|---|---|
| 37 | Turn | High | 12.05835, 78.10789 | 15 KM/Hr |

**Risk Type:** Turn  
**Risk Level:** High  
**Speed Limit:** 15 KM/Hr  
**Coordinates:** 12.05835, 78.10789

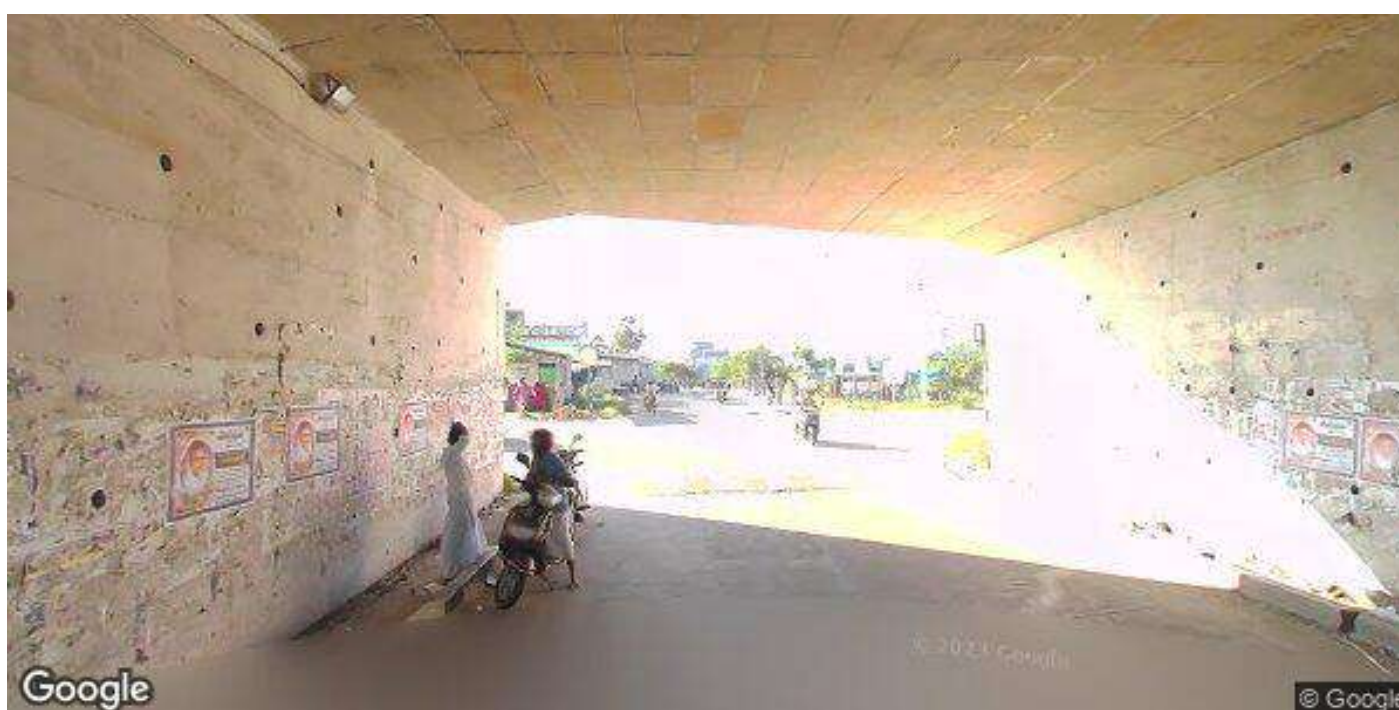
| | Risk Type | Risk Level | Coordinates | Speed Limit |
|---|---|---|---|---|
| 38 | Turn | Medium | 12.05840, 78.10812 | 30 KM/Hr |

**Risk Type:** Turn  
**Risk Level:** Medium  
**Speed Limit:** 30 KM/Hr  
**Coordinates:** 12.05840, 78.10812

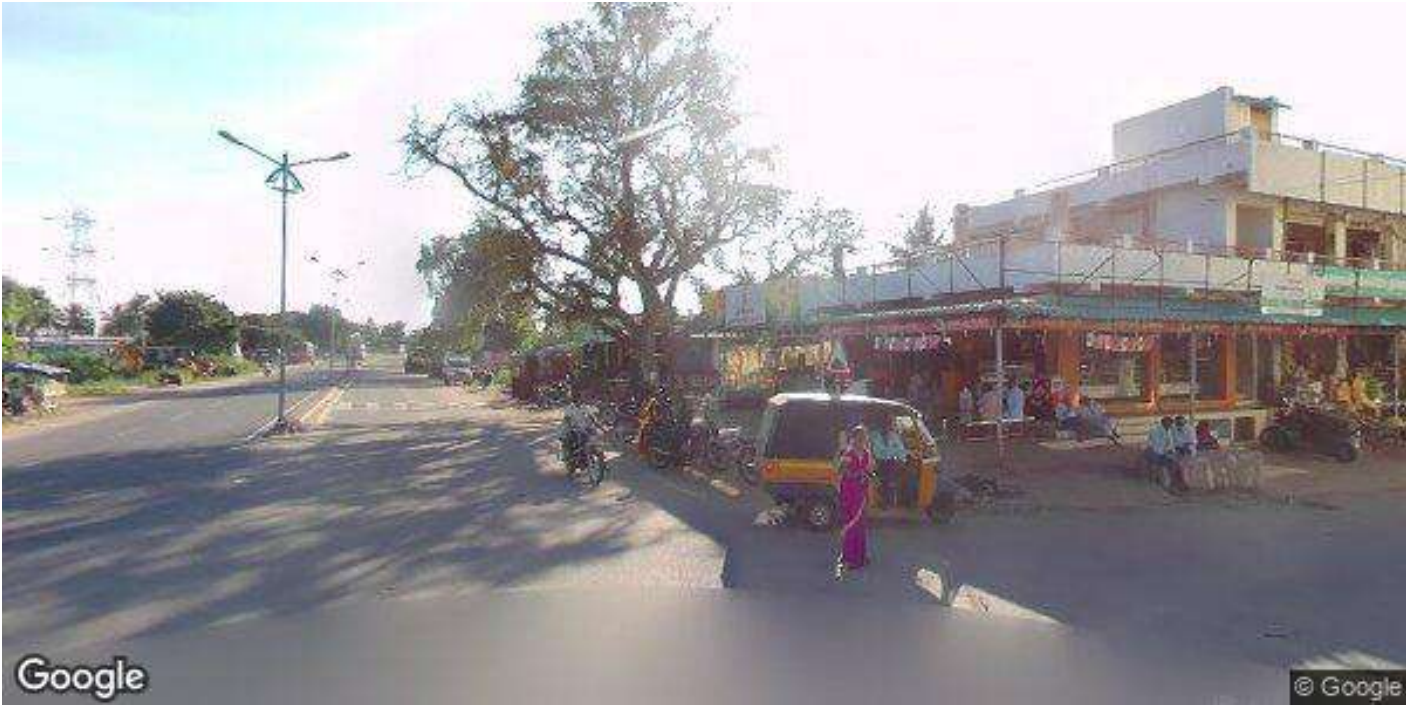
| | Risk Type | Risk Level | Coordinates | Speed Limit |
|---|---|---|---|---|
| 39 | Blind Spot | Blind Spot | 12.05721, 78.11107 | 10 KM/Hr |

**Risk Type:** Blind Spot  
**Risk Level:** Blind Spot  
**Speed Limit:** 10 KM/Hr  
**Coordinates:** 12.05721, 78.11107
