# IndianOil

## JOURNEY RISK MANAGEMENT (JRM) STUDY

### Salem Terminal TO PONNI FUELS

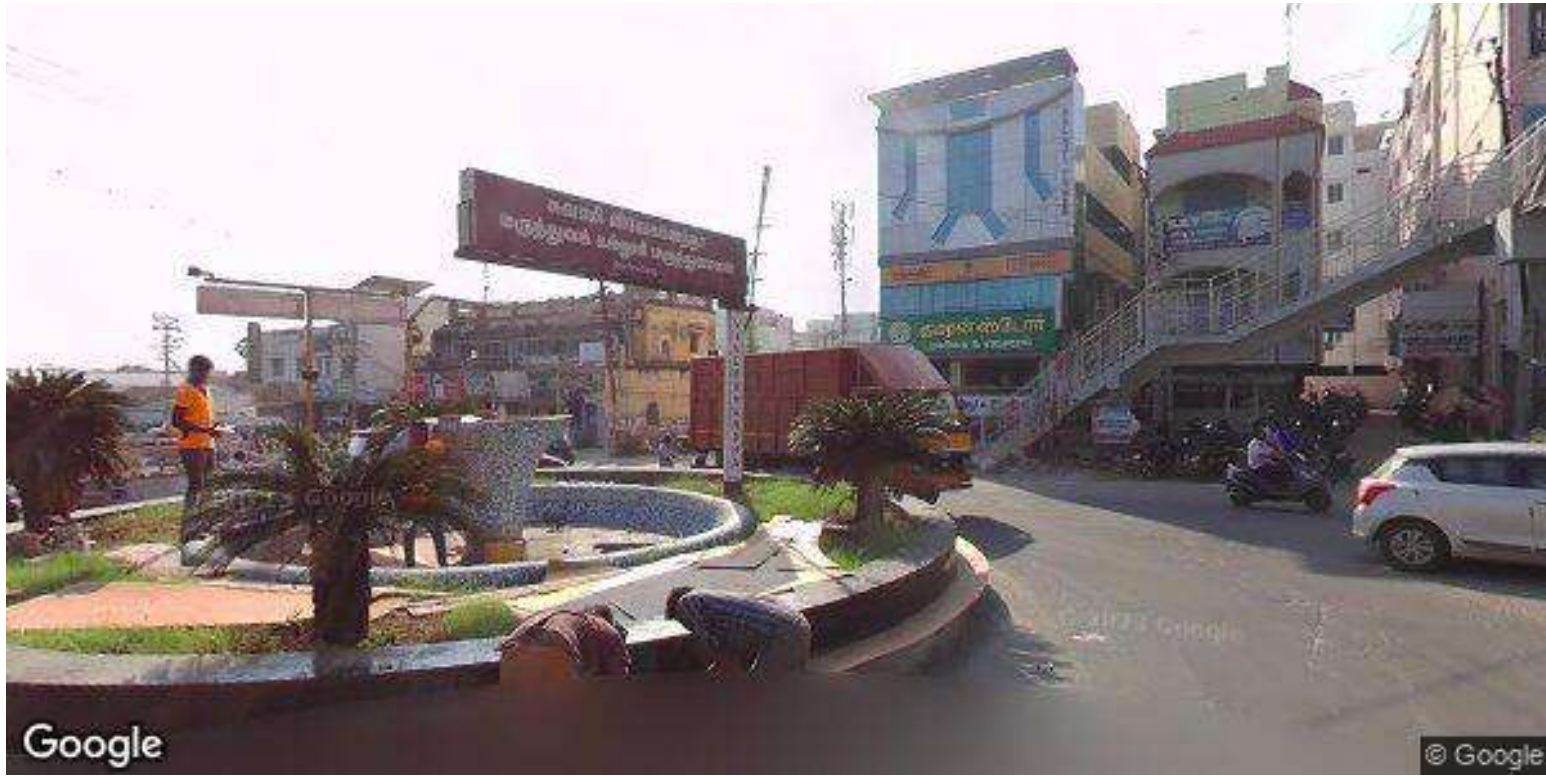
**Coordinates:** 11.38395, 77.89480

**Risk Type:** Roundabout

**Risk Level:** High

**Speed Limit:** 15 KM/Hr

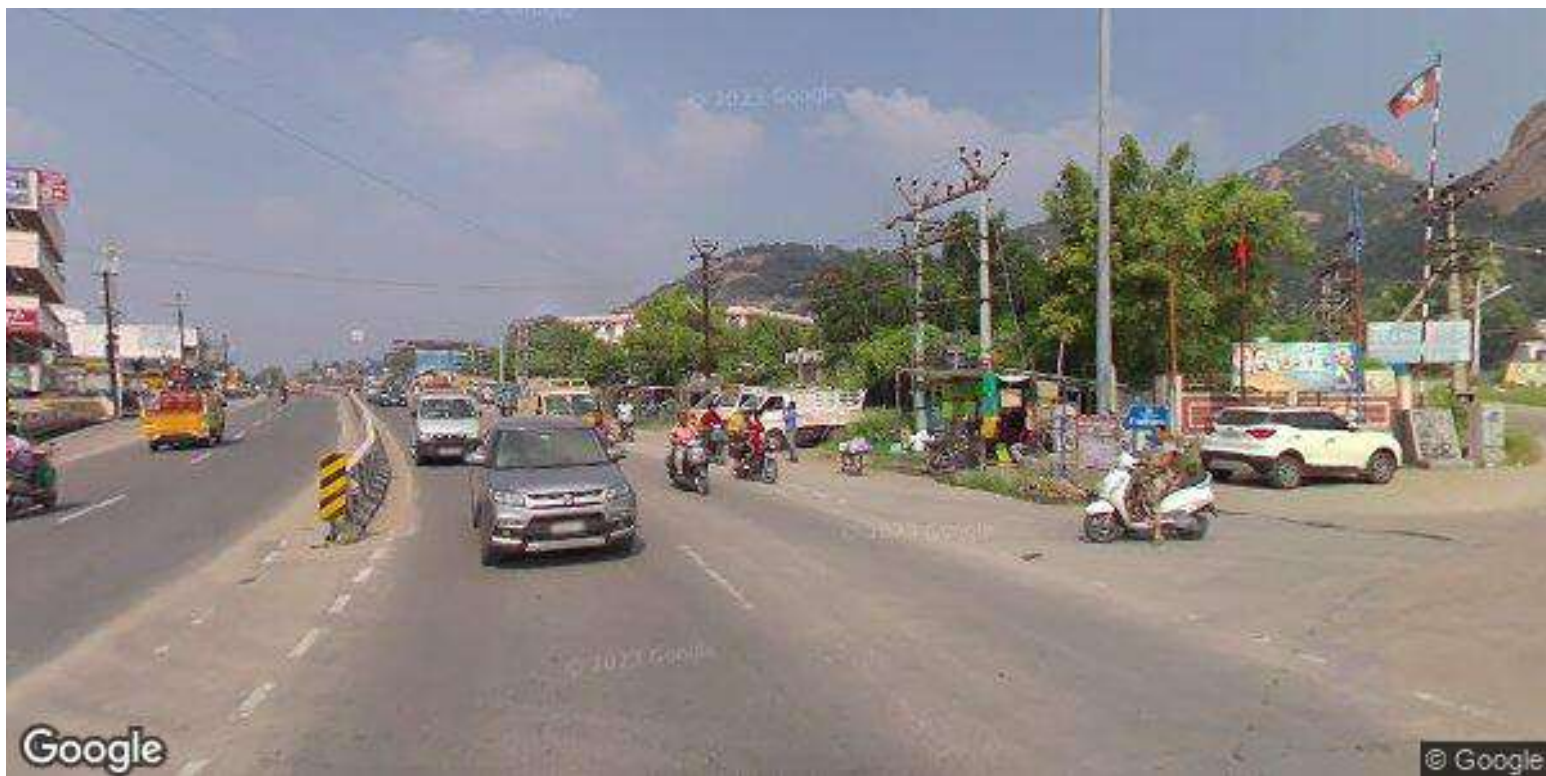
**Risk Type:** Turn  
**Risk Level:** Medium  
**Speed Limit:** 30 KM/Hr  
**Coordinates:** 11.39671, 77.88878

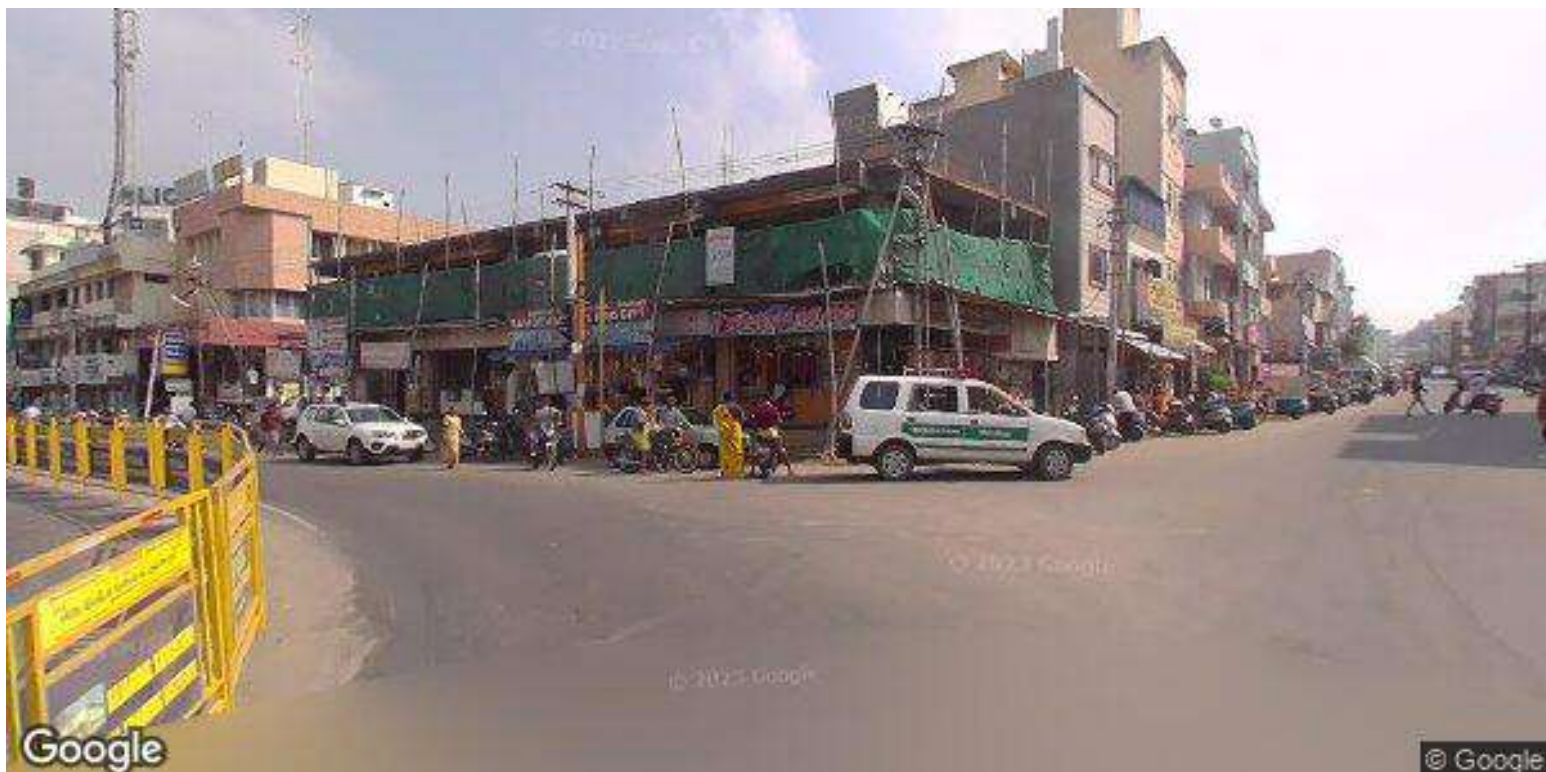
**Coordinates: 11.37868, 77.89498**

**Risk Type: Turn**

**Risk Level: High**

**Speed Limit: 15 KM/Hr**

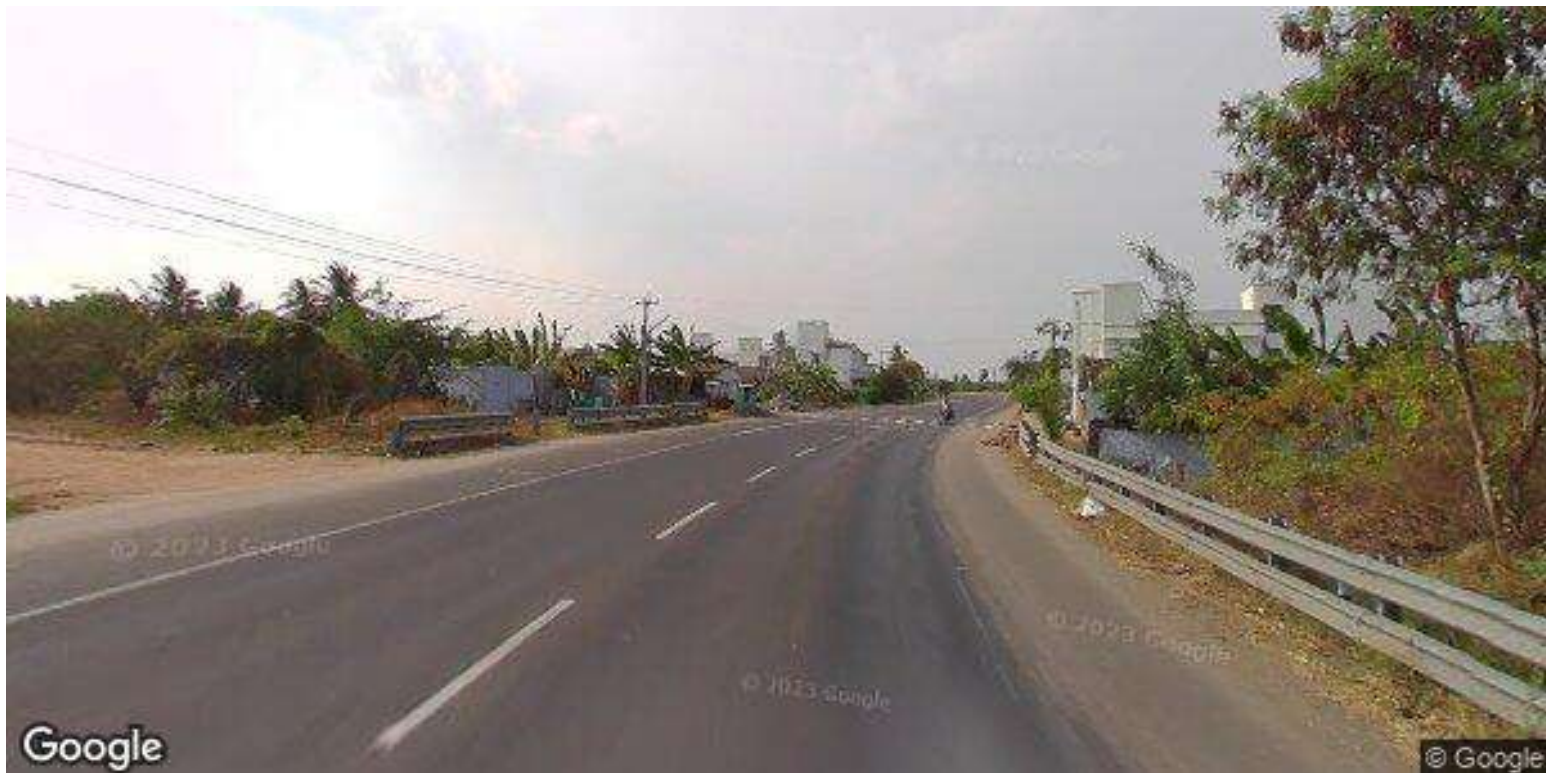
**Coordinates: 11.16764, 78.01565**

**Risk Type: Turn**

**Risk Level: Medium**

**Speed Limit: 30 KM/Hr**

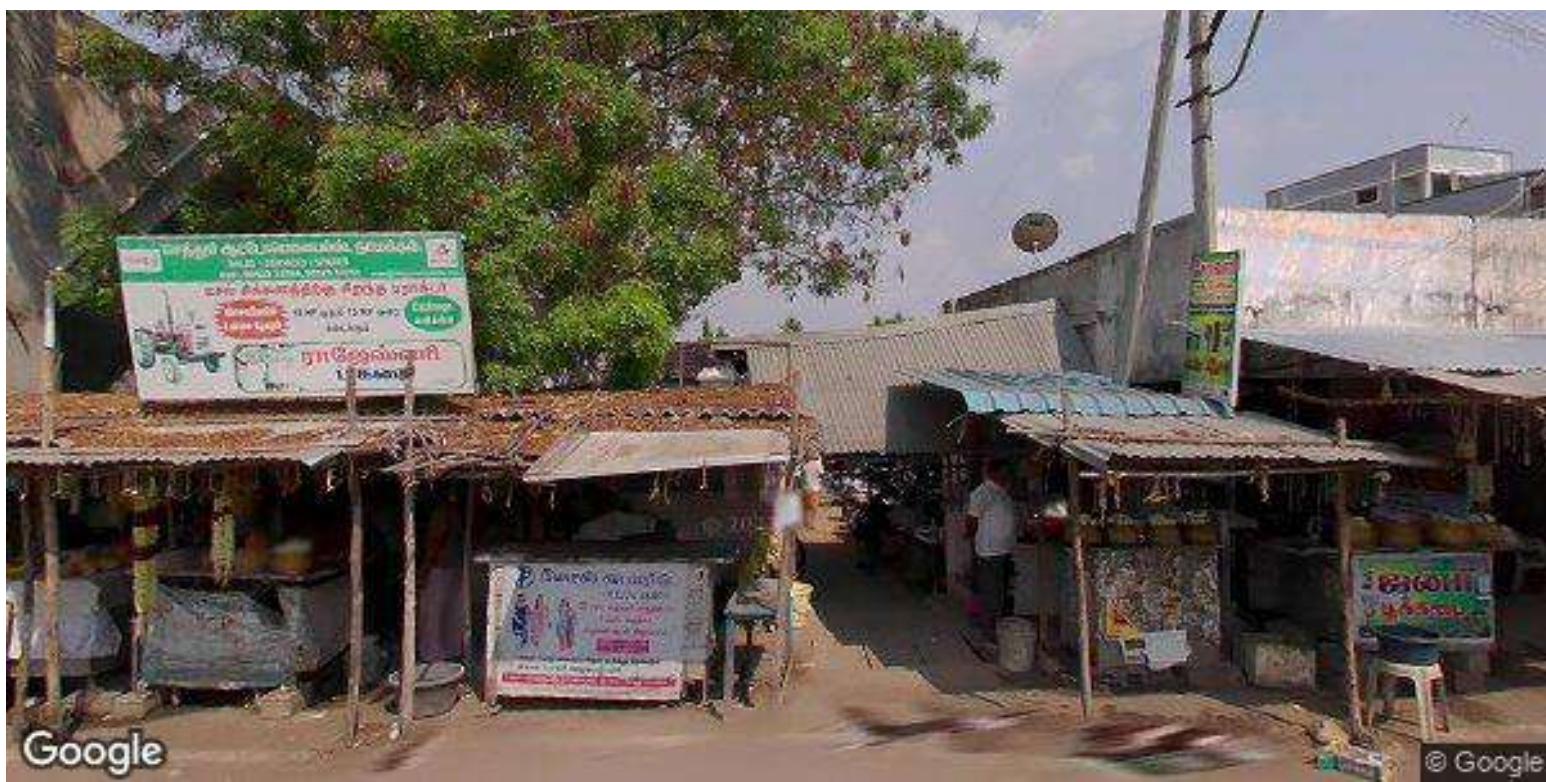
**Coordinates:** 11.15573, 78.02176

**Risk Type:** Turn

**Risk Level:** High

**Speed Limit:** 15 KM/Hr

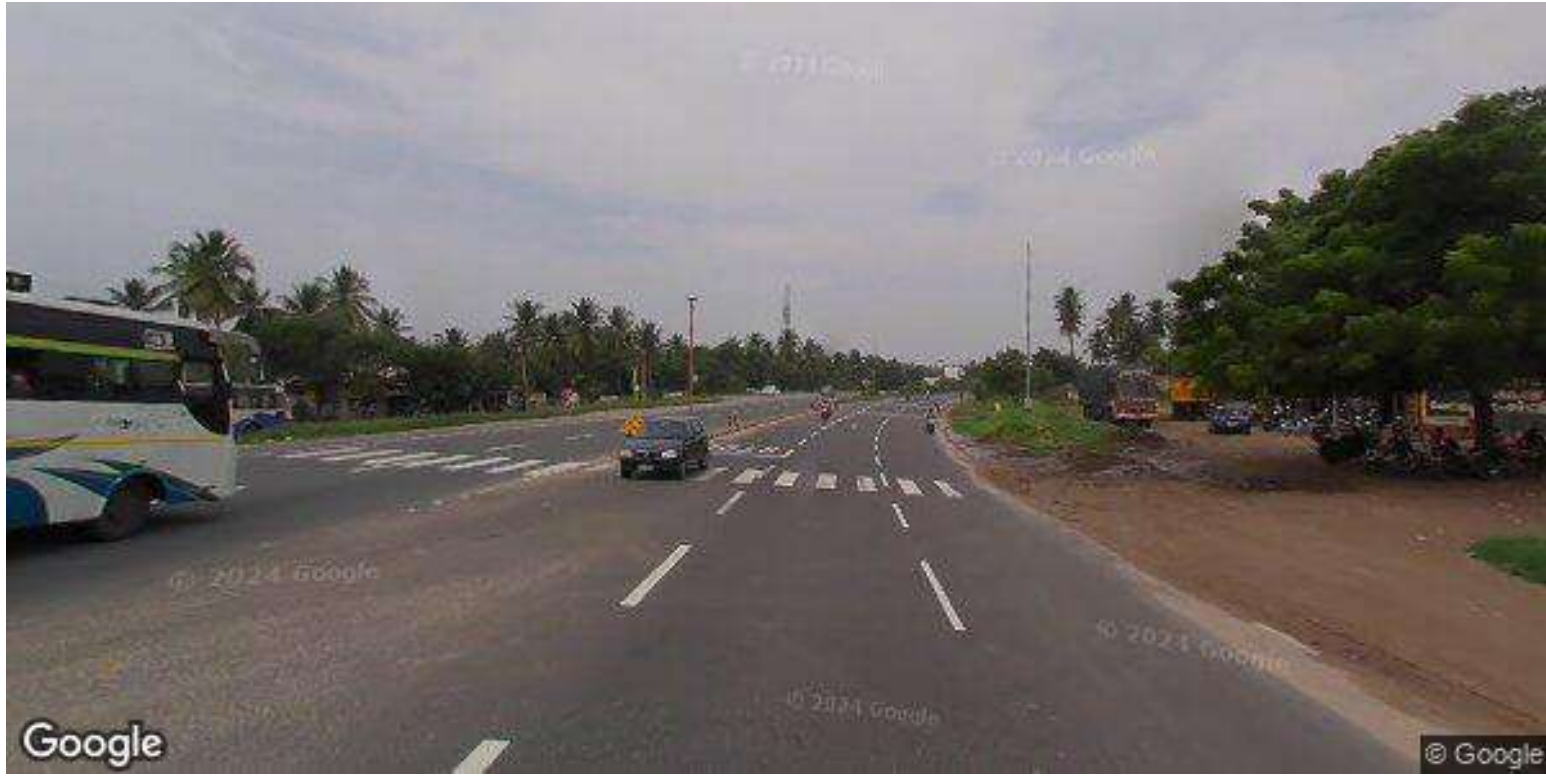
**Risk Type:** Turn  
**Risk Level:** High  
**Speed Limit:** 15 KM/Hr  
**Coordinates:** 11.12555, 78.01664

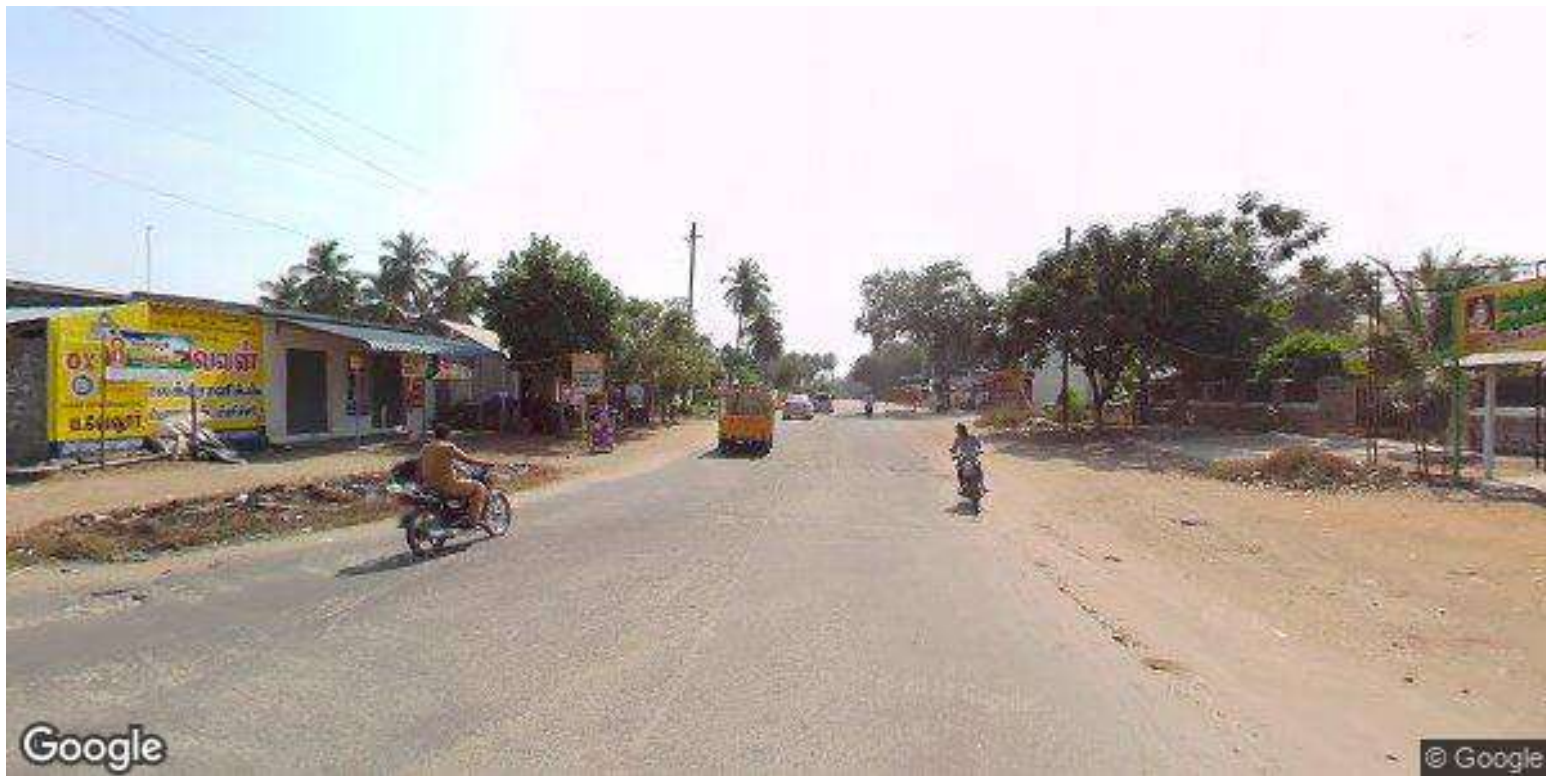
**Risk Type:** Turn  
**Risk Level:** High  
**Speed Limit:** 15 KM/Hr  
**Coordinates:** 11.12540, 78.01613

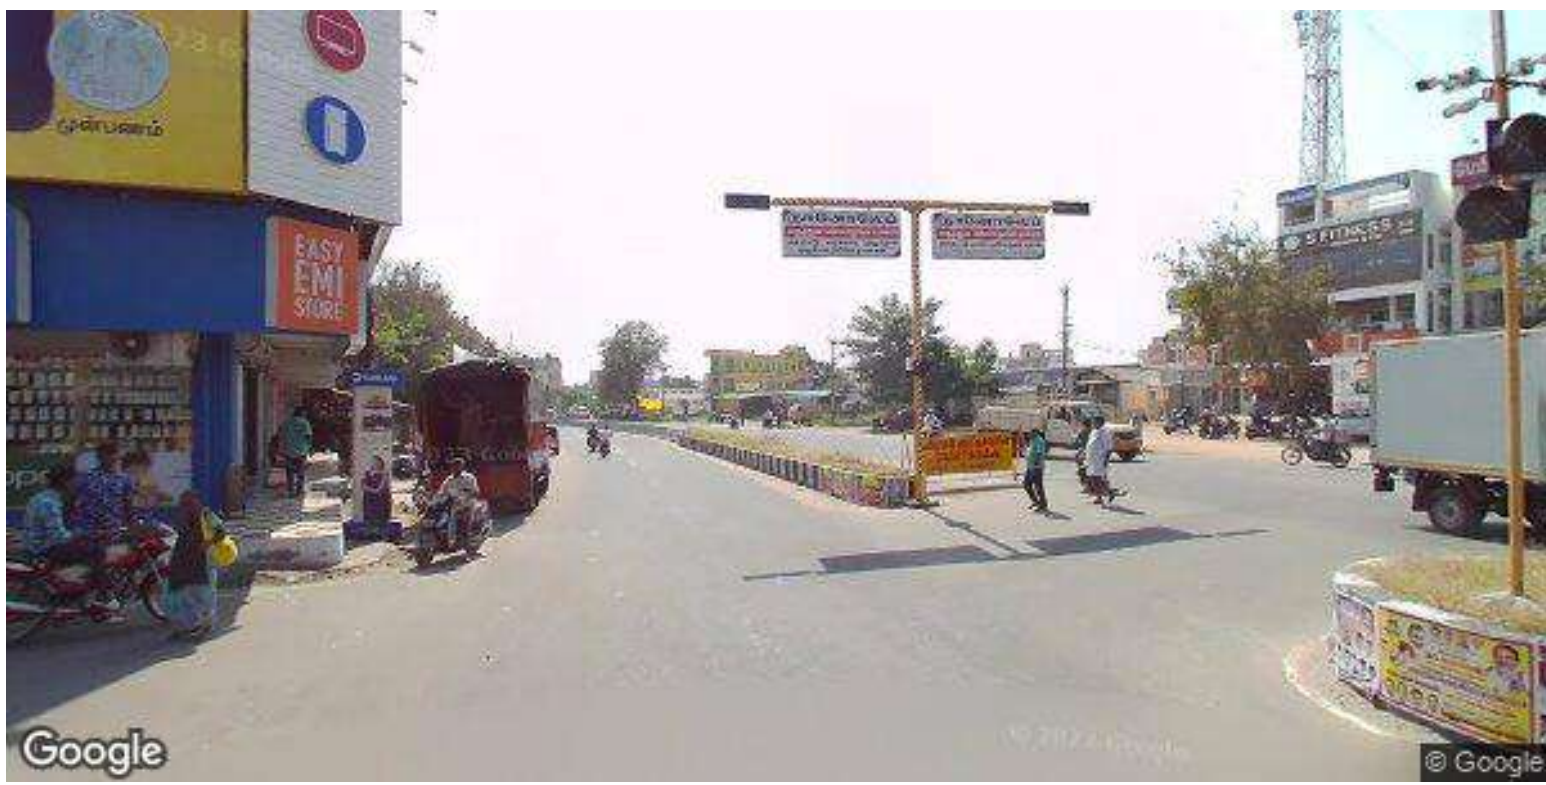
**Coordinates:** 11.11211, 78.00450

**Risk Type:** Turn

**Risk Level:** High

**Speed Limit:** 15 KM/Hr
