# IndianOil

## JOURNEY RISK MANAGEMENT (JRM) STUDY

### Salem Terminal TO RKV PETROL BUNK

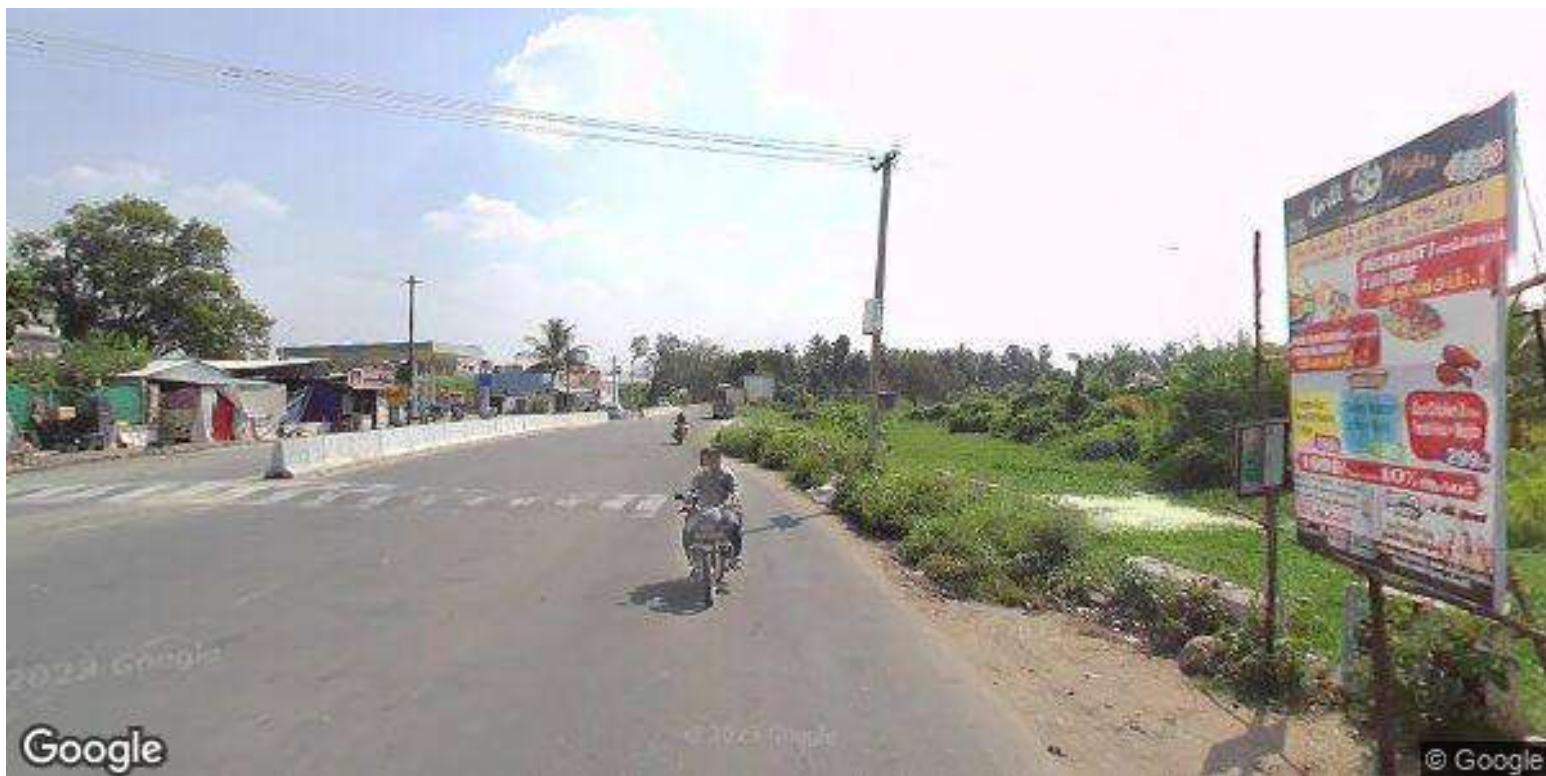
**Risk Type:** Turn  
**Risk Level:** High  
**Speed Limit:** 15 KM/Hr  
**Coordinates:** 11.44861, 77.87429

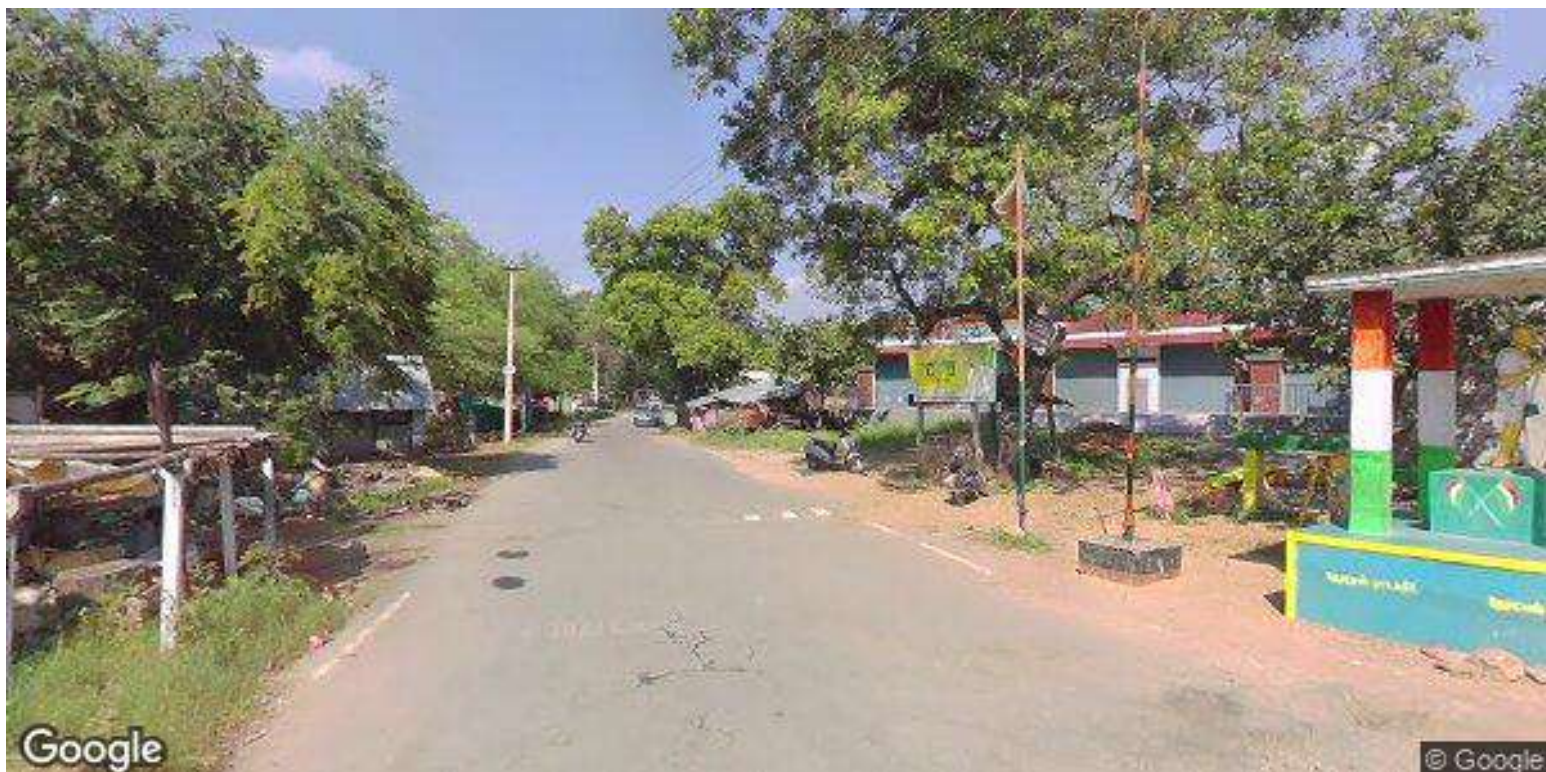
**Risk Type:** Turn  
**Risk Level:** High  
**Speed Limit:** 15 KM/Hr  
**Coordinates:** 11.43673, 77.91703

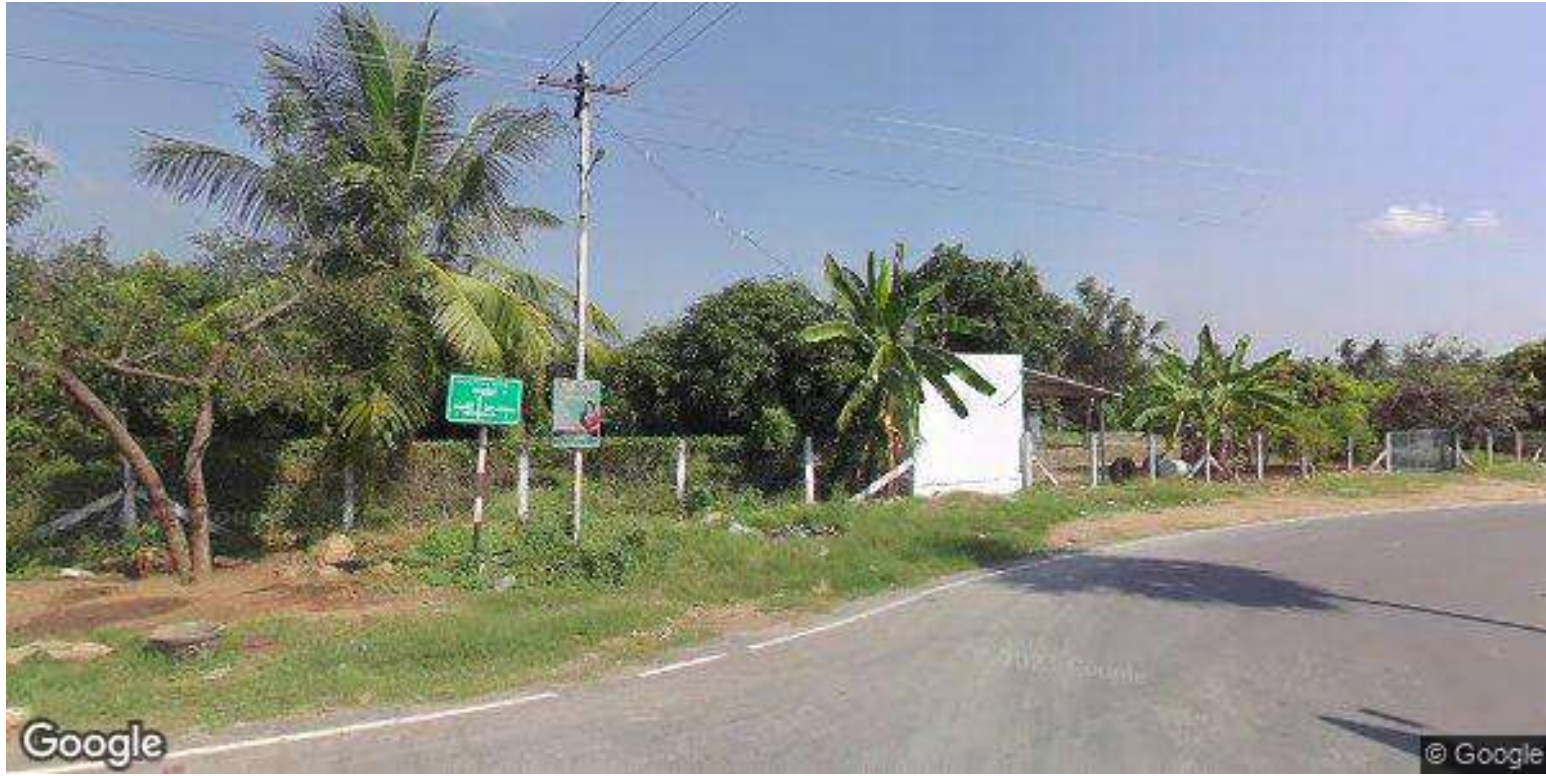
**Risk Type:** Turn  
**Risk Level:** High  
**Speed Limit:** 15 KM/Hr  
**Coordinates:** 11.43926, 77.91705

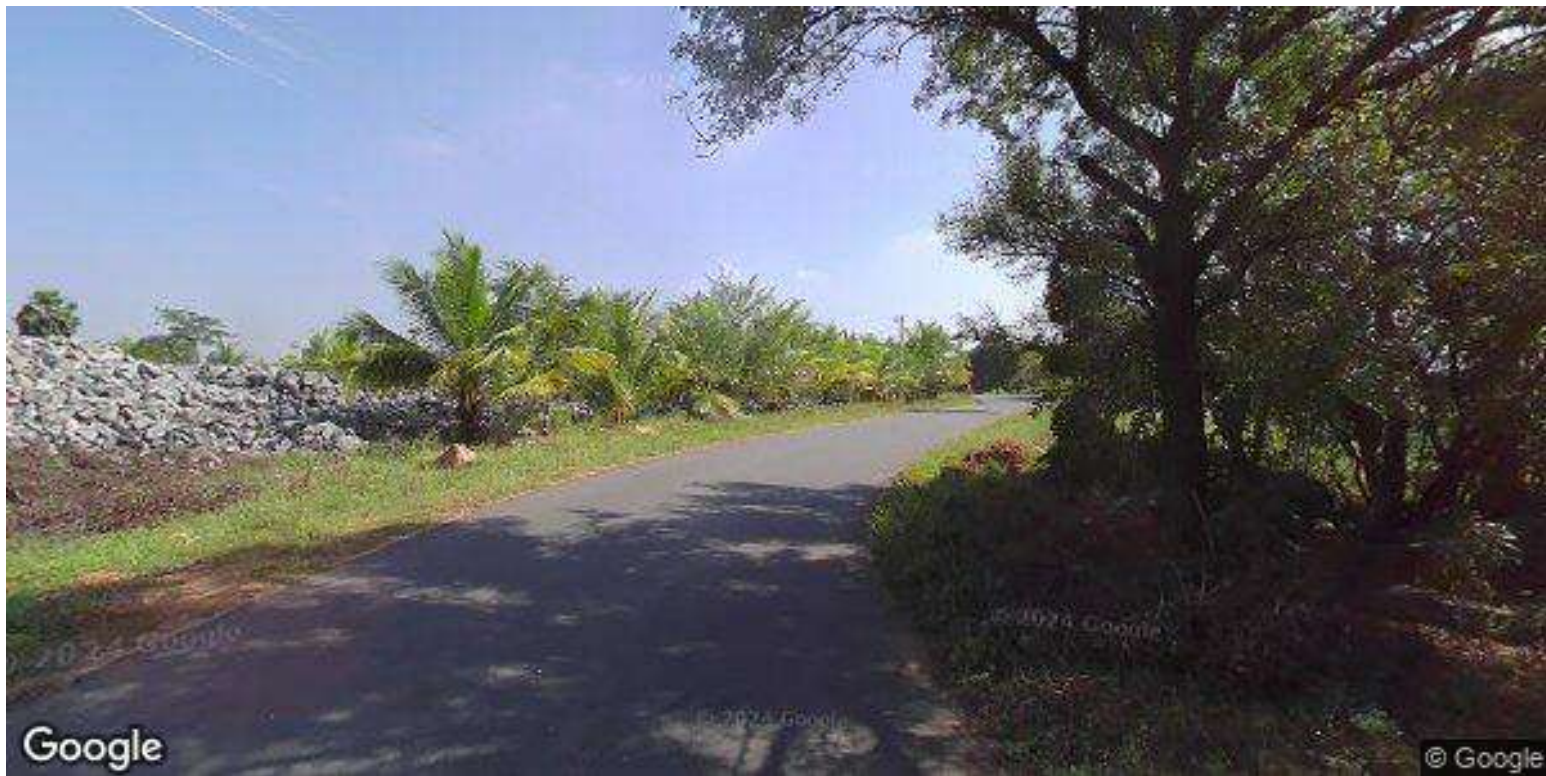
**Risk Type:** Turn  
**Risk Level:** Medium  
**Speed Limit:** 30 KM/Hr  
**Coordinates:** 11.44030, 77.93066

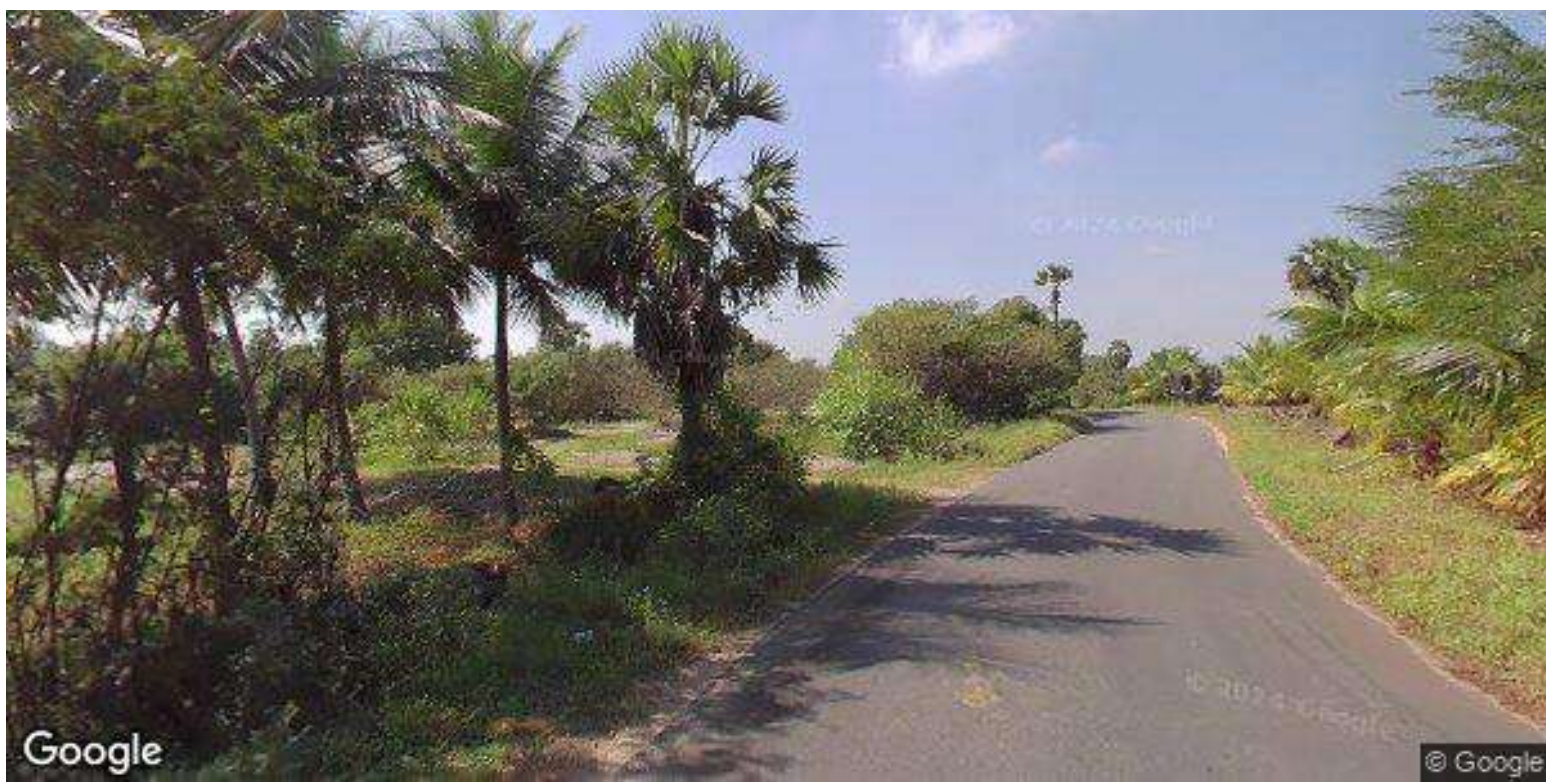
**Coordinates:** 11.44075, 77.93216

**Risk Type:** Turn

**Risk Level:** Medium

**Speed Limit:** 30 KM/Hr

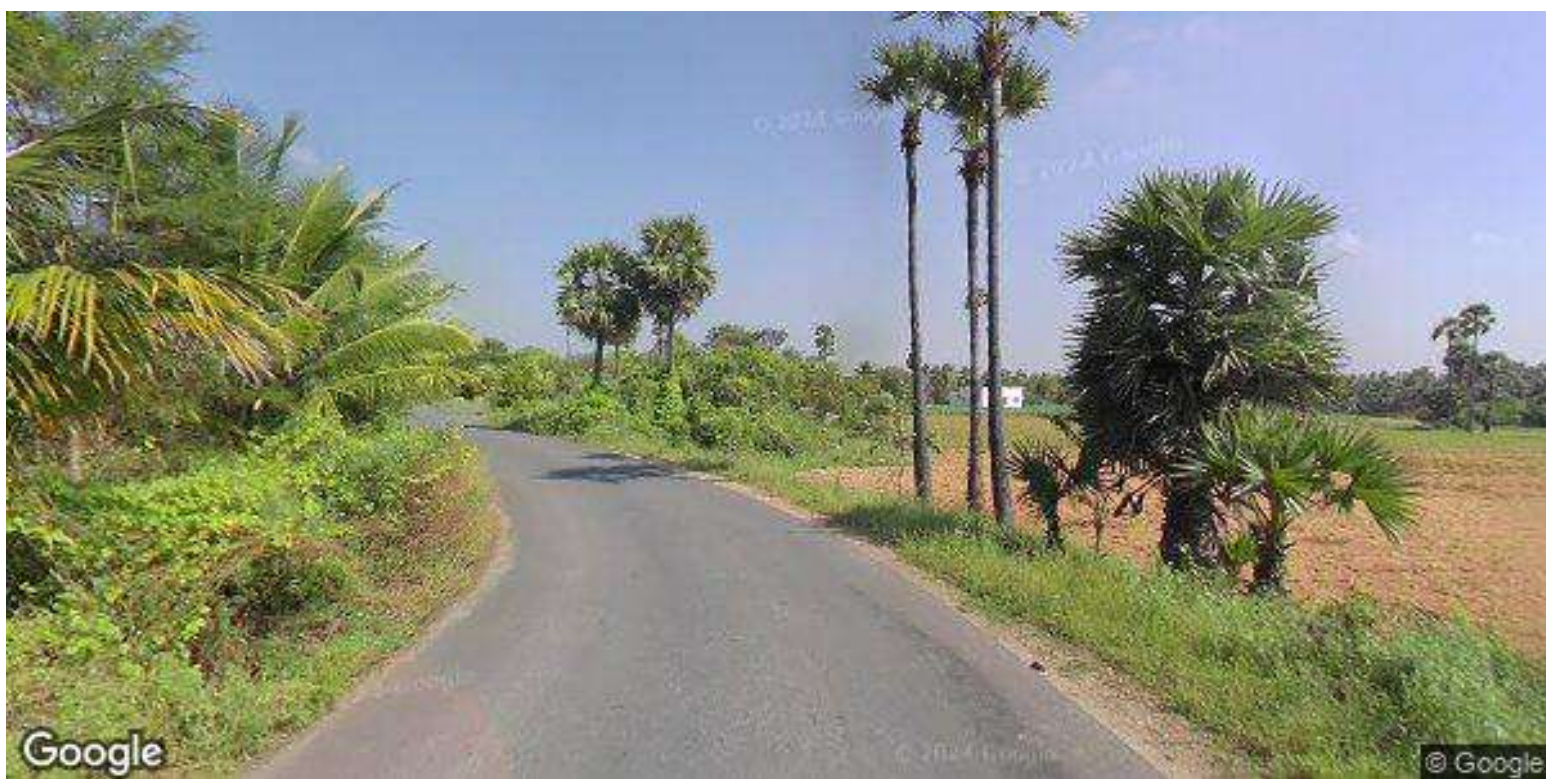
**Coordinates:** 11.44088, 77.93223

**Risk Type:** Turn

**Risk Level:** Medium

**Speed Limit:** 30 KM/Hr

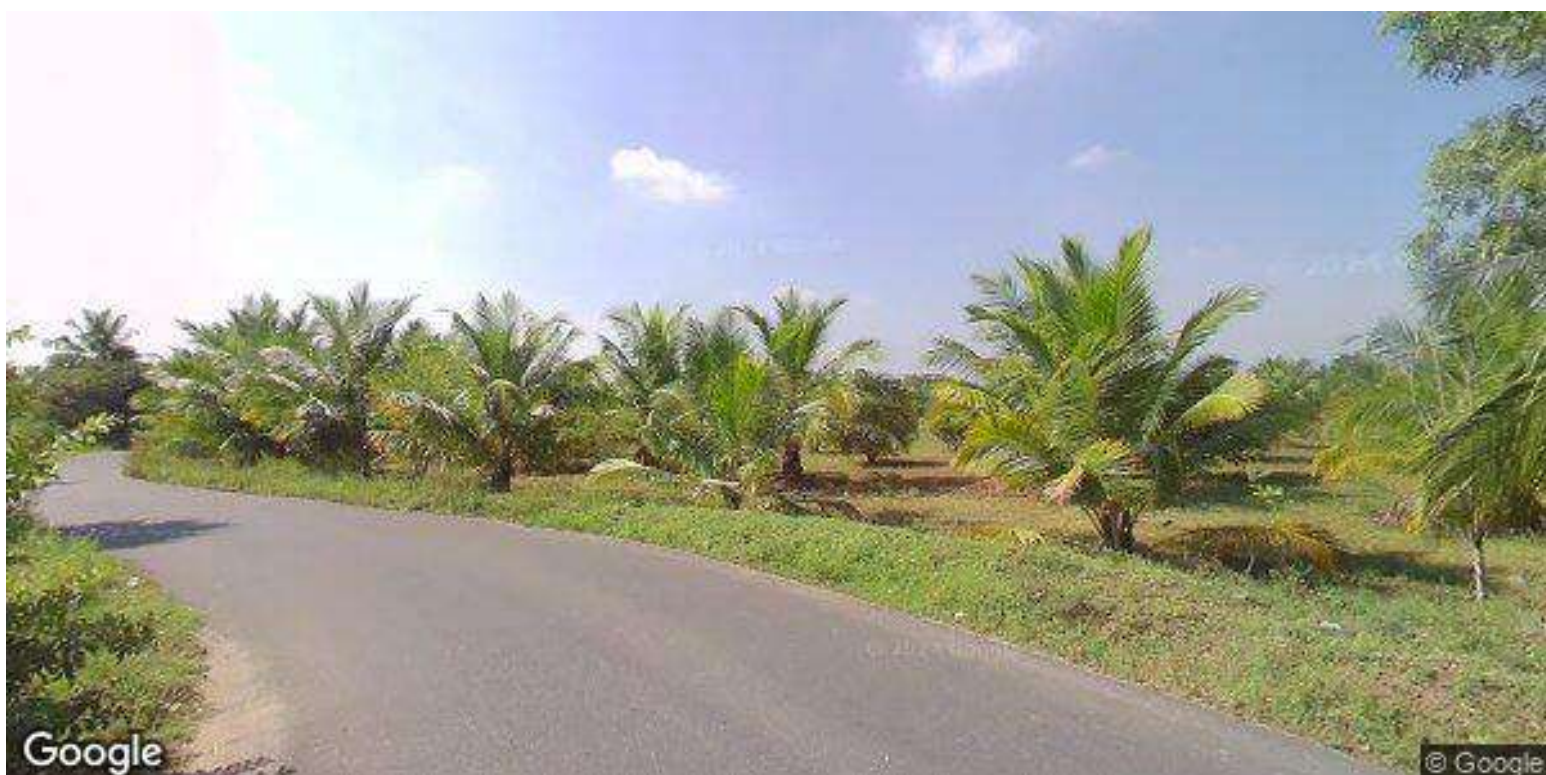
**Coordinates:** 11.44135, 77.93220

**Risk Type:** Turn

**Risk Level:** Medium

**Speed Limit:** 30 KM/Hr

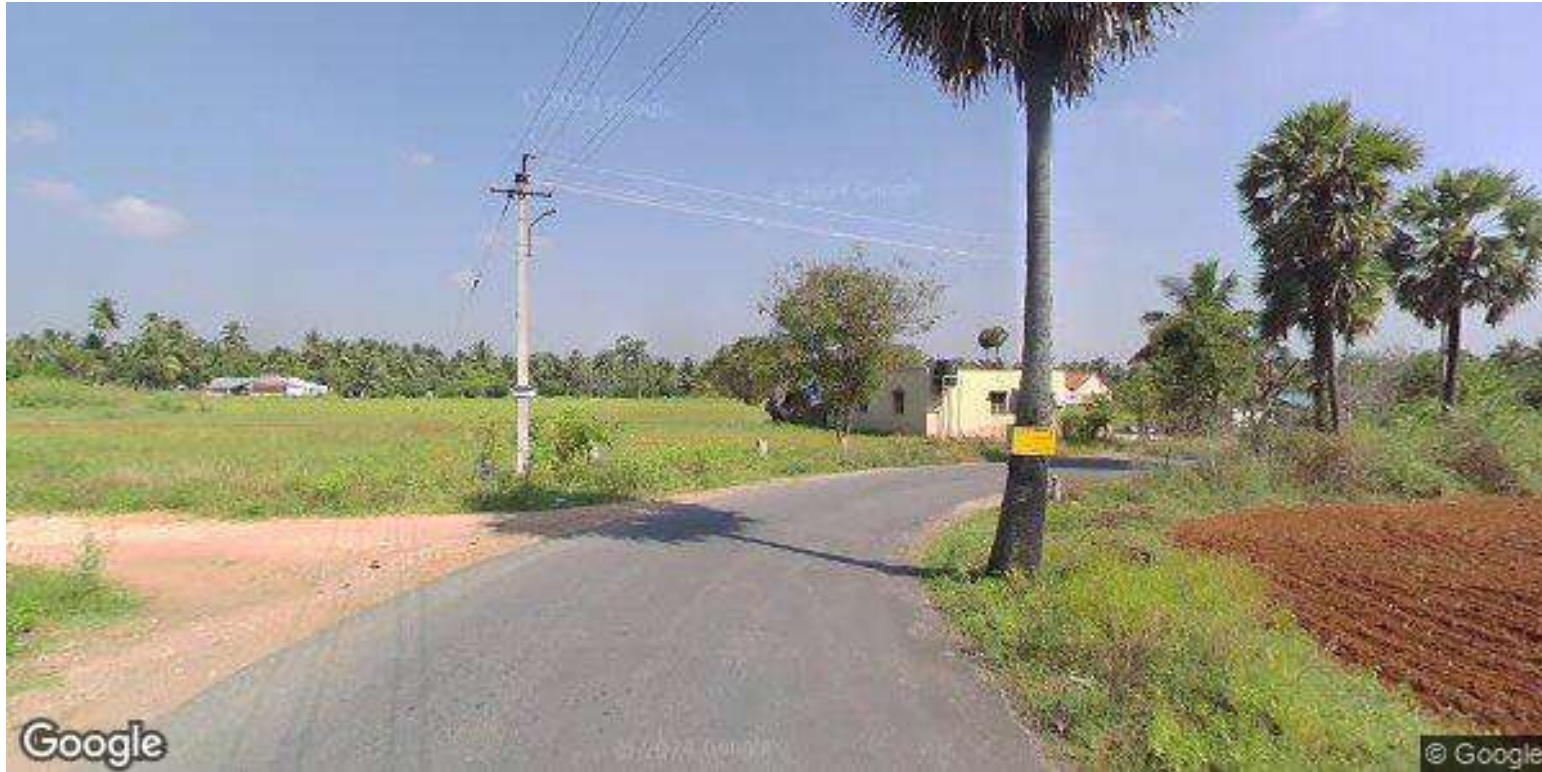
**Coordinates:** 11.44243, 77.93244

**Risk Type:** Turn

**Risk Level:** Medium

**Speed Limit:** 30 KM/Hr

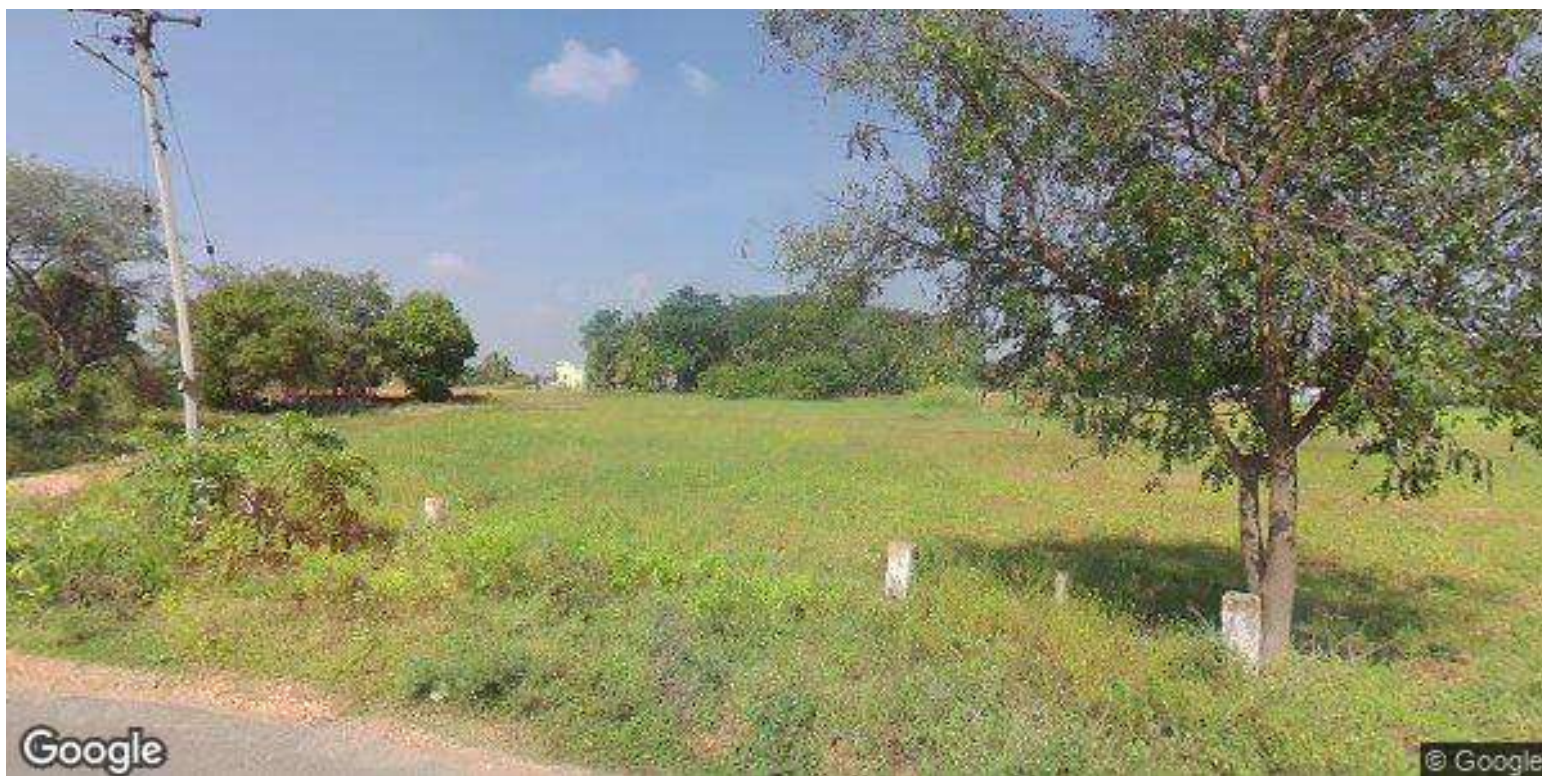
**Coordinates:** 11.44254, 77.93256

**Risk Type:** Turn

**Risk Level:** Medium

**Speed Limit:** 30 KM/Hr

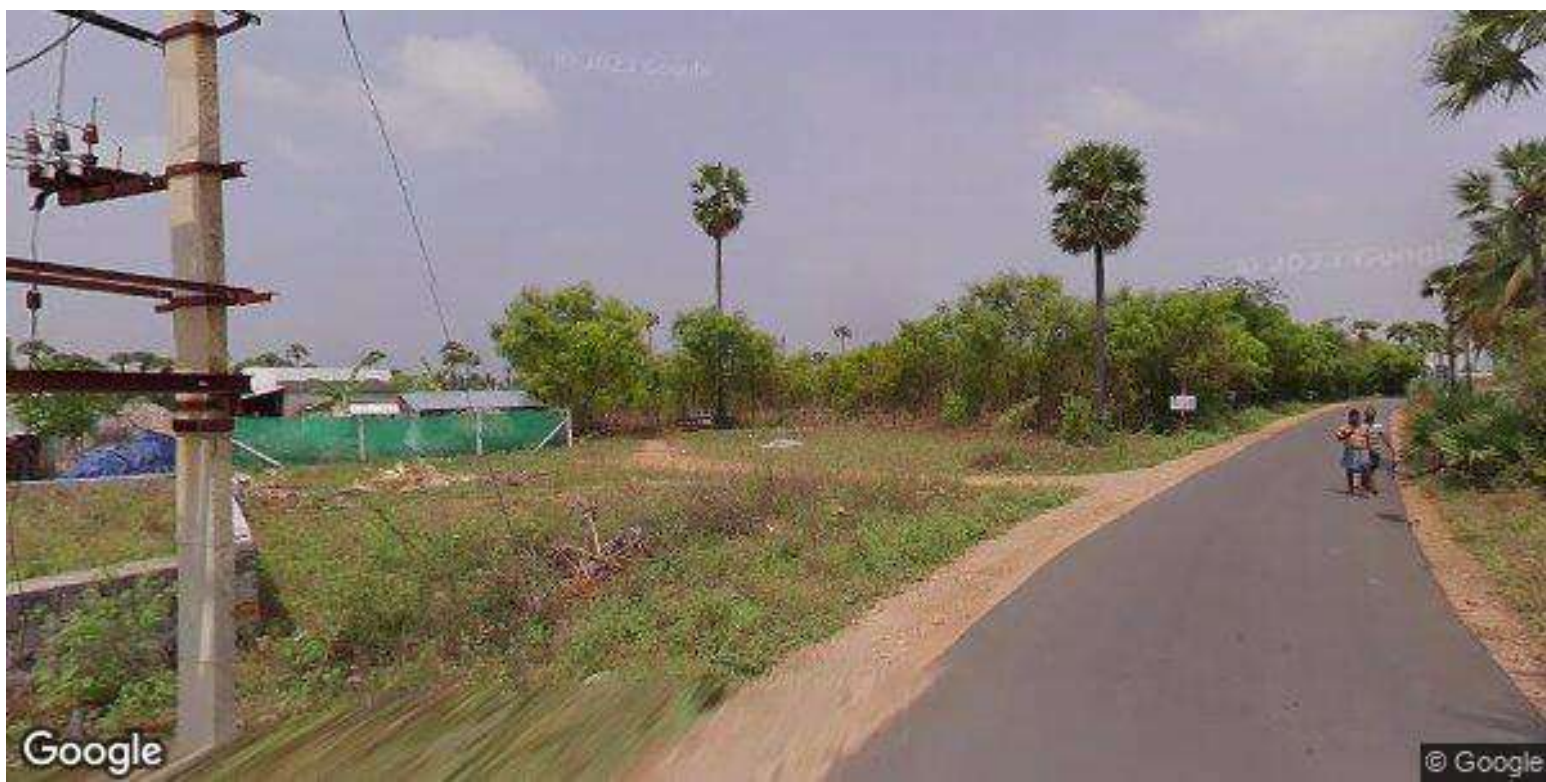
**Coordinates:** 11.44369, 77.96036

**Risk Type:** Turn

**Risk Level:** Medium

**Speed Limit:** 30 KM/Hr

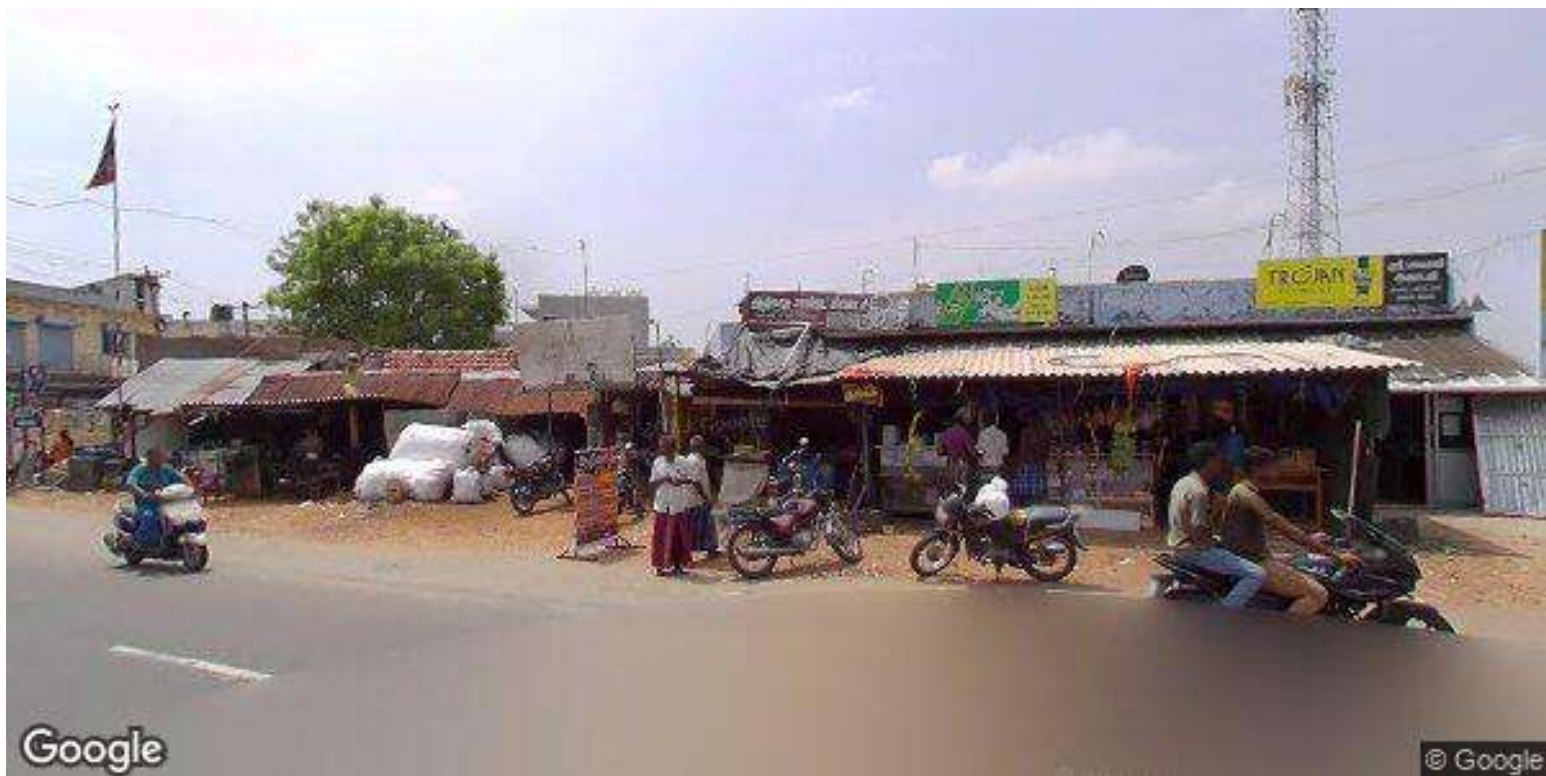
**Coordinates:** 11.44387, 77.96283

**Risk Type:** Turn

**Risk Level:** High

**Speed Limit:** 15 KM/Hr
