# IndianOil

## JOURNEY RISK MANAGEMENT (JRM) STUDY

### Salem Terminal to THE ERODE DT CONS COOP WHOL STORES

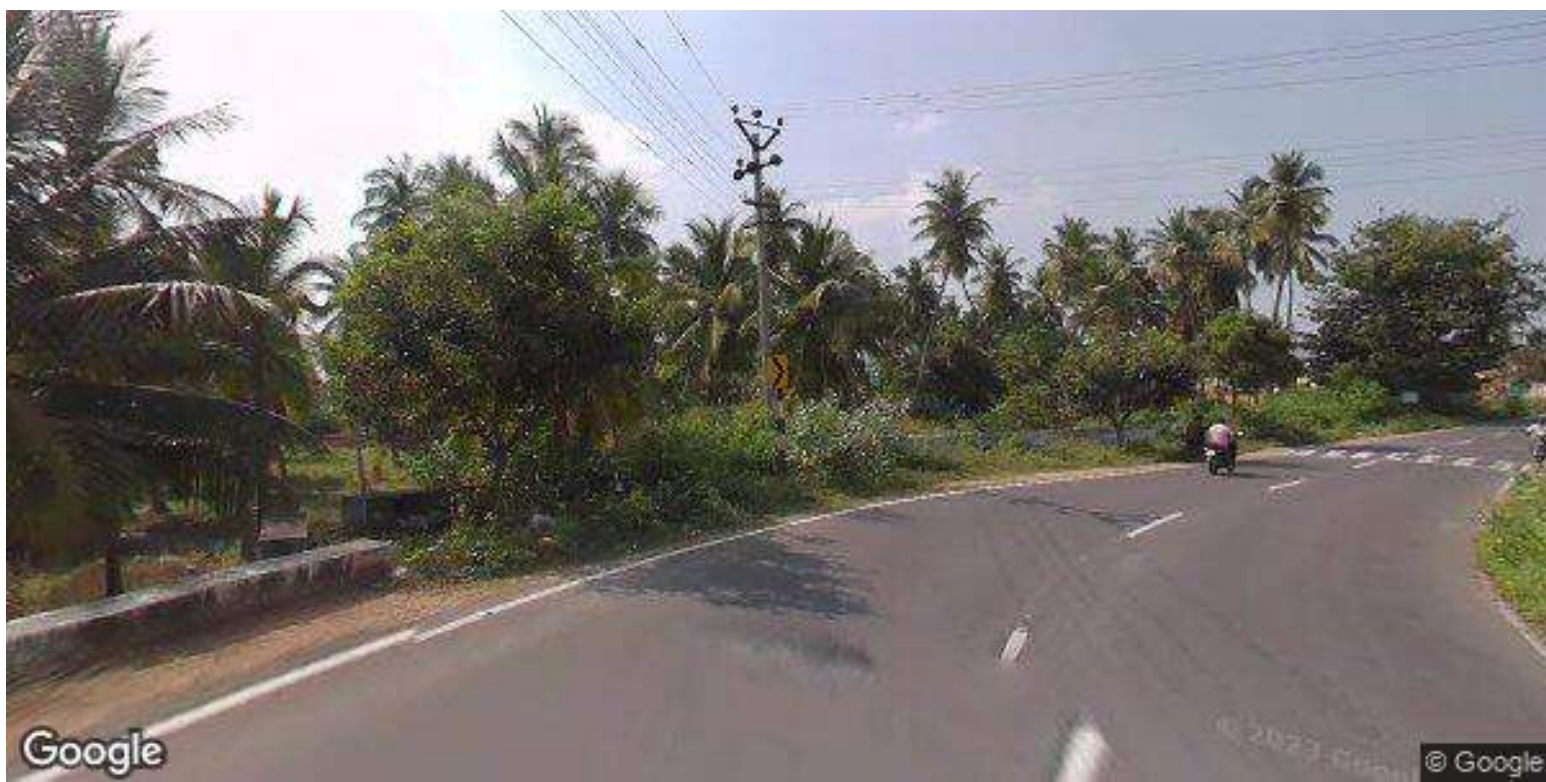
**Coordinates:** 11.45348, 77.85706

**Risk Type:** Turn

**Risk Level:** Medium

**Speed Limit:** 30 KM/Hr

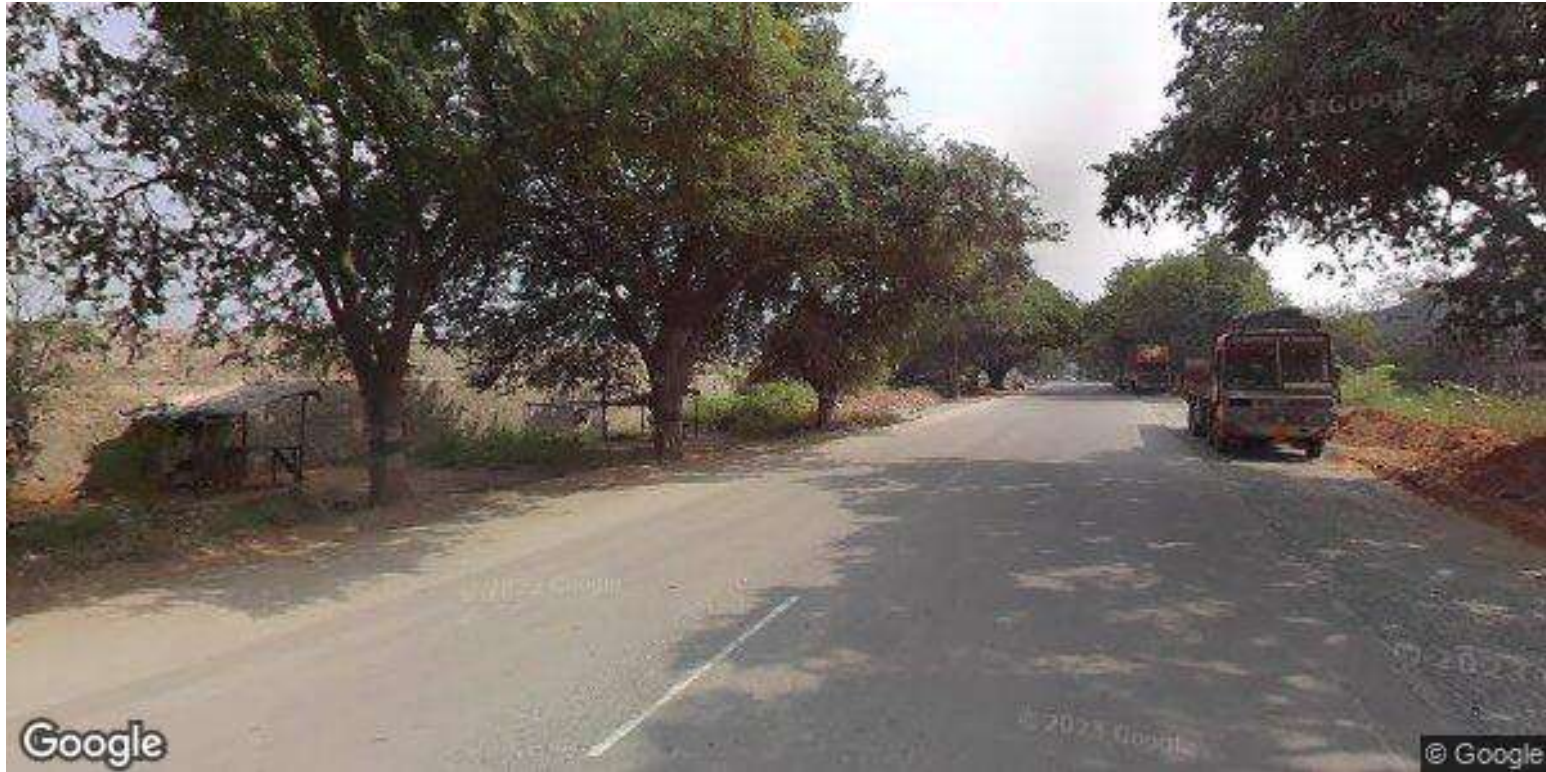
**Risk Type:** Turn  
**Risk Level:** Medium  
**Speed Limit:** 30 KM/Hr  
**Coordinates:** 11.45697, 77.82719

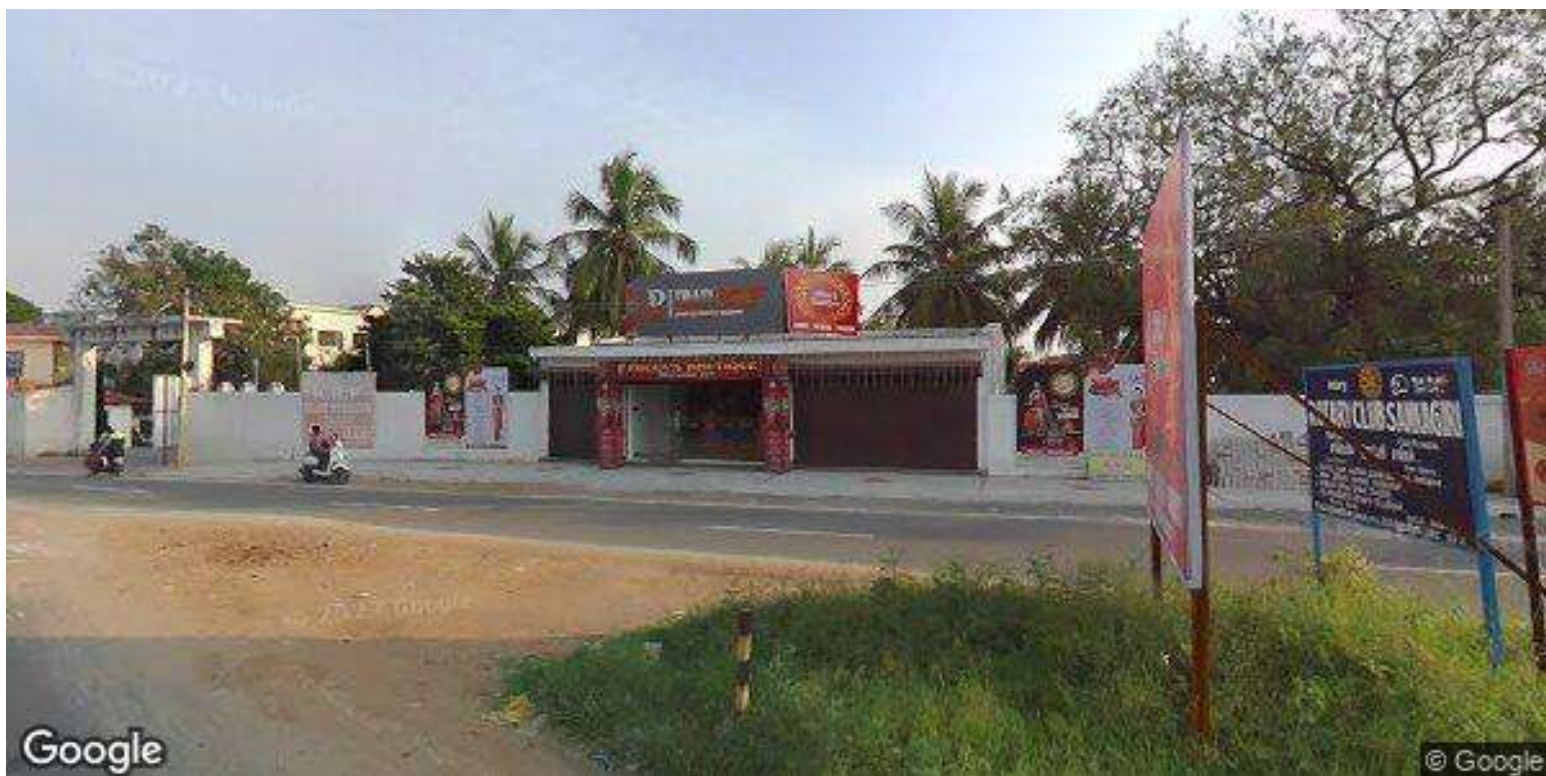
**Risk Type:** Turn  
**Risk Level:** High  
**Speed Limit:** 15 KM/Hr  
**Coordinates:** 11.45516, 77.81346

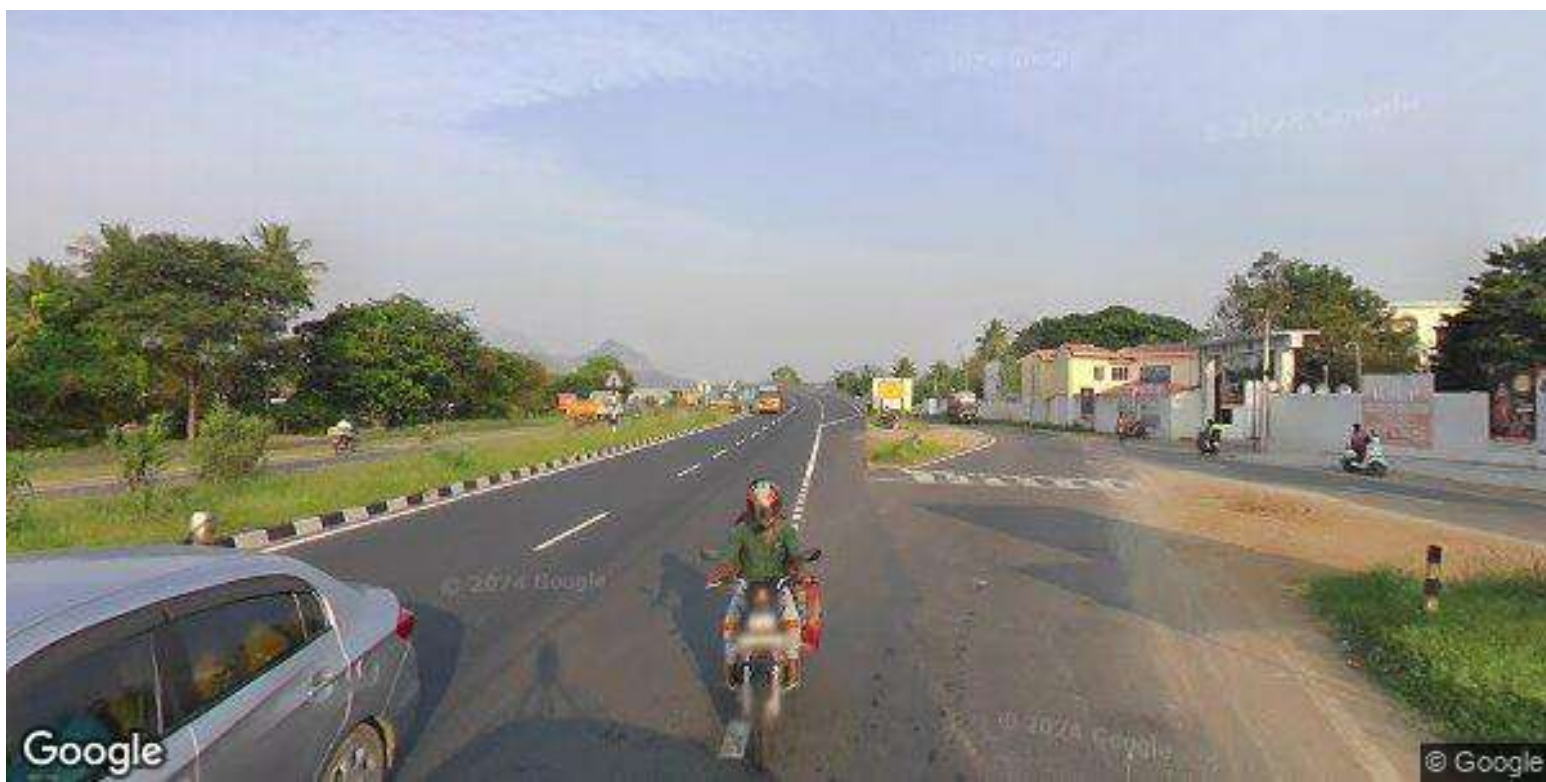
**Coordinates:** 11.45521, 77.81343

**Risk Type:** Turn

**Risk Level:** High

**Speed Limit:** 15 KM/Hr

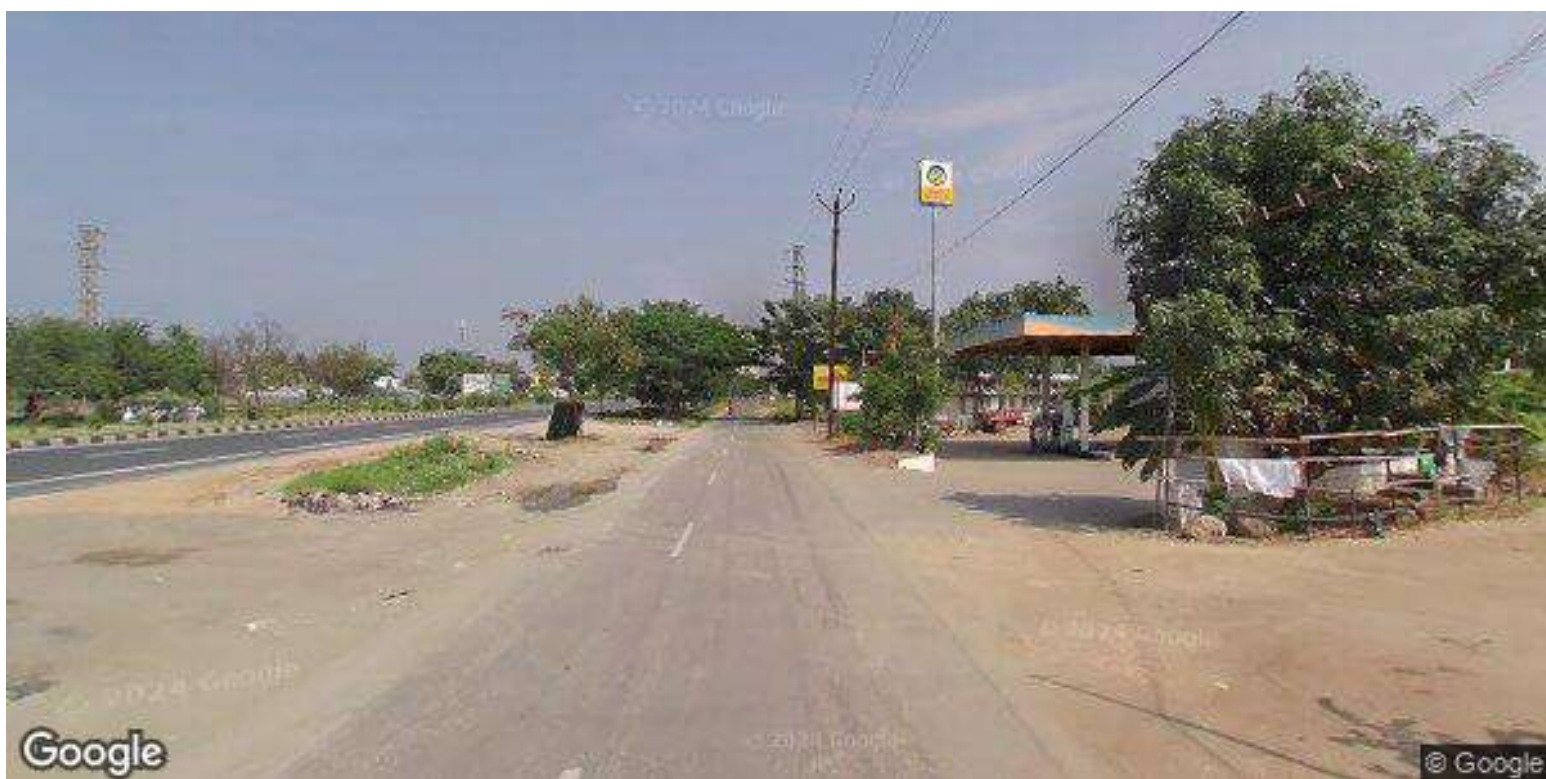
**Coordinates:** 11.43994, 77.71111

**Risk Type:** Turn

**Risk Level:** Medium

**Speed Limit:** 30 KM/Hr

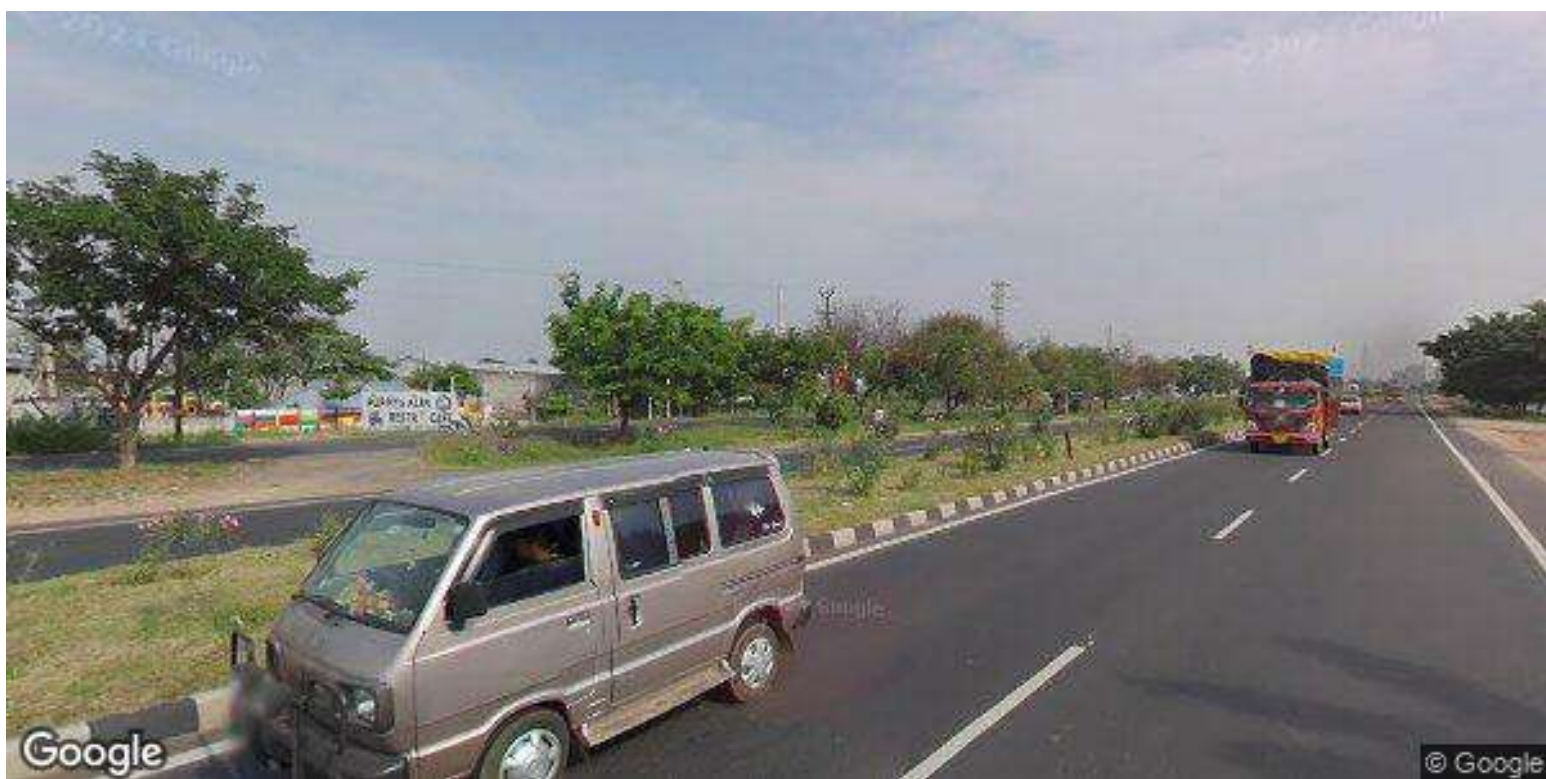
**Risk Type:** Turn  
**Risk Level:** Medium  
**Speed Limit:** 30 KM/Hr  
**Coordinates:** 11.43982, 77.71084

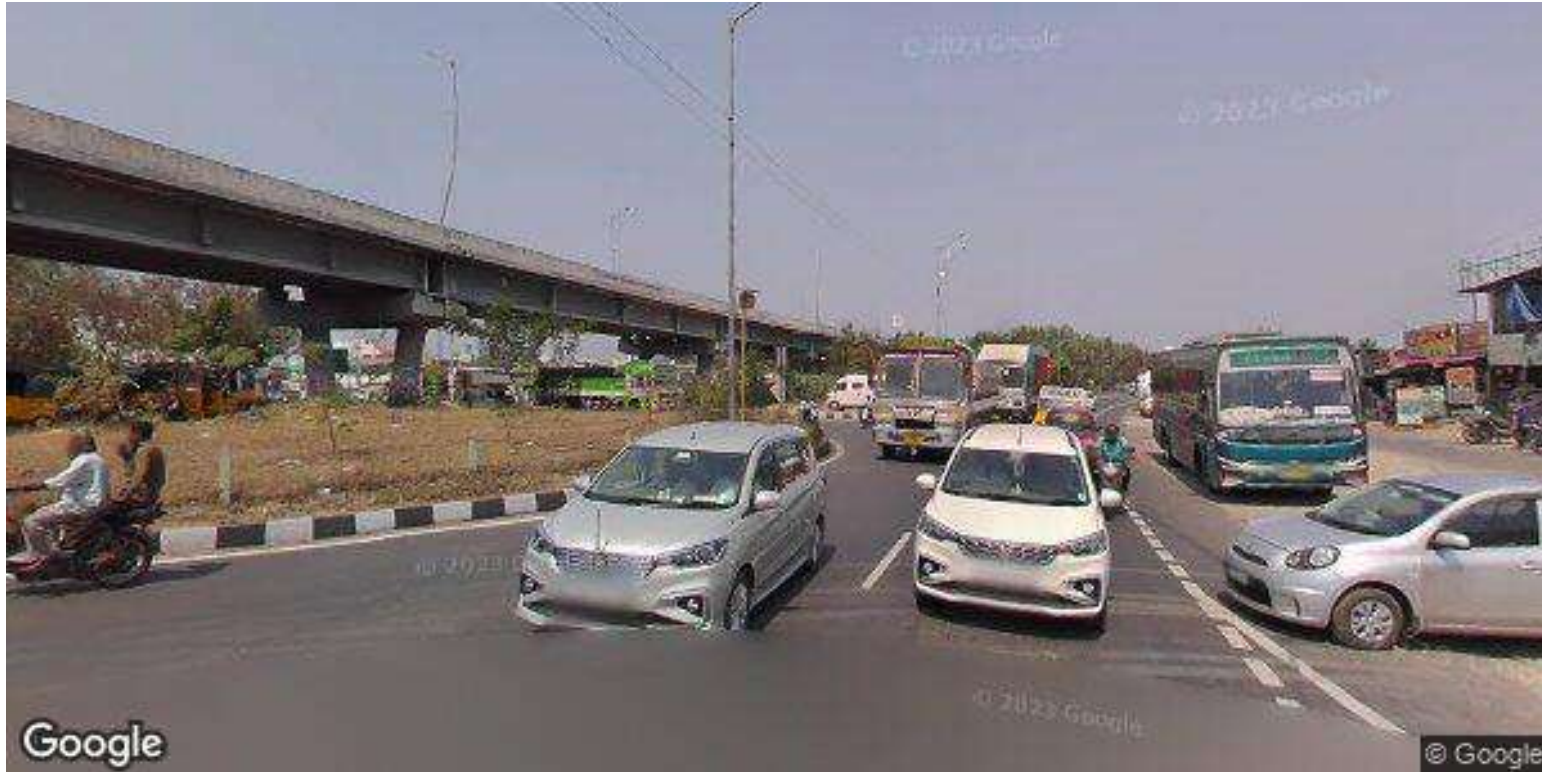
**Risk Type:** Turn  
**Risk Level:** High  
**Speed Limit:** 15 KM/Hr  
**Coordinates:** 11.43001, 77.67575

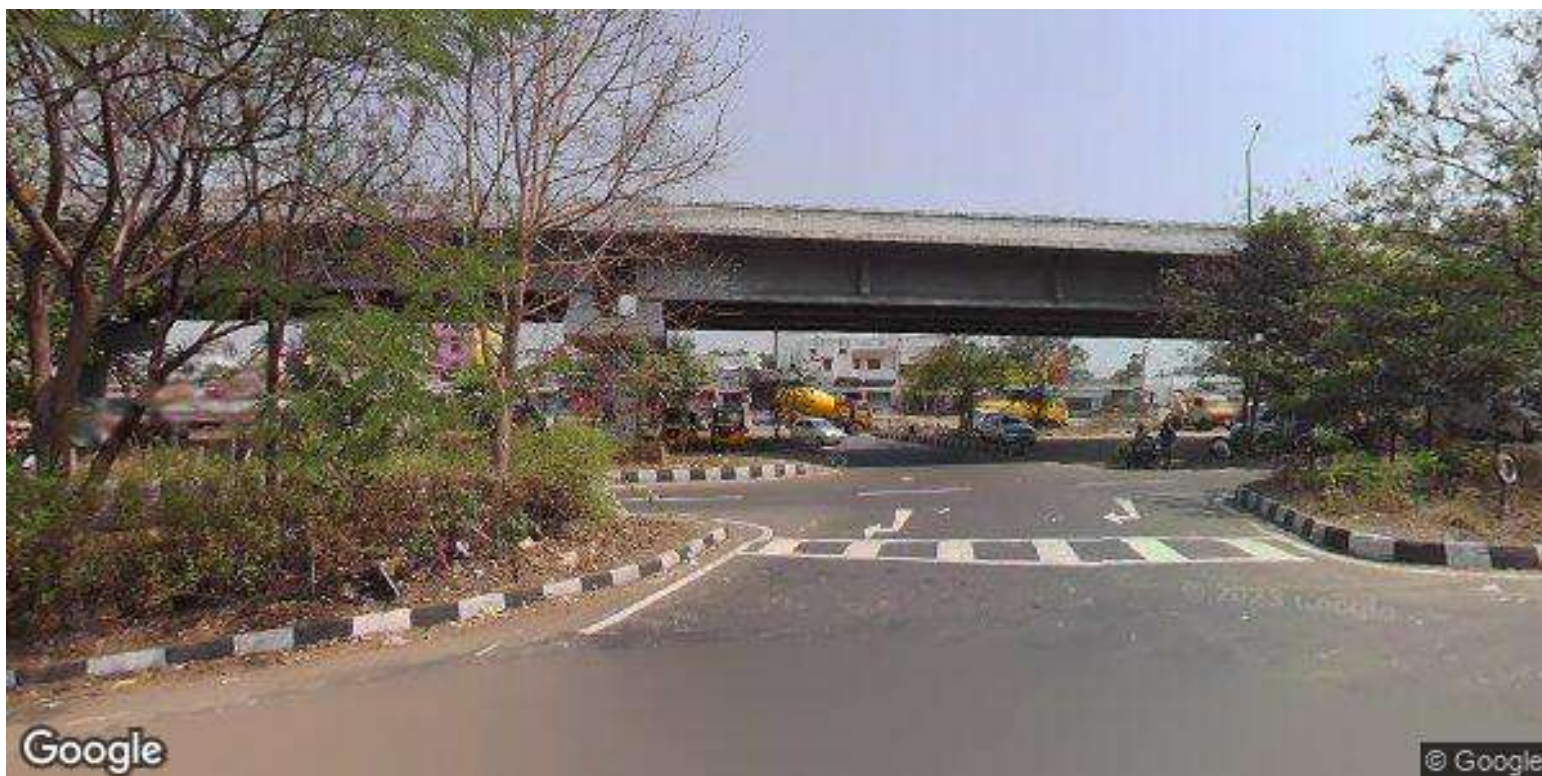
**Risk Type:** Turn  
**Risk Level:** High  
**Speed Limit:** 15 KM/Hr  
**Coordinates:** 11.43026, 77.67525

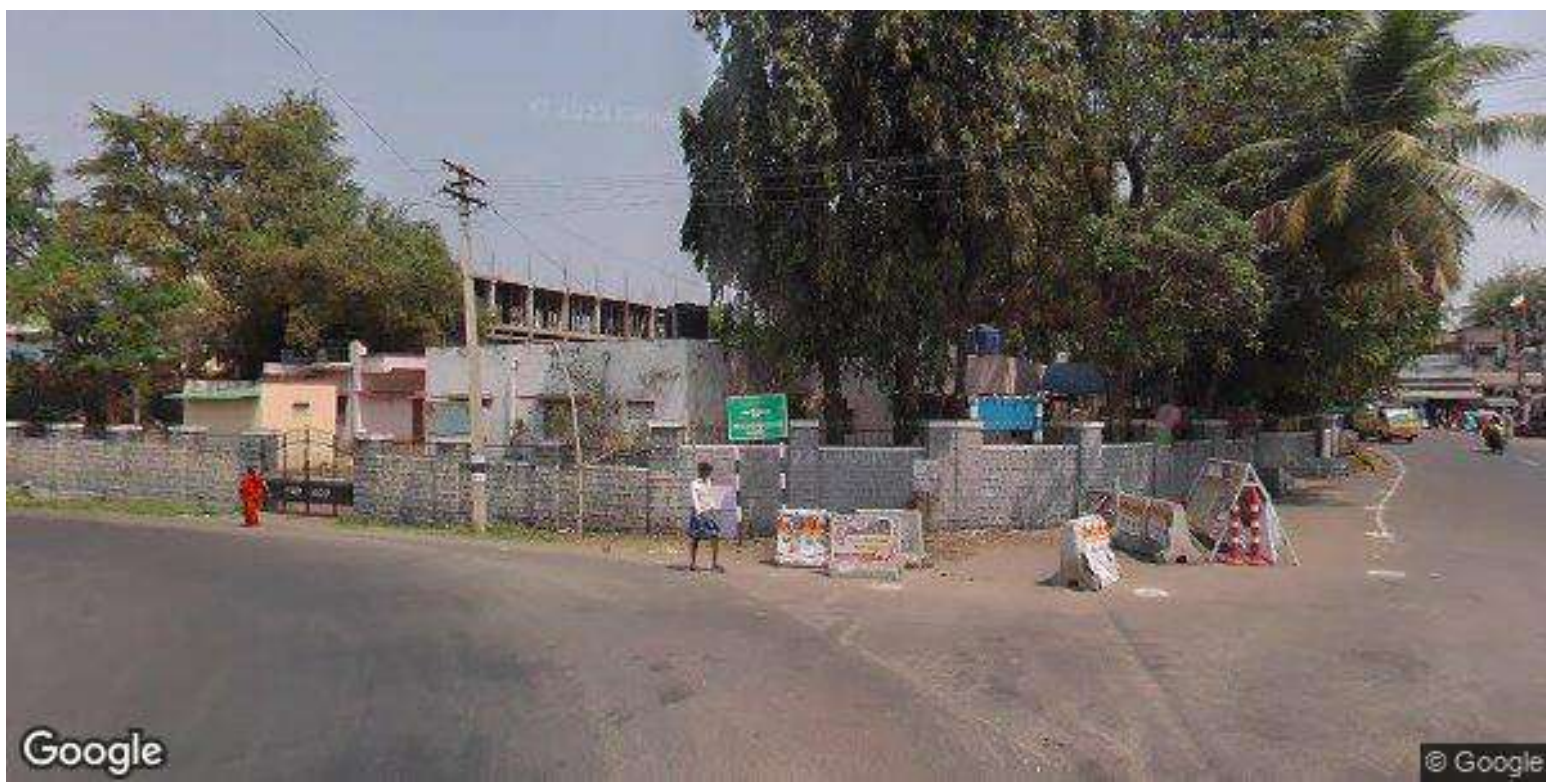
**Coordinates:** 11.43865, 77.68226

**Risk Type:** Turn

**Risk Level:** Medium

**Speed Limit:** 30 KM/Hr

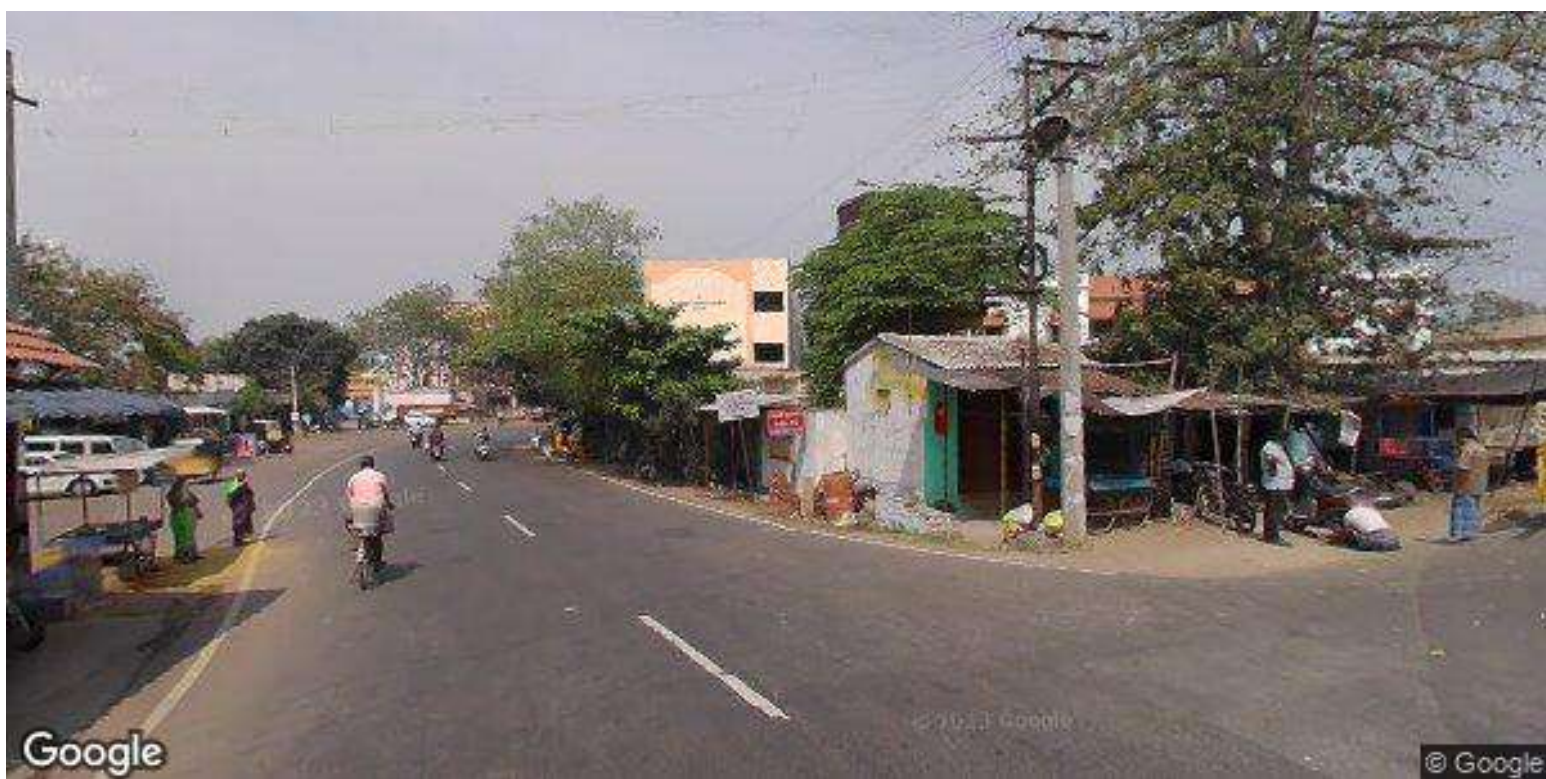
**Coordinates:** 11.43965, 77.68224

**Risk Type:** Turn

**Risk Level:** Medium

**Speed Limit:** 30 KM/Hr

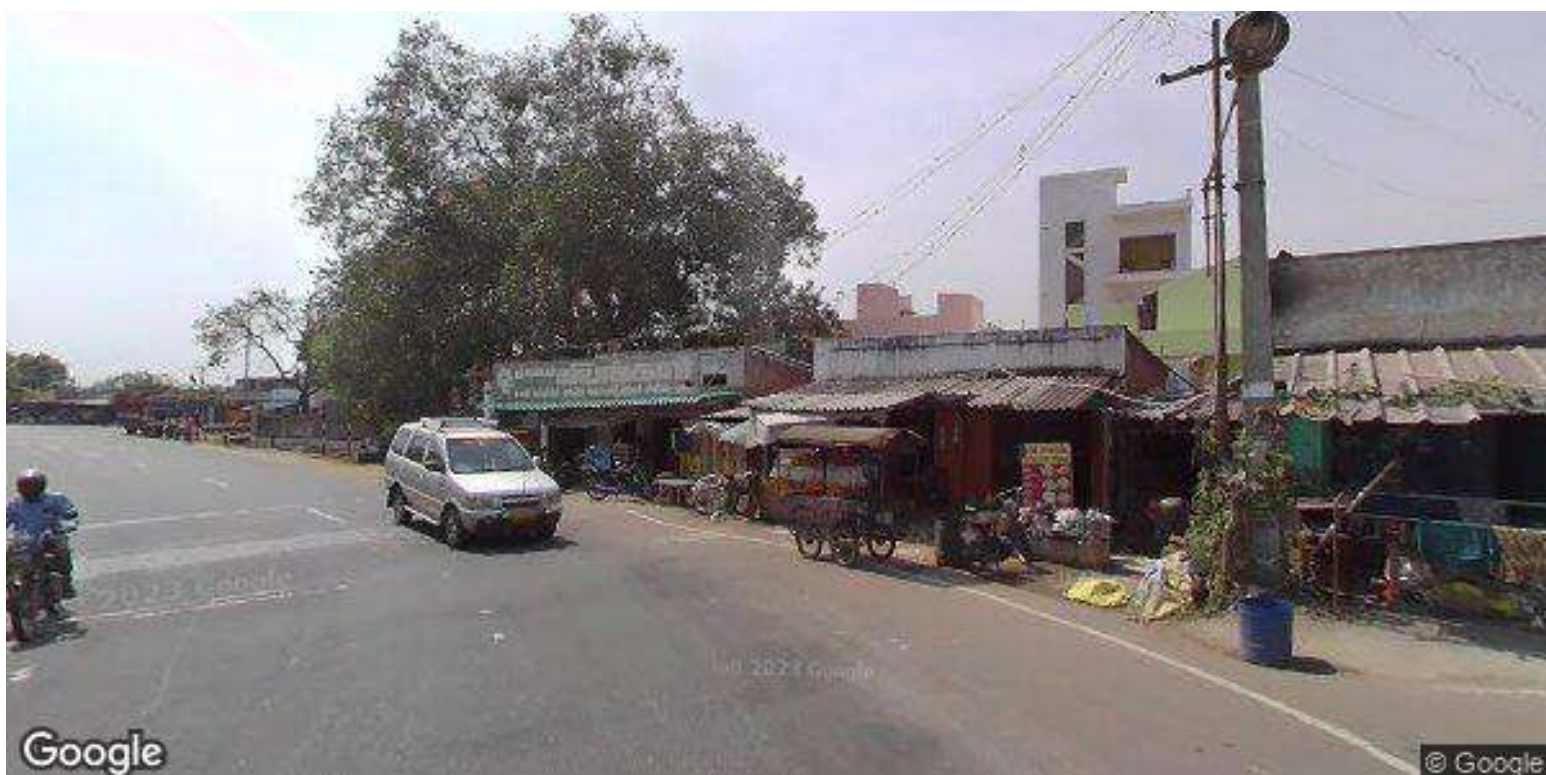
**Risk Type:** Turn  
**Risk Level:** High  
**Speed Limit:** 15 KM/Hr  
**Coordinates:** 11.44105, 77.68187

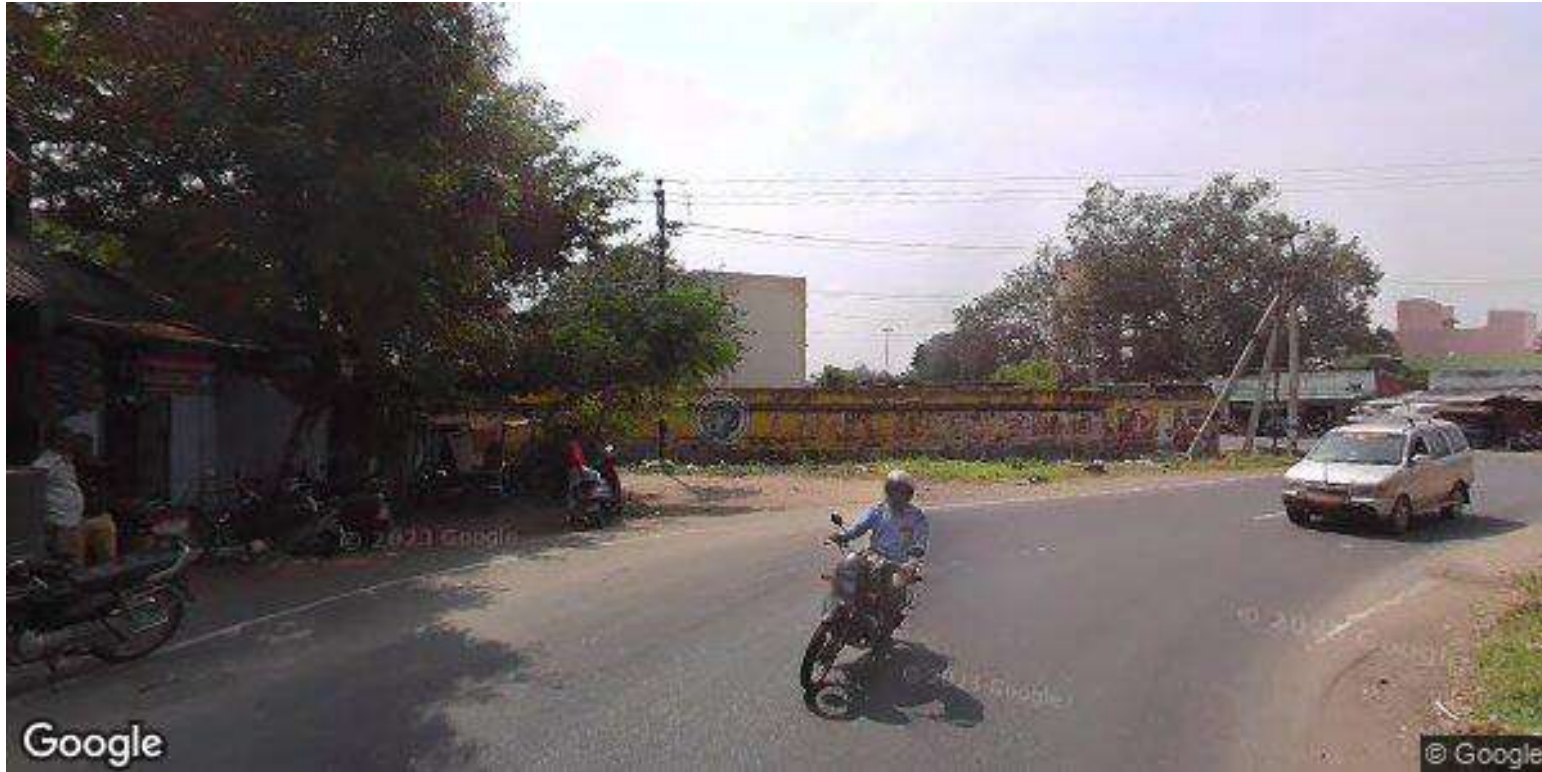
**Risk Type:** Turn  
**Risk Level:** Medium  
**Speed Limit:** 30 KM/Hr  
**Coordinates:** 11.44122, 77.68219

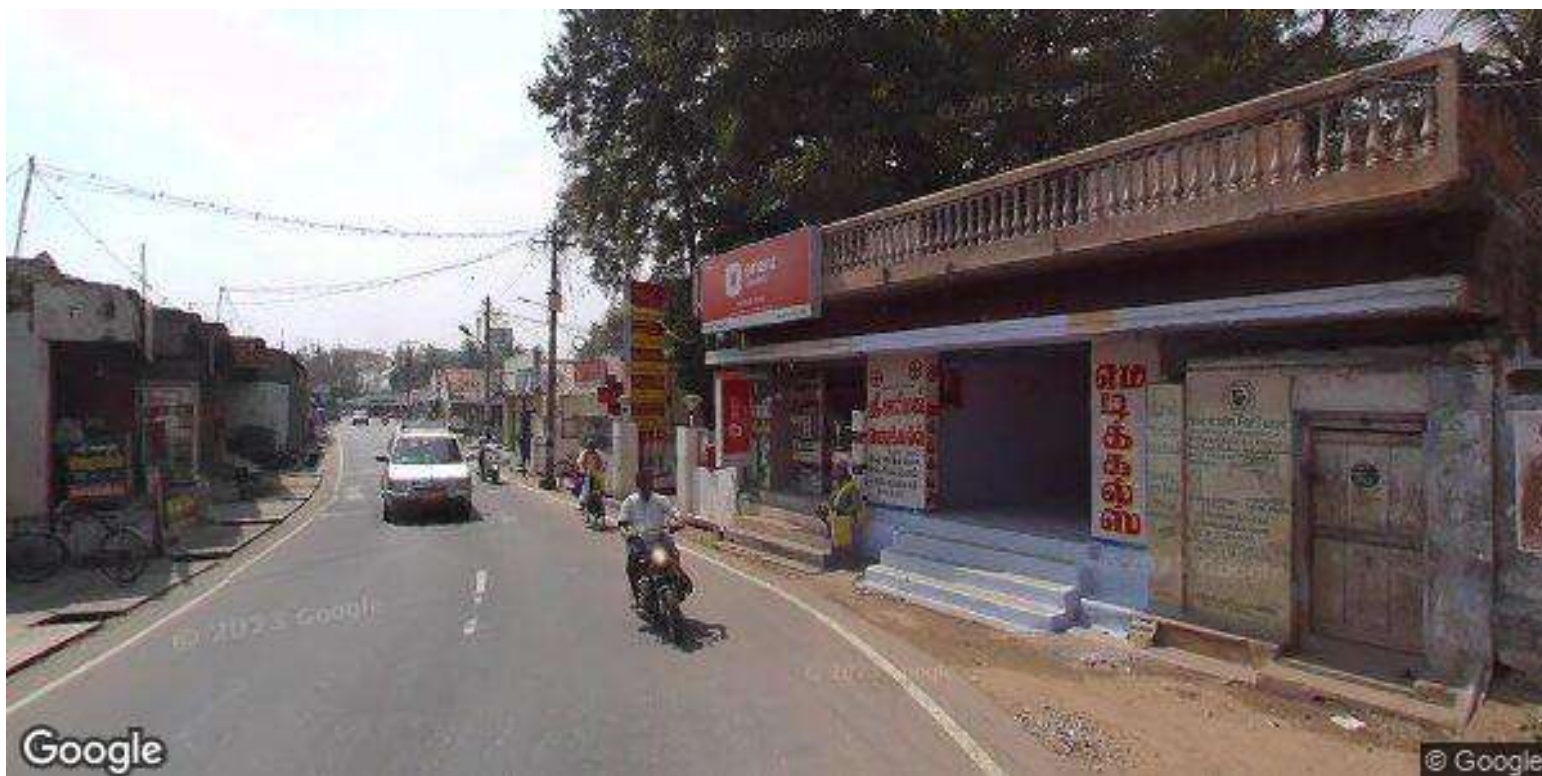
**Risk Type:** Turn  
**Risk Level:** Medium  
**Speed Limit:** 30 KM/Hr  
**Coordinates:** 11.44291, 77.68256

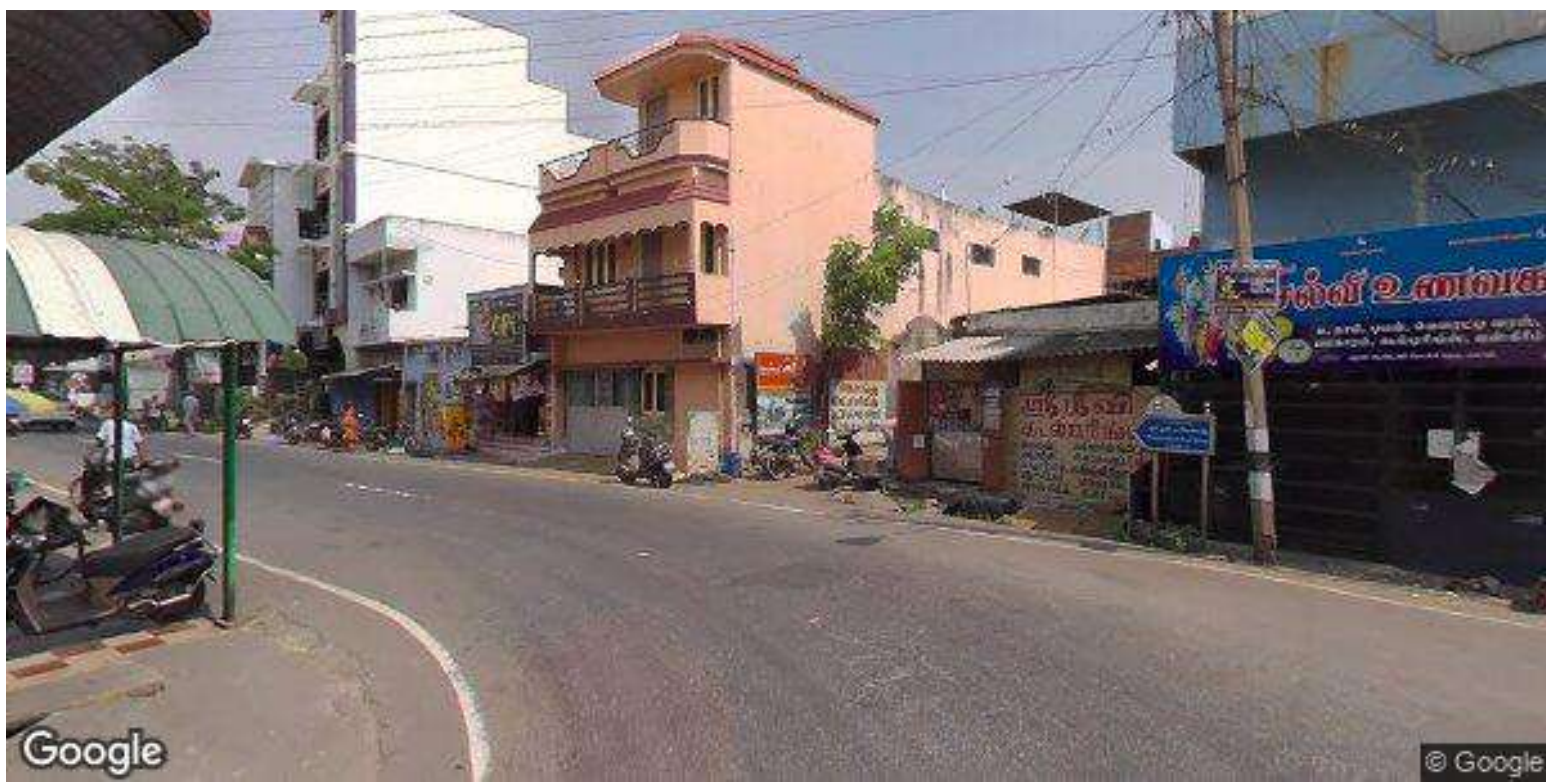
Coordinates: 11.44300, 77.68275

Risk Type: Turn

Risk Level: High

Speed Limit: 15 KM/Hr

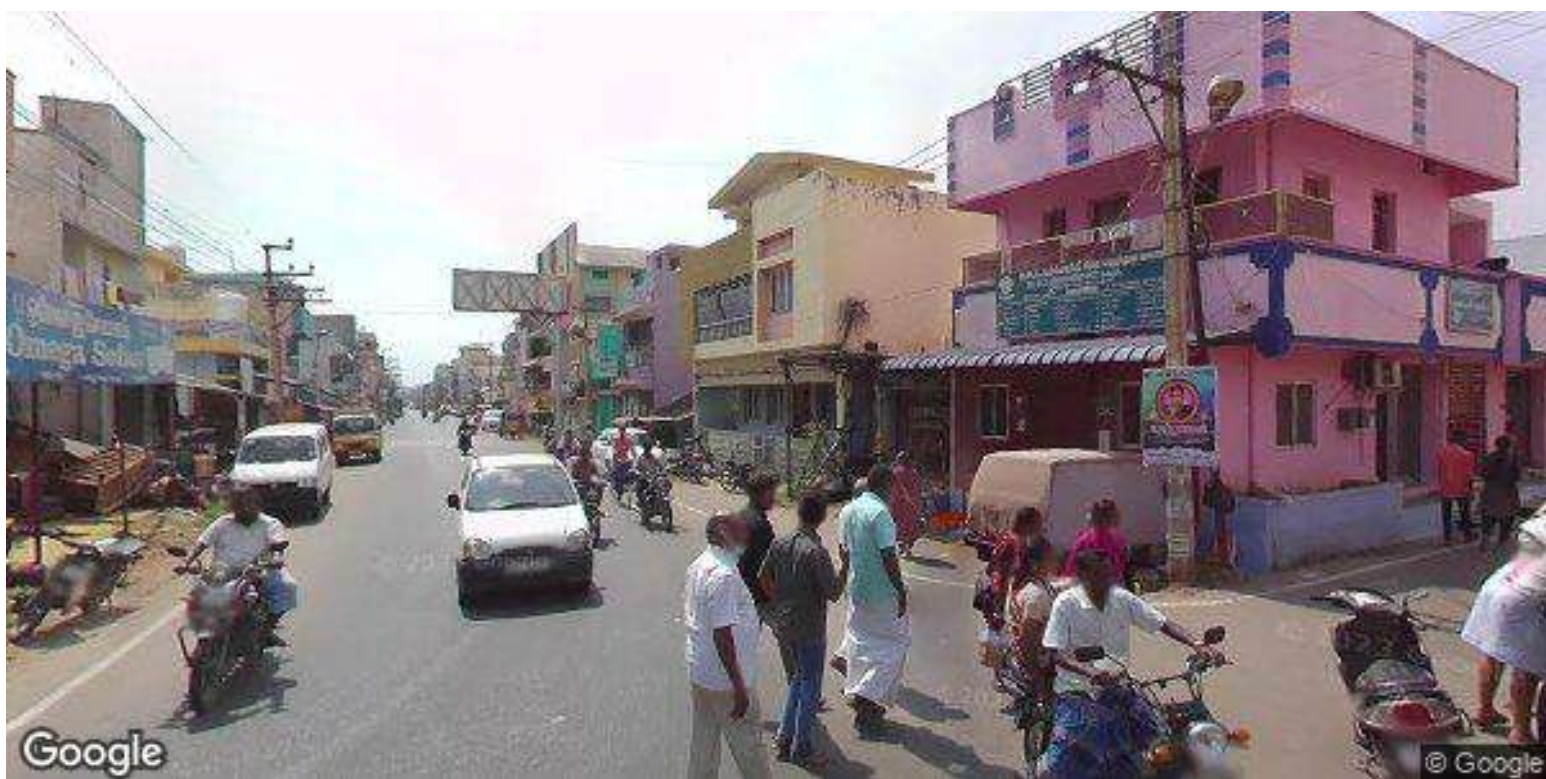
Coordinates: 11.44715, 77.68304

Risk Type: Turn

Risk Level: High

Speed Limit: 15 KM/Hr

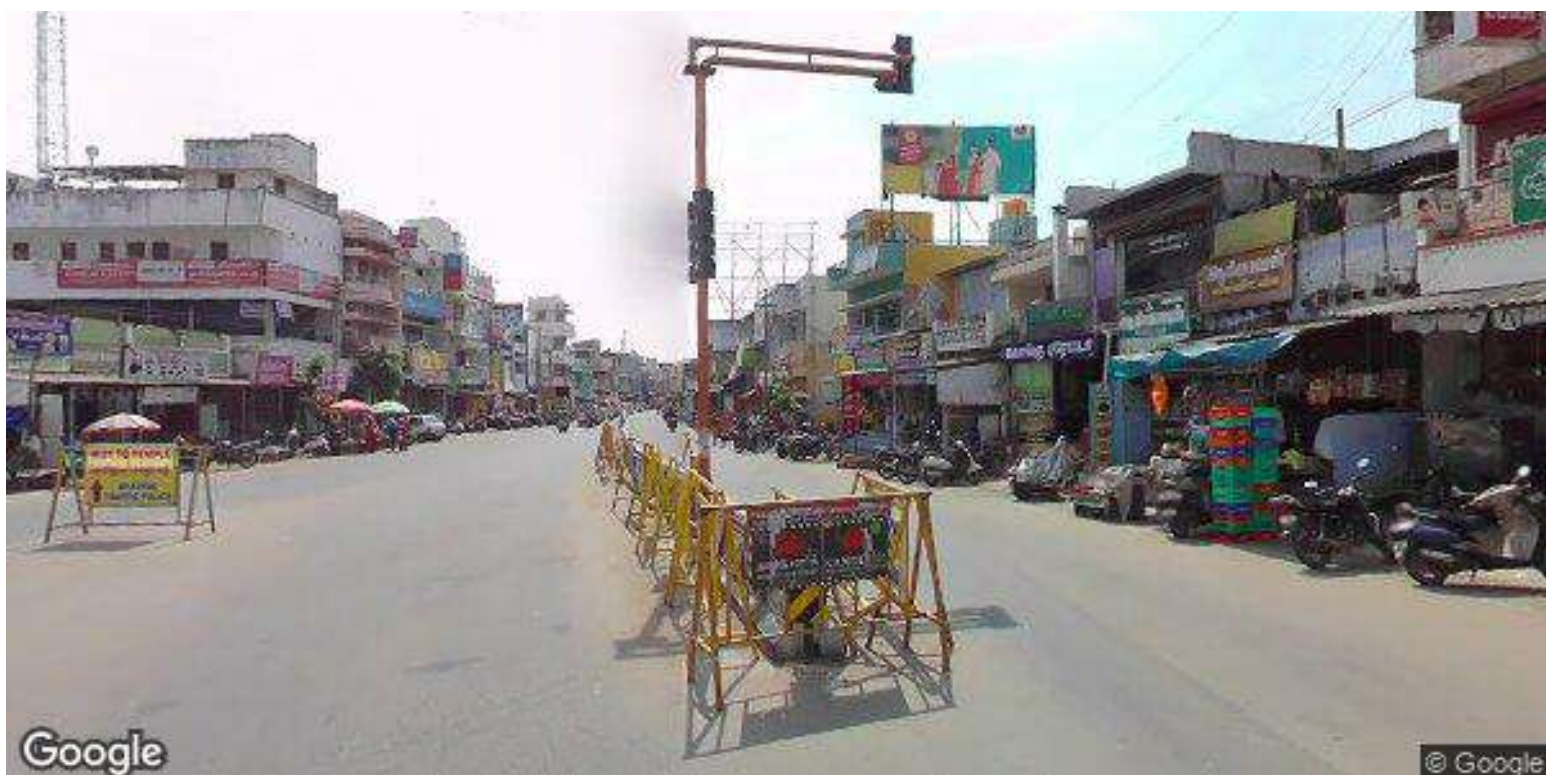
**Coordinates:** 11.44710, 77.68396

**Risk Type:** Turn

**Risk Level:** Medium

**Speed Limit:** 30 KM/Hr

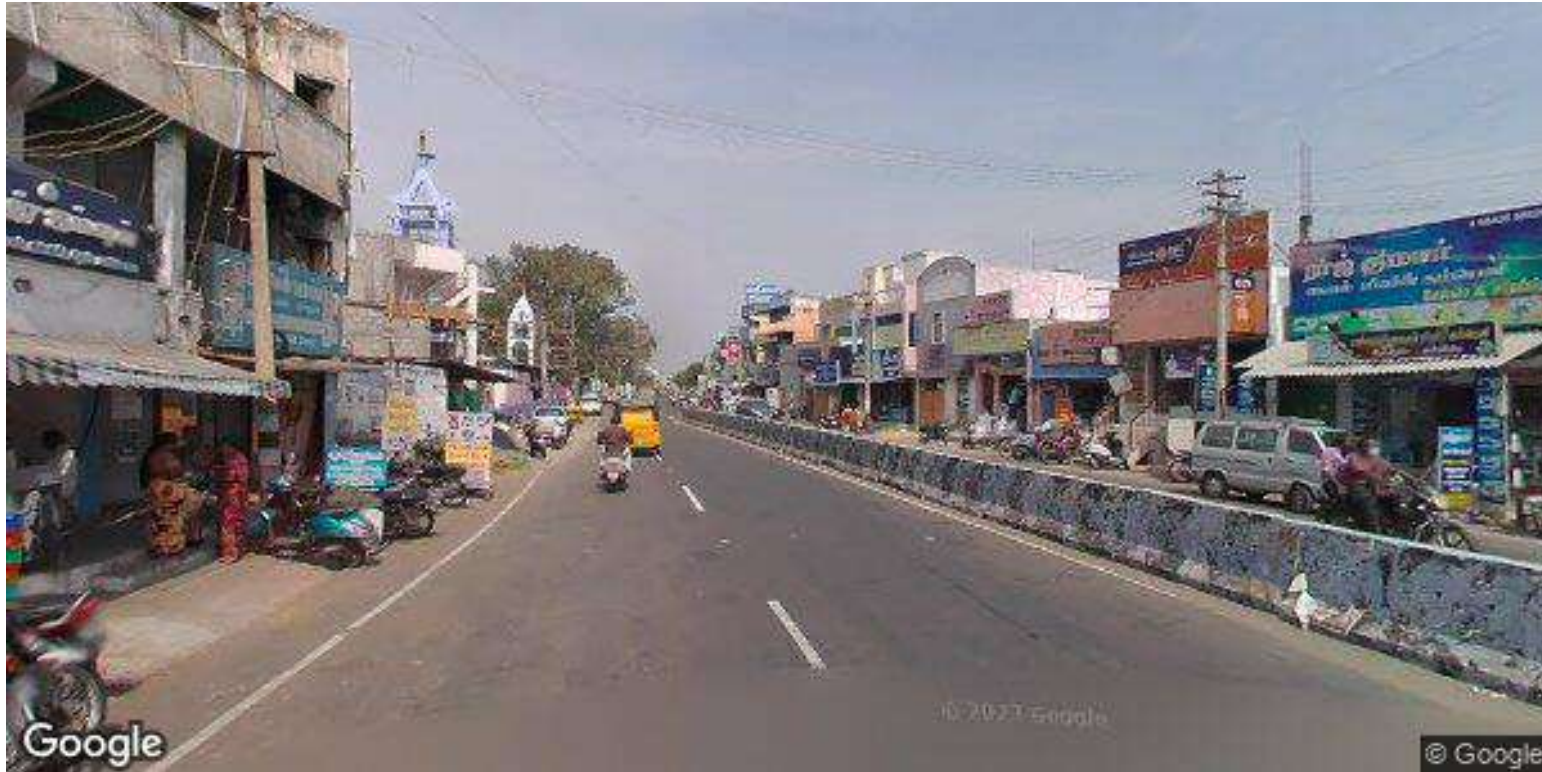
**Coordinates:** 11.44725, 77.68412

**Risk Type:** Turn

**Risk Level:** Medium

**Speed Limit:** 30 KM/Hr
