# IndianOil

## JOURNEY RISK MANAGEMENT (JRM) STUDY

### Salem Terminal to SRI EZHUMALAIYAN AGENCIES

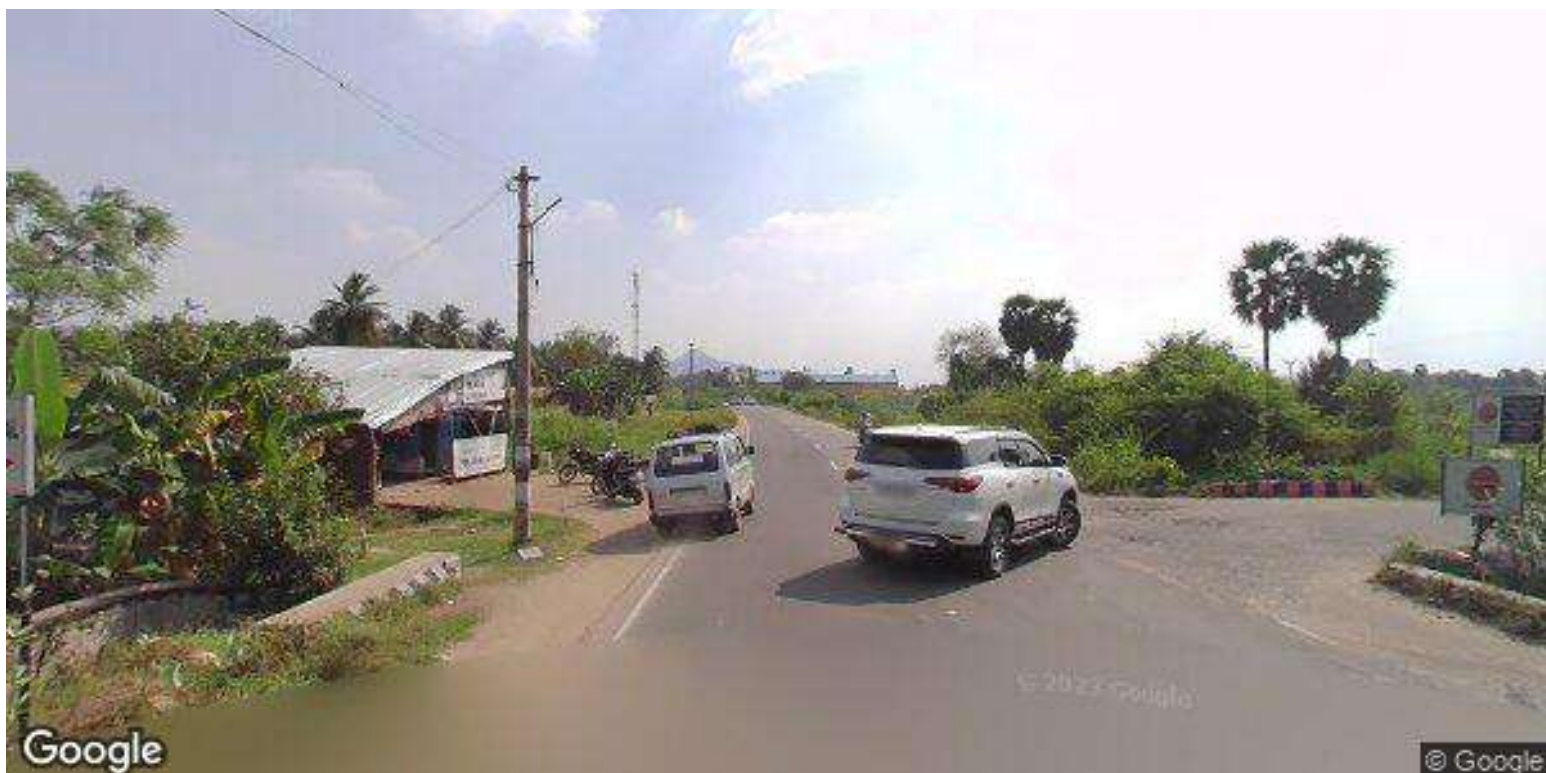
**Risk Type:** Blind Spot  
**Risk Level:** Blind Spot  
**Speed Limit:** 10 KM/Hr  
**Coordinates:** 11.44029, 77.87544

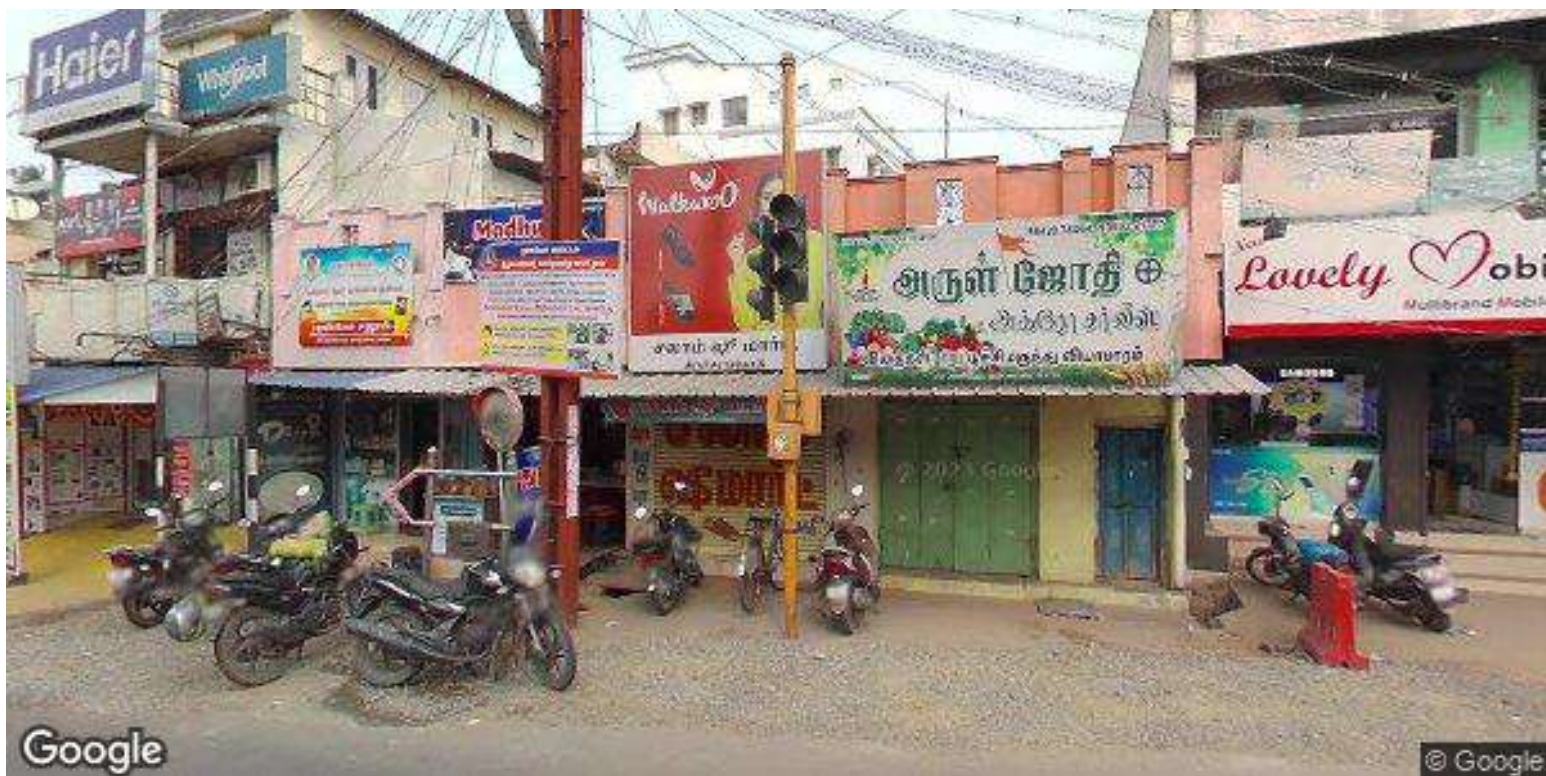
**Risk Type:** Turn  
**Risk Level:** High  
**Speed Limit:** 15 KM/Hr  
**Coordinates:** 11.37850, 77.89453

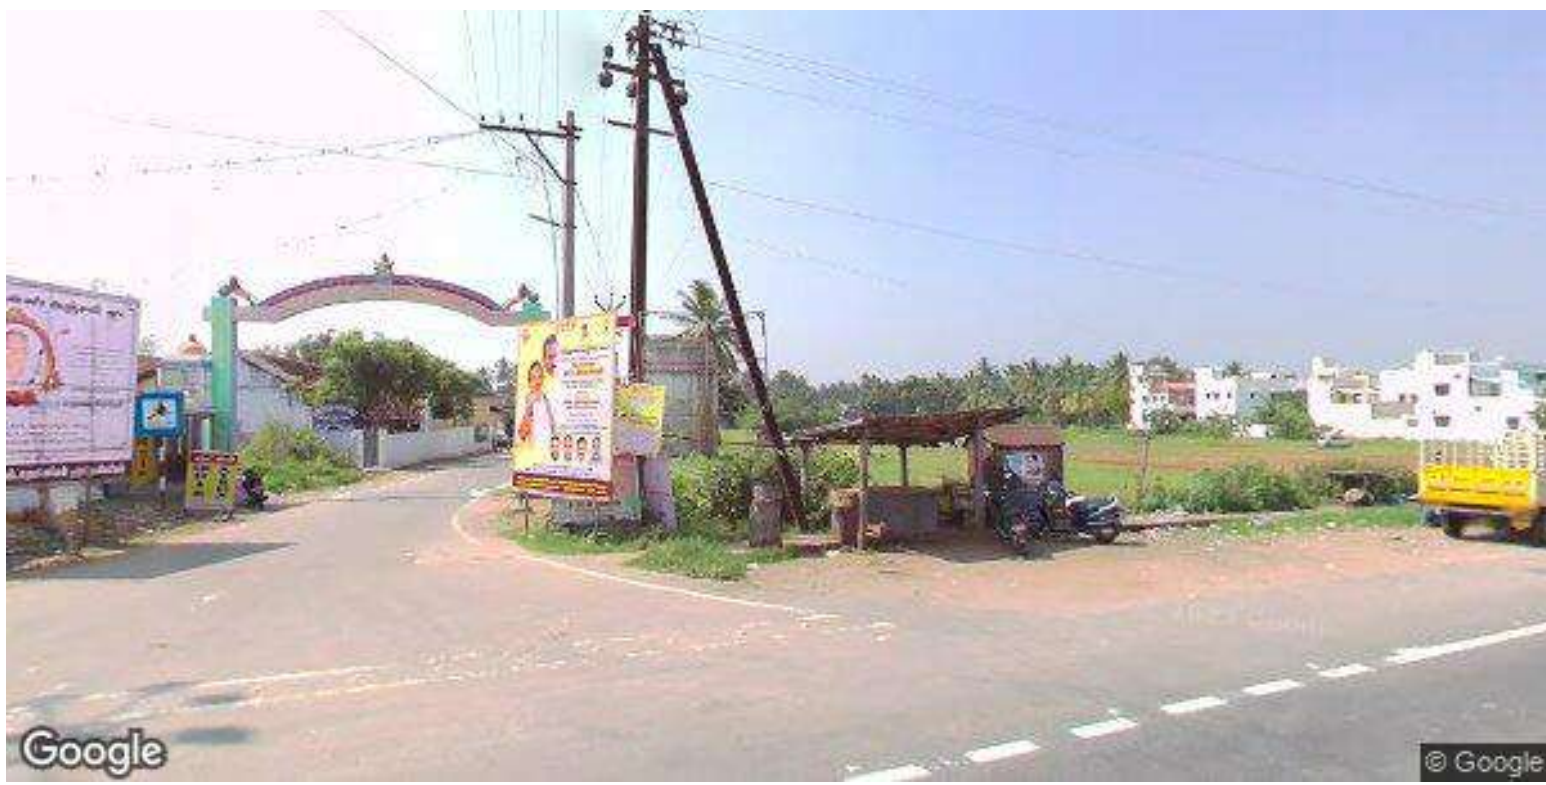
**Coordinates:** 11.20589, 77.99001

**Risk Type:** Blind Spot

**Risk Level:** Blind Spot

**Speed Limit:** 10 KM/Hr
