# IndianOil

## JOURNEY RISK MANAGEMENT (JRM) STUDY

### Salem Terminal TO JPS SAMY FUELS

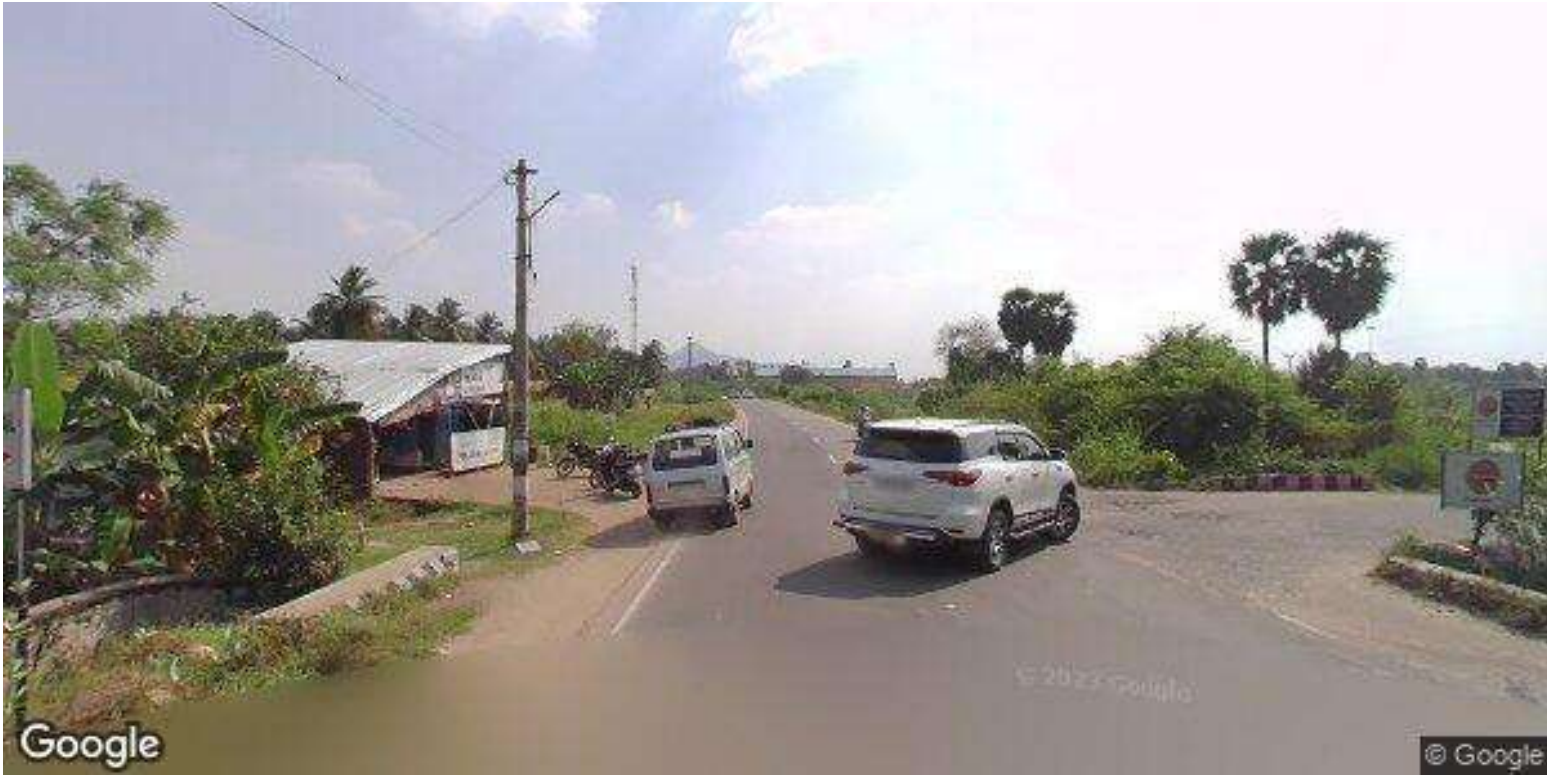
Coordinates: 11.44029, 77.87544

| | Risk Type | Risk Level | Coordinates | Speed Limit |
|---|---|---|---|---|
| 3 | Turn | High | 11.44029, 77.87544 | 15 KM/Hr |

Risk Type: Turn

Risk Level: High

Speed Limit: 15 KM/Hr

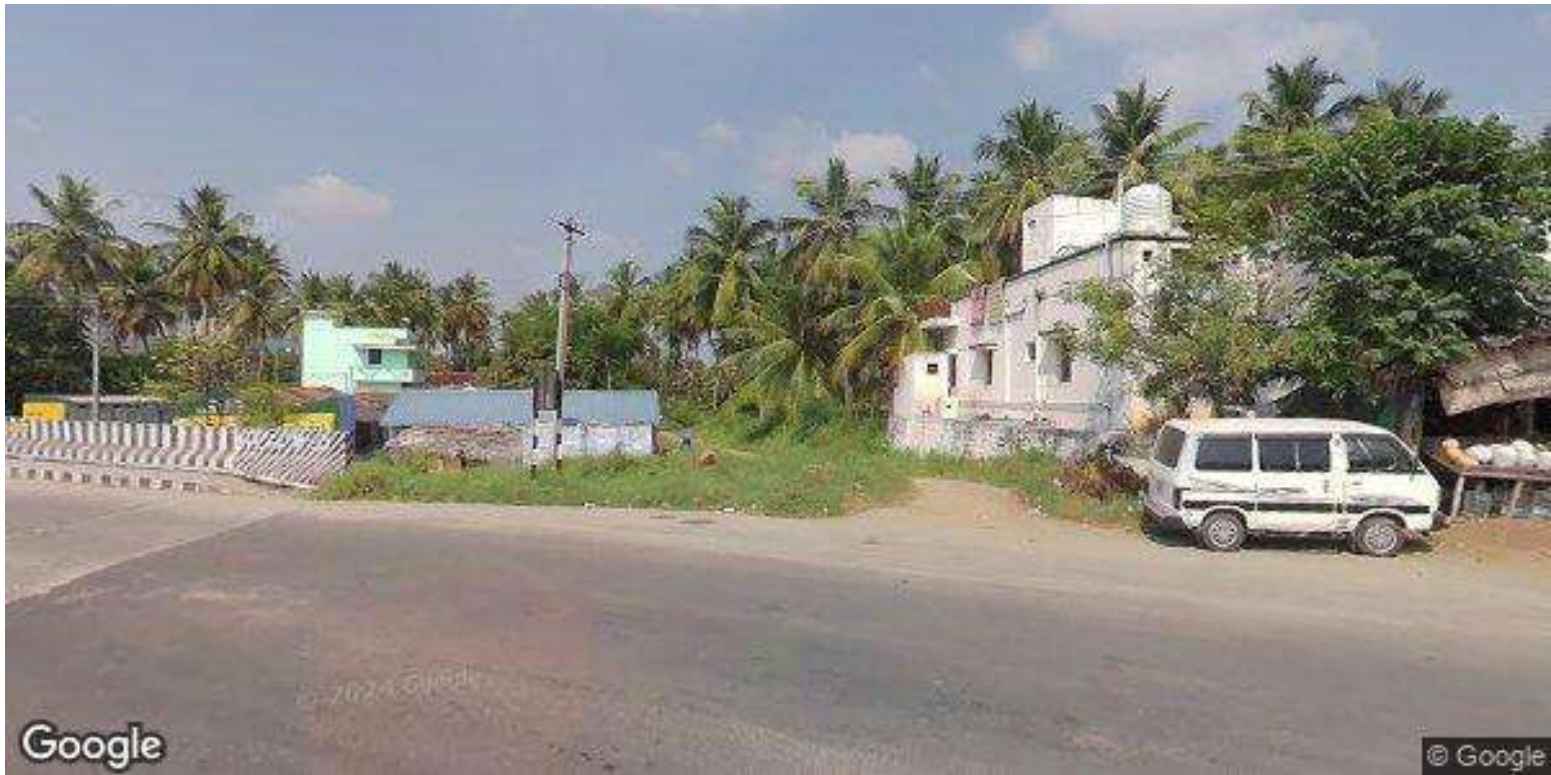
| | Risk Type | Risk Level | Coordinates | Speed Limit |
|---|---|---|---|---|
| 4 | Turn | Medium | 11.44898, 77.87410 | 30 KM/Hr |

**Risk Type:** Turn  
**Risk Level:** Medium  
**Speed Limit:** 30 KM/Hr  
**Coordinates:** 11.44898, 77.87410

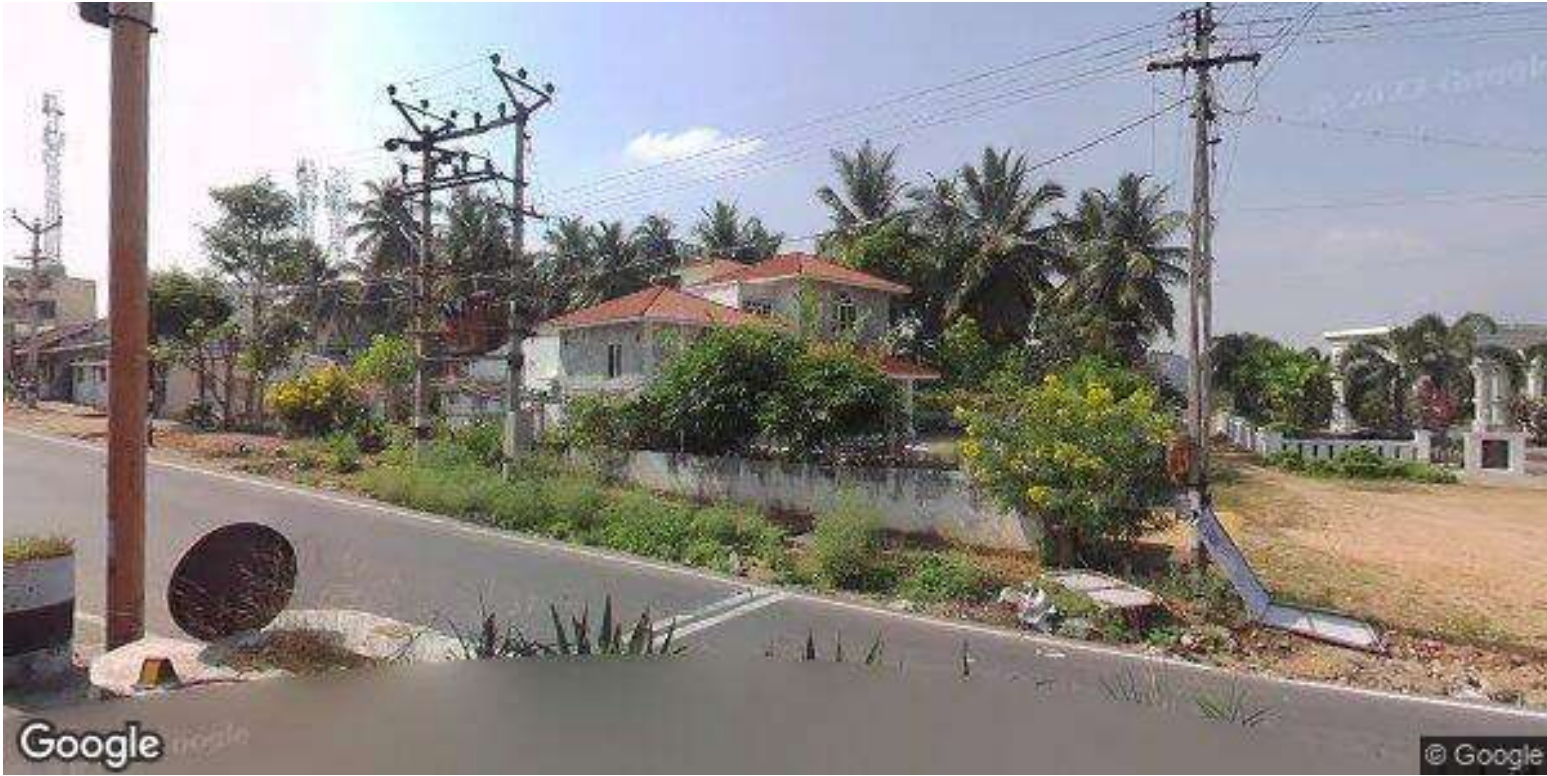
| | Risk Type | Risk Level | Coordinates | Speed Limit |
|---|---|---|---|---|
| 7 | Turn | Medium | 11.46303, 77.84945 | 30 KM/Hr |

**Risk Type:** Turn  
**Risk Level:** Medium  
**Speed Limit:** 30 KM/Hr  
**Coordinates:** 11.46303, 77.84945

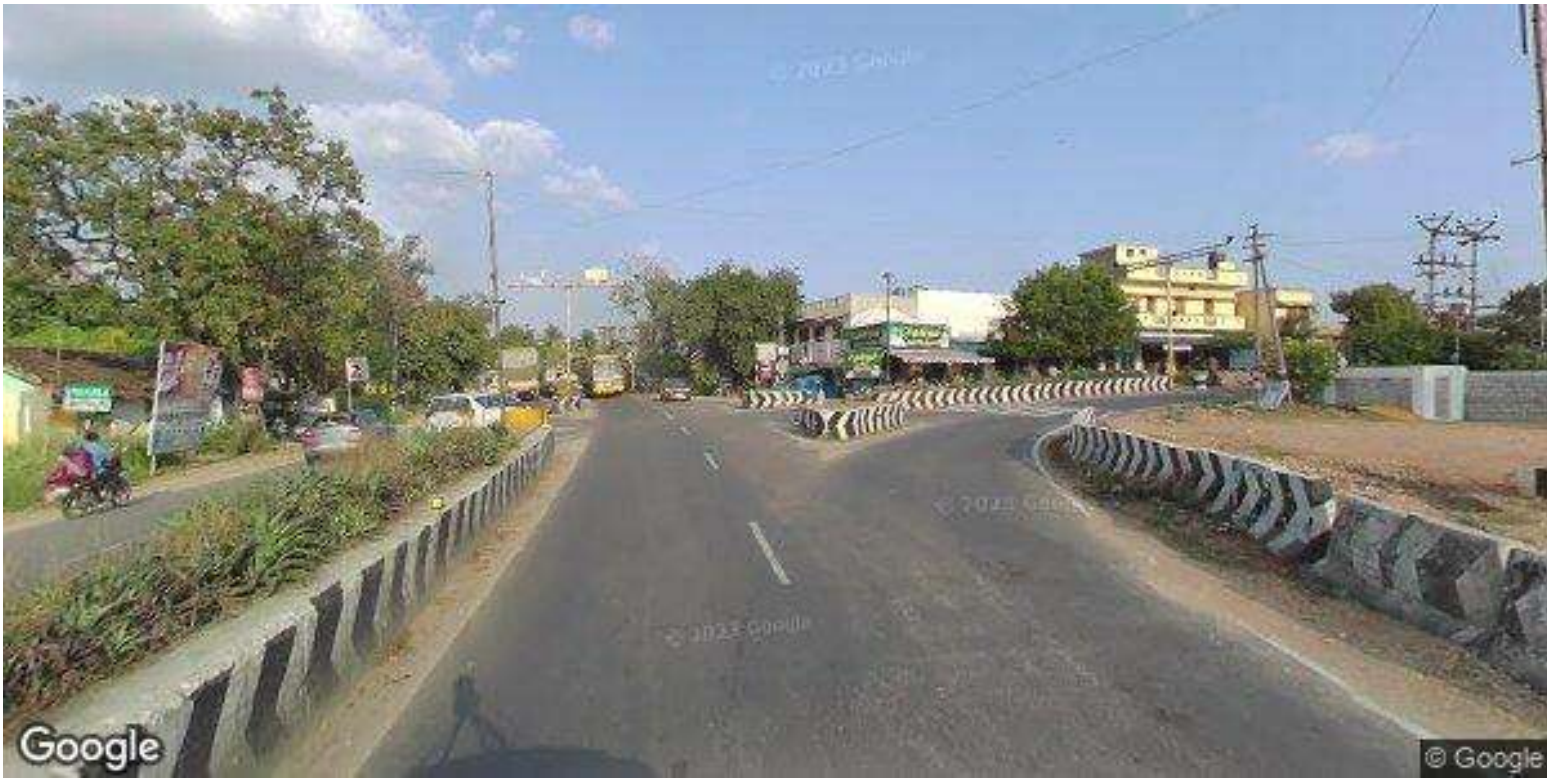
| | Risk Type | Risk Level | Coordinates | Speed Limit |
|---|---|---|---|---|
| 8 | Turn | Medium | 11.46318, 77.84913 | 30 KM/Hr |

**Risk Type:** Turn  
**Risk Level:** Medium  
**Speed Limit:** 30 KM/Hr  
**Coordinates:** 11.46318, 77.84913

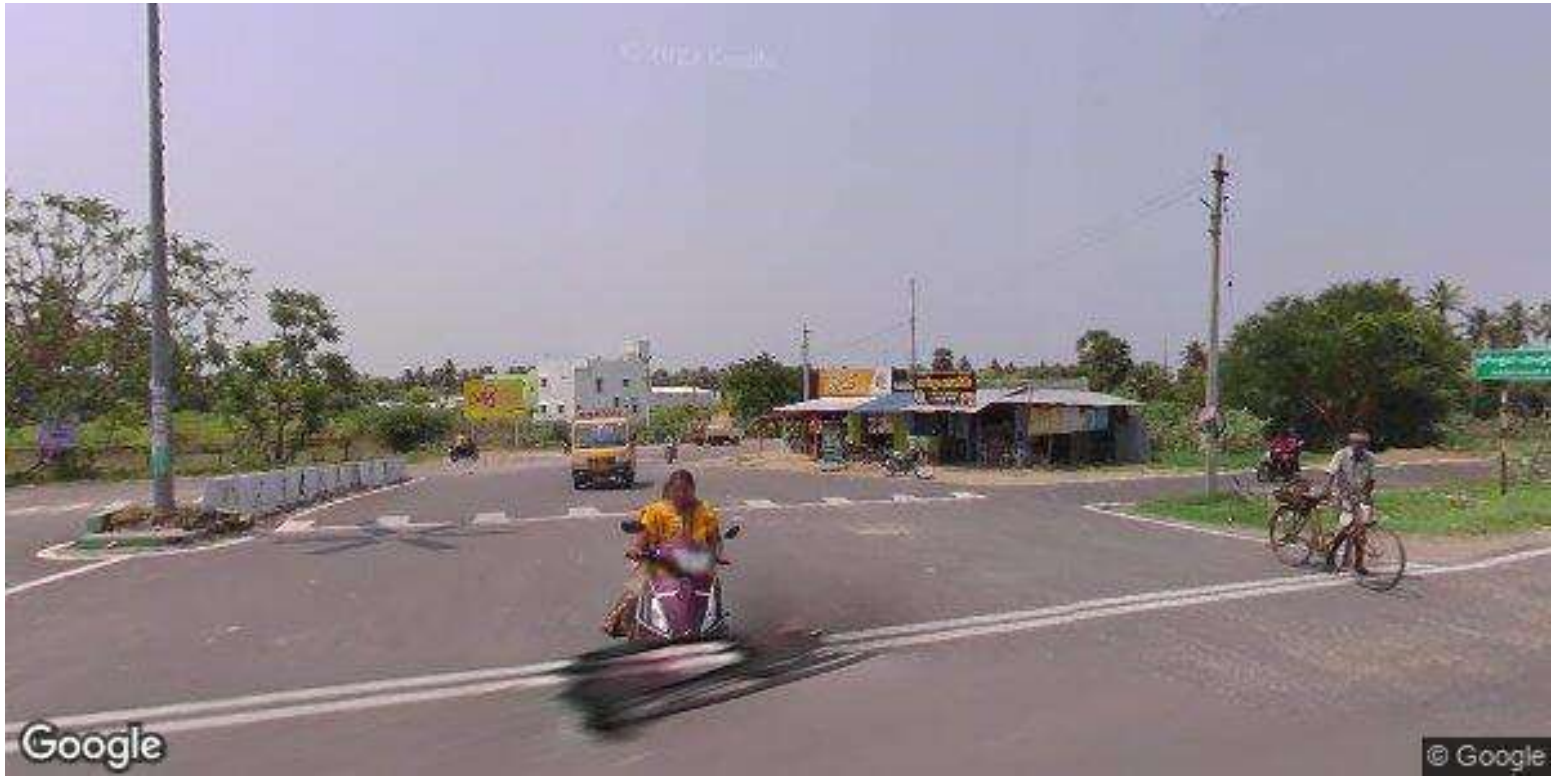
| | Risk Type | Risk Level | Coordinates | Speed Limit |
|---|---|---|---|---|
| 9 | Turn | High | 11.34530, 77.64058 | 15 KM/Hr |

**Risk Type:** Turn  
**Risk Level:** High  
**Speed Limit:** 15 KM/Hr  
**Coordinates:** 11.34530, 77.64058

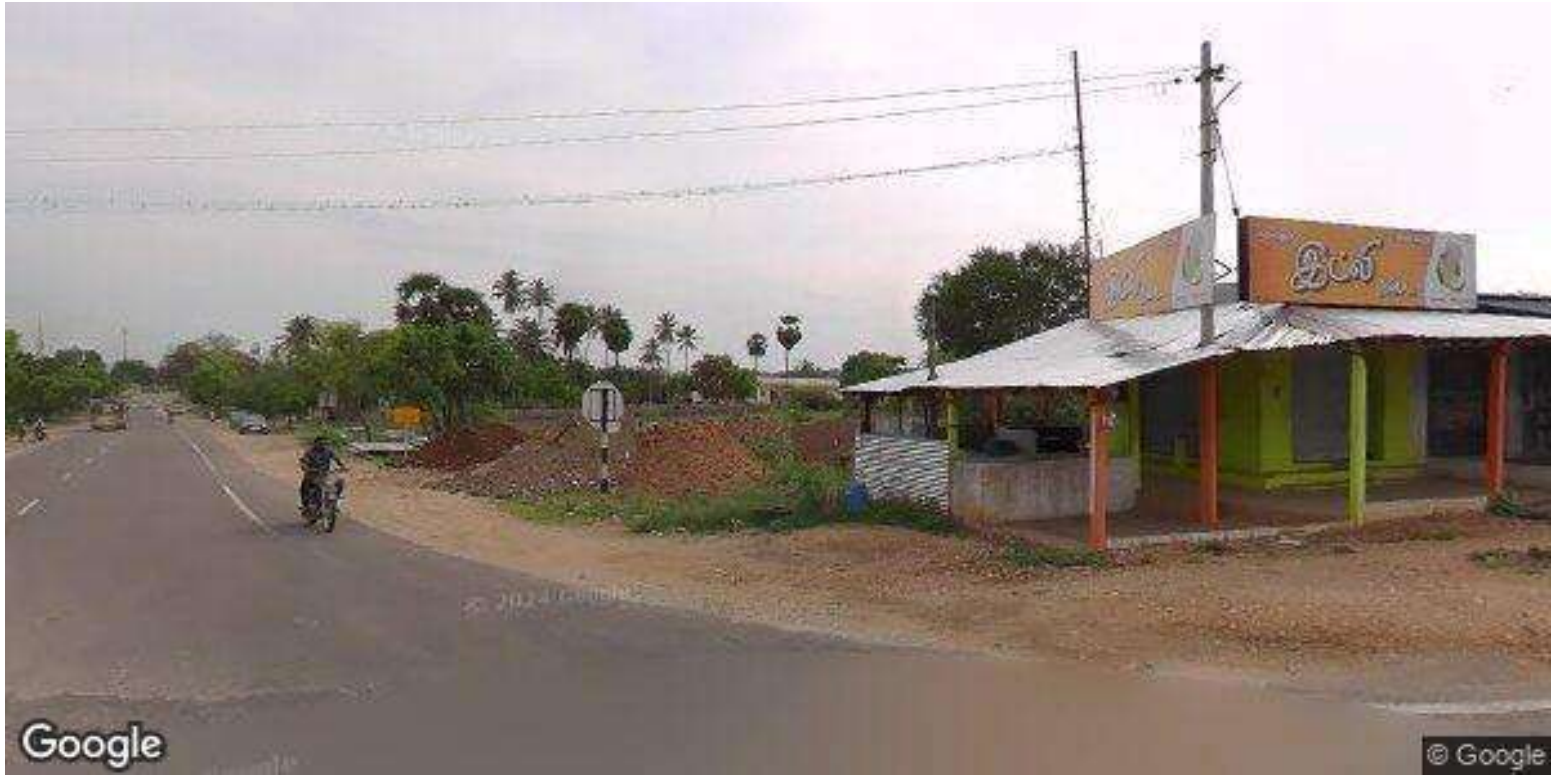
| | Risk Type | Risk Level | Coordinates | Speed Limit |
|---|---|---|---|---|
| 10 | Turn | High | 11.34499, 77.64081 | 15 KM/Hr |

**Risk Type:** Turn  
**Risk Level:** High  
**Speed Limit:** 15 KM/Hr  
**Coordinates:** 11.34499, 77.64081

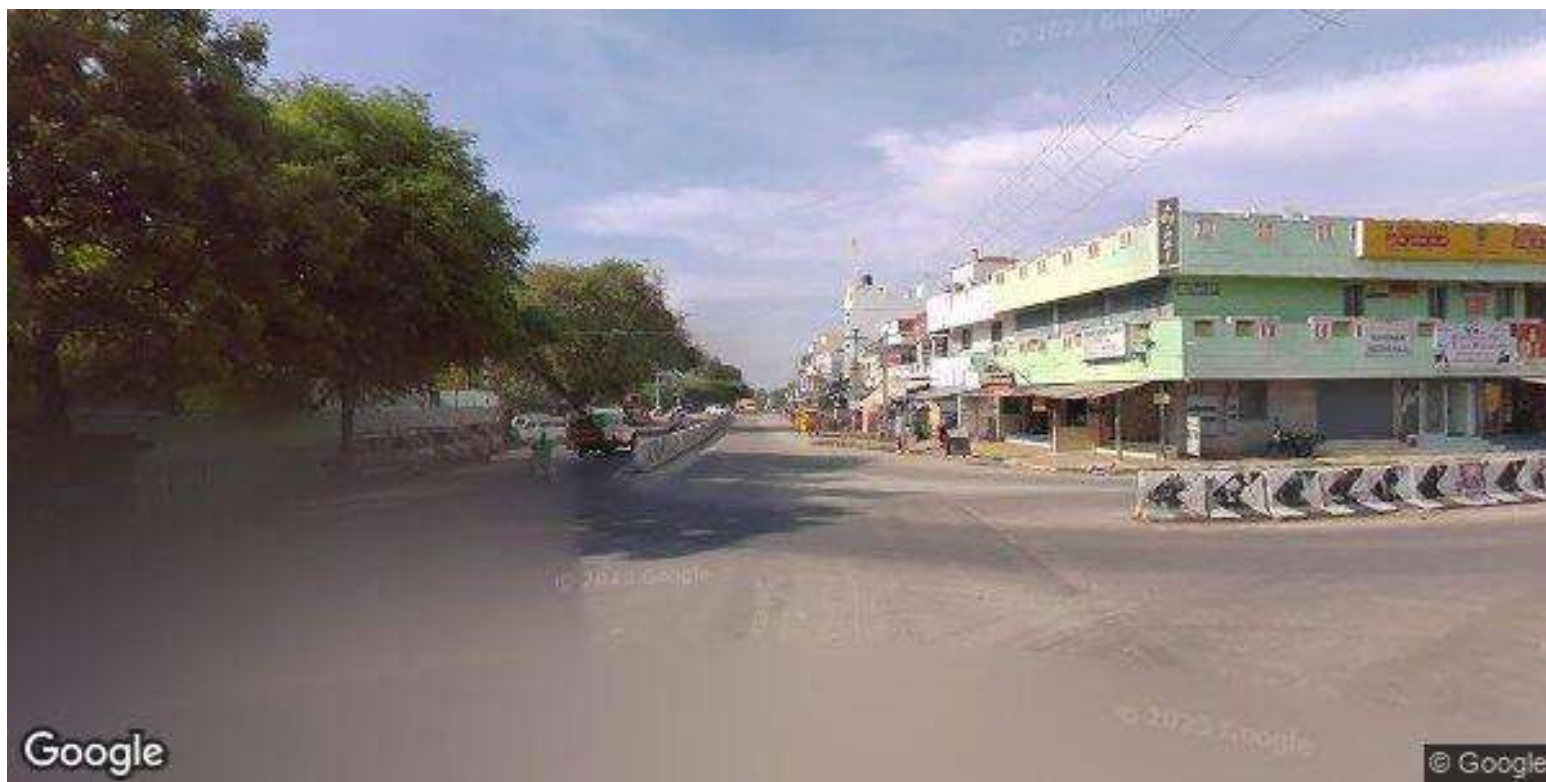
**Coordinates:** 11.33828, 77.63811

| | Risk Type | Risk Level | Coordinates | Speed Limit |
|---|---|---|---|---|
| 11 | Blind Spot | Blind Spot | 11.33828, 77.63811 | 10 KM/Hr |

**Risk Type:** Blind Spot

**Risk Level:** Blind Spot

**Speed Limit:** 10 KM/Hr

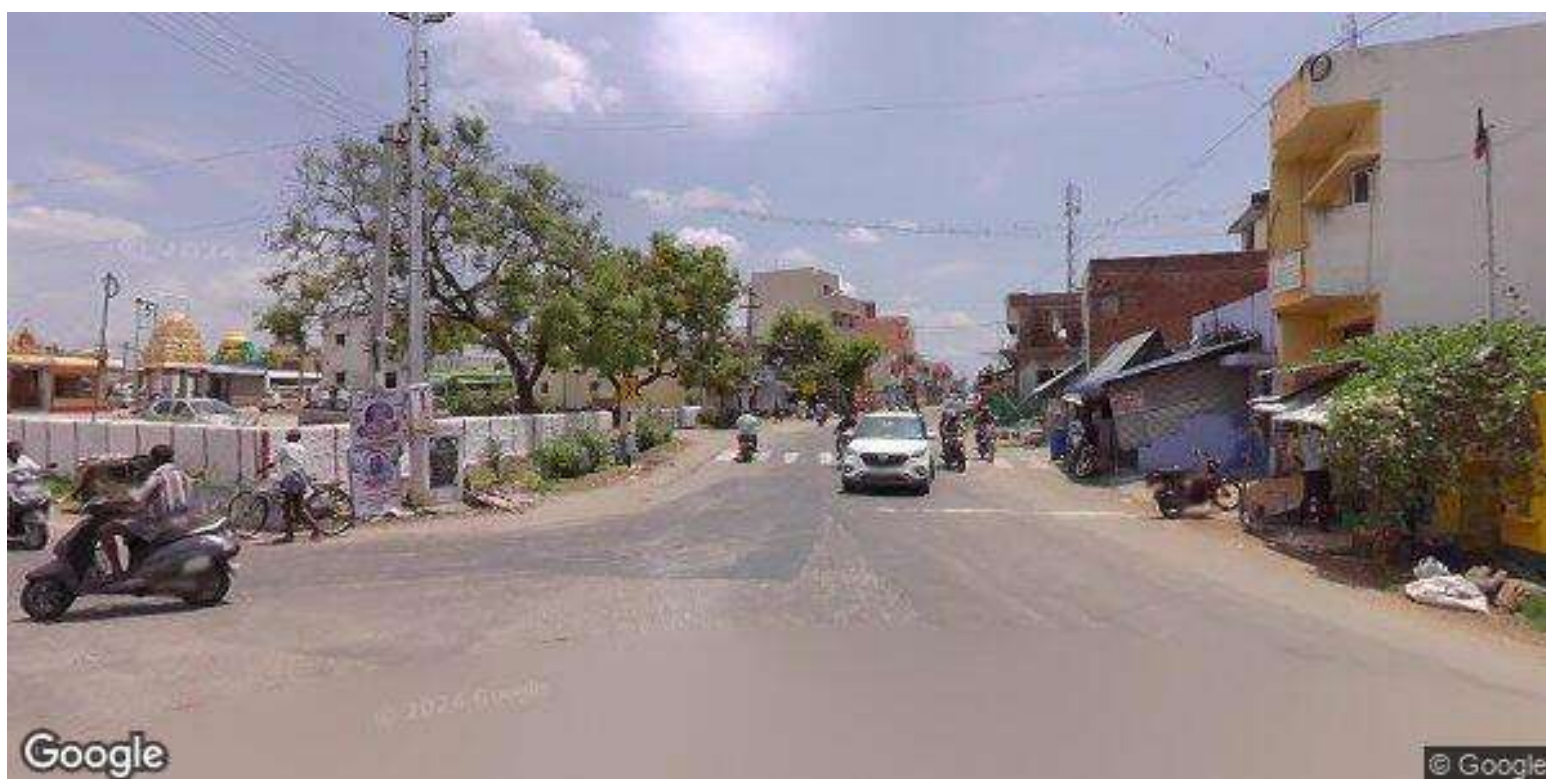
**Coordinates:** 11.33843, 77.64074

| | Risk Type | Risk Level | Coordinates | Speed Limit |
|---|---|---|---|---|
| 12 | Blind Spot | Blind Spot | 11.33843, 77.64074 | 10 KM/Hr |

**Risk Type:** Blind Spot

**Risk Level:** Blind Spot

**Speed Limit:** 10 KM/Hr

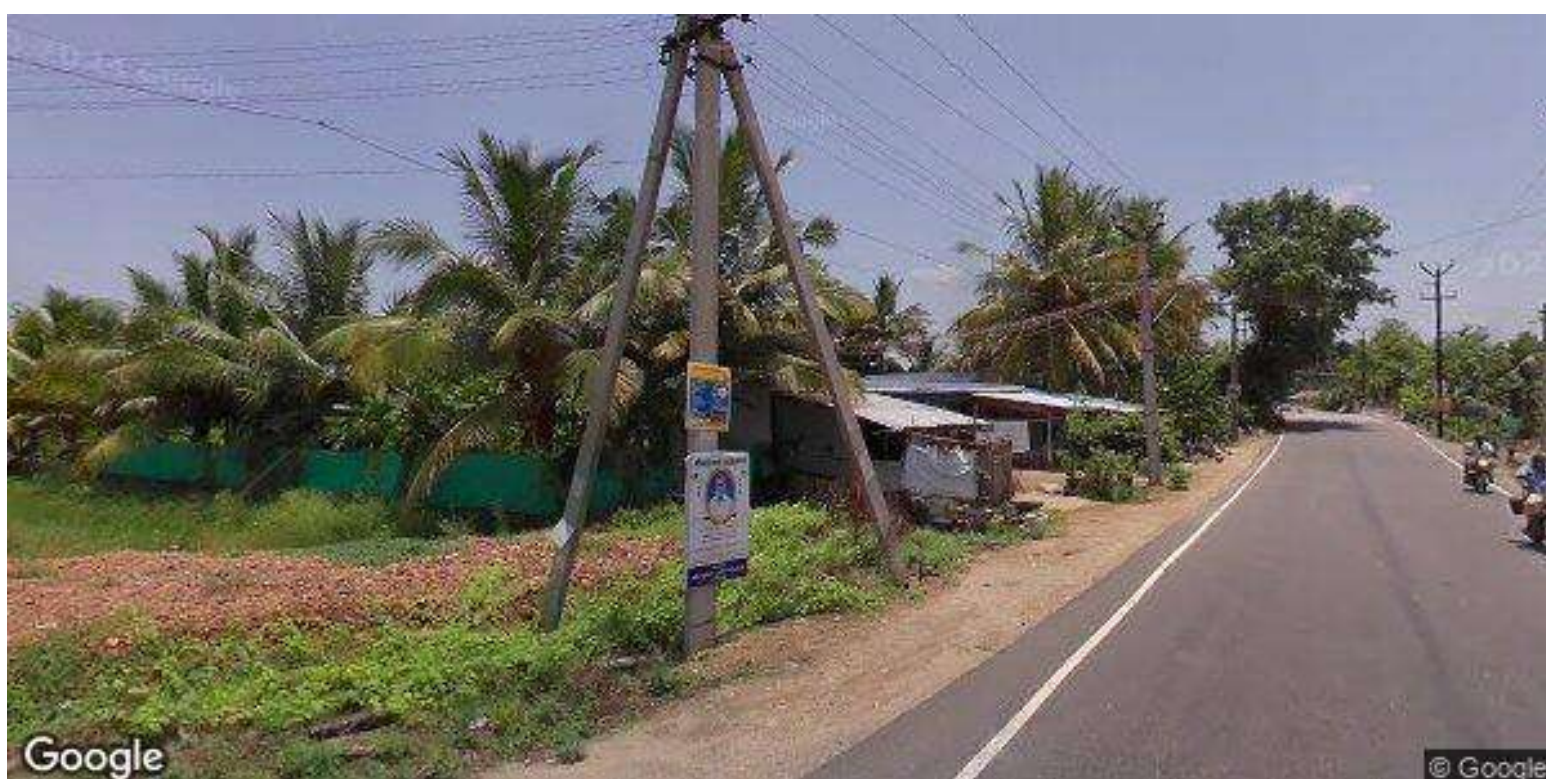
**Coordinates: 11.31036, 77.64416**

| | Risk Type | Risk Level | Coordinates | Speed Limit |
|---|---|---|---|---|
| 13 | Turn | High | 11.31036, 77.64416 | 15 KM/Hr |

**Risk Type: Turn**

**Risk Level: High**

**Speed Limit: 15 KM/Hr**

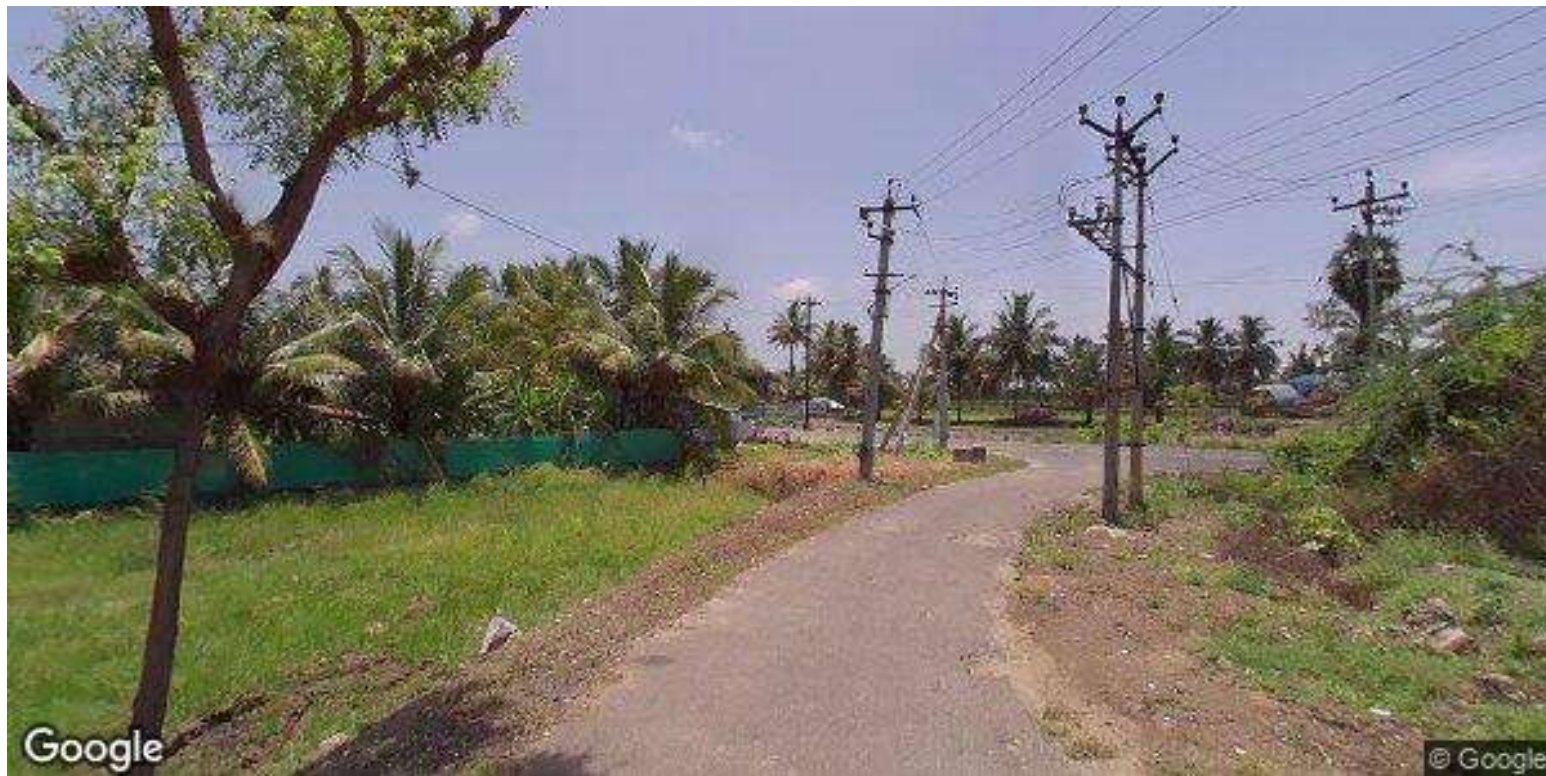
**Coordinates: 11.31017, 77.64390**

| | Risk Type | Risk Level | Coordinates | Speed Limit |
|---|---|---|---|---|
| 14 | Turn | Medium | 11.31017, 77.64390 | 30 KM/Hr |

**Risk Type: Turn**

**Risk Level: Medium**

**Speed Limit: 30 KM/Hr**

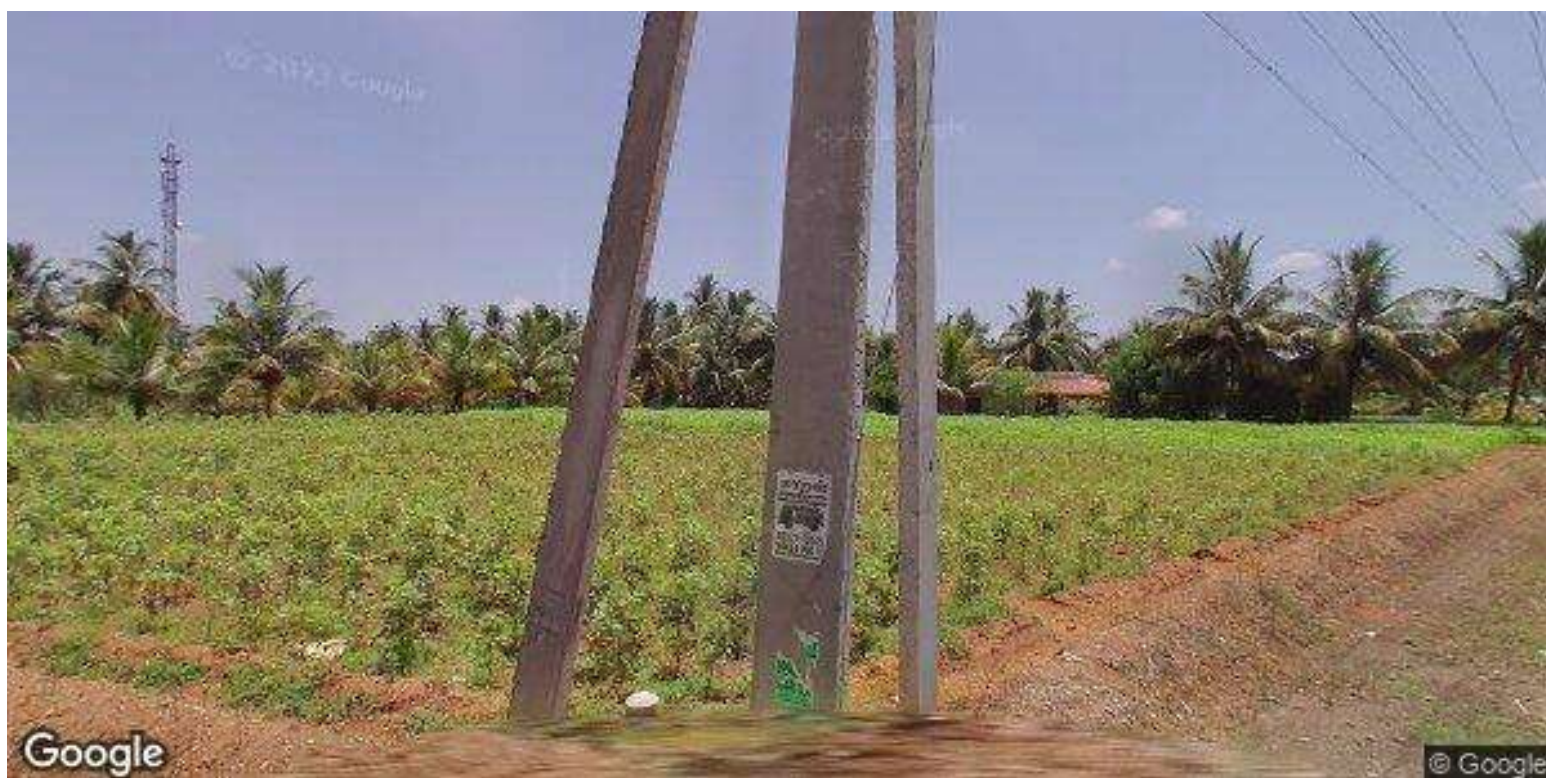
**Coordinates: 11.30925, 77.64361**

| | Risk Type | Risk Level | Coordinates | Speed Limit |
|---|---|---|---|---|
| 15 | Turn | High | 11.30925, 77.64361 | 15 KM/Hr |

**Risk Type: Turn**

**Risk Level: High**

**Speed Limit: 15 KM/Hr**

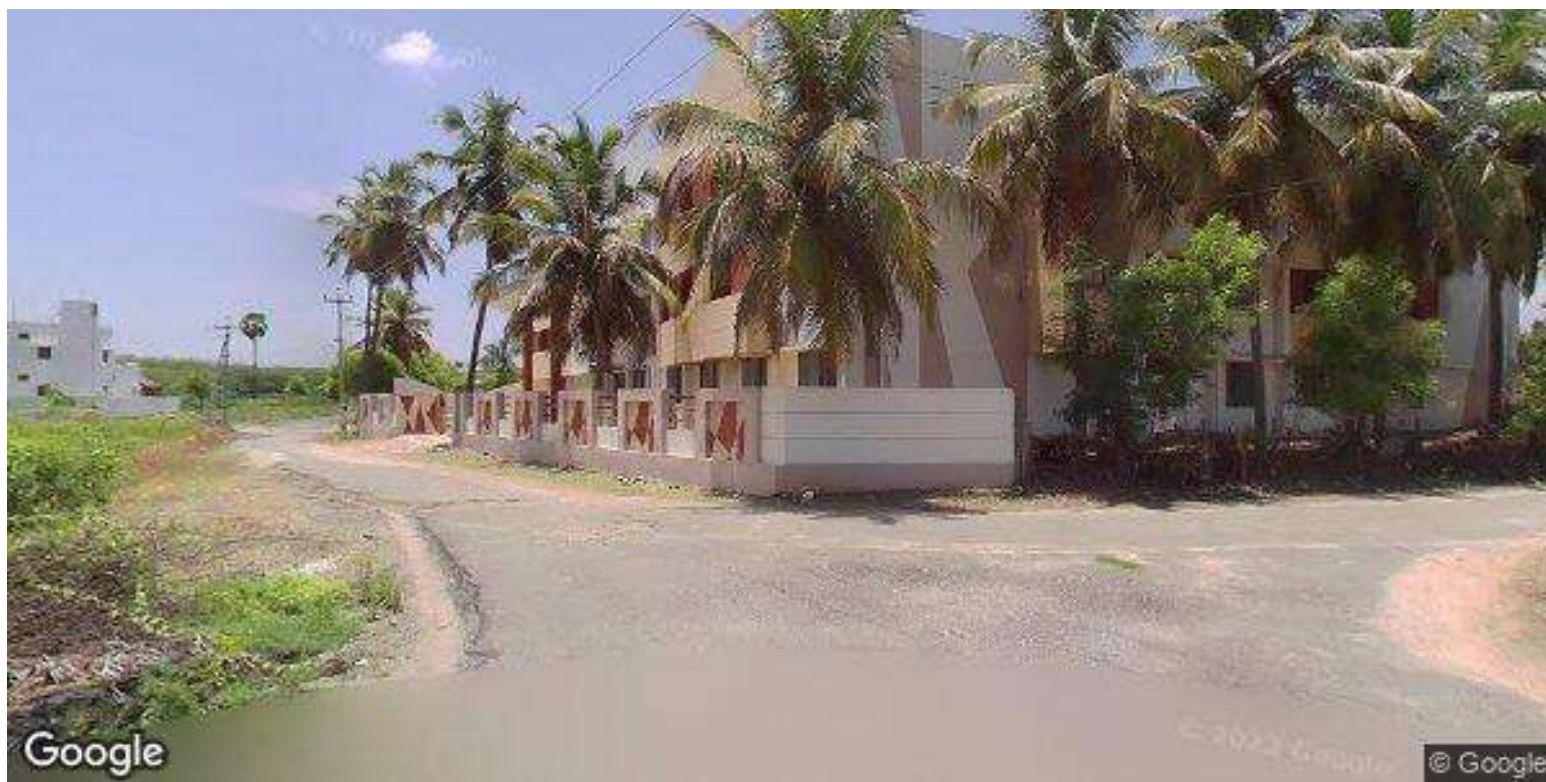
**Coordinates:** 11.30899, 77.64304

| | Risk Type | Risk Level | Coordinates | Speed Limit |
|---|---|---|---|---|
| 16 | Blind Spot | Blind Spot | 11.30899, 77.64304 | 10 KM/Hr |

**Risk Type:** Blind Spot

**Risk Level:** Blind Spot

**Speed Limit:** 10 KM/Hr

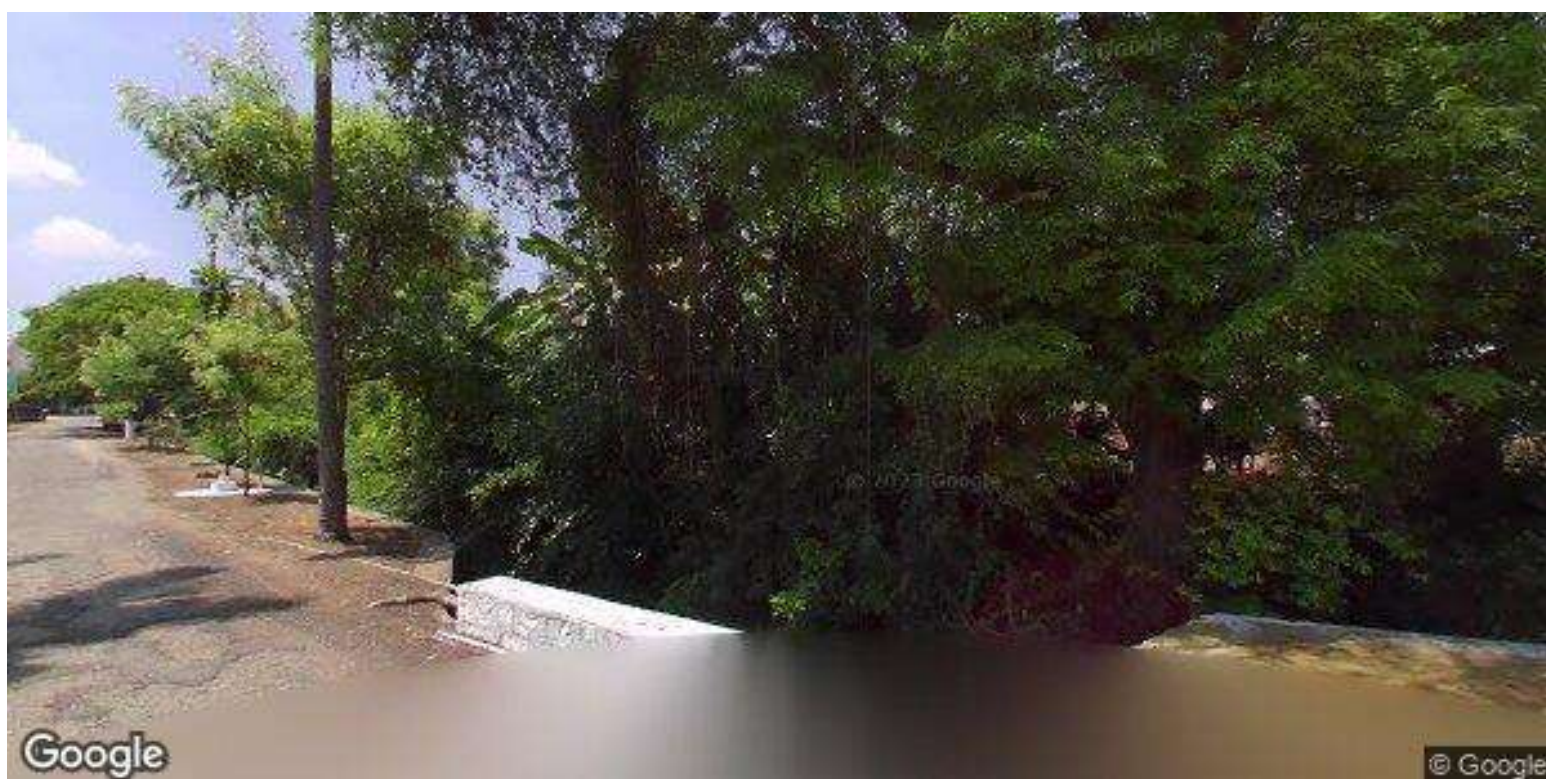
**Coordinates:** 11.30535, 77.64365

| | Risk Type | Risk Level | Coordinates | Speed Limit |
|---|---|---|---|---|
| 17 | Blind Spot | Blind Spot | 11.30535, 77.64365 | 10 KM/Hr |

**Risk Type:** Blind Spot

**Risk Level:** Blind Spot

**Speed Limit:** 10 KM/Hr

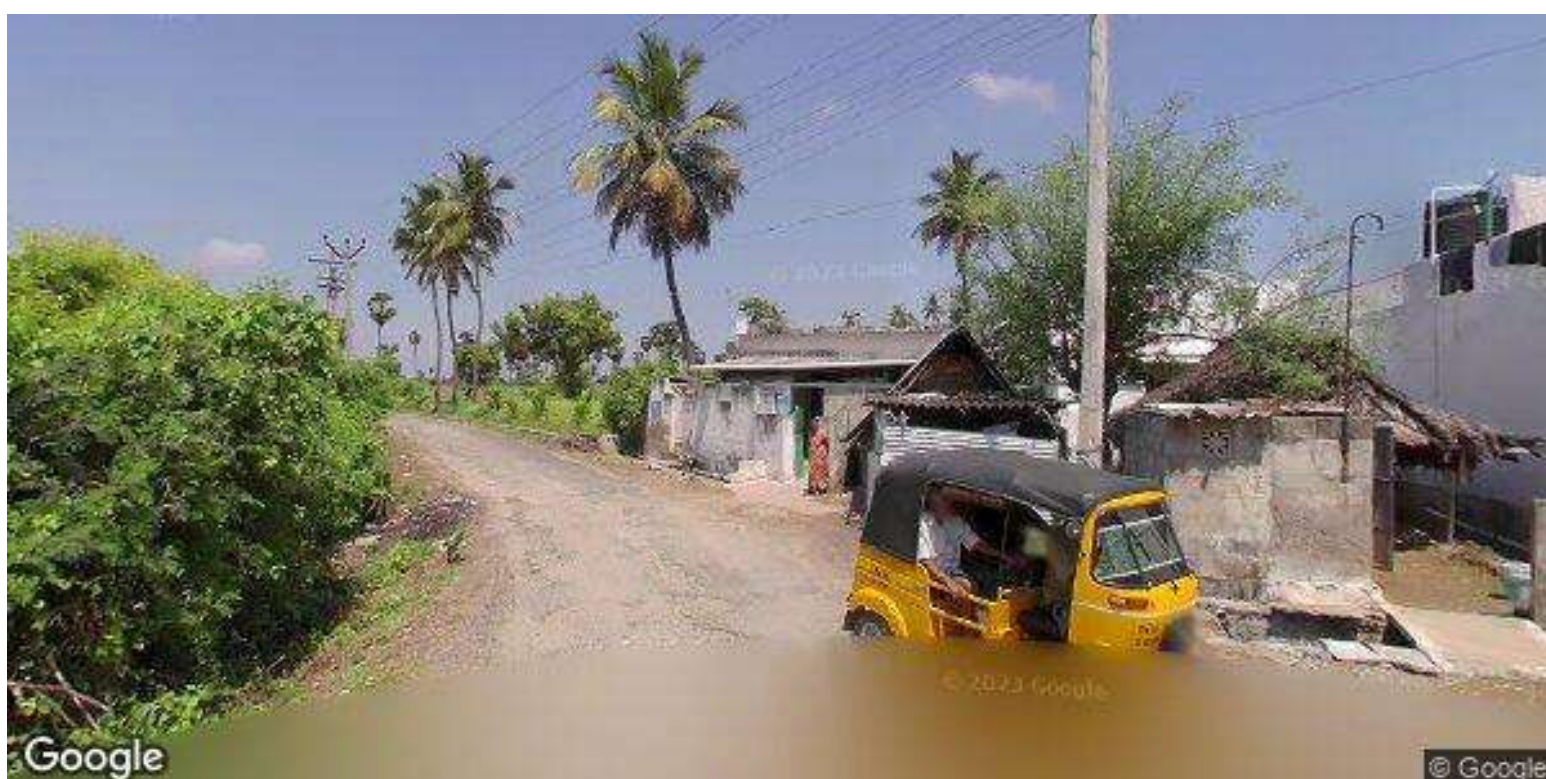
| | Risk Type | Risk Level | Coordinates | Speed Limit |
|---|---|---|---|---|
| 18 | Turn | Medium | 11.30536, 77.64333 | 30 KM/Hr |

**Risk Type:** Turn  
**Risk Level:** Medium  
**Speed Limit:** 30 KM/Hr  
**Coordinates:** 11.30536, 77.64333

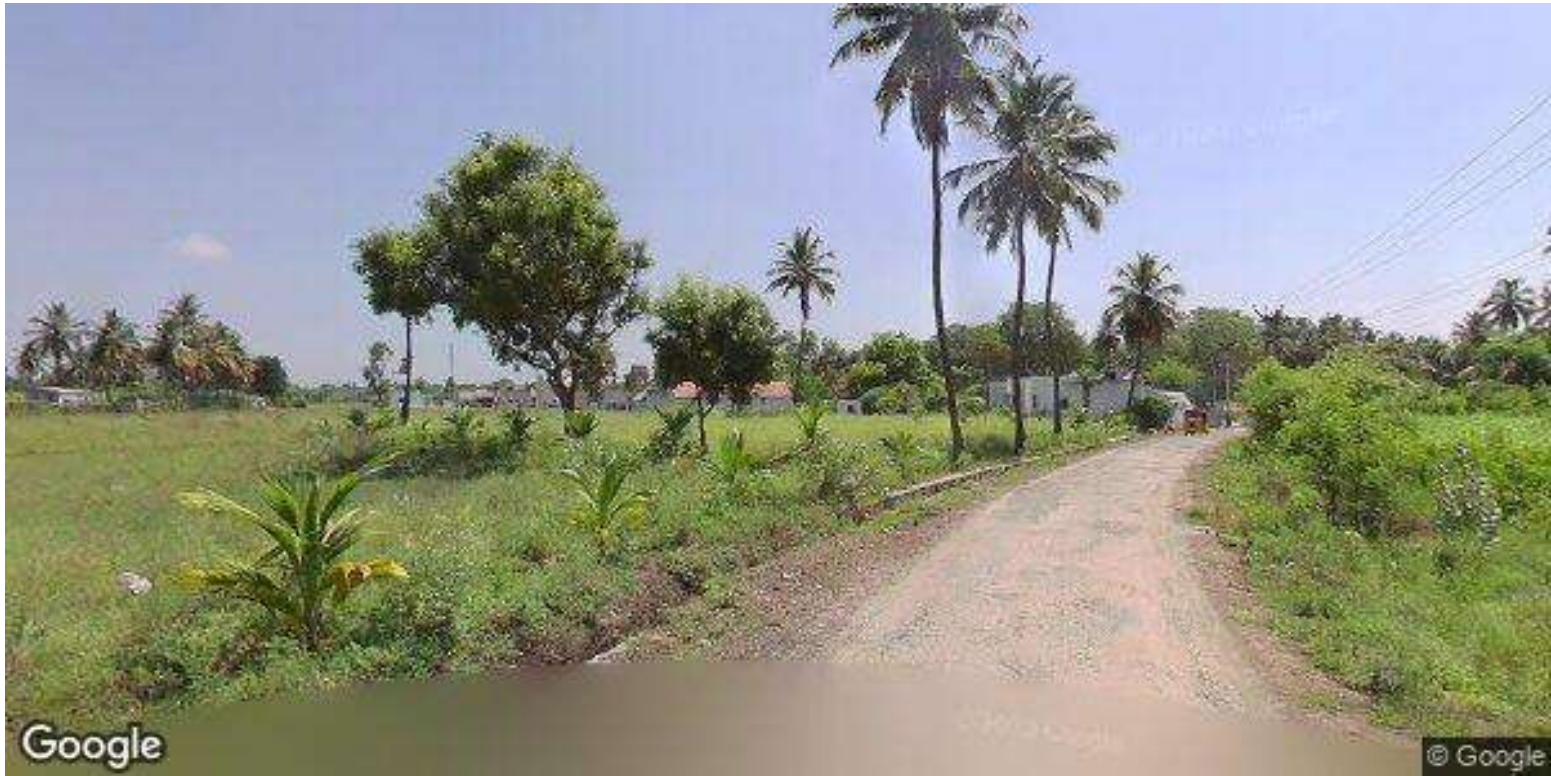
| | Risk Type | Risk Level | Coordinates | Speed Limit |
|---|---|---|---|---|
| 19 | Turn | Medium | 11.30490, 77.64269 | 30 KM/Hr |

**Risk Type:** Turn  
**Risk Level:** Medium  
**Speed Limit:** 30 KM/Hr  
**Coordinates:** 11.30490, 77.64269

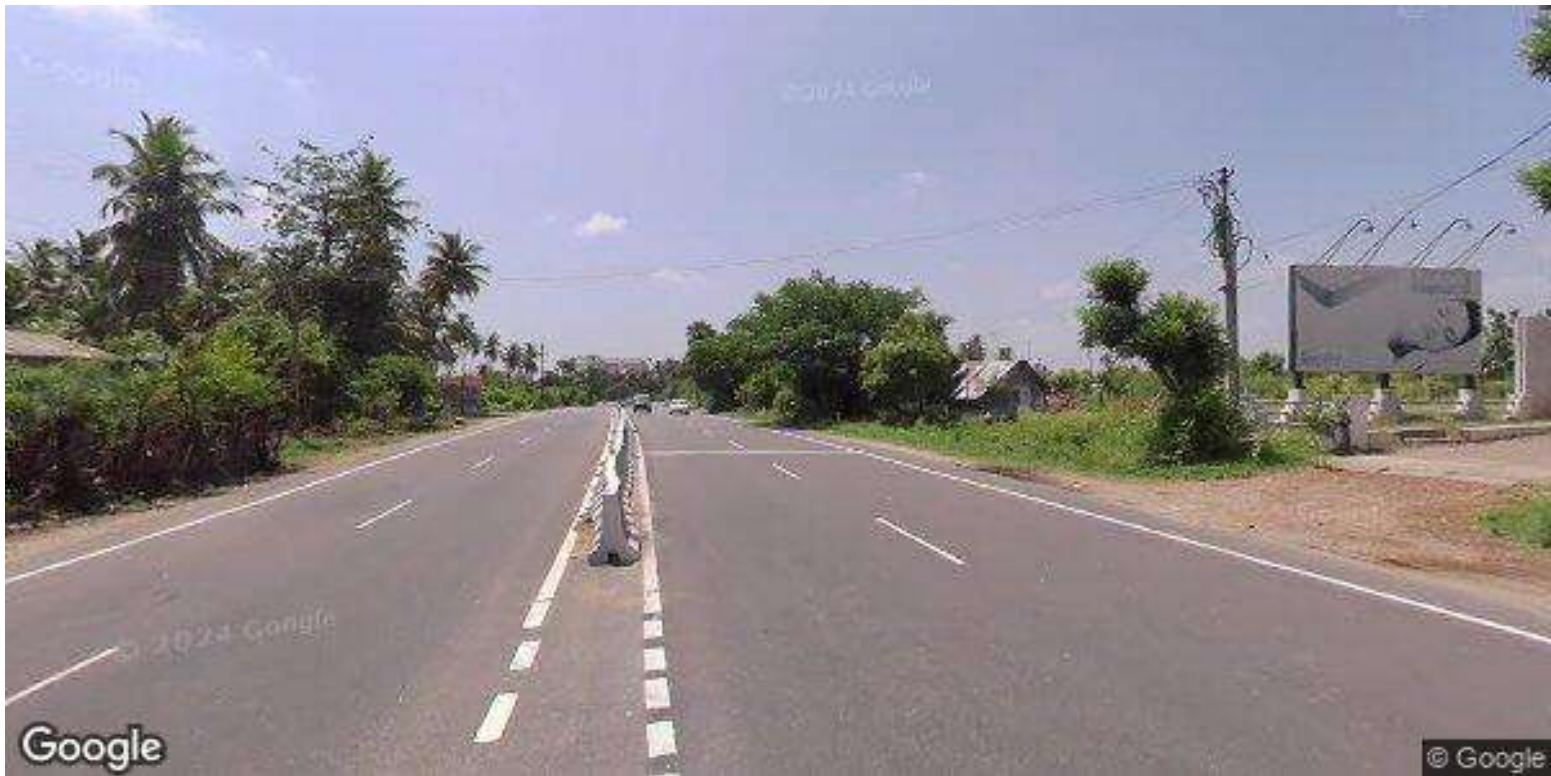
| | Risk Type | Risk Level | Coordinates | Speed Limit |
|---|---|---|---|---|
| 20 | Blind Spot | Blind Spot | 11.29945, 77.64212 | 10 KM/Hr |

**Risk Type:** Blind Spot  
**Risk Level:** Blind Spot  
**Speed Limit:** 10 KM/Hr  
**Coordinates:** 11.29945, 77.64212
