# IndianOil

## JOURNEY RISK MANAGEMENT (JRM) STUDY

### Salem Terminal to NEELA AGENCIES

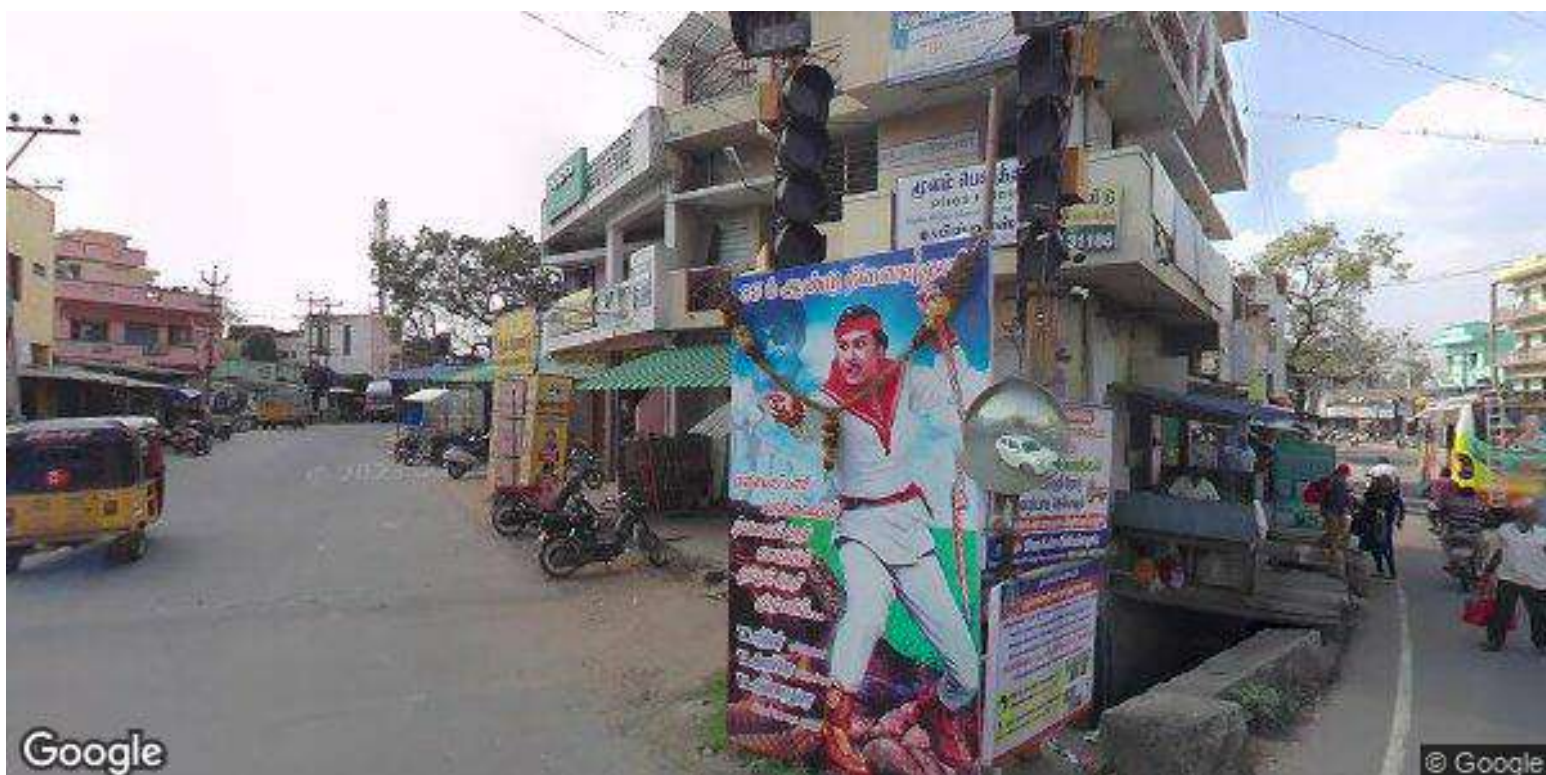
**Coordinates: 11.38342, 77.89975**

**Risk Type: Turn**

**Risk Level: Medium**

**Speed Limit: 30 KM/Hr**

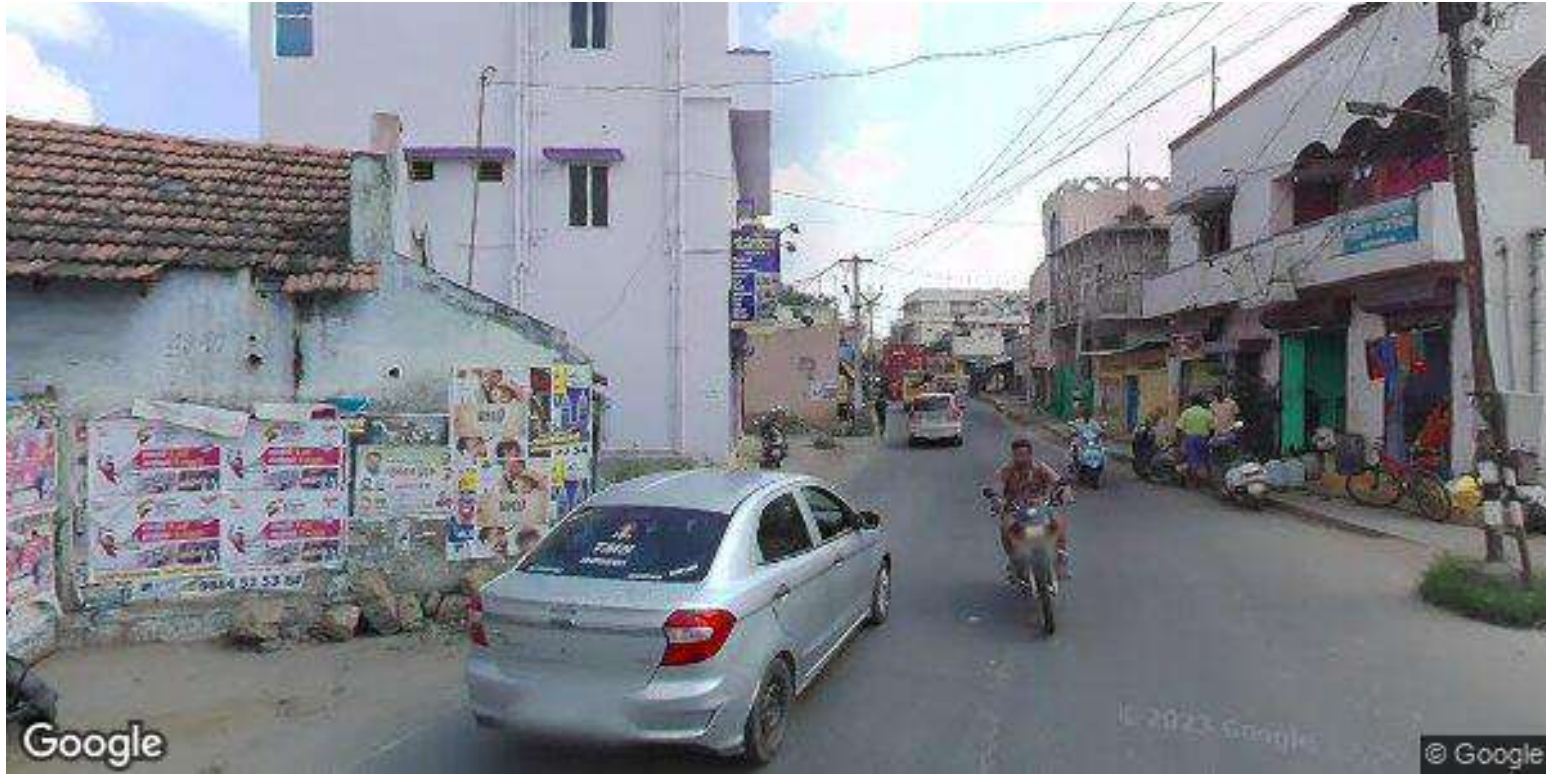
**Coordinates: 11.38295, 77.90001**

**Risk Type: Turn**

**Risk Level: Medium**

**Speed Limit: 30 KM/Hr**

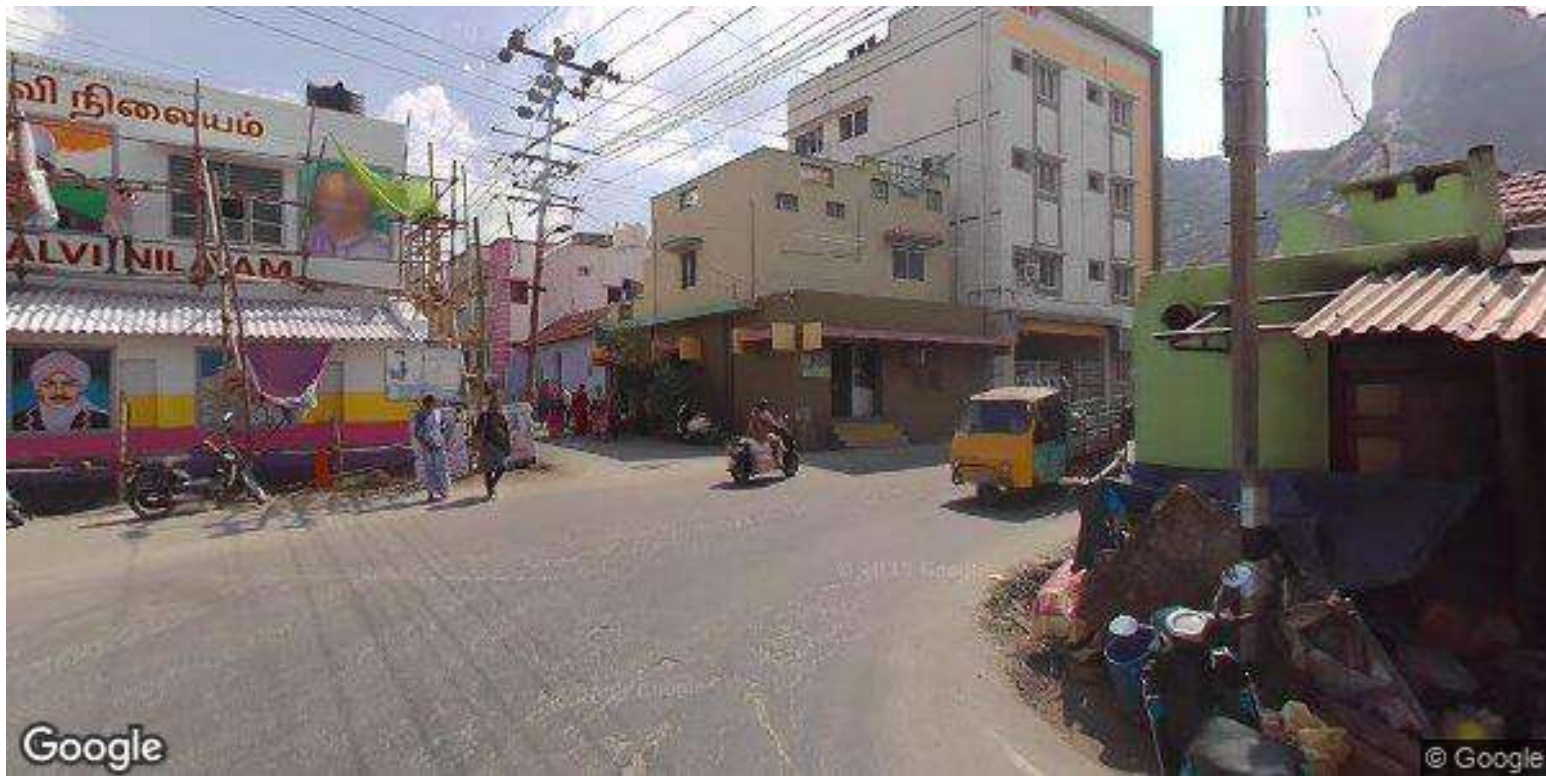
**Coordinates: 11.38186, 77.90258**

**Risk Type: Turn**

**Risk Level: High**

**Speed Limit: 15 KM/Hr**

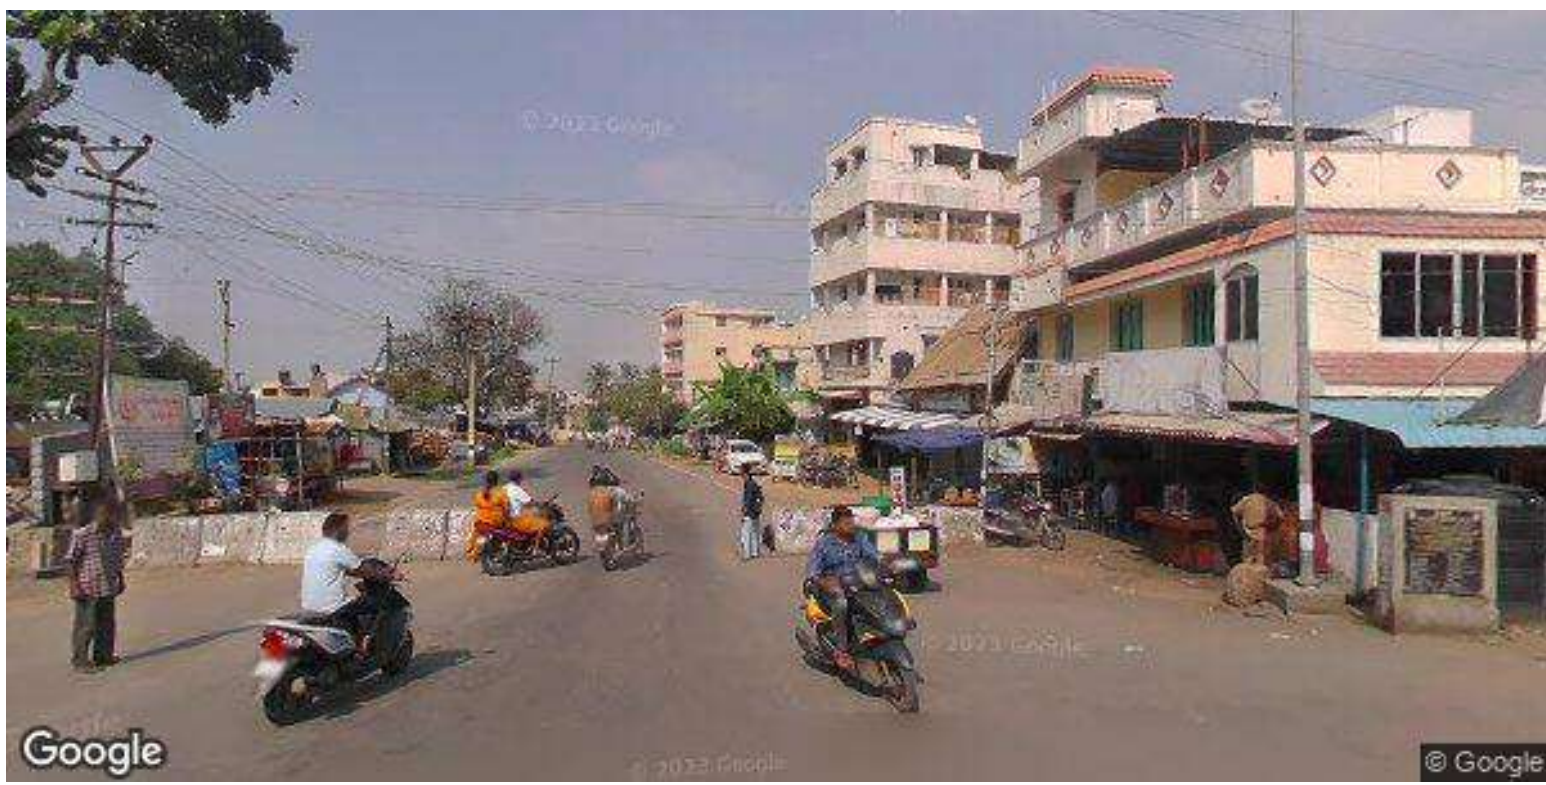
**Coordinates:** 11.37841, 77.90140

**Risk Type:** Blind Spot

**Risk Level:** Blind Spot

**Speed Limit:** 10 KM/Hr

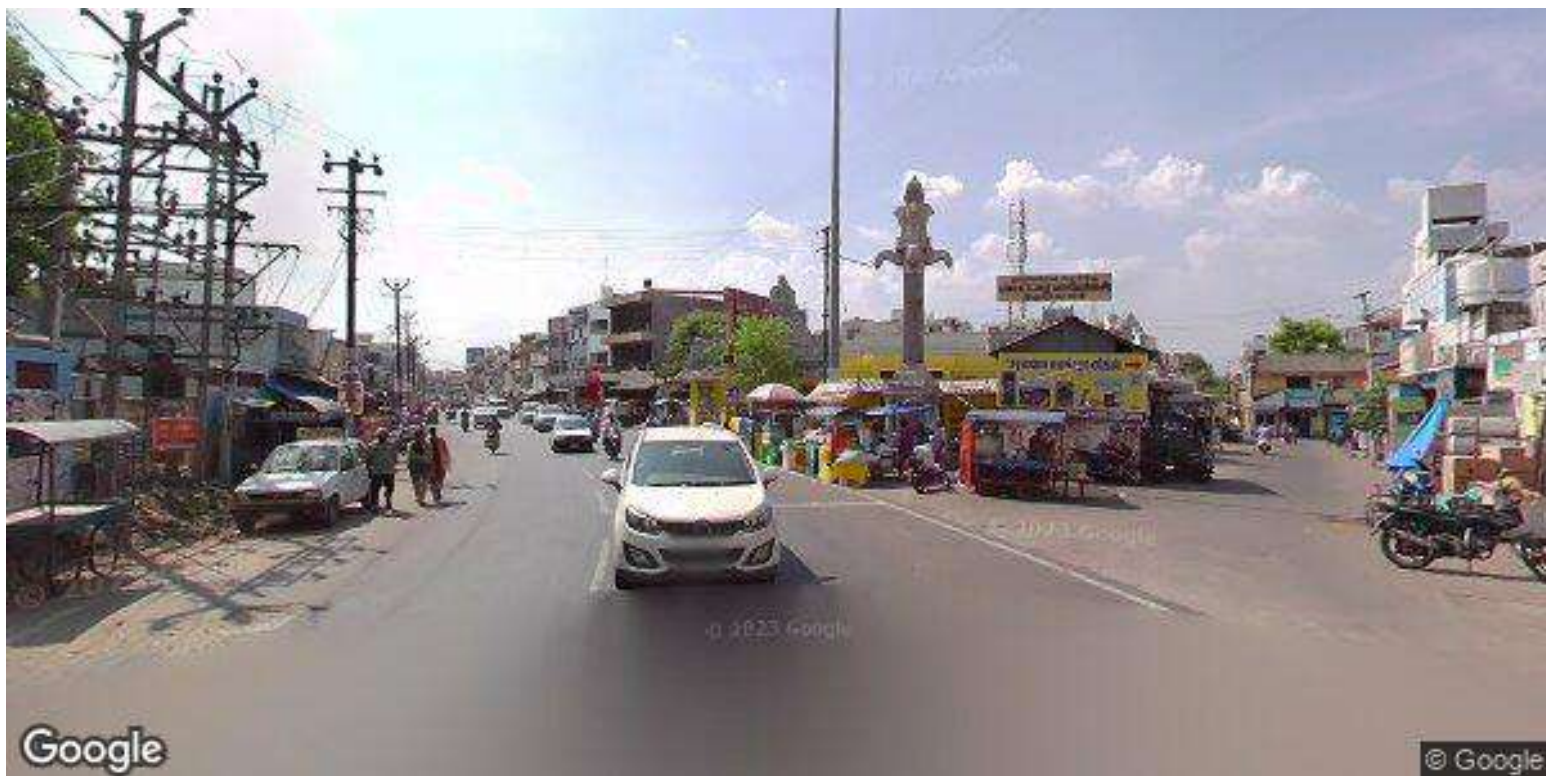
**Coordinates:** 11.22411, 78.16637

**Risk Type:** Turn

**Risk Level:** Medium

**Speed Limit:** 30 KM/Hr
