# IndianOil

## JOURNEY RISK MANAGEMENT (JRM) STUDY

### Salem Terminal TO NAVEEN AGENCY

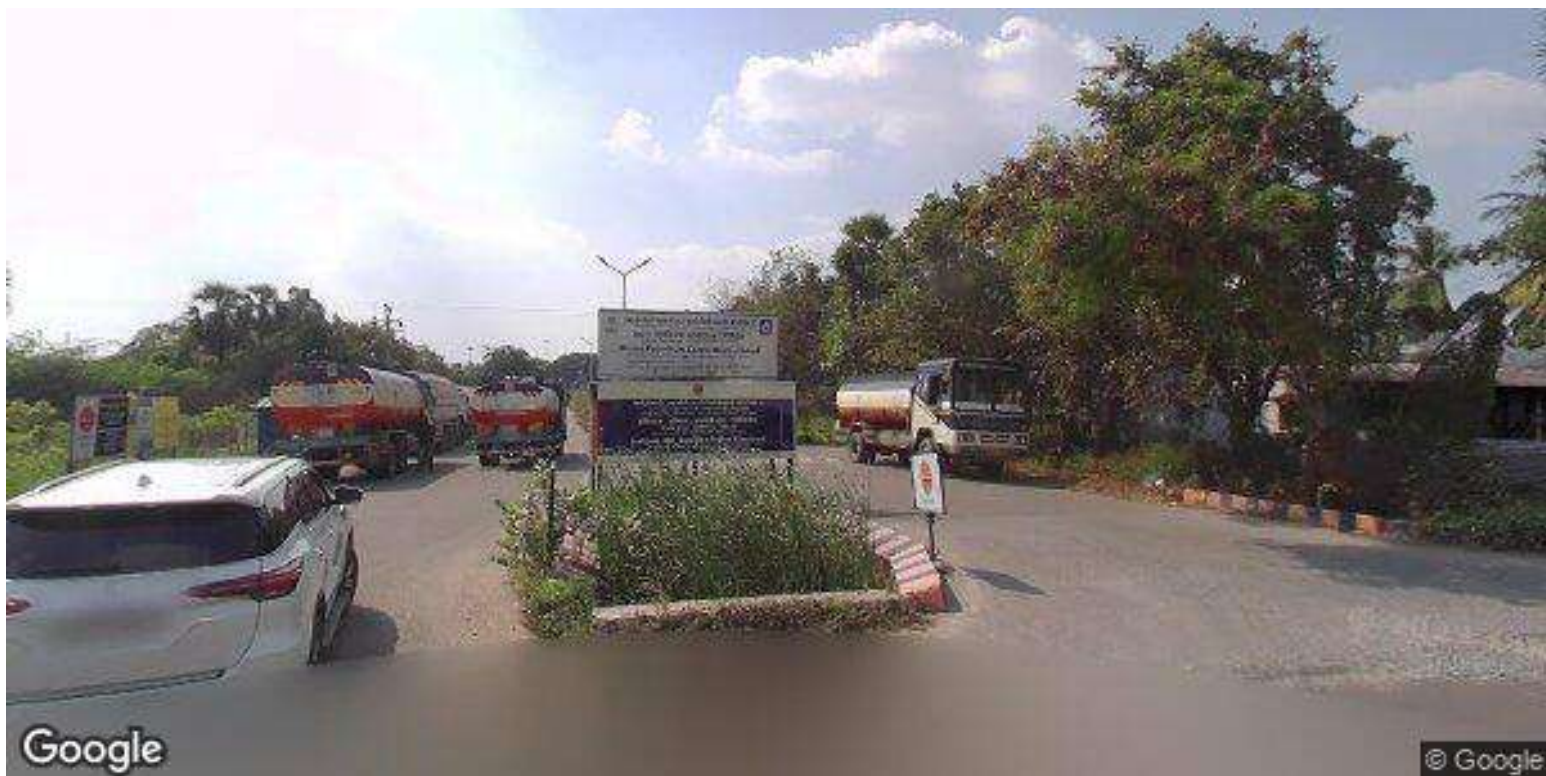
**Risk Type:** Turn  
**Risk Level:** High  
**Speed Limit:** 15 KM/Hr  
**Coordinates:** 11.44024, 77.87528

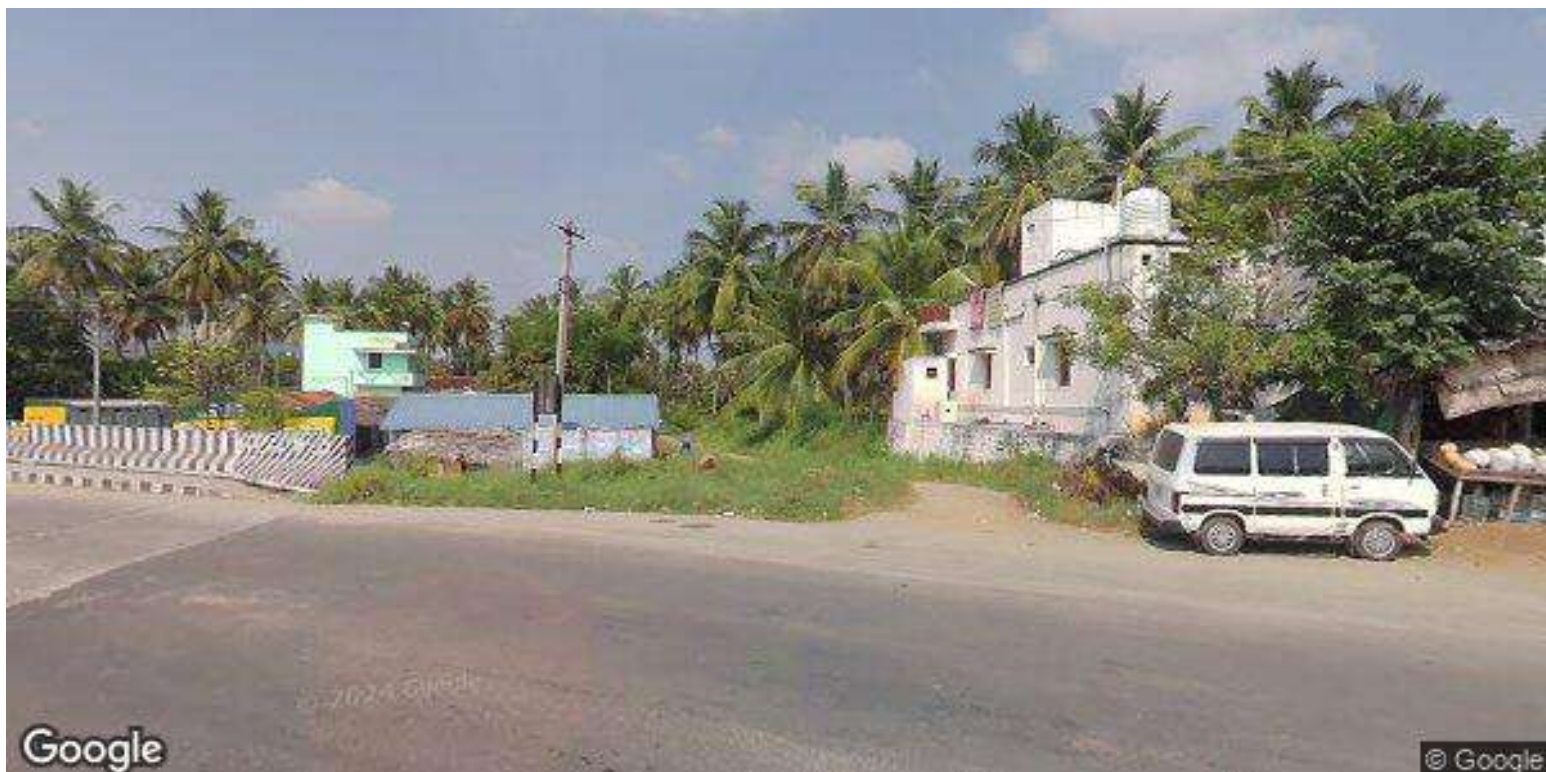
**Risk Type:** Turn  
**Risk Level:** High  
**Speed Limit:** 15 KM/Hr  
**Coordinates:** 11.44898, 77.87410

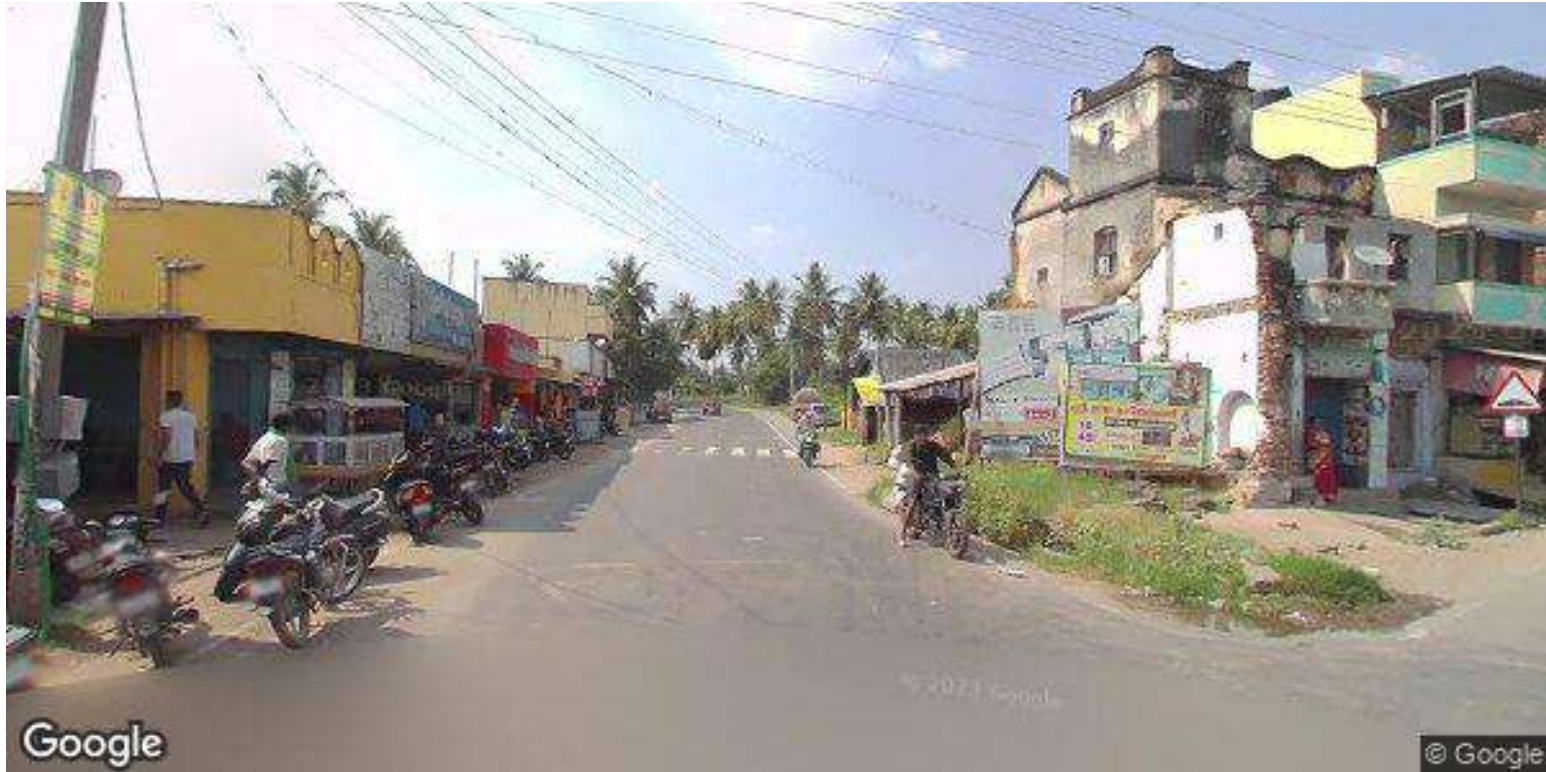
**Risk Type:** Turn  
**Risk Level:** High  
**Speed Limit:** 15 KM/Hr  
**Coordinates:** 11.45007, 77.87201

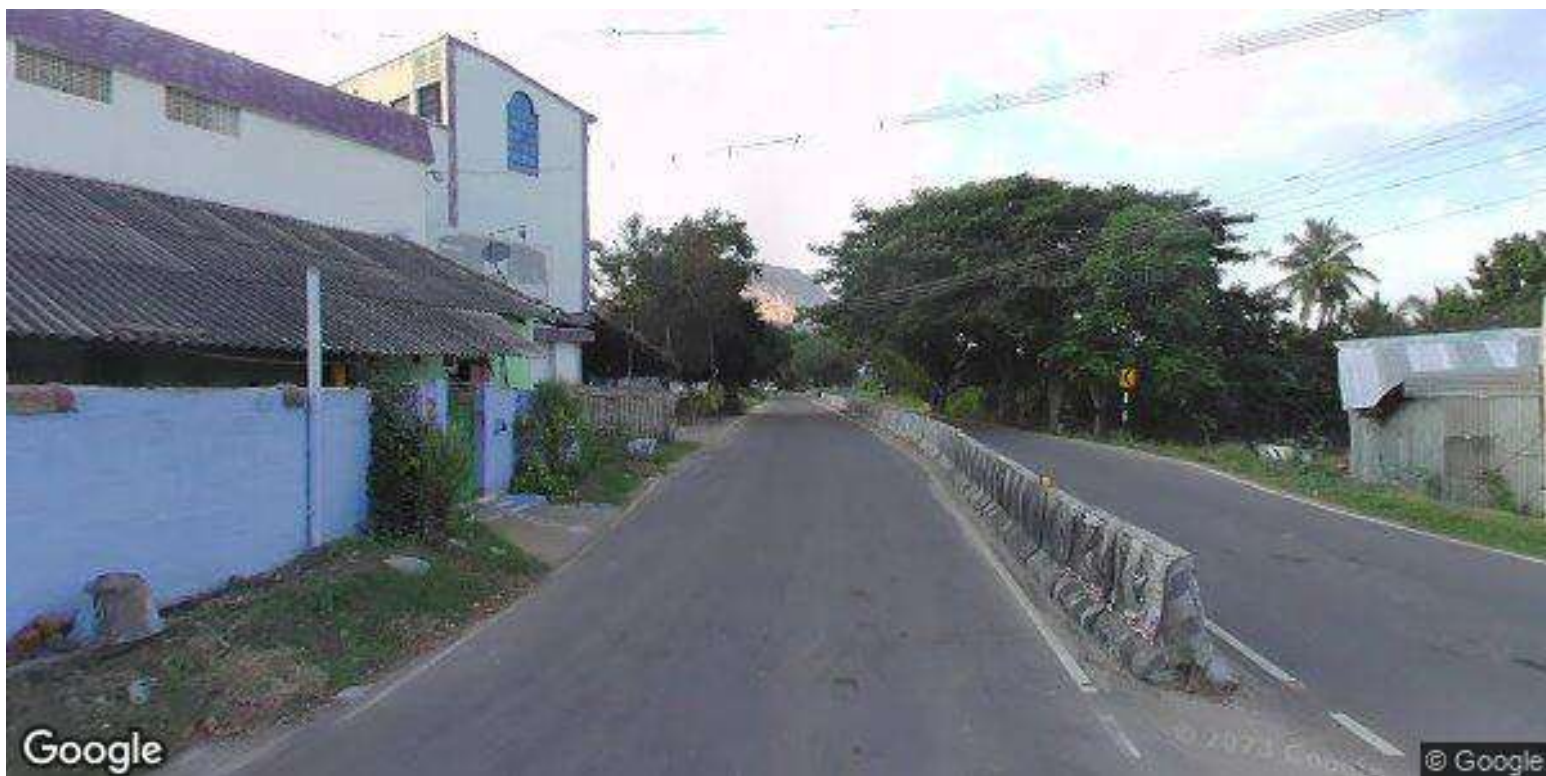
**Risk Type:** Turn  
**Risk Level:** Medium  
**Speed Limit:** 30 KM/Hr  
**Coordinates:** 11.46392, 77.87328

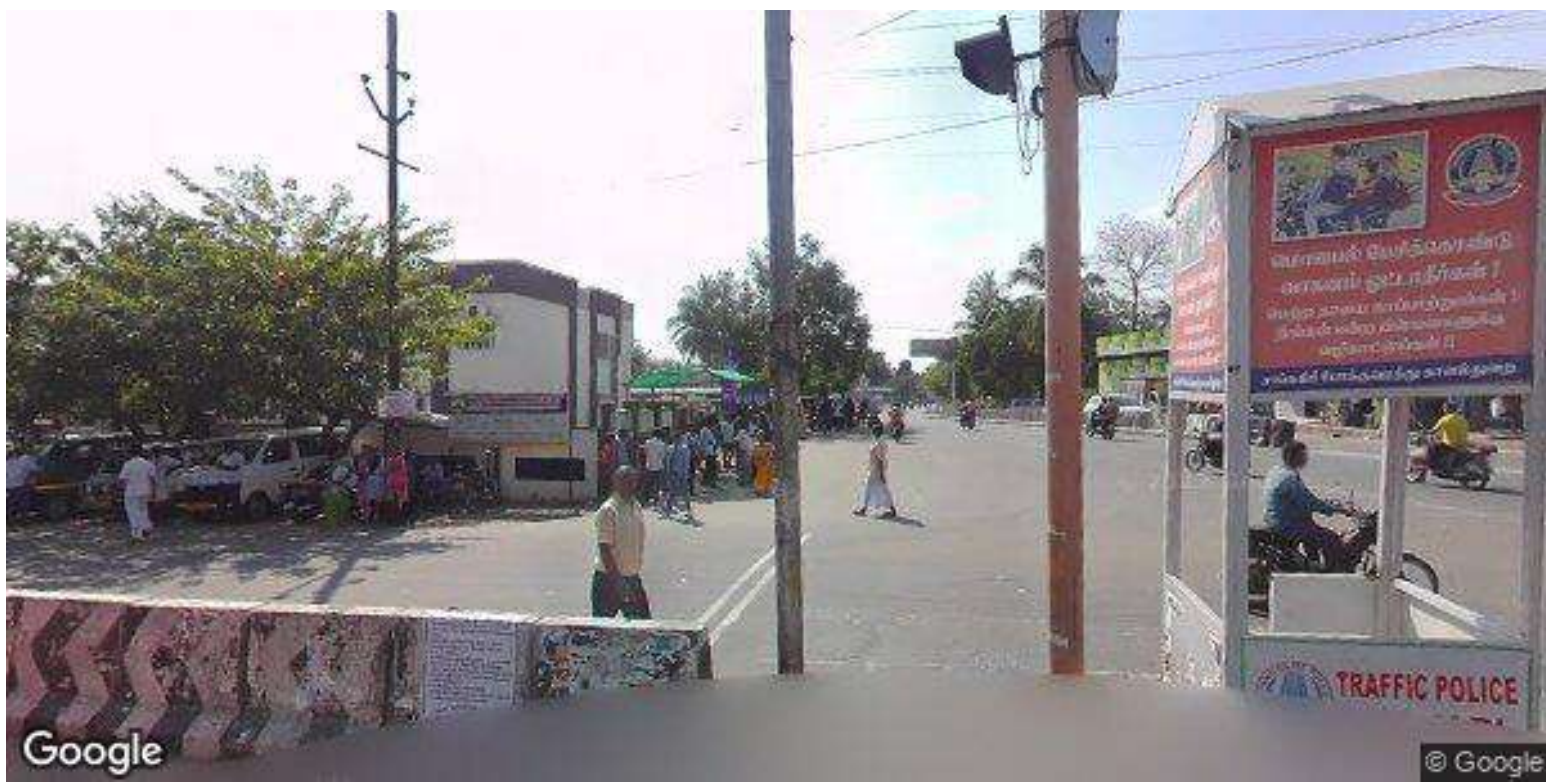
**Risk Type:** Turn

**Risk Level:** Medium

**Speed Limit:** 30 KM/Hr

**Coordinates:** 11.47391, 77.86844

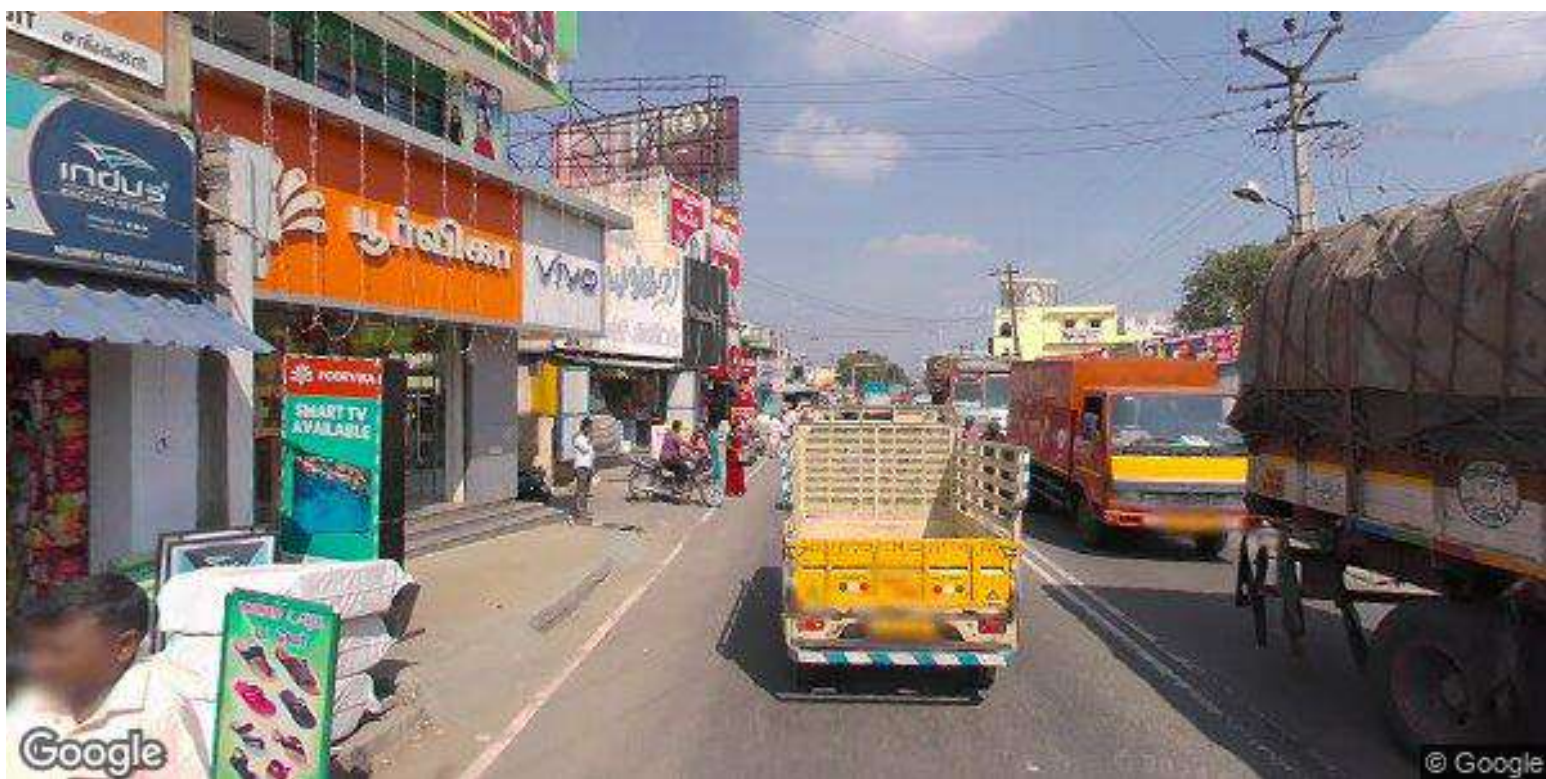
**Risk Type:** Turn

**Risk Level:** High

**Speed Limit:** 15 KM/Hr

**Coordinates:** 11.47412, 77.86848

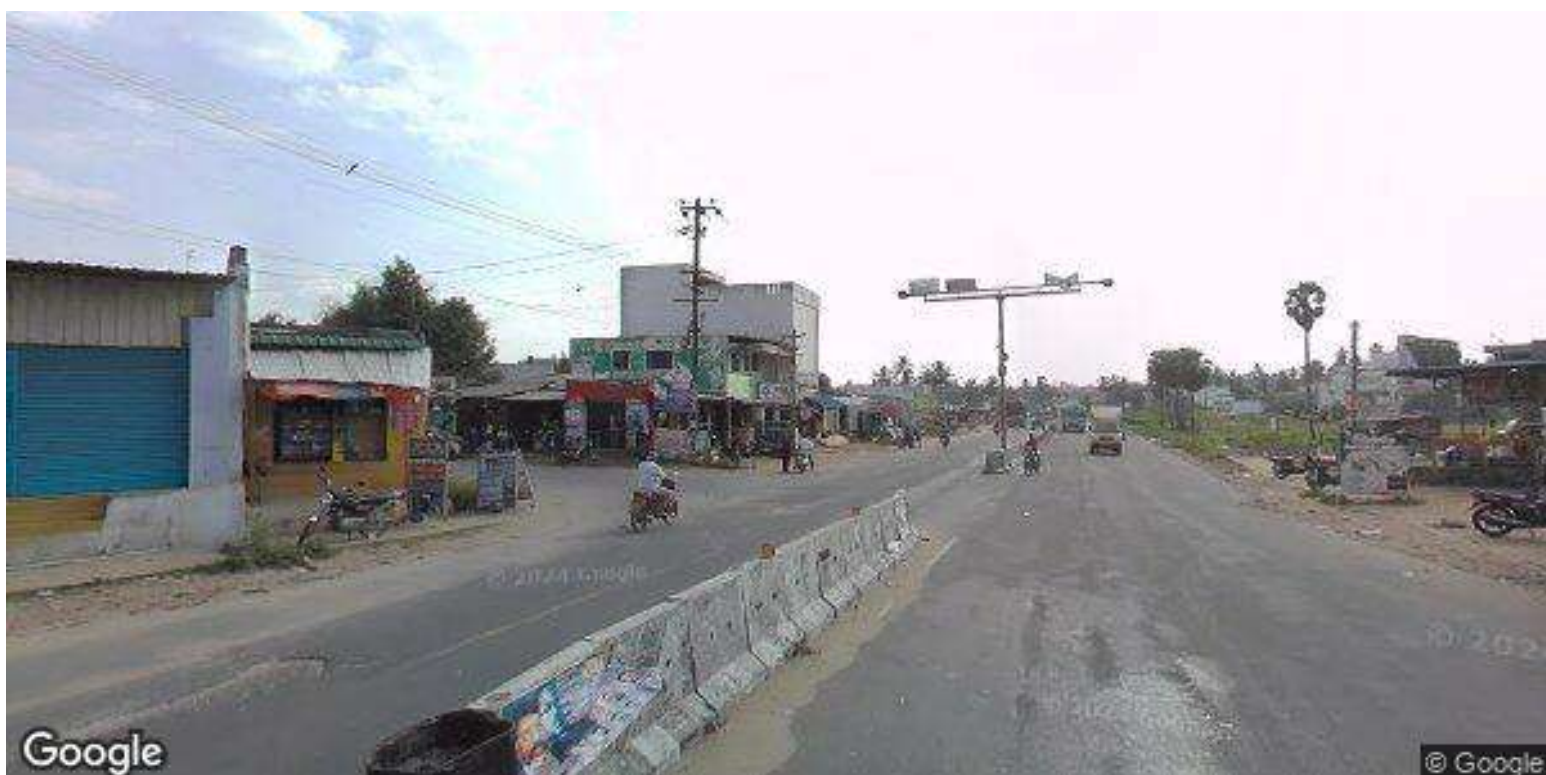
**Risk Type:** Turn

**Risk Level:** Medium

**Speed Limit:** 30 KM/Hr

**Coordinates:** 11.48361, 77.88779

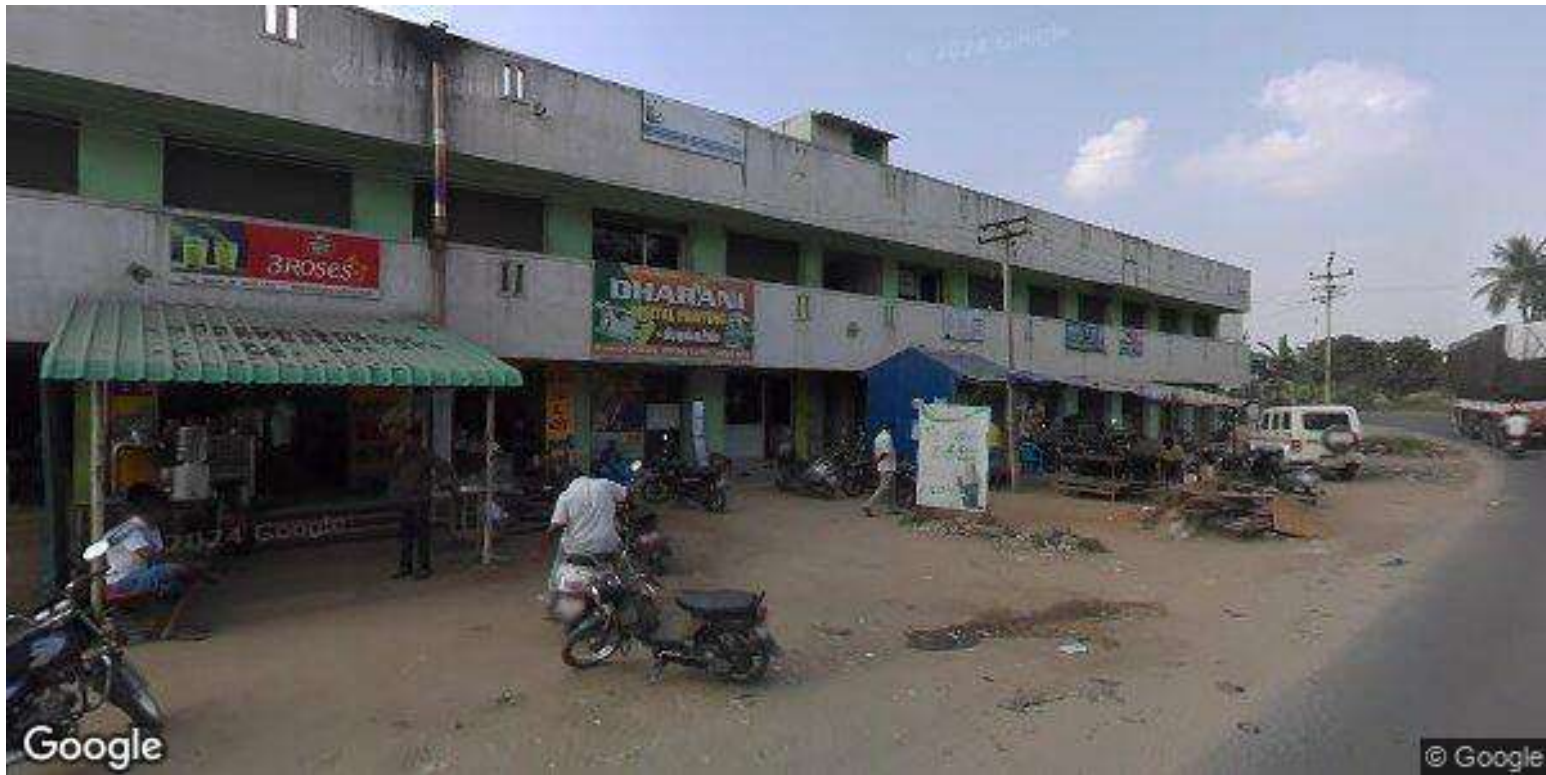
**Risk Type:** Turn

**Risk Level:** Medium

**Speed Limit:** 30 KM/Hr

**Coordinates:** 11.49167, 77.88772

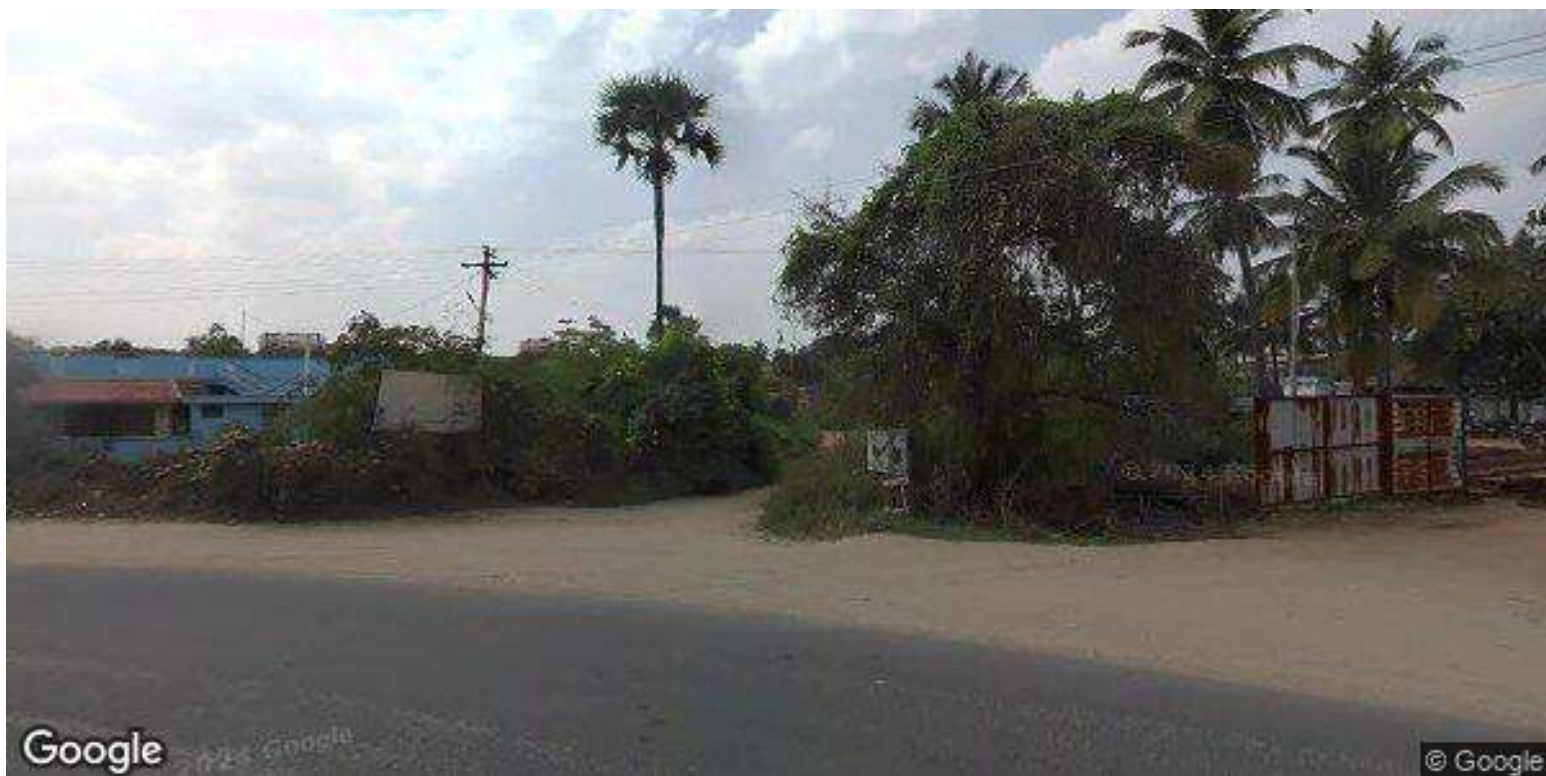
**Risk Type:** Turn

**Risk Level:** High

**Speed Limit:** 15 KM/Hr

**Coordinates:** 11.49440, 77.88480

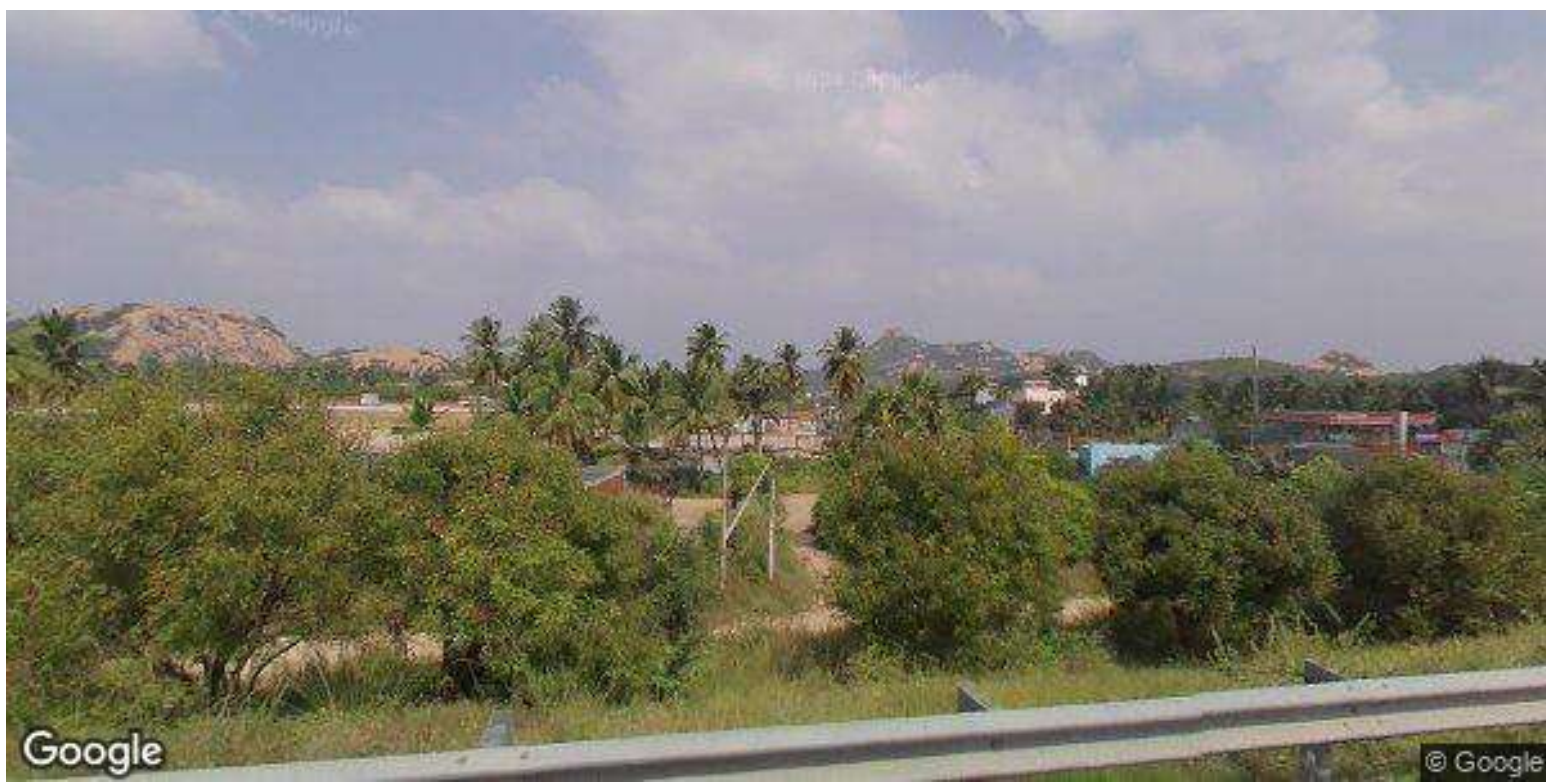
**Risk Type:** Turn

**Risk Level:** Medium

**Speed Limit:** 30 KM/Hr

**Coordinates:** 11.49412, 77.88450

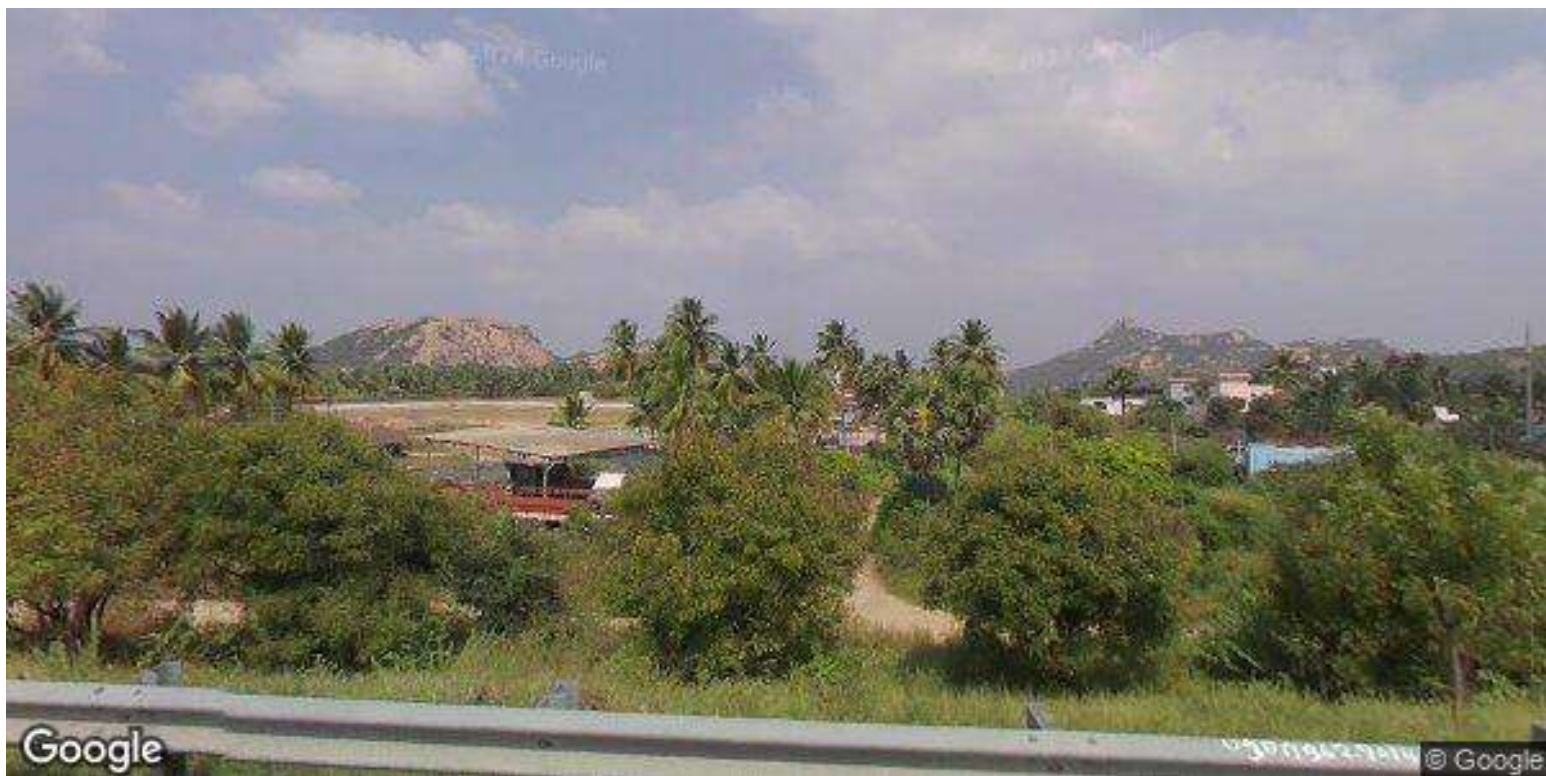
**Risk Type:** Blind Spot

**Risk Level:** Blind Spot

**Speed Limit:** 10 KM/Hr

**Coordinates:** 11.49383, 77.88442

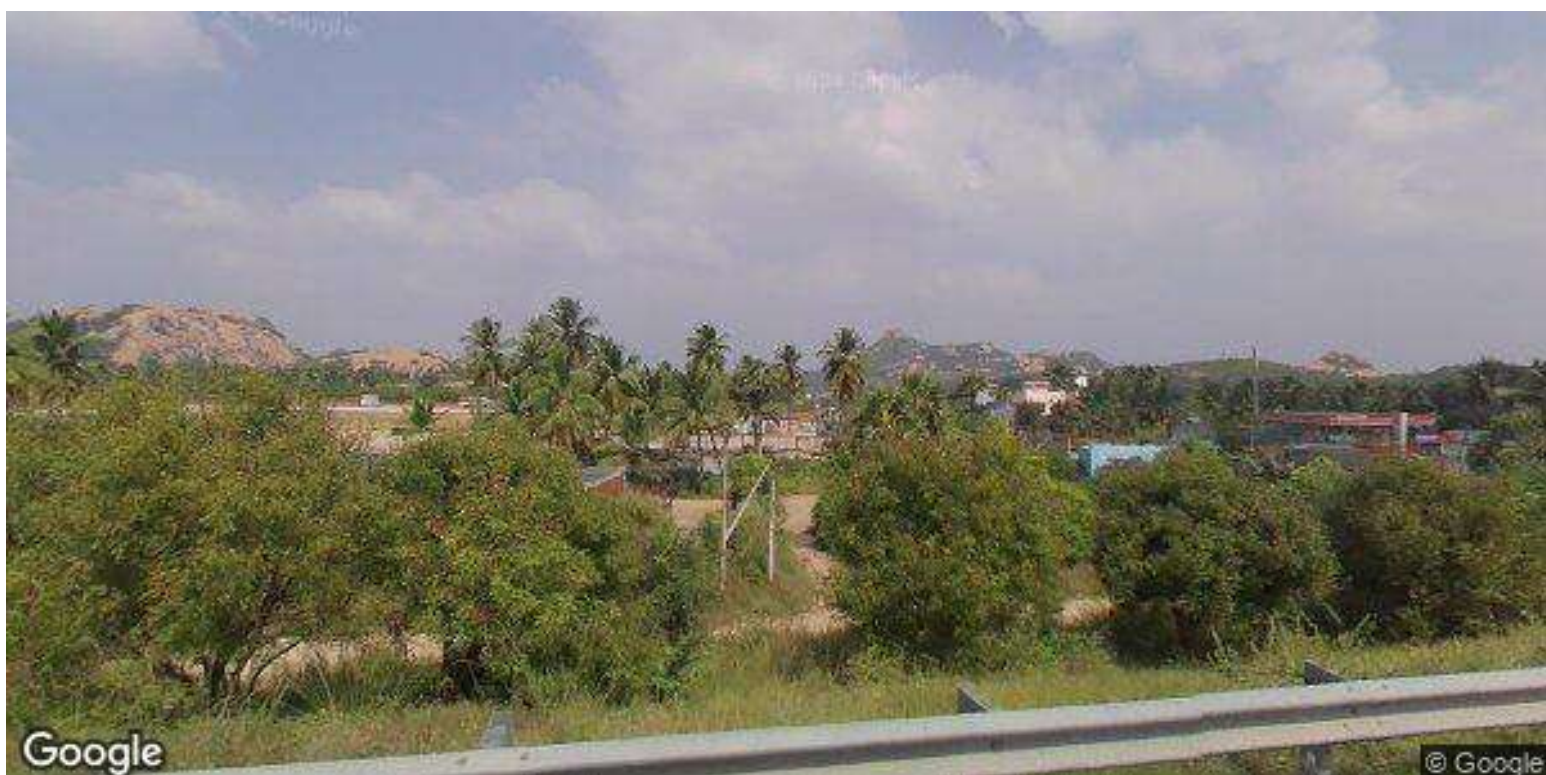
**Risk Type:** Turn

**Risk Level:** Medium

**Speed Limit:** 30 KM/Hr

**Coordinates:** 11.49412, 77.88450

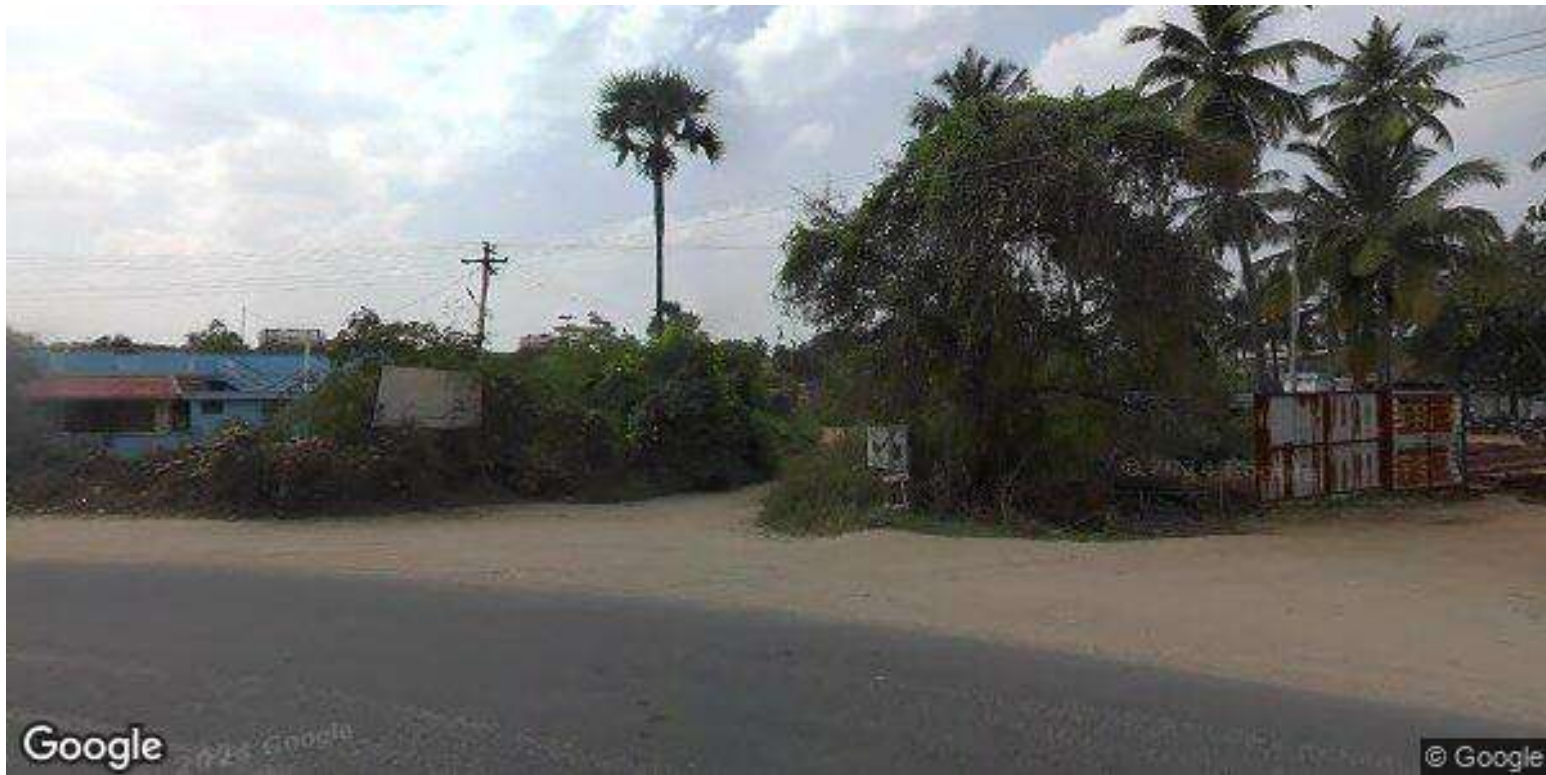
**Risk Type:** Turn

**Risk Level:** High

**Speed Limit:** 15 KM/Hr

**Coordinates:** 11.49440, 77.88480

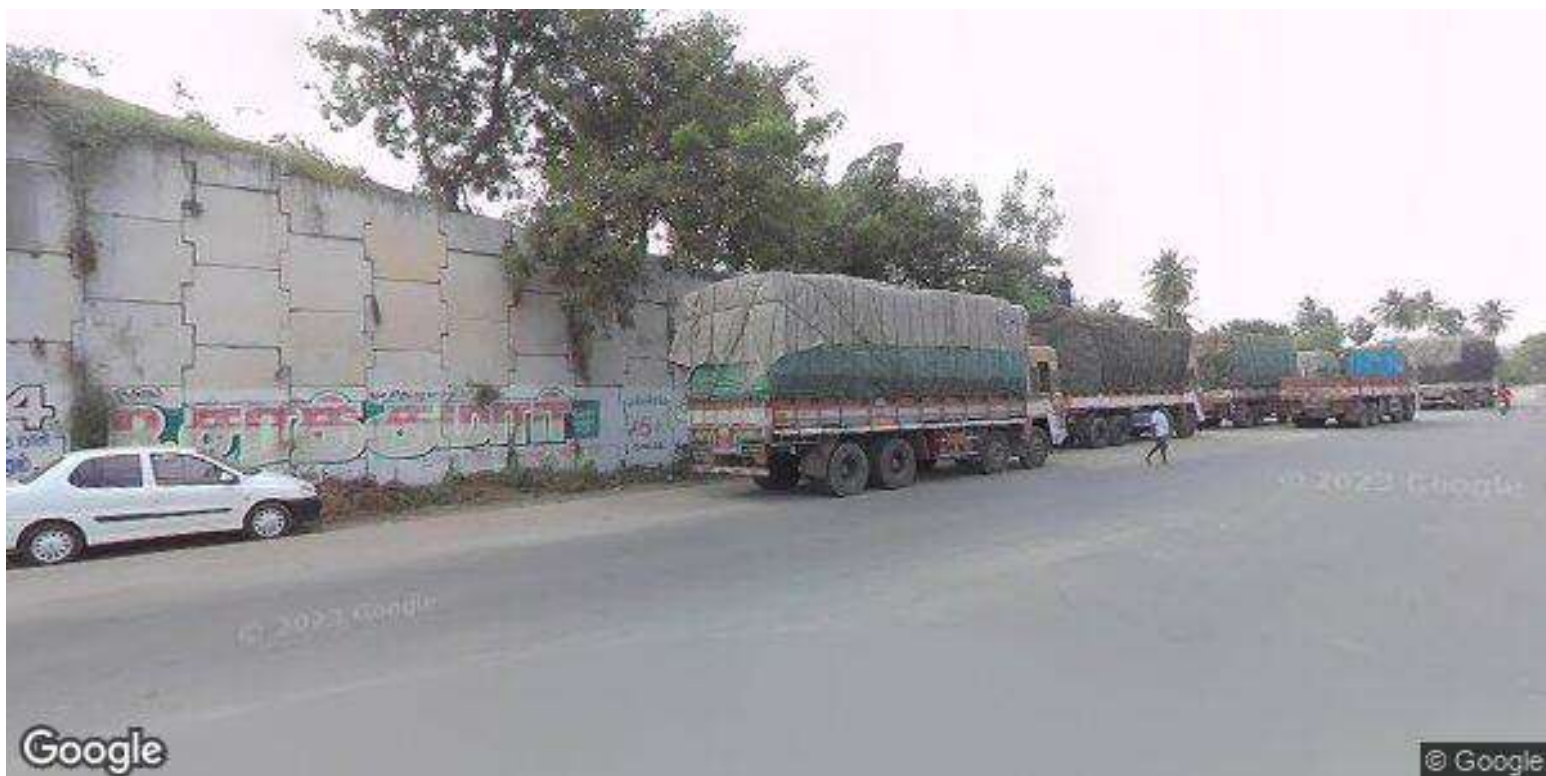
**Risk Type:** Turn

**Risk Level:** Medium

**Speed Limit:** 30 KM/Hr

**Coordinates:** 11.49365, 77.88596

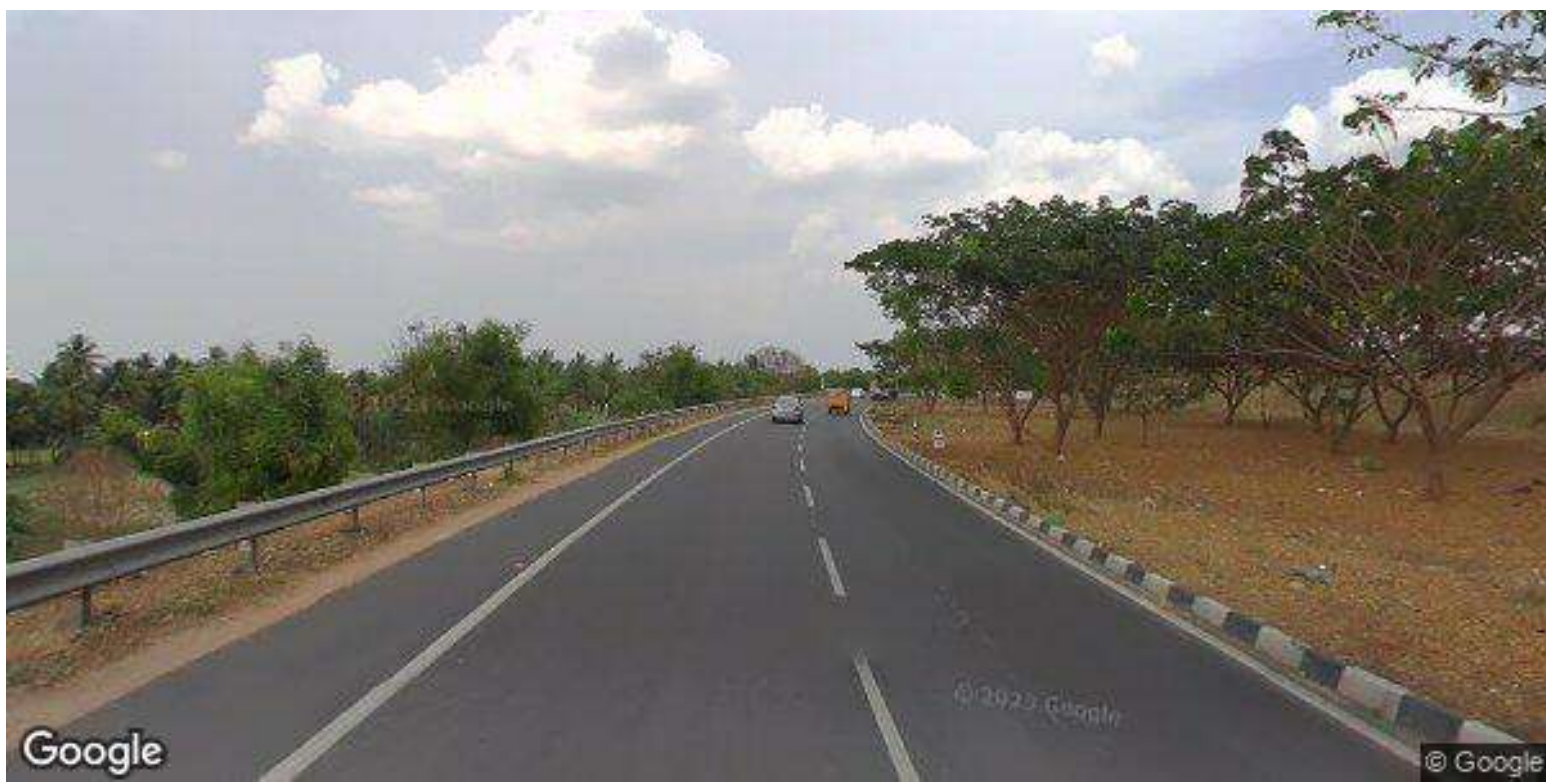
**Risk Type:** Turn

**Risk Level:** Medium

**Speed Limit:** 30 KM/Hr

**Coordinates:** 11.53588, 77.95823

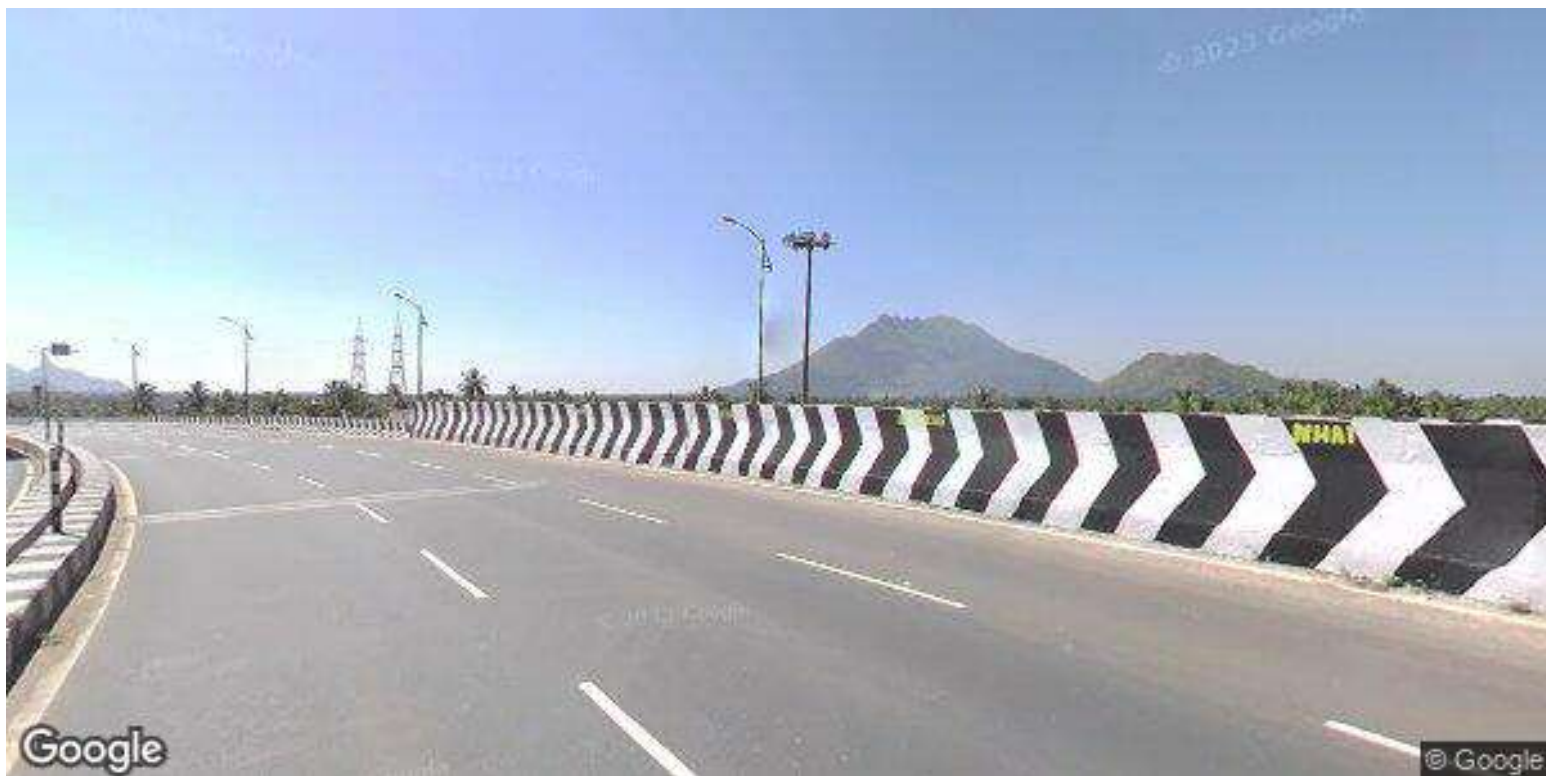
**Risk Type:** Turn

**Risk Level:** Medium

**Speed Limit:** 30 KM/Hr

**Coordinates:** 11.64151, 78.11805

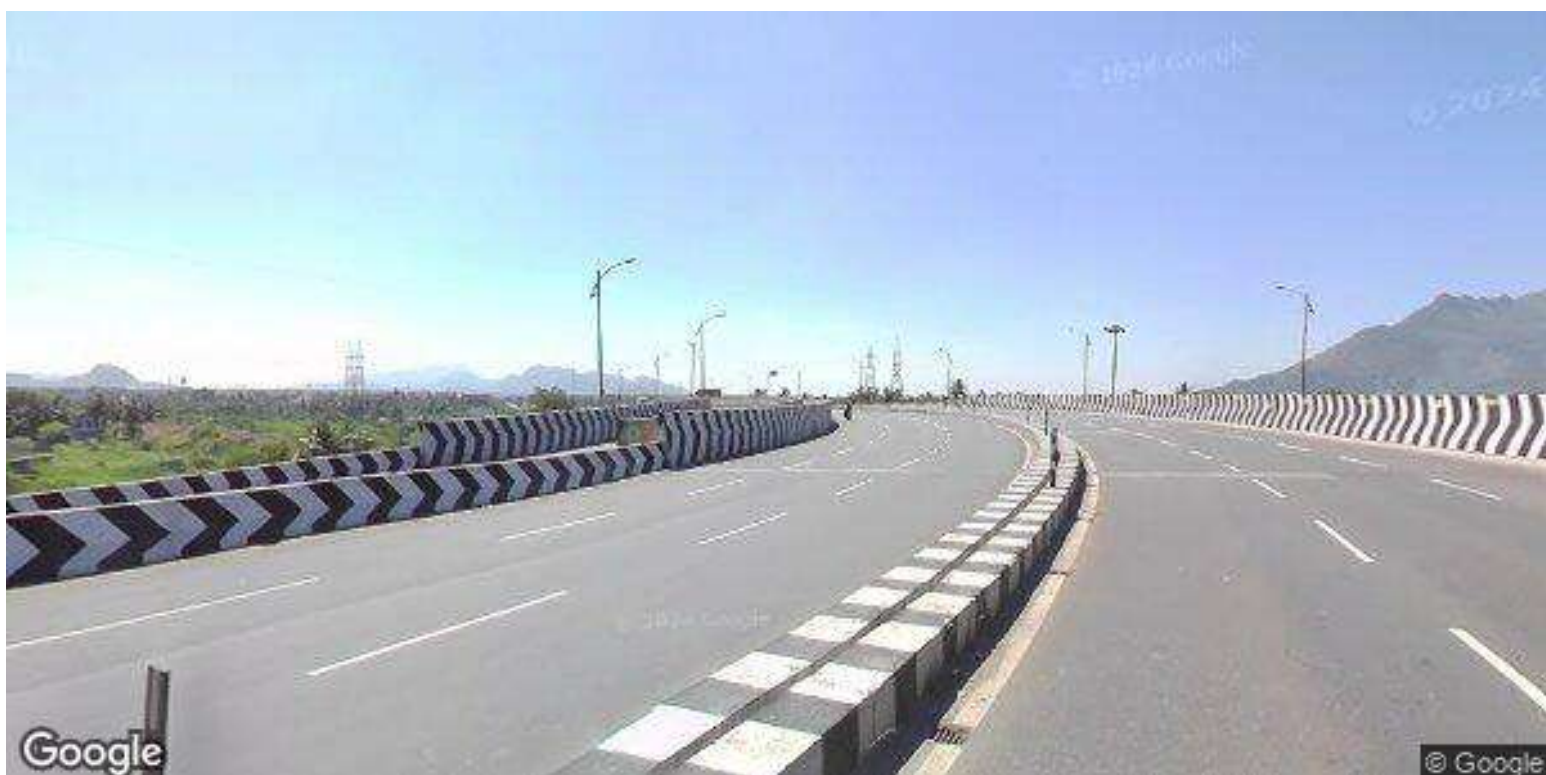
**Risk Type:** Turn  
**Risk Level:** Medium  
**Speed Limit:** 30 KM/Hr  
**Coordinates:** 11.64199, 78.11844

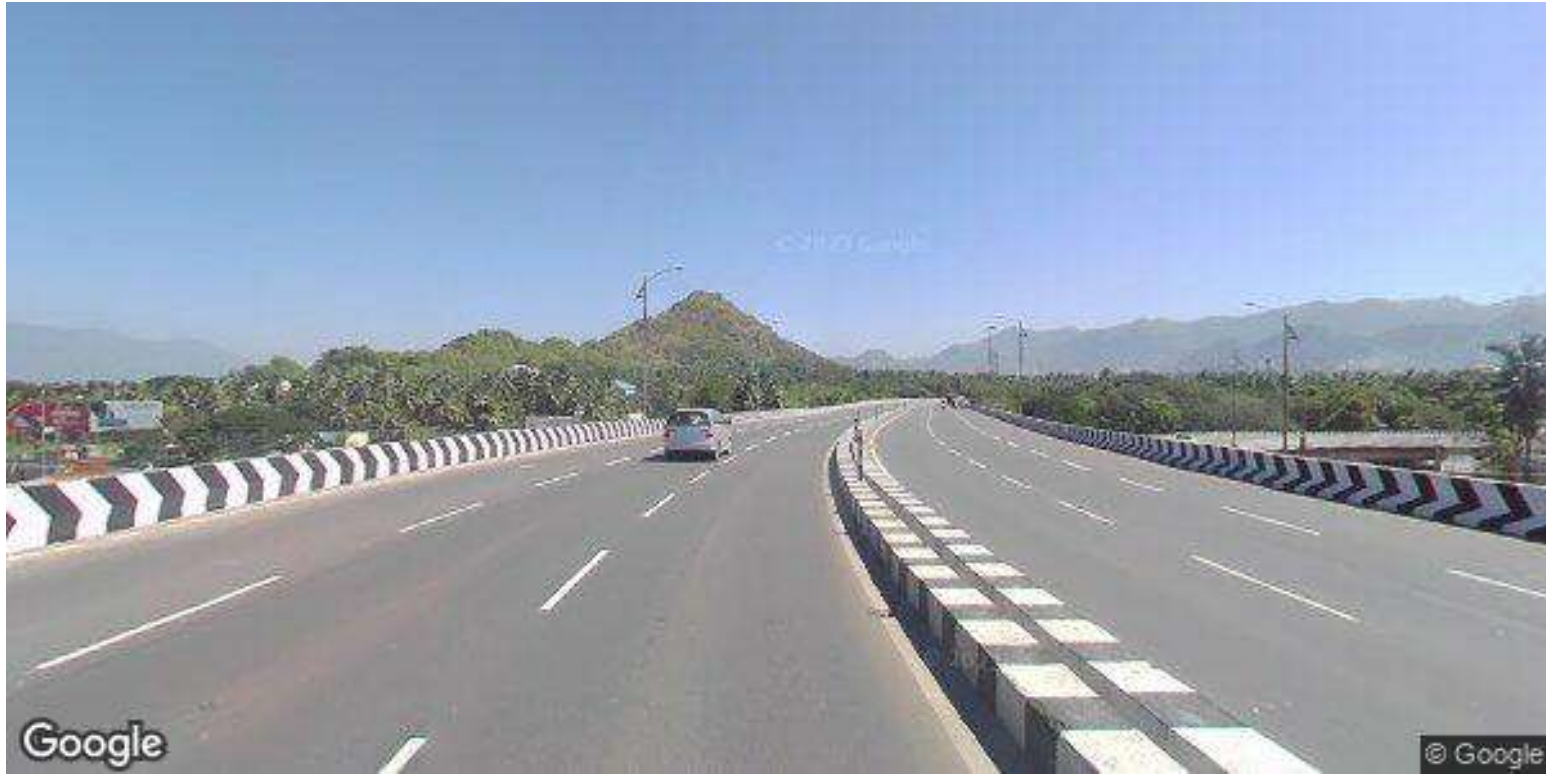
**Risk Type:** Turn  
**Risk Level:** Medium  
**Speed Limit:** 30 KM/Hr  
**Coordinates:** 11.64222, 78.11898

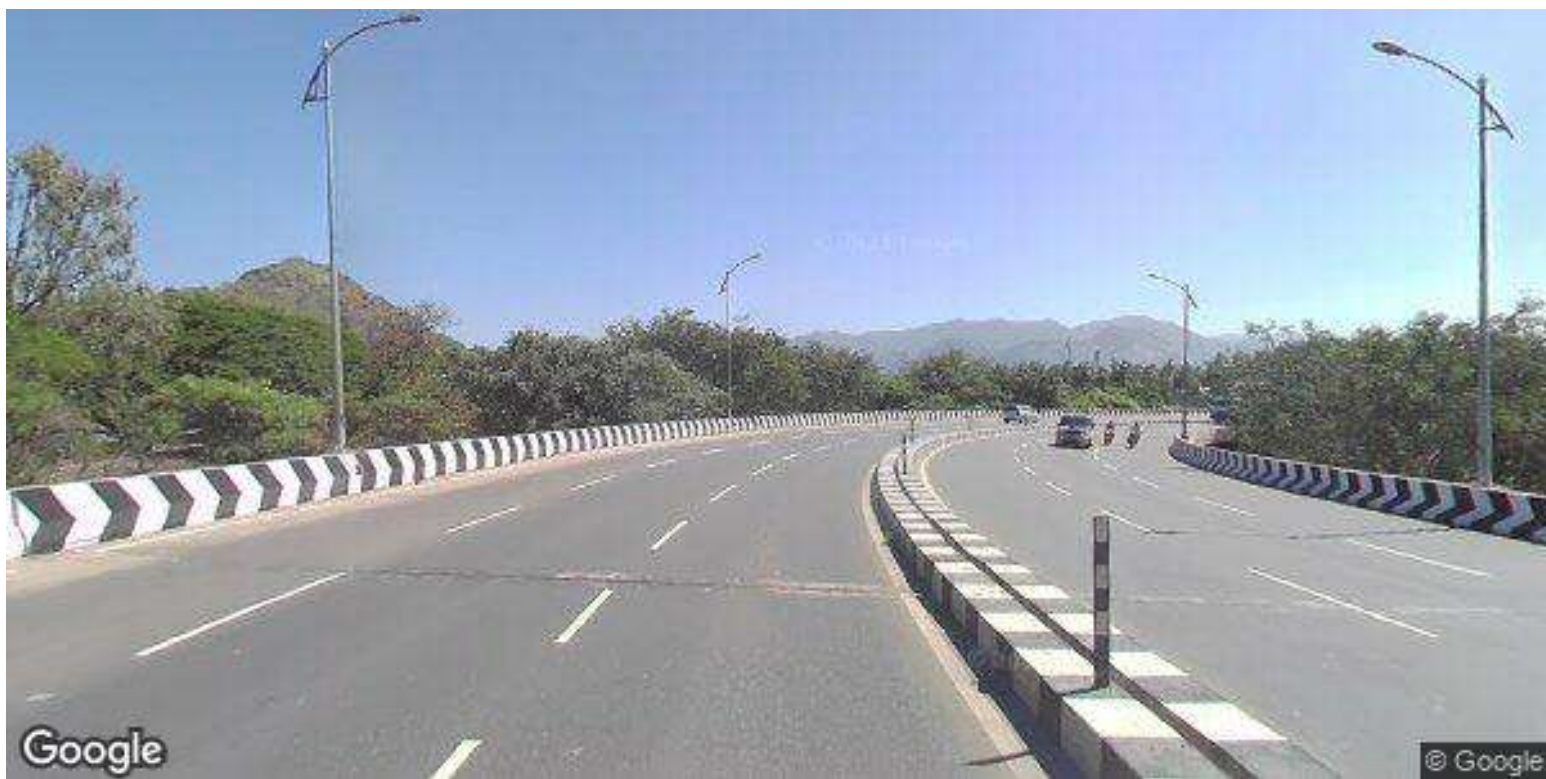
**Risk Type:** Turn  
**Risk Level:** Medium  
**Speed Limit:** 30 KM/Hr  
**Coordinates:** 11.64205, 78.12104
