# IndianOil

## JOURNEY RISK MANAGEMENT (JRM) STUDY

### Salem Terminal TO NAVEEN AGENCY

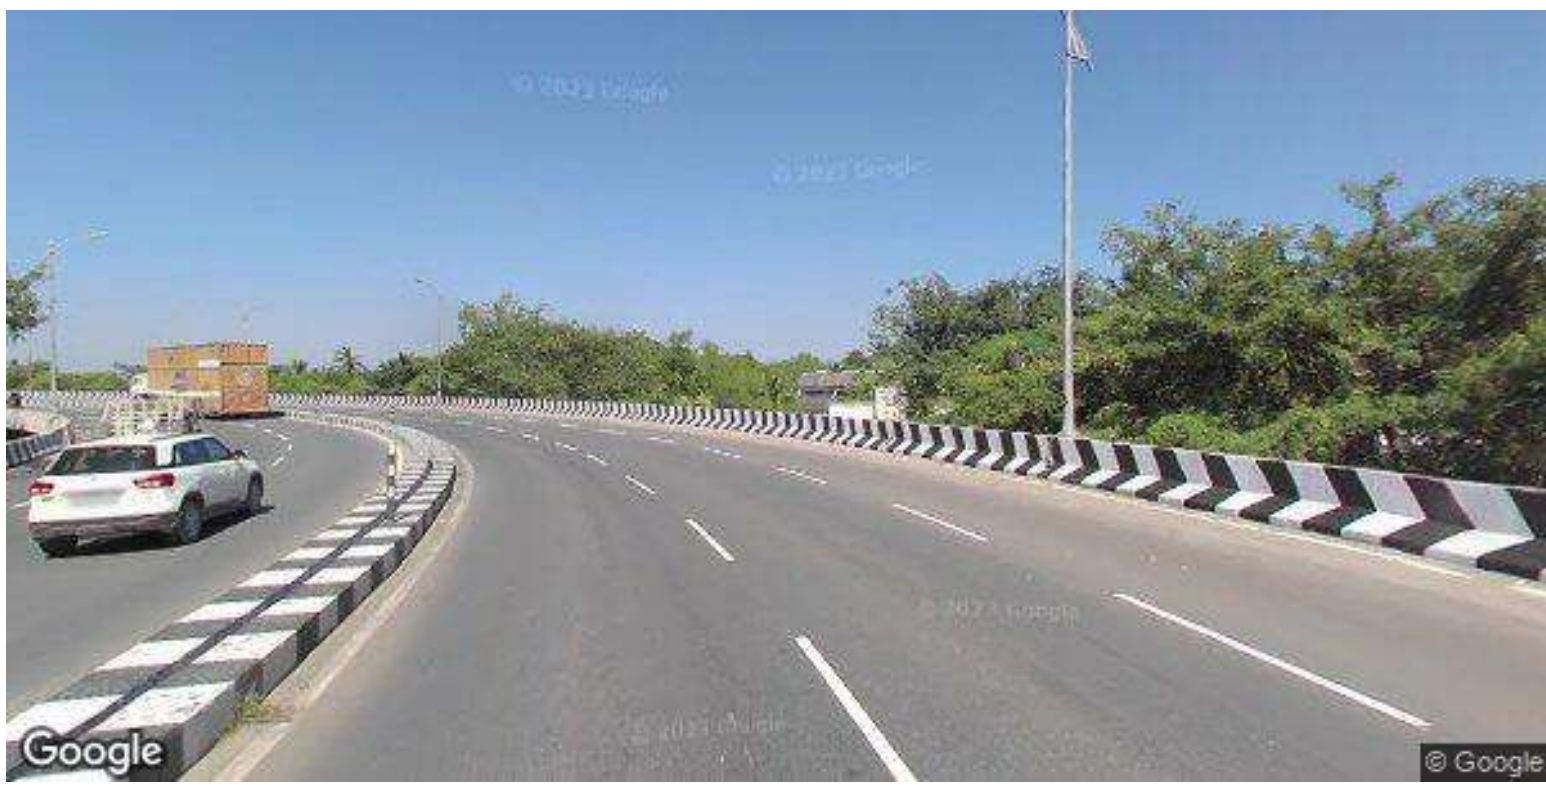
**Risk Type:** Turn

**Risk Level:** High

**Speed Limit:** 15 KM/Hr

**Coordinates:** 11.64139, 78.12168

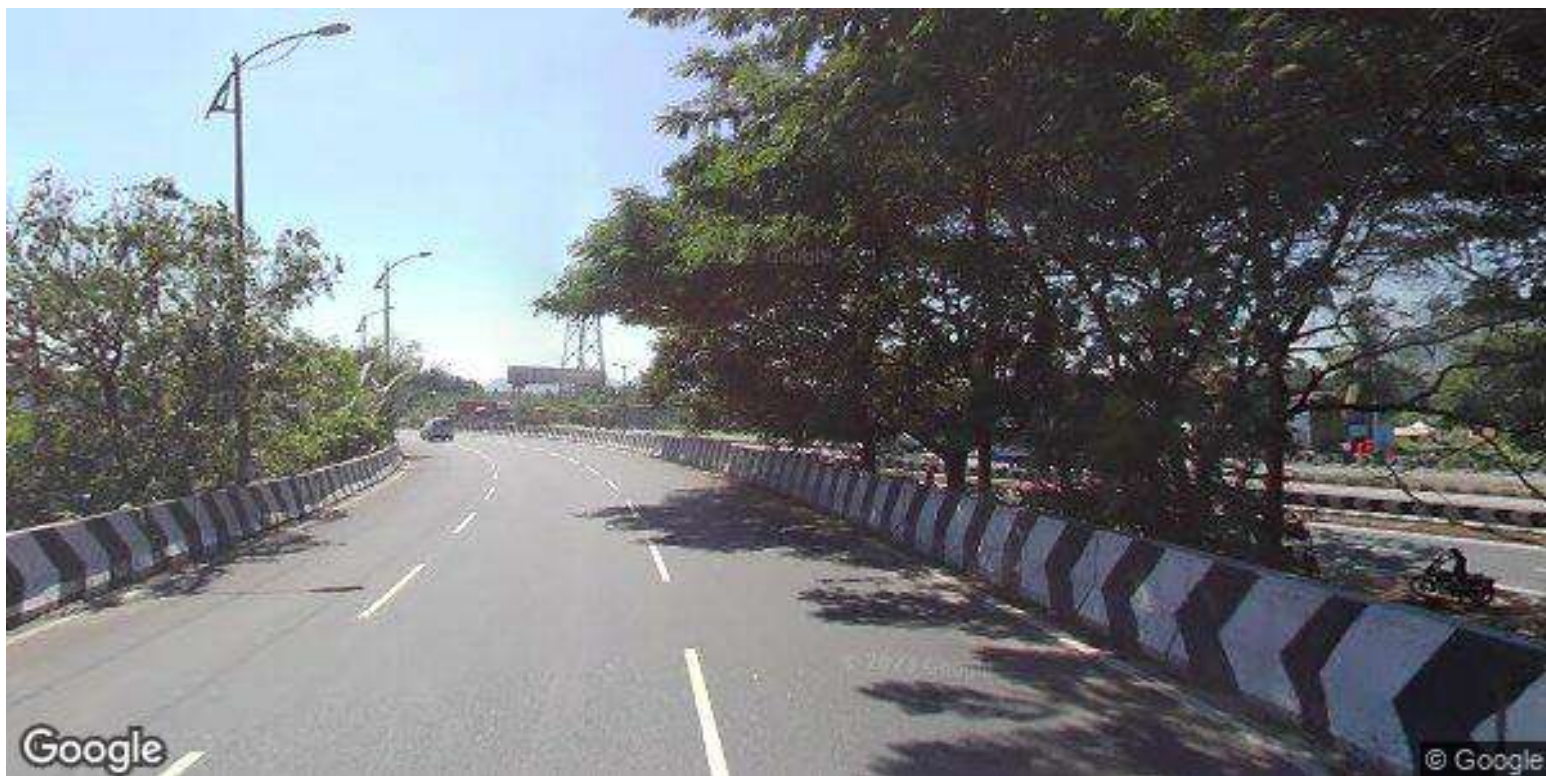
**Risk Type:** Turn

**Risk Level:** Medium

**Speed Limit:** 30 KM/Hr

**Coordinates:** 11.63984, 78.12086

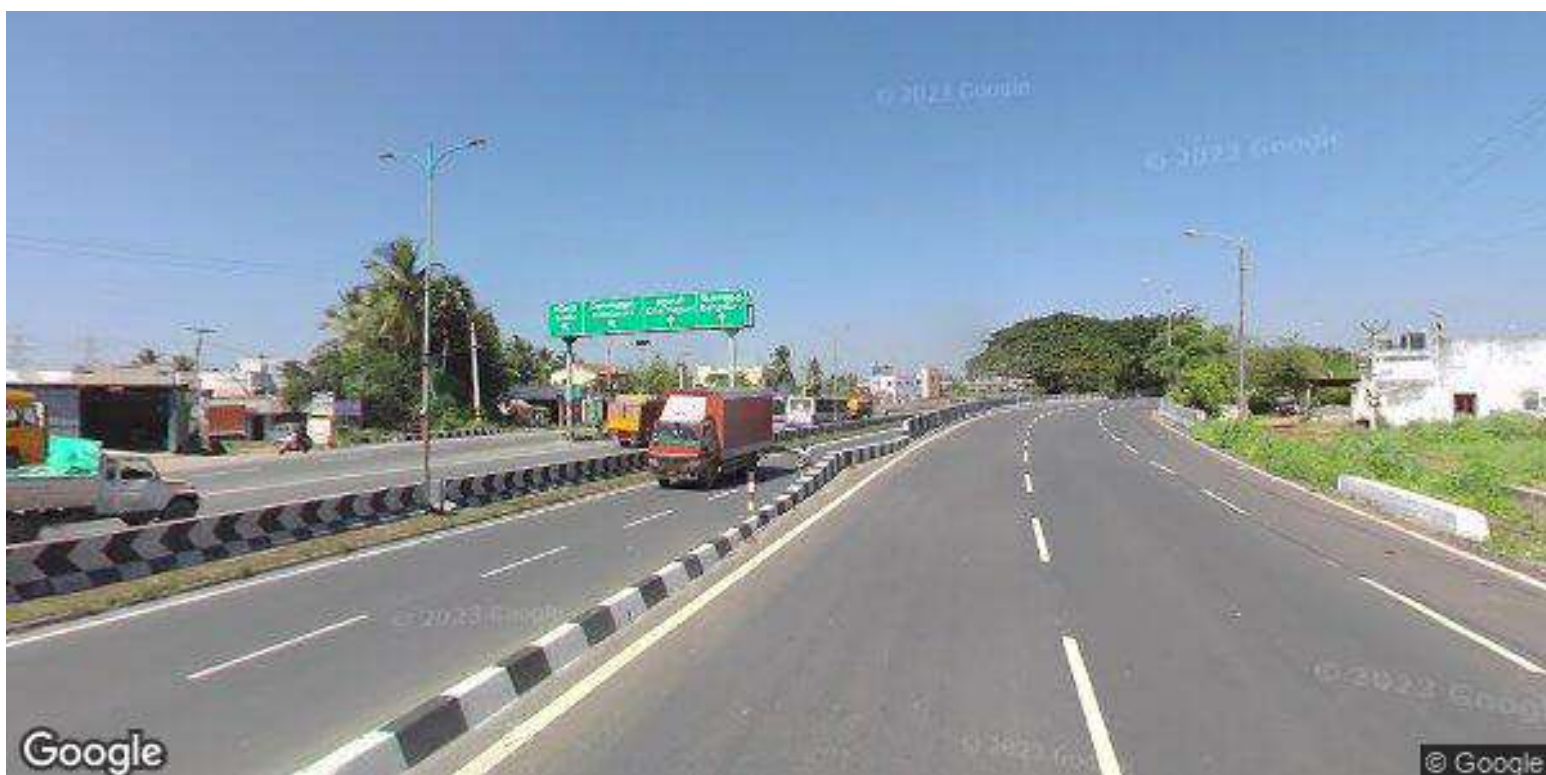
**Risk Type:** Turn  
**Risk Level:** Medium  
**Speed Limit:** 30 KM/Hr  
**Coordinates:** 11.63869, 78.12103

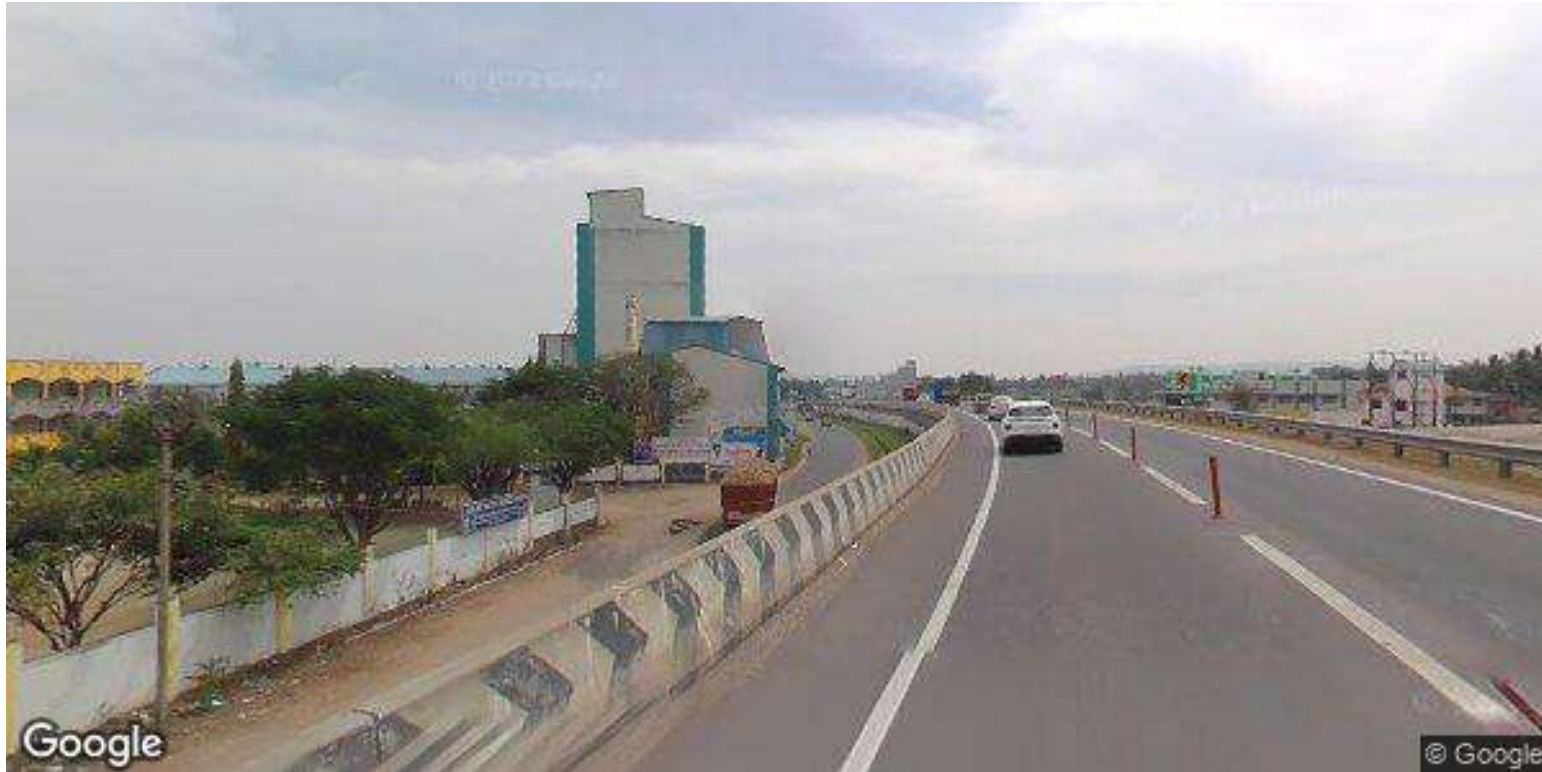
**Risk Type:** Turn  
**Risk Level:** Medium  
**Speed Limit:** 30 KM/Hr  
**Coordinates:** 11.59320, 78.62069

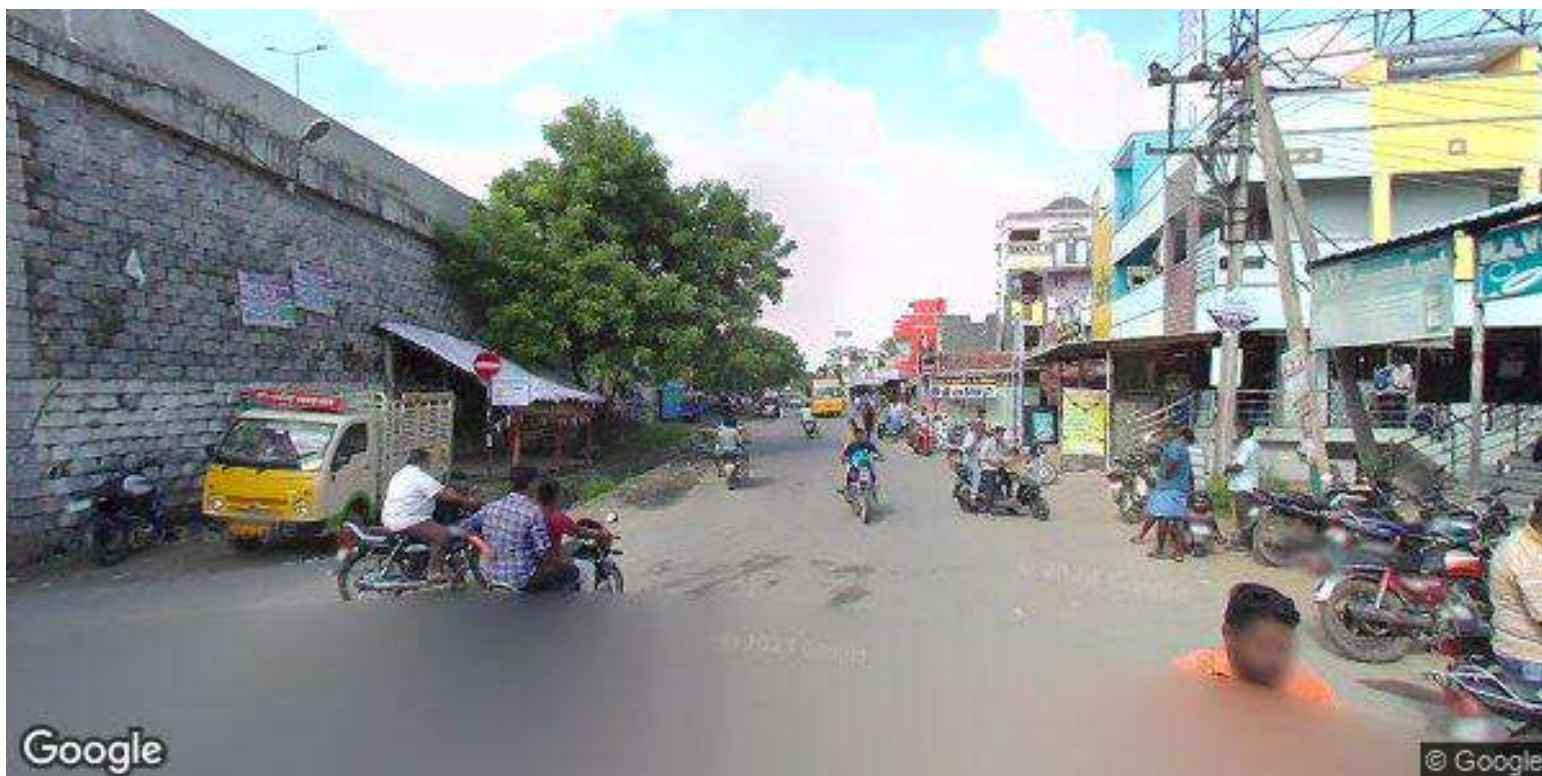
**Risk Type:** Blind Spot  
**Risk Level:** Blind Spot  
**Speed Limit:** 10 KM/Hr  
**Coordinates:** 11.59137, 78.66635

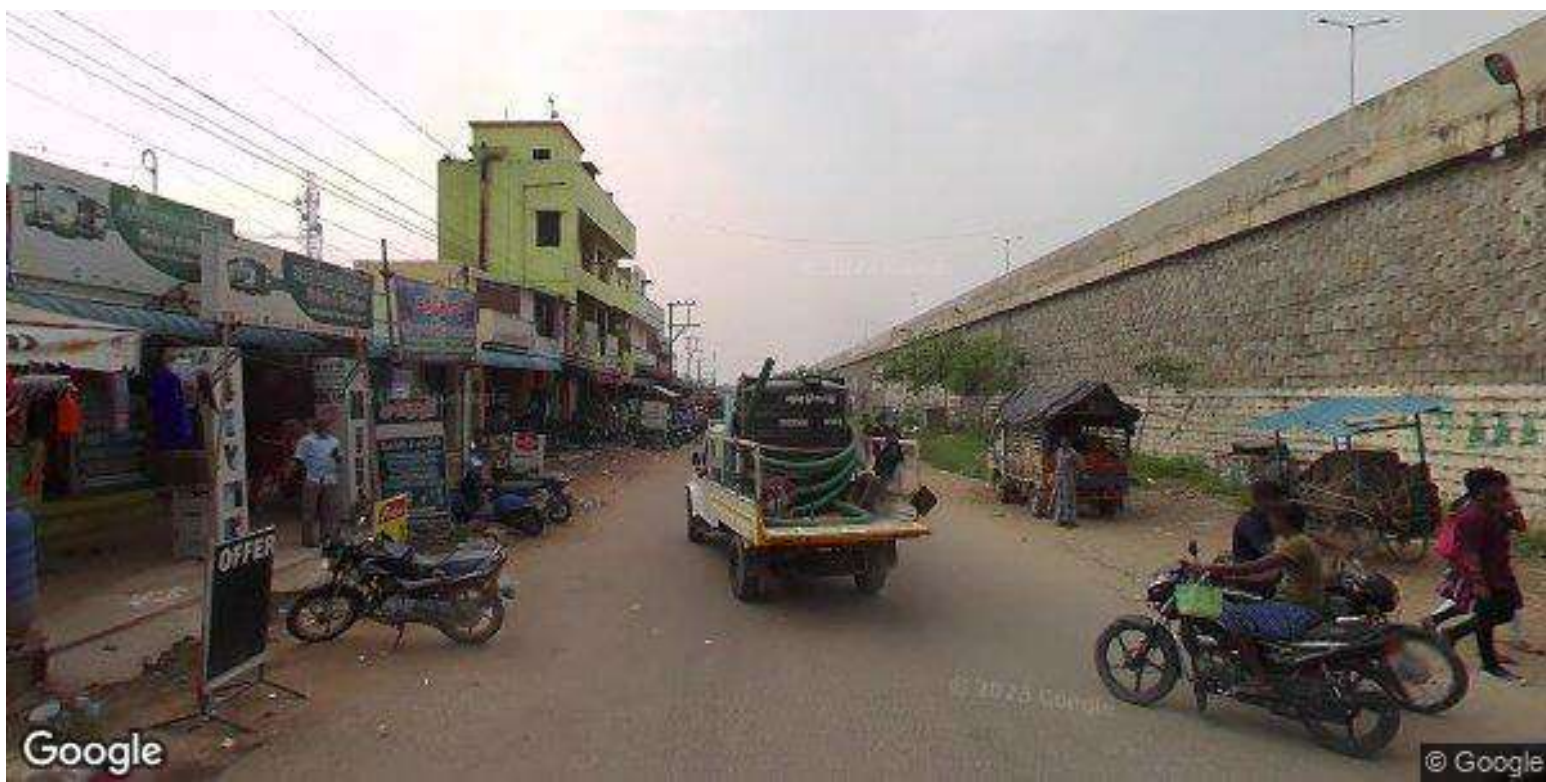
**Risk Type:** Turn

**Risk Level:** High

**Speed Limit:** 15 KM/Hr

**Coordinates:** 11.59099, 78.66630

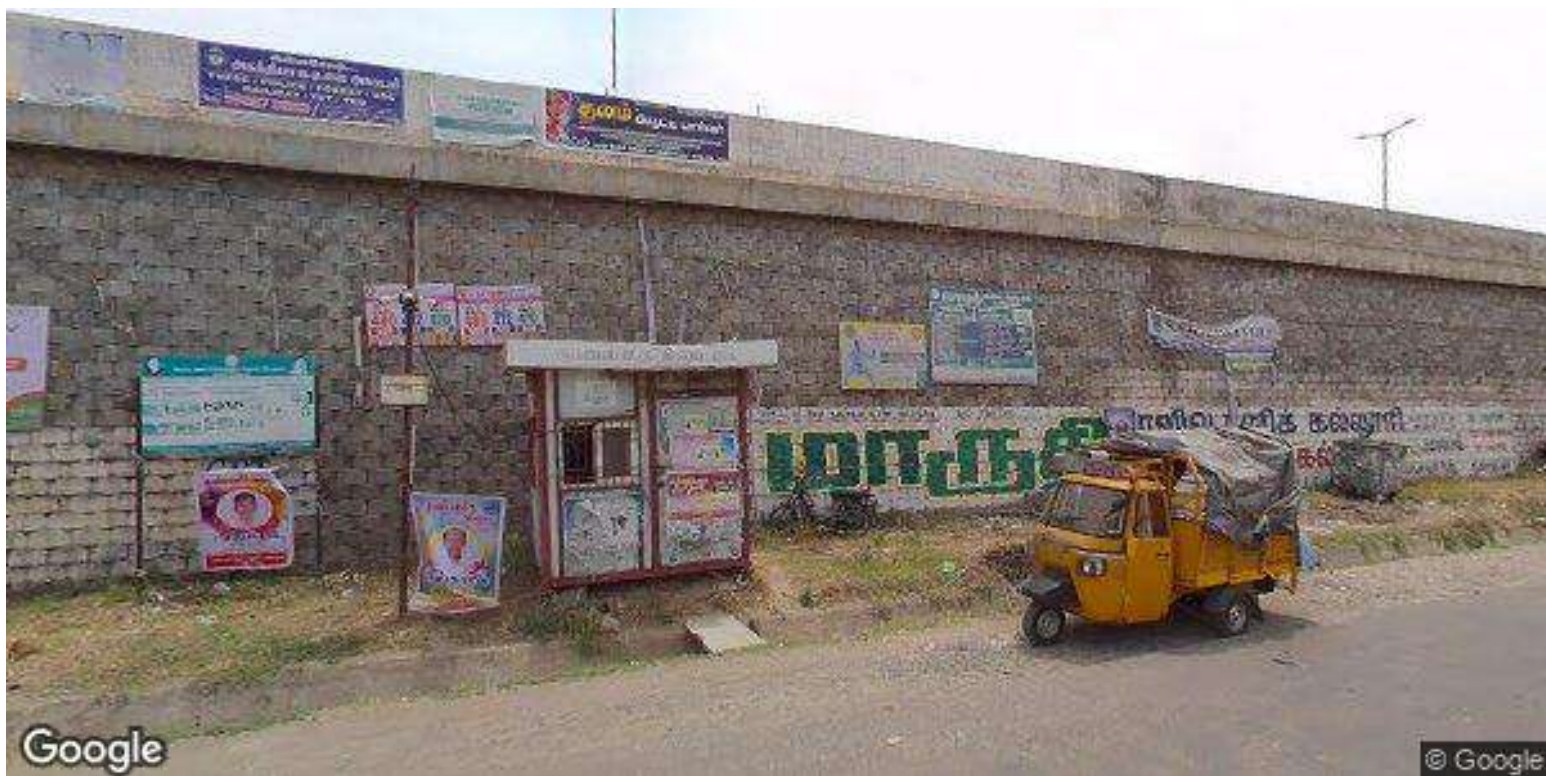
**Risk Type:** Turn

**Risk Level:** High

**Speed Limit:** 15 KM/Hr

**Coordinates:** 11.59101, 78.66563

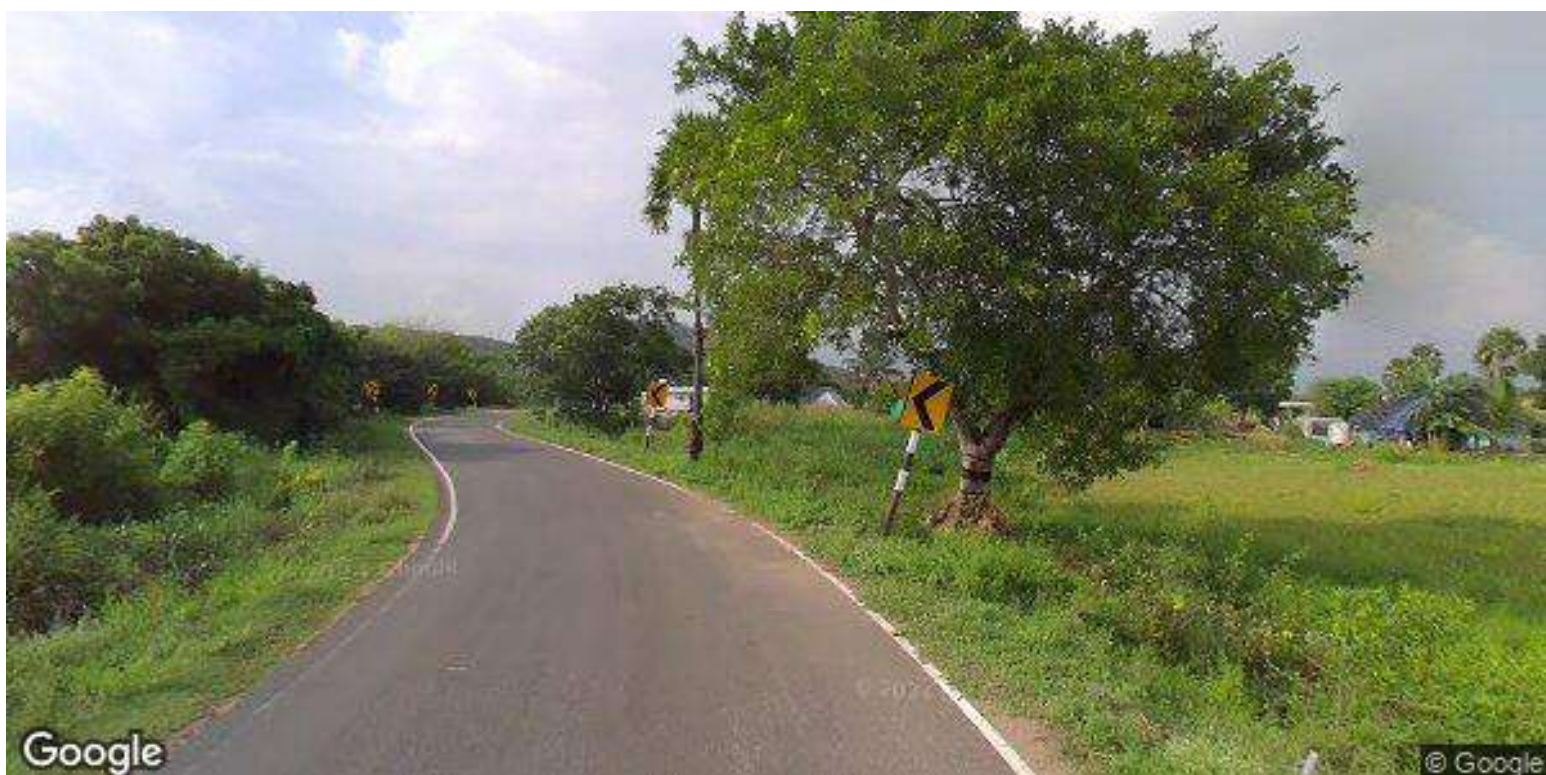
**Risk Type: Turn**

**Risk Level: Medium**

**Speed Limit: 30 KM/Hr**

**Coordinates: 11.57258, 78.66759**

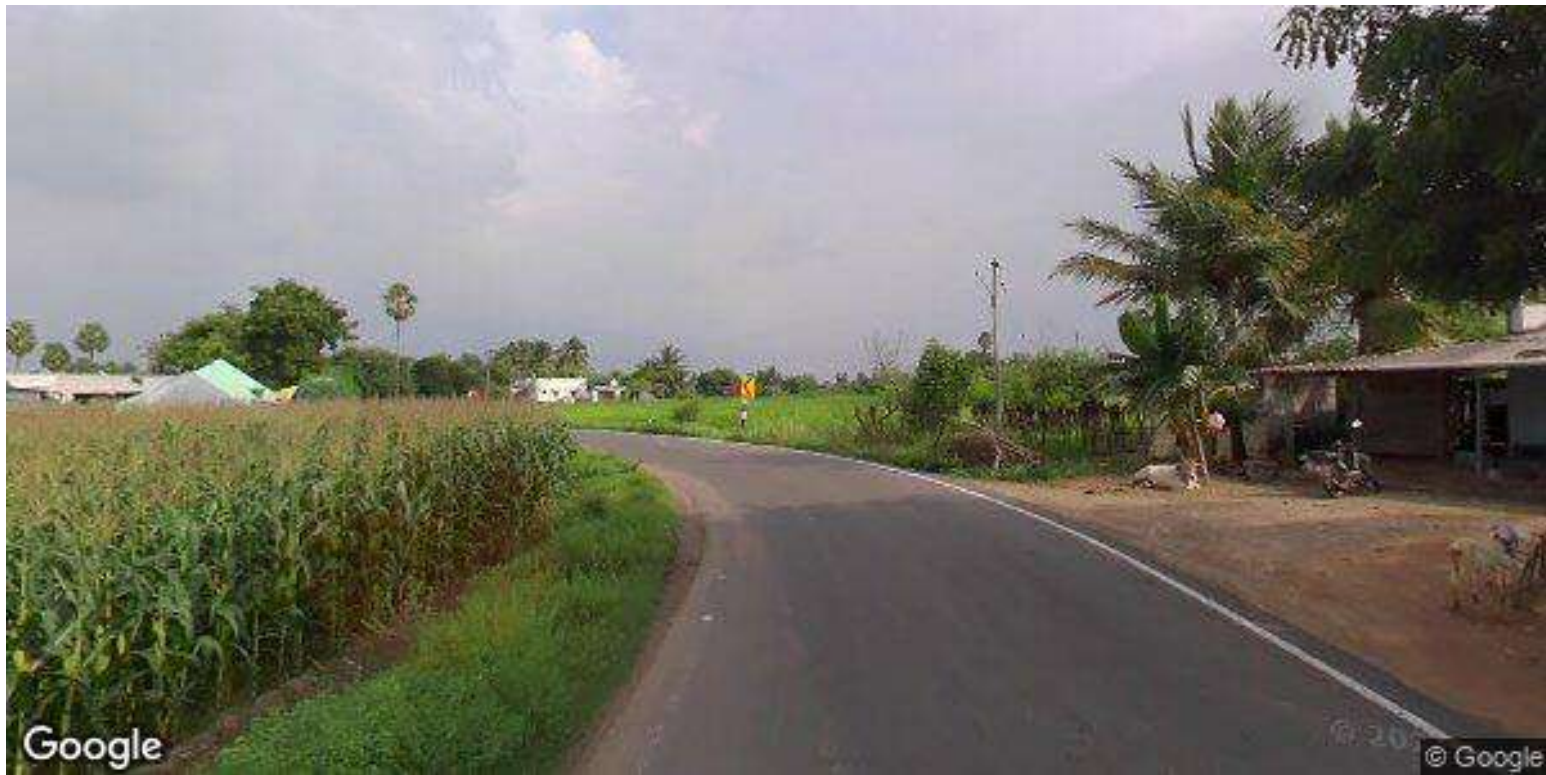
**Risk Type: Turn**

**Risk Level: High**

**Speed Limit: 15 KM/Hr**

**Coordinates: 11.57036, 78.66783**

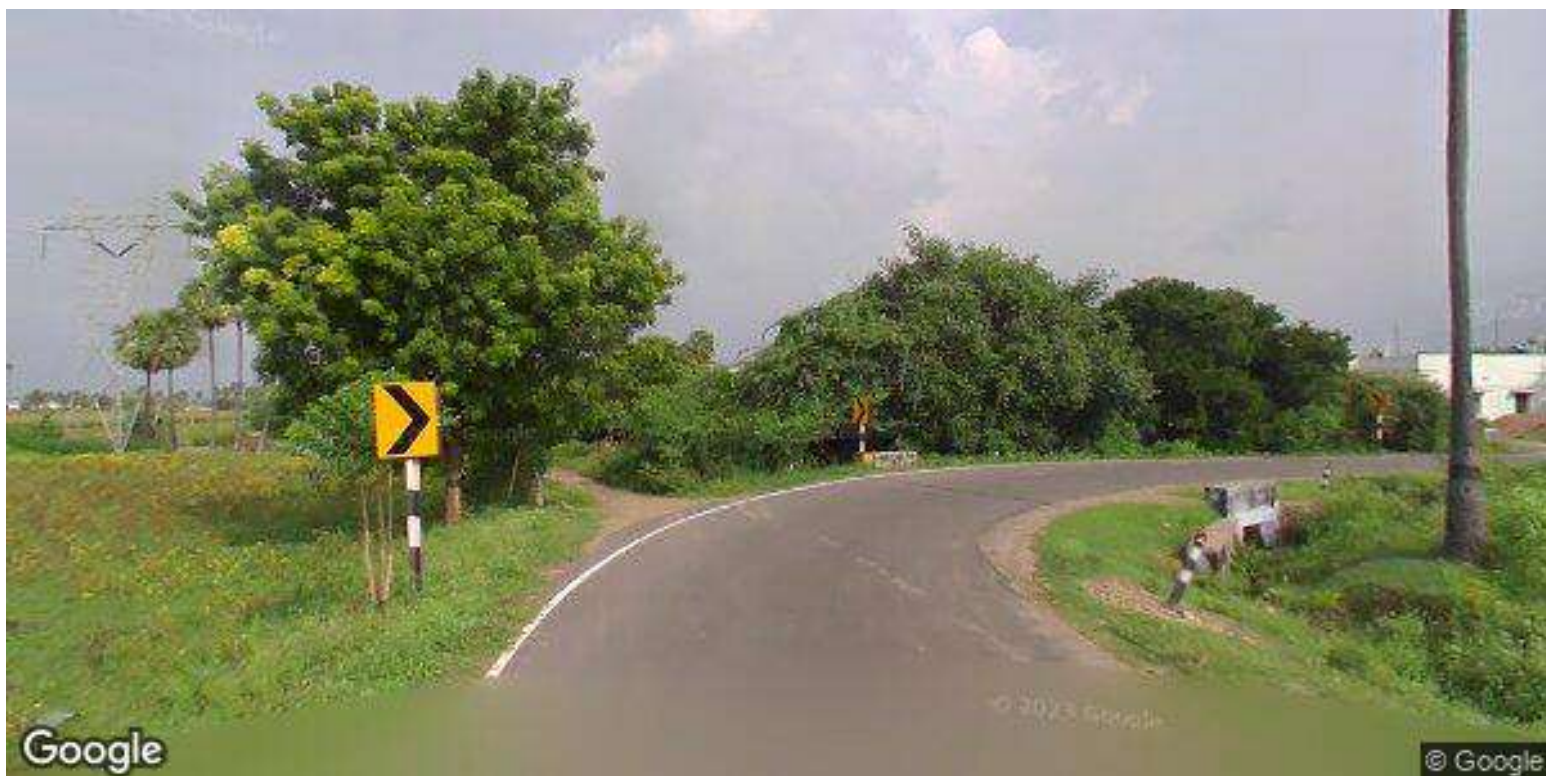
**Risk Type: Turn**

**Risk Level: High**

**Speed Limit: 15 KM/Hr**

**Coordinates: 11.57027, 78.66863**

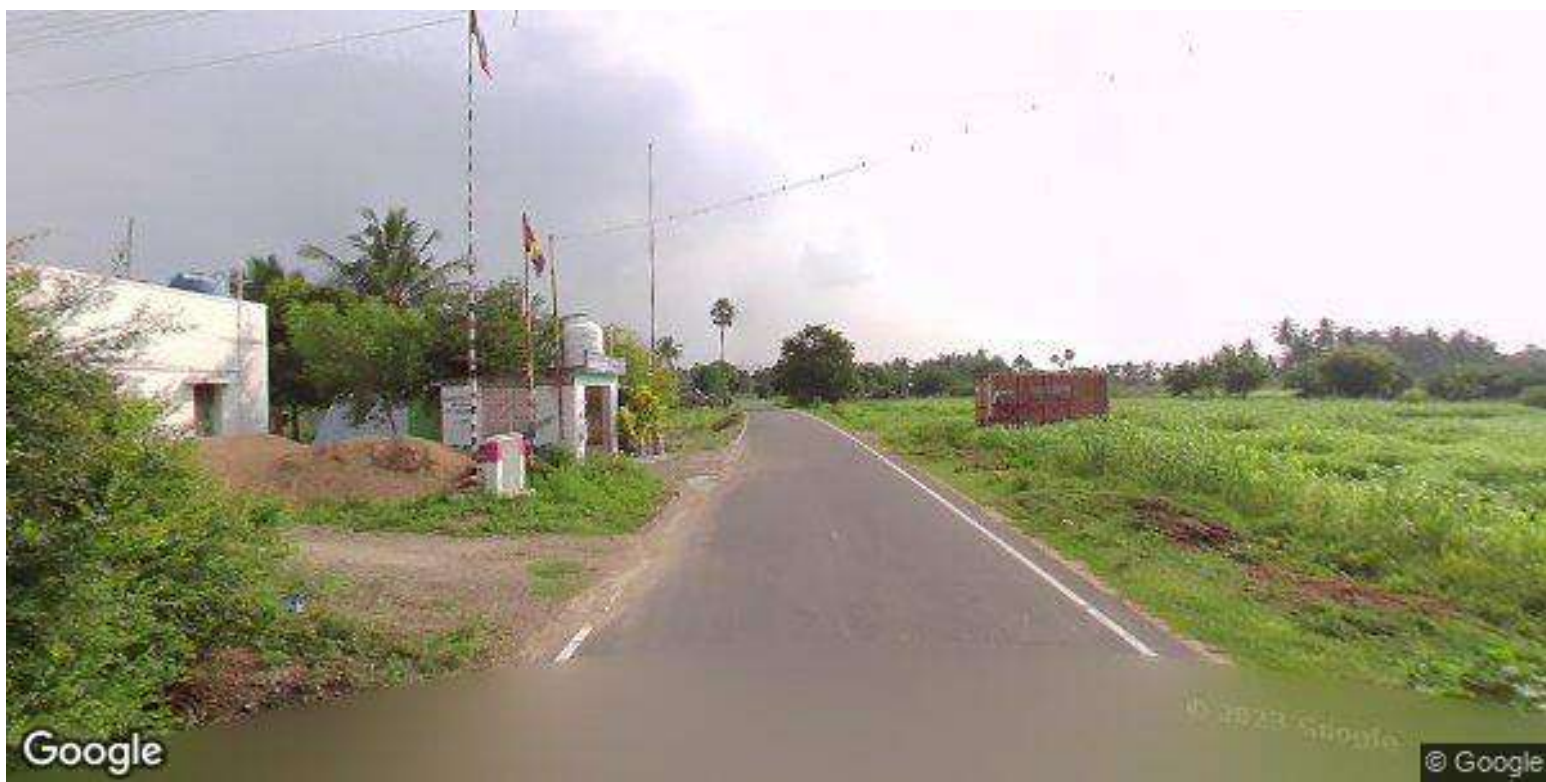
**Risk Type:** Turn

**Risk Level:** Medium

**Speed Limit:** 30 KM/Hr

**Coordinates:** 11.57000, 78.66881

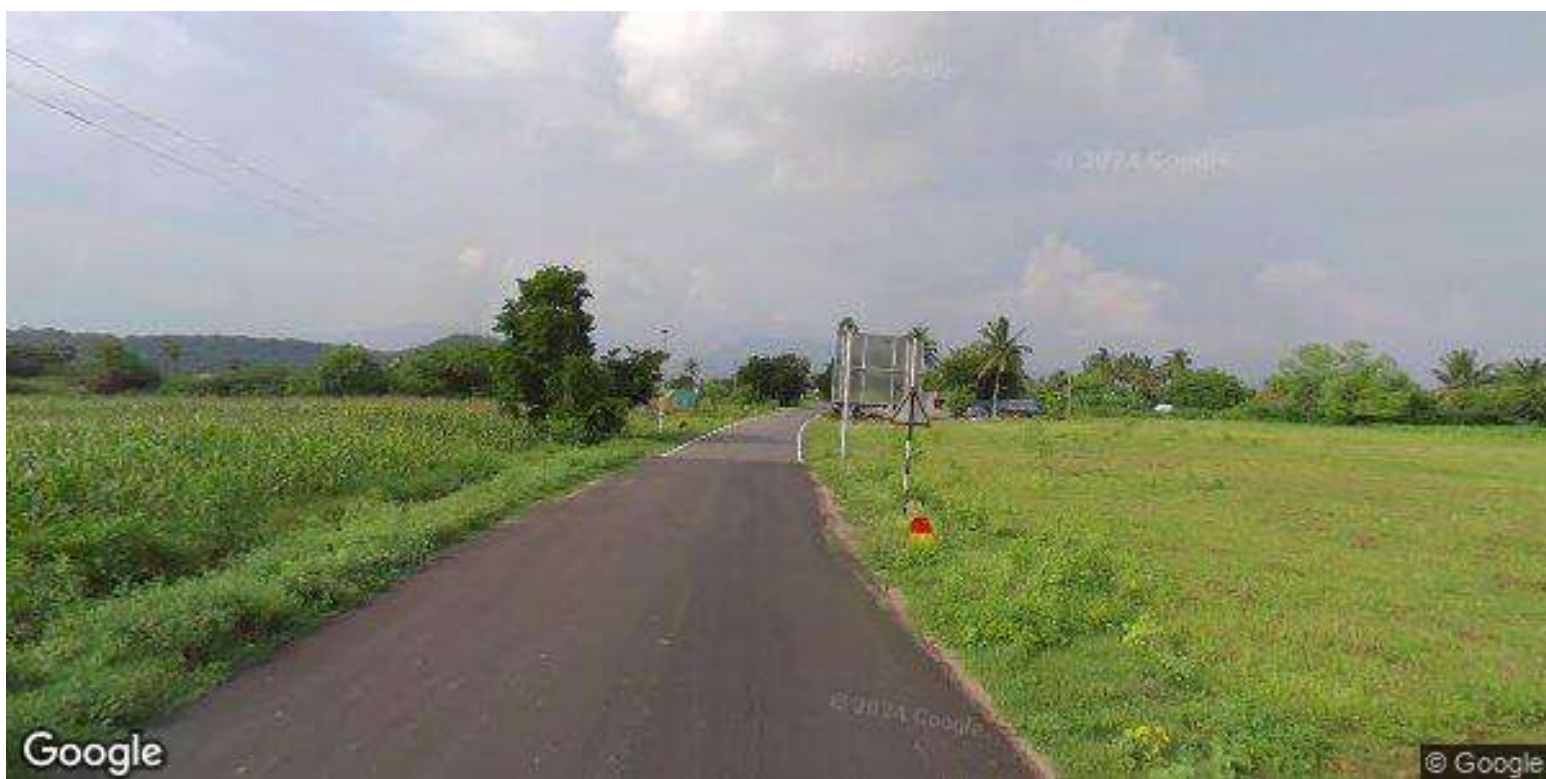
**Risk Type:** Turn

**Risk Level:** Medium

**Speed Limit:** 30 KM/Hr

**Coordinates:** 11.56791, 78.66867

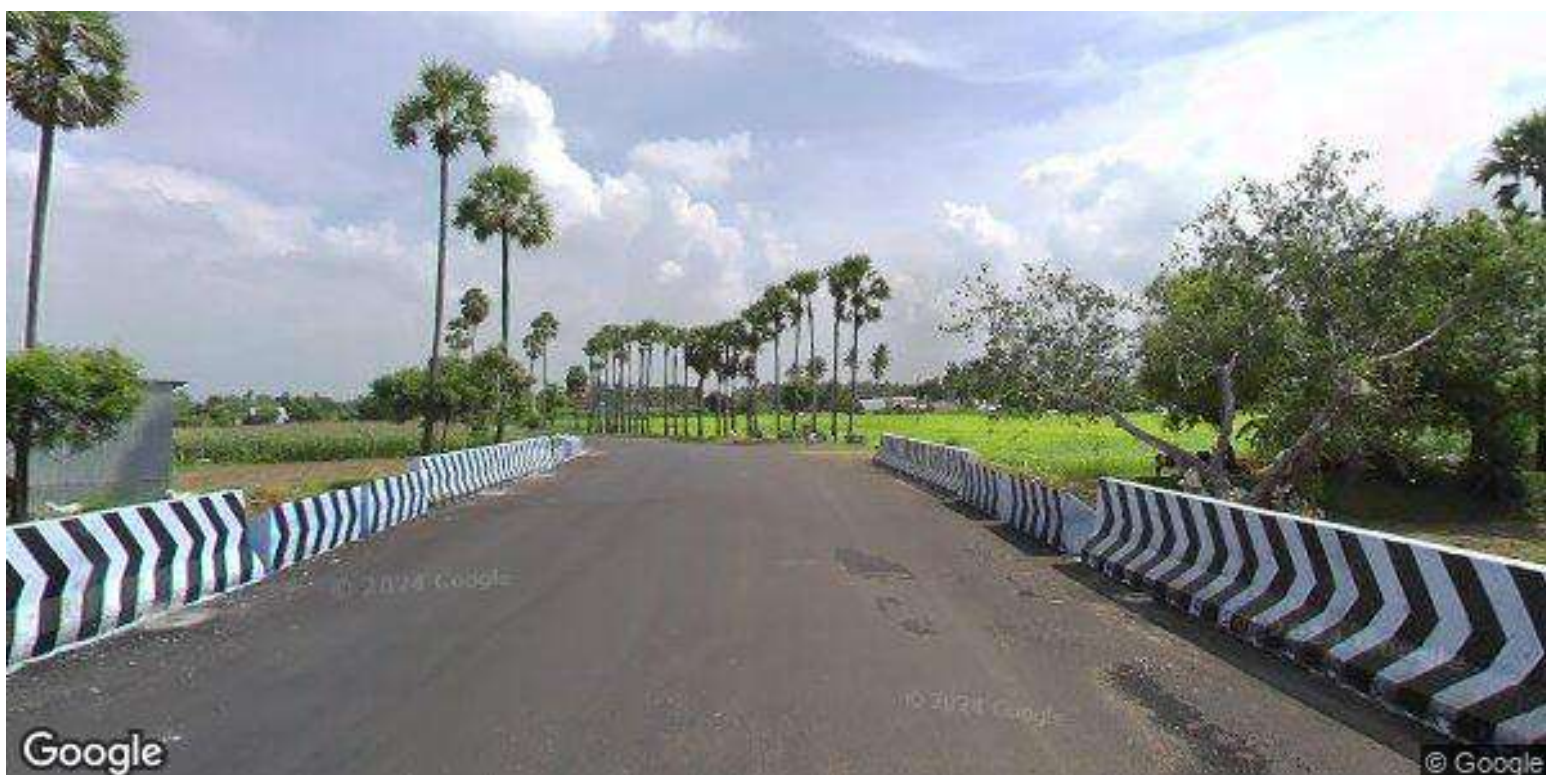
**Risk Type: Turn**

**Risk Level: Medium**

**Speed Limit: 30 KM/Hr**

**Coordinates: 11.56688, 78.66914**

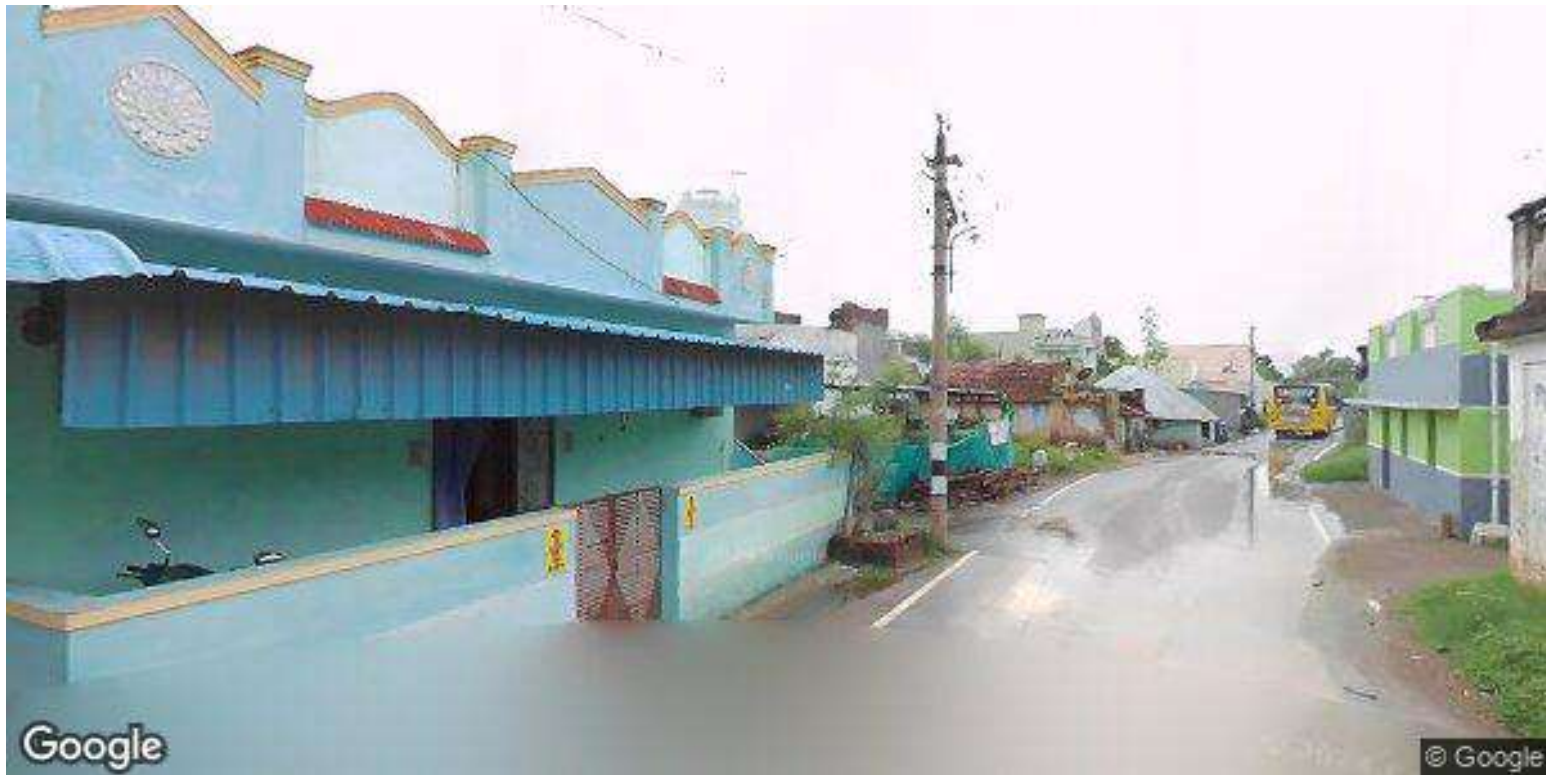
**Risk Type: Turn**

**Risk Level: Medium**

**Speed Limit: 30 KM/Hr**

**Coordinates: 11.56113, 78.67725**

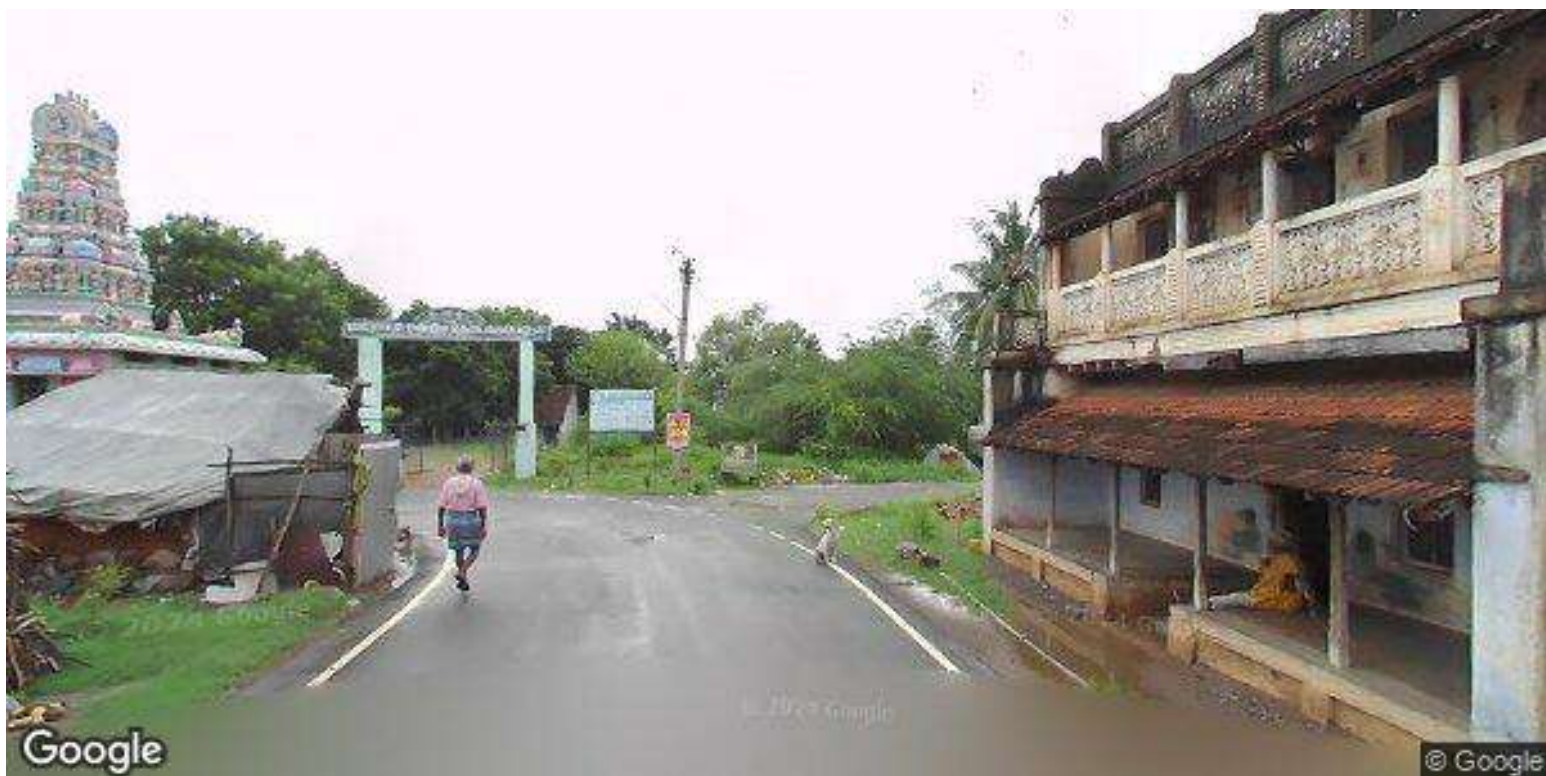
**Risk Type: Turn**

**Risk Level: High**

**Speed Limit: 15 KM/Hr**

**Coordinates: 11.56034, 78.67714**

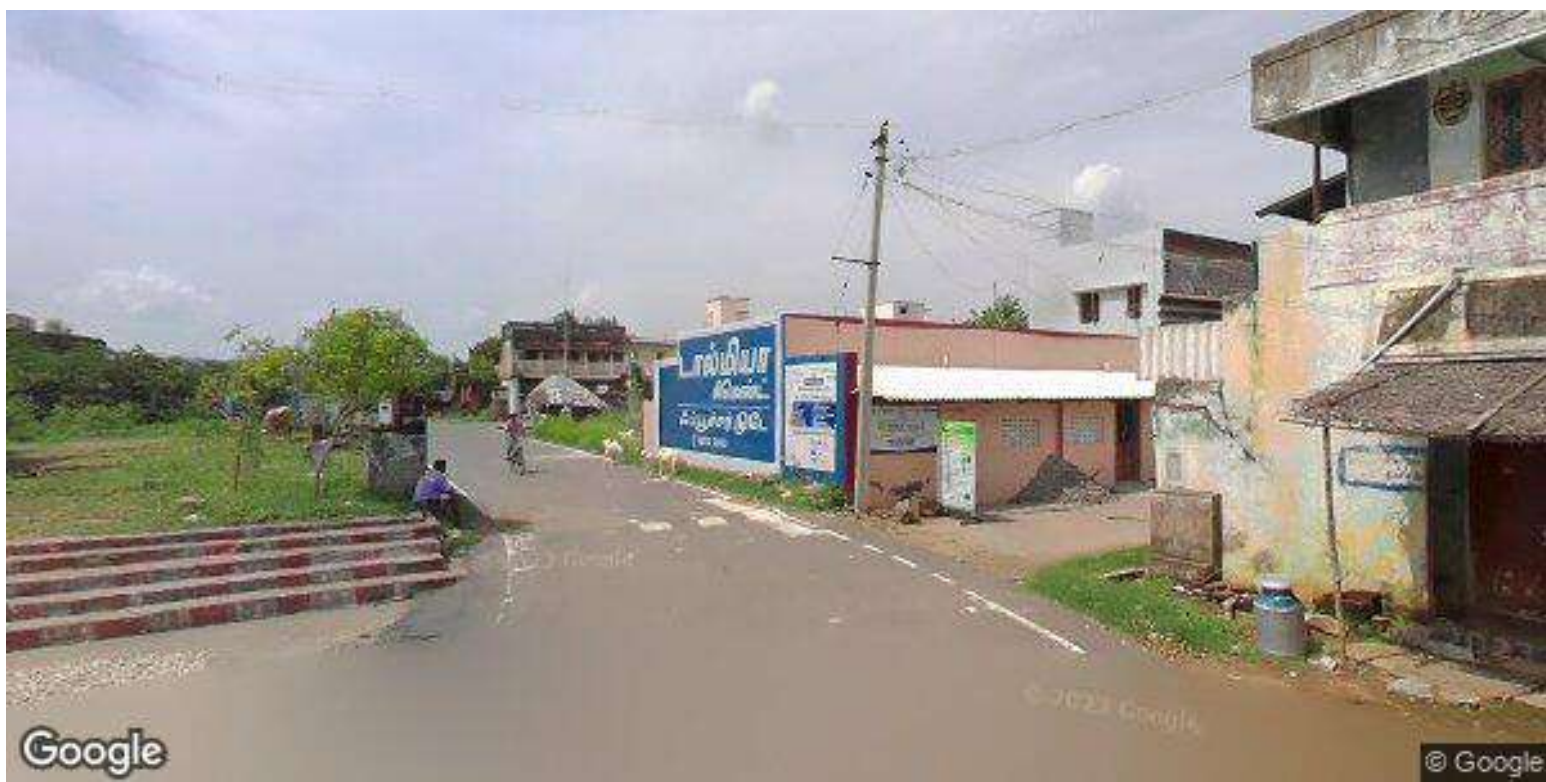
**Risk Type:** Turn

**Risk Level:** High

**Speed Limit:** 15 KM/Hr

**Coordinates:** 11.56015, 78.67751

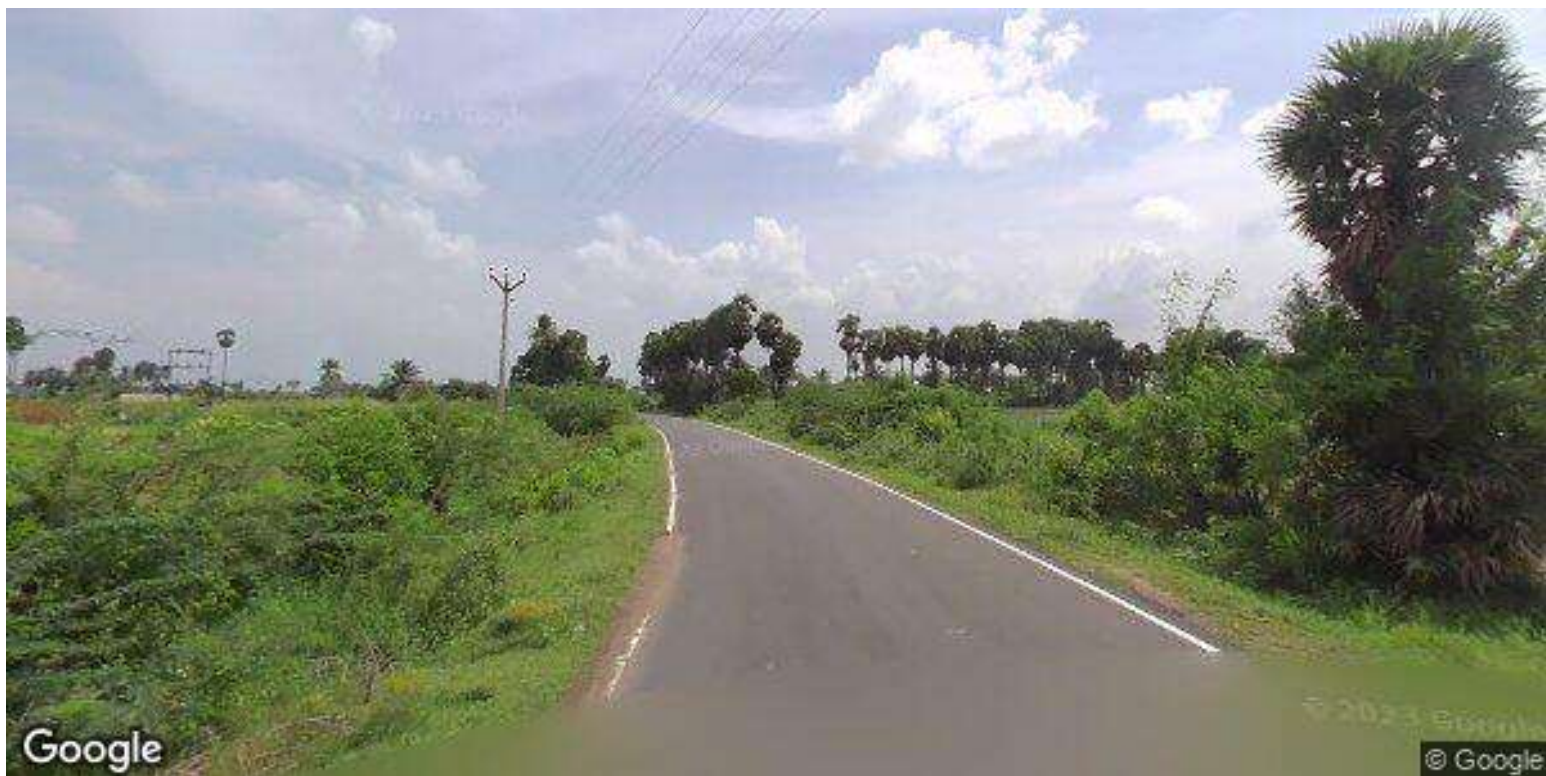
**Risk Type:** Turn

**Risk Level:** Medium

**Speed Limit:** 30 KM/Hr

**Coordinates:** 11.55524, 78.67911

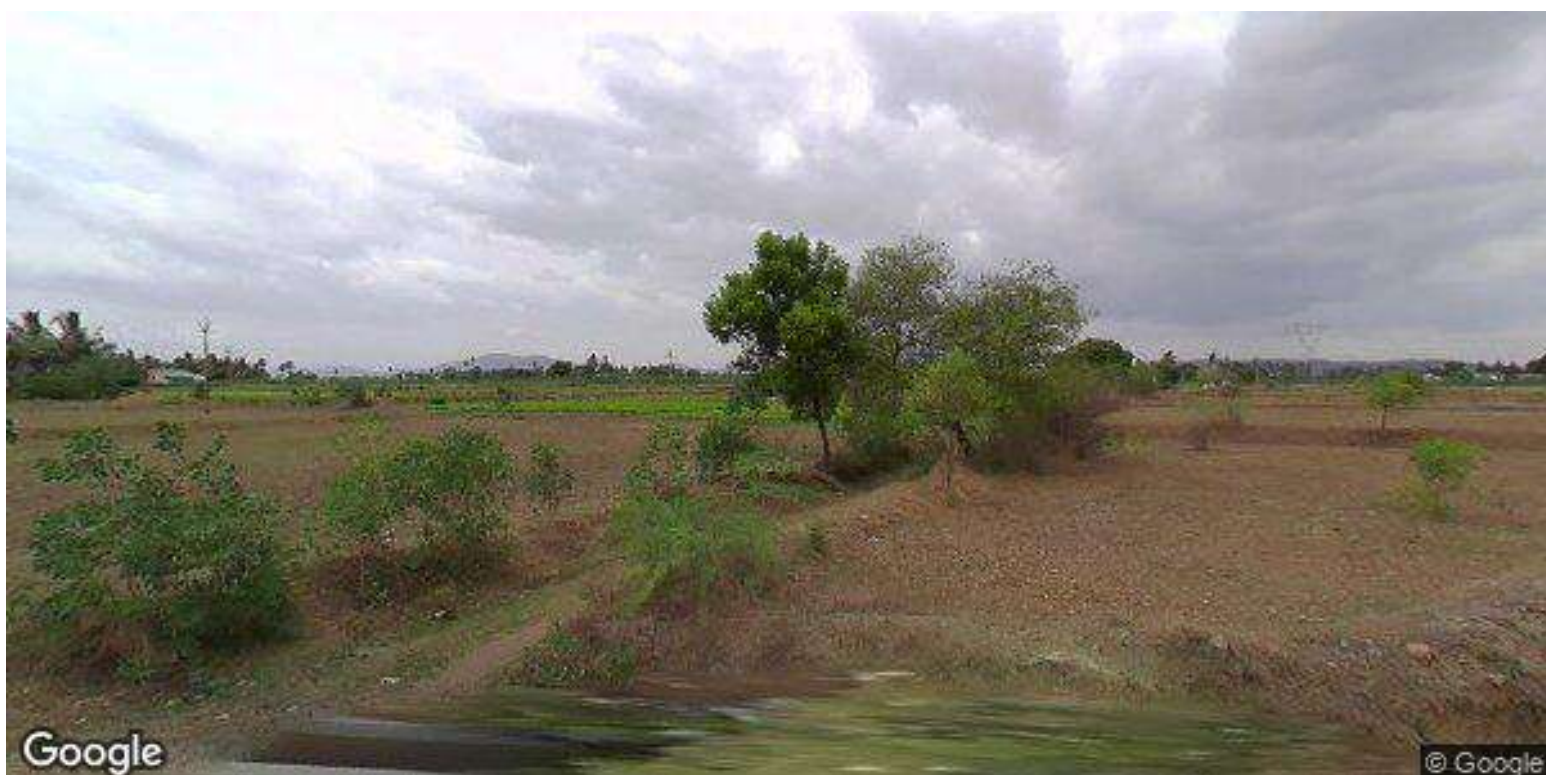
**Risk Type:** Turn

**Risk Level:** High

**Speed Limit:** 15 KM/Hr

**Coordinates:** 11.54254, 78.68881

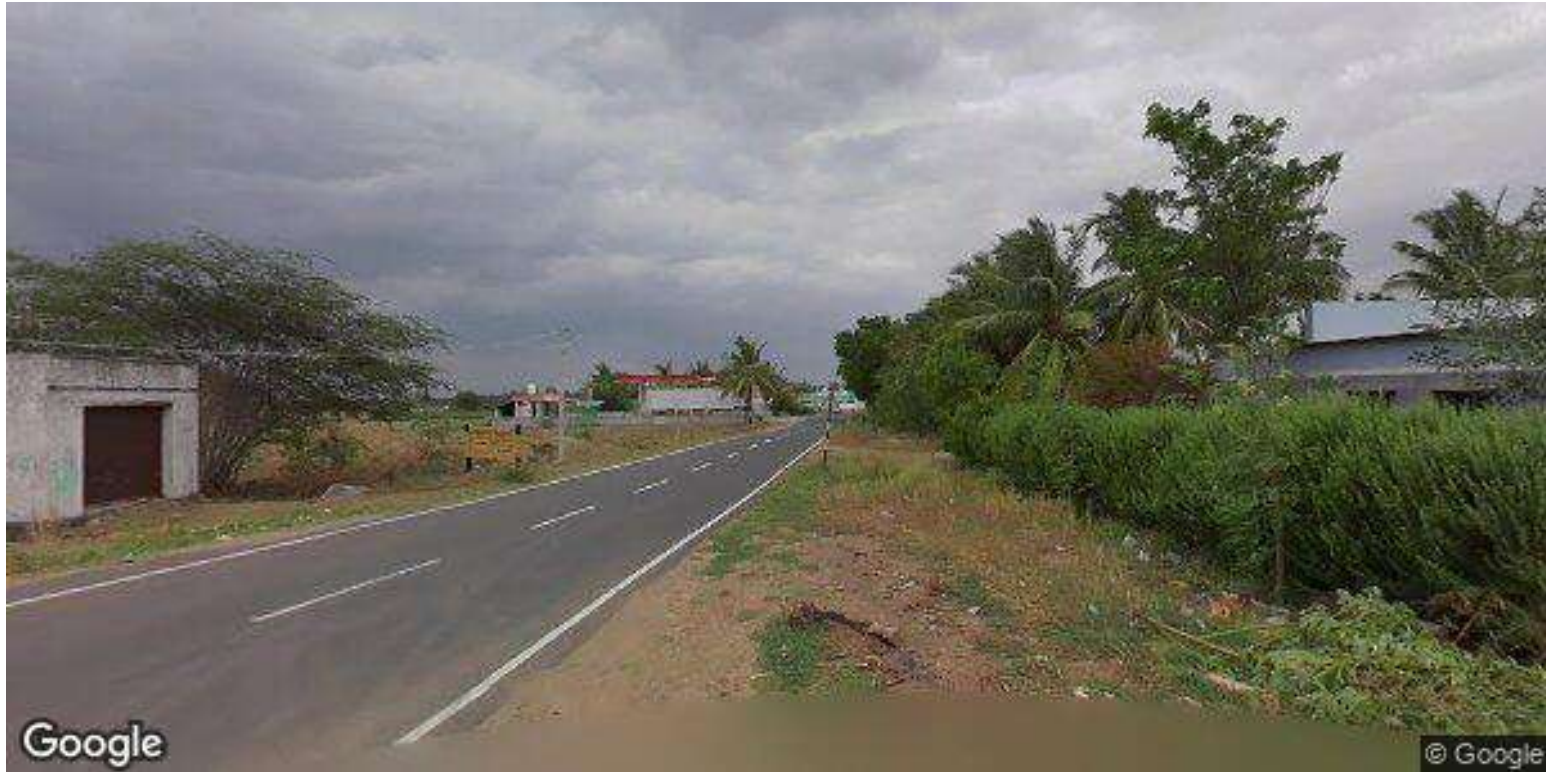
**Risk Type:** Turn

**Risk Level:** High

**Speed Limit:** 15 KM/Hr

**Coordinates:** 11.53979, 78.68804
