# IndianOil

## JOURNEY RISK MANAGEMENT (JRM) STUDY

### Salem Terminal TO SRI ATHAYAMMAN FUEL

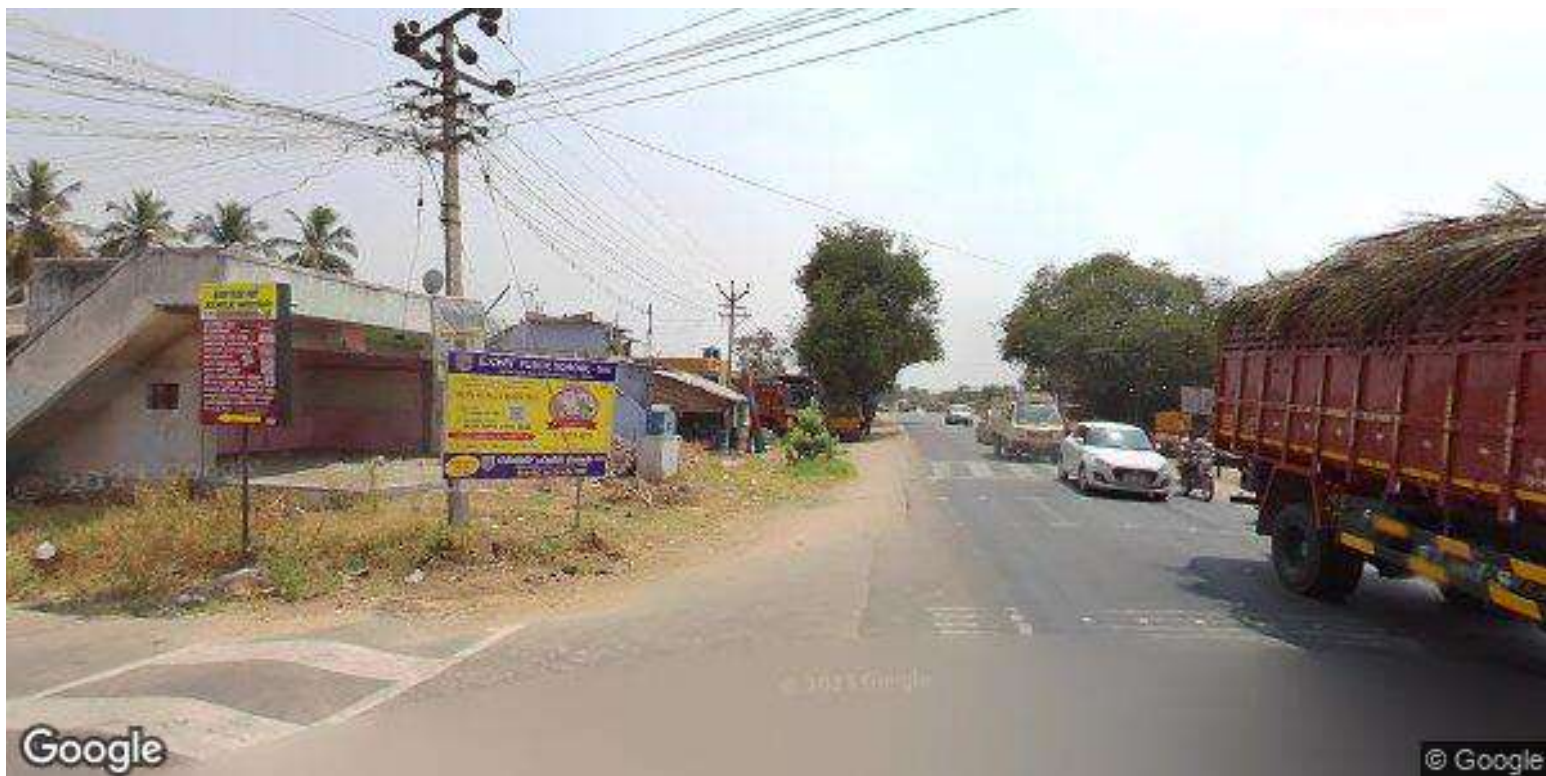
**Risk Type:** Blind Spot  
**Risk Level:** Blind Spot  
**Speed Limit:** 10 KM/Hr  
**Coordinates:** 11.41978, 77.88077

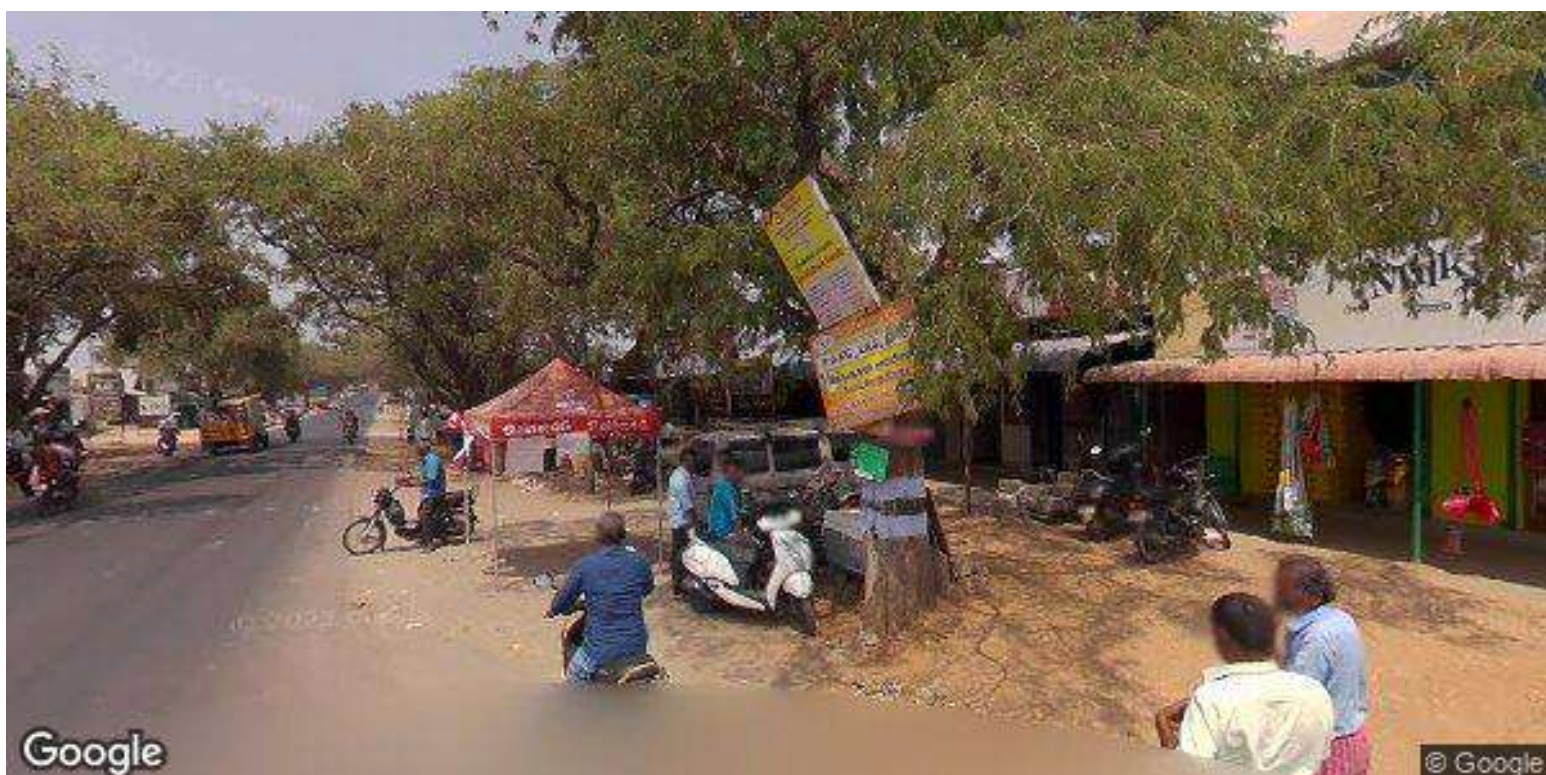
**Risk Type:** Turn  
**Risk Level:** High  
**Speed Limit:** 15 KM/Hr  
**Coordinates:** 11.41981, 77.88078

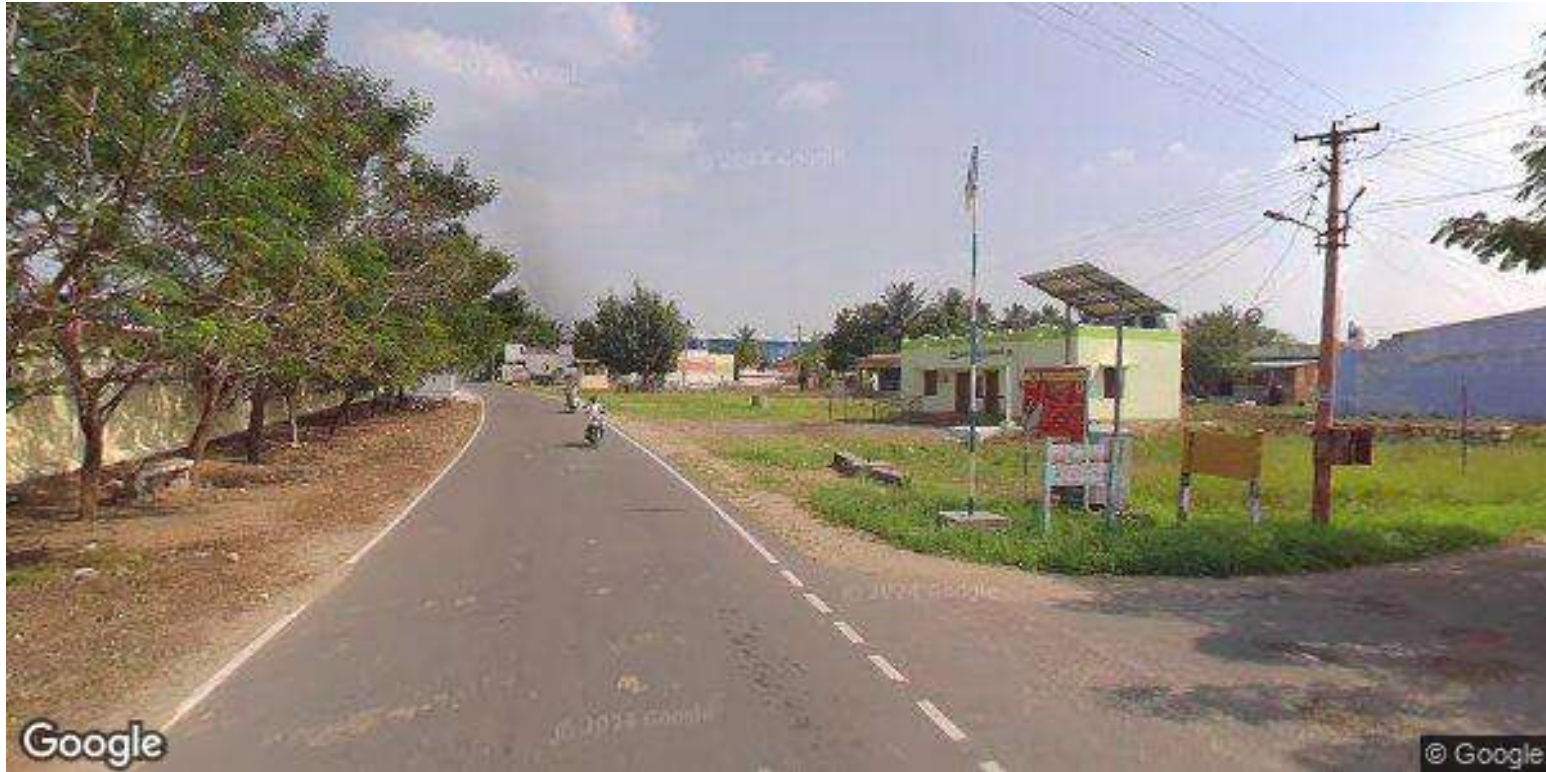
**Risk Type:** Blind Spot  
**Risk Level:** Blind Spot  
**Speed Limit:** 10 KM/Hr  
**Coordinates:** 11.42333, 77.87394

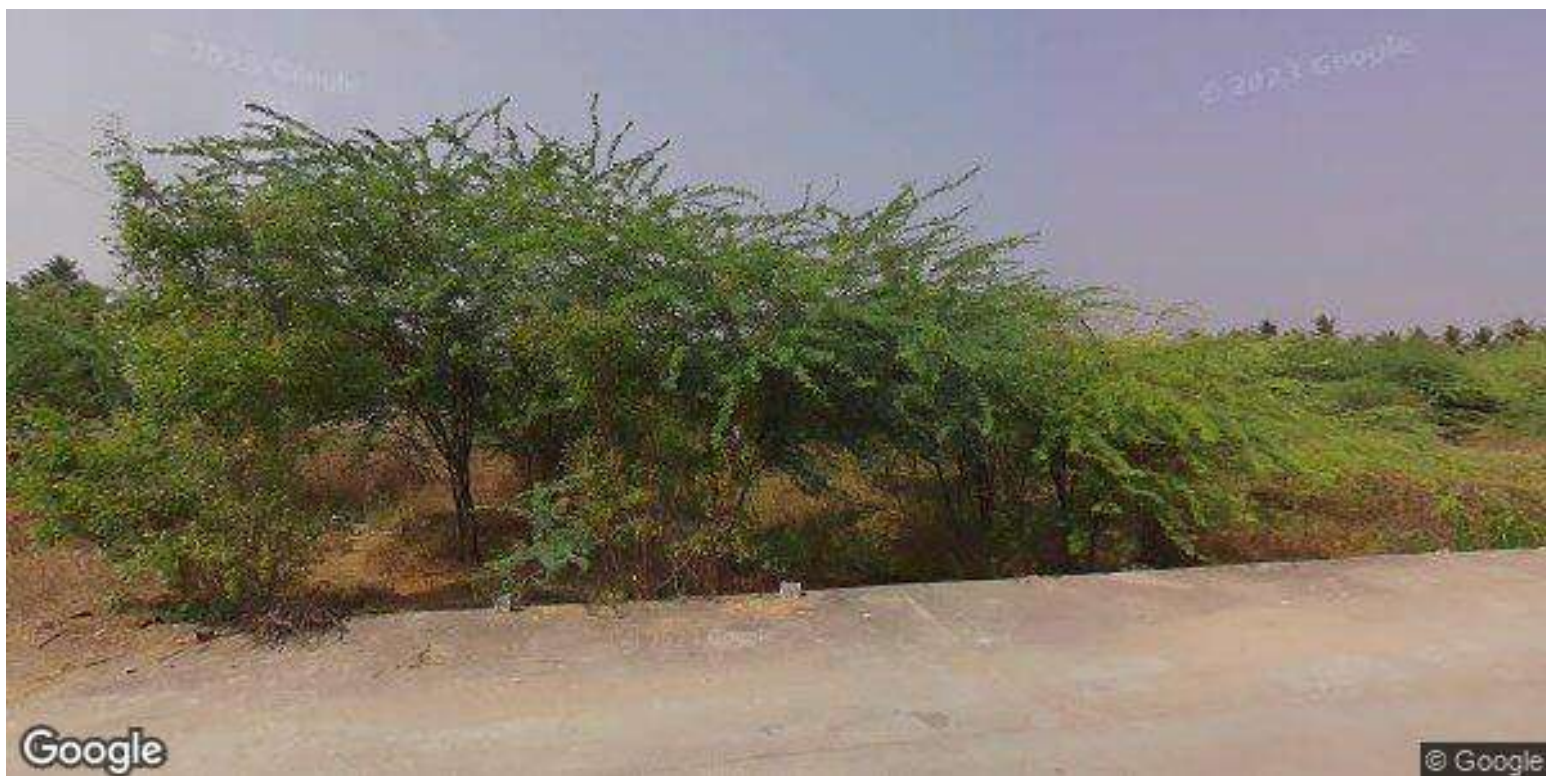
**Risk Type:** Turn  
**Risk Level:** High  
**Speed Limit:** 15 KM/Hr  
**Coordinates:** 11.41917, 77.87022

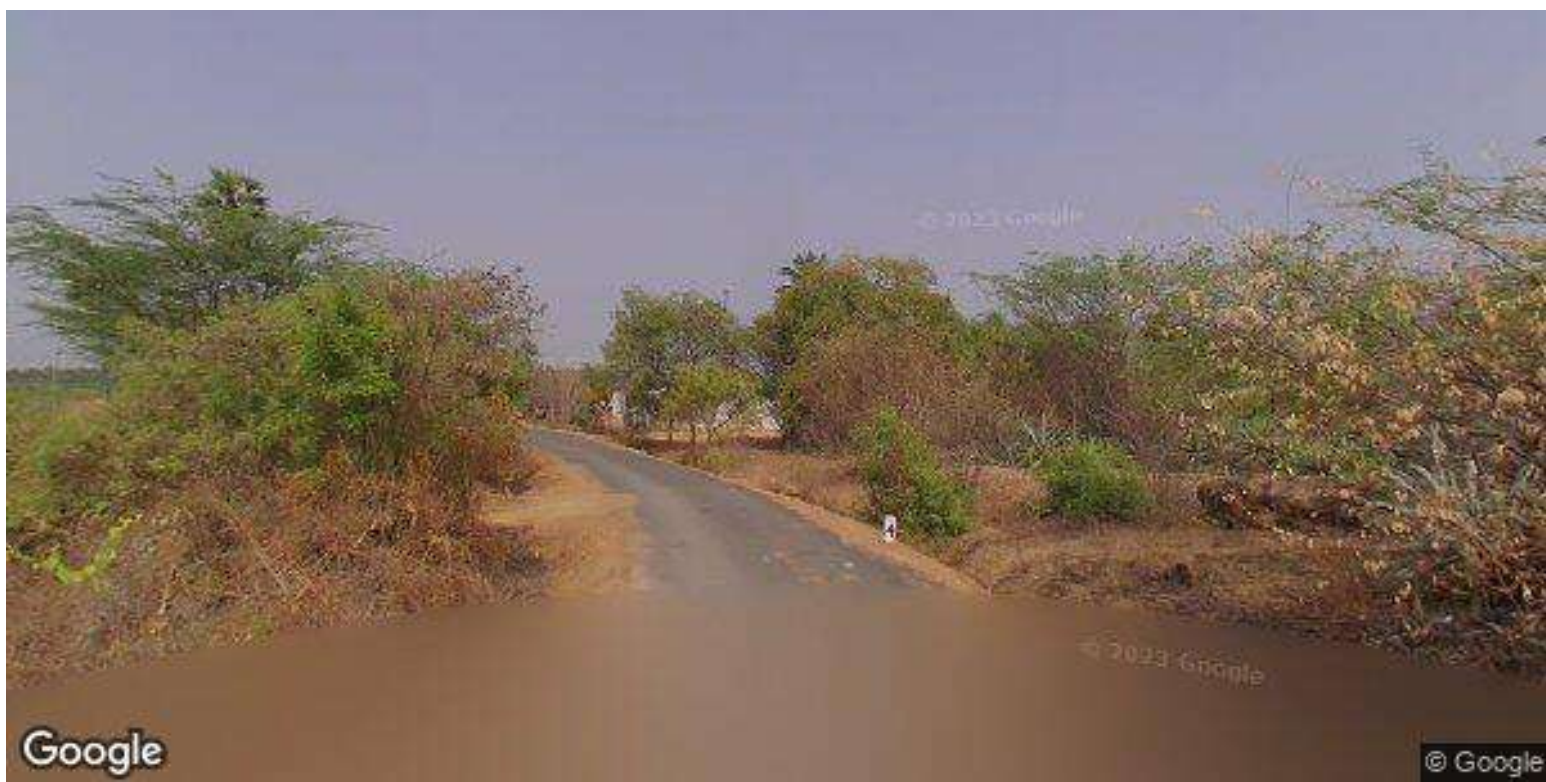
**Risk Type:** Turn

**Risk Level:** Medium

**Speed Limit:** 30 KM/Hr

**Coordinates:** 11.41641, 77.86797

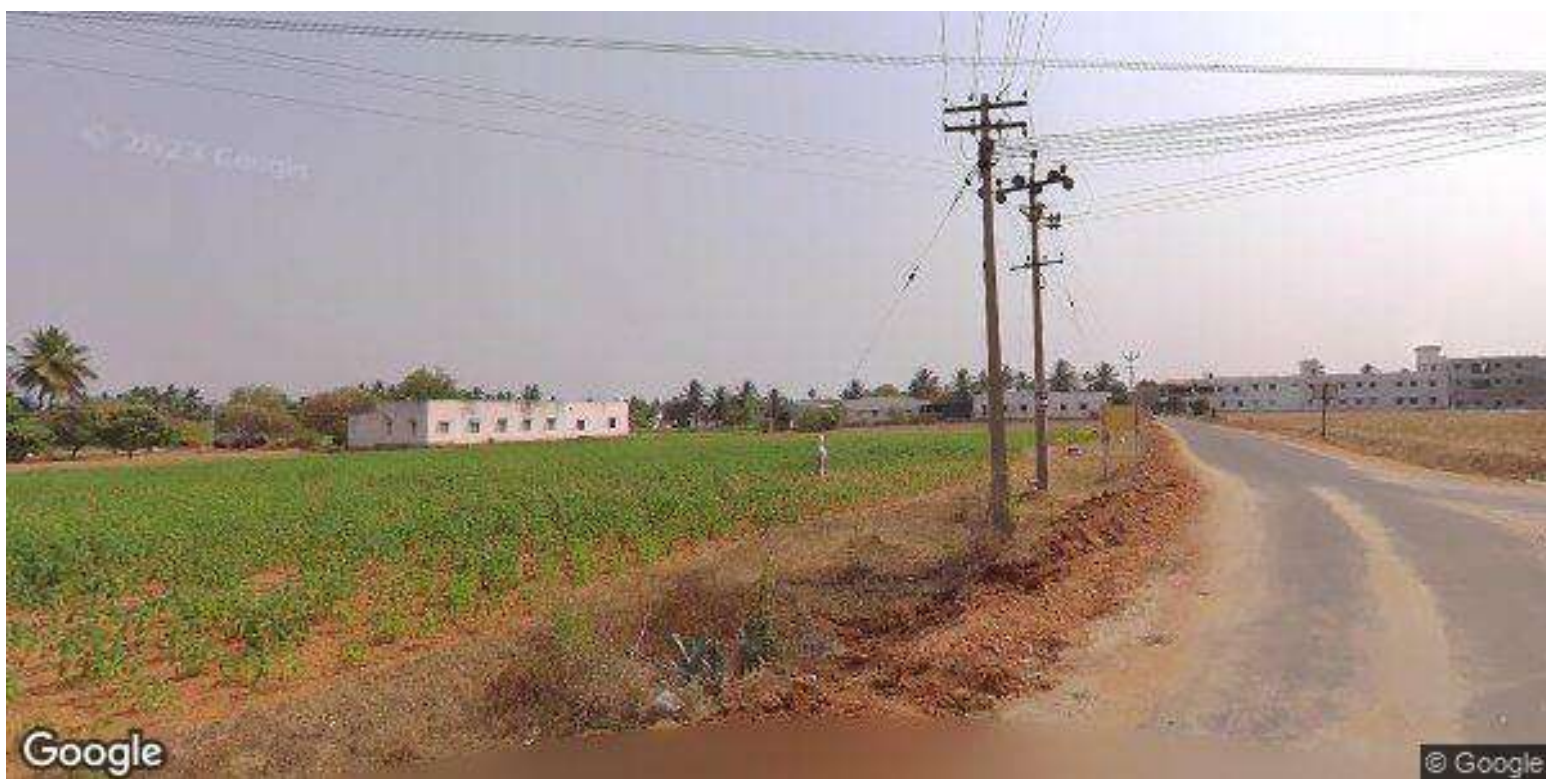
**Risk Type:** Turn

**Risk Level:** High

**Speed Limit:** 15 KM/Hr

**Coordinates:** 11.40478, 77.86020

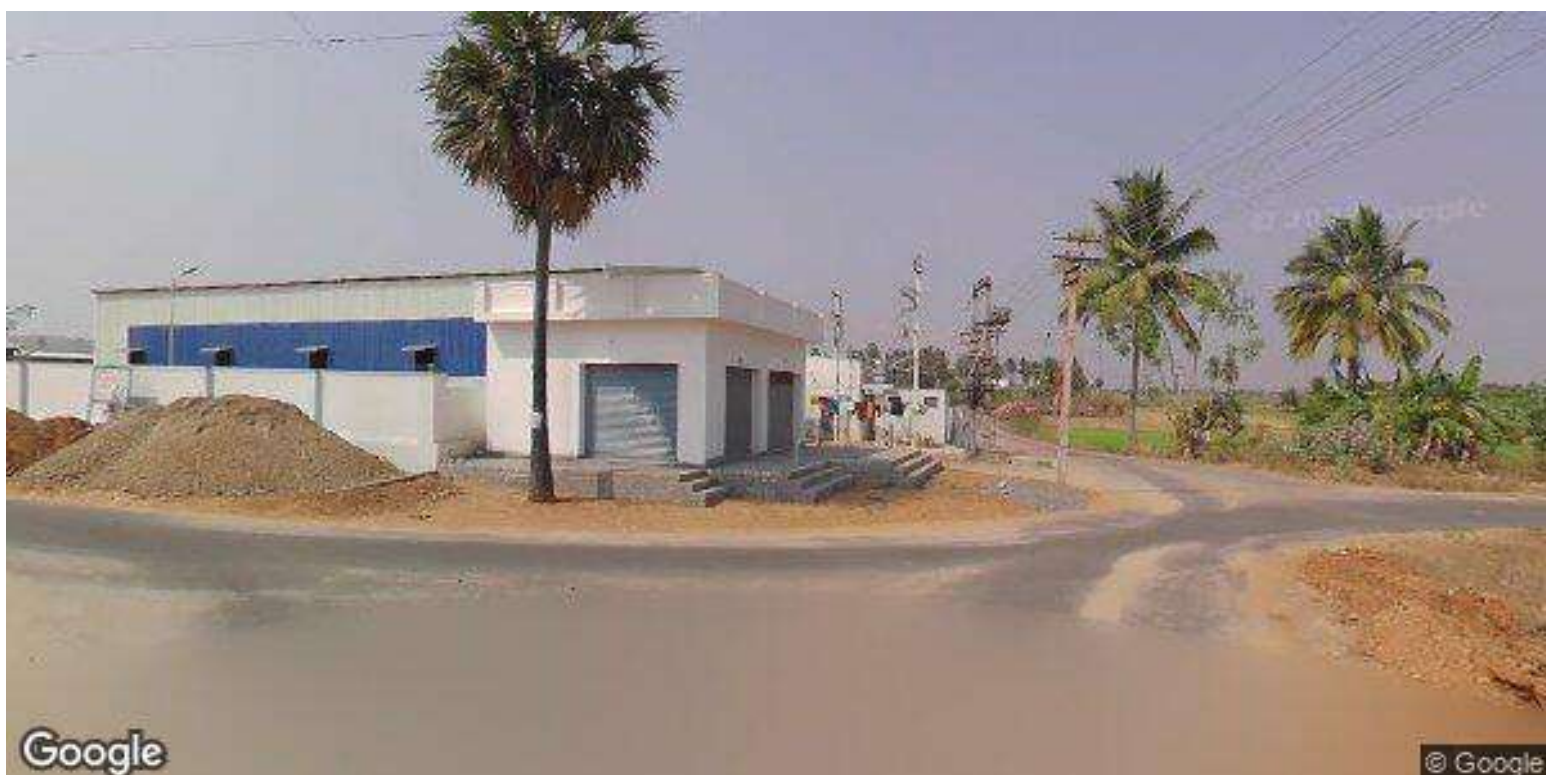
**Risk Type:** Turn  
**Risk Level:** High  
**Speed Limit:** 15 KM/Hr  
**Coordinates:** 11.40471, 77.86004

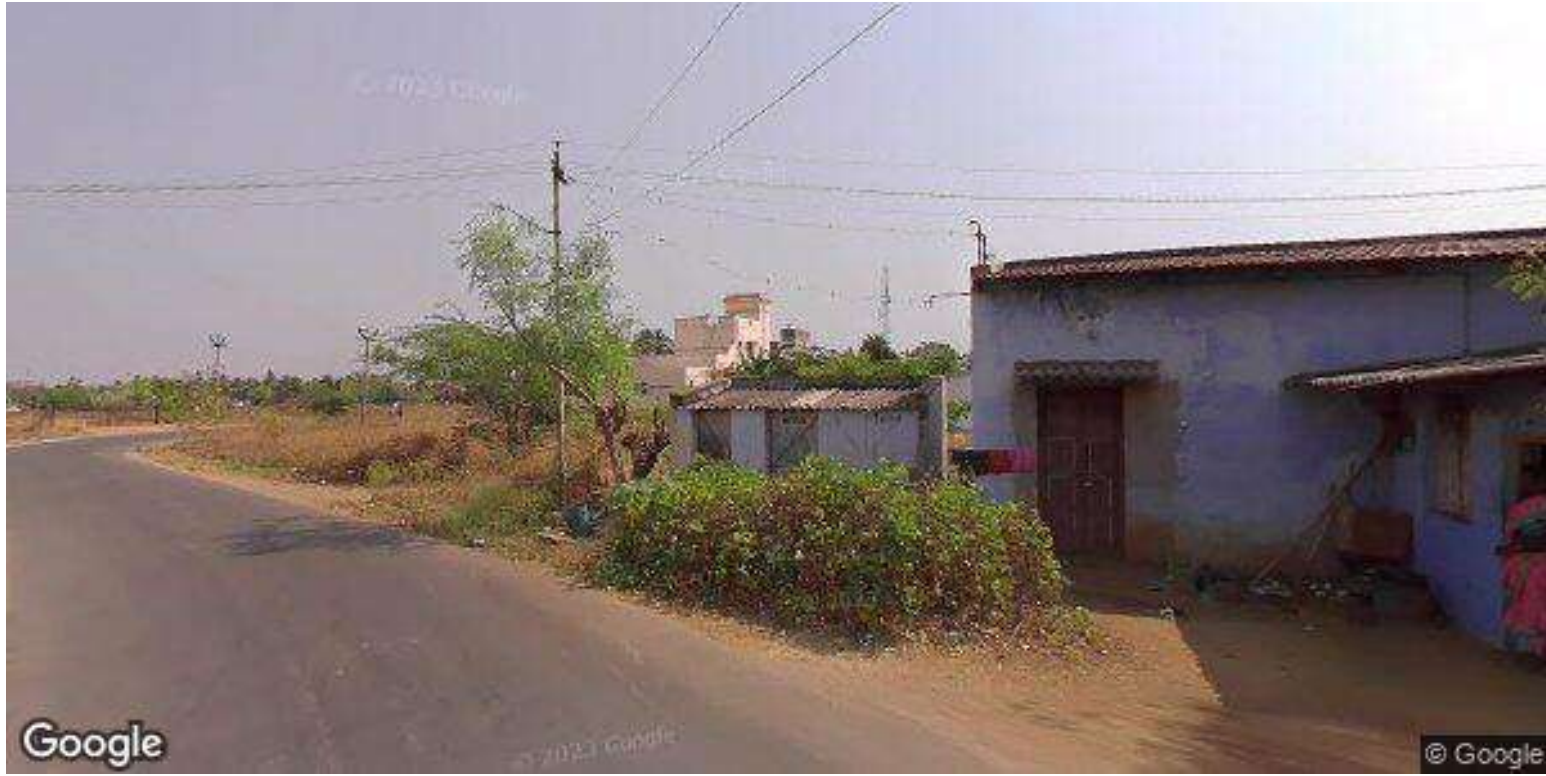
**Risk Type:** Turn  
**Risk Level:** Medium  
**Speed Limit:** 30 KM/Hr  
**Coordinates:** 11.39361, 77.85502

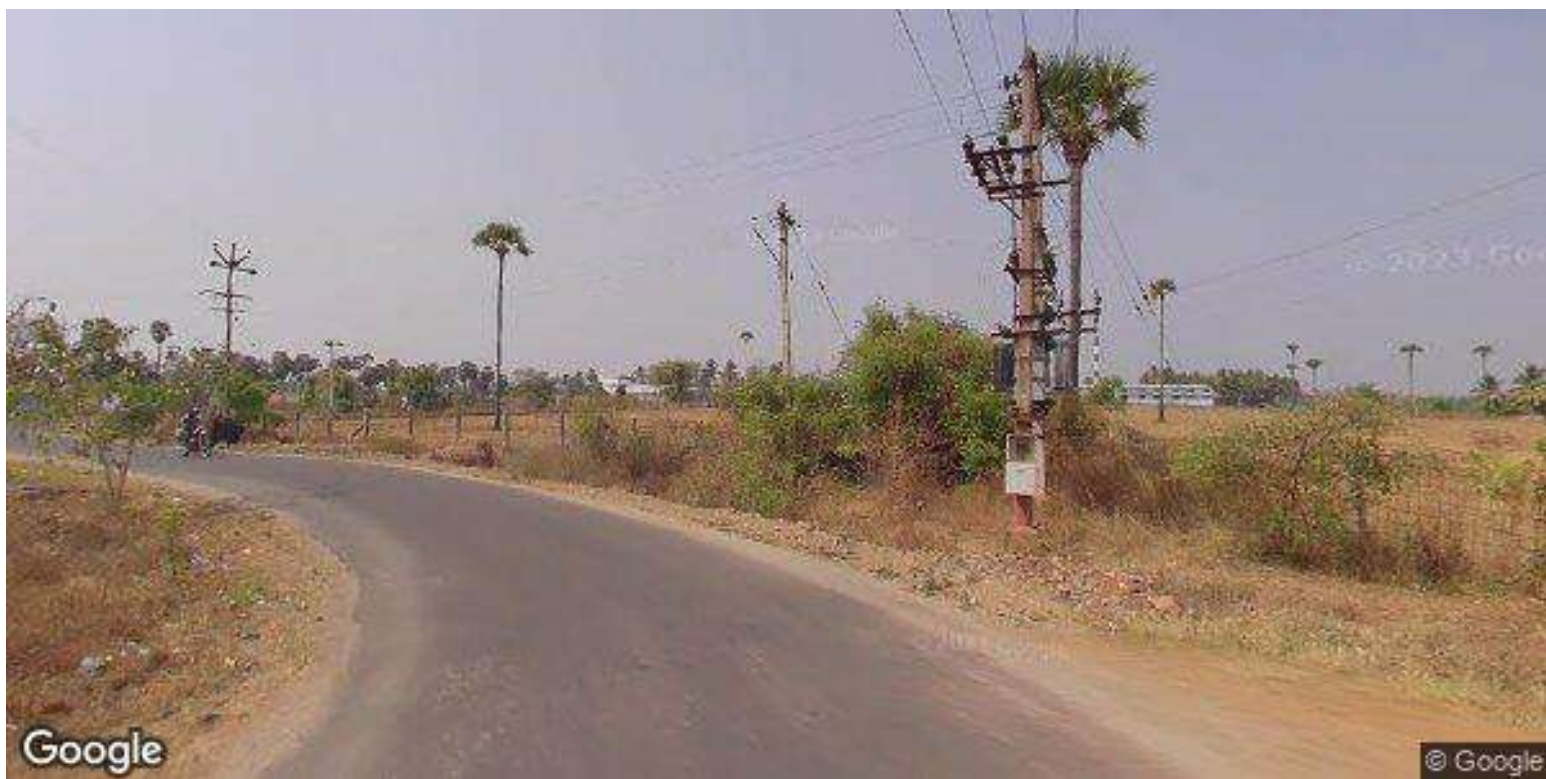
**Risk Type:** Turn  
**Risk Level:** High  
**Speed Limit:** 15 KM/Hr  
**Coordinates:** 11.39323, 77.85539

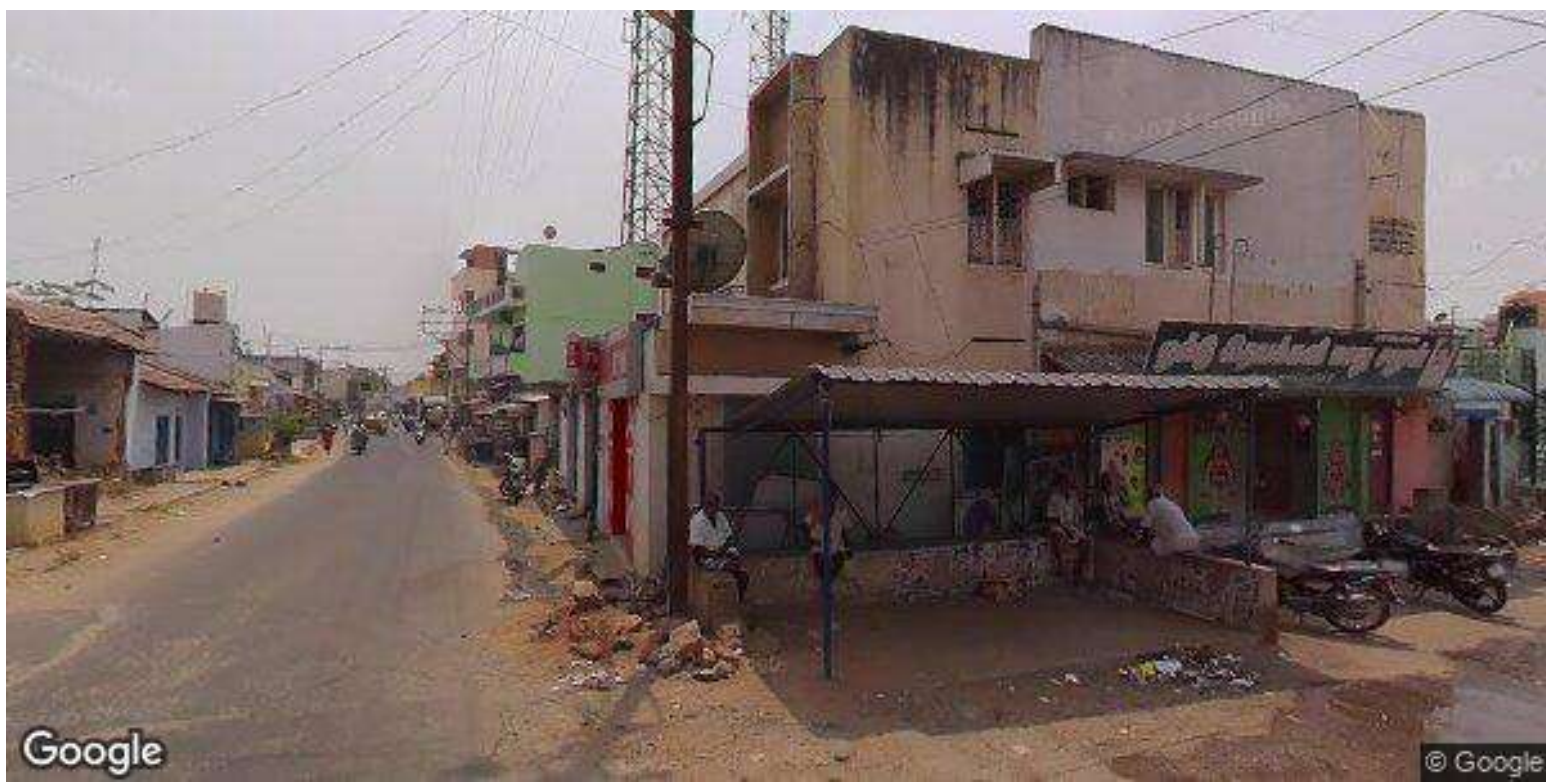
**Risk Type:** Blind Spot  
**Risk Level:** Blind Spot  
**Speed Limit:** 10 KM/Hr  
**Coordinates:** 11.39047, 77.85509

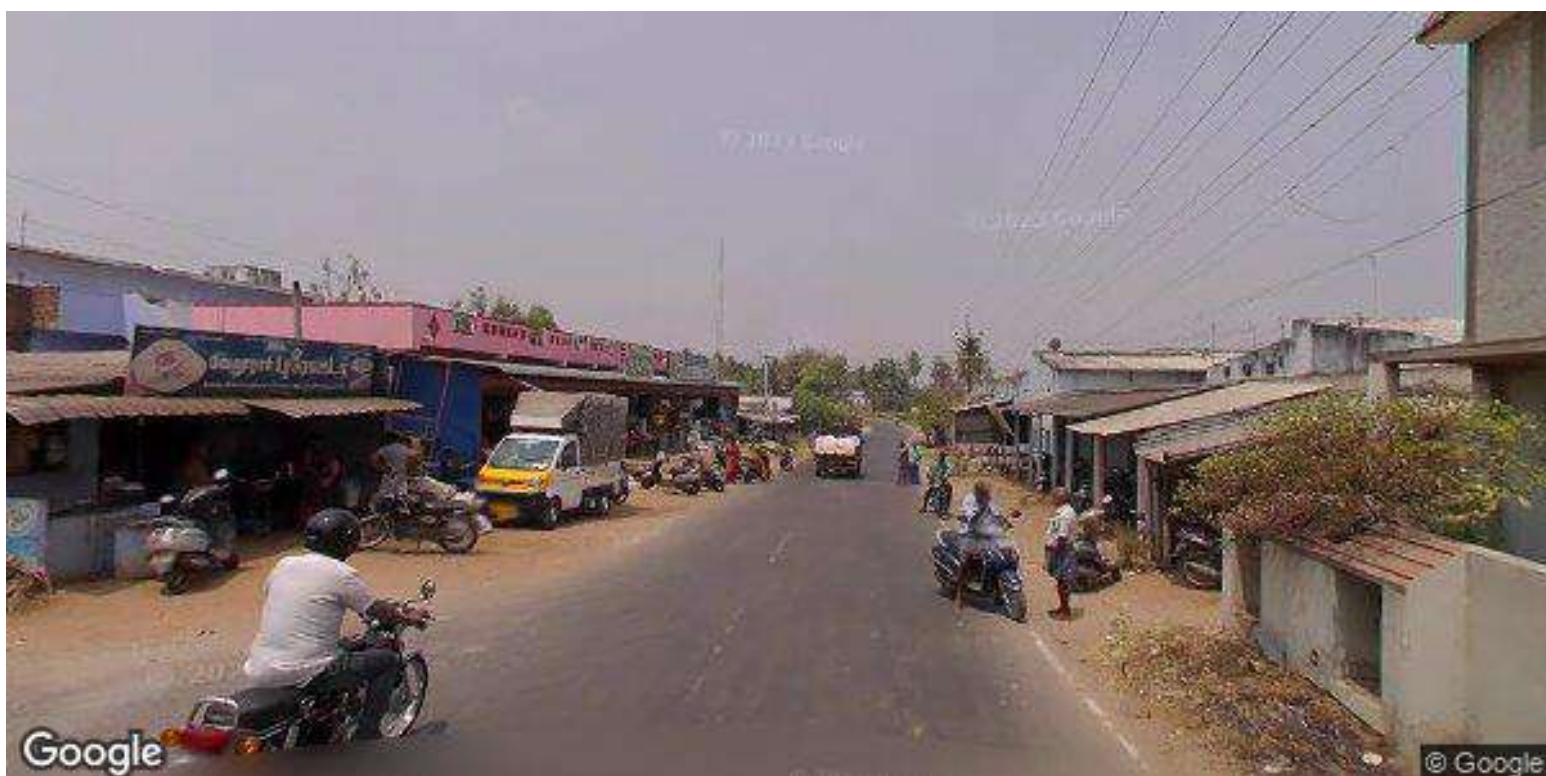
**Risk Type:** Turn  
**Risk Level:** High  
**Speed Limit:** 15 KM/Hr  
**Coordinates:** 11.39076, 77.85379

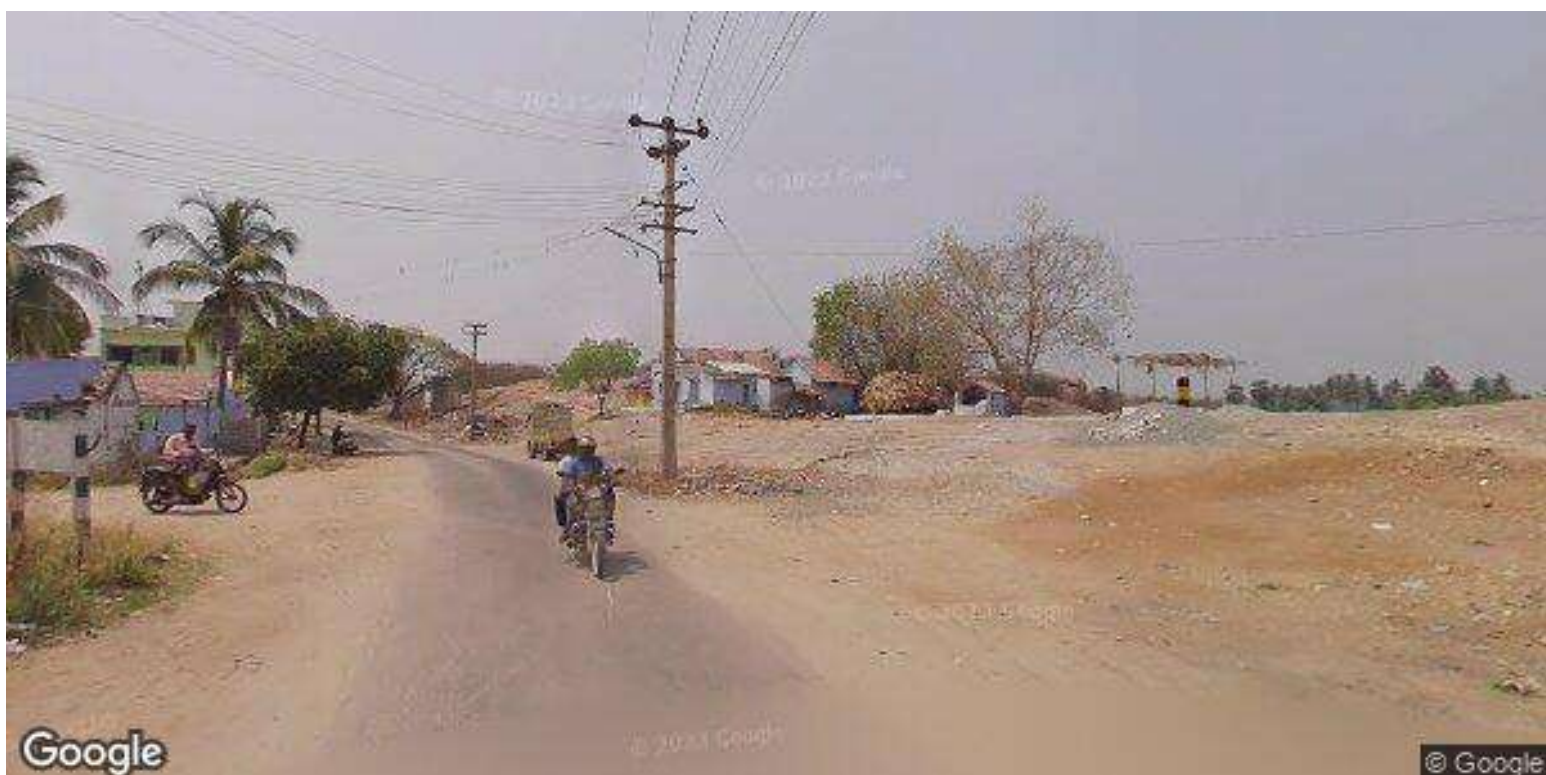
**Risk Type:** Turn

**Risk Level:** Medium

**Speed Limit:** 30 KM/Hr

**Coordinates:** 11.38963, 77.85303

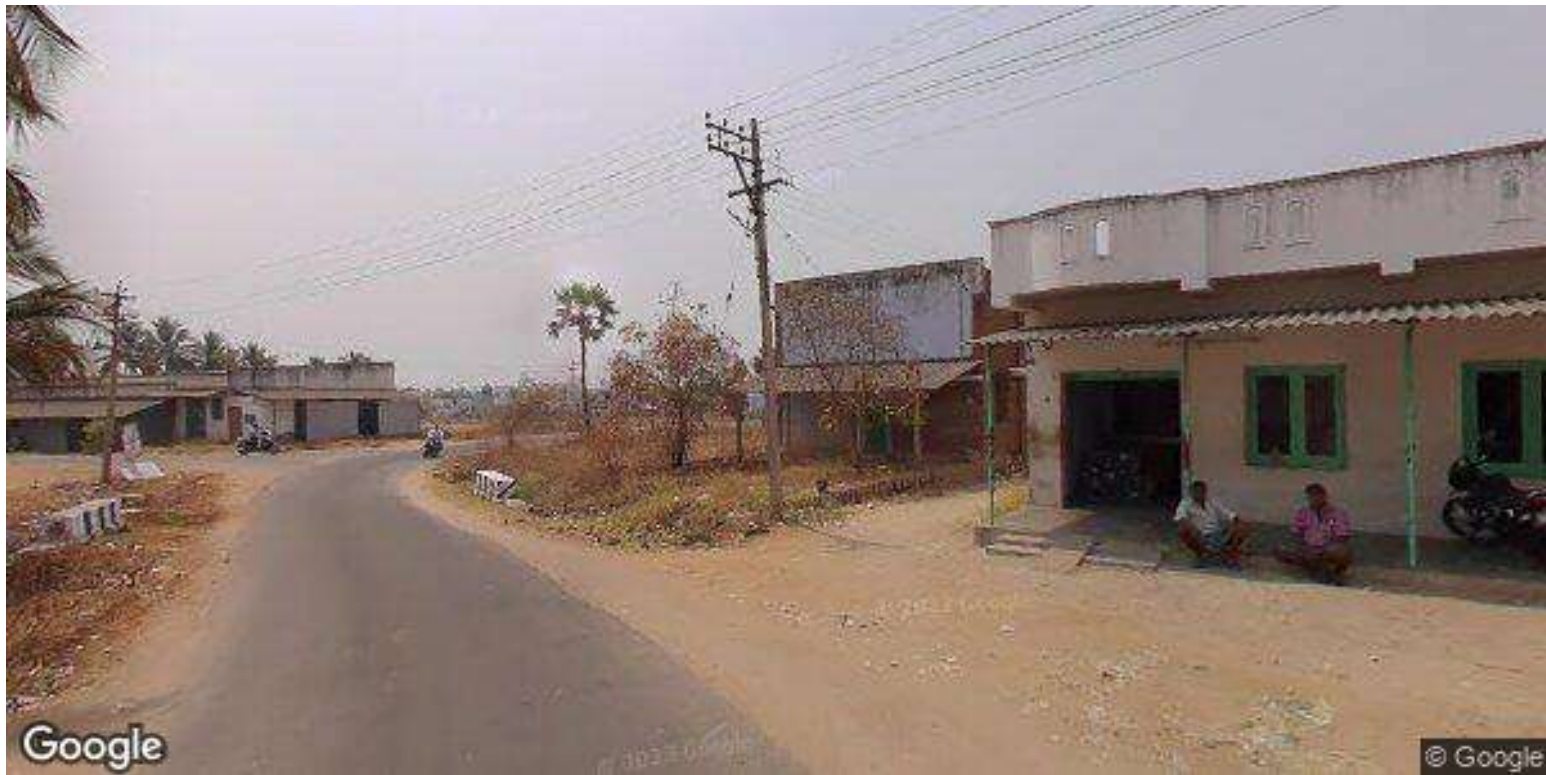
**Risk Type:** Turn

**Risk Level:** Medium

**Speed Limit:** 30 KM/Hr

**Coordinates:** 11.38629, 77.85258

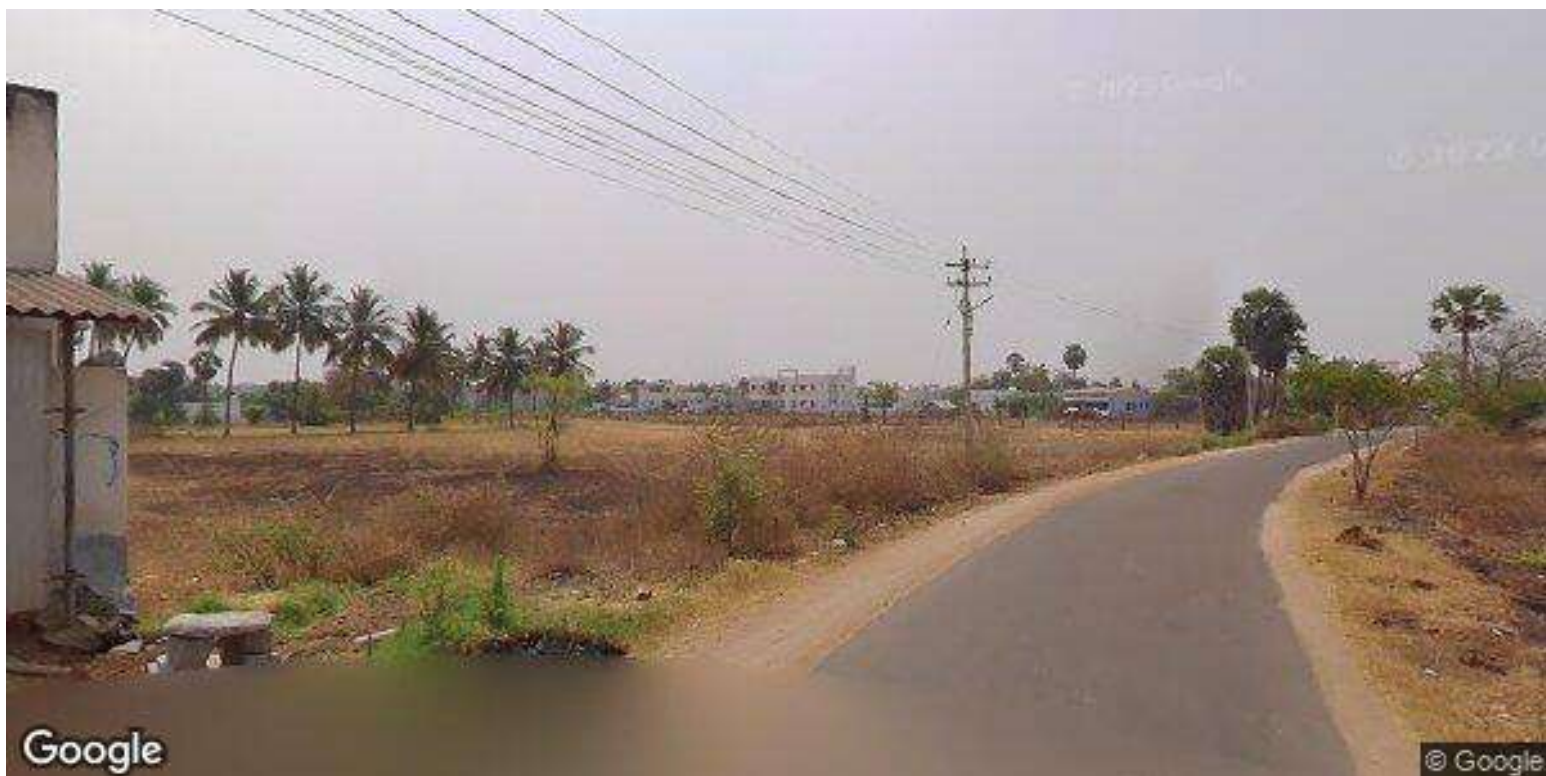
**Risk Type:** Turn

**Risk Level:** Medium

**Speed Limit:** 30 KM/Hr

**Coordinates:** 11.38591, 77.85279

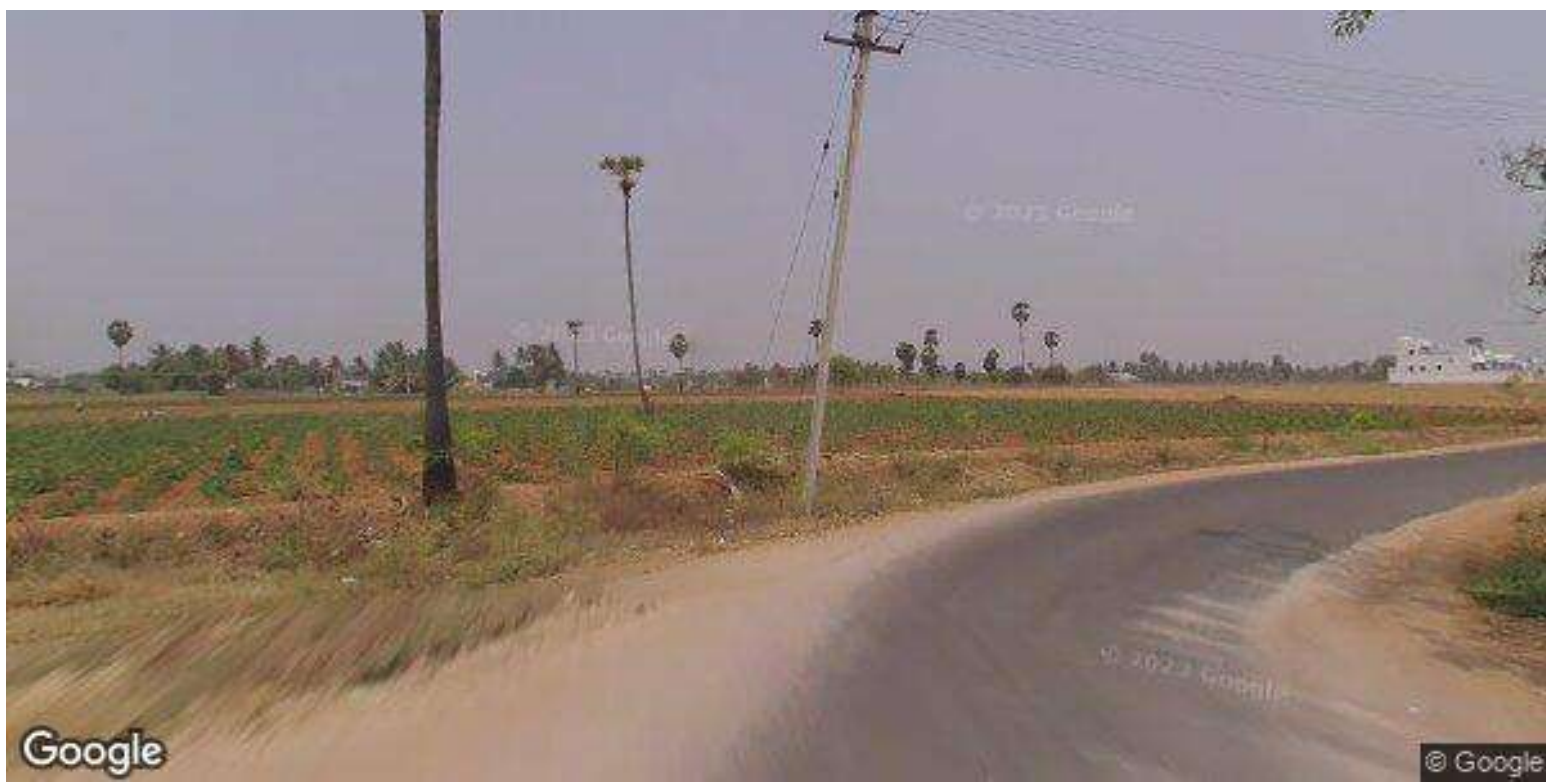
**Risk Type:** Turn

**Risk Level:** High

**Speed Limit:** 15 KM/Hr

**Coordinates:** 11.38248, 77.85174

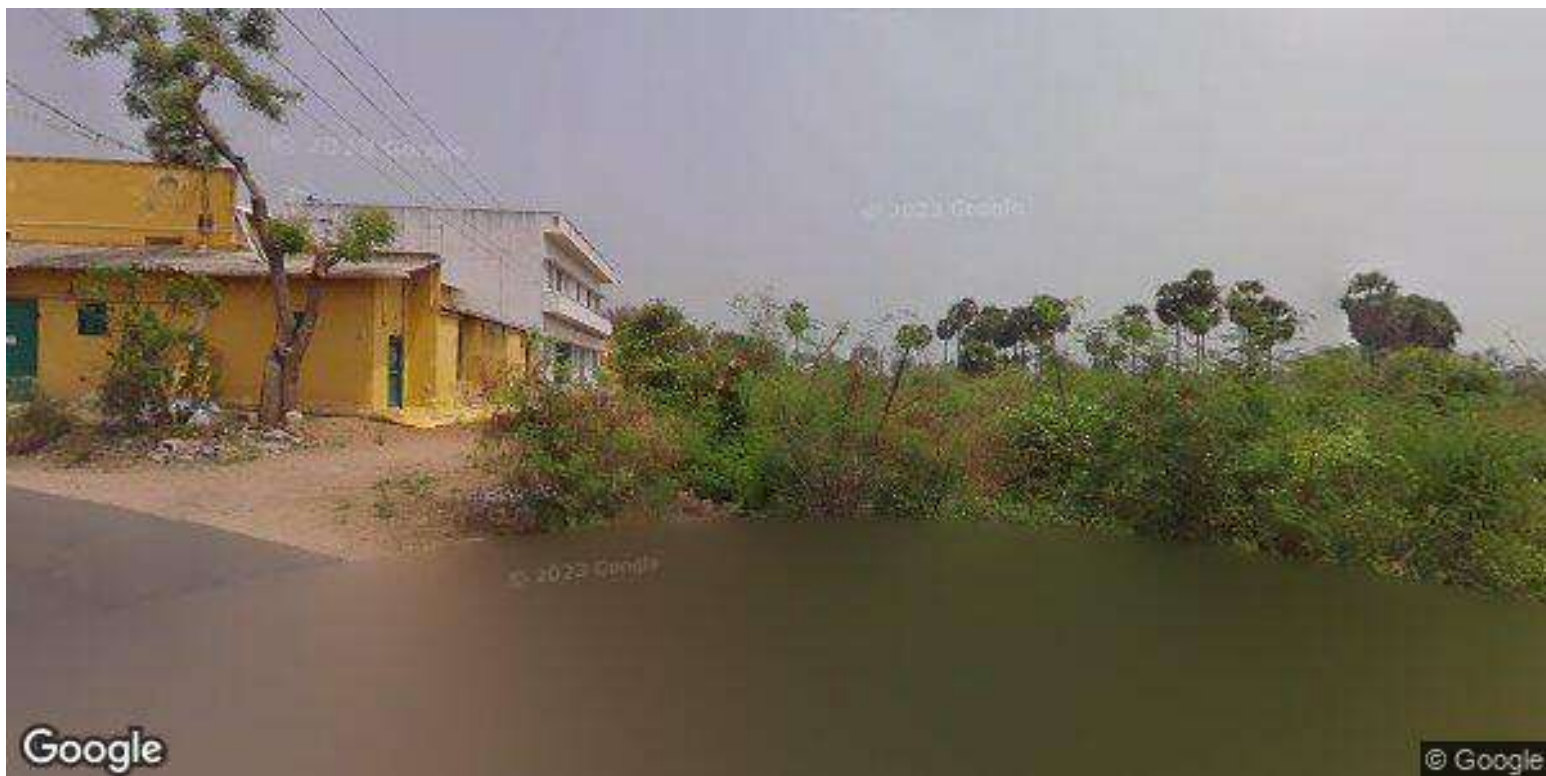
**Risk Type:** Turn

**Risk Level:** Medium

**Speed Limit:** 30 KM/Hr

**Coordinates:** 11.38217, 77.85223

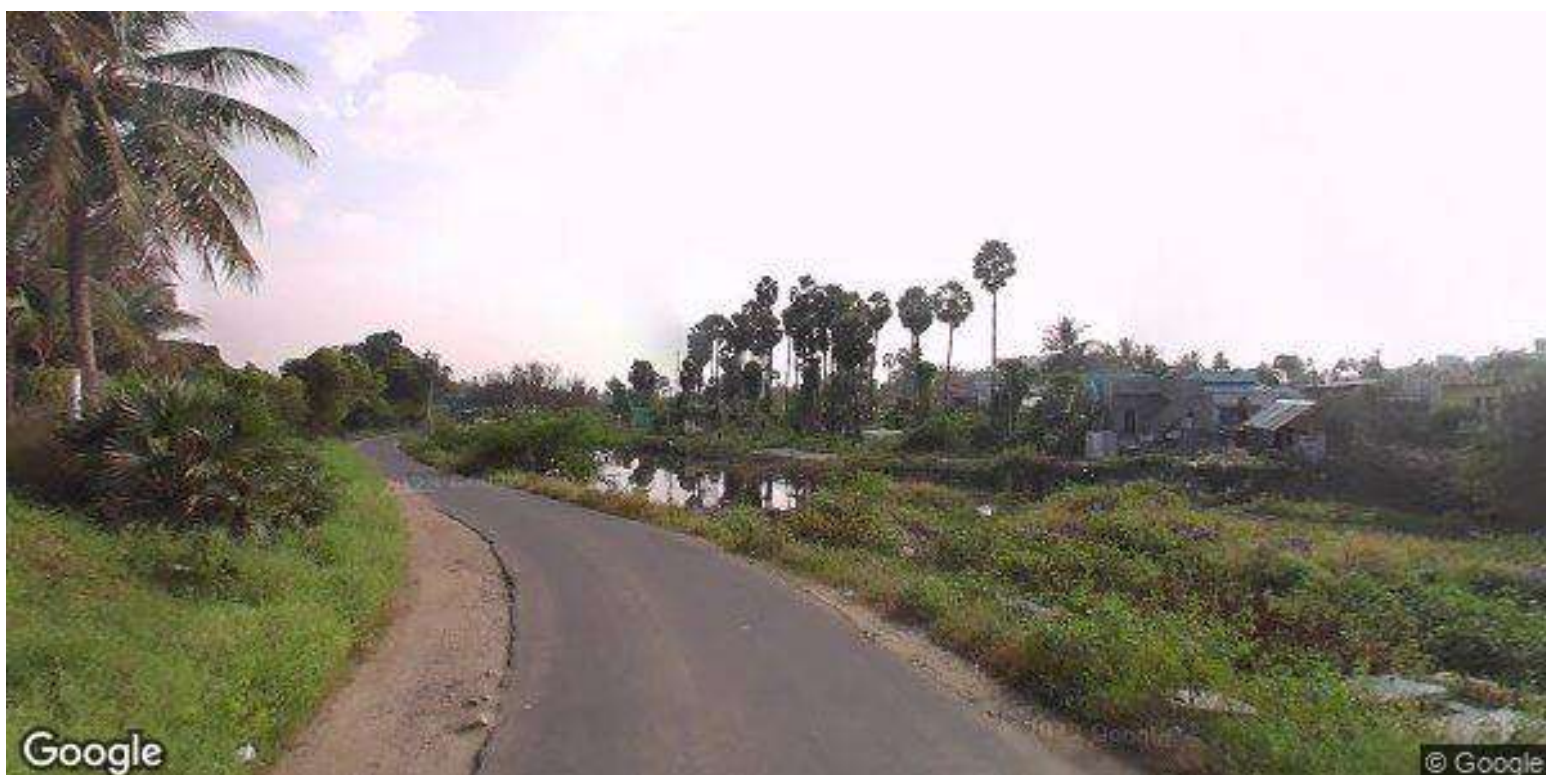
**Risk Type:** Turn  
**Risk Level:** Medium  
**Speed Limit:** 30 KM/Hr  
**Coordinates:** 11.37017, 77.84376

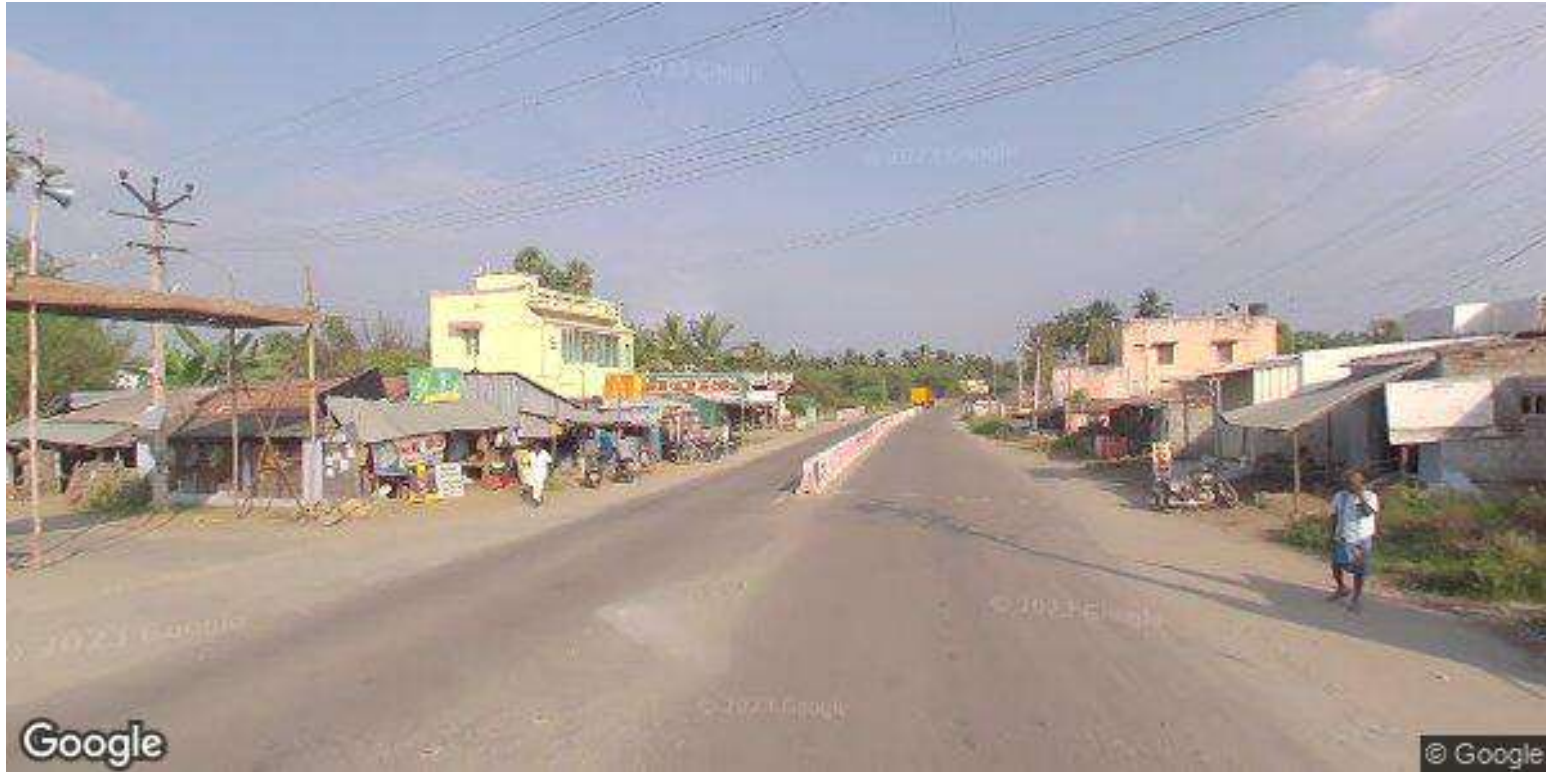
**Risk Type:** Turn  
**Risk Level:** High  
**Speed Limit:** 15 KM/Hr  
**Coordinates:** 11.36568, 77.84272

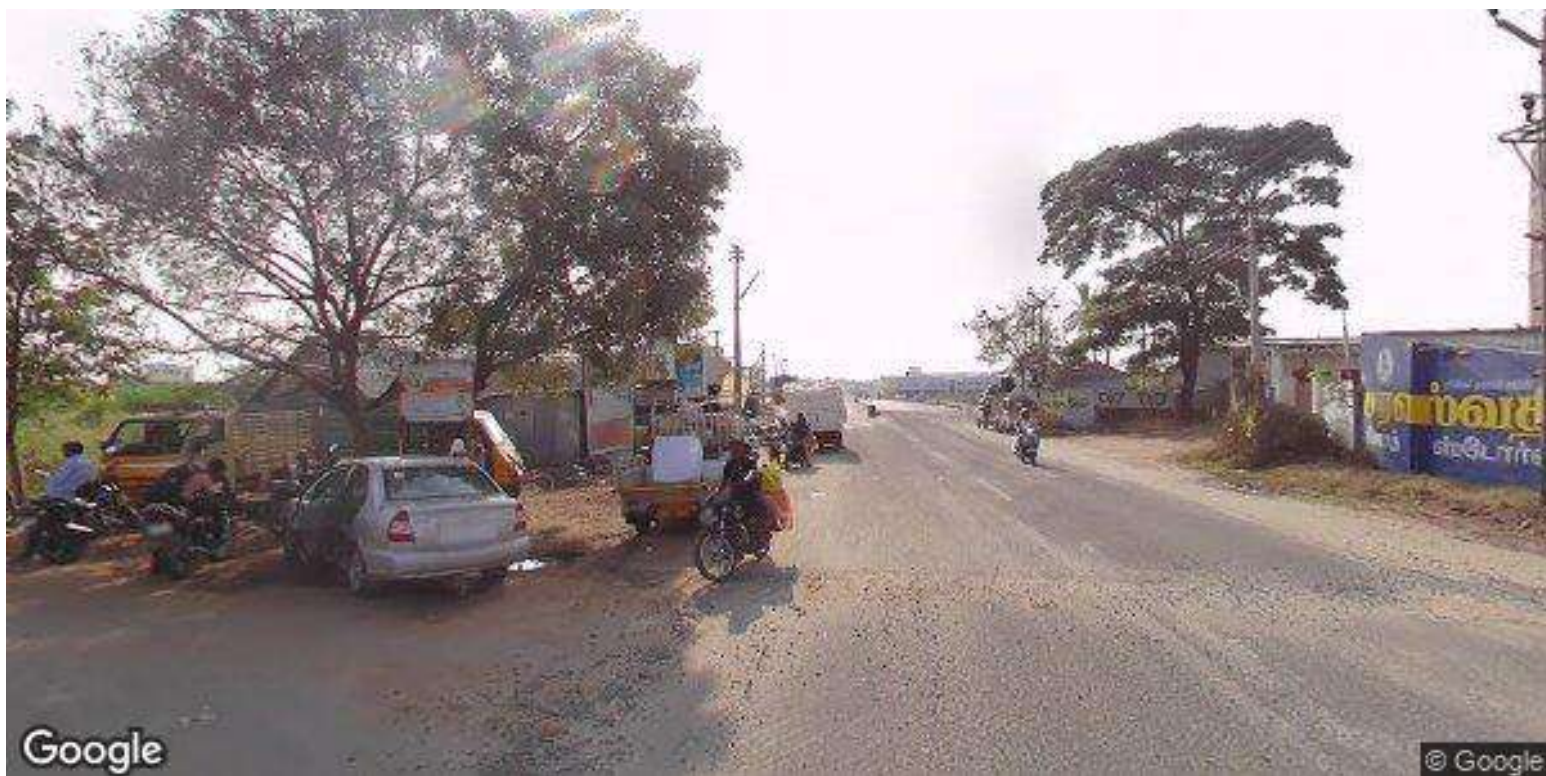
**Risk Type:** Turn  
**Risk Level:** High  
**Speed Limit:** 15 KM/Hr  
**Coordinates:** 11.36551, 77.84183
