# IndianOil

## JOURNEY RISK MANAGEMENT (JRM) STUDY

### Salem Terminal TO SRI ATHAYAMMAN FUEL

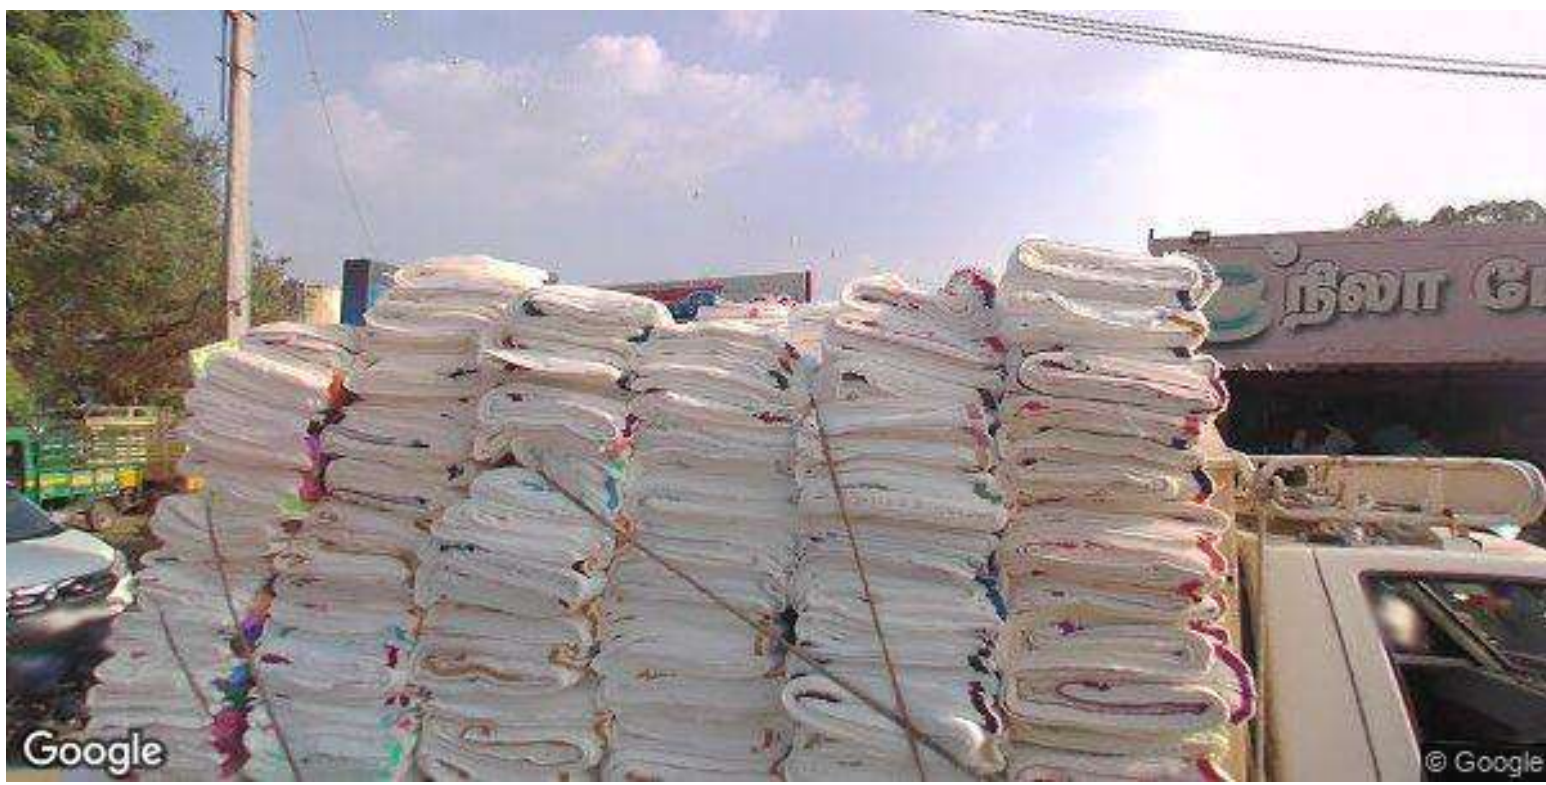
**Risk Type:** Turn

**Risk Level:** Medium

**Speed Limit:** 30 KM/Hr

**Coordinates:** 11.36505, 77.84189

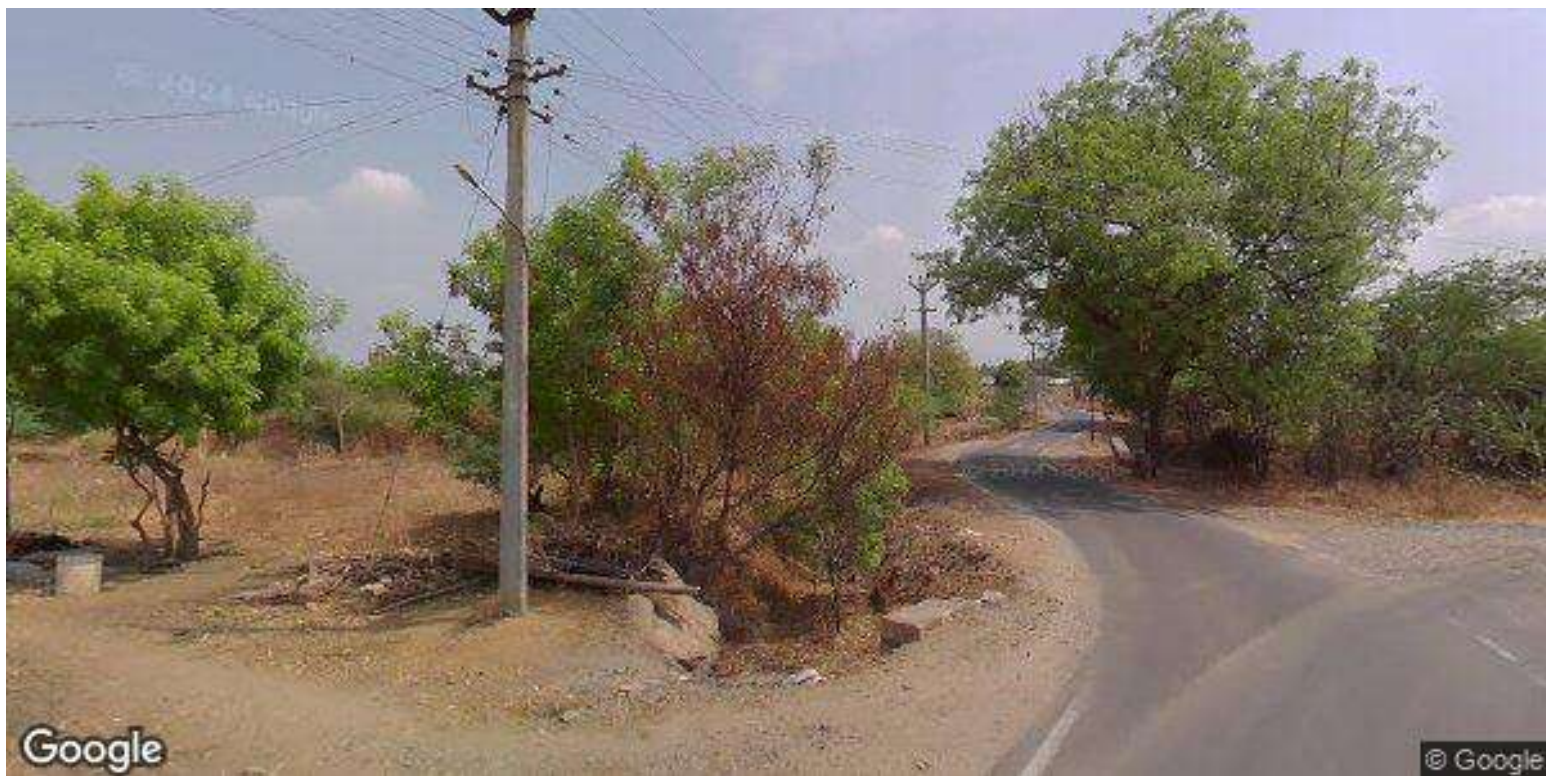
**Risk Type:** Turn

**Risk Level:** Medium

**Speed Limit:** 30 KM/Hr

**Coordinates:** 11.33668, 77.81596

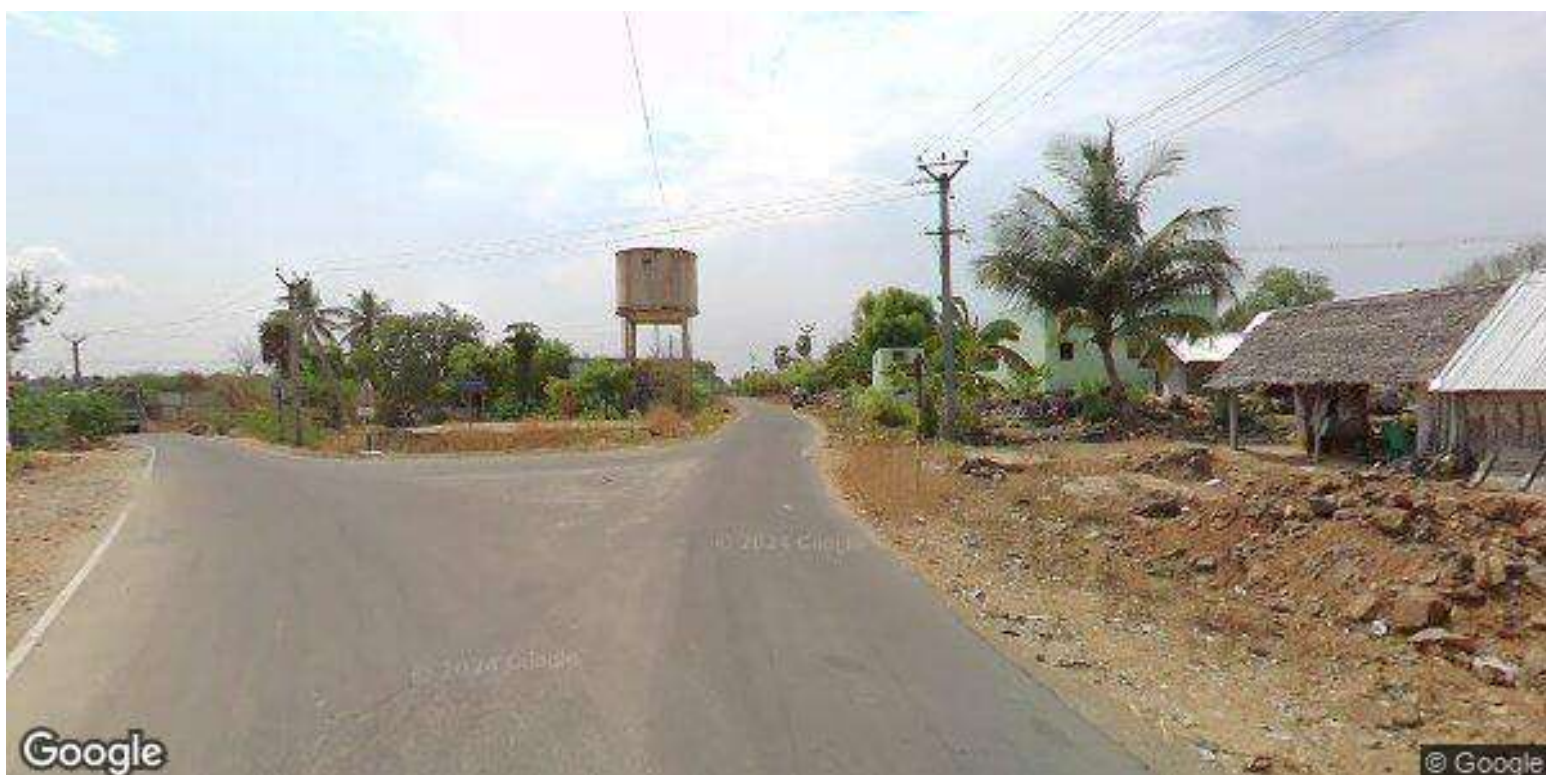
**Risk Type:** Turn  
**Risk Level:** Medium  
**Speed Limit:** 30 KM/Hr  
**Coordinates:** 11.33552, 77.81470

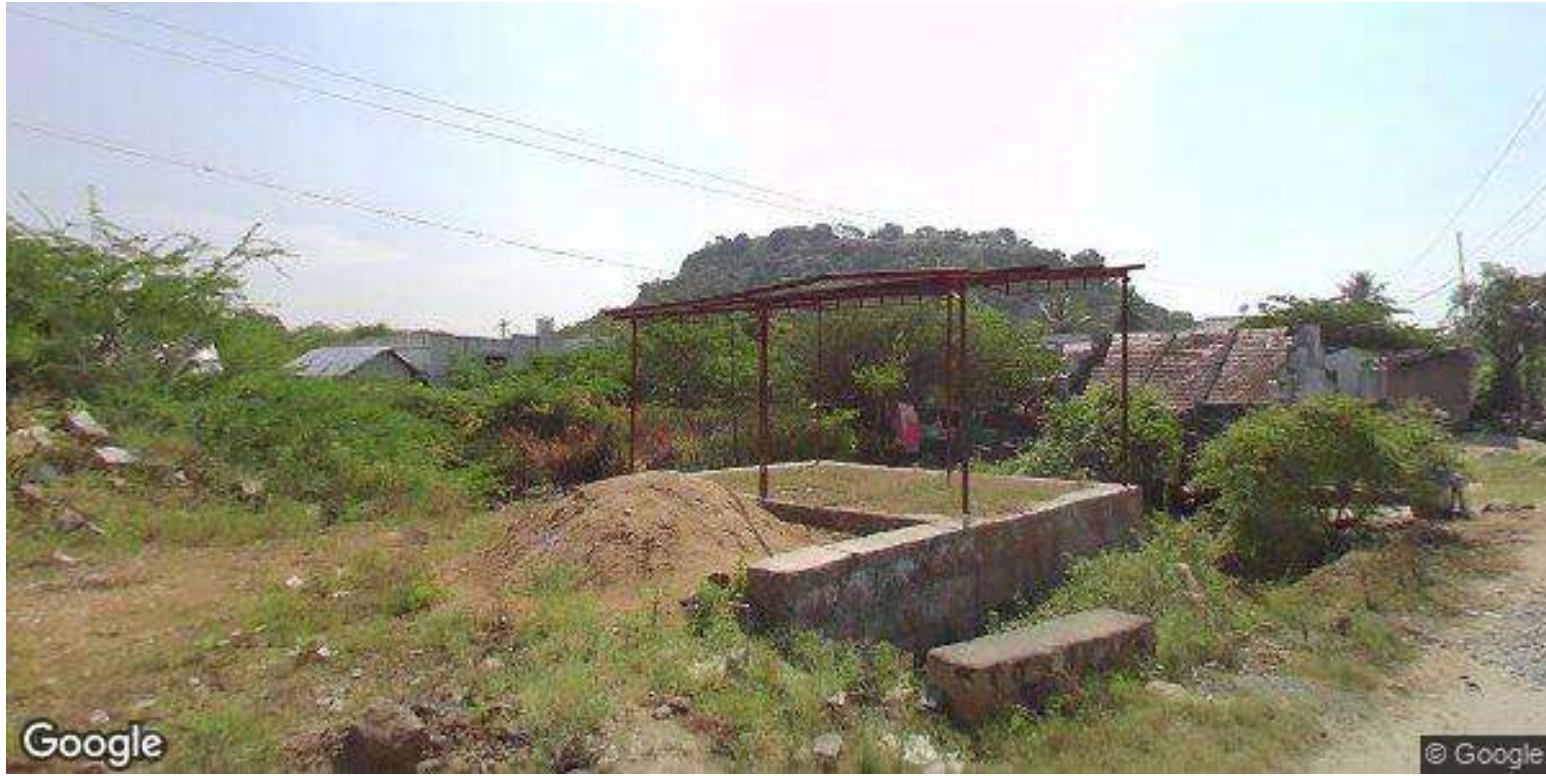
**Risk Type:** Turn  
**Risk Level:** High  
**Speed Limit:** 15 KM/Hr  
**Coordinates:** 11.33554, 77.81355

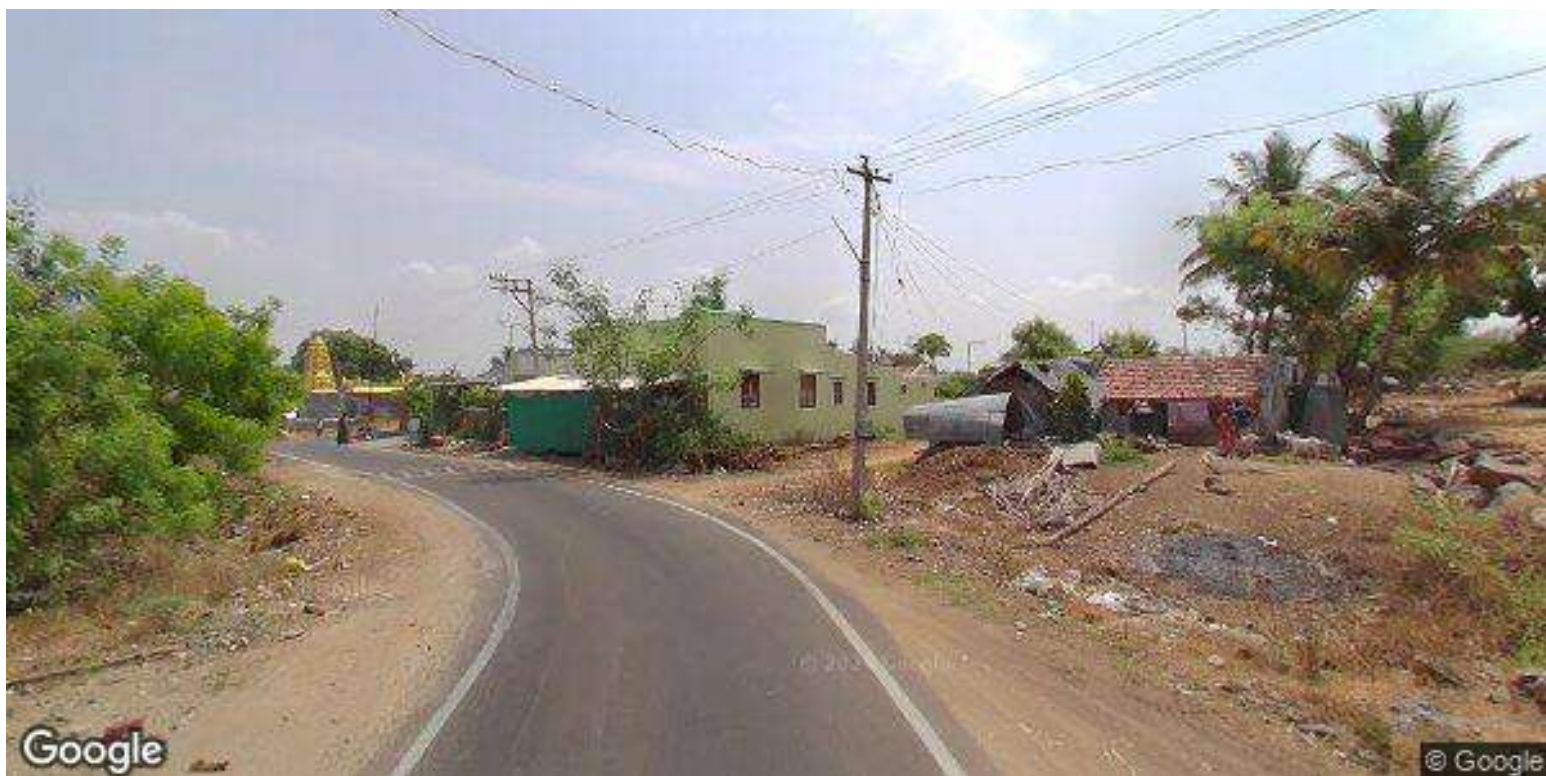
**Risk Type:** Turn  
**Risk Level:** Medium  
**Speed Limit:** 30 KM/Hr  
**Coordinates:** 11.33480, 77.81344

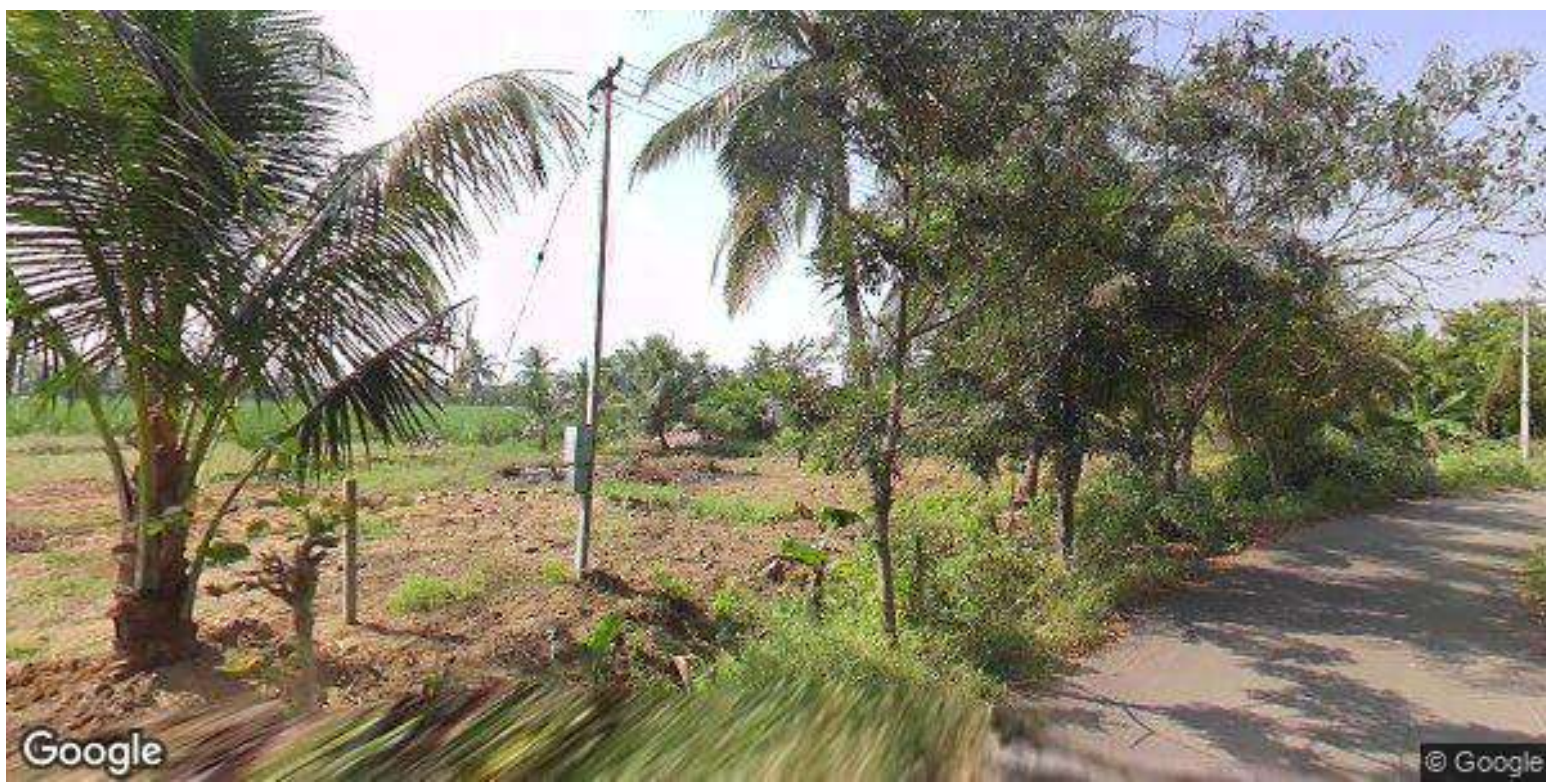
**Risk Type:** Turn

**Risk Level:** High

**Speed Limit:** 15 KM/Hr

**Coordinates:** 11.32143, 77.79174

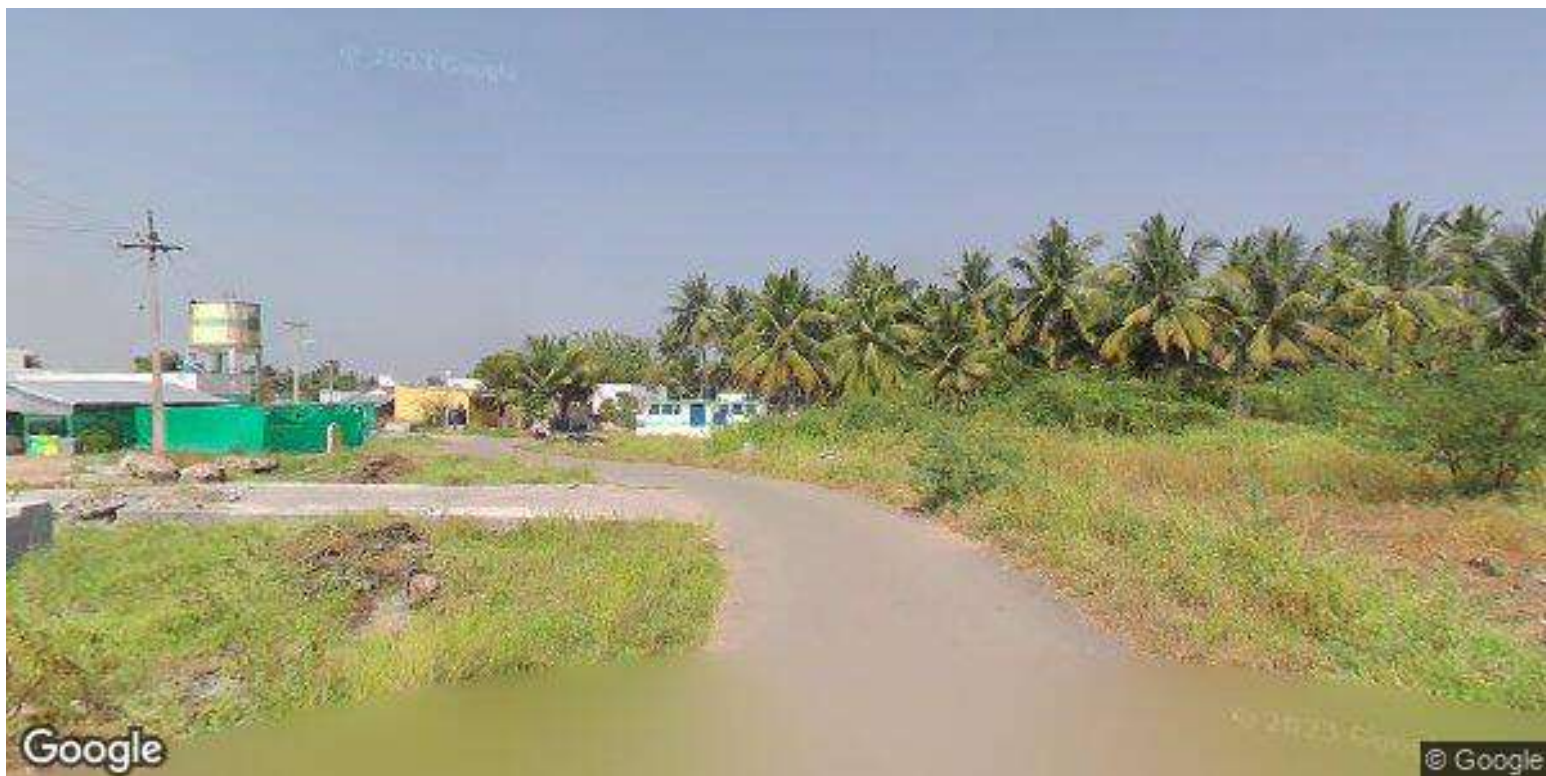
**Risk Type:** Turn

**Risk Level:** Medium

**Speed Limit:** 30 KM/Hr

**Coordinates:** 11.32349, 77.79012

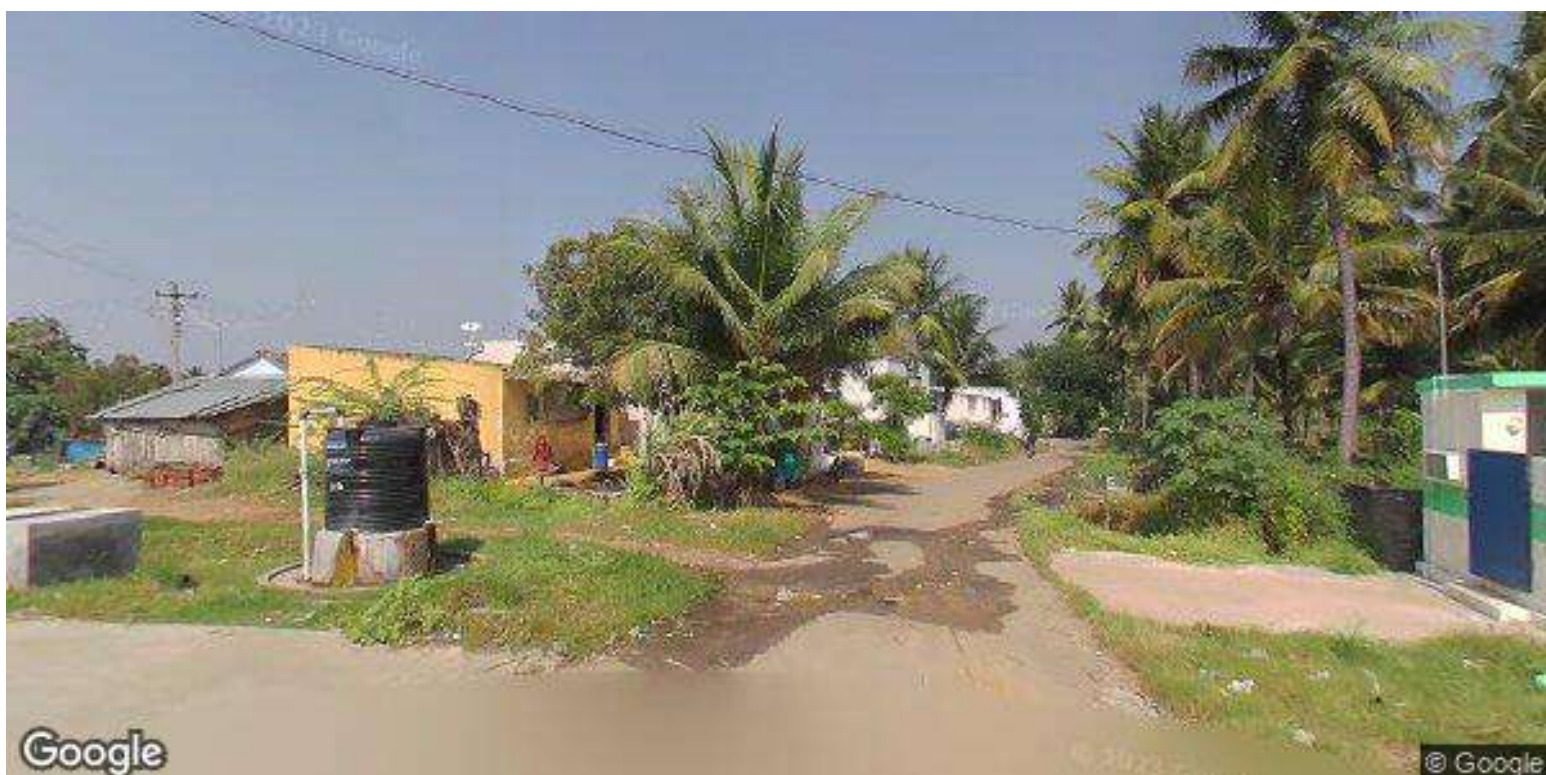
**Risk Type:** Turn  
**Risk Level:** Medium  
**Speed Limit:** 30 KM/Hr  
**Coordinates:** 11.32378, 77.78975

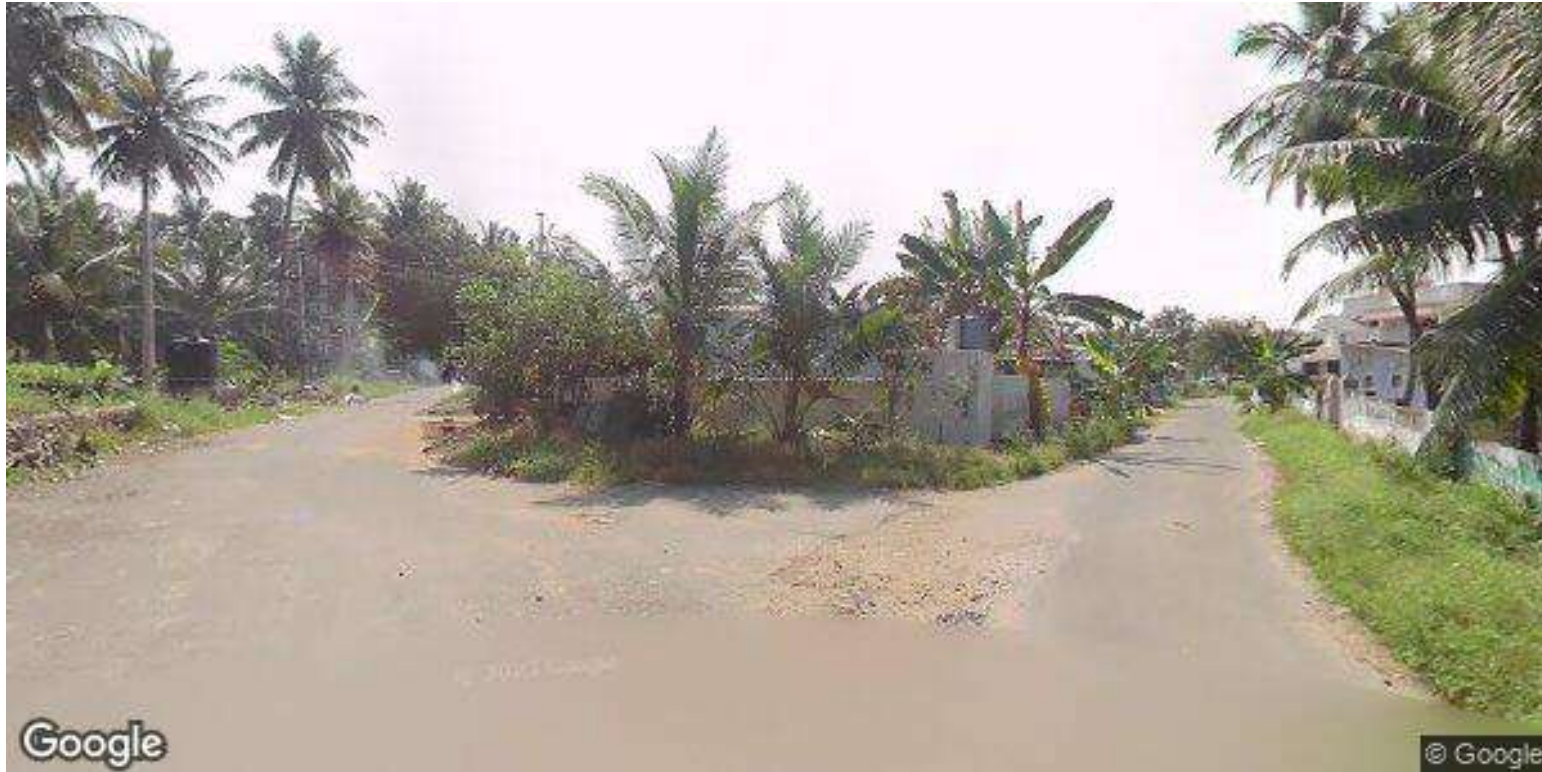
**Risk Type:** Blind Spot  
**Risk Level:** Blind Spot  
**Speed Limit:** 10 KM/Hr  
**Coordinates:** 11.32490, 77.78918

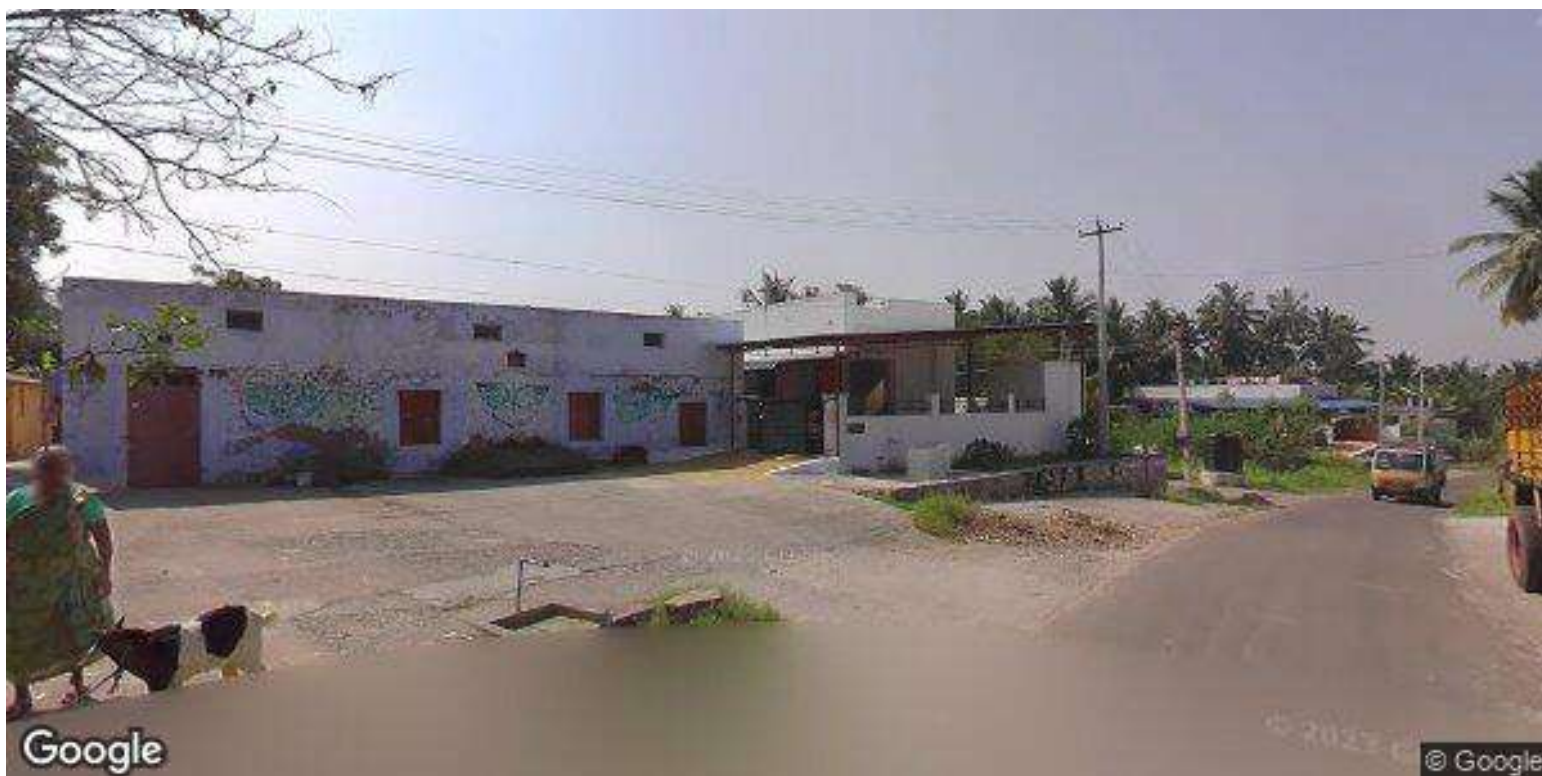
**Risk Type:** Turn  
**Risk Level:** Medium  
**Speed Limit:** 30 KM/Hr  
**Coordinates:** 11.32408, 77.78895

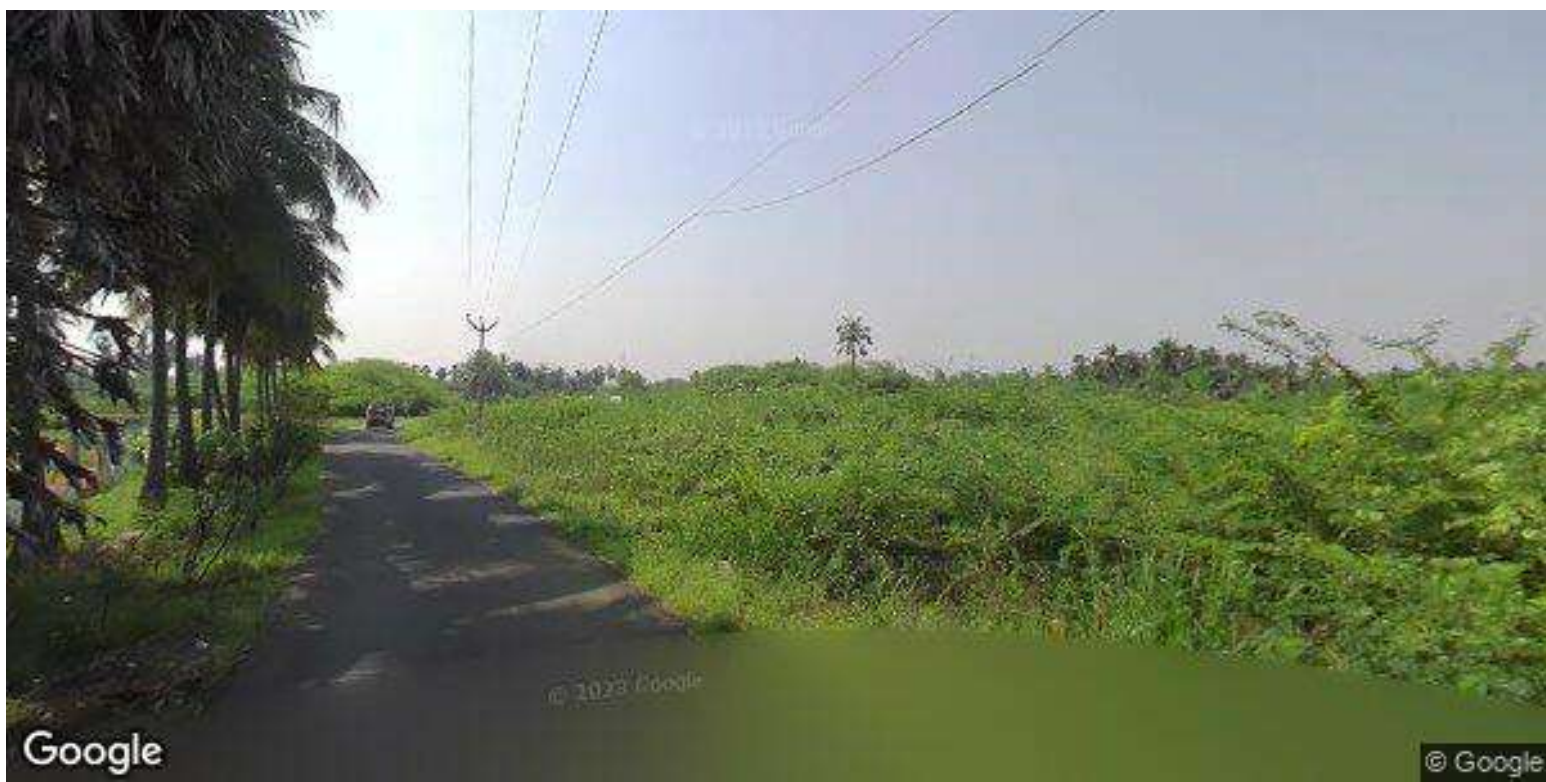
**Risk Type:** Turn

**Risk Level:** Medium

**Speed Limit:** 30 KM/Hr

**Coordinates:** 11.32243, 77.78555

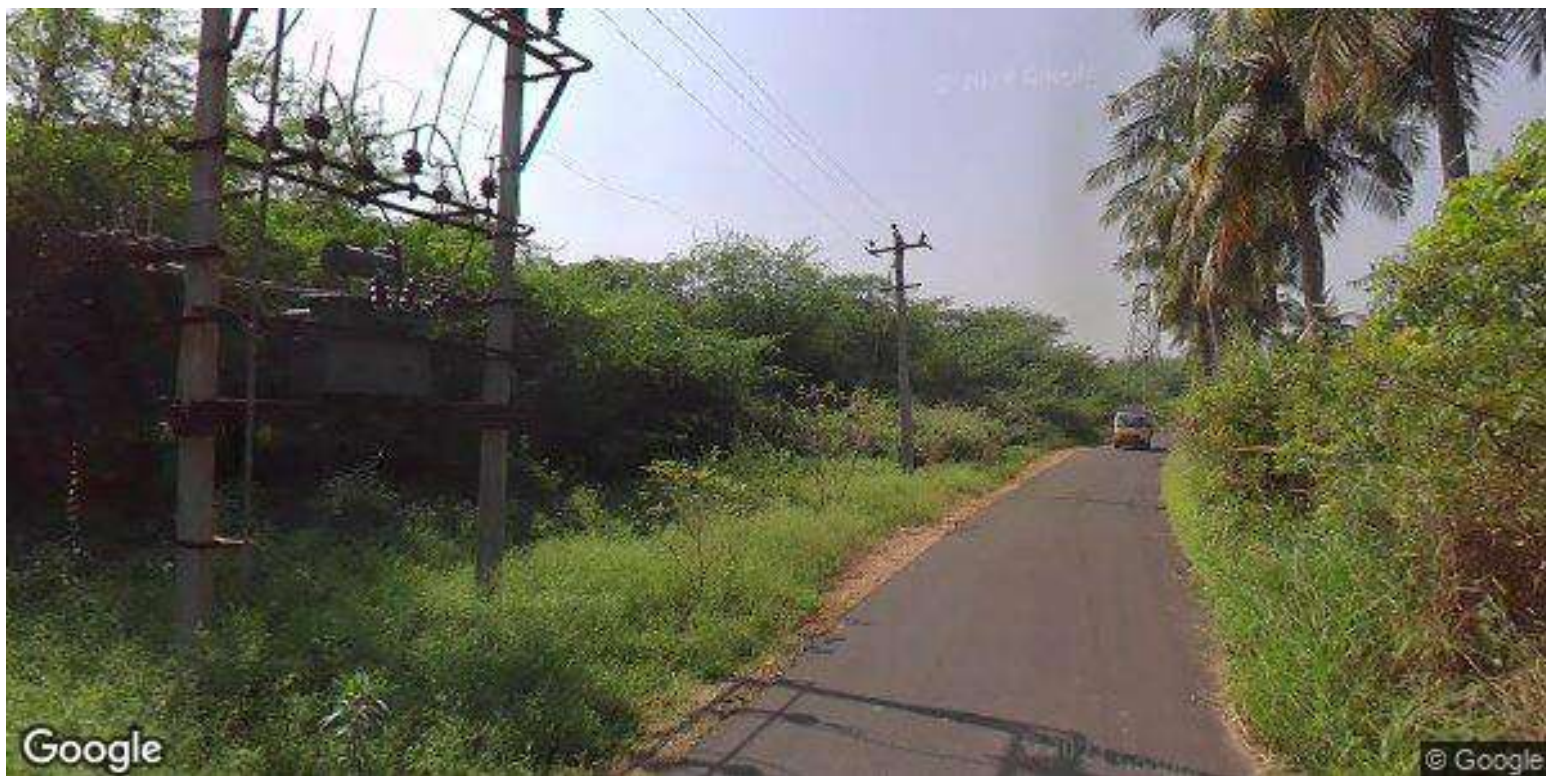
**Risk Type:** Turn

**Risk Level:** Medium

**Speed Limit:** 30 KM/Hr

**Coordinates:** 11.32013, 77.78492

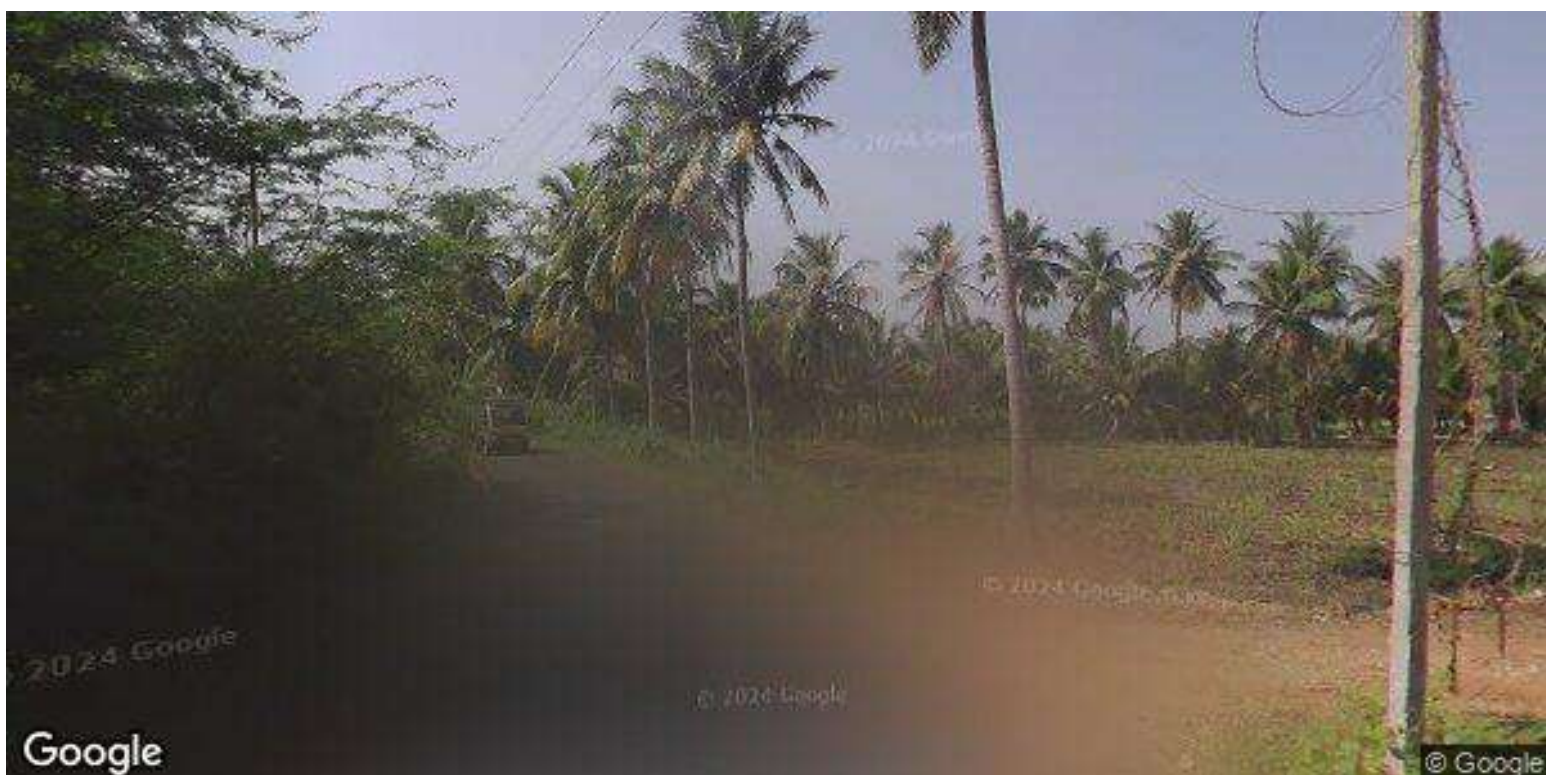
**Risk Type:** Turn

**Risk Level:** Medium

**Speed Limit:** 30 KM/Hr

**Coordinates:** 11.31955, 77.78388

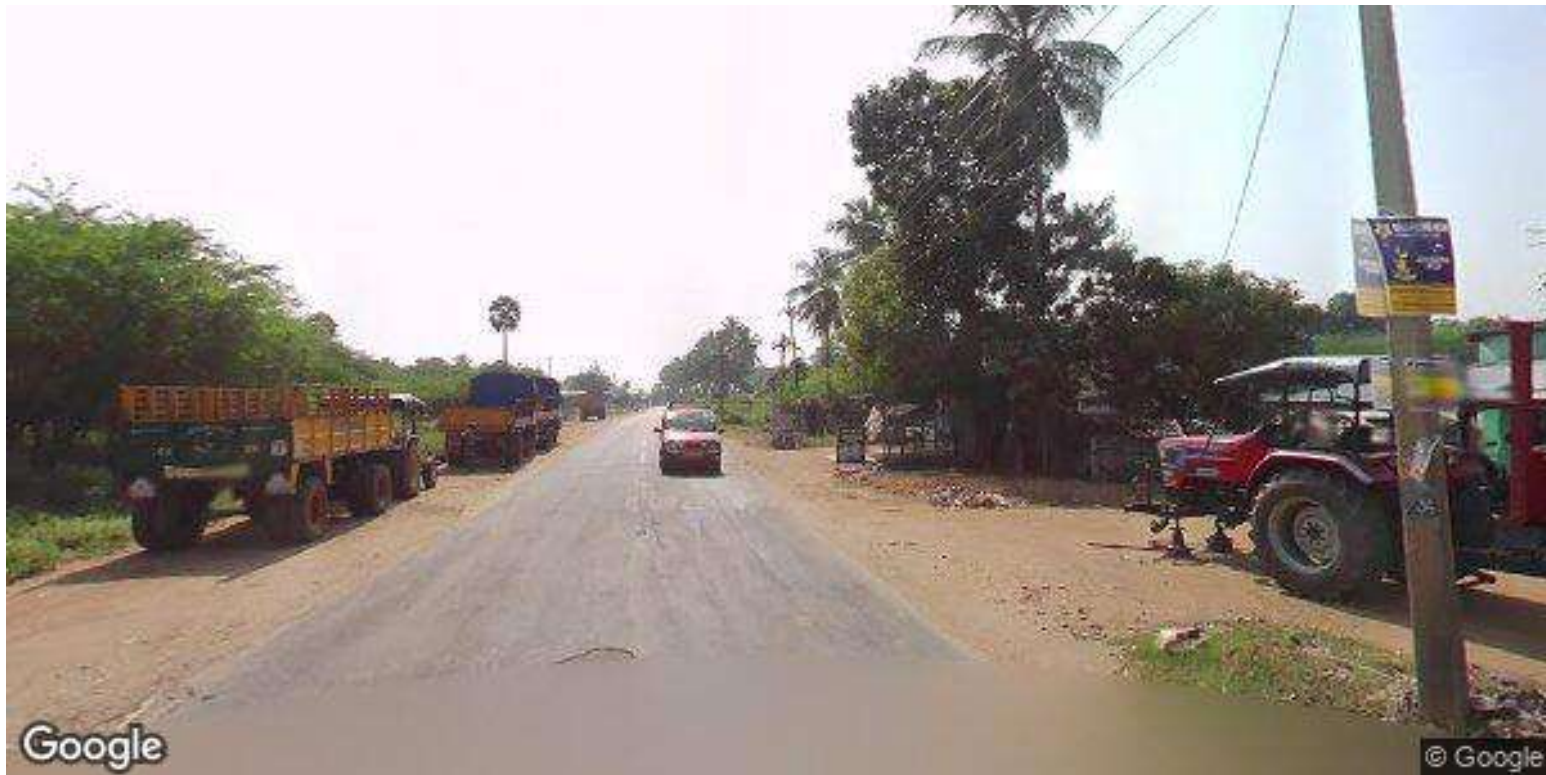
**Risk Type:** Blind Spot

**Risk Level:** Blind Spot

**Speed Limit:** 10 KM/Hr

**Coordinates:** 11.31627, 77.78274
