## JOURNEY RISK MANAGEMENT (JRM) STUDY

### Salem Terminal to ABHI FUELS

#### Objective of the JRM Report

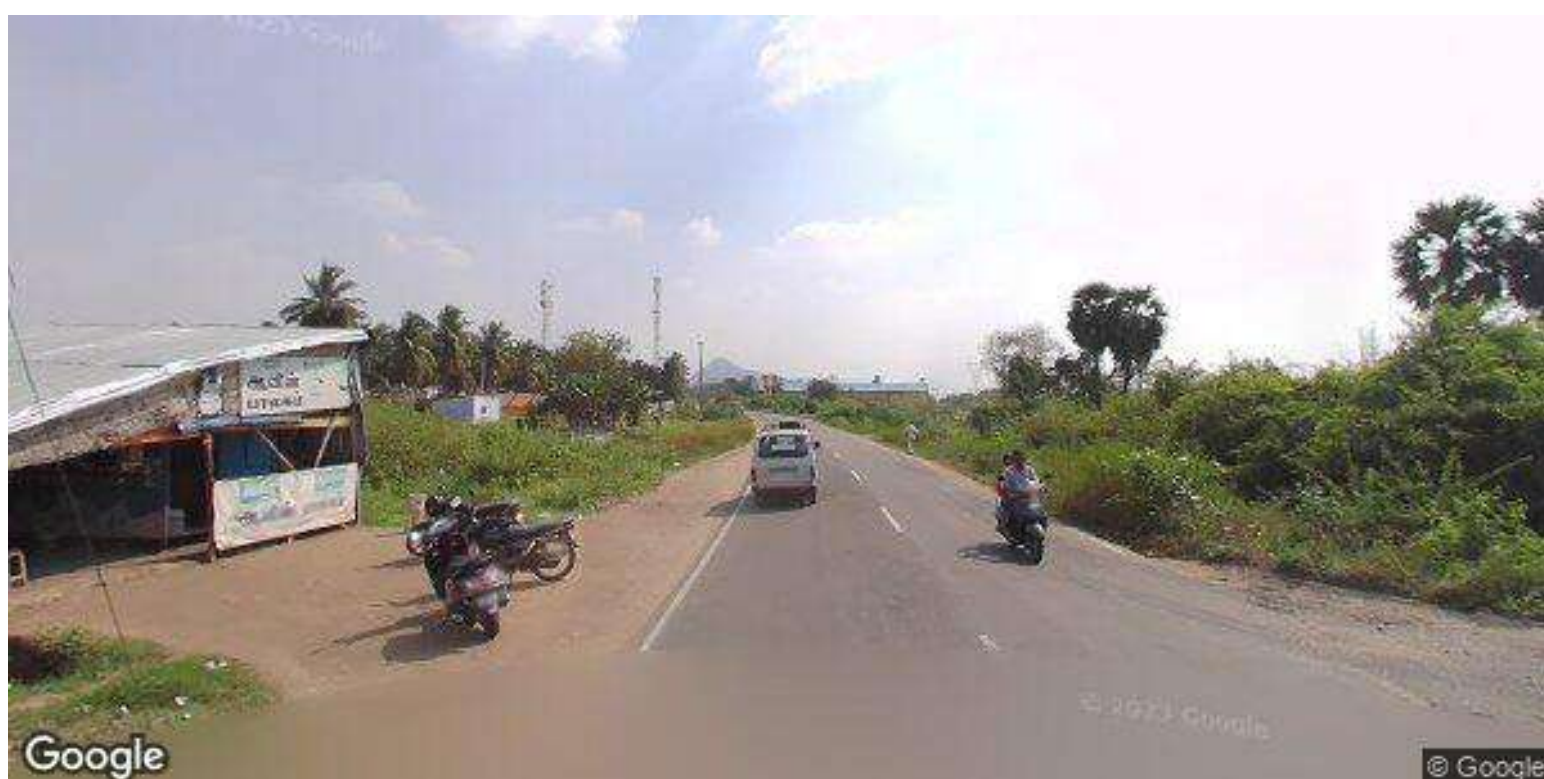
**Risk Type:** Turn

**Risk Level:** High

**Speed Limit: 15 KM/Hr**  
**Coordinates: 11.44022, 77.87546**

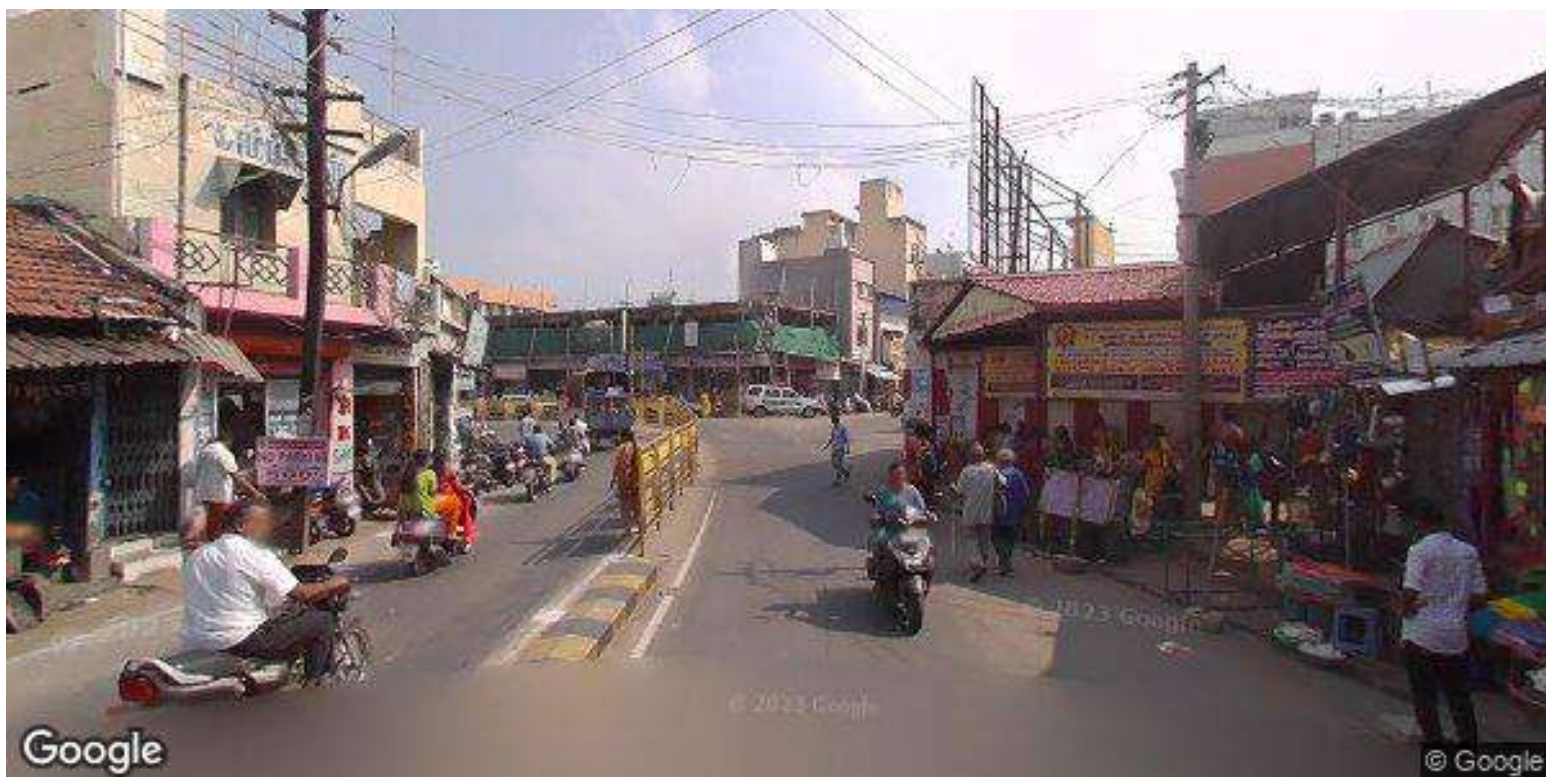
**Risk Type: Turn**  
**Risk Level: Medium**  
**Speed Limit: 30 KM/Hr**  
**Coordinates: 11.37857, 77.89473**

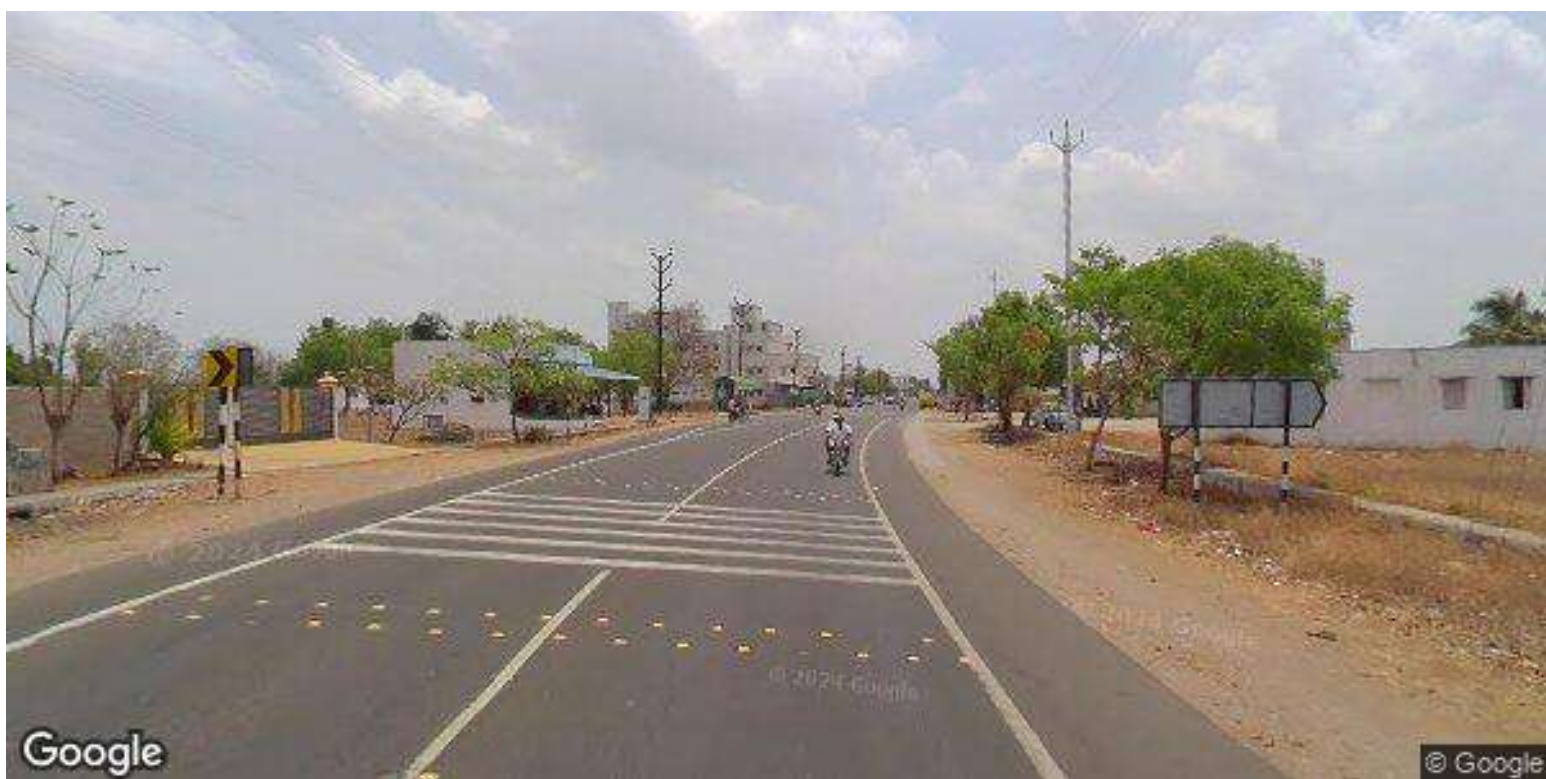
**Coordinates:** 11.26050, 77.94758

**Risk Type:** Turn

**Risk Level:** Medium

**Speed Limit:** 30 KM/Hr

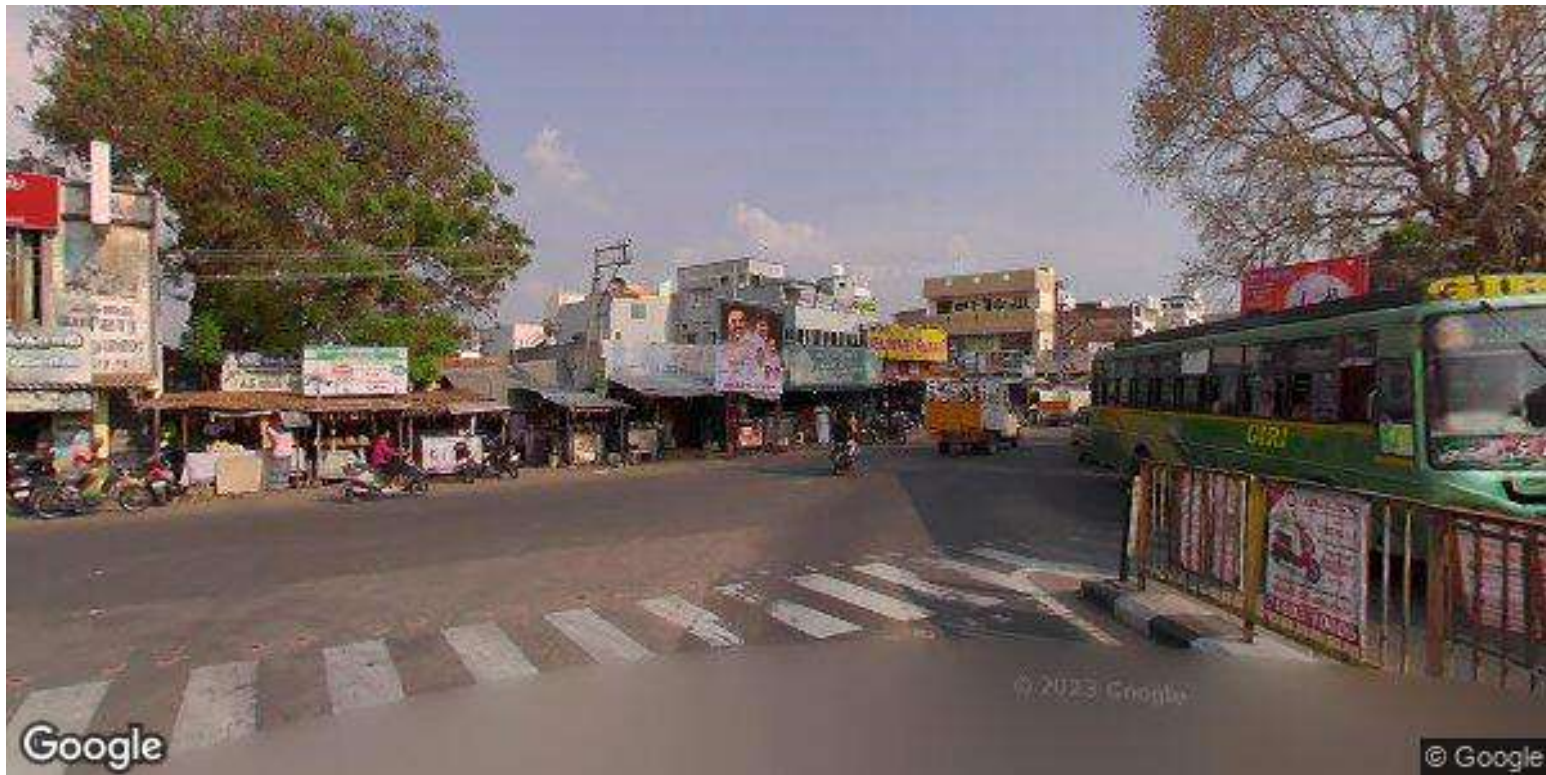
**Coordinates:** 11.15579, 78.02169

**Risk Type:** Turn

**Risk Level:** Medium

**Speed Limit:** 30 KM/Hr

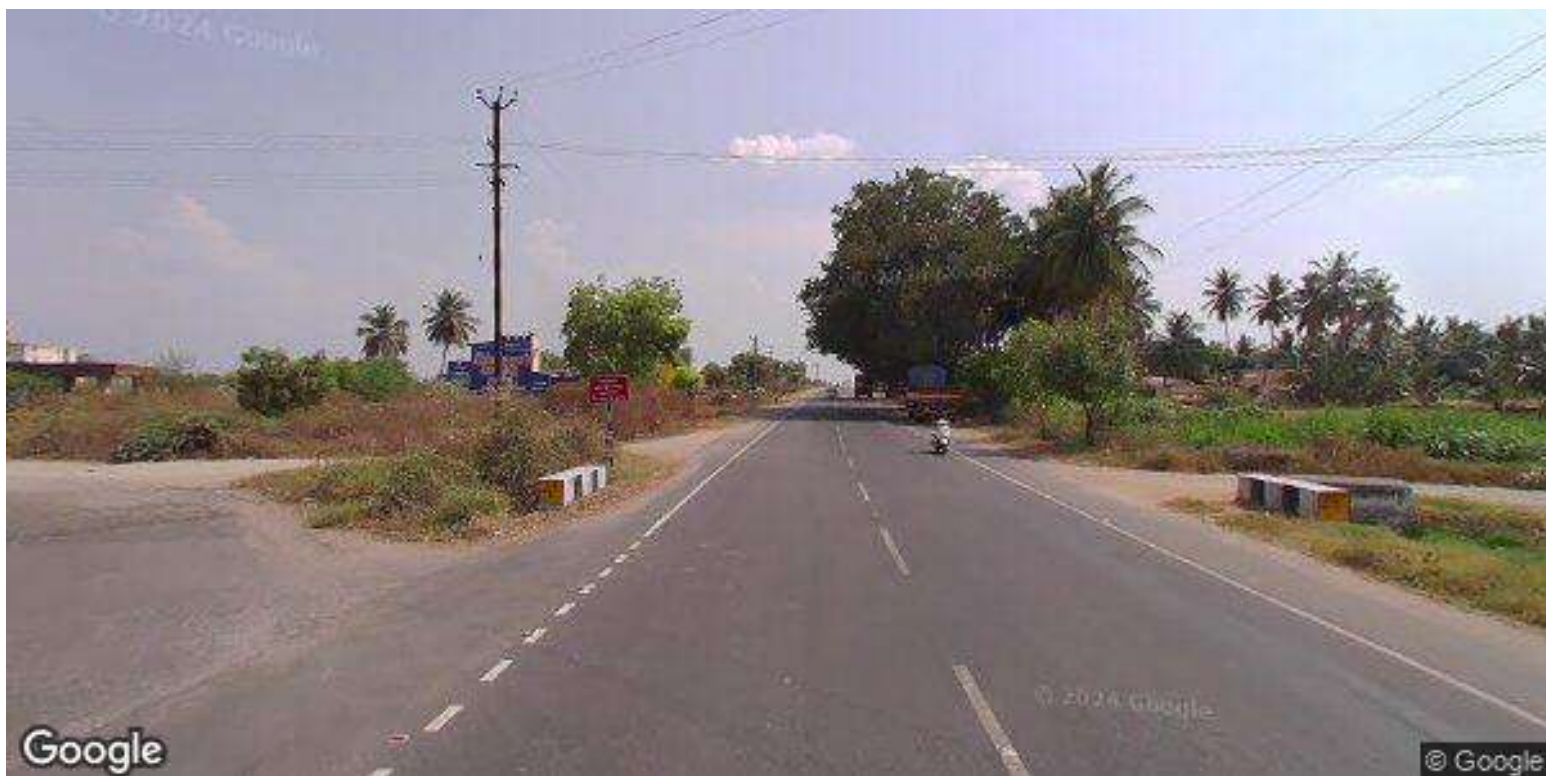
**Coordinates:** 11.14545, 78.02208

**Risk Type:** Turn

**Risk Level:** High

**Speed Limit:** 15 KM/Hr

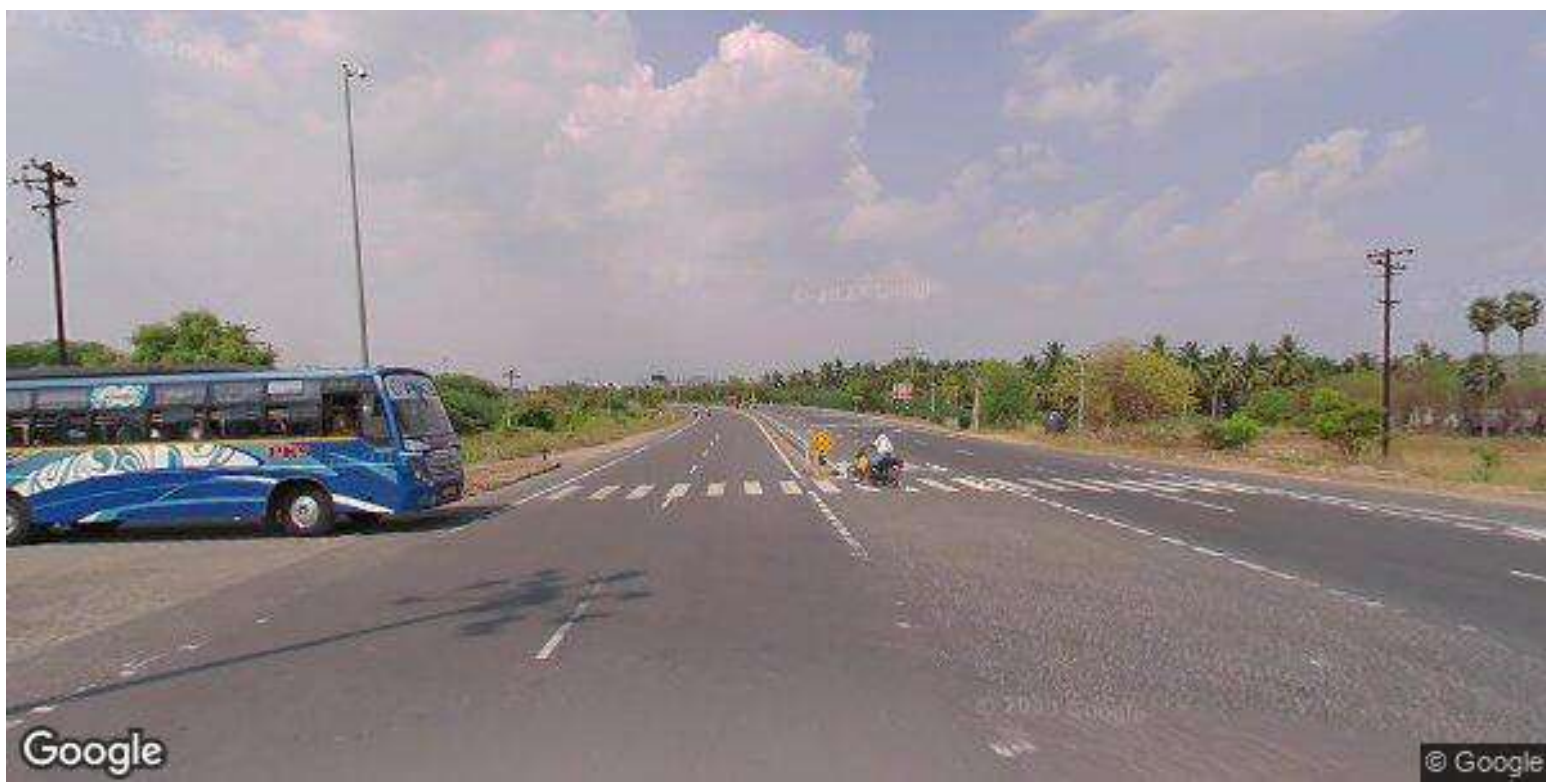
**Coordinates:** 11.14485, 78.02282

**Risk Type:** Turn

**Risk Level:** High

**Speed Limit:** 15 KM/Hr

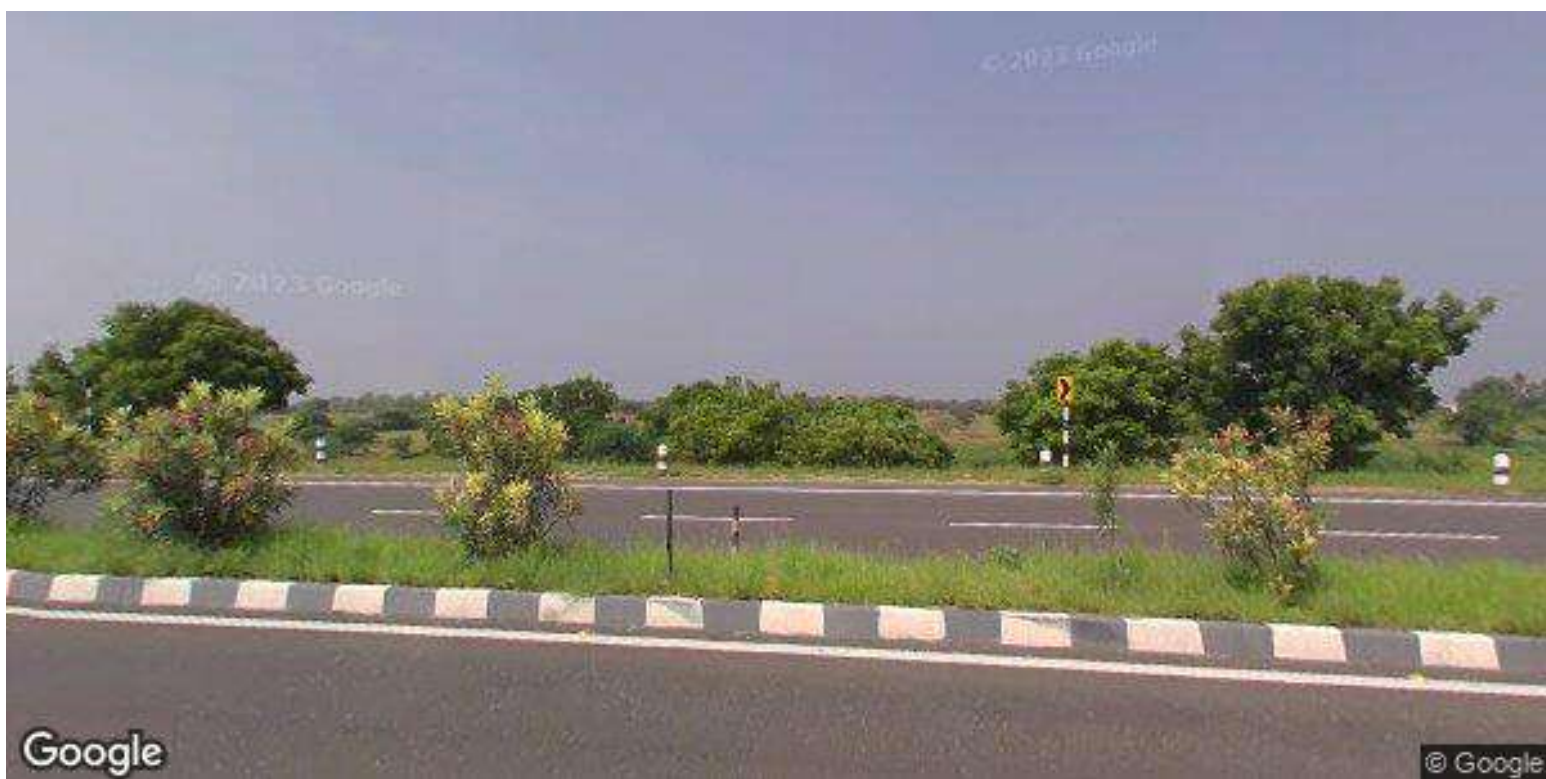
**Coordinates:** 10.79871, 77.92719

**Risk Type:** Turn

**Risk Level:** Medium

**Speed Limit:** 30 KM/Hr

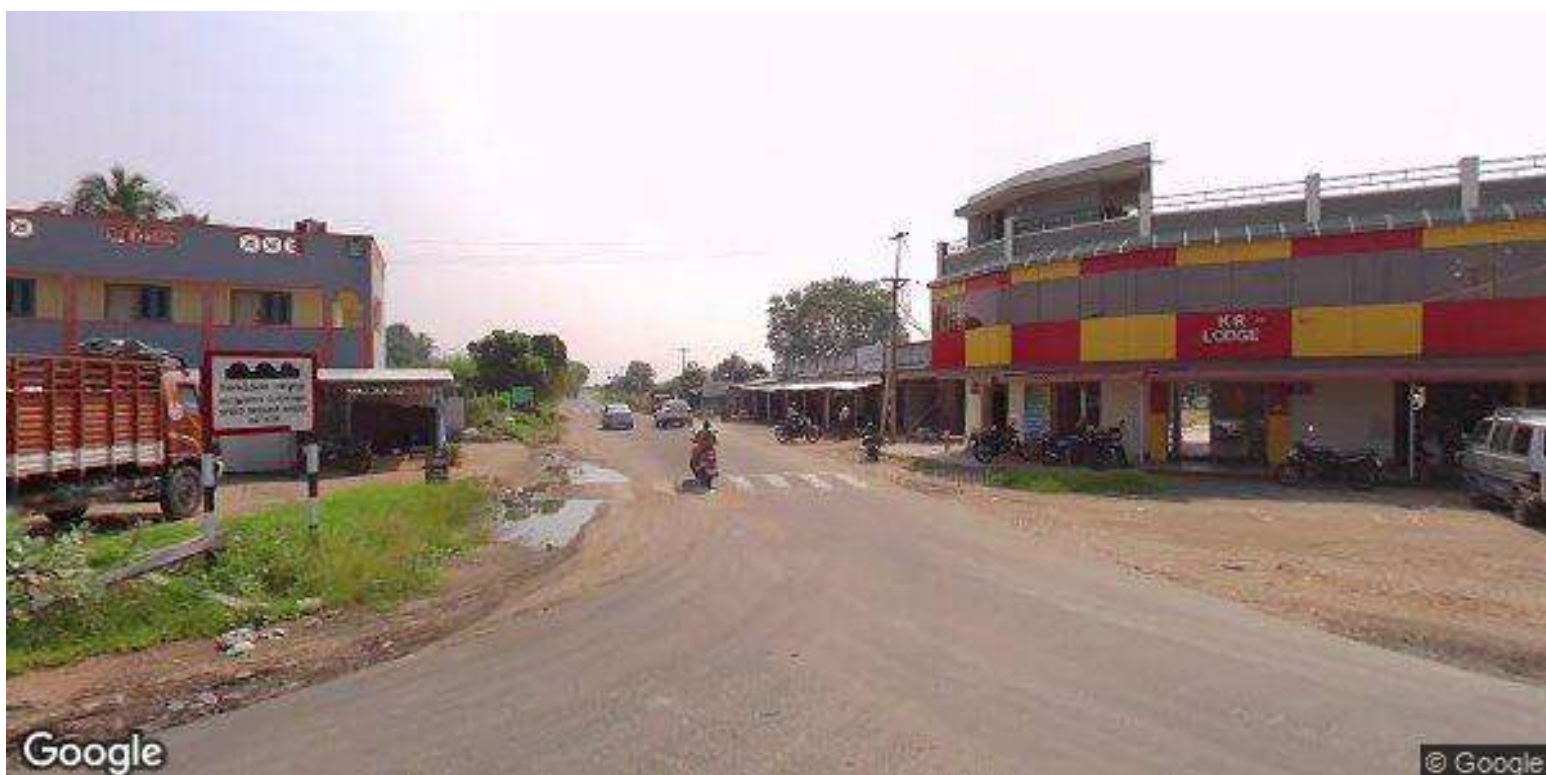
**Risk Type:** Blind Spot  
**Risk Level:** Blind Spot  
**Speed Limit:** 10 KM/Hr  
**Coordinates:** 10.77306, 77.91788

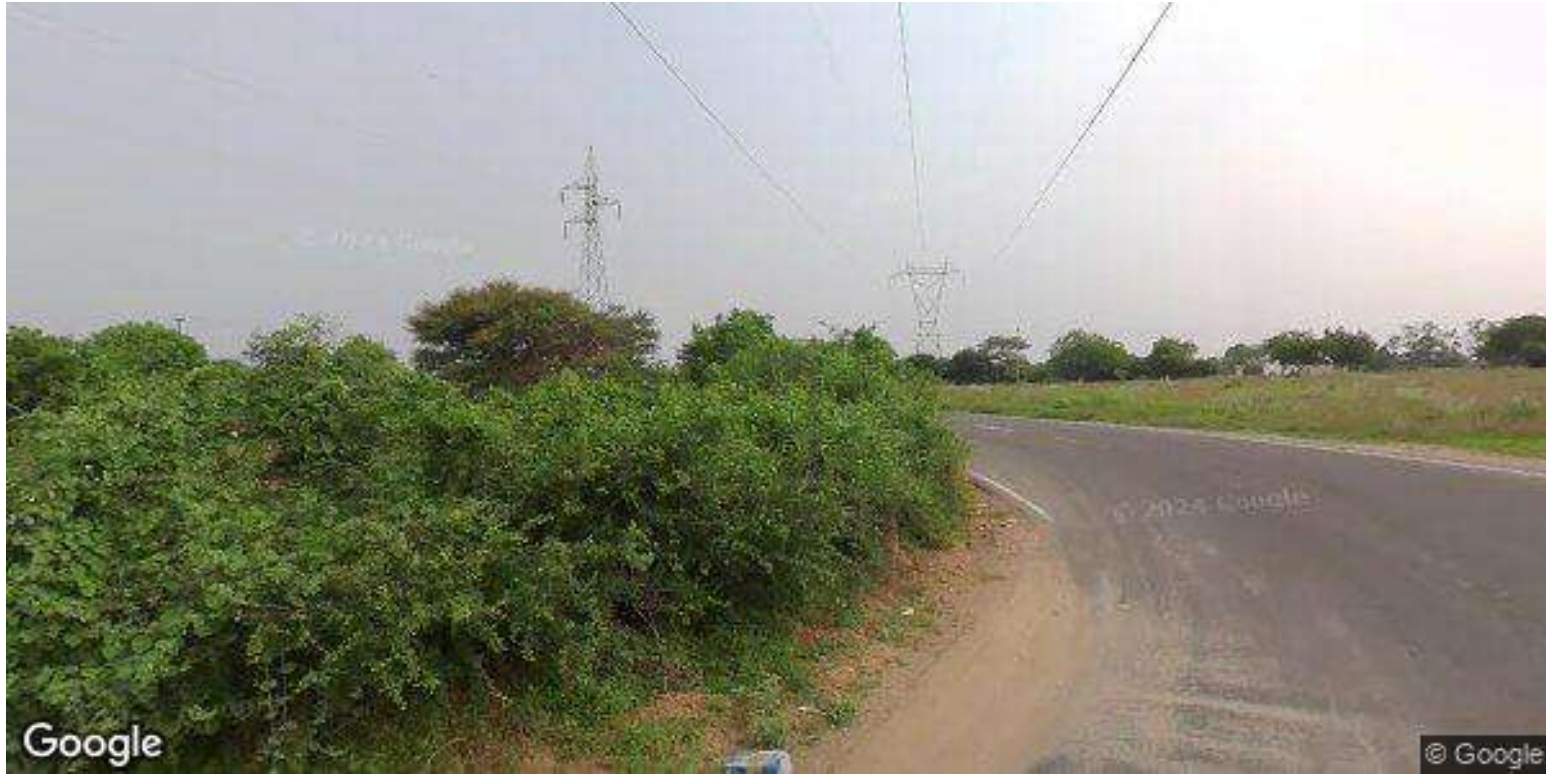
**Risk Type:** Turn  
**Risk Level:** High  
**Speed Limit:** 15 KM/Hr  
**Coordinates:** 10.77230, 77.93223

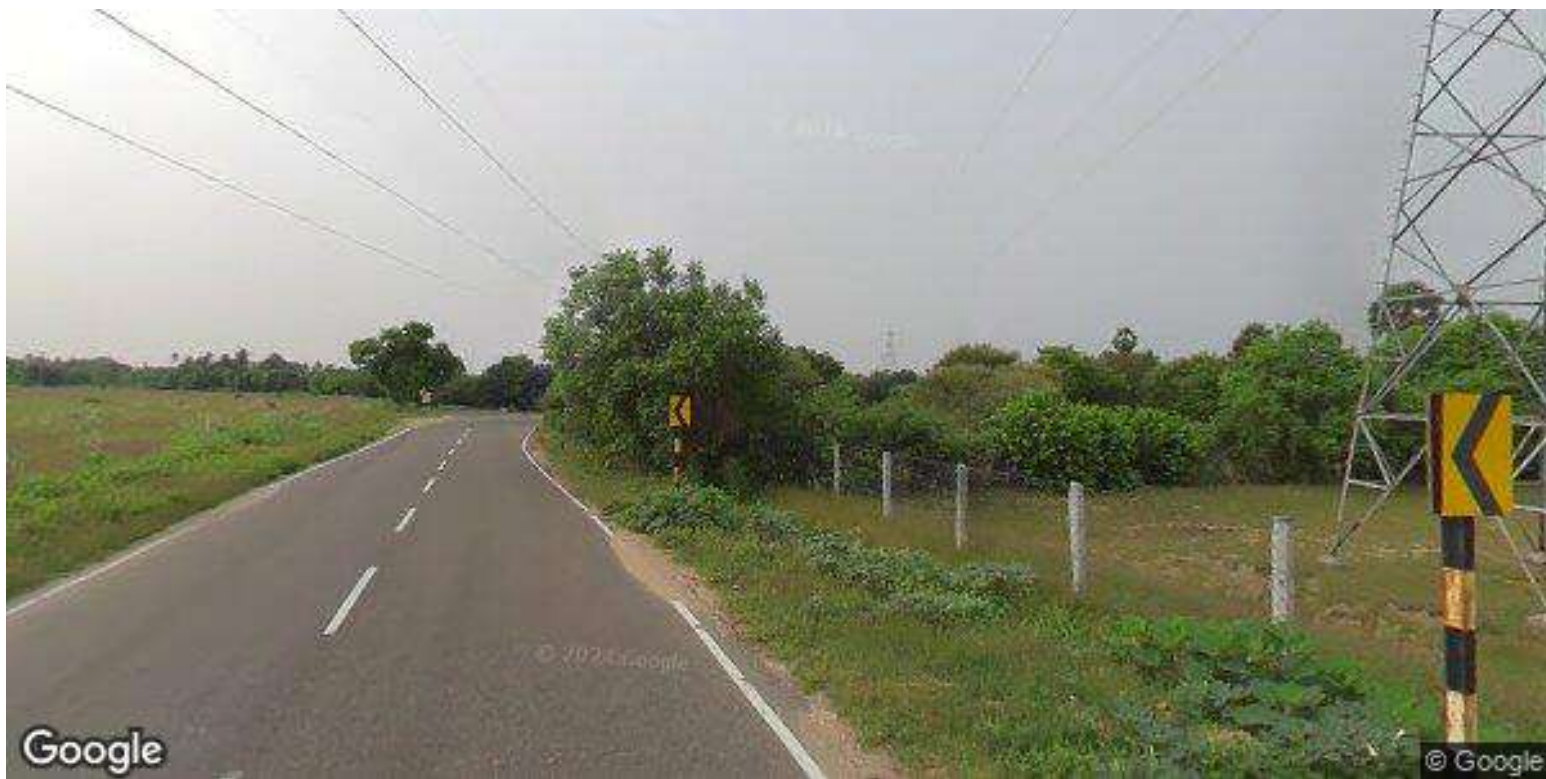
**Risk Type:** Turn  
**Risk Level:** High  
**Speed Limit:** 15 KM/Hr  
**Coordinates:** 10.77294, 77.93238

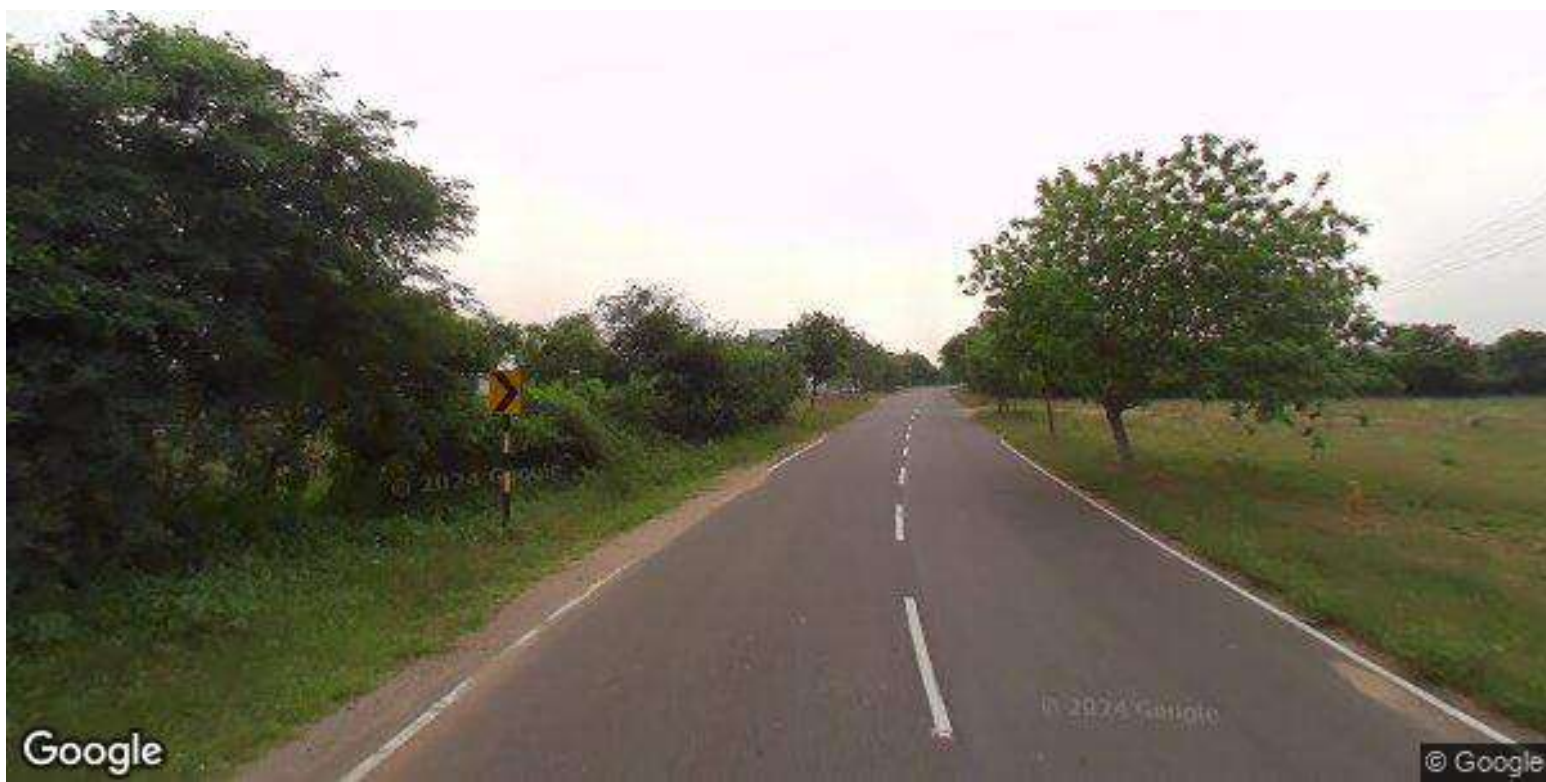
**Coordinates:** 10.77303, 77.93269

**Risk Type:** Turn

**Risk Level:** Medium

**Speed Limit:** 30 KM/Hr

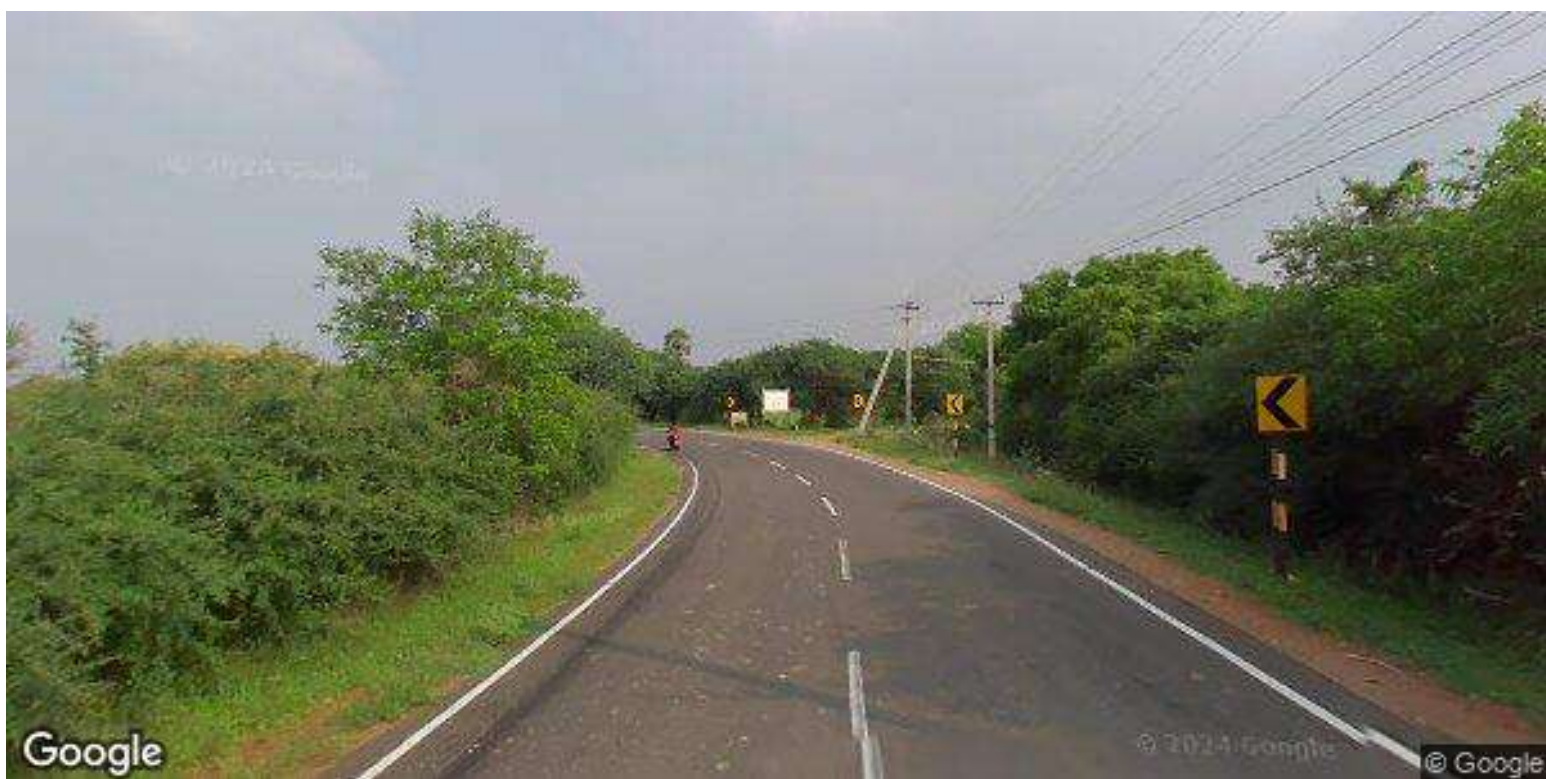
**Coordinates:** 10.76865, 77.93912

**Risk Type:** Turn

**Risk Level:** Medium

**Speed Limit:** 30 KM/Hr
