# IndianOil

## JOURNEY RISK MANAGEMENT (JRM) STUDY

### Salem Terminal TO SRI VELMURUGA FUELS

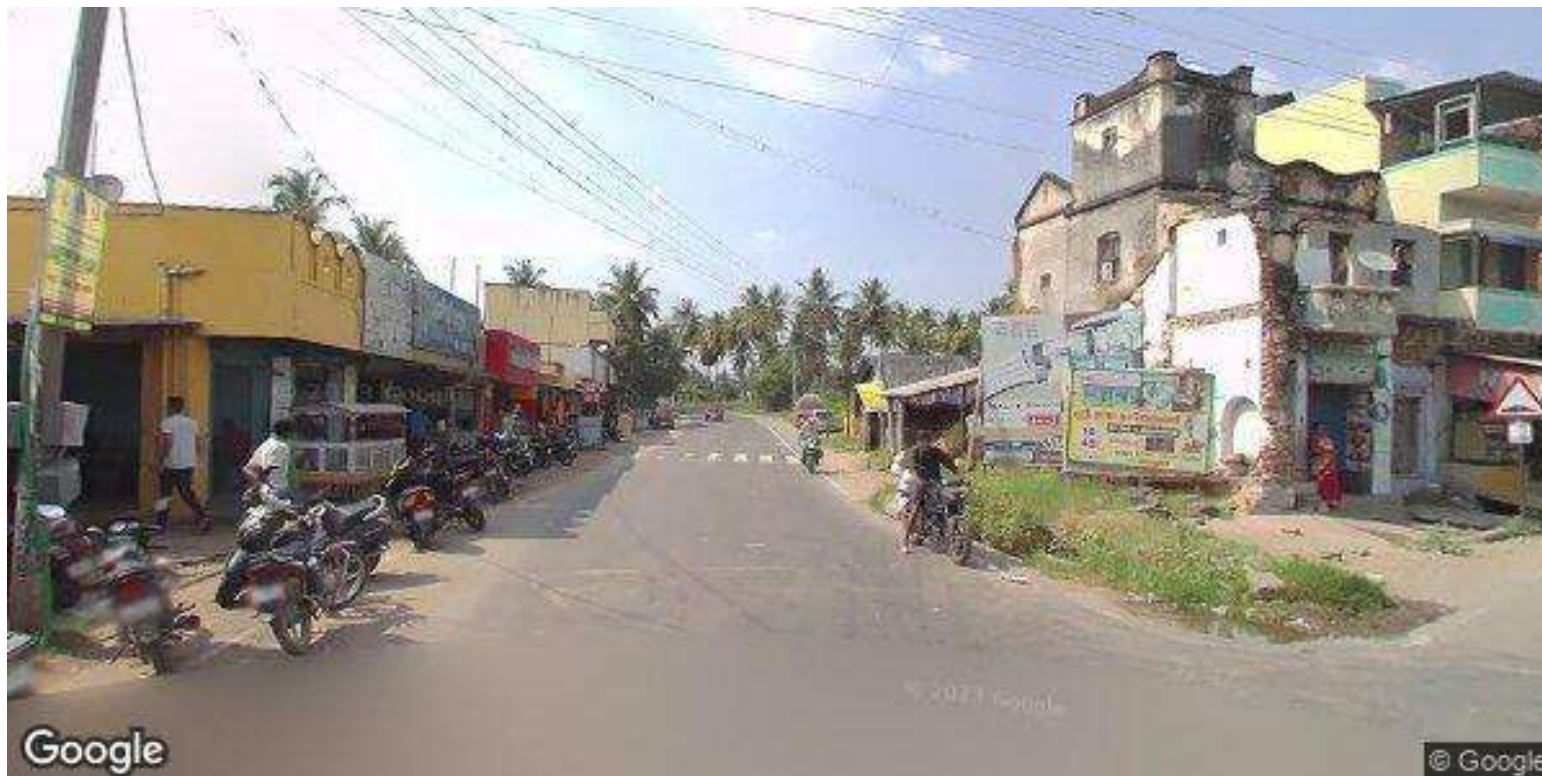
**Coordinates: 11.45007, 77.87201**

**Risk Type: Turn**

**Risk Level: High**

**Speed Limit: 15 KM/Hr**

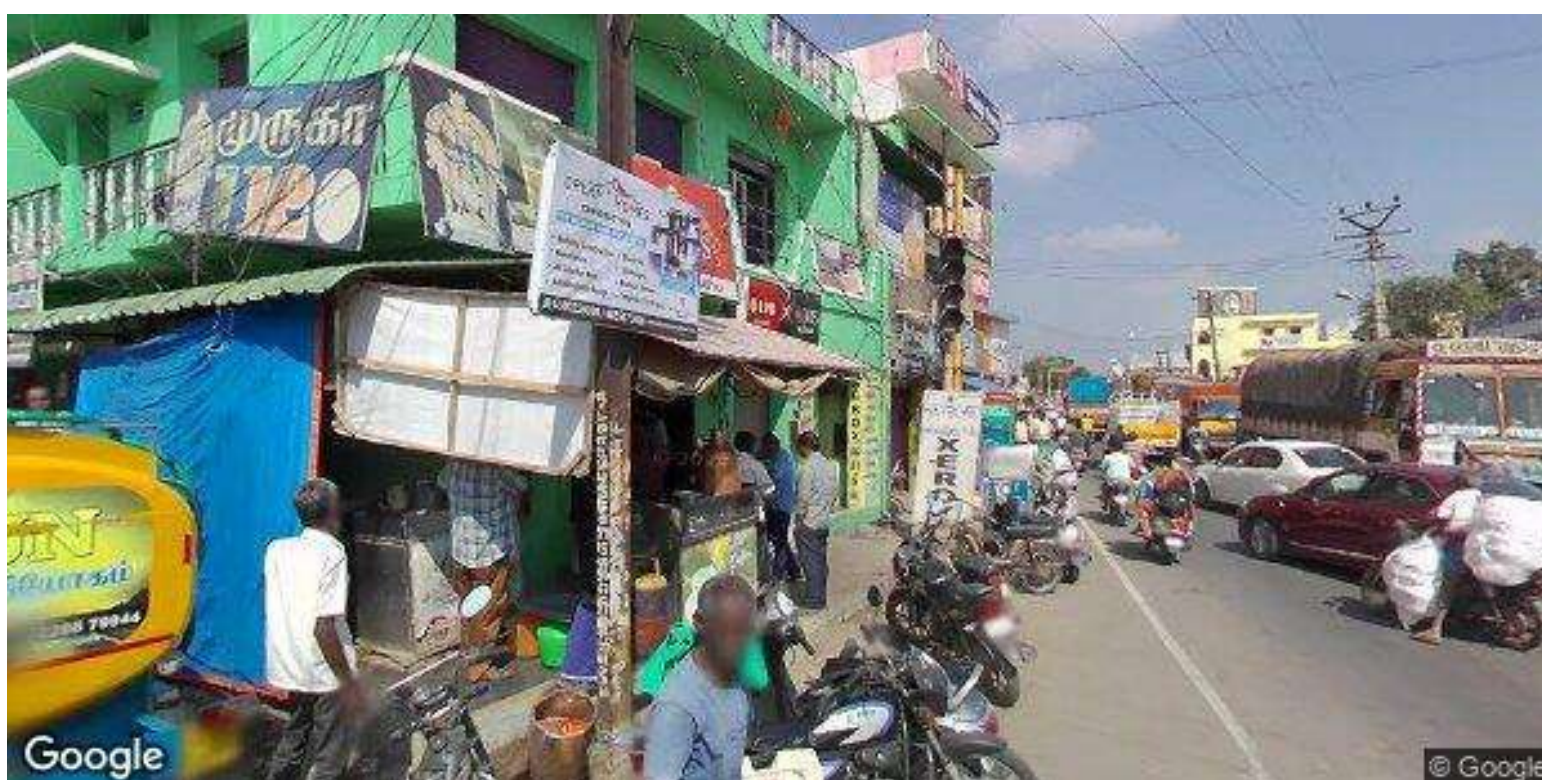
**Coordinates: 11.47407, 77.86839**

**Risk Type: Turn**

**Risk Level: High**

**Speed Limit: 15 KM/Hr**

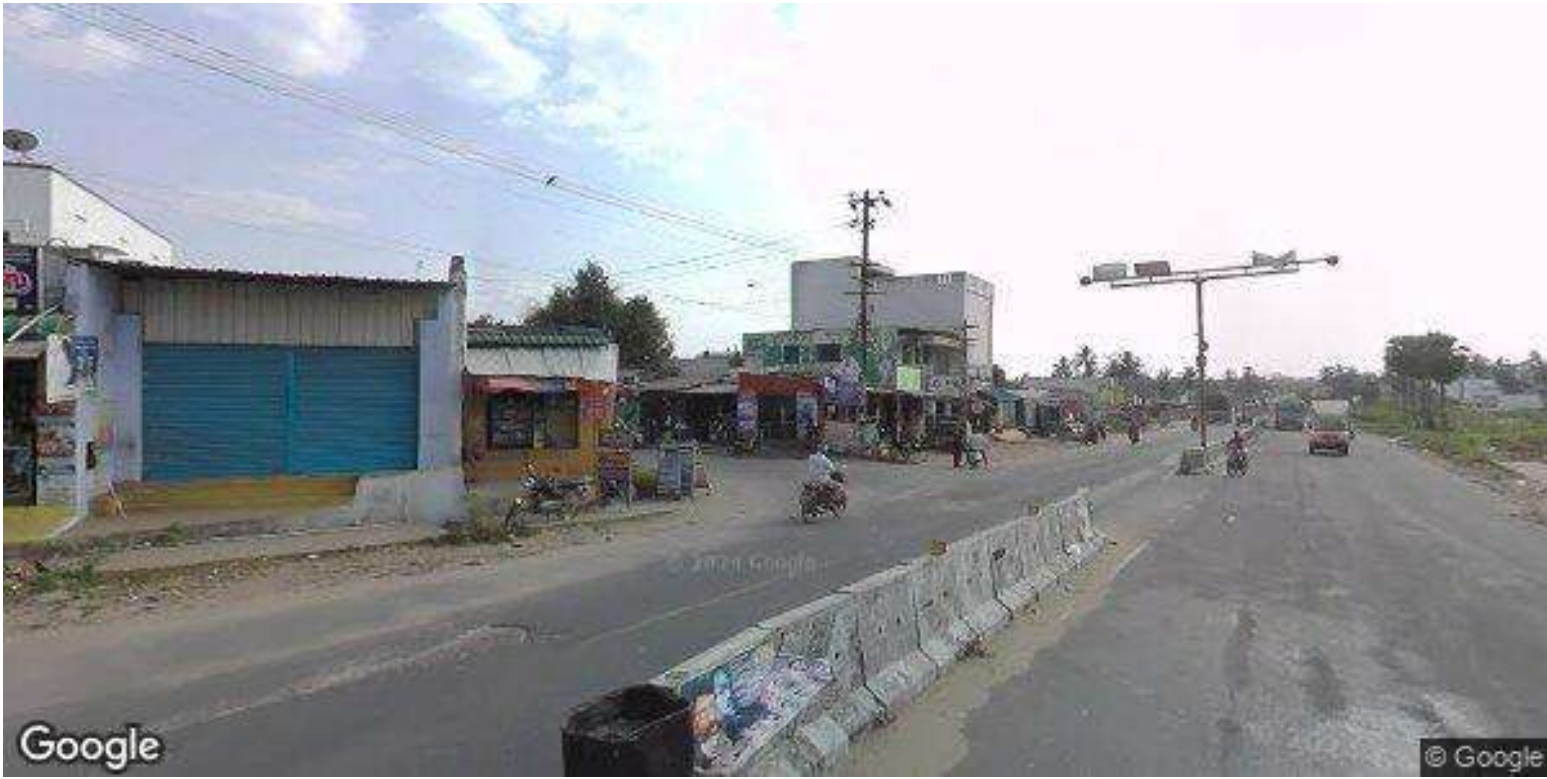
**Risk Type:** Turn  
**Risk Level:** Medium  
**Speed Limit:** 30 KM/Hr  
**Coordinates:** 11.48363, 77.88780

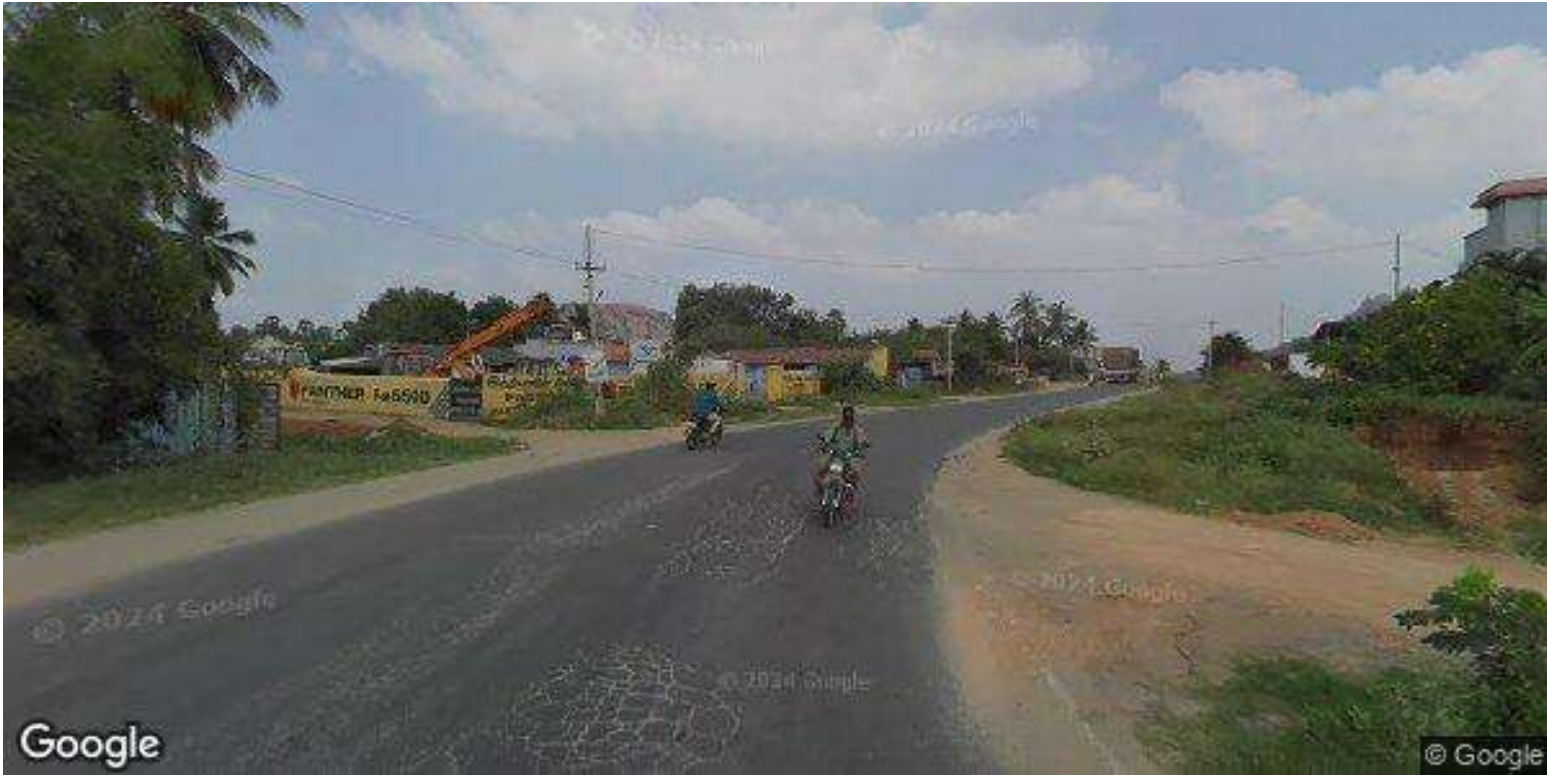
**Risk Type:** Turn  
**Risk Level:** Medium  
**Speed Limit:** 30 KM/Hr  
**Coordinates:** 11.49451, 77.88489

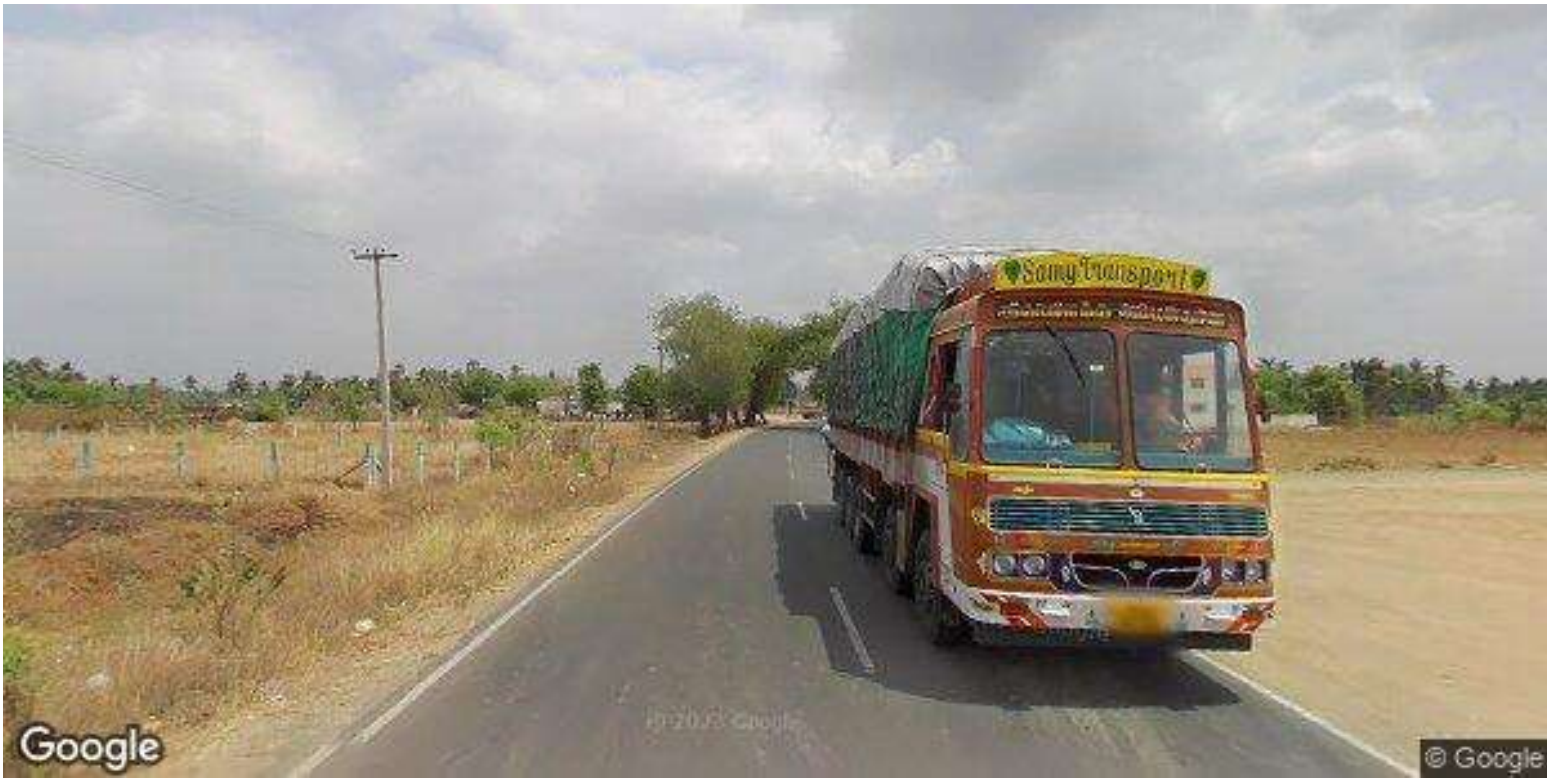
**Risk Type:** Turn  
**Risk Level:** High  
**Speed Limit:** 15 KM/Hr  
**Coordinates:** 11.55614, 77.89764

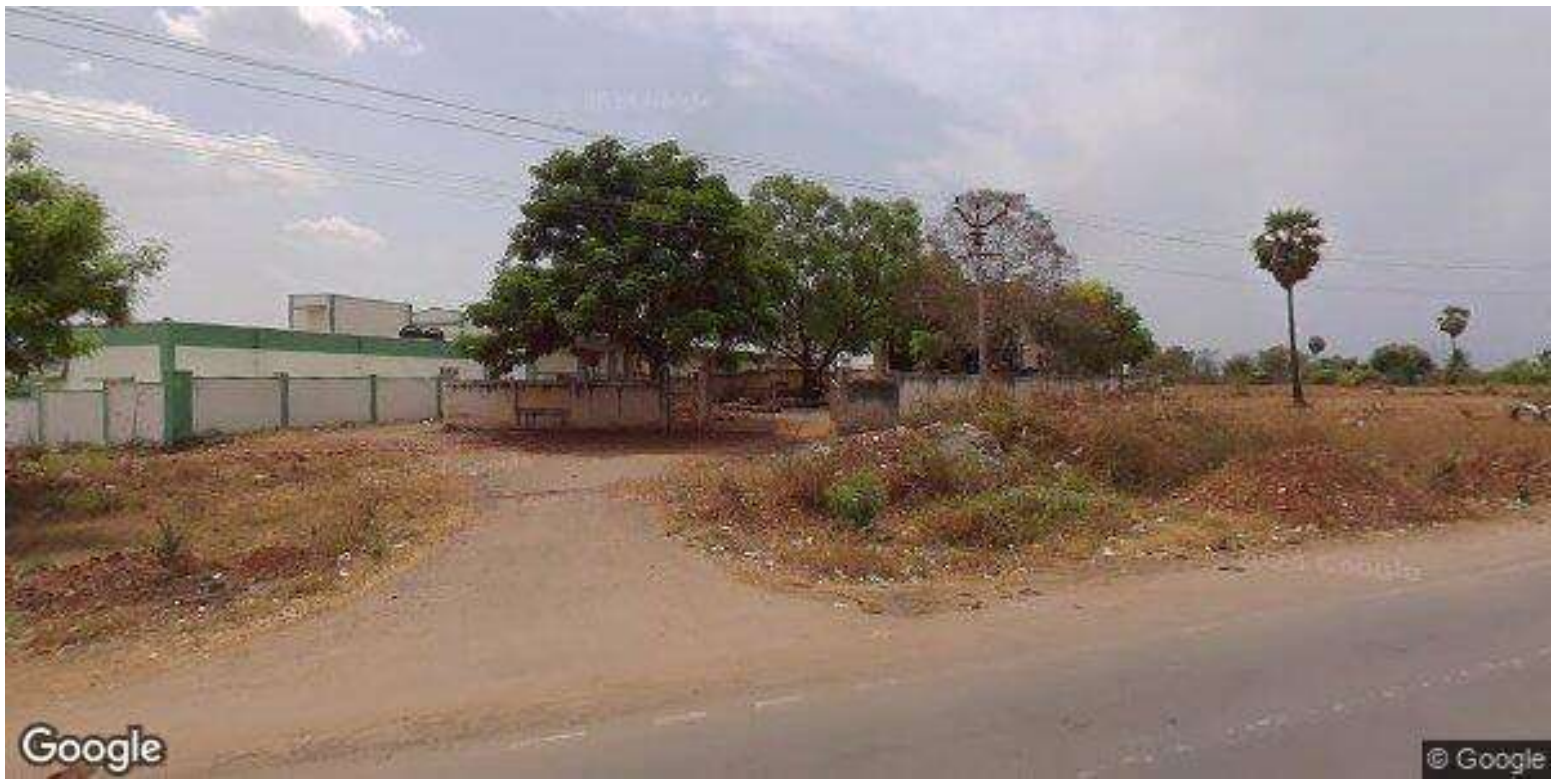
**Risk Type:** Turn  
**Risk Level:** High  
**Speed Limit:** 15 KM/Hr  
**Coordinates:** 11.58317, 77.90647

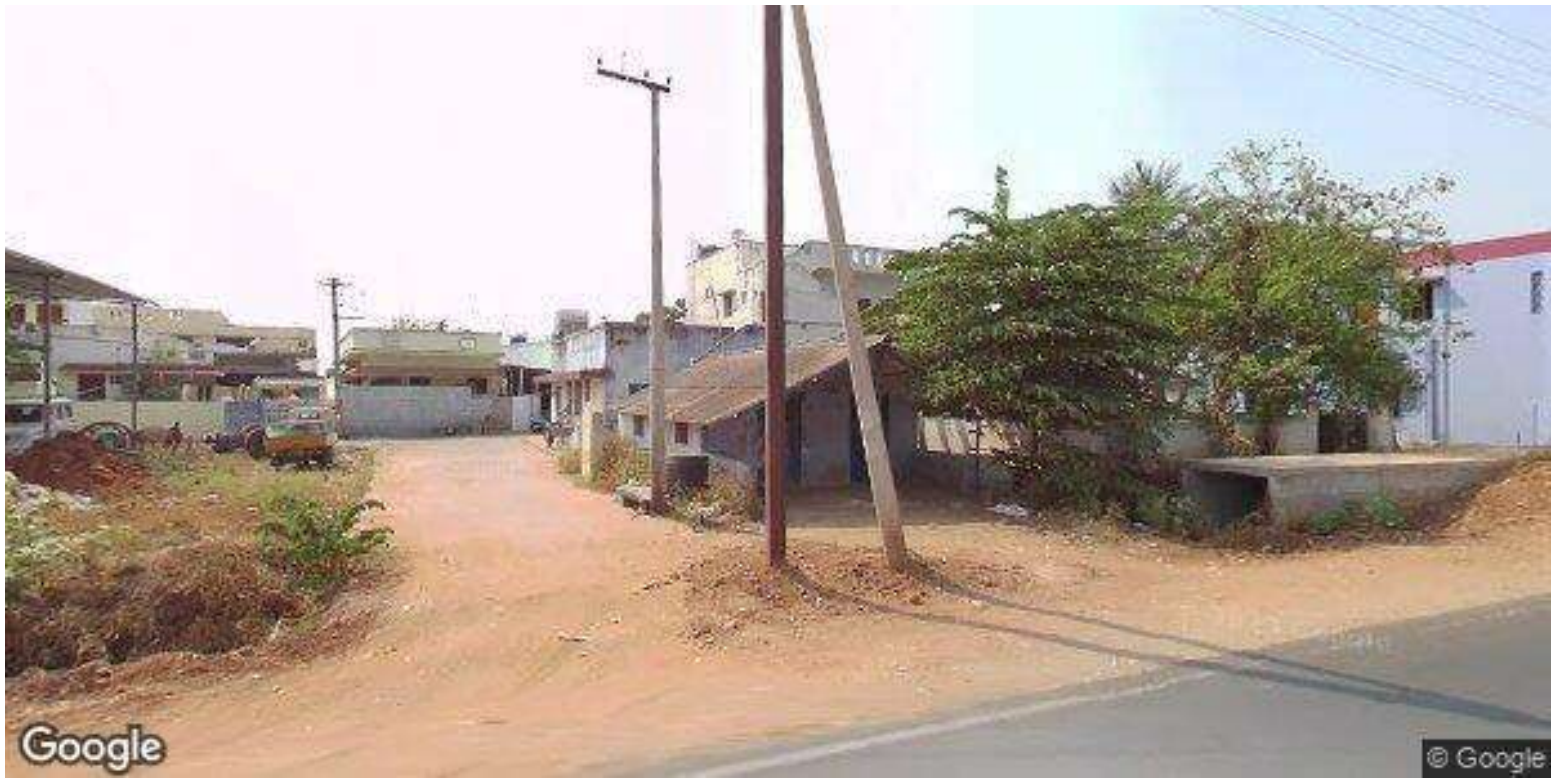
**Risk Type:** Turn  
**Risk Level:** Medium  
**Speed Limit:** 30 KM/Hr  
**Coordinates:** 11.59061, 77.90583

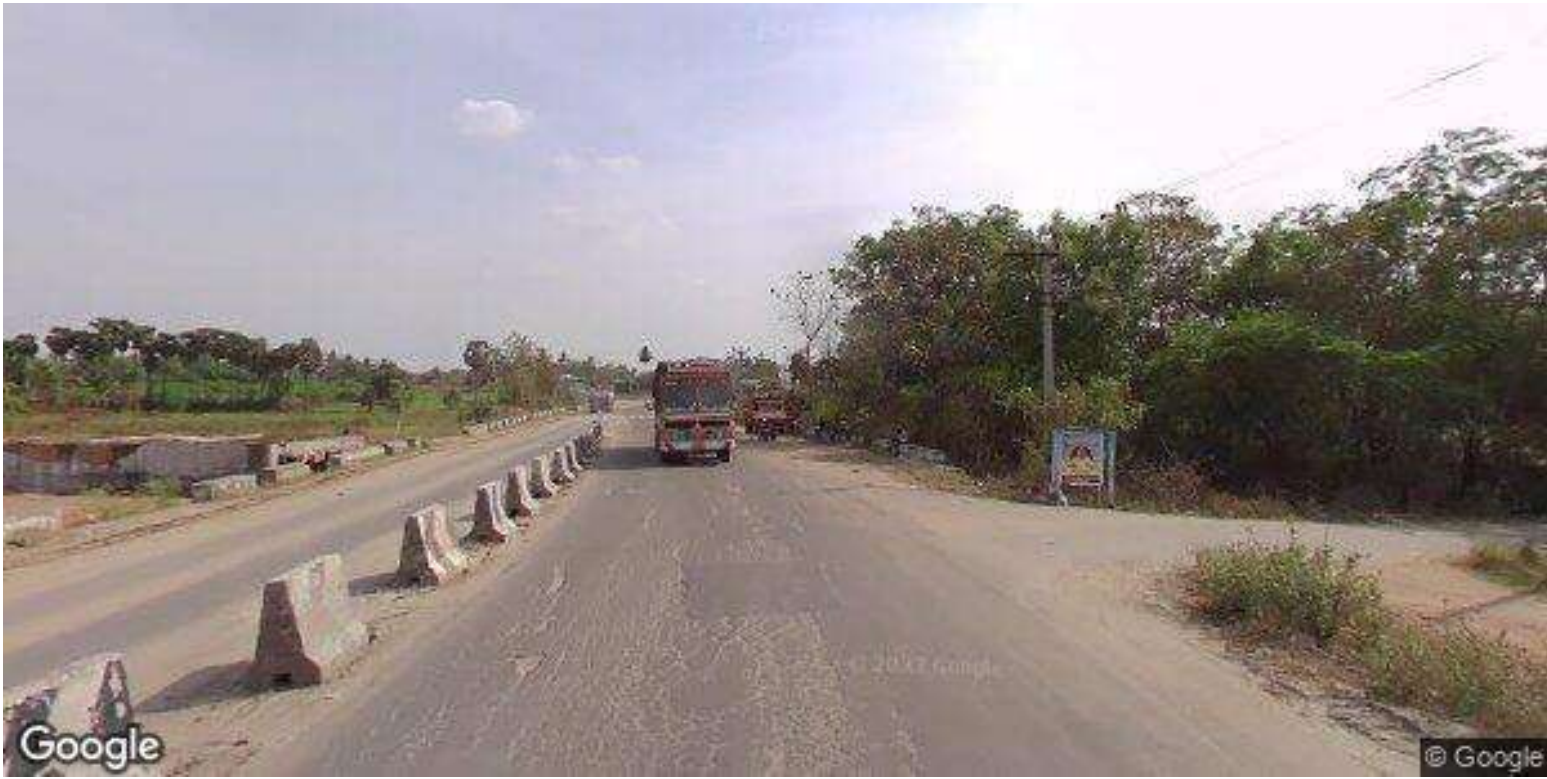
**Risk Type:** Turn  
**Risk Level:** Medium  
**Speed Limit:** 30 KM/Hr  
**Coordinates:** 11.63840, 77.94820

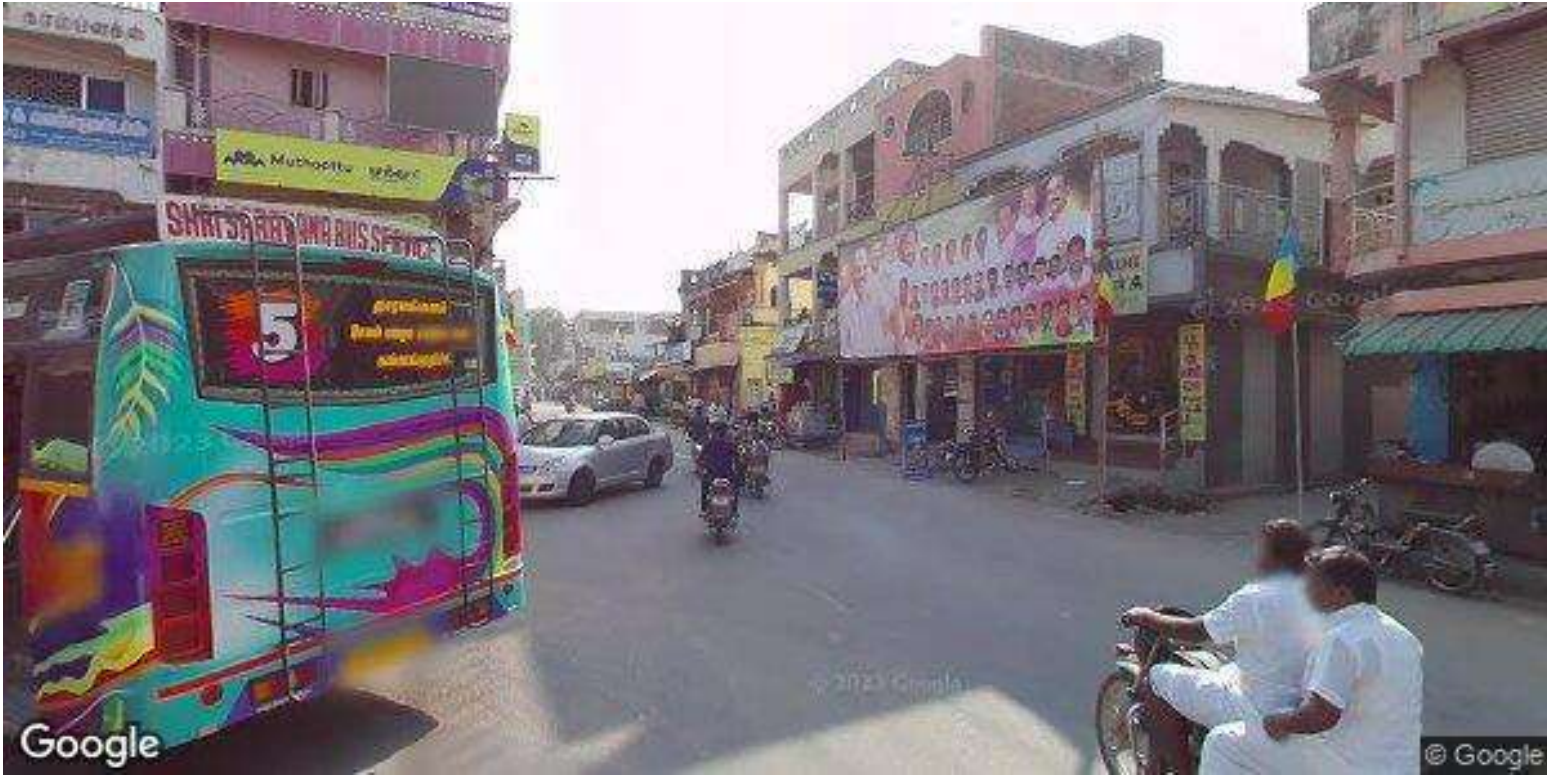
**Risk Type:** Turn  
**Risk Level:** Medium  
**Speed Limit:** 30 KM/Hr  
**Coordinates:** 11.69436, 77.97102

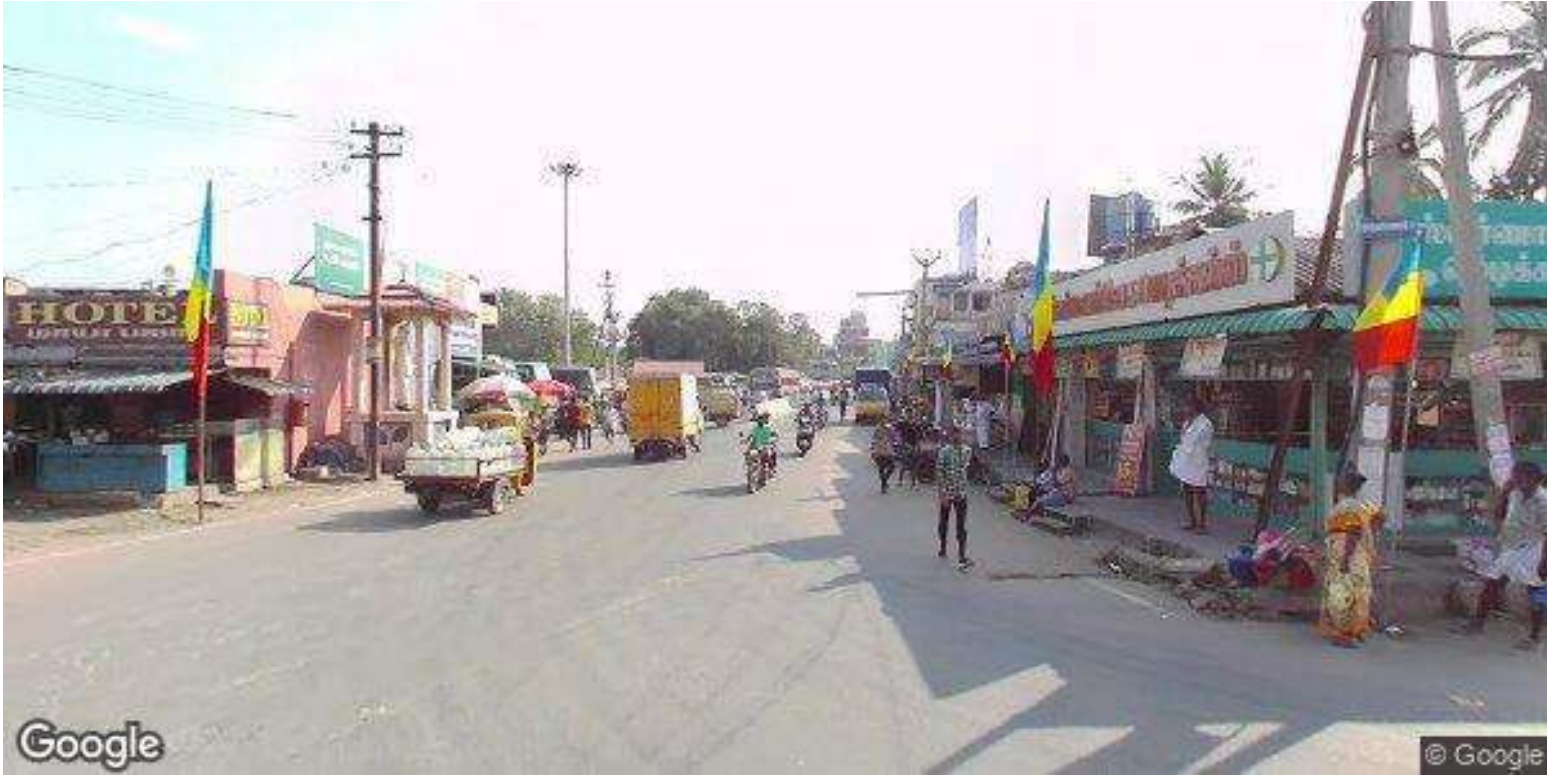
**Risk Type:** Blind Spot  
**Risk Level:** Blind Spot  
**Speed Limit:** 10 KM/Hr  
**Coordinates:** 11.69590, 77.97114

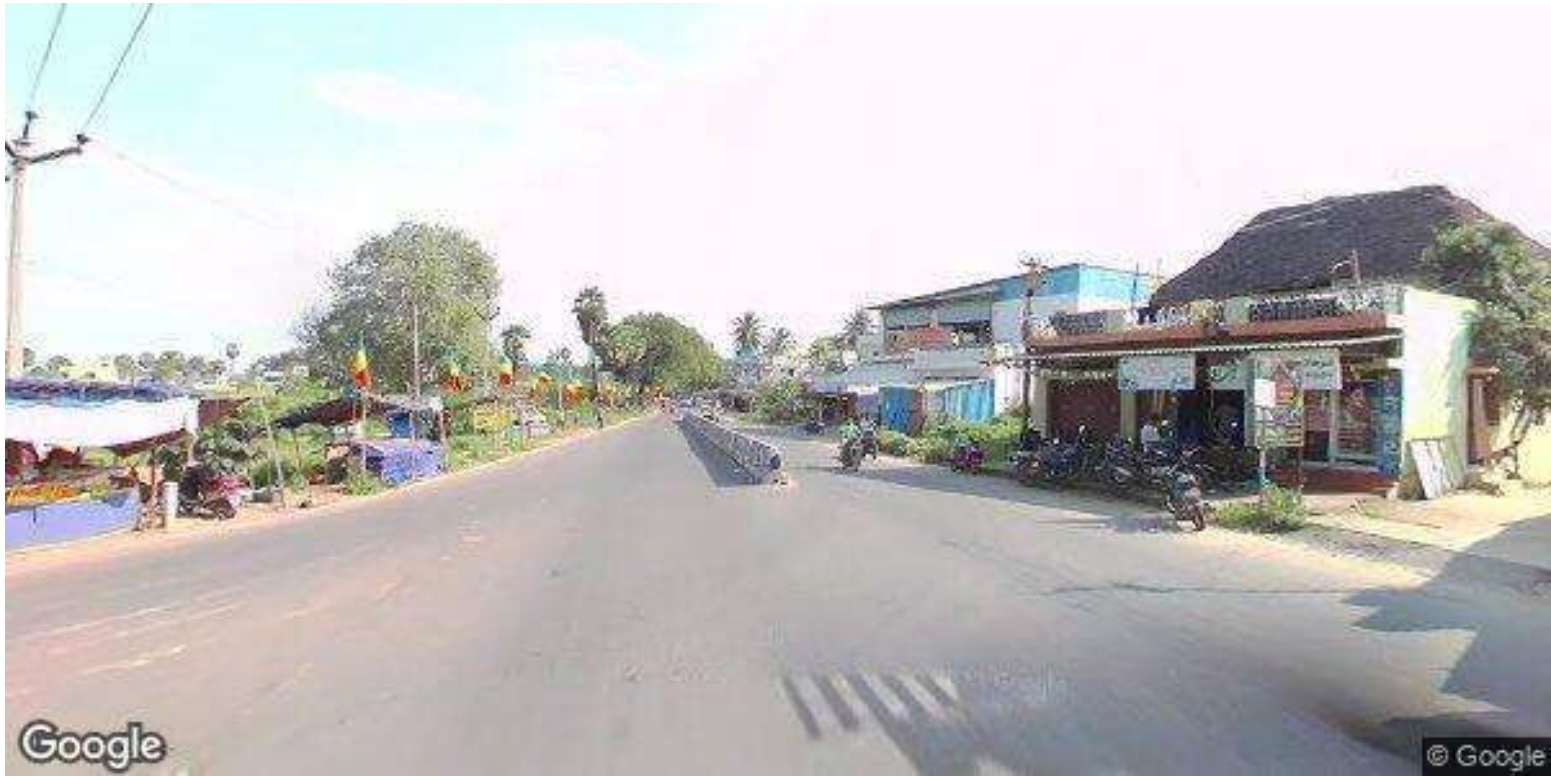
**Risk Type:** Turn  
**Risk Level:** High  
**Speed Limit:** 15 KM/Hr  
**Coordinates:** 11.70129, 77.96360
