## JOURNEY RISK MANAGEMENT (JRM) STUDY

### Salem Terminal TO RAJ FUEL SERVICE

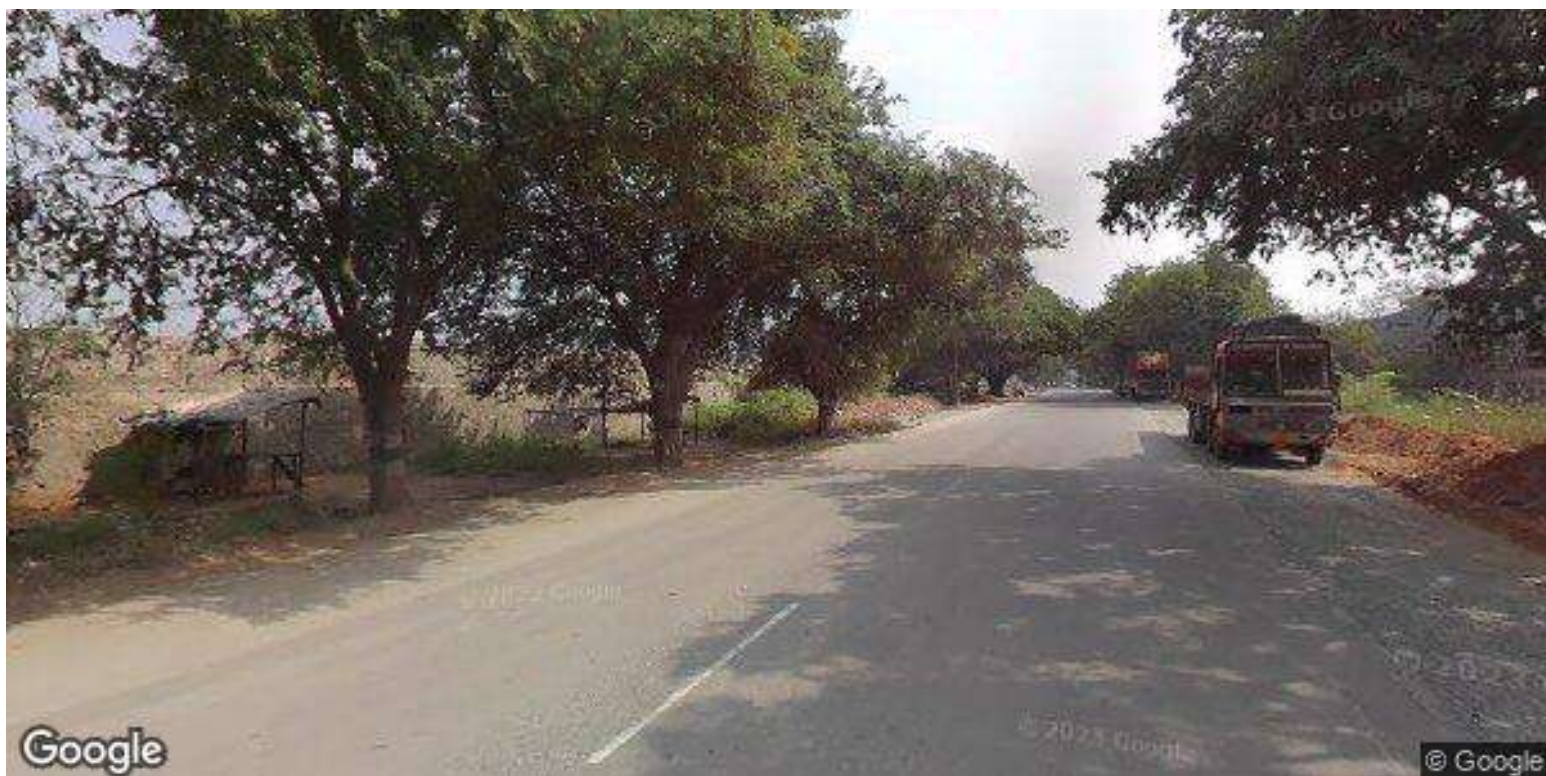
**Coordinates: 11.45697, 77.82719**

**Risk Type: Turn**

**Risk Level: Medium**

**Speed Limit: 30 KM/Hr**

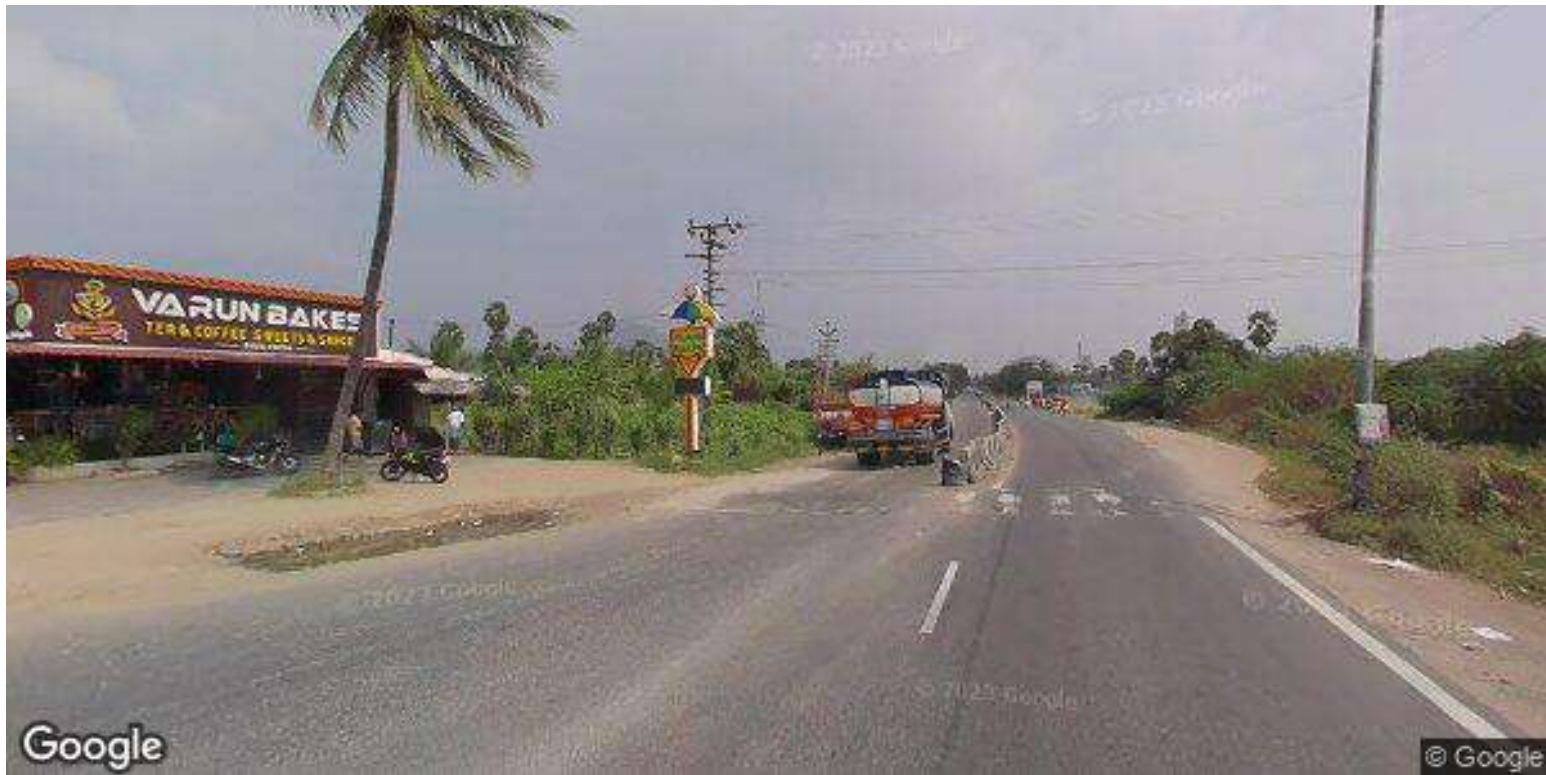
**Coordinates: 11.45543, 77.81740**

**Risk Type: Blind Spot**

**Risk Level: Blind Spot**

**Speed Limit: 10 KM/Hr**

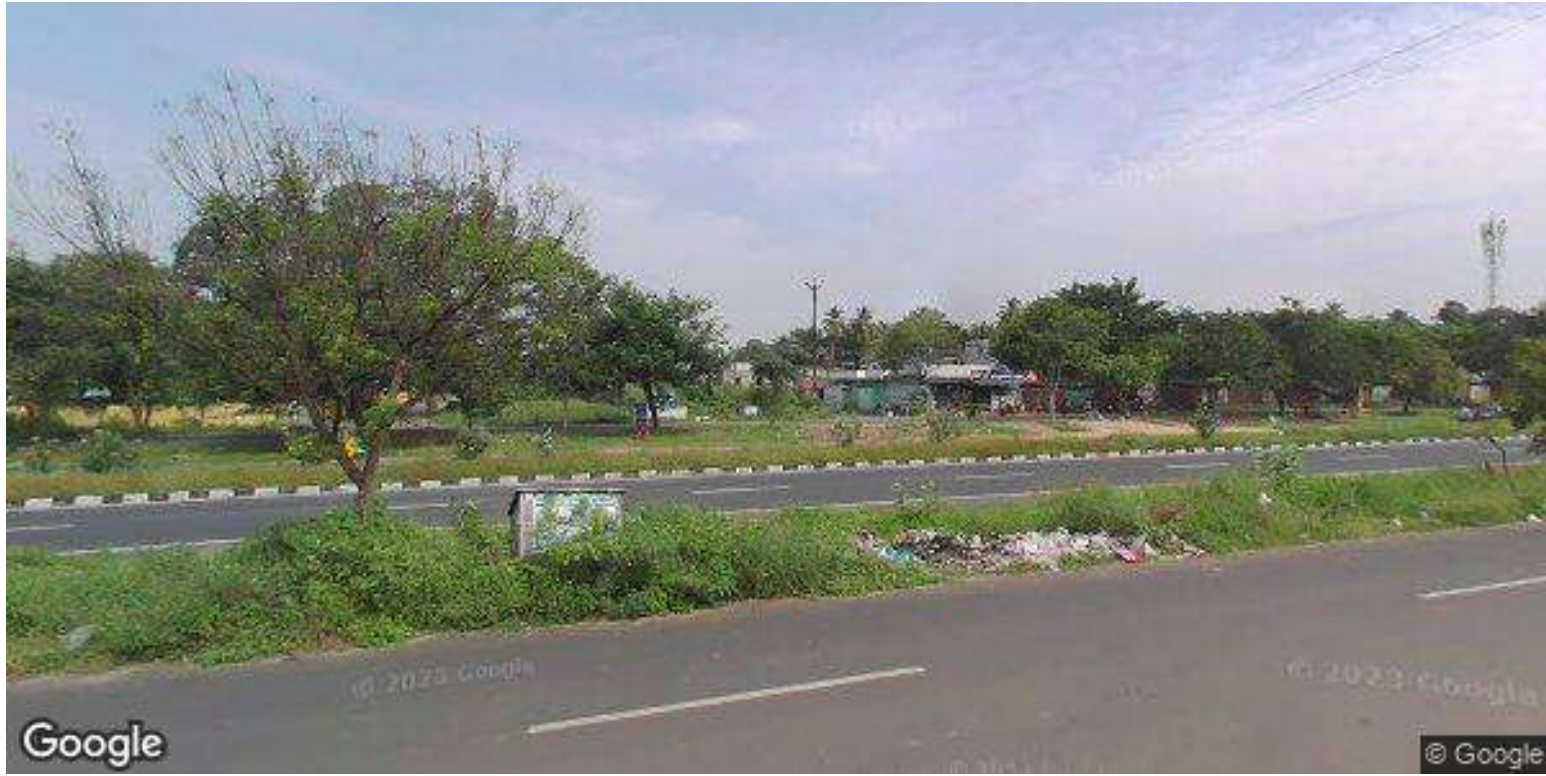
**Risk Type:** Turn  
**Risk Level:** High  
**Speed Limit:** 15 KM/Hr  
**Coordinates:** 11.44474, 77.72485

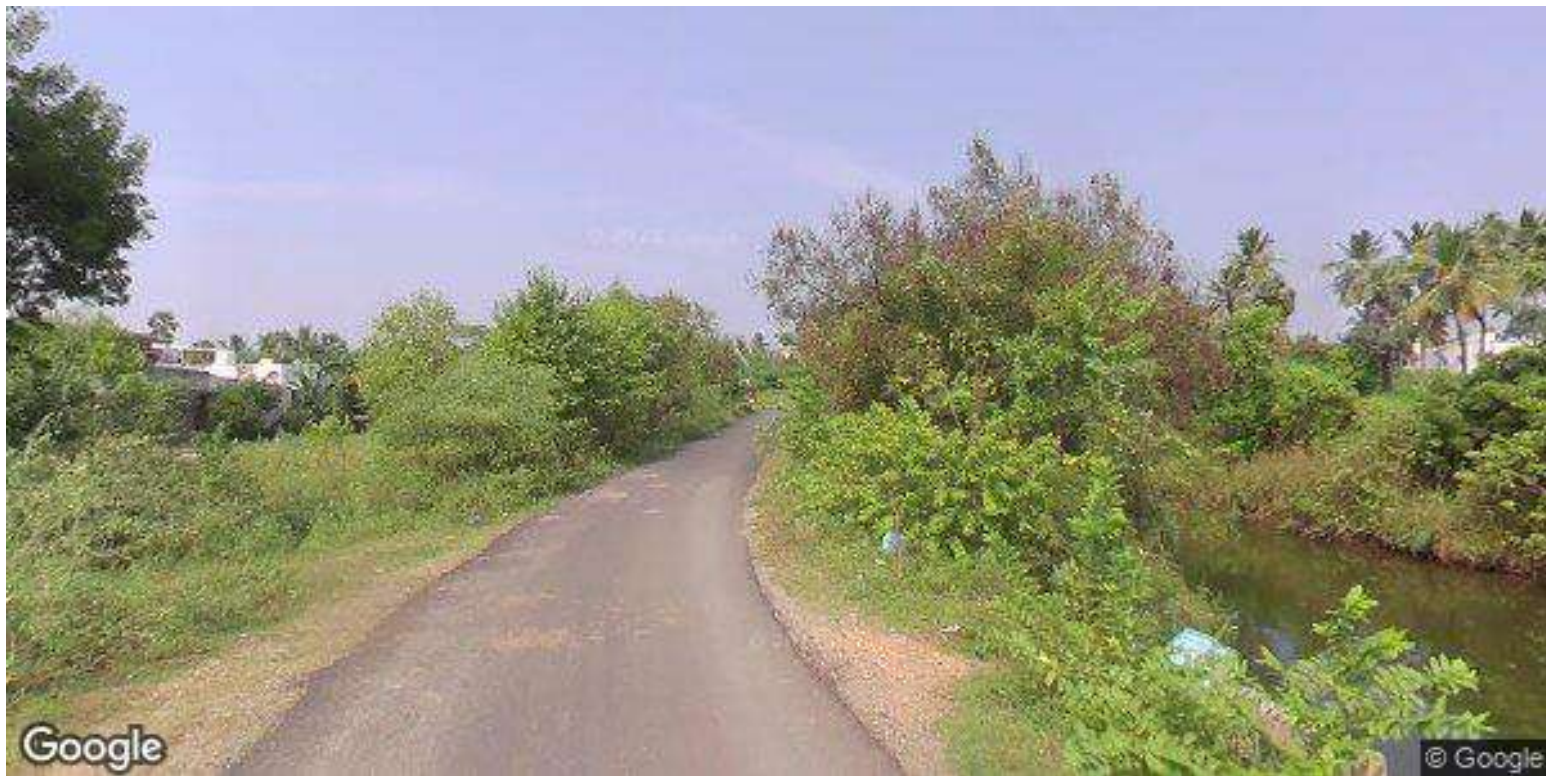
**Risk Type:** Turn  
**Risk Level:** High  
**Speed Limit:** 15 KM/Hr  
**Coordinates:** 11.43618, 77.72111

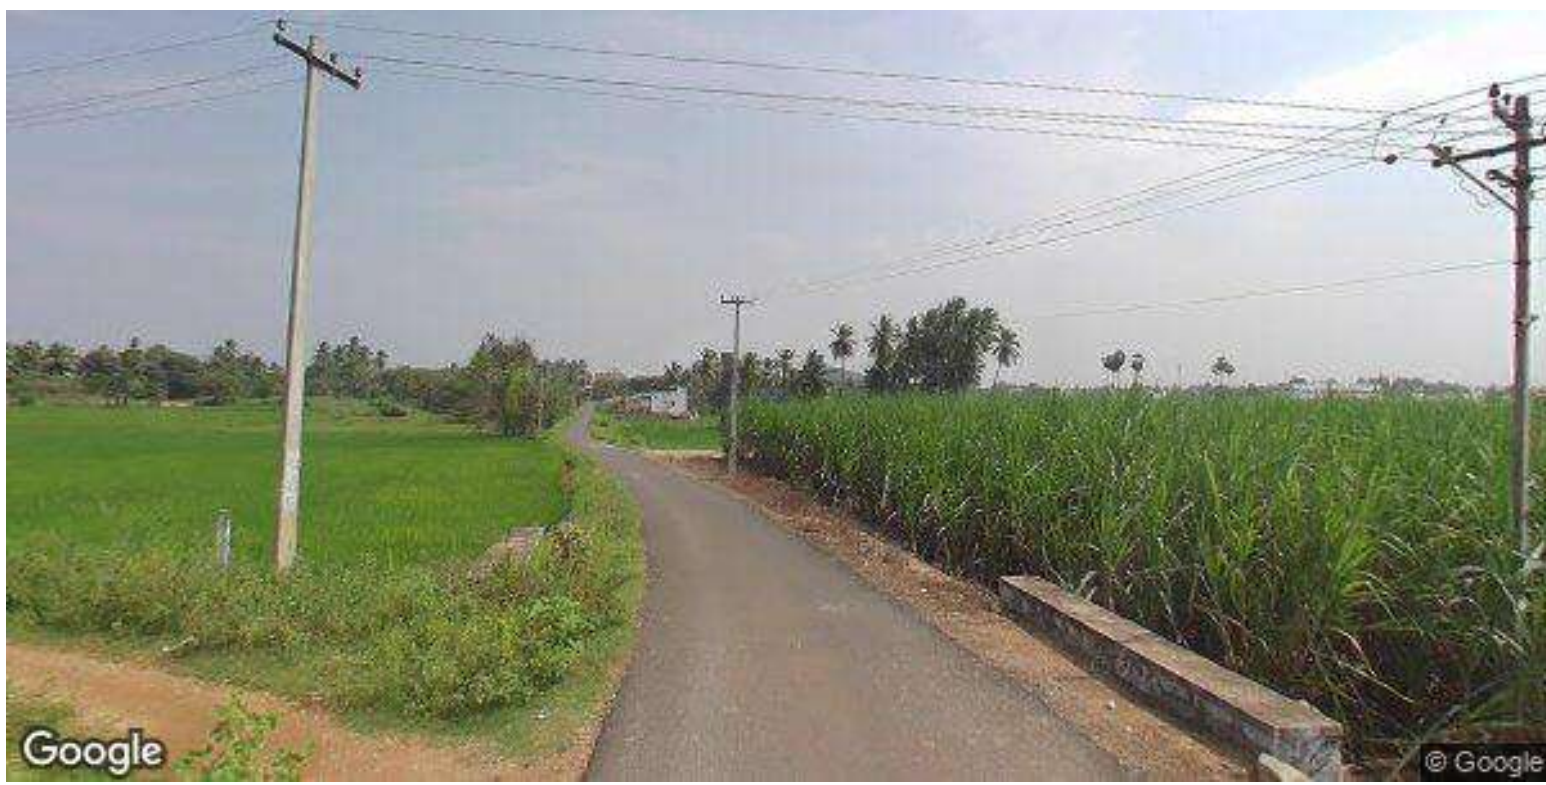
**Coordinates:** 11.43408, 77.72009

**Risk Type:** Turn

**Risk Level:** High

**Speed Limit:** 15 KM/Hr
