# IndianOil

## JOURNEY RISK MANAGEMENT (JRM) STUDY

### Salem Terminal TO JAI SRI RAM AGENCIES

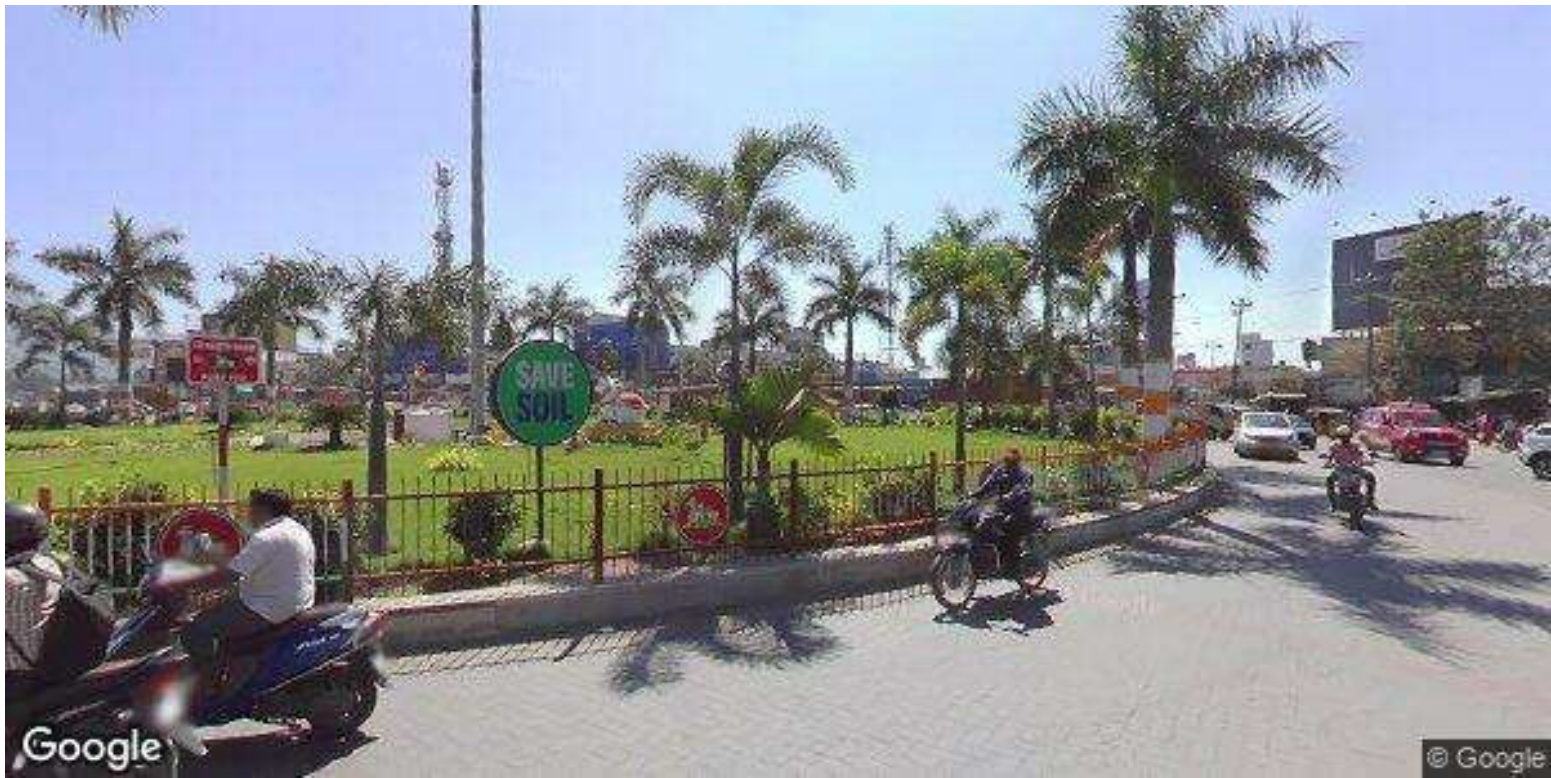
Risk Type: Roundabout  
Risk Level: High  
Speed Limit: 15 KM/Hr  
Coordinates: 11.63303, 78.12713

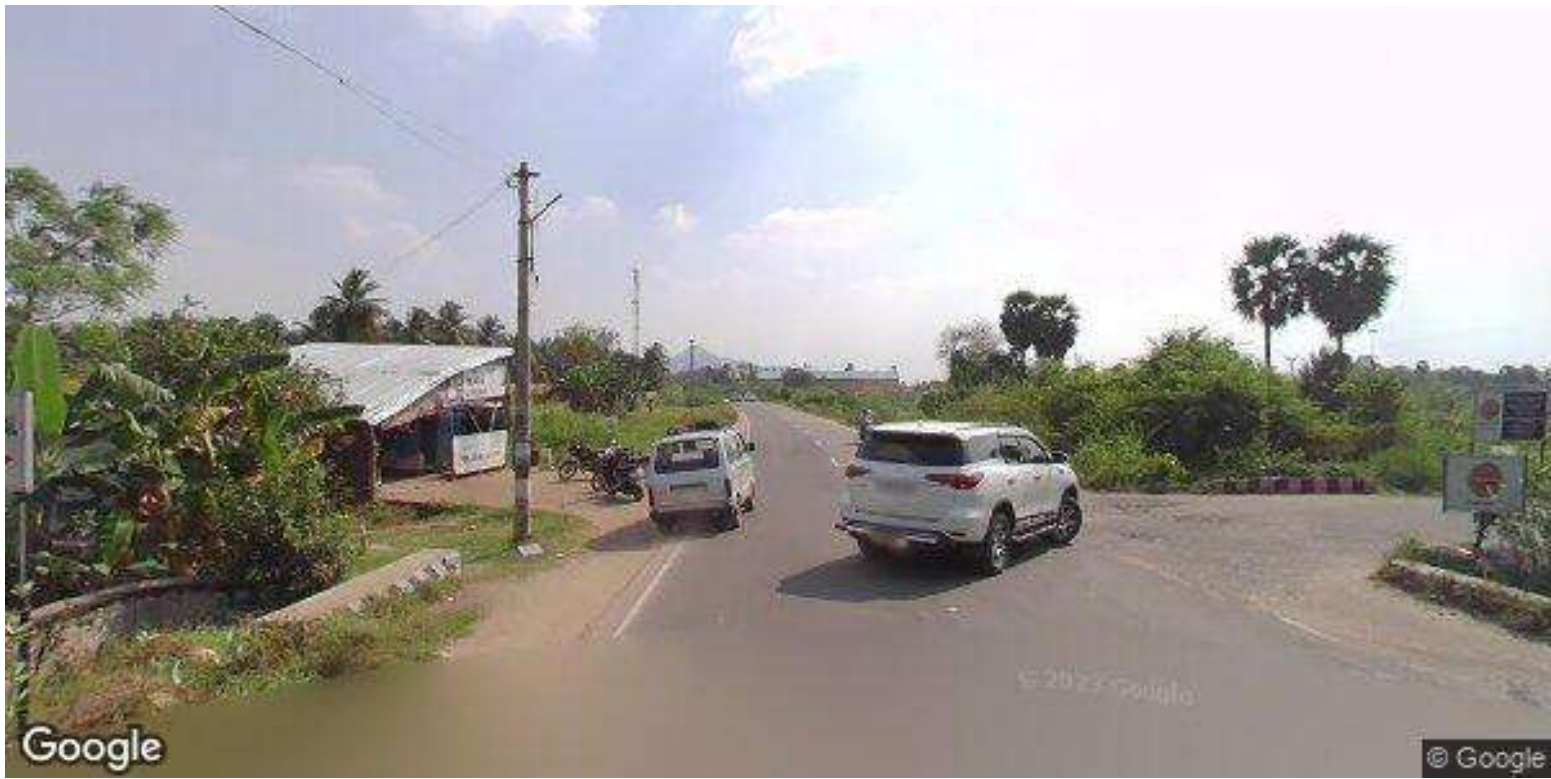
Risk Type: Turn  
Risk Level: High

**Speed Limit: 15 KM/Hr**  
**Coordinates: 11.44029, 77.87544**

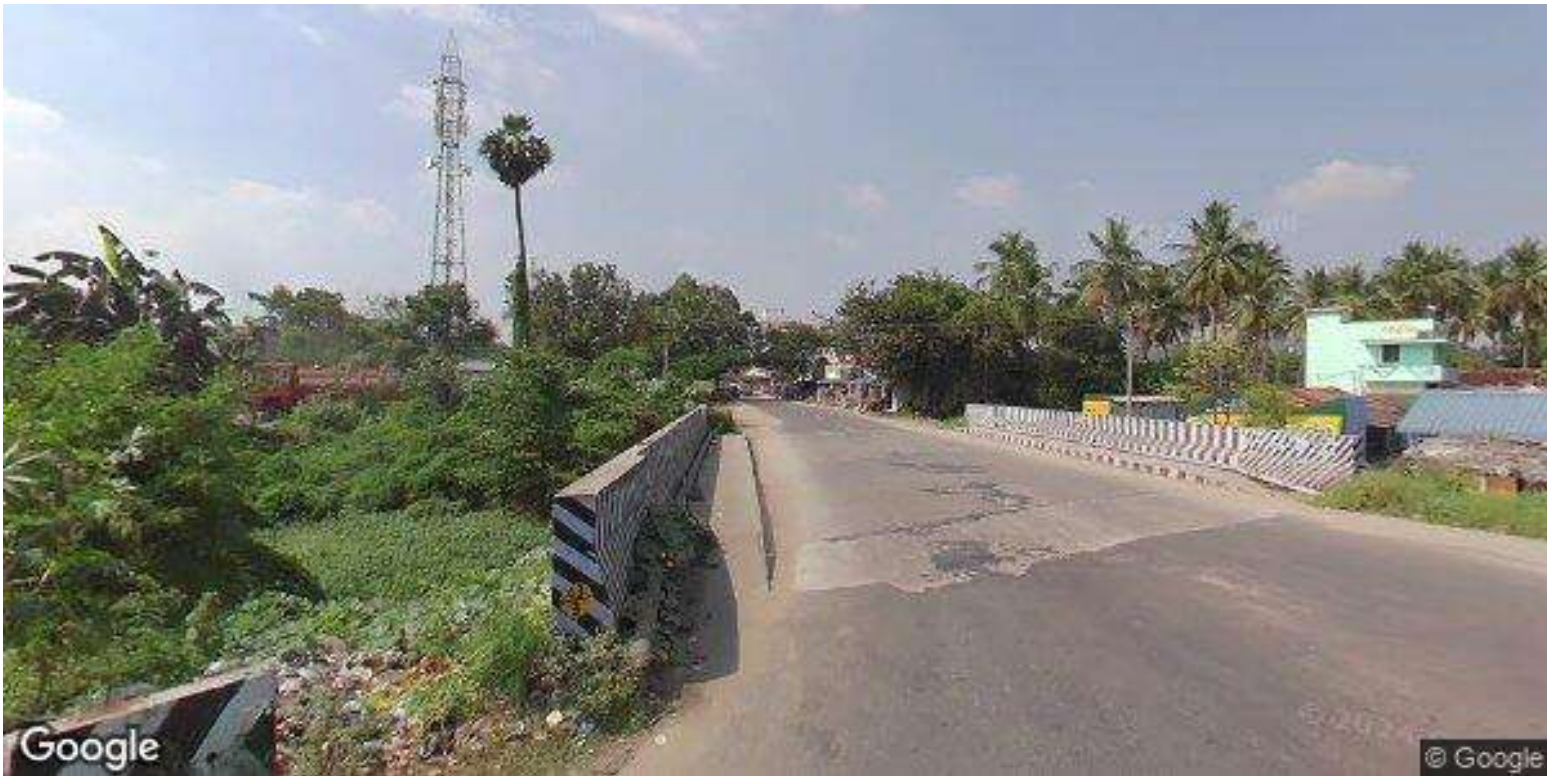
**Risk Type: Turn**  
**Risk Level: Medium**  
**Speed Limit: 30 KM/Hr**  
**Coordinates: 11.44900, 77.87406**

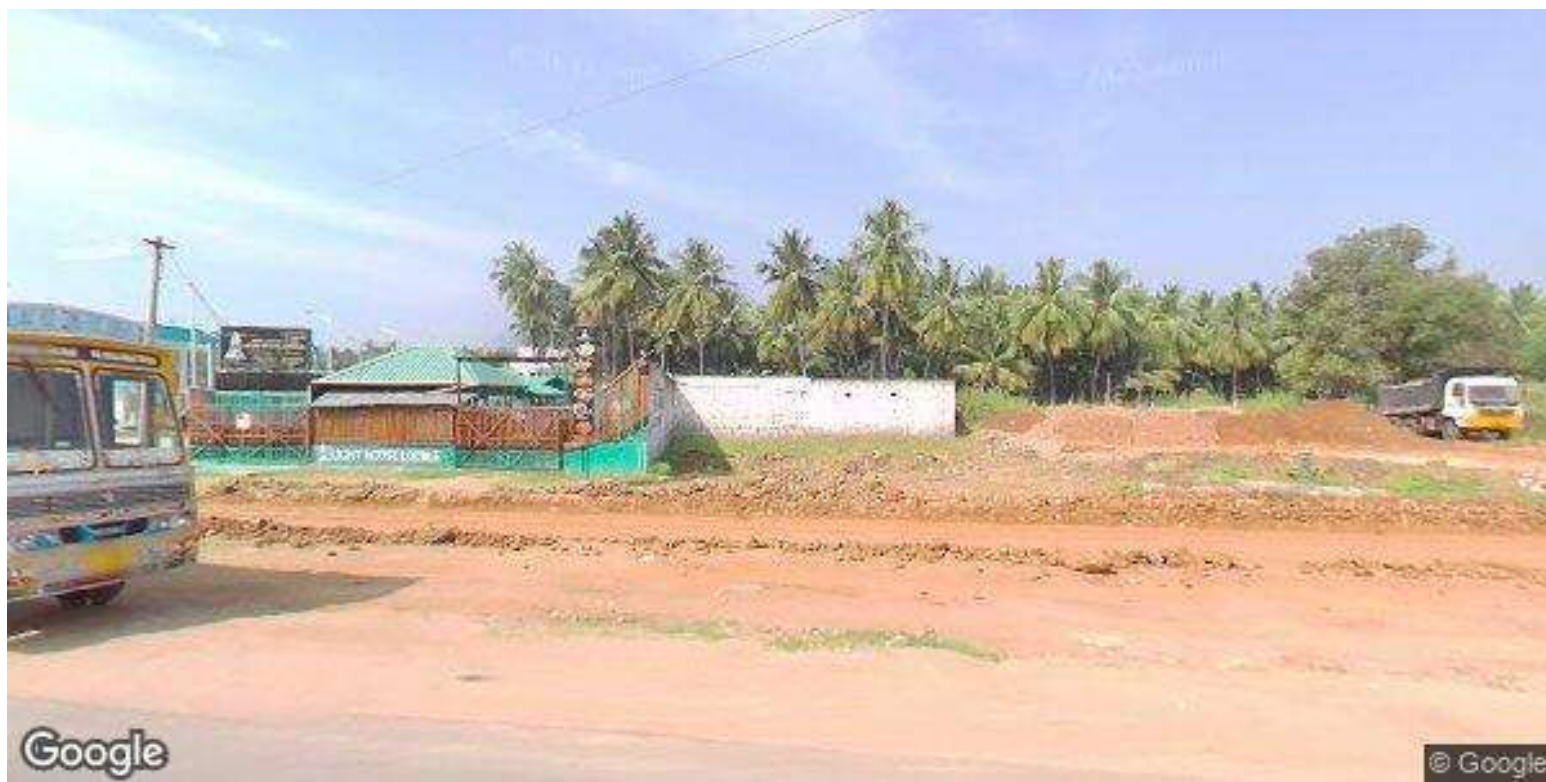
**Risk Type:** Turn

**Risk Level:** Medium

**Speed Limit:** 30 KM/Hr

**Coordinates:** 11.61736, 78.10588

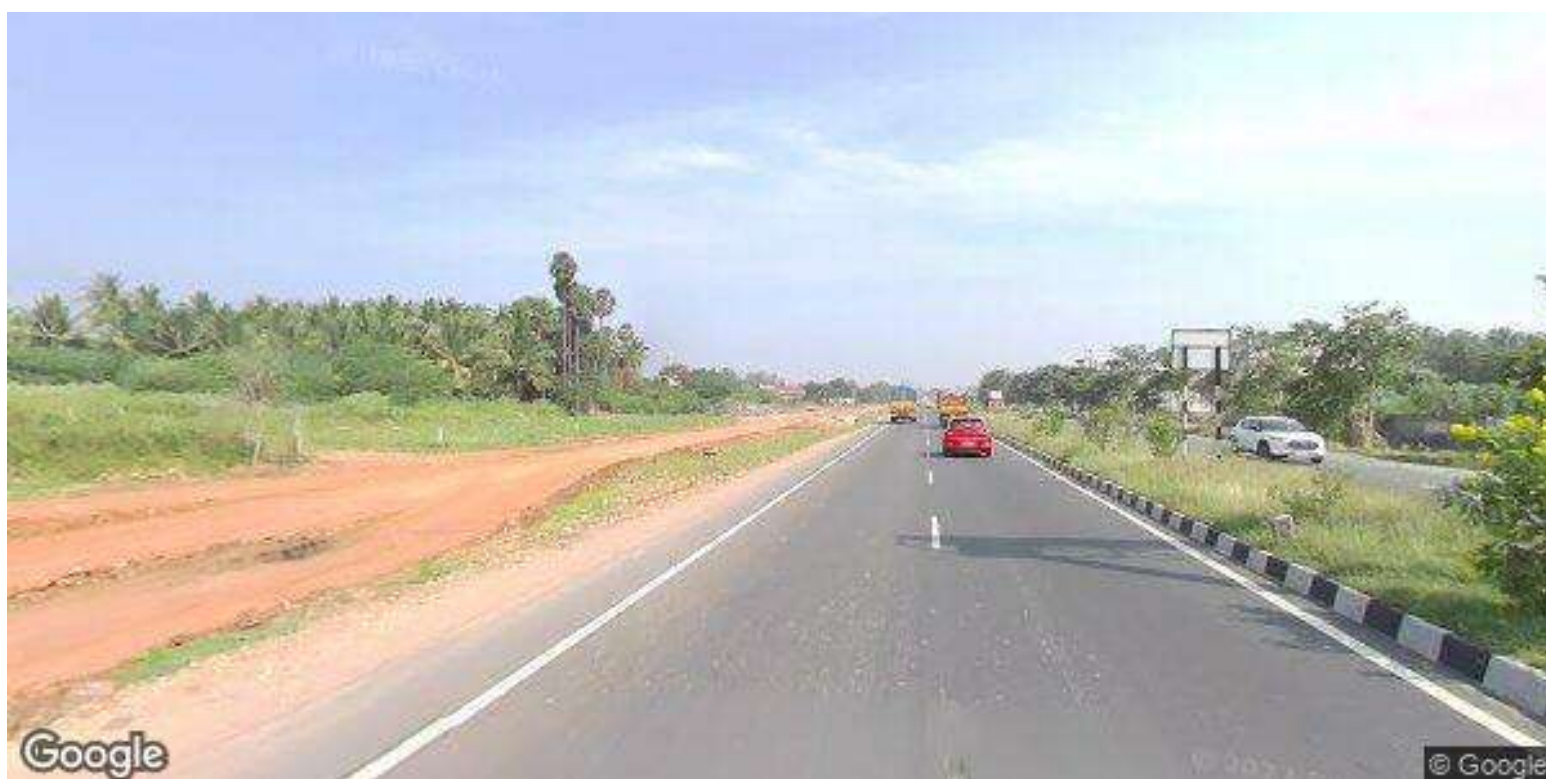
**Risk Type:** Turn

**Risk Level:** Medium

**Speed Limit:** 30 KM/Hr

**Coordinates:** 11.61753, 78.10608

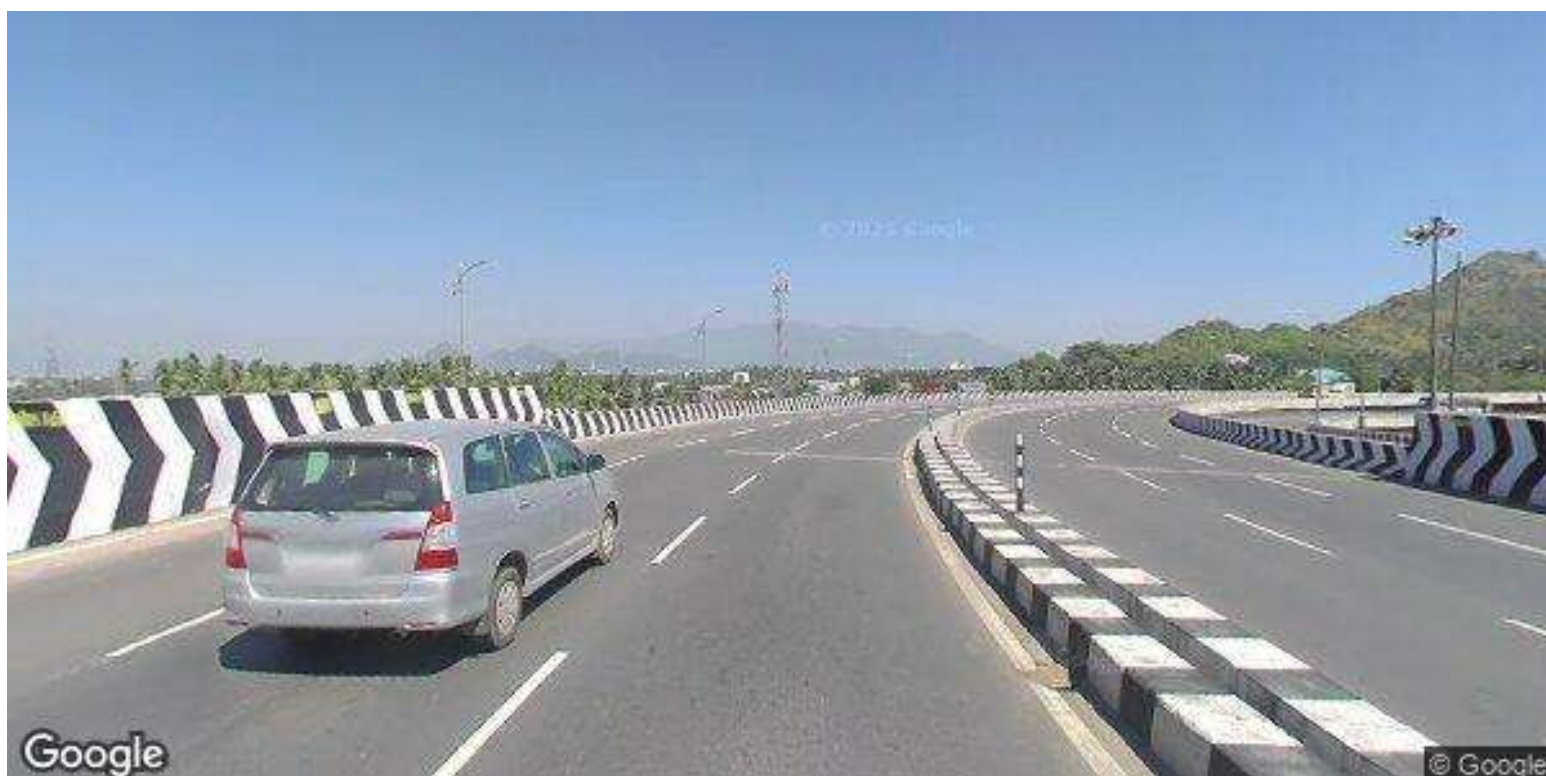
**Risk Type:** Turn  
**Risk Level:** Medium  
**Speed Limit:** 30 KM/Hr  
**Coordinates:** 11.64172, 78.11817

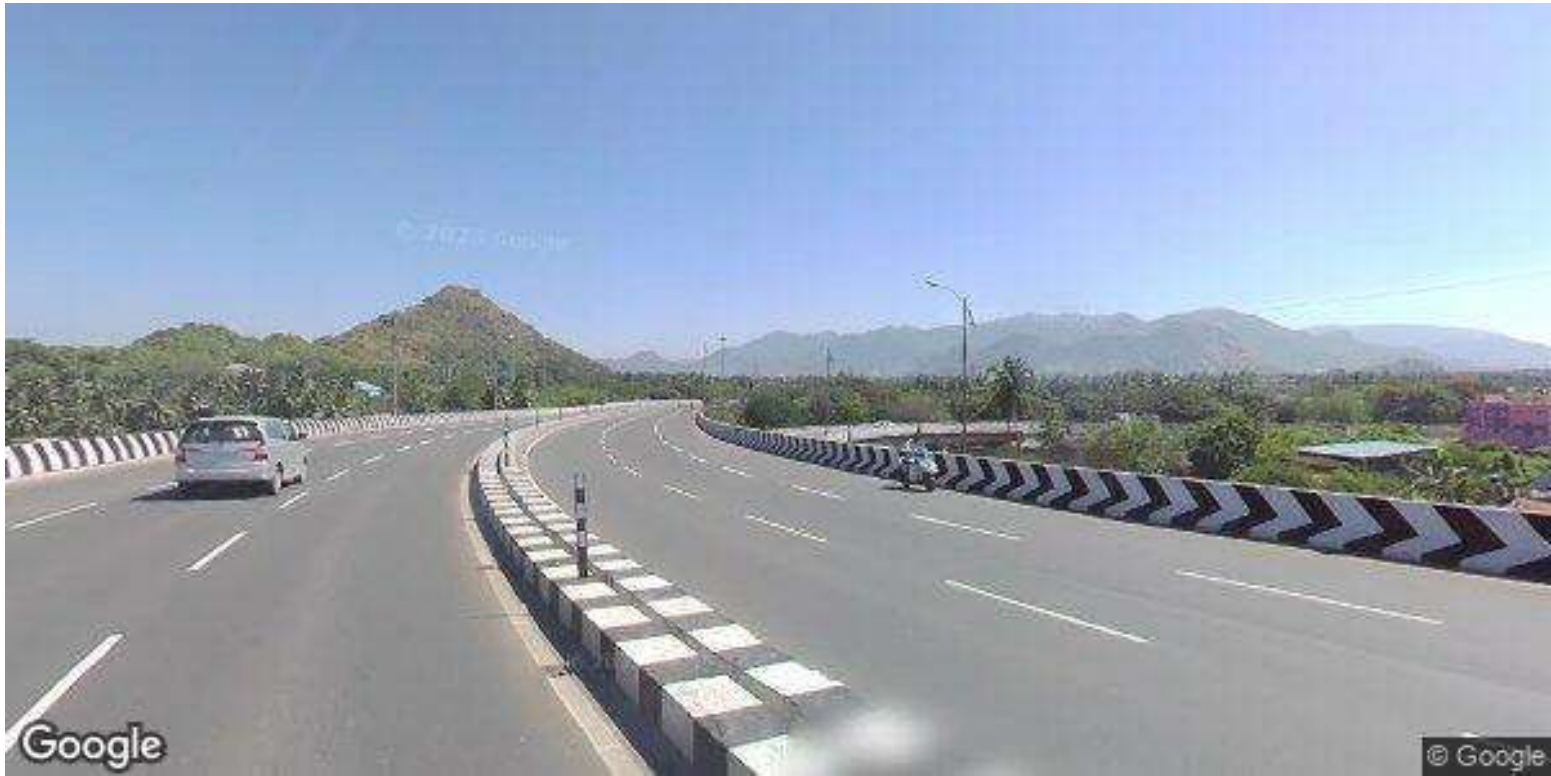
**Risk Type:** Turn  
**Risk Level:** Medium  
**Speed Limit:** 30 KM/Hr  
**Coordinates:** 11.64216, 78.11875

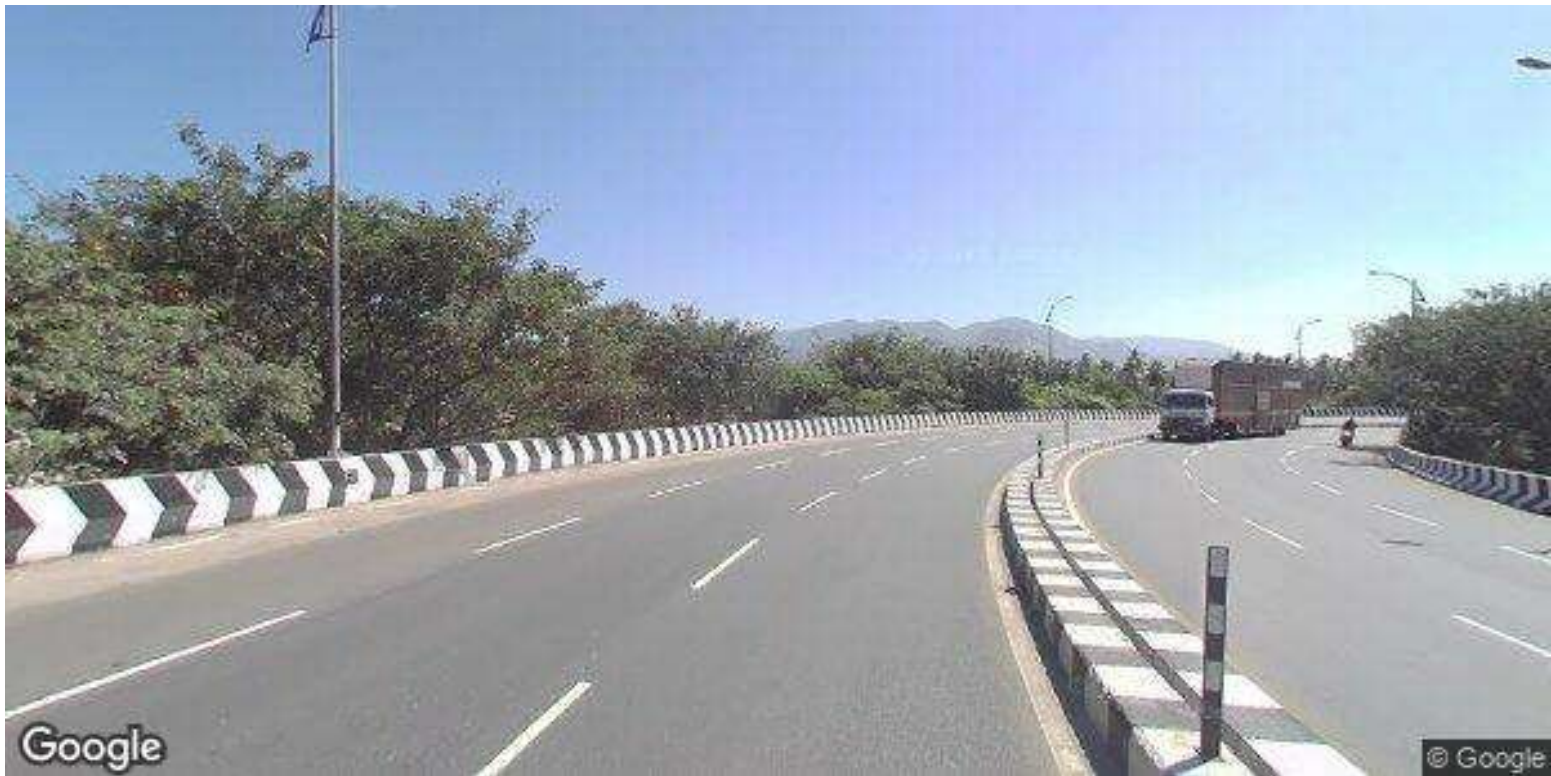
**Risk Type:** Turn  
**Risk Level:** Medium  
**Speed Limit:** 30 KM/Hr  
**Coordinates:** 11.64195, 78.12129

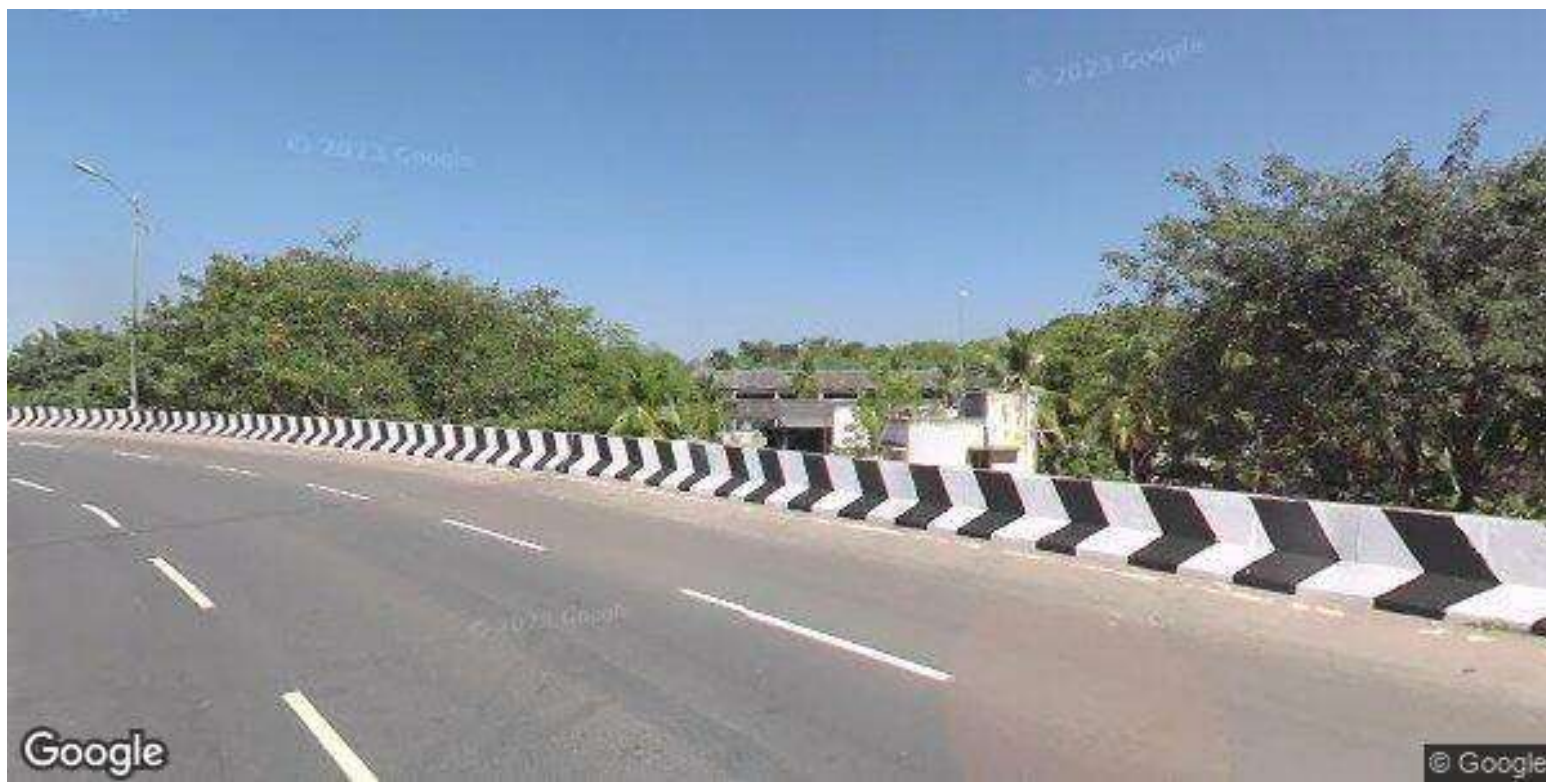
**Risk Type:** Turn

**Risk Level:** Medium

**Speed Limit:** 30 KM/Hr

**Coordinates:** 11.64162, 78.12160

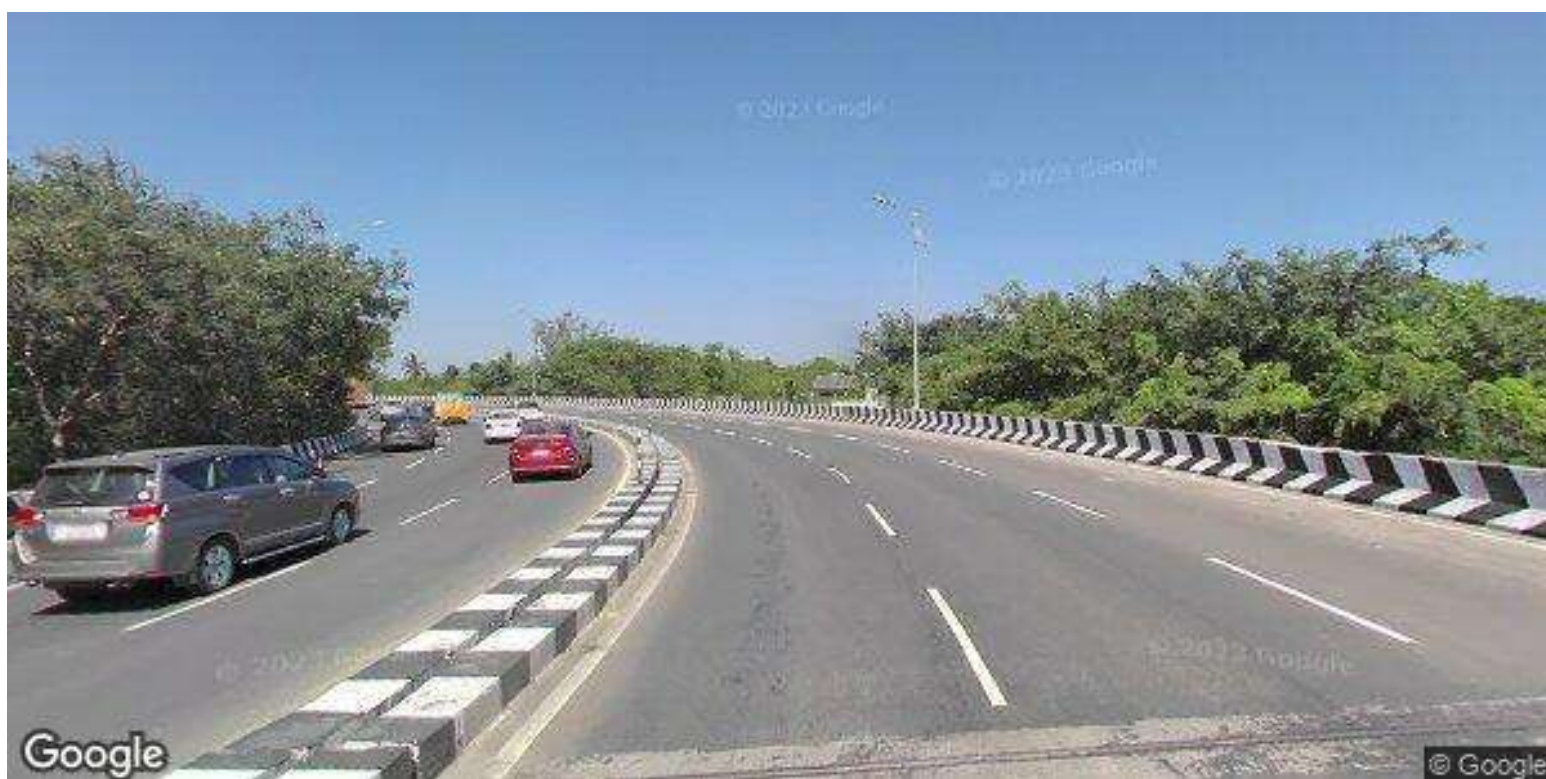
**Risk Type:** Turn

**Risk Level:** Medium

**Speed Limit:** 30 KM/Hr

**Coordinates:** 11.64120, 78.12168

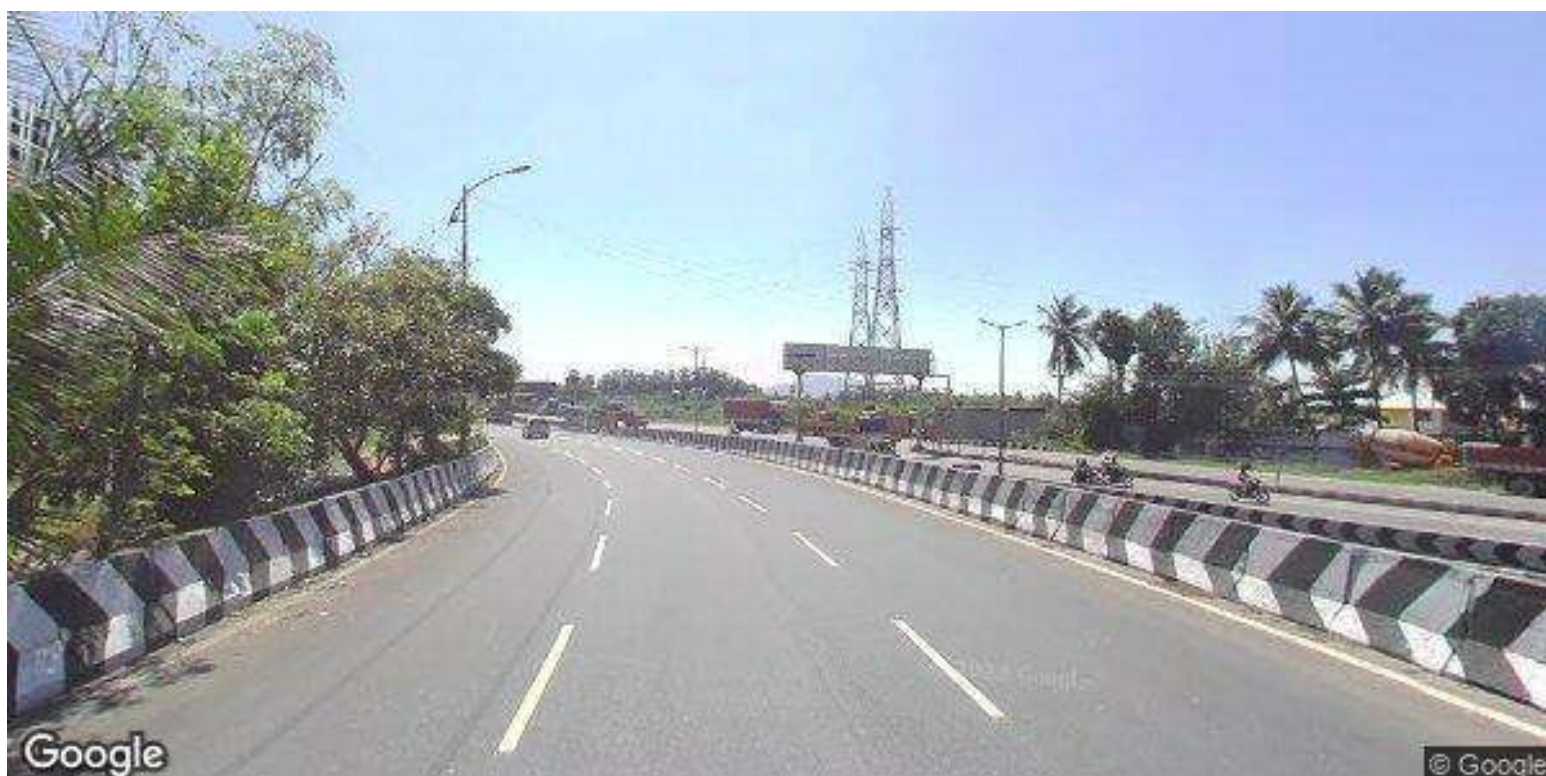
**Risk Type:** Turn  
**Risk Level:** Medium  
**Speed Limit:** 30 KM/Hr  
**Coordinates:** 11.63948, 78.12081

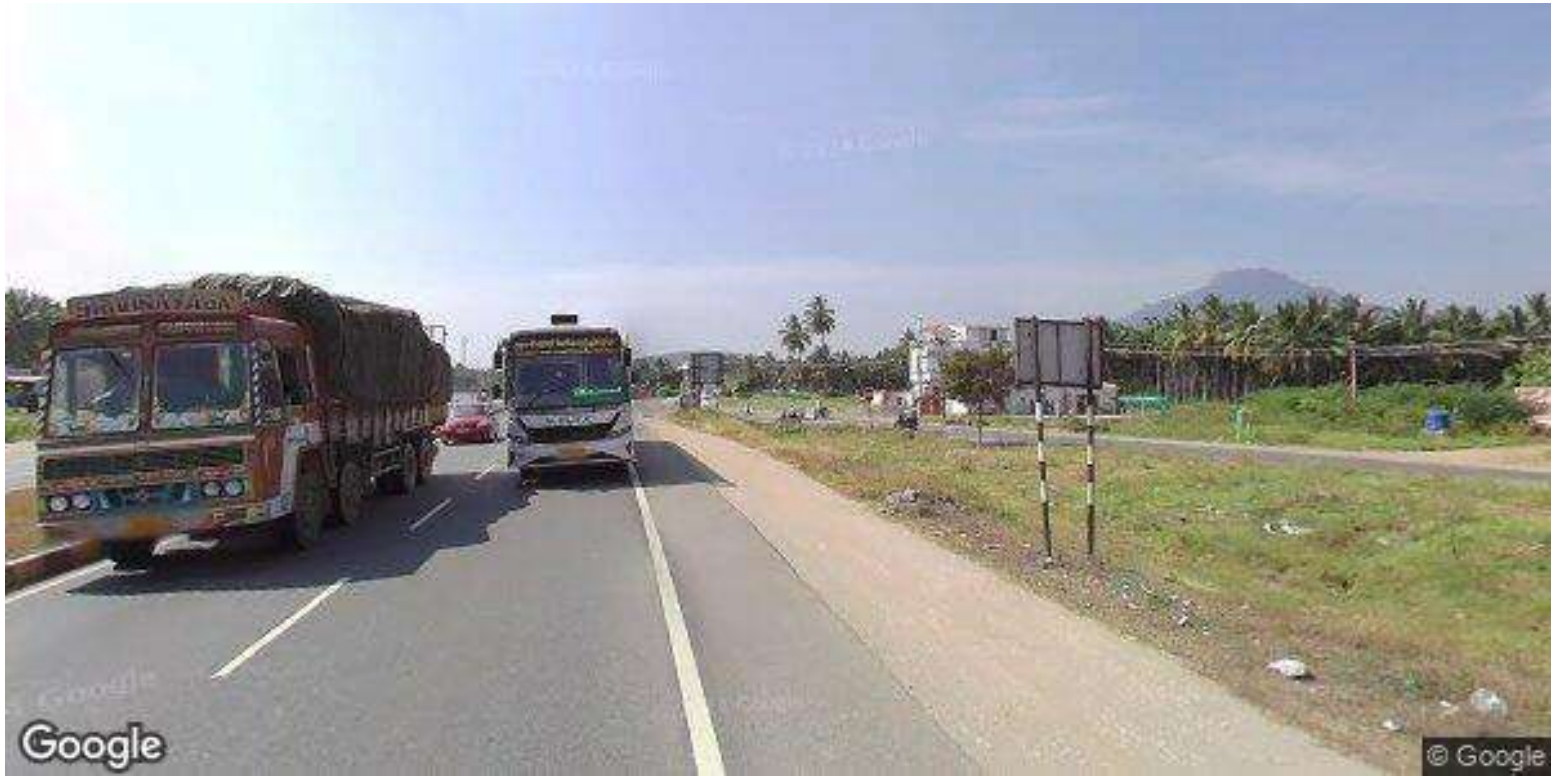
**Risk Type:** Turn  
**Risk Level:** High  
**Speed Limit:** 15 KM/Hr  
**Coordinates:** 11.65458, 78.37988

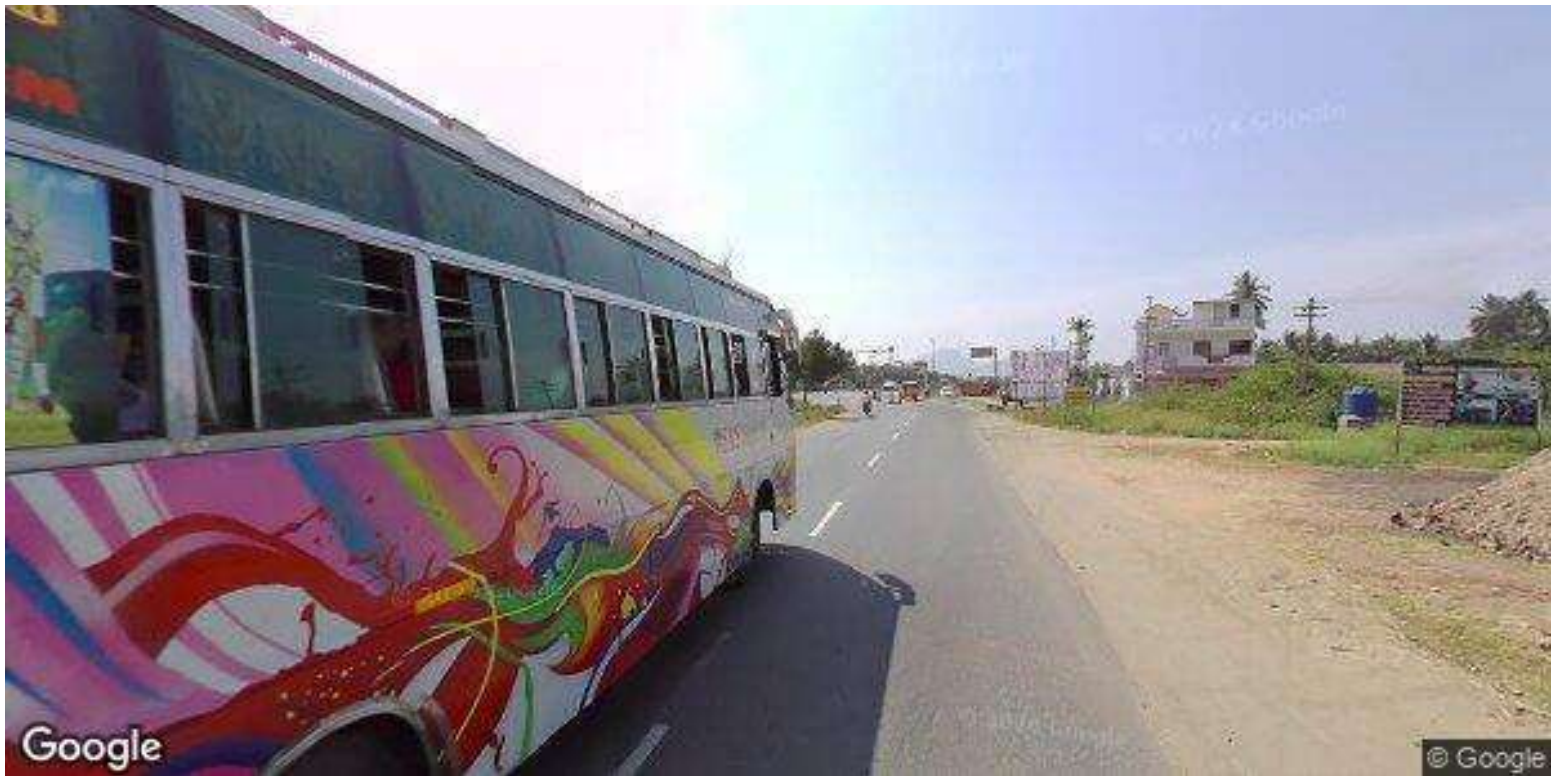
**Risk Type:** Turn  
**Risk Level:** Medium  
**Speed Limit:** 30 KM/Hr  
**Coordinates:** 11.65484, 78.38000

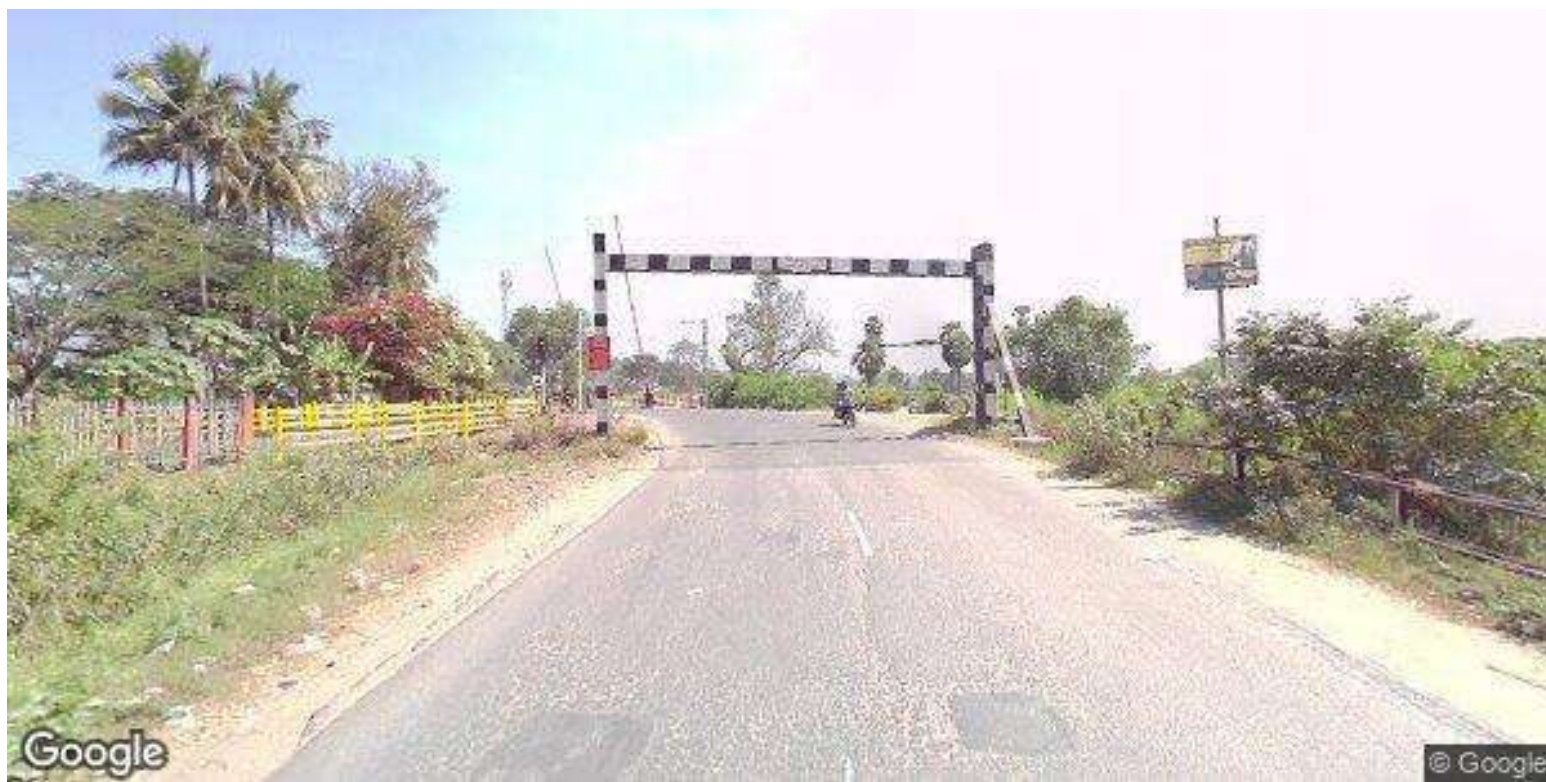
**Risk Type:** Turn

**Risk Level:** Medium

**Speed Limit:** 30 KM/Hr

**Coordinates:** 11.65602, 78.38711

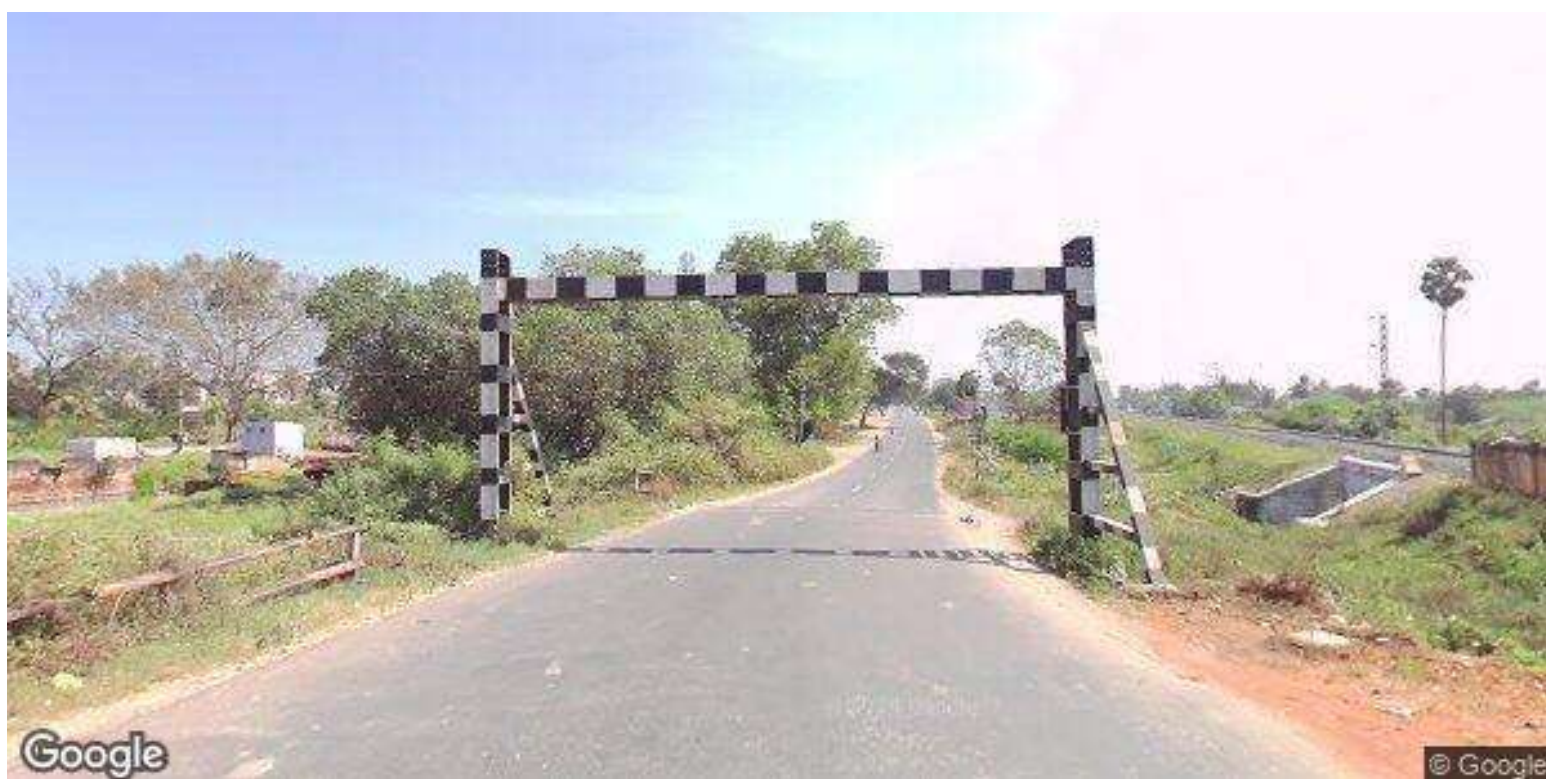
**Risk Type:** Turn

**Risk Level:** Medium

**Speed Limit:** 30 KM/Hr

**Coordinates:** 11.65631, 78.38769

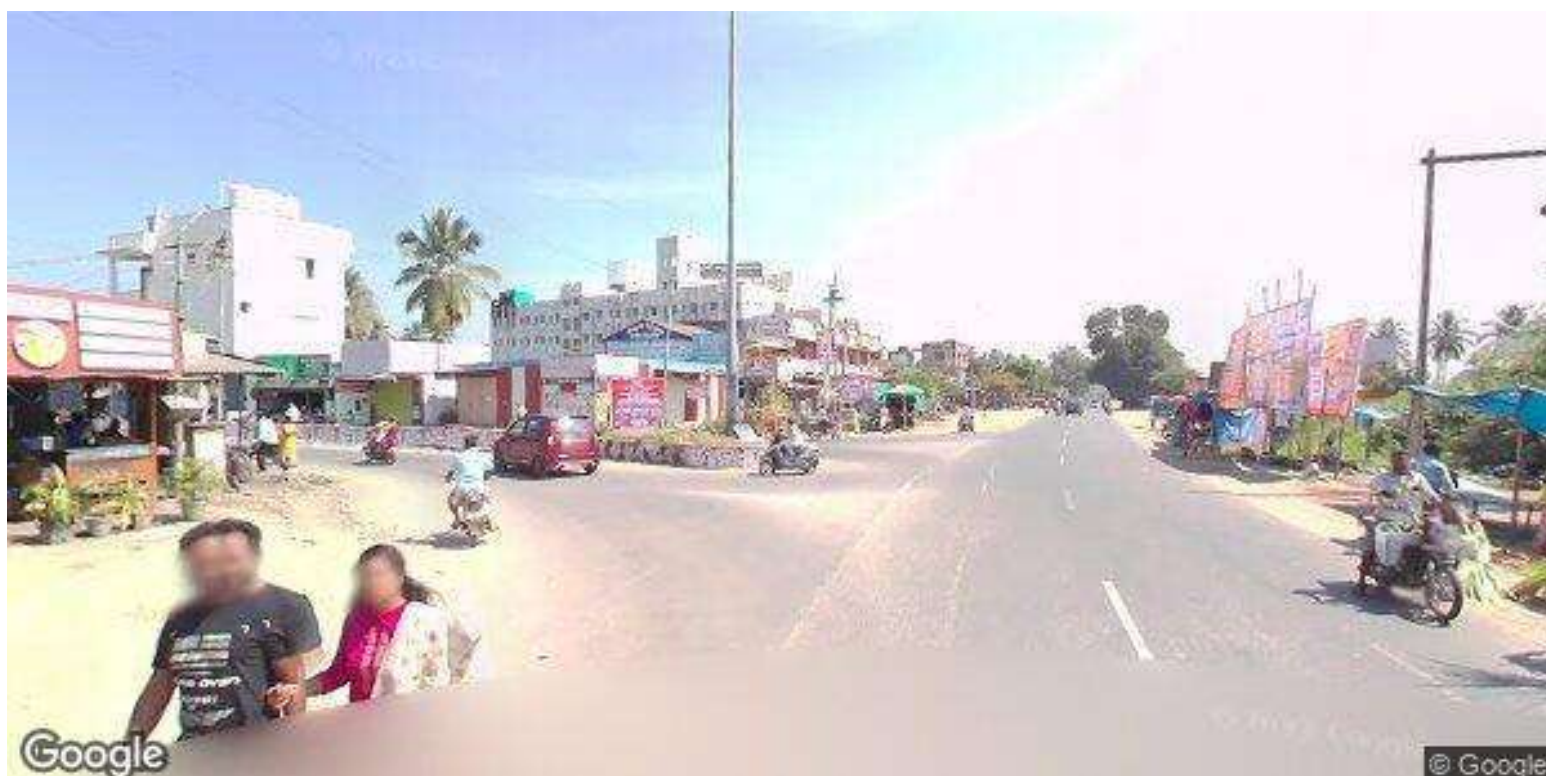
**Risk Type:** Turn

**Risk Level:** High

**Speed Limit:** 15 KM/Hr

**Coordinates:** 11.65716, 78.40570

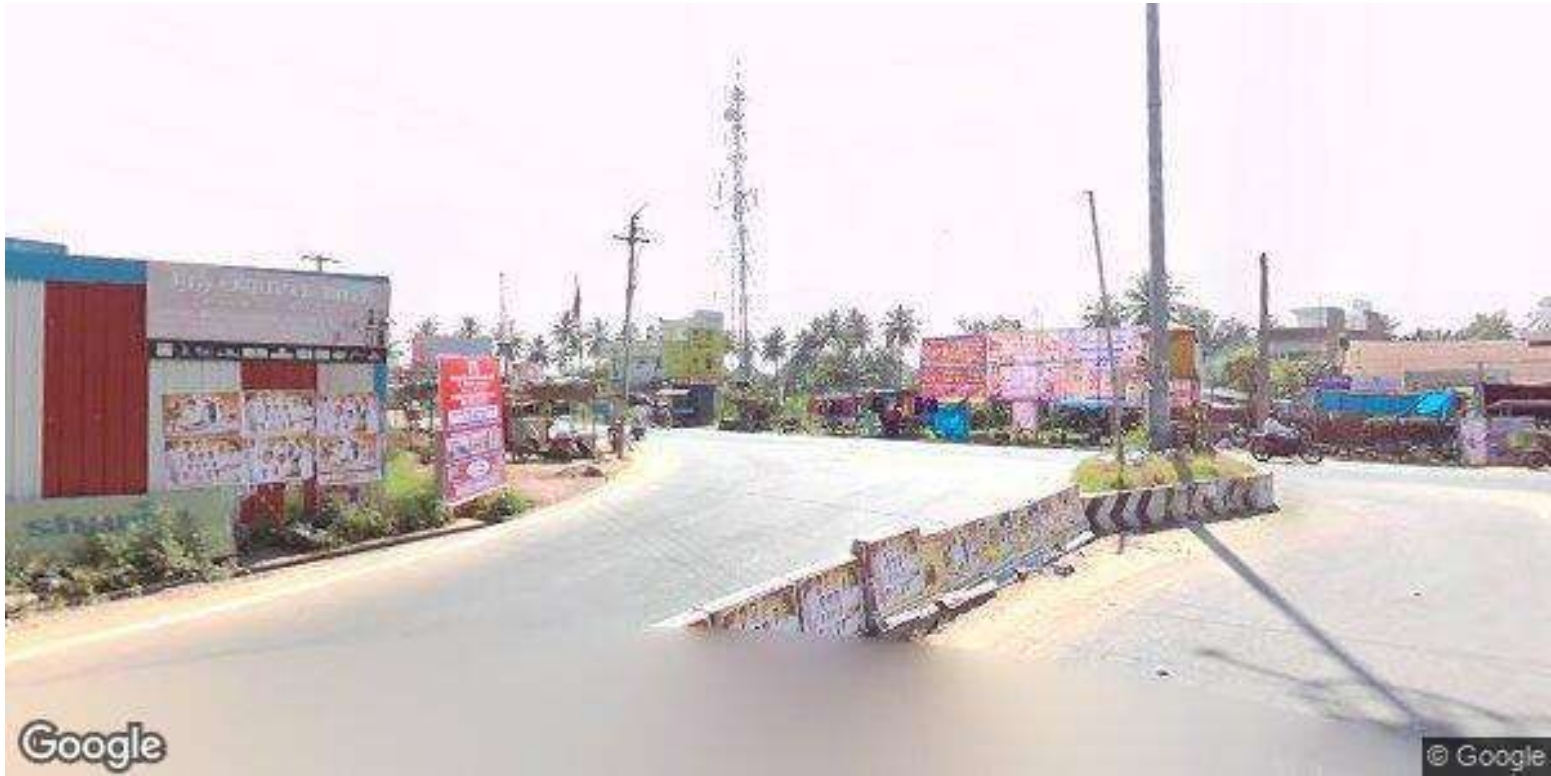
**Risk Type:** Turn

**Risk Level:** Medium

**Speed Limit:** 30 KM/Hr

**Coordinates:** 11.65743, 78.40584
