# IndianOil

## JOURNEY RISK MANAGEMENT (JRM) STUDY

### Salem Terminal to ADHOC SREE PALANIVEL TRADERS UNIT II

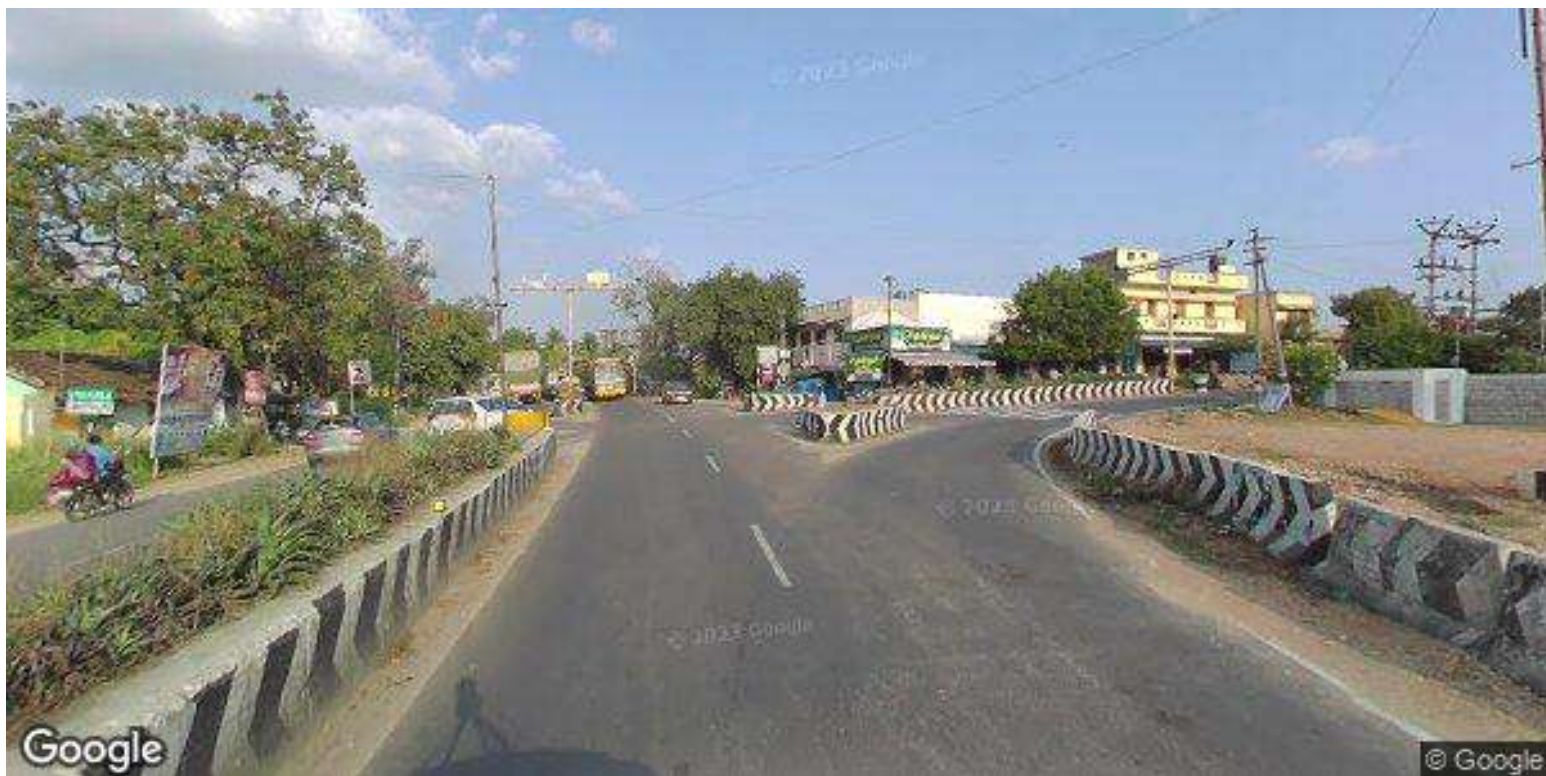
**Coordinates:** 11.46318, 77.84913

**Risk Type:** Turn

**Risk Level:** Medium

**Speed Limit:** 30 KM/Hr

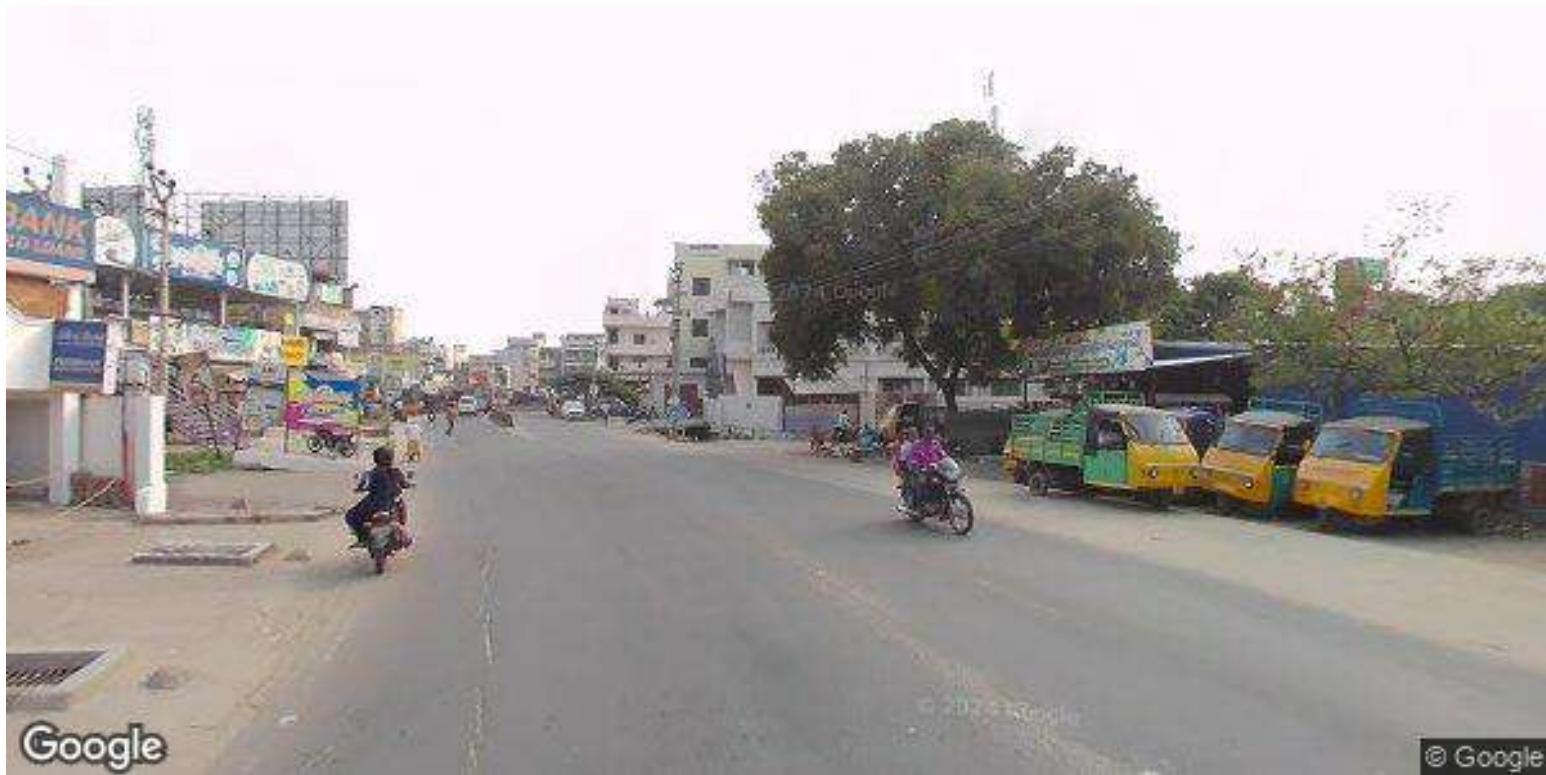
**Coordinates: 11.36626, 77.74788**

**Risk Type: Turn**

**Risk Level: Medium**

**Speed Limit: 30 KM/Hr**

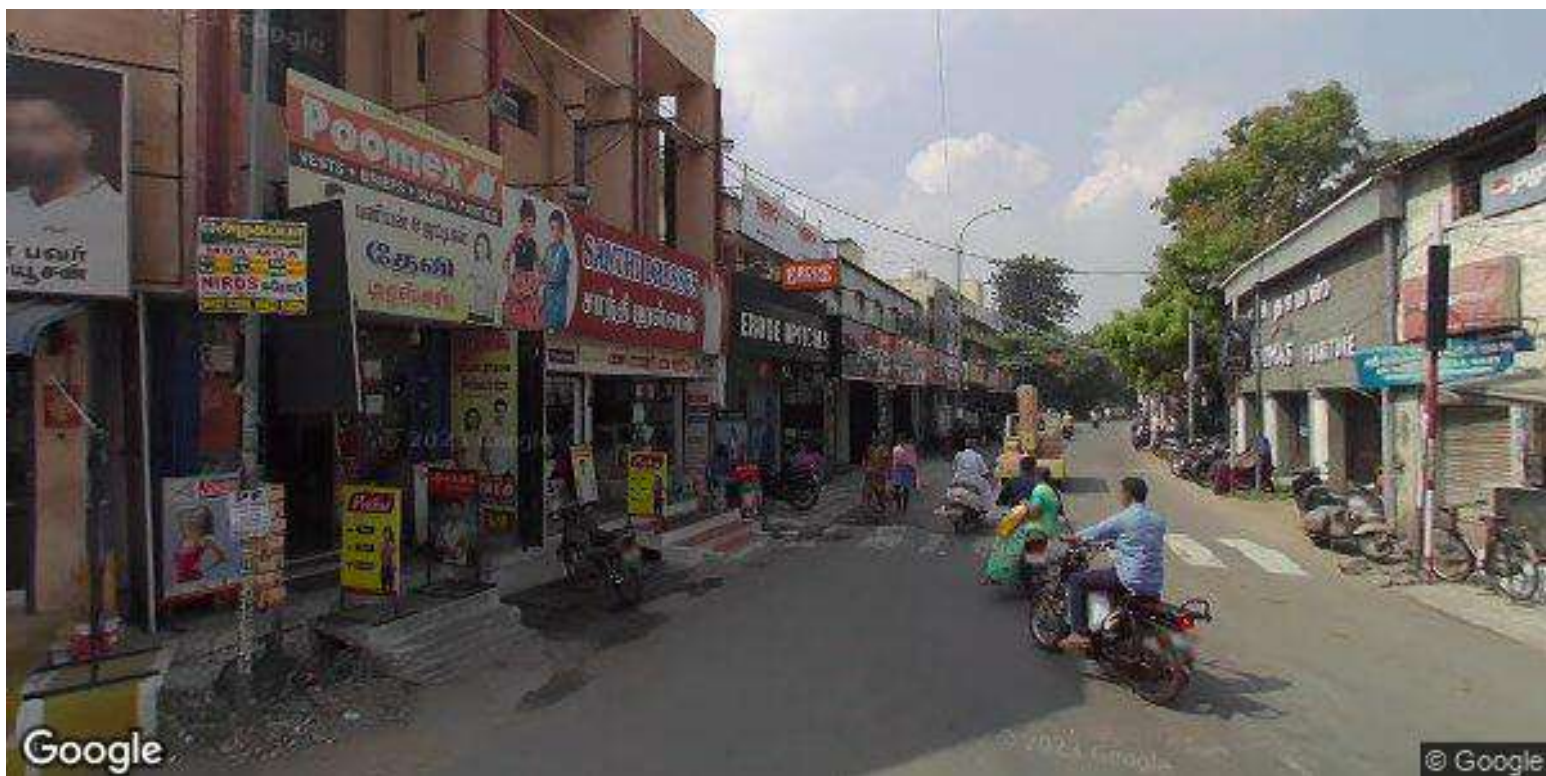
**Coordinates: 11.33920, 77.72902**

**Risk Type: Blind Spot**

**Risk Level: Blind Spot**

**Speed Limit: 10 KM/Hr**

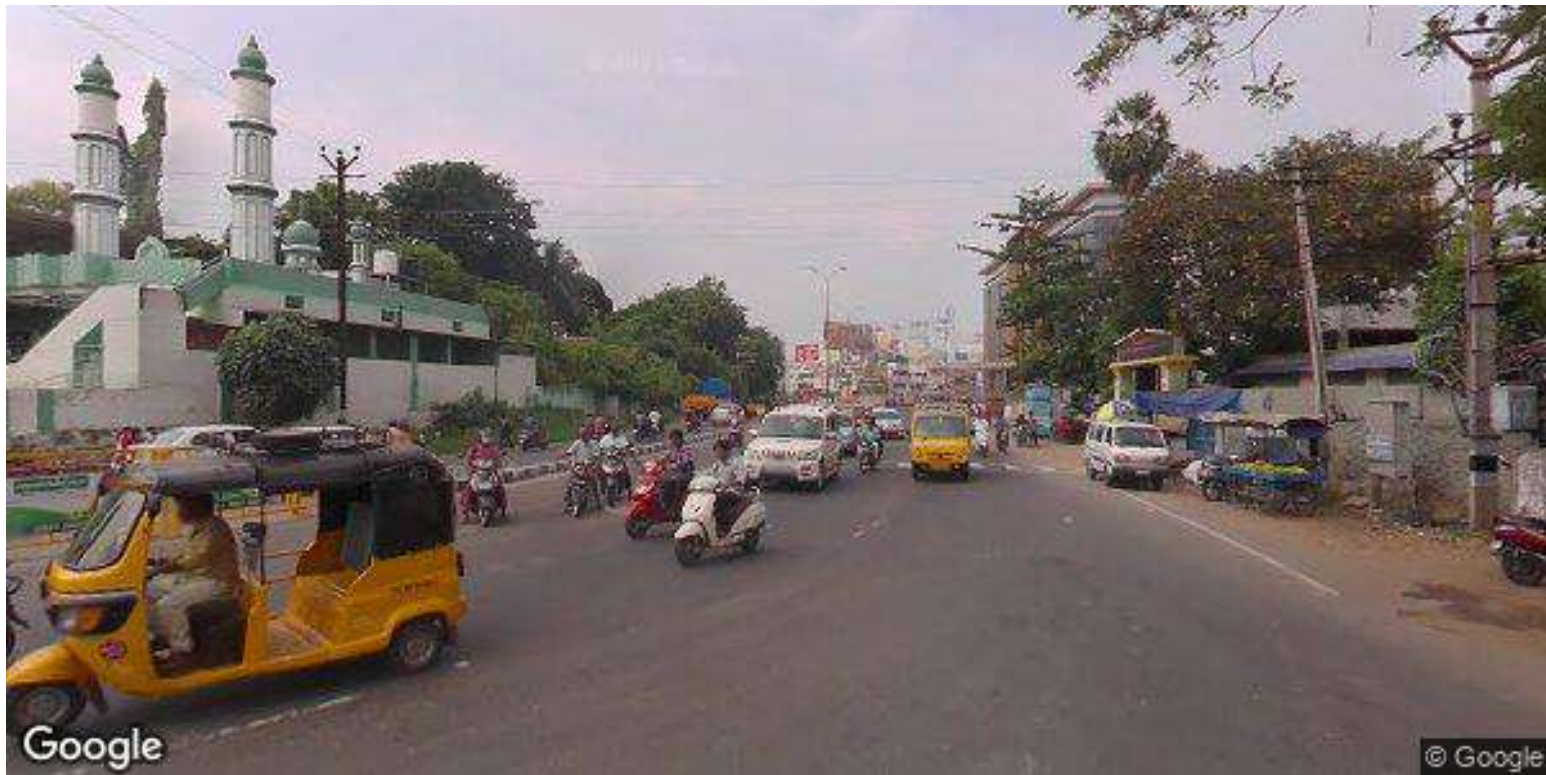
**Coordinates: 11.33076, 77.72884**

**Risk Type: Turn**

**Risk Level: Medium**

**Speed Limit: 30 KM/Hr**

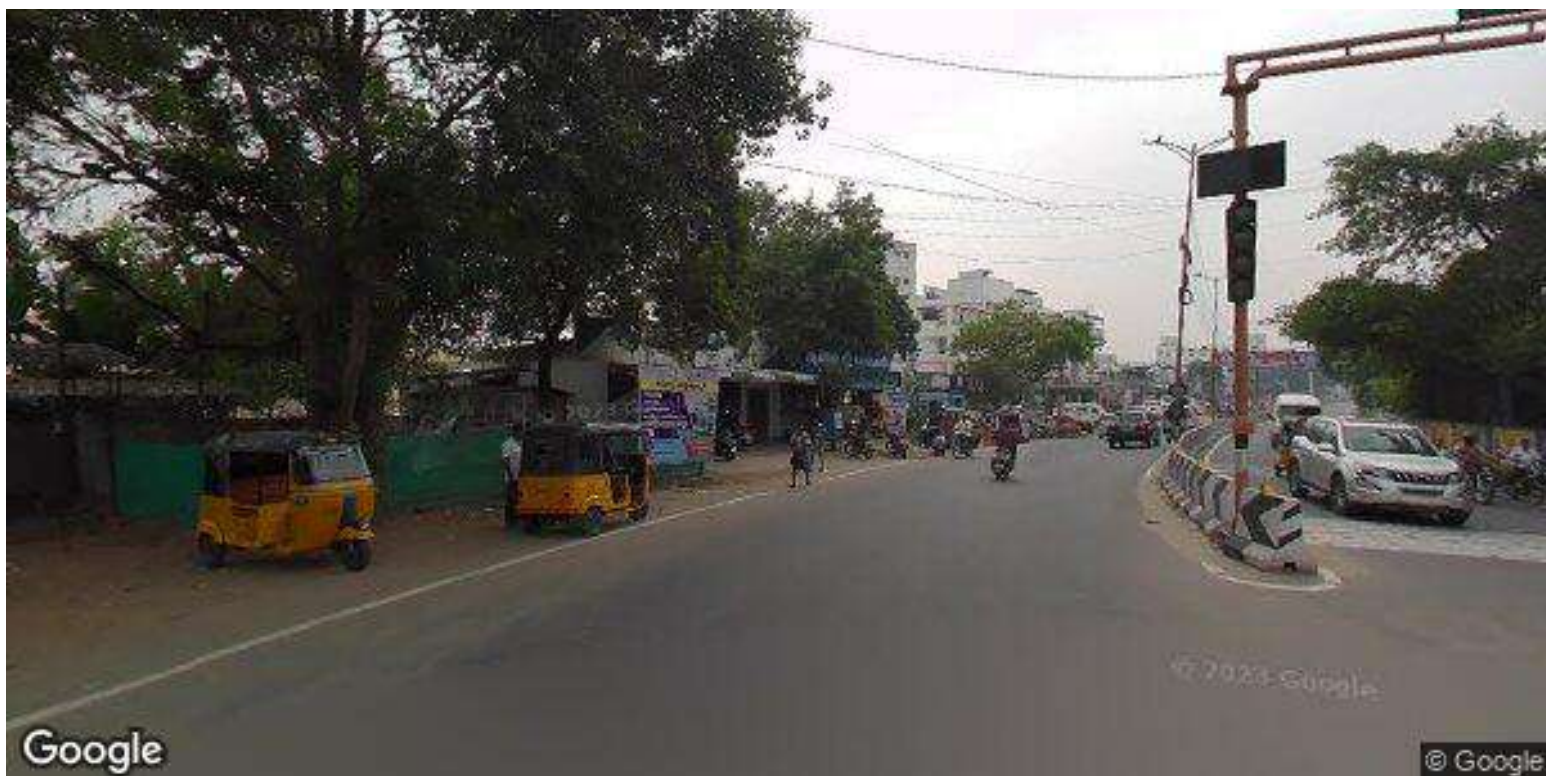
**Coordinates: 11.32694, 77.73073**

**Risk Type: Turn**

**Risk Level: High**

**Speed Limit: 15 KM/Hr**

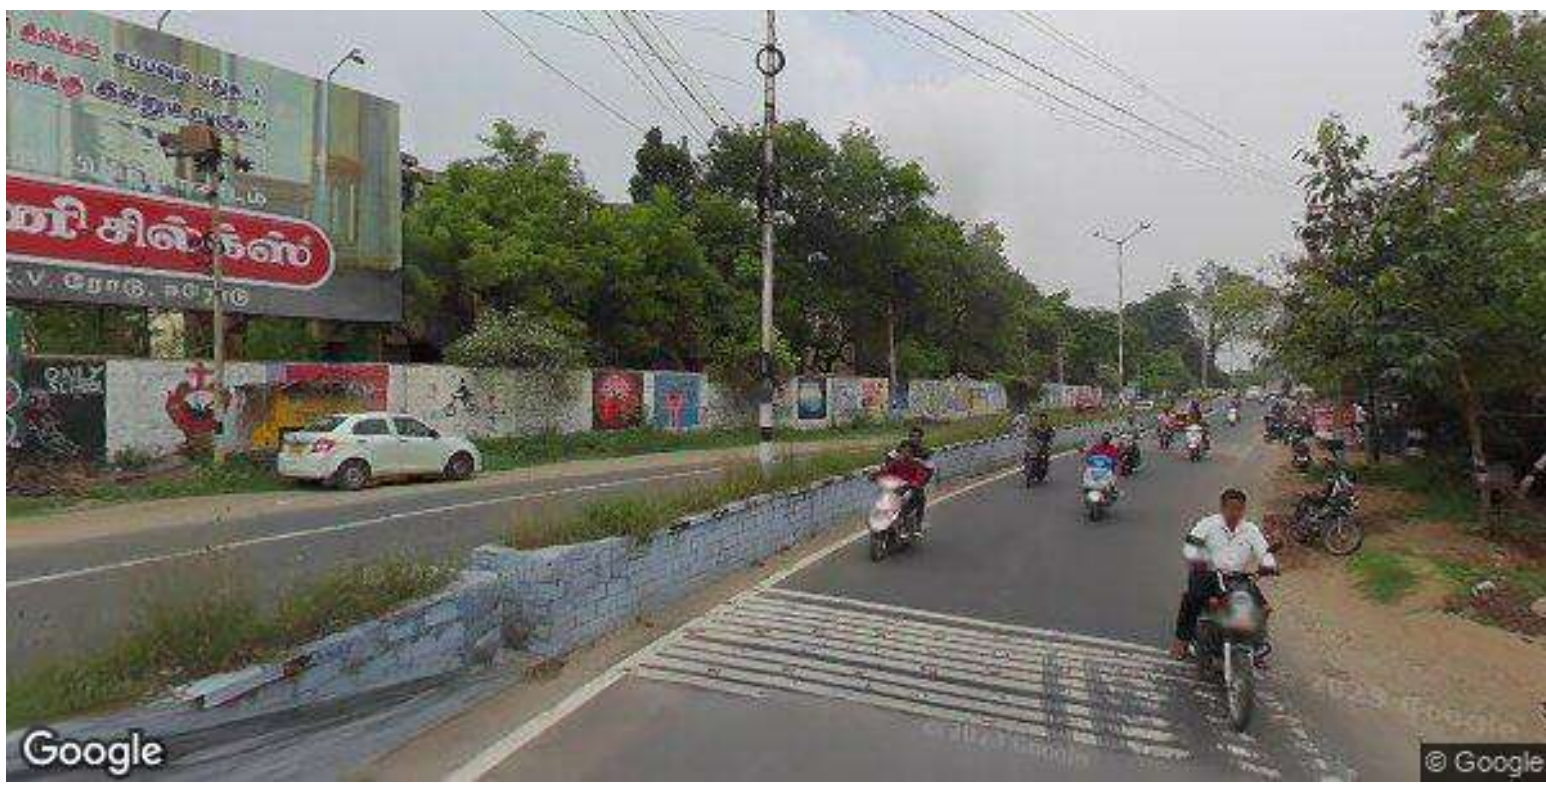
**Coordinates:** 11.32427, 77.72730

**Risk Type:** Turn

**Risk Level:** Medium

**Speed Limit:** 30 KM/Hr

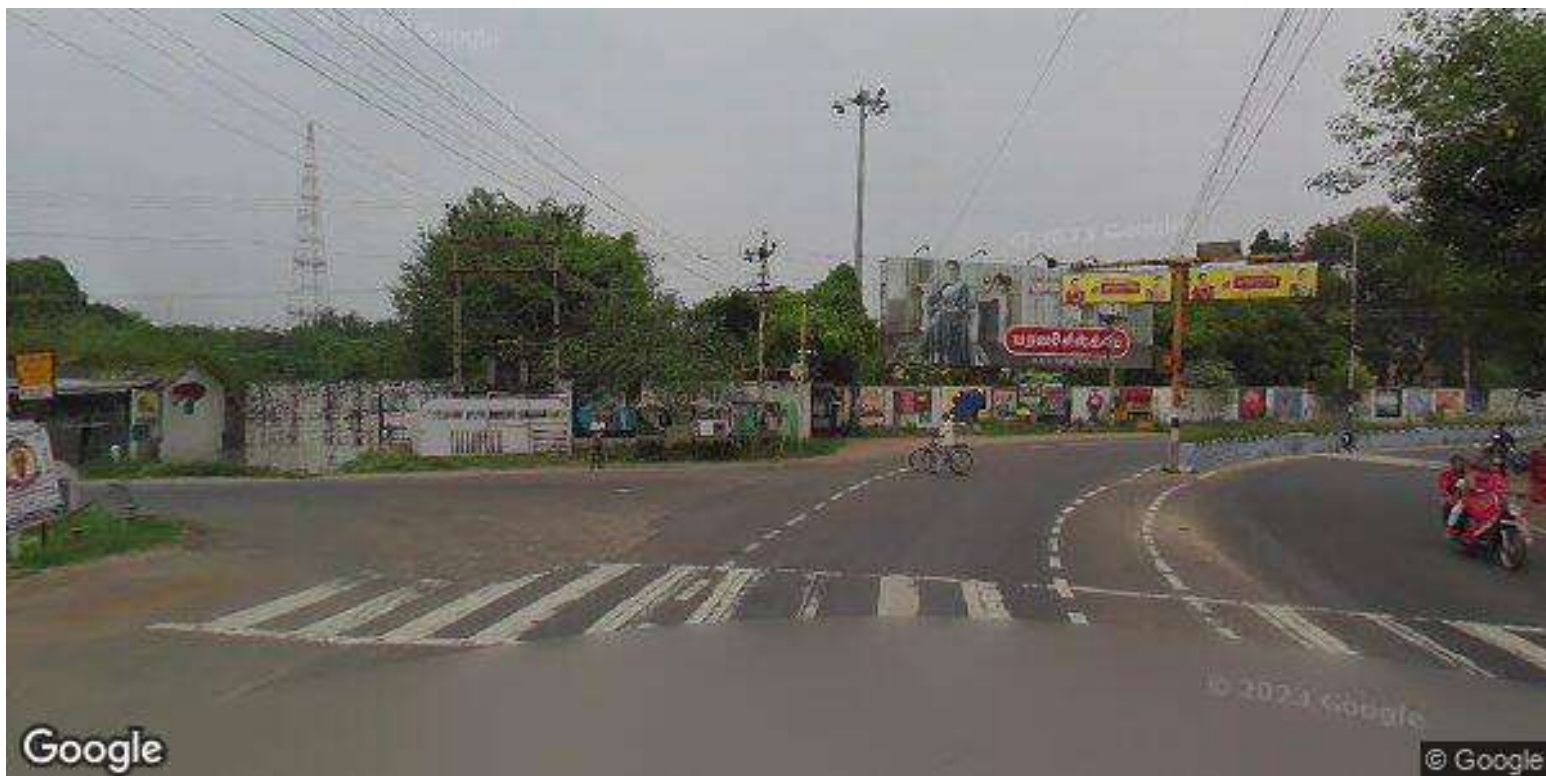
**Coordinates:** 11.32401, 77.72723

**Risk Type:** Turn

**Risk Level:** Medium

**Speed Limit:** 30 KM/Hr
