# IndianOil

## JOURNEY RISK MANAGEMENT (JRM) STUDY

### Salem Terminal to SARAL PETROLEUM

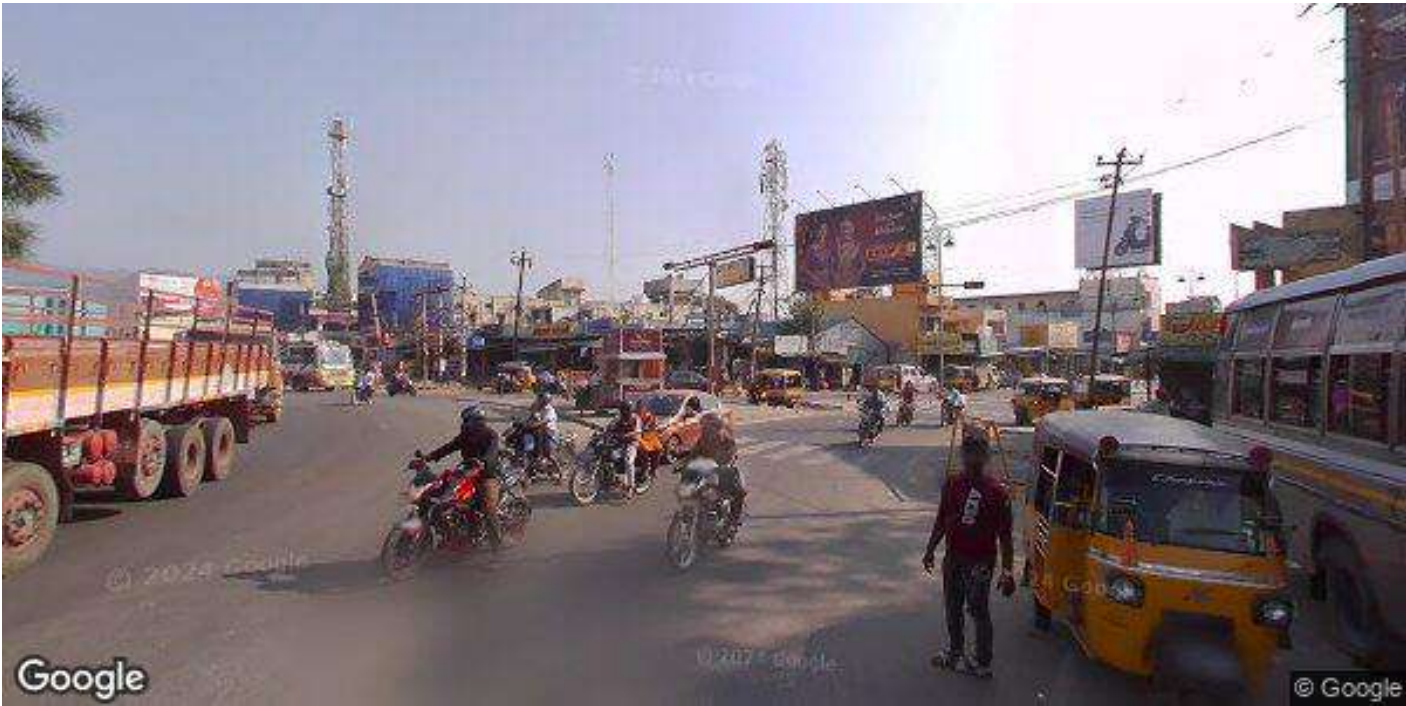
Risk Type: Roundabout

Risk Level: High

Speed Limit: 15 KM/Hr

Coordinates: 11.63266, 78.12699

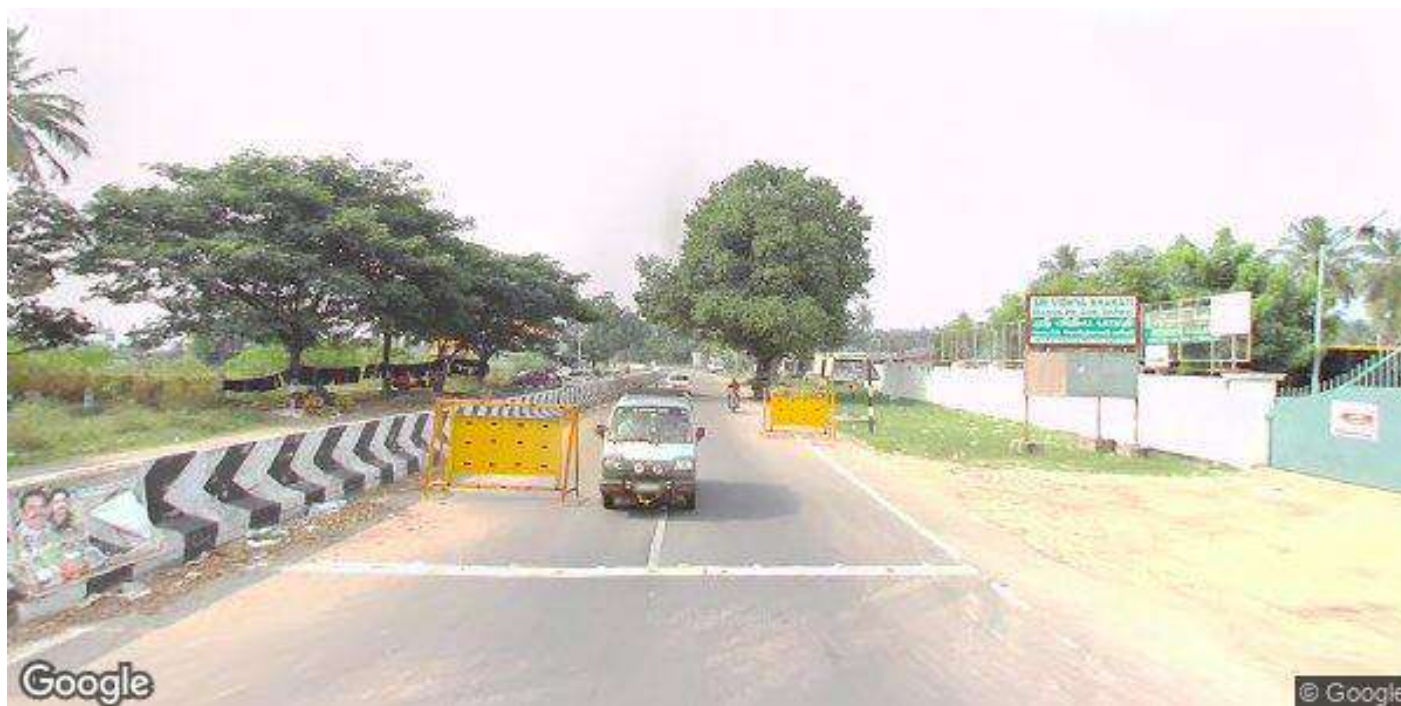
**Risk Type:** U-Turn  
**Risk Level:** High  
**Speed Limit:** 10 KM/Hr  
**Coordinates:** 11.6180669, 78.1109048

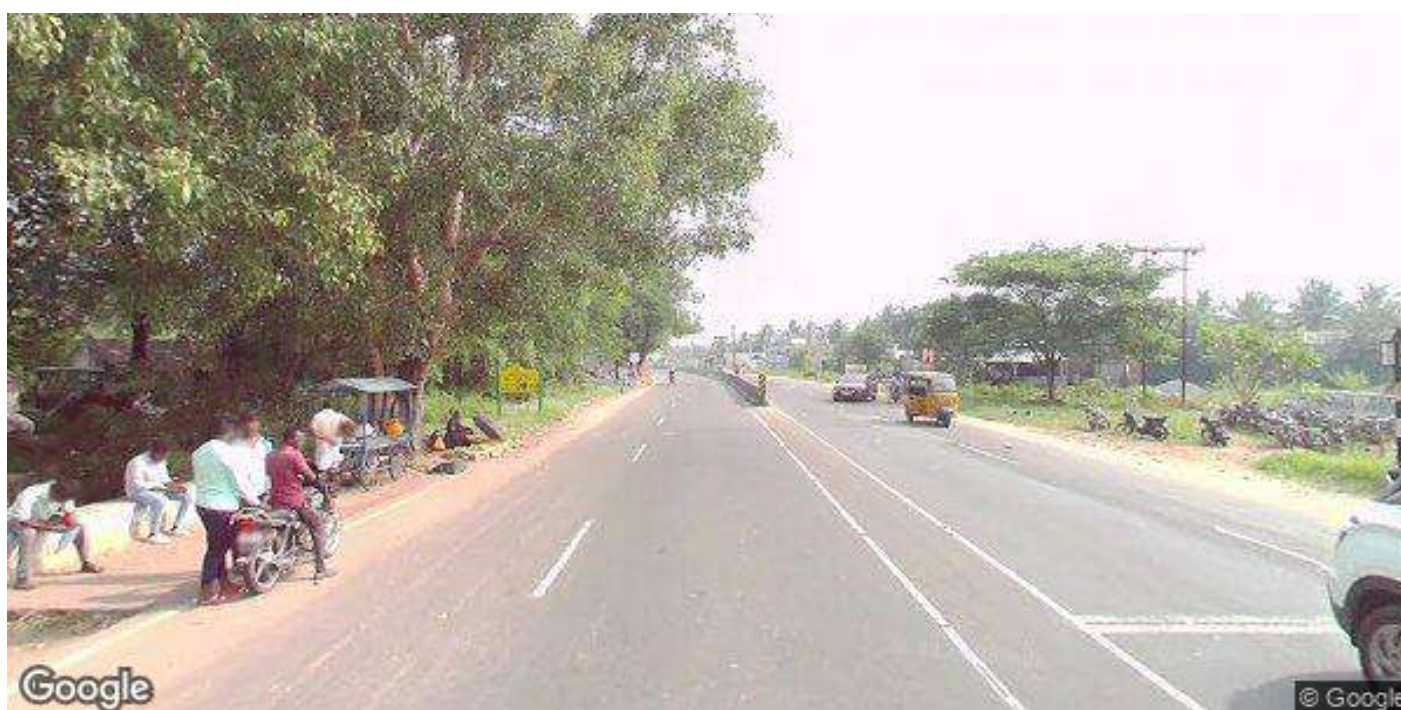
**Risk Type:** U-Turn  
**Risk Level:** High  
**Speed Limit:** 10 KM/Hr  
**Coordinates:** 11.6128439, 78.1059968

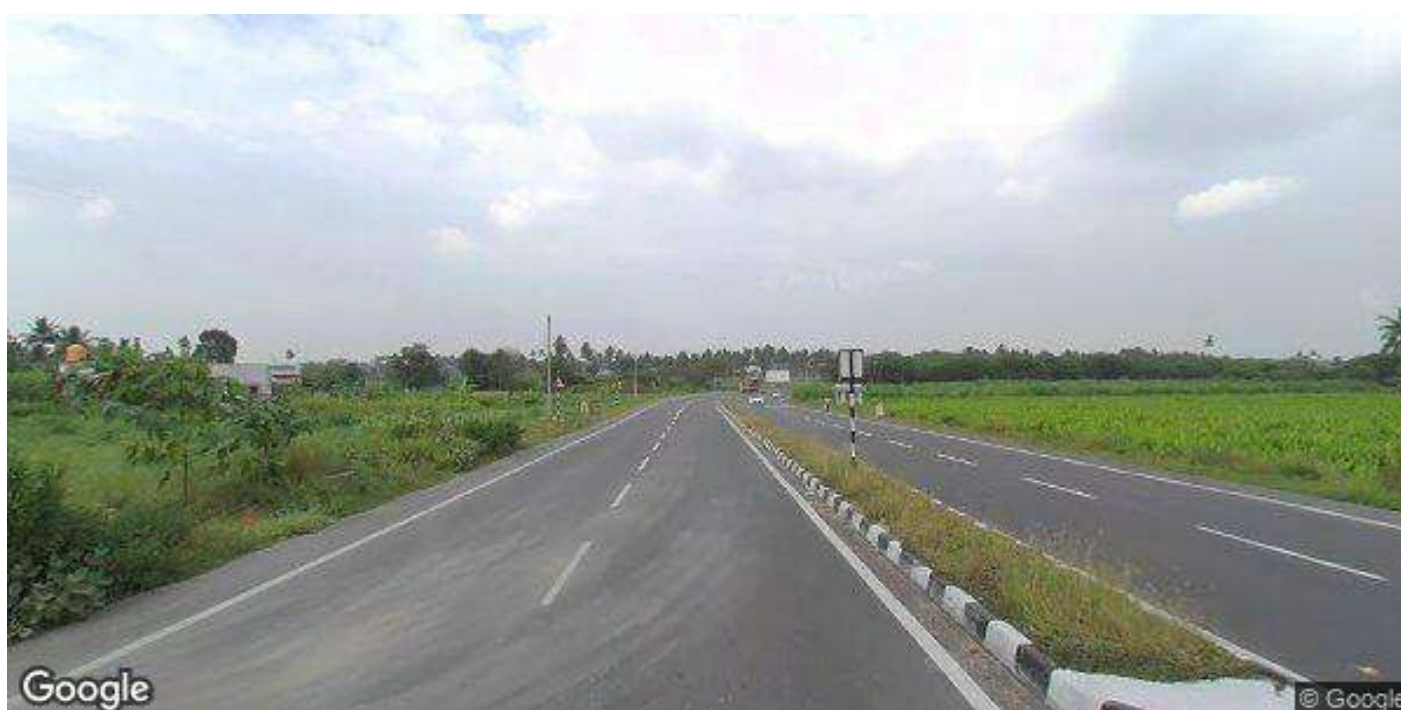
**Risk Type:** U-Turn  
**Risk Level:** High  
**Speed Limit:** 10 KM/Hr  
**Coordinates:** 12.1178163, 78.4982242

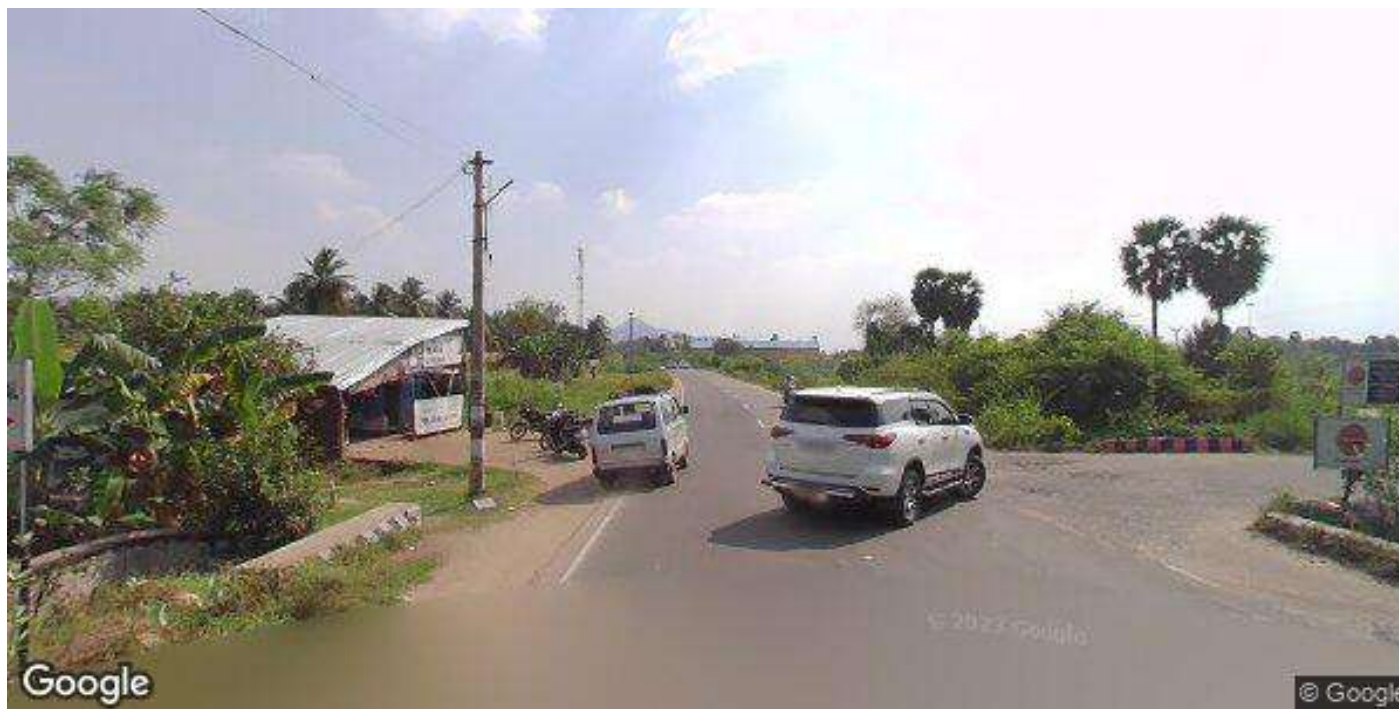
**Risk Type:** Turn  
**Risk Level:** High  
**Speed Limit:** 15 KM/Hr  
**Coordinates:** 11.44029, 77.87544

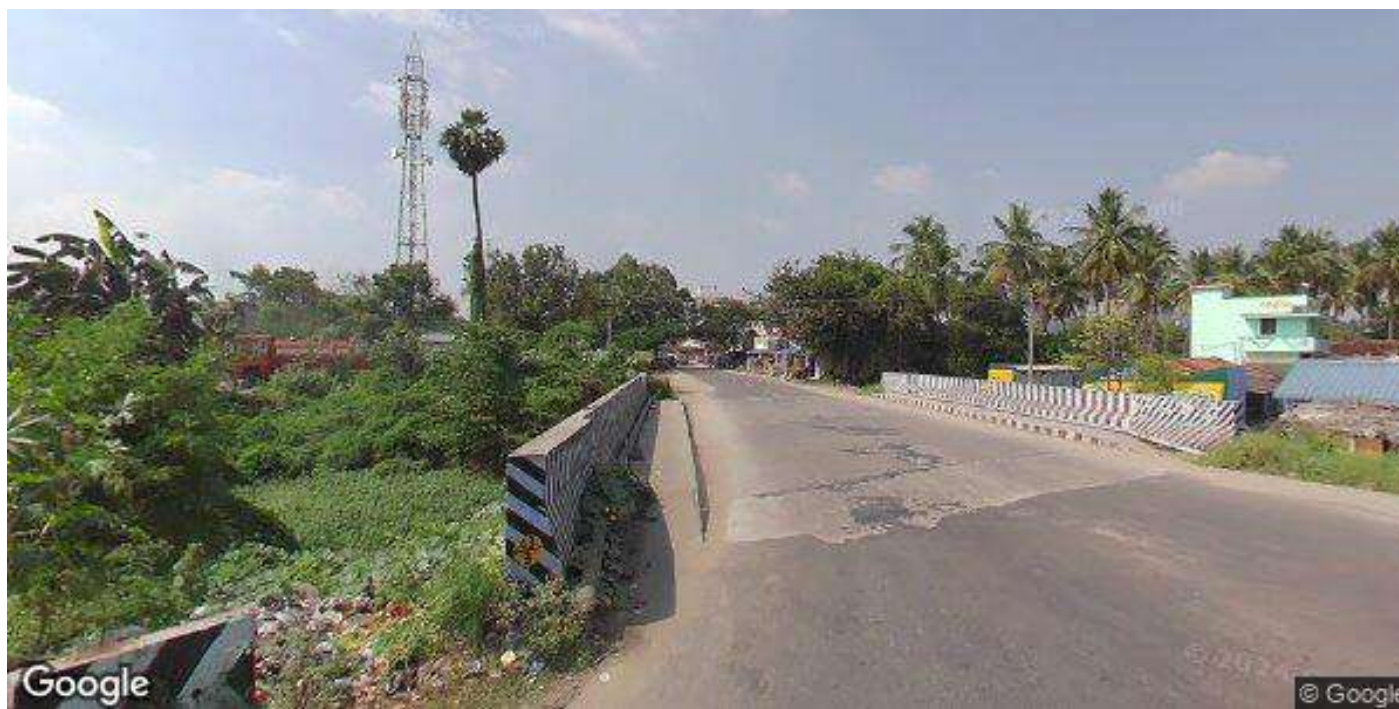
**Risk Type:** Turn  
**Risk Level:** High  
**Speed Limit:** 15 KM/Hr  
**Coordinates:** 11.44900, 77.87406

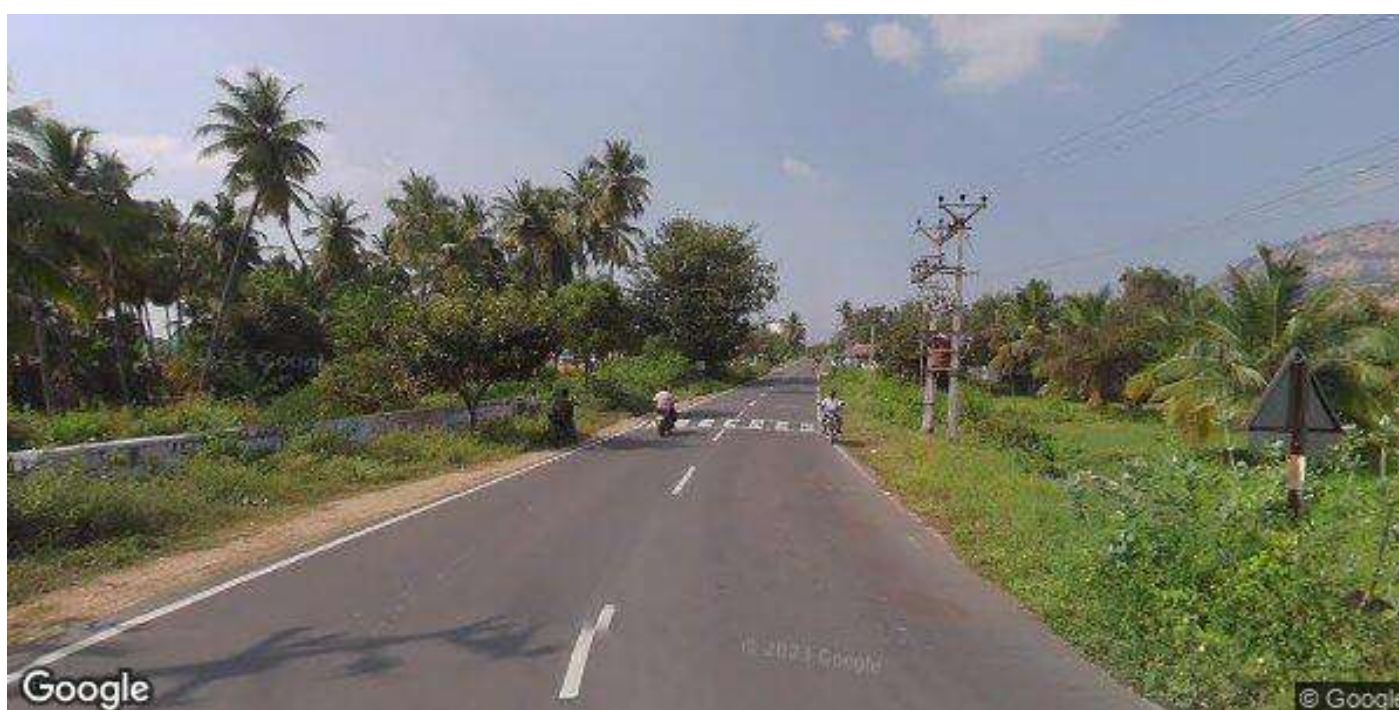
**Risk Type:** Turn  
**Risk Level:** High  
**Speed Limit:** 15 KM/Hr  
**Coordinates:** 11.45353, 77.85697

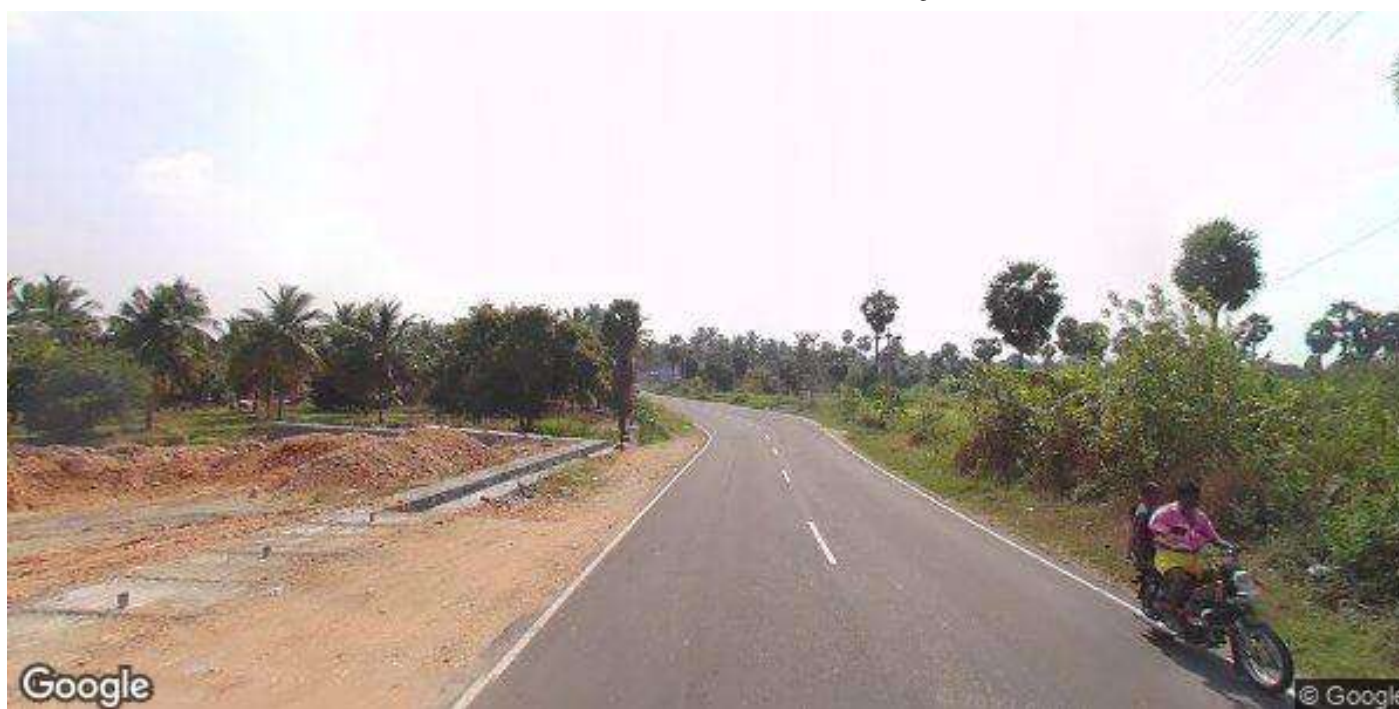
**Risk Type:** Turn  
**Risk Level:** Medium  
**Speed Limit:** 30 KM/Hr  
**Coordinates:** 11.45781, 77.85203

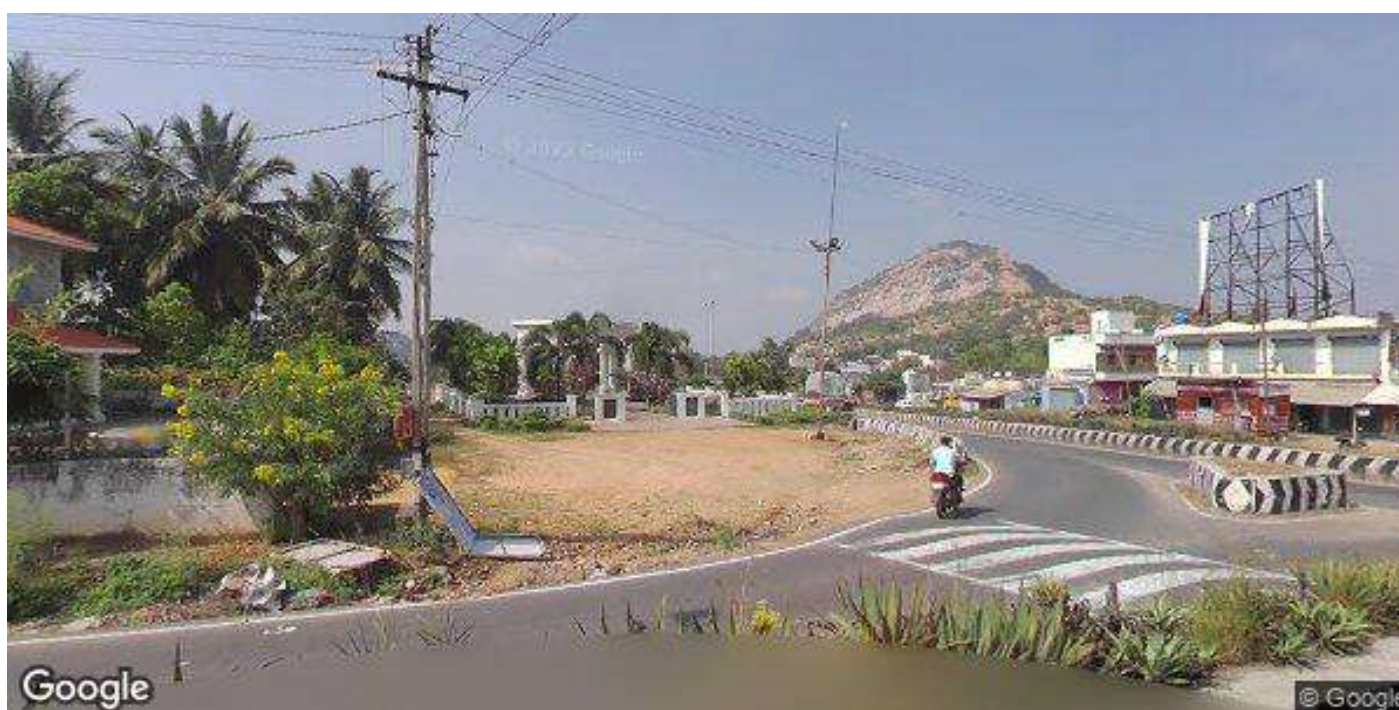
**Risk Type:** Turn  
**Risk Level:** High  
**Speed Limit:** 15 KM/Hr  
**Coordinates:** 11.46307, 77.84941

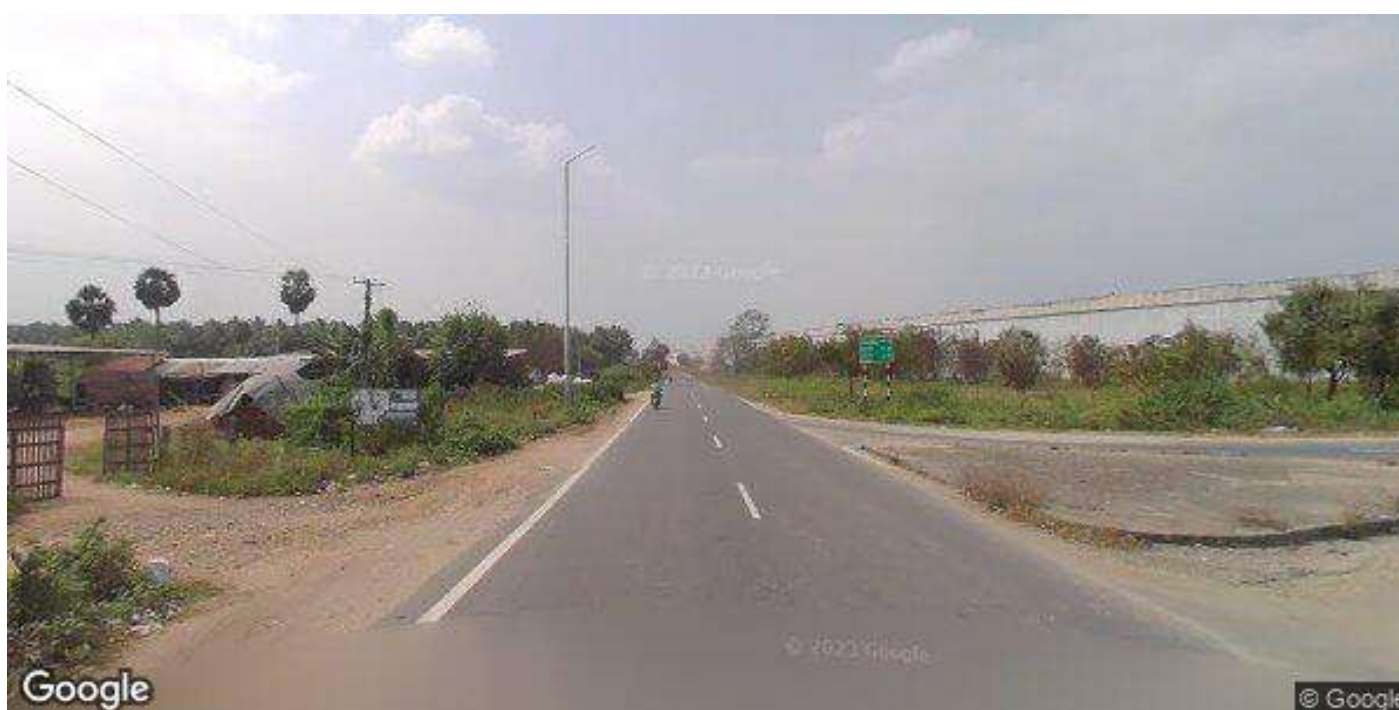
**Risk Type:** Turn  
**Risk Level:** High  
**Speed Limit:** 15 KM/Hr  
**Coordinates:** 11.45542, 77.81725

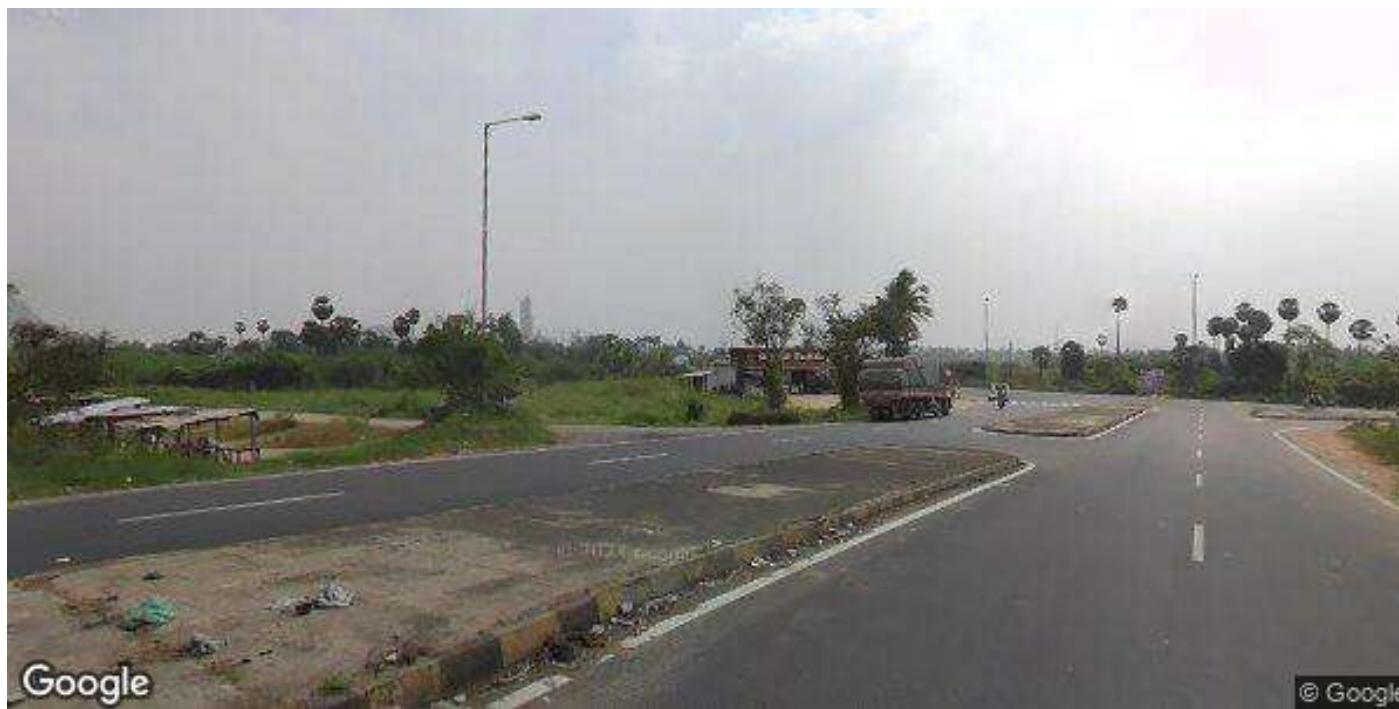
**Risk Type:** Turn  
**Risk Level:** High  
**Speed Limit:** 15 KM/Hr  
**Coordinates:** 11.45605, 77.81683

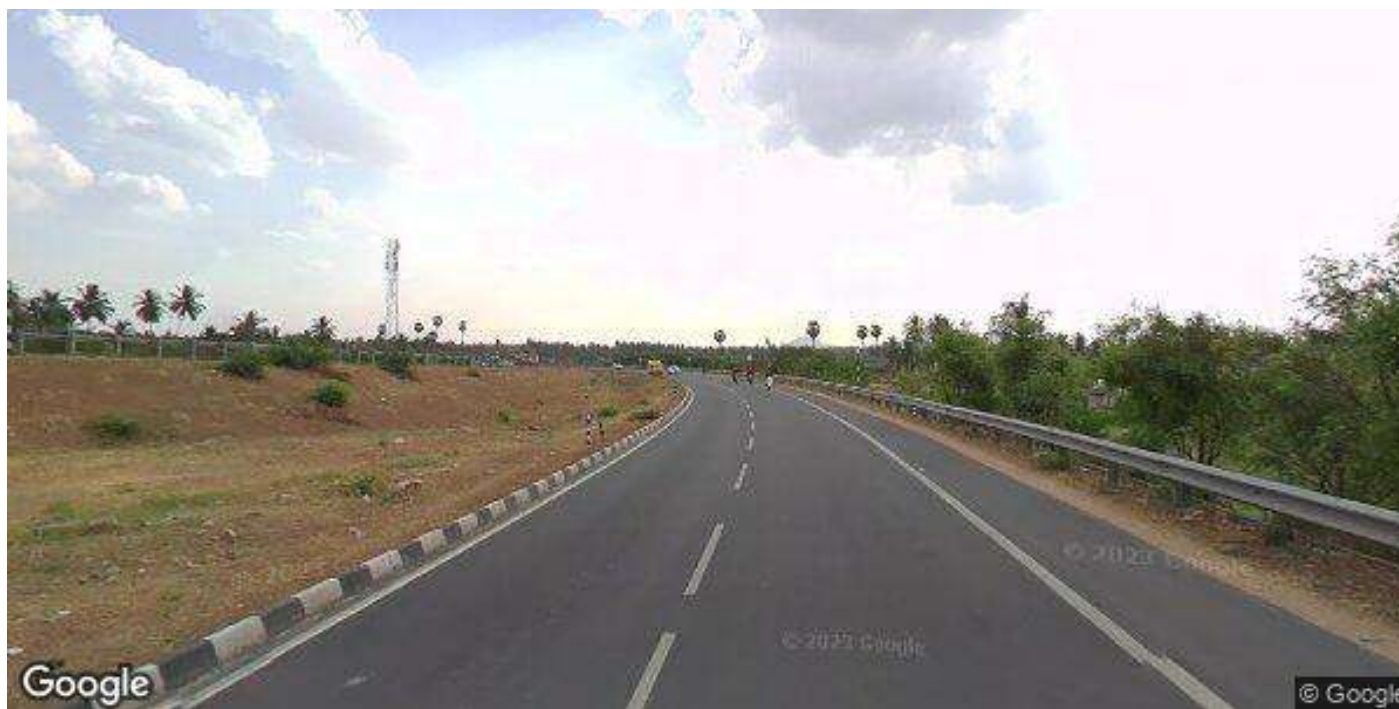
**Risk Type:** Turn  
**Risk Level:** Medium  
**Speed Limit:** 30 KM/Hr  
**Coordinates:** 11.53573, 77.95794

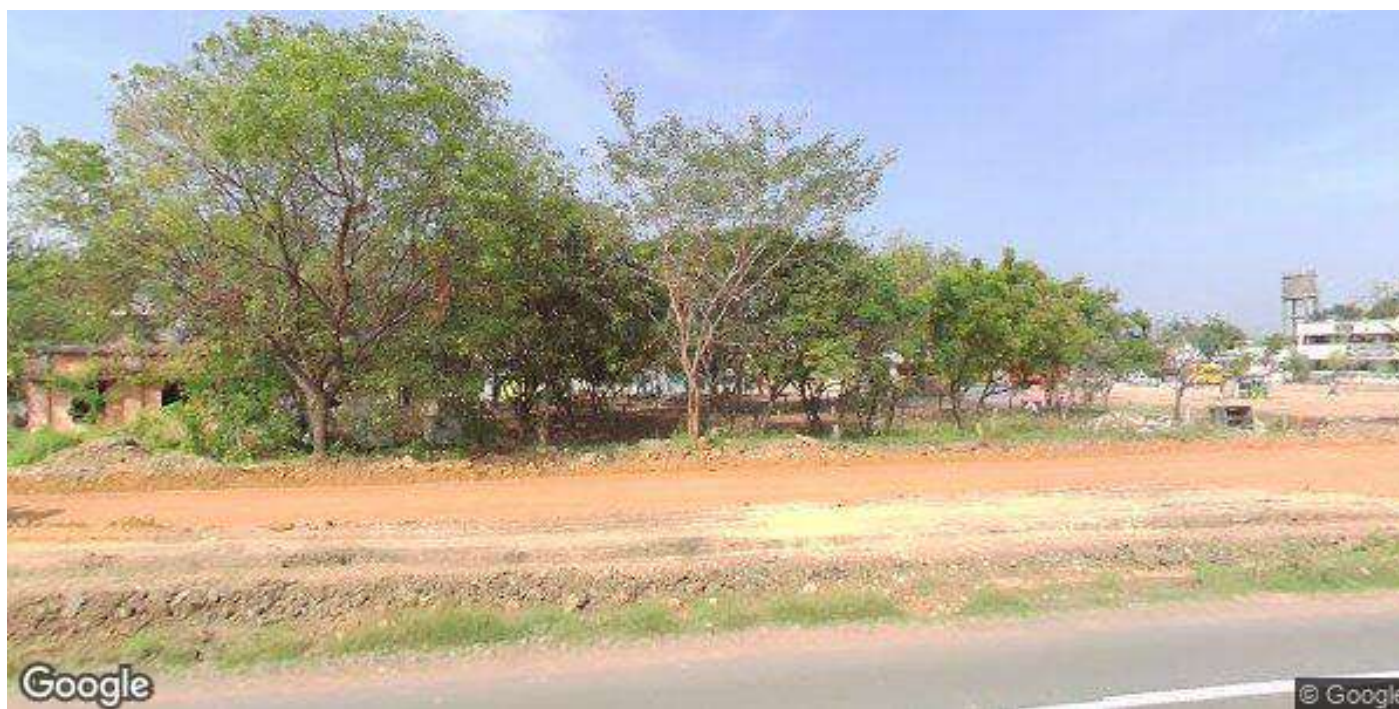
**Risk Type:** Turn  
**Risk Level:** Medium  
**Speed Limit:** 30 KM/Hr  
**Coordinates:** 11.62100, 78.10723

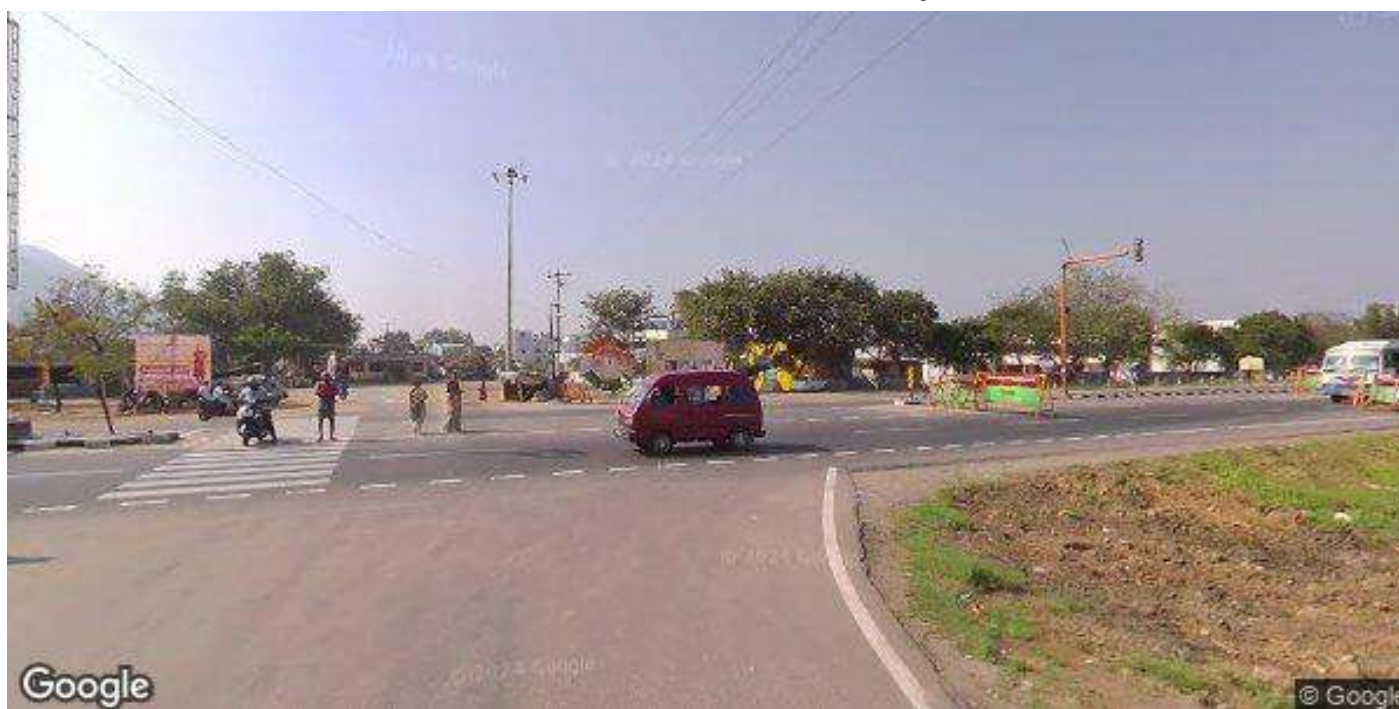
**Risk Type:** Blind Spot  
**Risk Level:** Blind Spot  
**Speed Limit:** 10 KM/Hr  
**Coordinates:** 11.62130, 78.10776

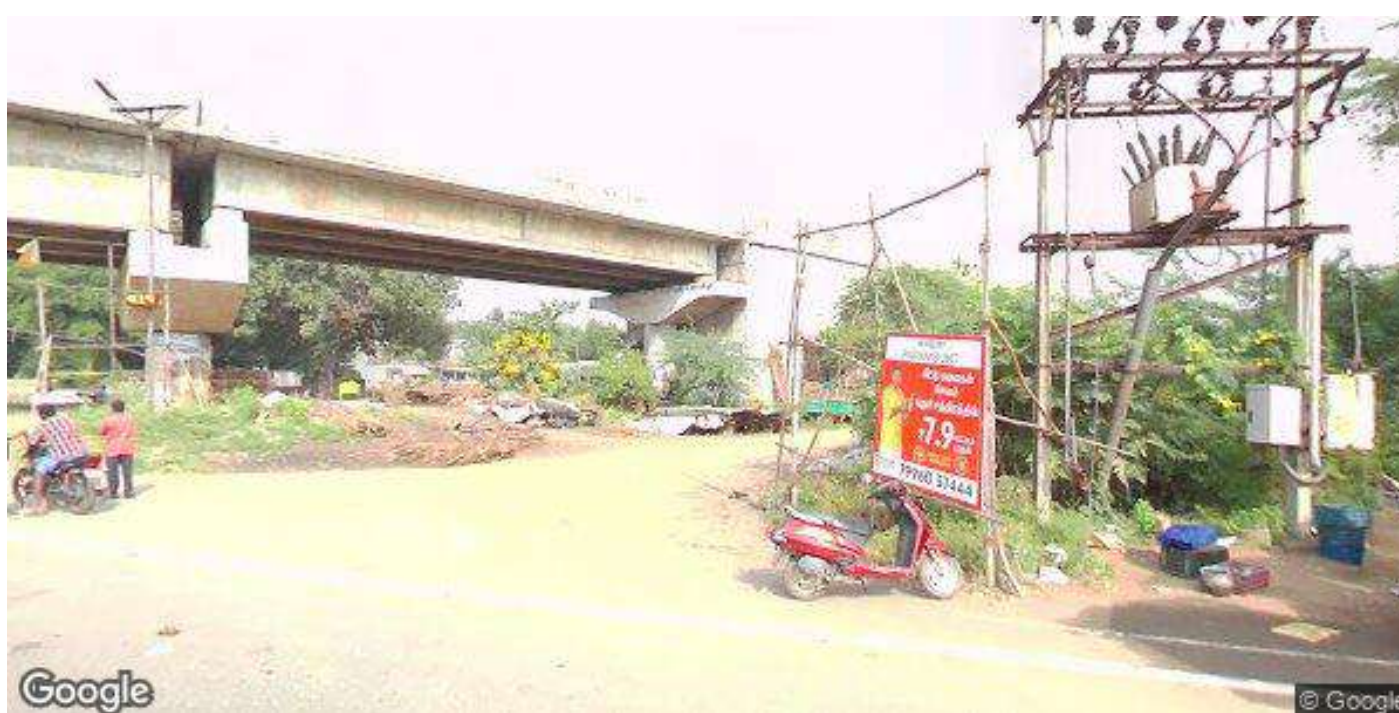
**Risk Type:** Blind Spot  
**Risk Level:** Blind Spot  
**Speed Limit:** 10 KM/Hr  
**Coordinates:** 11.61235, 78.10438

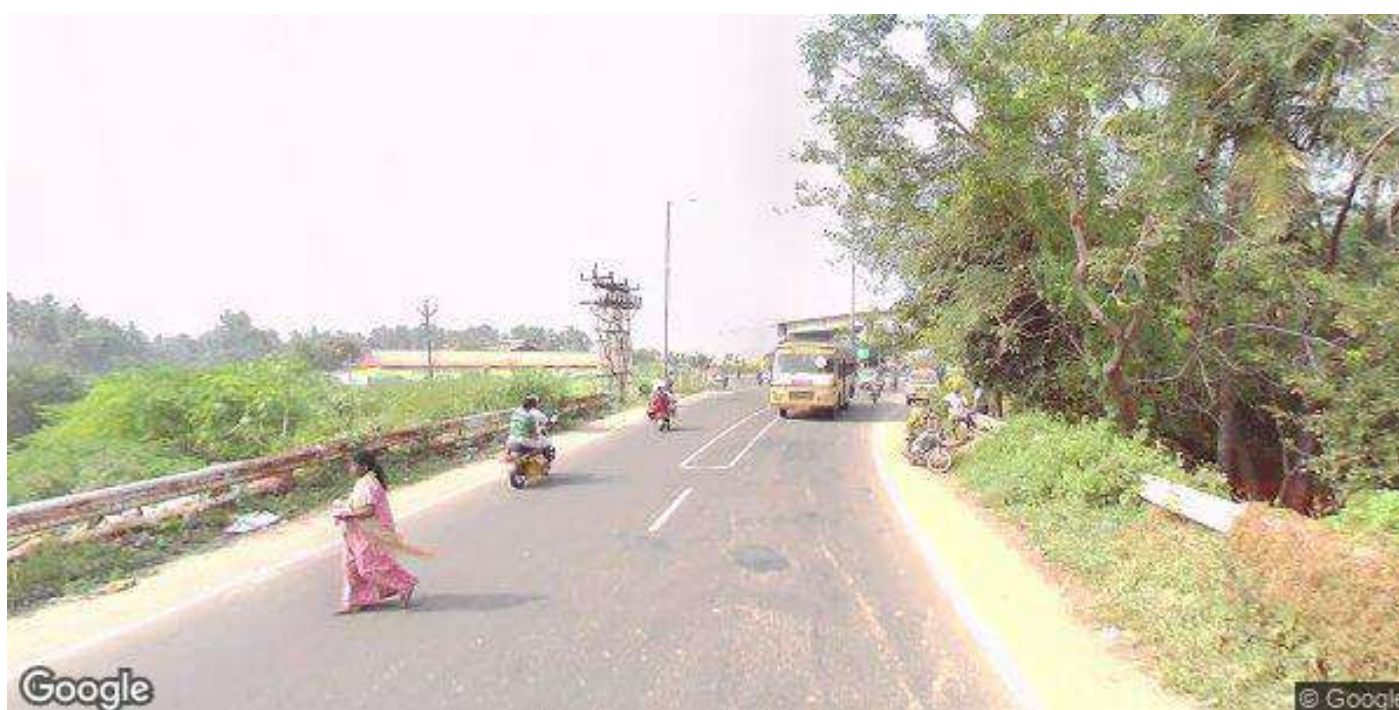
**Risk Type:** Turn  
**Risk Level:** Medium  
**Speed Limit:** 30 KM/Hr  
**Coordinates:** 11.61235, 78.10495

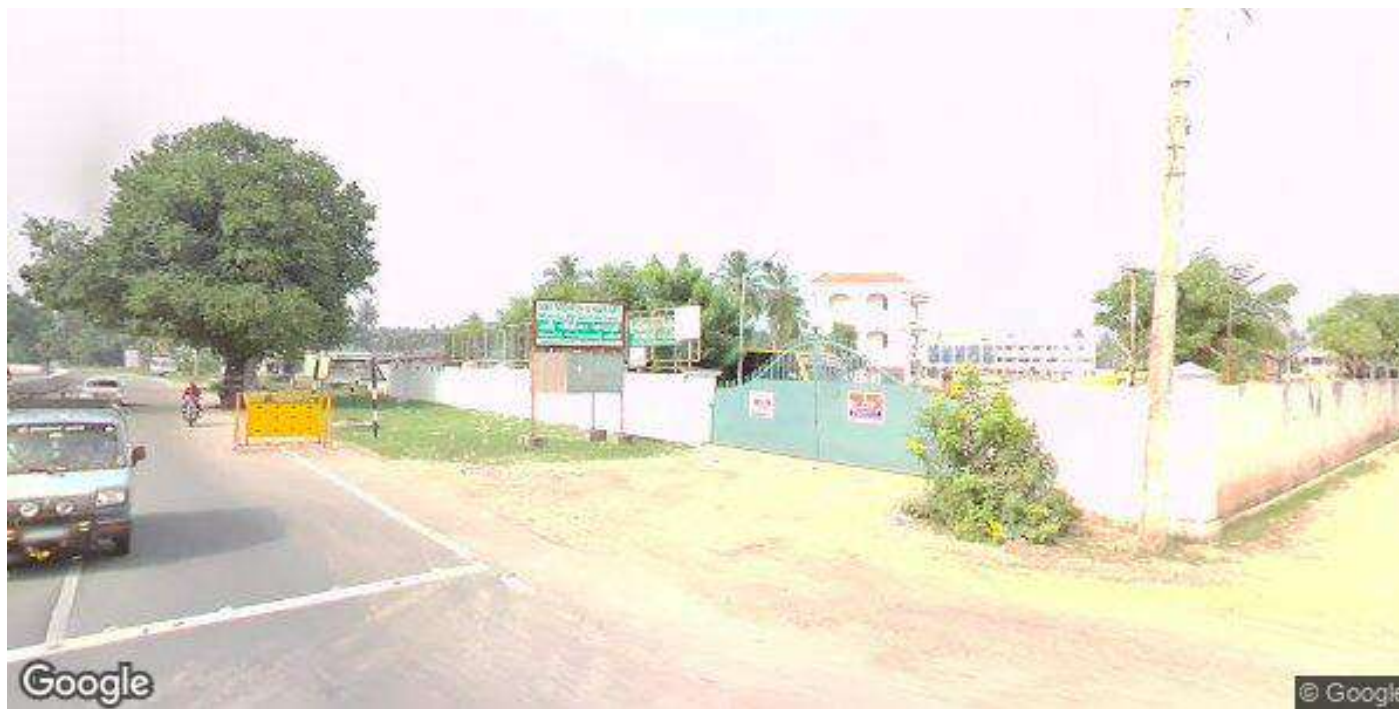
**Risk Type:** Blind Spot  
**Risk Level:** Blind Spot  
**Speed Limit:** 10 KM/Hr  
**Coordinates:** 11.61807, 78.11090

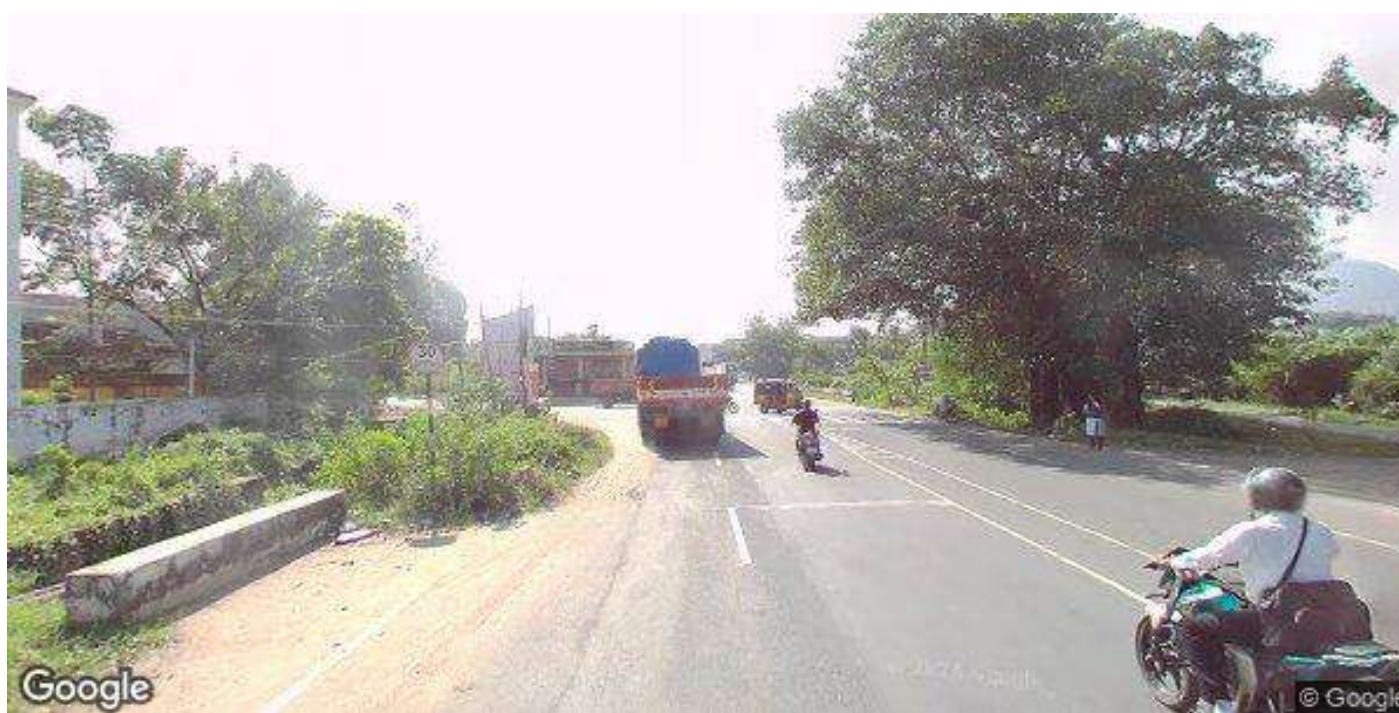
**Risk Type:** Blind Spot  
**Risk Level:** Blind Spot  
**Speed Limit:** 10 KM/Hr  
**Coordinates:** 11.61286, 78.10611

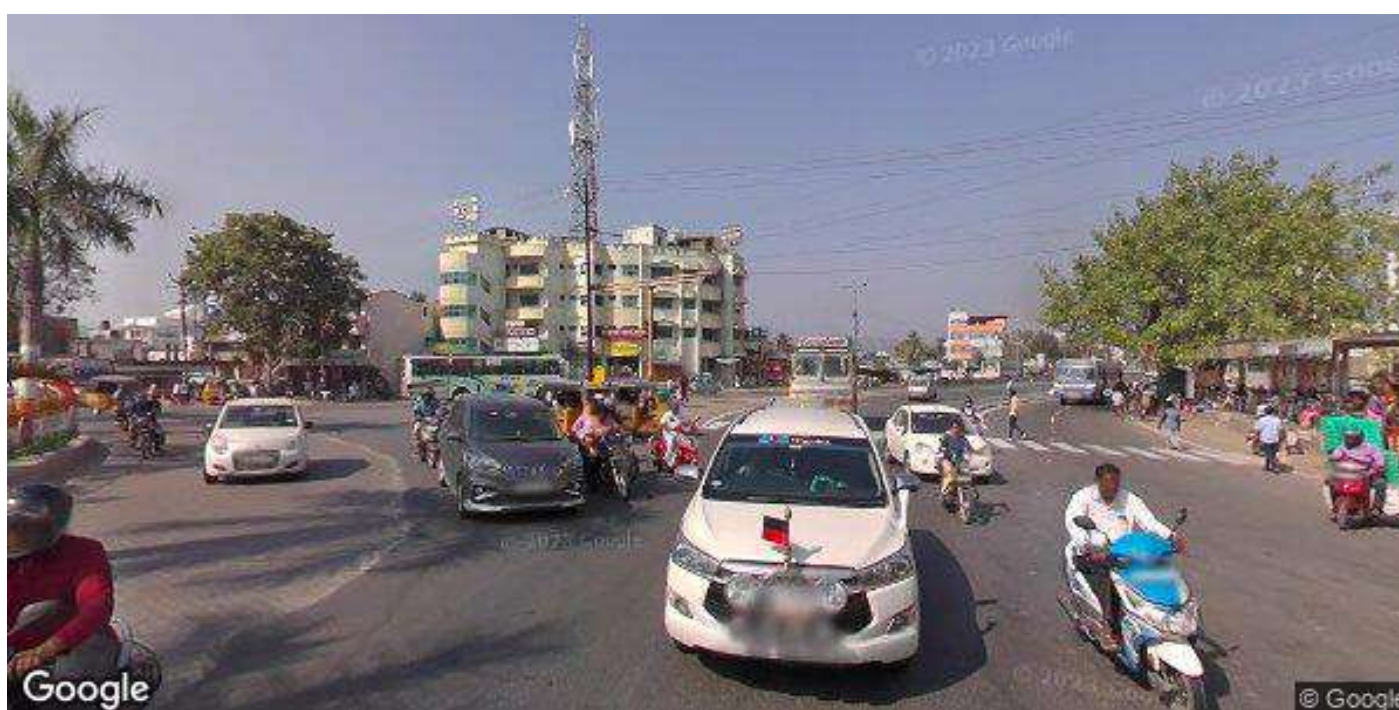
**Risk Type:** Blind Spot  
**Risk Level:** Blind Spot  
**Speed Limit:** 10 KM/Hr  
**Coordinates:** 11.63306, 78.12722

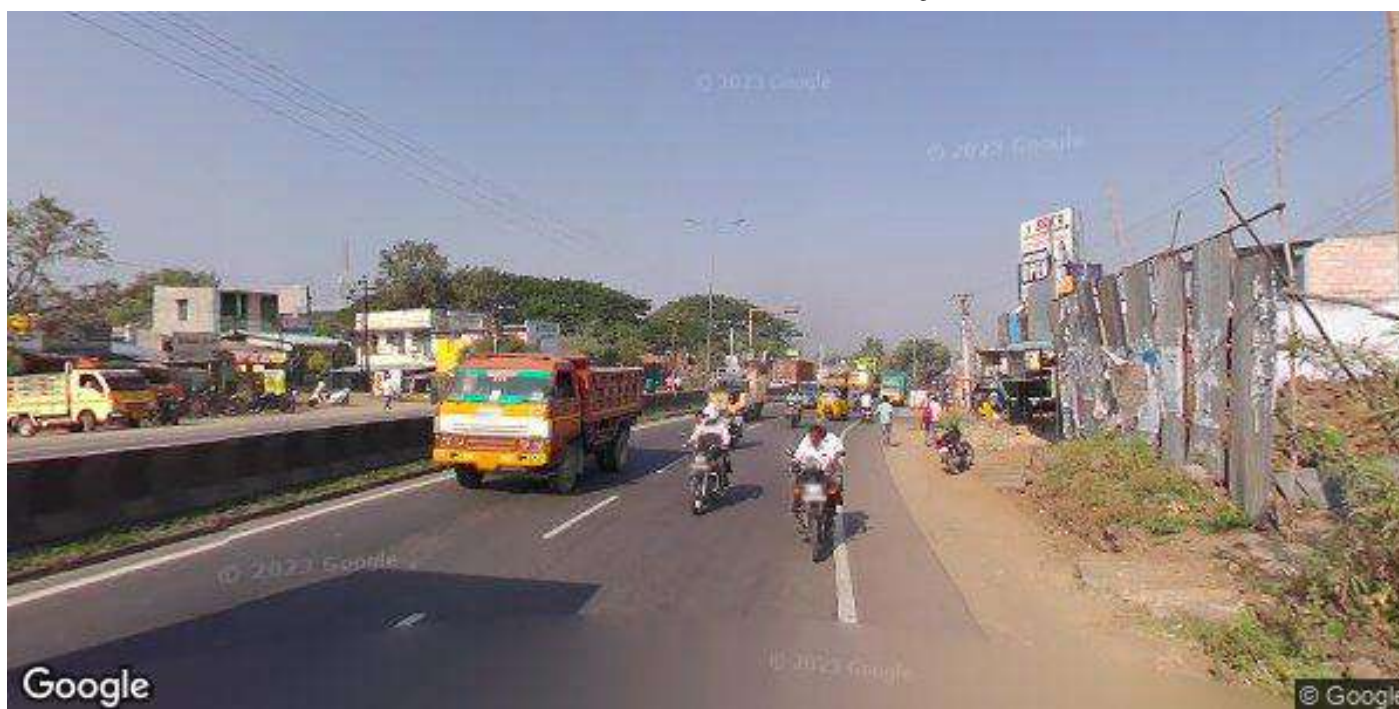
**Risk Type:** Turn  
**Risk Level:** Medium  
**Speed Limit:** 30 KM/Hr  
**Coordinates:** 11.62821, 78.13348

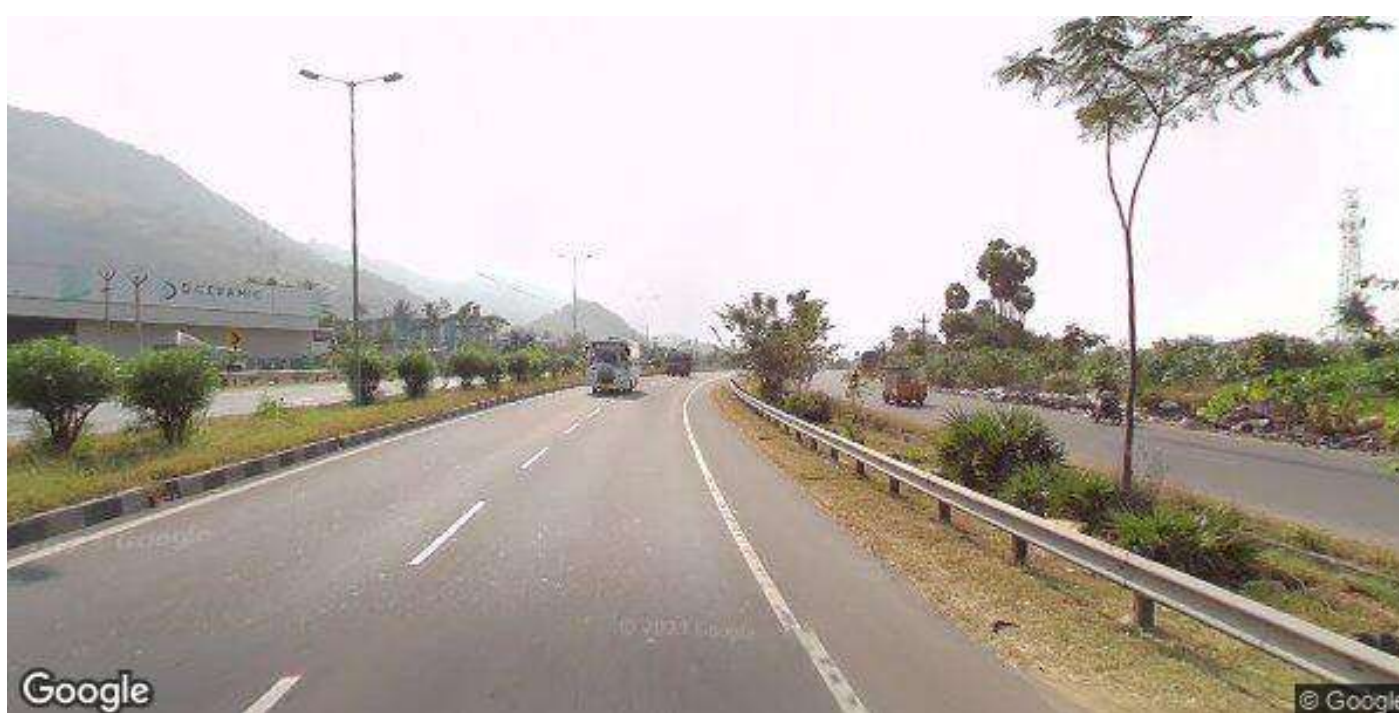
**Risk Type:** Turn  
**Risk Level:** Medium  
**Speed Limit:** 30 KM/Hr  
**Coordinates:** 11.62851, 78.16509

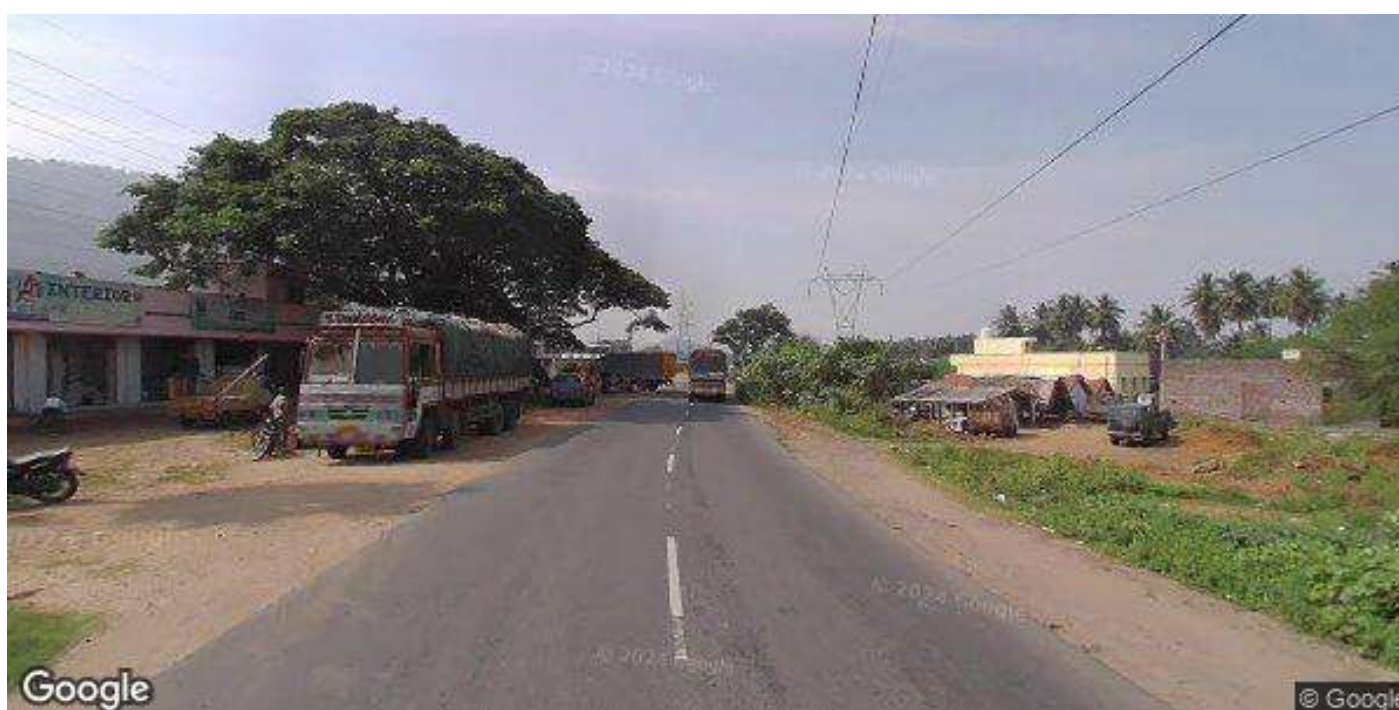
**Risk Type:** Turn  
**Risk Level:** Medium  
**Speed Limit:** 30 KM/Hr  
**Coordinates:** 11.65782, 78.20430
