# IndianOil

## JOURNEY RISK MANAGEMENT (JRM) STUDY

### Salem Terminal to SARAL PETROLEUM

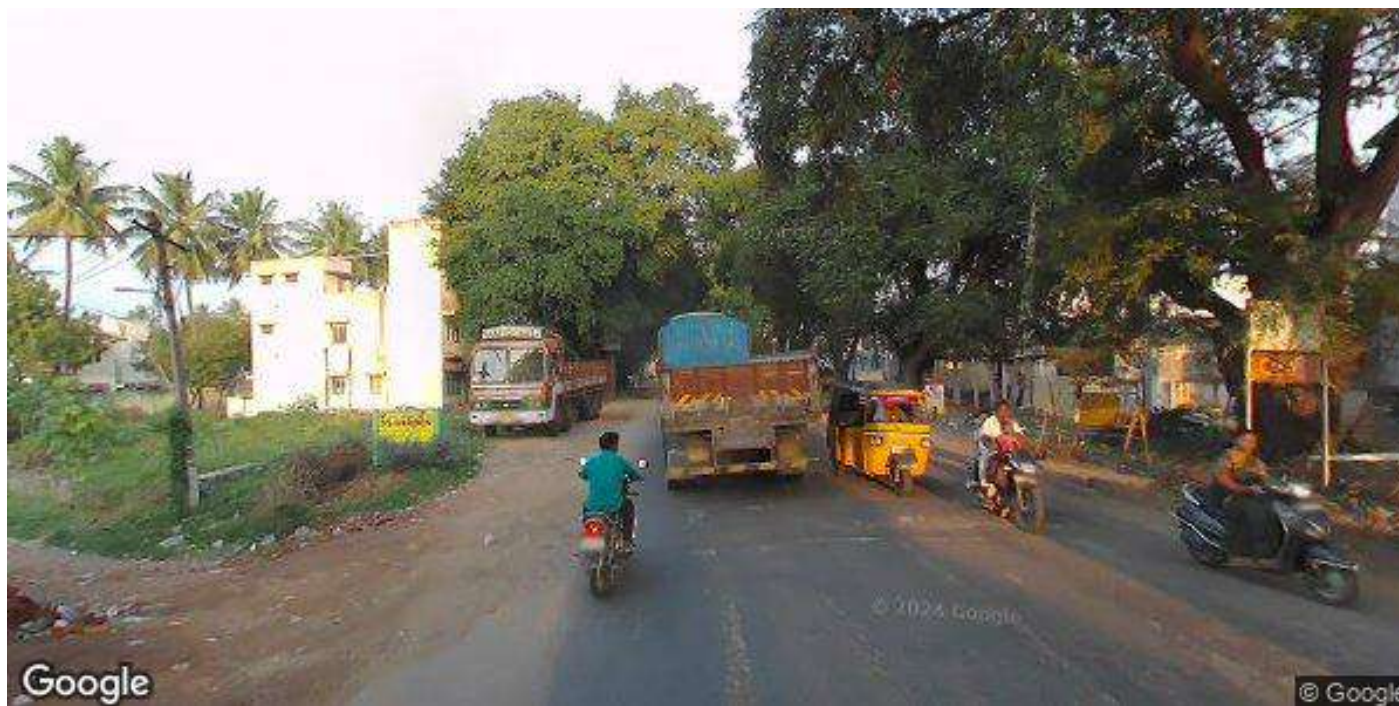
**Risk Type:** Turn  
**Risk Level:** High  
**Speed Limit:** 15 KM/Hr  
**Coordinates:** 11.66387, 78.20665

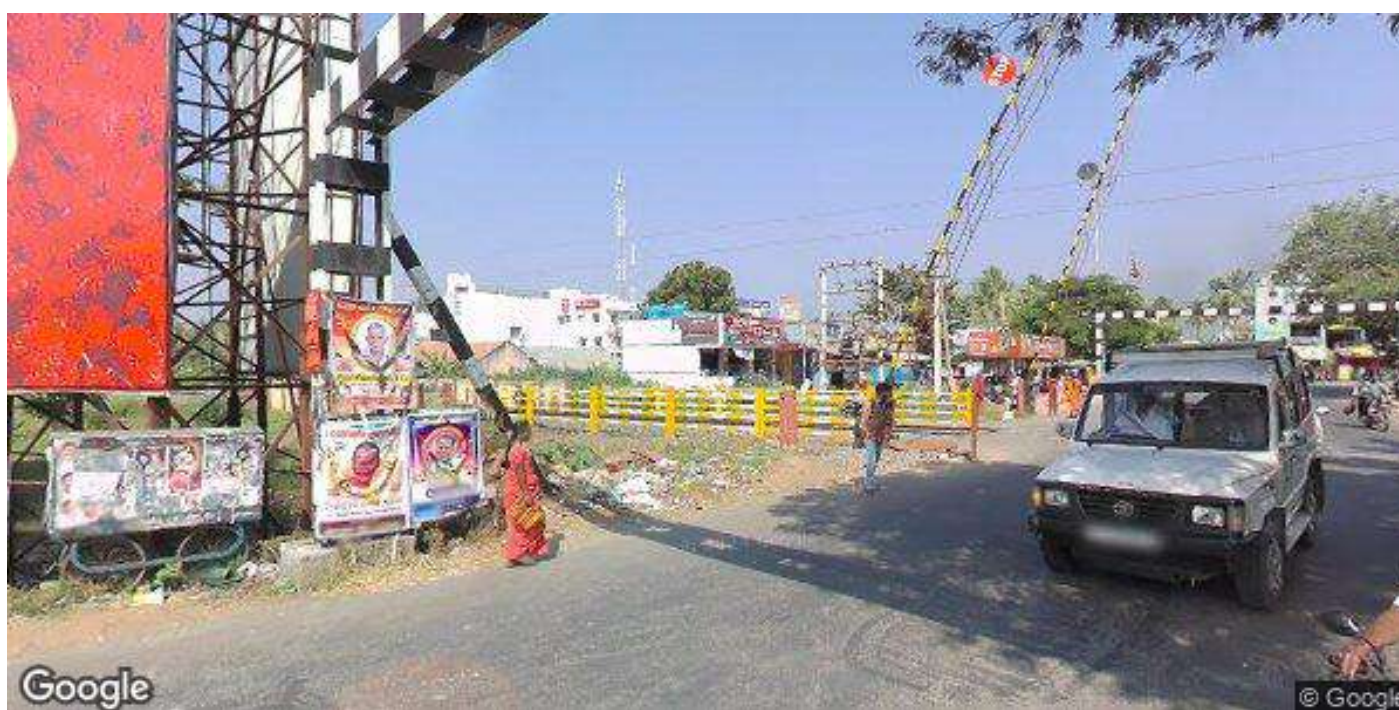
**Risk Type:** Turn  
**Risk Level:** High  
**Speed Limit:** 15 KM/Hr  
**Coordinates:** 11.67131, 78.23138

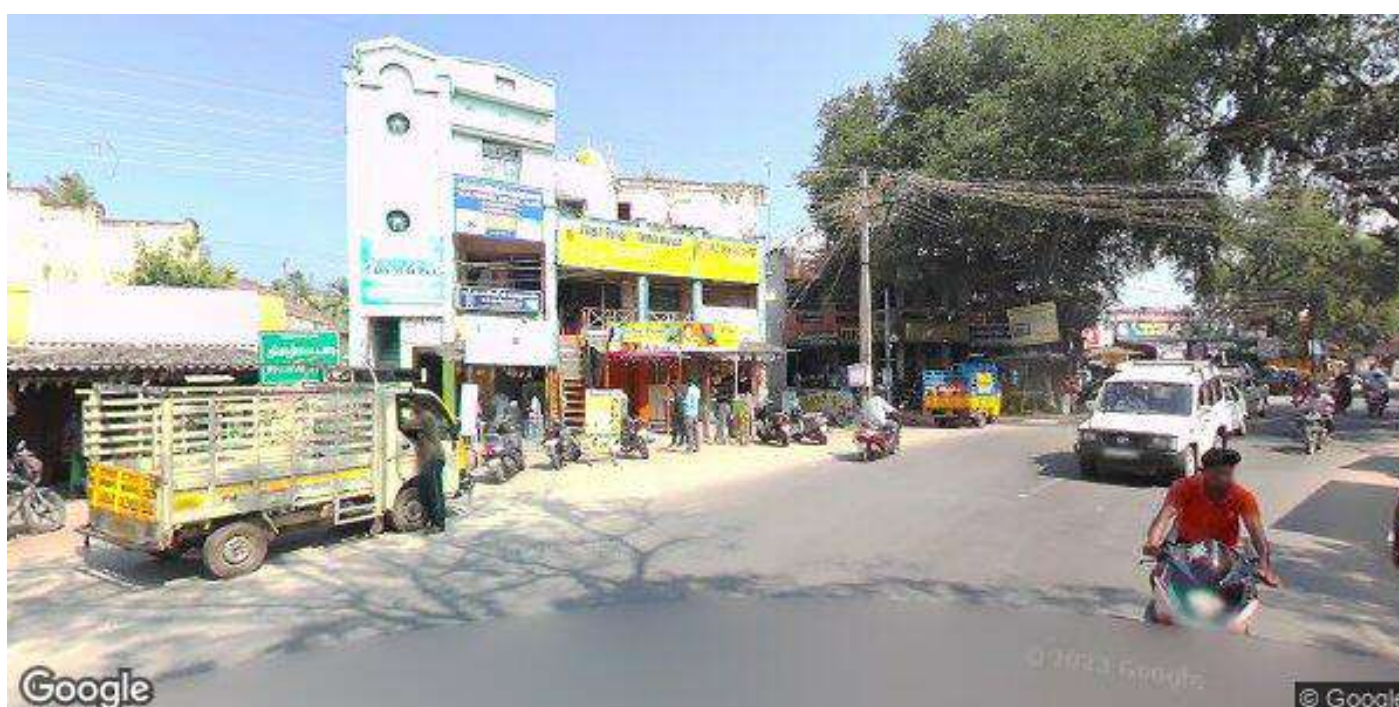
**Risk Type:** Turn  
**Risk Level:** High  
**Speed Limit:** 15 KM/Hr  
**Coordinates:** 11.67195, 78.23146

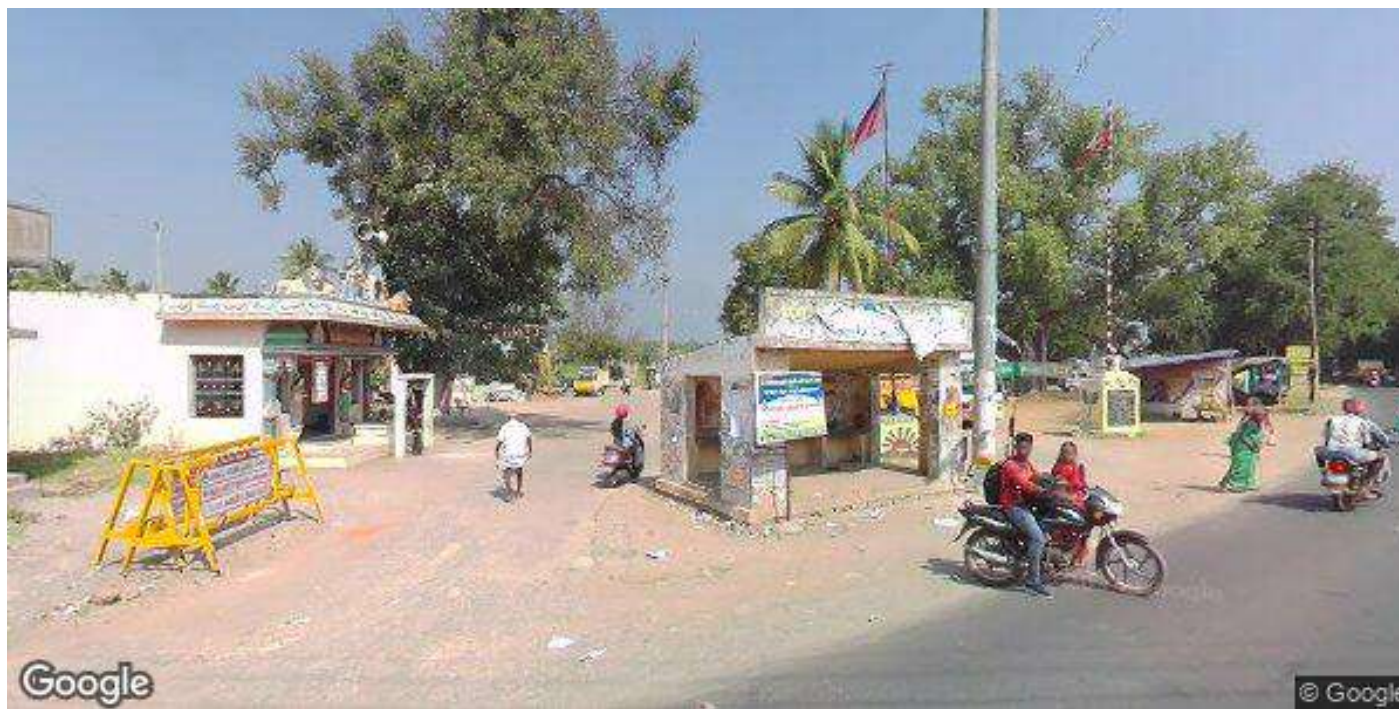
**Risk Type:** Turn  
**Risk Level:** Medium  
**Speed Limit:** 30 KM/Hr  
**Coordinates:** 11.67433, 78.23905

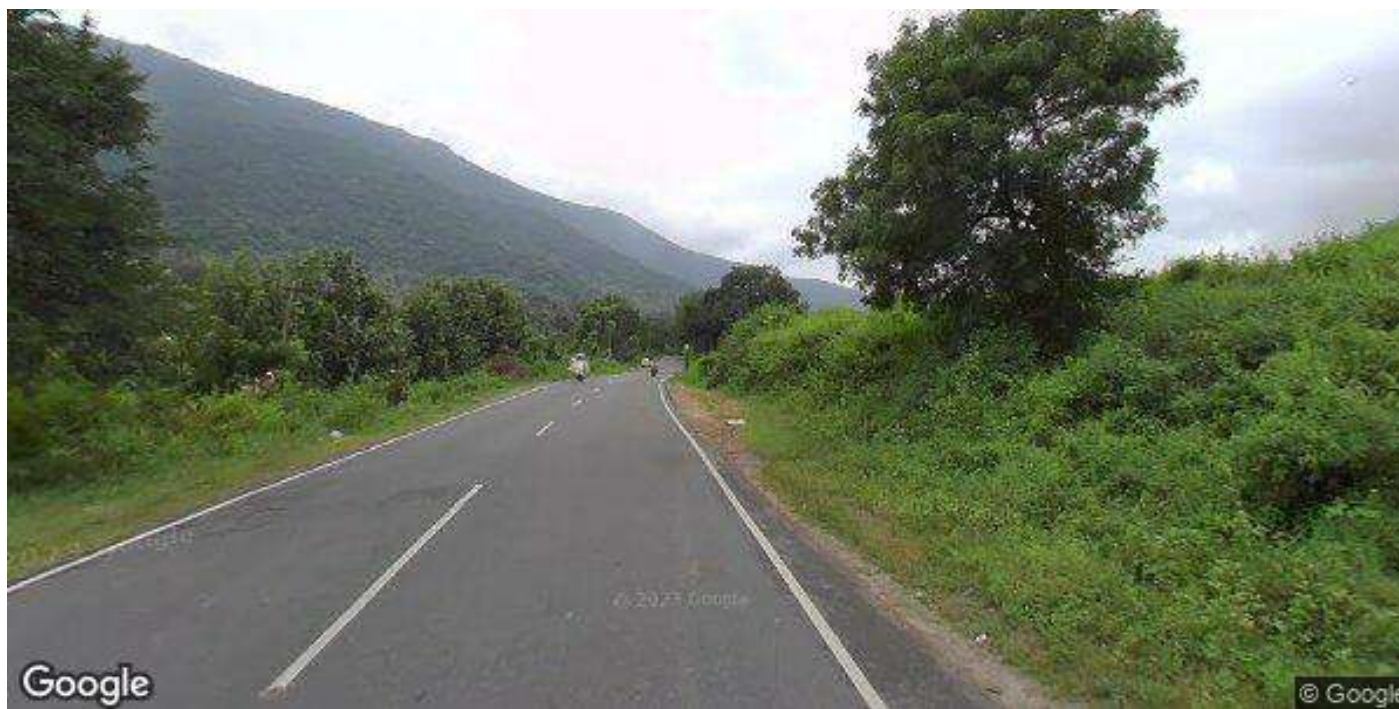
**Risk Type:** Turn  
**Risk Level:** Medium  
**Speed Limit:** 30 KM/Hr  
**Coordinates:** 11.80416, 78.33319

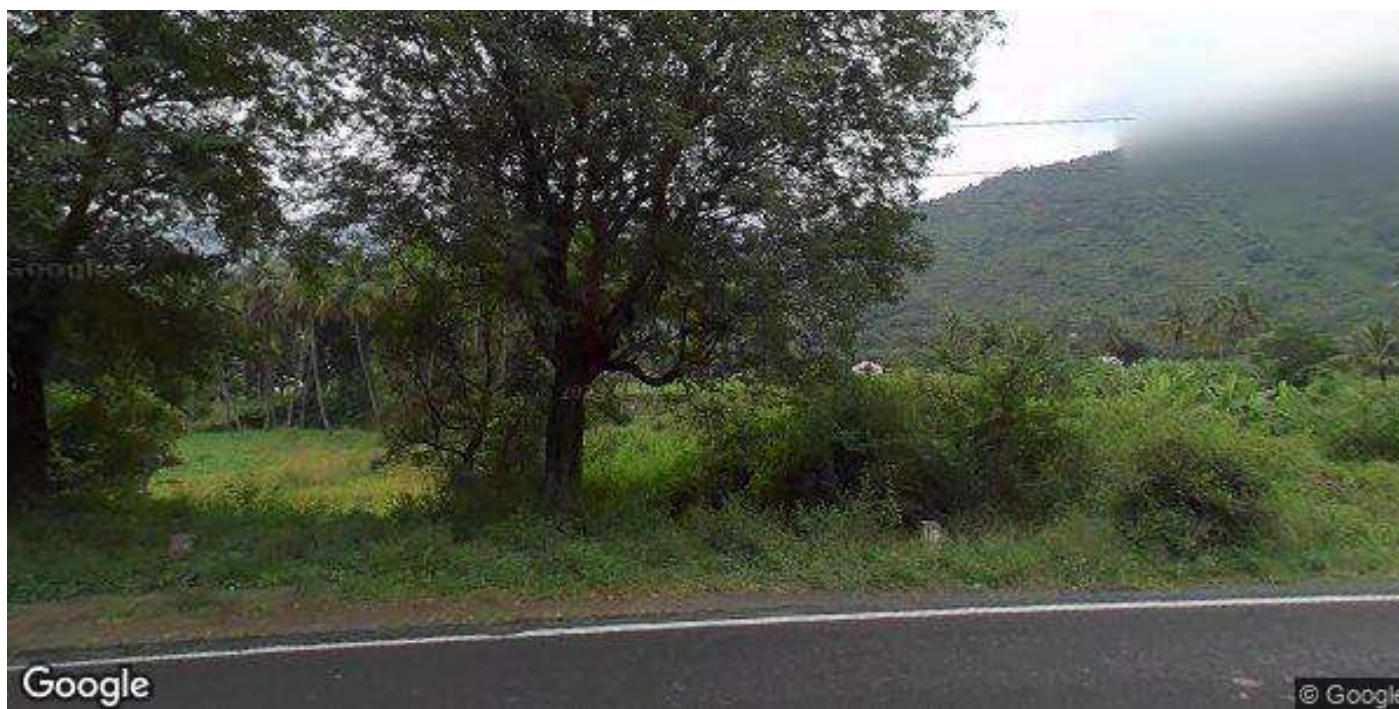
**Risk Type:** Turn  
**Risk Level:** Medium  
**Speed Limit:** 30 KM/Hr  
**Coordinates:** 11.81219, 78.34077

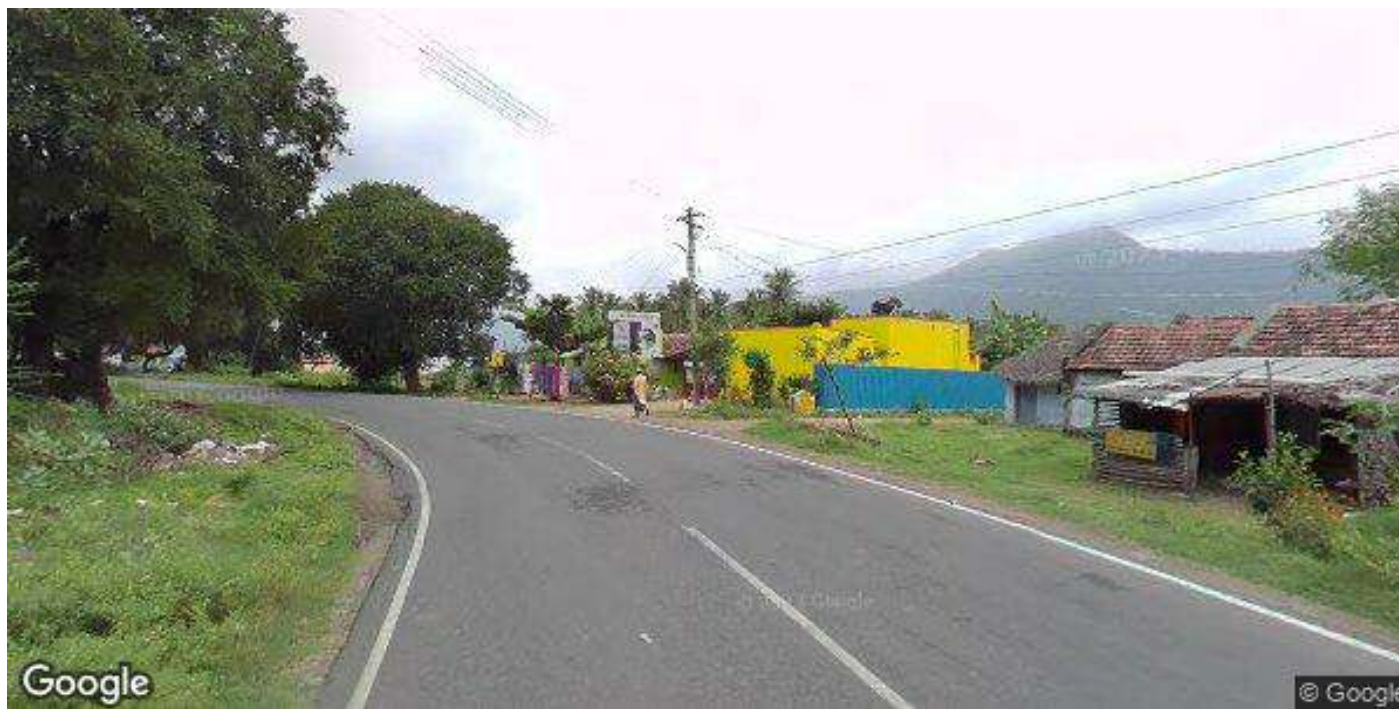
**Risk Type:** Turn  
**Risk Level:** Medium  
**Speed Limit:** 30 KM/Hr  
**Coordinates:** 11.83472, 78.35285

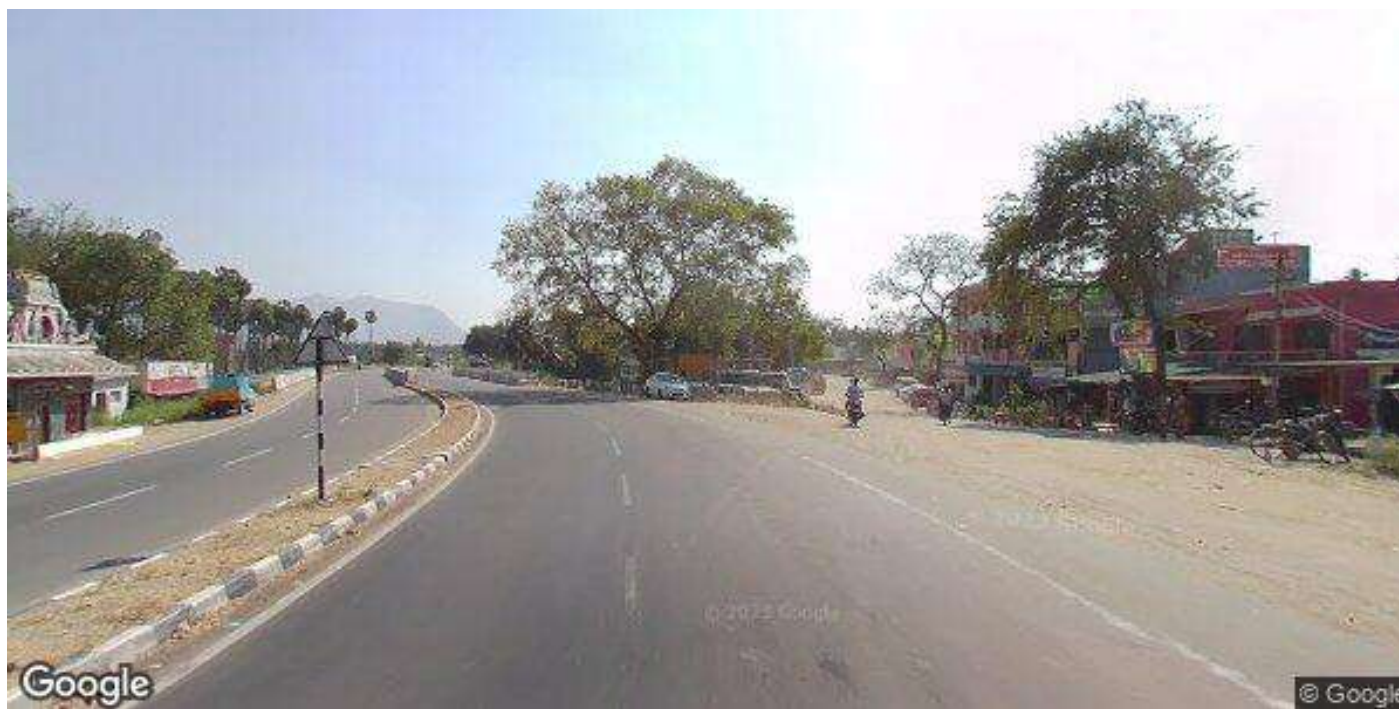
**Risk Type:** Turn  
**Risk Level:** Medium  
**Speed Limit:** 30 KM/Hr  
**Coordinates:** 11.99572, 78.44559

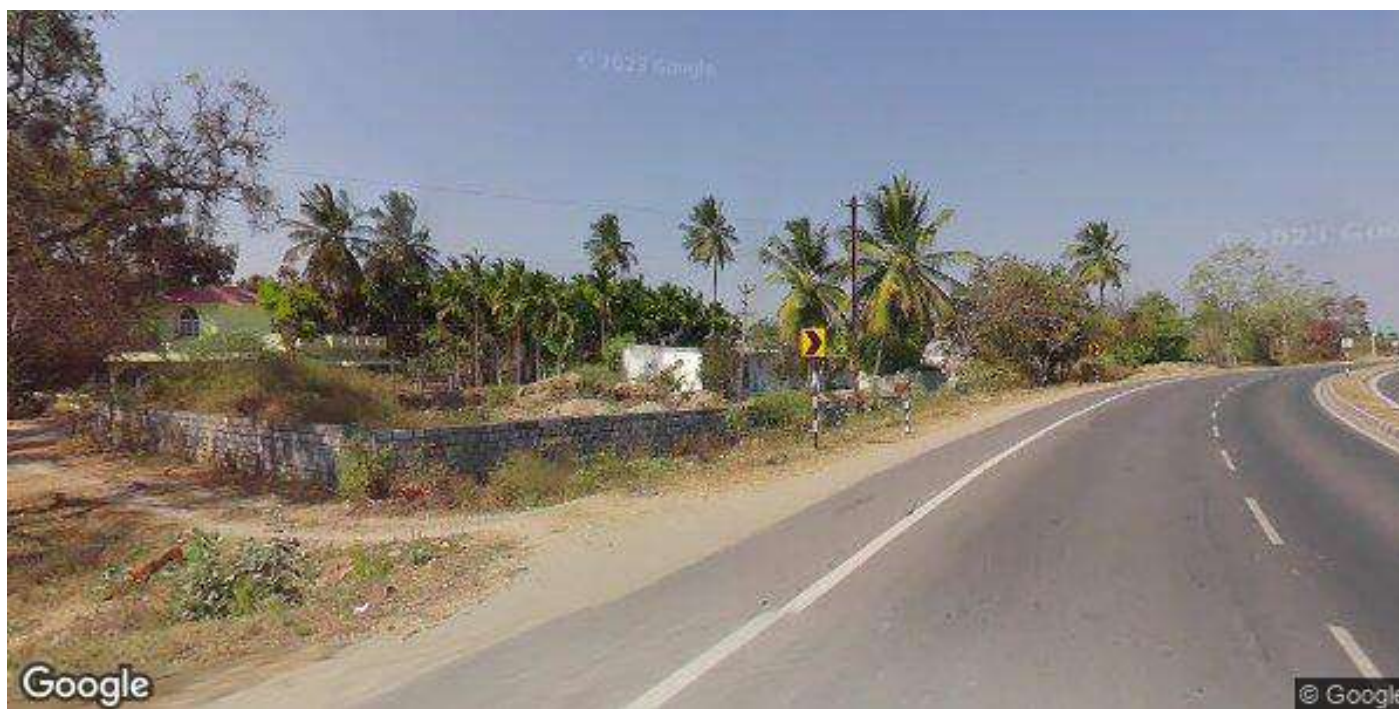
**Risk Type:** Turn  
**Risk Level:** Medium  
**Speed Limit:** 30 KM/Hr  
**Coordinates:** 12.01548, 78.45650

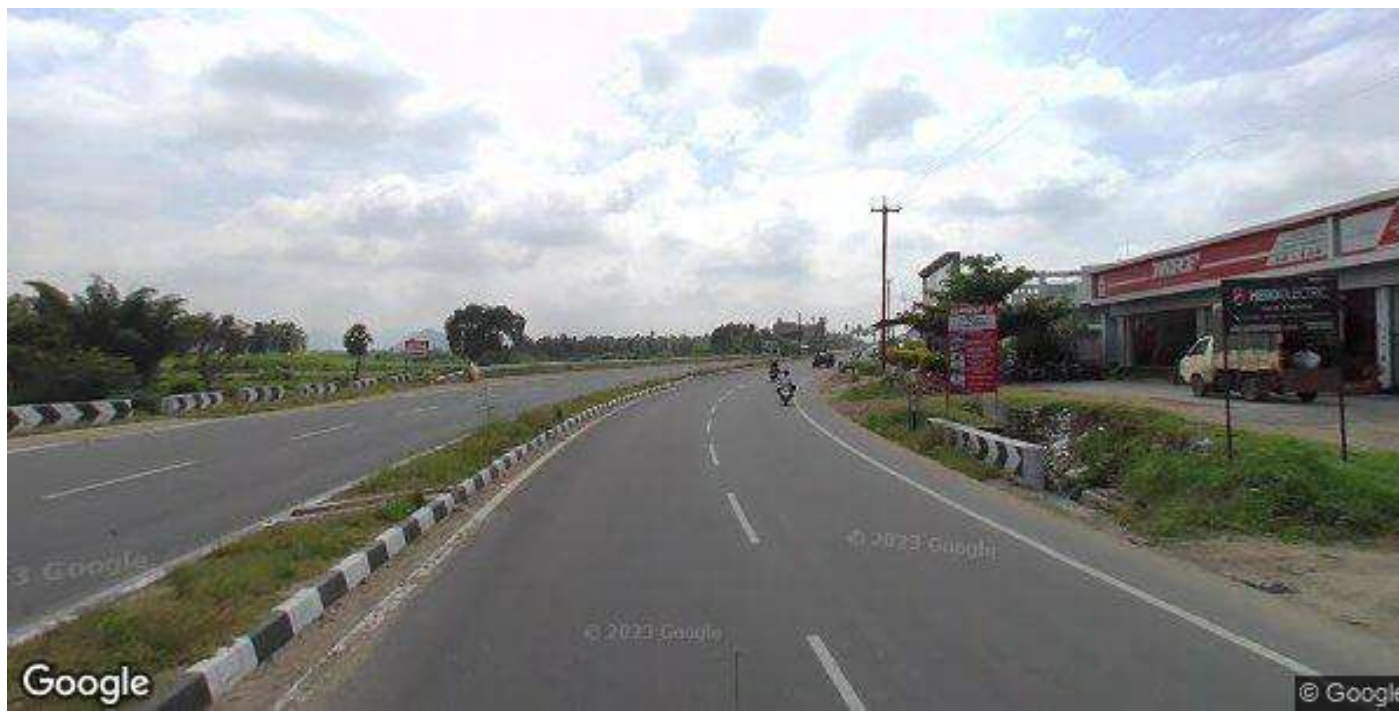
**Risk Type:** Turn  
**Risk Level:** Medium  
**Speed Limit:** 30 KM/Hr  
**Coordinates:** 12.04309, 78.48361

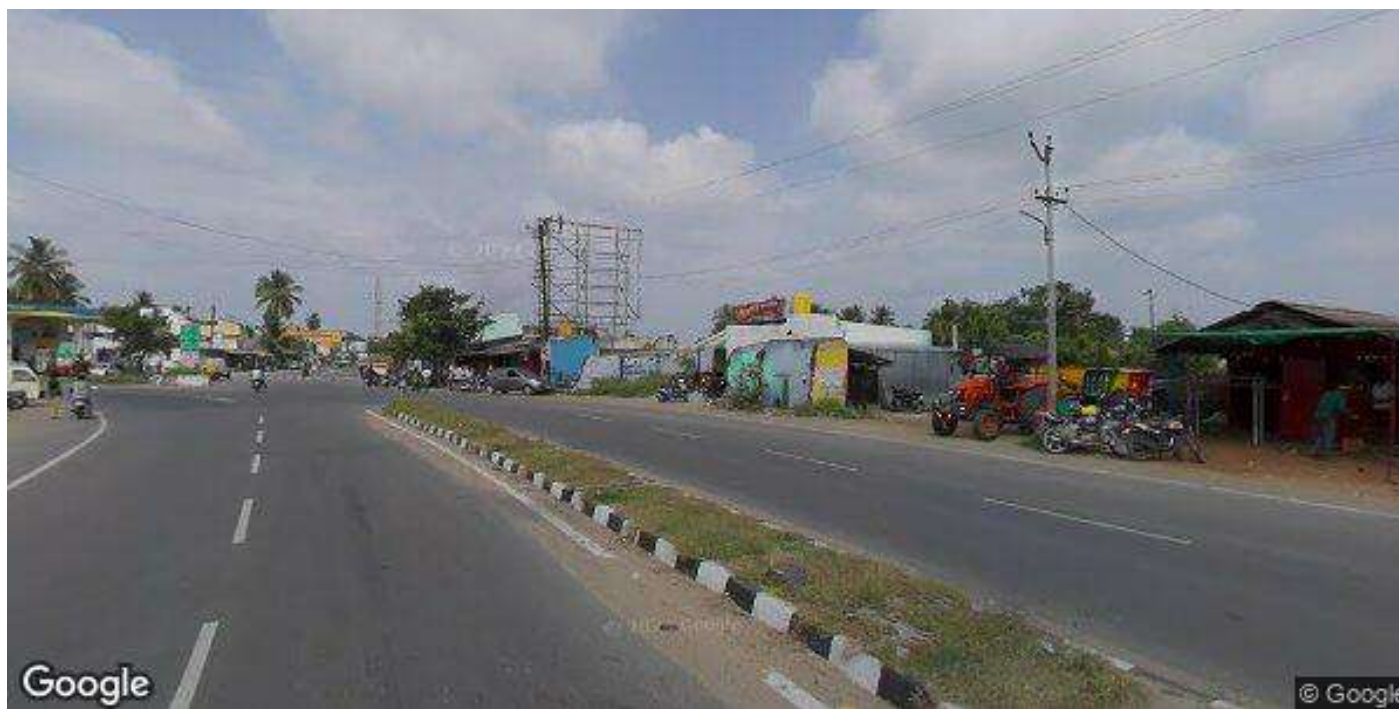
**Risk Type:** Turn  
**Risk Level:** Medium  
**Speed Limit:** 30 KM/Hr  
**Coordinates:** 12.04429, 78.48380

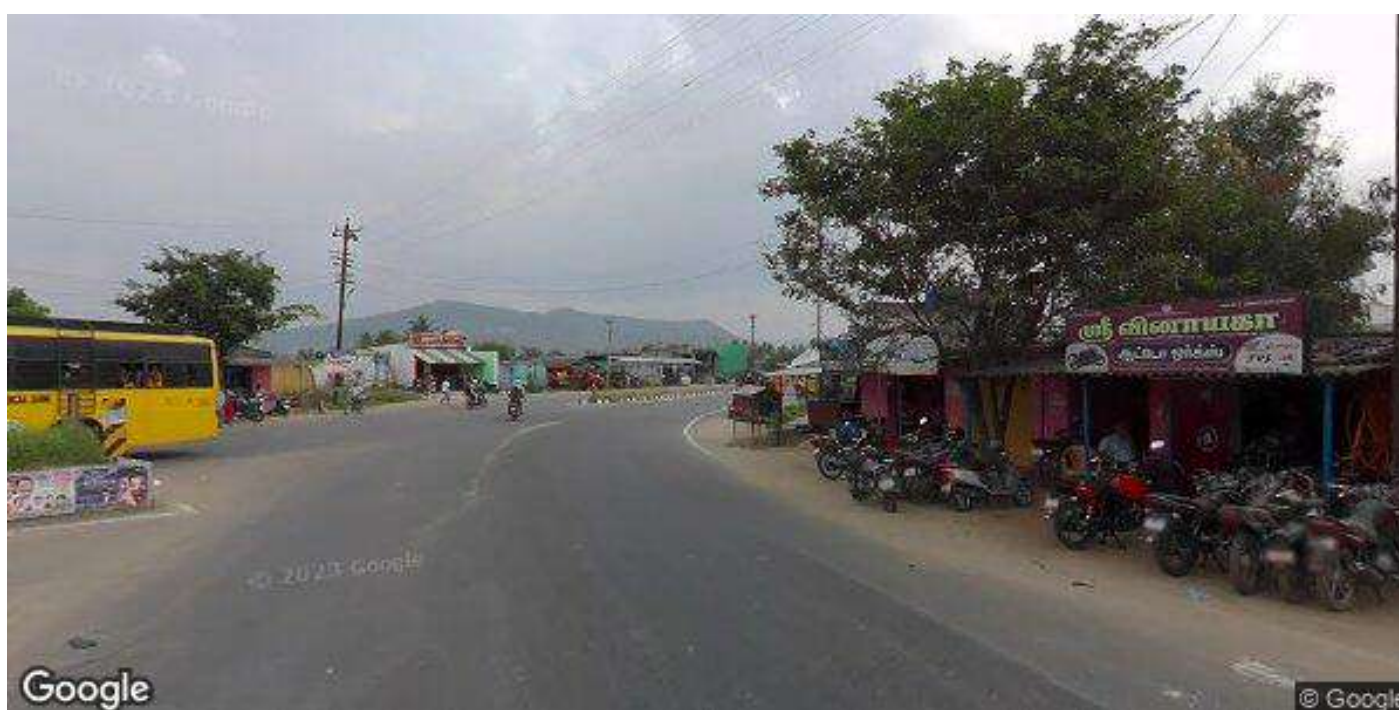
**Risk Type:** Turn  
**Risk Level:** Medium  
**Speed Limit:** 30 KM/Hr  
**Coordinates:** 12.04490, 78.48355

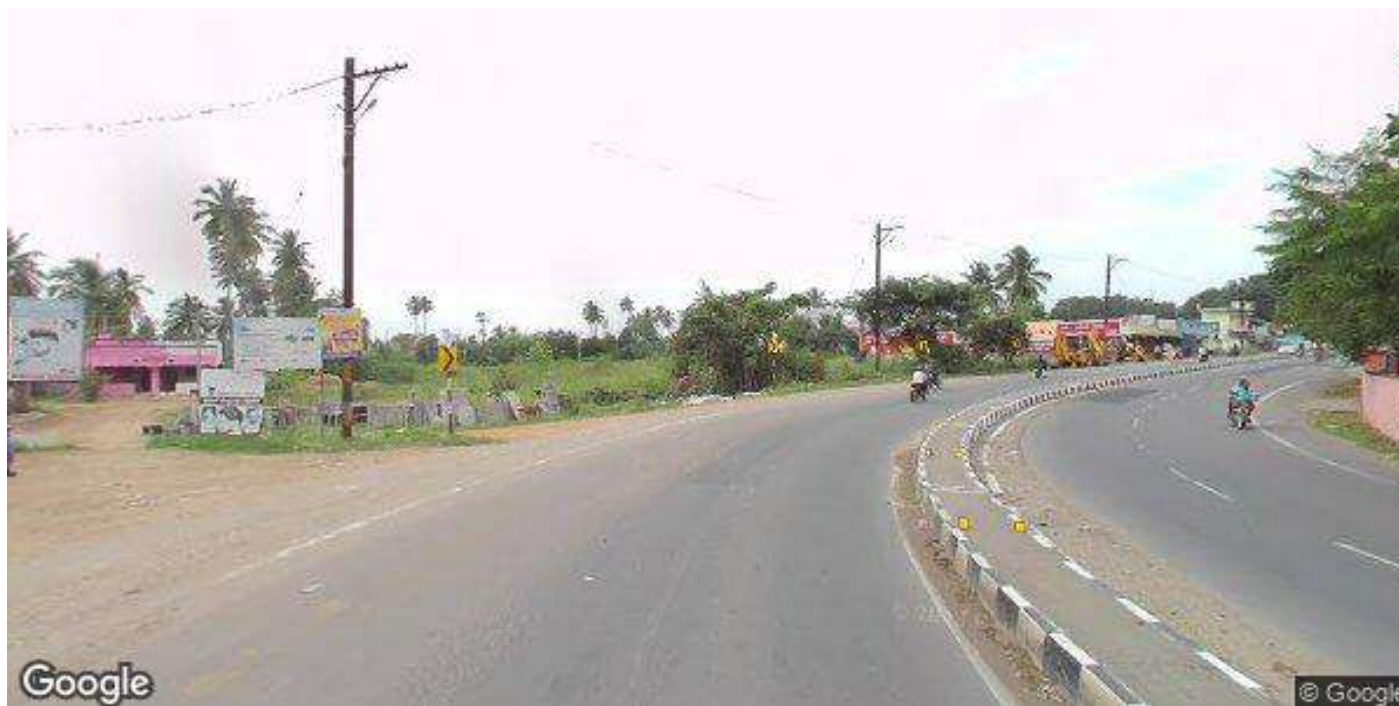
**Risk Type:** Turn  
**Risk Level:** High  
**Speed Limit:** 15 KM/Hr  
**Coordinates:** 12.04984, 78.47480

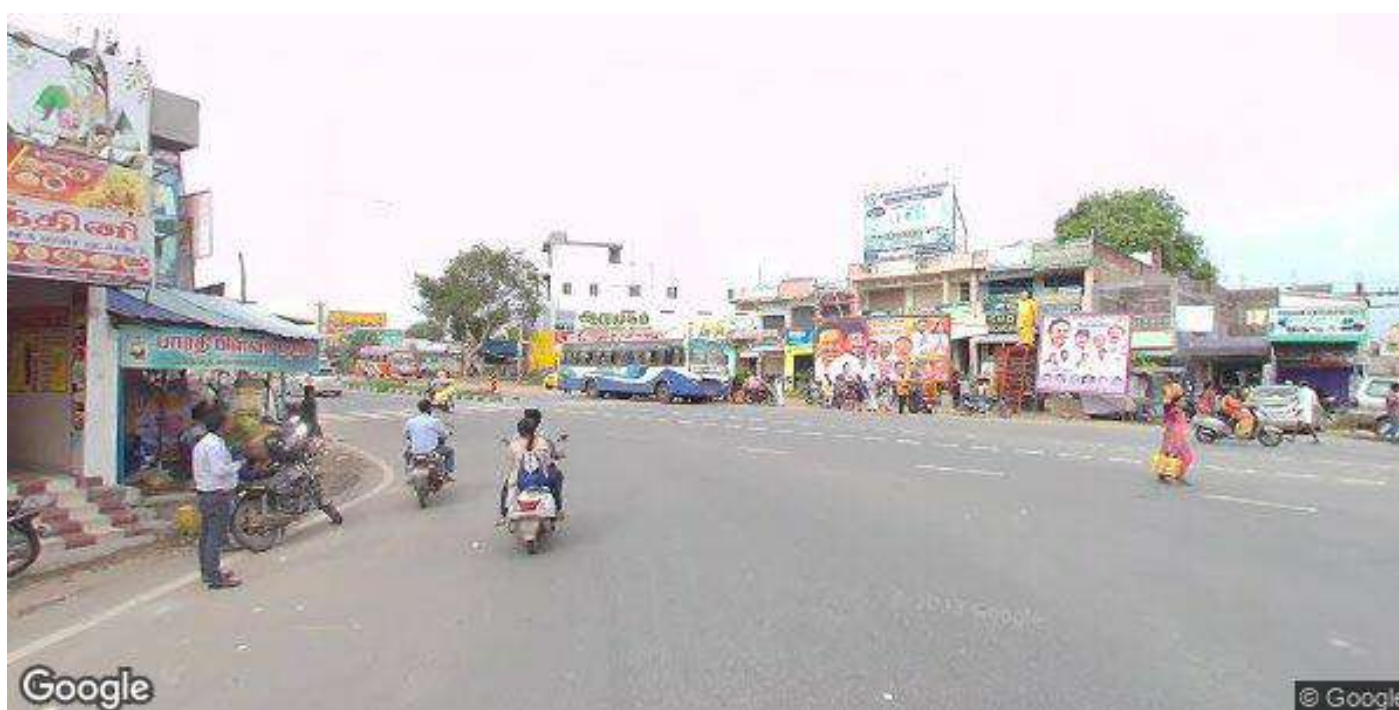
**Risk Type:** Turn  
**Risk Level:** Medium  
**Speed Limit:** 30 KM/Hr  
**Coordinates:** 12.06014, 78.47787

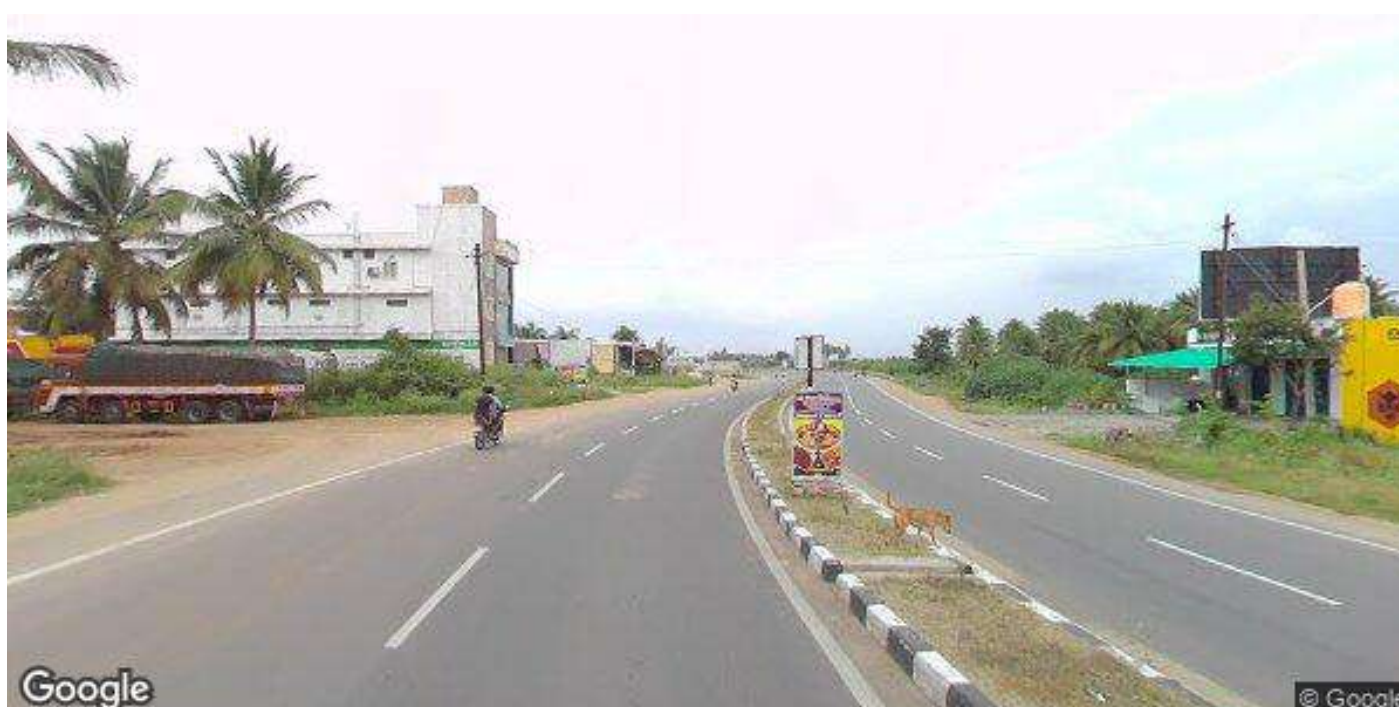
**Risk Type:** Turn  
**Risk Level:** Medium  
**Speed Limit:** 30 KM/Hr  
**Coordinates:** 12.06962, 78.47655

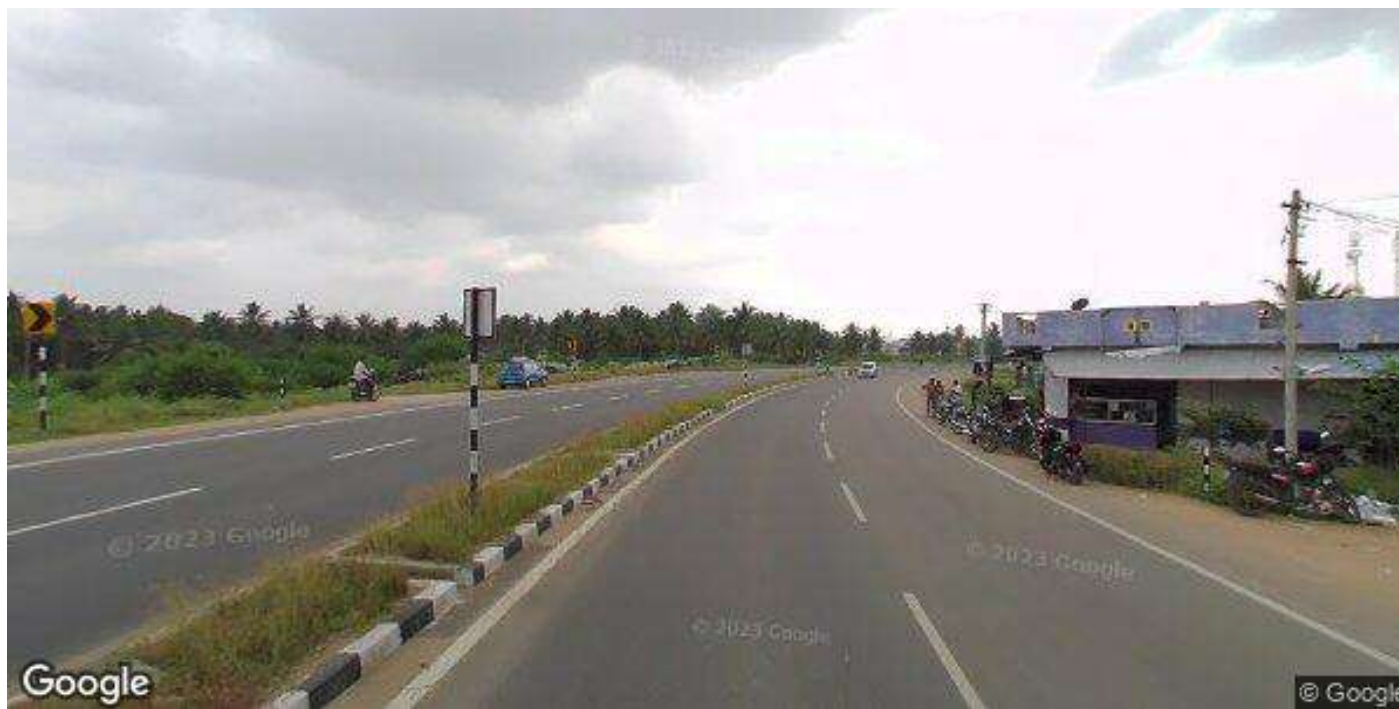
**Risk Type:** Turn  
**Risk Level:** Medium  
**Speed Limit:** 30 KM/Hr  
**Coordinates:** 12.07207, 78.47727

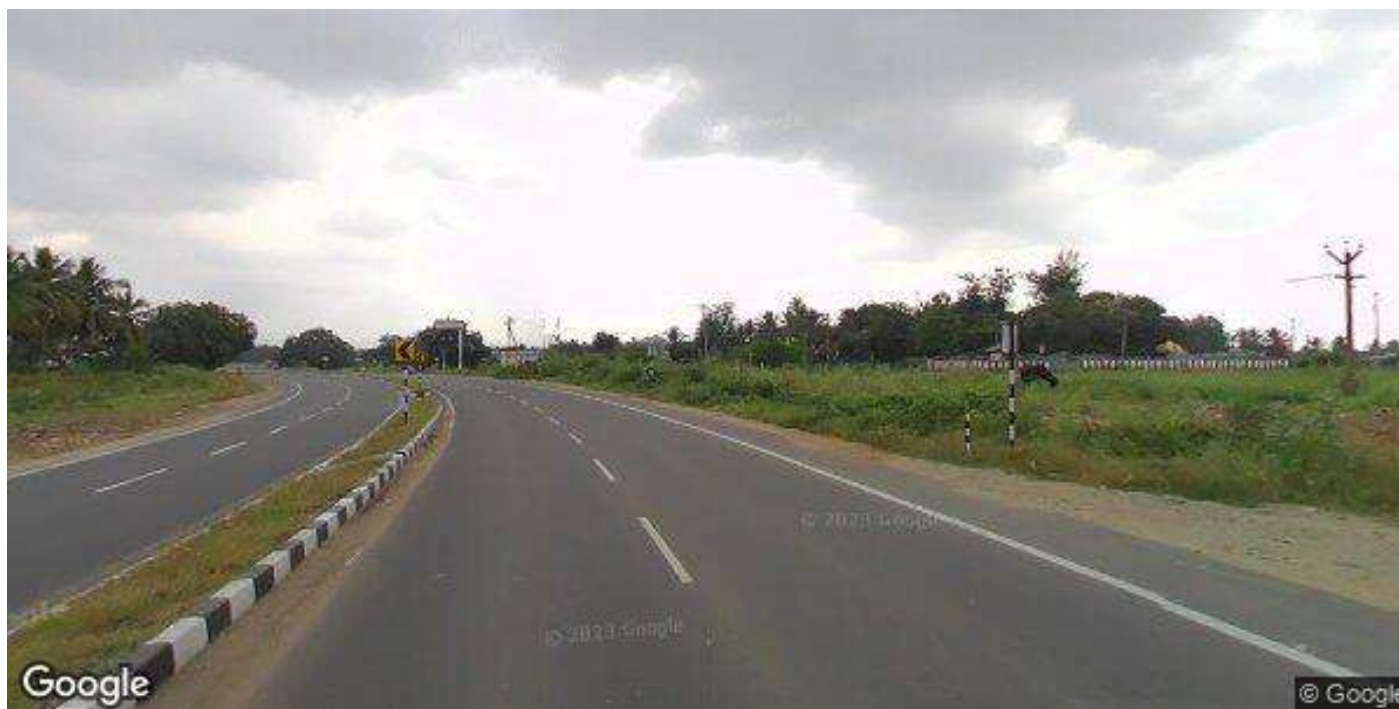
**Risk Type:** Turn  
**Risk Level:** Medium  
**Speed Limit:** 30 KM/Hr  
**Coordinates:** 12.07536, 78.47607

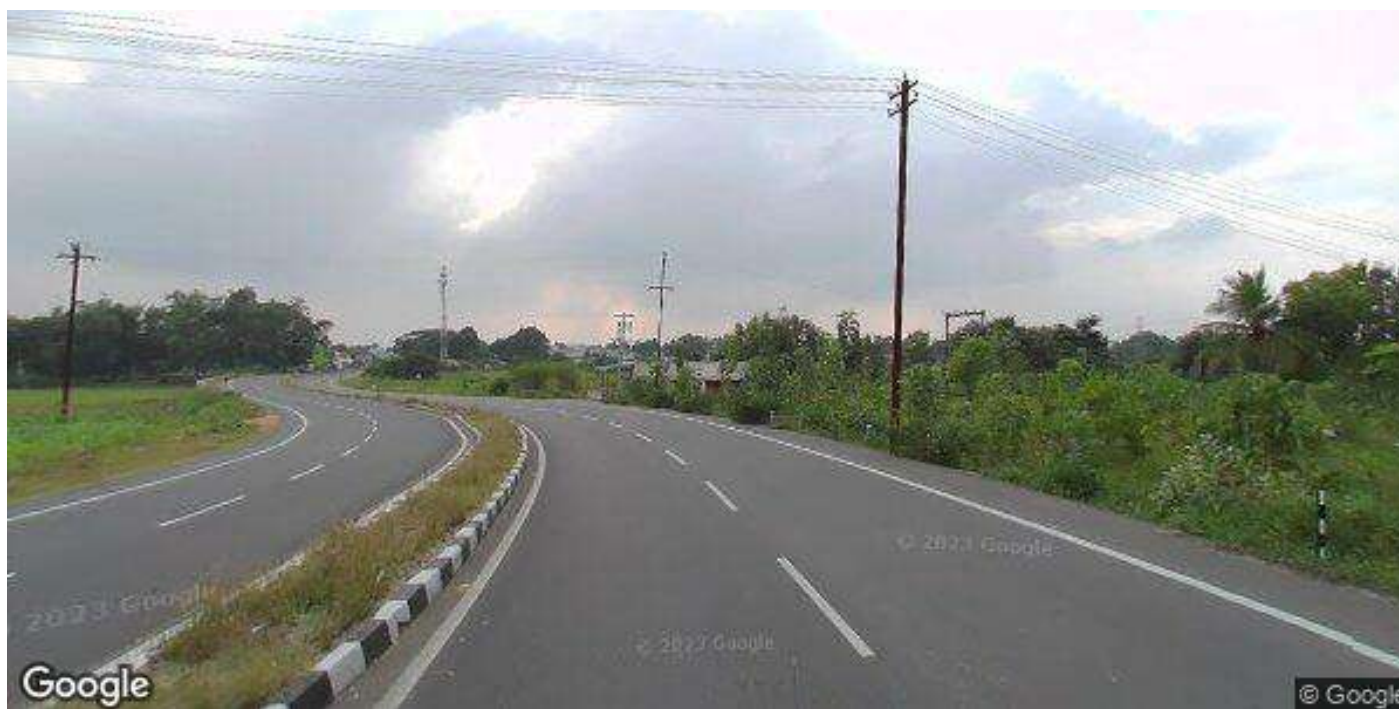
**Risk Type:** Turn  
**Risk Level:** Medium  
**Speed Limit:** 30 KM/Hr  
**Coordinates:** 12.11562, 78.49617

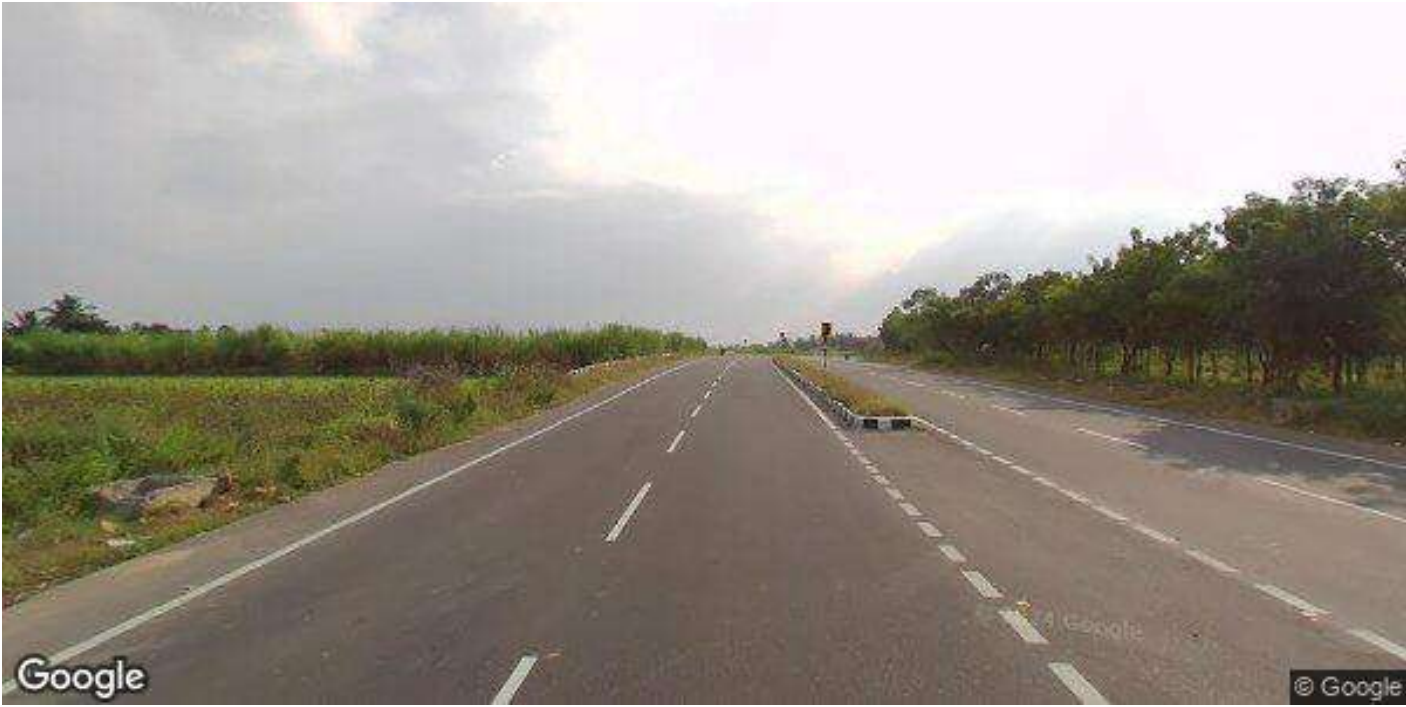
**Risk Type:** Blind Spot  
**Risk Level:** Blind Spot  
**Speed Limit:** 10 KM/Hr  
**Coordinates:** 12.11778, 78.49830

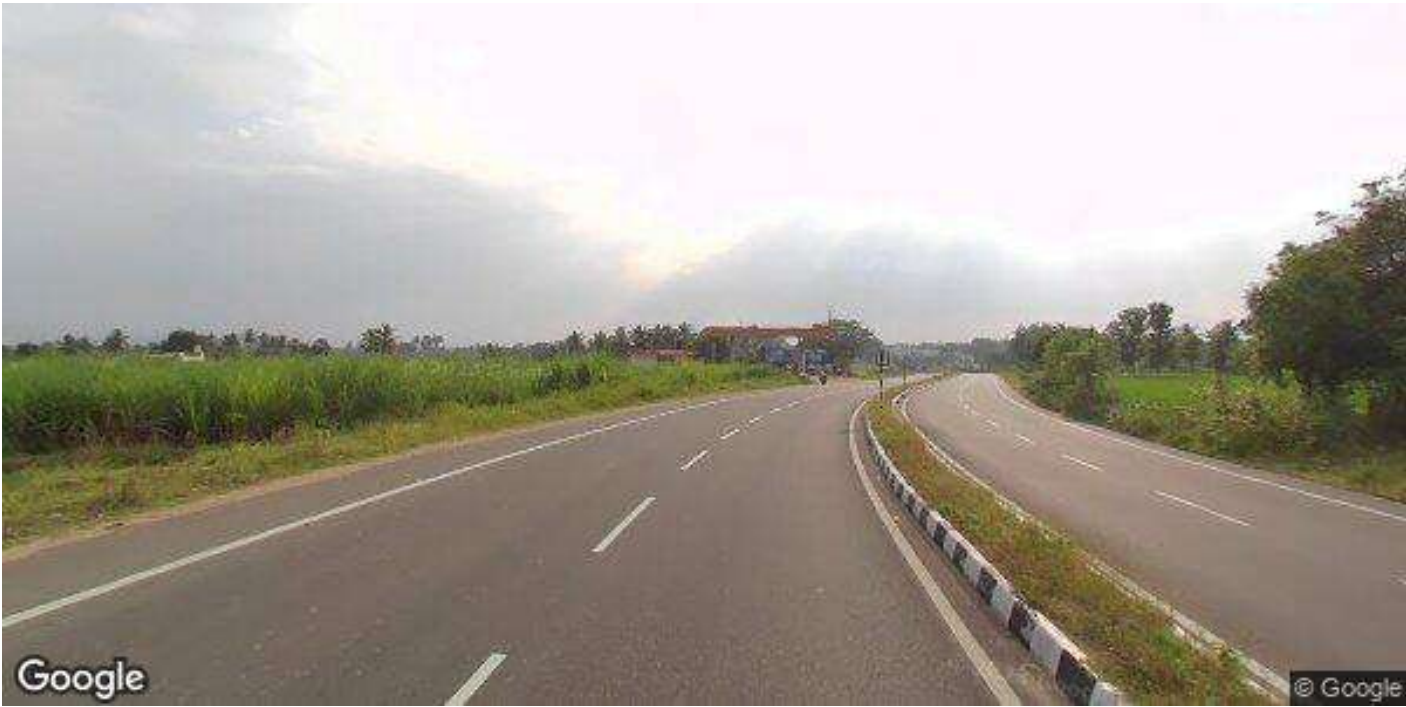
**Risk Type:** Turn  
**Risk Level:** Medium  
**Speed Limit:** 30 KM/Hr  
**Coordinates:** 12.11665, 78.49779
