# IndianOil

## JOURNEY RISK MANAGEMENT (JRM) STUDY

### Salem Terminal TO HARSITA FUELS

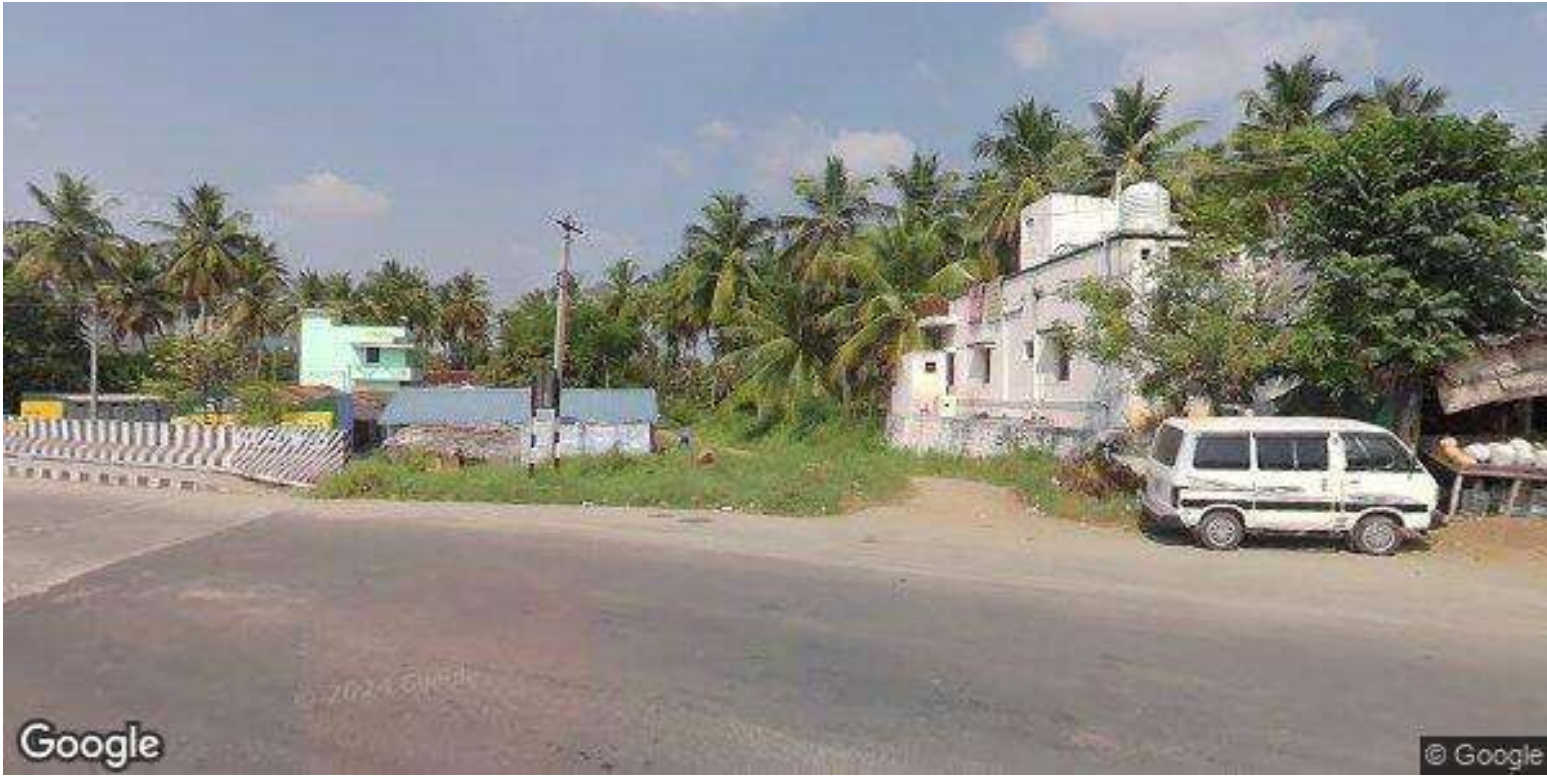
| | Risk Type | Risk Level | Coordinates | Speed Limit |
|---|---|---|---|---|
| 3 | Turn | High | 11.44898, 77.87410 | 15 KM/Hr |

**Risk Type:** Turn  
**Risk Level:** High  
**Speed Limit:** 15 KM/Hr  
**Coordinates:** 11.44898, 77.87410

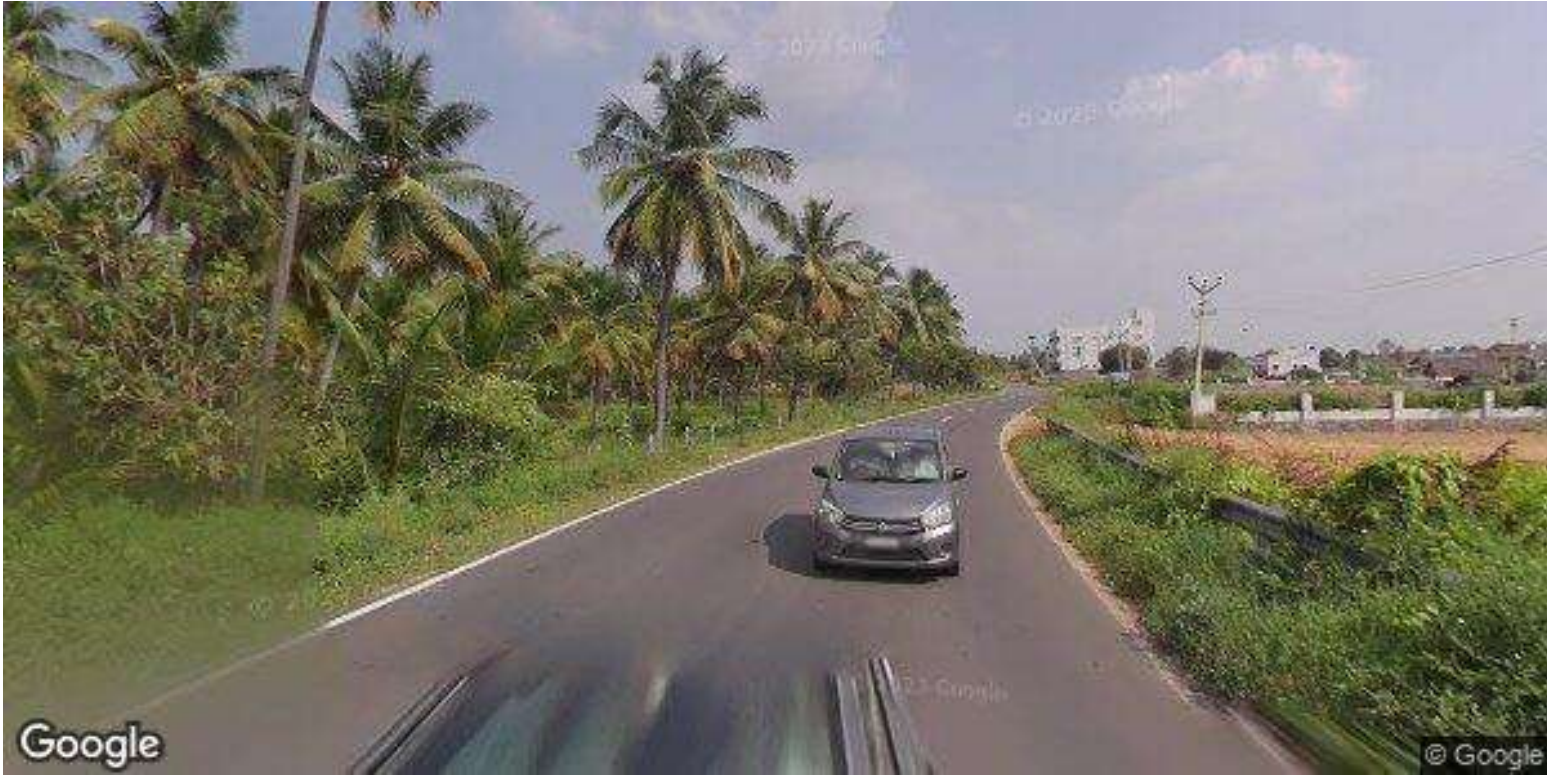
| | Risk Type | Risk Level | Coordinates | Speed Limit |
|---|---|---|---|---|
| 4 | Turn | Medium | 11.45357, 77.85789 | 30 KM/Hr |

**Risk Type:** Turn  
**Risk Level:** Medium  
**Speed Limit:** 30 KM/Hr  
**Coordinates:** 11.45357, 77.85789

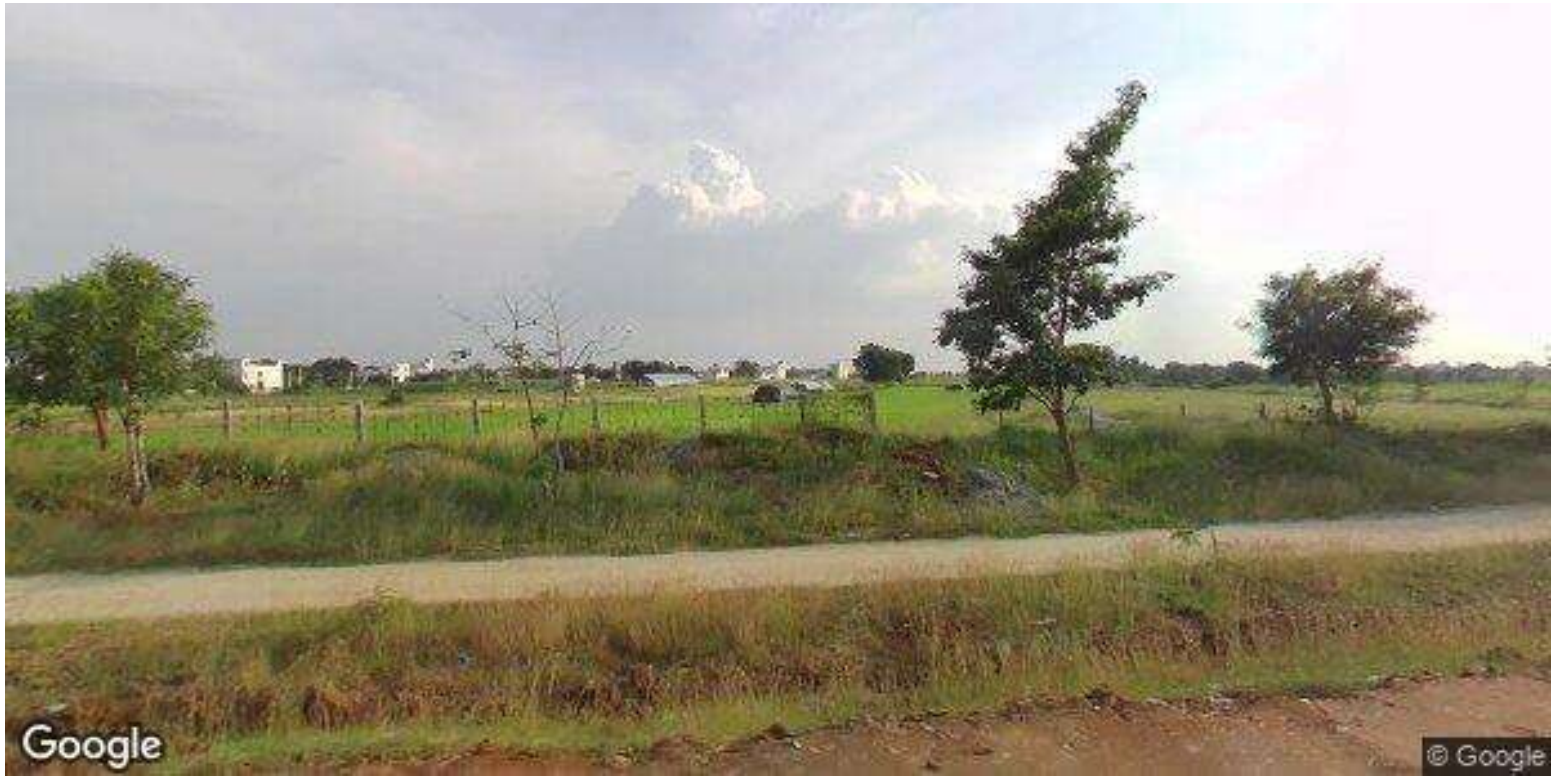
| | Risk Type | Risk Level | Coordinates | Speed Limit |
|---|---|---|---|---|
| 10 | Turn | Medium | 11.29288, 77.59029 | 30 KM/Hr |

**Risk Type:** Turn  
**Risk Level:** Medium  
**Speed Limit:** 30 KM/Hr  
**Coordinates:** 11.29288, 77.59029

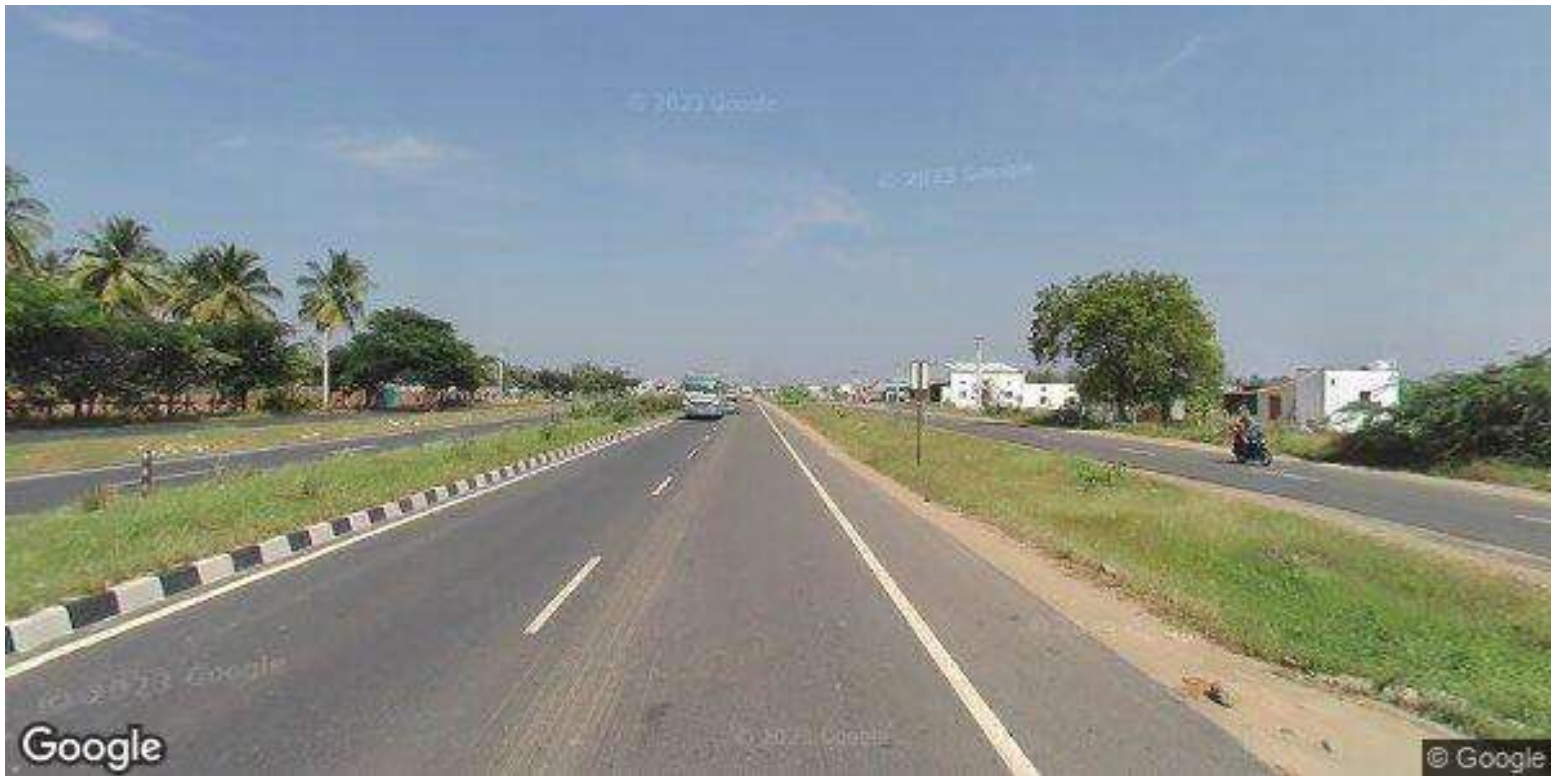
| | Risk Type | Risk Level | Coordinates | Speed Limit |
|---|---|---|---|---|
| 11 | Turn | High | 11.20358, 77.42732 | 15 KM/Hr |

**Risk Type:** Turn  
**Risk Level:** High  
**Speed Limit:** 15 KM/Hr  
**Coordinates:** 11.20358, 77.42732

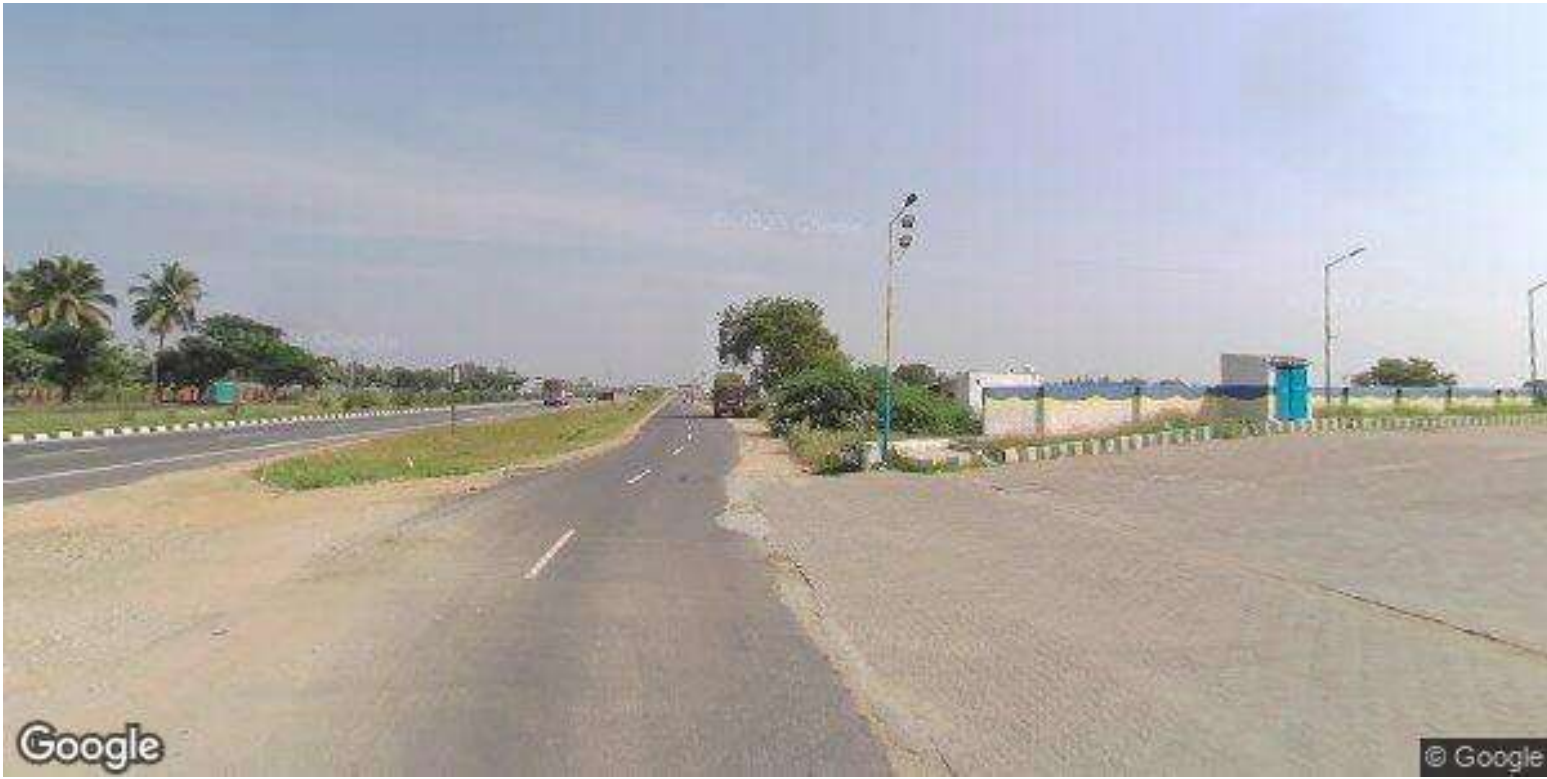
| | Risk Type | Risk Level | Coordinates | Speed Limit |
|---|---|---|---|---|
| 12 | Turn | High | 11.20335, 77.42730 | 15 KM/Hr |

**Risk Type:** Turn  
**Risk Level:** High  
**Speed Limit:** 15 KM/Hr  
**Coordinates:** 11.20335, 77.42730

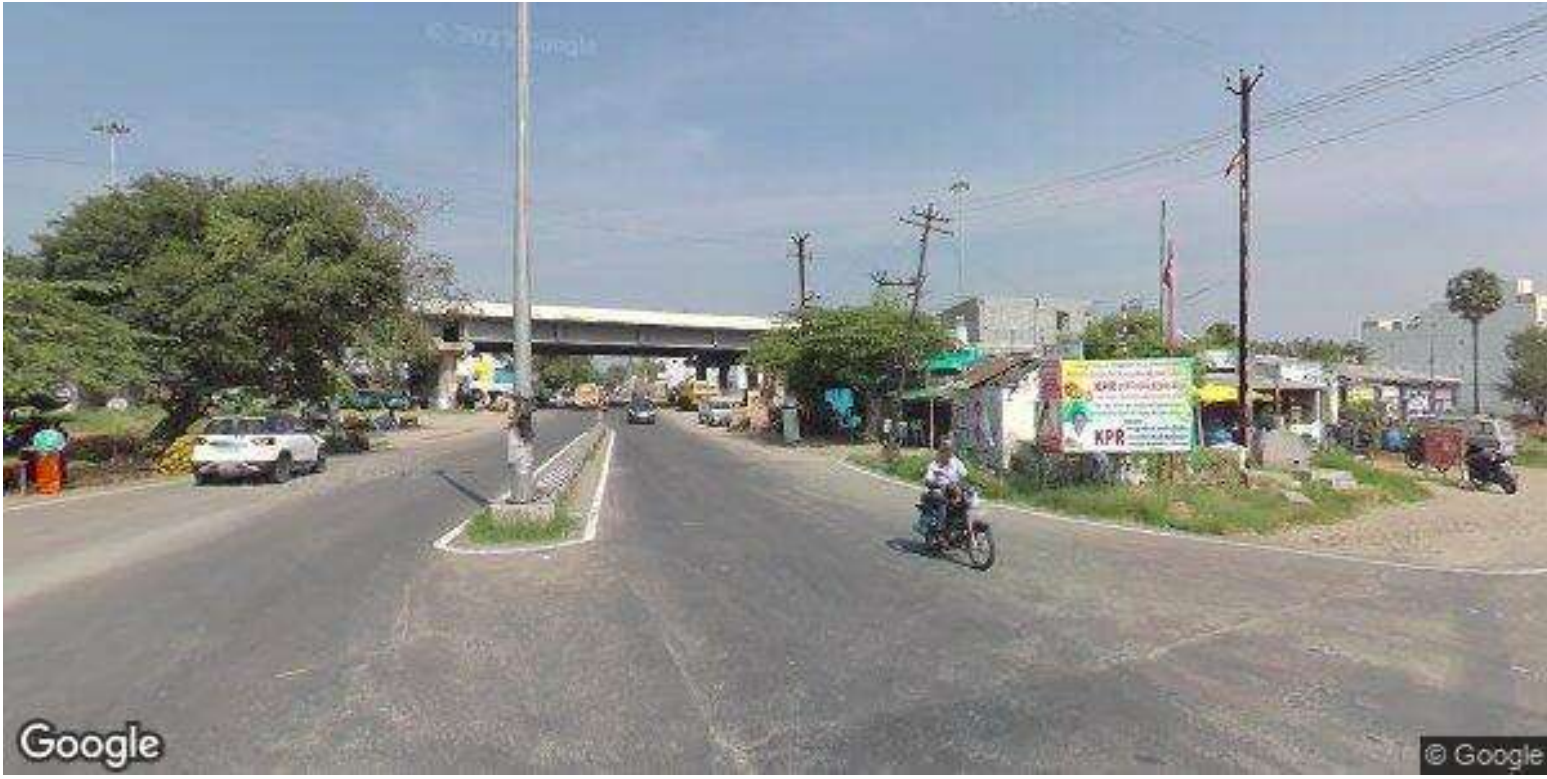
| | Risk Type | Risk Level | Coordinates | Speed Limit |
|---|---|---|---|---|
| 13 | Turn | High | 11.19962, 77.42240 | 15 KM/Hr |

**Risk Type:** Turn  
**Risk Level:** High  
**Speed Limit:** 15 KM/Hr  
**Coordinates:** 11.19962, 77.42240

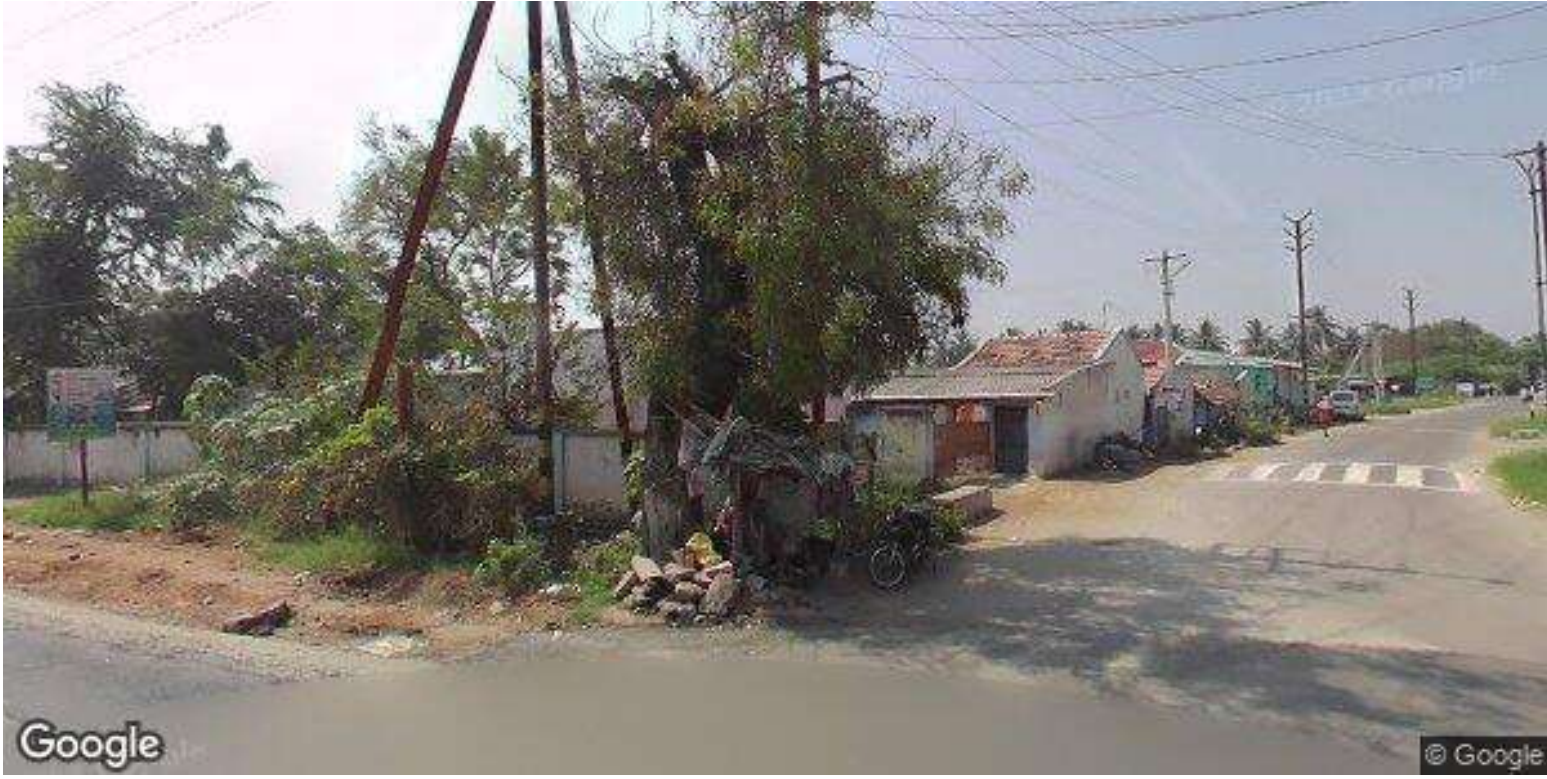
| | Risk Type | Risk Level | Coordinates | Speed Limit |
|---|---|---|---|---|
| 14 | Blind Spot | Blind Spot | 11.19748, 77.42349 | 10 KM/Hr |

**Risk Type: Blind Spot**

**Risk Level: Blind Spot**

**Speed Limit: 10 KM/Hr**

**Coordinates: 11.19748, 77.42349**

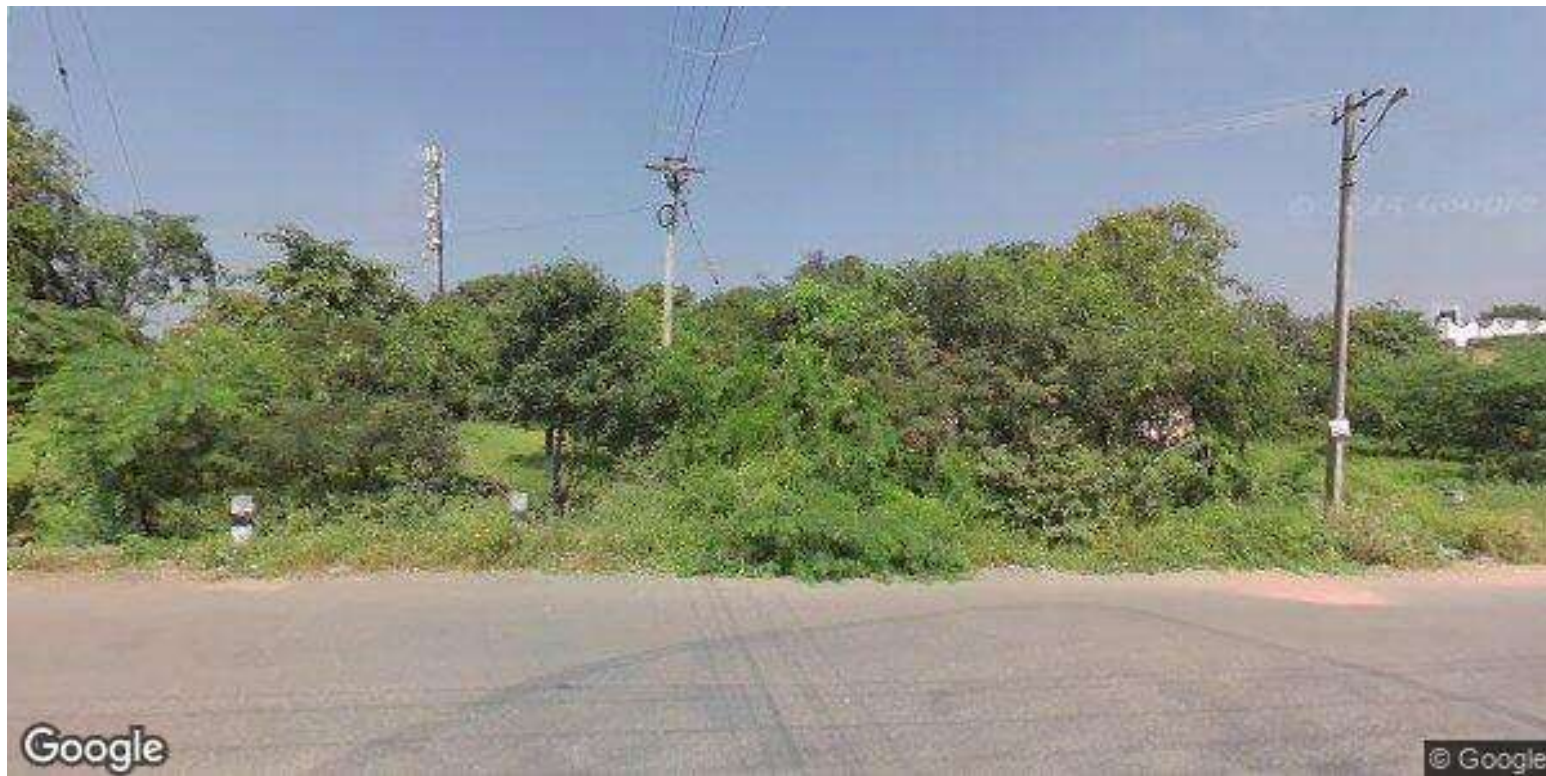
| | Risk Type | Risk Level | Coordinates | Speed Limit |
|---|---|---|---|---|
| 15 | Turn | High | 11.19731, 77.42240 | 15 KM/Hr |

**Risk Type: Turn**

**Risk Level: High**

**Speed Limit: 15 KM/Hr**

**Coordinates: 11.19731, 77.42240**

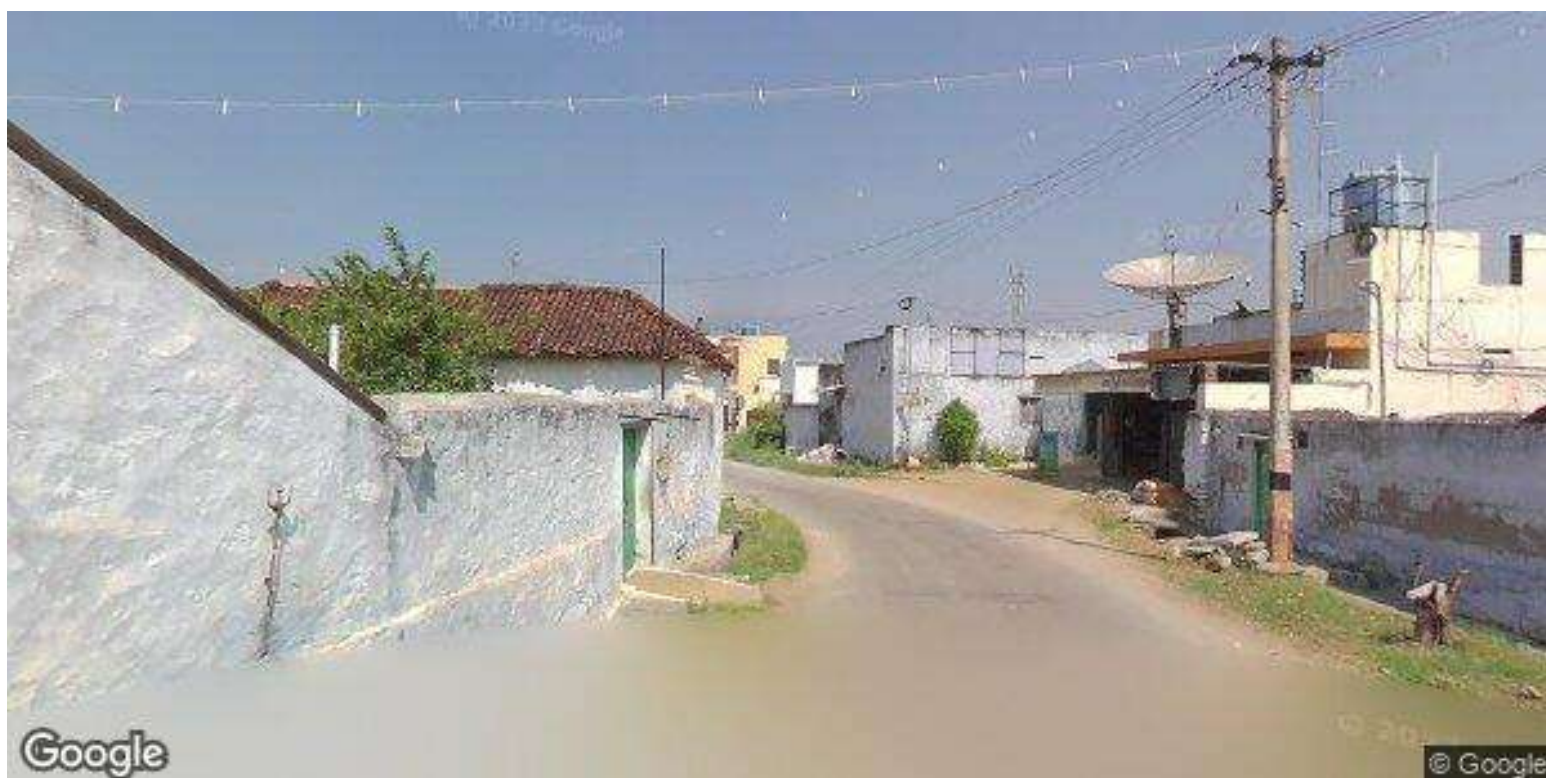
| | Risk Type | Risk Level | Coordinates | Speed Limit |
|---|---|---|---|---|
| 16 | Turn | Medium | 11.18014, 77.42388 | 30 KM/Hr |

**Risk Type: Turn**

**Risk Level: Medium**

**Speed Limit: 30 KM/Hr**

**Coordinates: 11.18014, 77.42388**

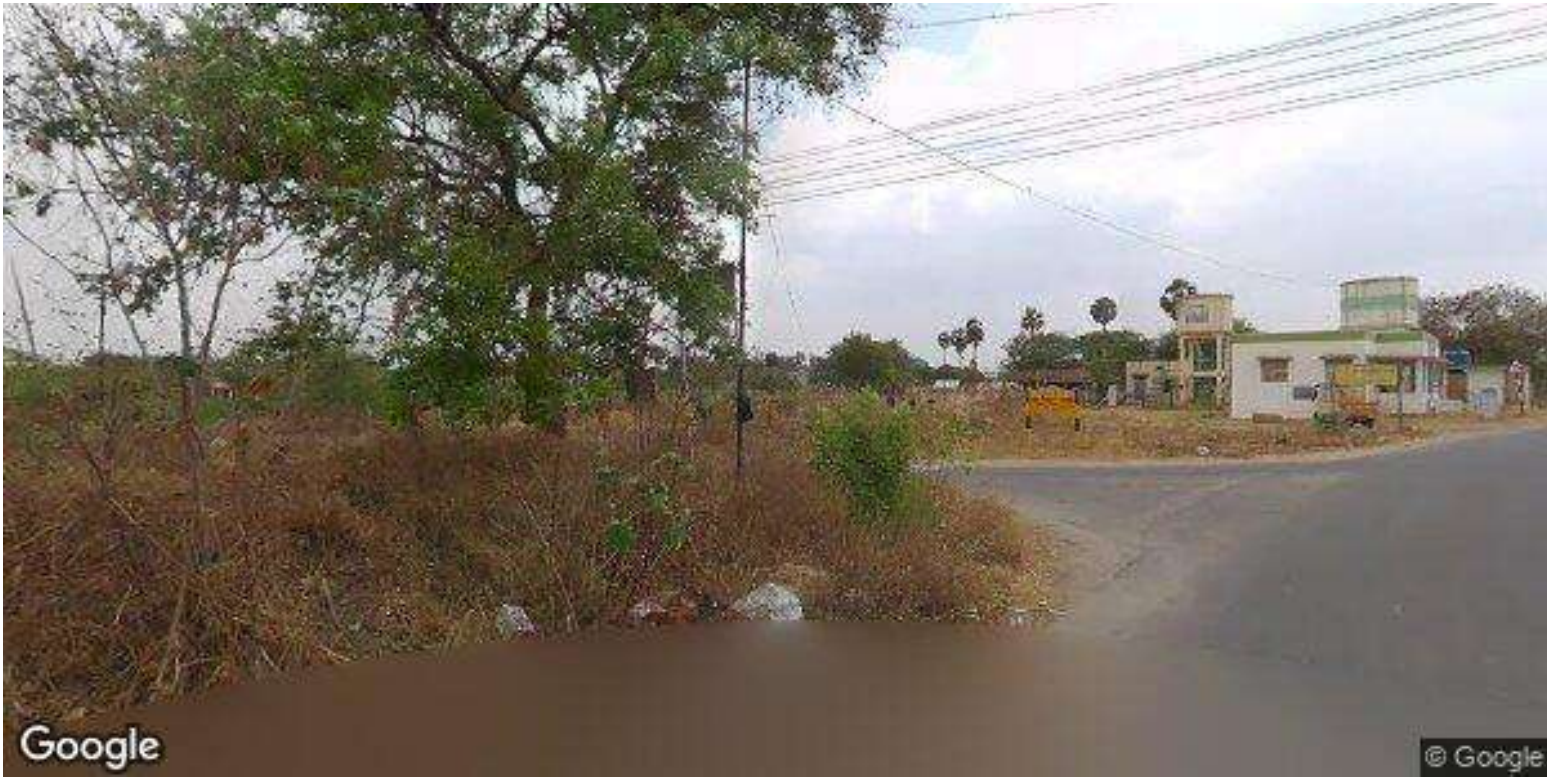
| | Risk Type | Risk Level | Coordinates | Speed Limit |
|---|---|---|---|---|
| 17 | Turn | High | 11.15927, 77.42044 | 15 KM/Hr |

**Risk Type:** Turn  
**Risk Level:** High  
**Speed Limit:** 15 KM/Hr  
**Coordinates:** 11.15927, 77.42044

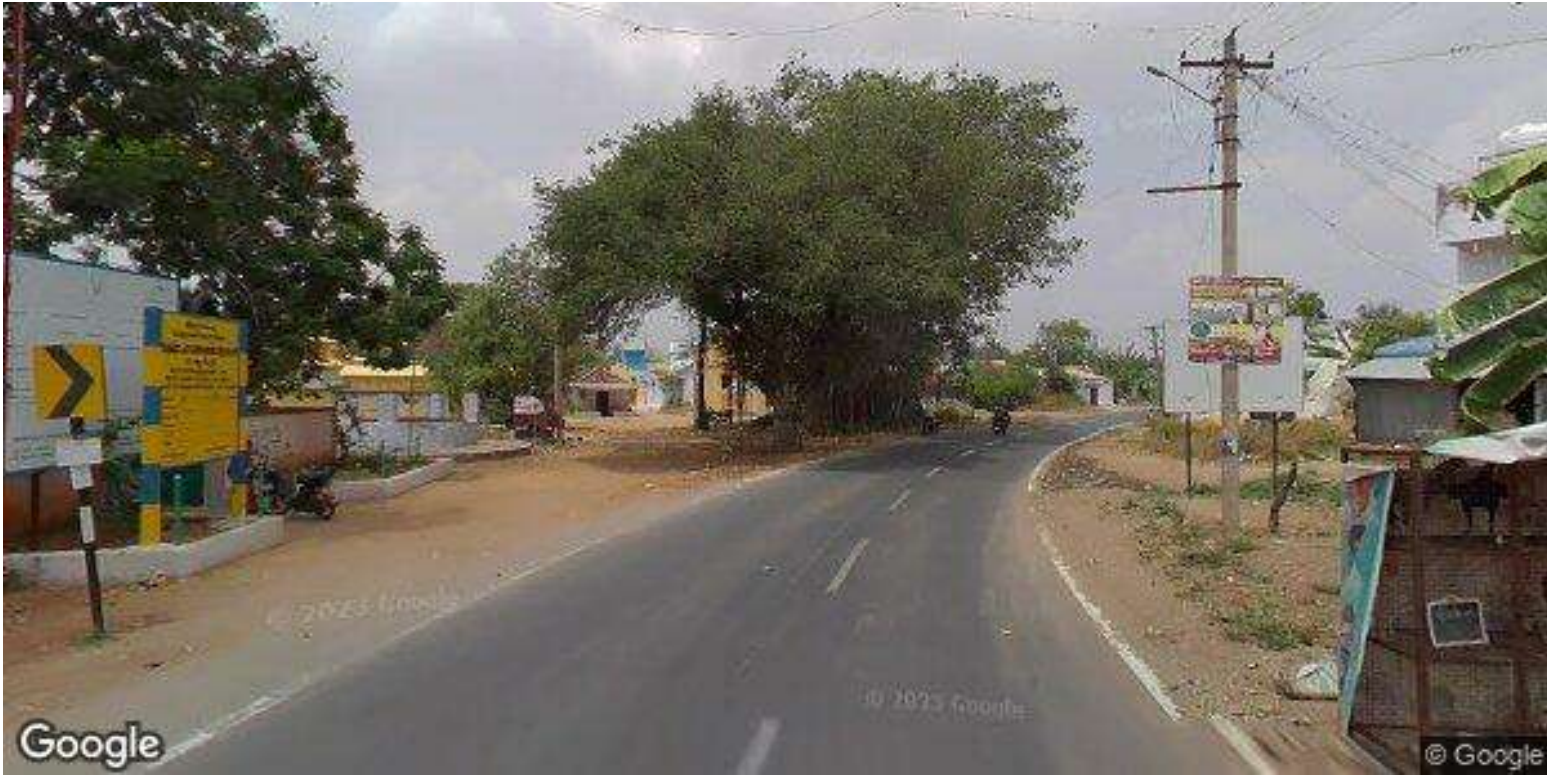
| | Risk Type | Risk Level | Coordinates | Speed Limit |
|---|---|---|---|---|
| 18 | Turn | Medium | 11.15930, 77.41866 | 30 KM/Hr |

**Risk Type:** Turn  
**Risk Level:** Medium  
**Speed Limit:** 30 KM/Hr  
**Coordinates:** 11.15930, 77.41866

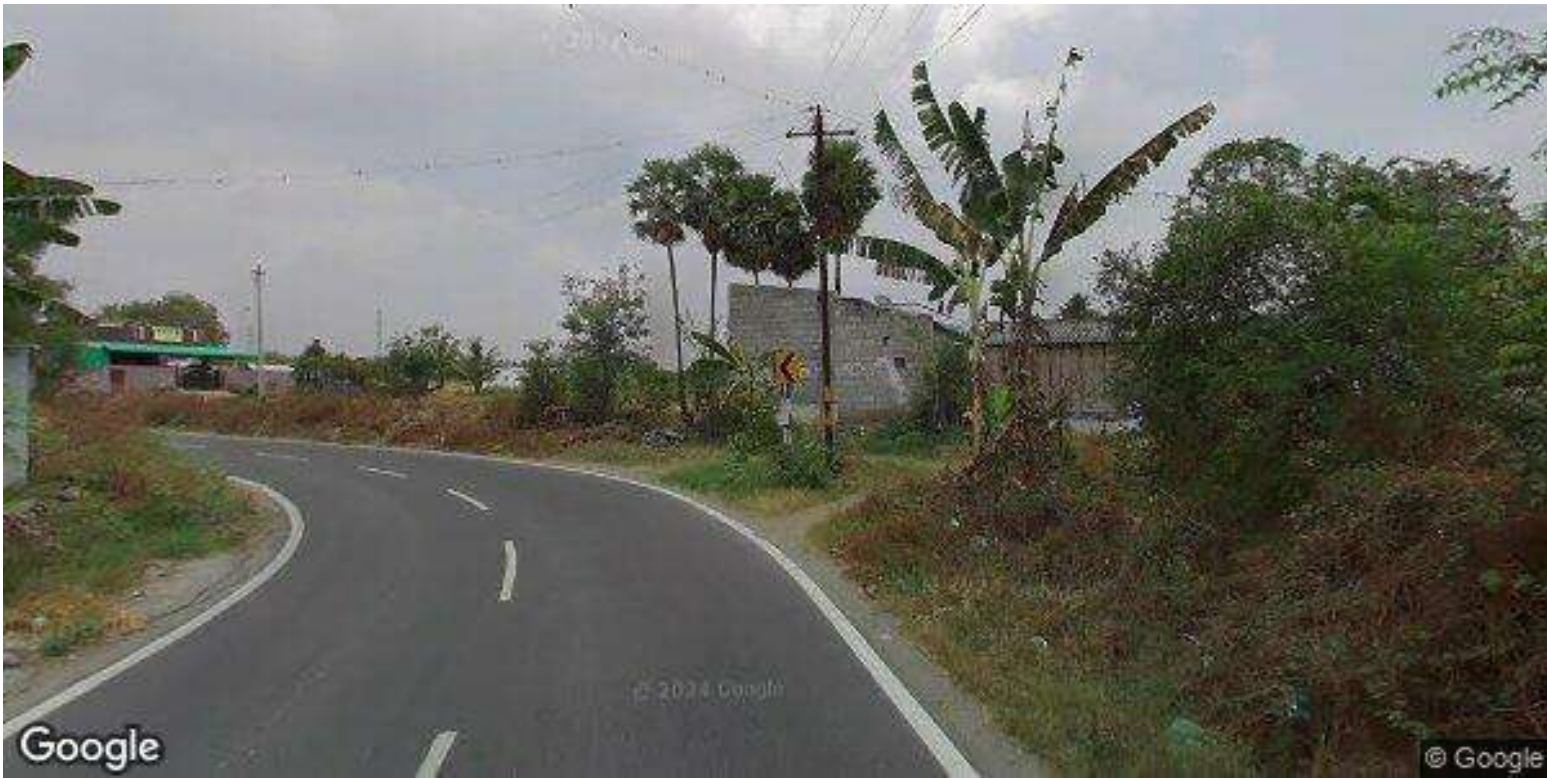
| | Risk Type | Risk Level | Coordinates | Speed Limit |
|---|---|---|---|---|
| 19 | Turn | Medium | 11.15996, 77.41806 | 30 KM/Hr |

**Risk Type:** Turn  
**Risk Level:** Medium  
**Speed Limit:** 30 KM/Hr  
**Coordinates:** 11.15996, 77.41806

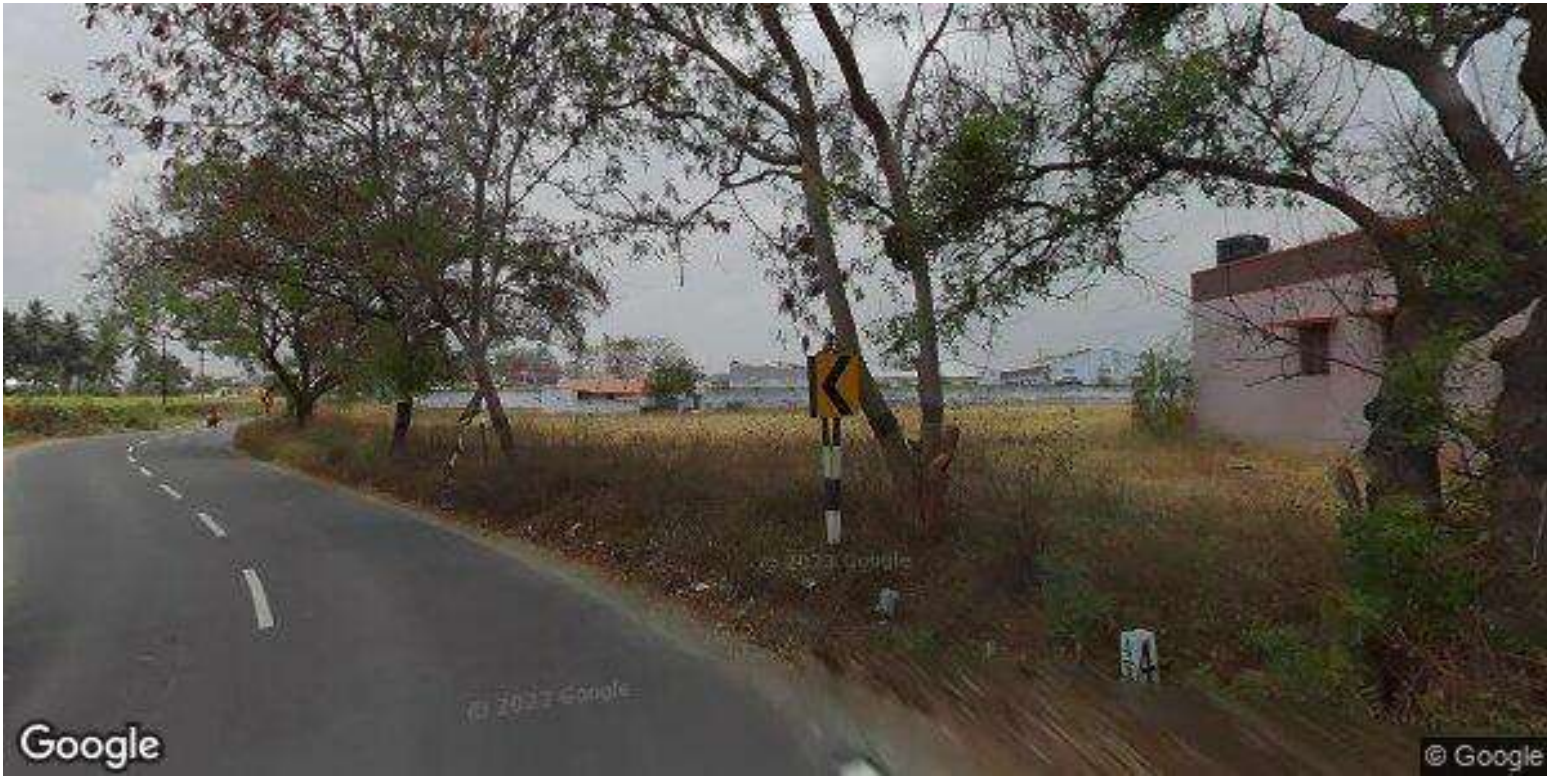
| | Risk Type | Risk Level | Coordinates | Speed Limit |
|---|---|---|---|---|
| 20 | Turn | Medium | 11.16004, 77.41760 | 30 KM/Hr |

**Risk Type:** Turn  
**Risk Level:** Medium  
**Speed Limit:** 30 KM/Hr  
**Coordinates:** 11.16004, 77.41760

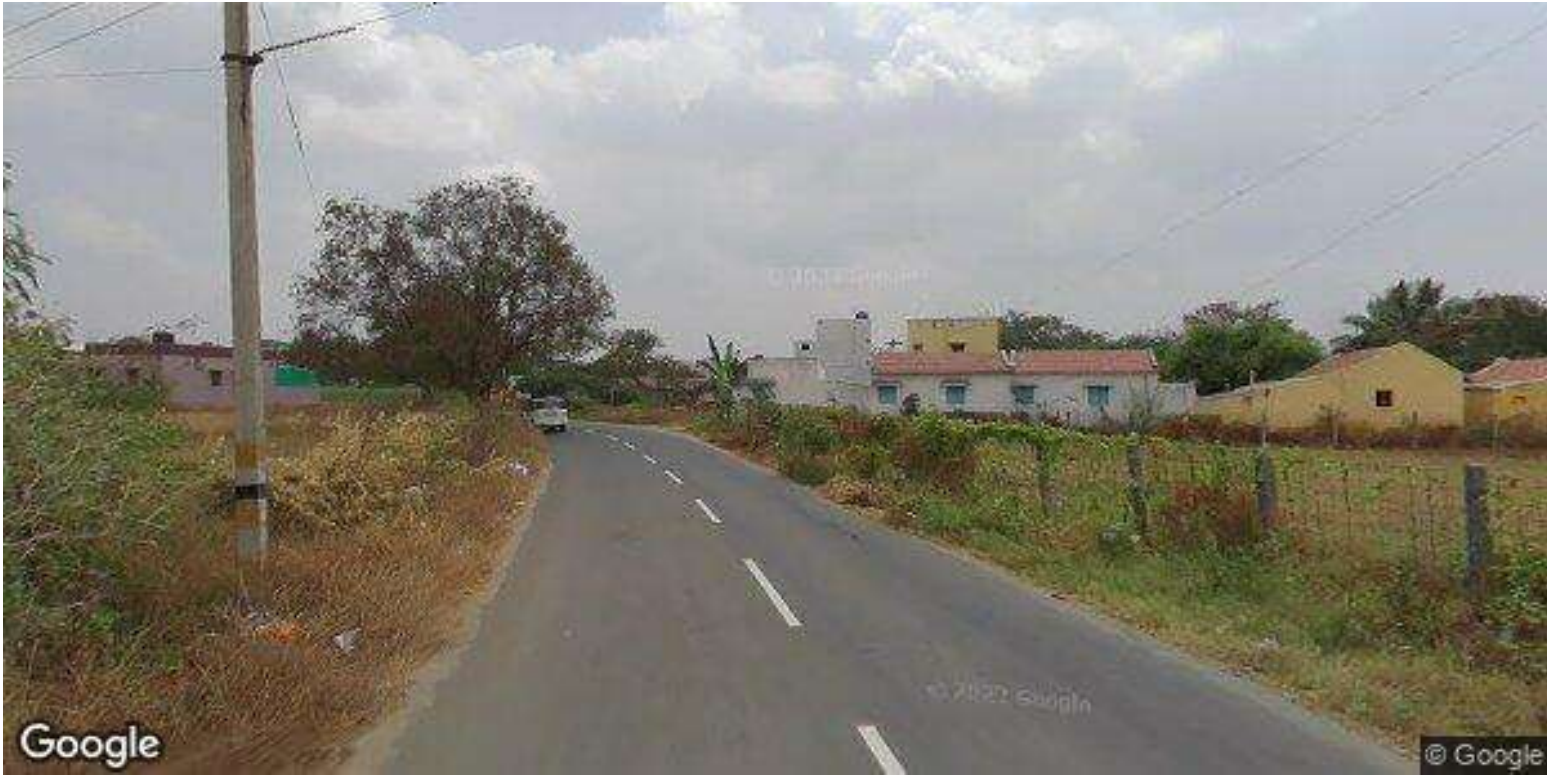
| | Risk Type | Risk Level | Coordinates | Speed Limit |
|---|---|---|---|---|
| 21 | Turn | Medium | 11.15963, 77.41700 | 30 KM/Hr |

**Risk Type:** Turn  
**Risk Level:** Medium  
**Speed Limit:** 30 KM/Hr  
**Coordinates:** 11.15963, 77.41700
