# IndianOil

## JOURNEY RISK MANAGEMENT (JRM) STUDY

### Salem Terminal to A.S. FUEL ZONE

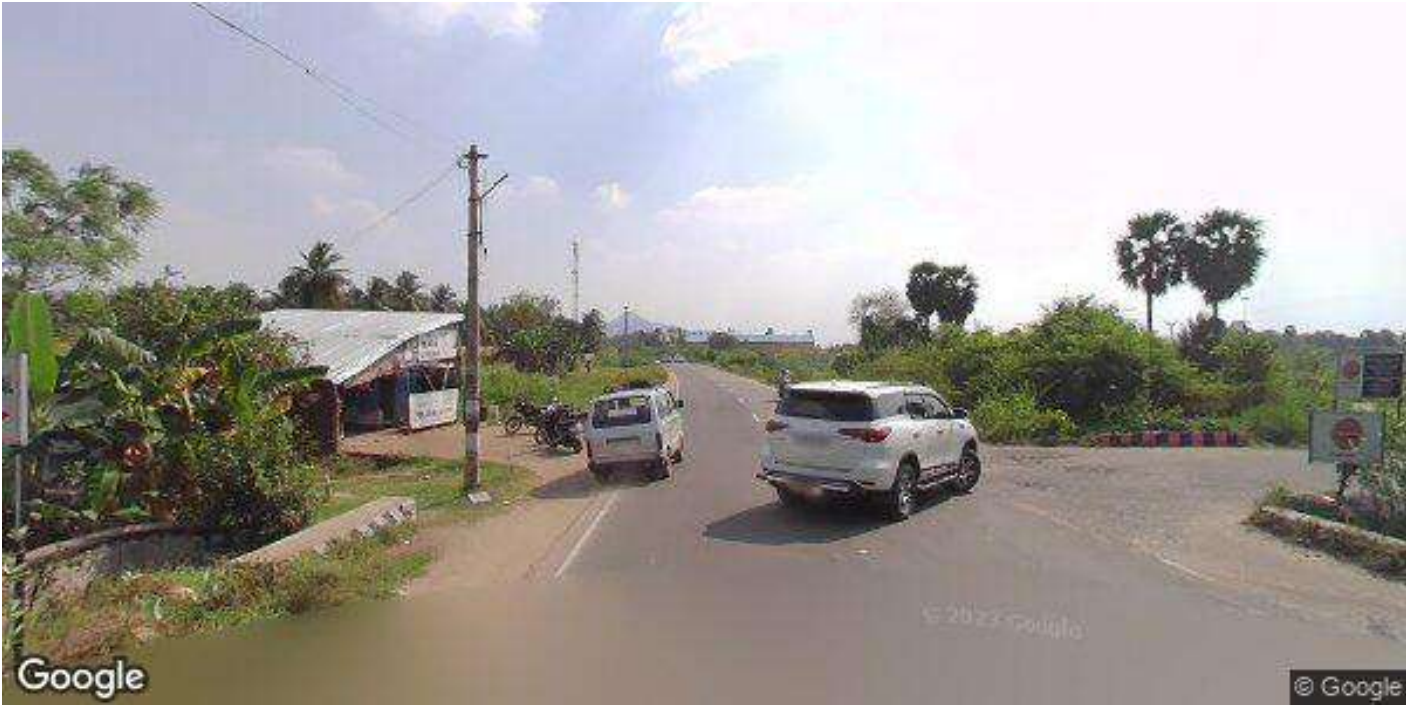
Risk Type: Turn  
Risk Level: High  
Speed Limit: 15 KM/Hr  
Coordinates: 11.44029, 77.87544

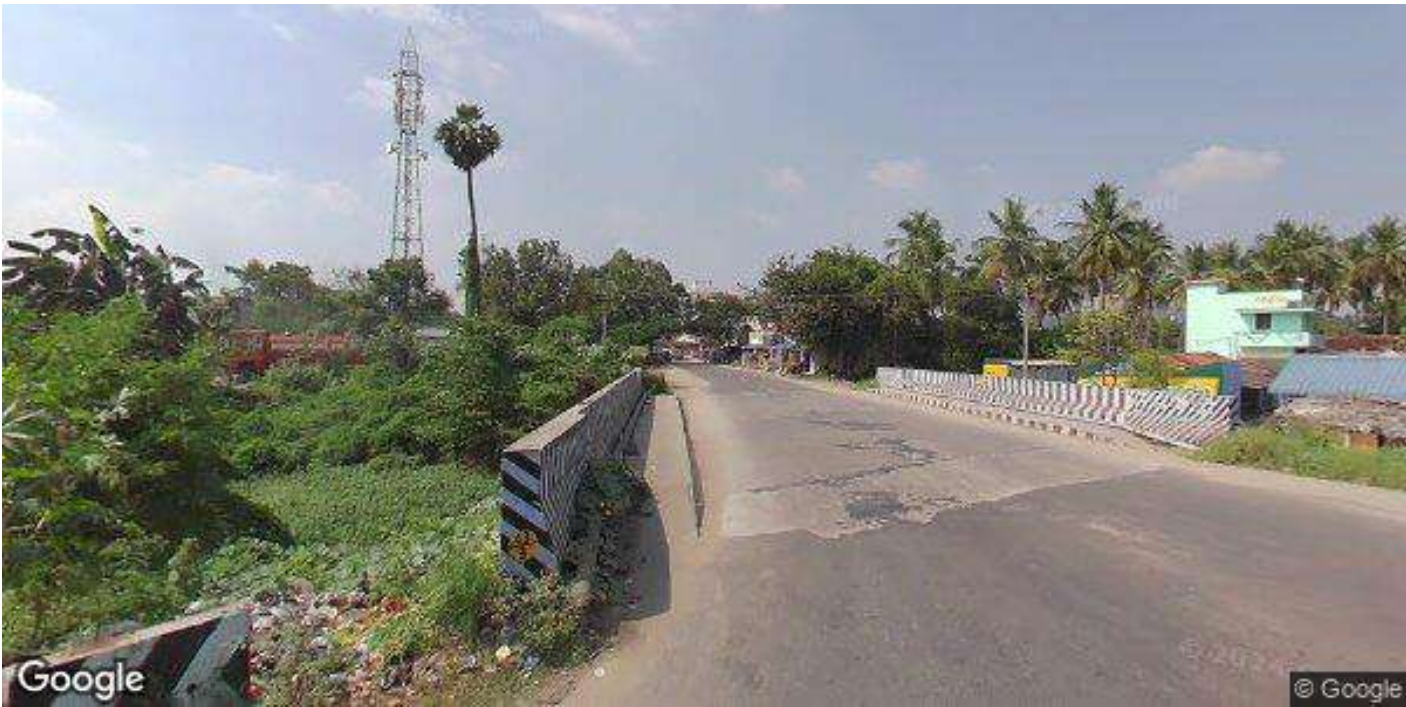
Risk Type: Turn  
Risk Level: High

**Speed Limit: 15 KM/Hr**  
**Coordinates: 11.44900, 77.87406**

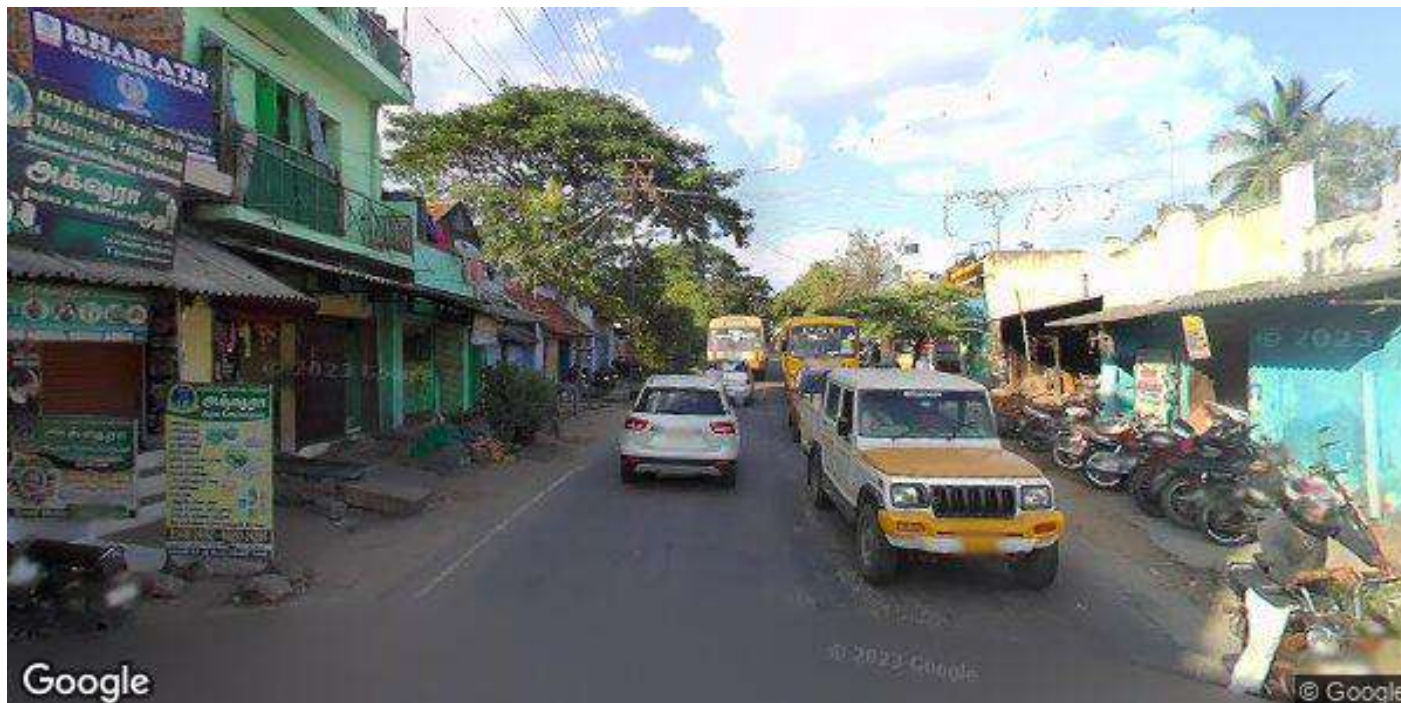
**Risk Type: Turn**  
**Risk Level: High**  
**Speed Limit: 15 KM/Hr**  
**Coordinates: 11.45028, 77.87202**

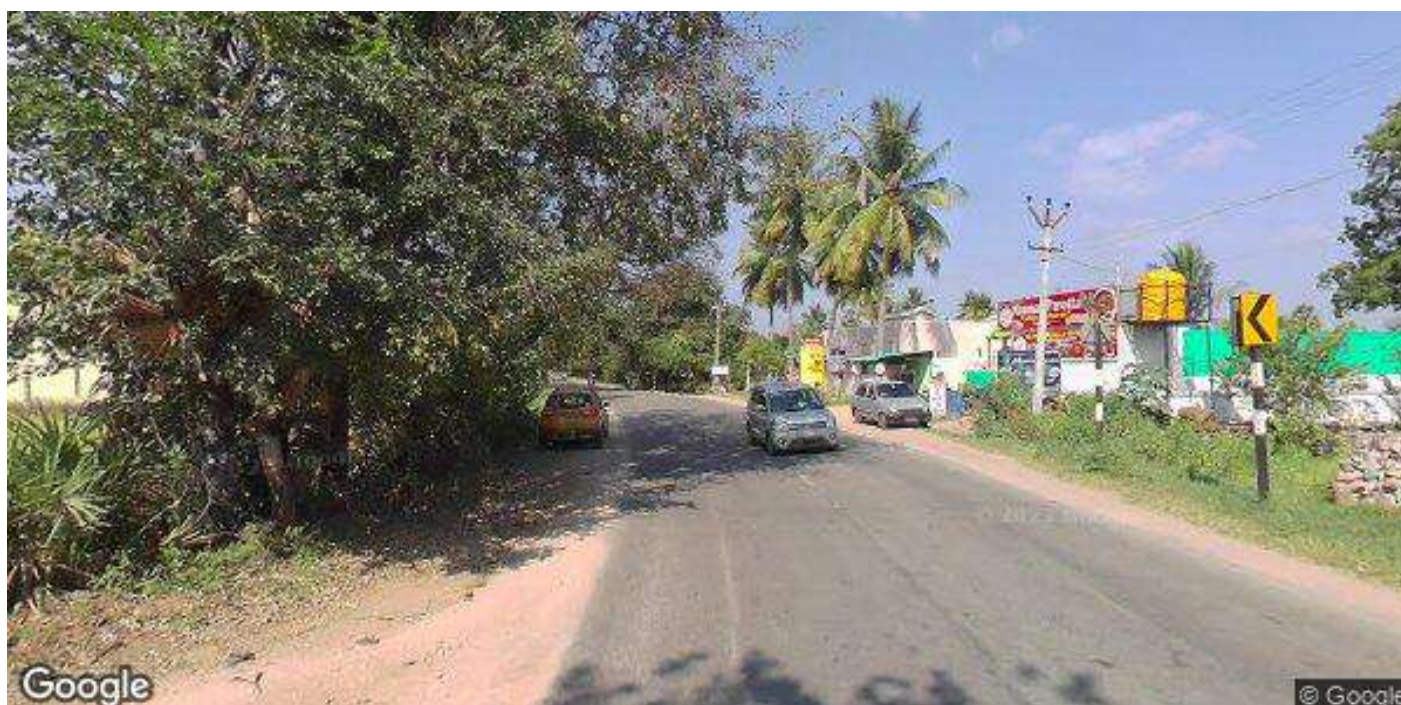
**Risk Type: Turn**  
**Risk Level: Medium**  
**Speed Limit: 30 KM/Hr**  
**Coordinates: 11.45309, 77.87325**

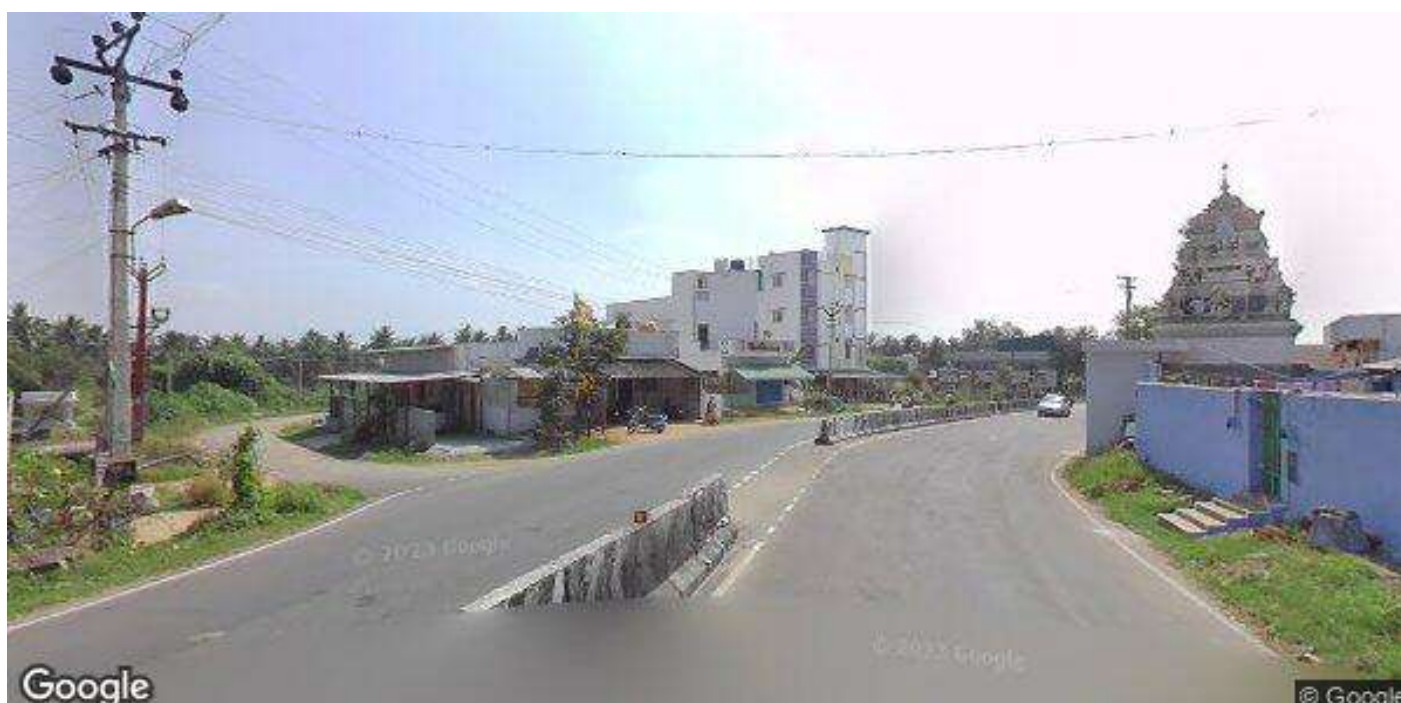
**Risk Type:** Turn  
**Risk Level:** Medium  
**Speed Limit:** 30 KM/Hr  
**Coordinates:** 11.46400, 77.87323

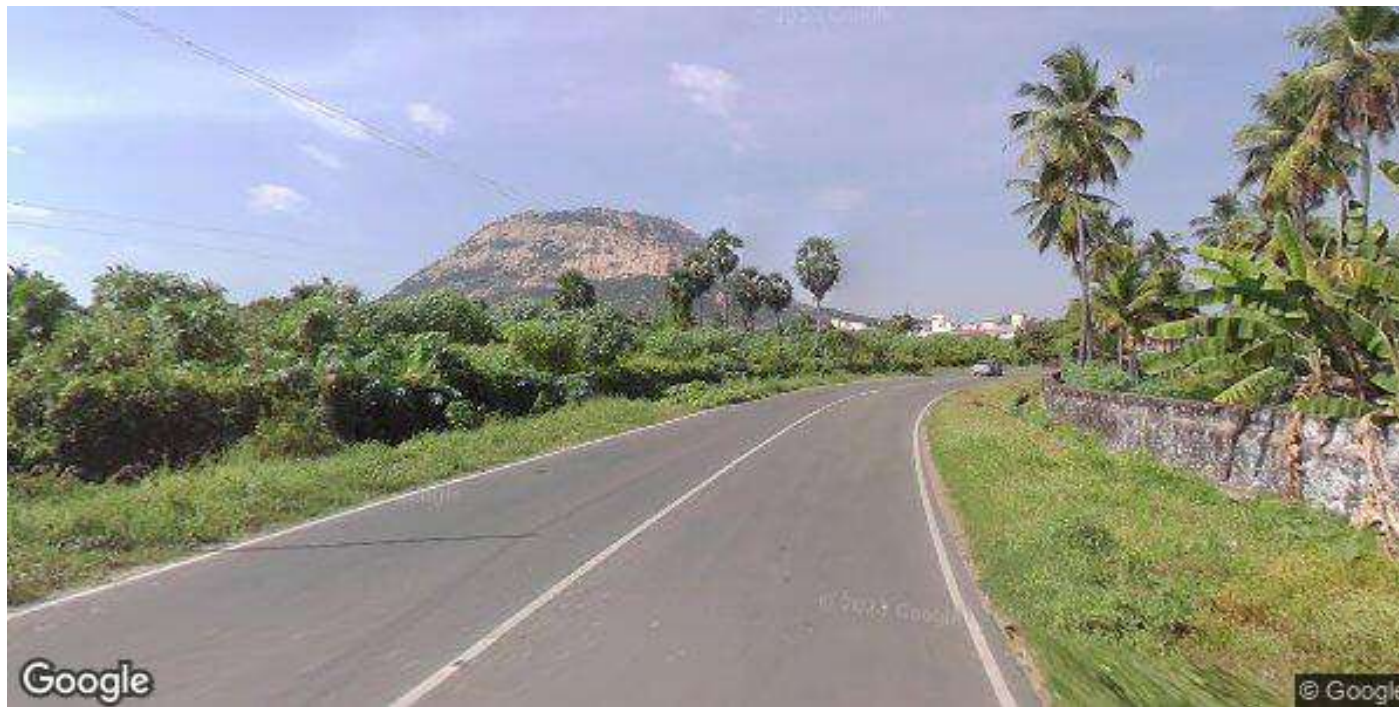
**Risk Type:** Turn  
**Risk Level:** Medium  
**Speed Limit:** 30 KM/Hr  
**Coordinates:** 11.46765, 77.87037

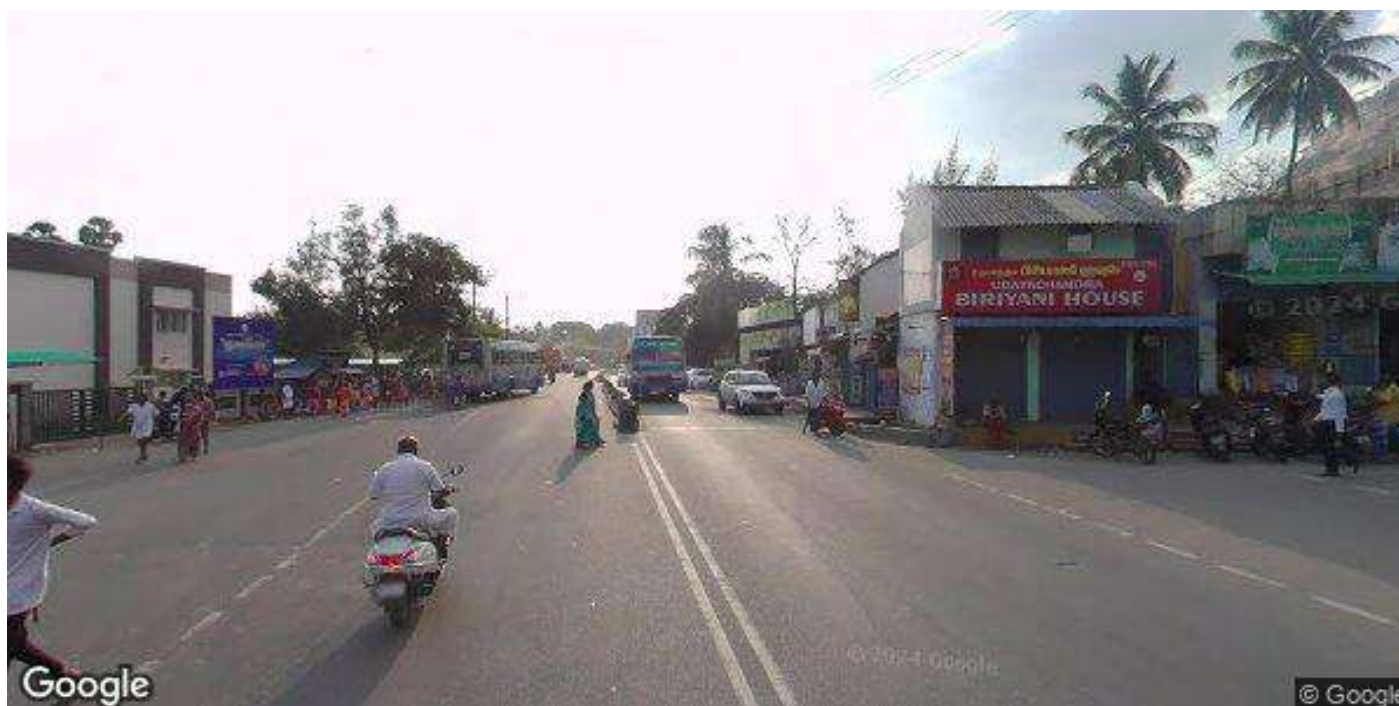
**Risk Type:** Turn  
**Risk Level:** High  
**Speed Limit:** 15 KM/Hr  
**Coordinates:** 11.47403, 77.86841

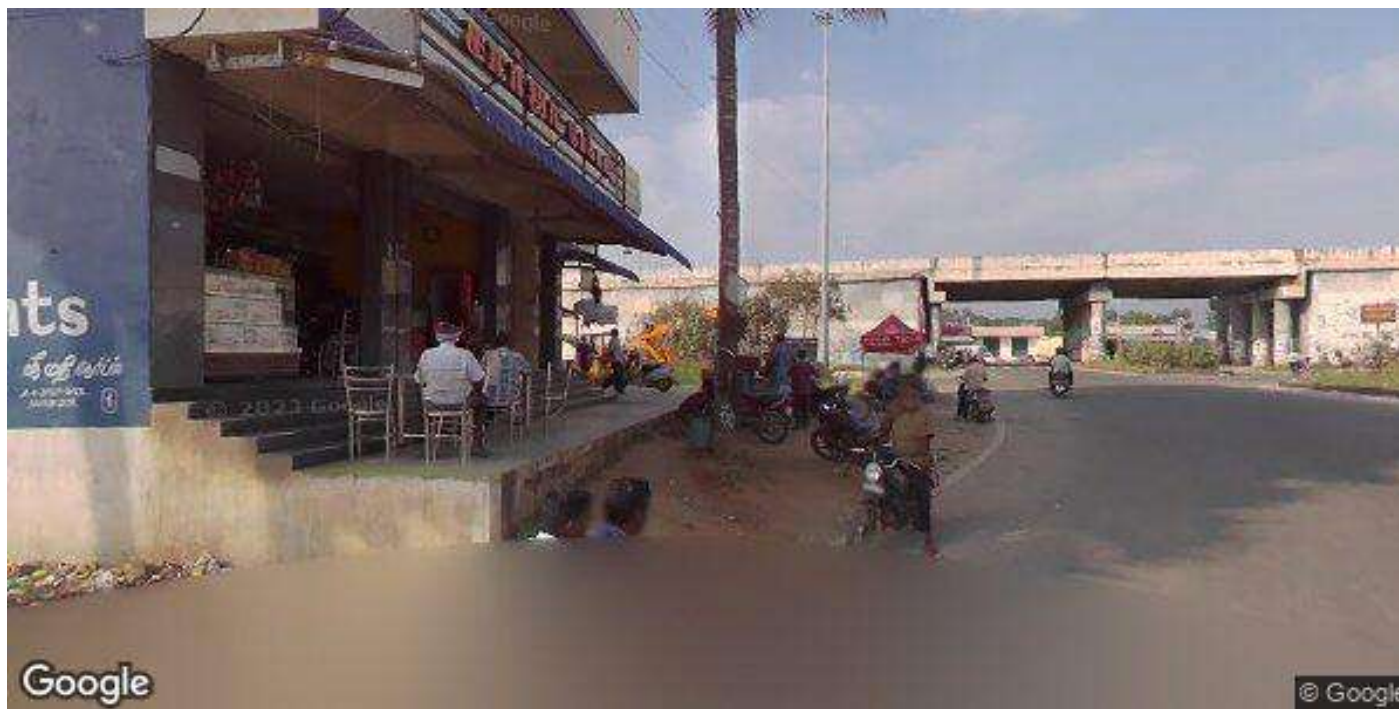
**Risk Type:** Turn  
**Risk Level:** High  
**Speed Limit:** 15 KM/Hr  
**Coordinates:** 11.49149, 77.89601

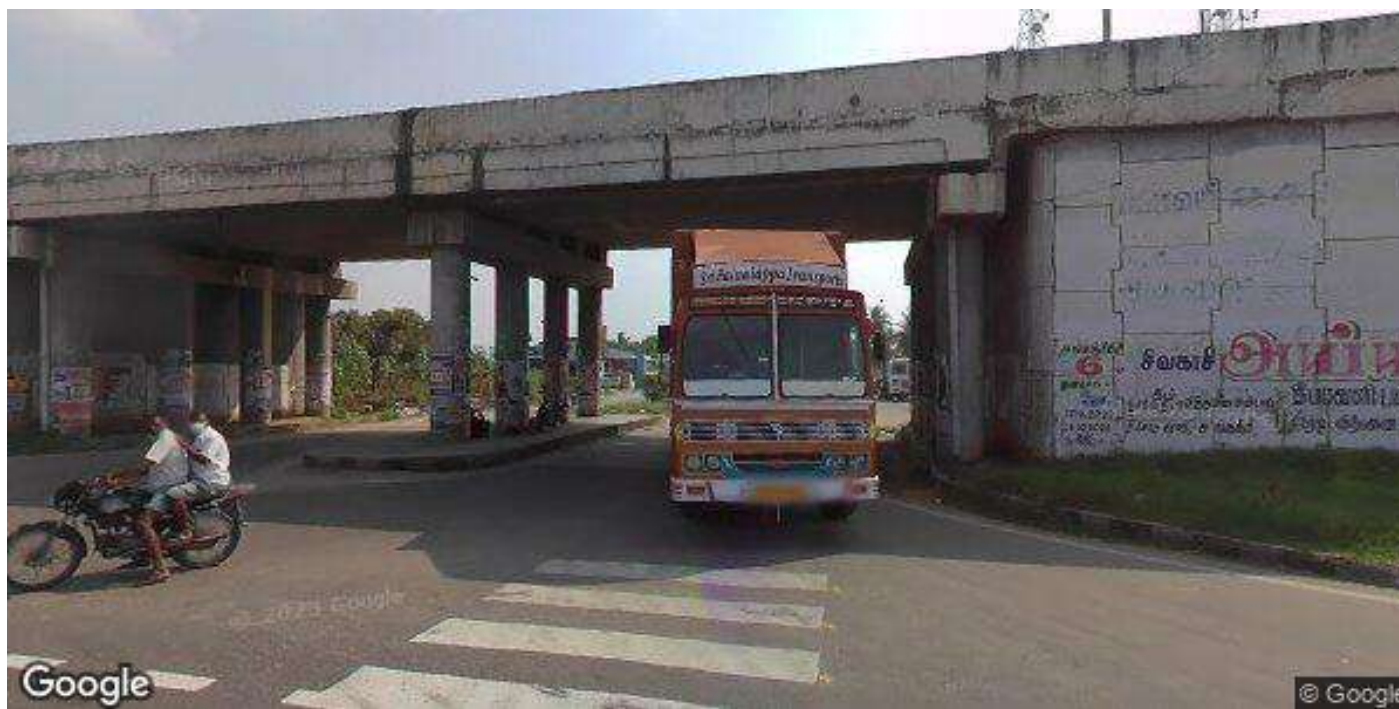
**Risk Type:** Turn  
**Risk Level:** High  
**Speed Limit:** 15 KM/Hr  
**Coordinates:** 11.49224, 77.89601

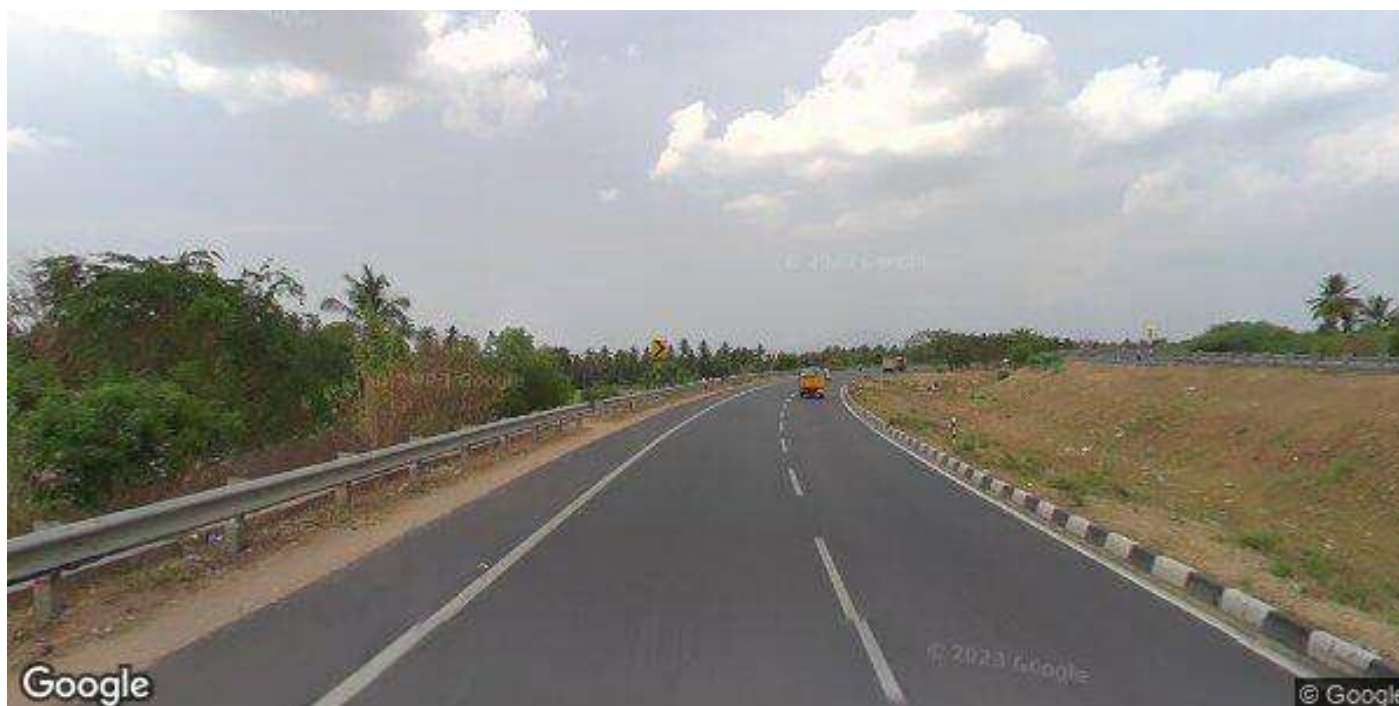
**Risk Type:** Turn  
**Risk Level:** Medium  
**Speed Limit:** 30 KM/Hr  
**Coordinates:** 11.53501, 77.95707

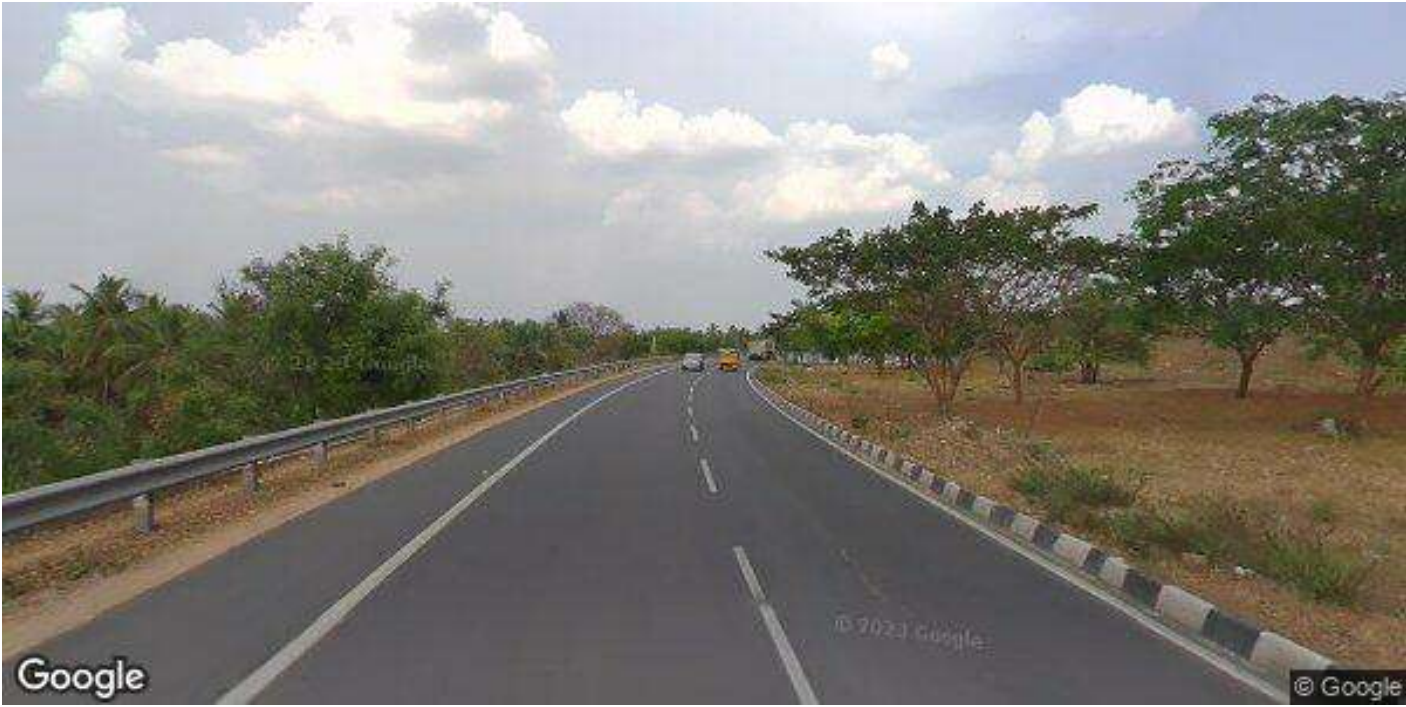
**Risk Type:** Turn  
**Risk Level:** Medium  
**Speed Limit:** 30 KM/Hr  
**Coordinates:** 11.53601, 77.95856

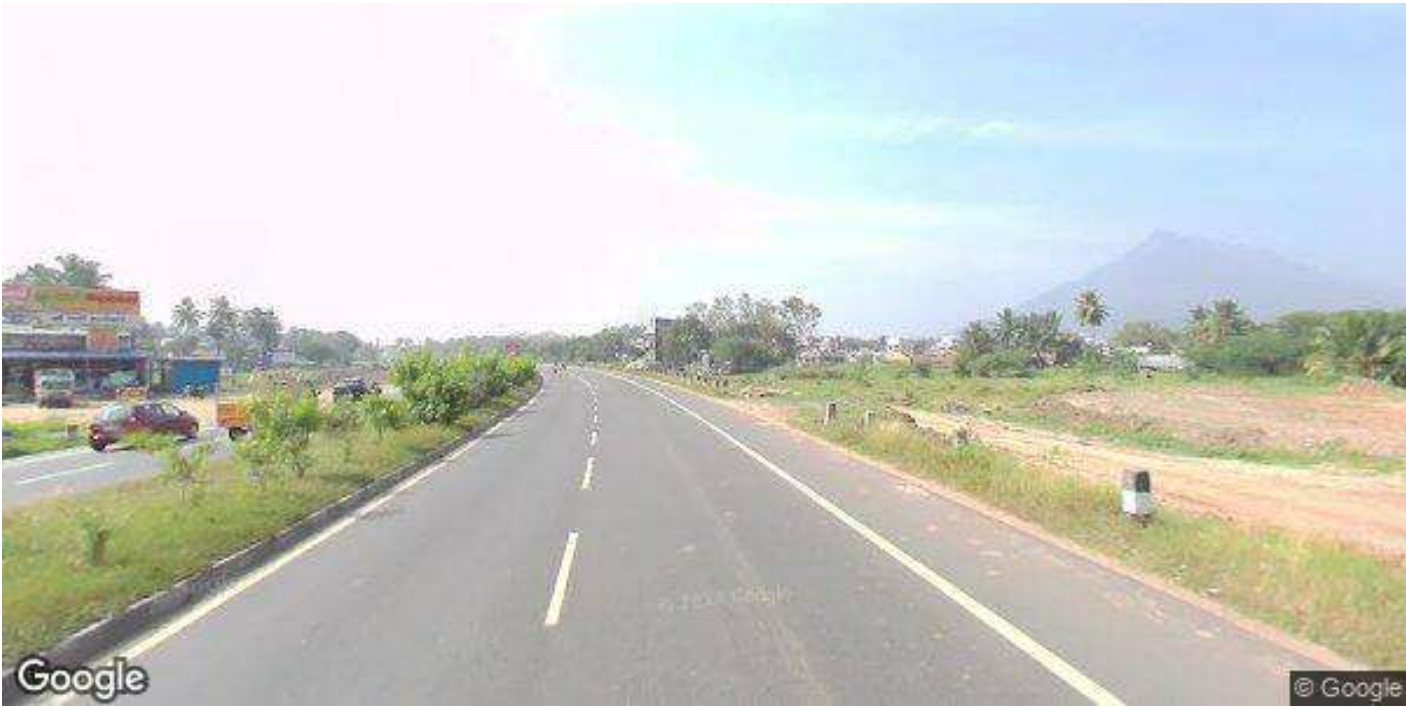
**Risk Type:** Turn  
**Risk Level:** Medium  
**Speed Limit:** 30 KM/Hr  
**Coordinates:** 11.62403, 78.10893

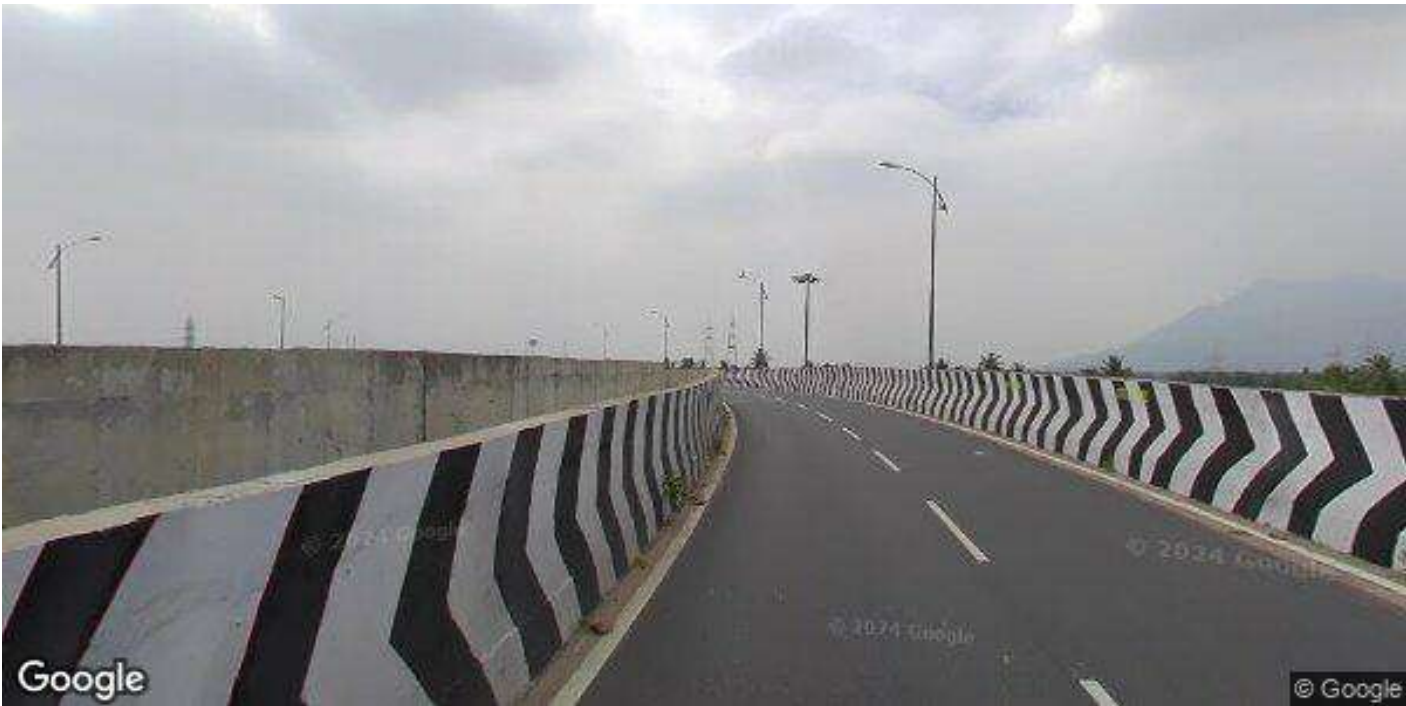
**Risk Type:** Turn  
**Risk Level:** Medium  
**Speed Limit:** 30 KM/Hr  
**Coordinates:** 11.64180, 78.11808

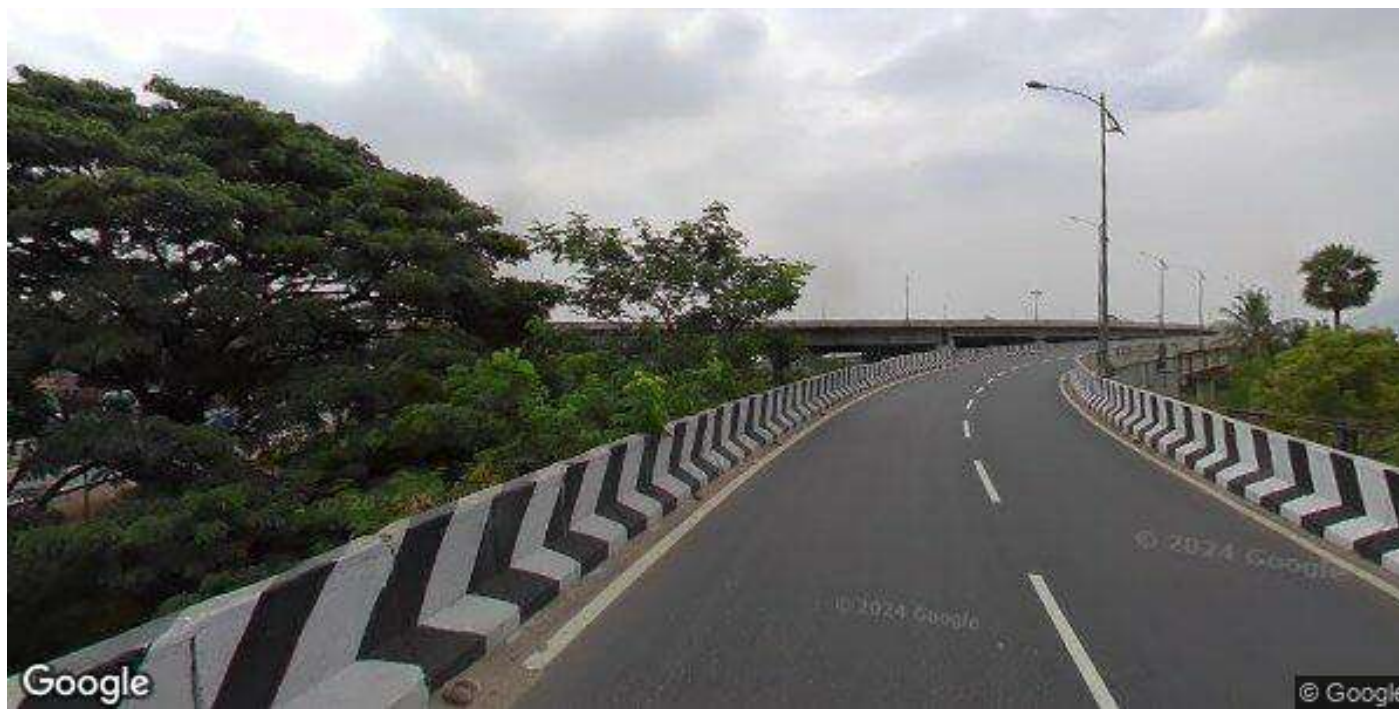
**Risk Type:** Turn  
**Risk Level:** Medium  
**Speed Limit:** 30 KM/Hr  
**Coordinates:** 11.64325, 78.11993

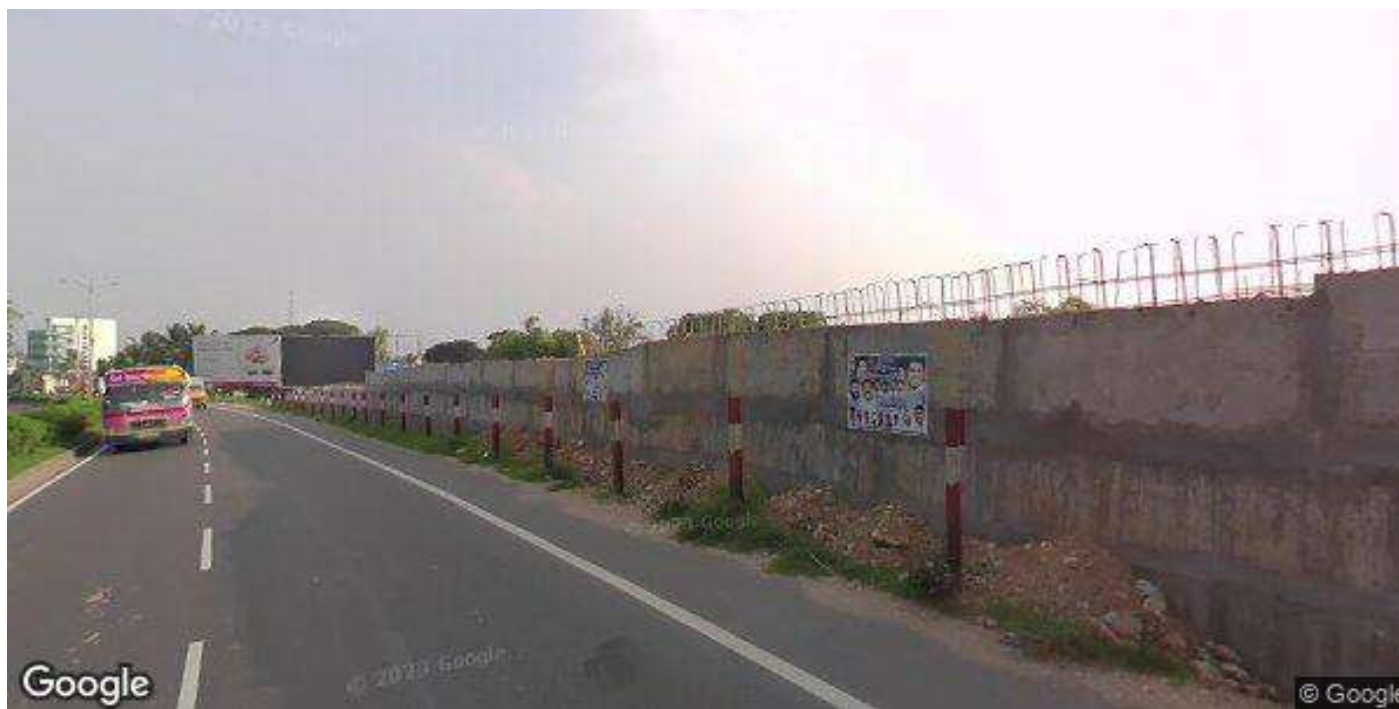
**Risk Type:** Turn  
**Risk Level:** Medium  
**Speed Limit:** 30 KM/Hr  
**Coordinates:** 11.69519, 78.10775

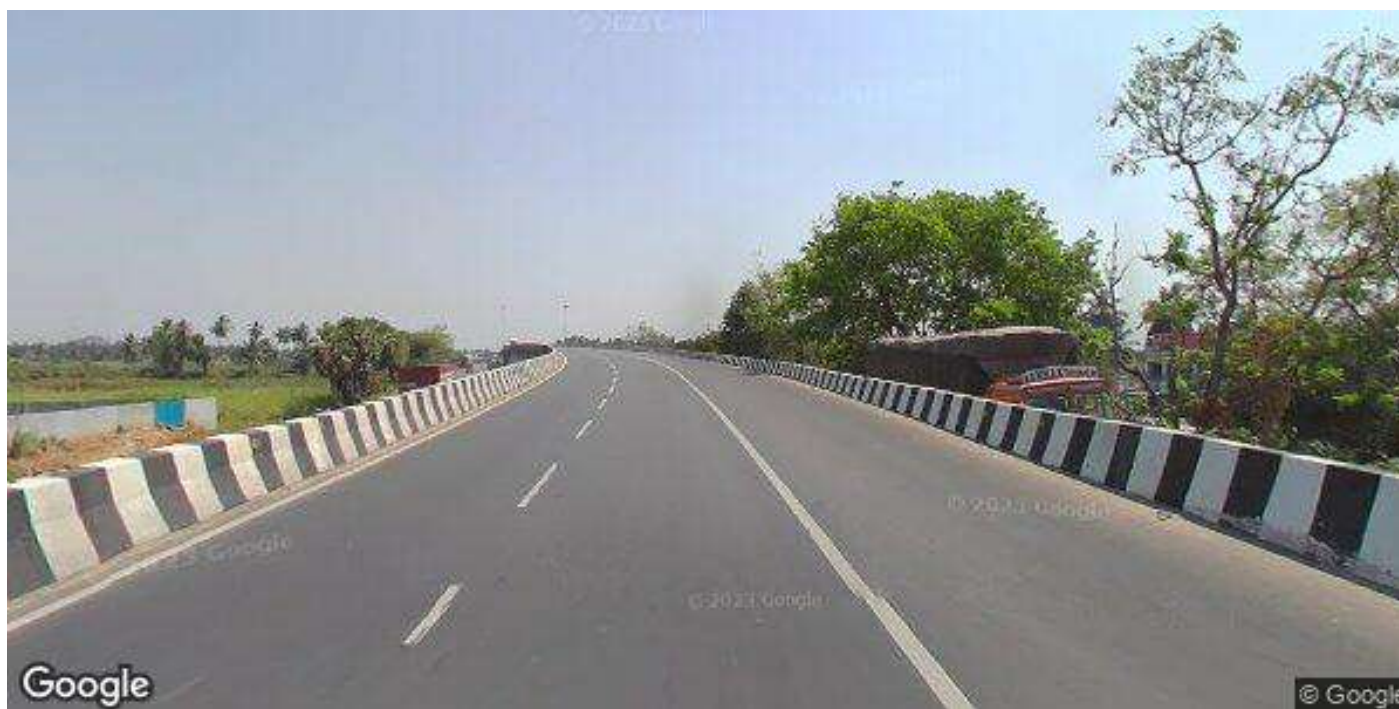
**Risk Type:** Turn  
**Risk Level:** Medium  
**Speed Limit:** 30 KM/Hr  
**Coordinates:** 11.73958, 78.05105

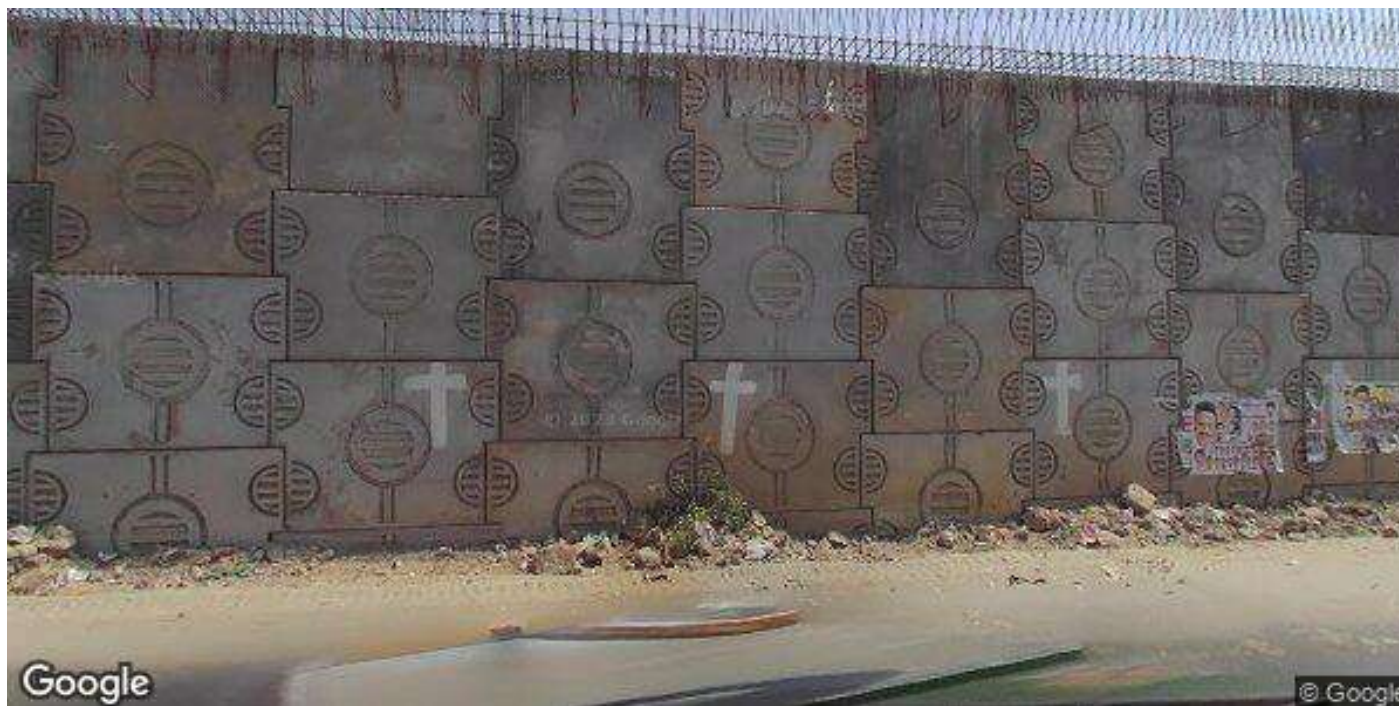
**Risk Type:** Turn  
**Risk Level:** Medium  
**Speed Limit:** 30 KM/Hr  
**Coordinates:** 11.75835, 78.05016

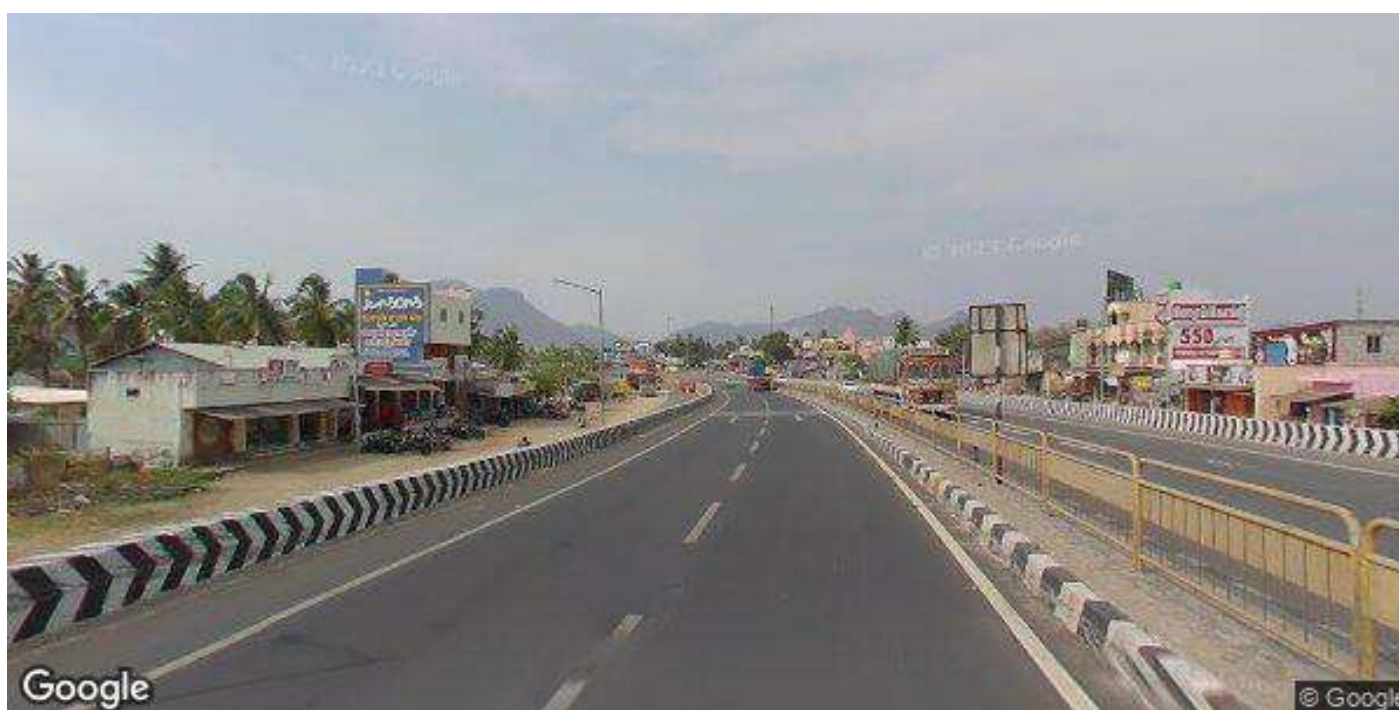
**Risk Type:** Turn  
**Risk Level:** Medium  
**Speed Limit:** 30 KM/Hr  
**Coordinates:** 11.86847, 78.08367

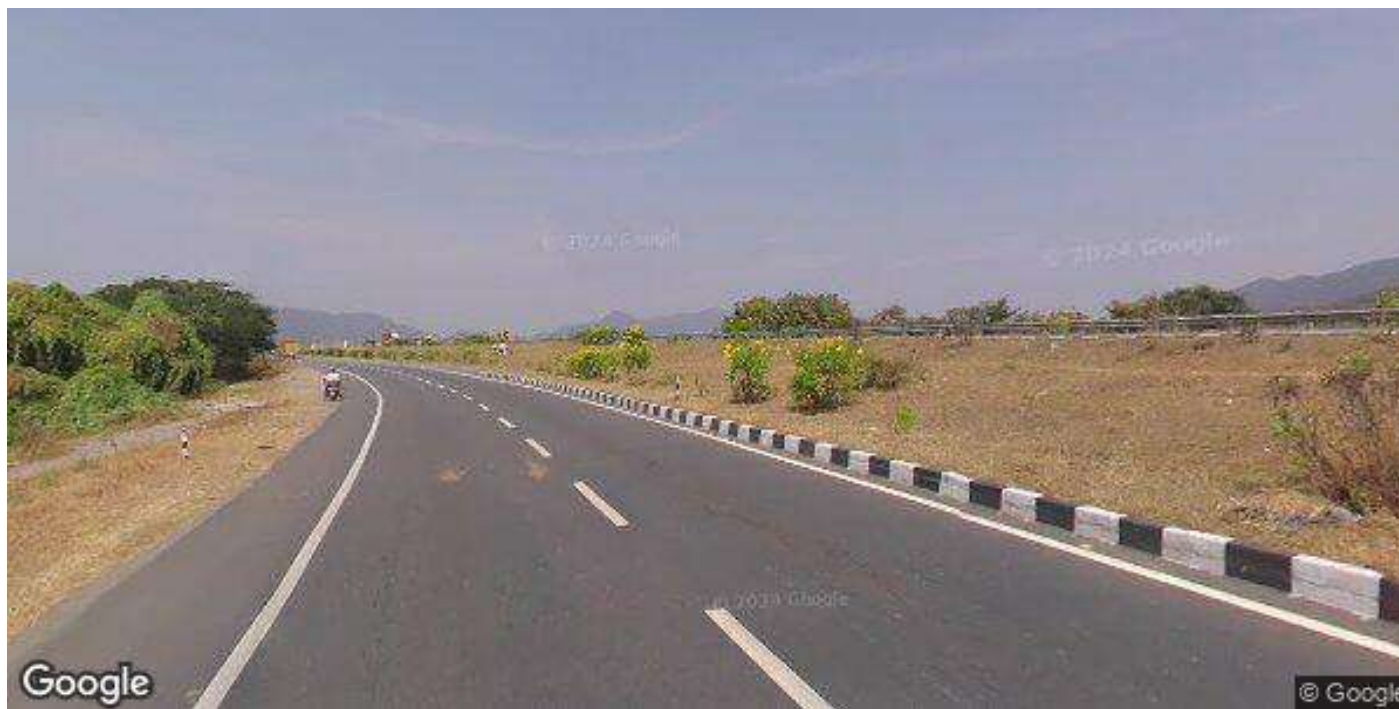
**Risk Type:** Turn  
**Risk Level:** Medium  
**Speed Limit:** 30 KM/Hr  
**Coordinates:** 11.92585, 78.06507

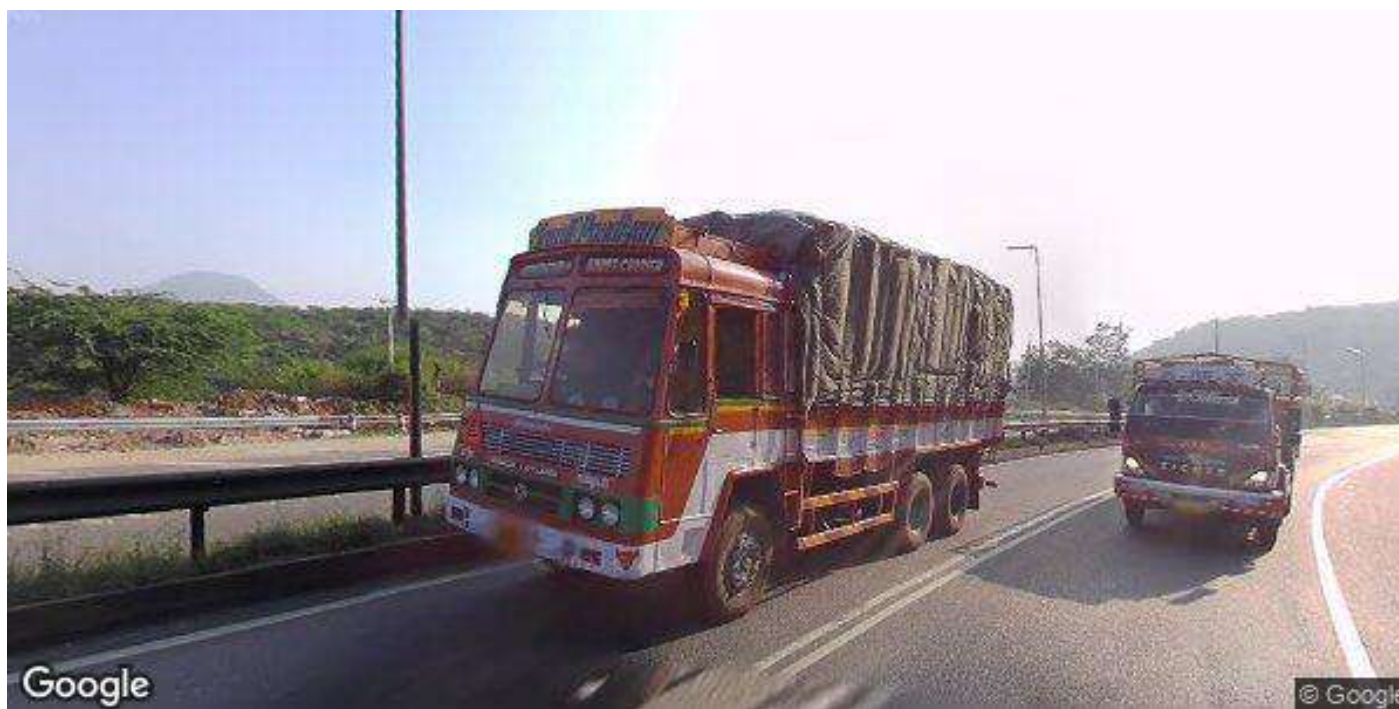
**Risk Type:** Turn  
**Risk Level:** High  
**Speed Limit:** 15 KM/Hr  
**Coordinates:** 11.95818, 78.04978

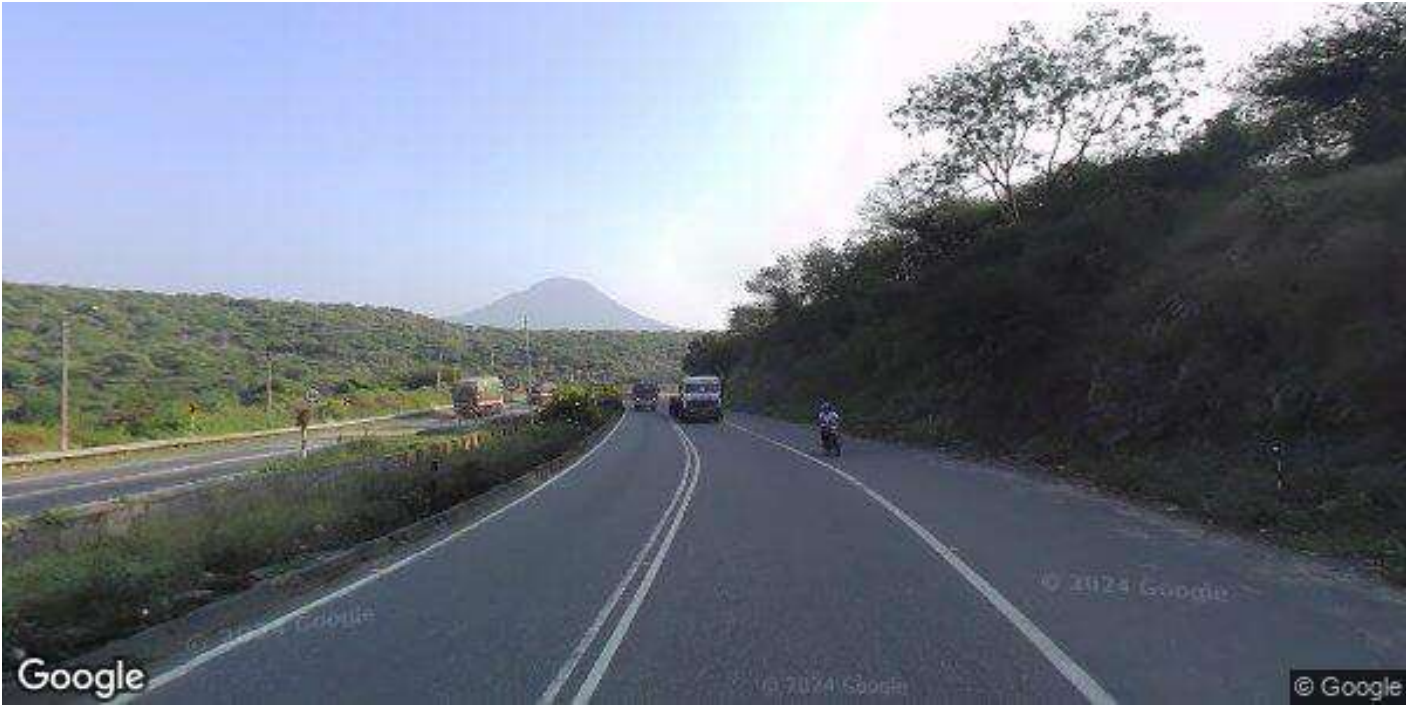
**Risk Type:** Turn  
**Risk Level:** Medium  
**Speed Limit:** 30 KM/Hr  
**Coordinates:** 11.95988, 78.04948

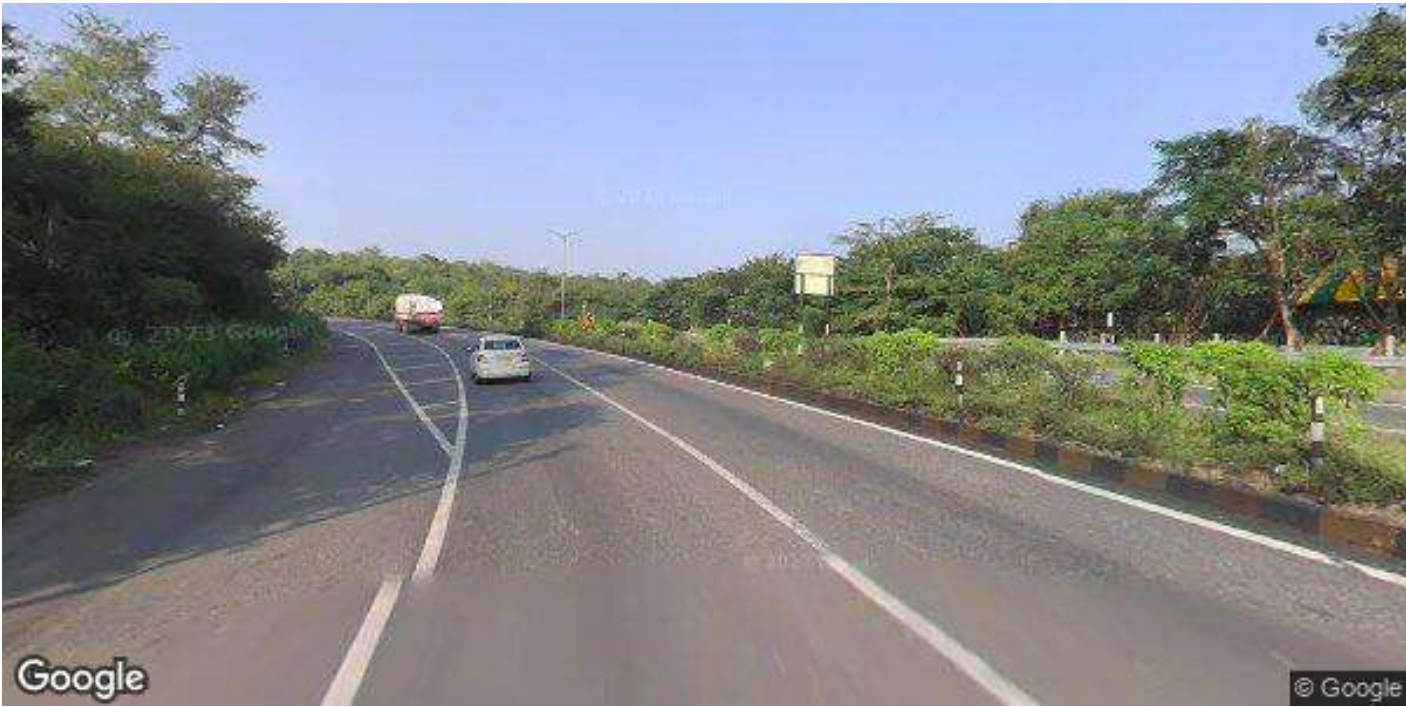
**Risk Type:** Turn  
**Risk Level:** Medium  
**Speed Limit:** 30 KM/Hr  
**Coordinates:** 11.96304, 78.05136
