# IndianOil

## JOURNEY RISK MANAGEMENT (JRM) STUDY

### Salem Terminal to A.S. FUEL ZONE

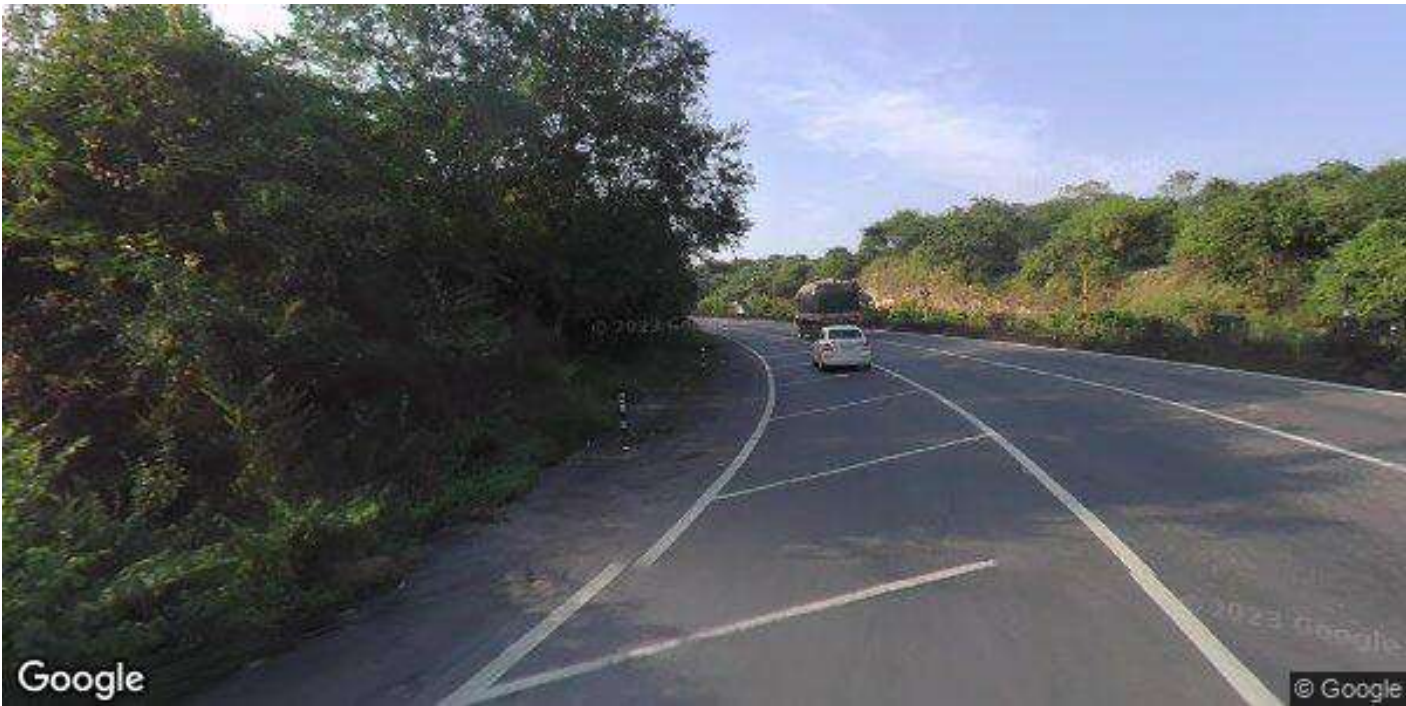
**Risk Type:** Turn  
**Risk Level:** High  
**Speed Limit:** 15 KM/Hr  
**Coordinates:** 11.96399, 78.05135

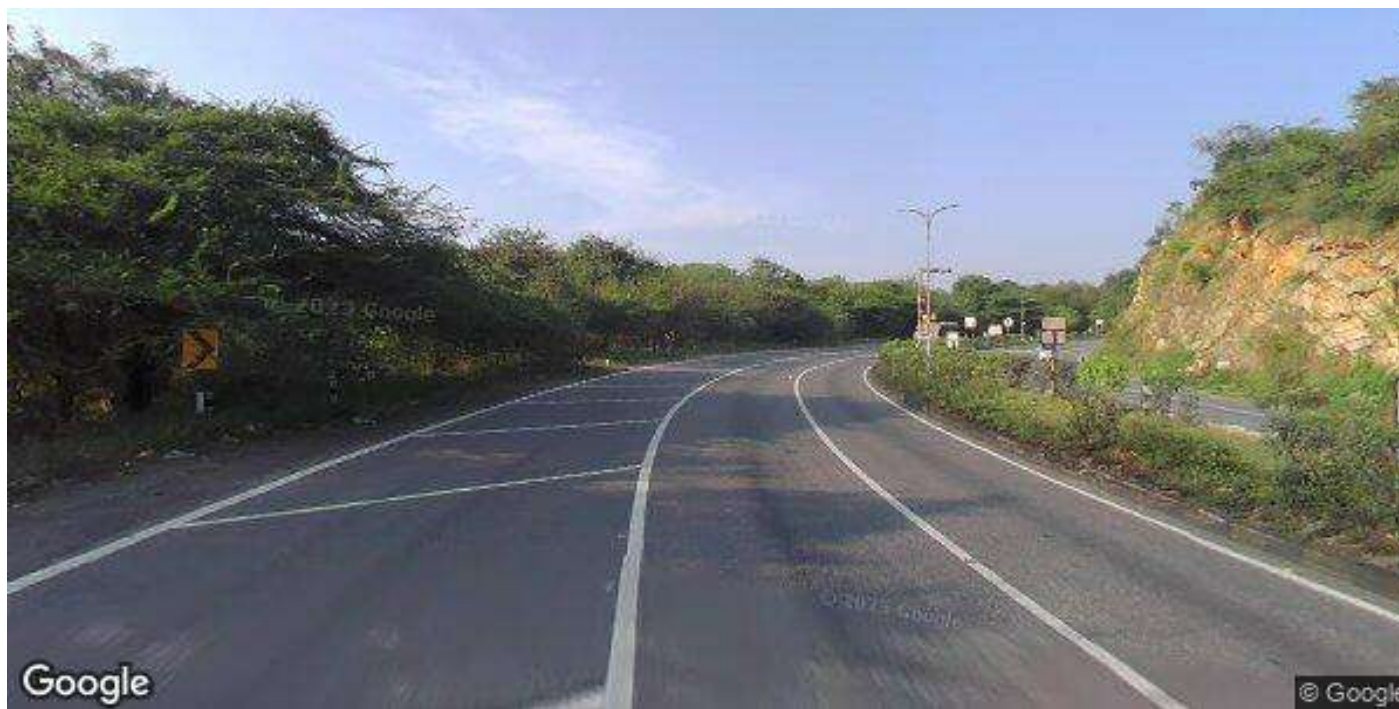
**Risk Type:** Turn  
**Risk Level:** High  
**Speed Limit:** 15 KM/Hr  
**Coordinates:** 11.96580, 78.04923

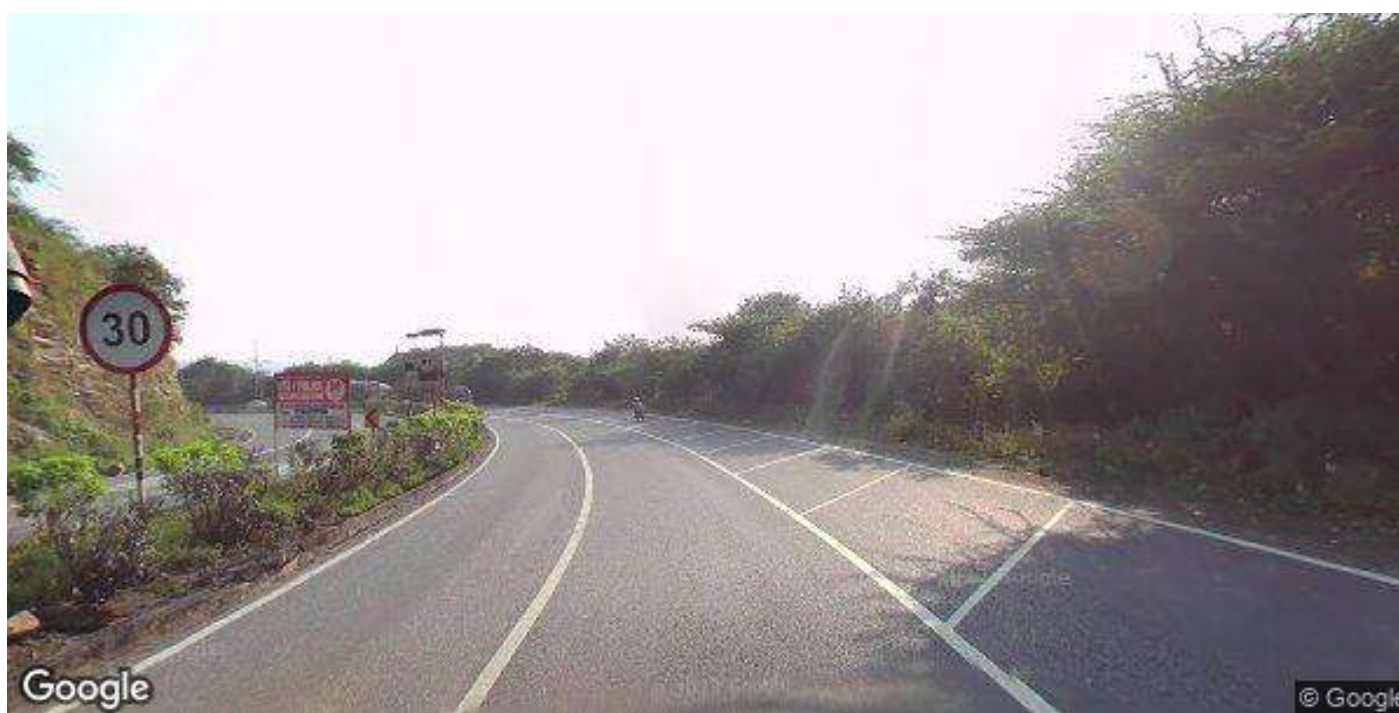
**Risk Type:** Turn  
**Risk Level:** Medium  
**Speed Limit:** 30 KM/Hr  
**Coordinates:** 11.96675, 78.04939

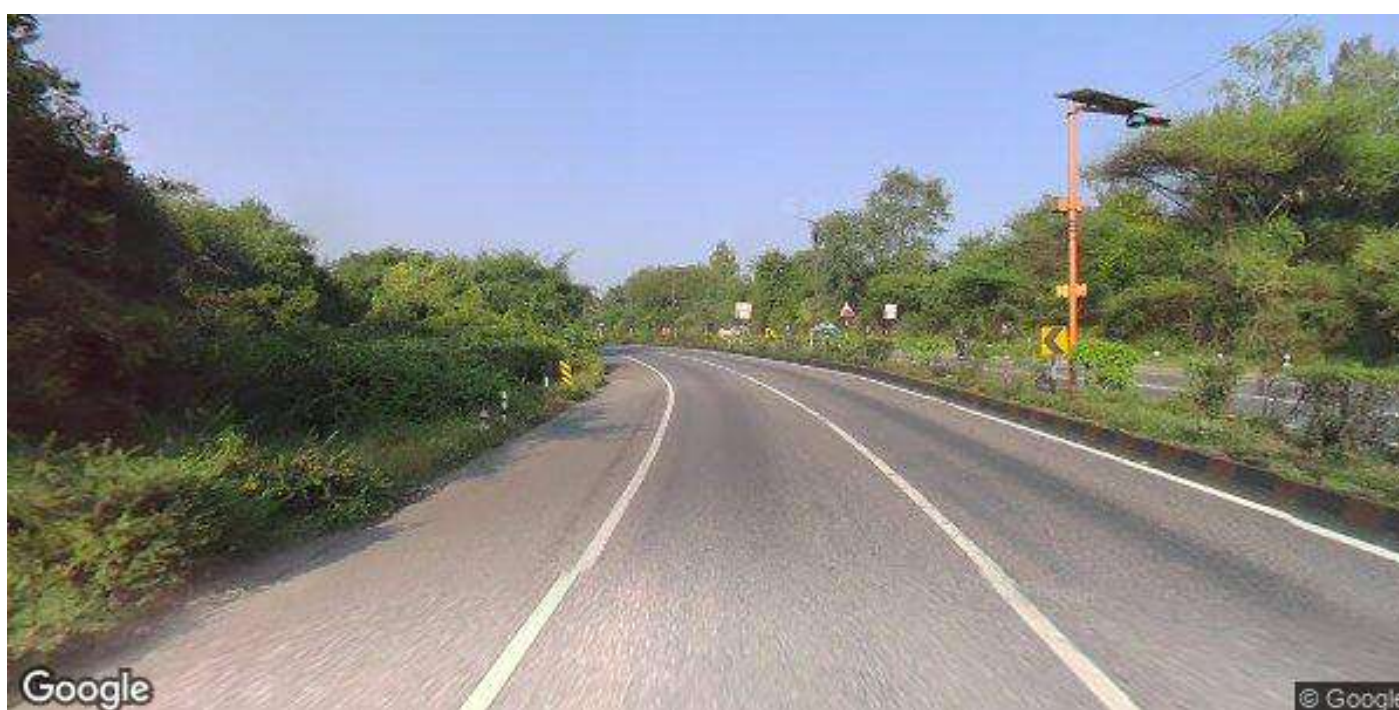
**Risk Type:** Turn  
**Risk Level:** Medium  
**Speed Limit:** 30 KM/Hr  
**Coordinates:** 11.96791, 78.05070

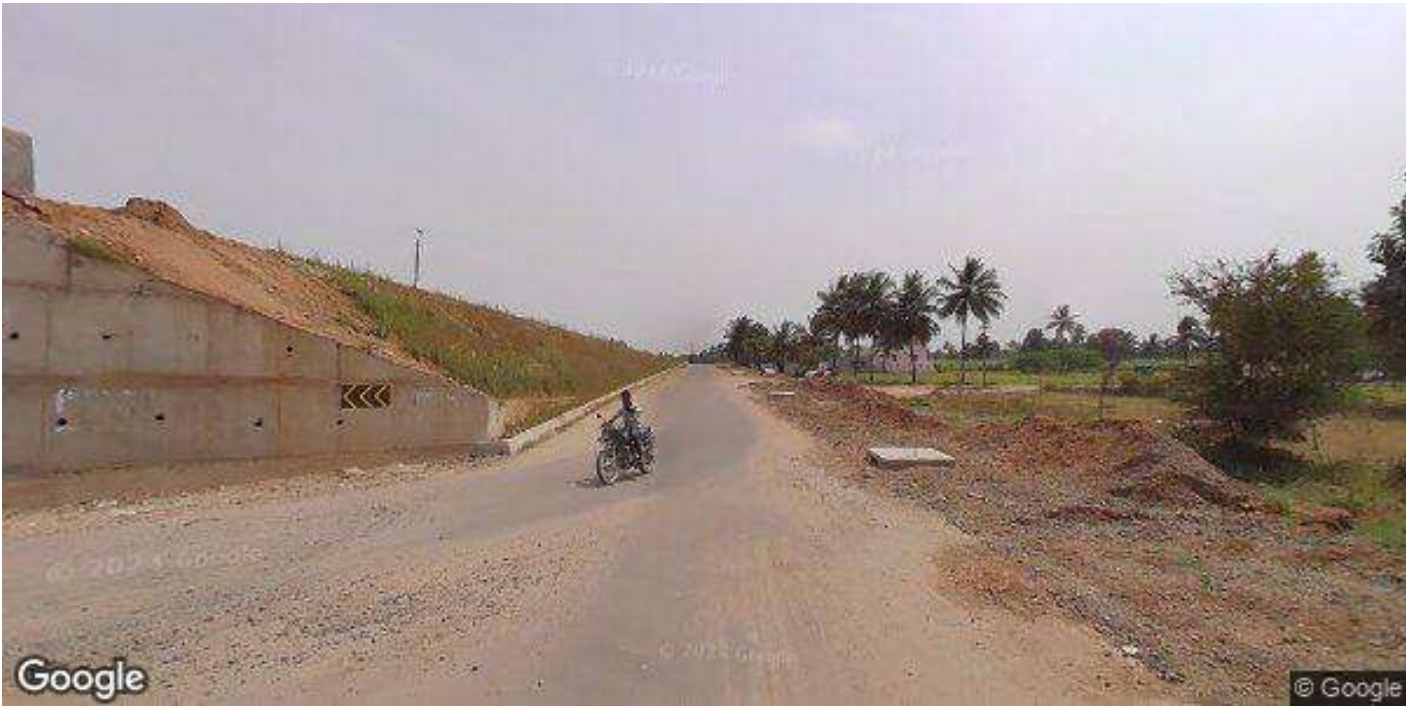
**Risk Type:** Turn  
**Risk Level:** High  
**Speed Limit:** 15 KM/Hr  
**Coordinates:** 12.26527, 78.08422

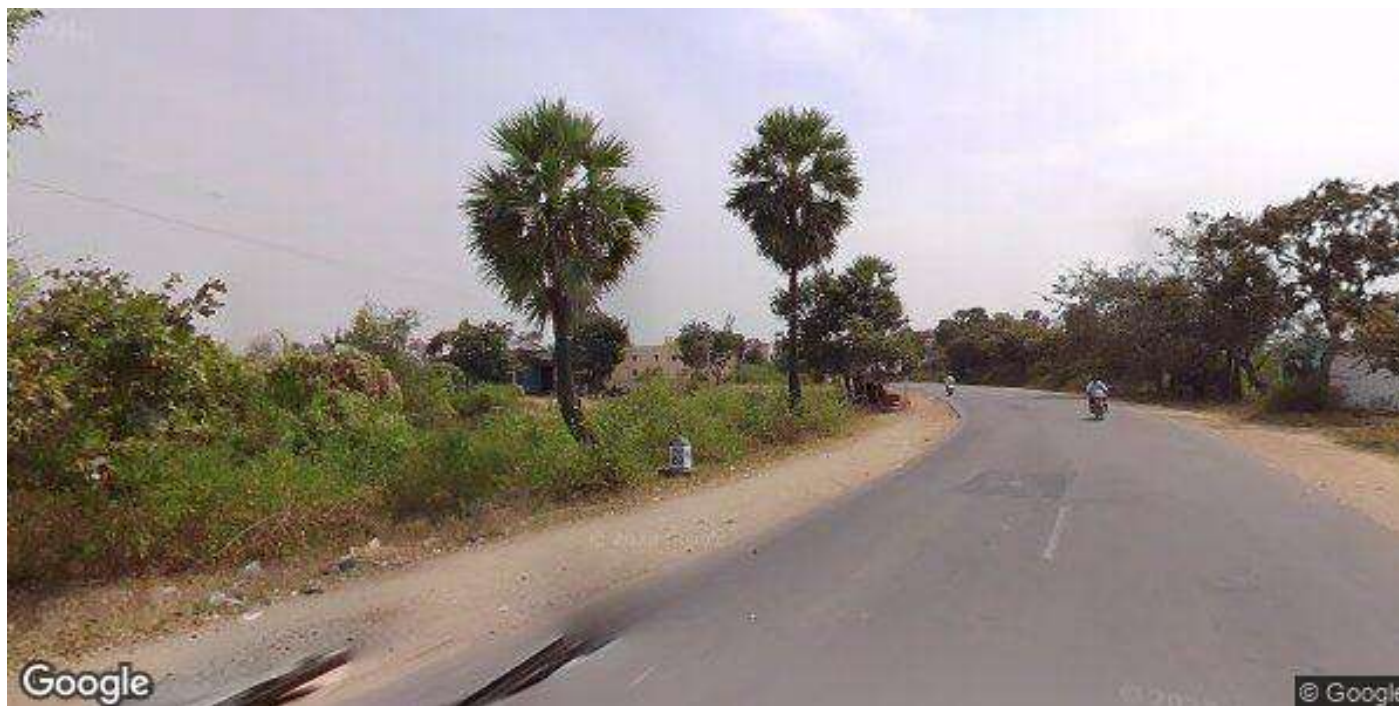
**Risk Type:** Turn  
**Risk Level:** Medium  
**Speed Limit:** 30 KM/Hr  
**Coordinates:** 12.27192, 78.08091

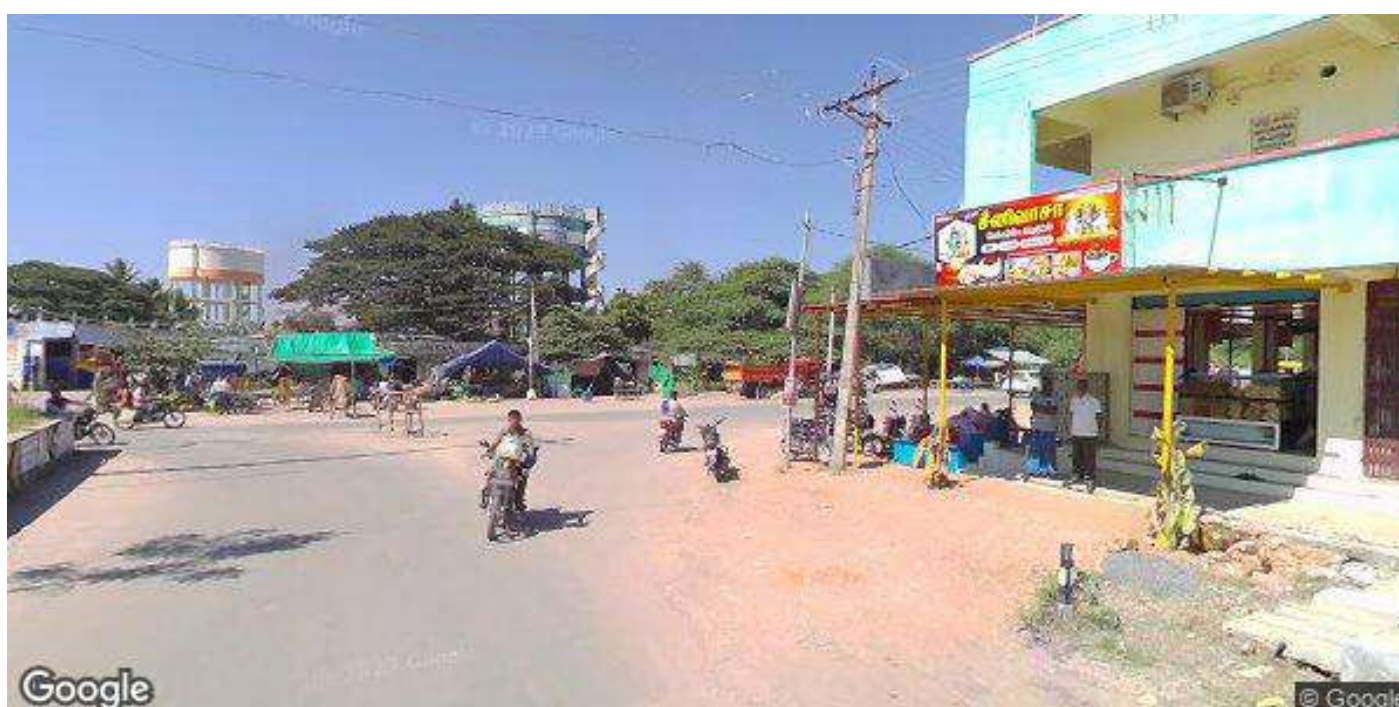
**Risk Type:** Turn  
**Risk Level:** High  
**Speed Limit:** 15 KM/Hr  
**Coordinates:** 12.29603, 78.07395

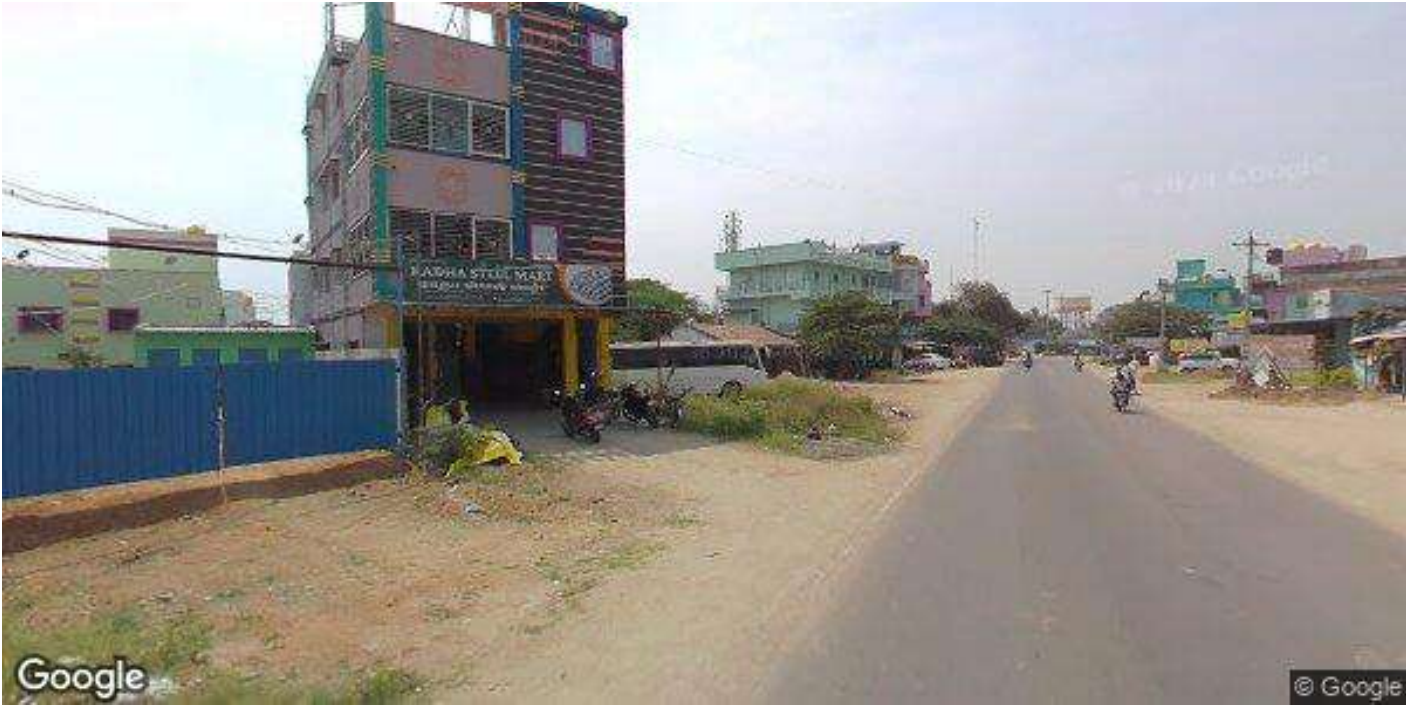
**Risk Type:** Turn  
**Risk Level:** Medium  
**Speed Limit:** 30 KM/Hr  
**Coordinates:** 12.29641, 78.07527

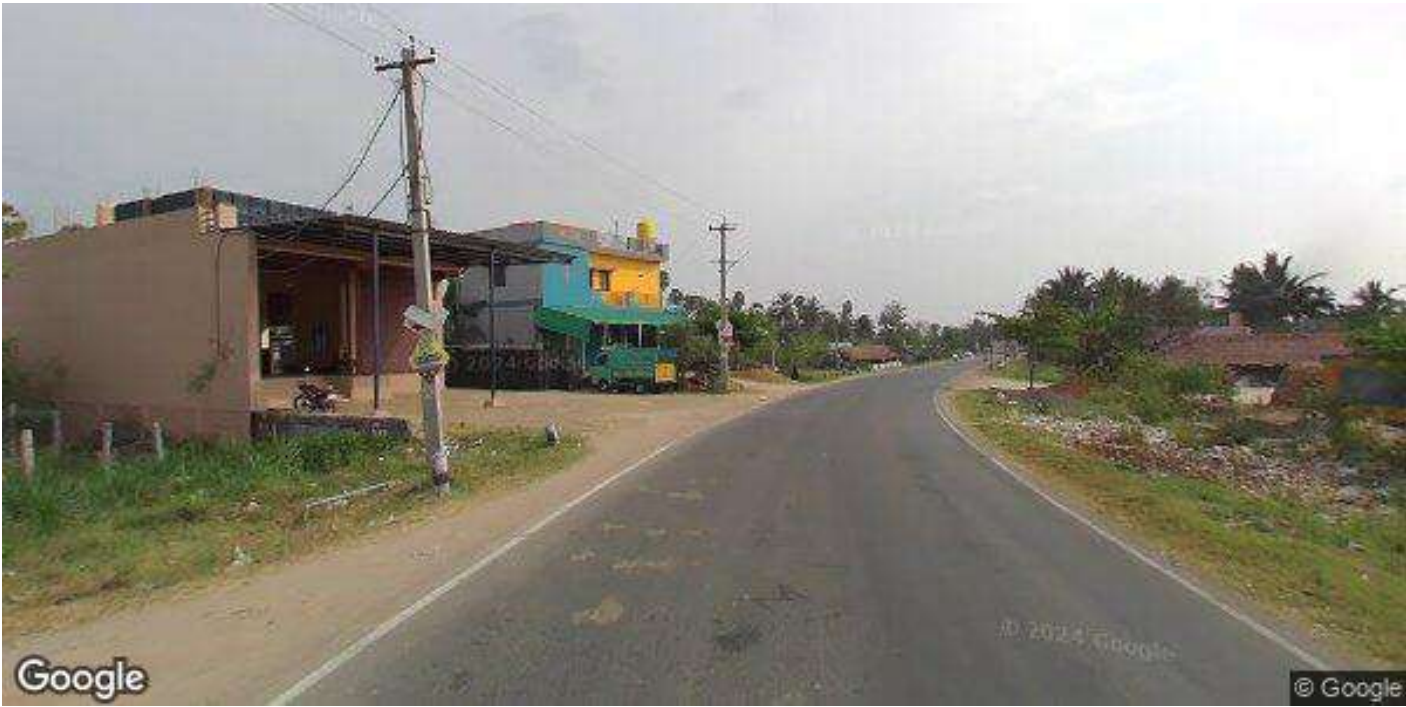
**Risk Type:** Turn  
**Risk Level:** Medium  
**Speed Limit:** 30 KM/Hr  
**Coordinates:** 12.31180, 78.07854

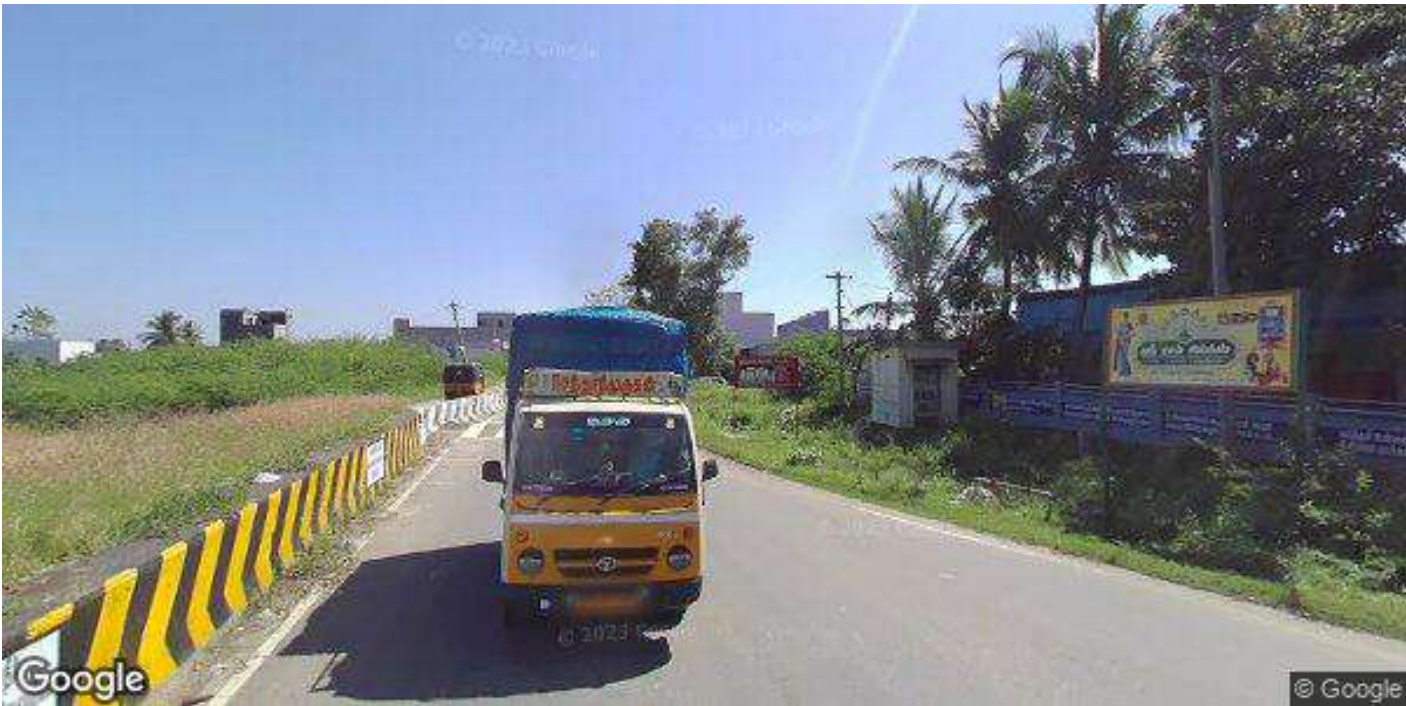
**Risk Type:** Blind Spot  
**Risk Level:** Blind Spot  
**Speed Limit:** 10 KM/Hr  
**Coordinates:** 12.31360, 78.07464

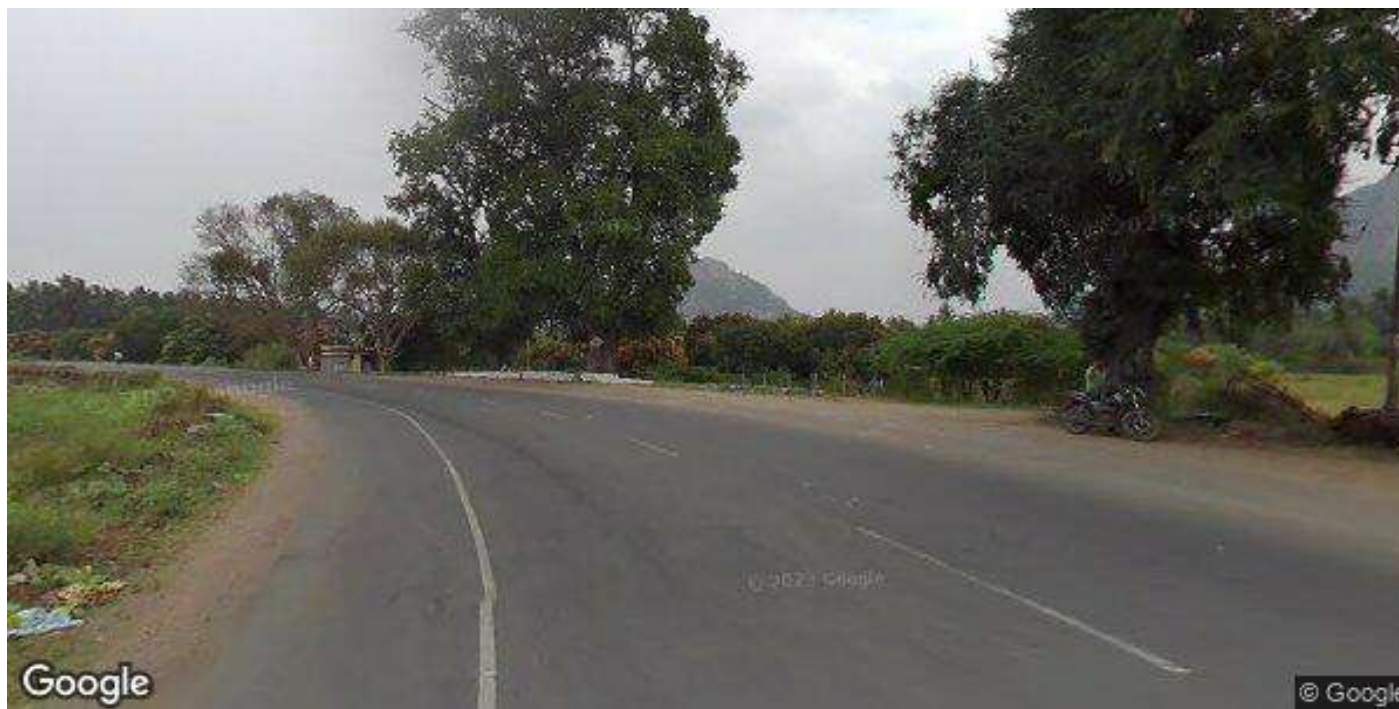
**Risk Type:** Turn  
**Risk Level:** Medium  
**Speed Limit:** 30 KM/Hr  
**Coordinates:** 12.37241, 78.08518

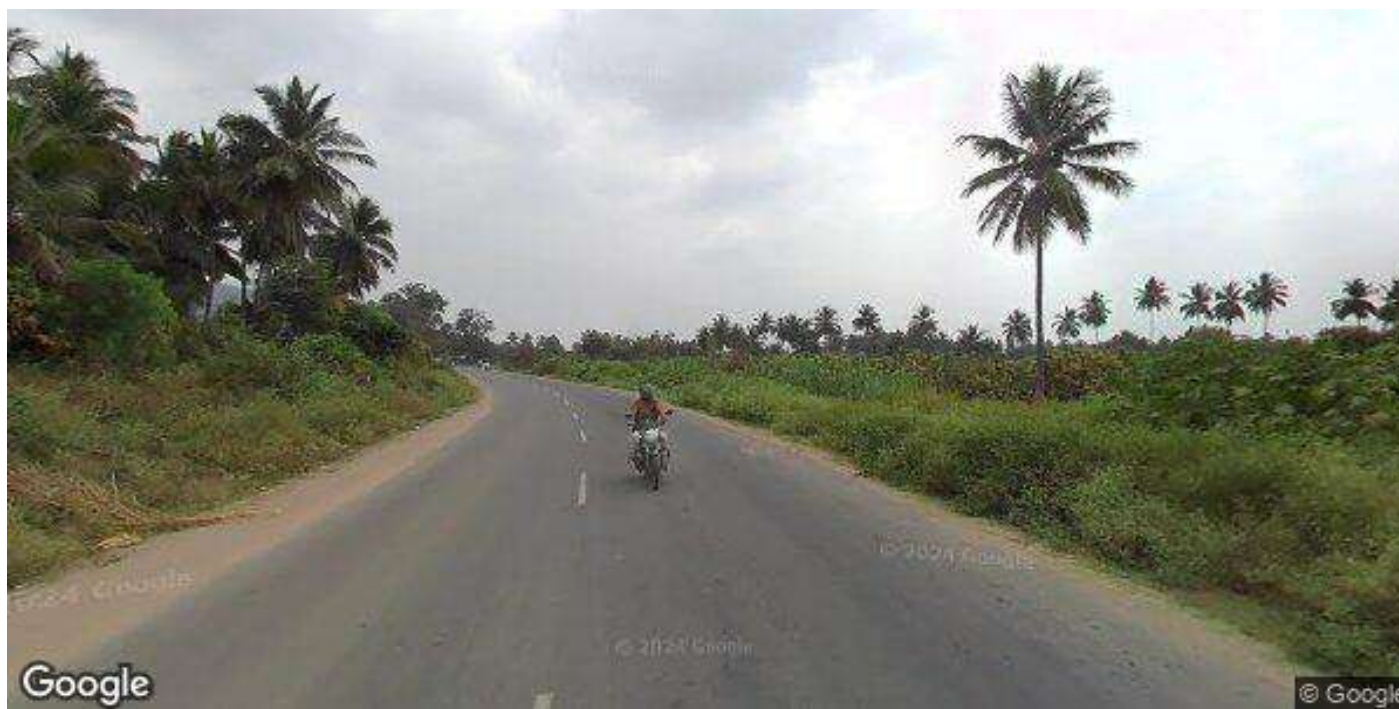
**Risk Type:** Turn  
**Risk Level:** Medium  
**Speed Limit:** 30 KM/Hr  
**Coordinates:** 12.37470, 78.08379

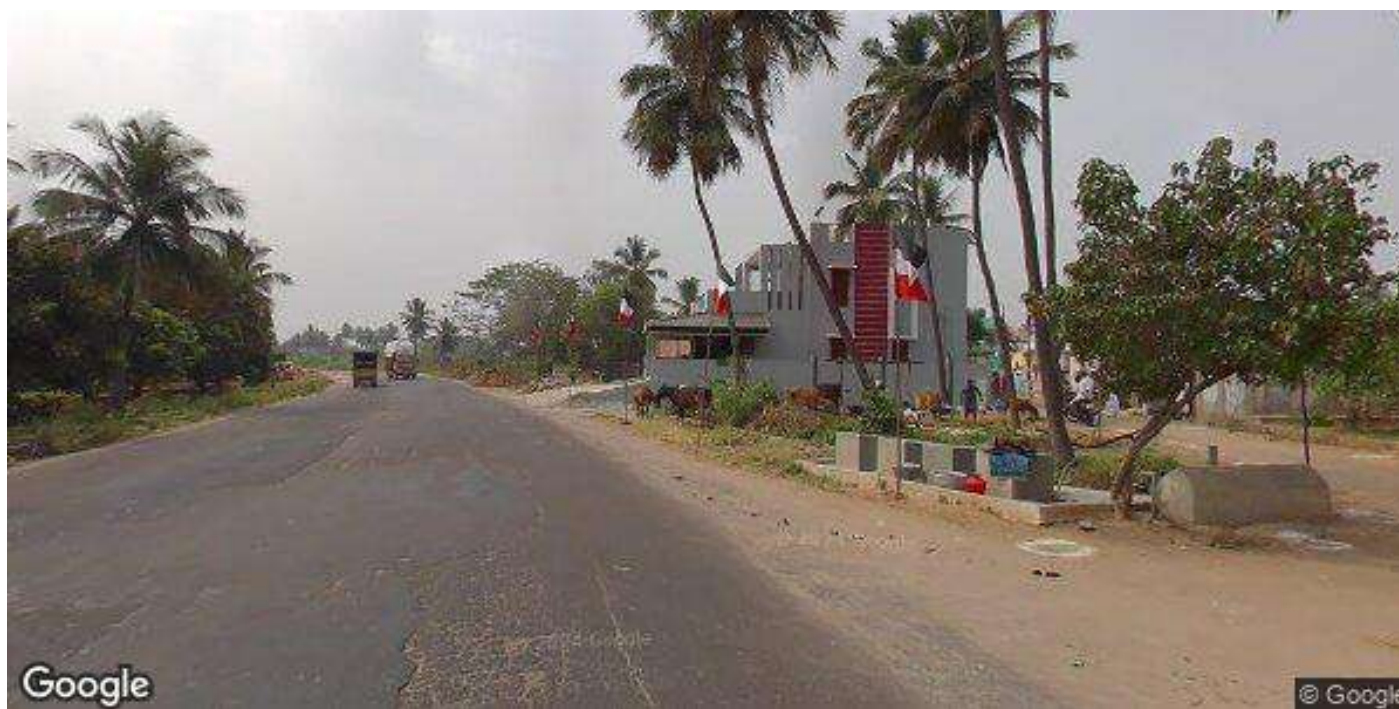
**Risk Type:** Turn  
**Risk Level:** Medium  
**Speed Limit:** 30 KM/Hr  
**Coordinates:** 12.37573, 78.08362

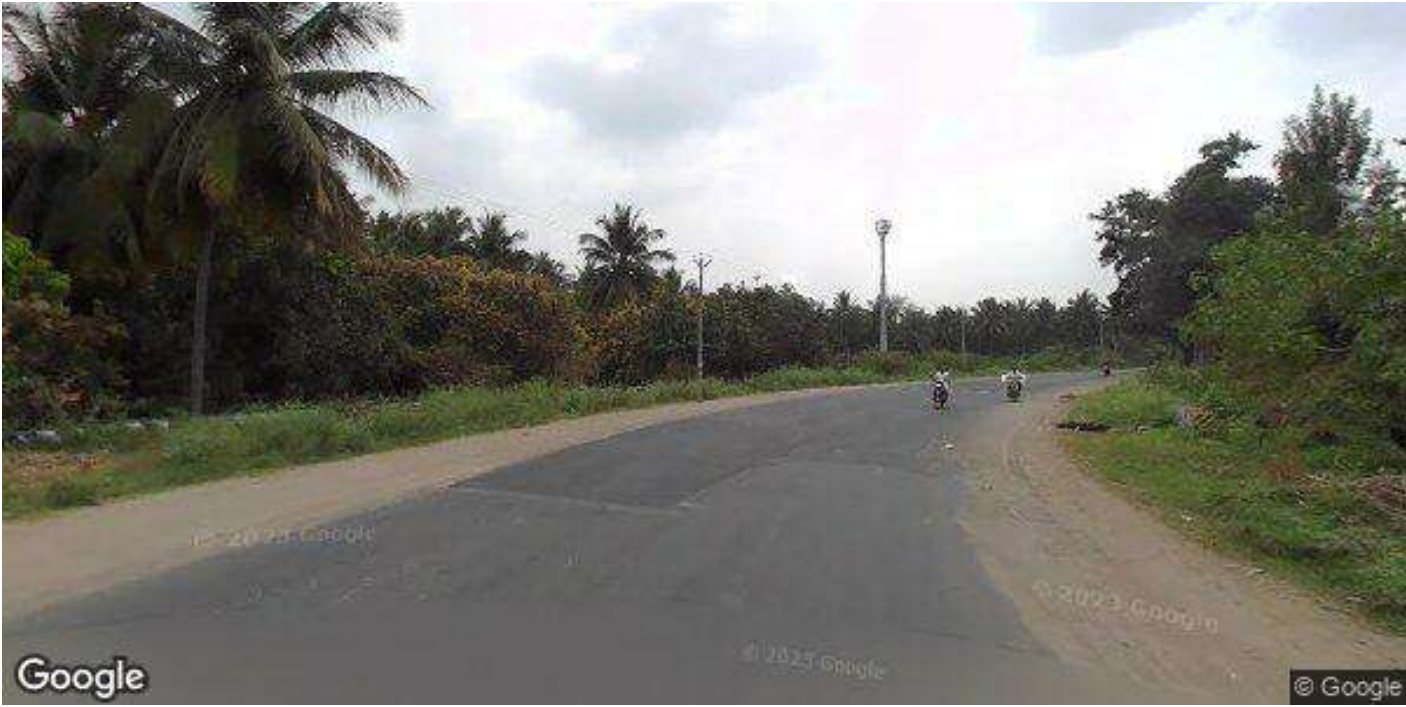
**Risk Type:** Turn  
**Risk Level:** High  
**Speed Limit:** 15 KM/Hr  
**Coordinates:** 12.37820, 78.08522

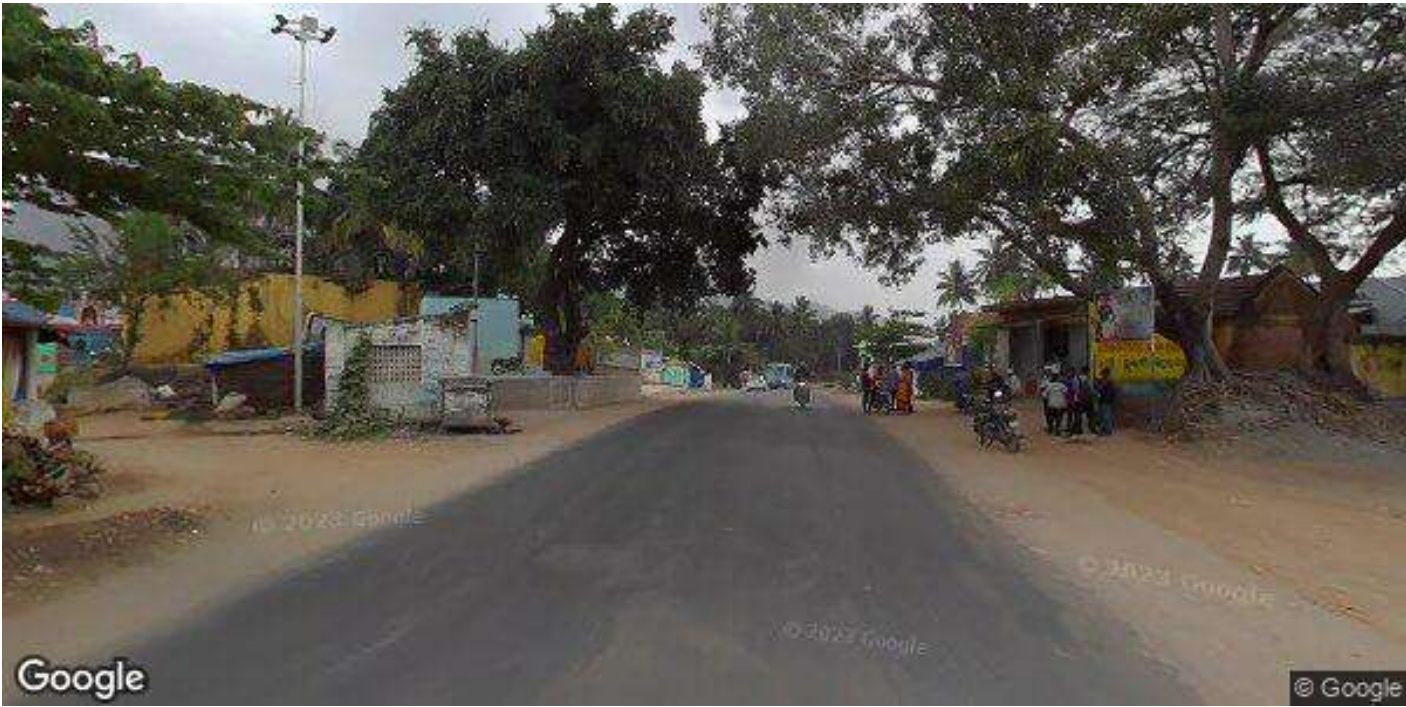
**Risk Type:** Turn  
**Risk Level:** Medium  
**Speed Limit:** 30 KM/Hr  
**Coordinates:** 12.37945, 78.08449

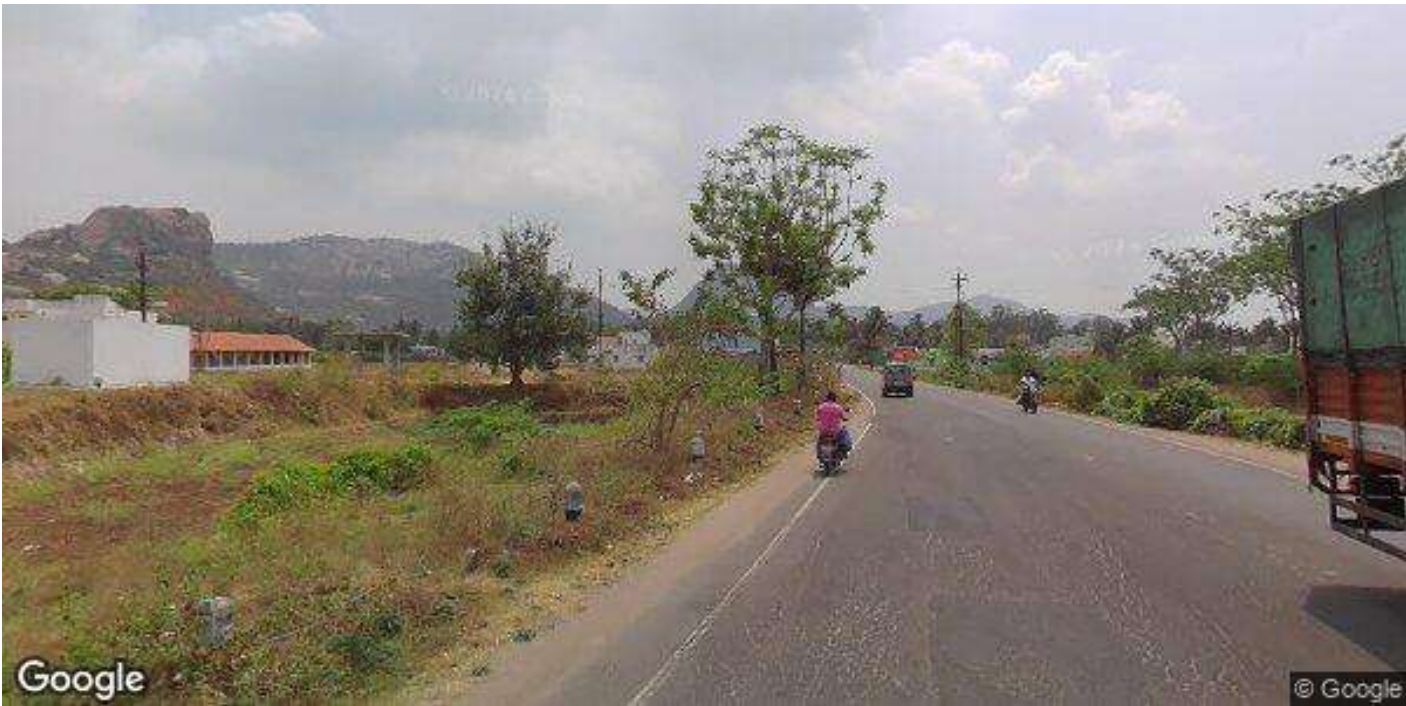
**Risk Type:** Turn  
**Risk Level:** Medium  
**Speed Limit:** 30 KM/Hr  
**Coordinates:** 12.38653, 78.07520

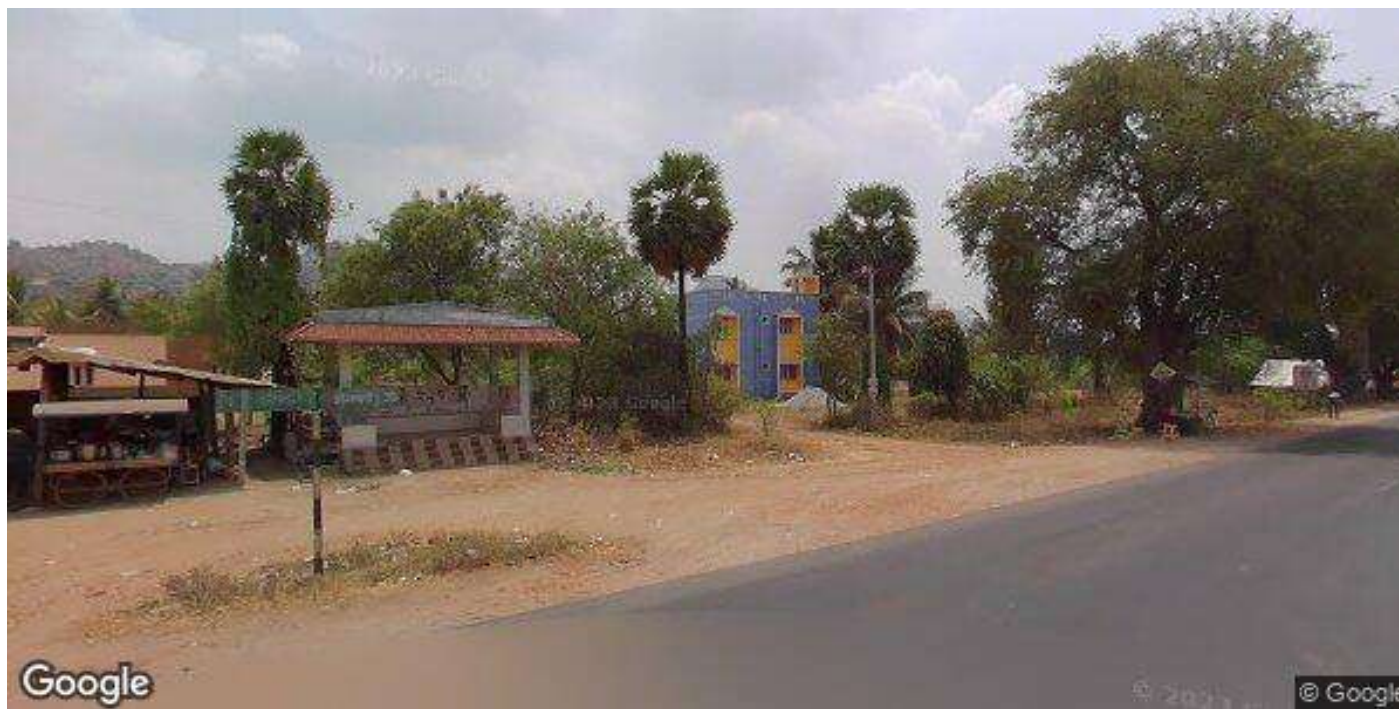
**Risk Type:** Turn  
**Risk Level:** High  
**Speed Limit:** 15 KM/Hr  
**Coordinates:** 12.38868, 78.07430

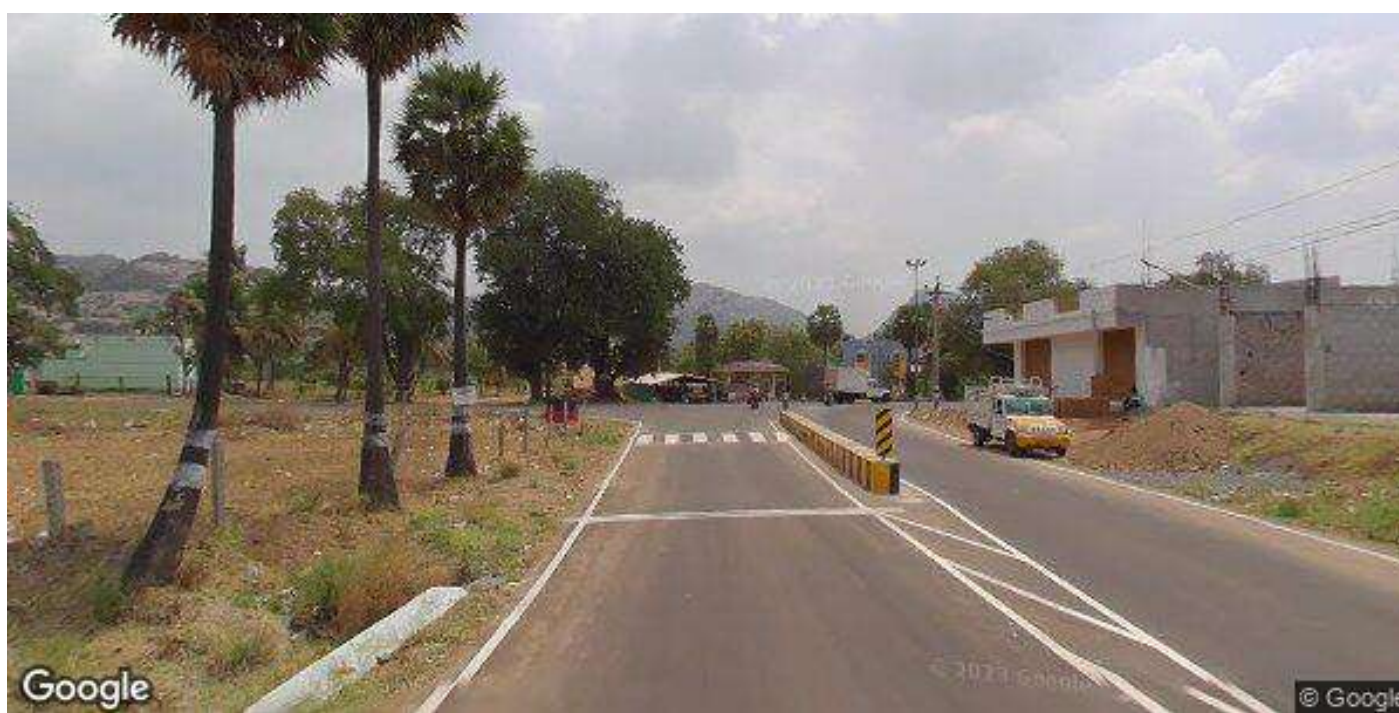
**Risk Type:** Turn  
**Risk Level:** High  
**Speed Limit:** 15 KM/Hr  
**Coordinates:** 12.38878, 78.07386
