# IndianOil

## JOURNEY RISK MANAGEMENT (JRM) STUDY

### Salem Terminal to SRI UDAYAGIRI FUELS KSK

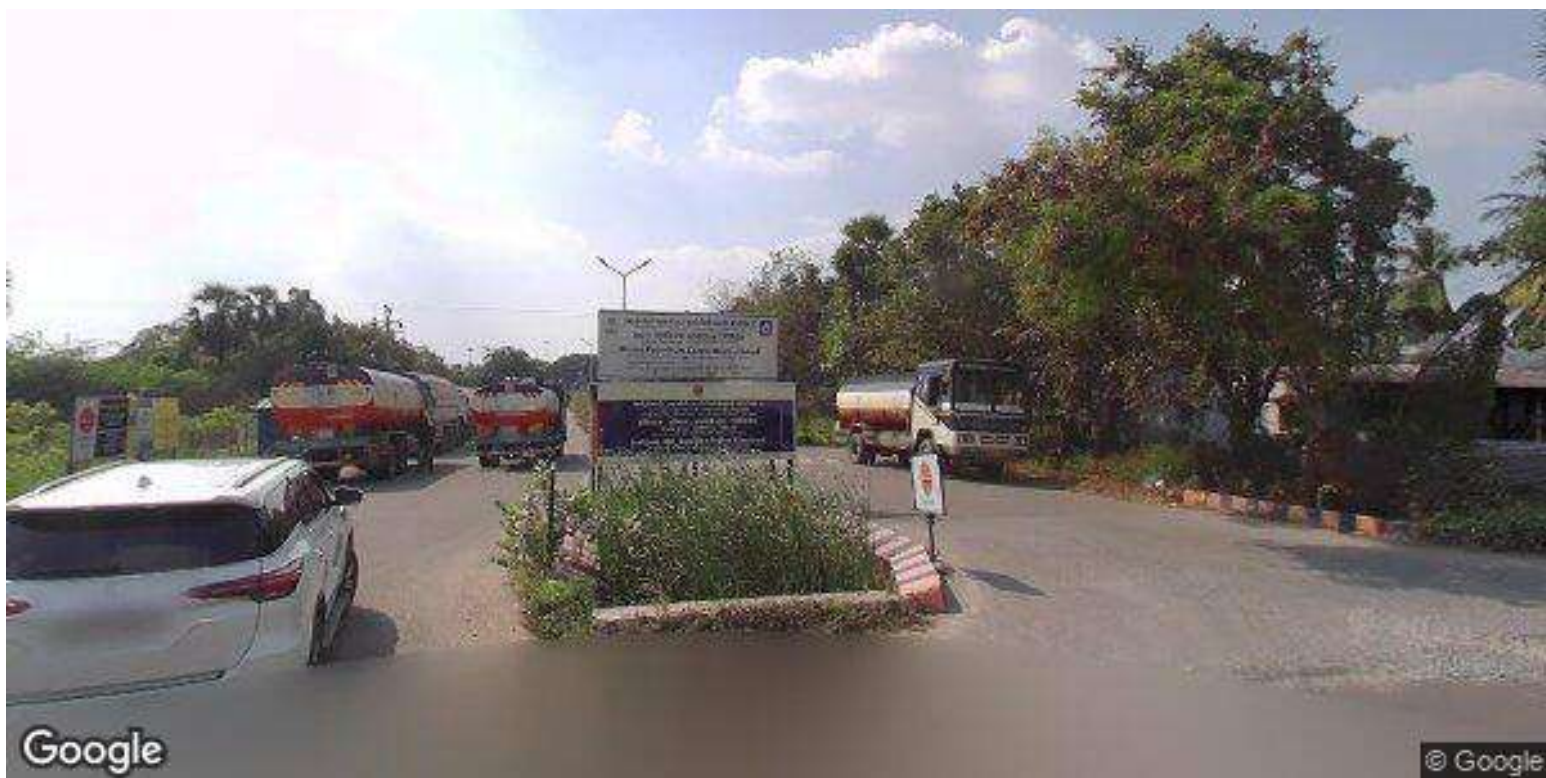
**Coordinates:** 11.44024, 77.87528

**Risk Type:** Turn

**Risk Level:** High

**Speed Limit:** 15 KM/Hr

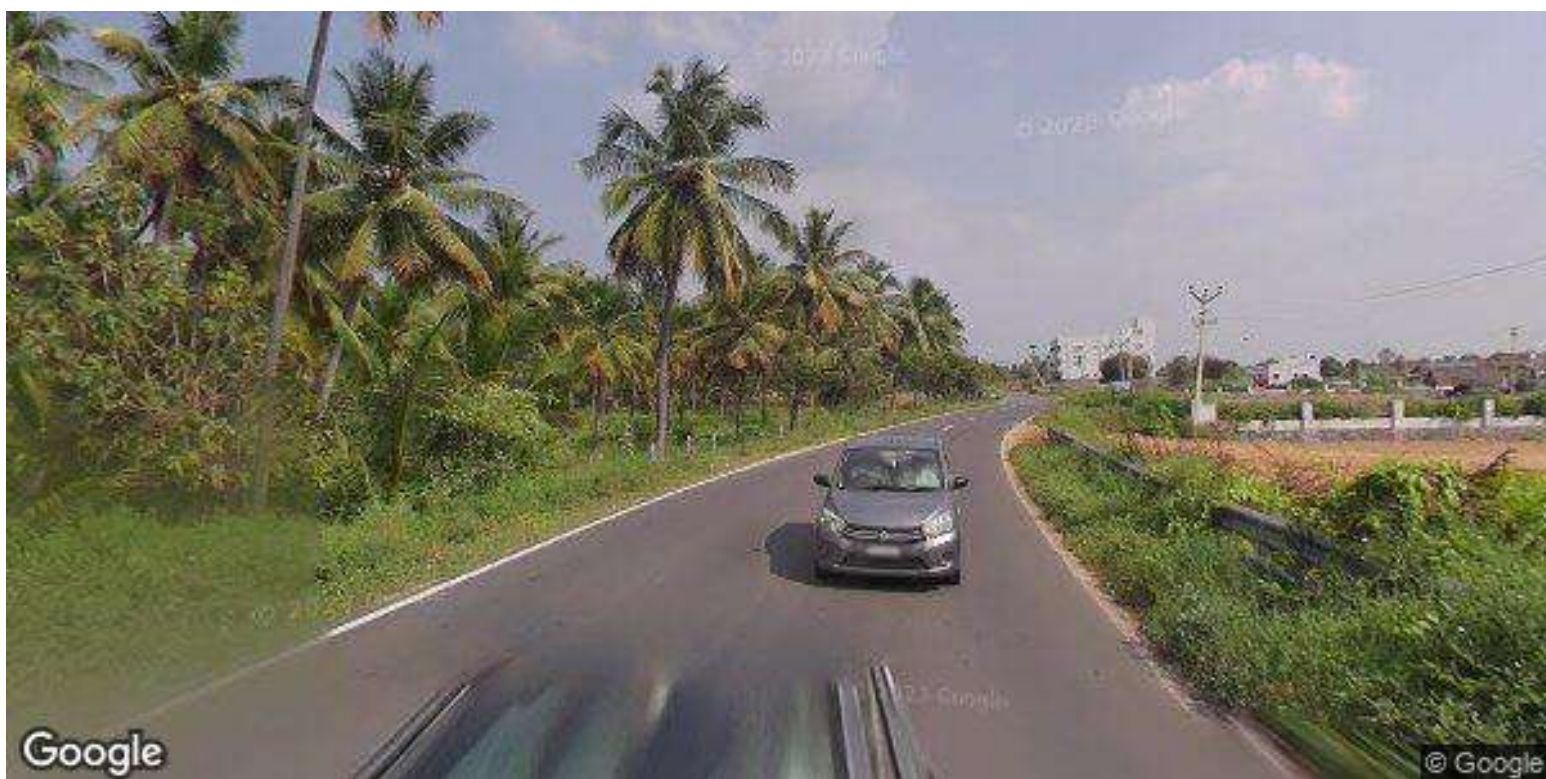
**Coordinates:** 11.45357, 77.85789

**Risk Type:** Turn

**Risk Level:** Medium

**Speed Limit:** 30 KM/Hr

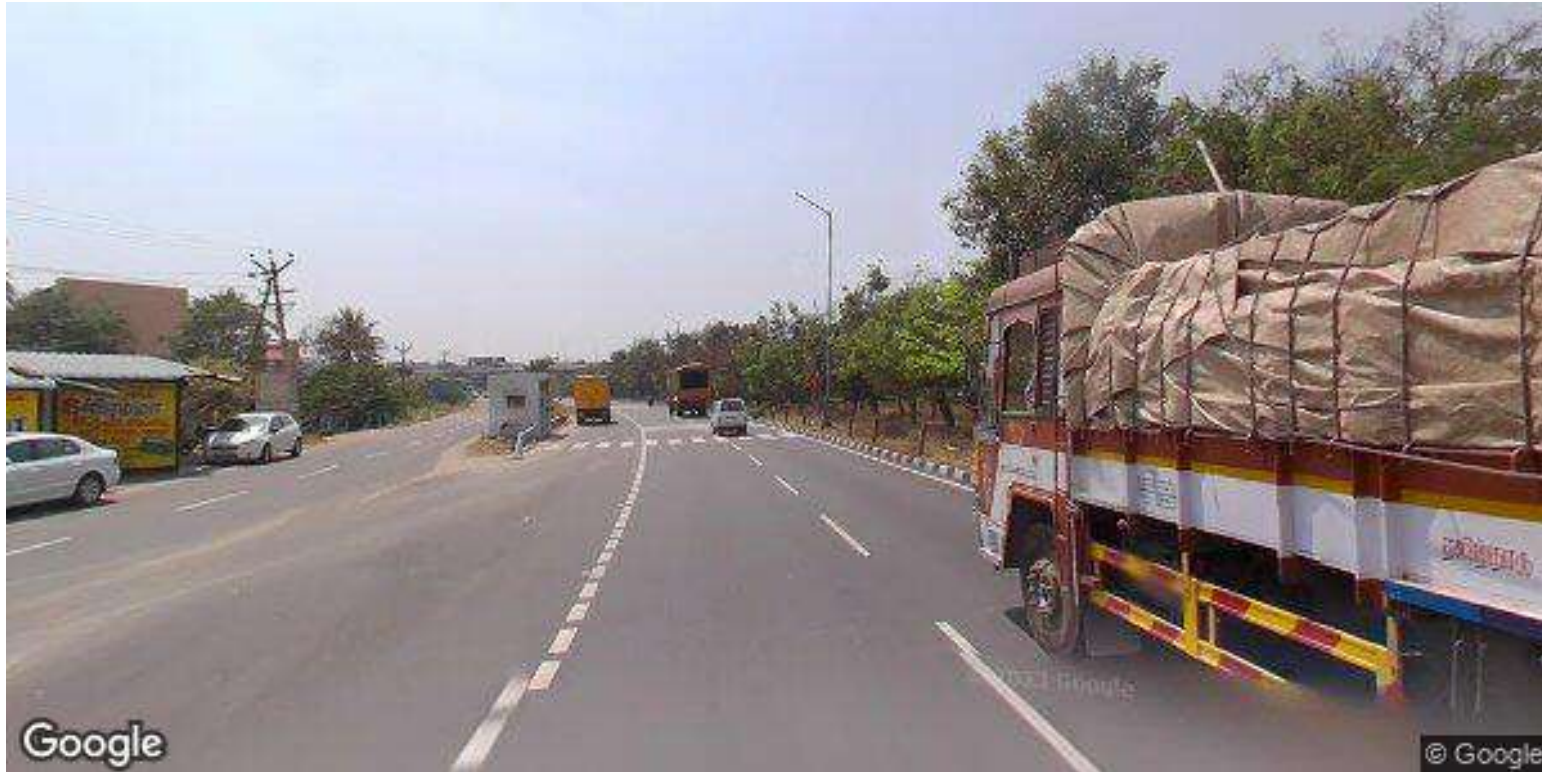
**Risk Type:** Turn  
**Risk Level:** Medium  
**Speed Limit:** 30 KM/Hr  
**Coordinates:** 11.43165, 77.67734

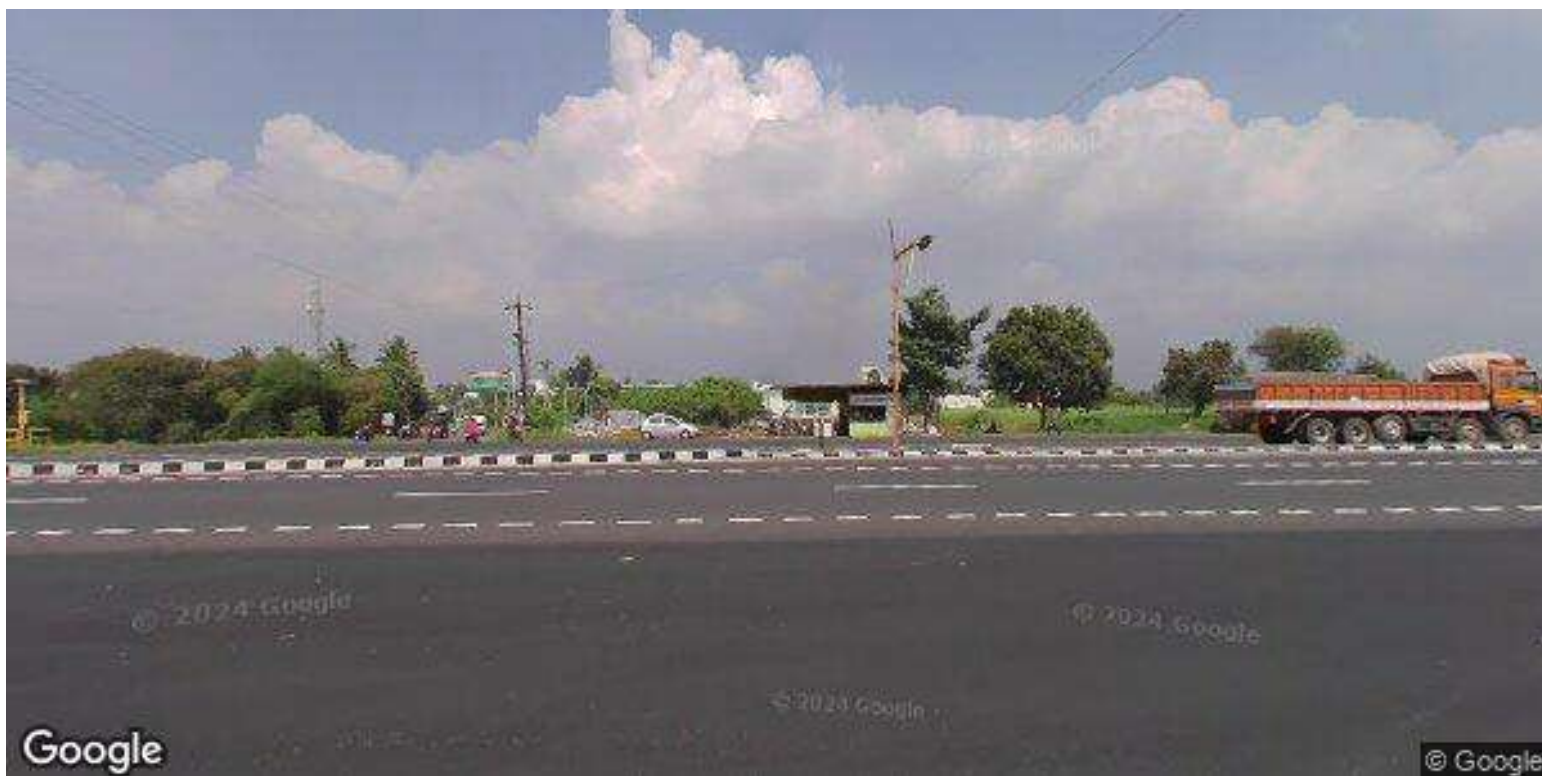
**Risk Type:** Blind Spot  
**Risk Level:** Blind Spot  
**Speed Limit:** 10 KM/Hr  
**Coordinates:** 11.28888, 77.56550

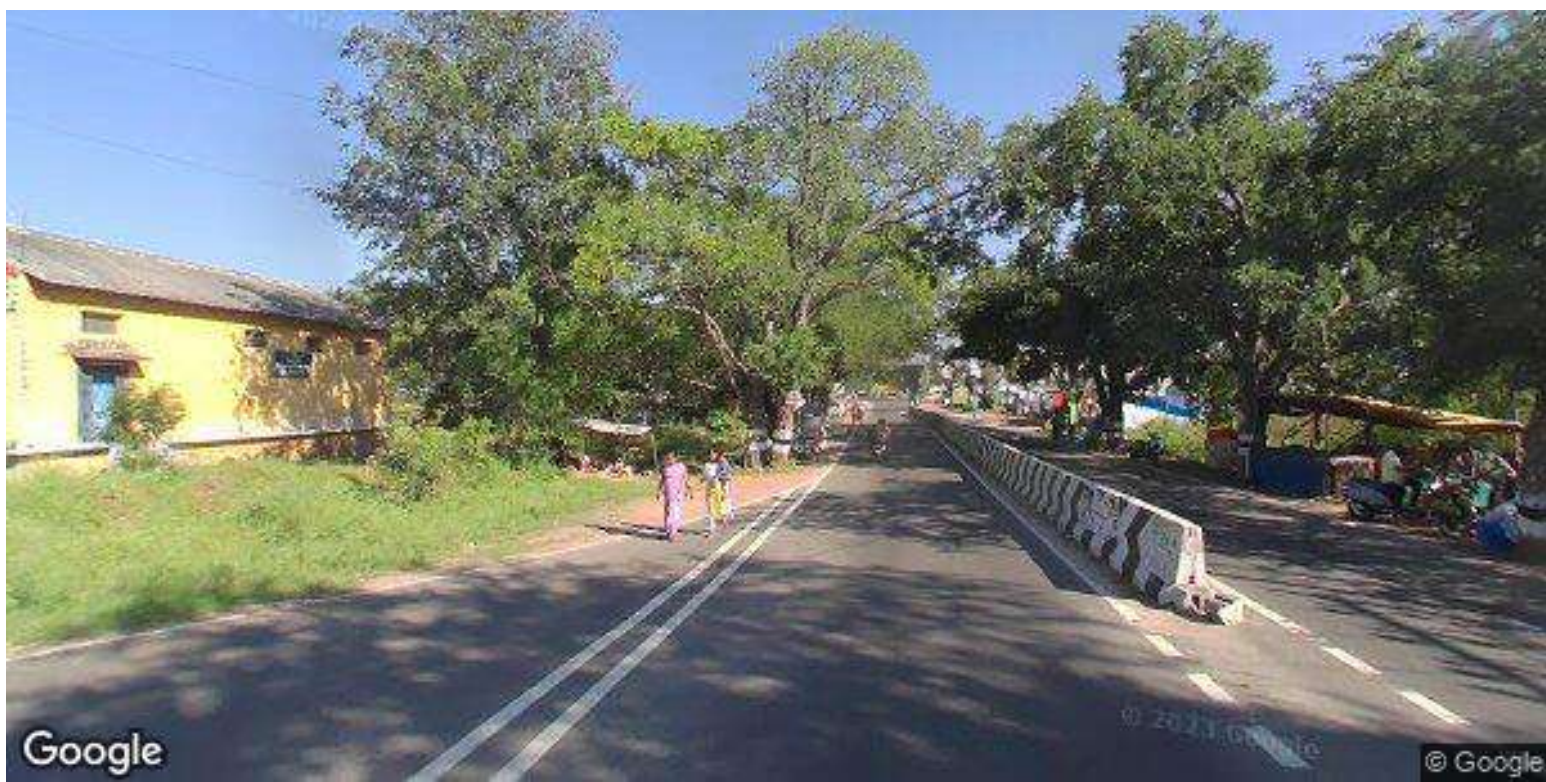
**Risk Type:** Blind Spot  
**Risk Level:** Blind Spot  
**Speed Limit:** 10 KM/Hr  
**Coordinates:** 11.28189, 77.56929

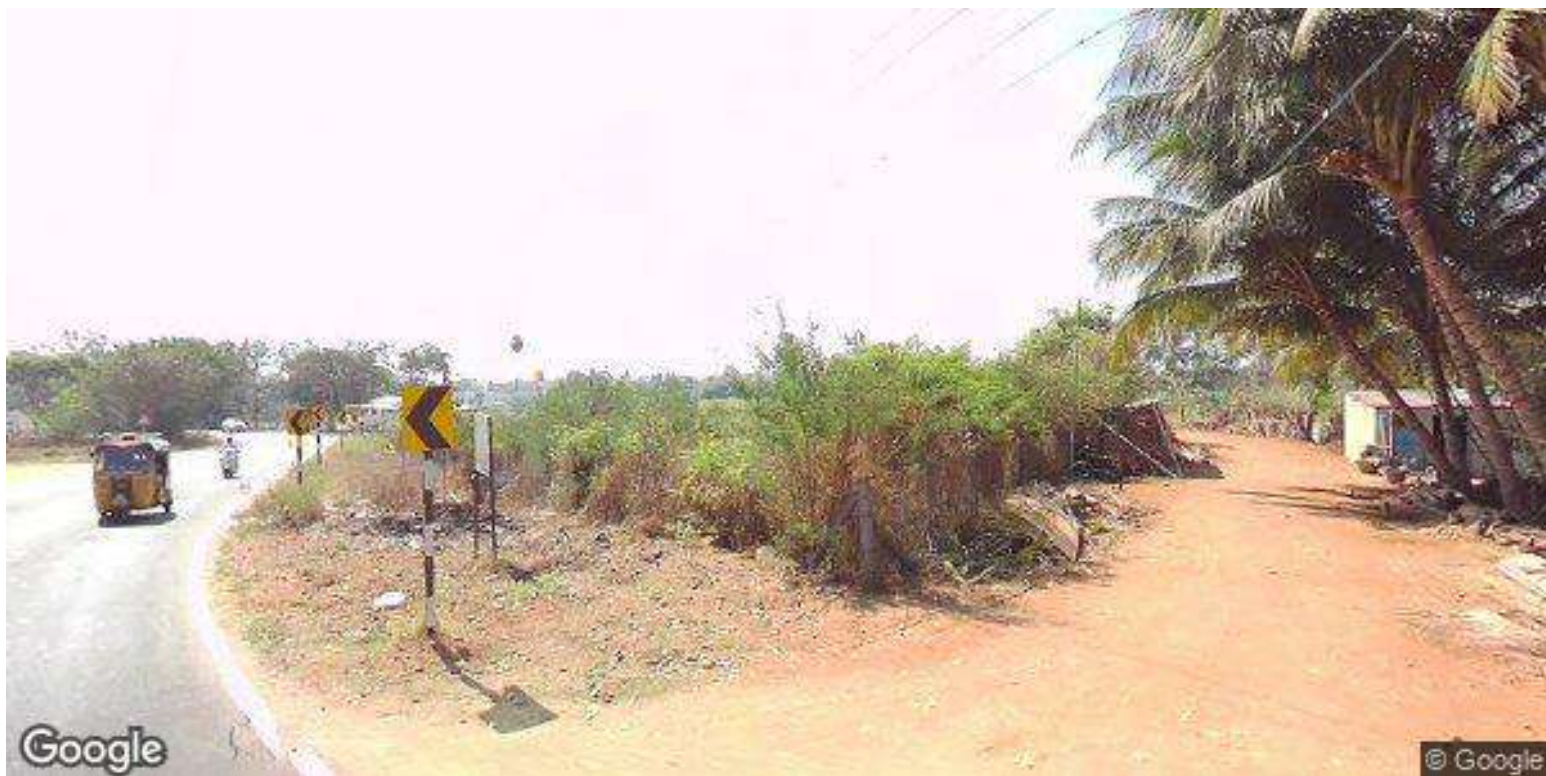
**Risk Type:** Turn  
**Risk Level:** Medium  
**Speed Limit:** 30 KM/Hr  
**Coordinates:** 11.29281, 77.53814

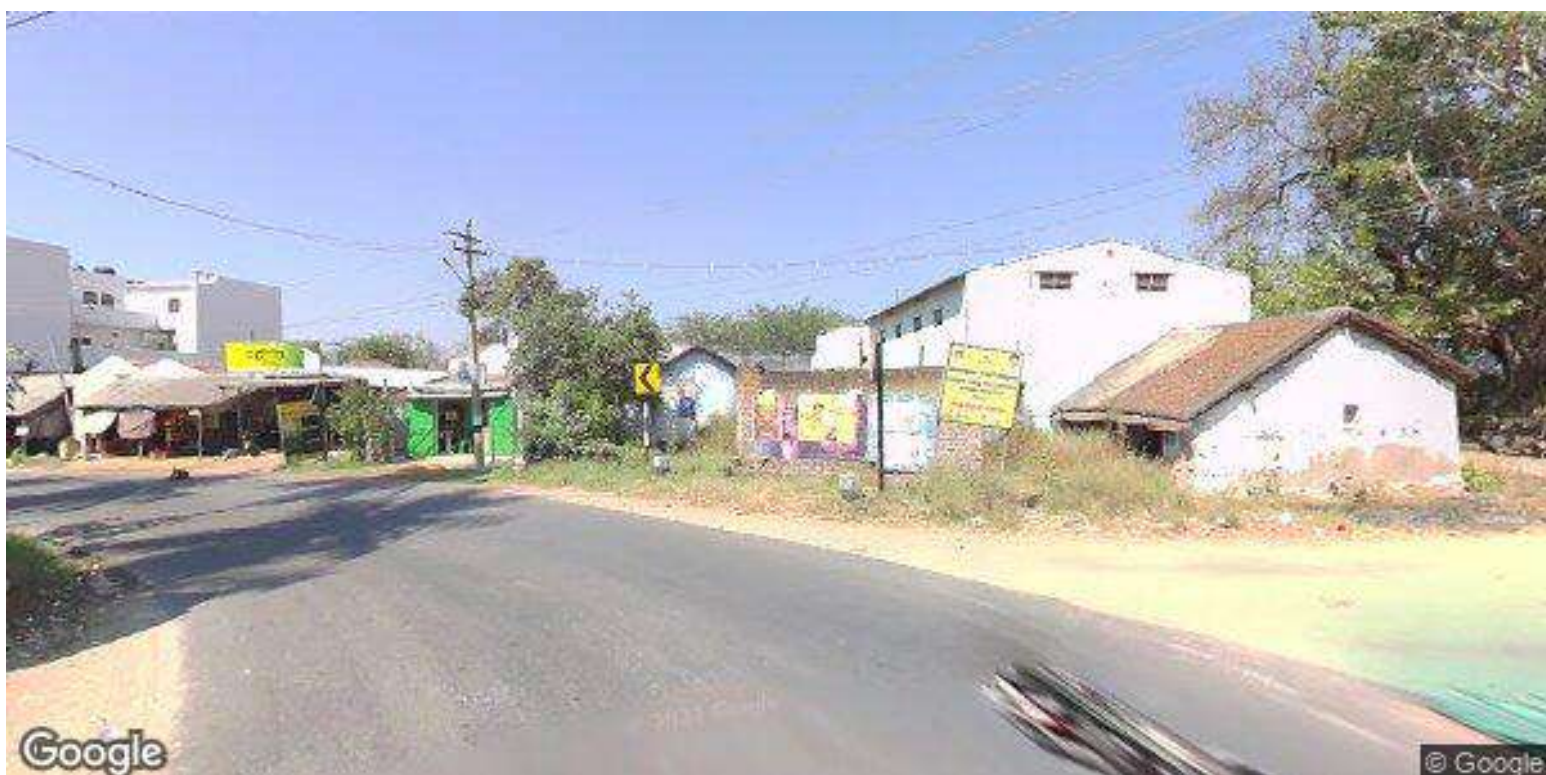
**Coordinates:** 11.29251, 77.53037

**Risk Type:** Turn

**Risk Level:** High

**Speed Limit:** 15 KM/Hr

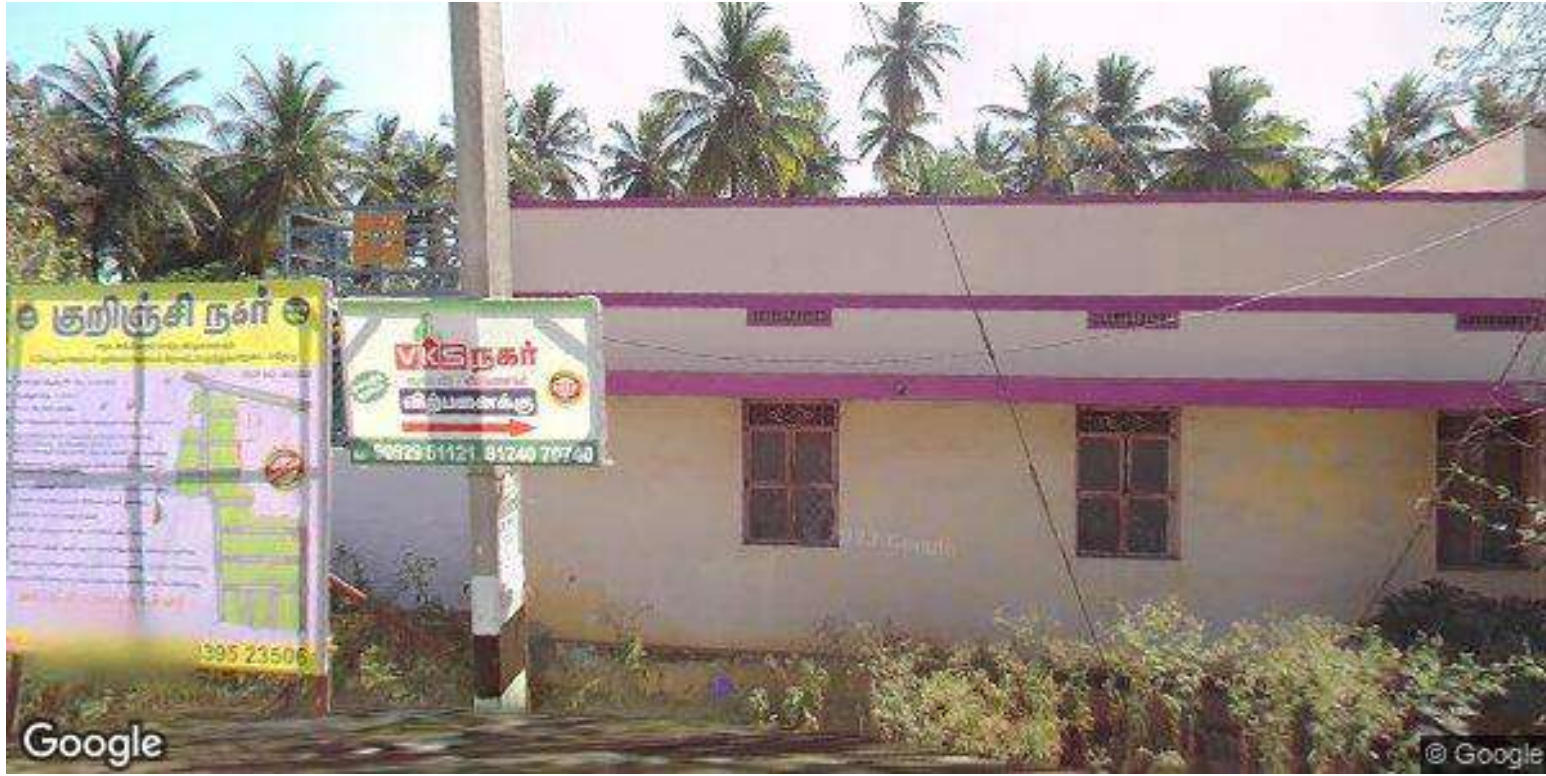
**Coordinates:** 11.29192, 77.52990

**Risk Type:** Turn

**Risk Level:** Medium

**Speed Limit:** 30 KM/Hr

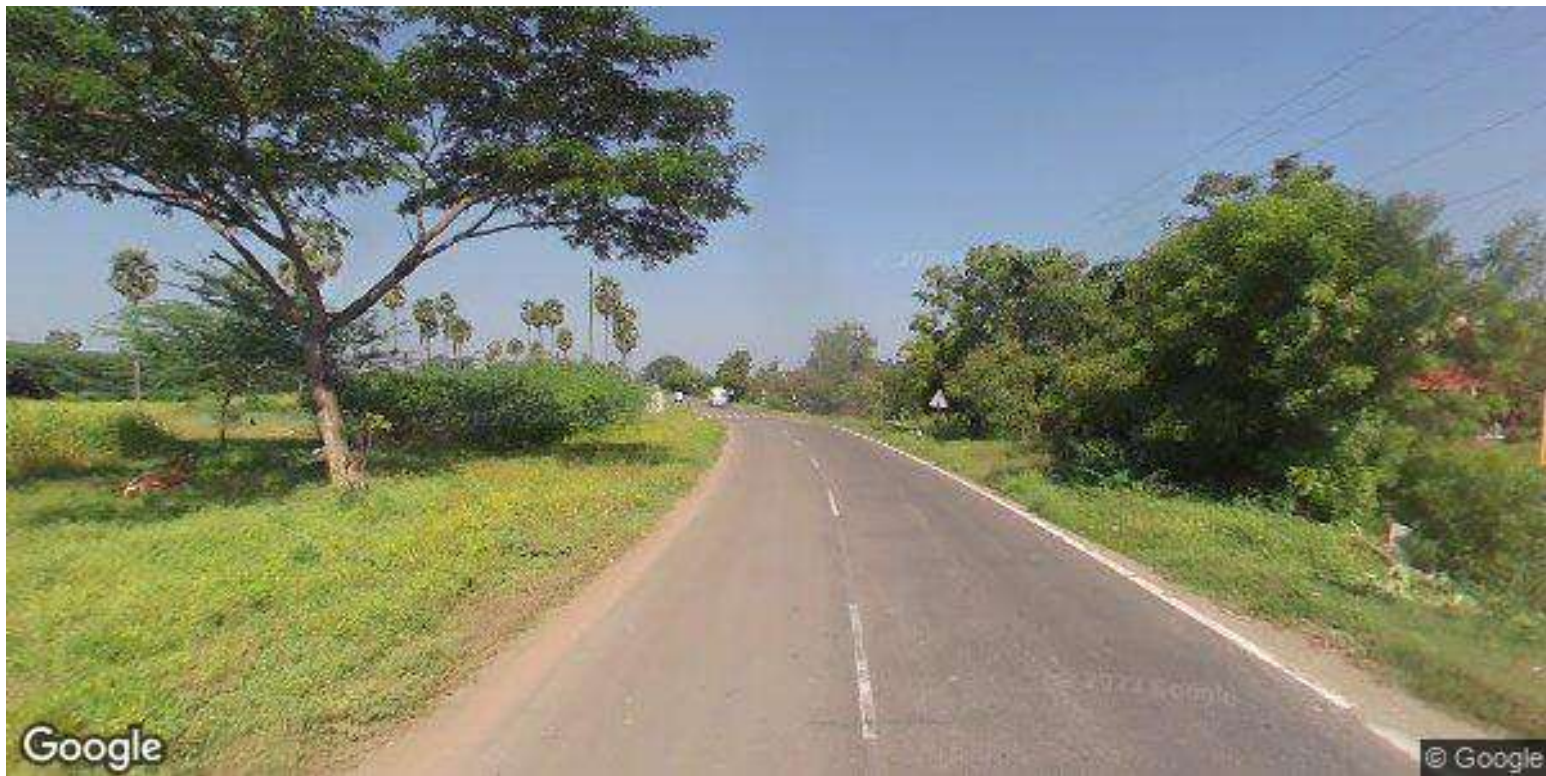
**Coordinates:** 11.27393, 77.42230

**Risk Type:** Turn

**Risk Level:** Medium

**Speed Limit:** 30 KM/Hr

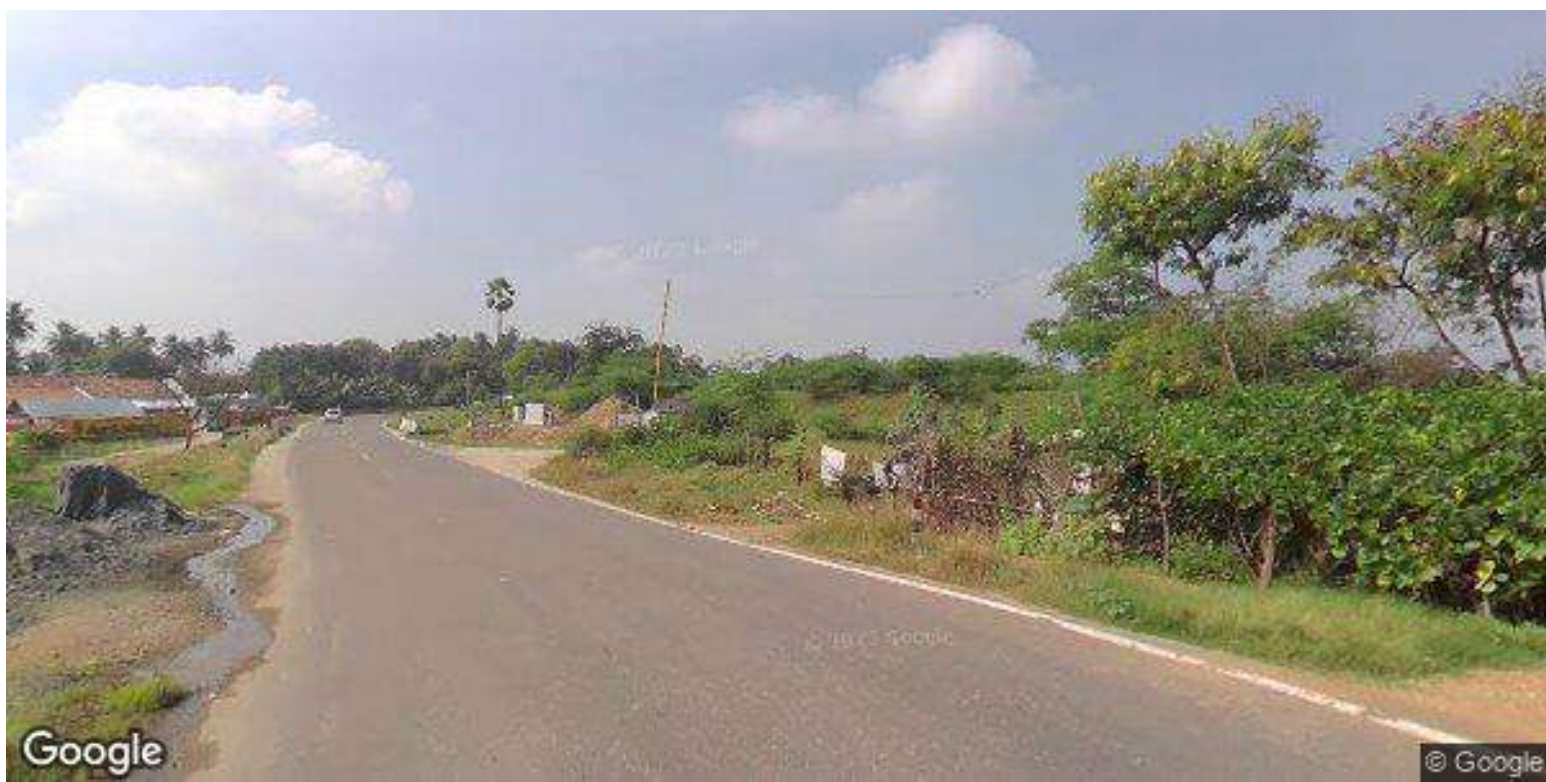
**Coordinates:** 11.27378, 77.41973

**Risk Type:** Turn

**Risk Level:** Medium

**Speed Limit:** 30 KM/Hr

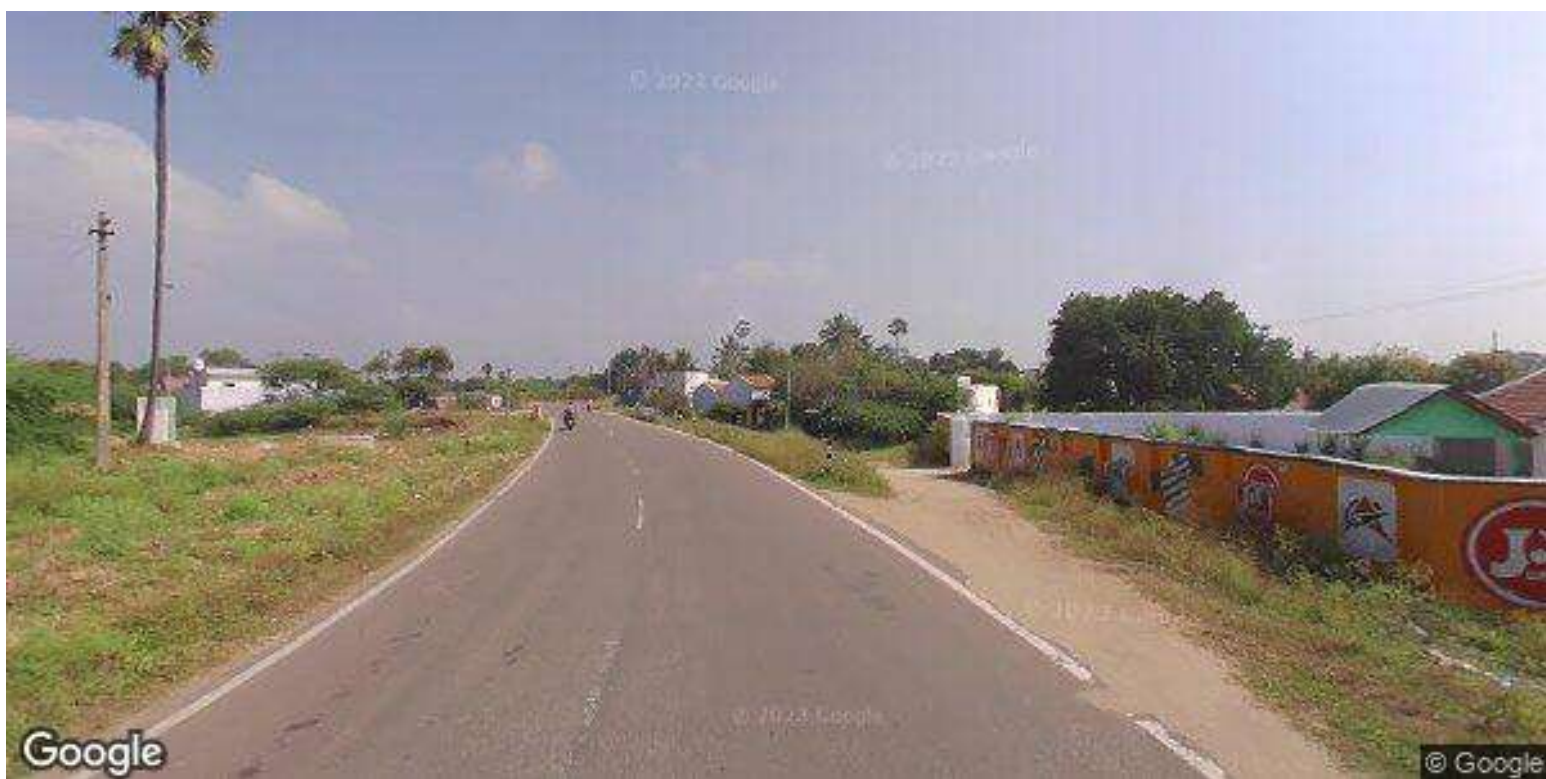
**Coordinates:** 11.27288, 77.41914

**Risk Type:** Turn

**Risk Level:** Medium

**Speed Limit:** 30 KM/Hr

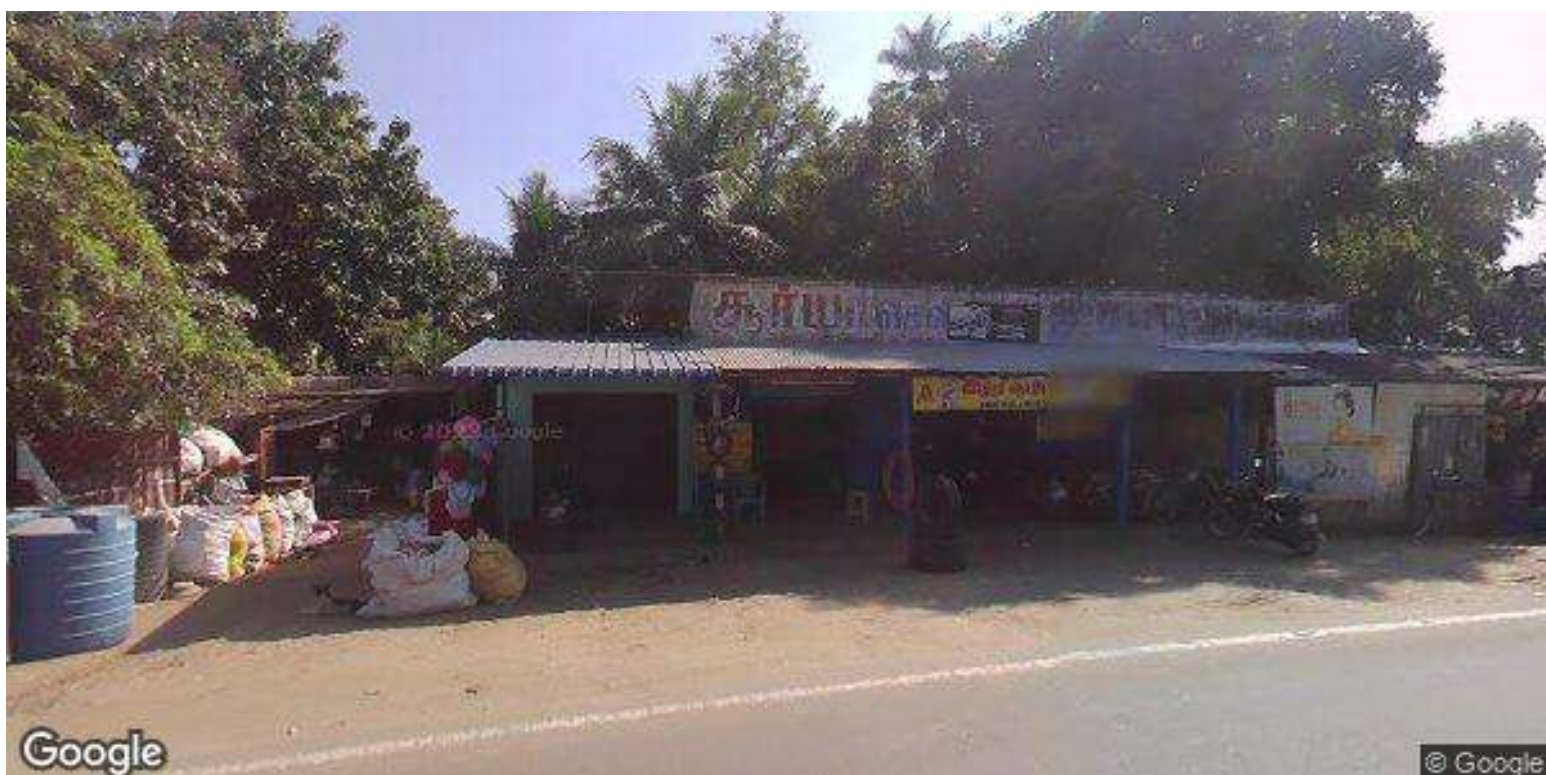
**Risk Type:** Turn  
**Risk Level:** Medium  
**Speed Limit:** 30 KM/Hr  
**Coordinates:** 11.27254, 77.41851

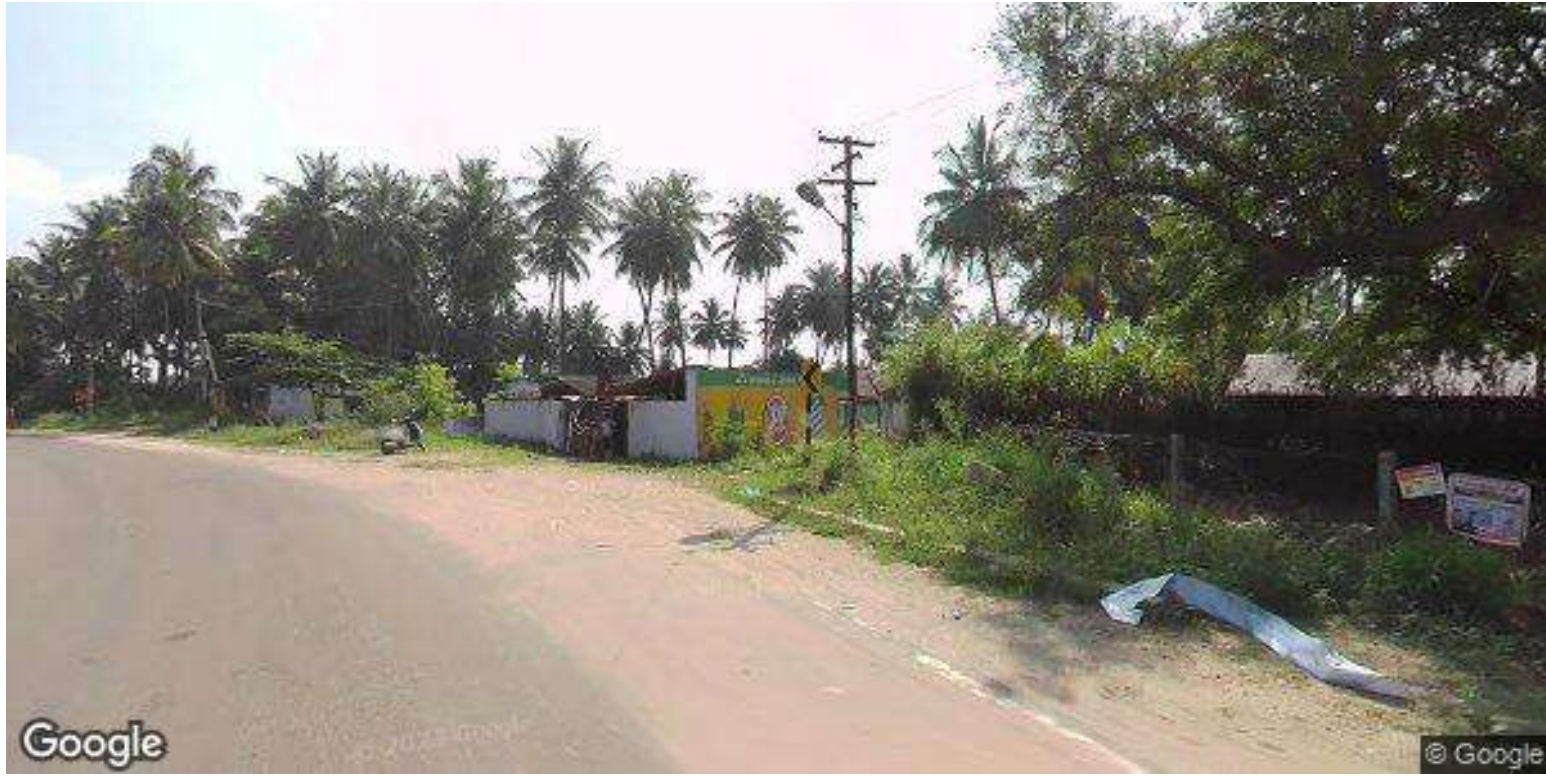
**Risk Type:** Turn  
**Risk Level:** Medium  
**Speed Limit:** 30 KM/Hr  
**Coordinates:** 11.27228, 77.41323

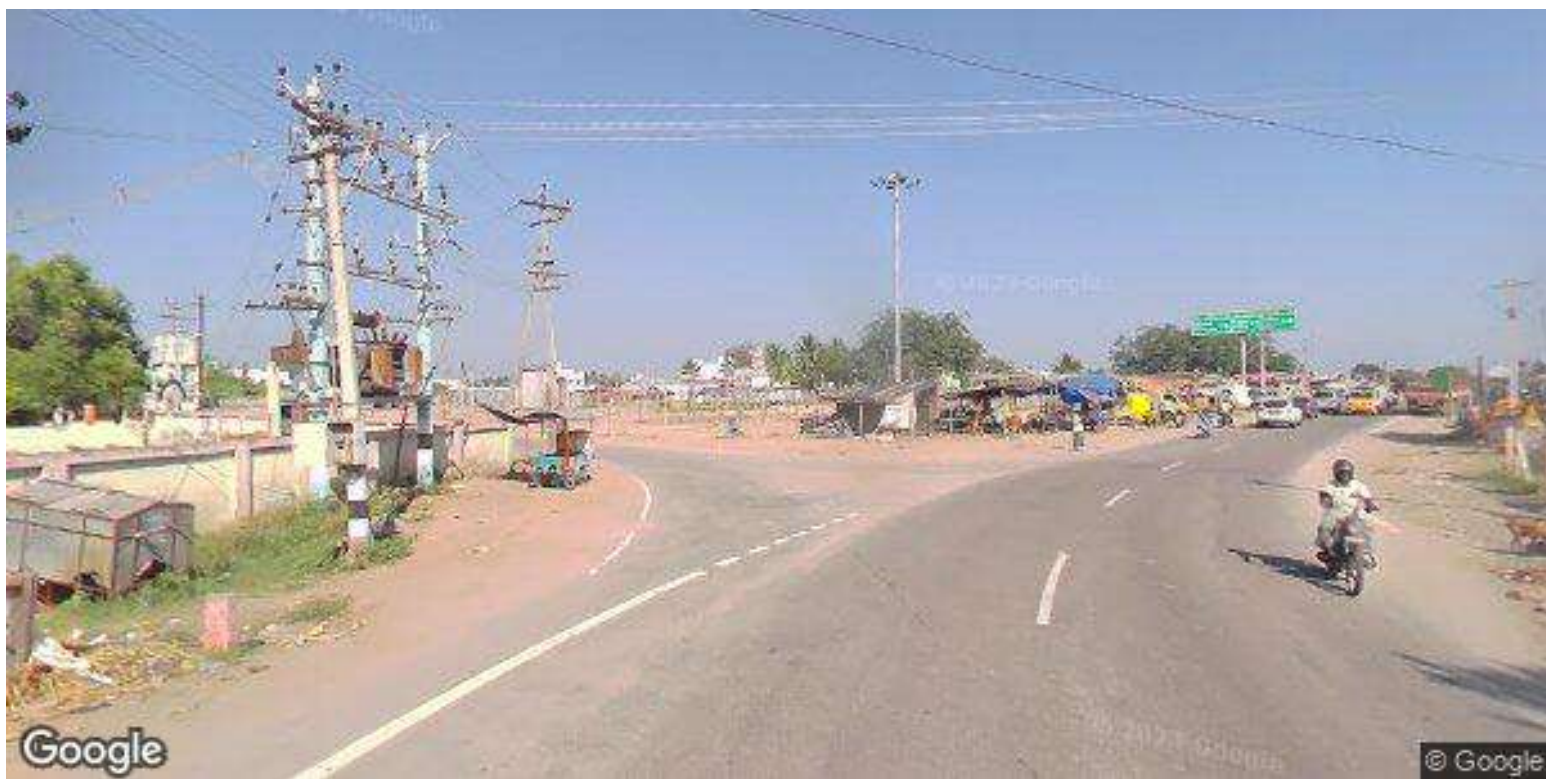
**Risk Type:** Turn  
**Risk Level:** Medium  
**Speed Limit:** 30 KM/Hr  
**Coordinates:** 11.27353, 77.40862

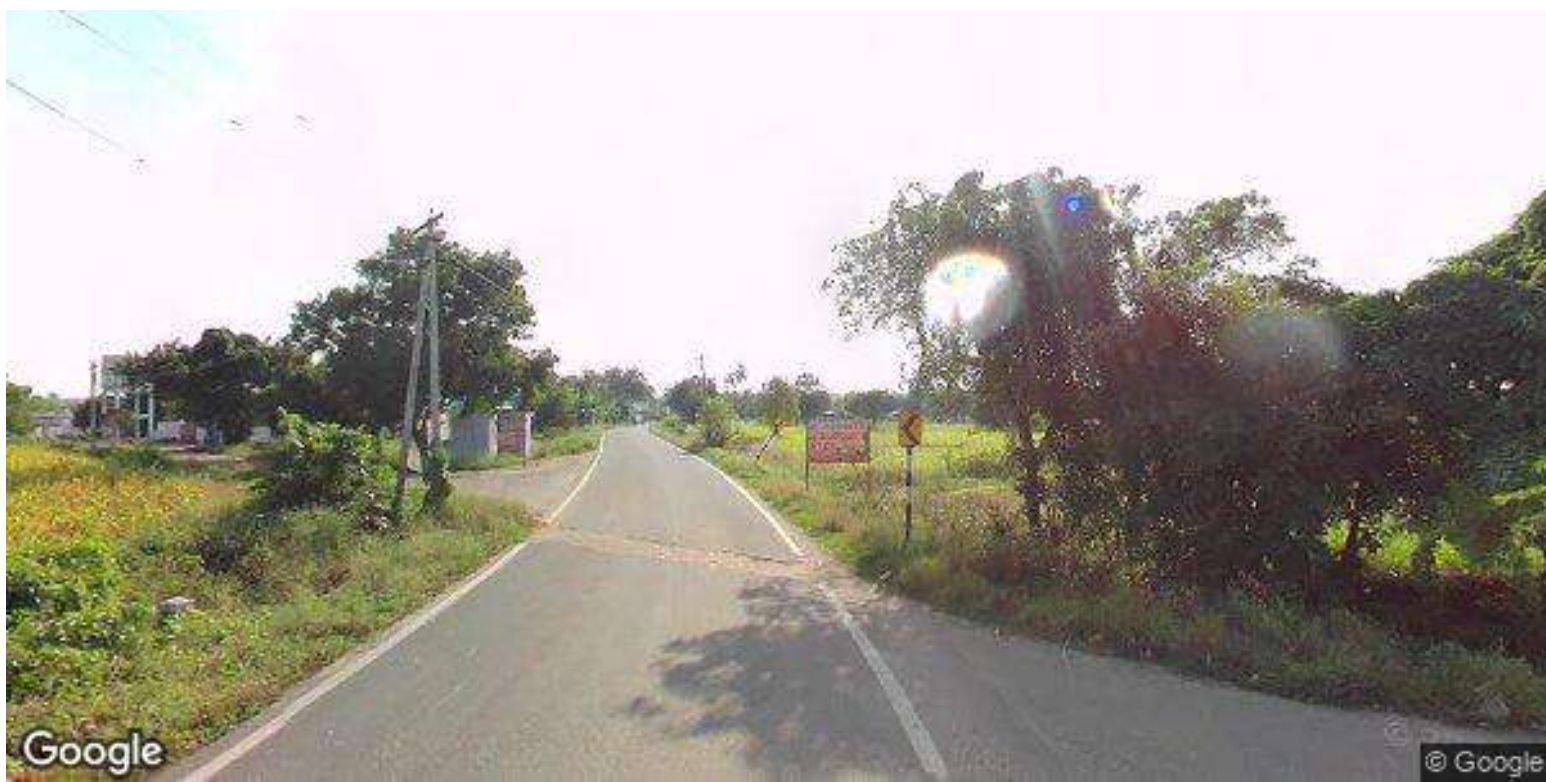
**Coordinates:** 11.27057, 77.38574

**Risk Type:** Turn

**Risk Level:** High

**Speed Limit:** 15 KM/Hr

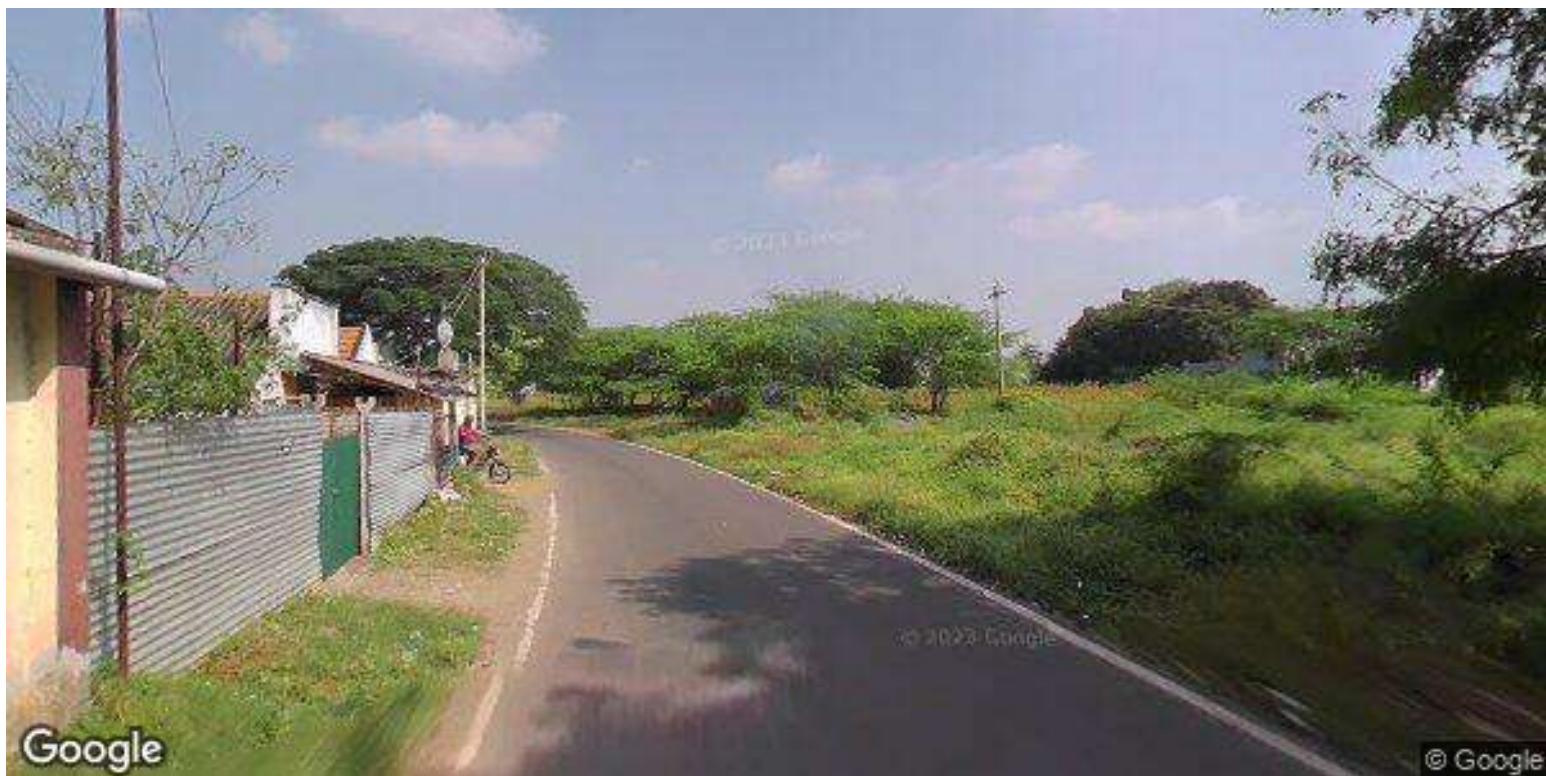
**Coordinates:** 11.26001, 77.36845

**Risk Type:** Turn

**Risk Level:** Medium

**Speed Limit:** 30 KM/Hr

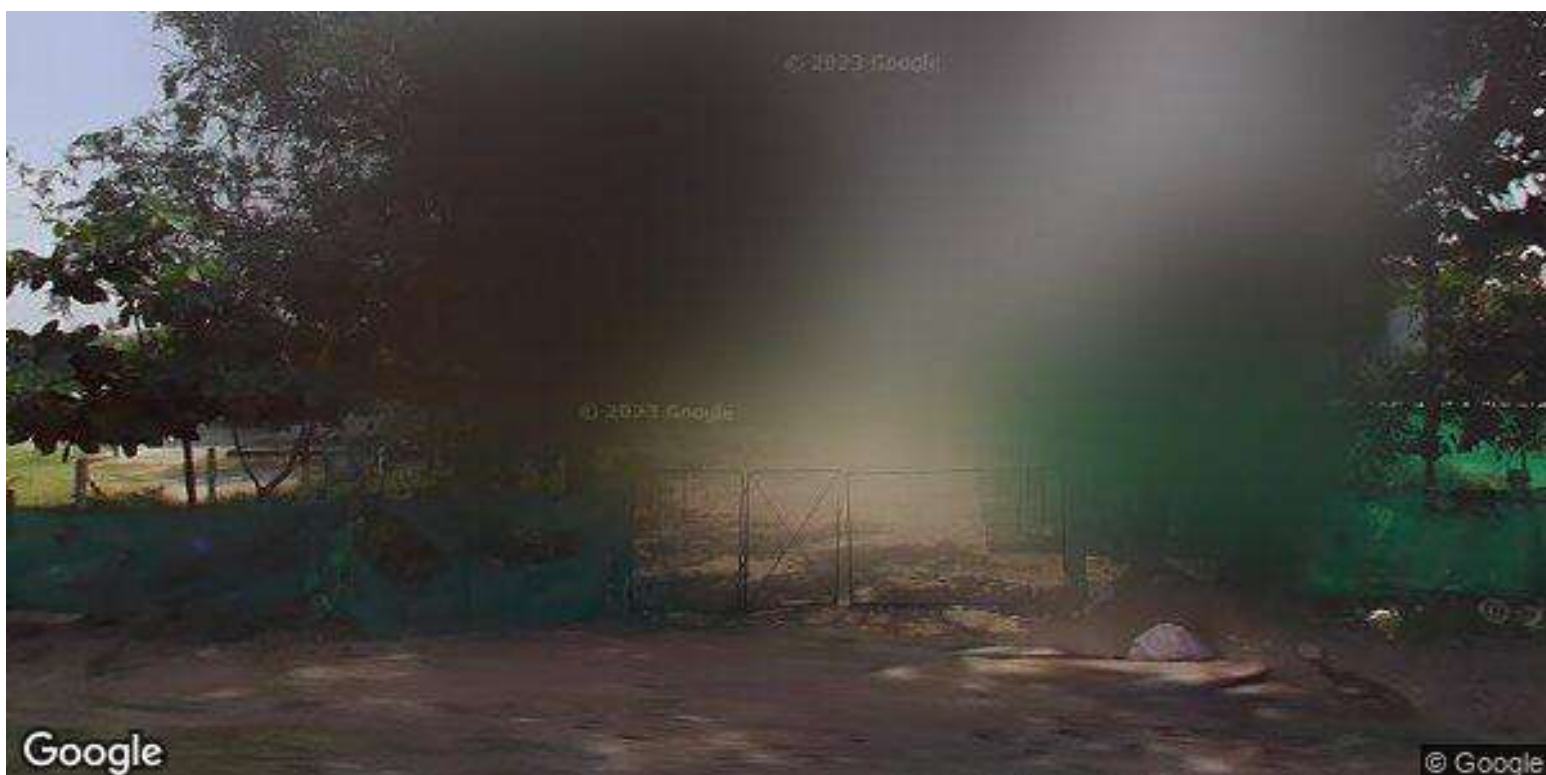
**Risk Type:** Turn  
**Risk Level:** Medium  
**Speed Limit:** 30 KM/Hr  
**Coordinates:** 11.25977, 77.36633

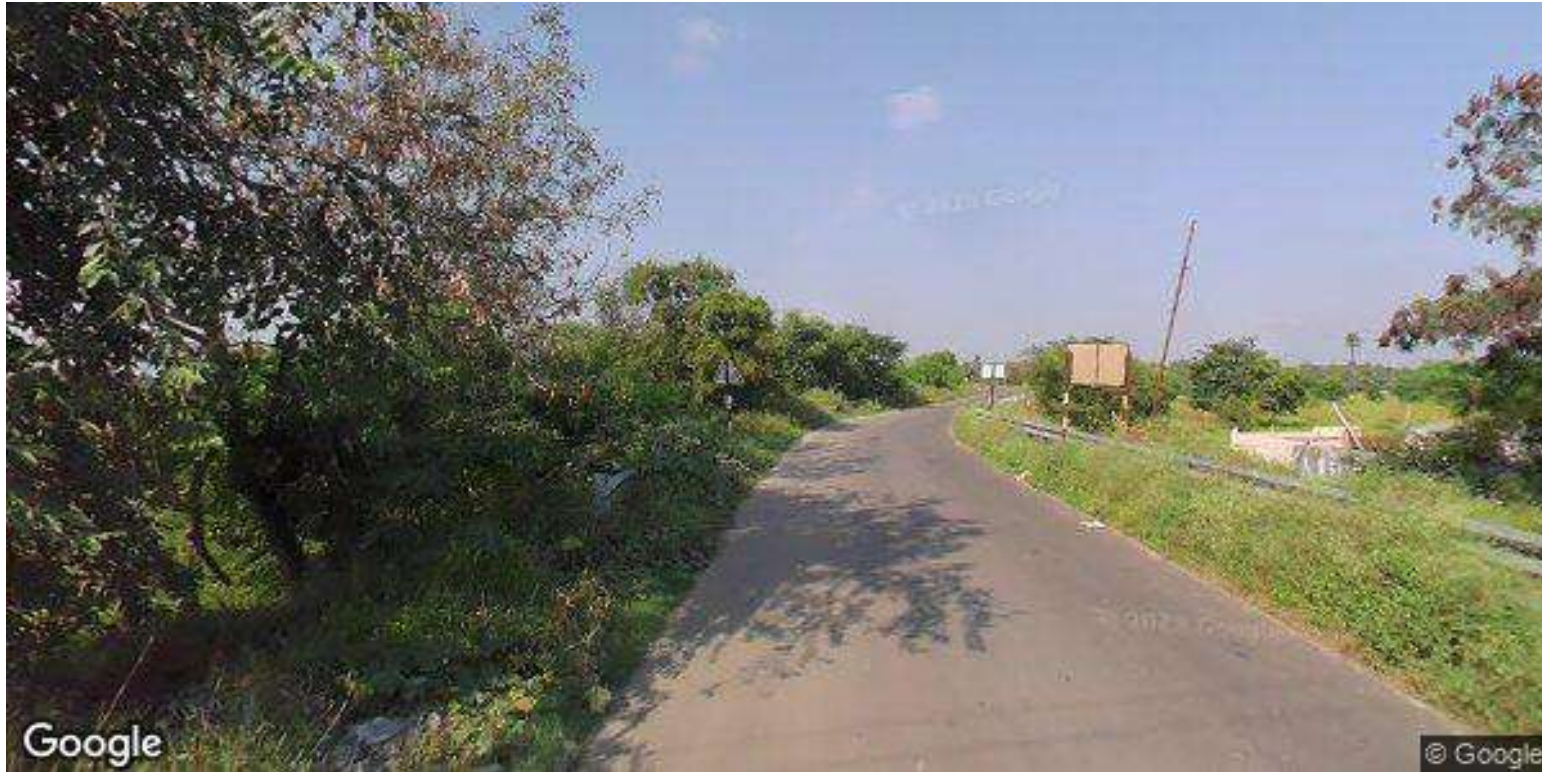
**Risk Type:** Blind Spot  
**Risk Level:** Blind Spot  
**Speed Limit:** 10 KM/Hr  
**Coordinates:** 11.25985, 77.36605

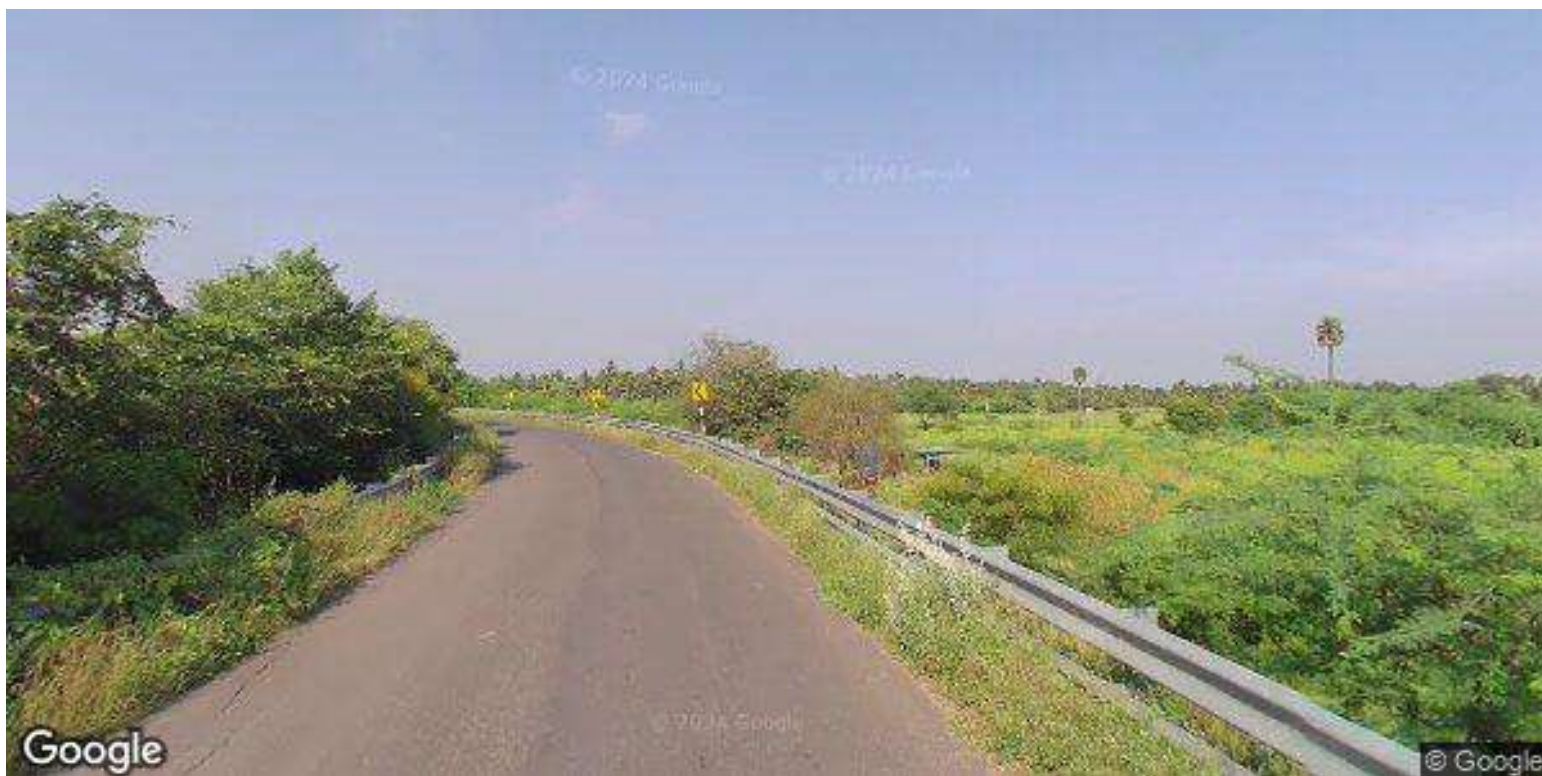
**Risk Type:** Turn  
**Risk Level:** Medium  
**Speed Limit:** 30 KM/Hr  
**Coordinates:** 11.26055, 77.36646
