# IndianOil

## JOURNEY RISK MANAGEMENT (JRM) STUDY

### Salem Terminal to SRI UDAYAGIRI FUELS KSK

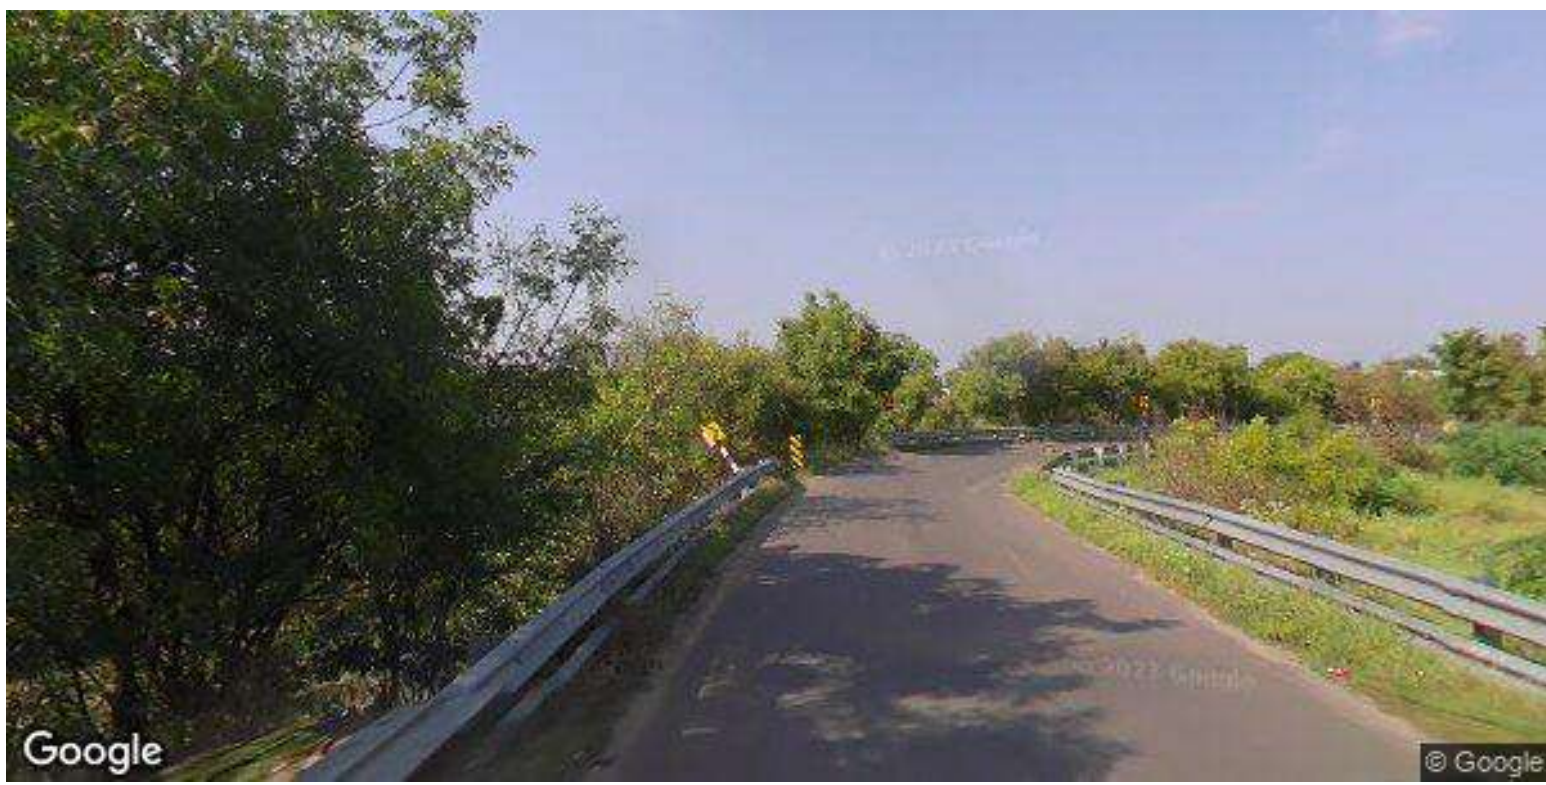
**Coordinates:** 11.26413, 77.36636

**Risk Type:** Turn

**Risk Level:** Medium

**Speed Limit:** 30 KM/Hr

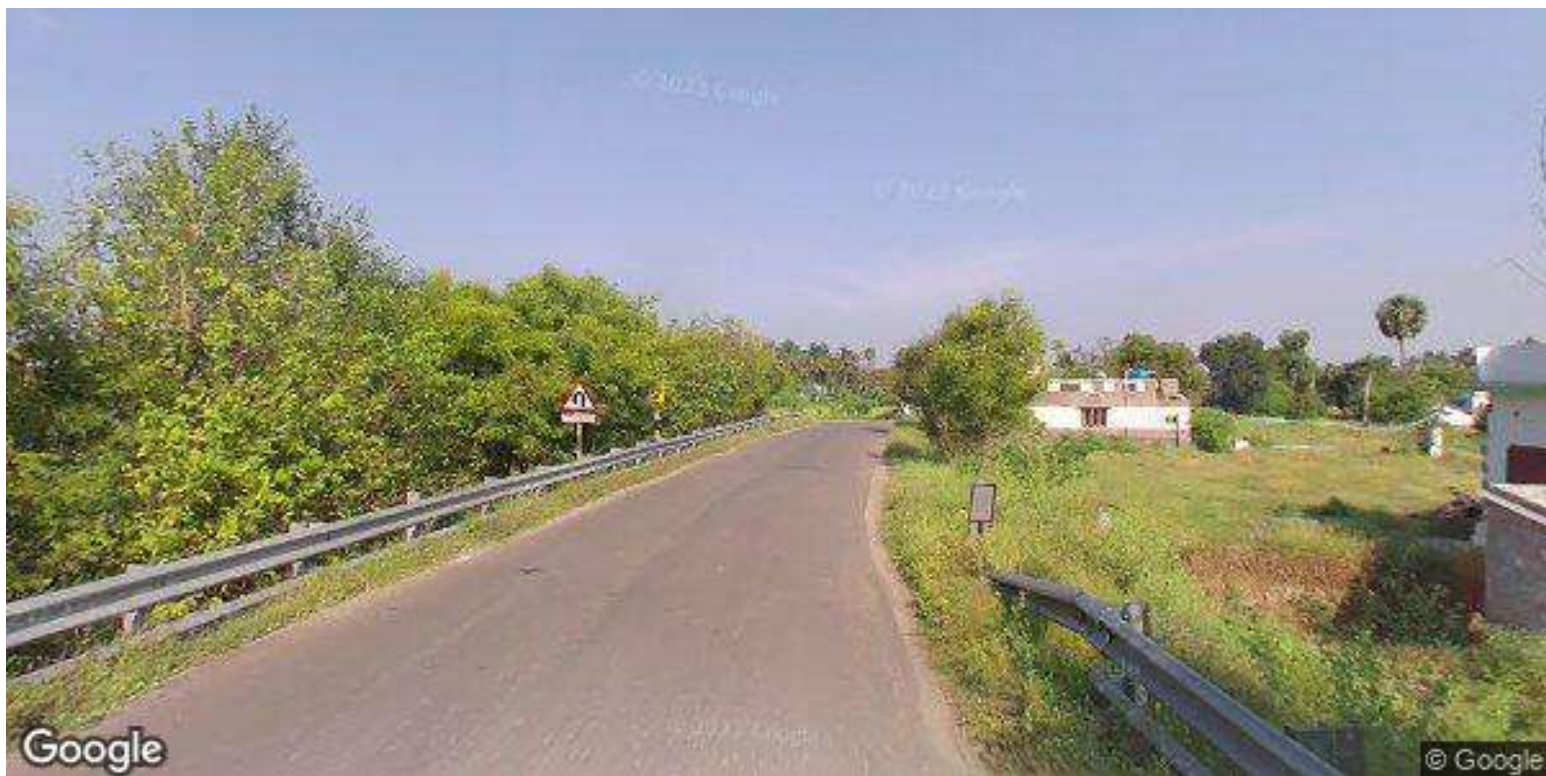
**Coordinates:** 11.26461, 77.36664

**Risk Type:** Turn

**Risk Level:** Medium

**Speed Limit:** 30 KM/Hr

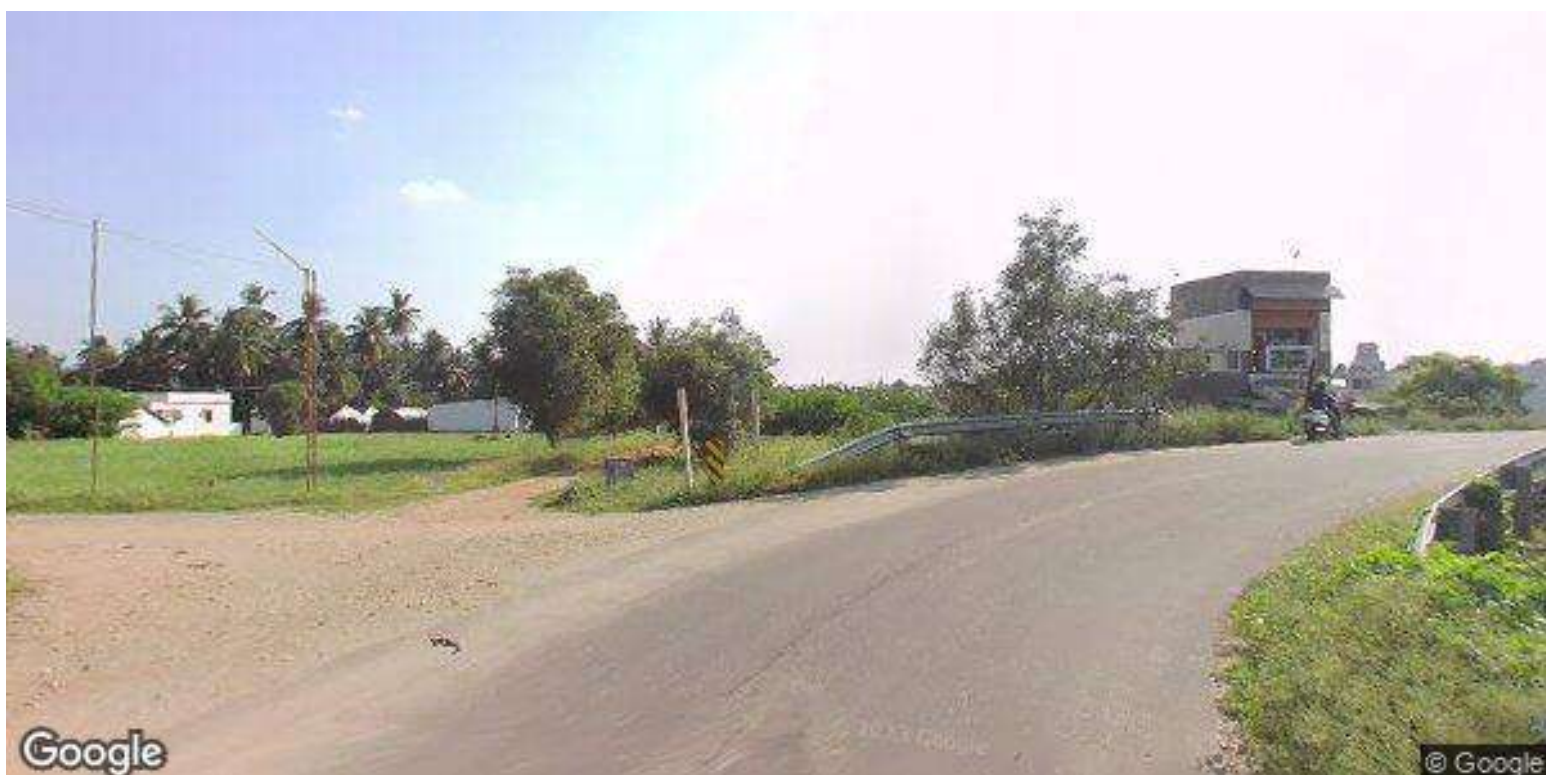
**Risk Type:** Blind Spot  
**Risk Level:** Blind Spot  
**Speed Limit:** 10 KM/Hr  
**Coordinates:** 11.26487, 77.36723

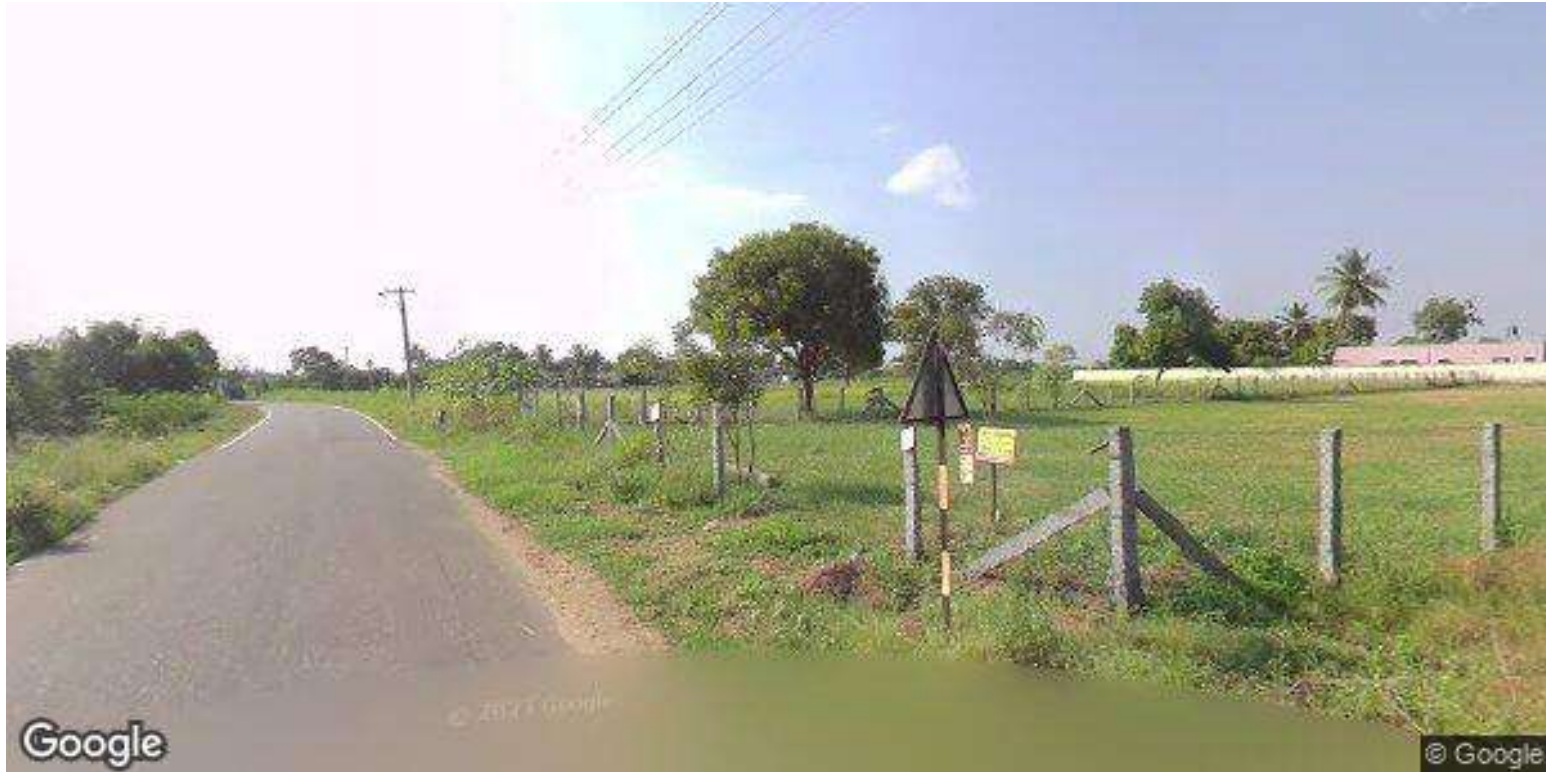
**Risk Type:** Turn  
**Risk Level:** High  
**Speed Limit:** 15 KM/Hr  
**Coordinates:** 11.26516, 77.36707

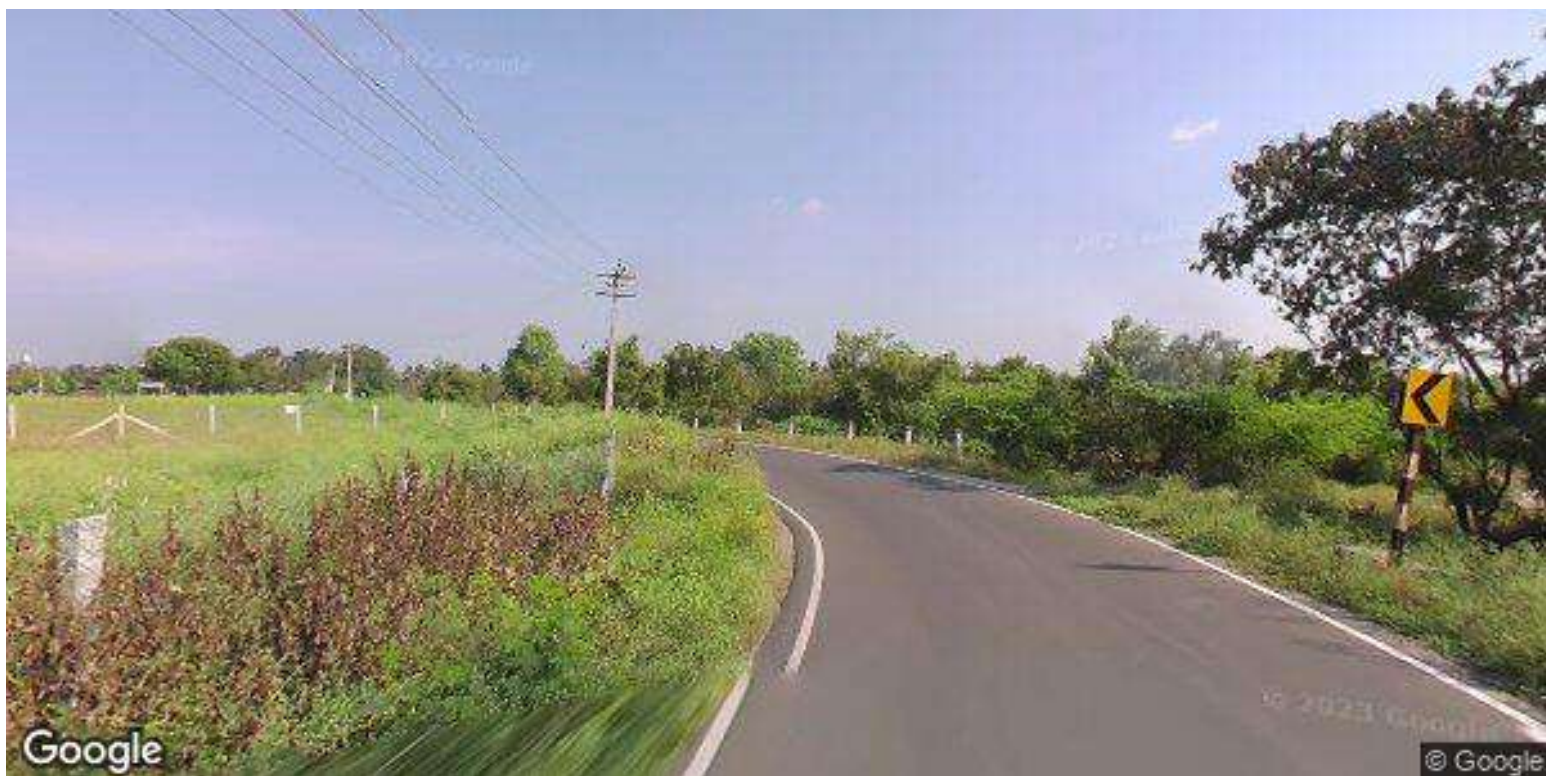
**Risk Type:** Turn  
**Risk Level:** High  
**Speed Limit:** 15 KM/Hr  
**Coordinates:** 11.26513, 77.36557

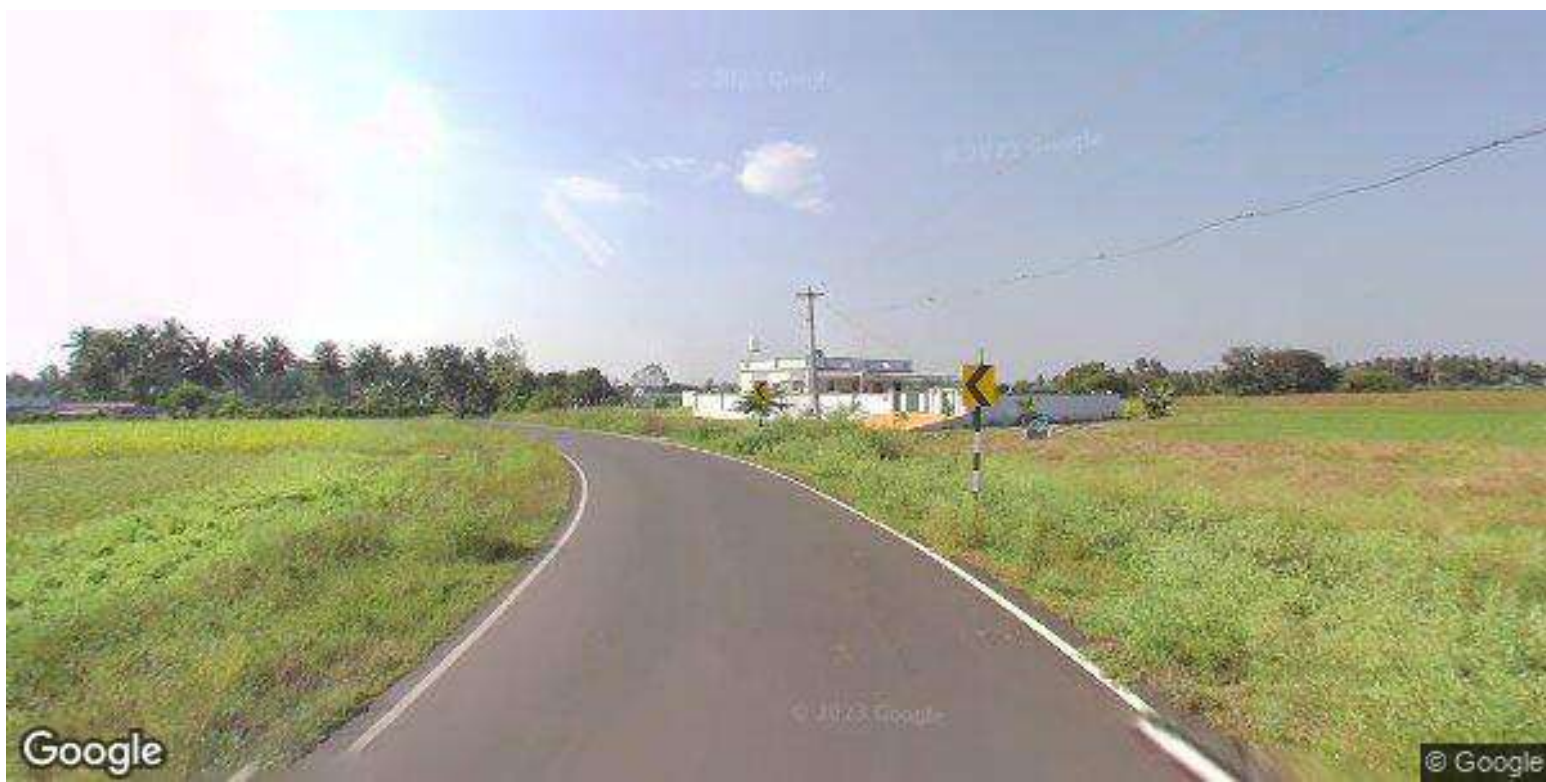
**Coordinates:** 11.26796, 77.36396

**Risk Type:** Turn

**Risk Level:** Medium

**Speed Limit:** 30 KM/Hr

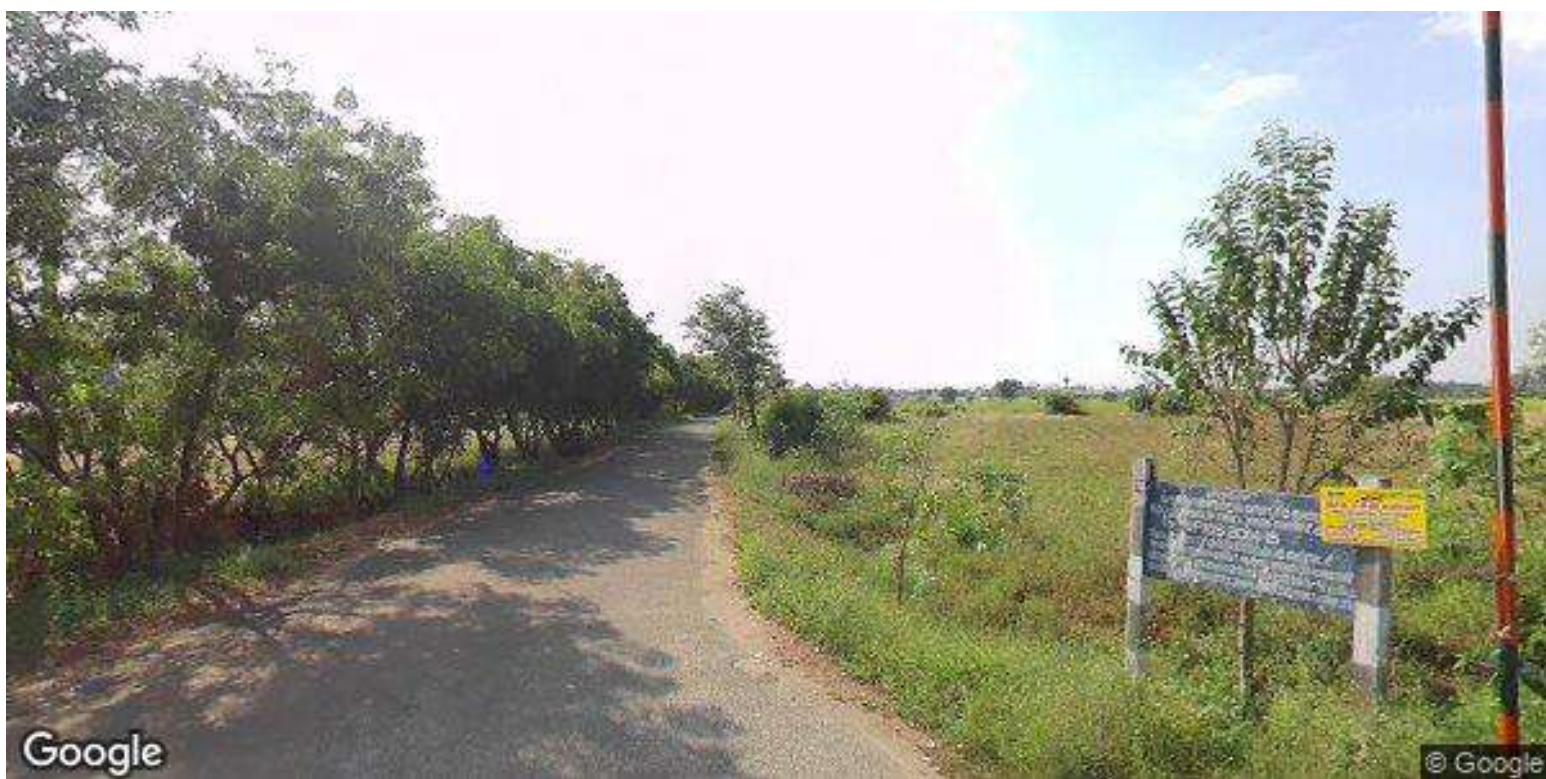
**Coordinates:** 11.27740, 77.35788

**Risk Type:** Turn

**Risk Level:** High

**Speed Limit:** 15 KM/Hr

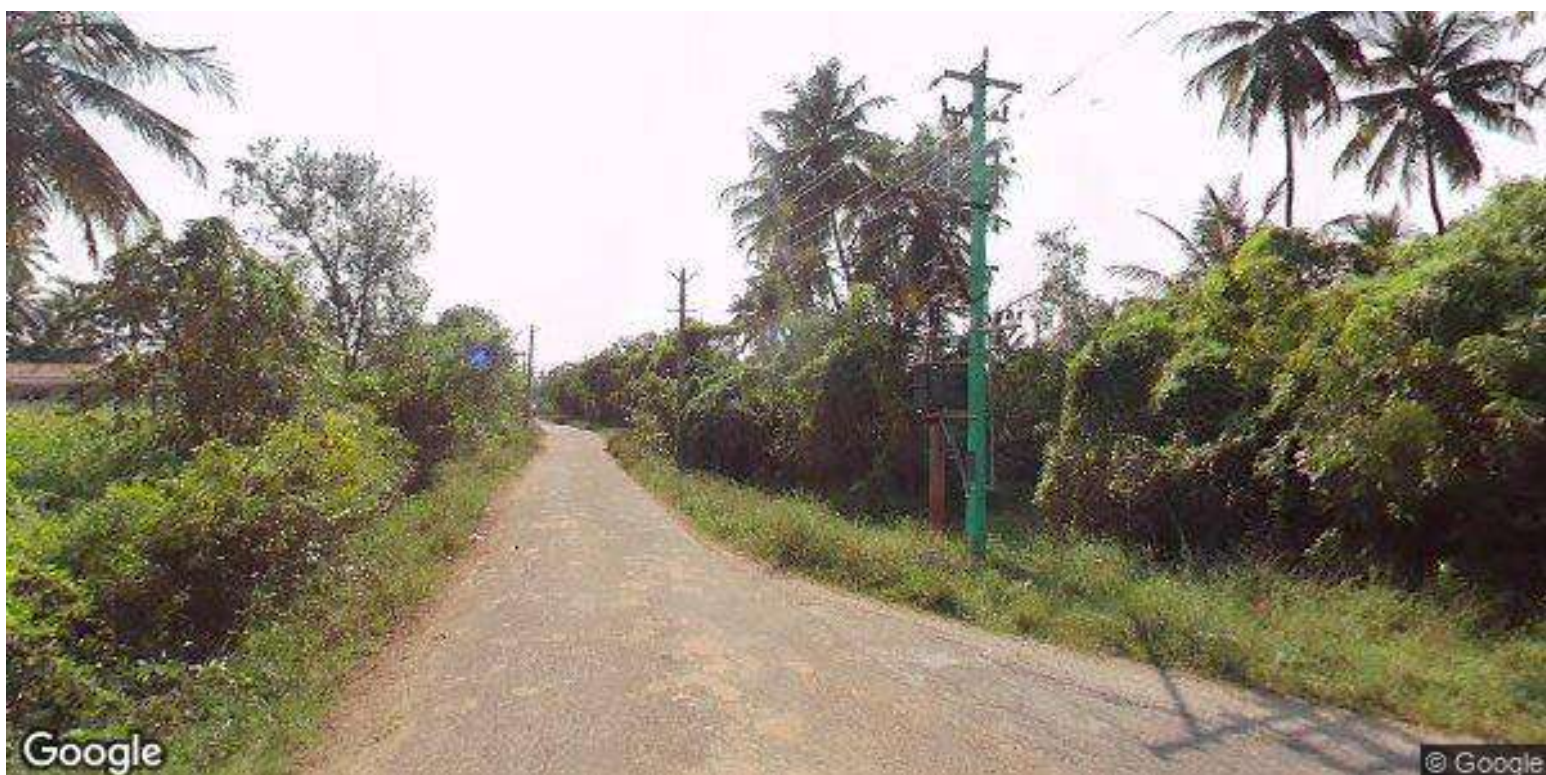
**Risk Type:** Blind Spot  
**Risk Level:** Blind Spot  
**Speed Limit:** 10 KM/Hr  
**Coordinates:** 11.27682, 77.34555

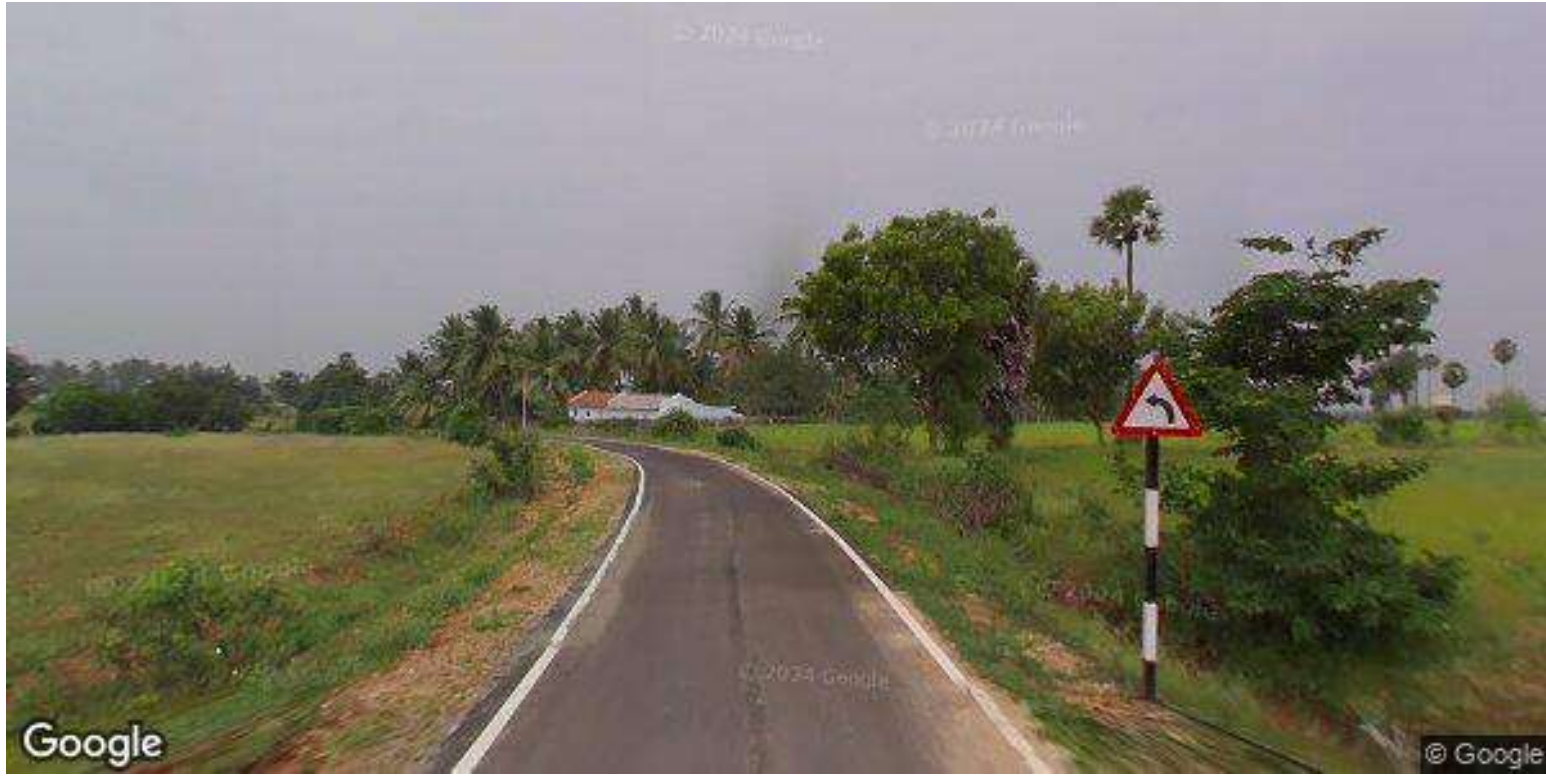
**Risk Type:** Turn  
**Risk Level:** Medium  
**Speed Limit:** 30 KM/Hr  
**Coordinates:** 11.28158, 77.34302

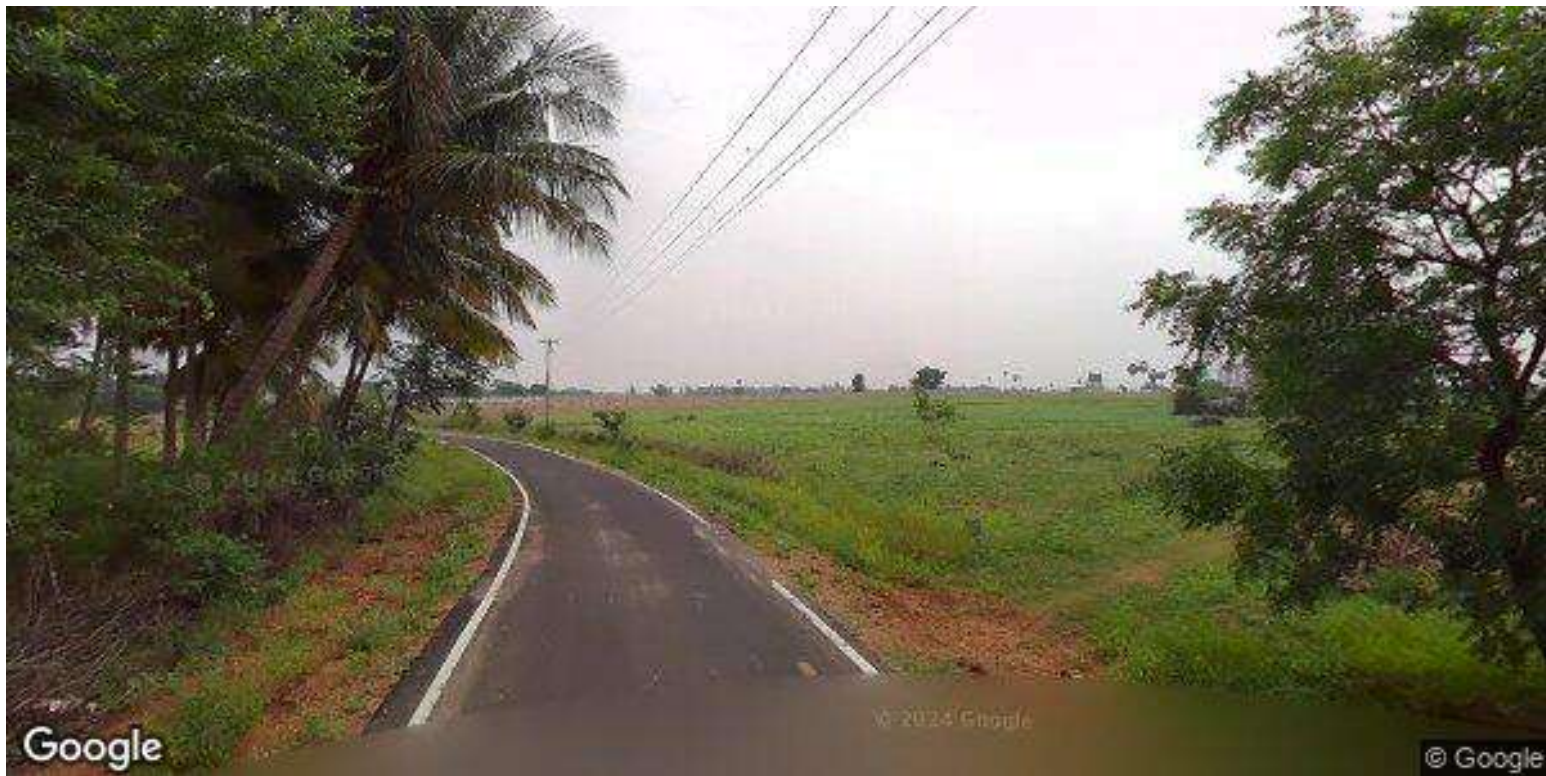
**Risk Type:** Turn  
**Risk Level:** Medium  
**Speed Limit:** 30 KM/Hr  
**Coordinates:** 11.28239, 77.33843

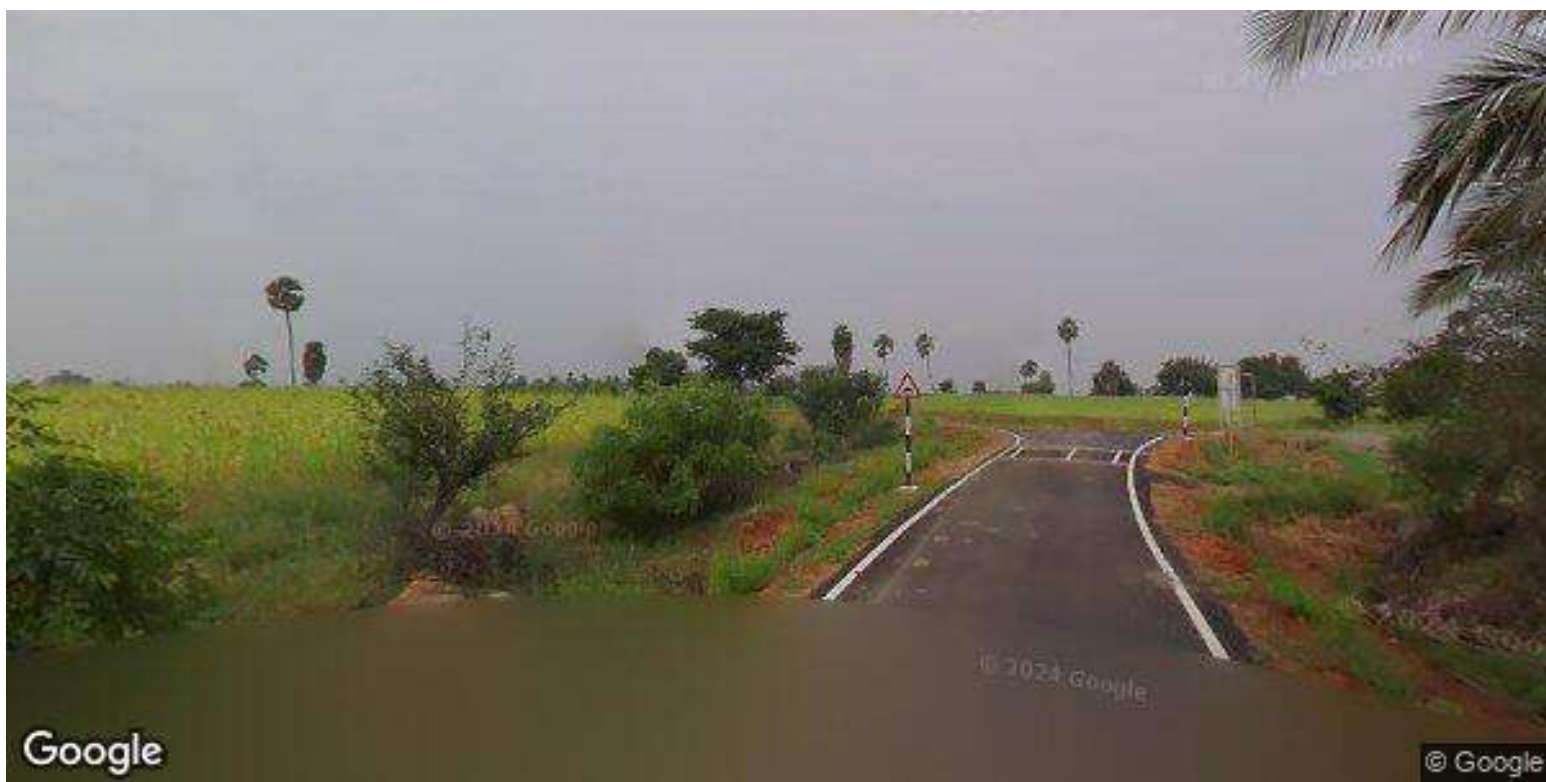
**Coordinates:** 11.28317, 77.33761

**Risk Type:** Turn

**Risk Level:** Medium

**Speed Limit:** 30 KM/Hr

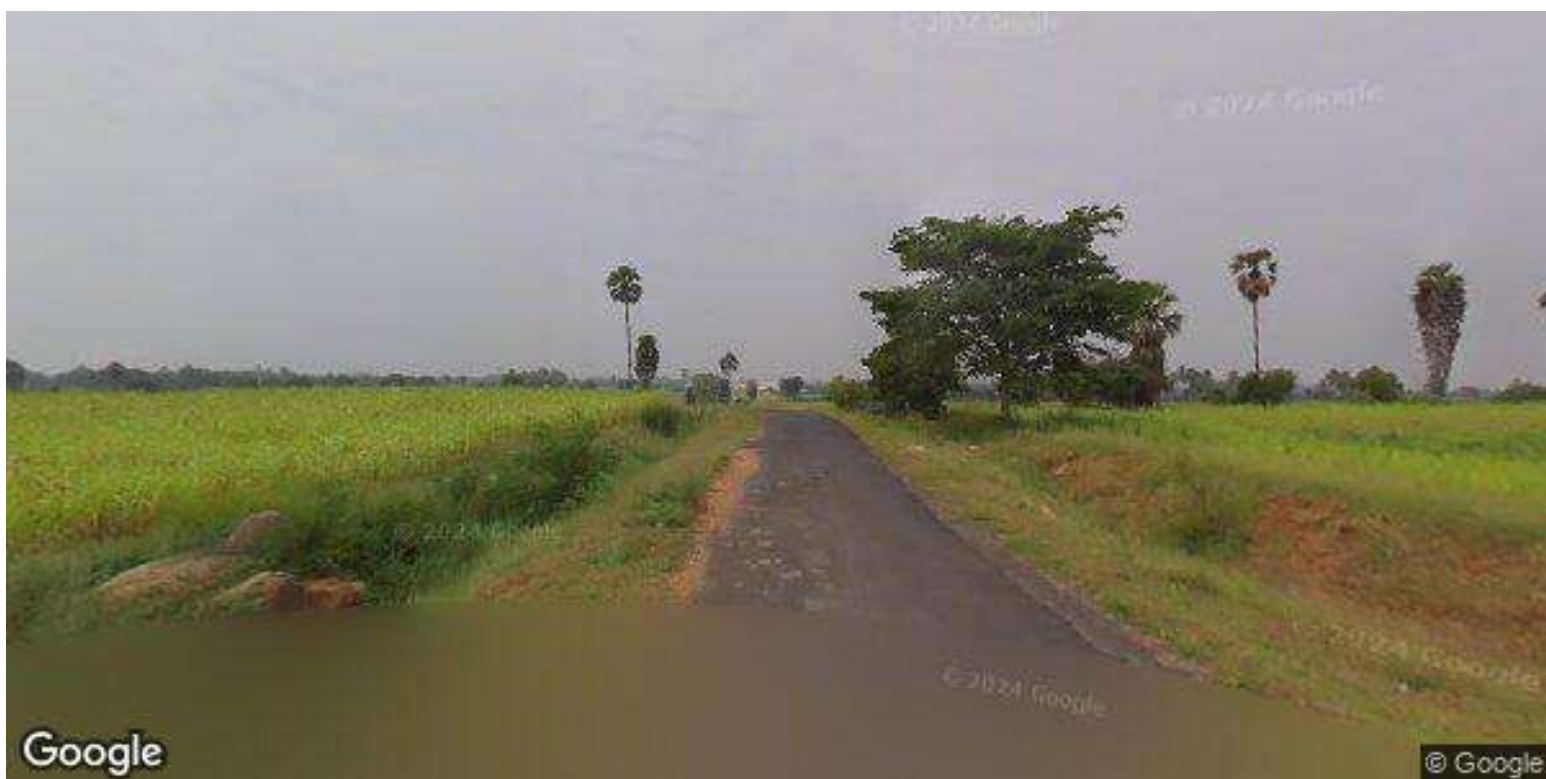
**Coordinates:** 11.28349, 77.33752

**Risk Type:** Turn

**Risk Level:** High

**Speed Limit:** 15 KM/Hr

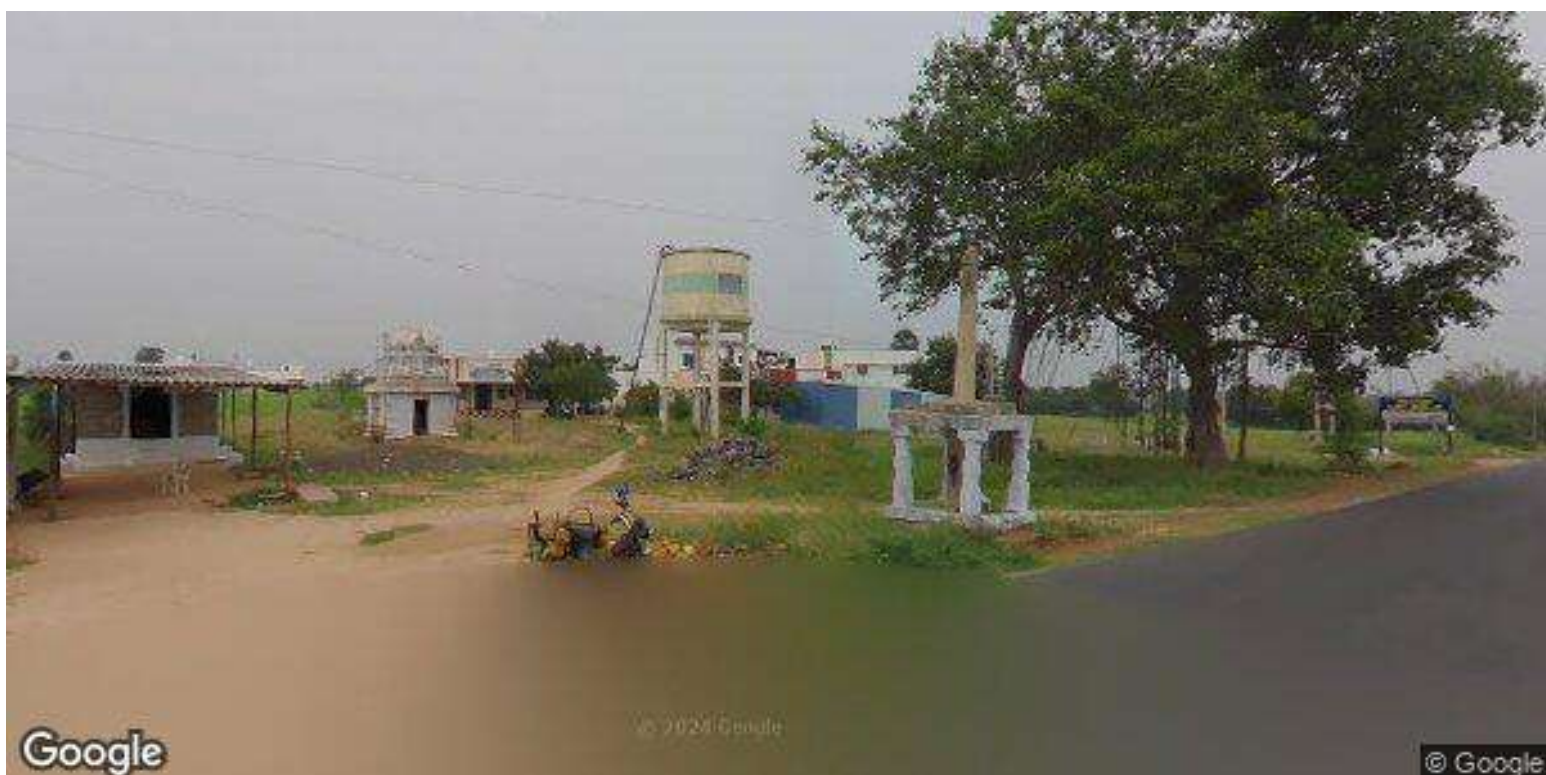
**Risk Type:** Blind Spot  
**Risk Level:** Blind Spot  
**Speed Limit:** 10 KM/Hr  
**Coordinates:** 11.28369, 77.33267

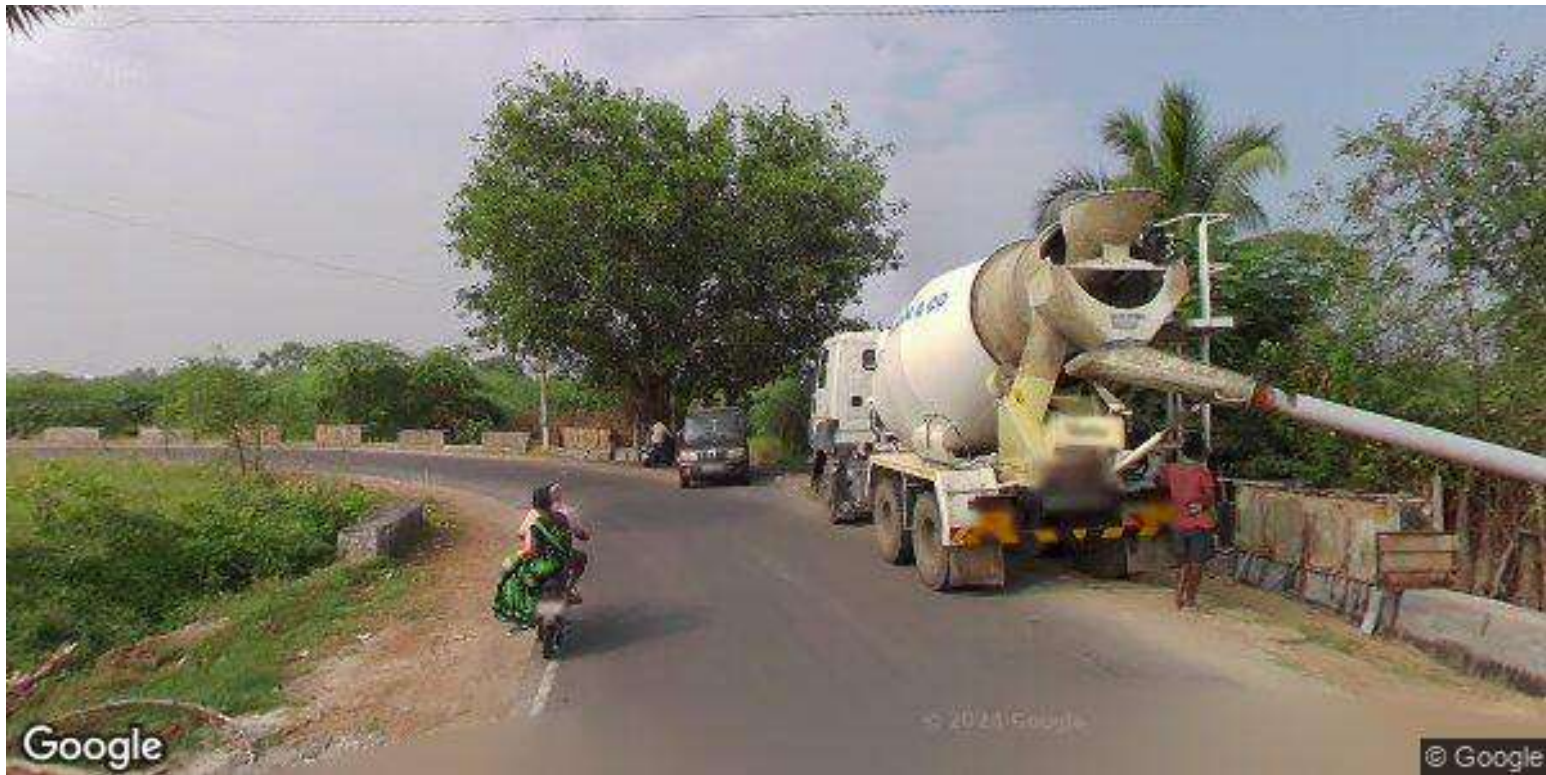
**Risk Type:** Turn  
**Risk Level:** Medium  
**Speed Limit:** 30 KM/Hr  
**Coordinates:** 11.28760, 77.33292

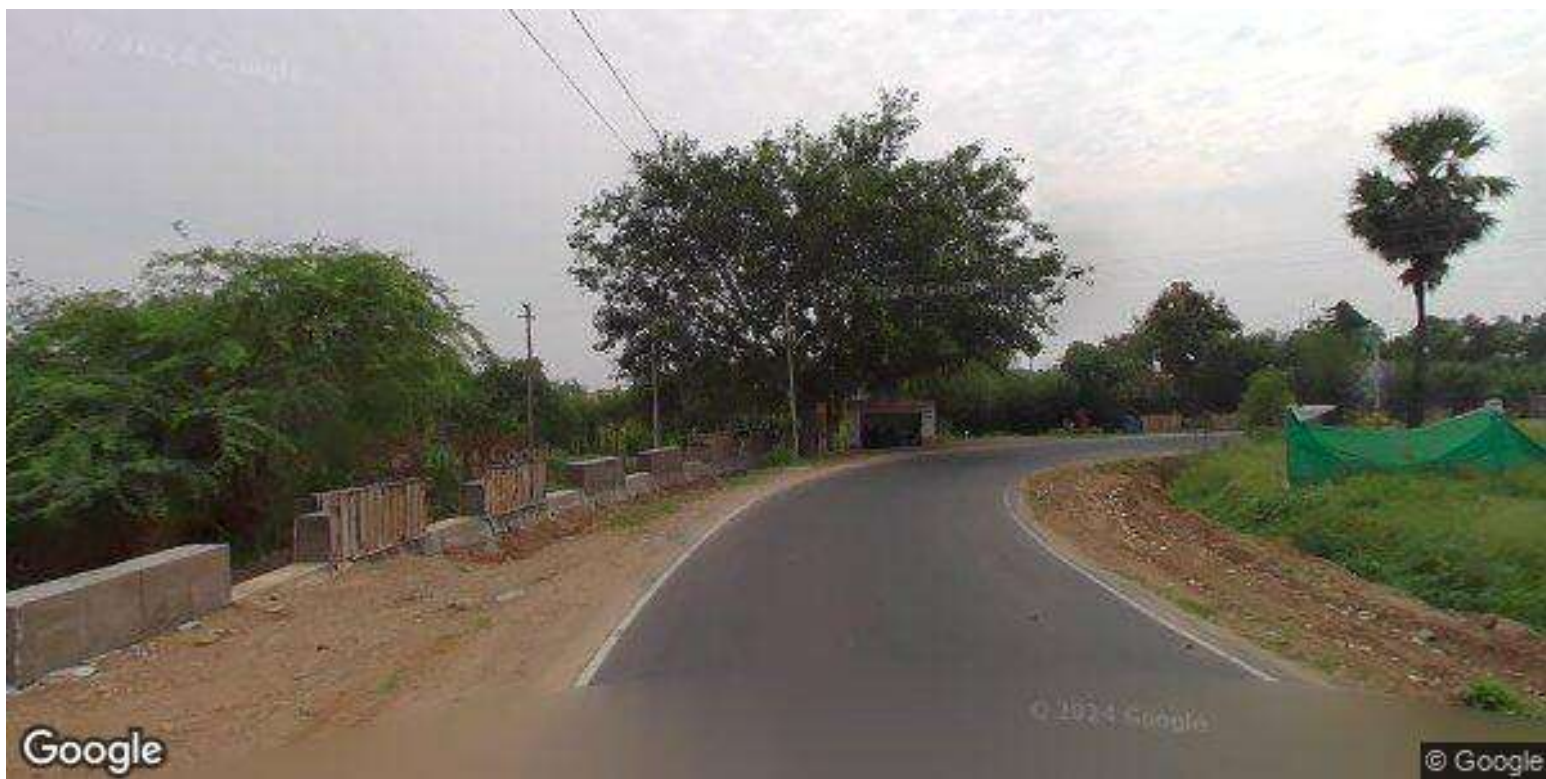
**Risk Type:** Turn  
**Risk Level:** Medium  
**Speed Limit:** 30 KM/Hr  
**Coordinates:** 11.28784, 77.33263

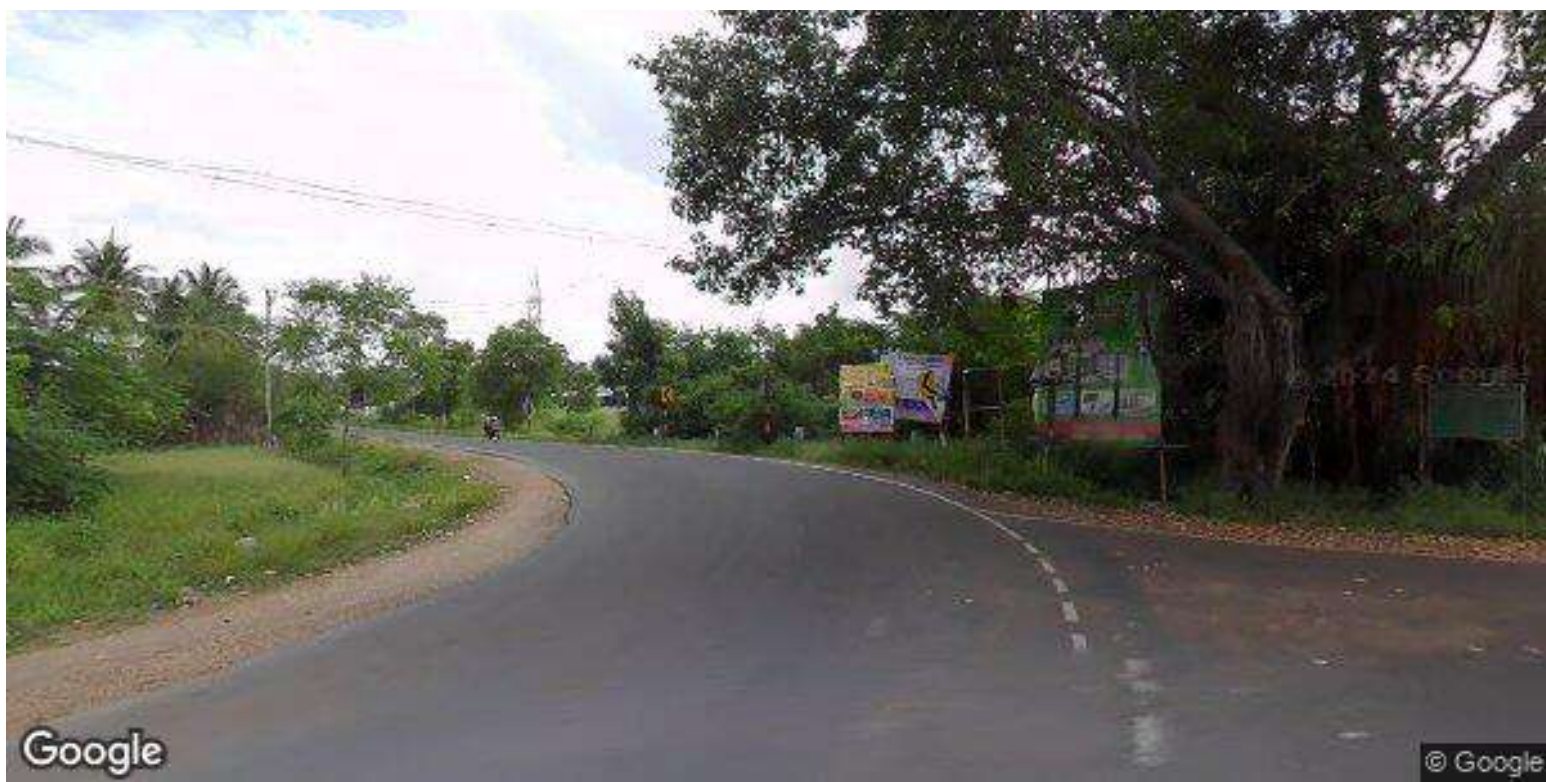
**Coordinates:** 11.28799, 77.32982

**Risk Type:** Turn

**Risk Level:** High

**Speed Limit:** 15 KM/Hr

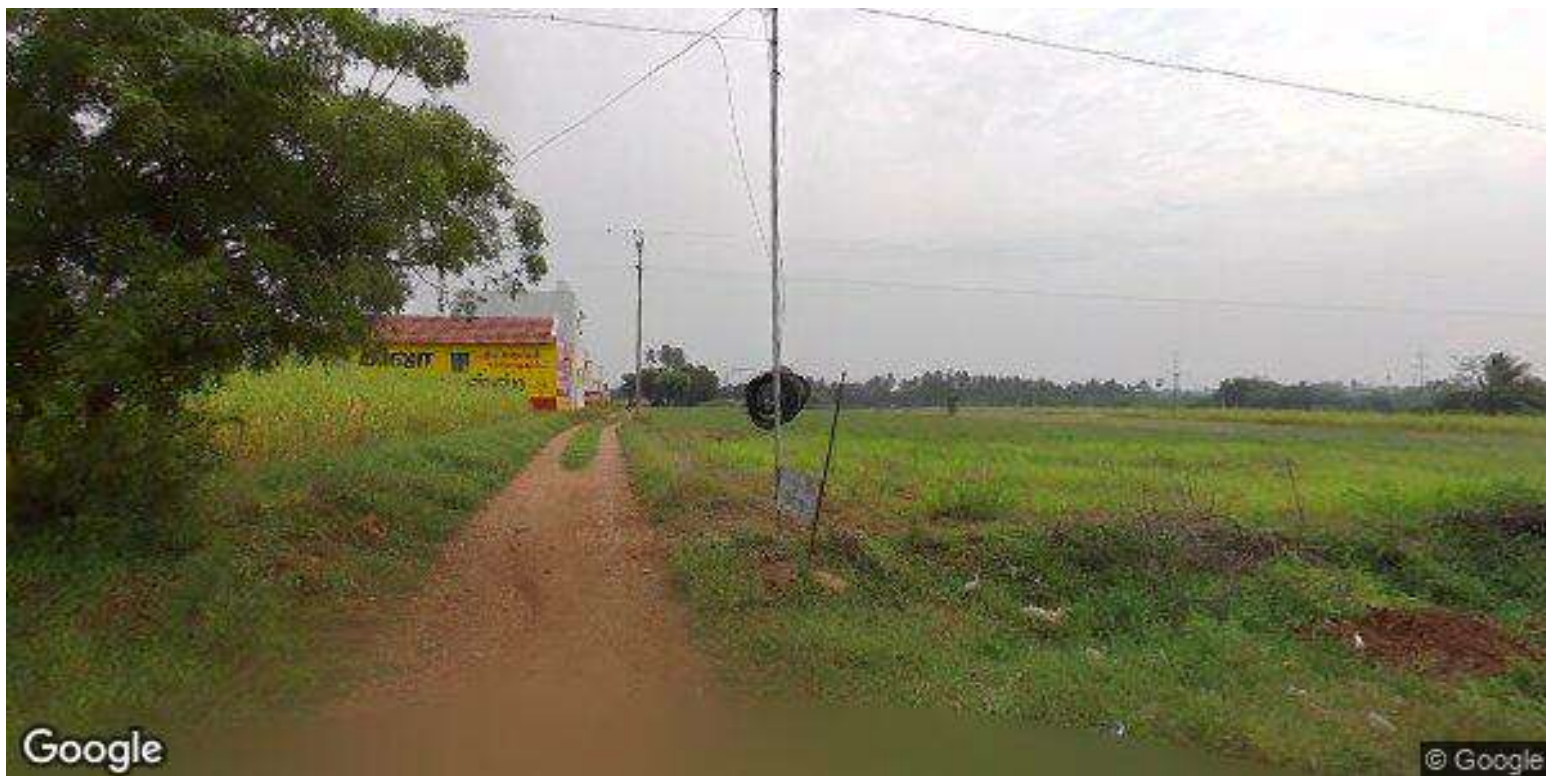
**Coordinates:** 11.29047, 77.32961

**Risk Type:** Turn

**Risk Level:** High

**Speed Limit:** 15 KM/Hr
