## JOURNEY RISK MANAGEMENT (JRM) STUDY

**Salem Terminal TO KAVERIPATTINAM APCMS LTD.**

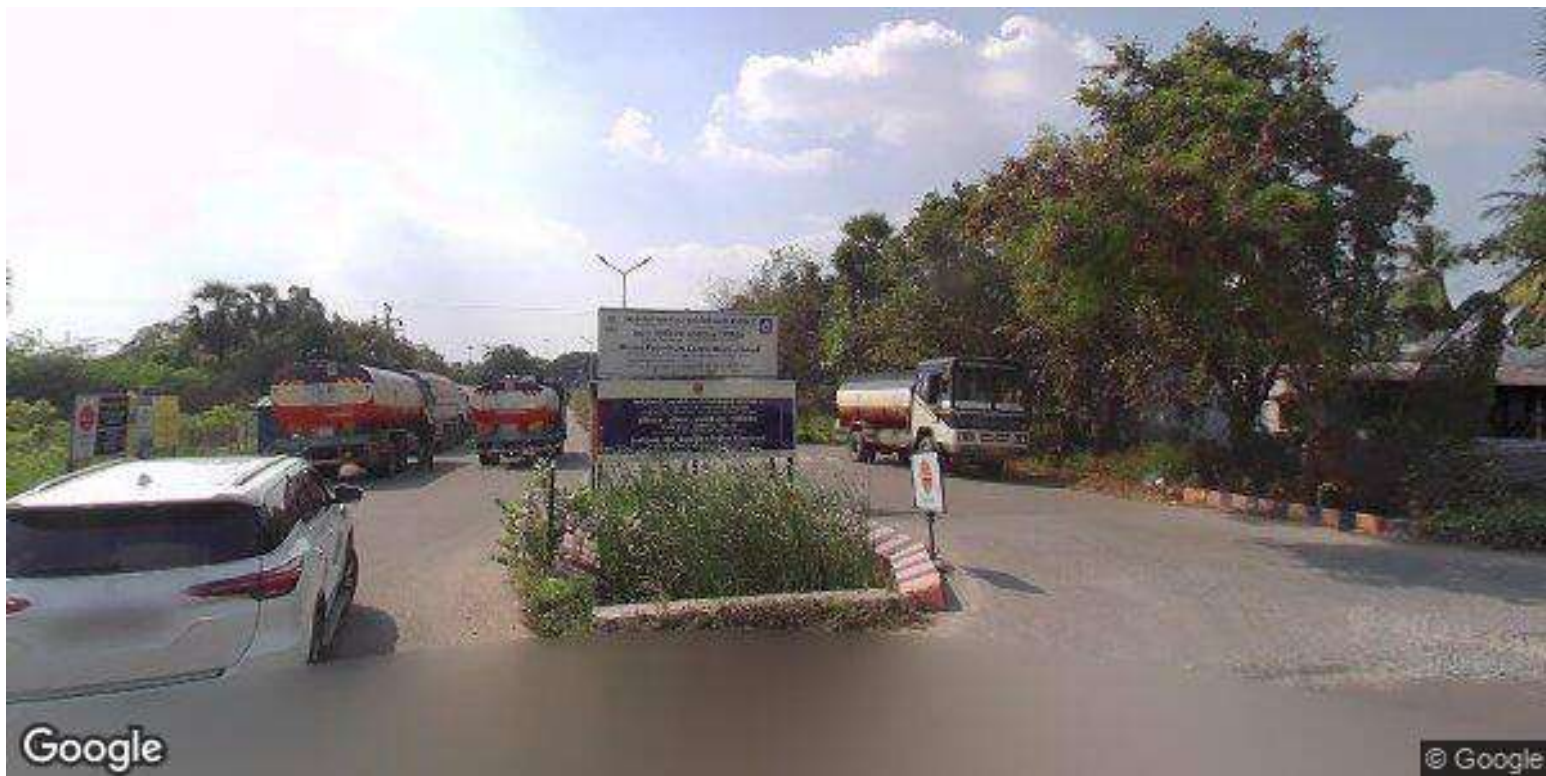
**Coordinates:** 11.44024, 77.87528

**Risk Type:** Turn

**Risk Level:** High

**Speed Limit:** 15 KM/Hr

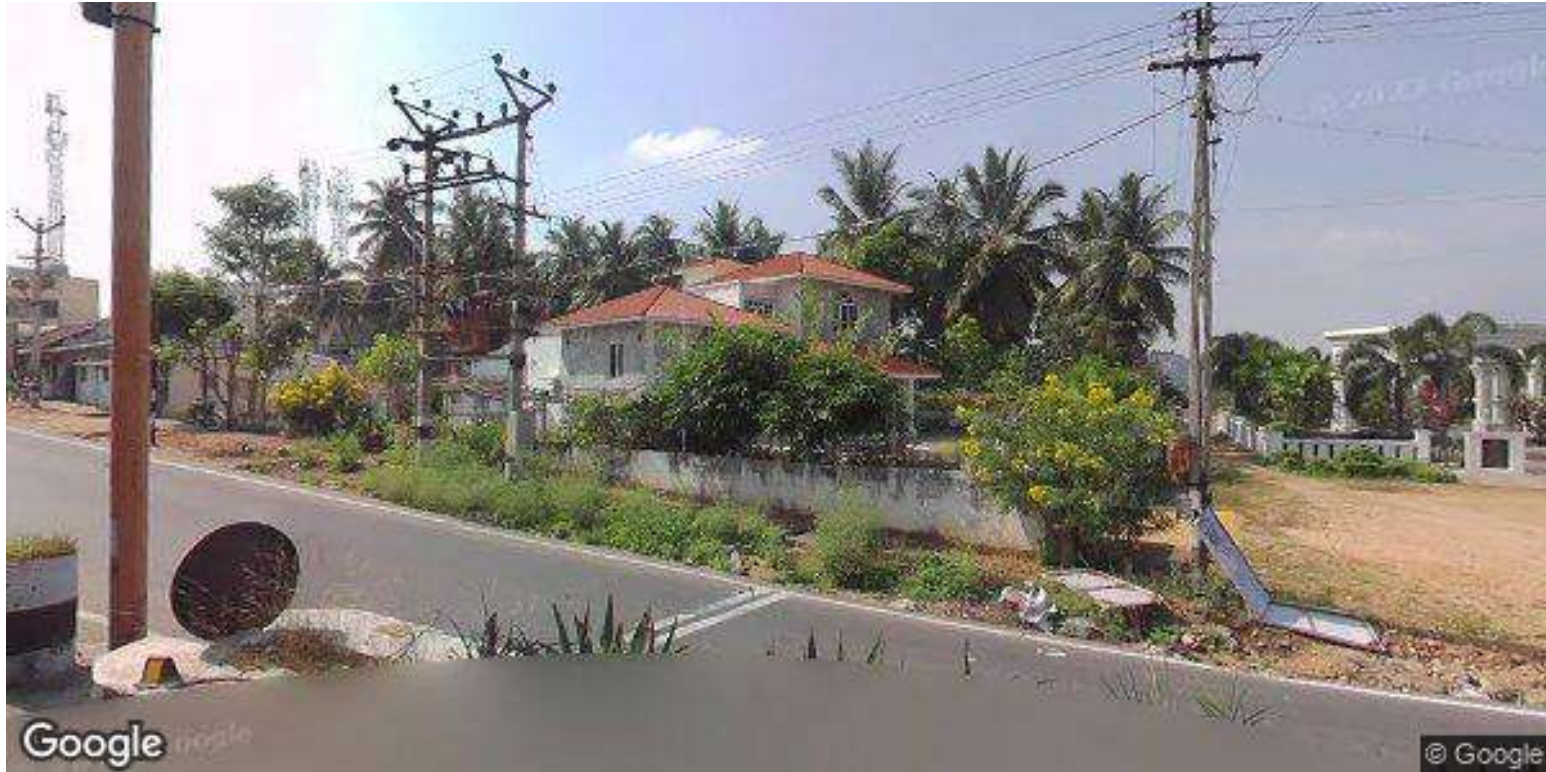
**Coordinates: 11.46303, 77.84945**

**Risk Type: Turn**

**Risk Level: High**

**Speed Limit: 15 KM/Hr**

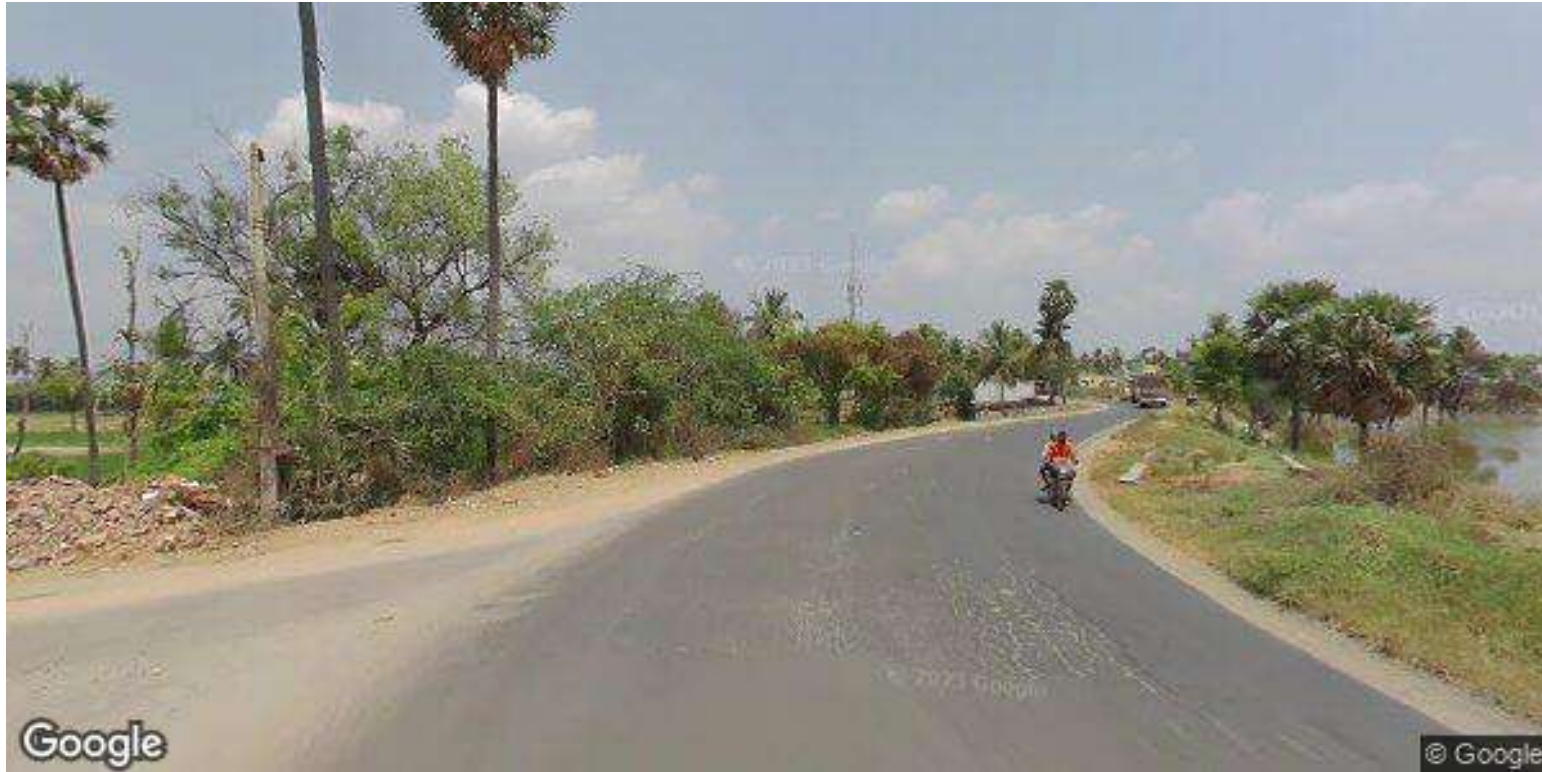
**Risk Type:** Turn  
**Risk Level:** Medium  
**Speed Limit:** 30 KM/Hr  
**Coordinates:** 11.56083, 77.89921

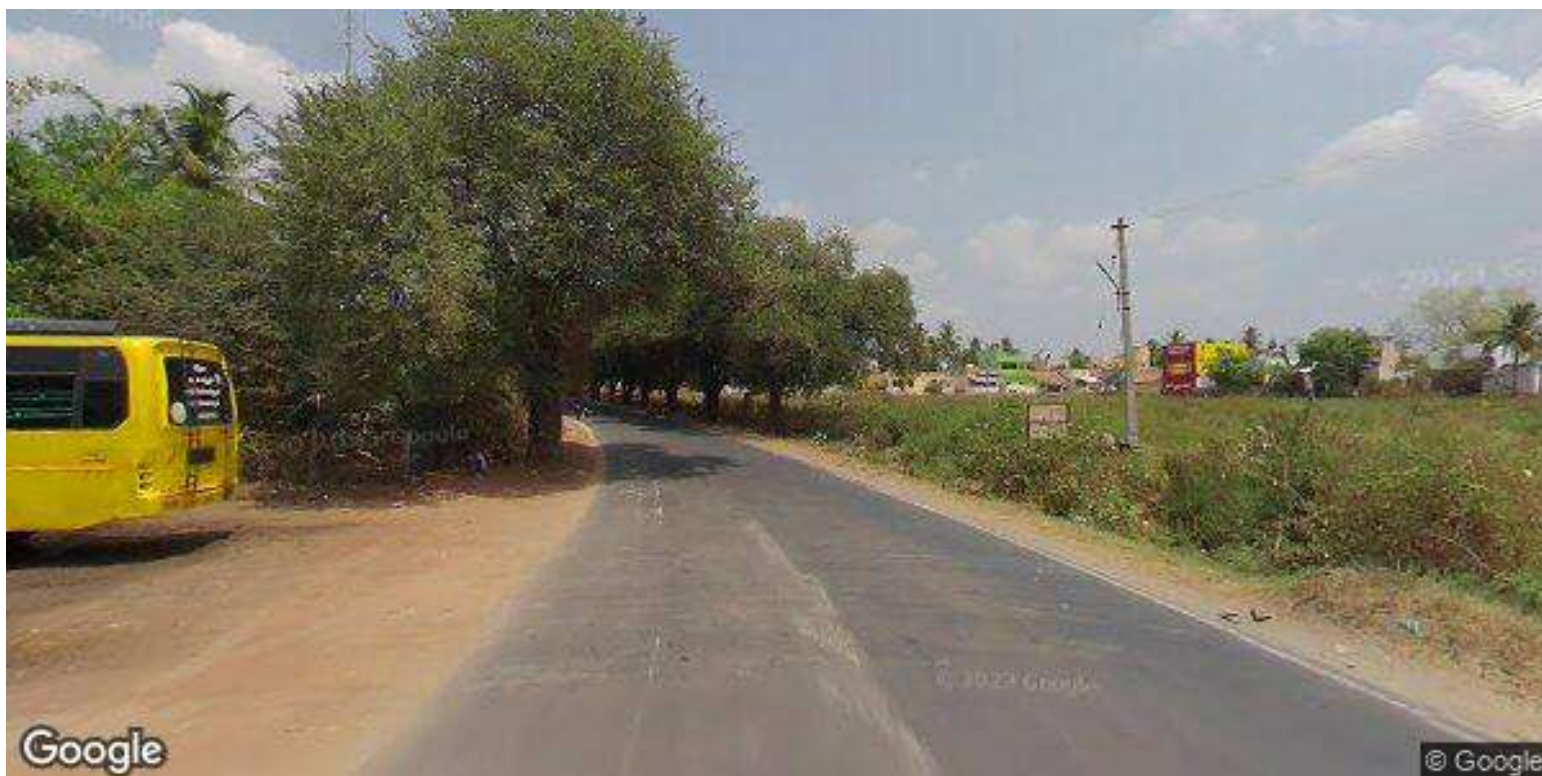
**Risk Type:** Turn  
**Risk Level:** Medium  
**Speed Limit:** 30 KM/Hr  
**Coordinates:** 11.56180, 77.90019

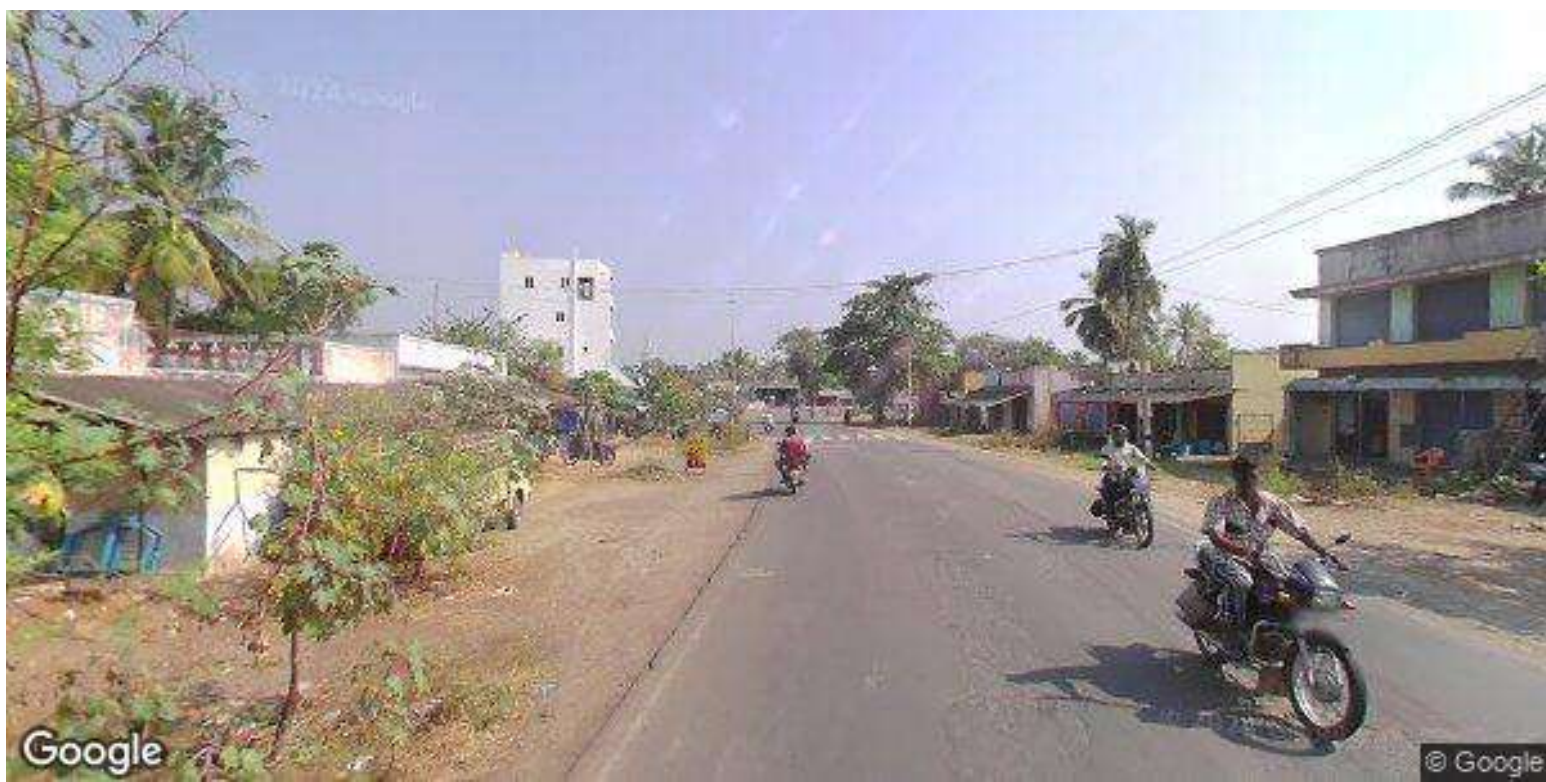
**Coordinates:** 11.59189, 77.90645

**Risk Type:** Turn

**Risk Level:** Medium

**Speed Limit:** 30 KM/Hr

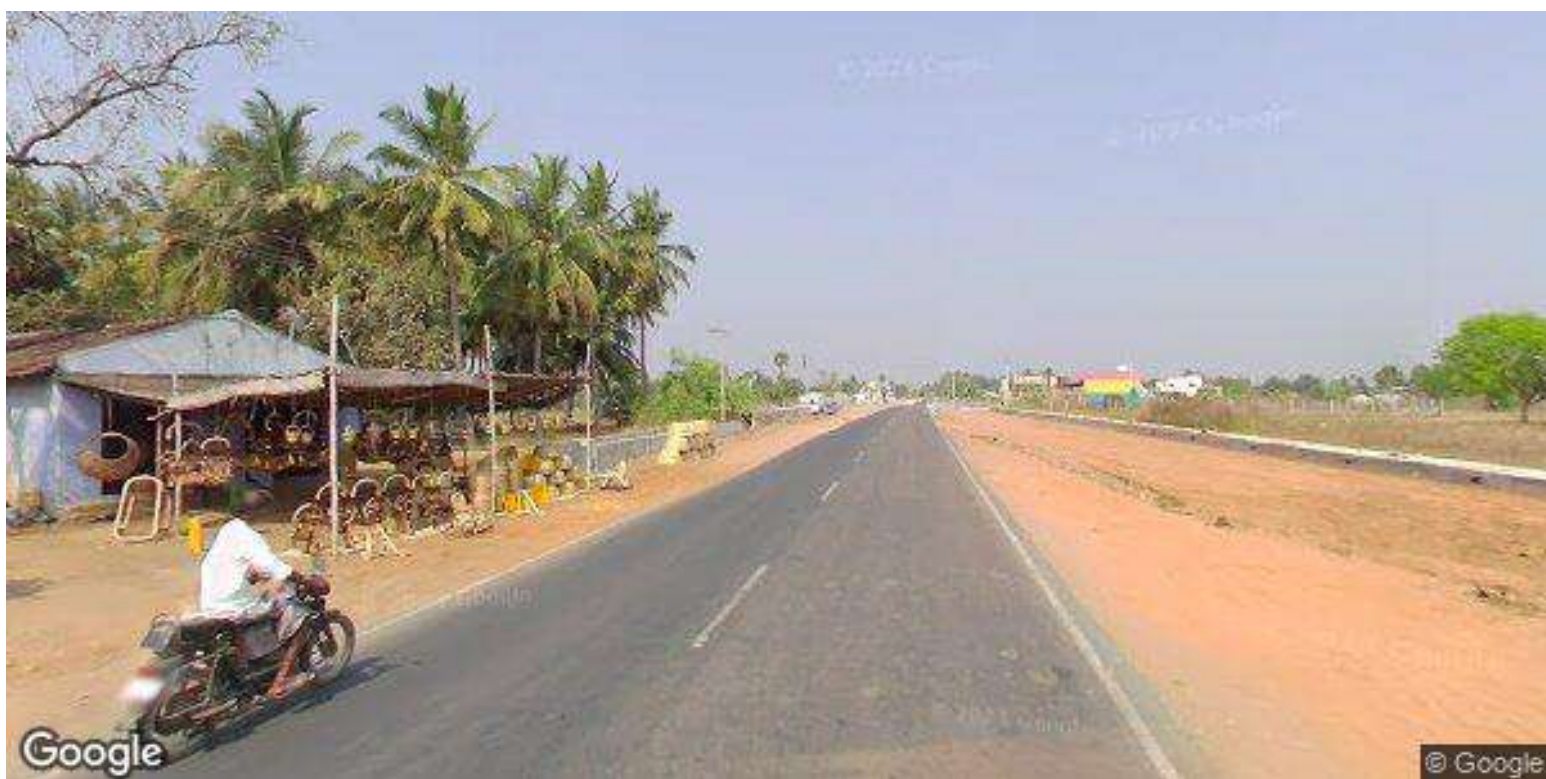
**Coordinates:** 11.59328, 77.90809

**Risk Type:** Turn

**Risk Level:** Medium

**Speed Limit:** 30 KM/Hr

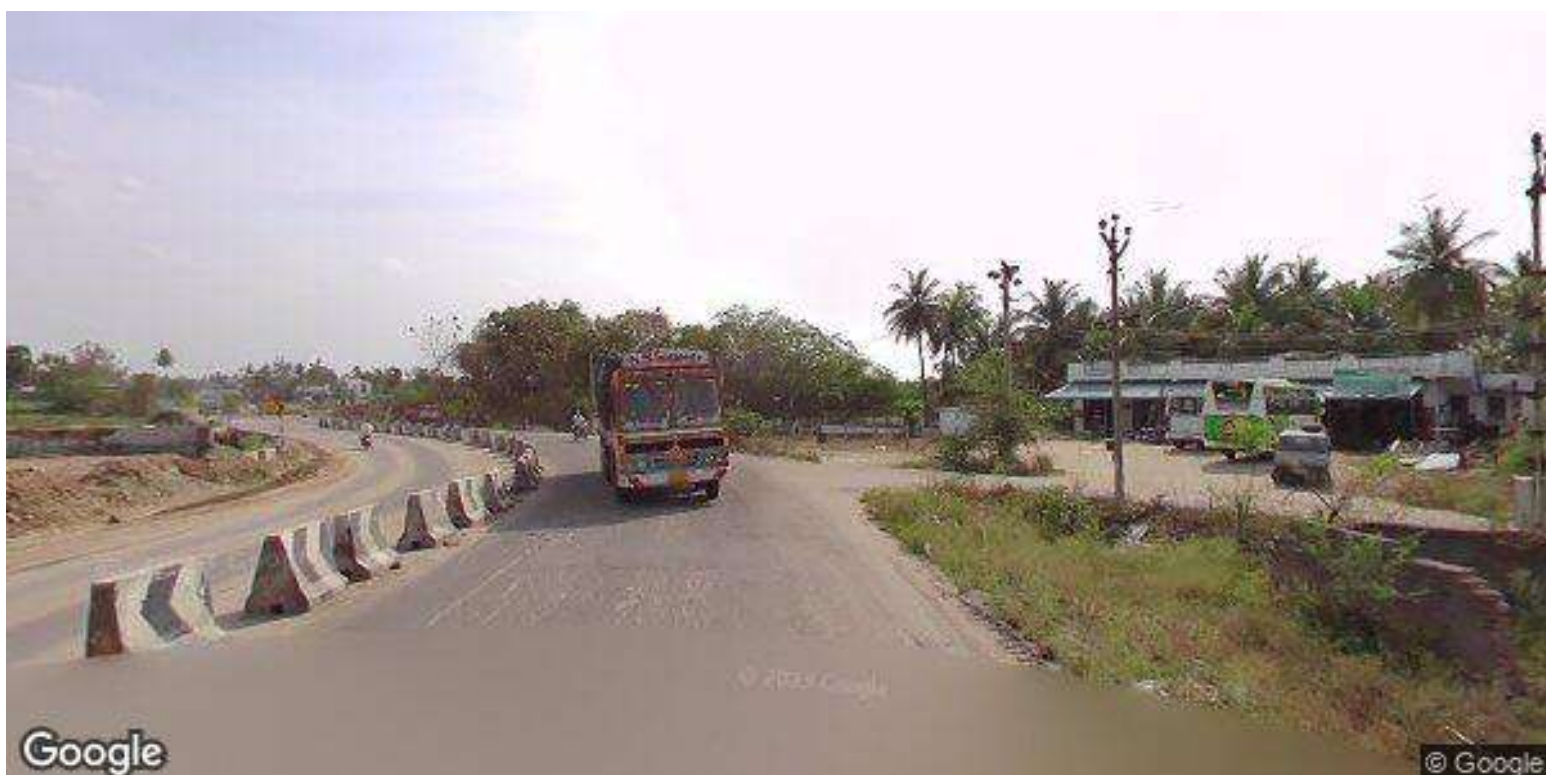
**Coordinates: 11.63867, 77.94841**

**Risk Type: Turn**

**Risk Level: Medium**

**Speed Limit: 30 KM/Hr**

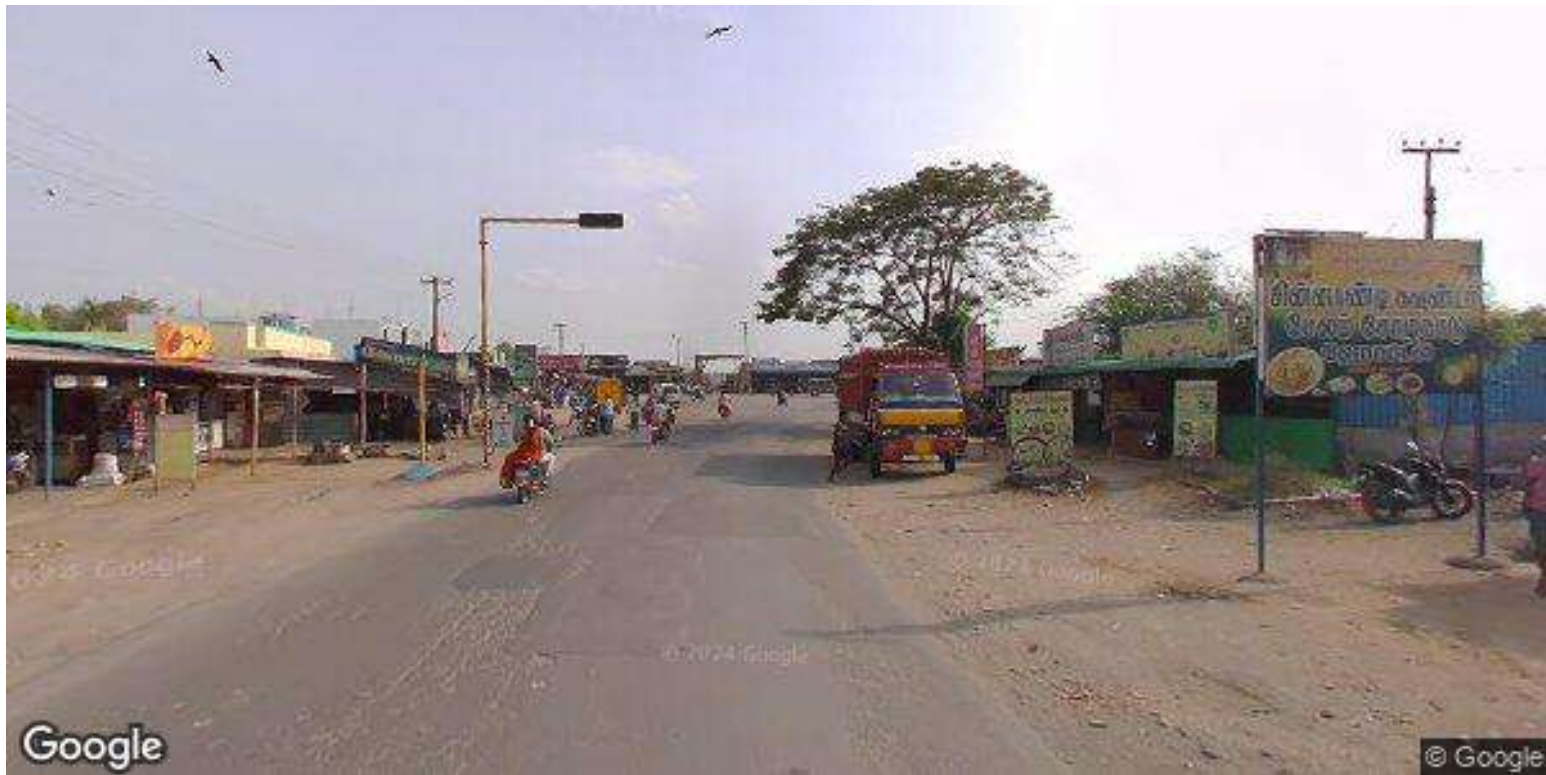
**Coordinates: 11.64217, 77.95200**

**Risk Type: Turn**

**Risk Level: High**

**Speed Limit: 15 KM/Hr**

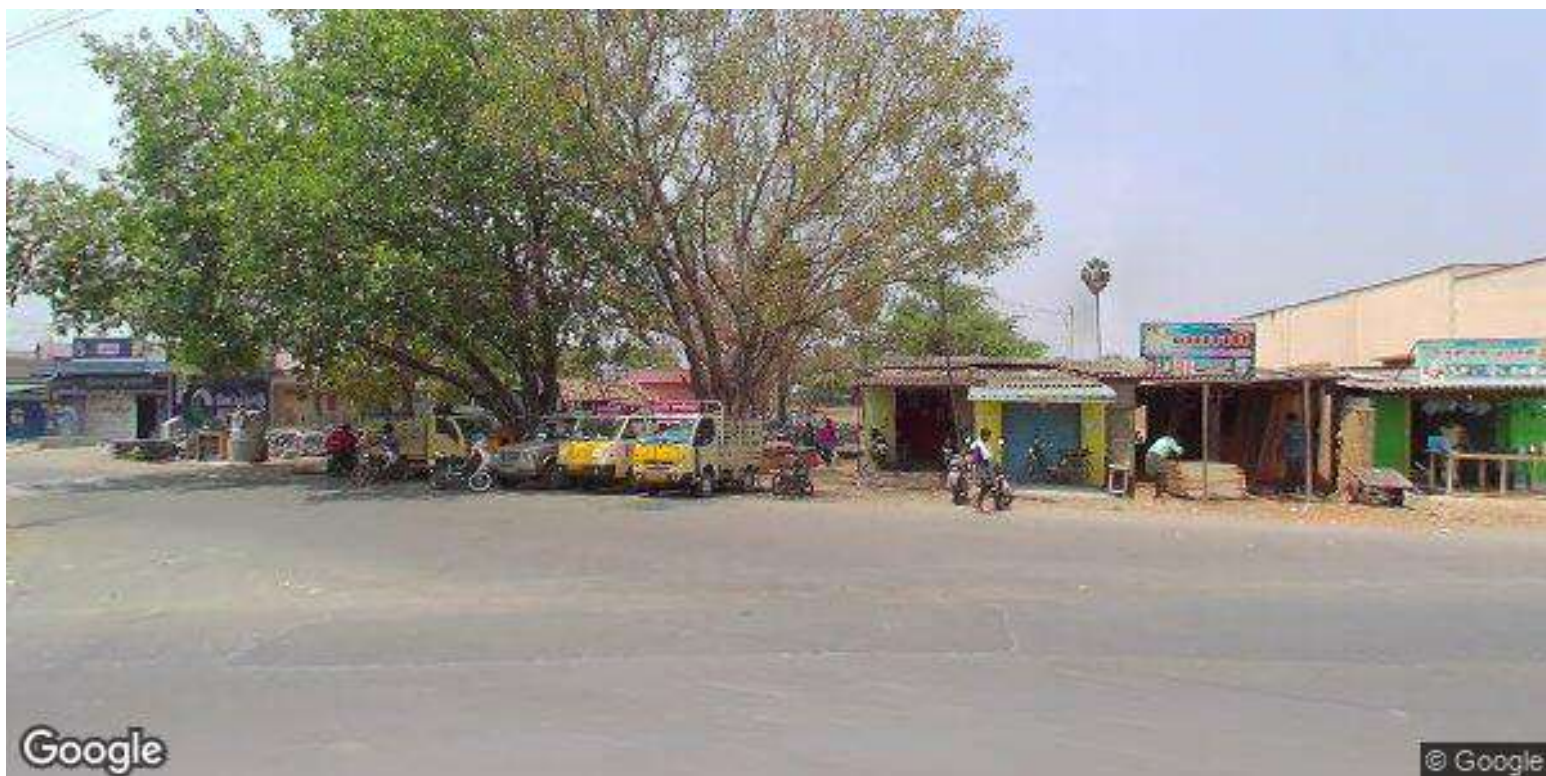
**Coordinates: 11.64712, 77.95118**

**Risk Type: Turn**

**Risk Level: Medium**

**Speed Limit: 30 KM/Hr**

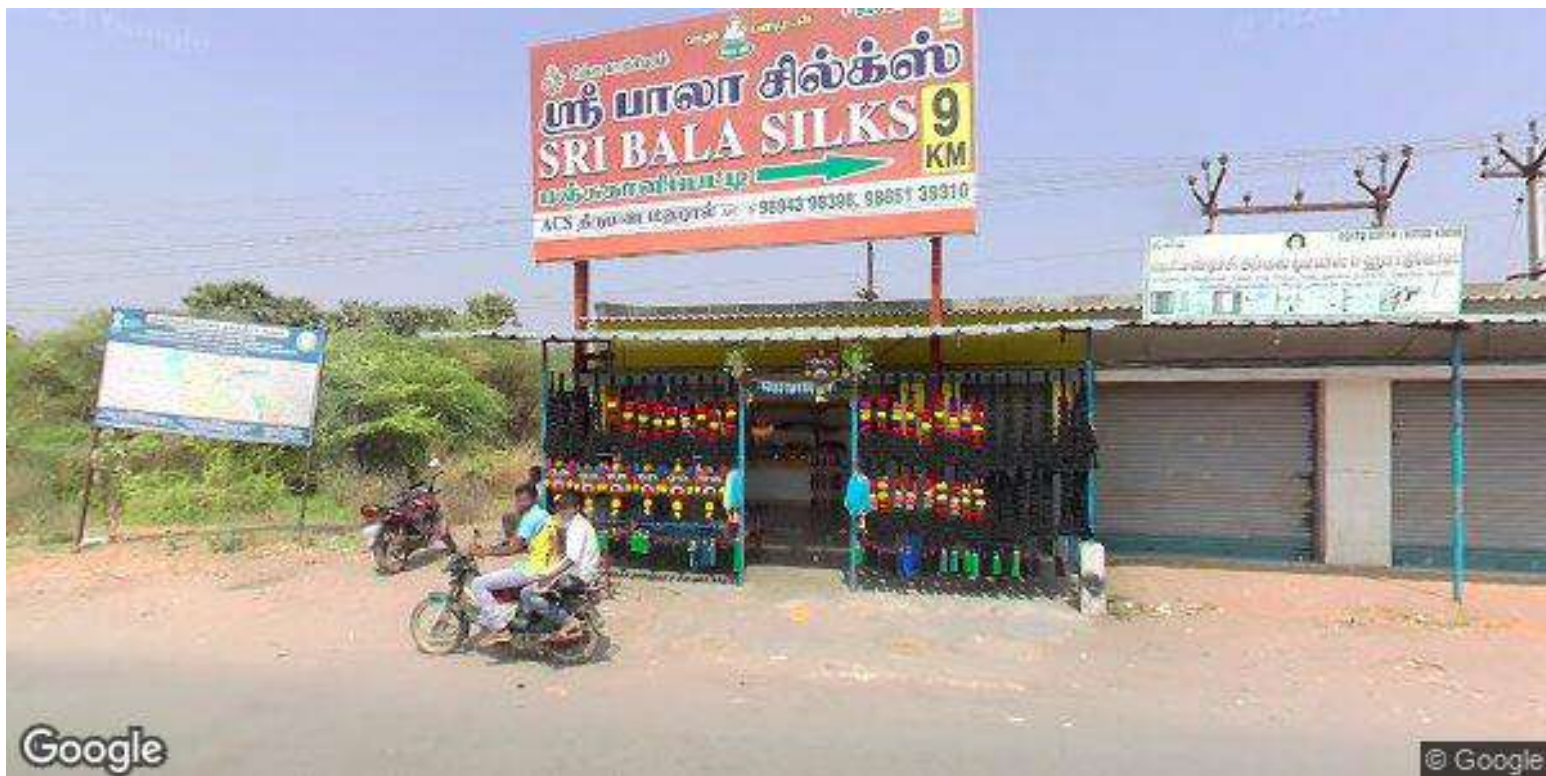
**Coordinates:** 11.70233, 77.97869

**Risk Type:** Turn

**Risk Level:** High

**Speed Limit:** 15 KM/Hr

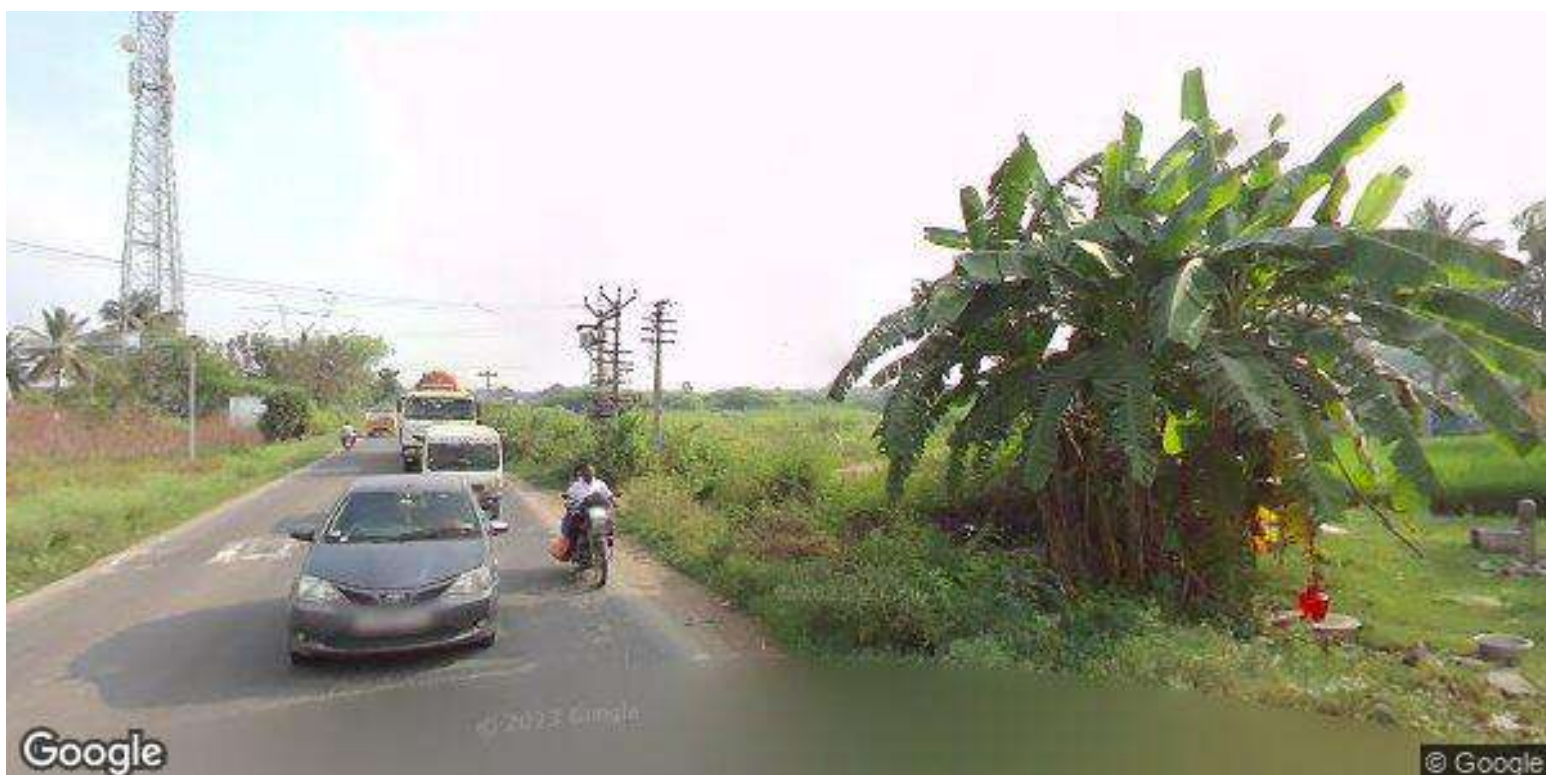
**Coordinates:** 11.71394, 77.99572

**Risk Type:** Turn

**Risk Level:** Medium

**Speed Limit:** 30 KM/Hr

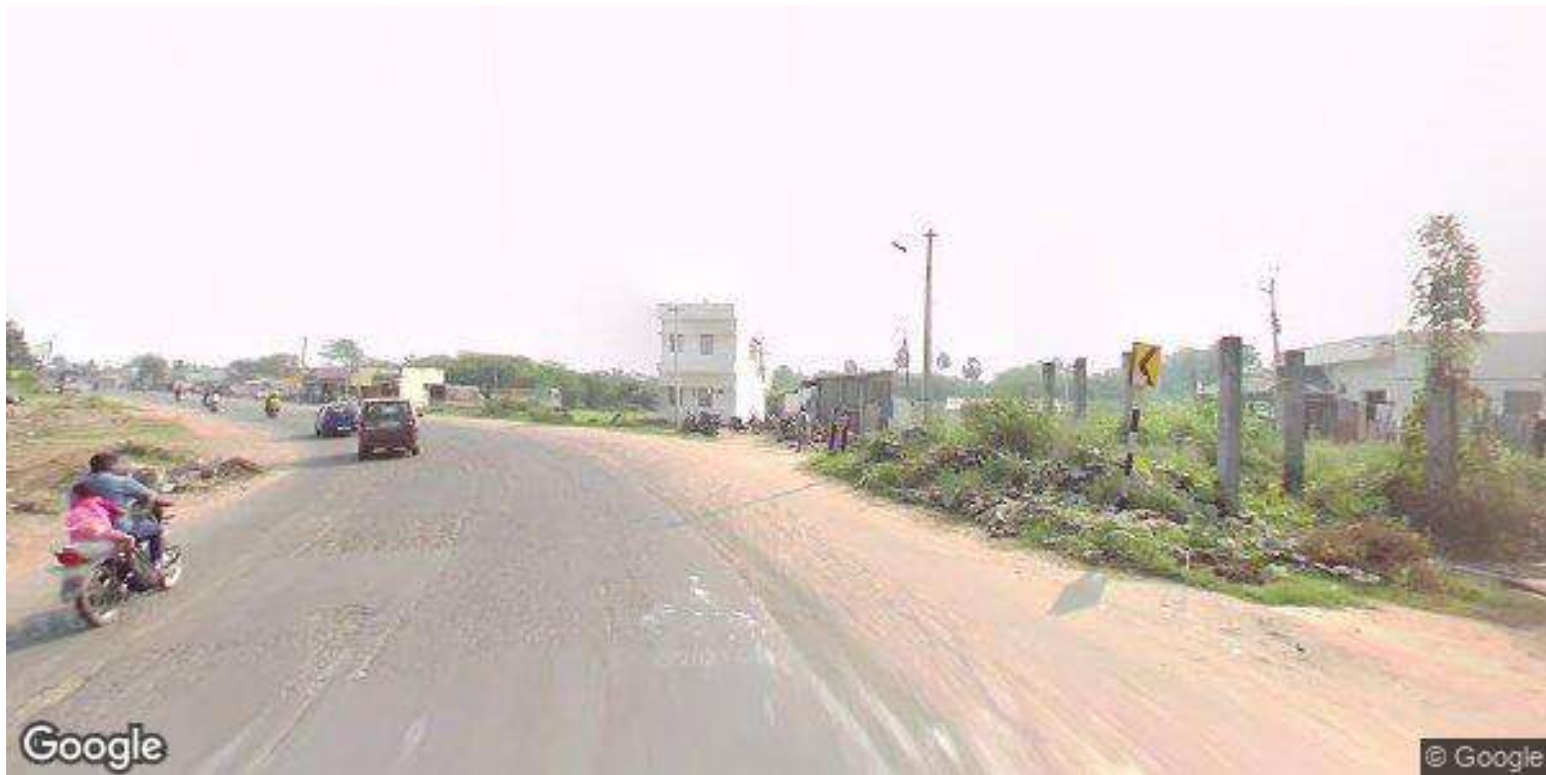
**Coordinates:** 11.71916, 78.01117

**Risk Type:** Turn

**Risk Level:** Medium

**Speed Limit:** 30 KM/Hr

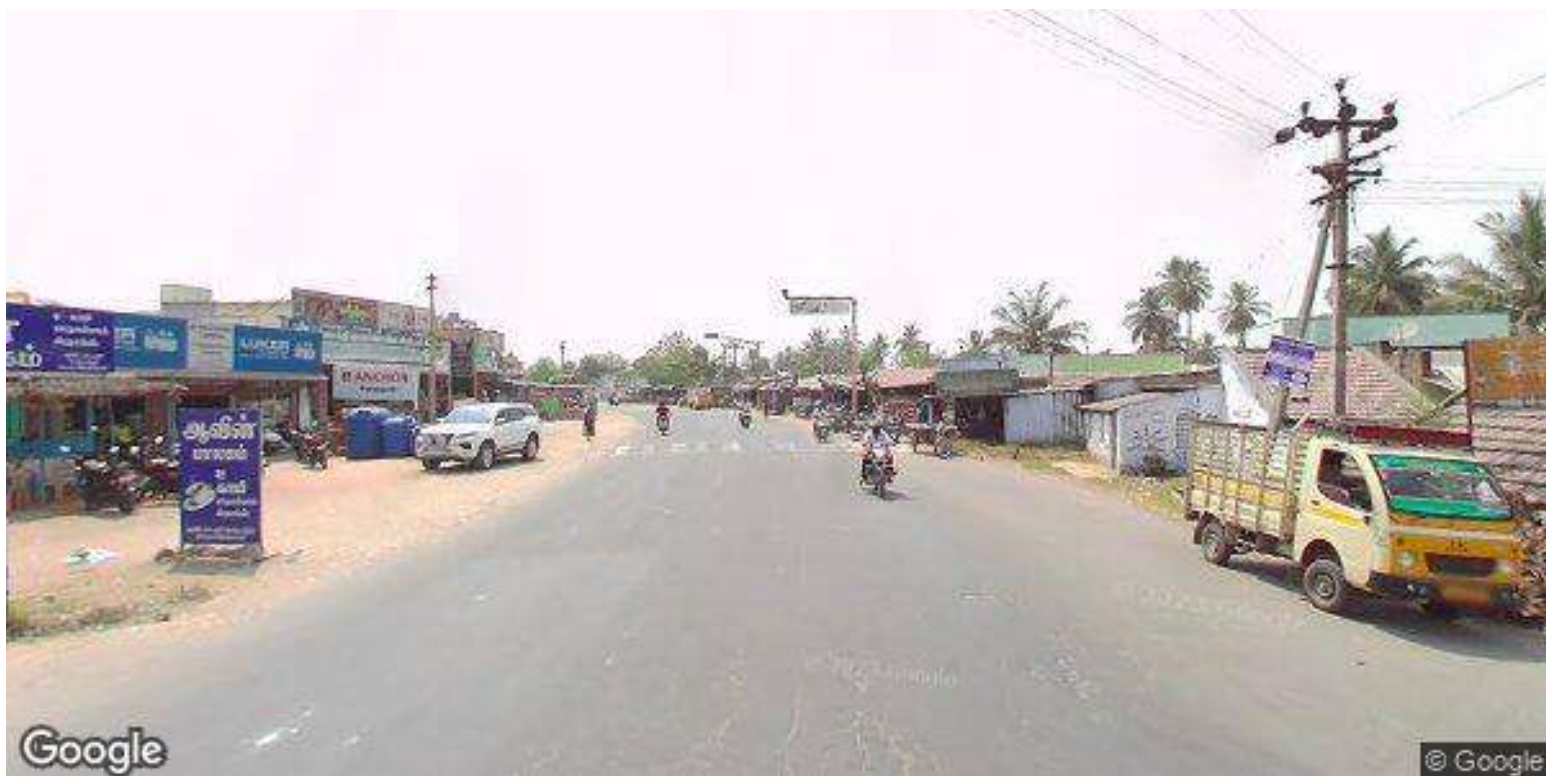
**Coordinates:** 11.73787, 78.03528

**Risk Type:** Turn

**Risk Level:** Medium

**Speed Limit:** 30 KM/Hr

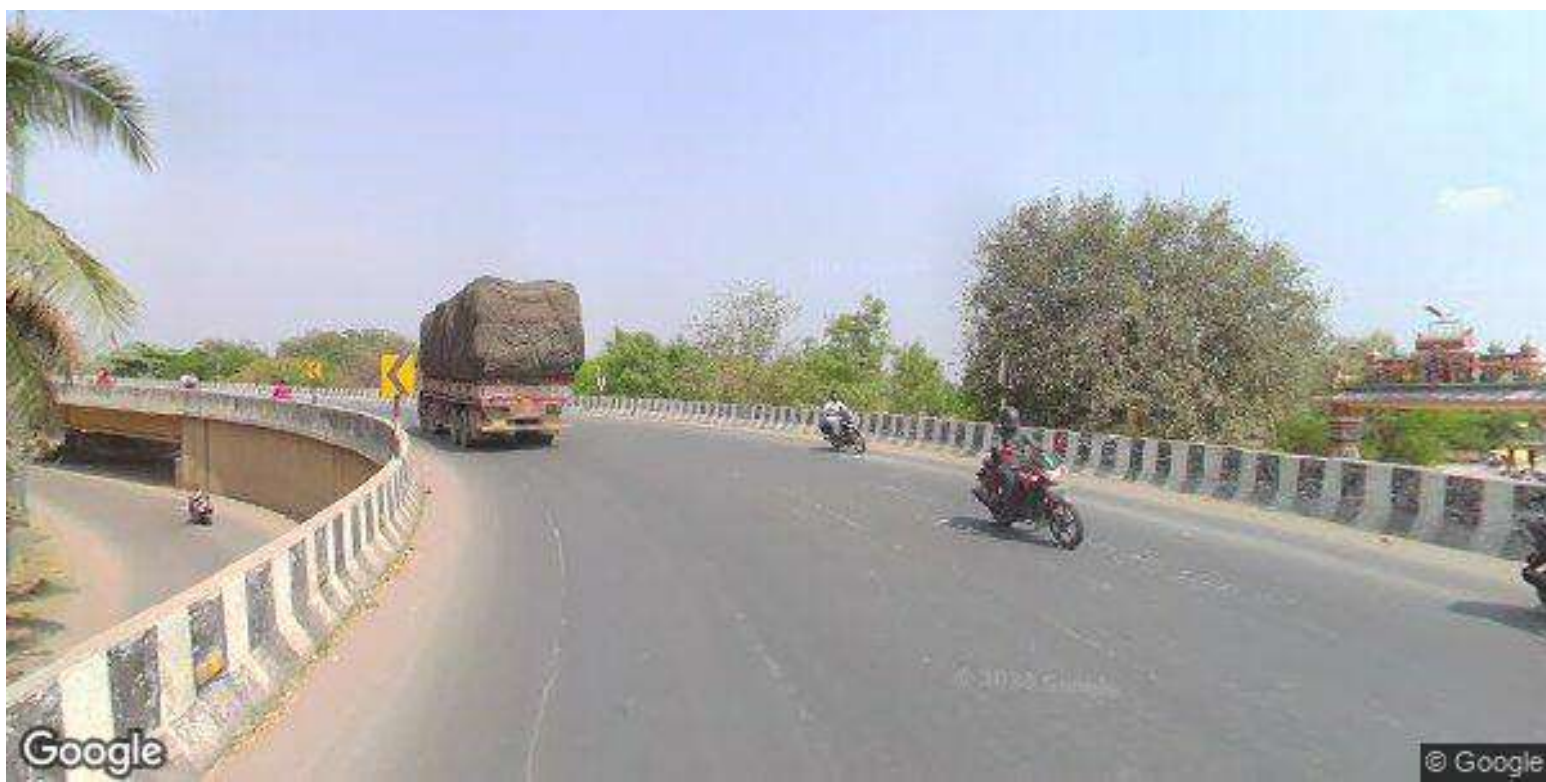
**Coordinates:** 11.73651, 78.03868

**Risk Type:** Turn

**Risk Level:** High

**Speed Limit:** 15 KM/Hr

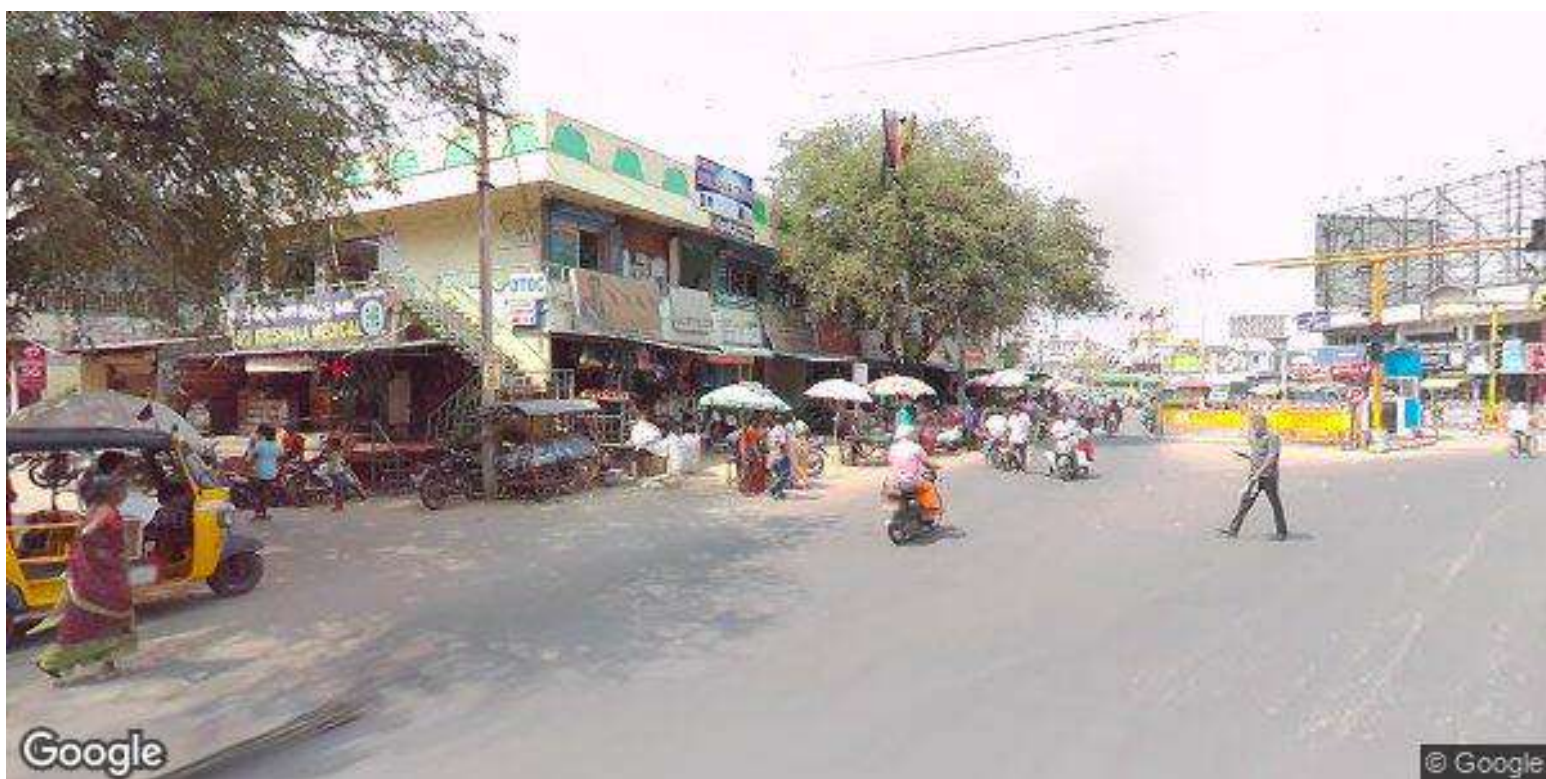
**Coordinates:** 11.74257, 78.04708

**Risk Type:** Turn

**Risk Level:** Medium

**Speed Limit:** 30 KM/Hr

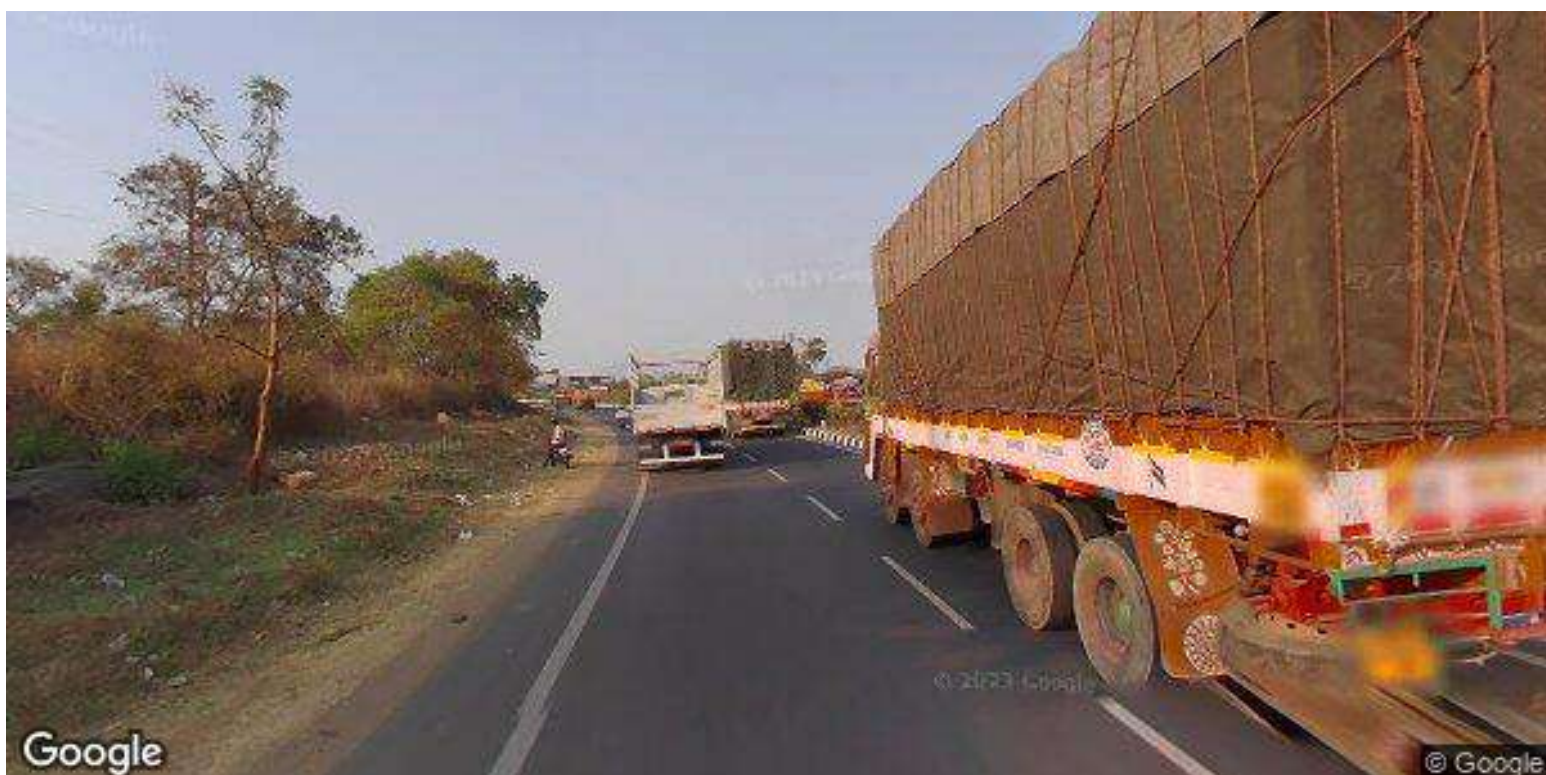
**Coordinates:** 11.77998, 78.05786

**Risk Type:** Turn

**Risk Level:** Medium

**Speed Limit:** 30 KM/Hr

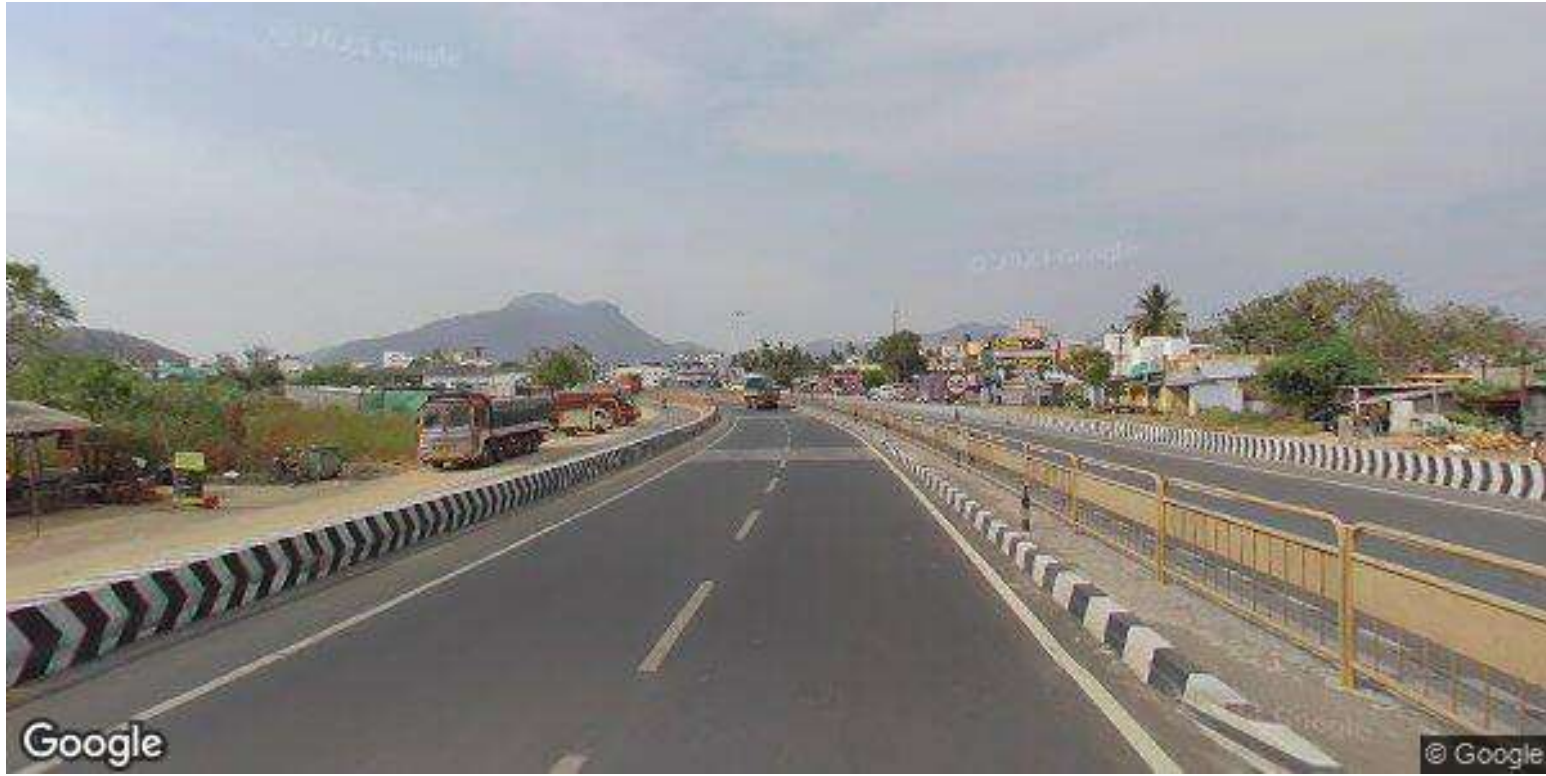
**Coordinates:** 11.86915, 78.08382

**Risk Type:** Turn

**Risk Level:** Medium

**Speed Limit:** 30 KM/Hr

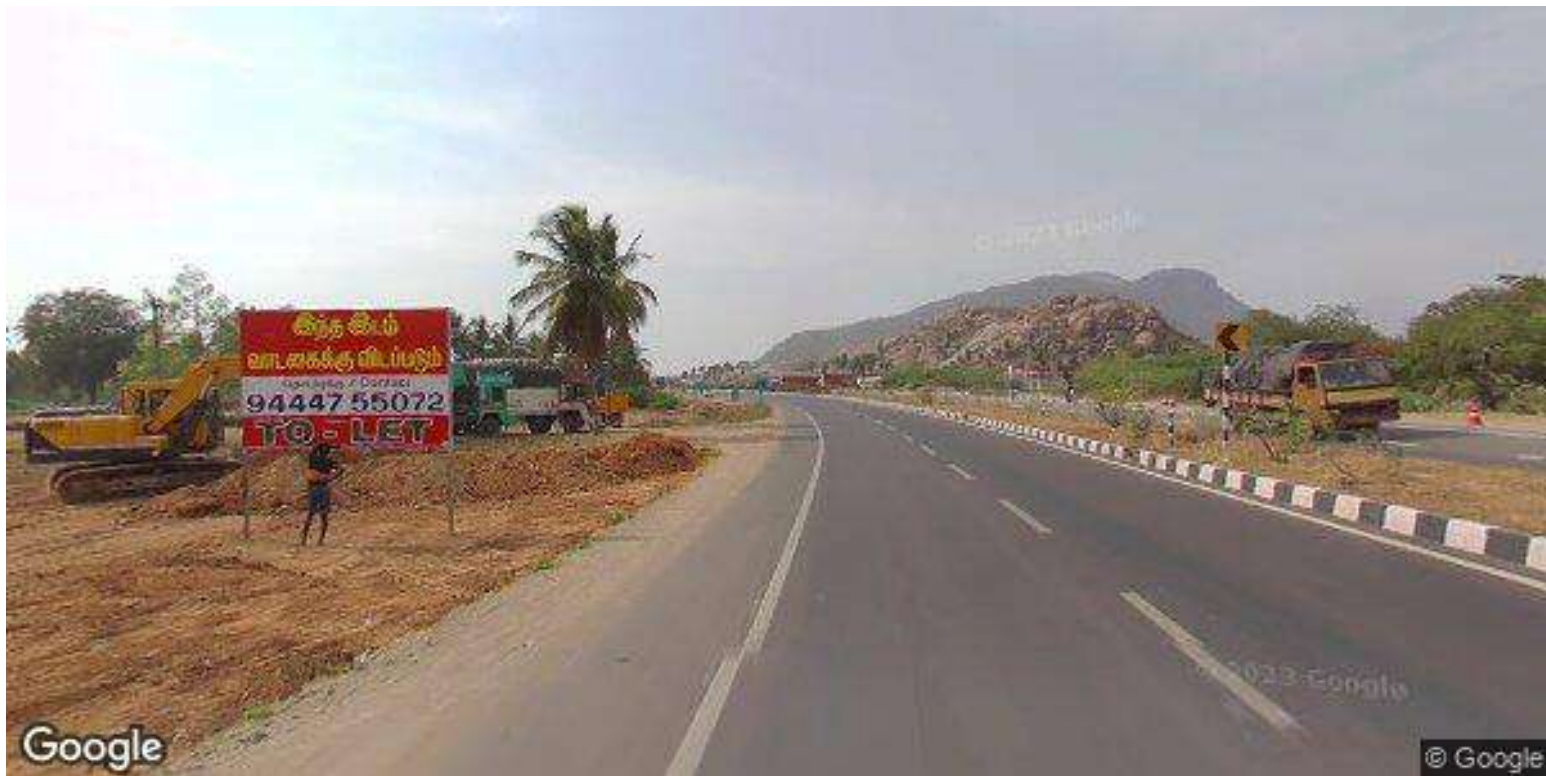
**Coordinates:** 11.87998, 78.08170

**Risk Type:** Turn

**Risk Level:** Medium

**Speed Limit:** 30 KM/Hr

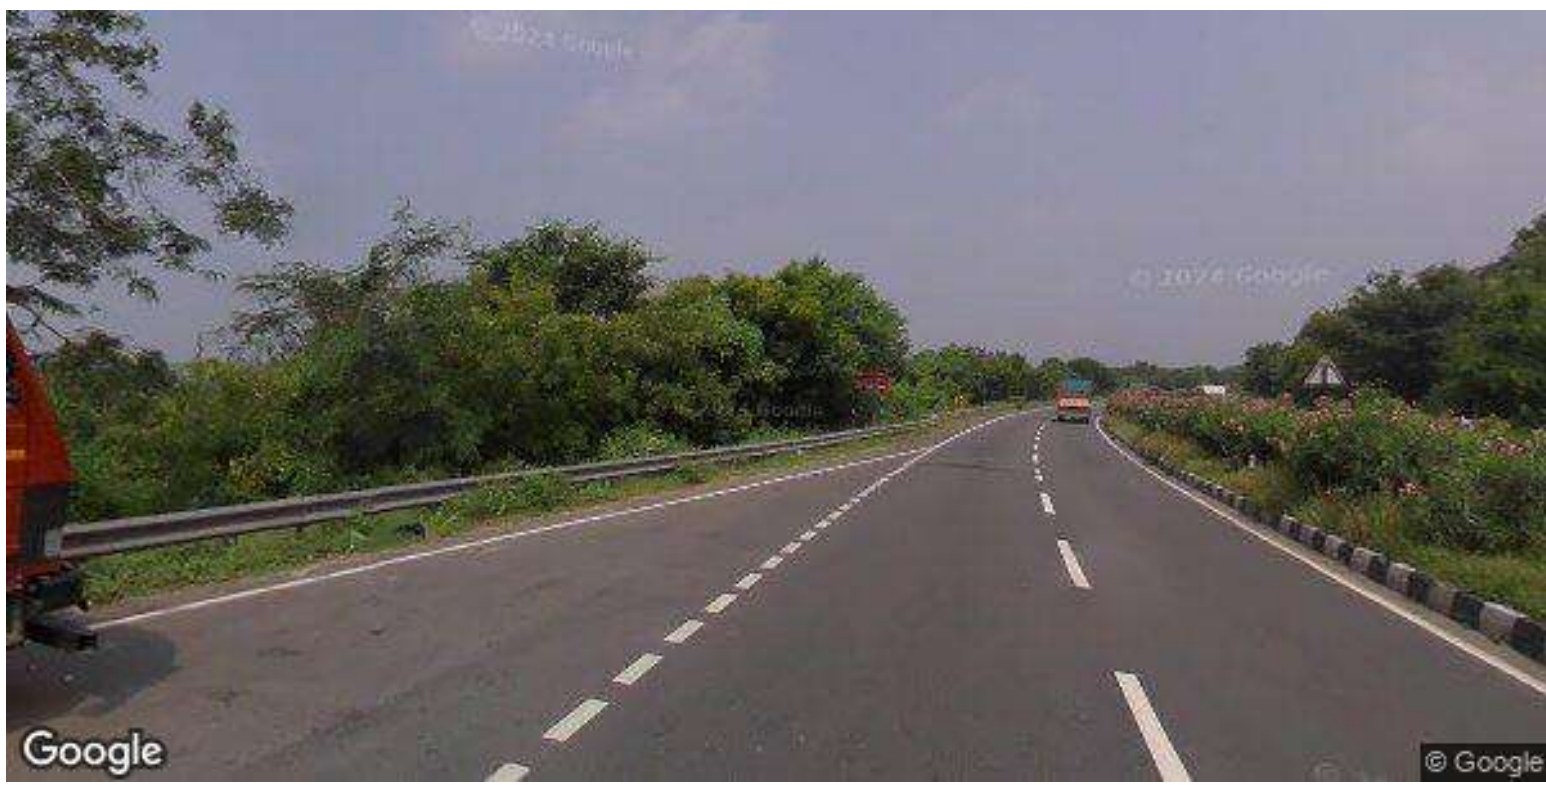
**Coordinates:** 11.91266, 78.05852

**Risk Type:** Turn

**Risk Level:** Medium

**Speed Limit:** 30 KM/Hr
