## JOURNEY RISK MANAGEMENT (JRM) STUDY

**Salem Terminal TO KAVERIPATTINAM APCMS LTD.**

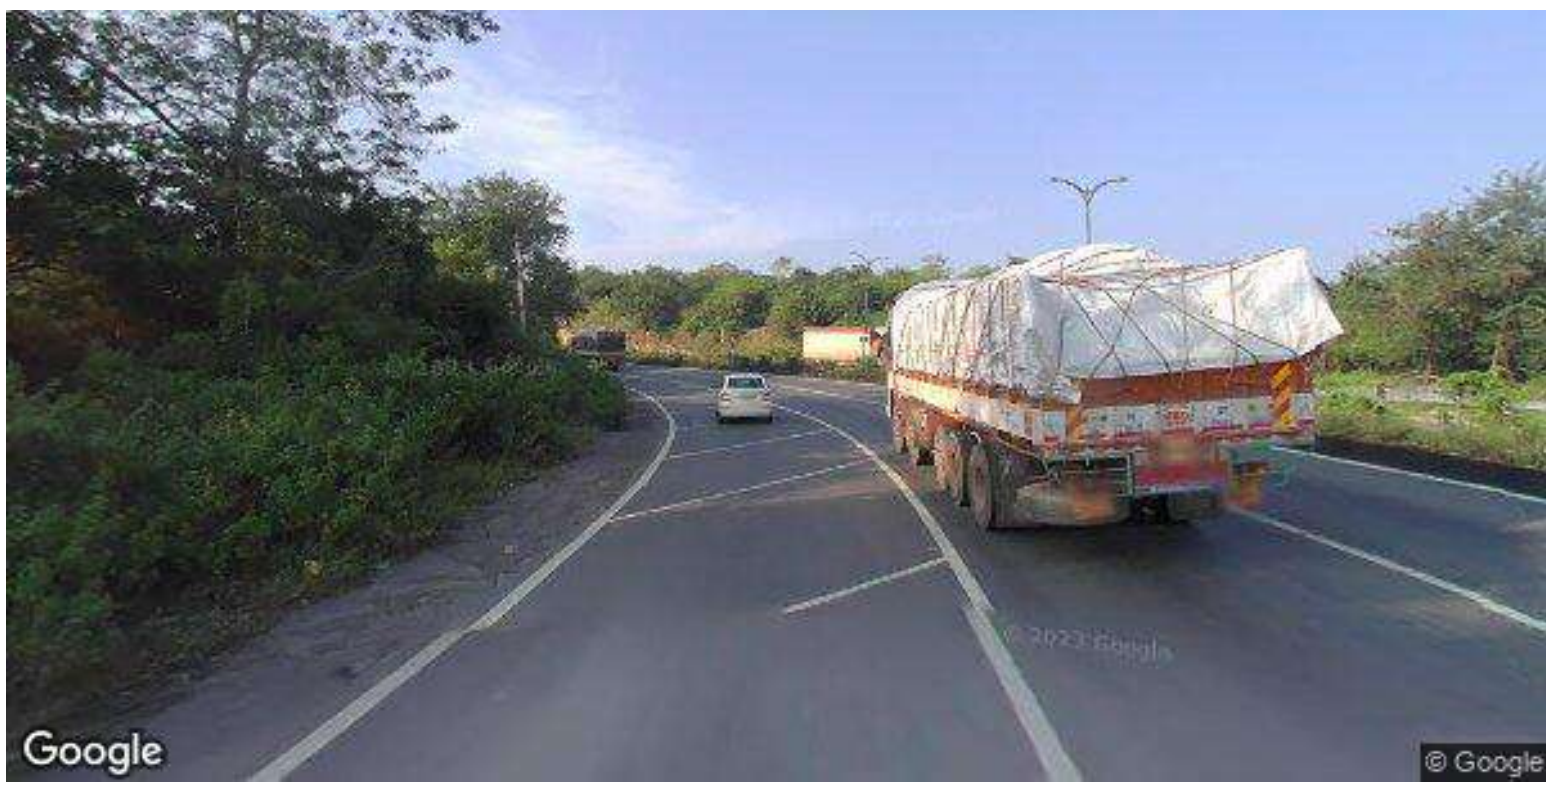
**Coordinates:** 11.96370, 78.05142

**Risk Type:** Turn

**Risk Level:** Medium

**Speed Limit:** 30 KM/Hr

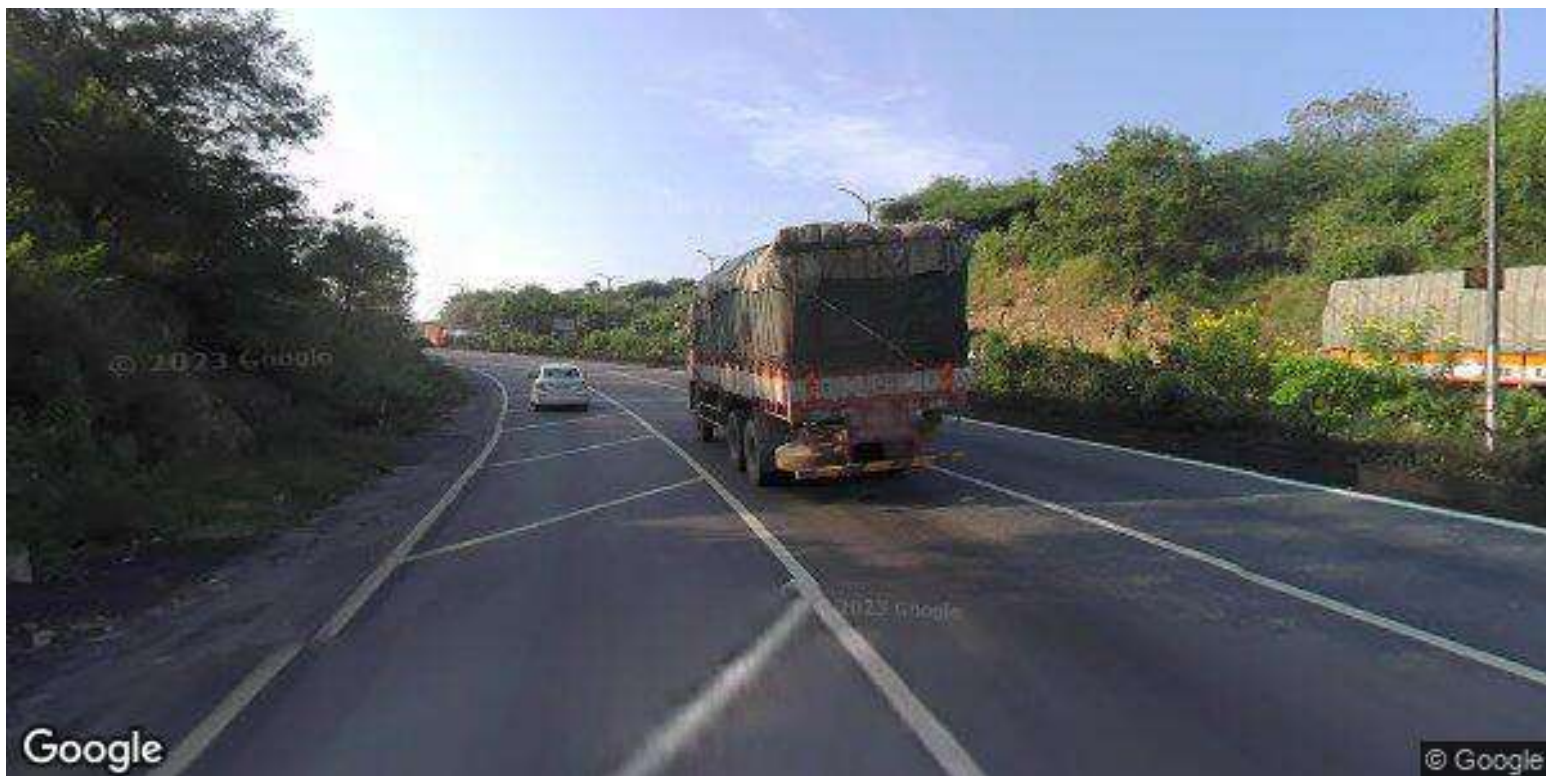
**Coordinates:** 11.96433, 78.05113

**Risk Type:** Turn

**Risk Level:** Medium

**Speed Limit:** 30 KM/Hr

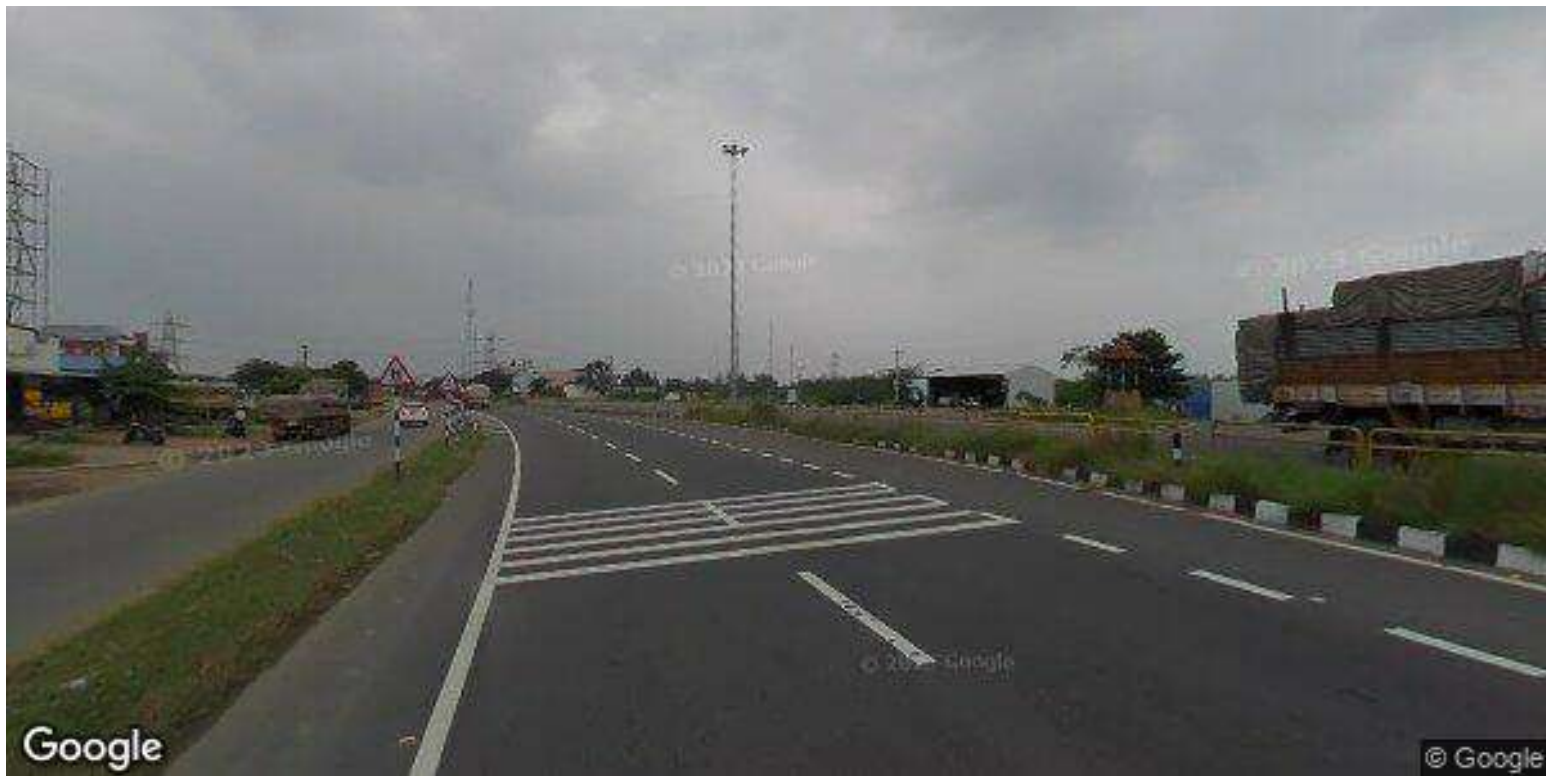
**Risk Type:** Turn  
**Risk Level:** Medium  
**Speed Limit:** 30 KM/Hr  
**Coordinates:** 12.17041, 78.16823

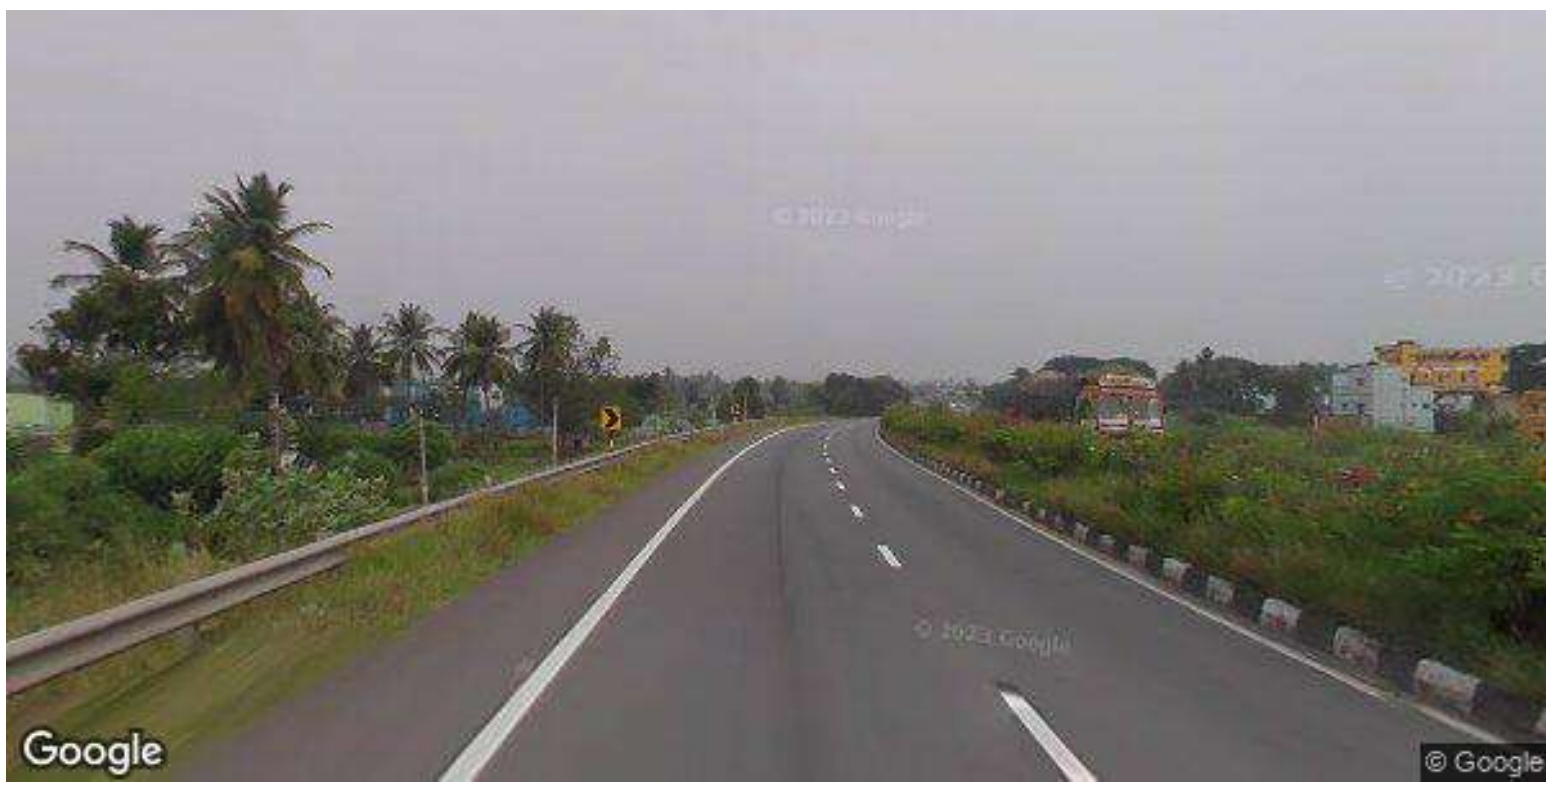
**Coordinates:** 12.22515, 78.19158

**Risk Type:** Turn

**Risk Level:** Medium

**Speed Limit:** 30 KM/Hr

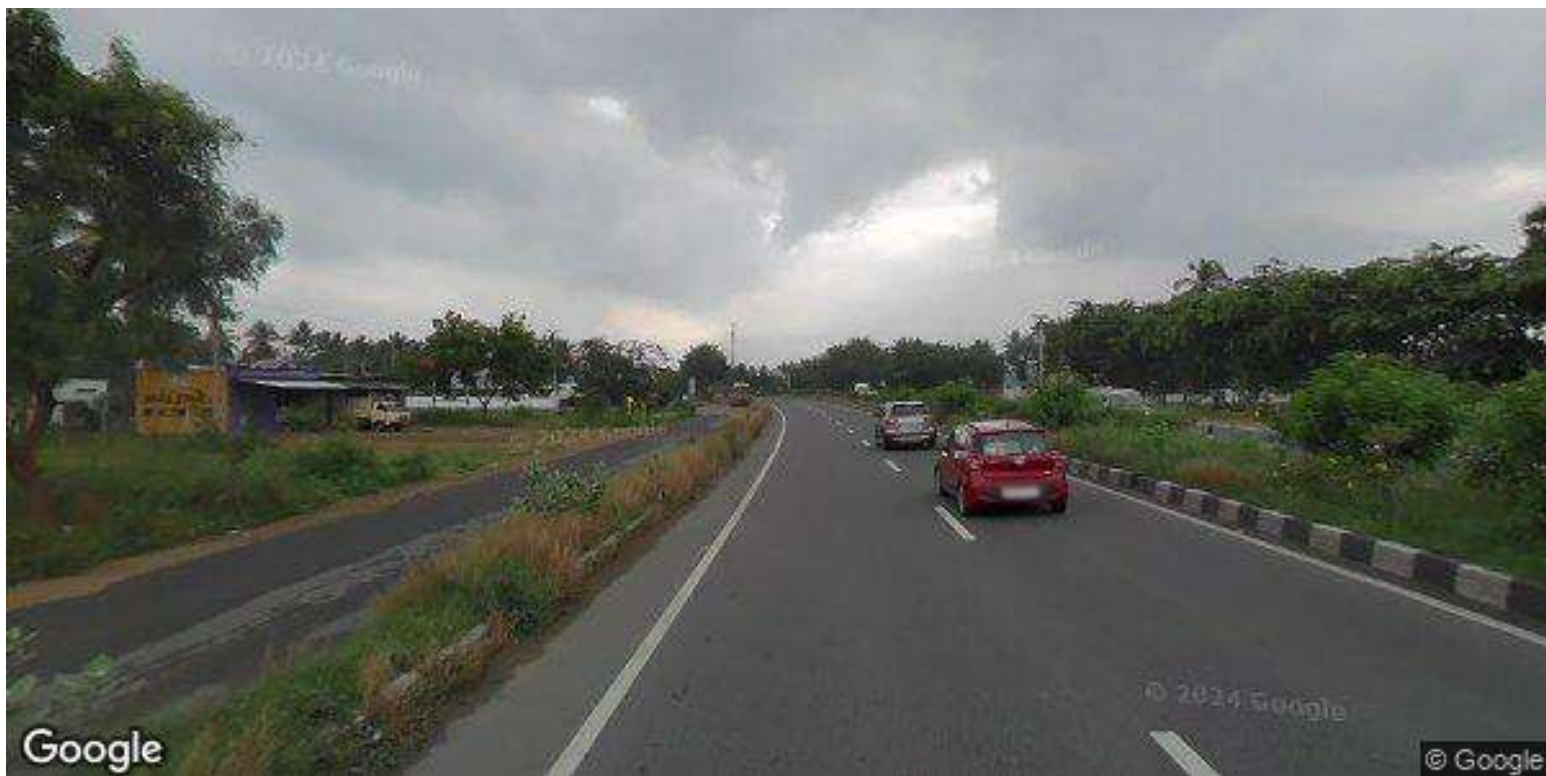
**Coordinates:** 12.22995, 78.19466

**Risk Type:** Turn

**Risk Level:** Medium

**Speed Limit:** 30 KM/Hr

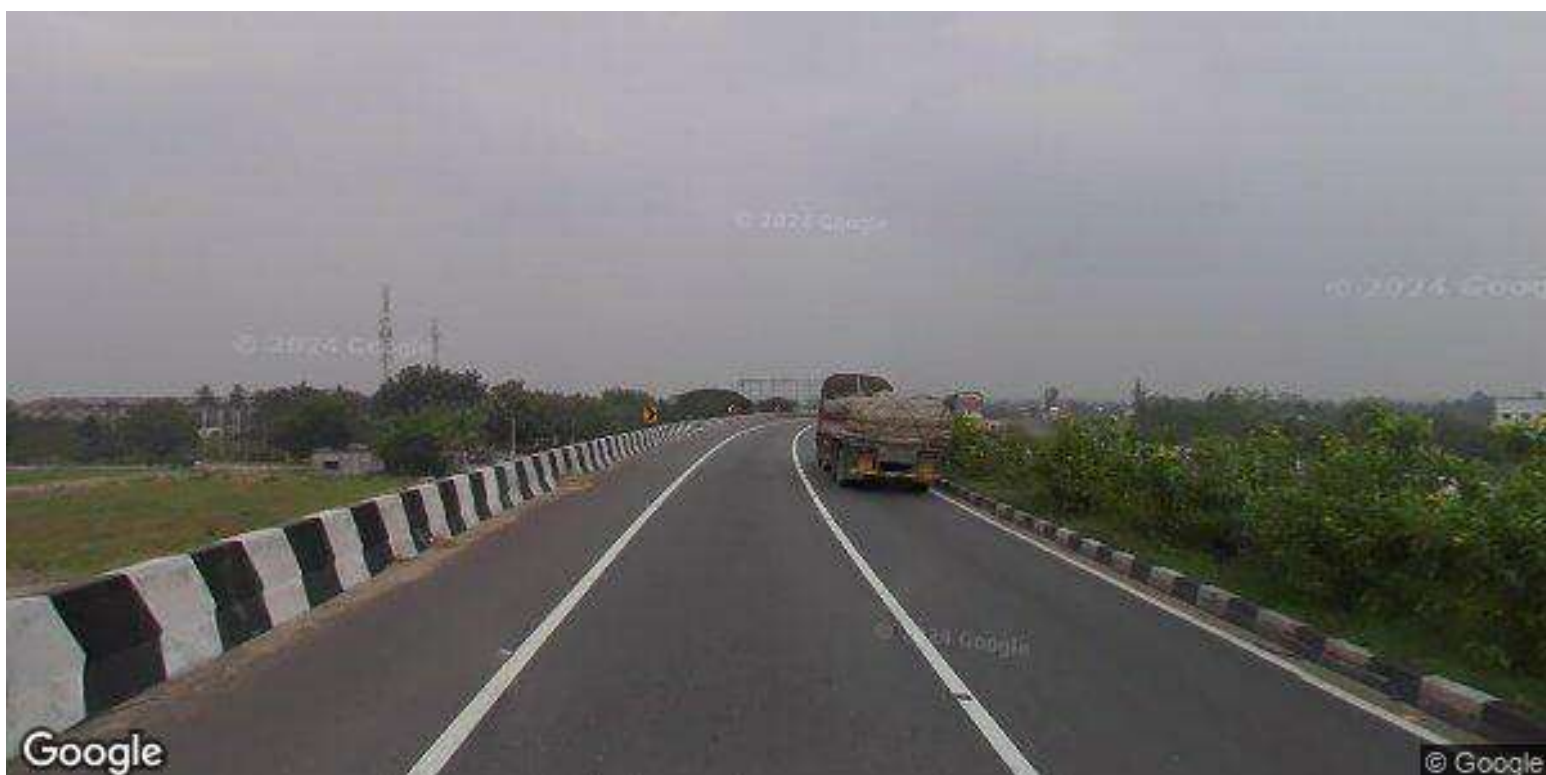
**Risk Type:** Turn  
**Risk Level:** Medium  
**Speed Limit:** 30 KM/Hr  
**Coordinates:** 12.24547, 78.19501

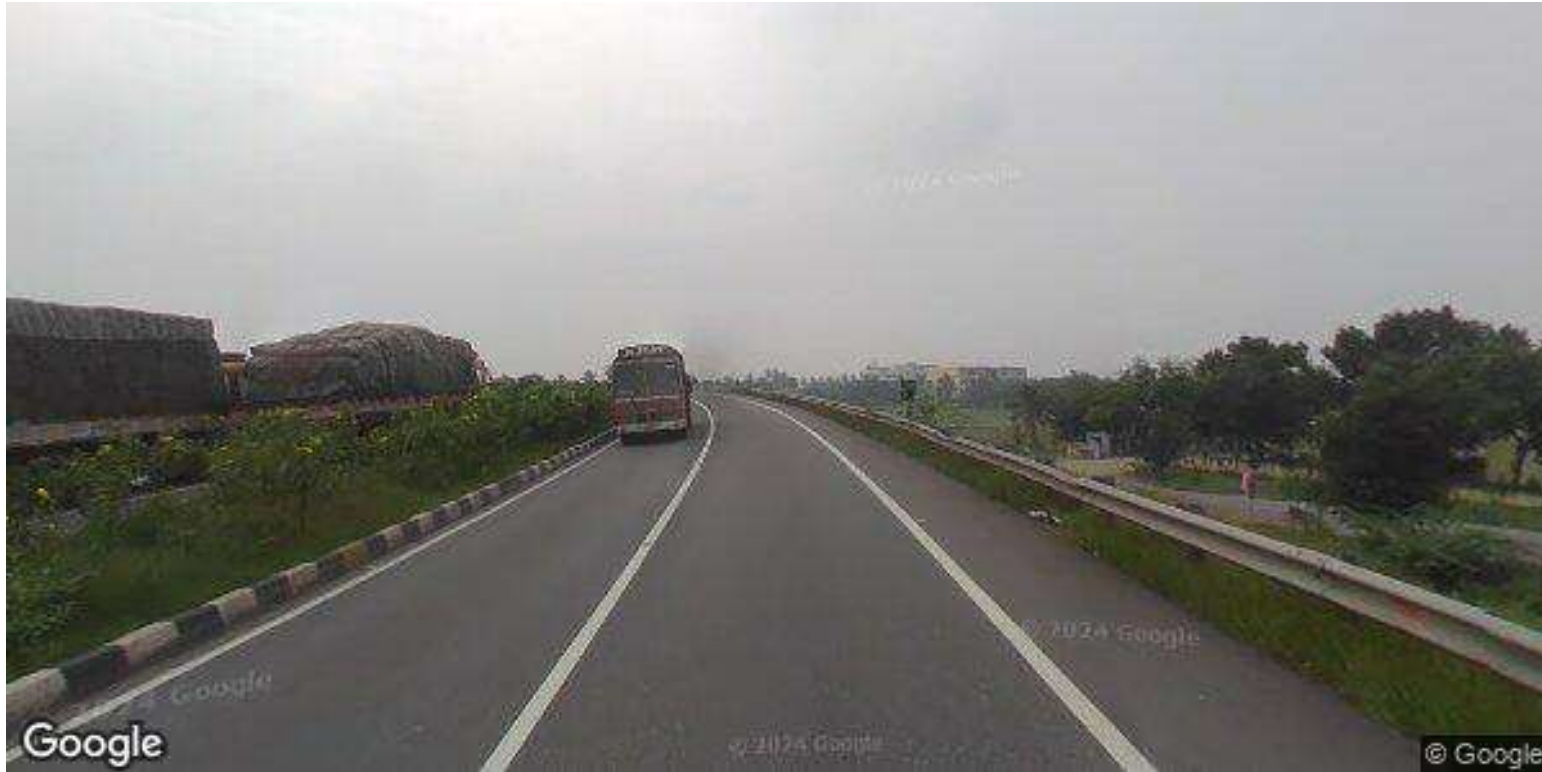
**Risk Type:** Turn  
**Risk Level:** Medium  
**Speed Limit:** 30 KM/Hr  
**Coordinates:** 12.24685, 78.19561

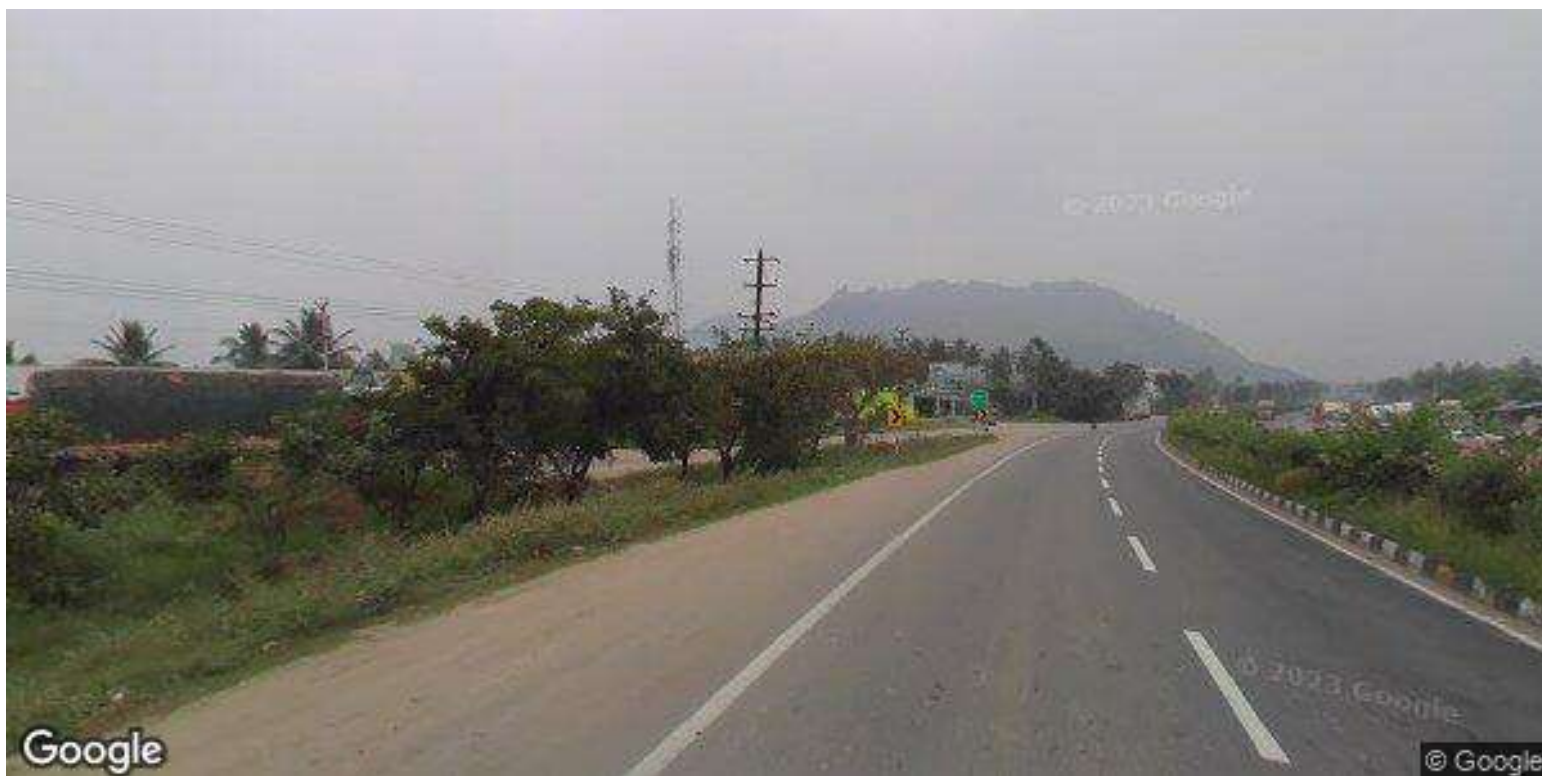
**Risk Type:** Turn  
**Risk Level:** Medium  
**Speed Limit:** 30 KM/Hr  
**Coordinates:** 12.31992, 78.20732

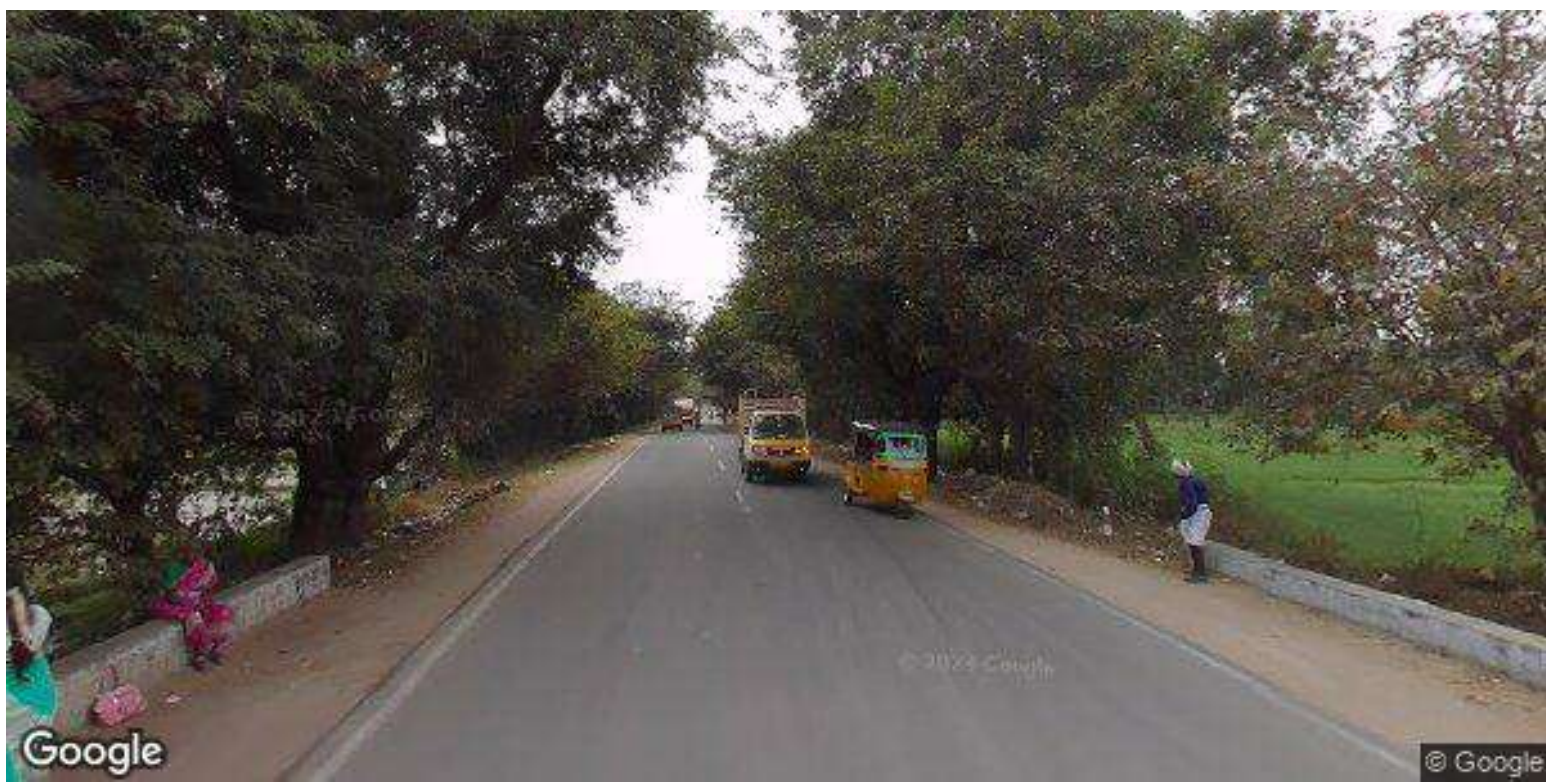
**Risk Type:** Blind Spot  
**Risk Level:** Blind Spot  
**Speed Limit:** 10 KM/Hr  
**Coordinates:** 12.40692, 78.21762

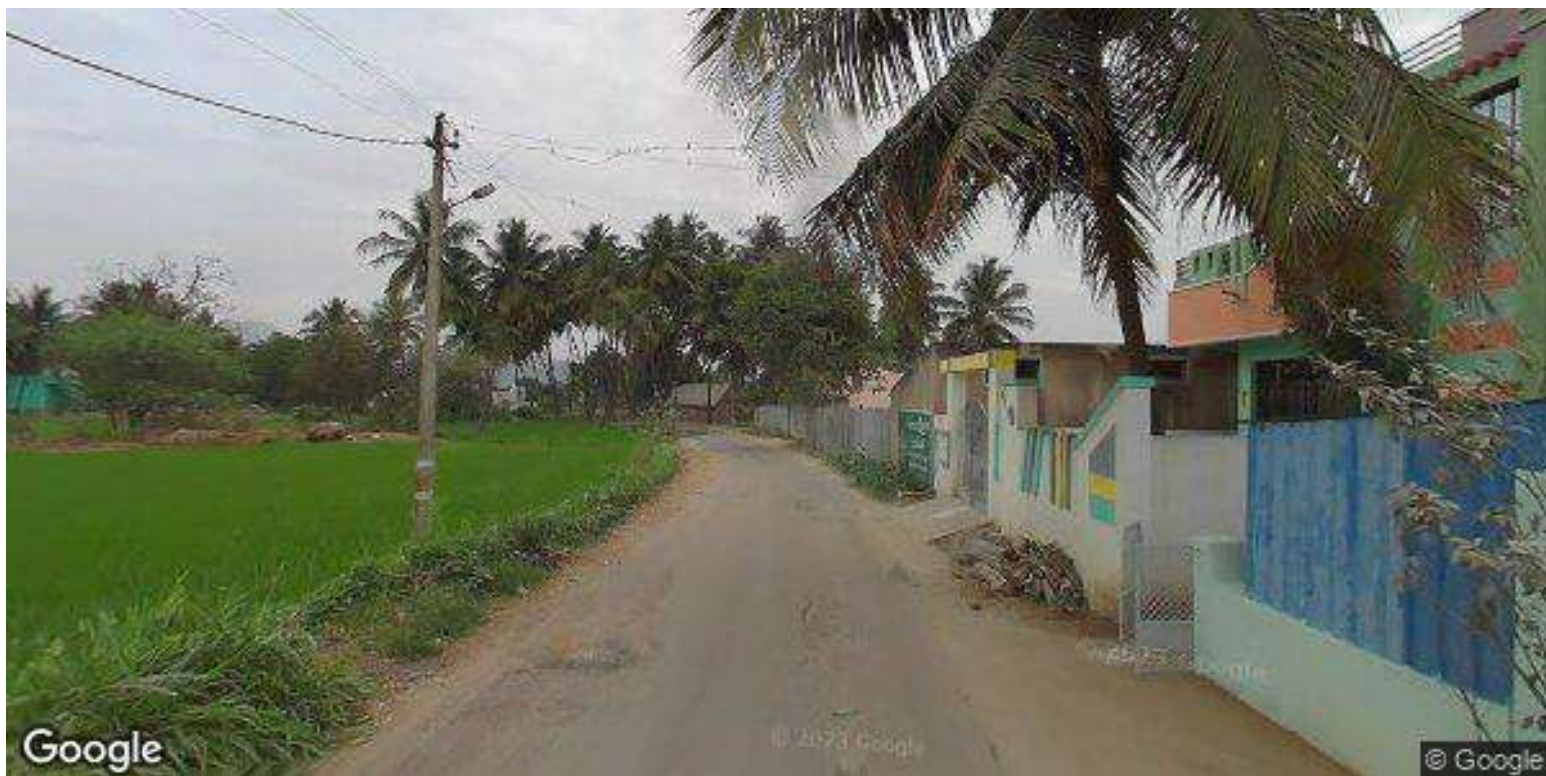
**Risk Type:** Turn  
**Risk Level:** Medium  
**Speed Limit:** 30 KM/Hr  
**Coordinates:** 12.40632, 78.22017

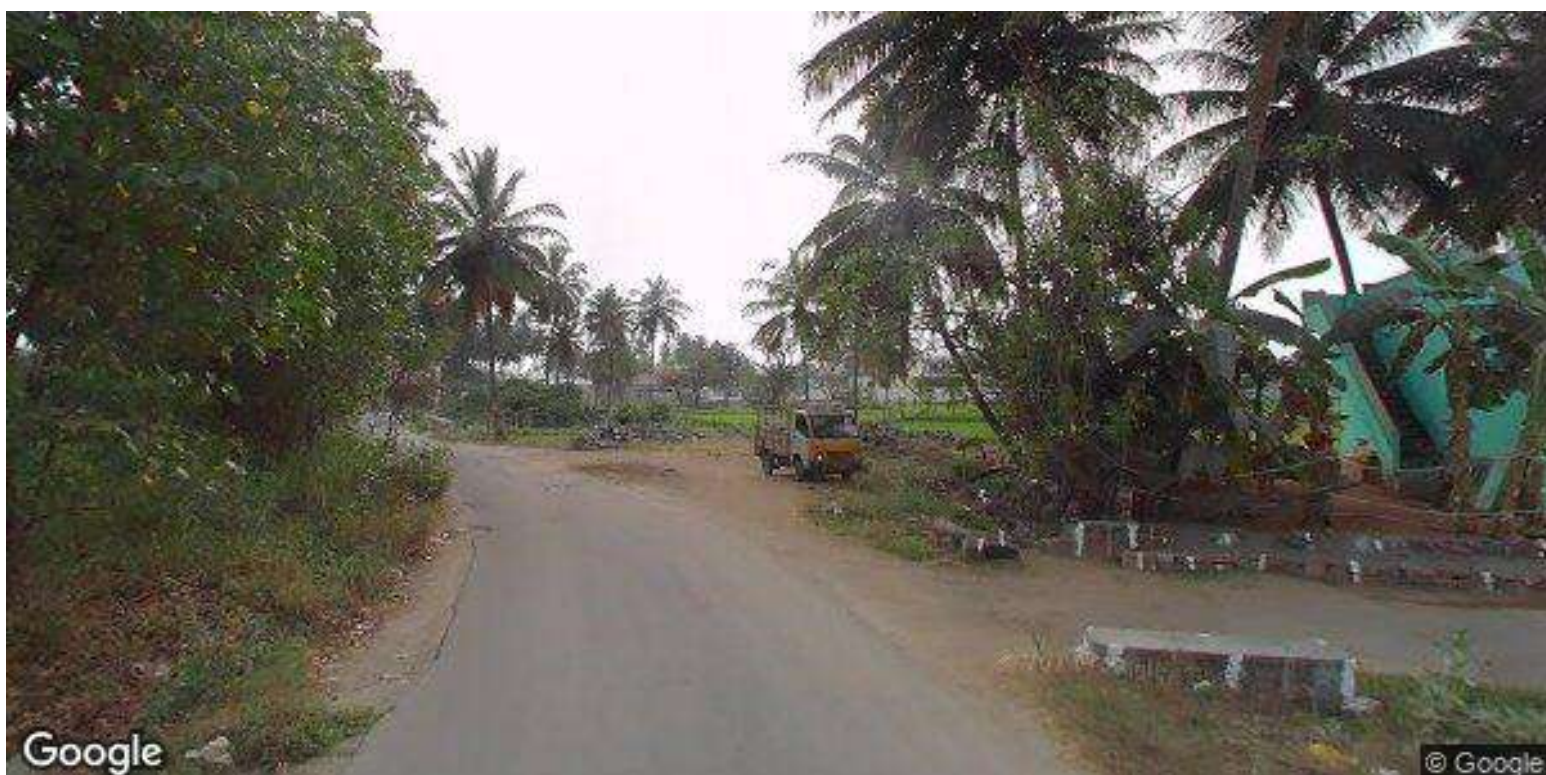
**Risk Type:** Turn  
**Risk Level:** Medium  
**Speed Limit:** 30 KM/Hr  
**Coordinates:** 12.40687, 78.22133

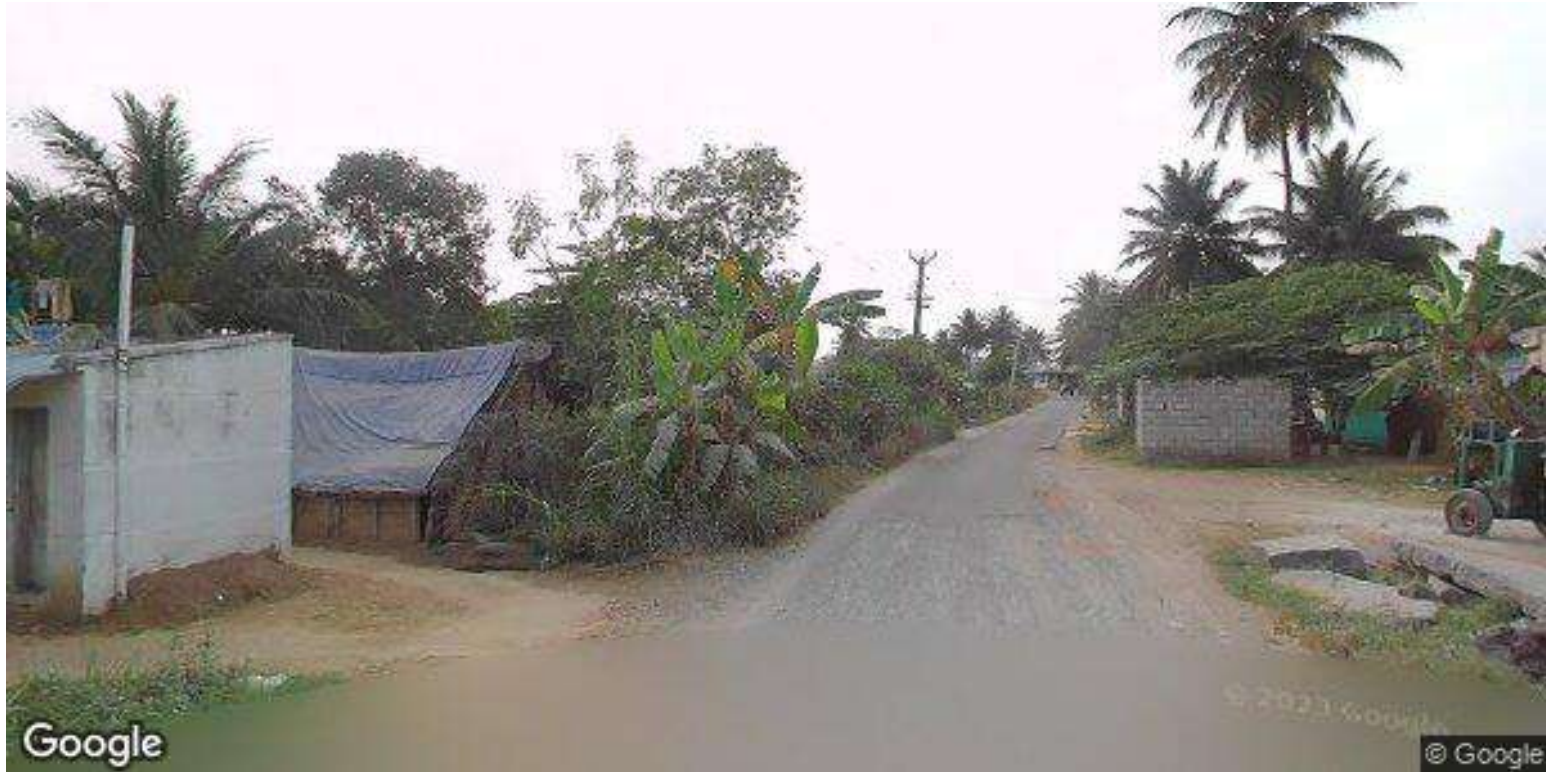
**Risk Type:** Turn  
**Risk Level:** High  
**Speed Limit:** 15 KM/Hr  
**Coordinates:** 12.40667, 78.22271

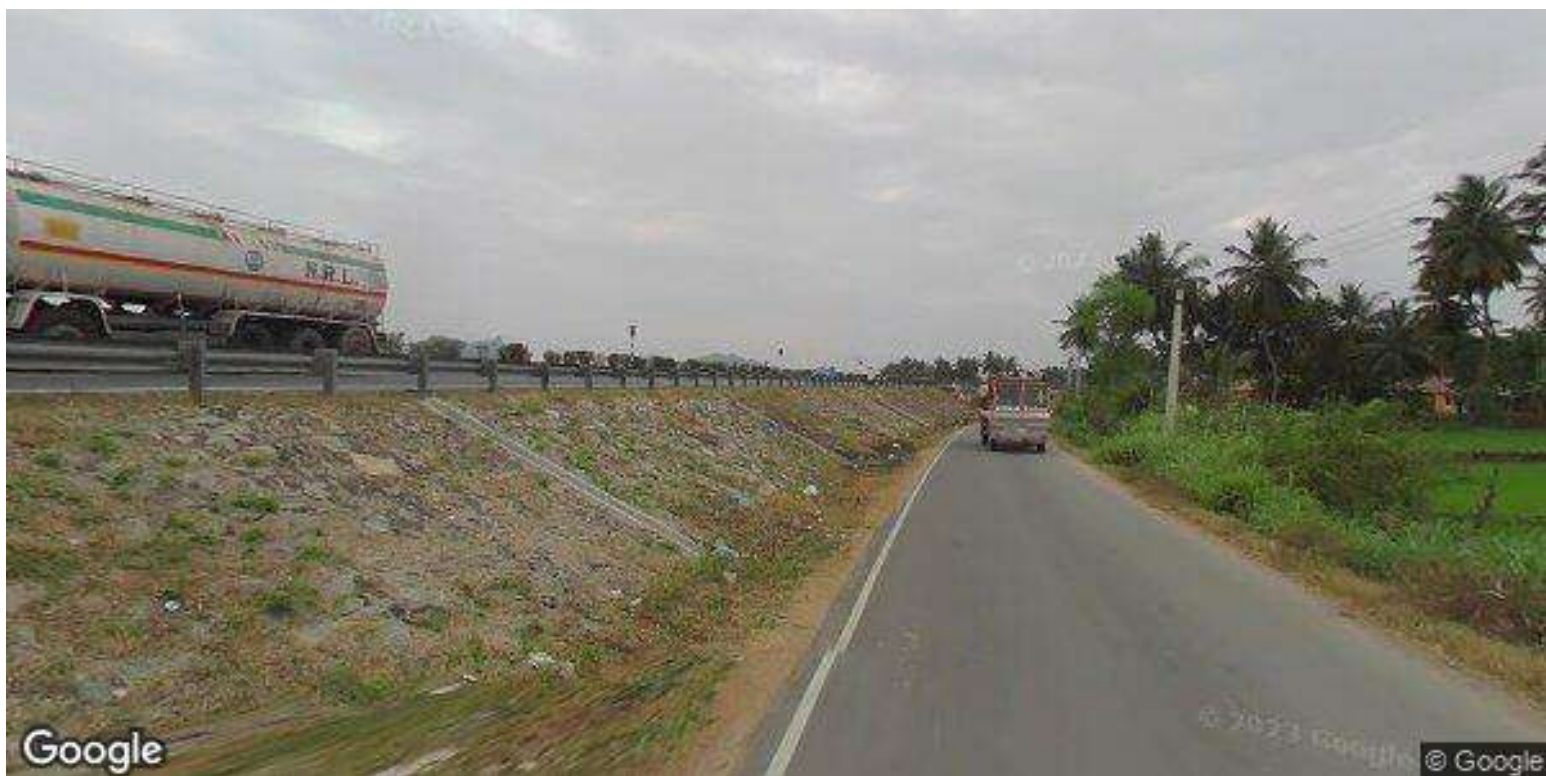
**Risk Type:** Turn  
**Risk Level:** Medium  
**Speed Limit:** 30 KM/Hr  
**Coordinates:** 12.40763, 78.22338

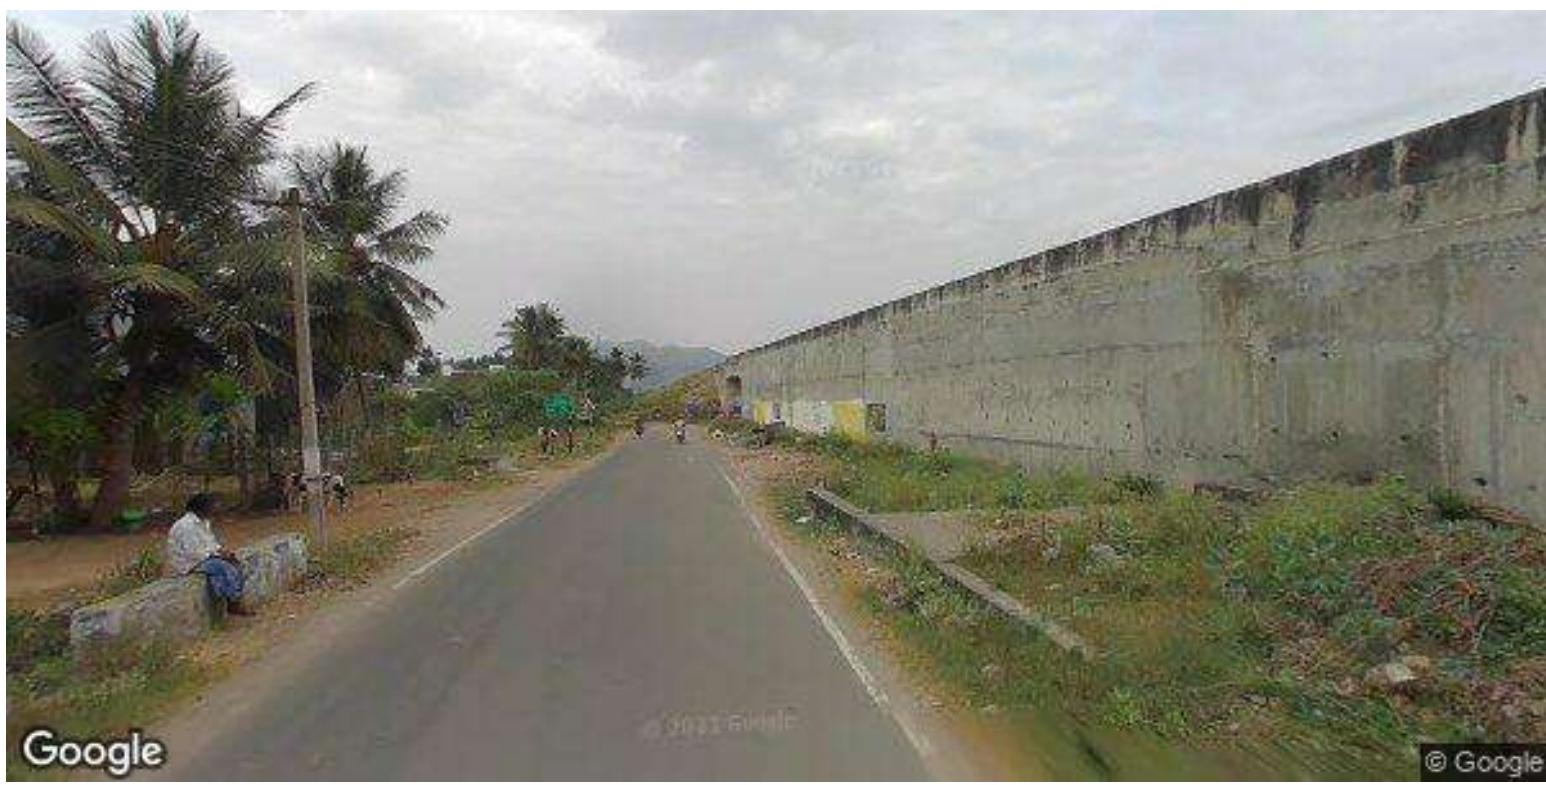
**Coordinates:** 12.41678, 78.22485

**Risk Type:** Turn

**Risk Level:** Medium

**Speed Limit:** 30 KM/Hr

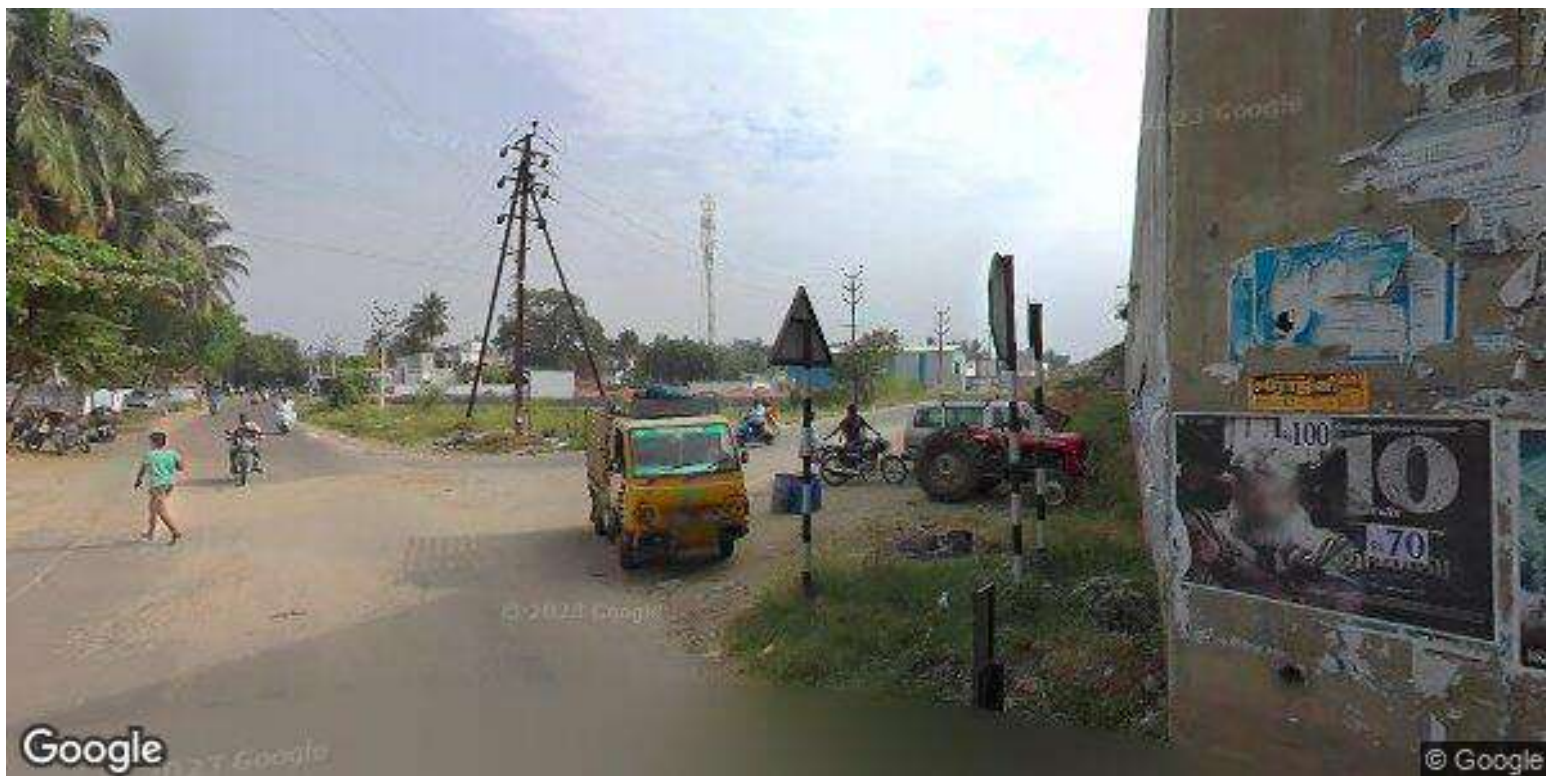
**Coordinates:** 12.41727, 78.22529

**Risk Type:** Blind Spot

**Risk Level:** Blind Spot

**Speed Limit:** 10 KM/Hr

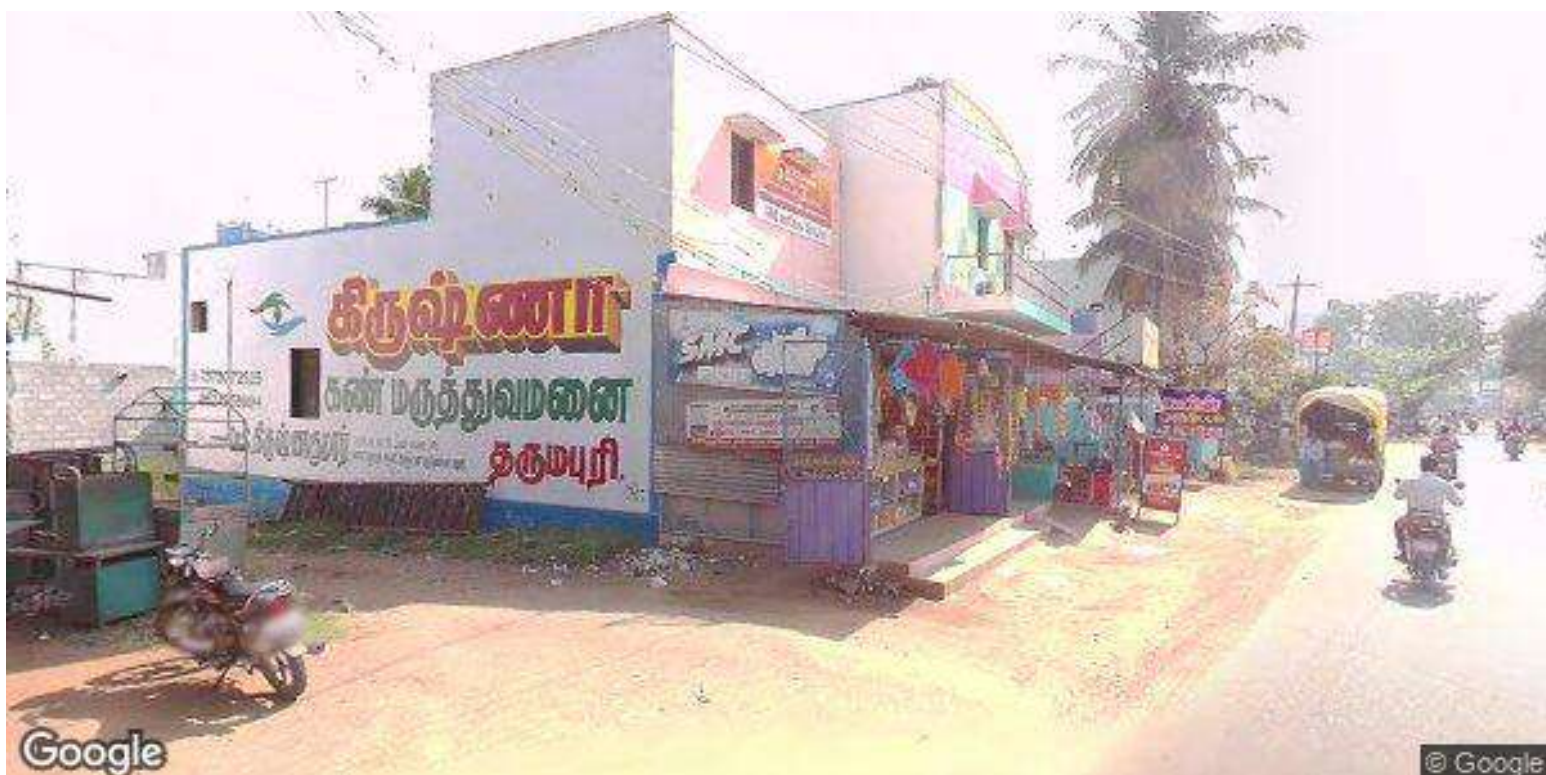
**Coordinates:** 12.41437, 78.22823

**Risk Type:** Turn

**Risk Level:** Medium

**Speed Limit:** 30 KM/Hr
