# IndianOil

## **JOURNEY RISK MANAGEMENT (JRM) STUDY**

### **Salem Terminal to ACMS COOPERATIVE PETROL BUNK**

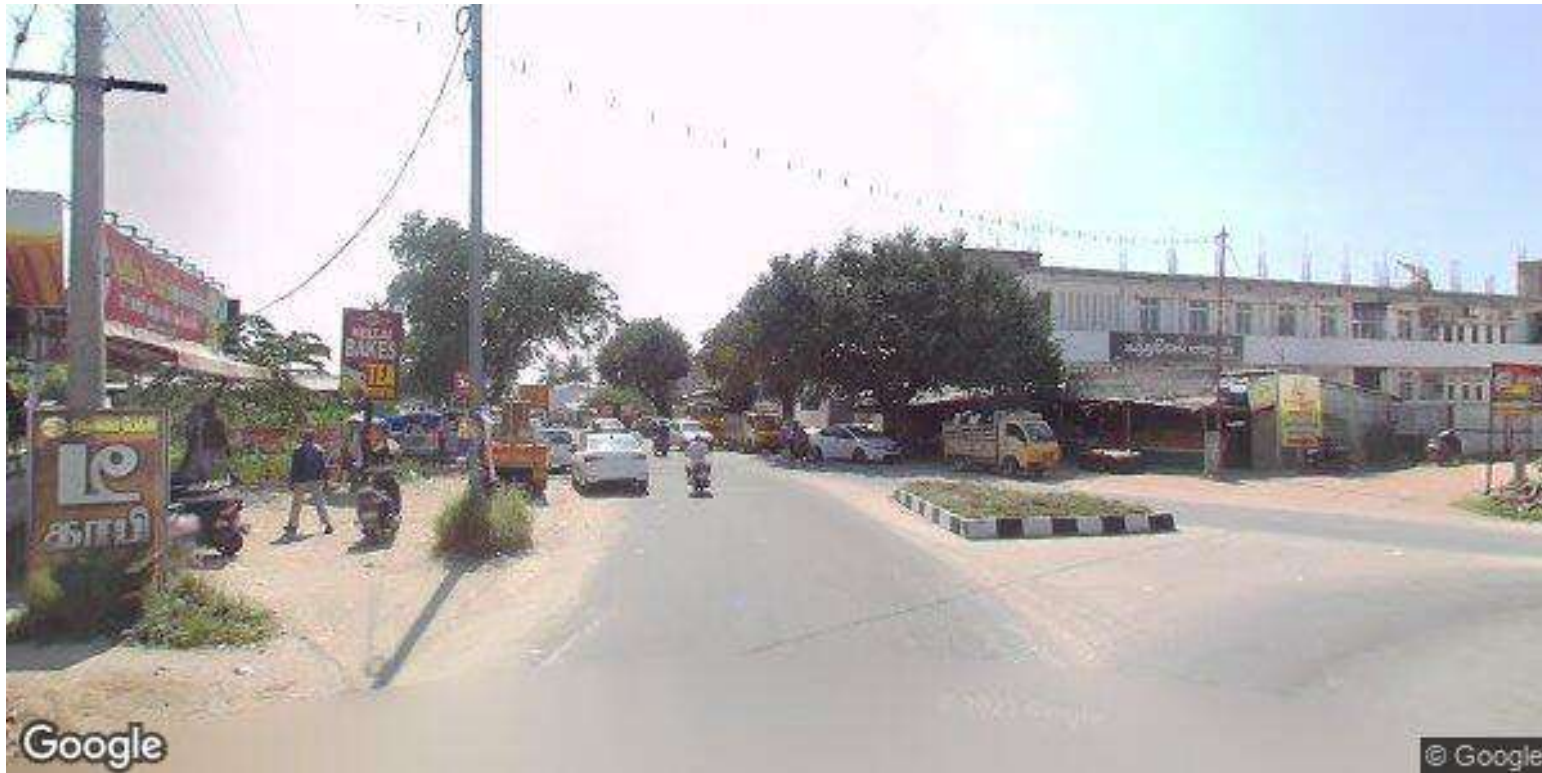
**Coordinates:** 11.17250, 77.26863

**Risk Type:** Roundabout

**Risk Level:** High

**Speed Limit:** 15 KM/Hr

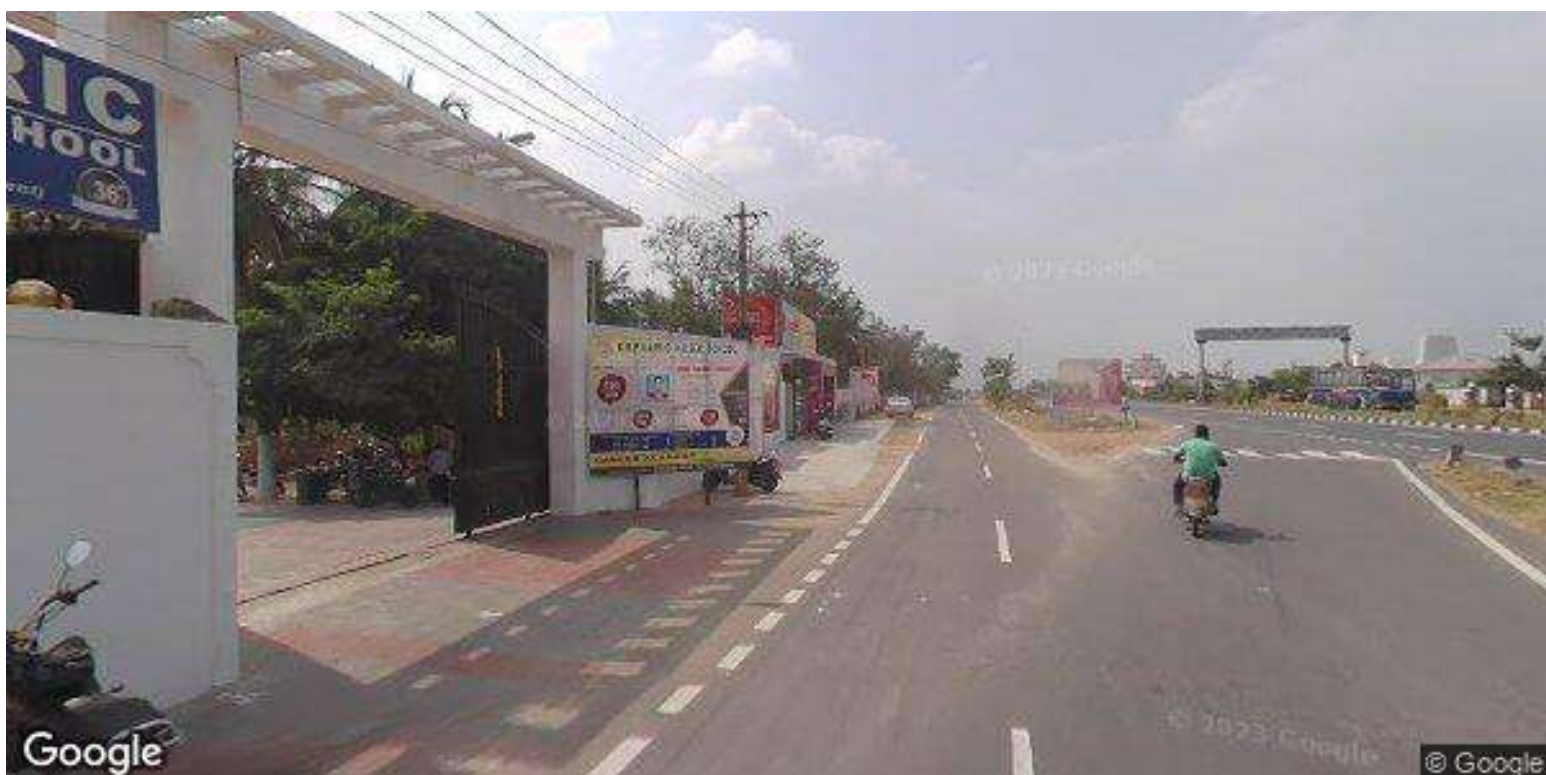
**Coordinates:** 11.45509, 77.81383

**Risk Type:** Turn

**Risk Level:** Medium

**Speed Limit:** 30 KM/Hr
