# IndianOil

## JOURNEY RISK MANAGEMENT (JRM) STUDY

### Salem Terminal to CHENDUR FUEL SERVICE

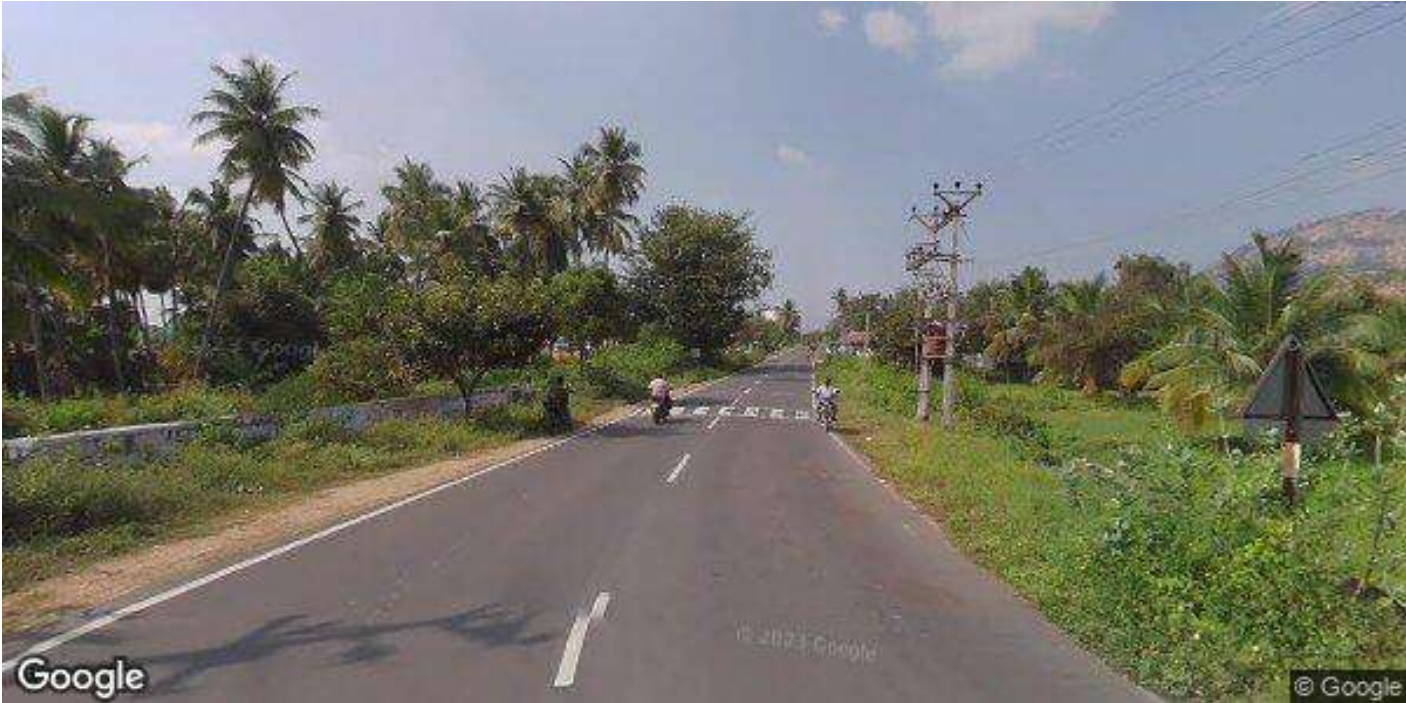
Risk Type: Turn  
Risk Level: Medium  
Speed Limit: 30 KM/Hr  
Coordinates: 11.45353, 77.85697

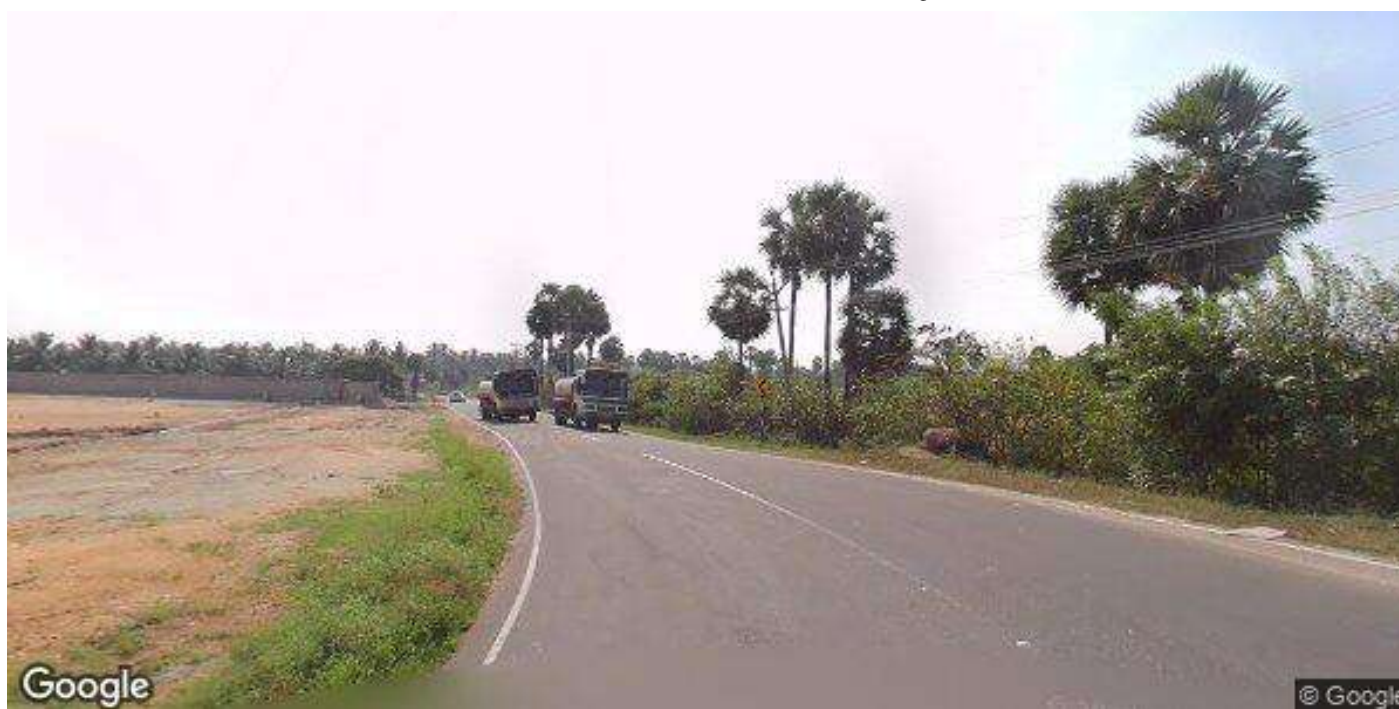
**Risk Type:** Turn  
**Risk Level:** Medium  
**Speed Limit:** 30 KM/Hr  
**Coordinates:** 11.45839, 77.85143

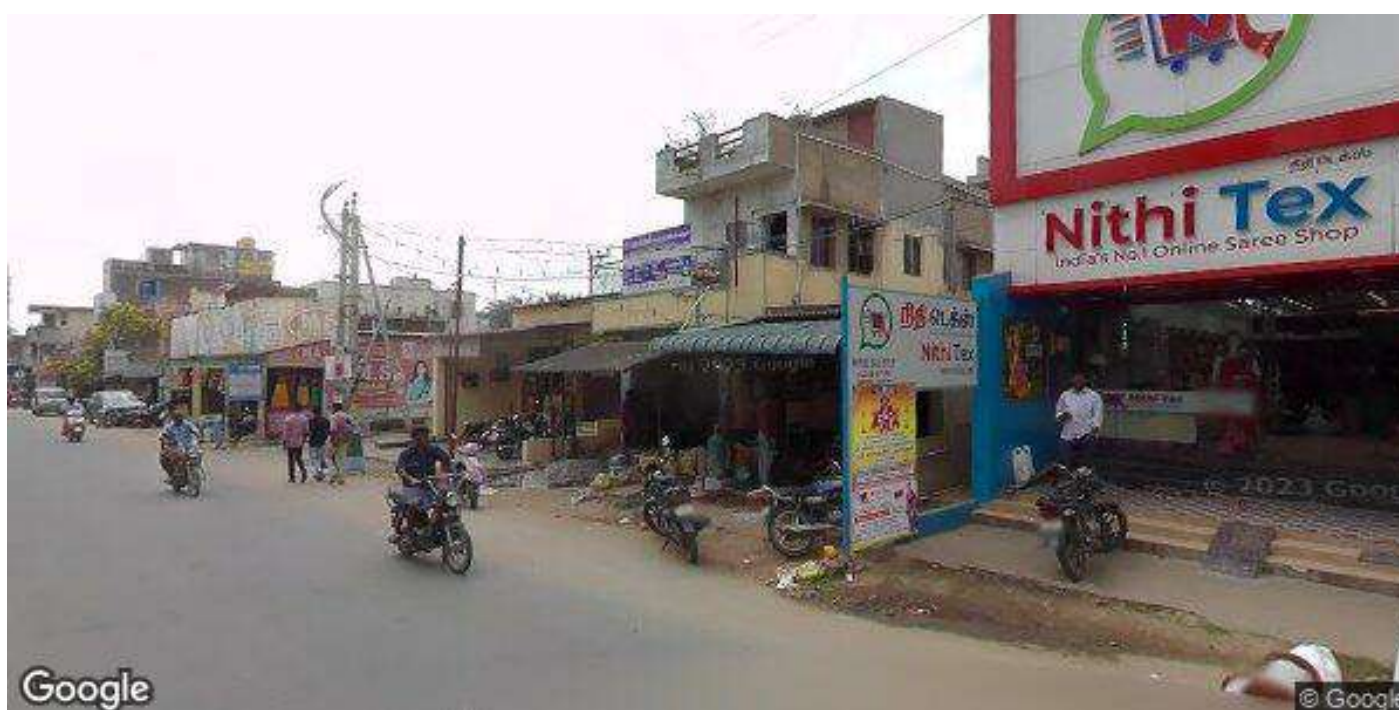
**Risk Type:** Turn  
**Risk Level:** Medium  
**Speed Limit:** 30 KM/Hr  
**Coordinates:** 11.60526, 78.00451

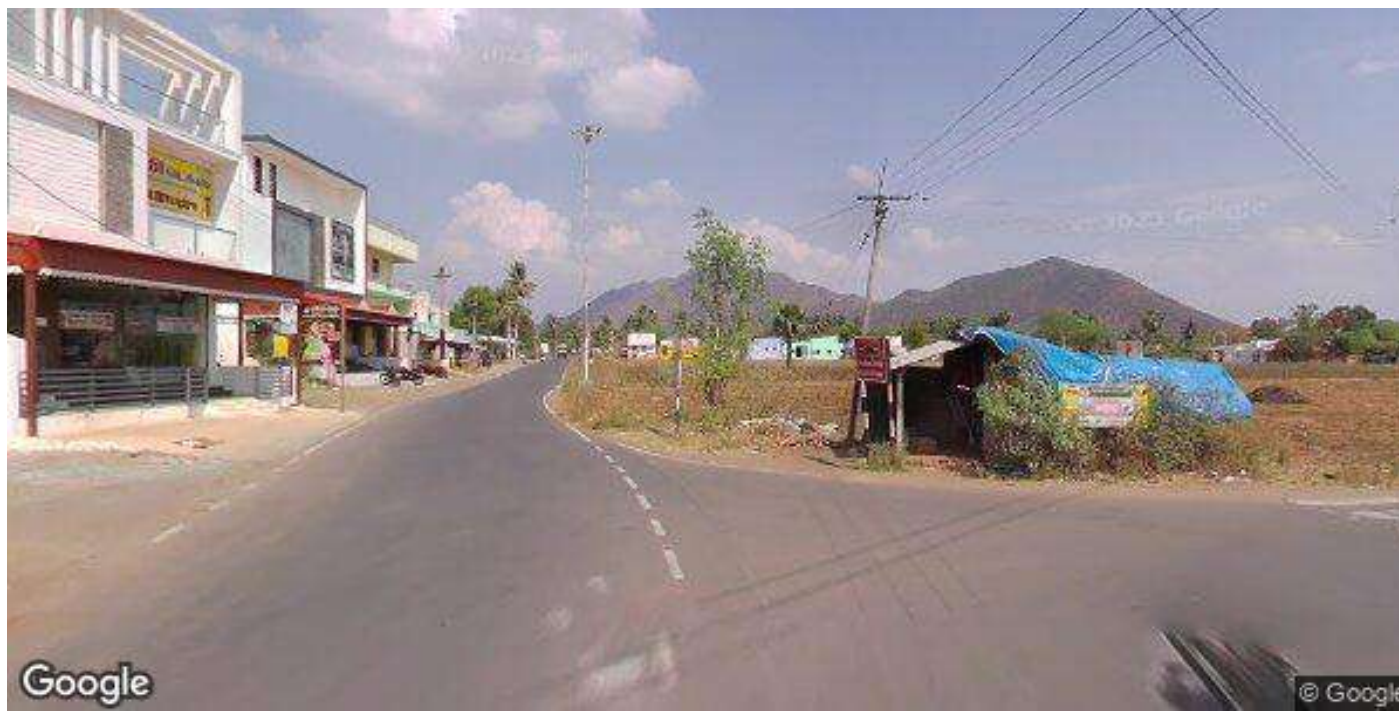
**Risk Type:** Turn  
**Risk Level:** High  
**Speed Limit:** 15 KM/Hr  
**Coordinates:** 11.62660, 78.00986

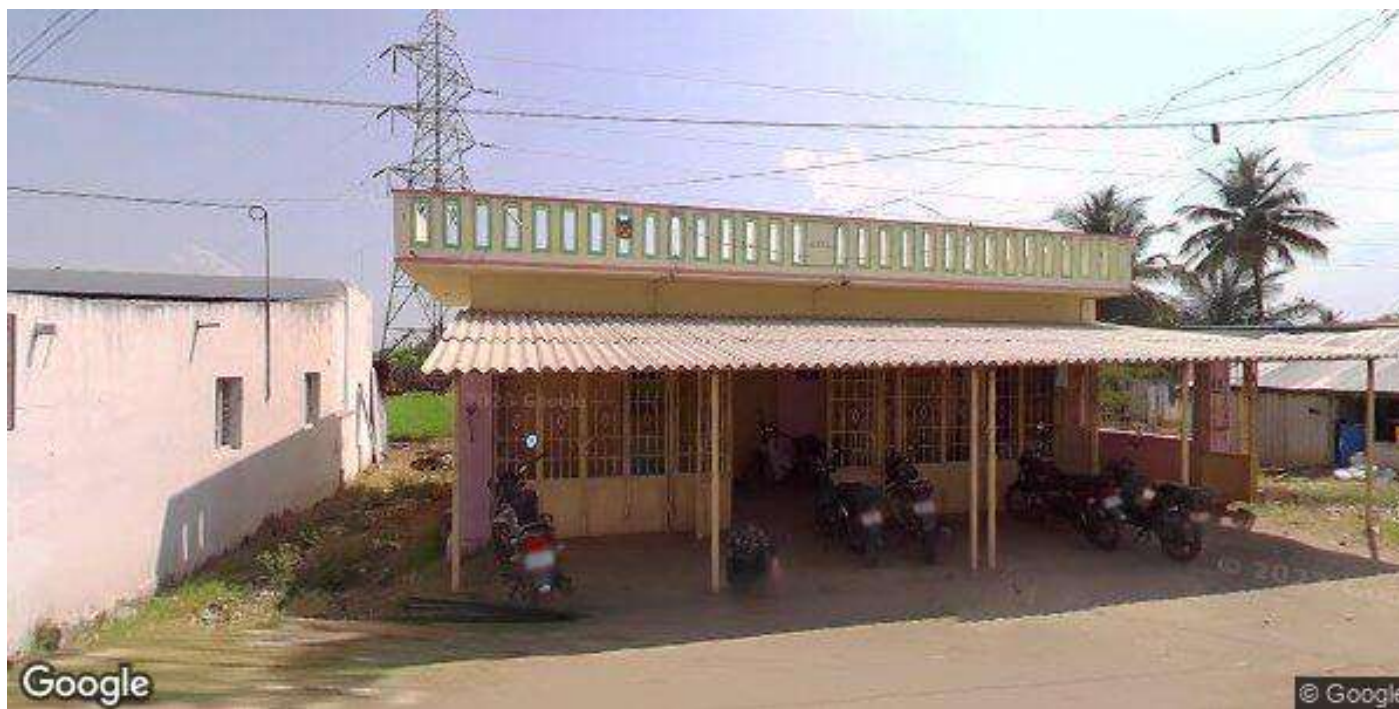
**Risk Type:** Turn  
**Risk Level:** High  
**Speed Limit:** 15 KM/Hr  
**Coordinates:** 11.62692, 78.00883

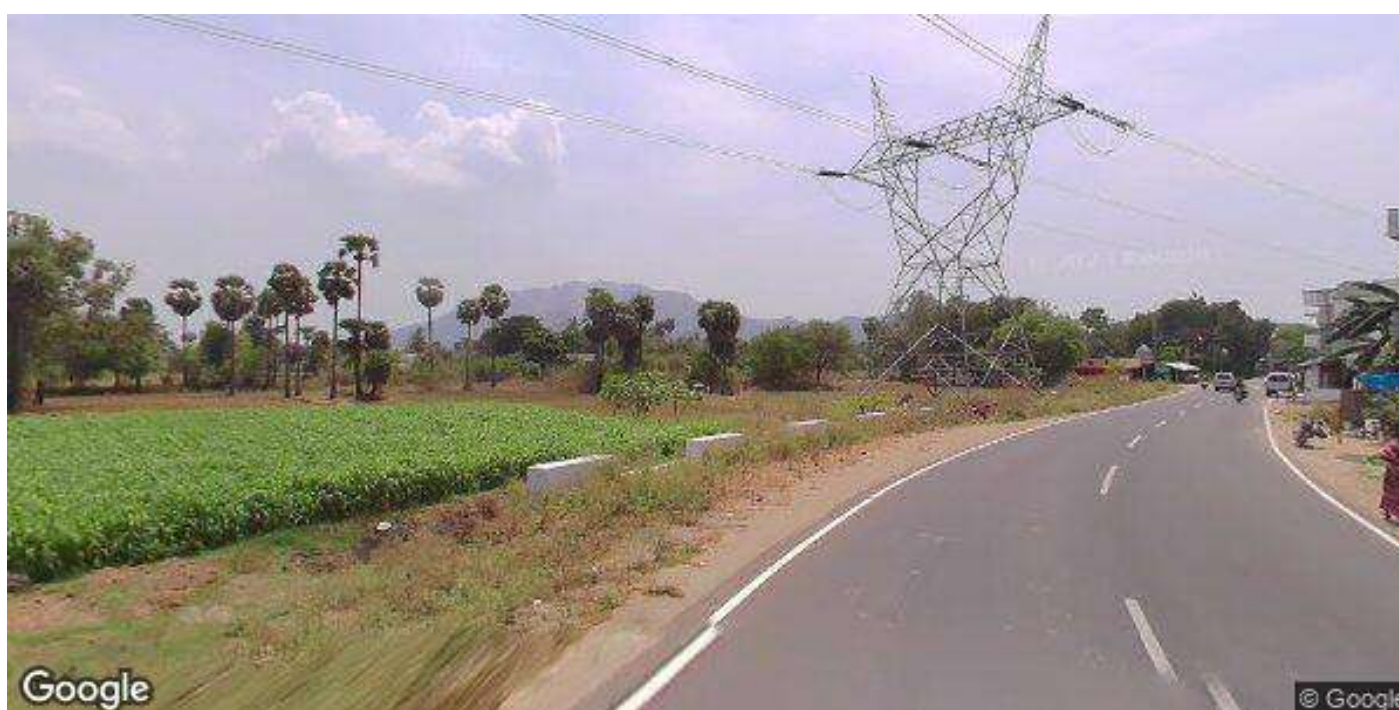
**Risk Type:** Turn  
**Risk Level:** Medium  
**Speed Limit:** 30 KM/Hr  
**Coordinates:** 11.64031, 78.00923

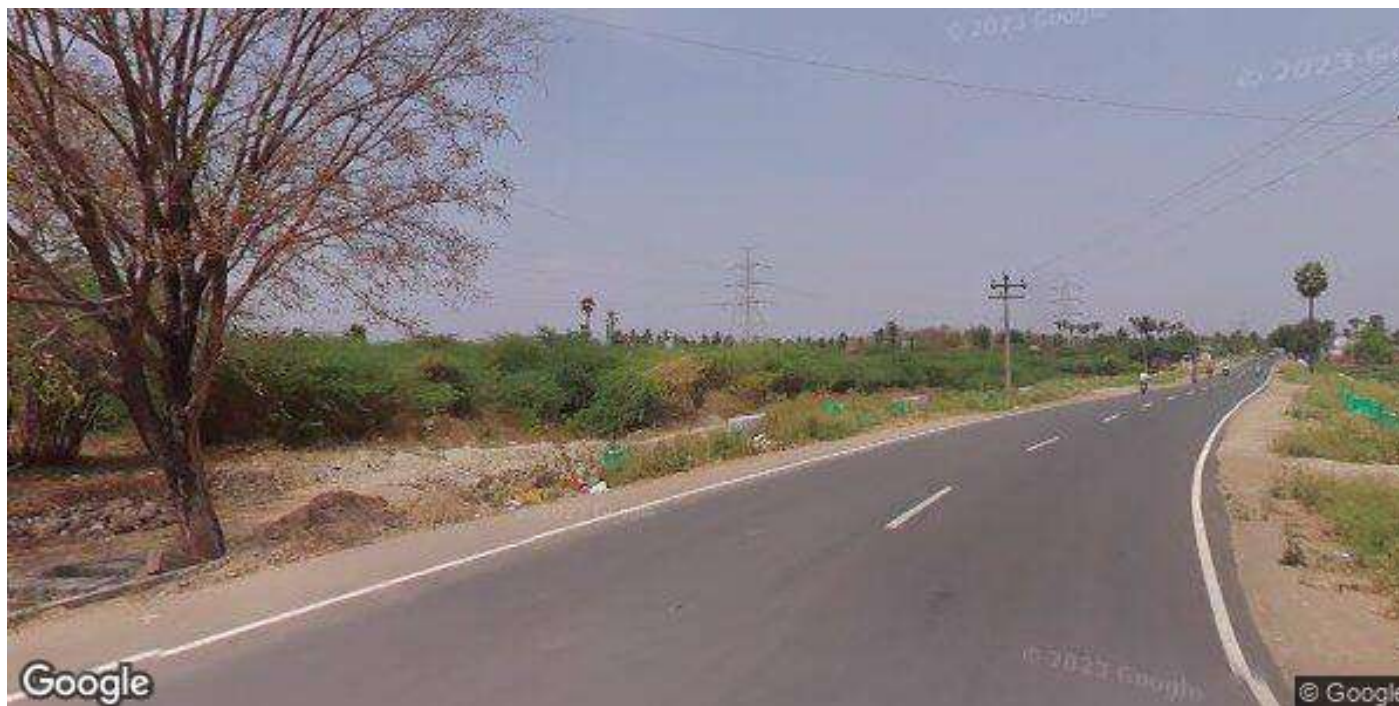
**Risk Type:** Turn  
**Risk Level:** Medium  
**Speed Limit:** 30 KM/Hr  
**Coordinates:** 11.64874, 78.00717

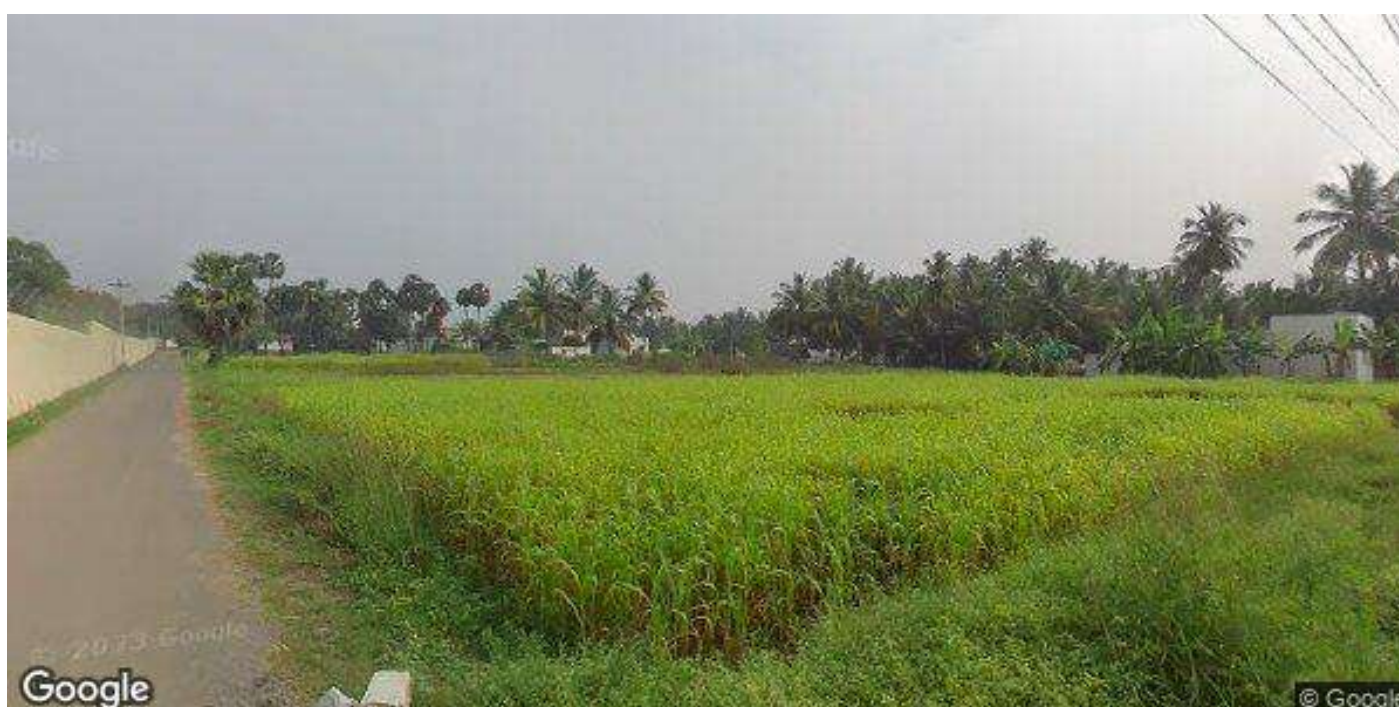
**Risk Type:** Turn  
**Risk Level:** High  
**Speed Limit:** 15 KM/Hr  
**Coordinates:** 11.66762, 78.00863

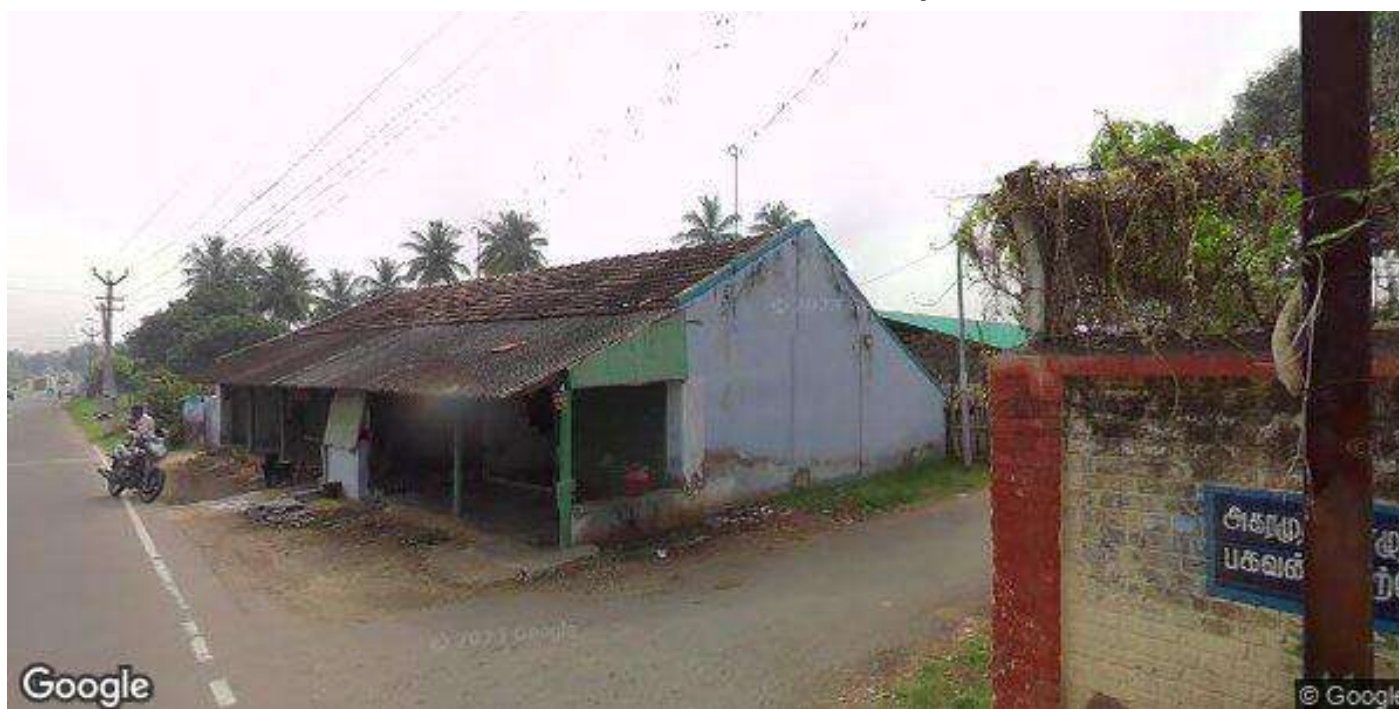
**Risk Type:** Blind Spot  
**Risk Level:** Blind Spot  
**Speed Limit:** 10 KM/Hr  
**Coordinates:** 11.67168, 78.00922

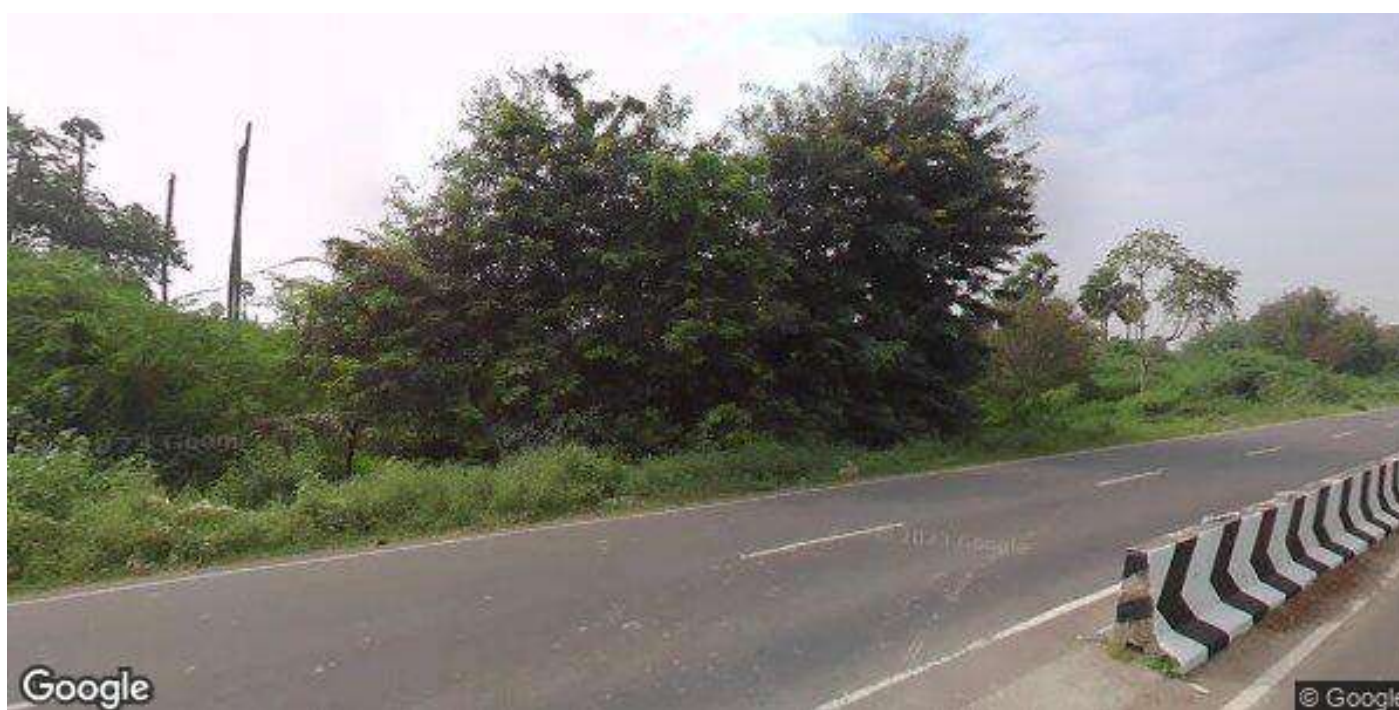
**Risk Type:** Blind Spot  
**Risk Level:** Blind Spot  
**Speed Limit:** 10 KM/Hr  
**Coordinates:** 11.66830, 78.04357

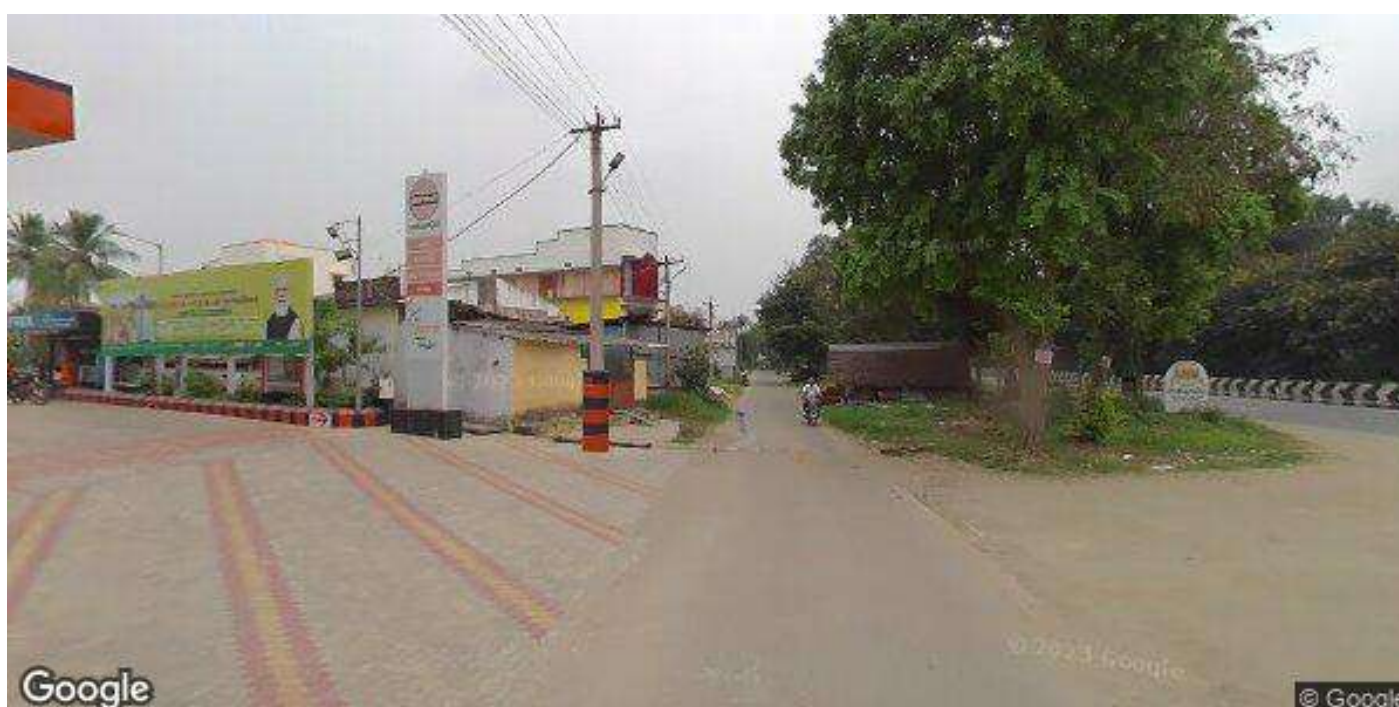
**Risk Type:** Blind Spot  
**Risk Level:** Blind Spot  
**Speed Limit:** 10 KM/Hr  
**Coordinates:** 11.66847, 78.04352
